PAVEMENT SETTLEMENT ISSUES AND HYDRO- GEOCHEMICAL WATER TESTING RESULTS FOR THE CUMBERLAND GAP TUNNEL

KTC-10-03/KH58-07-1F

March 2010

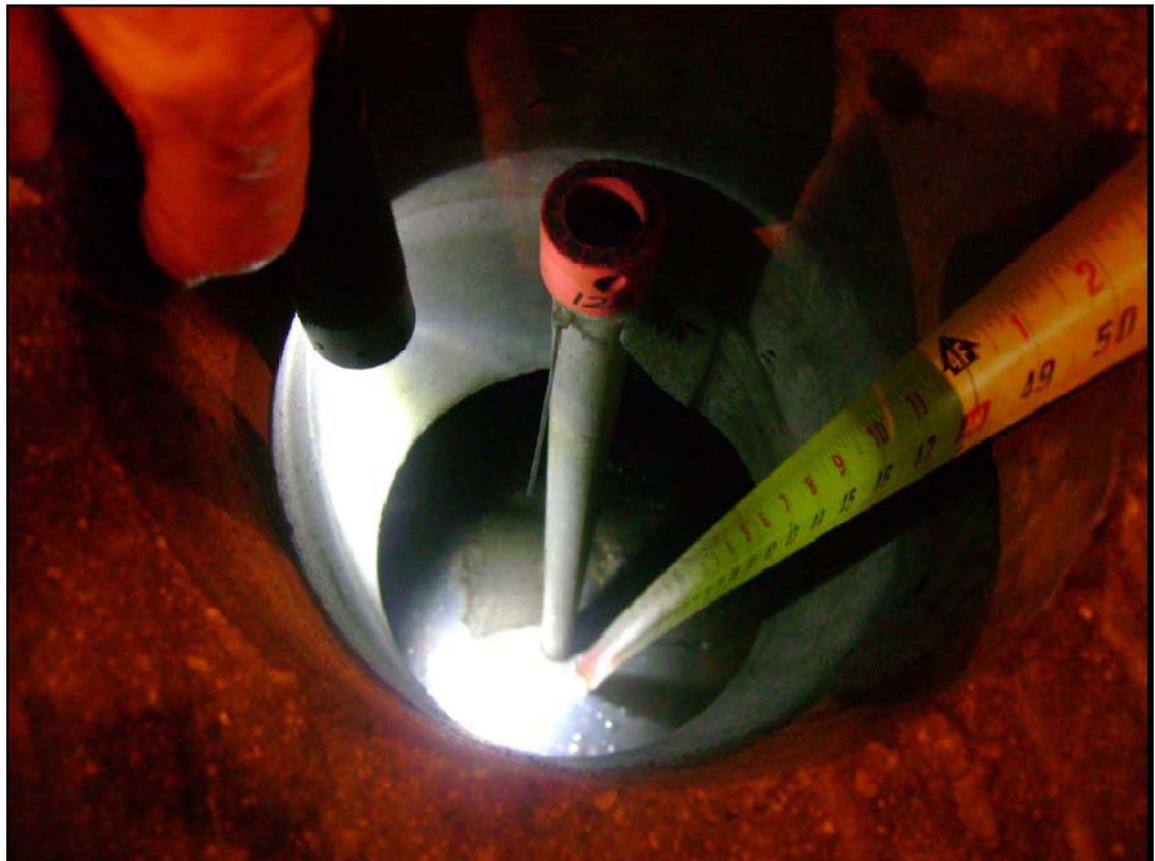
beneath it. These voids ranged from 2 to 40 inches in depth. Figure 1 below displays a 40 inch deep void located beneath the left driving lane of the southbound tunnel at approximately station 128+90. It can be inferred that the concrete pavement is essentially performing as a bridge in these void locations. Only because reinforcing steel was placed inside the concrete, is the pavement structure able to be in-service without complete failure today. Structural loading calculations indicate that the concrete pavement should only be able to span 6 feet before permanent deformation of the steel takes place. As seen in Appendix A, some of the void areas are spanning across both lanes (30 feet wide) and extending 1 to 70 feet in length.

Figure 1: Forty-inch void beneath concrete pavement

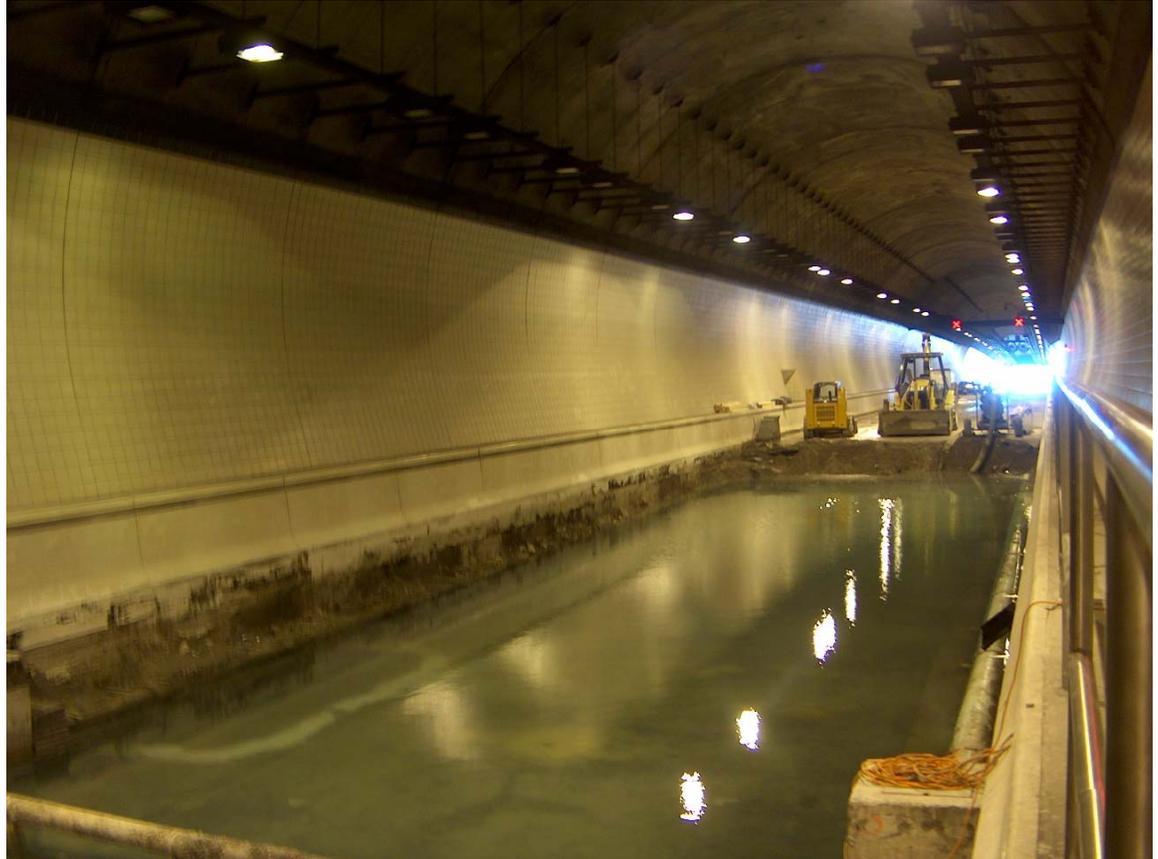
A new discovery was determined during this investigative repair. It was found that the ground water inflow into the tunnel backfill material beneath the concrete pavement was aggressive to calcite. The tunnel backfill material is a limestone material (approximately #57 size aggregate) that is rich in calcium. Figure 2 displays the ground water inflow into the repaired area.

Approximately 500,000 to 1.2 million gallons of ground water flows beneath the tunnels on any given day depending on the rainfall events.

Figure 2: Water inflow into the repaired area

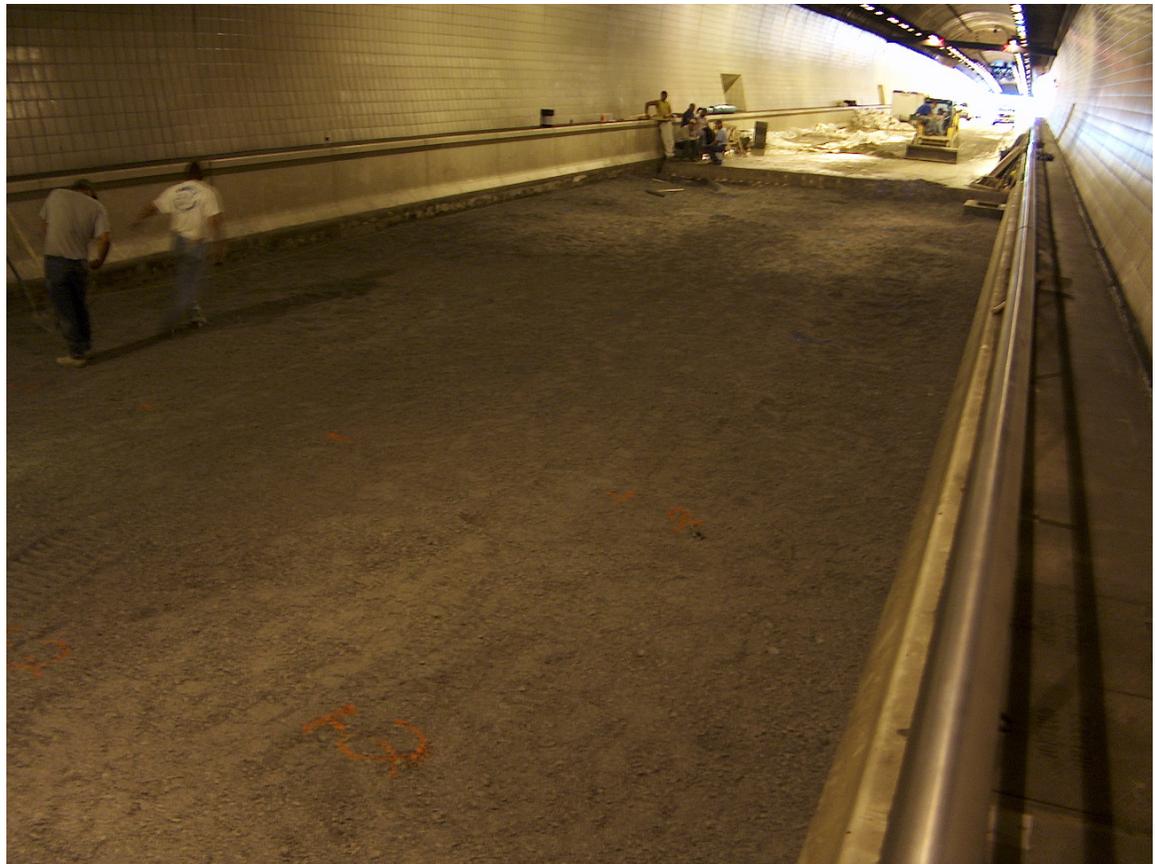
Figure 3: Repair area with granite backfill and DGA prior to concrete pavement placement

This limestone backfill material ranges from 4-6 feet in depth by design throughout both tunnels. The technical advisory group determined that the appropriate repair would be to replace the excavated material with an inert granite backfill material. The backfill material consisted of a number 57 size aggregate, overlaid by a six inch layer of dense-graded-aggregate (DGA) separated by a geo-grid fabric. Next, a new 10 inch CRCP pavement was installed (Figure 3).

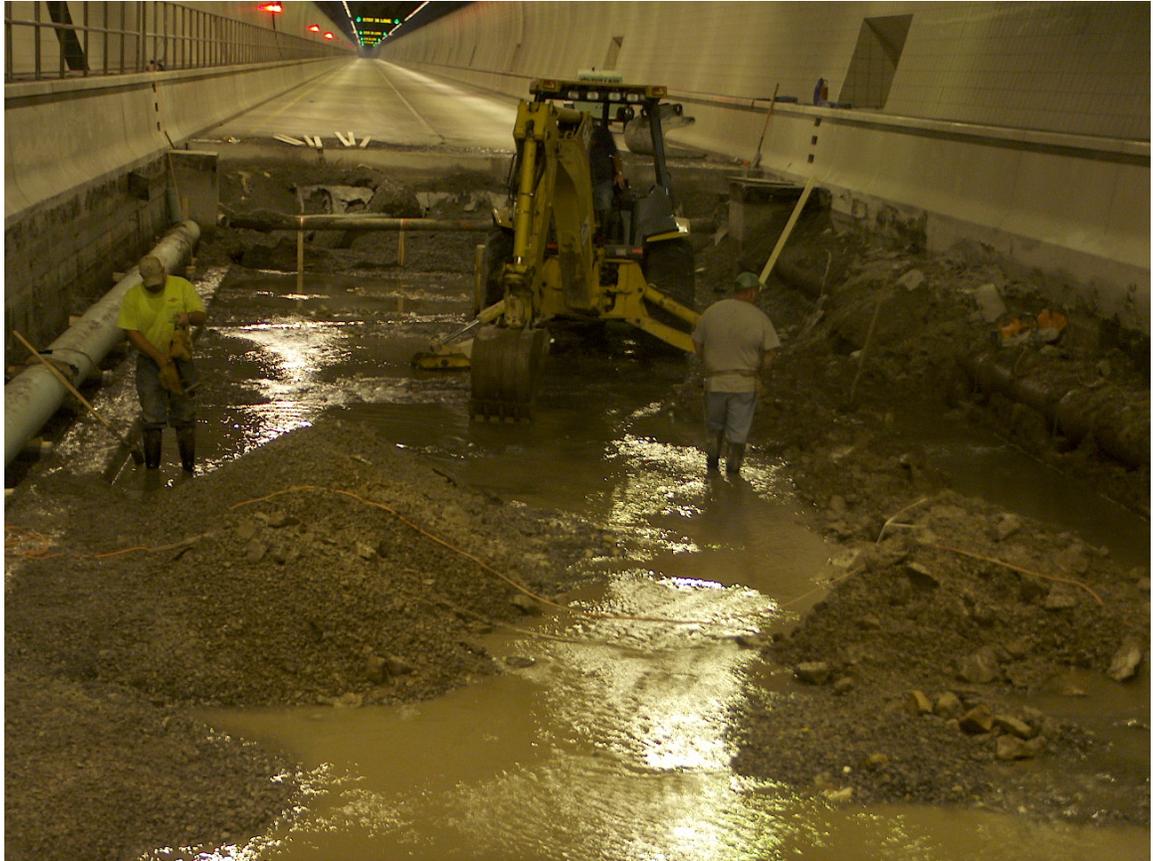
Another discovery made during the investigative repair was that the groundwater collection system is elevated approximately 2 to 3 feet above the invert of the tunnel (Figure 4). The ground water collection pipe can be seen in Figure 4 as the green pipe on the left side of photo.

Figure 4: Groundwater collection pipe location in relation to tunnel invert

For convenience of construction, the elevation of the groundwater collection system was constructed higher than the invert of the tunnel. Thus, the limestone backfill material throughout the tunnel was constructed to act as a natural drainage structure for the ground water in-flow to pass through. It has been presumed, after research of both design and construction documents, that no water test were conducted to measure calcium deficiency during either the design or construction phase of the tunnel.
