**EFFECTIVENESS OF
ANTISTRIPPING ADDITIVES
VOLUME I**

1. Report No. FHWA-OR-RD-89-03A	2. Government Accession No.	3. Recipient's Catalog No.	
4. Title and Subtitle EFFECTIVENESS OF ANTISTRIPPING ADDITIVES Volume I		5. Report Date May 1989	6. Performing Organization Code

15. Supplementary Notes		14. Sponsoring Agency Code	
16. Abstract <p>Volume I of this report summarizes the findings on the extent of stripping in 32 Oregon DOT projects and discusses the significant findings from a literature review. Of the 32 projects, 10 had not used an asphalt or aggregate antistripping additive, 19 contained lime-treated aggregate, and 3 contained asphalt treated with an amine-type antistripping additive. These projects range in age from 1 to 9 years. The percent of aggregate coated with asphalt, which was used to determine if a project was stripping, was established from breaking and visually evaluating core samples taken from each project site. Using the criteria that a coating less than 85% classified a project as stripping, the following results were obtained: 7 of the 10 projects without an additive, 5 of the 19 lime-treated aggregate projects, and 2 of the 3 amine-treated asphalt projec

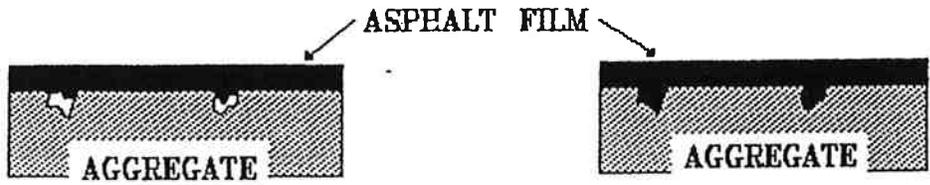
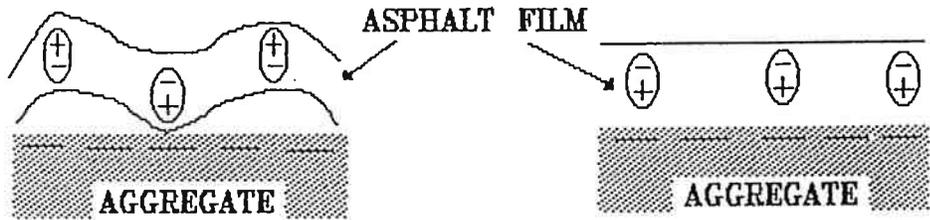
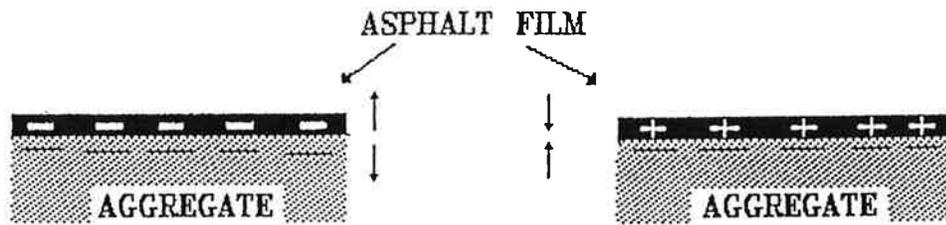
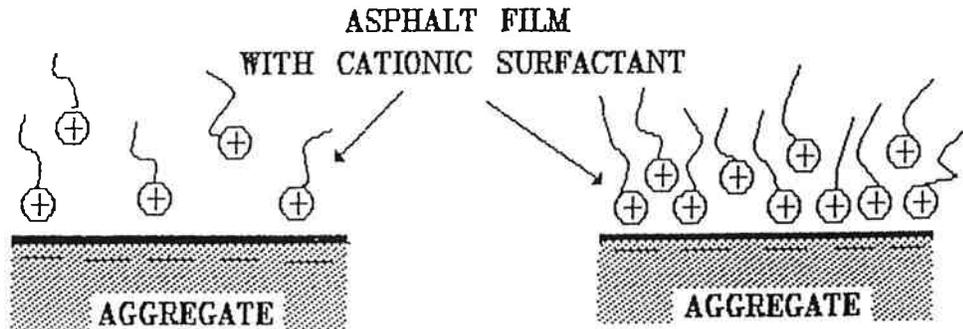
Figure 2.1. Mechanisms of Asphalt Adhesion Improvement with Microwave Energy Treatment (after Al-Ohaly and Terrel, 1988).

BEFORE MW AFTER MW

A) EFFECT FROM HEATING AND MELTING ASPHALT

B) MOLECULAR REORIENTATION

C) POLARIZATION EFFECT

D) INCREASED POLAR ADDITIVE MIGRATION

Additional methods have been studied to increase the adhesive bond between the asphalt and aggregate. Al-Ohaly and Terrel (1988) studied the effects of microwaves on asphalt mixes. They found the use of microwave treatment can enhance the resistance to stripping of an asphalt mixture by: 1) decreasing the viscosity of the asphalt and allowing it to redeposit in impermeable voids, 2) increasing the migration of chemical additives to the asphalt/aggregate interface by forced polarization, and/or 3) reducing the random orientation of the molecules at the interface. These mechanisms are illustrated in Figure 2.1.

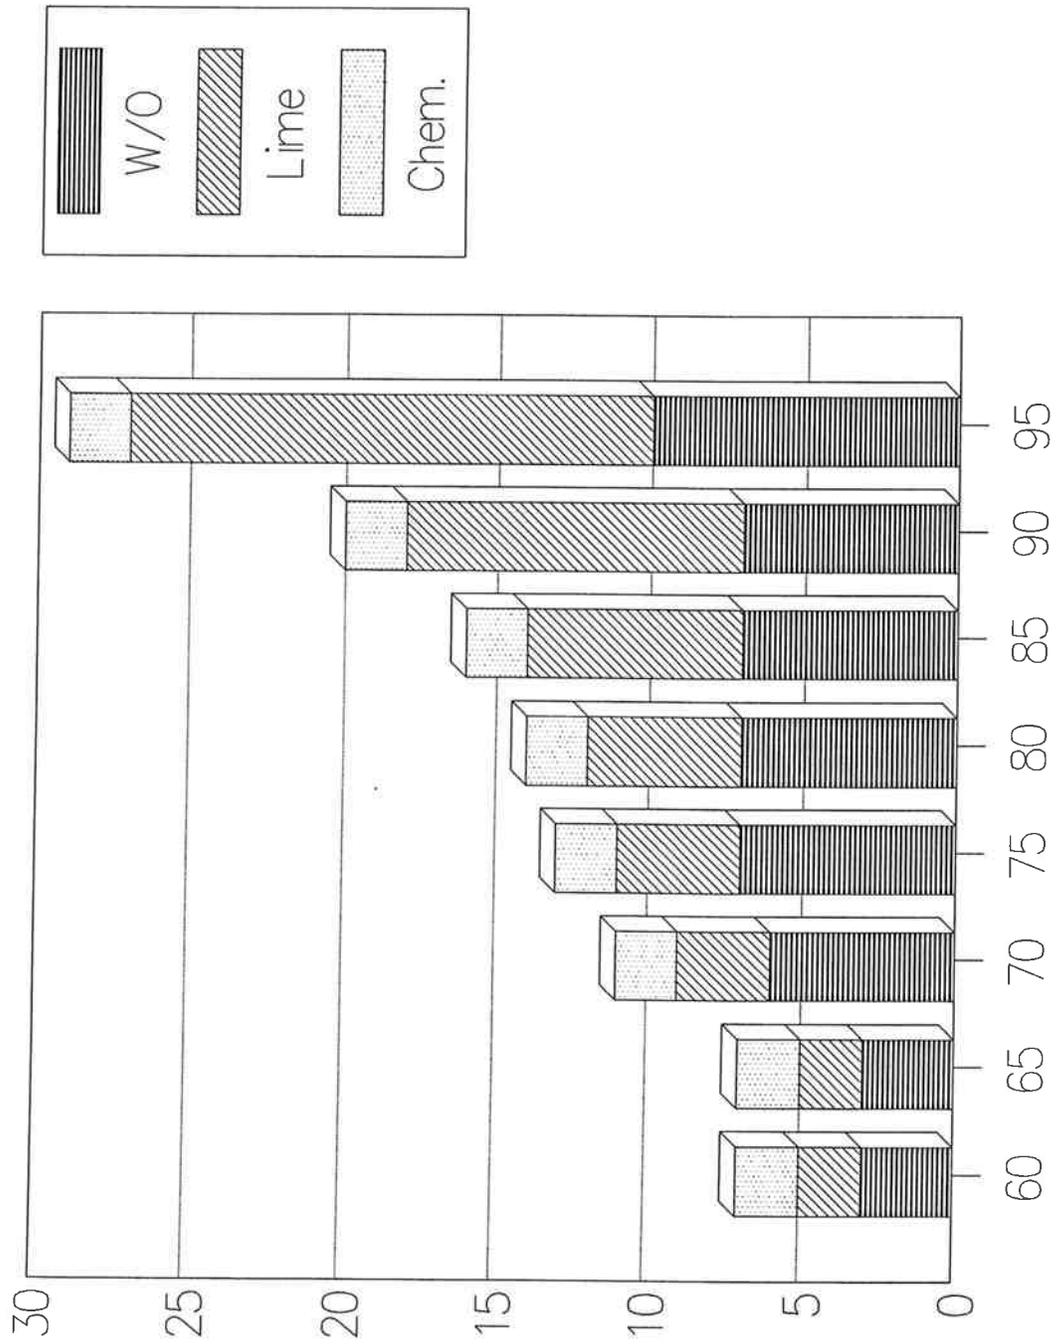
Figure 4.4. Number of Projects Classified as Stripping vs. Percent Asphalt Coating.

Theoretically, if a core did not receive a rating of 100% retained coating, then stripping is occurring within the pavement. The lowest rated core for each project was used. However, the 100% criterion is too severe as only 3 of the 32 projects would be considered as not stripping using this guideline. The relation between the number of projects classified as stripping as the percent coating criterion is varied from 60 to 95% is shown in Figure 4.4. As can be seen from the graph, the number of projects with an asphalt (chemical) additive remains unchanged at 2 for the entire coating range on the graph. For projects without additives, 7 would be classified as stripping if 75, 80, 85, or 90% were used as the decision criterion. The lime-treated aggregate projects, 19 of the 32 projects evaluated, show the greatest variation in the figure due to the larger number of projects. In addition, coarse aggregate may be partially stripped without severe detrimental effects to the pavement structure. Therefore, the decision was reached to use a retained coating of 80% or less on at least one core to determine if a project should be classified as stripping.

Of the 32 projects surveyed, 14 showed stripping in at least one of the cores and, of these, 7 had stripping in both core samples. Seventy percent of the projects that did not receive an additive treatment exhibited stripping (including 6 projects with only one core determined to be stripping). Of the 19 lime-treated aggregate projects, 4 had stripping occurring in both cores and one project had stripping in one core. Of the 3 amine-treated projects, 2 were classified as stripping, one in one core and the other in both cores.

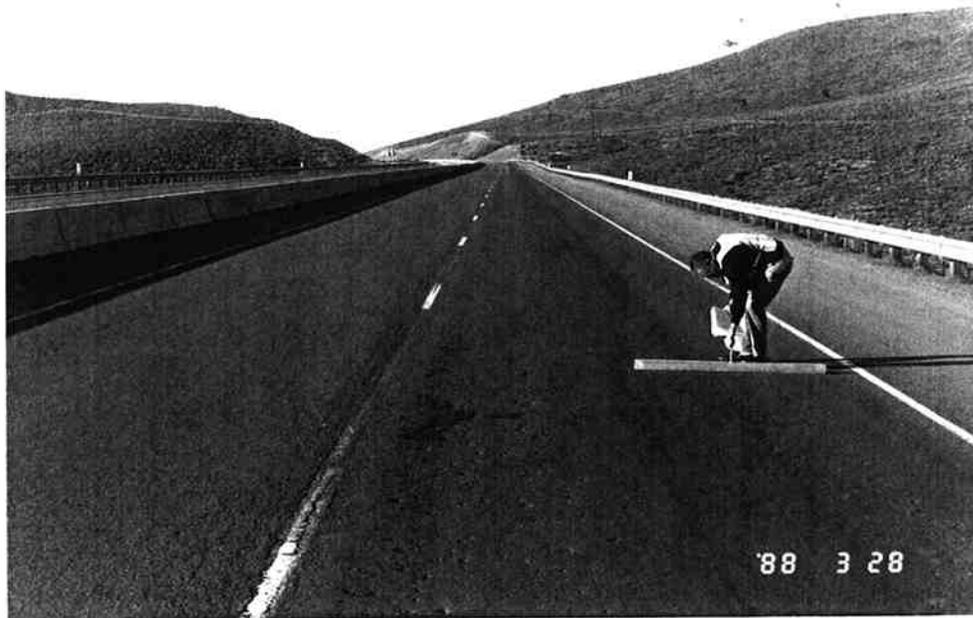
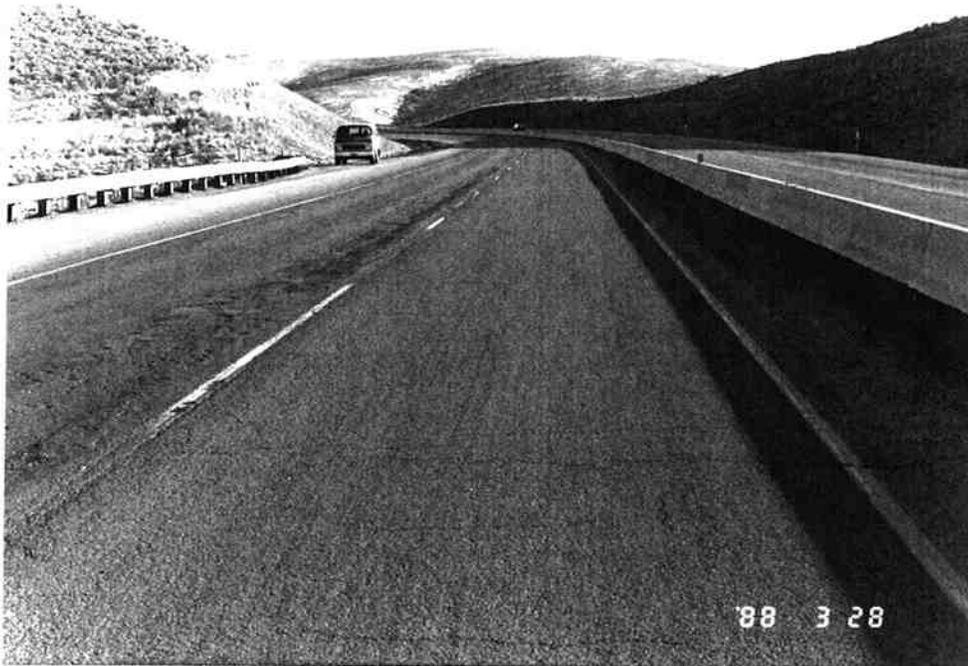
Figure 4.5. Baldock Slough-South Baker Interchange.

a) Milepost 305.8 Westbound

b) Milepost 305.8 Westbound

Baldock Slough to South Baker Interchange, built in 1979, is the only project in this category with an overall condition survey evaluation of "poor." This project had received some chip seal maintenance. However, the outside lane at milepost 305.8 westbound did not receive a chip seal application. This outside lane is pitting in the wheel paths, as displayed in Figure 4.5a, and does not show signs of thermal cracking. However, the inside lane, with a chip seal, does not show signs of pitting, but thermal cracking is present as illustrated in Figure 4.5b. It appears the chip seal, acting as a barrier, has helped reduce the moisture damage in the outside lane by limiting water intrusion into the pavement structure. The aggregate in the mix has a coating of 40%, shown in Figure 4.6a, which indicates this project

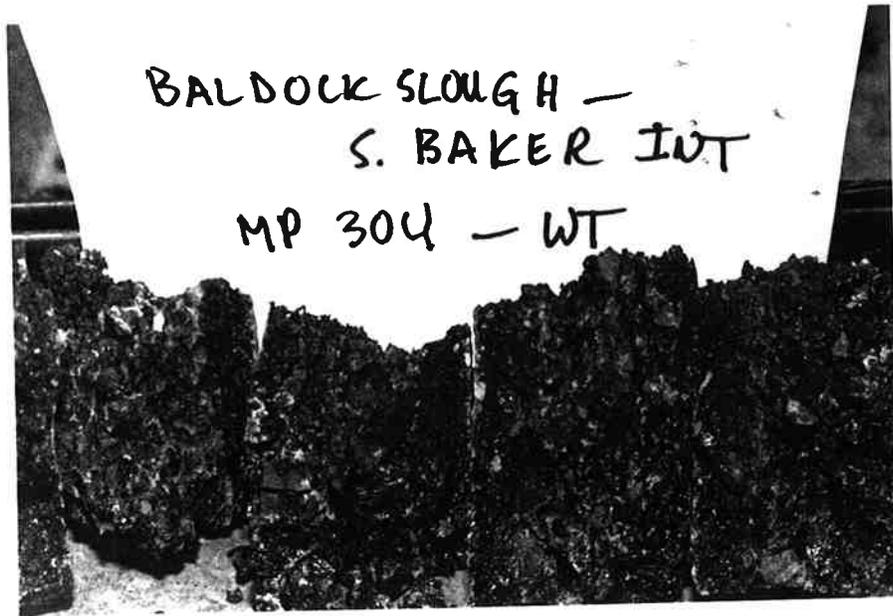
Figure 4.6. Baldock Slough-South Baker Interchange.

a) Wheel Track Core

b) Fog Line Core

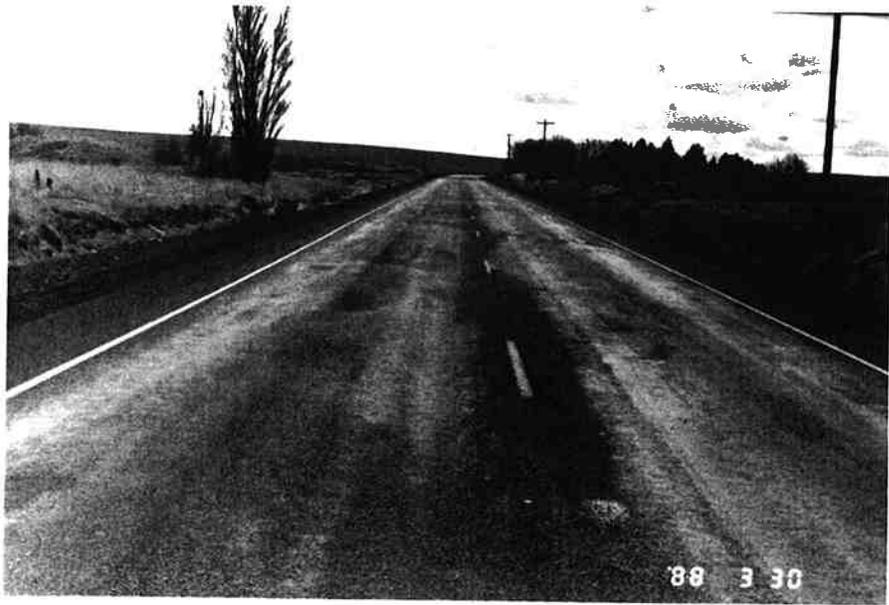
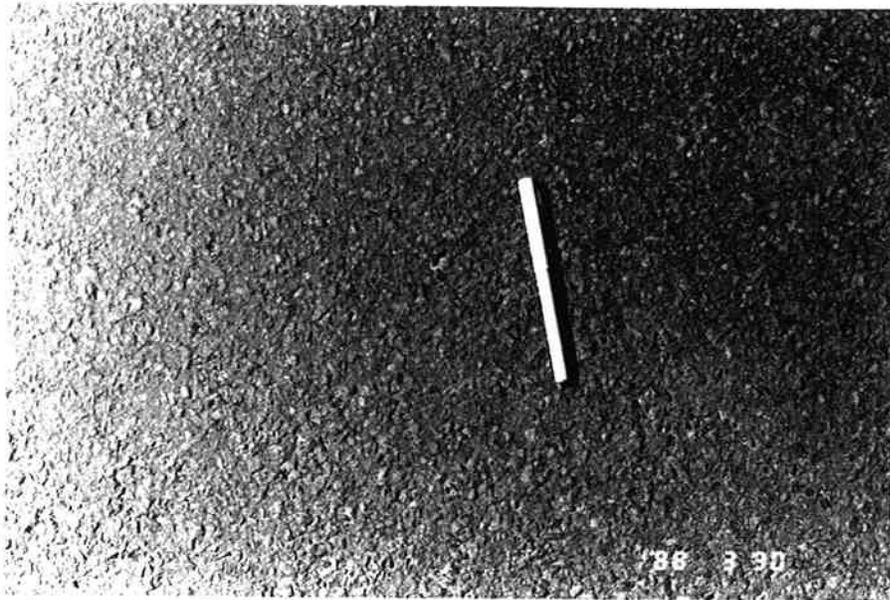
Figure 4.7. Moro-Grass Valley

a) Overview

b) Close-up

One project which, from the condition survey, had signs of possible stripping that was not confirmed from the core analysis. The Port of Moro Interchange project has a closed surface texture with excessive surface asphalt. However, the project had an asphalt coating of 95%. This could indicate the pavement contained an excessive amount of fine aggregate or asphalt in the mixture.

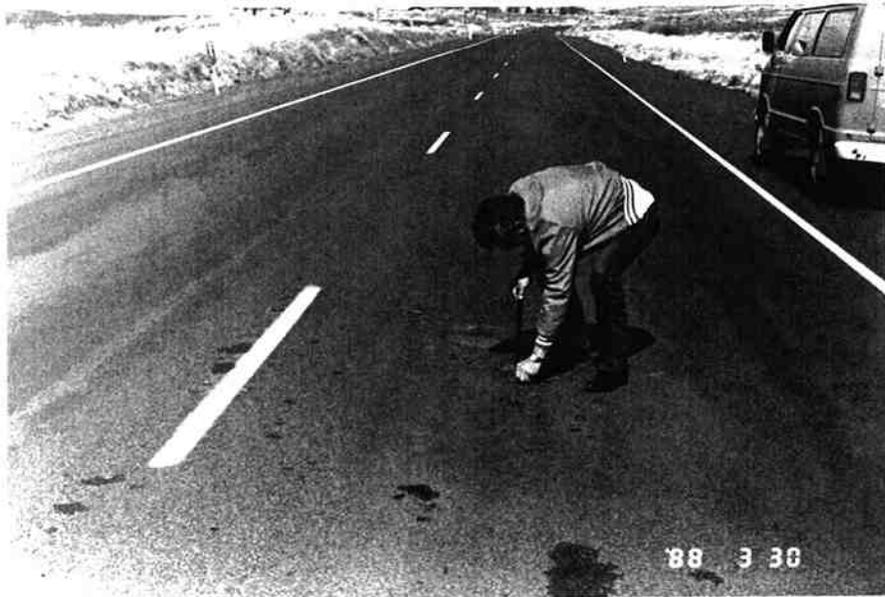
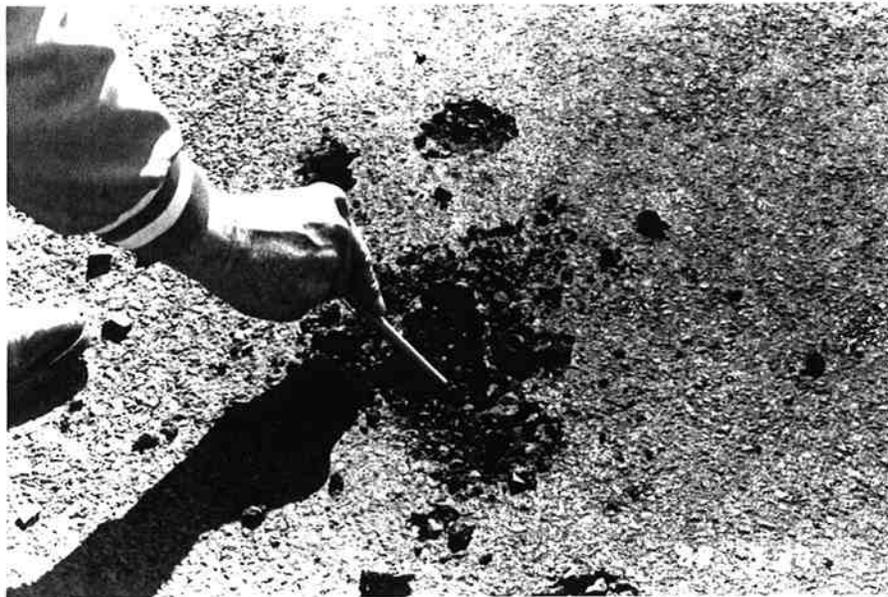
Figure 4.8. Moro-Grass Valley

a) Overview

b) Close-up

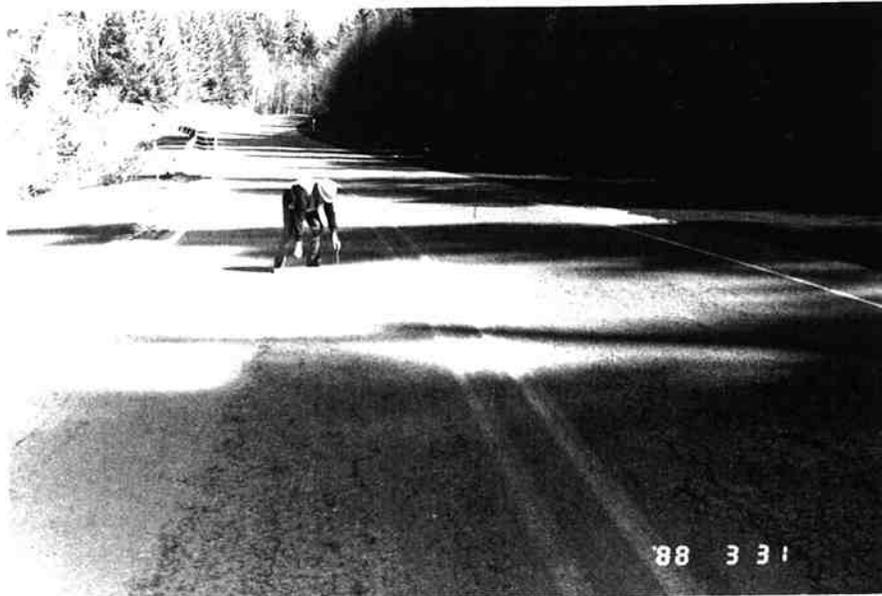
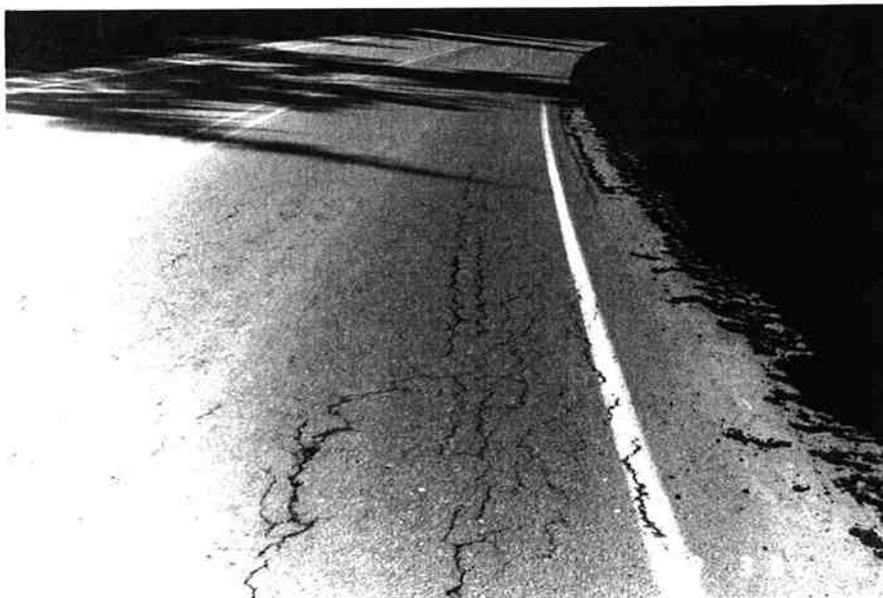
Figure 4.9. Marion County Line-Bugaboo Road.

a) Overview

b) Closeup

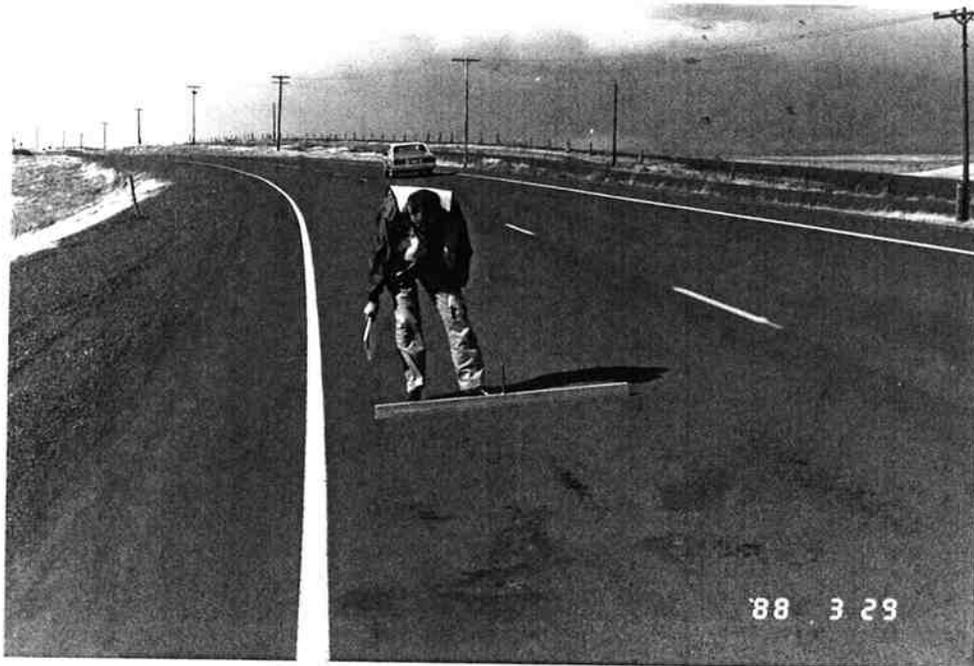
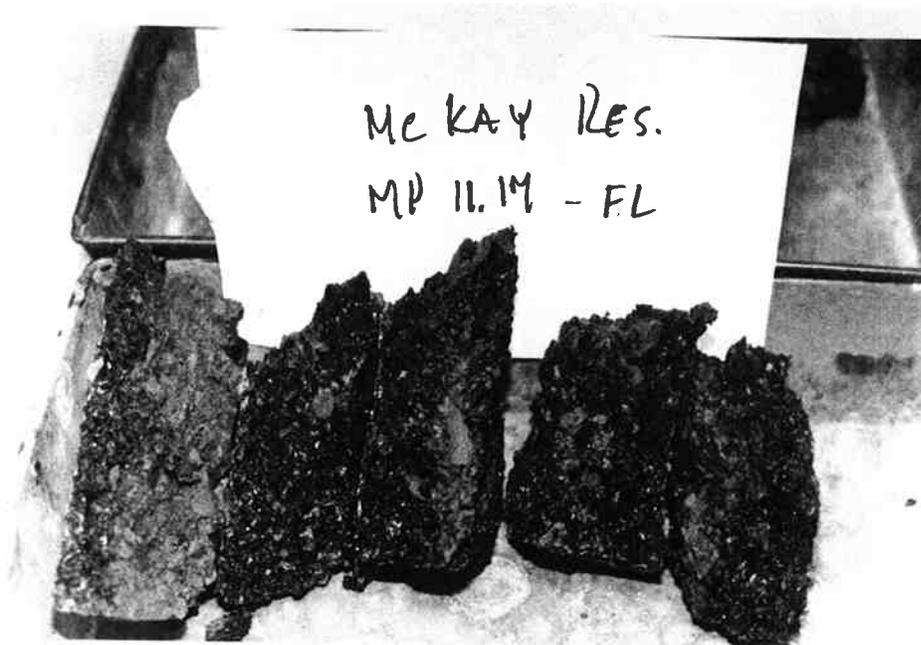
Figure 4.10. McKay Reservoir-Milepost 11.17.

a) Overview

b) Close-up of Broken Cores

McKay Reservoir to Milepost 11.17 and Salt Creek Tunnel to Klamath County Line both received an overall rating of "average" from the condition survey. Figure 4.10a shows the pitting that is occurring at mile post #9 on the McKay Reservoir project which also has a closed surface texture at mile post #10 due to a high asphalt content for the mix gradation. The core analysis for McKay Reservoir indicates this project is stripping. The asphalt coating is 40%, as shown in Figure 4.10b, with a dry coating thickness for both the wheel track and fog line core locations. A major concern for this project is that there may be considerable variation from the mix design gradation and/or asphalt content during construction. Therefore, it could not be substantiated that the lime added to the McKay project met design criteria. The problem of a closed surface is also being experienced on the Salt Creek Tunnel project. However, the core results for this project show the aggregate is 100% coated with a thick film of asphalt.

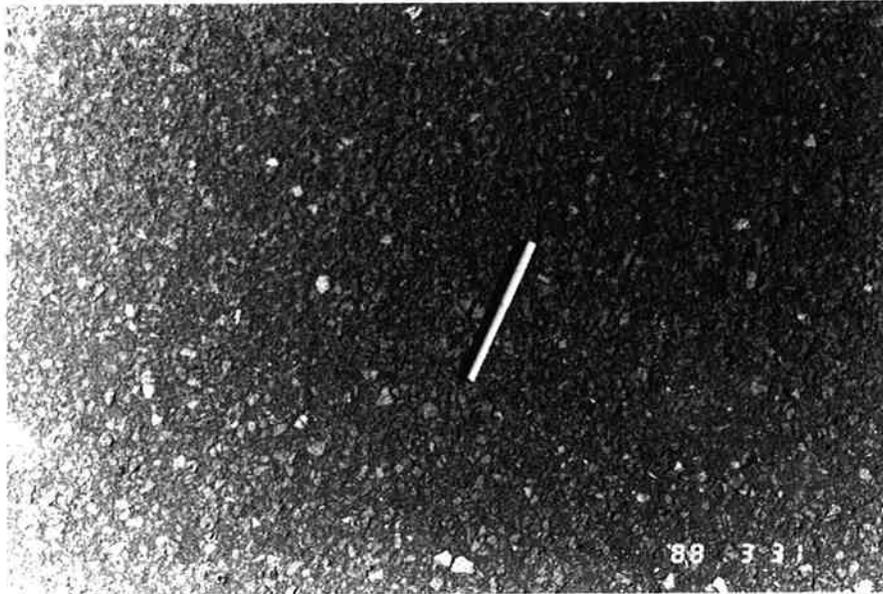
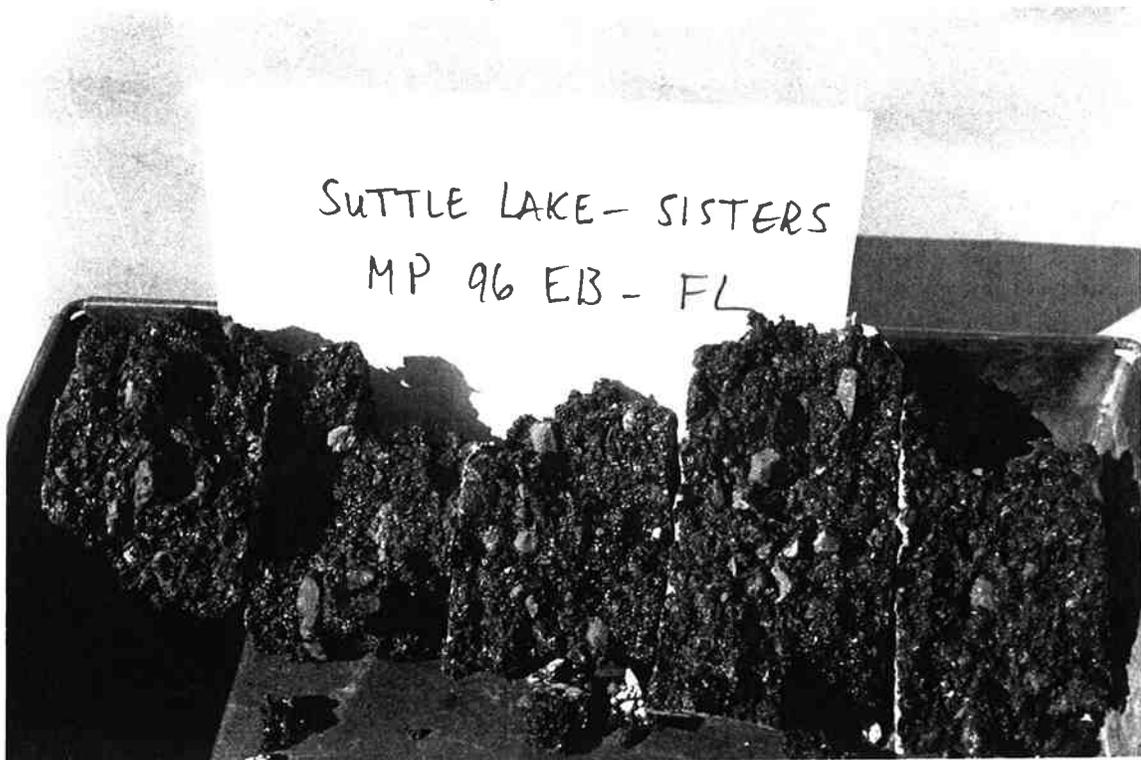
Figure 4.11. Suttle Lake-Sisters.

a) Close-Up

b) Core Sample

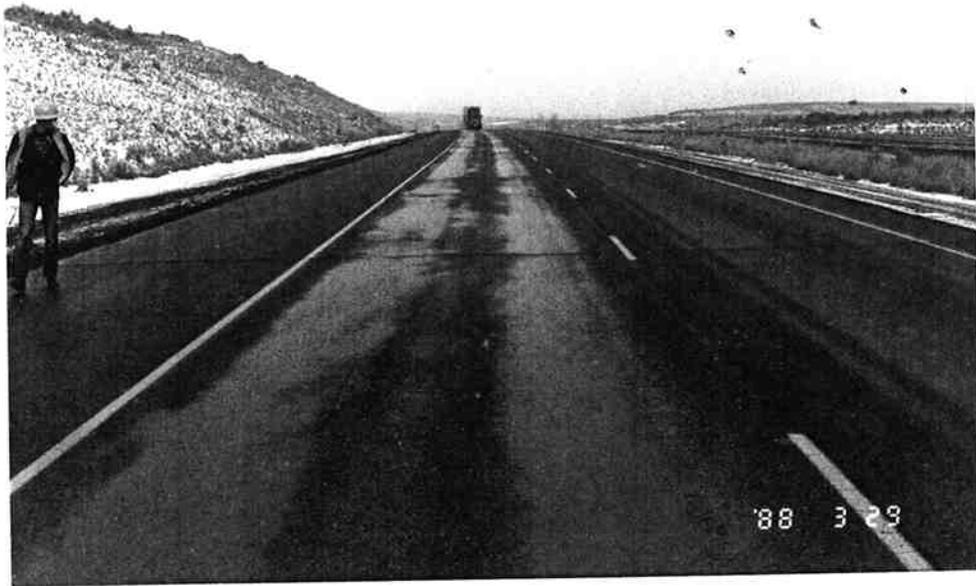
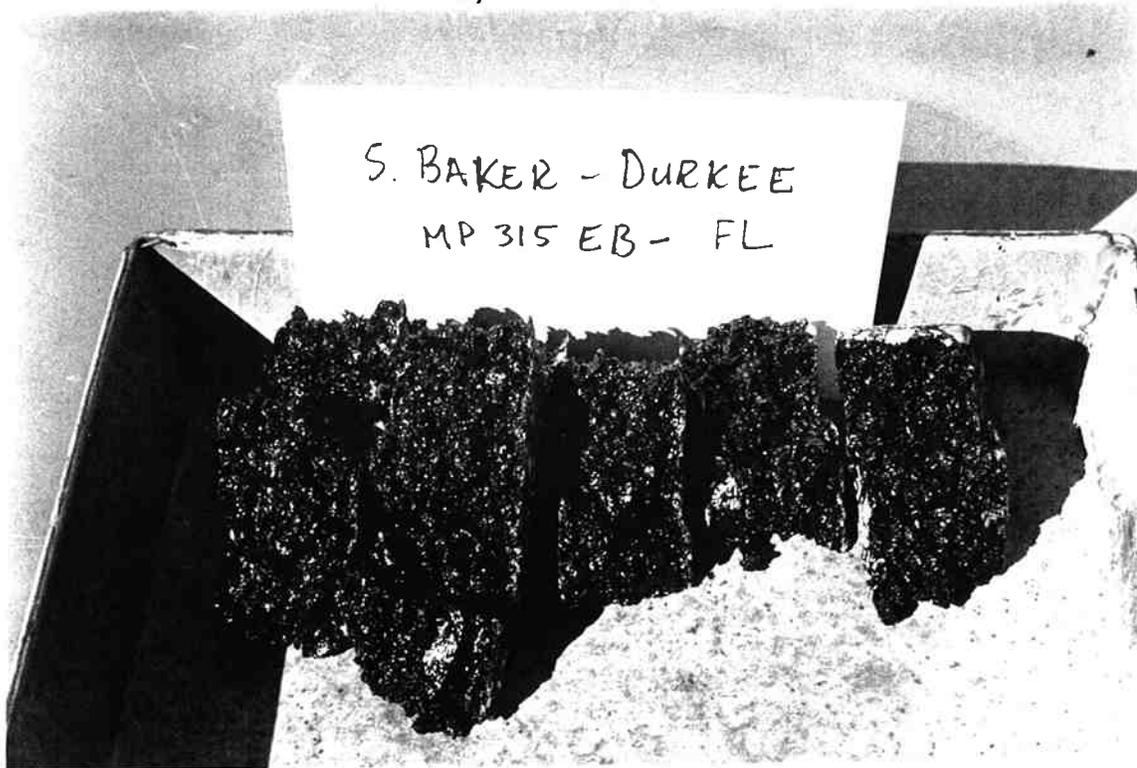
Figure 4.12. South Baker-Durkee.

a) Overview

b) Core Sample

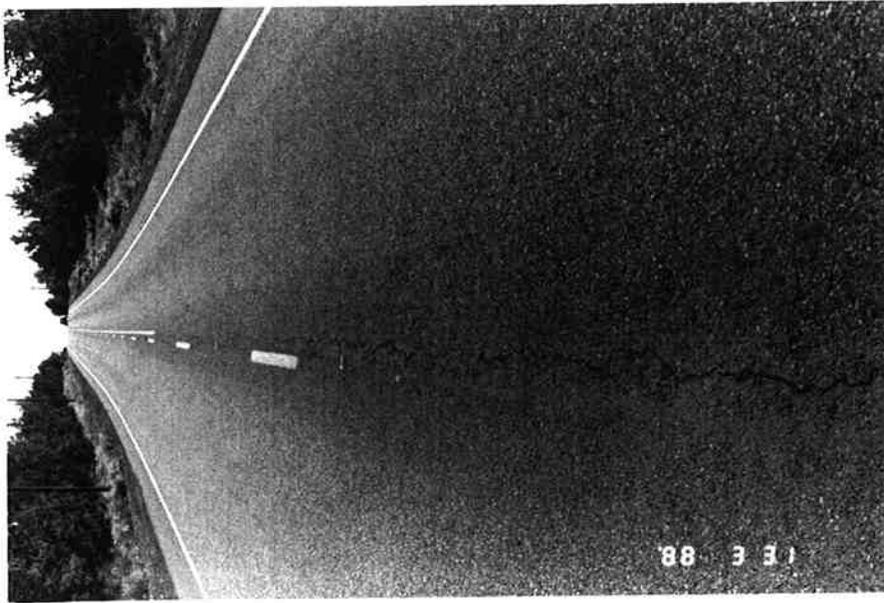
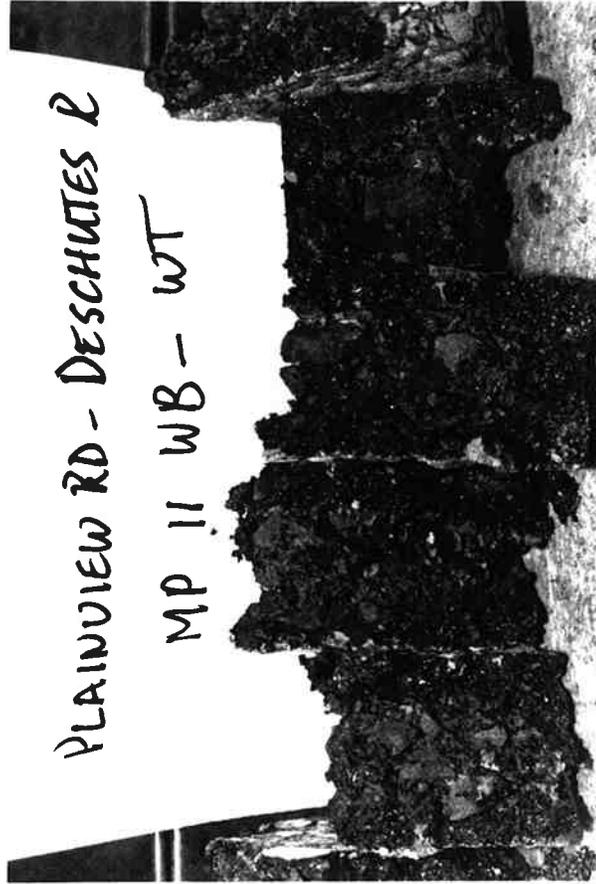
Figure 4.13. Plainview Road-Deschutes River.

a) Overview

b) Close-up of Broken Cores

Even though the Plainview project is four years older, its overall evaluation from the pavement condition survey was "good" compared to the "average" to "good" for the Sandy River project and the "average" rating received by the South Baker project. The Sandy River and South Baker to Durkee projects are showing signs of stripping-related distress. The Sandy River pavement has had frequent overlays and considerable rock loss. In the South Baker project, as shown in Figure 4.12a, the outside lane is flushed in the wheel paths. However, the results from the core analysis indicate the project is not stripping. Figure 4.12b shows the aggregate is 100% coated with a thick film of asphalt. The core analysis for the Sandy River to Mitchell point project
