**A STUDY OF THE WEARING  
CAUSED BY STUDED TIRES  
ON OREGON HIGHWAYS**

SPR Project 5273, Phase II

Oregon Department of Transportation  
Salem, Oregon 97310

December 1996

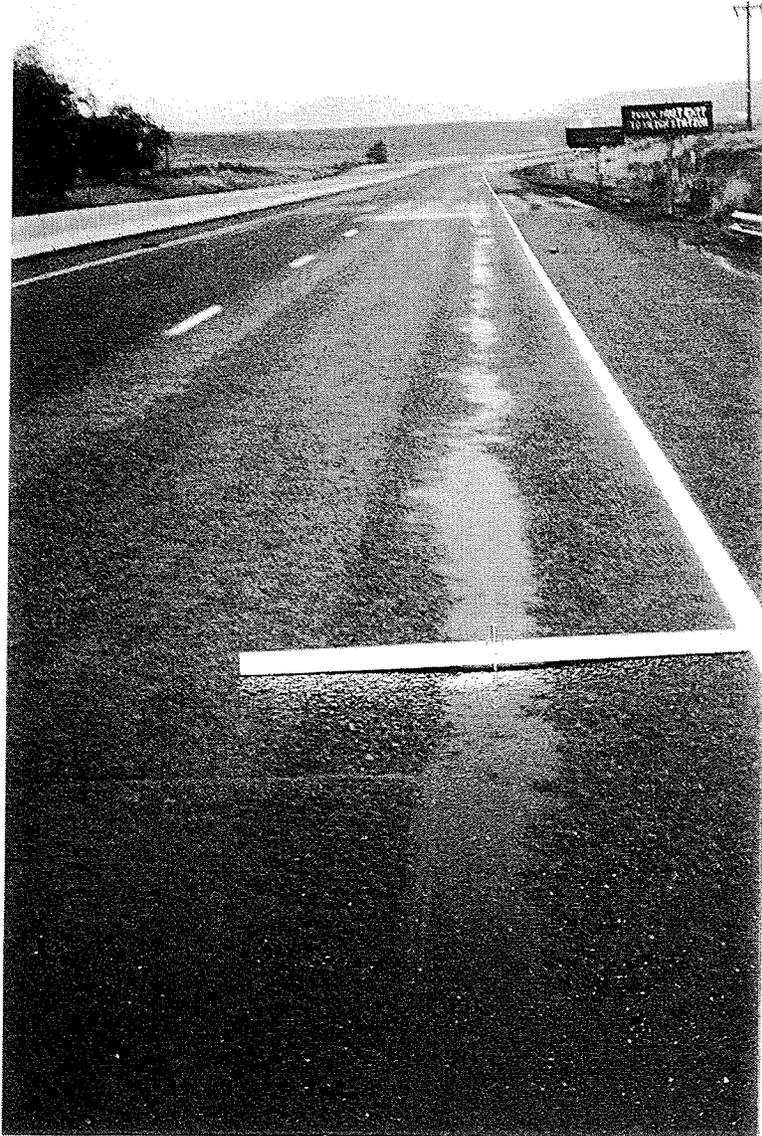
Fig. 2.1. Hydroplaning in a wheel track rut channel

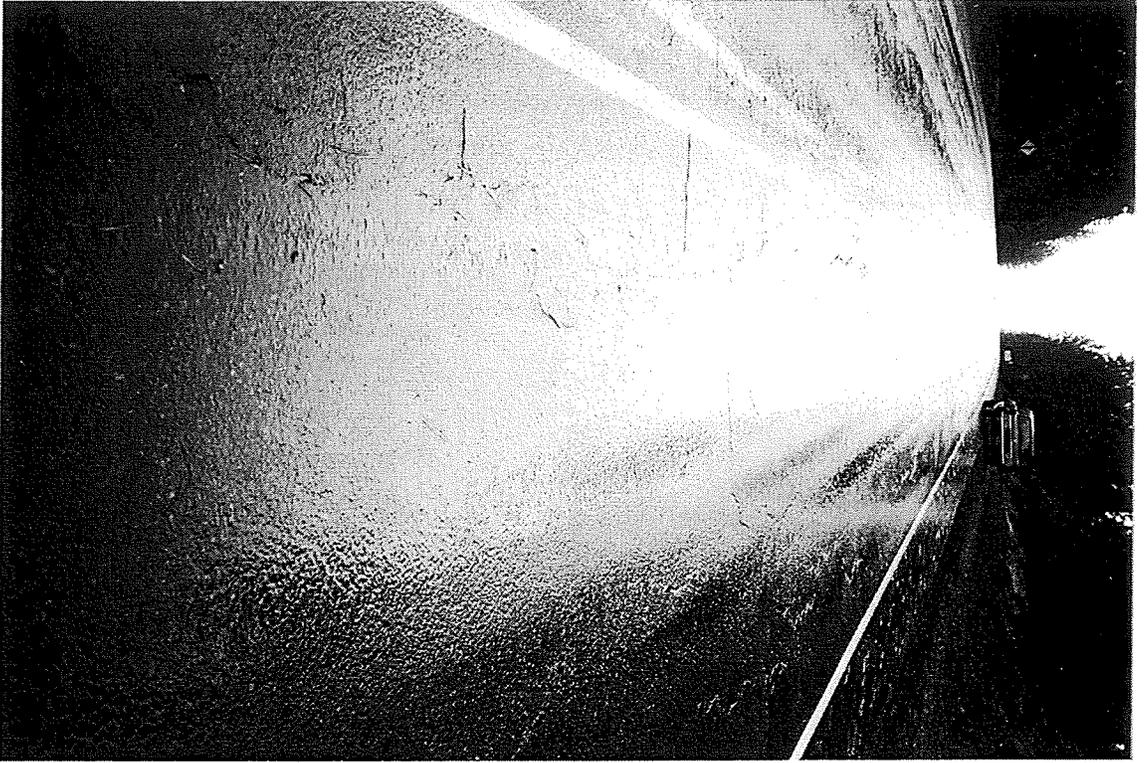
Fig. 2.2. Pavement disintegration due to continuous studded tire rut wear

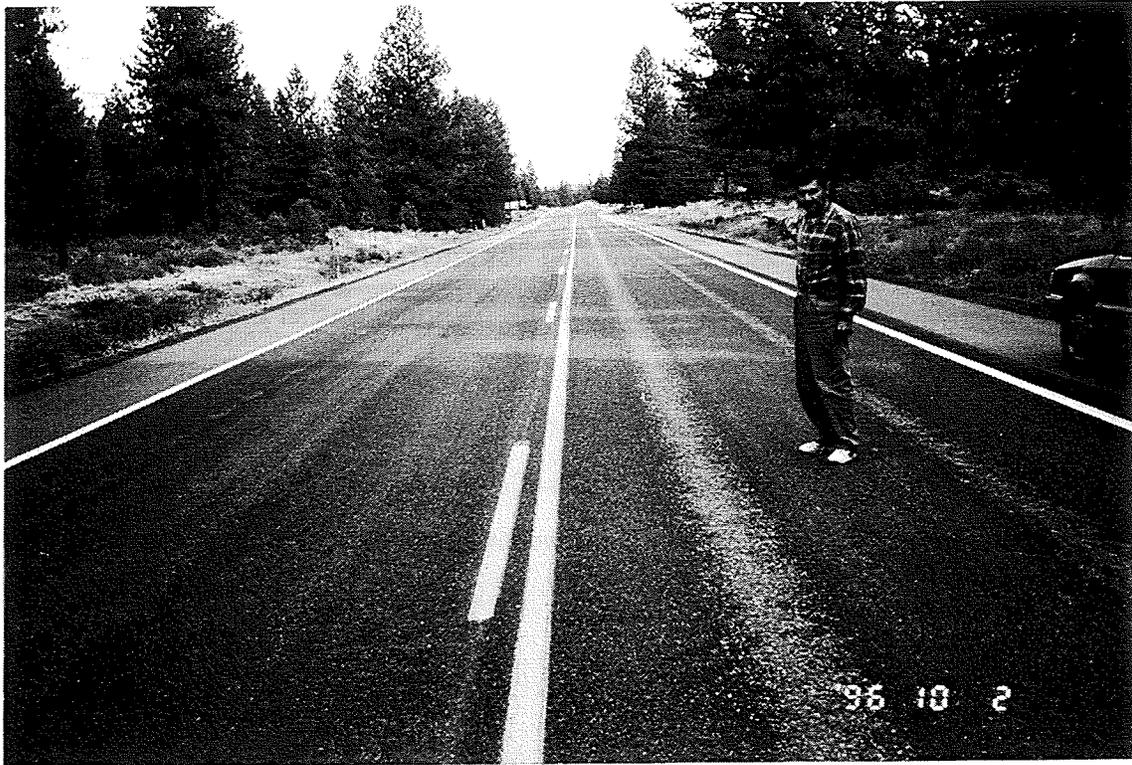
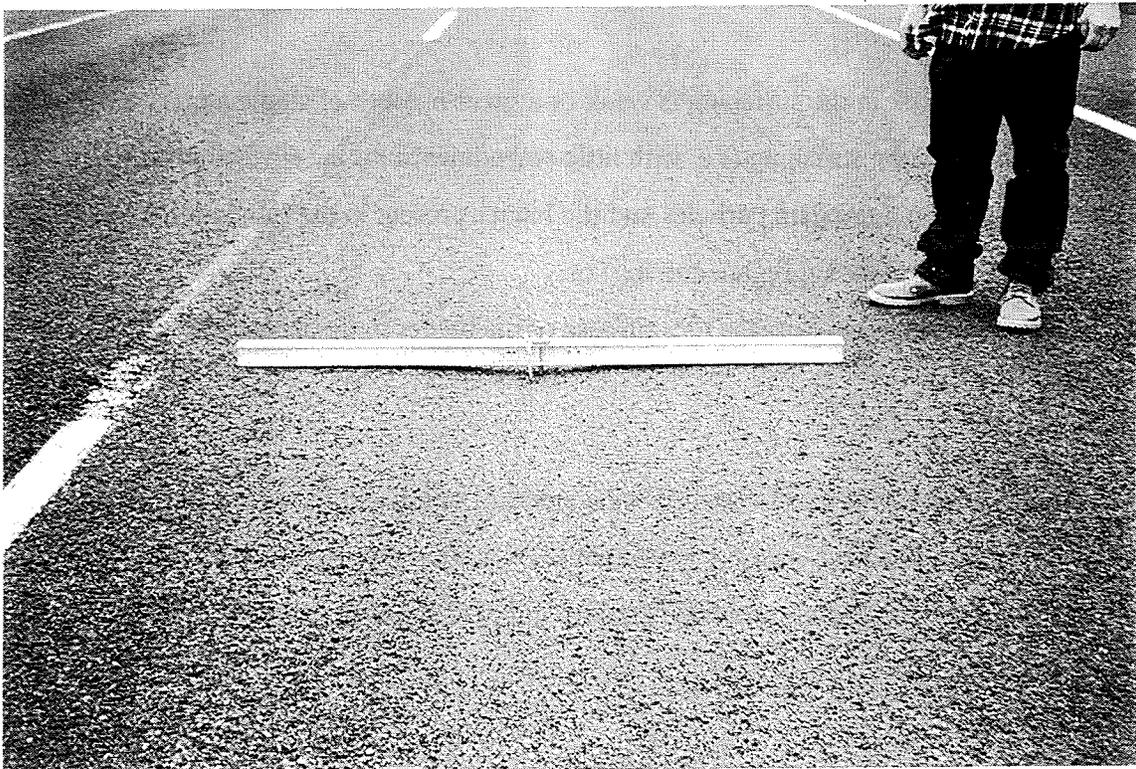
a) General view

b) Wear rutting

Fig. 2.3. Studded tire rutting due to wearing of aggregates

Studded tires, unlike the rubber tires mostly wear the aggregates rather than polishing them. A typical case of aggregate wearing under the action of studded tires is shown in Fig. 2.3 (a and b). It can be seen from this figure that the continuous wearing action has brought about a pronounced rutting in the surfacing.

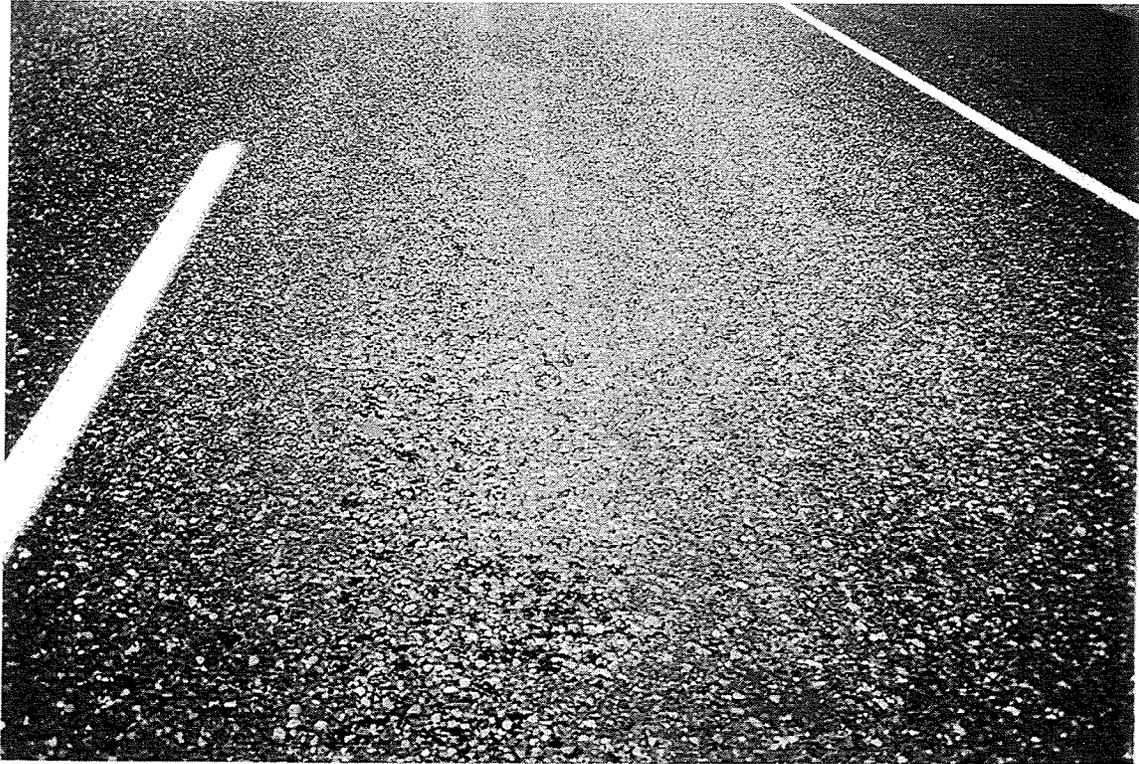
a) General view

b) Stone picking up rut

Fig. 2.5. Studded tire rutting due to aggregate picking up from the road surface

In all the above circumstances, the continuous hammering action of the studs will finally pick the loose or exposed particles up from the pavement (as it is shown schematically in Fig. 2.4). A field example of the stone picking up problem is shown in Fig. 2.5, taken from a rural highway in North-West Oregon.

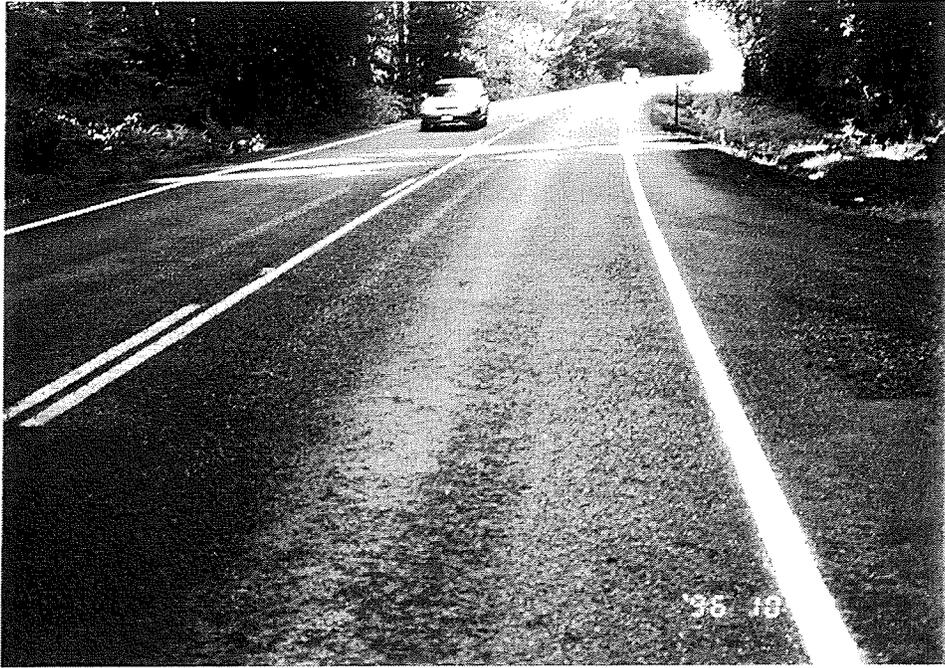
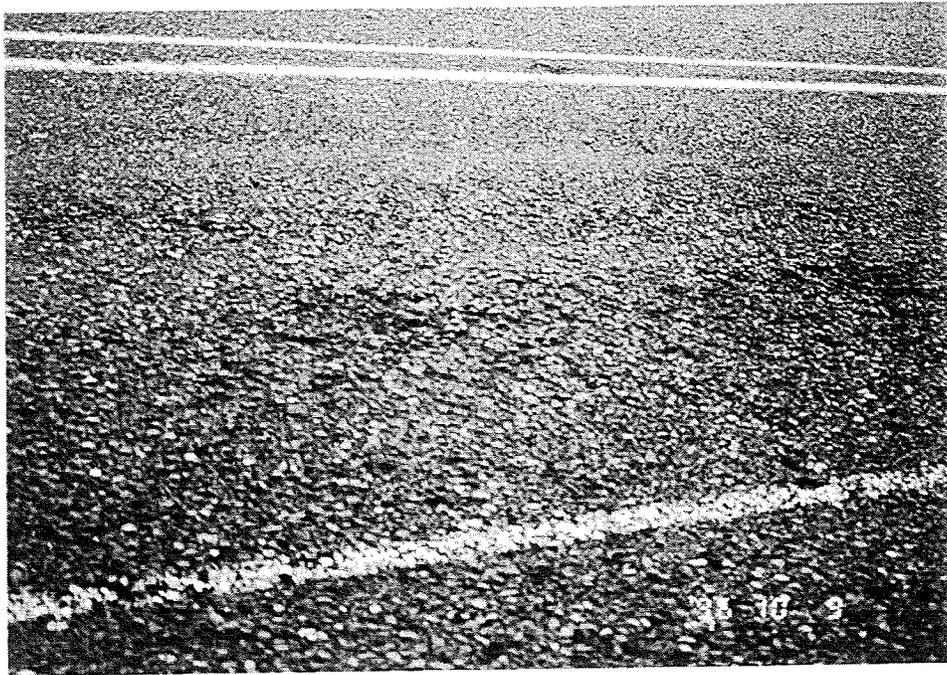
Fig. 2.6. Stone picking up problem in the shaded roads surrounded by trees

1. In the roads located in the areas within the Cascades, the rate of wear is greater than the other parts,
2. In the shaded roads (i.e. the areas surrounded by trees), the stone picking up phenomenon is more pronounced. In these conditions continuous water droplets from the trees contribute to the lower temperatures of the shaded areas.

In these cases the action of the studded tires would be to pick up the stone particles from the road surfacing. The consequence would be the formation of small separated holes on the surfacing (Fig. 2.6). If a sand patch texture measurement is performed in these sites, the wheel path areas will show a higher texture depth than the areas not worn by the studded tires.

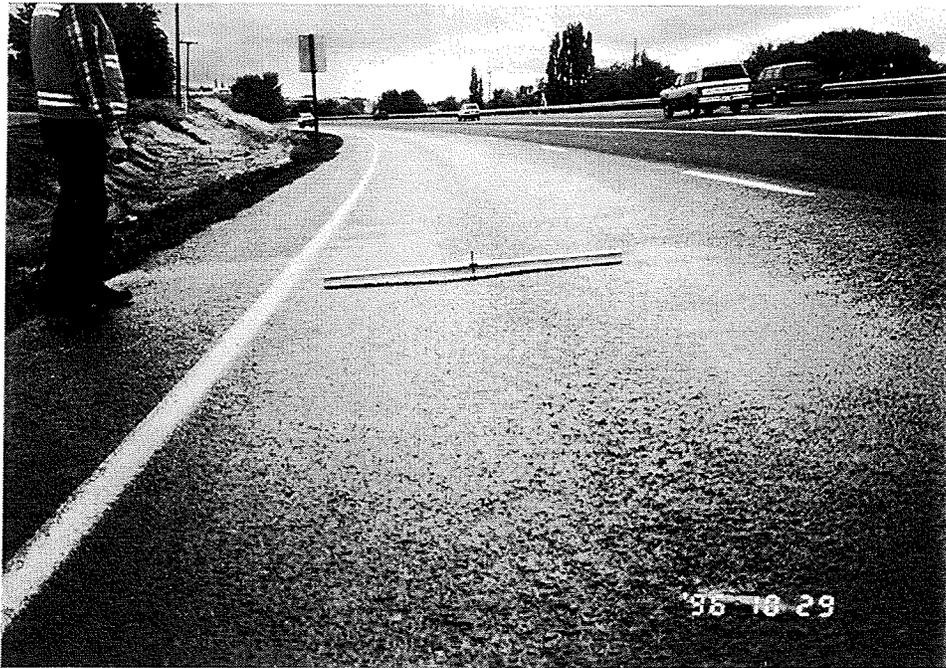
Fig. 2.7. Aggravated studded tire wearing in the curved sections of roads

1. The rate of wear is greater in the curved parts of roads and the rutting forms a wider channel (Fig. 2.7). This might be because of the applied sideway forces on vehicle turnings, and
2. On the steep roads the downhill lanes do wear more than the uphill ones (Fig. 2.8). The greater speeds and frequent breaking of vehicles could be the main reasons for this occurring.

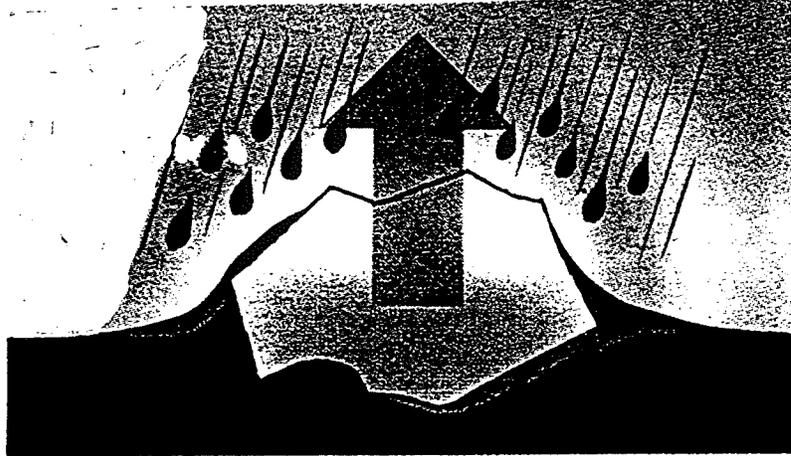
Fig. 2.9. Presence of water and the aggregate stripping problem

The stripping itself is a major problem for road pavements when a continuous wet conditions prevails. Fig. 2.9 shows the schematics.
