**ASSESSMENT OF DRIVER YIELD
RATES PRE- AND POST-RRFB
INSTALLATION, BEND, OREGON**

Oregon Department of Transportation

December 2011

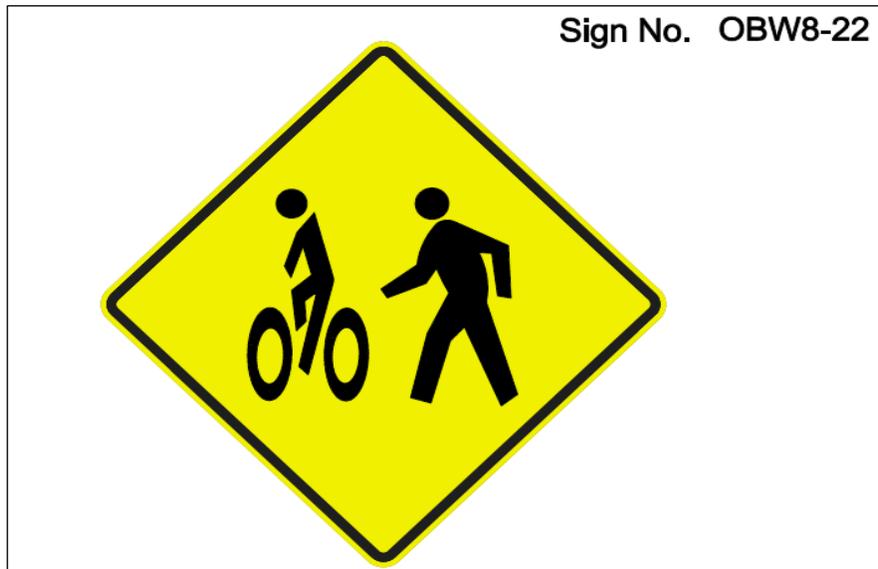
Figure 2.1 Bike/Pedestrian Warning sign displayed at Reed Lane and Badger Road crosswalks

The Bend Parkway, was constructed in 2001 as a bypass with limited access, well-spaced signals, and two marked crosswalks at uncontrolled intersections to accommodate pedestrians. The crosswalks were indicated with continental markings. At the two crosswalks a bike/pedestrian warning sign as shown in Figure 2.1 was accompanied by a diagonal downward pointing arrow. Signs in advance of the intersection were accompanied by a supplemental plaque containing the legend "AHEAD."

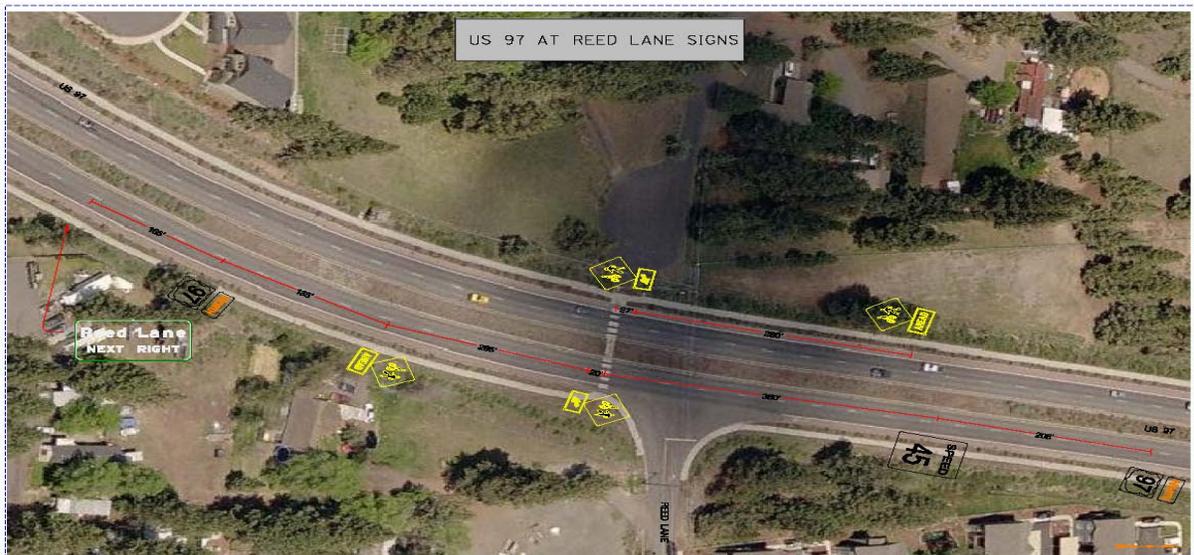
Figure 2.2: Pre-RRFB crosswalk and signing at the Reed Lane and Bend Parkway intersection

The crosswalk design and signing at the Reed Lane intersection prior to installation of the RRFBs is shown in Figure 2.2.

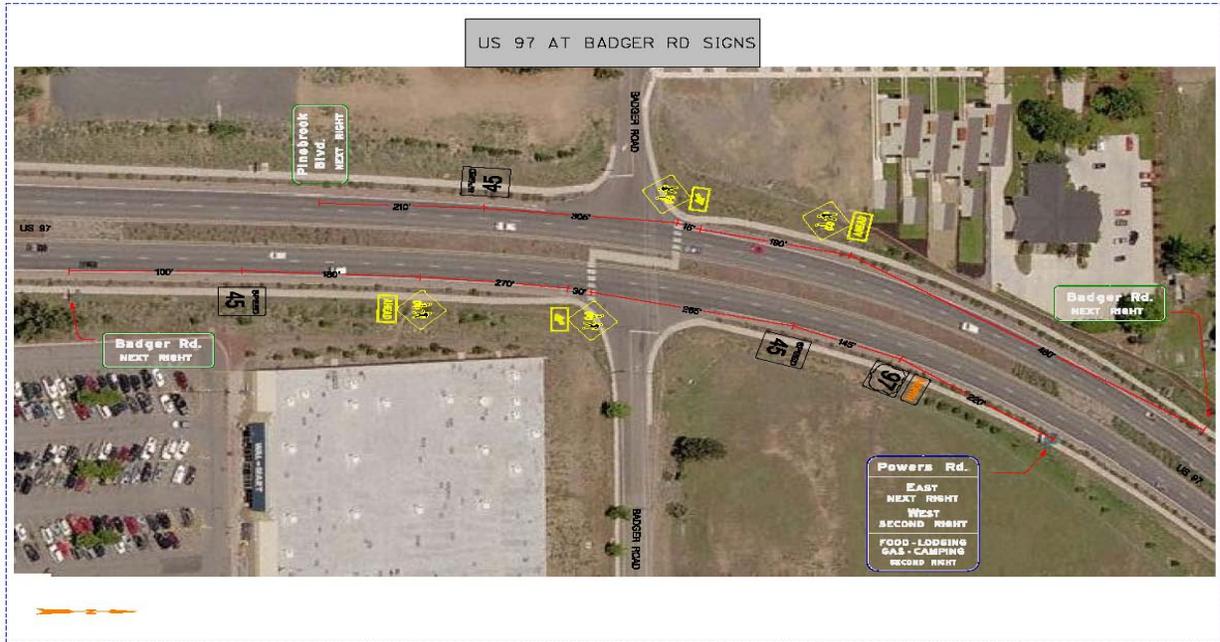
Figure 2.3: Pre-RRFB crosswalk and signing at the Badger Road and Bend Parkway intersection

At Badger Road, the crosswalk configuration is such that the pedestrian crossing the median is facing toward traffic. The pre-RRFB crosswalk configuration and signs at Badger Road are shown in Figure 2.3.

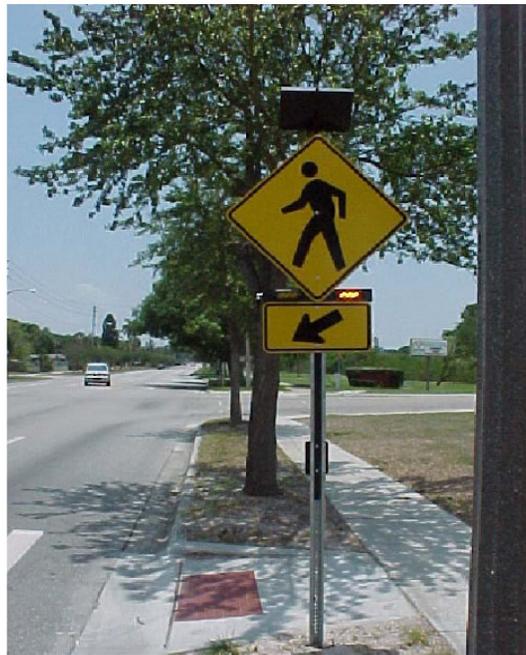
Figure 2.4: Rectangular Flashing Beacon Device (FHWA 2011)

Rapid Rectangular Flashing Beacons (RRFBs) were installed at both intersections in May 2011. Figure 2.4 is a picture of a typical RRFB device.

The RRFBs at both locations were installed in accordance with conditions given in the Federal Highway Administration (FHWA) memorandum regarding Interim Approval for Optional Use of Rectangular Flashing Beacons (IA-11) dated July 16, 2008 as well as conditions noted in an approval letter from the State Traffic Engineer dated December 10, 2010. These include the following:

- Four pedestrian beacons meeting FHWA specifications shall be installed for each approach, for each direction. Two RRFB assemblies will be installed at the crosswalk (one on shoulder and one in median) and two will be installed approximately 500' in advance of the crosswalk (one in shoulder and one in median). (Previously the advance signs were on the right side of the road only and were placed about 350 feet from the crosswalk.) Beacons will be combined with combined Bicycle/Pedestrian signs that are fluorescent yellow in color. Forty-eight inch signs will replace 36 inch signs that were not fluorescent yellow. The RRFB assemblies at the crosswalk and those in advance of the crosswalk are activated simultaneously when a pedestrian or bicyclist pushes the button. When the pushbutton is activated the following message is heard: "Lights are on to cross the Parkway. Traffic may not stop."

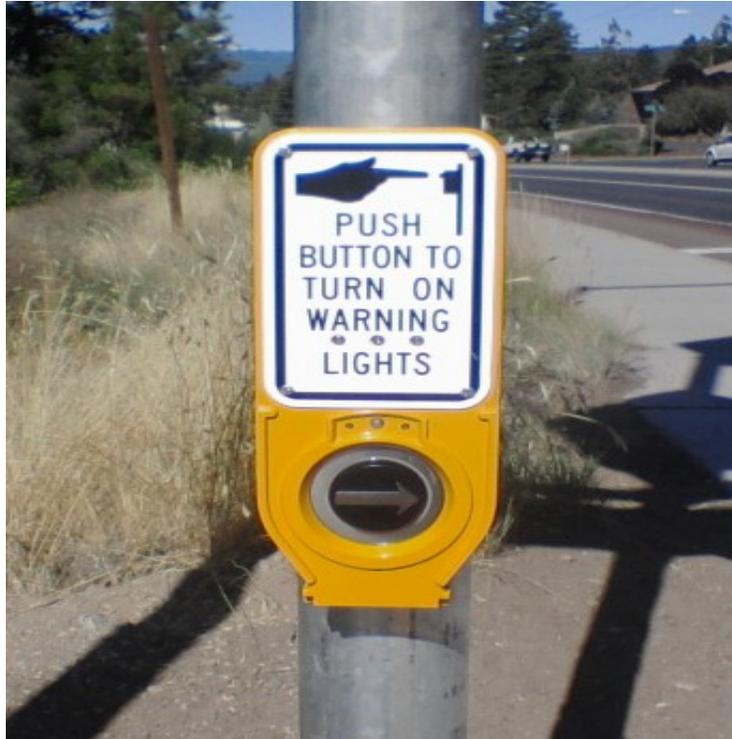
Figure 2.6: Pushbutton at Greenwood Avenue and NE 12th Street RRFB location

A pedestrian push button (similar to the photo in Figure 2.6 which shows the push button at 12th and Greenwood) was used at the two locations on the Bend Parkway. When the push button was activated on the Parkway the following message was heard: "Warning lights are on to cross Bend Parkway. Traffic may not stop."

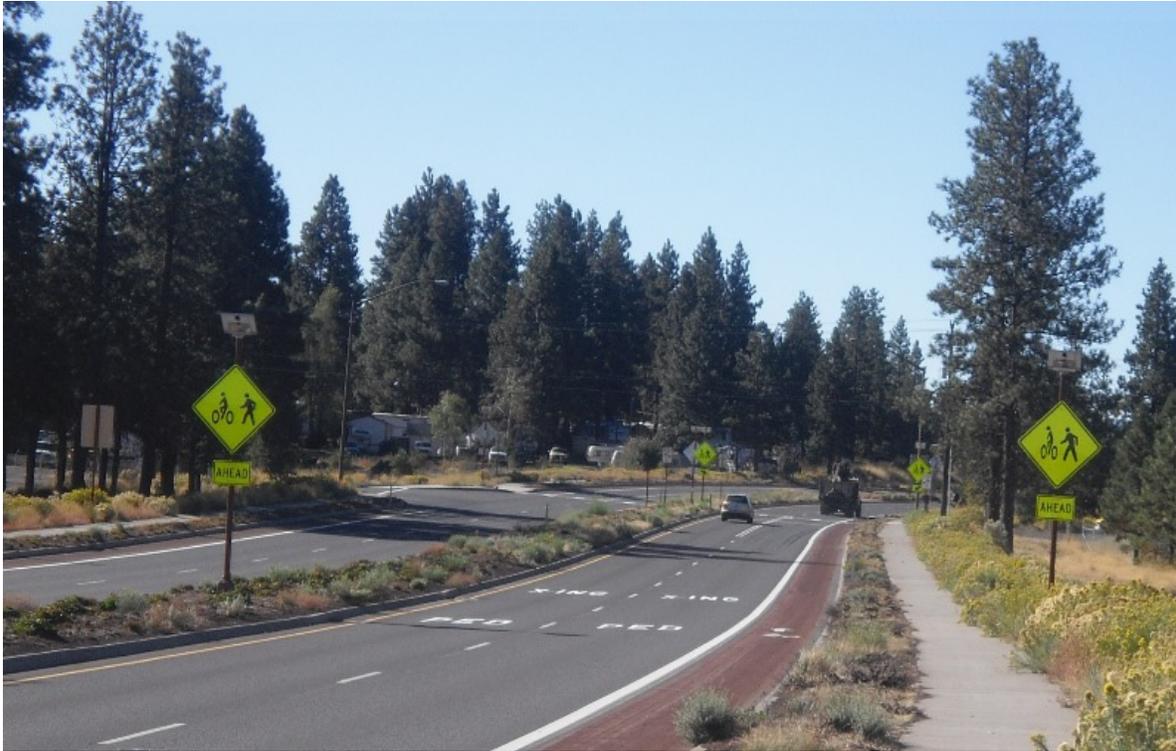
Figure 3.1 Driver's perspective of RRFB installation at the Bend Parkway and Reed Lane

Data were collected at the intersection of the Bend Parkway and Reed Lane on July 28, 2011 from 10:15 AM to 11:50 AM by two ODOT staff following the methodology given in the previous section. The weather was clear and warm. Figures 3.1 and 3.2 show the installation of the RRFB devices at the Reed Lane intersection. Figure 3.1 shows the Reed Lane intersection from the driver’s point of view, taken to include the advance RRFBs as well as the RRFBs at the crossing. Figure 3.2 shows the crossing from the pedestrian’s point of view.

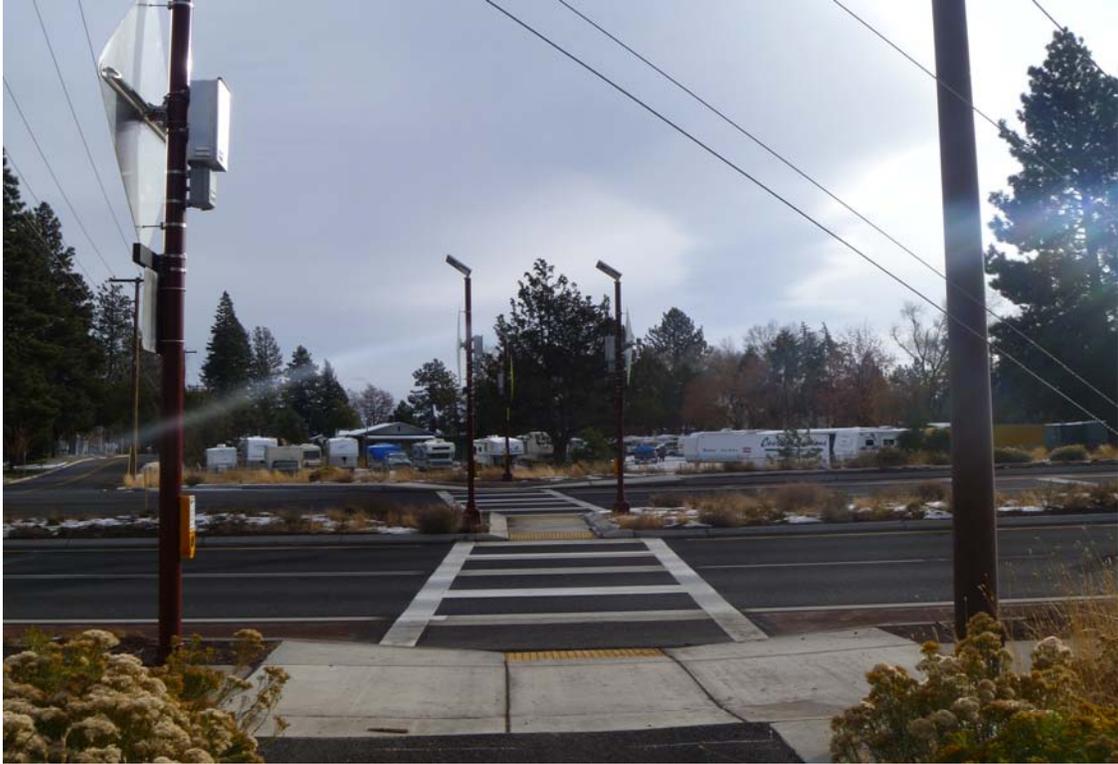
Figure 3.2 Pedestrian's perspective of RRFB installation at the Bend Parkway and Reed Lane

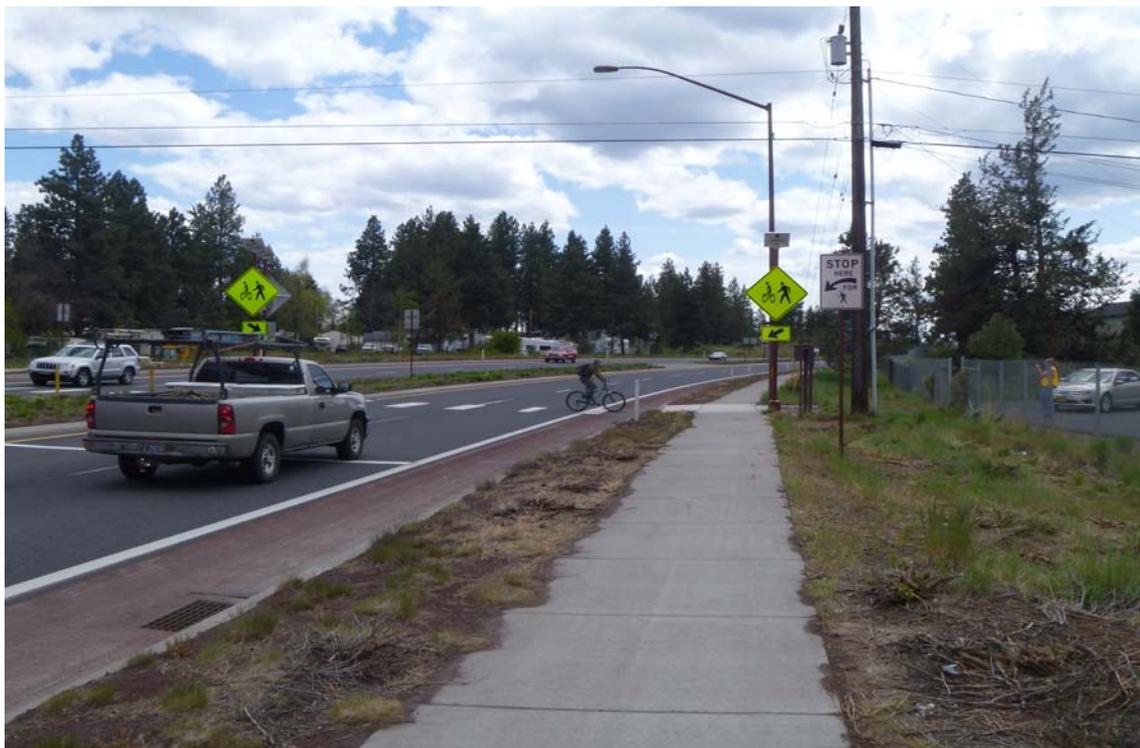
Figure 3.3: Bicycle crossing at the Bend Parkway and Reed Lane

The Reed Lane crosswalk was video recorded from 4:00 AM on Friday, September 23, 2011 to 4:00 AM on Sunday September 25th. Pedestrians and bicyclists were observed during this period and it was noted if they activated the RRFBs to cross. There were a total of 78 crossings during the period and majority of the crossers were bicyclists (64%). Half of the bicyclists did not activate the flasher; most pedestrians (75%) activated the flashers. All bicyclists rode their bikes across the highway except one. (See Figure 3.3 which was taken prior to modifying the crosswalk.) Note that the RRFB was not activated and the bicyclist was riding in the crosswalk.

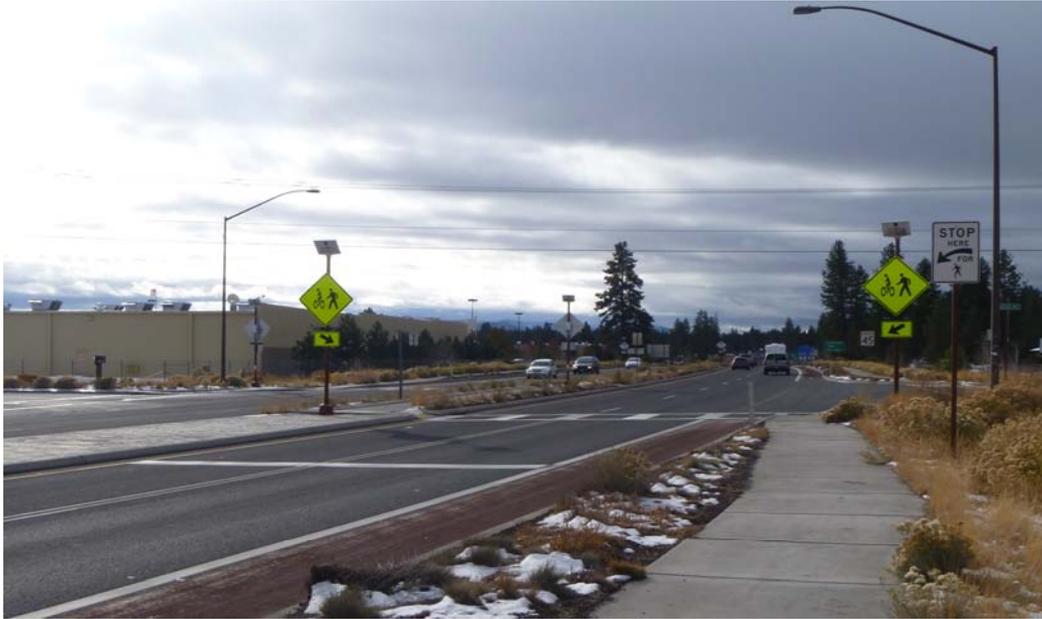
Figure 3.4 Driver's perspective of RRFB installation at the Bend Parkway and Badger Road

Data was collected at the intersection of the Bend Parkway and Badger Road on June 24, 2011 from 10:00 AM to 11:15 AM by two ODOT staff following the methodology given in the previous section. The weather was clear and warm. Figures 3.4 and 3.5 show the installation of the RRFB devices at the Badger Road intersection. Figure 3.4 shows the

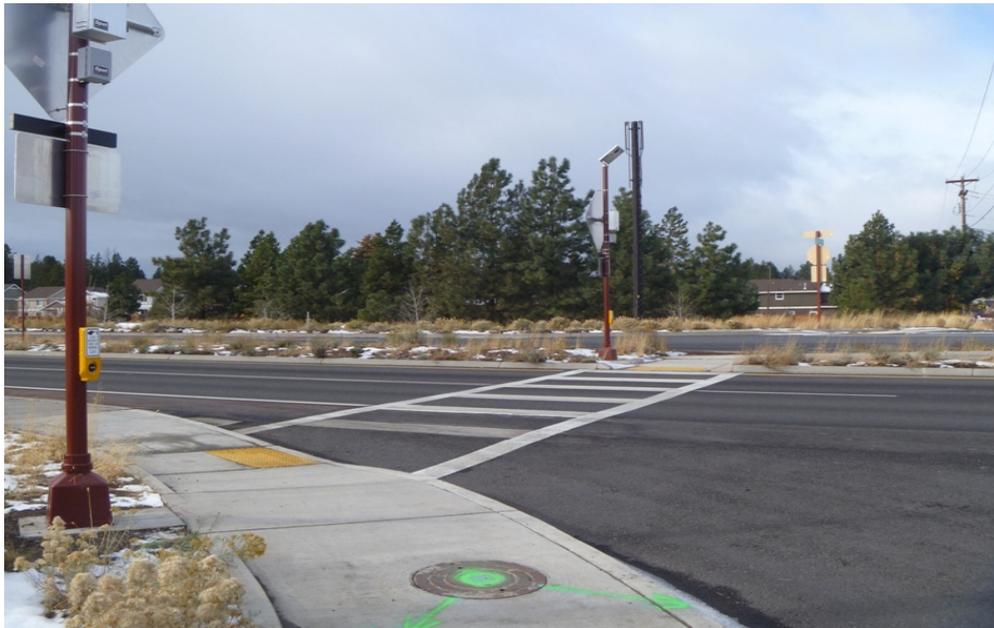
Figure 3.5 Pedestrian's perspective of RRFB installation at the Bend Parkway and Badger Road

crossing from the driver's point of view and Figure 3.4 shows the crossing from the pedestrian's point of view.

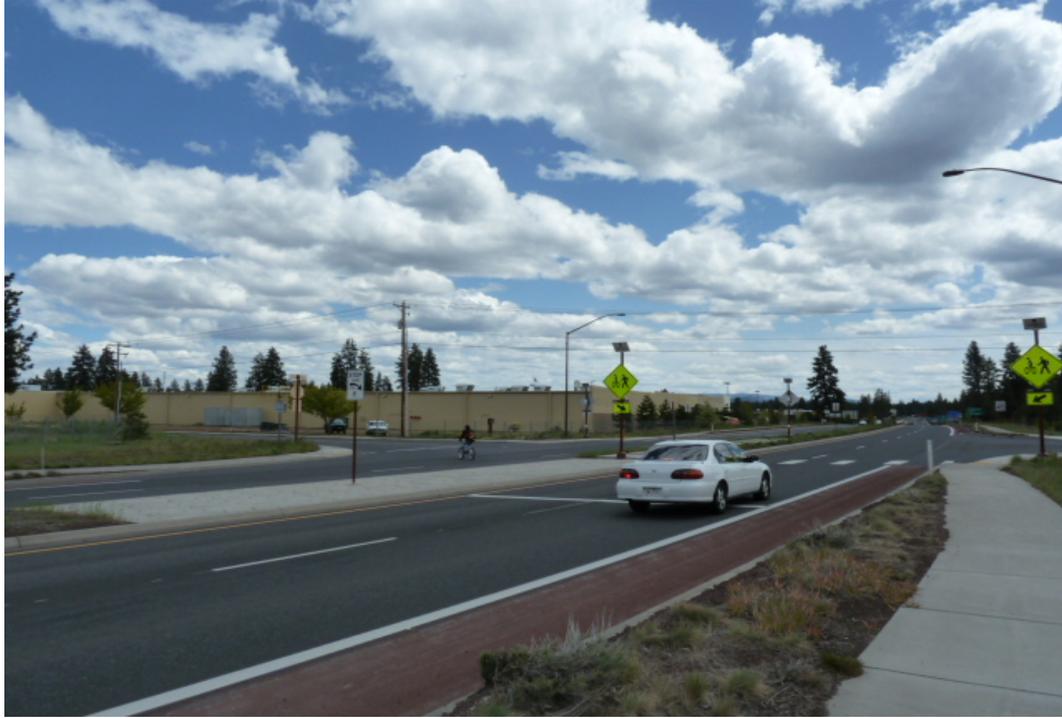
Figure 3.6: Bicyclist traveling across Badger Road not in “Z” crossing (note RRFB is not activated)

- Activation of the RRFBs resulted in a quieter and more comfortable environment for the crossing pedestrian.
- Vehicles often stopped or slowed down far from the intersection when activation occurred, giving the pedestrian a safe opportunity to cross.
- Crossers generally did not activate the pushbutton but typically waited for a safe gap and crossed.
- Pedestrians and bicyclists were observed crossing outside of the Z-Crossing. (See Figure 3.6.).

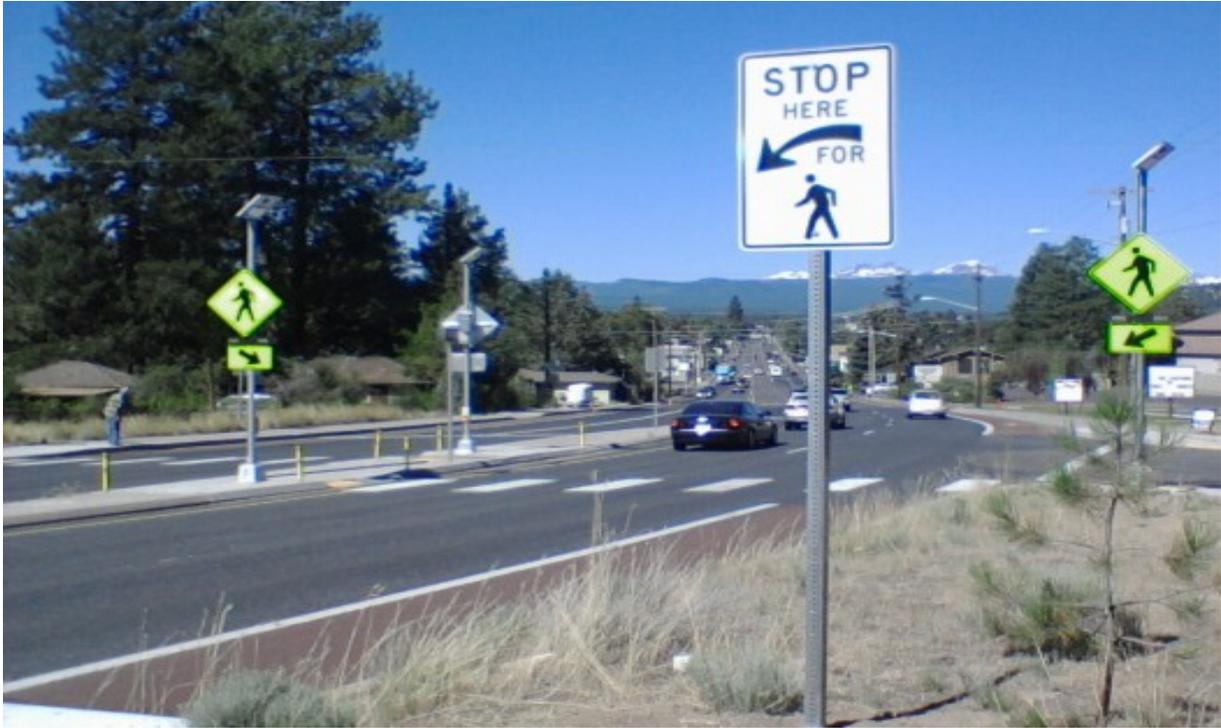
Figure 3.7: Driver's perspective of RRFB crossing at Greenwood Avenue and NE 12th Street

Data was collected at the intersection of Greenwood Avenue and NE 12th Street in the City of Bend on August 19, 2011 from 10:00AM to 11:00AM by City of Bend staff following the methodology given in the previous section. The weather was warm and sunny. Figures 3.5 and 3.6 show two views of this intersection. Figure 3.7 is taken from the northeast corner of 12th and Greenwood Avenue and shows the driver’s perspective. Figure 3.8 shows the intersection as a pedestrian crossing Greenwood Avenue in the northbound direction would see it. This crossing was designed to be a two-stage crossing with the pedestrian pushing the button to cross from the sidewalk to the median and then pushing a second push button to continue from the median to the other side of the street.

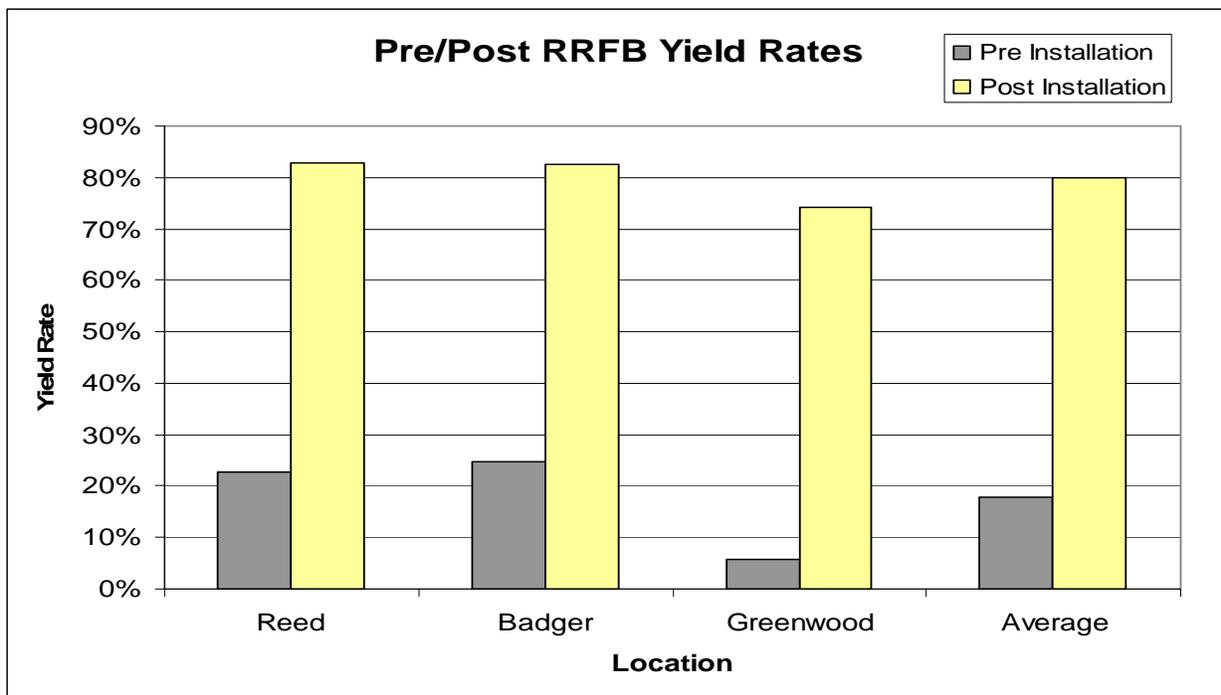
Figure 3.9: Pre- and post-RRFB installation yield rates at three intersections

The average yielding rate was 17.8%; following installation the average rate more than tripled to 79.9%. Table 3.8 summarizes the yield rates observed before the RRFBs were installed and two to four months later. The data given for the Greenwood Avenue location is from October after the conversion to a one-stage crossing was completed. Figure 3.9 presents the same information as a bar graph.

Location	Pre-RRFB Installation	Post-RRFB Installation
Bend Parkway and Reed Lane	22.8%	82.9%
xBend Parkway and Badger Road	24.7%	82.6%
Greenwood Avenue and NE 12 th Street	5.8%	74.3%
AVERAGE	17.8%	79.9%
