MASH TEST 3-11 ON THE 5-INCH CAST IN PLACE DECK BARRIER ANCHORS

Test Report 9-1002-7

16. Abstract A full-scale crash test was performed to evaluate the impact performance of a Texas T223 concrete beam and post bridge rail anchored to a 5-inch cast-in-place deck (CIPD). The testing followed the <i>MASH</i> standards for Test Level 3 (TL-3) longitudinal barriers. The test performed was American Association of State Highways and Transportation Officials (AAHSTO) <i>Manual for Assessing Safety Hardware (MASH)</i> test 3-11, which involves a 2270P (5000 lb) pickup truck impacting the critical impact point (CIP) of the barrier at a nominal impact speed and angle of 62 mi/h and 25 degrees, respectively. This test evaluated the strength of the barrier and its anchorage to the 5-inch CIPD. The T223 bridge rail anchored to a 5-inch CIPD successfully met all required <i>MASH</i> evaluation criteria. The rail anchorage withstood the design impact without any visible distress. The rail anchorage detail is considered suitable for implementation when concrete bridge rails are attached to 5-inch decks cast on prestressed box and slab beams. The anchorage detail is considered acceptable for use w

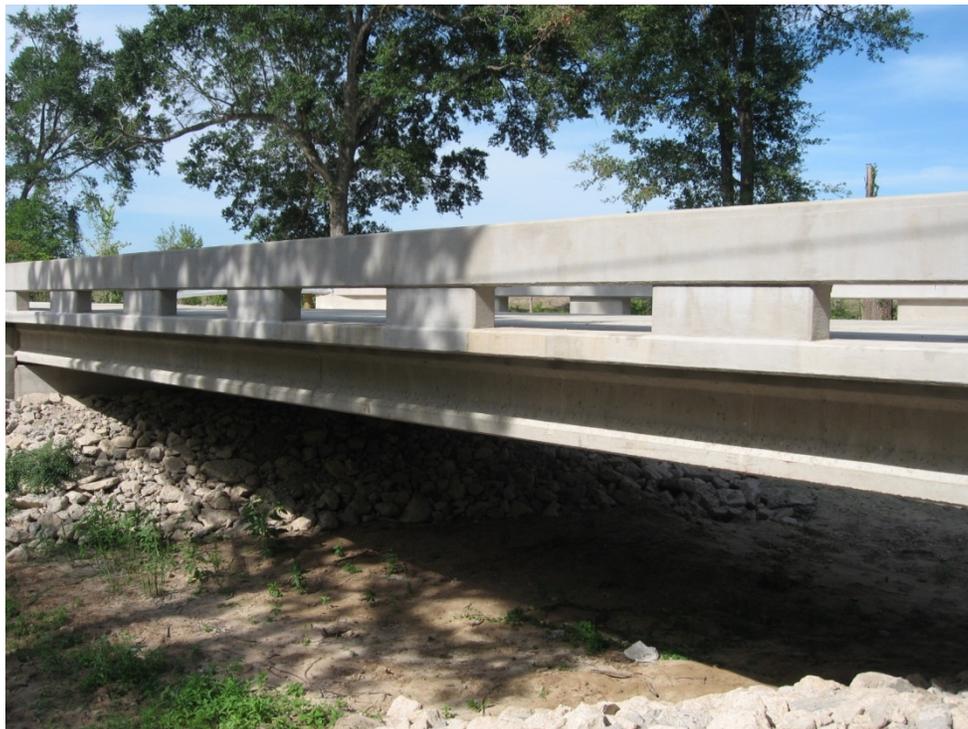
After evaluation of TxDOT's current barrier standards, only the T223 barrier, shown in Figure 2.1, fits these constraints. This barrier profile is also the primary concrete barrier used by TxDOT in these locations. The selected T223 barrier also provides a worst case for anchorage failure in the event of a vehicle impact when compared to other concrete barrier profiles in TxDOT's current design standards. The narrow thickness and width of the support posts in the T223 design standard provide for a worst case from an anchorage standpoint. The narrow thickness increases the pullout load on the rebar anchors by reducing the moment couple formed by the compression zone of the concrete post and the tension developed in the rebar anchor. The narrow width of the posts localizes the rebar anchors to discrete locations as opposed to being spread along the entire length of the barrier as in a continuous F-shape profile. This again results in an increased load in the rebar anchors.

Figure 2.1. TxDOT T223 Barrier.

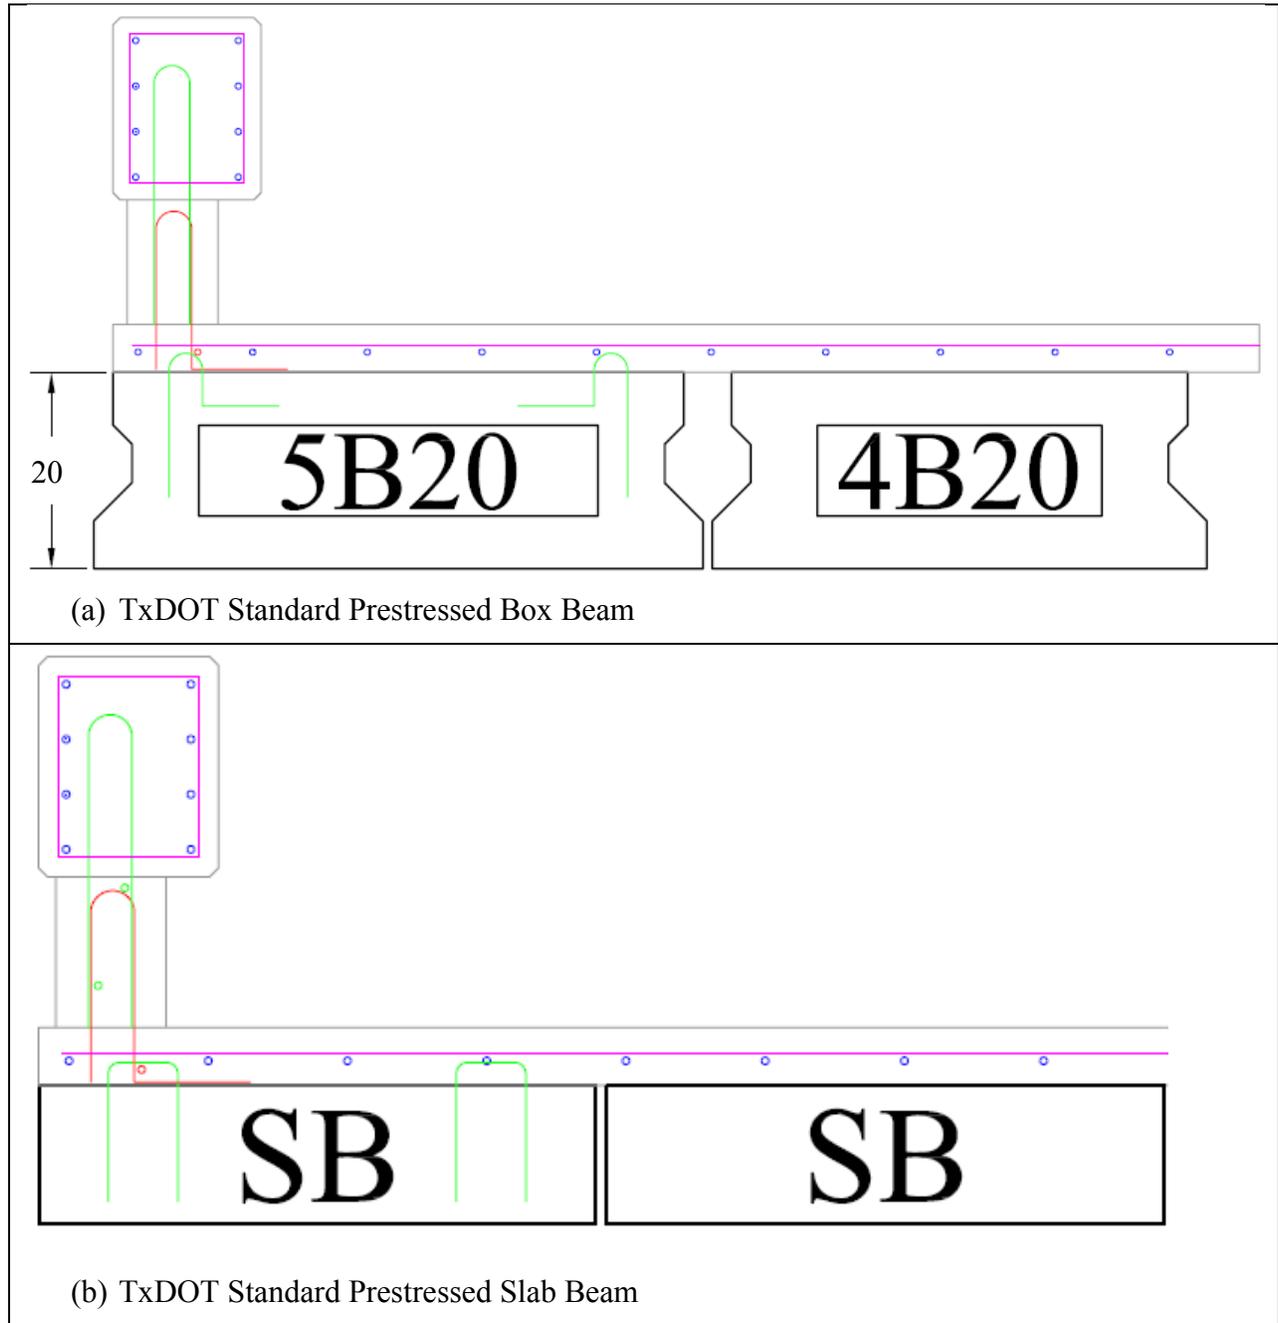
Both the standard box and slab beam sections, illustrated in Figure 2.2, were evaluated to determine which would provide the worst case for anchorage of the T223 barrier profile. It was concluded that the 5.5-inch thick top flange of the prestressed concrete box beam made it a worst case for anchorage compared to the 12-inch thick uniform prestressed slab beam. Therefore, a simulated concrete box beam was selected for testing in conjunction with a T223 barrier profile anchored into 5-inch thick composite cast-in-place deck (CIPD).

Figure 2.2. Comparison of TxDOT Standard Prestressed Box and Slab Beams.

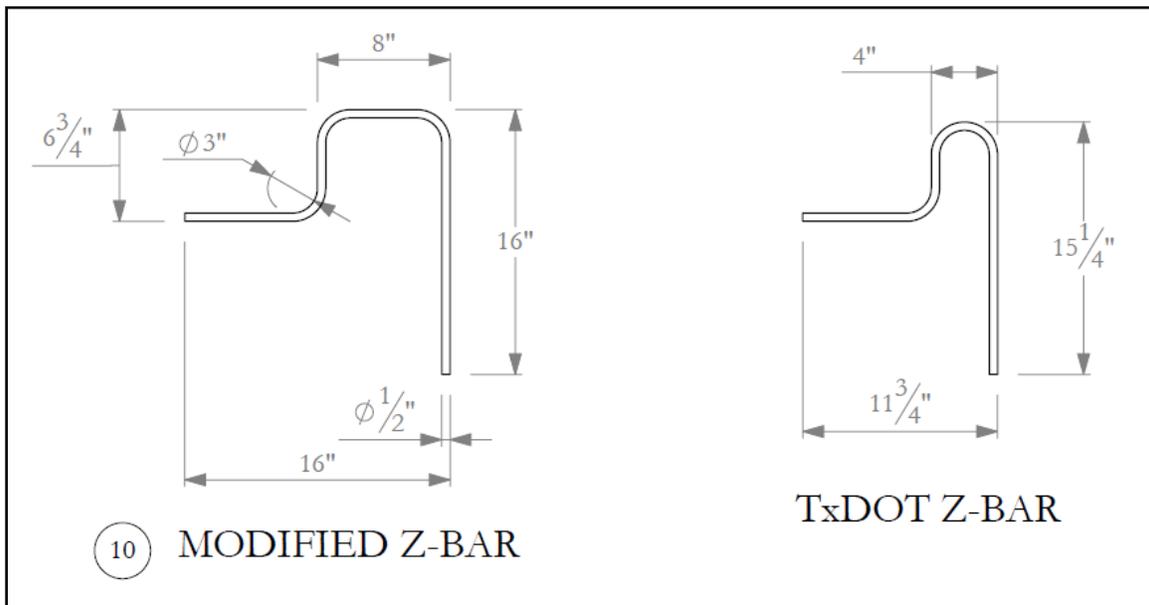
Third, due to the narrowness of the protruding portion of the “Z” bar, it is not possible for a #5 rebar to be thread through the “Z” bar and still traverse the embedded leg of the “U” bar. For this reason the protruding portion of the “Z” bar was widened, as shown in Figure 2.3.

Figure 2.3. Comparison of TxDOT Standard “Z” Bar and Modified “Z” Bar Dimensions.

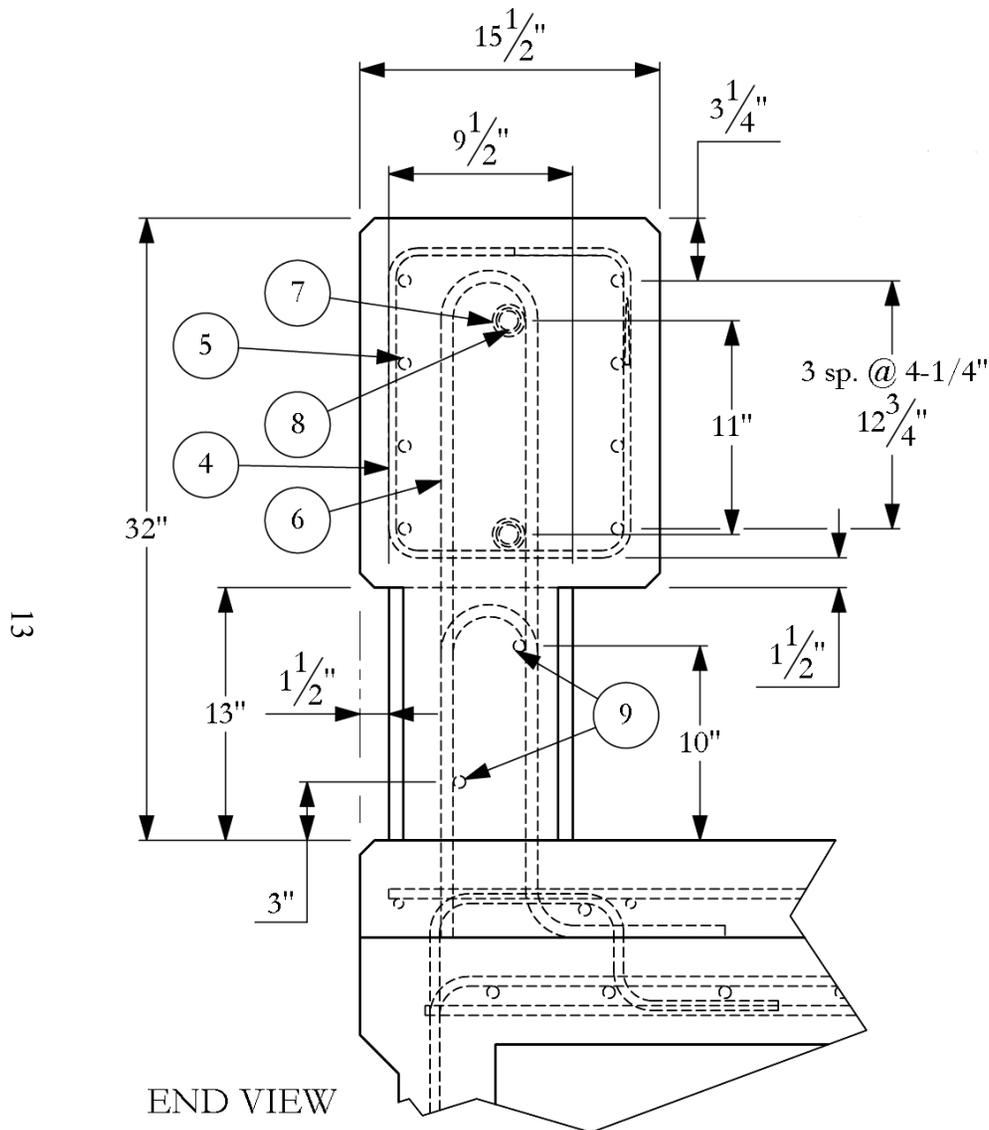
All rebar details followed the TxDOT box beam standard with the exception of the composite anchor bars (Z-bars). Eight #5 bars spaced 6-inches on centers were placed in the top deck along the length of the box beam section. Transverse “A” bars and 49-inch transverse “B” bars were placed in the top deck every 4 inches for the first 48-inches on each end of the beam. The spacing was then increased to 6-inches throughout the rest of the barrier. Modified “Z” bars were spaced every 12 inches along the length of the beam. Each “Z” bar protrudes out of the top of the beam approximately 2¼-inches. Finally, an additional #5 bar was tied inside the interior radius of the protruding modified “Z” bar. This bar was added to improve anchorage of the T223 bridge rail in the thin 5-inch thick cast-in-place bridge deck.

Figure 4.2. Details of the 5-inch CIPD Barrier Anchor Installation.

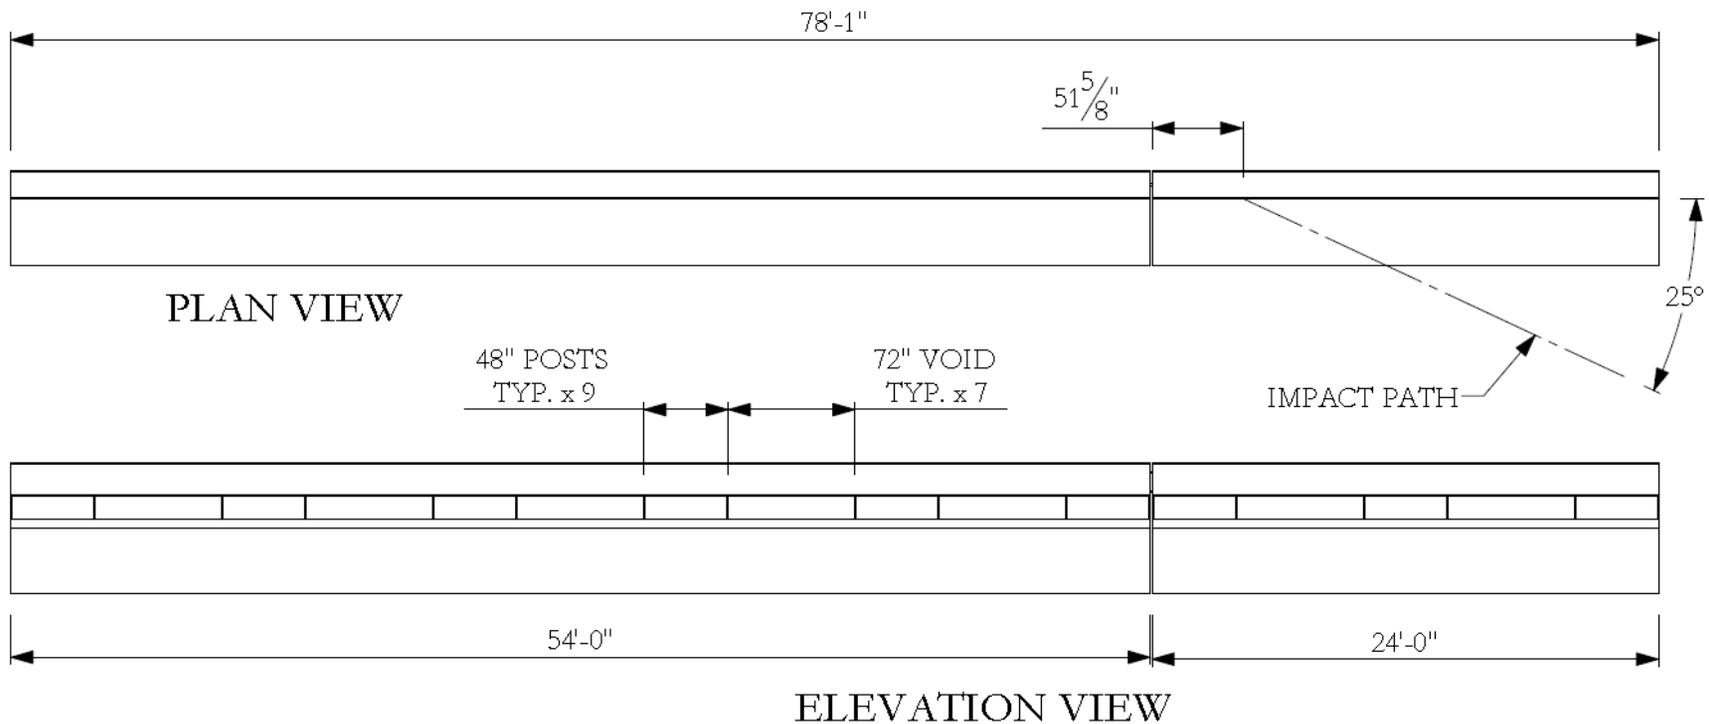
The top deck of the box beam was then finished to provide a uniform rough wood float finish to enhance the bonding of the beam to the 5-inch thick CIPD. A 1-inch wide expansion joint was cast through the entire cross-section of the box beam 24-ft downstream of the upstream end of the installation.

Figure 4.3. Layout of the 5-inch CIPD Barrier Anchor Installation.

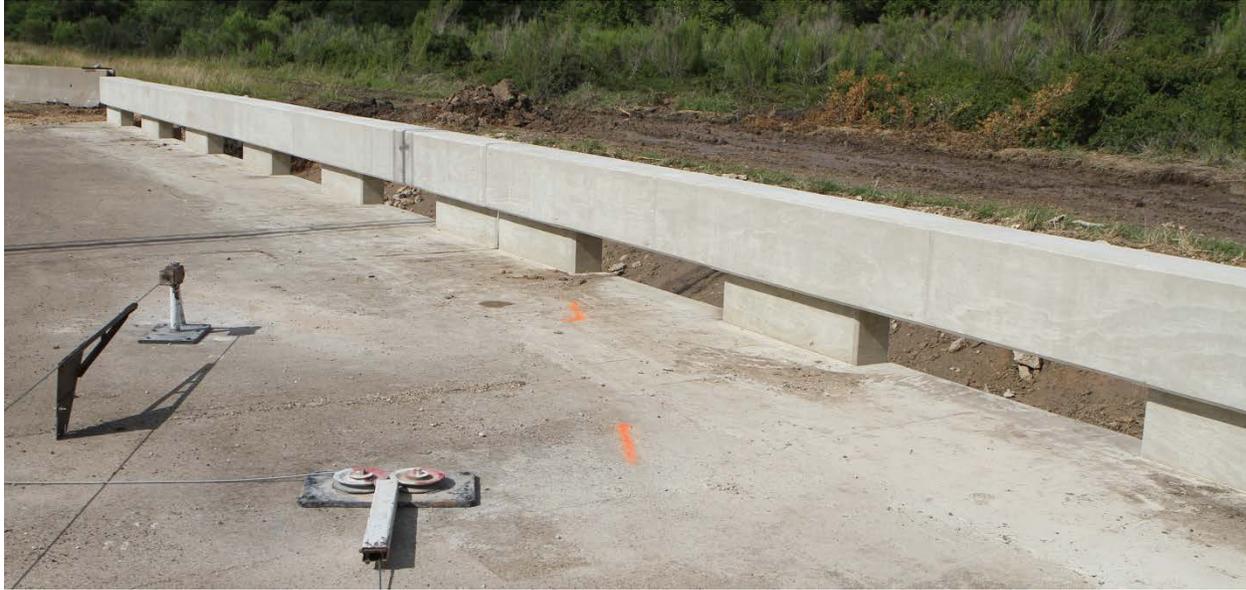
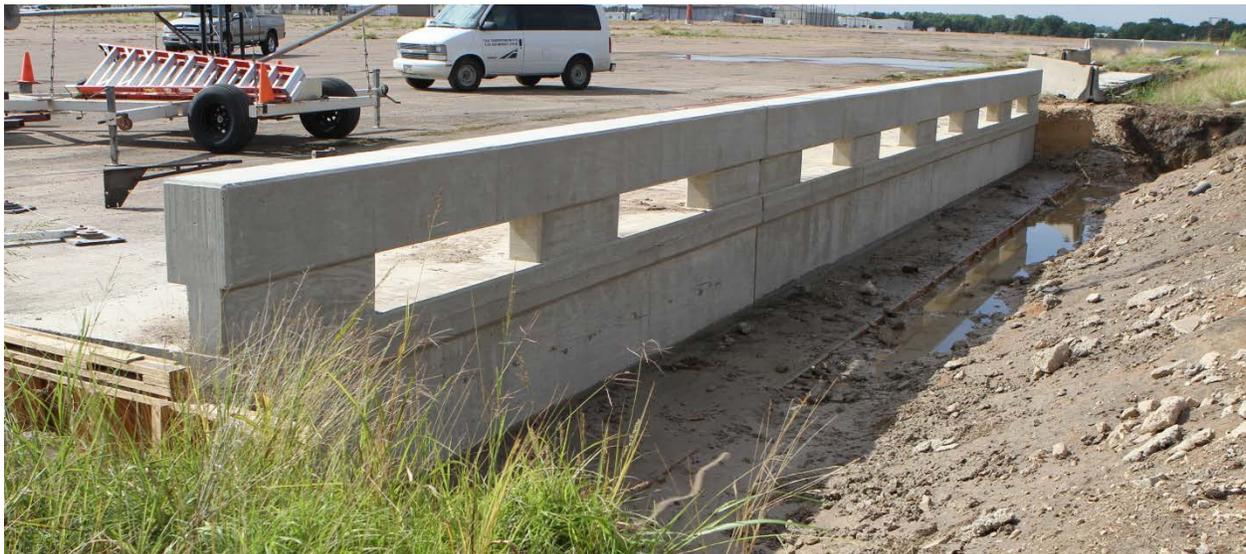
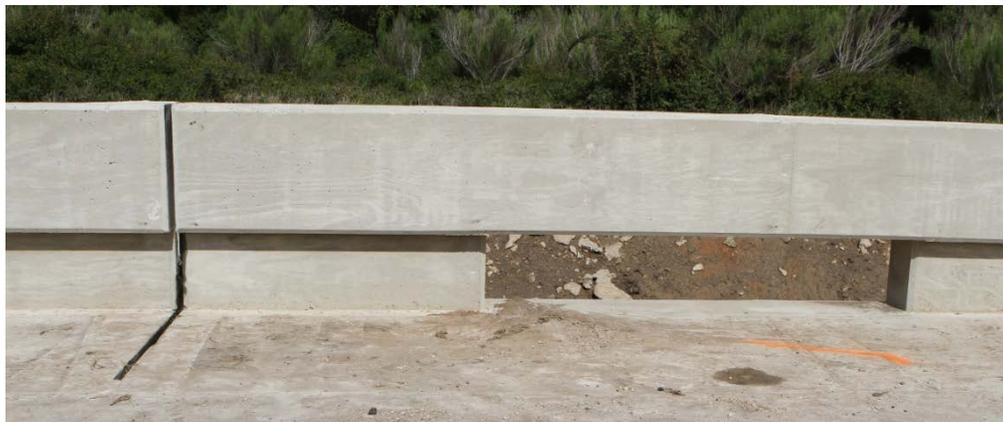
Figure 4.4. 5-inch CIPD Barrier Anchor Installation before Test No. 420021-5.

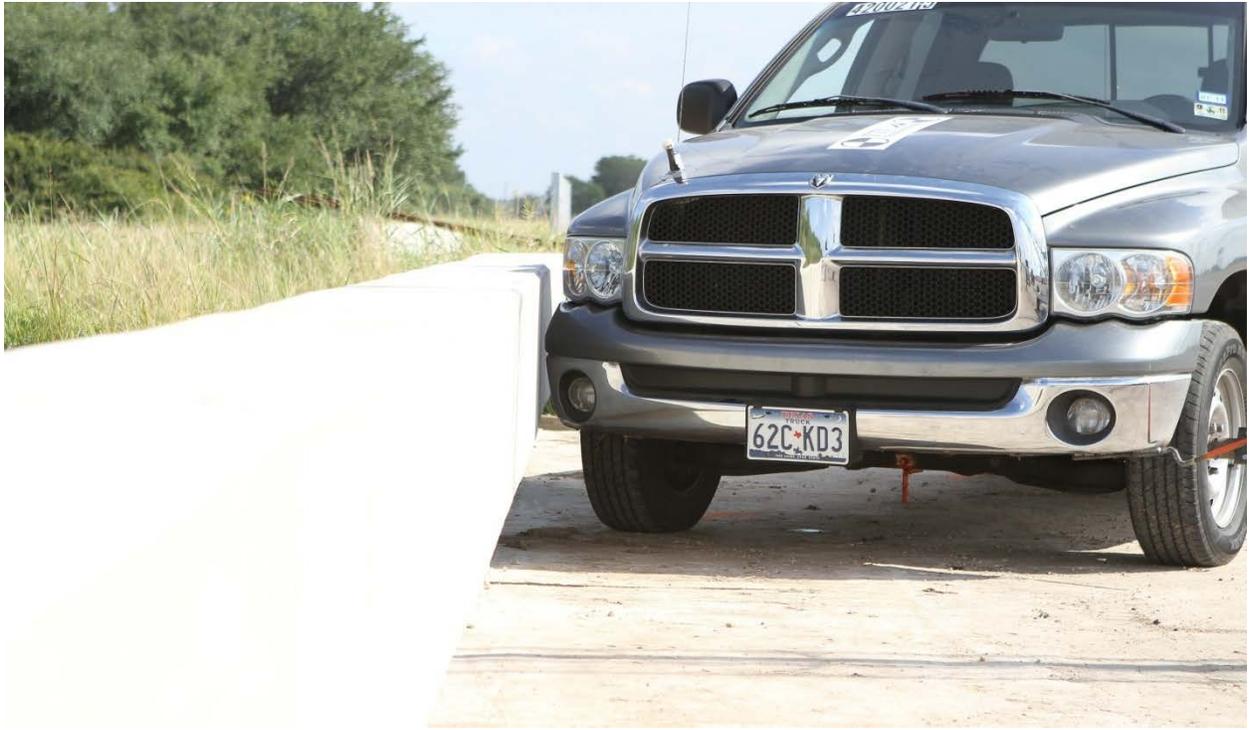
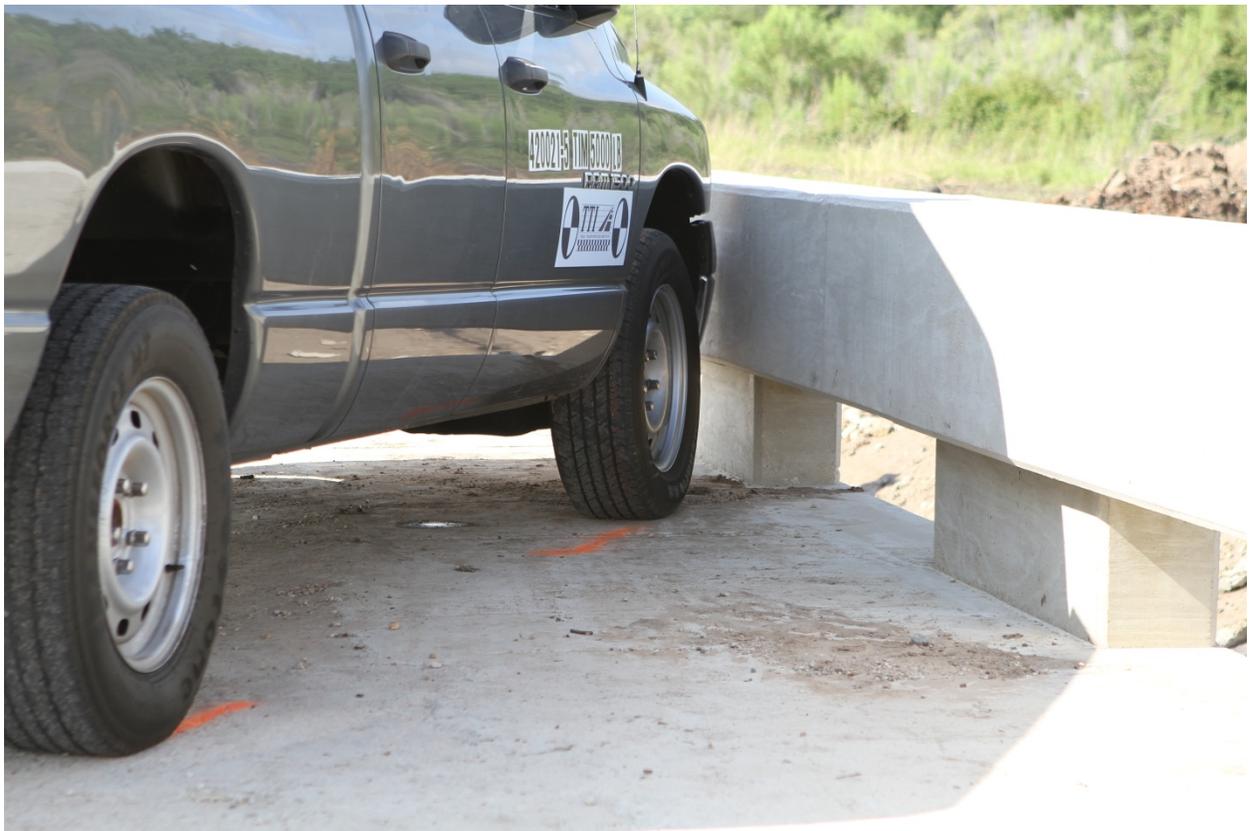
The 2005 Dodge Ram 1500 Quad-Cab pickup truck, travelling at an impact speed of 62.5 mi/h, impacted the TxDOT T223 bridge rail anchored to a 5-inch thick cast-in-place deck 54.5 inches upstream of the expansion joint between posts 3 and 4 at an impact angle of 26.3 degrees. At 0.022 s after impact, the 2270P vehicle began to redirect. The left front wheel steered abruptly clockwise at 0.035 s, and the right front passenger door contacted the barrier at 0.044 s. At 0.187 s, the vehicle was traveling parallel with the barrier at a speed of 50.7 mi/h. The rear bumper contacted the barrier at 0.203 s. At 0.356 s, the vehicle lost contact with the barrier at an exit speed and exit angle of 49.1 mi/h and 9.4 degrees, respectively. Brakes on the vehicle were applied 5.0 s after impact, and the vehicle came to rest 225 ft downstream of impact and 7.0 ft toward traffic lanes. Figures D1 and D2 in Appendix D show sequential photographs of the test period.

Figure 7.1. Vehicle/Installation Geometrics for Test No. 420021-5.

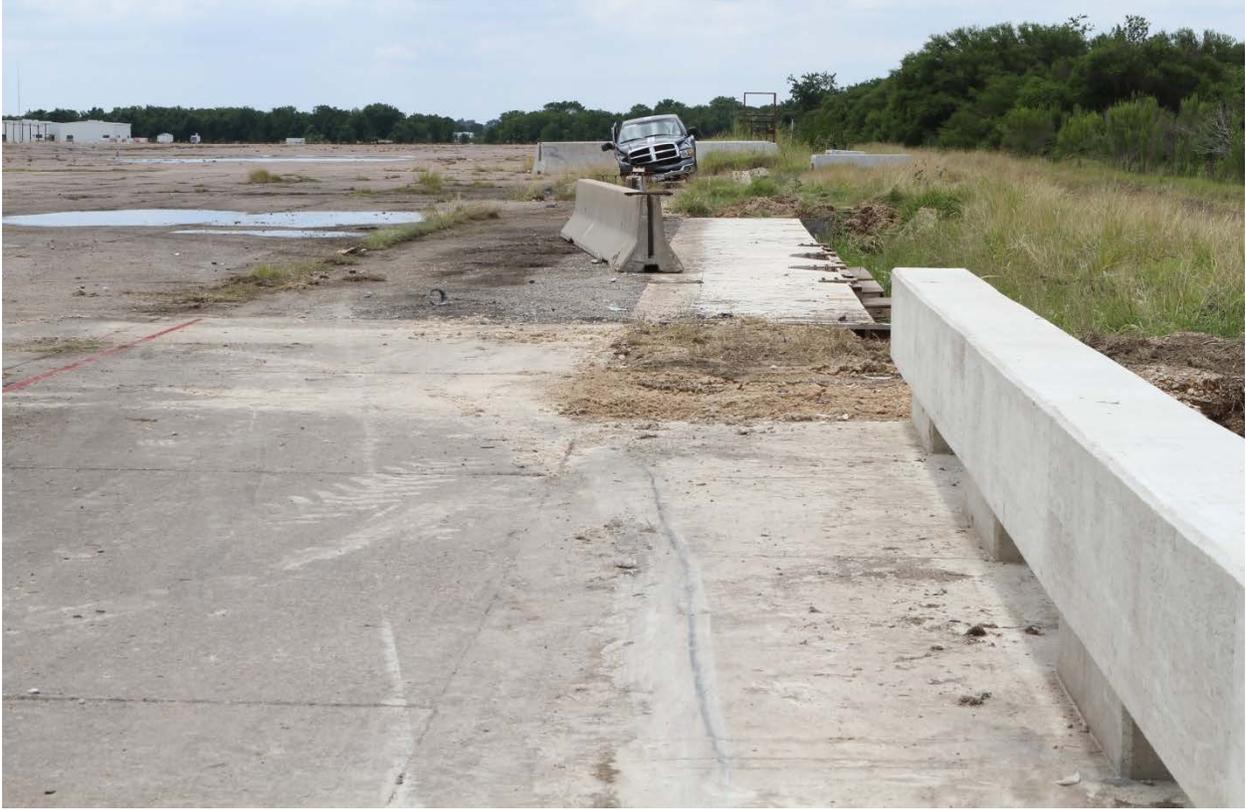
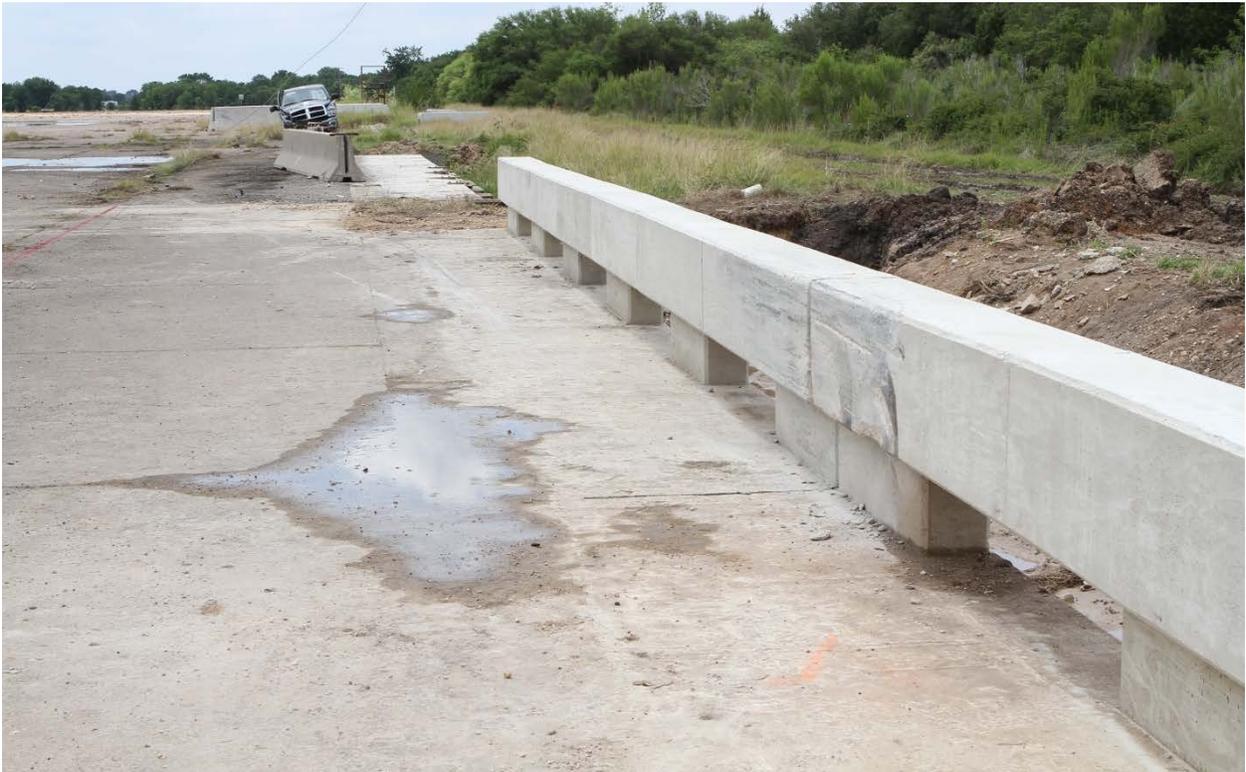
Figure 7.3 and 7.4 show damage to the TxDOT T223 bridge rail anchored to a 5-inch thick (CIPD). Damage to the barrier was cosmetic in nature with only tire marks and a few gouges observed in the concrete traffic face of the upper beam of the barrier. A few tire scuff marks were noted on the face of posts 3 and 4. No cracks were noted in the beam, posts, or bridge deck. Total length of contact of the vehicle with the barrier was 12.9 ft. The vehicle crossed the exit box 82 ft downstream of impact (≥ 32.8 ft allowed). Working width was 16.0 inches, and maximum deflection of the barrier was 0.9 inch.

Figure 7.3. After Impact Vehicle/Barrier Positions for Test No. 420021-5.

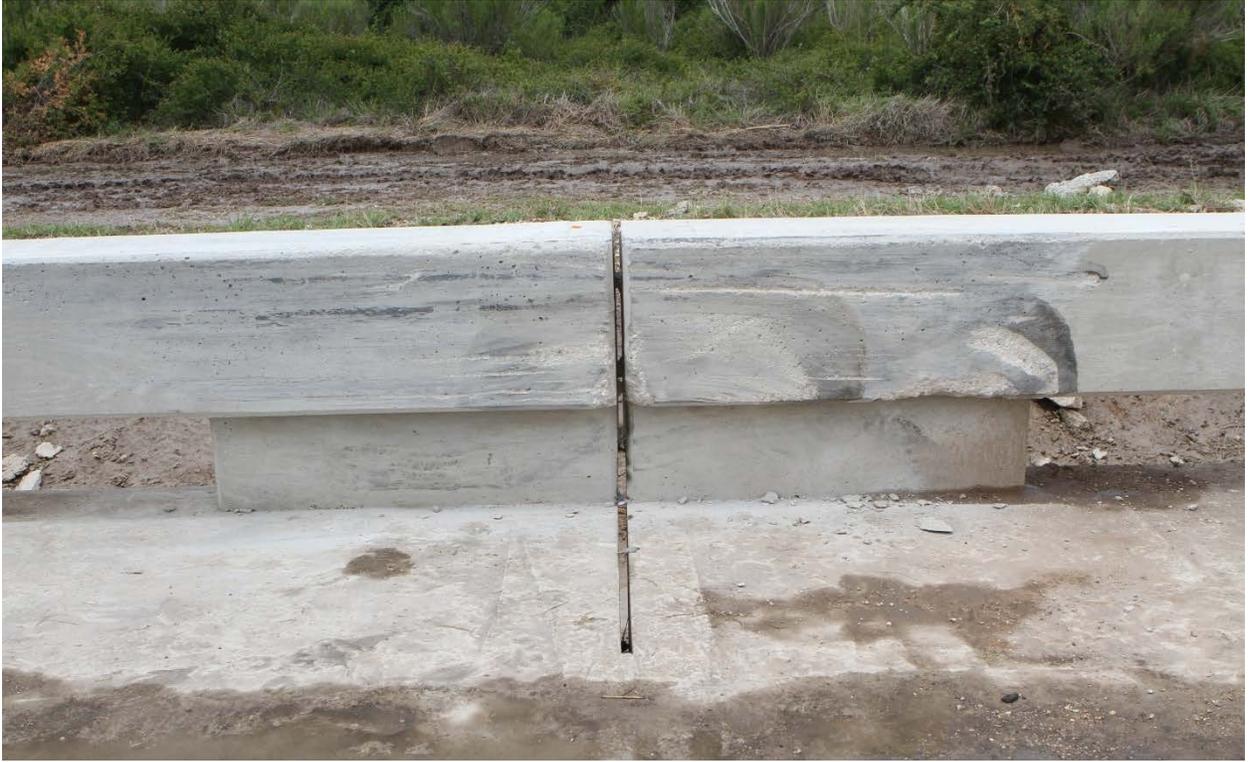
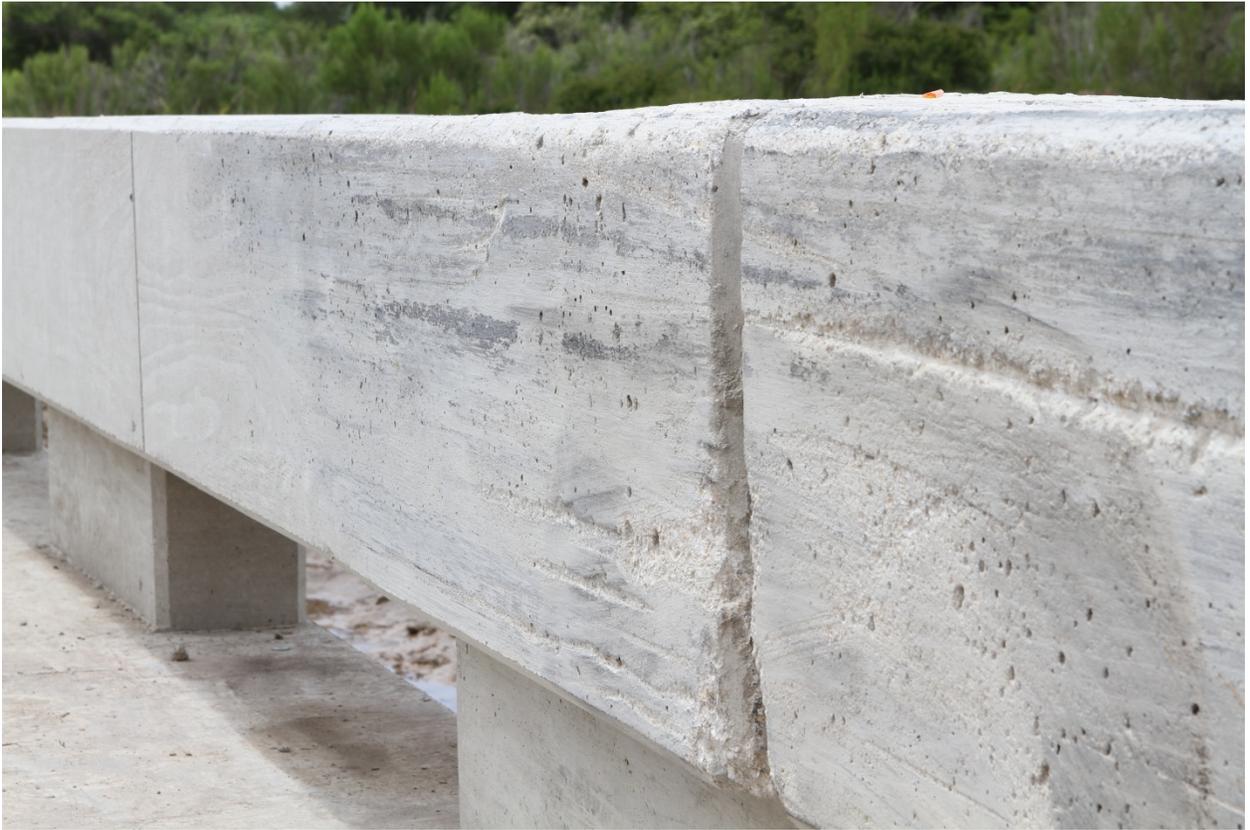
Figure 7.4. Installation after Test No. 420021-5.

The TxDOT T223 barrier anchored in a 5-inch CIPD on a simulated TxDOT prestressed box beam performed acceptably for *MASH* test 3-11, as shown in Table 8.1. No structural damage to the T223 or 5-inch CIPD was observed after the test. The modified anchorage details provided sufficient capacity to contain and redirect the impacting vehicle without causing any damage to the 5-inch CIPD.

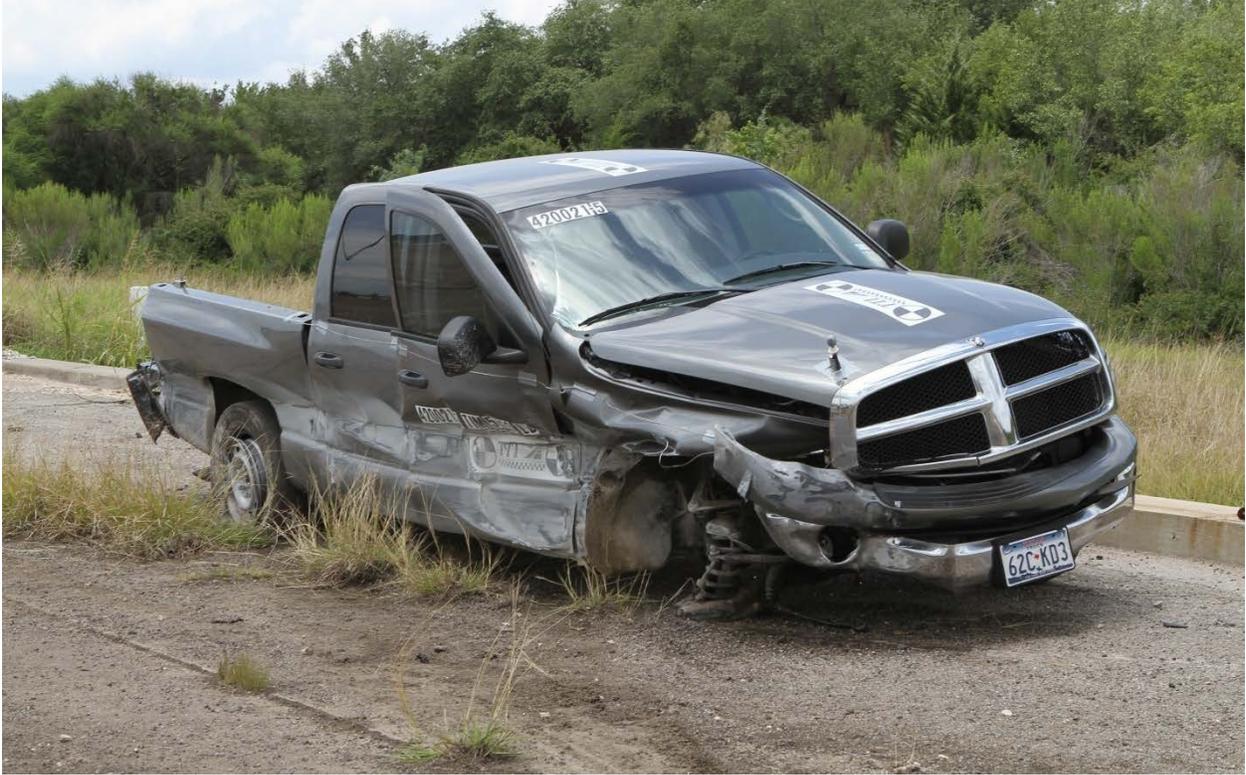
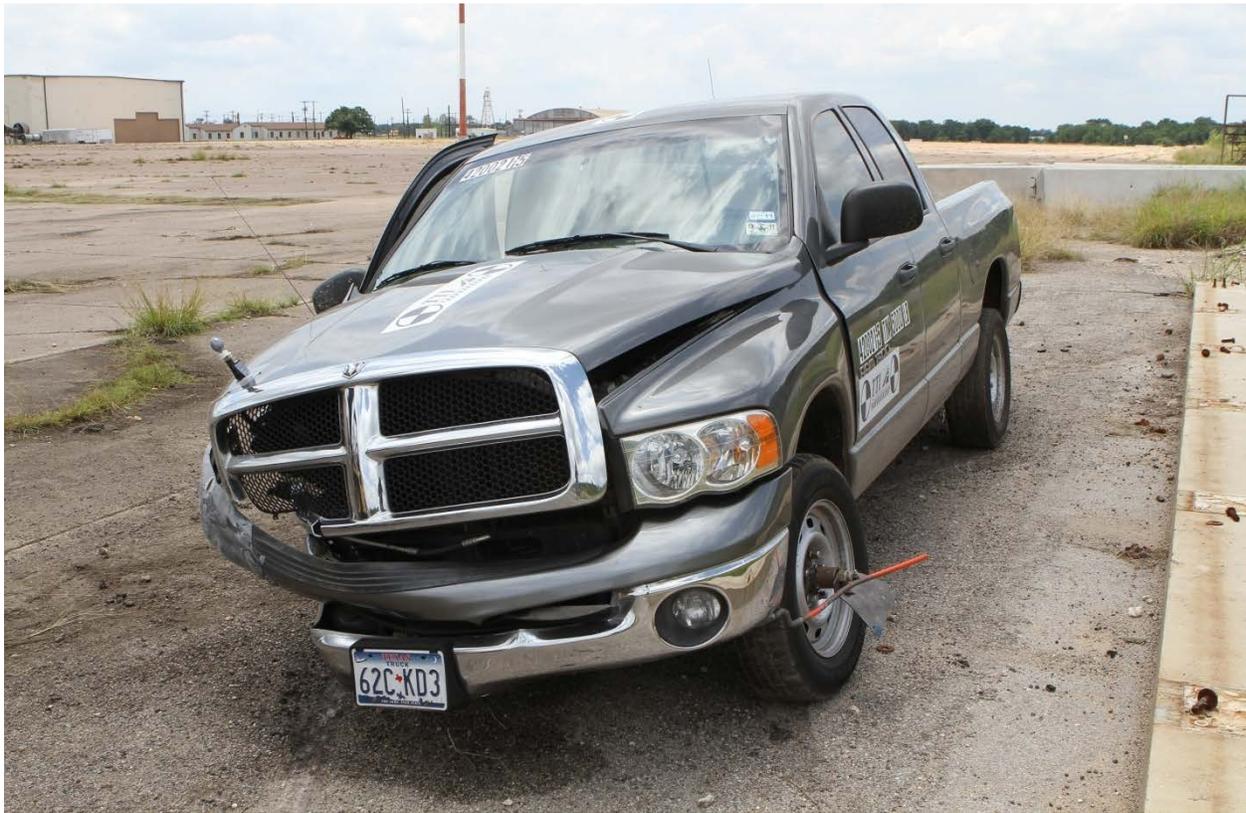
The 2270P vehicle sustained structural damage to the right frame rail, right upper and lower A-arm, right side sway bar, and right front spring and cup. The right upper ball joint pulled out of the socket and the right lower ball joint broke. Figure 7.5 shows damage to the front bumper, right front fender, right front door, right front tire and wheel rim, right rear door, right rear exterior bed, right rear tire and wheel rim, and the rear bumper. Maximum exterior crush to the 2270P vehicle was 18.0 inches in the side plane at the right front corner at bumper height. Maximum occupant compartment deformation was 5.25 inches in the kick panel laterally across the lower cab near the right front passenger side foot well area. Figure 7.6 shows photographs of the interior of the vehicle. Tables C3 and C4 in Appendix D provide exterior crush and occupant compartment deformation measurements.

Figure 7.5. Vehicle after Test No. 420021-5.

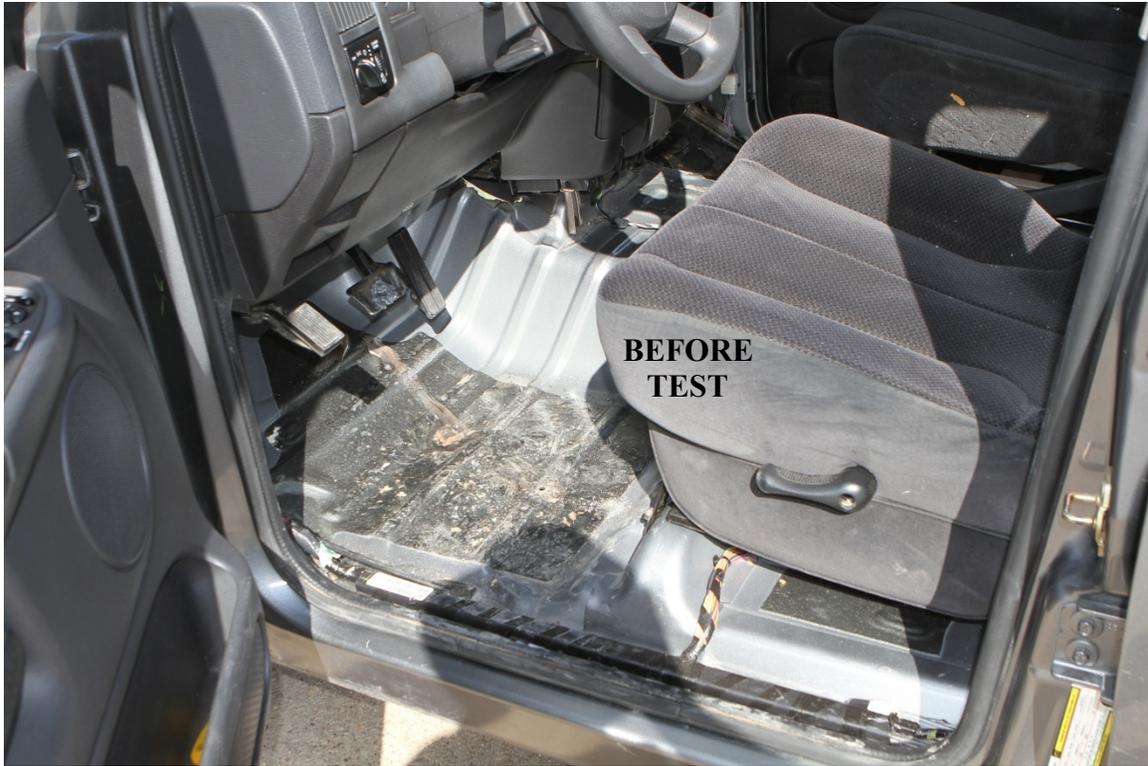
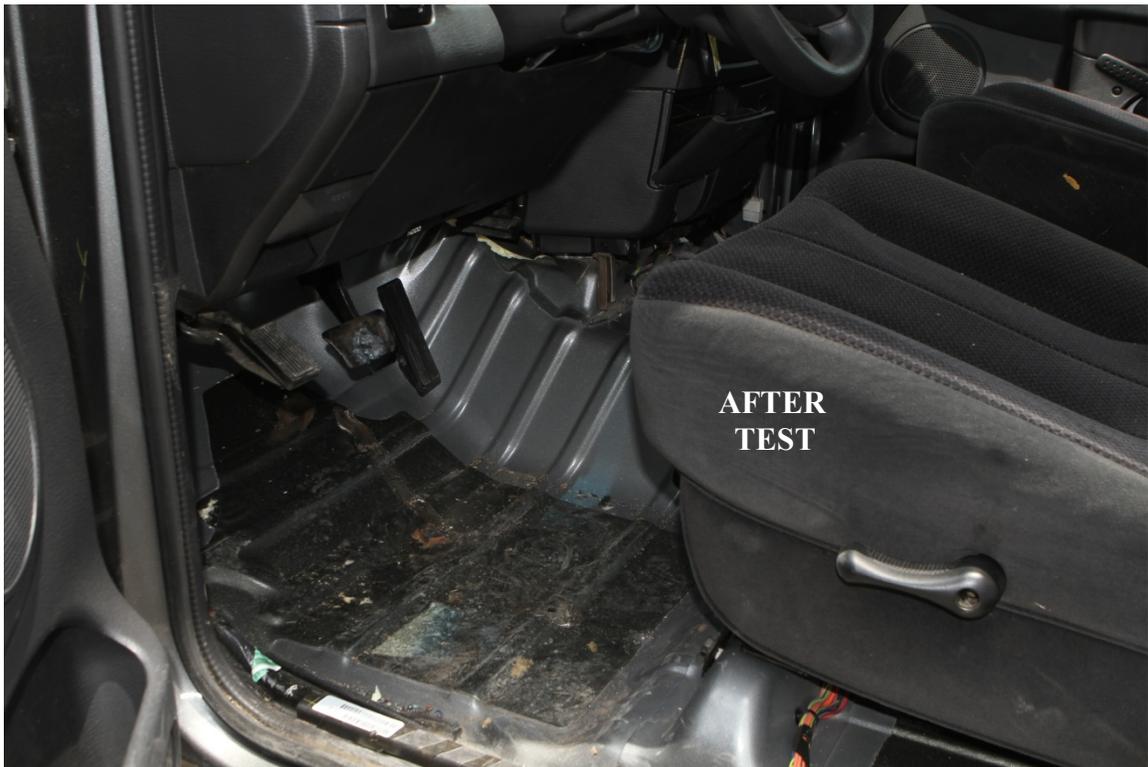
Figure 7.6. Interior of Vehicle for Test No. 420021-5.

Results: No detached elements, fragments, or other debris were present to penetrate or to show potential for penetrating the occupant compartment, or to present hazard to others in the area. (PASS)
Maximum occupant compartment deformation was 5.25 inches in the kick panel laterally across the lower cab near the right front passenger side foot well area. (PASS)

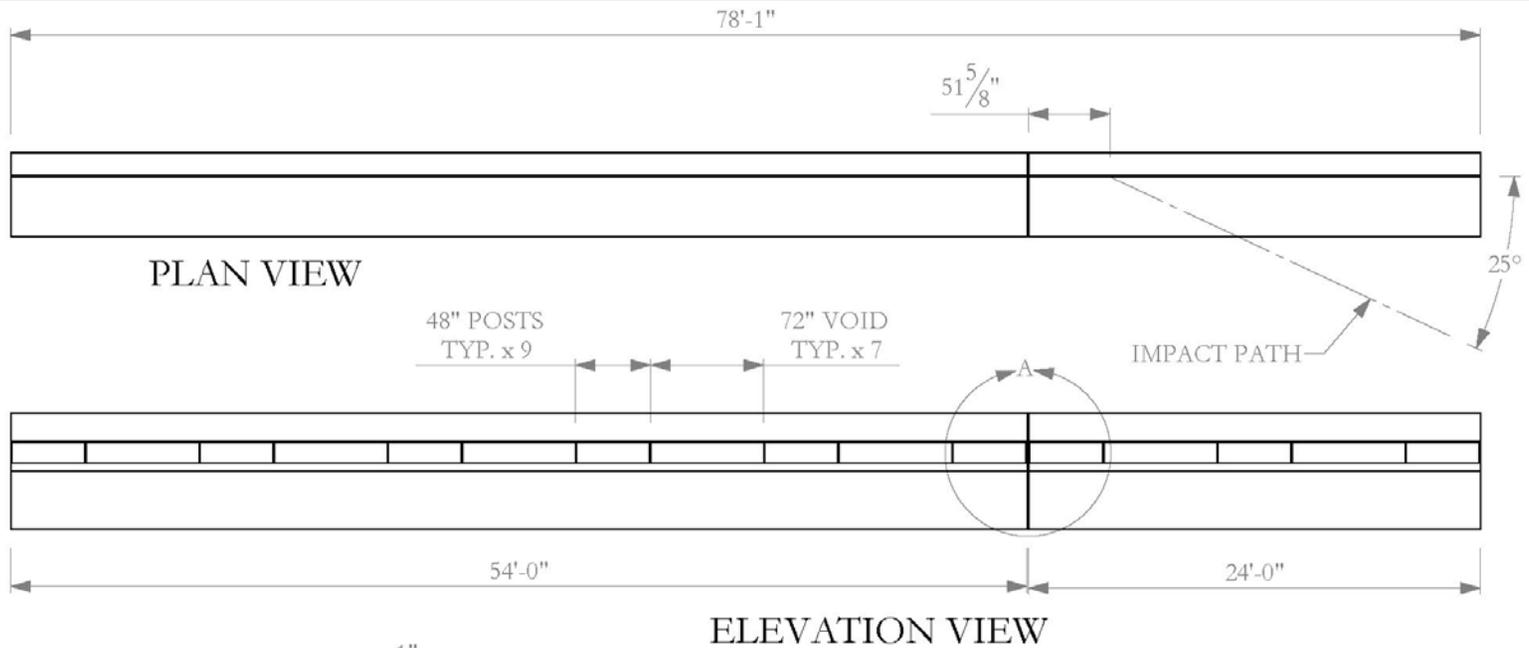
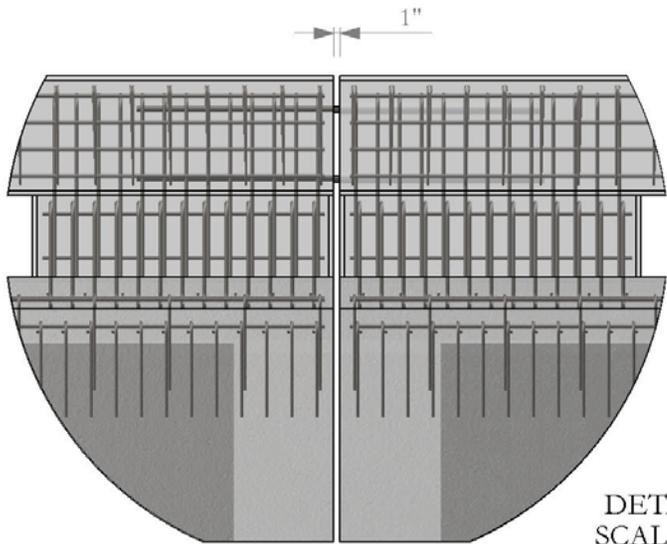
DETAIL A
SCALE 1 : 25

- 1a. All rebar is grade 60.
- 1b. Concrete strength: Box Beam - Class H (5000 psi)
5" Deck - Class S (4000 psi)
T223 Parapet - Class C (3600 psi)
- 1c. Thoroughly wet all forms, prestressed concrete panels, T-beams, and concrete box beams on which concrete is to be placed before placing concrete. Remove any remaining puddles of excess water before placing concrete. Provide surfaces that are in a moist, saturated surface-dry condition when concrete is placed on them.

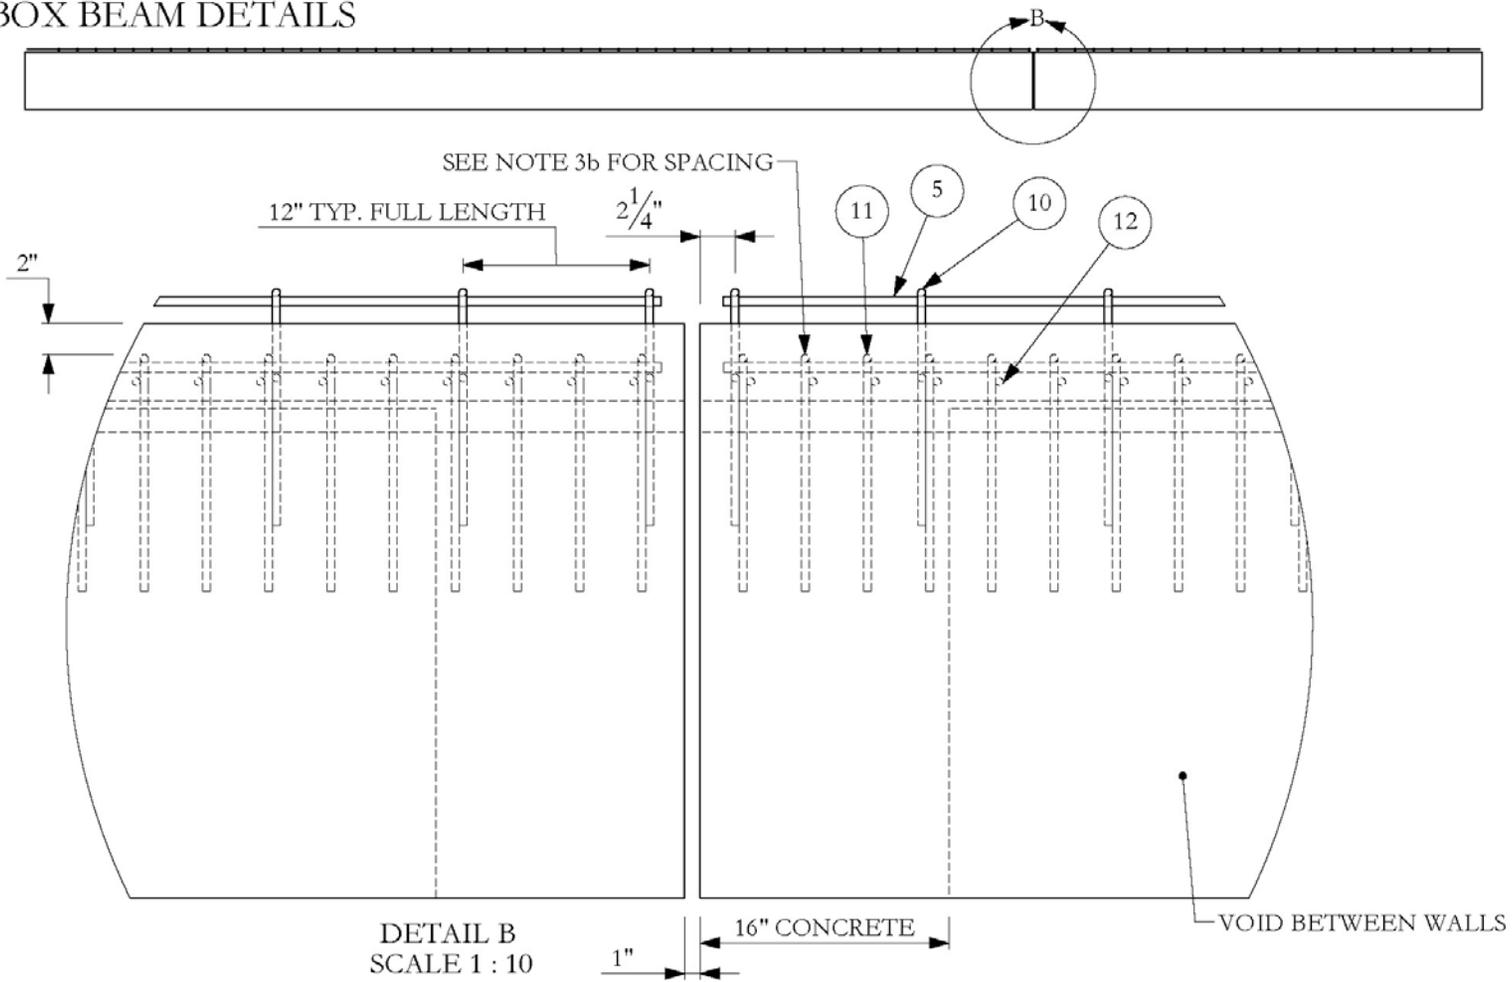
DETAIL B
SCALE 1 : 10

- 3a. Concrete is Class H.
- 3b. Spacing for Bar A (11) and Bar B (12) is 4" for 48" (12 spaces) each side of the expansion joint, then 6" to each end.
- 3c. Lap for #5 bars is 26", and not permissible within 10' of expansion joint.
- 3d. Rebar and concrete is symmetrical from expansion joint to end of short section.
- 3e. Provide a uniform rough wood float finish for the top surface of the concrete.
