MASH TEST 3-11 ON THE 5-INCH CAST IN PLACE DECK BARRIER ANCHORS

Test Report 9-1002-7

16. Abstract A full-scale crash test was performed to evaluate the impact performance of a Texas T223 concrete beam and post bridge rail anchored to a 5-inch cast-in-place deck (CIPD). The testing followed the <i>MASH</i> standards for Test Level 3 (TL-3) longitudinal barriers. The test performed was American Association of State Highways and Transportation Officials (AAHSTO) <i>Manual for Assessing Safety Hardware (MASH)</i> test 3-11, which involves a 2270P (5000 lb) pickup truck impacting the critical impact point (CIP) of the barrier at a nominal impact speed and angle of 62 mi/h and 25 degrees, respectively. This test evaluated the strength of the barrier and its anchorage to the 5-inch CIPD. The T223 bridge rail anchored to a 5-inch CIPD successfully met all required <i>MASH</i> evaluation criteria. The rail anchorage withstood the design impact without any visible distress. The rail anchorage detail is considered suitable for implementation when concrete bridge rails are attached to 5-inch decks cast on prestressed box and slab beams. The anchorage detail is considered acceptable for use w

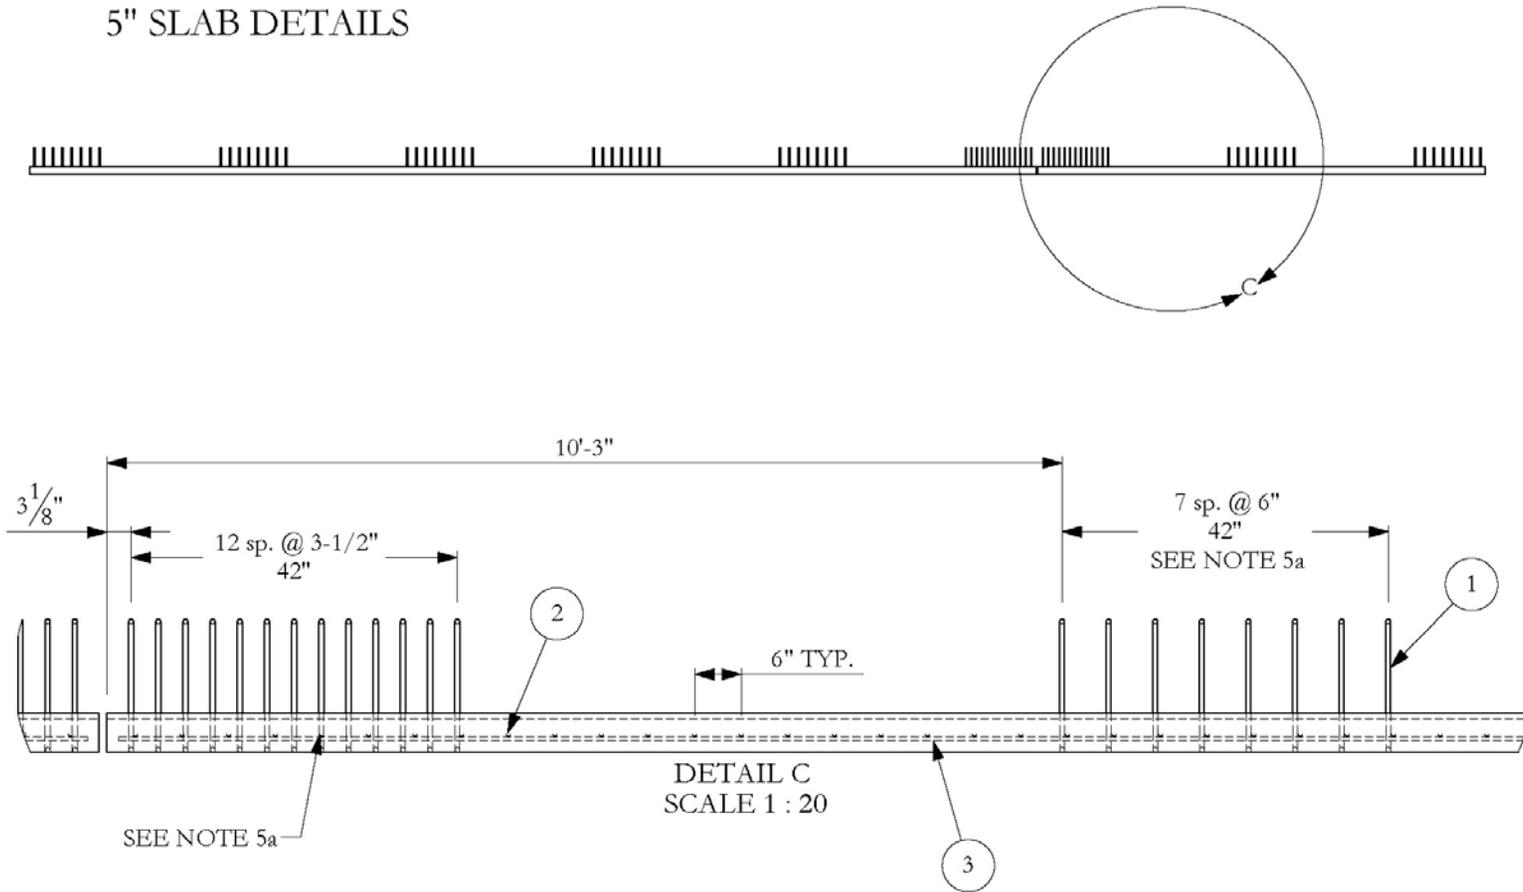
5" SLAB DETAILS

- 5a. U-bar (1) spacing is 3-1/2" at the first post on each side of the expansion joint, U-bar spacing at all other posts is 6". Adjust spacing of transverse bars (2) where necessary to maintain U-bar spacing.
- 5b. Rebar is symmetrical from expansion joint to end of short section.
- 5c. Concrete strength is 4000 psi.
- 5d. Lap for #4 bars is 17", and not permissible within 10' of expansion joint.

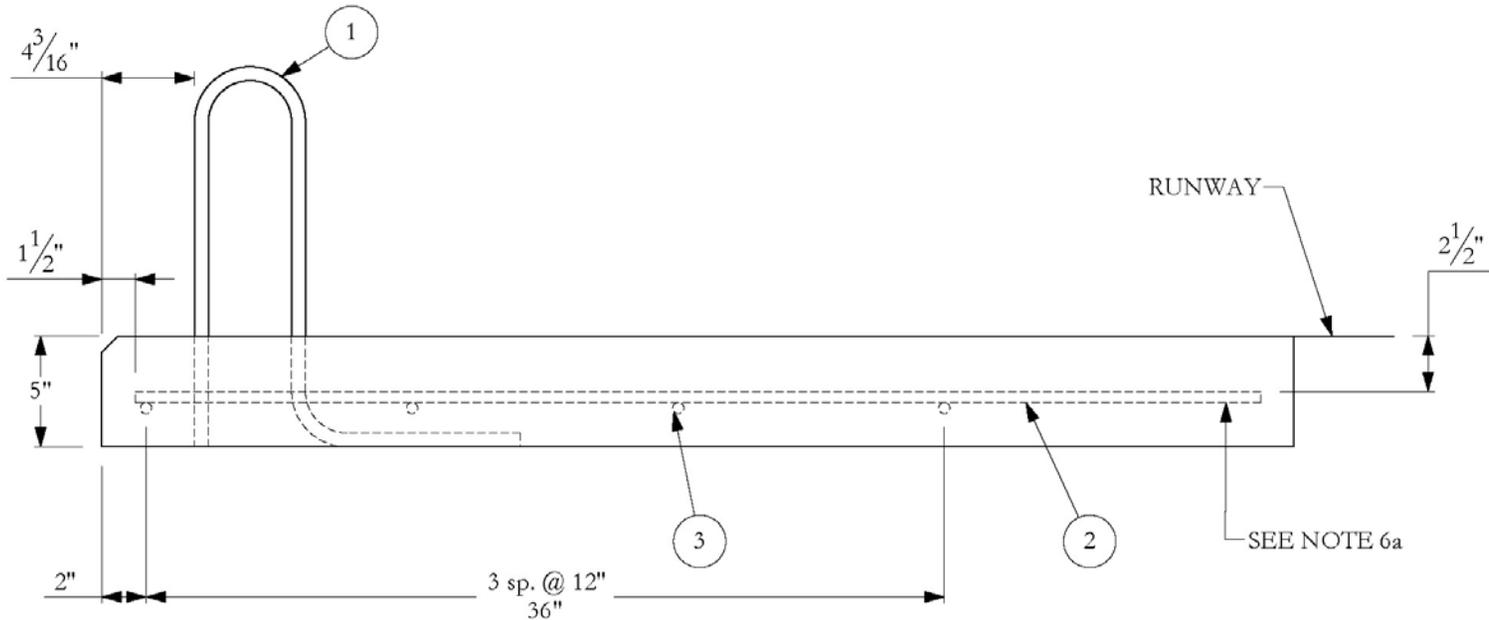
5" SLAB DETAILS

- 6a. Transverse bars (2) weld to existing rebar or strap (not shown) protruding from runway.
- 6b. 3/4" chamfer exposed edge of deck.

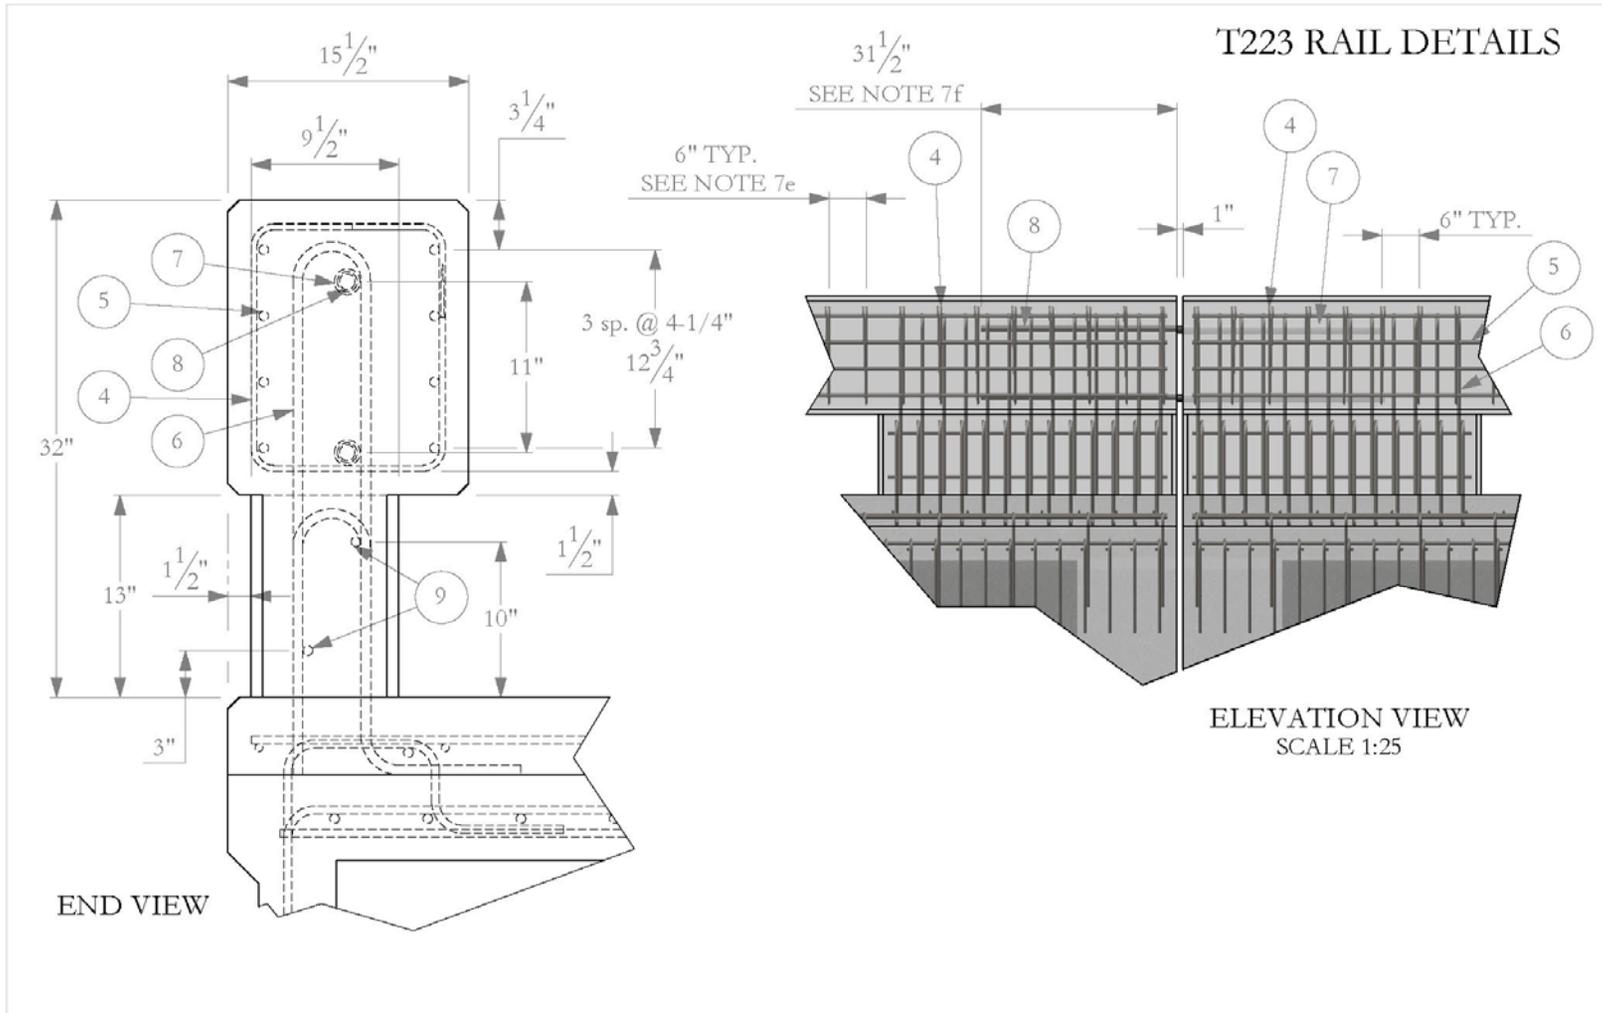
- 7a. 3/4" chamfer all exposed edges of parapet (some chamfers not shown here).
- 7b. Concrete is Class C.
- 7c. Lap for #5 bars is 26", and not permissible within 10' of expansion joint.
- 7d. Spacing on V-bars (6) is same as U-bars (1) (see Note 5a).
- 7e. Adjust spacing of S-bars (4) as necessary to maintain spacing of V-bars.
- 7f. Embedment depth of Ø1" rod (8) in concrete.

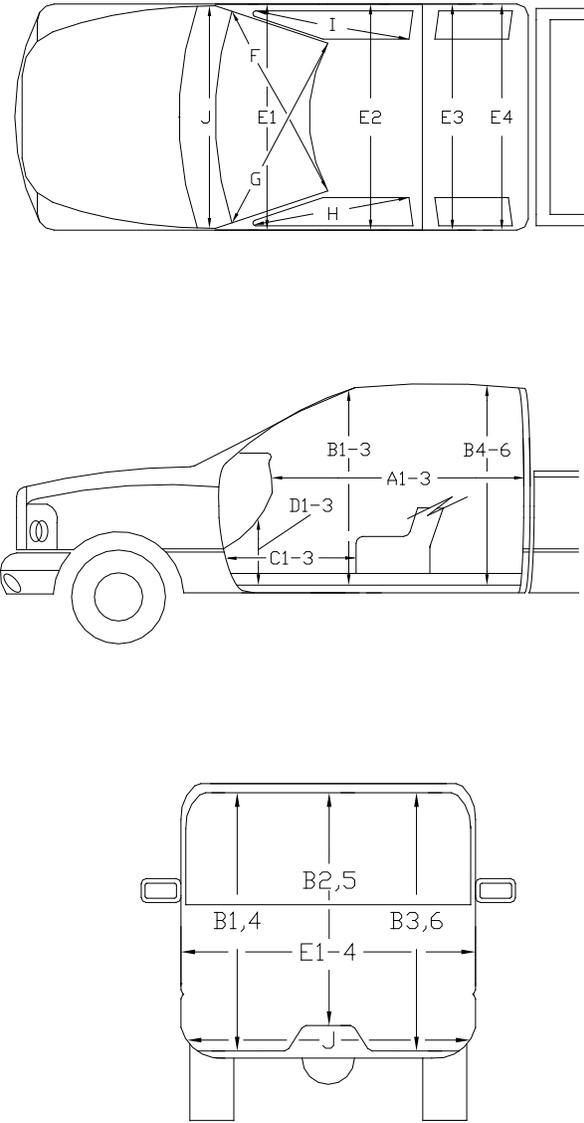
OCCUPANT COMPARTMENT DEFORMATION MEASUREMENT

Before (inches)	After (inches)
A1	64.50	64.50
A2	64.50	64.00
A3	65.50	64.50
B1	45.00	45.00
B2	39.25	38.75
B3	45.50	44.75
B4	42.25	42.25
B5	42.75	42.75
B6	42.25	42.25
C1	27.50	27.50
C2	----	----
C3	27.50	26.50
D1	12.75	12.75
D2	2.50	2.50
D3	11.25	11.75
E1	64.25	64.75
E2	64.25	64.50
E3	64.00	62.25
E4	64.00	63.50
F	60.00	60.00
G	60.00	60.00
H	39.50	39.50
I	39.50	39.50
J*	62.75	57.00

*Lateral area across the cab from driver's side kickpanel to passenger's side kickpanel.

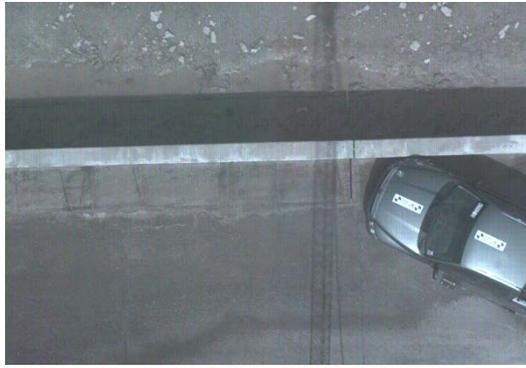
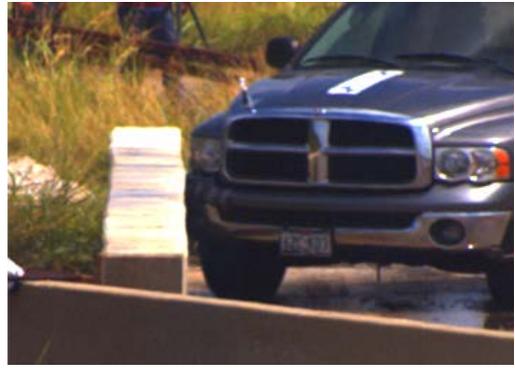
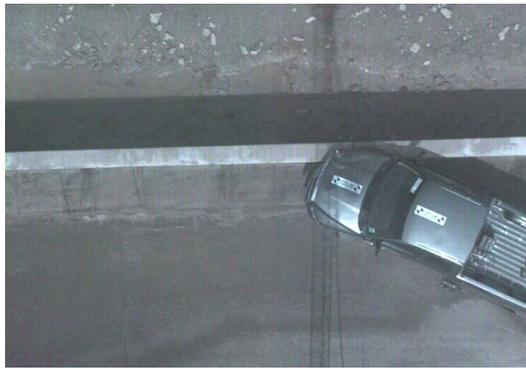
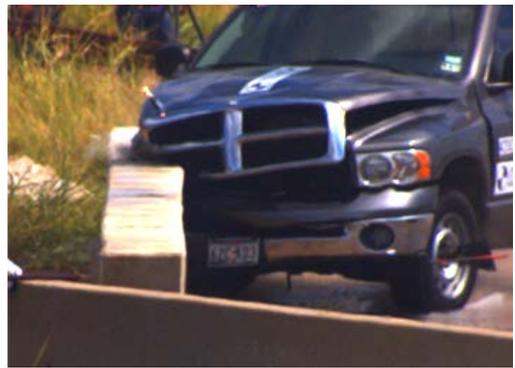
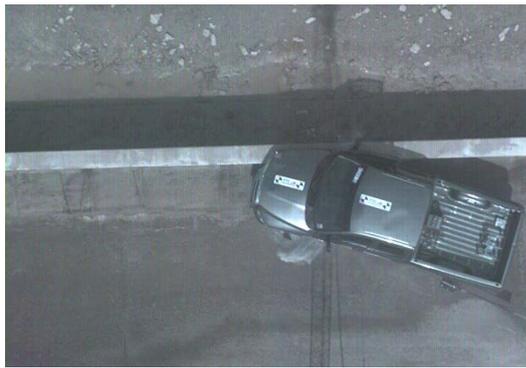
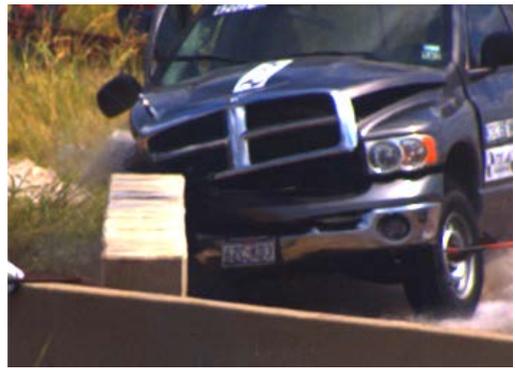
Figure D1. Sequential Photographs for Test No. 420021-5 (Overhead and Frontal Views).

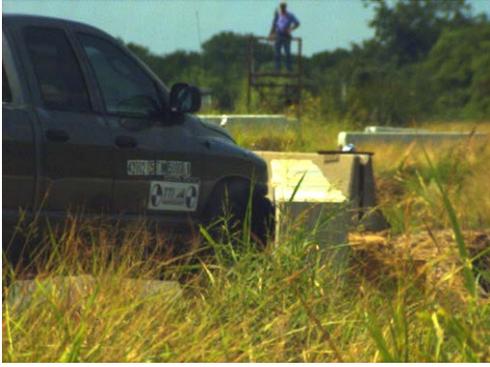
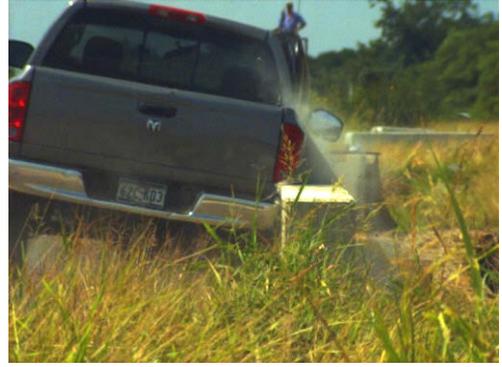
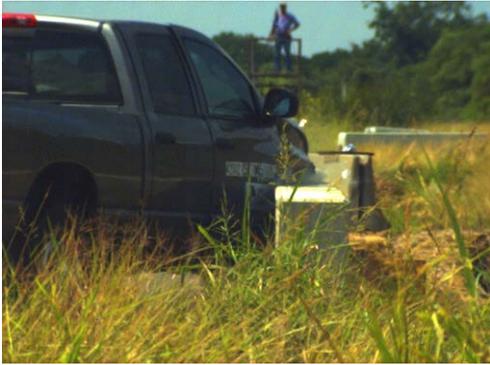
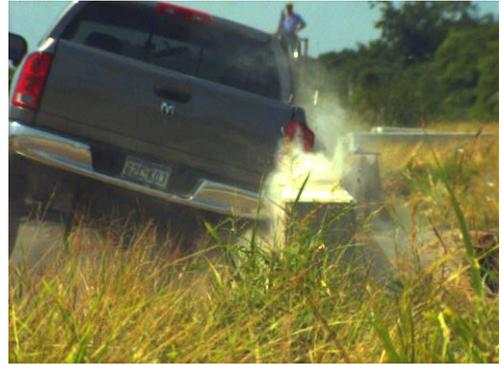
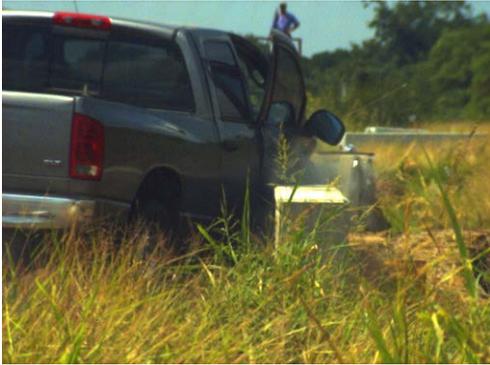
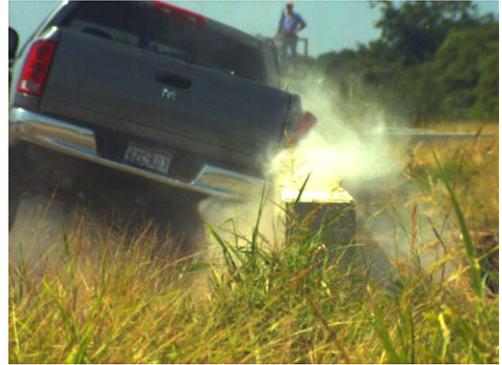
Figure D2. Sequential Photographs for Test No. 420021-5 (Rear View).

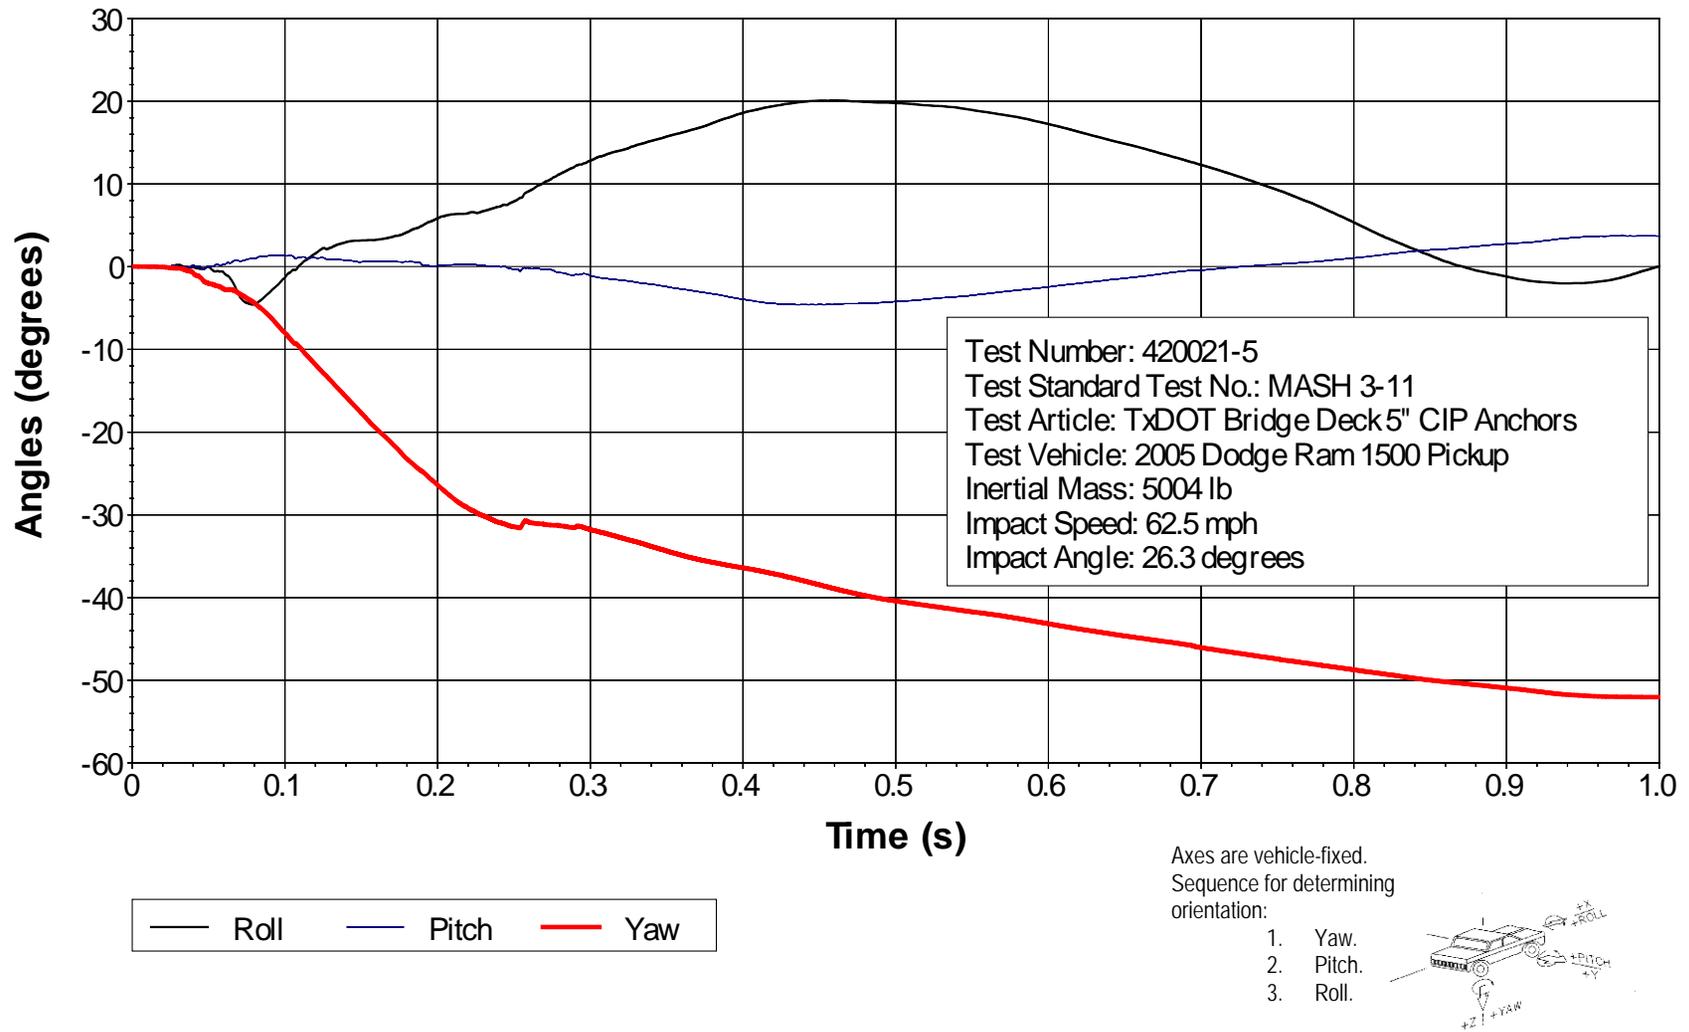
Figure E1. Vehicle Angular Displacements for Test No. 420021-5.

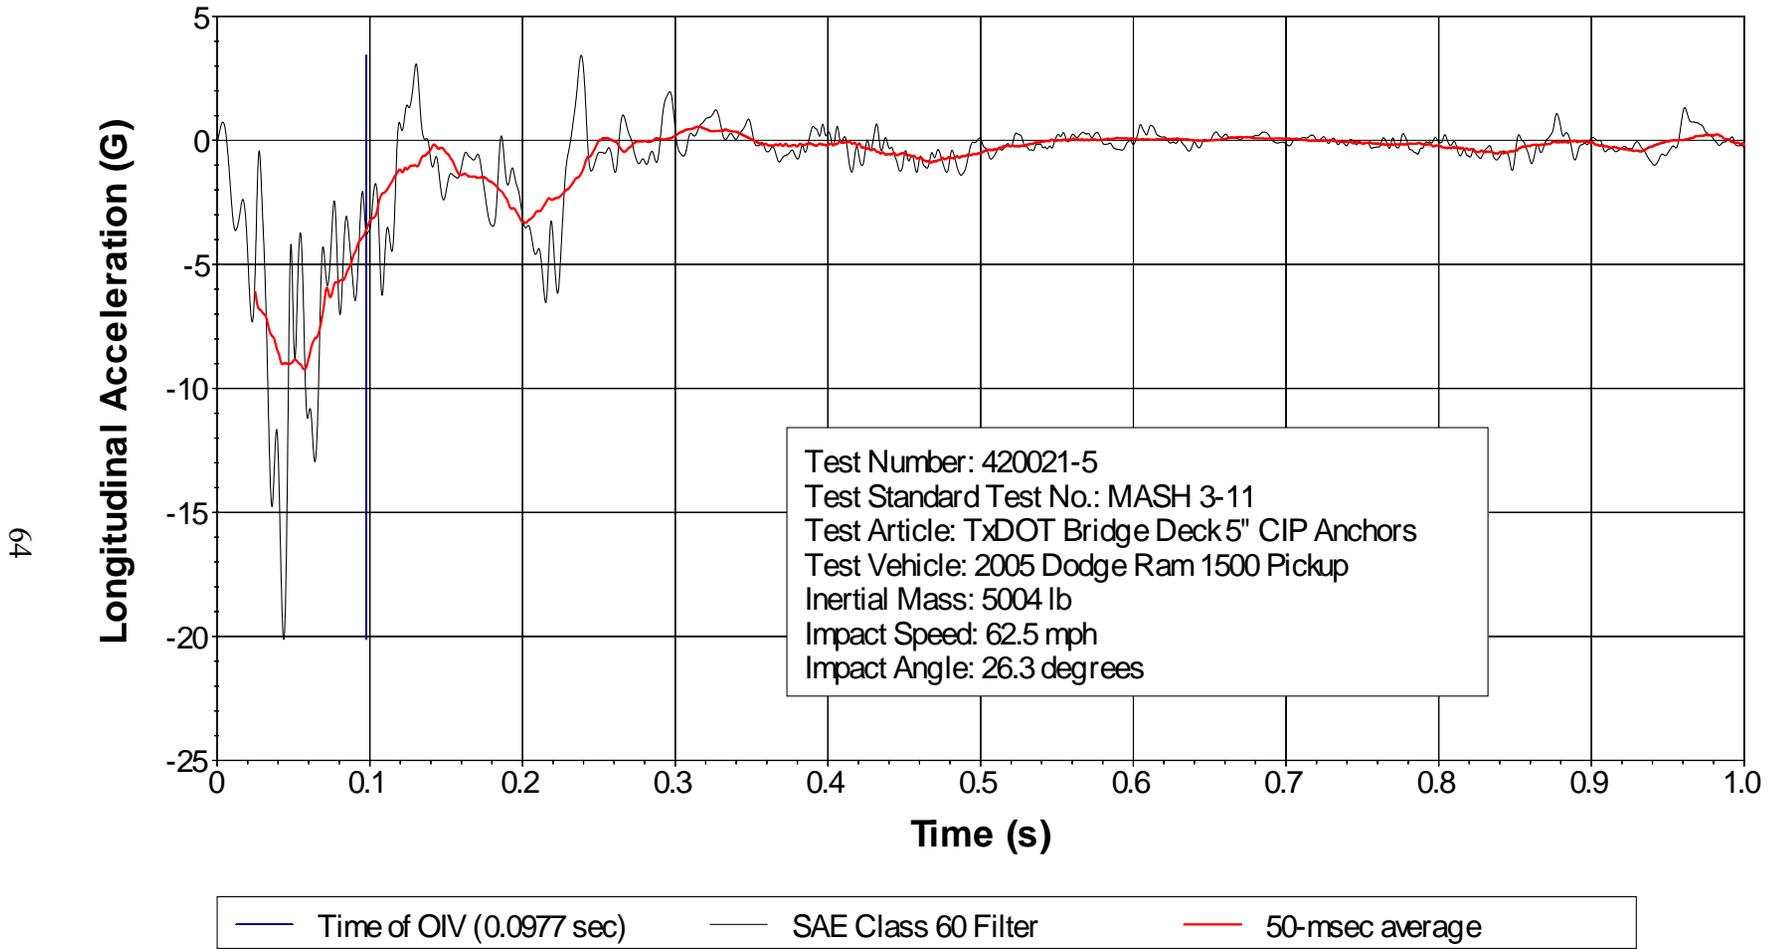
Data from the accelerometer, located at the vehicle center of gravity, were digitized for evaluation of occupant risk. In the longitudinal direction, the occupant impact velocity was 19.7 ft/s at 0.098 s, the highest 0.010-s occupant ridedown acceleration was 5.6 Gs from 0.207 to 0.217 s, and the maximum 0.050-s average acceleration was -9.2 Gs between 0.032 and 0.082 s. In the lateral direction, the occupant impact velocity was 26.6 ft/s at 0.098 s, the highest 0.010-s occupant ridedown acceleration was 7.2 Gs from 0.239 to 0.249 s, and the maximum 0.050-s average was -13.0 Gs between 0.041 and 0.081 s. Theoretical Head Impact Velocity (THIV) was 36.8 km/h or 10.2 m/s at 0.095 s; Post-Impact Head Decelerations (PHD) was 8.4 Gs between 0.210 and 0.220 s; and Acceleration Severity Index (ASI) was 1.62 between 0.033 and 0.083 s. Figure 7.7 summarizes these data and other pertinent information from the test. Vehicle angular displacements and accelerations versus time traces are presented in Appendix E, Figures E1 through D7.

**Figure E2. Vehicle Longitudinal Accelerometer Trace for Test No. 420021-5
(Accelerometer Located at Center of Gravity).**

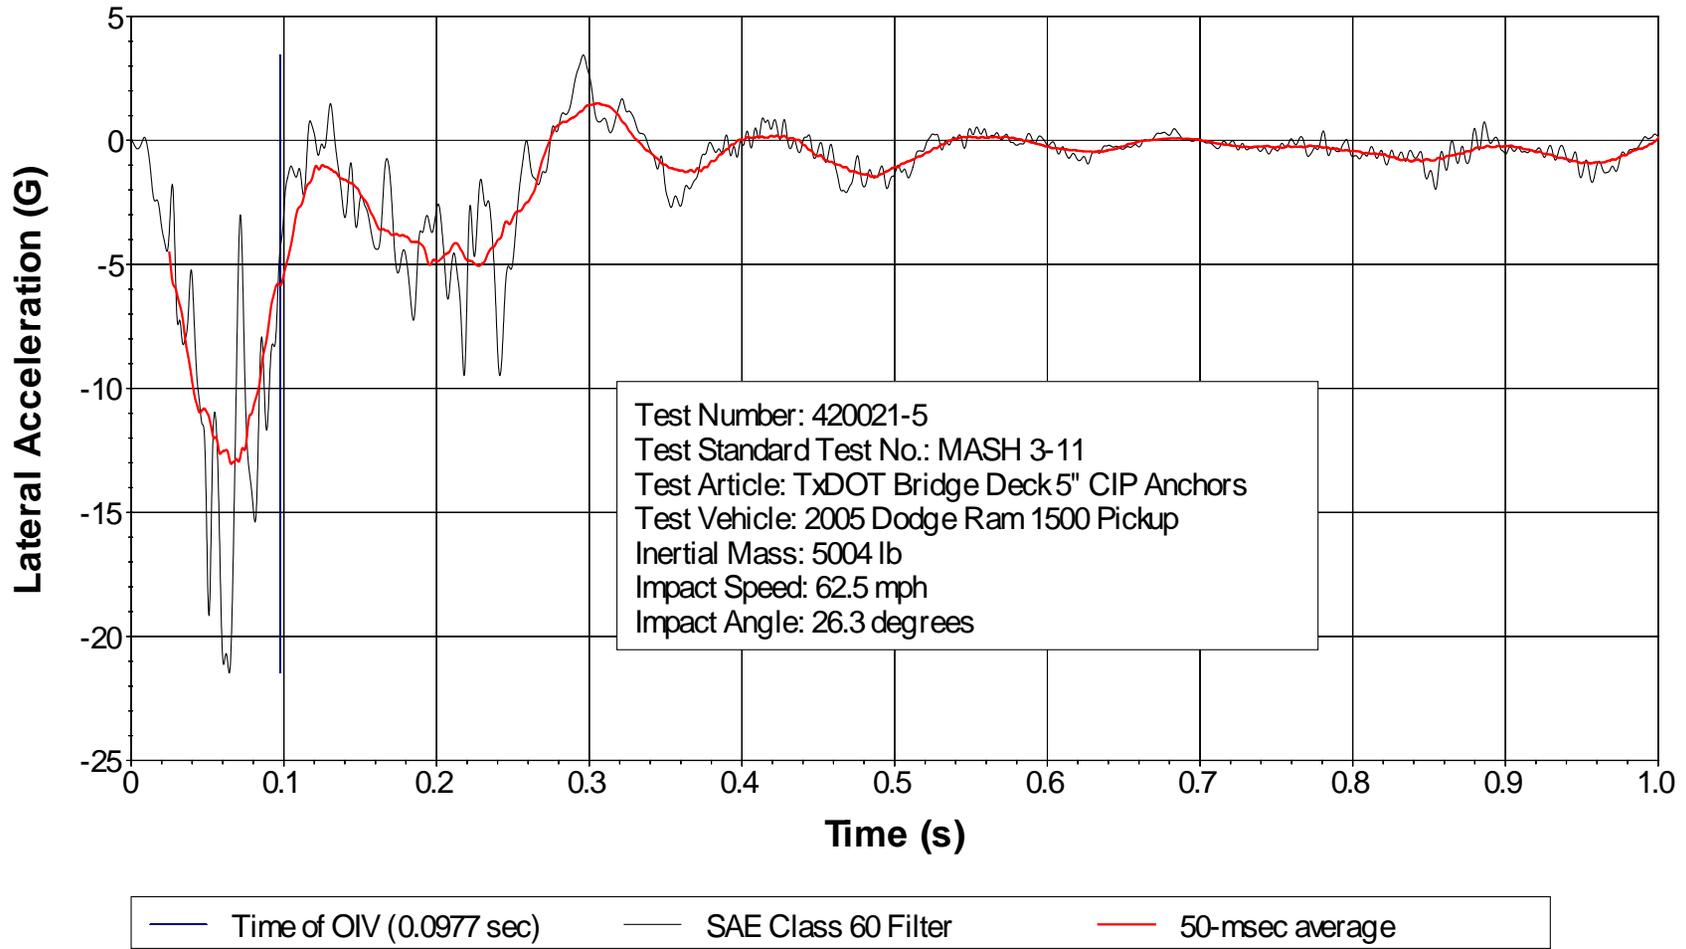
Figure E3. Vehicle Lateral Accelerometer Trace for Test No. 420021-5 (Accelerometer Located at Center of Gravity).

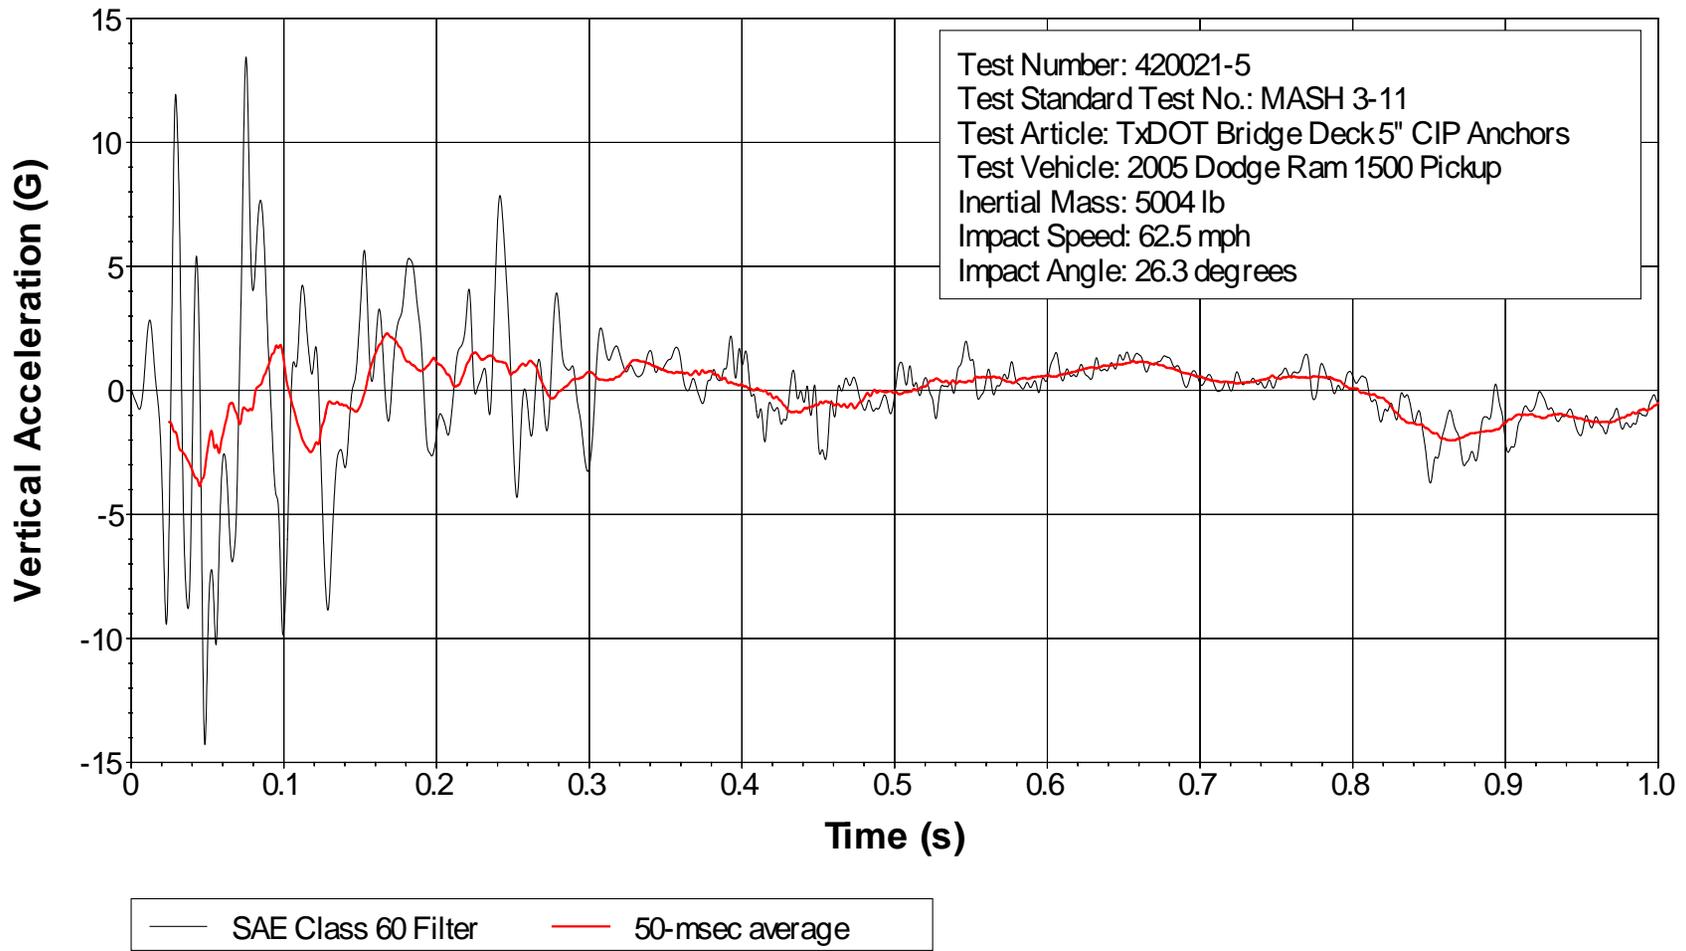
Figure E4. Vehicle Vertical Accelerometer Trace for Test No. 420021-5
(Accelerometer Located at Center of Gravity).

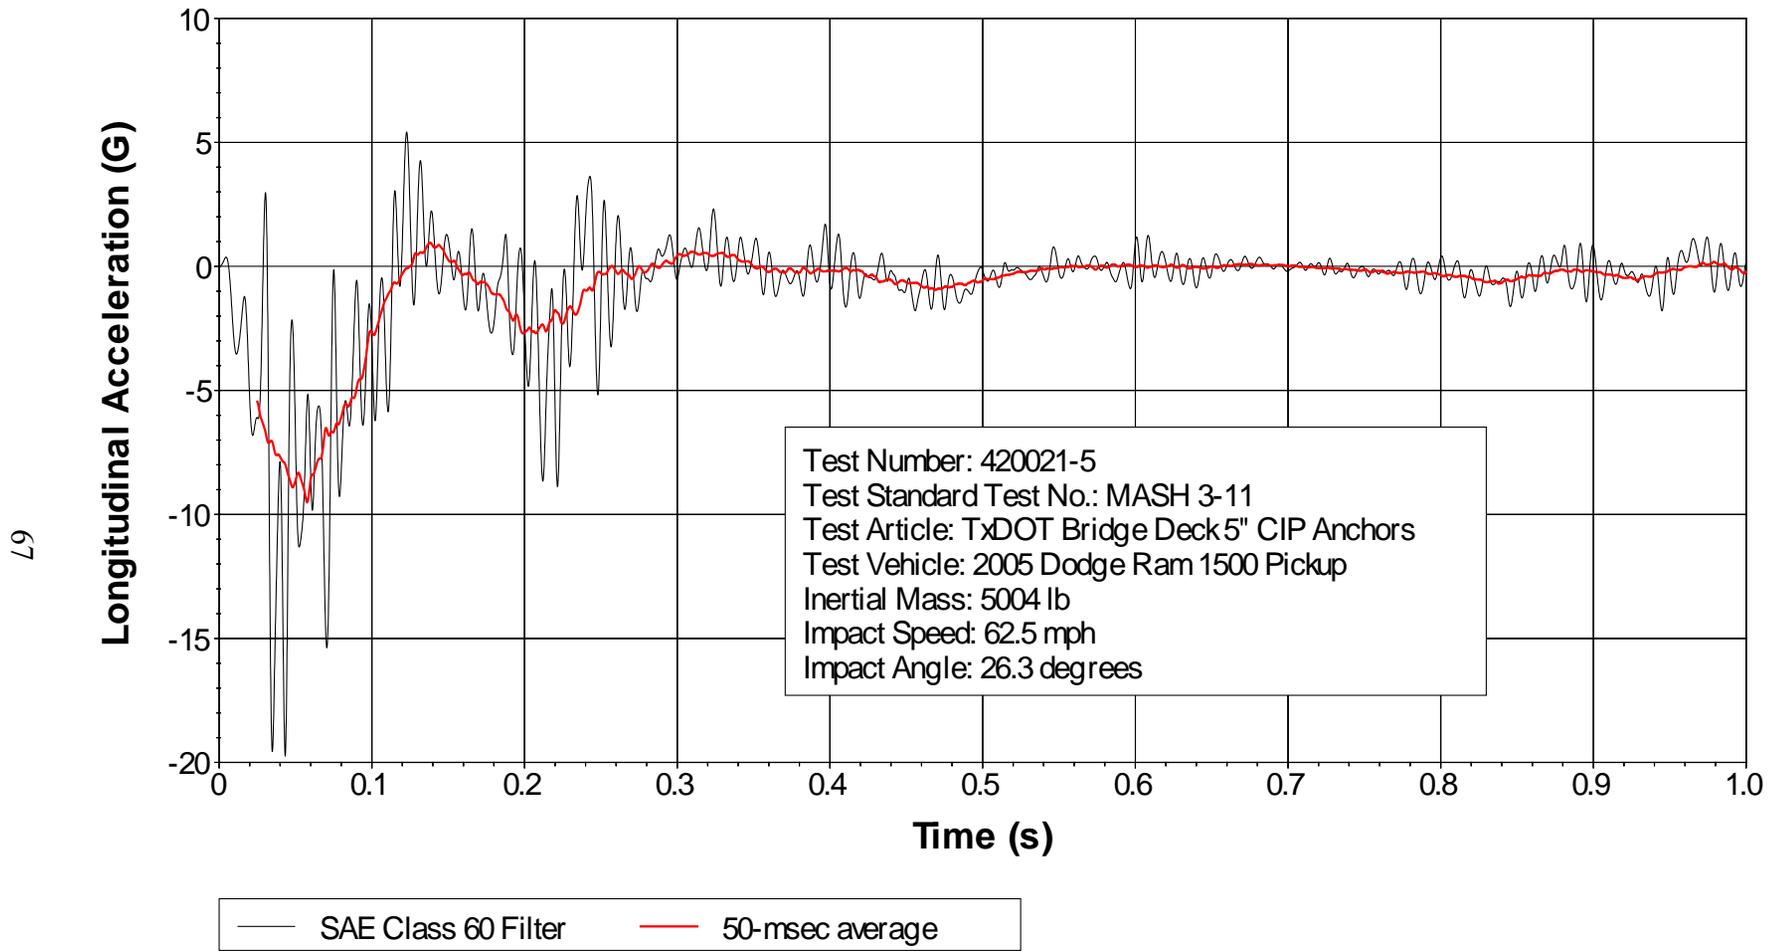
**Figure E5. Vehicle Longitudinal Accelerometer Trace for Test No. 420021-5
(Accelerometer Located over Rear Axle).**

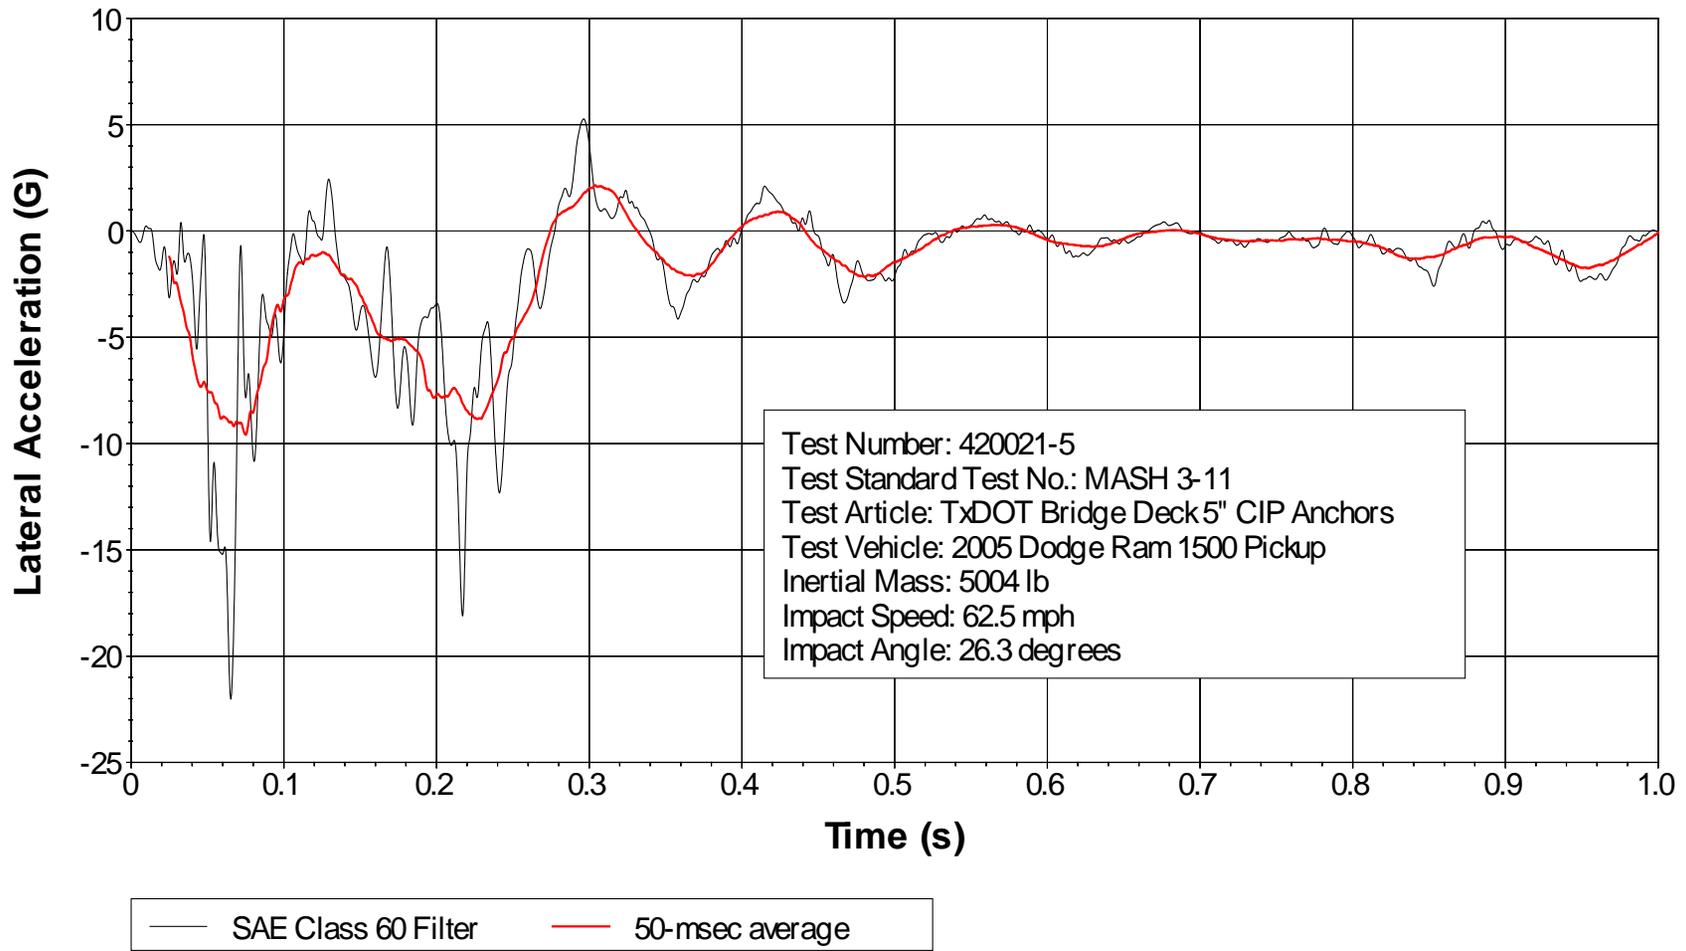
**Figure E6. Vehicle Lateral Accelerometer Trace for Test No. 420021-5
(Accelerometer Located over Rear Axle).**

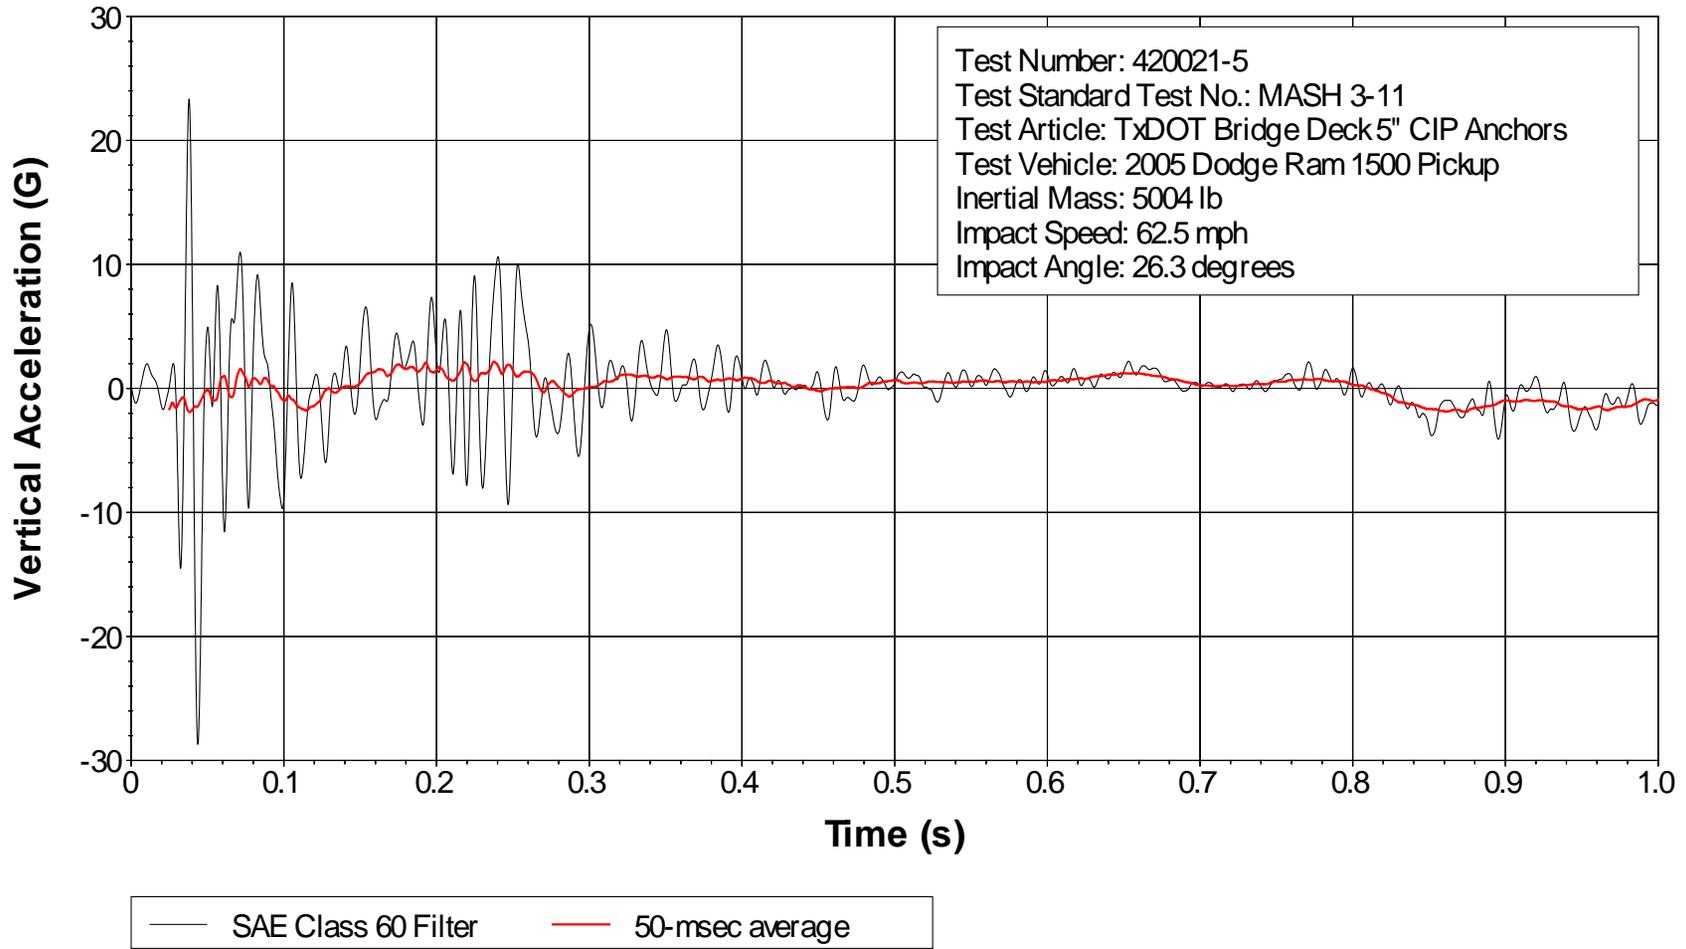
**Figure E7. Vehicle Vertical Accelerometer Trace for Test No. 420021-5
(Accelerometer Located over Rear Axle).**
