Sensing Technology for Damage Assessment of Sign Supports and Cantilever Poles

FINAL REPORT

By Piervincenzo Rizzo and Xuan Zhu
University of Pittsburgh

COMMONWEALTH OF PENNSYLVANIA
DEPARTMENT OF TRANSPORTATION

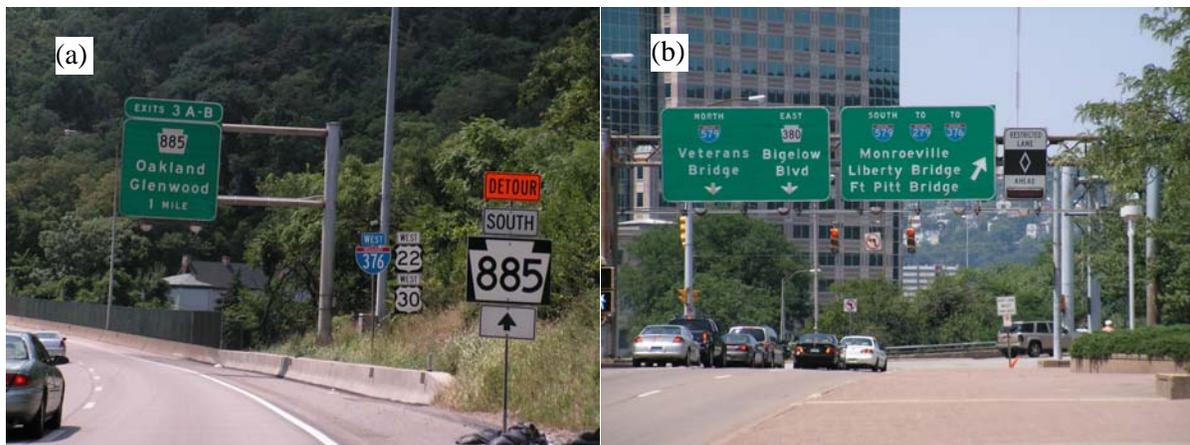
Figure 1.1 – Examples of: (a) overhead cantilever with single pole; (b) overhead bridge truss with truss poles.

Cantilevered support structures can be an attractive option because the cost is typically less than 40 percent of the cost of bridge supports. Also, the single upright increases motorist safety by reducing the probability of vehicle collision (Dexter and Ricker 2002). In Pennsylvania two types of overhead sign support structures are mainly used, namely the cantilever with single pole and overhead bridge truss with bridge pole.

Photos of these two structures taken in the Pittsburgh area are presented in Fig. 1.1.

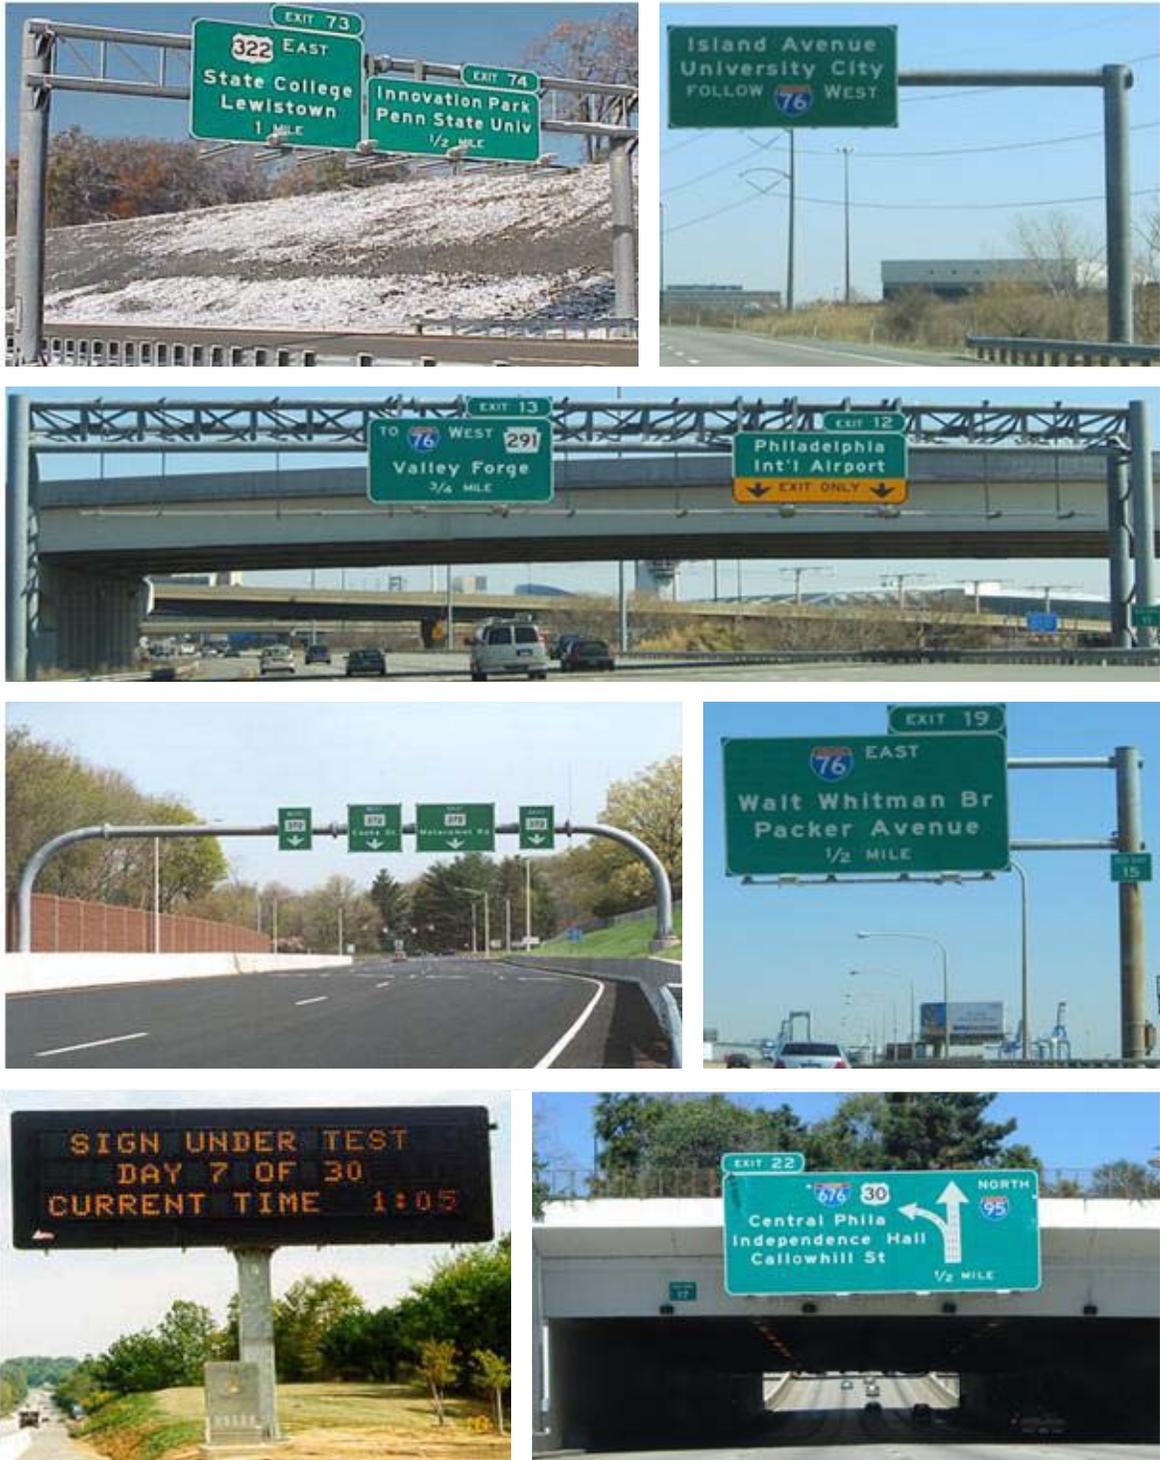
Figure 1.2 - Examples of (clockwise from top left): overhead truss with single pole supports, cantilevered single pole, overhead truss with truss supports, cantilever with double pole, a structure mounted sign, pole mounted VMS, monotube structure.

Nationwide and through the years, the configuration of the full-span overhead sign supports has evolved, and today many structures consist of a truss-type structure that contains fully welded pipe-to-pipe connections (Ginal 2003). A gallery of different sign support structures is provided in Fig. 1.2.

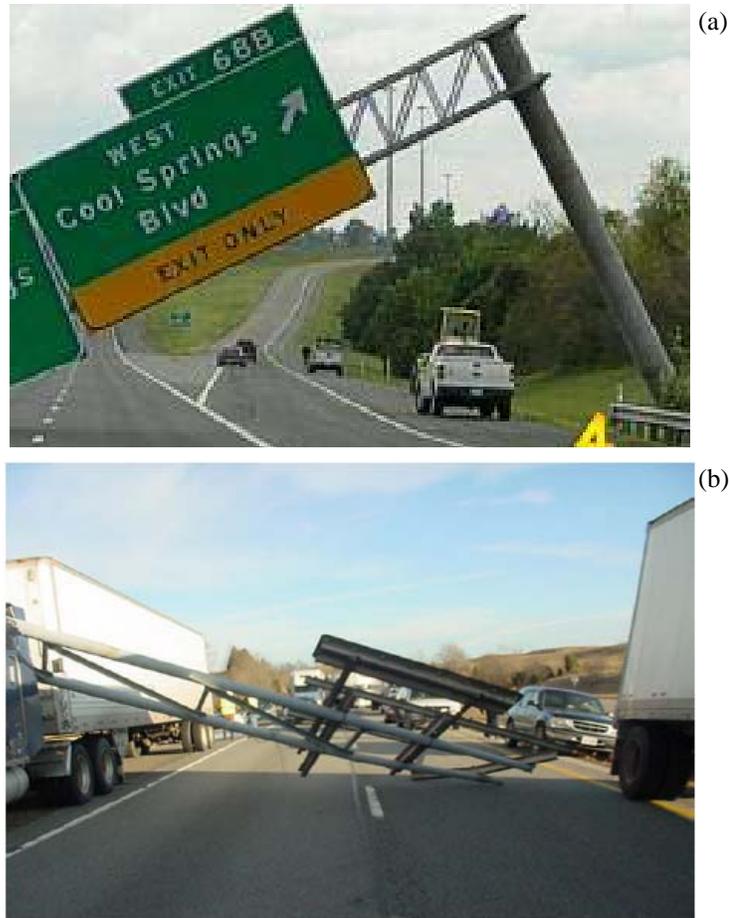
Figure 1.3 – (a) Collapse of a sign structure along I-65 in Tennessee. <http://updatewindowssecurity.com/?id=34452915477> (b) Cantilever Sign Structure Failure: (Source: <http://www.fhwa.dot.gov/BRIDGE/signinspection03.cfm>).

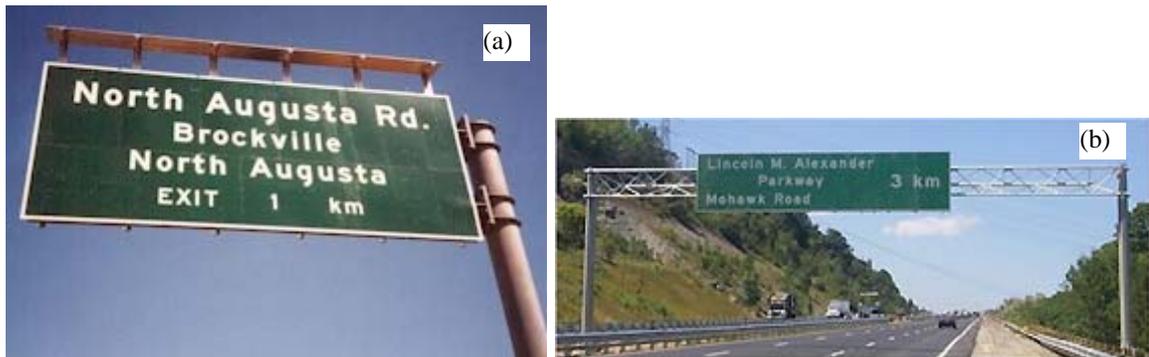
Figure 2.1 – (a) Cantilever sign support structure with a damping plate (along top) to combat the destructive forces of sympathetic wind vibrations. (b) Trichord overhead sign support
Source: <http://www.burgesseng.com/sign.htm>

As described in the introduction cantilevered signal, sign, and light support structures have a single vertical column referred to as an upright, post, or pole (Fig. 2.1a). Structures supported on both sides of the roadway are referred to as bridge supports, also called span-type structures, sign bridges, or overhead structures. The horizontal span of the structure can have the shape of a monotube or a tri-chord truss (Fig. 2.1b) or a four-chord truss (Fig. 2.2). Across the United States there is great variety in the types of sign structures used.

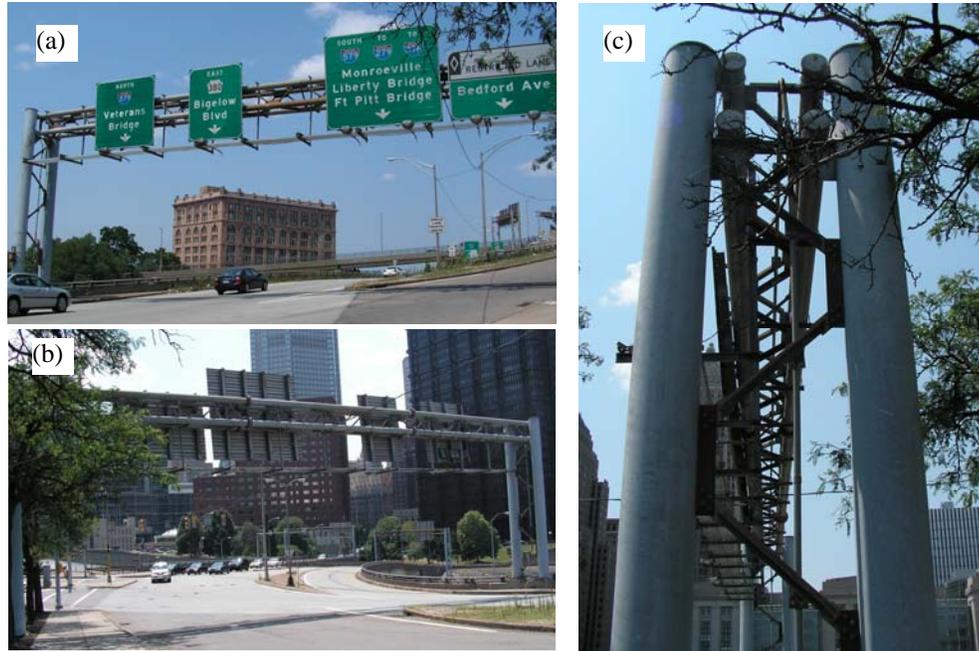
Figure 2.2 – Four-chord overhead truss structure in Pittsburgh, PA. (a) Front view; (b) rear view; (c) side view.

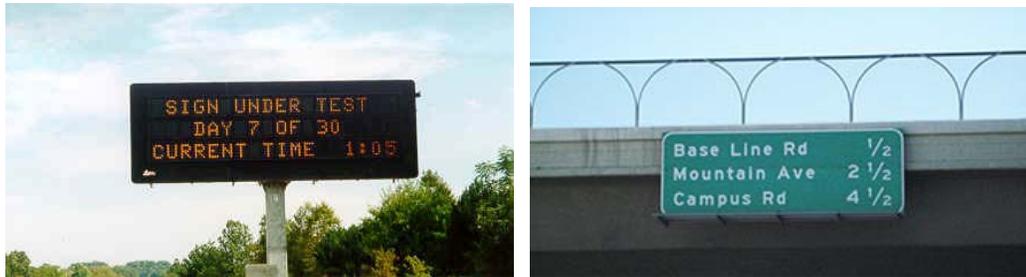
Figure 3.2– (a) Pole mounted VMS (<http://www.paturnpike.com/newsletters/summer99/vmstest.jpg>); (b) structure mounted sign (<http://www.universalindustrialsales.com/images/pic-001.jpg>)

District 4 reported the use of overhead cantilever with double pole and district 5 uses a pole mounted VMS (Fig. 3.2a) and a structure mounted sign (Fig. 3.2b).

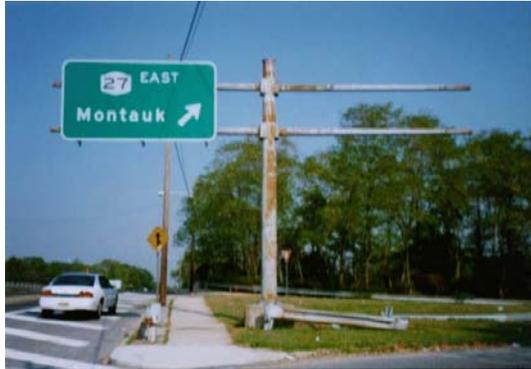
Figure 3.4 – Butterfly cantilever structure (NYDOT, 2-11)

- Box truss with cantilever (MO)
- Bridge mounted frame (CN, TN)
- Bridge truss with truss pole parallel to traffic (WA)
- Butterfly cantilever with single pole (CN, IL, NY. See Fig. 3.4)
- Butterfly truss (KS, NY, TN, MO)
- Cantilever monotube (WA)
- Cantilever truss with truss pole (AR)
- Cantilever with double poles (PA 9)
- Double tube butterfly (MO)
- Overhead spans in highway cuts supported on retaining walls with no poles (NY)
- Propped cantilever with truss pole (AR)
- Single tube with hinge at top of pole (IA)
- Single tube tapered span (KS, MO)
- Timber poles with steel cables (WI)
- T-mount truss on truss pole (AR)

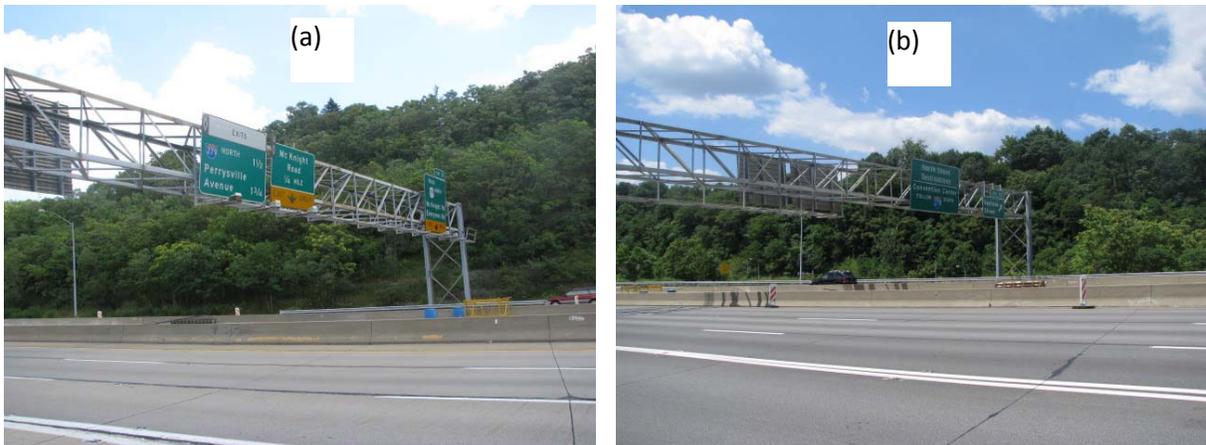
The overhead four-chord box truss shown in Fig. 4.1 was studied. The structure, built in 1988, spans 59.1 m (194 ft) over nine lanes of traffic. The structure is made of steel members, while the signs are flat aluminum panels. Both the box truss and the upright webs are constructed with angles, while the uprights posts are made of wide flanges. Design plan and drawings of the structure are in Kacin (2009) and Kacin et al. (2009).

Figure 4.1 – Overhead sign structure modeled in this study for fatigue analysis.

The structure mounts five signs of varying shapes and sizes, though the original plans for the structure showed four signs. Since erection, another sign has been added. A catwalk spans over the northbound lanes. Both welded and bolted connections are present. The chords are continuous members that are spliced in four locations. On the top and bottom truss sections a plate is welded to the chord and the diagonals are connected to this plate via high strength bolts. The cross bracing is connected with bolts to a separate plate that is welded to the chord. On the front and back truss the diagonals and the vertical members are

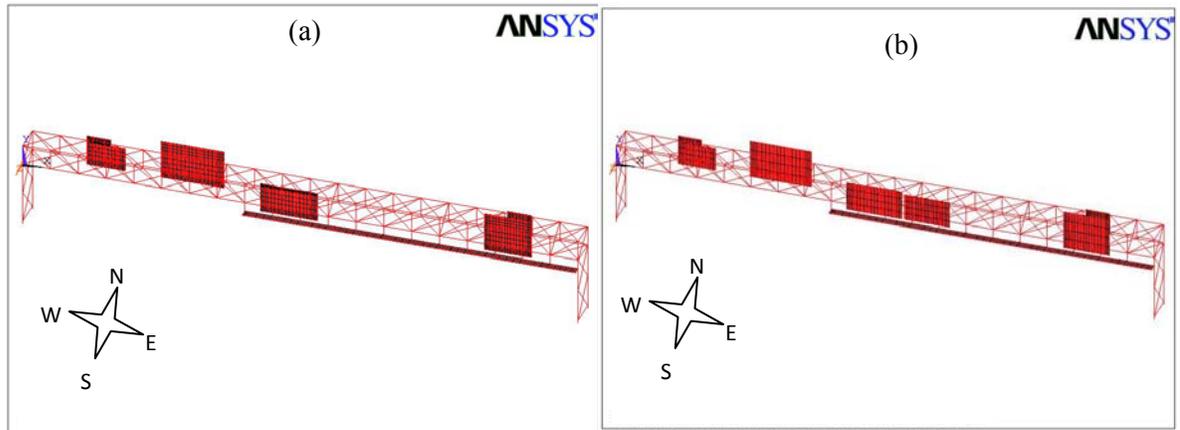
Figure 4.2 - ANSYS model of sign structure 511-76. (a) Model with 4 four aluminum signs attached. (b) Model with 5 five aluminum signs attached.

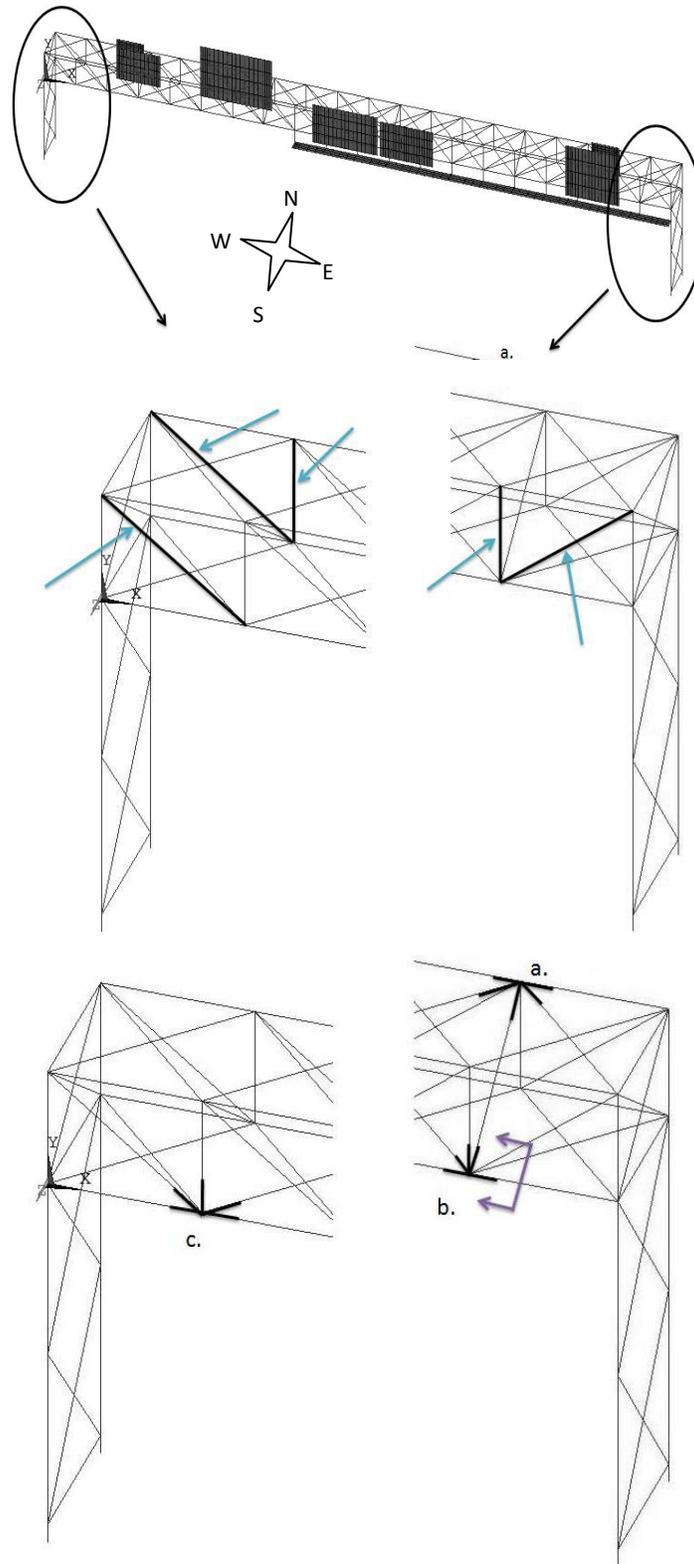
Figure 4.8 - (a) Finite element model. (b) Close-up view of the critical members considered in the present analysis. (c) location of connection details.

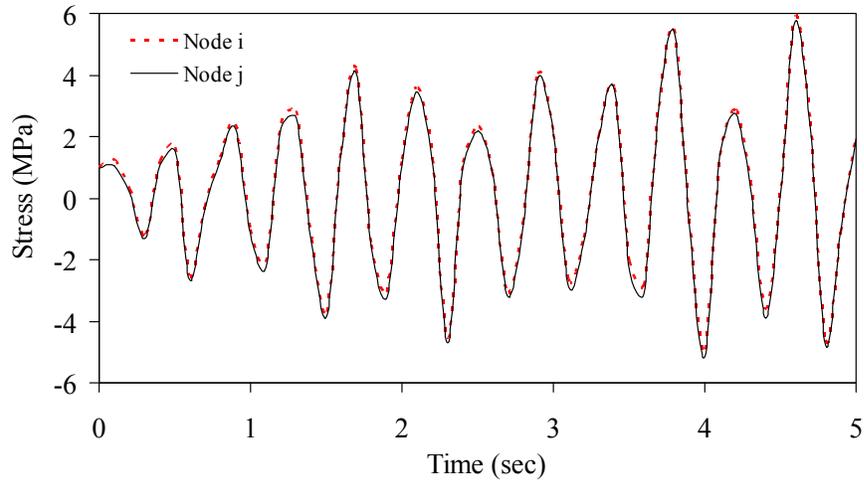
Figure 4.9 - Stress time history for element 1921 at a base speed of 11.8 m/s (25 mph).

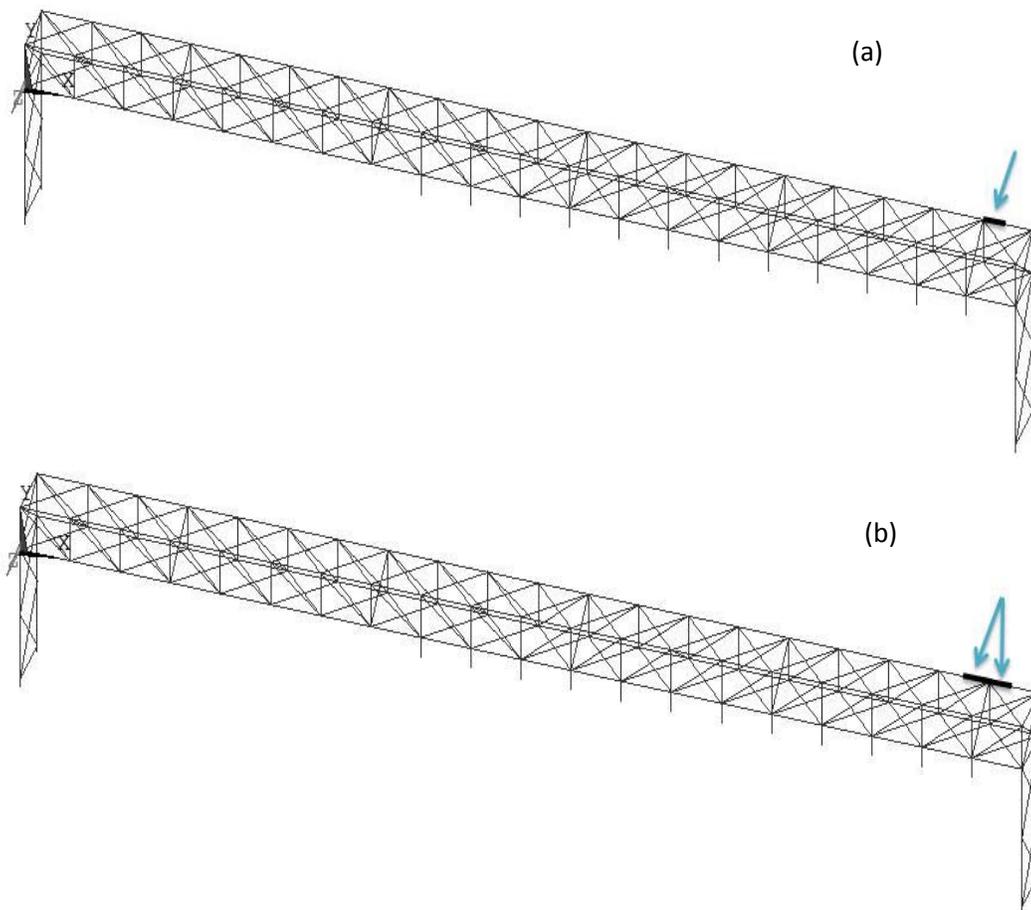
Figure 4.11 - Sign support structure with reduced capacity. (a) One member with Young's modulus halved. (b) Two members with Young's modulus halved. (Note that the signs are not shown to ease the visibility of the chosen element).

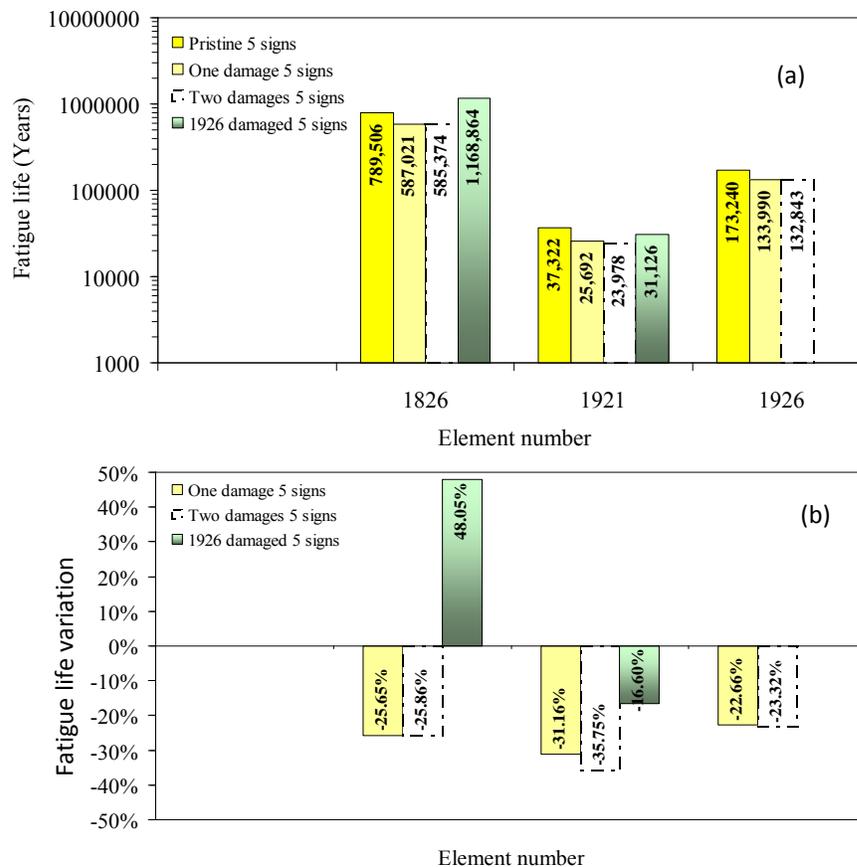
Figure 4.12 - Expected fatigue life in the five-signs support structure that has no damage, one member, two members, or member 1826 damaged; (b) variation of fatigue life with respect to the pristine structure when one member, two members, or member 1826 are damages.

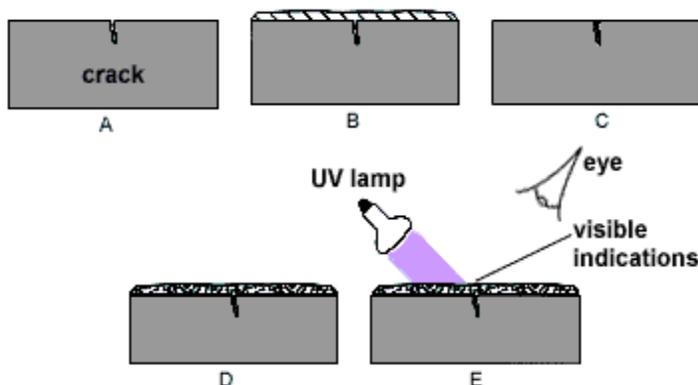
Figure 5.1 - Steps of an inspection conducted by using liquid penetrant testing. (a) Sample before testing; (b) liquid penetrant applied; (c) surplus wiped off leaving penetrant in crack; (d) developer powder applied, dye soaks into powder; (e) View coloured indications, or UV lamp shows up fluorescent indications. (<http://www.twi.co.uk/content/ksijm001.html>)

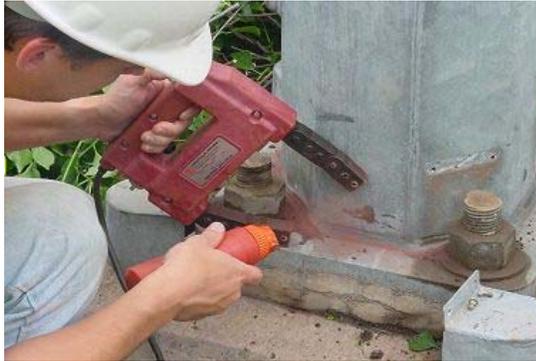
Figure 5.2 - Magnetic particle testing of a welded area.

electromagnet, flexible cables, or hand-held prods. Fine ferromagnetic particles are then applied into the specimen's surface. If the material is sound, most of the magnetic flux is concentrated below the material's surface and the particles follow the induced magnetic field (Shull 2002, TWI 2008). However, if a flaw is present, such that it interacts with the magnetic field, the flux is distorted locally and 'leaks' from the surface of the specimen in the region of the flaw. The particles create a visible indication of the flaw. Magnetic particles commonly used are black iron particles and red (Fig. 5.2) or yellow iron oxides. In some cases, the iron particles are coated with a fluorescent material enabling them to be viewed under a UV lamp in darkened conditions.

Magnetic particles are usually applied as a suspension in water or paraffin. This enables the particles to flow over the surface and to migrate to any flaws. On hot surfaces, or where contamination is a concern, dry powders may be used as an alternative to wet inks. On dark surfaces, a thin layer of white paint is usually applied, to increase the contrast between the background and the black magnetic particles. The most sensitive technique, however, is to use fluorescent particles viewed under UV (black) light.

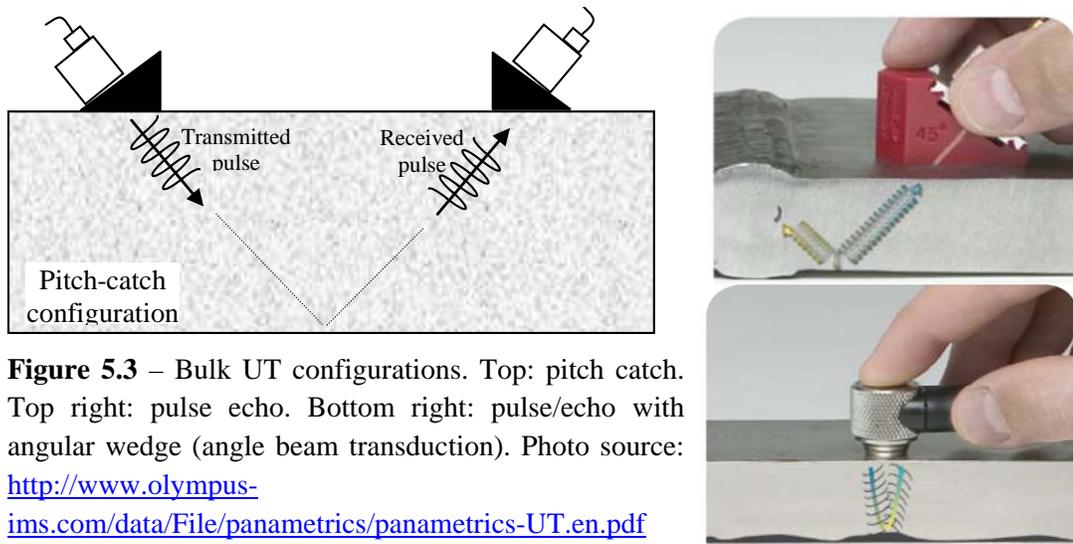
Figure 5.3 – Bulk UT configurations. Top: pitch catch. Top right: pulse echo. Bottom right: pulse/echo with angular wedge (angle beam transduction). Photo source: <http://www.olympus-ims.com/data/File/panametrics/panametrics-UT.en.pdf>

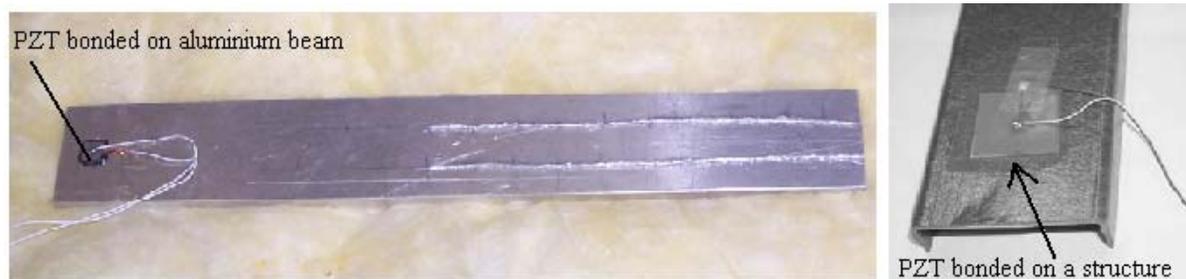
Figure 5.6 - PZT bonded on aluminum and steel beams.

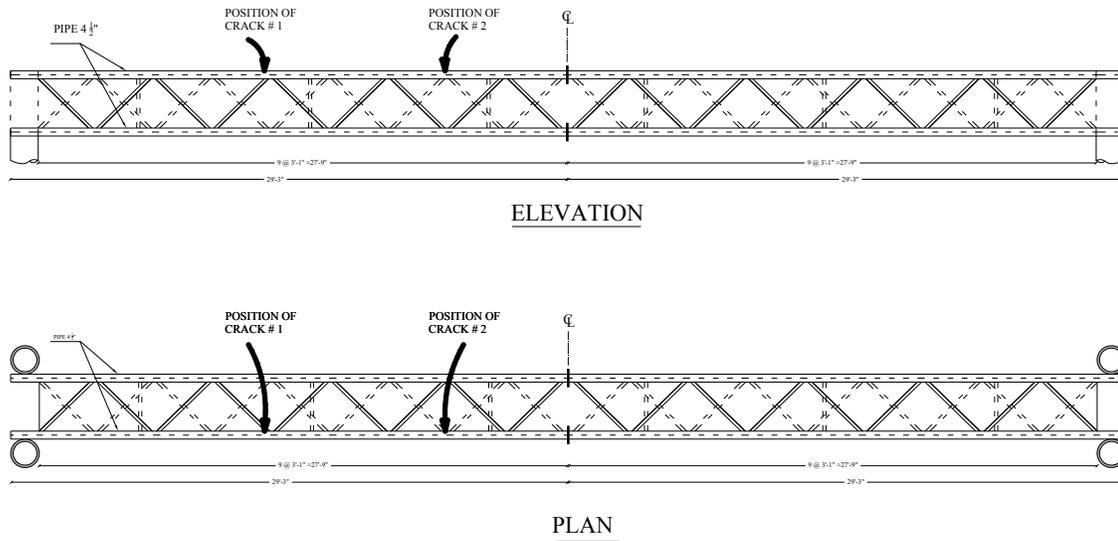
Figure 6.2 – Location of cracks found during the investigation conducted in Connor (2008).

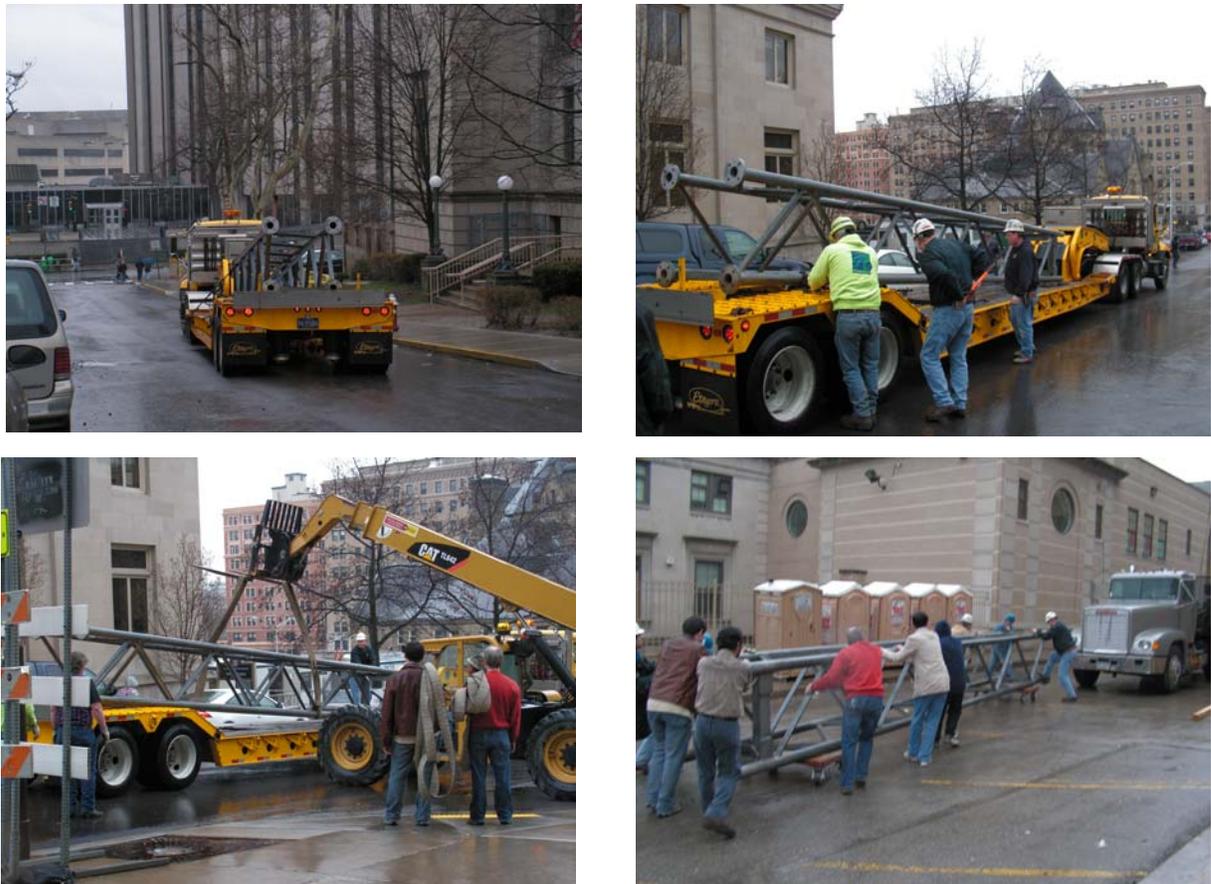
Figure 6.3 – Delivering the truss at the University of Pittsburgh.

One of the two trusses connected with bolts in the original structure was delivered at the University of Pittsburgh. Photos of the delivery are presented in Fig. 6.3.

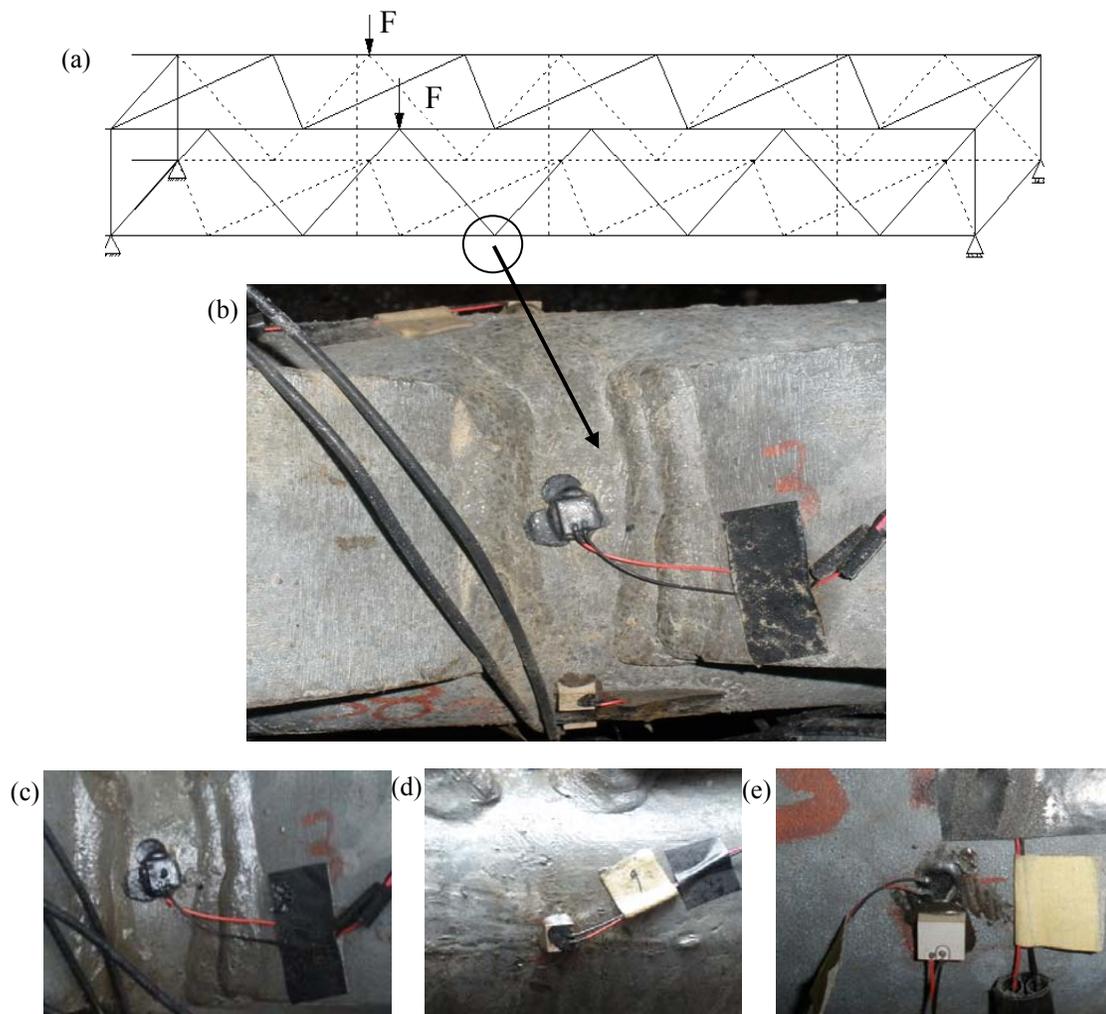
Figure 6.8 - (a) Sketch of the truss structure. (b) View from the top of the joint under investigation and PZT EM1. (c-e) Close up view pf for EM1 located between two joints (d) close up view for EM2 located inner side of the chord (e) close up view for EM3 located outer side of the chord.

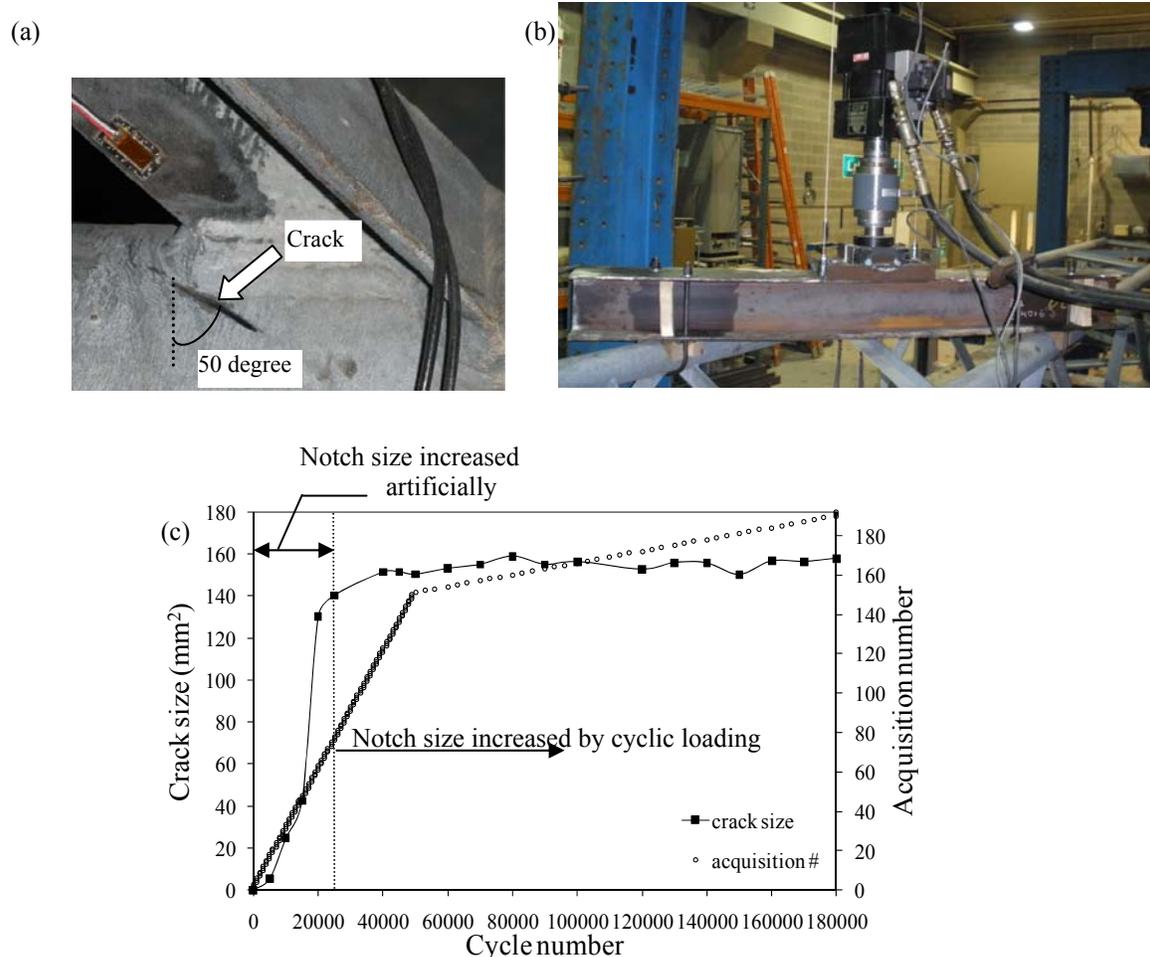
Figure 6.9 - (a) Close-up view of the artificial notch machined along the weld between the chord and one angular diagonal member. (b) Loading setup (c) Crack size and acquisition number as a function of cycle loading number.

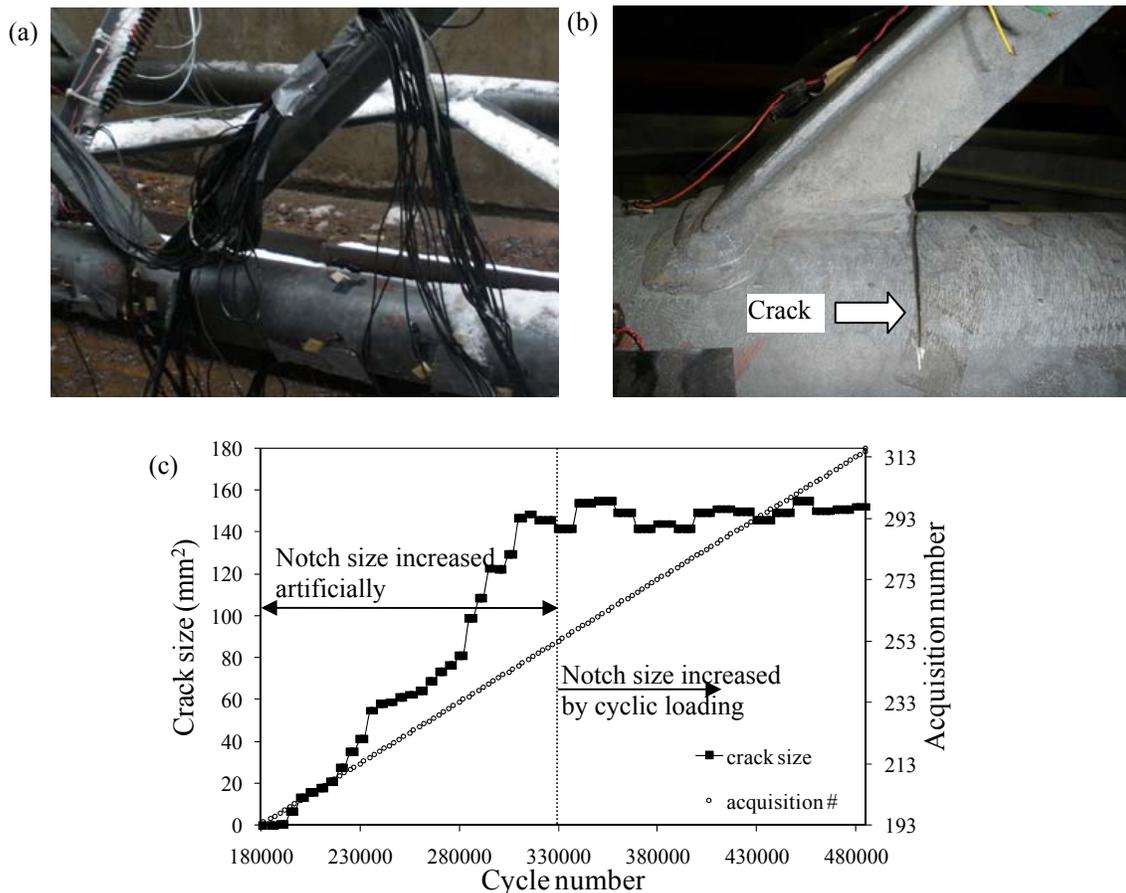
Figure 6.10 - (a) Close-up view of the joint where artificial notch was machined (b) the artificial notch along the weld between the chord and one angular diagonal member. (c) Crack size and acquisition number as a function of cycle loading number.

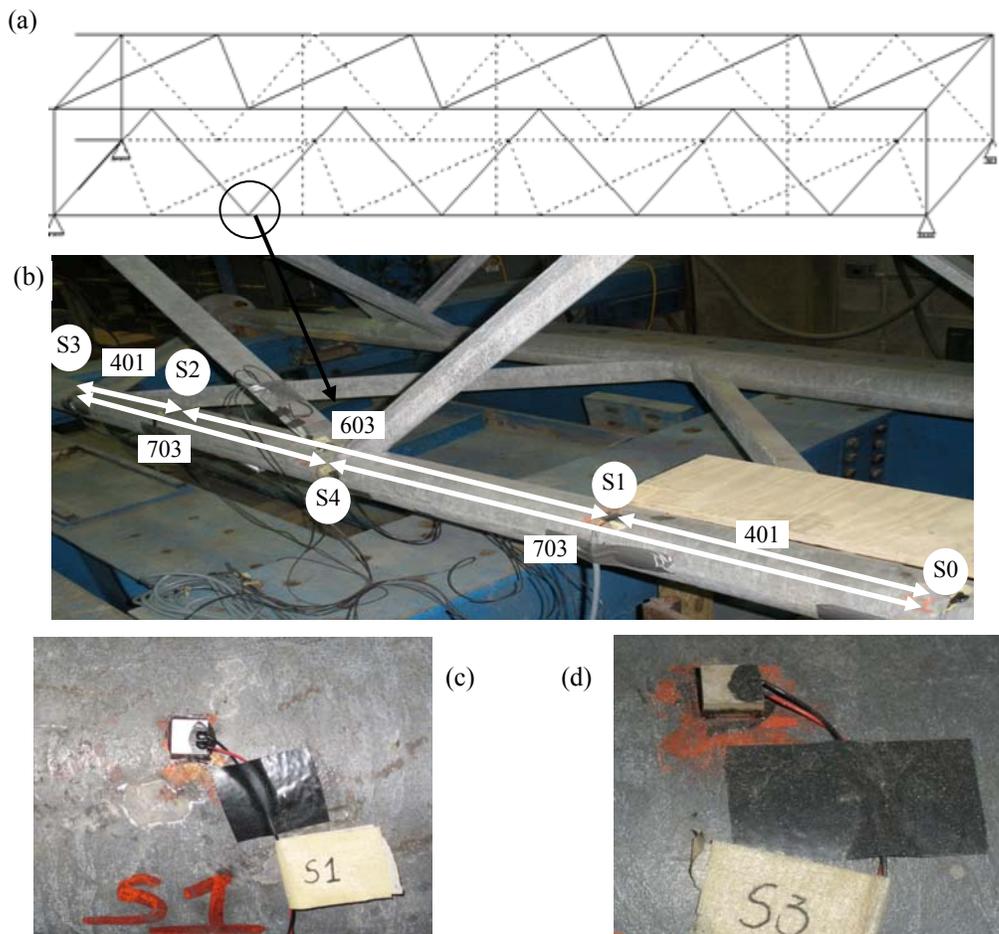
Figure 6.11 - (a) Sketch of the truss structure. (b) Location and relative distance of PZTs S0,...,S4. (c) Close up view of PZT S1. (d) Close up view of PZT S3. Dimensions are expressed in mm.

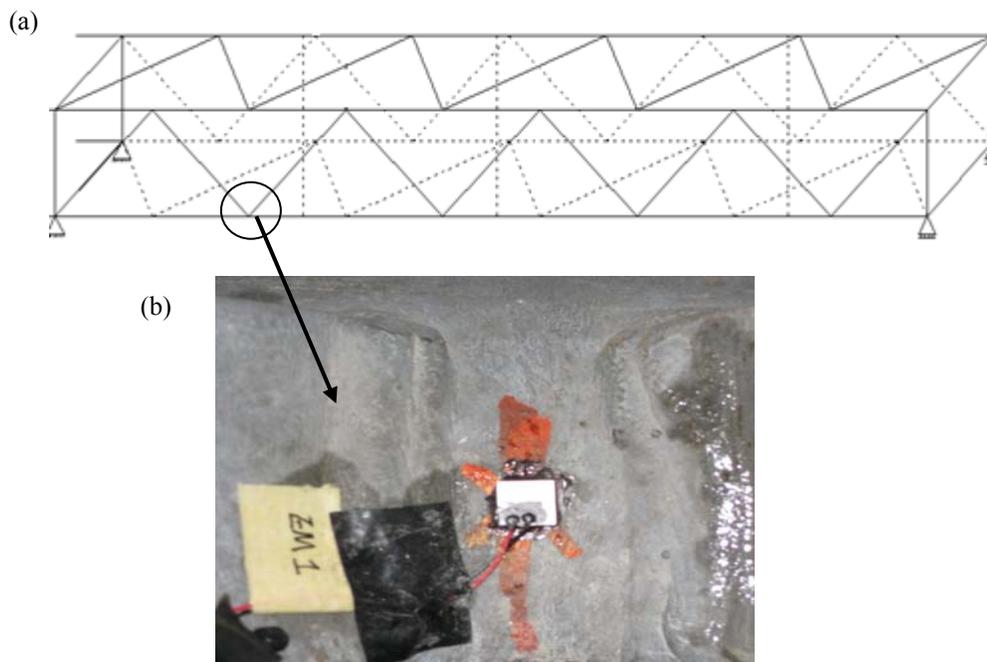
Figure 6.12 - (a) Sketch of the truss structure. (b) View from the top of the joint under investigation and PZT EM1.

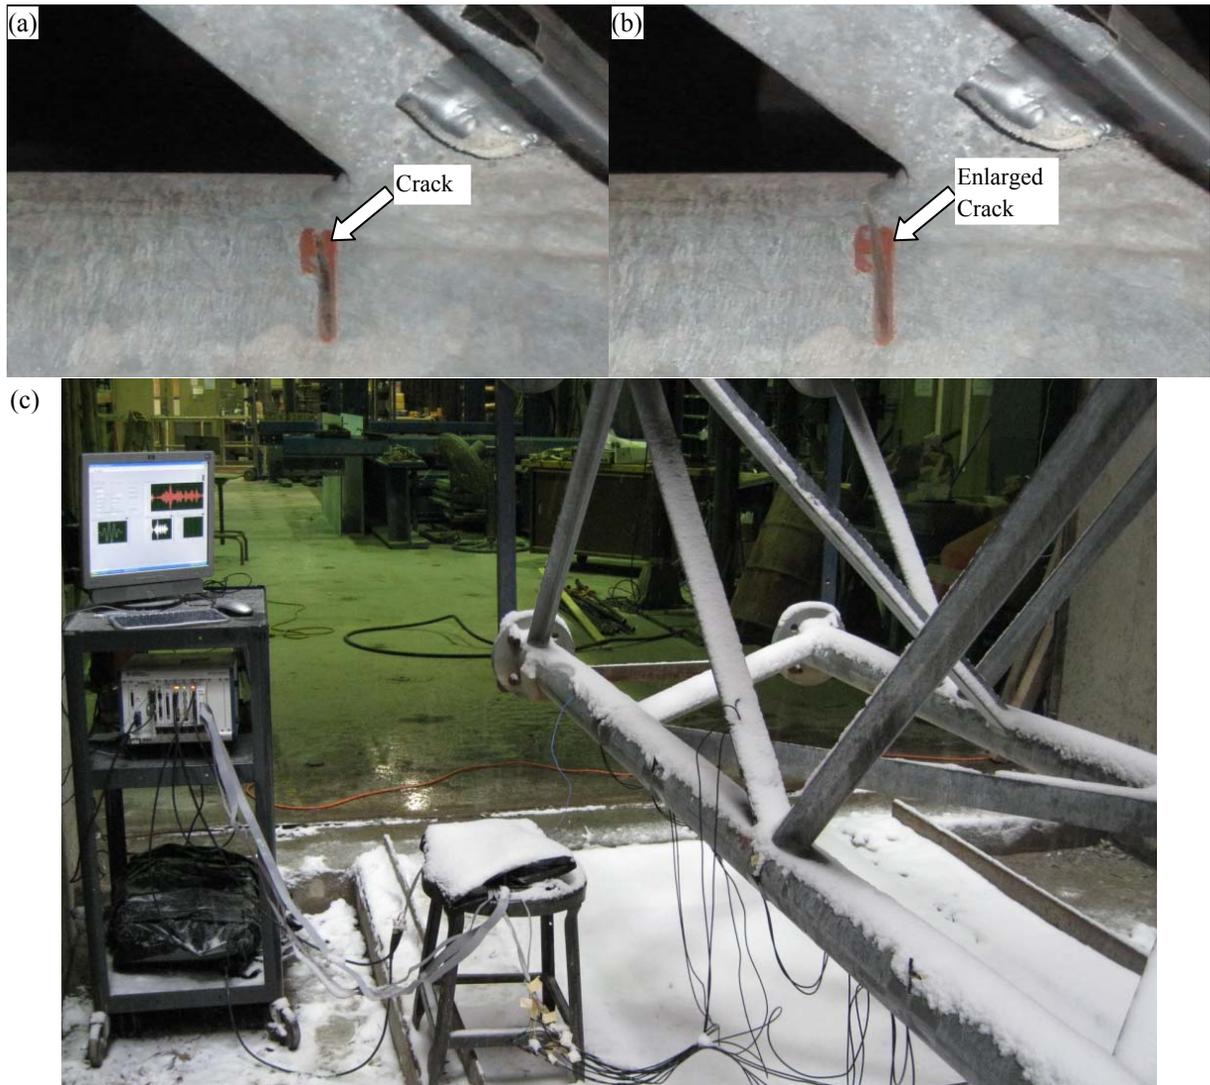
Figure 6.13 - (a) Close-up view of the artificial notch machined along the weld between the chord and one angular diagonal member. (b) Close-up view of enlarged crack. (c) Snowing condition.

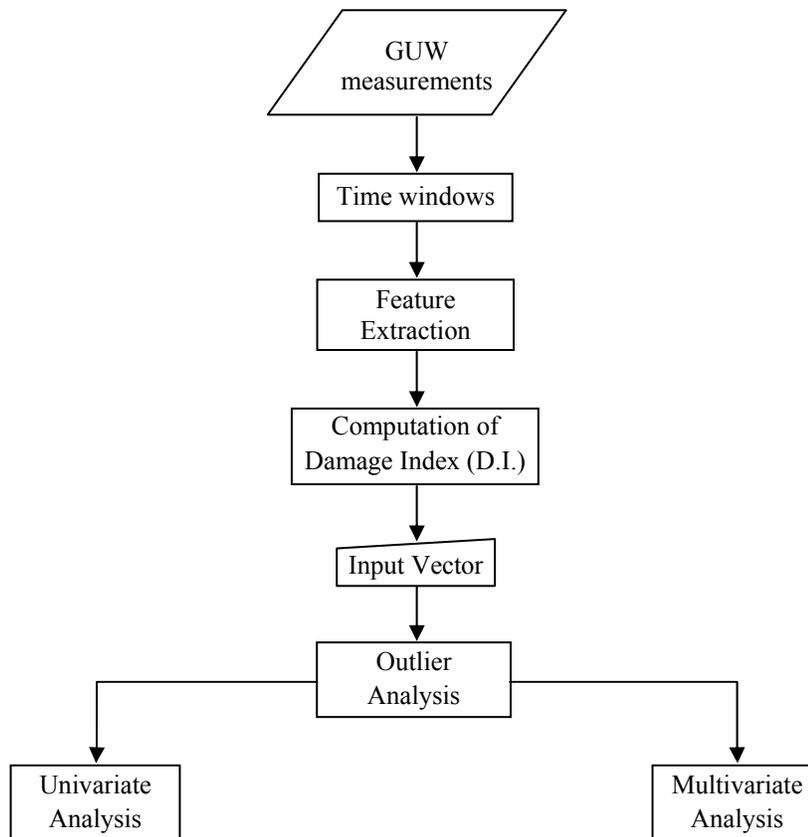
Figure 6.14 - Flowchart of the defect detection procedure.
