Sensing Technology for Damage Assessment of Sign Supports and Cantilever Poles

FINAL REPORT

By Piervincenzo Rizzo and Xuan Zhu
University of Pittsburgh

COMMONWEALTH OF PENNSYLVANIA
DEPARTMENT OF TRANSPORTATION

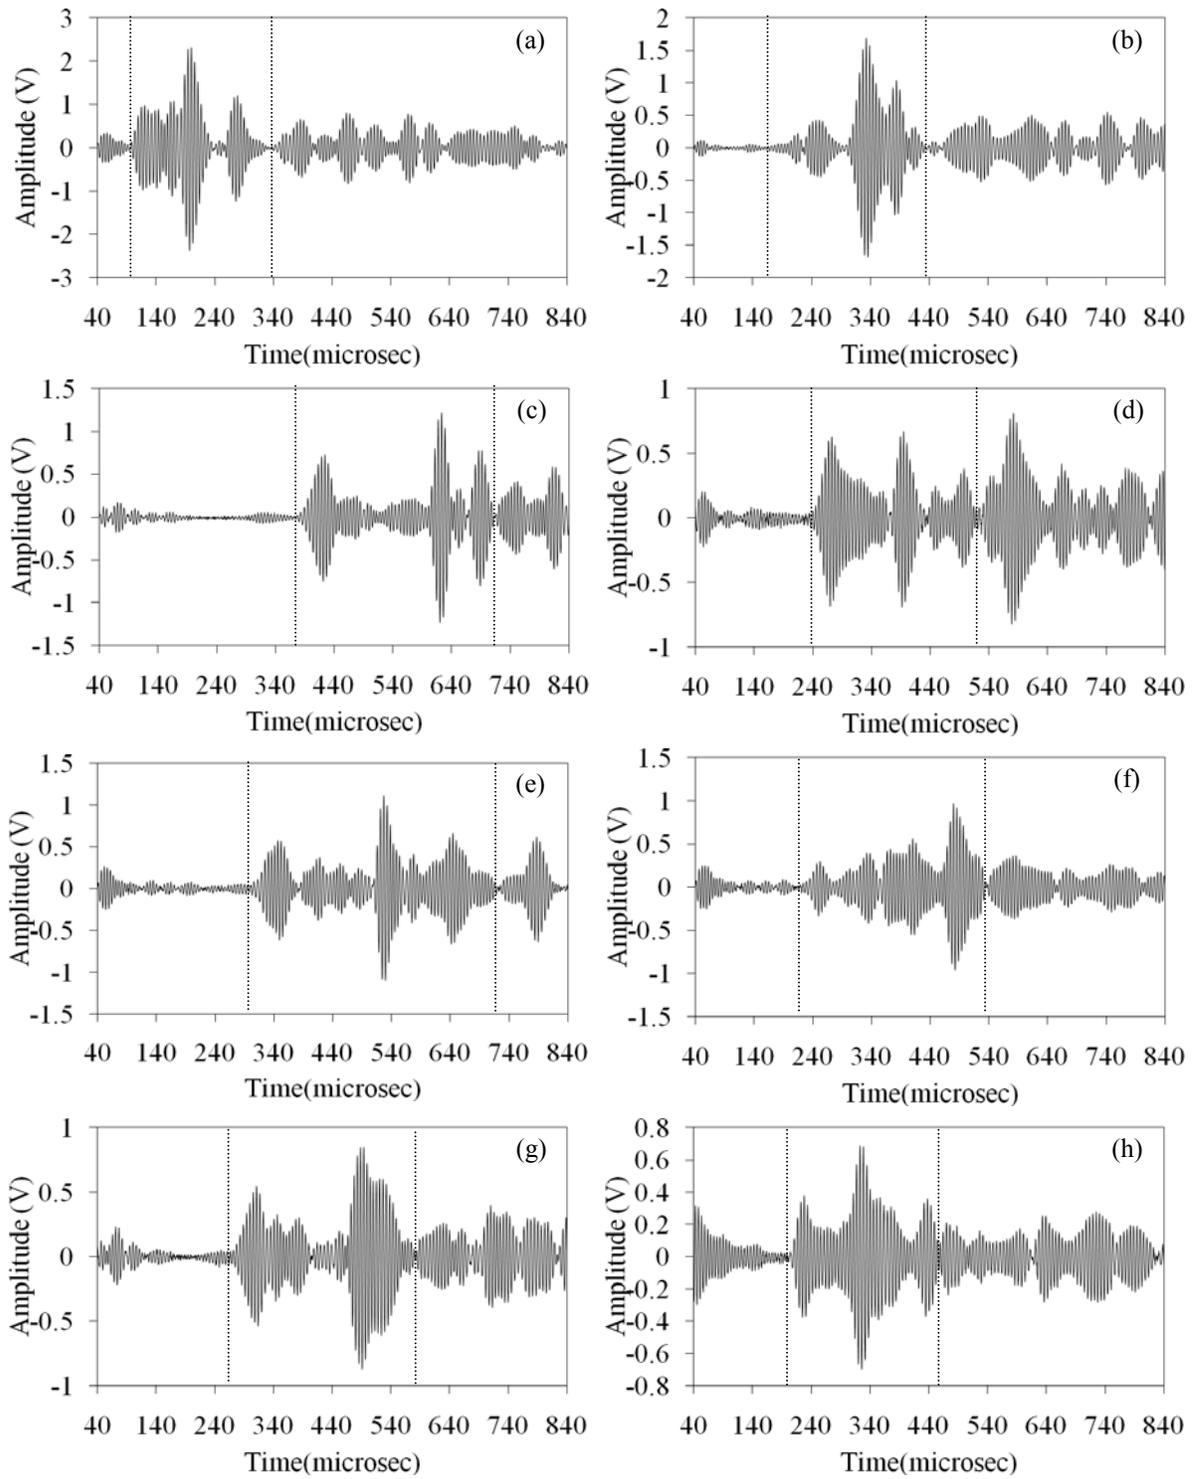
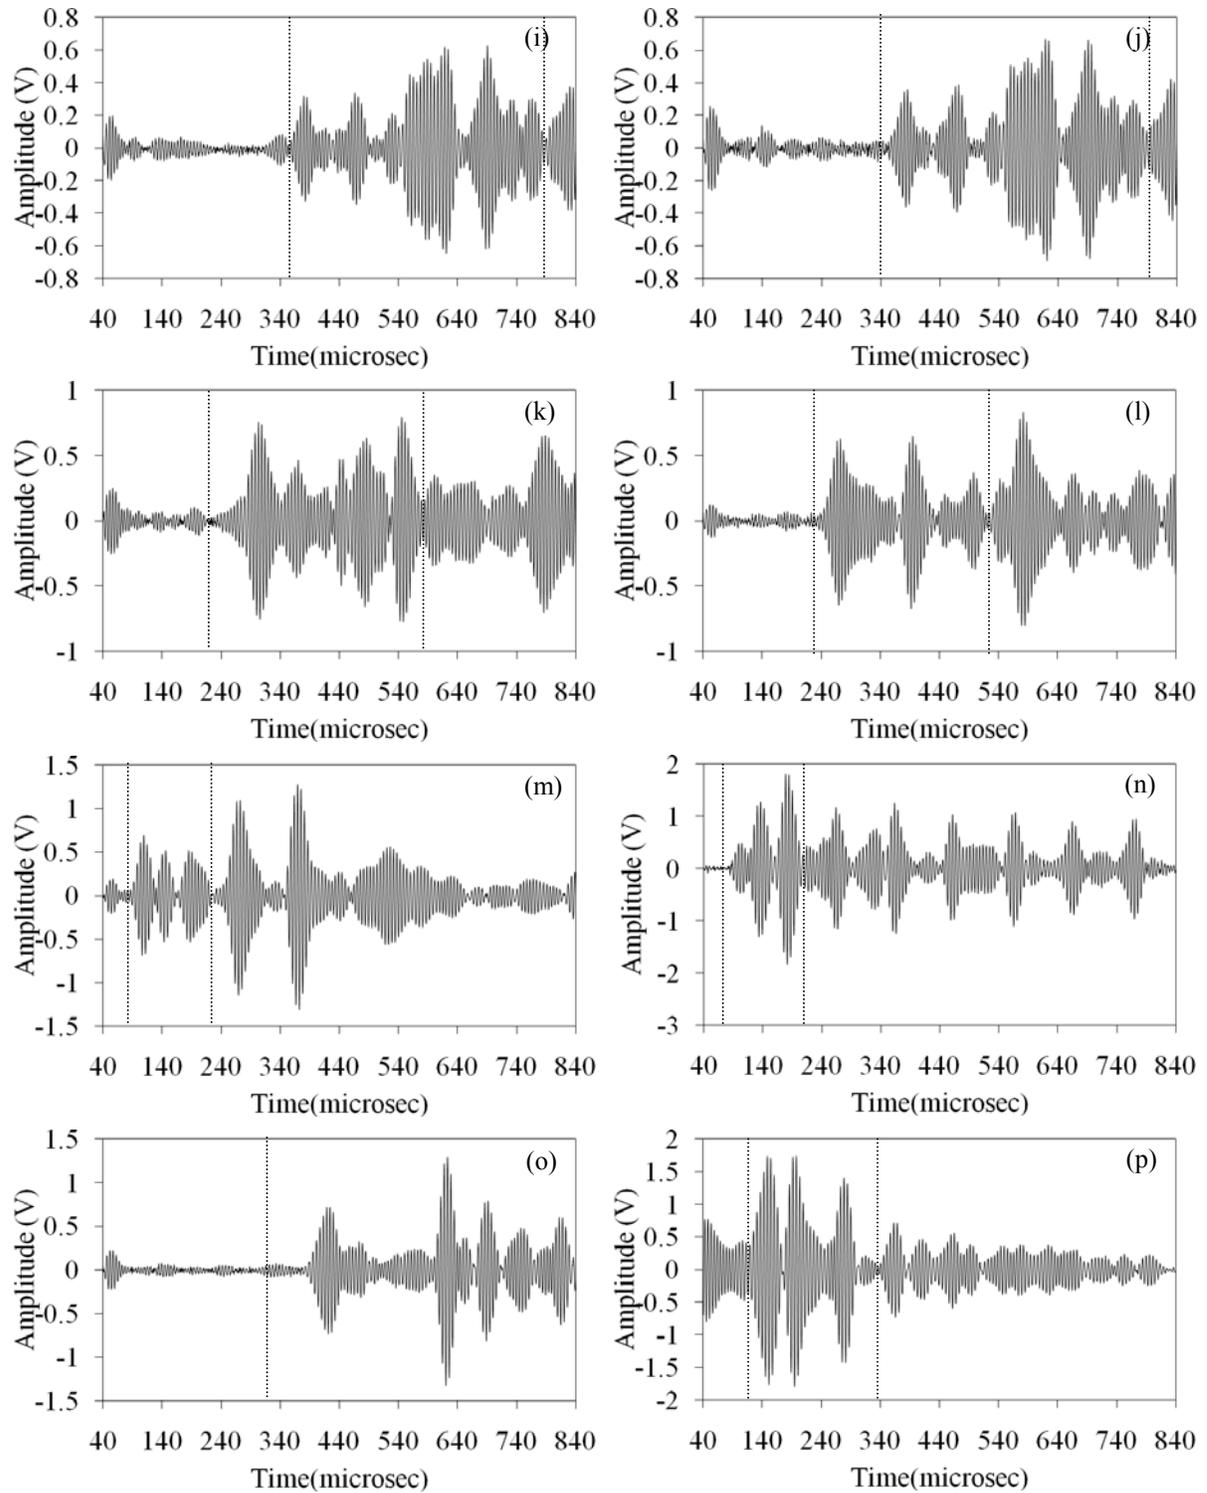
Figure 6.15 - Time waveforms recorded at the beginning of the experimental program from actuator-sensor pairs: (a) S5=>S4 (b) S5=>S8 (c) S5=>S0 (d) S9=>S6 (e) S0=>S4 (f) S1=>S4 (g) S9=>S0 (h) S9=>S1 (i) S5=>S6 (j) S6=>S5 (k) S6=>S4 (l) S6=>S9 (m) S9=>S8 (n) S6=>S7 (o) S0=>S5 (p) S0=>S1.

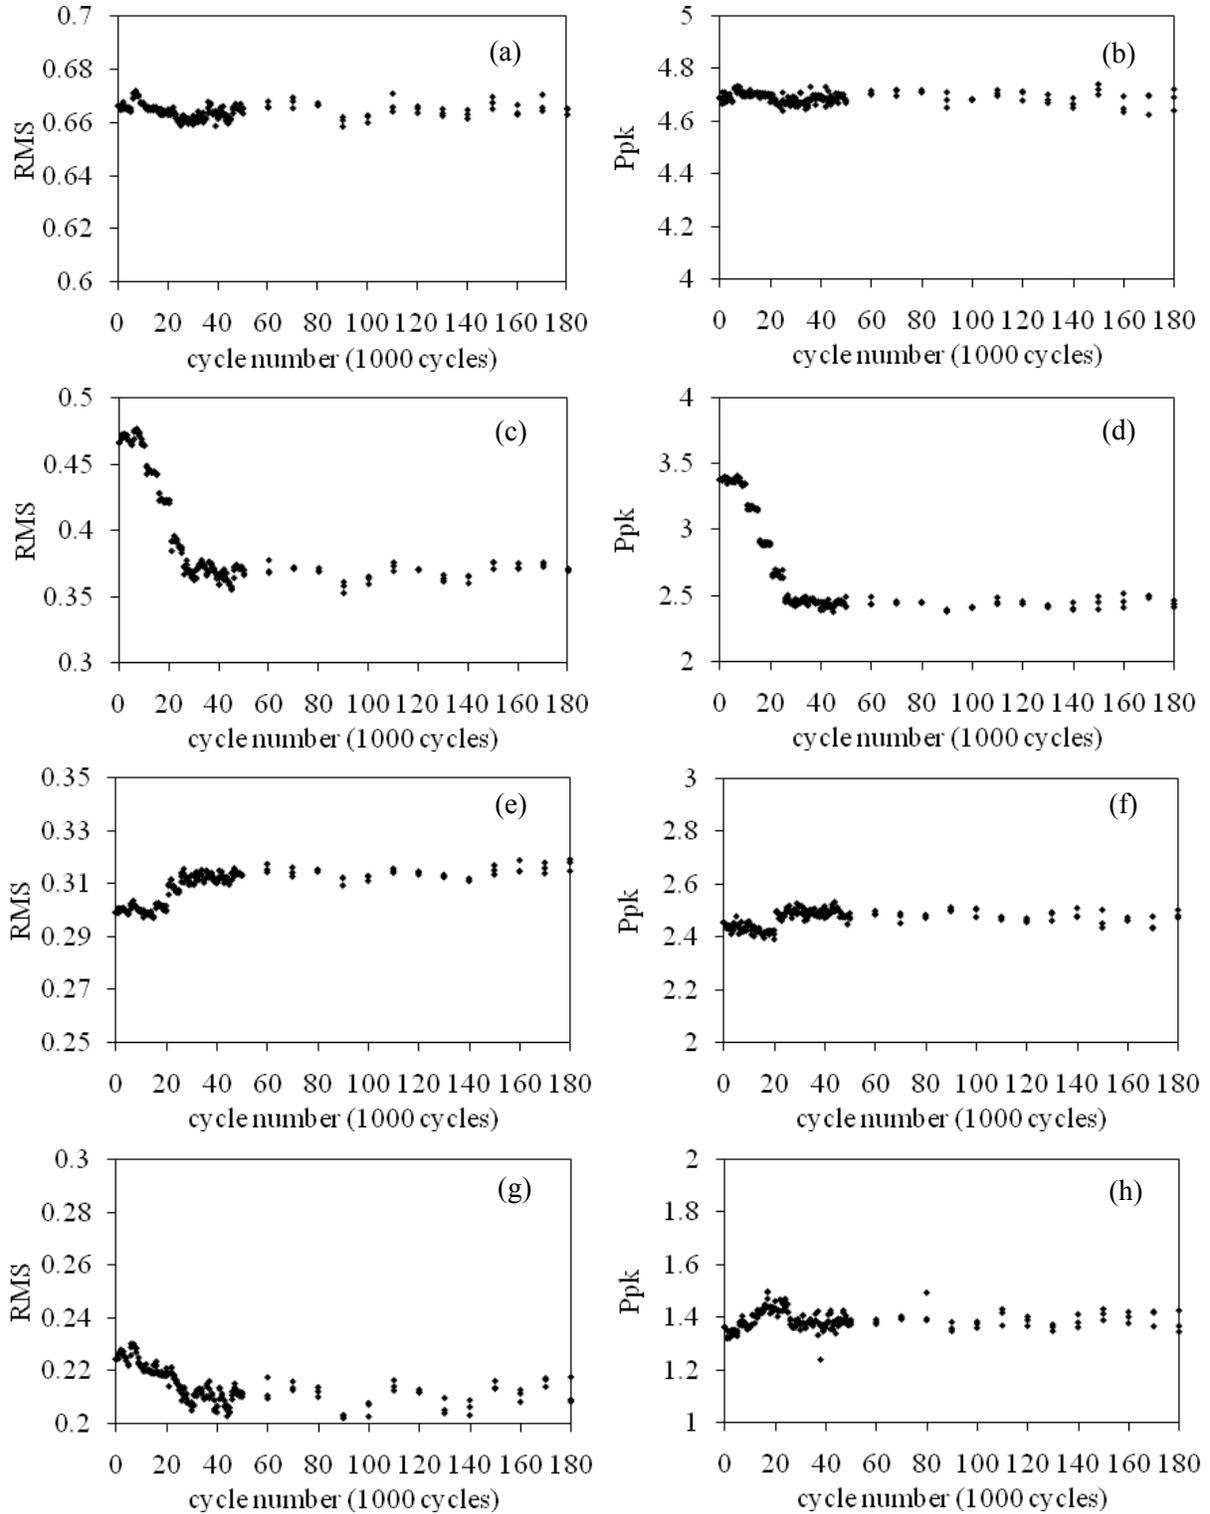
Figure 6.16 - Statistical features as a function of the loading number of cycles. (a) RMS S5=>S4 (b)Ppk S5=>S4 (c) RMS S5=>S8 (d) Ppk S5=>S8 (e) RMS S5=>S0 (f) Ppk S5=>S0 (g) RMS S9=>S6 (h) Ppk S9=>S6.

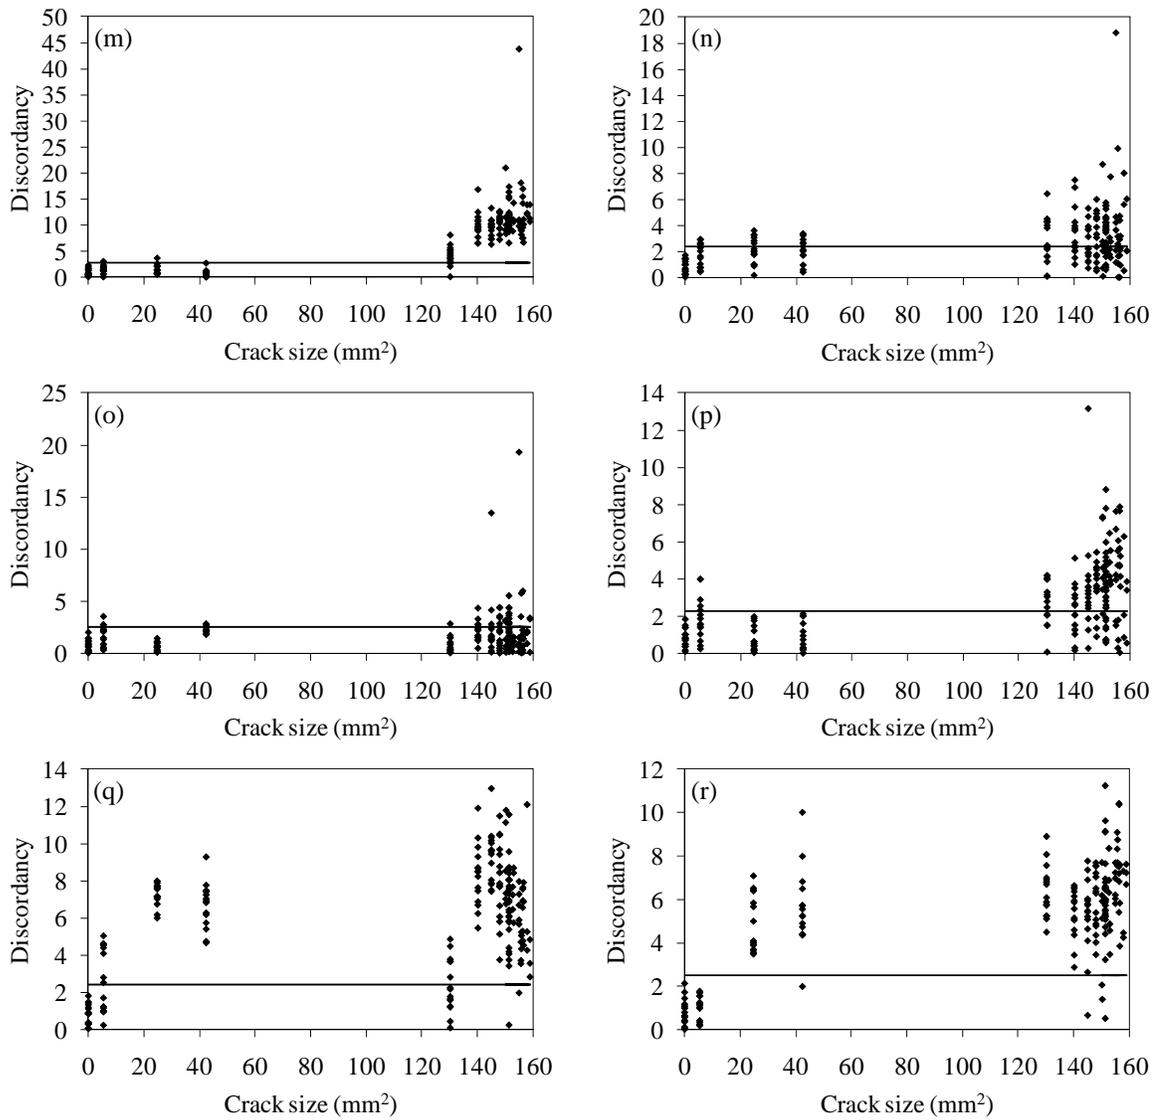
Figure 7.2: Univariate analysis. Discordancy as a function of the crack size for the following features and actuator-sensor pairs: (a) RMS_S5=>S8/S5=>S4 (b) Ppk_S5=>S8/S5=>S4; (c) RMS_S9=>S6/S9=>S8 (d) Ppk_S9=>S6/S9=>S8 (e) RMS_S5=>S0/S5=>S4 (f) Ppk_S5=>S0/S5=>S4; (g) RMS_S5=>S6/S5=>S4 (h) Ppk_S5=>S6/S5=>S4 (i) RMS_S5=>S1/S5=>S4 (j) Ppk_S5=>S1/S5=>S4; (k) RMS_S0=>S4/S0=>S2 (l) Ppk_S0=>S4/S0=>S2 (m) RMS_S0=>S5/S0=>S1 (n) Ppk_S0=>S5/S0=>S1; (o) RMS_S0=>S4/S0=>S1 (p) Ppk_S0=>S4/S0=>S1 (q) RMS_S9=>S1/S9=>S8 (r) Ppk_S9=>S1/S9=>S8.

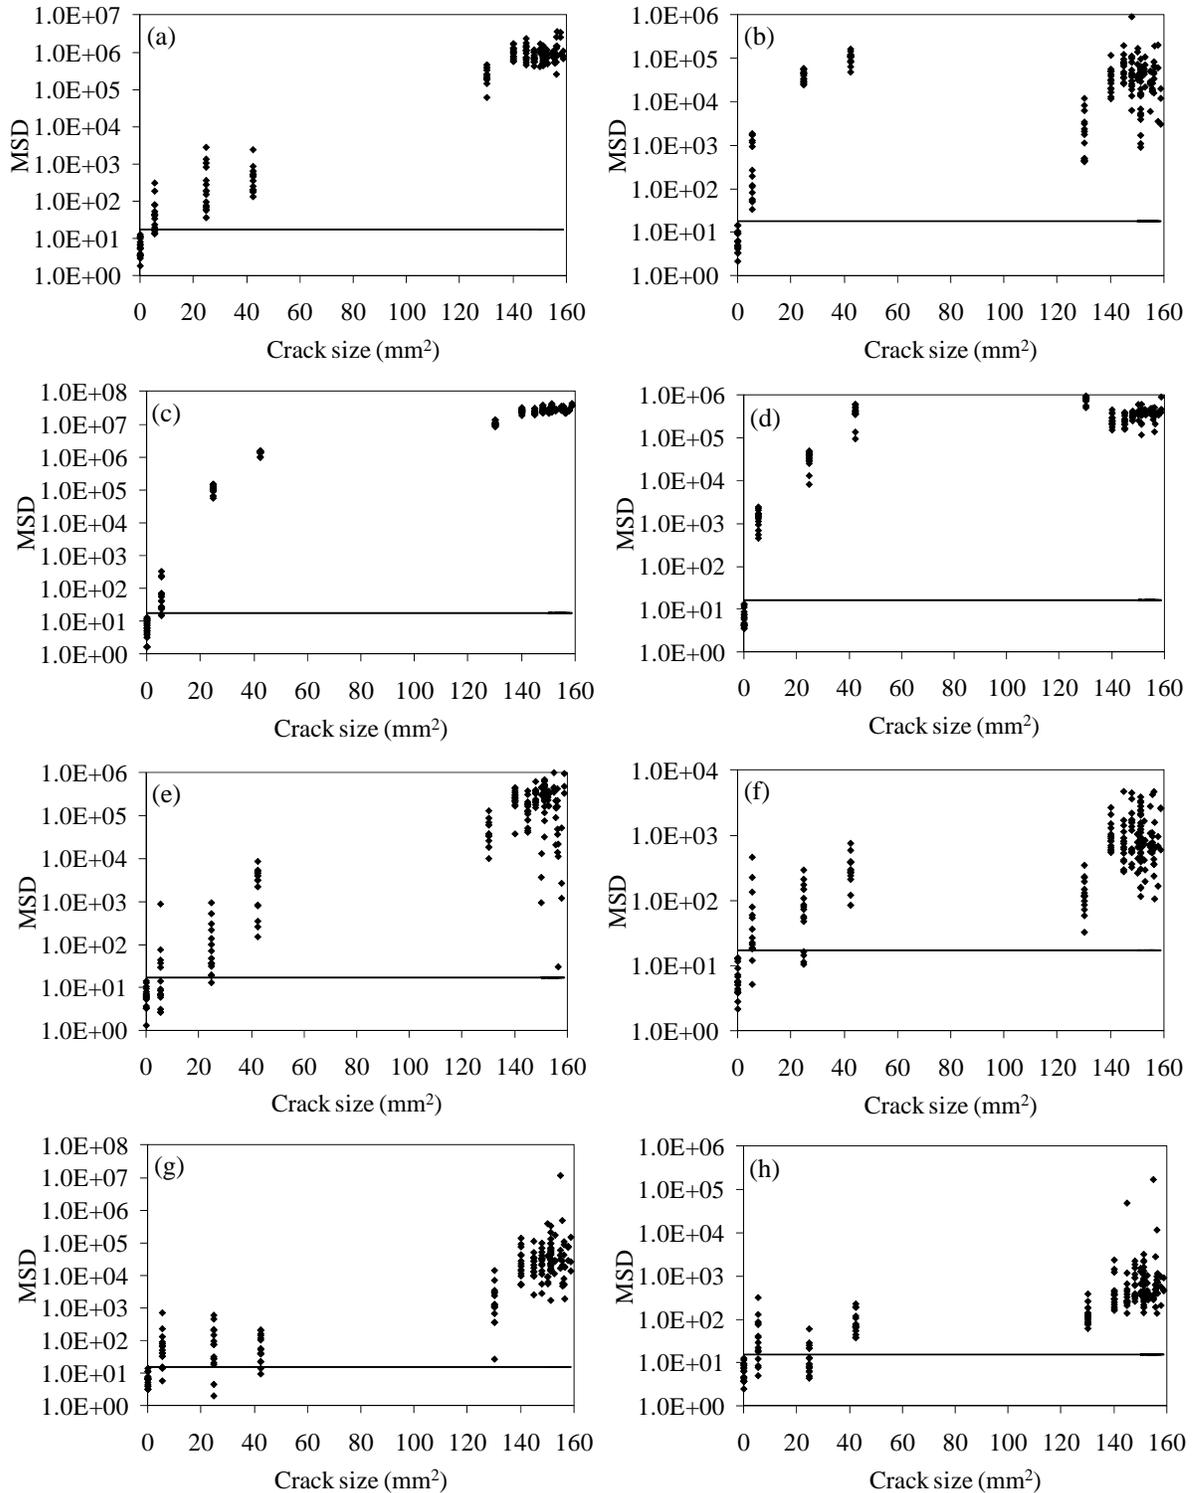
Figure 7.3 - Multivariate analysis. Mahalanobis squared distances as a function of the crack size for the actuator-sensor pairs considering all seven features: (a) $S5 \Rightarrow S0/S5 \Rightarrow S4$; (b) $S9 \Rightarrow S6/S9 \Rightarrow S8$; (c) $S5 \Rightarrow S8/S5 \Rightarrow S4$; (d) $S5 \Rightarrow S6/S5 \Rightarrow S4$; (e) $S5 \Rightarrow S1/S5 \Rightarrow S4$; (f) $S0 \Rightarrow S4/S0 \Rightarrow S2$; (g) $S0 \Rightarrow S5/S0 \Rightarrow S1$; (h) $S0 \Rightarrow S4/S0 \Rightarrow S1$.

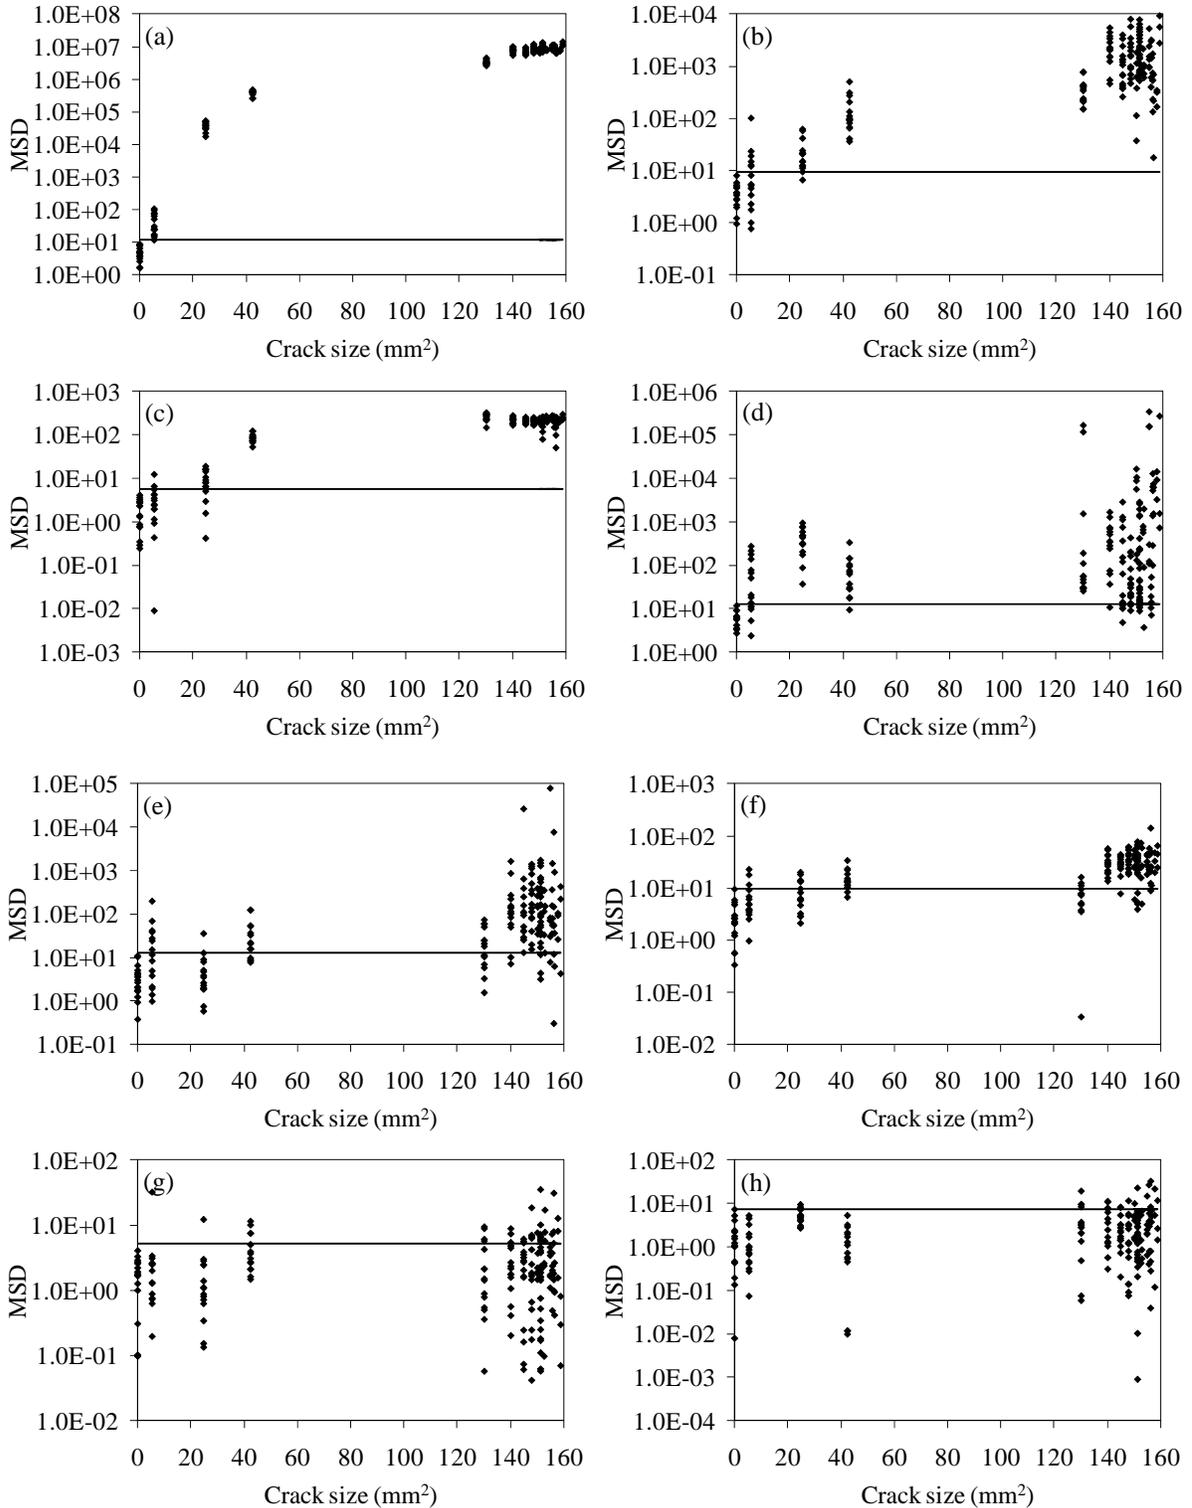
Figure 7.4 - Mahalanobis squared distances as a function of the crack size for the actuator-sensor pairs: (a) $S5 \Rightarrow S8/S5 \Rightarrow S4$ with krt, cf, kf ppk and max; (b) $S5 \Rightarrow S2/S5 \Rightarrow S4$ with krt, var, cf, kf, max and ppk; (c) $S5 \Rightarrow S6/S5 \Rightarrow S4$ with kf and max; (d) $S5 \Rightarrow S7/S5 \Rightarrow S4$ with krt, var, cf, kf, max and ppk; (e) $S0 \Rightarrow S4/S0 \Rightarrow S1$ with rms, var, kf and max; (f) $S0 \Rightarrow S4/S0 \Rightarrow S2$ with rms, cf and ppk; (g) $S5 \Rightarrow S2/S5 \Rightarrow S4$ with max and ppk; (h) $S0 \Rightarrow S8/S0 \Rightarrow S1$ with max and ppk; krt, rms, var, cf, kf, max and ppk.

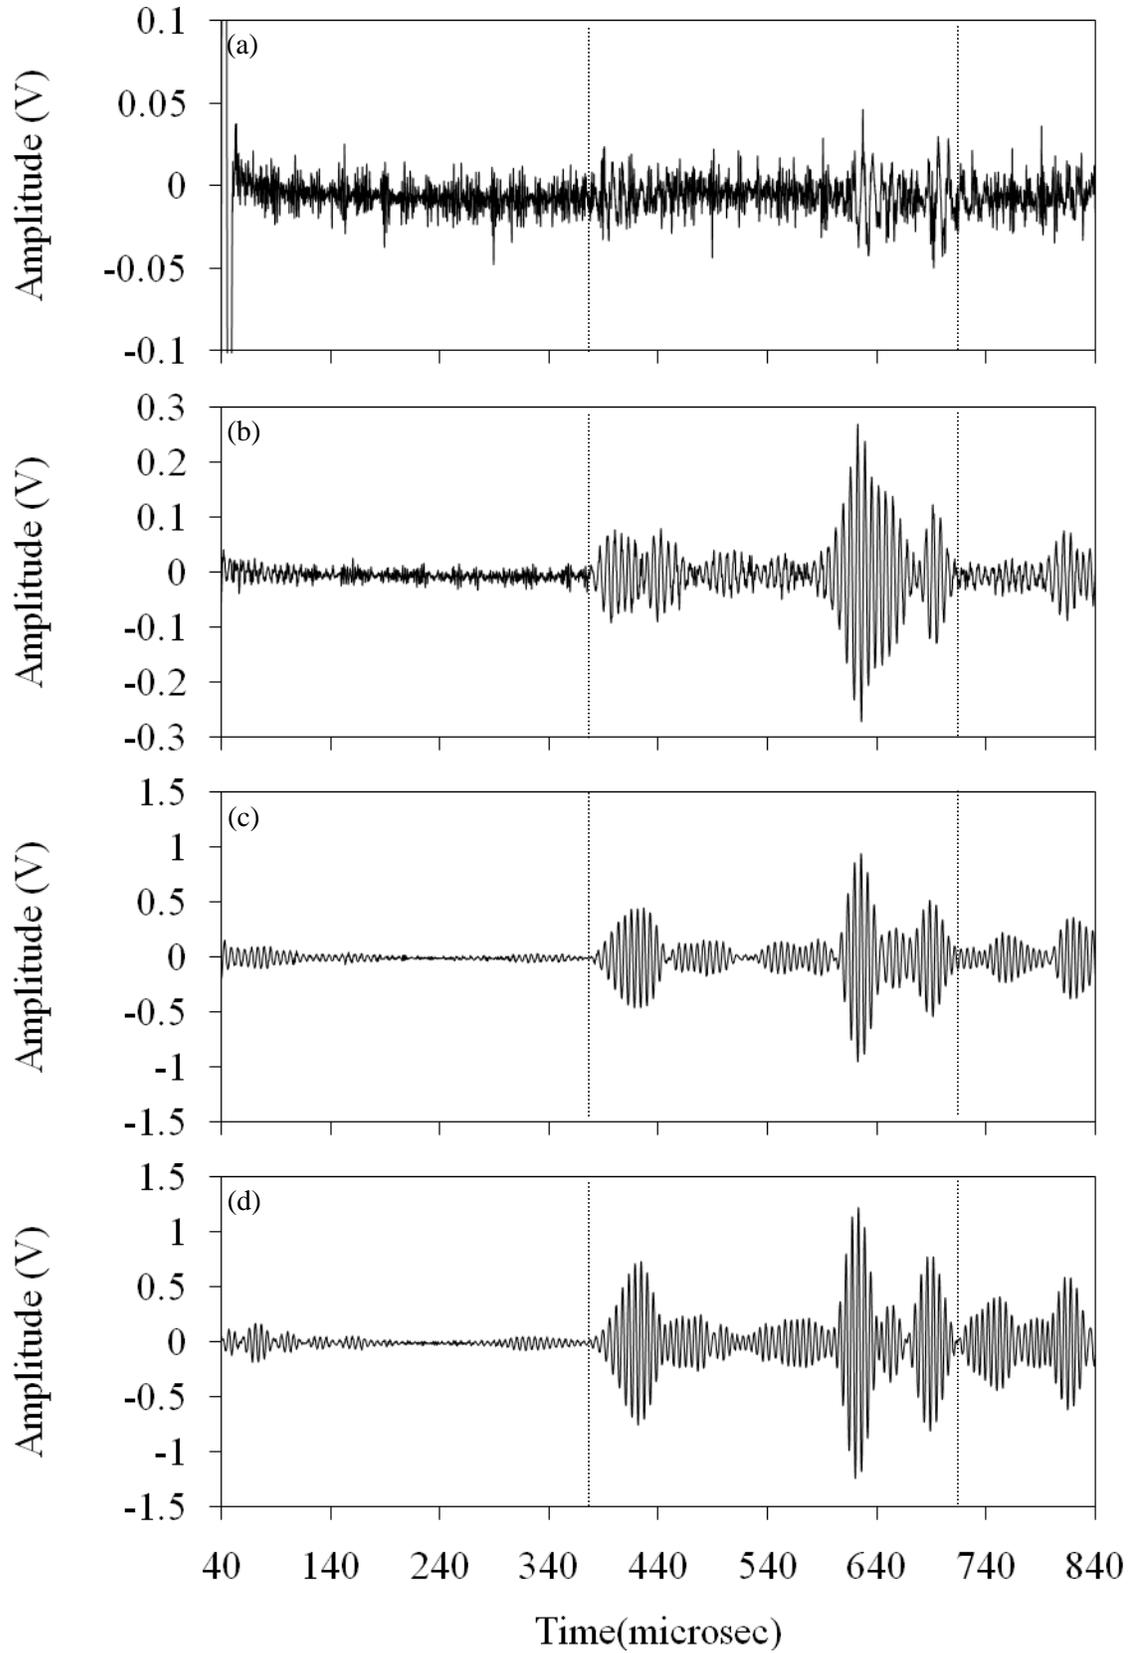
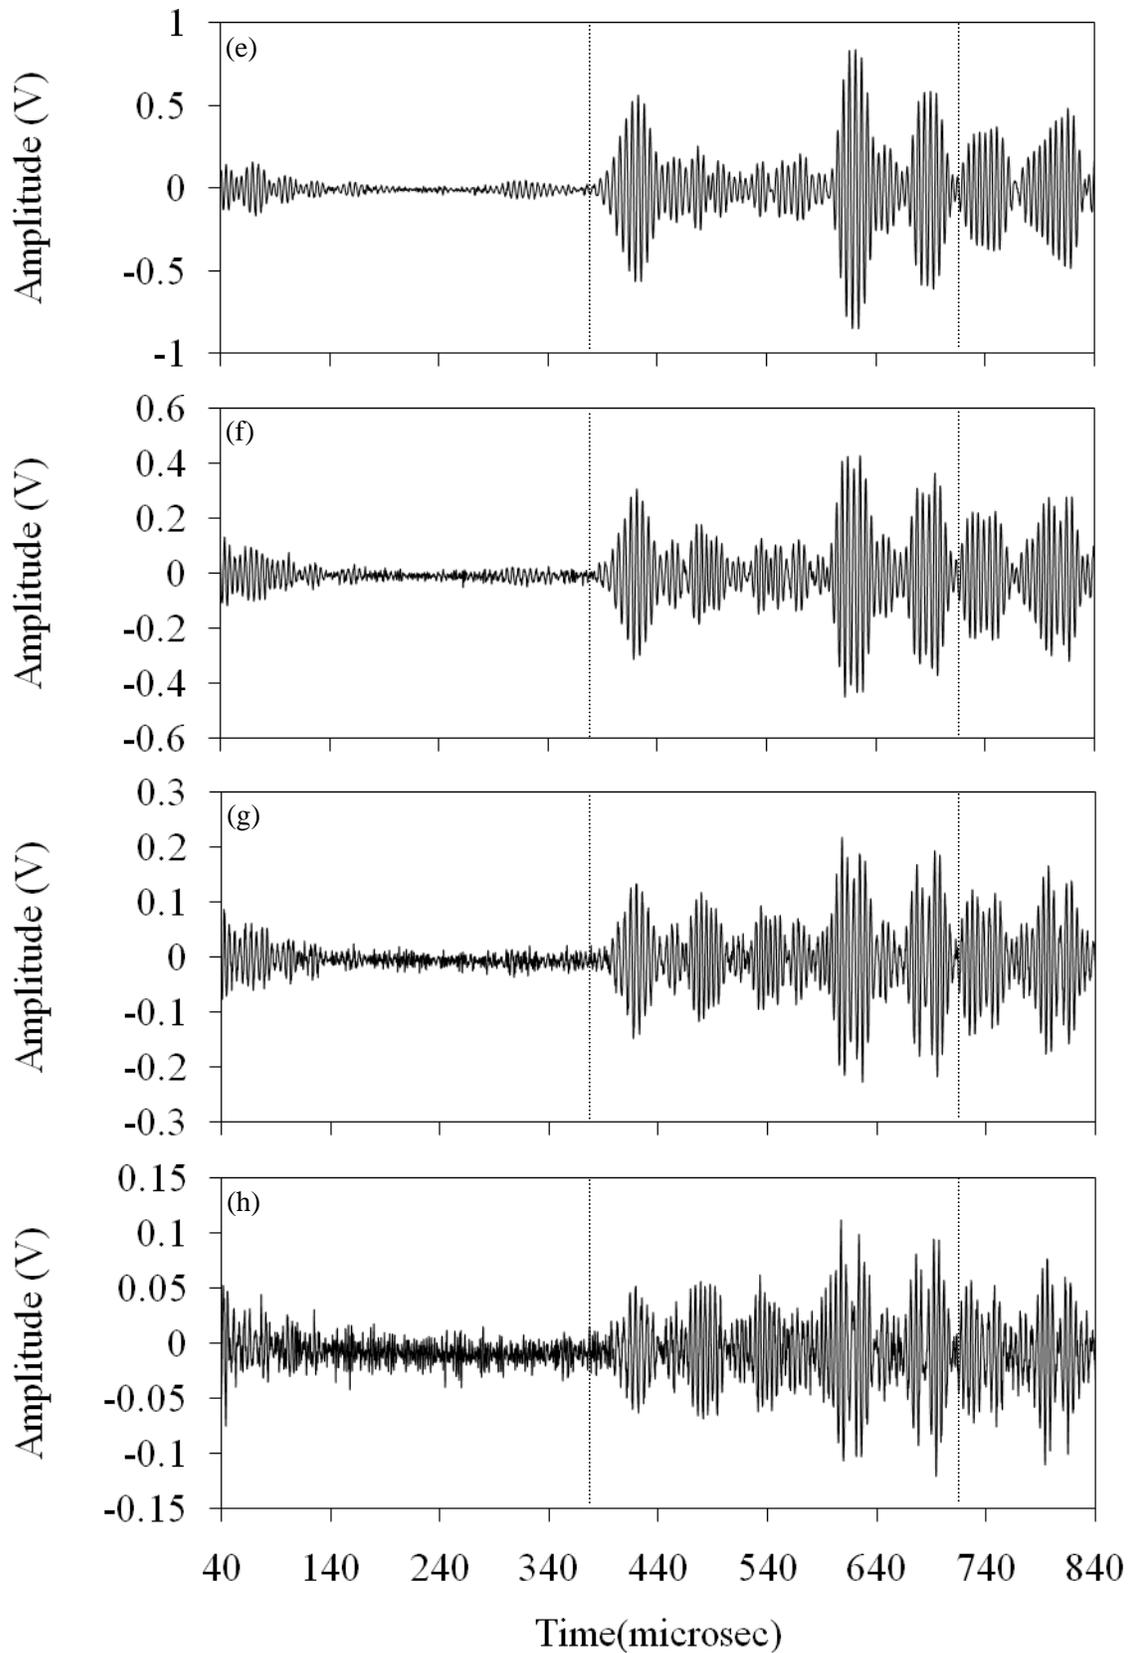
Figure 7.5 - Time waveforms of S5=>S0 in different frequencies: (a) 100 KHz; (b) 125 KHz; (c) 150 KHz; (d) 175 KHz; (e) 200 KHz; (f) 225 KHz; (g) 250 KHz; (h) 275 KHz.

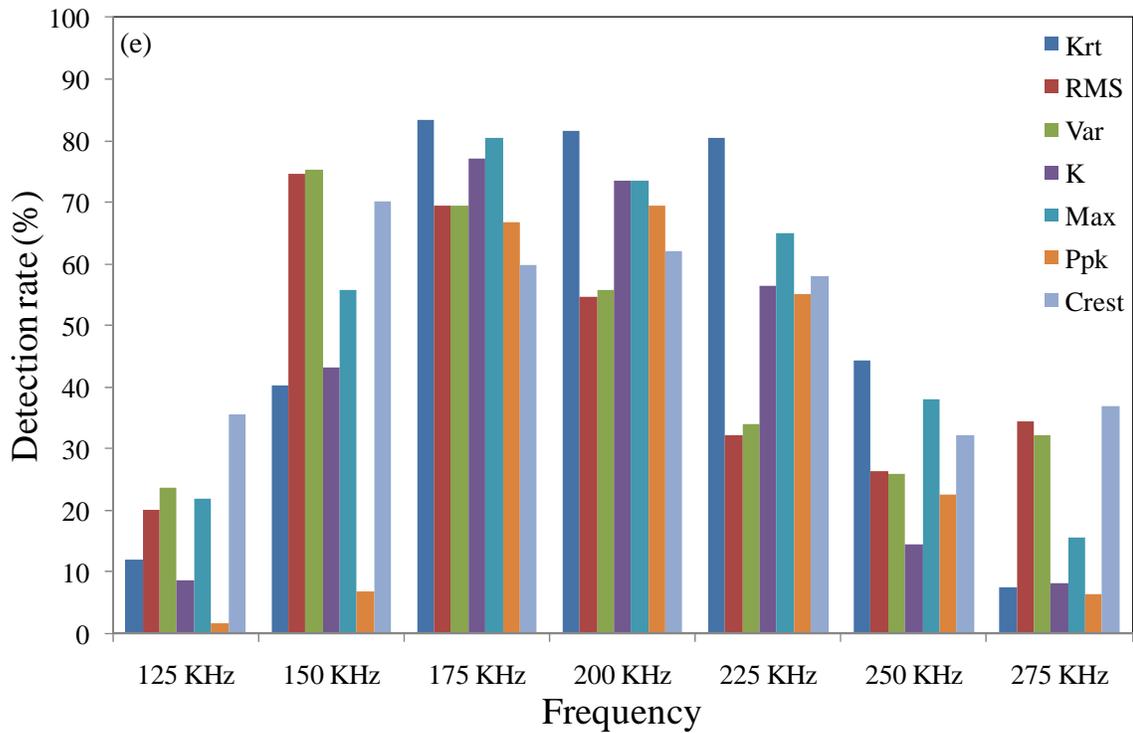
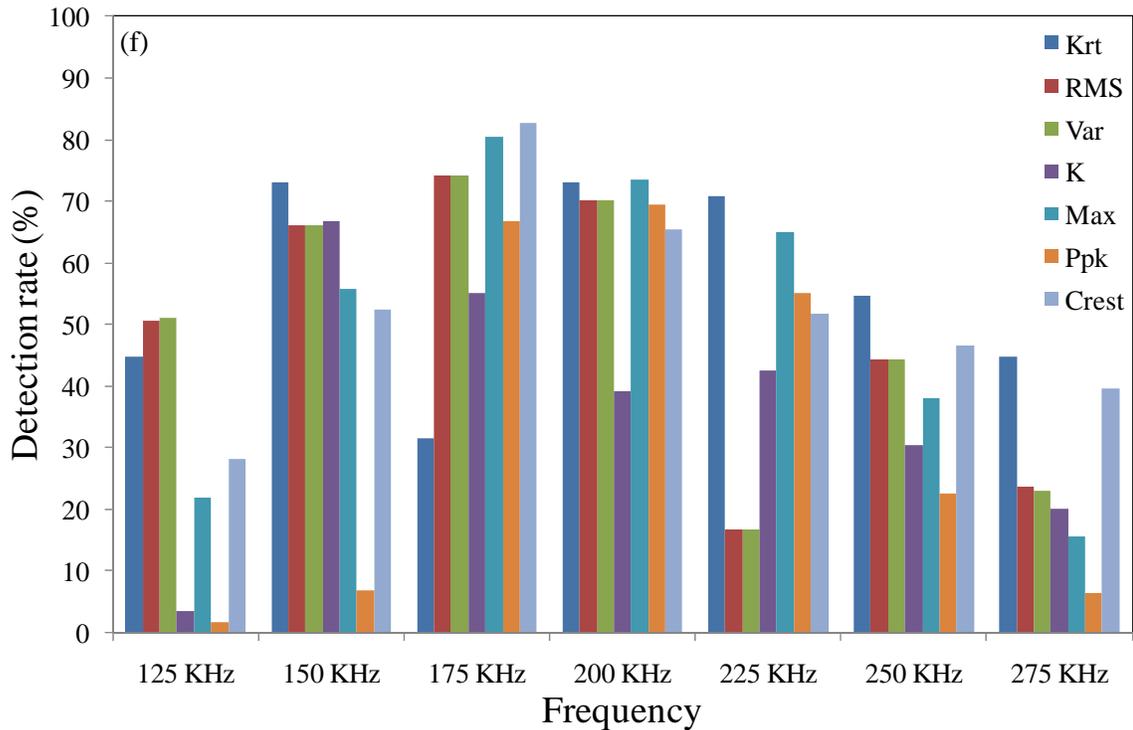
Figure 7.6 - Univariate analysis. Detection rate as a function of frequency for the following features: (a) $S5 \Rightarrow S0/S5 \Rightarrow S4$ (b) $S5 \Rightarrow S6/S5 \Rightarrow S4$; (c) $S5 \Rightarrow S8/S5 \Rightarrow S4$ (d) $S0 \Rightarrow S4/S0 \Rightarrow S1$ (e) $S6 \Rightarrow S5/S6 \Rightarrow S7$ (f) $S0 \Rightarrow S5/S0 \Rightarrow S1$.

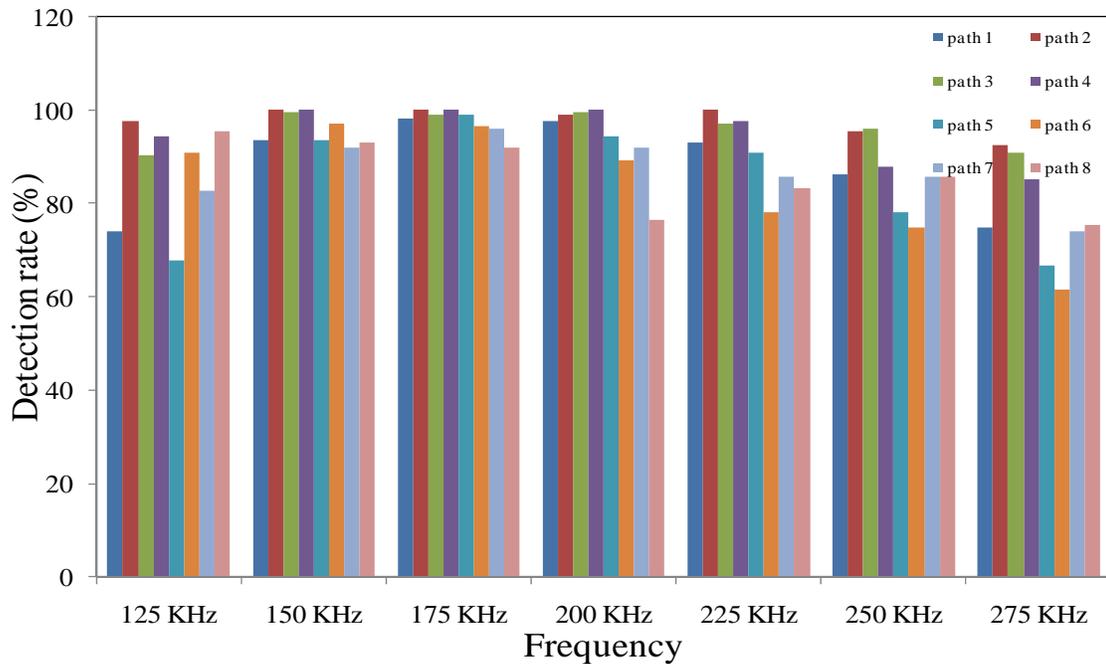
Figure 7.7 - MSD considering all seven features: path (1) $S5 \Rightarrow S0/S5 \Rightarrow S4$; (2) $S9 \Rightarrow S6/S9 \Rightarrow S8$; (3) $S5 \Rightarrow S8/S5 \Rightarrow S4$; (4) $S5 \Rightarrow S6/S5 \Rightarrow S4$; (5) $S5 \Rightarrow S1/S5 \Rightarrow S4$; (6) $S0 \Rightarrow S4/S0 \Rightarrow S2$; (7) $S0 \Rightarrow S5/S0 \Rightarrow S1$; (8) $S0 \Rightarrow S4/S0 \Rightarrow S1$.

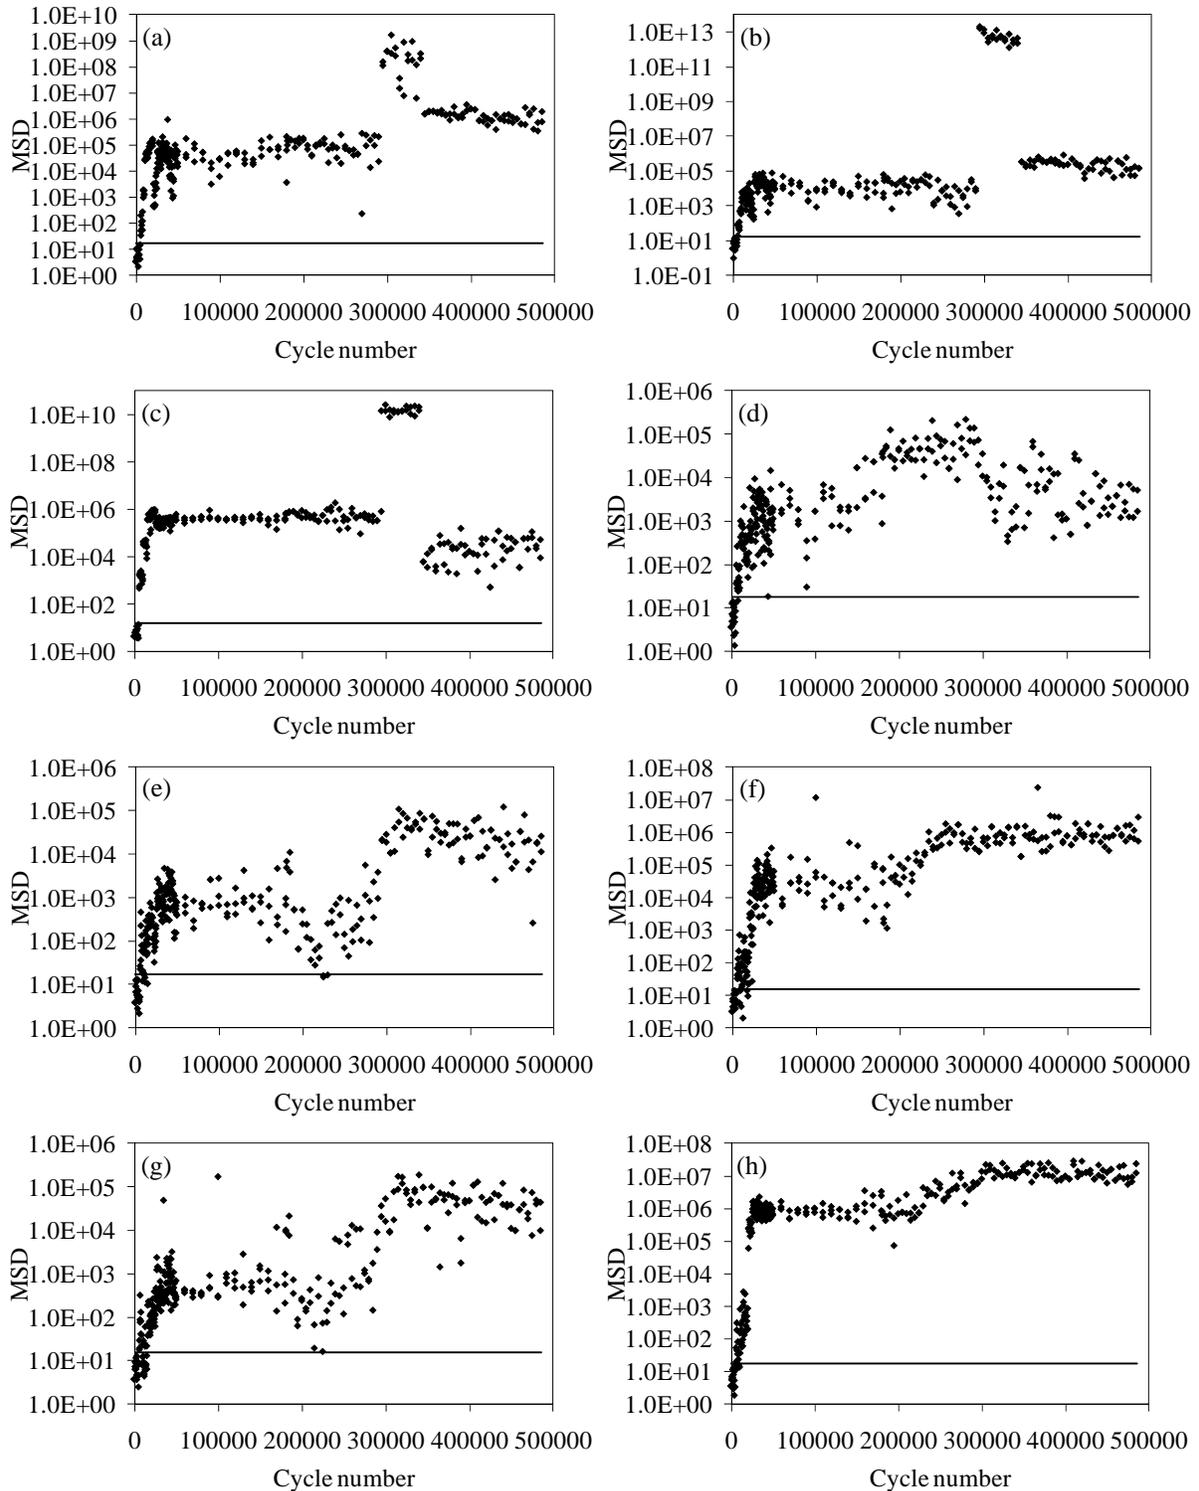
Figure 7.8 - Multivariate analysis. Mahalanobis squared distances as a function of the crack size for the actuator-sensor pairs considering all seven features: (a) $S9 \Rightarrow S6/S9 \Rightarrow S8$; (b) $S9 \Rightarrow S1/S9 \Rightarrow S8$; (c) $S5 \Rightarrow S6/S5 \Rightarrow S4$; (d) $S5 \Rightarrow S1/S5 \Rightarrow S4$; (e) $S0 \Rightarrow S4/S0 \Rightarrow S2$; (f) $S0 \Rightarrow S5/S0 \Rightarrow S1$; (g) $S0 \Rightarrow S4/S0 \Rightarrow S1$; (h) $S5 \Rightarrow S0/S5 \Rightarrow S4$.

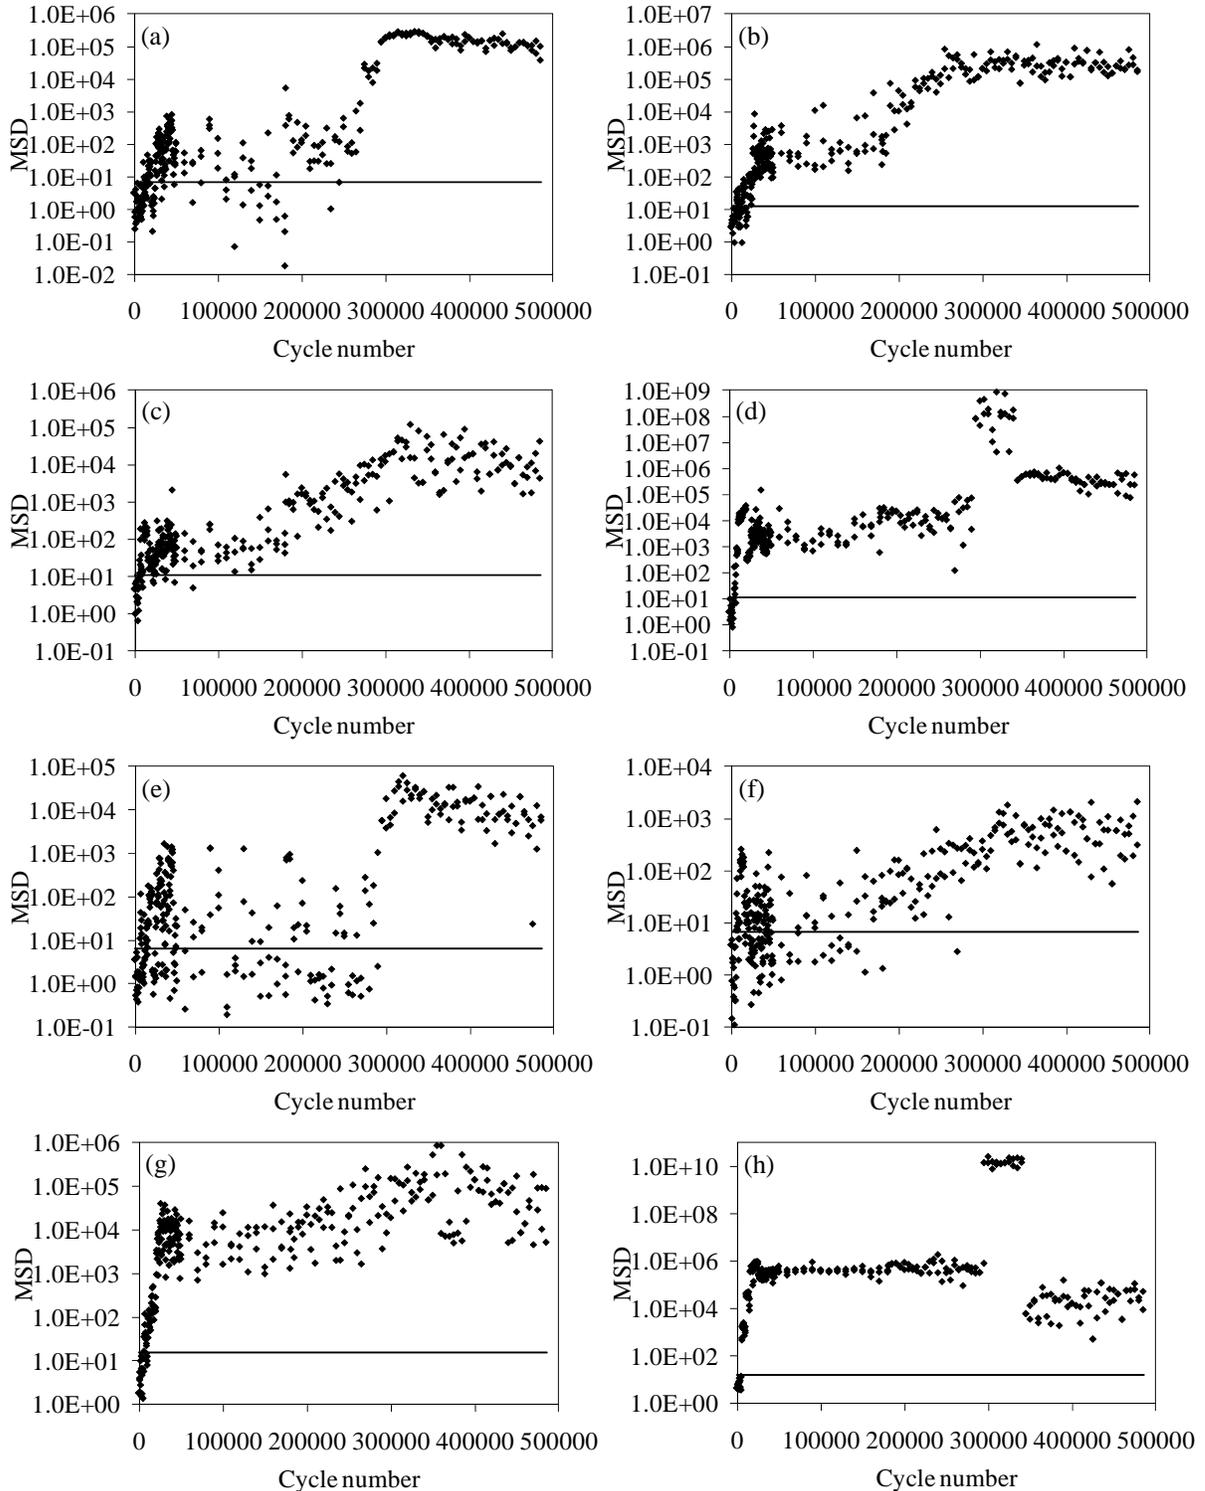
Figure 7.9 - Mahalanobis squared distances as a function of the crack size for the actuator-sensor pairs: (a) S1=>S4/S1=>S2 with rms and var (b) S0=>S5/S0=>S1 with krt, var, cf, kf, and ppk (c) S1=>S5/S1=>S2 with krt, var, cf, and kf (d) S9=>S6/S9=>S8 with rms, var, cf, and ppk; (e) S0=>S4/S0=>S2 with rms and var; (f) S1=>S4/S1=>S2 with krt and max; (g) S5=>S0/S5=>S4 with krt, rms, kf, max and ppk; (h) S5=>S6/S5=>S4 with krt, rms, var, cf, kf, and max.

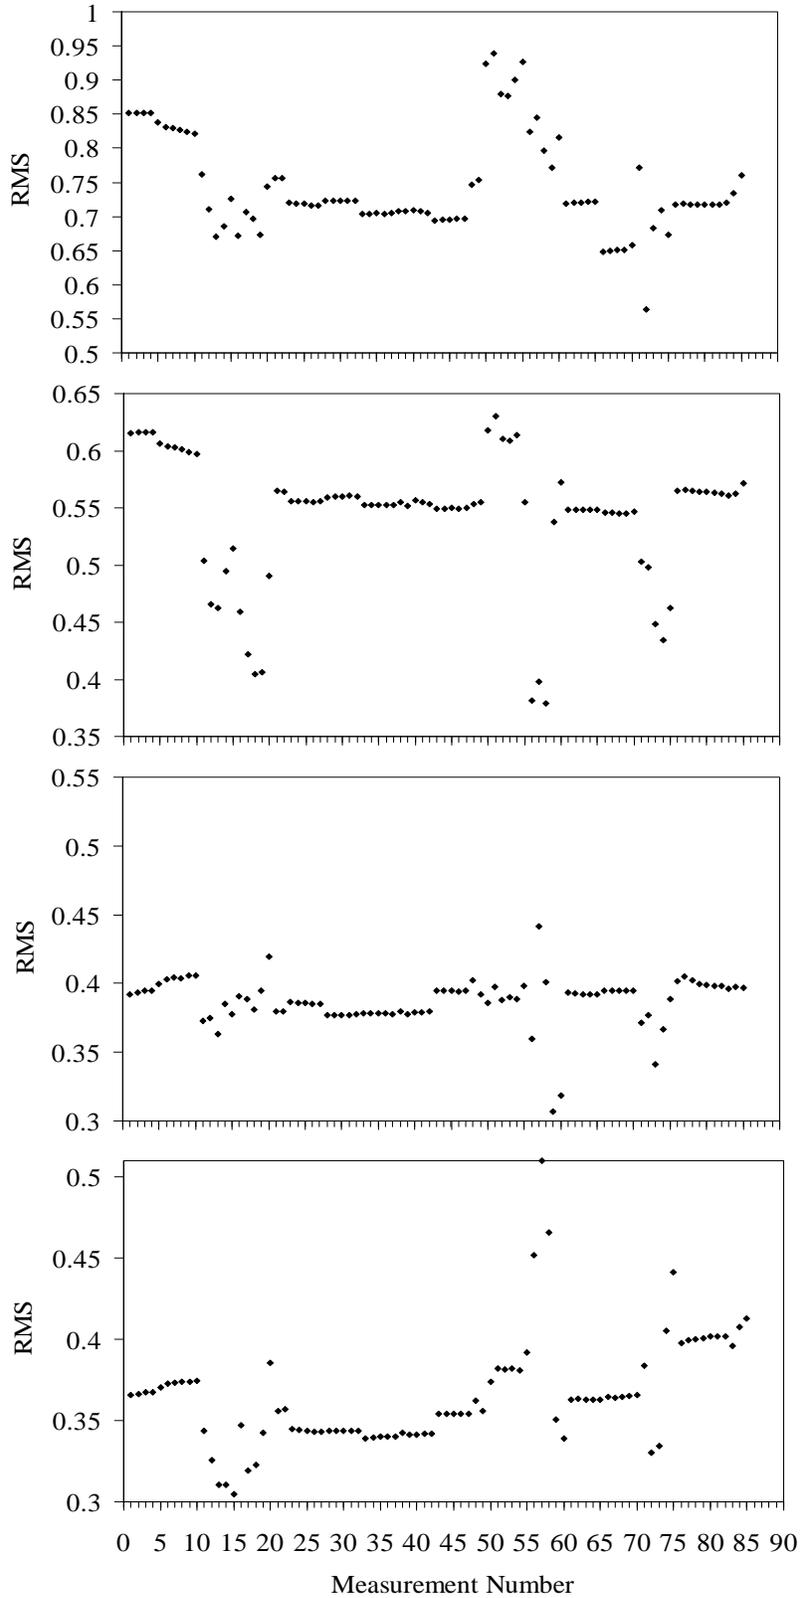
Figure 7.10 – Root Mean Square values as a function of the measurement number for: (a) $S3 \Rightarrow S4/S3 \Rightarrow S2$; (b) $S3 \Rightarrow S0/S3 \Rightarrow S2$; (c) $S0 \Rightarrow S3/S0 \Rightarrow S1$; (d) $S0 \Rightarrow S4/S0 \Rightarrow S1$.
