Sensing Technology for Damage Assessment of Sign Supports and Cantilever Poles

FINAL REPORT

By Piervincenzo Rizzo and Xuan Zhu
University of Pittsburgh

COMMONWEALTH OF PENNSYLVANIA
DEPARTMENT OF TRANSPORTATION

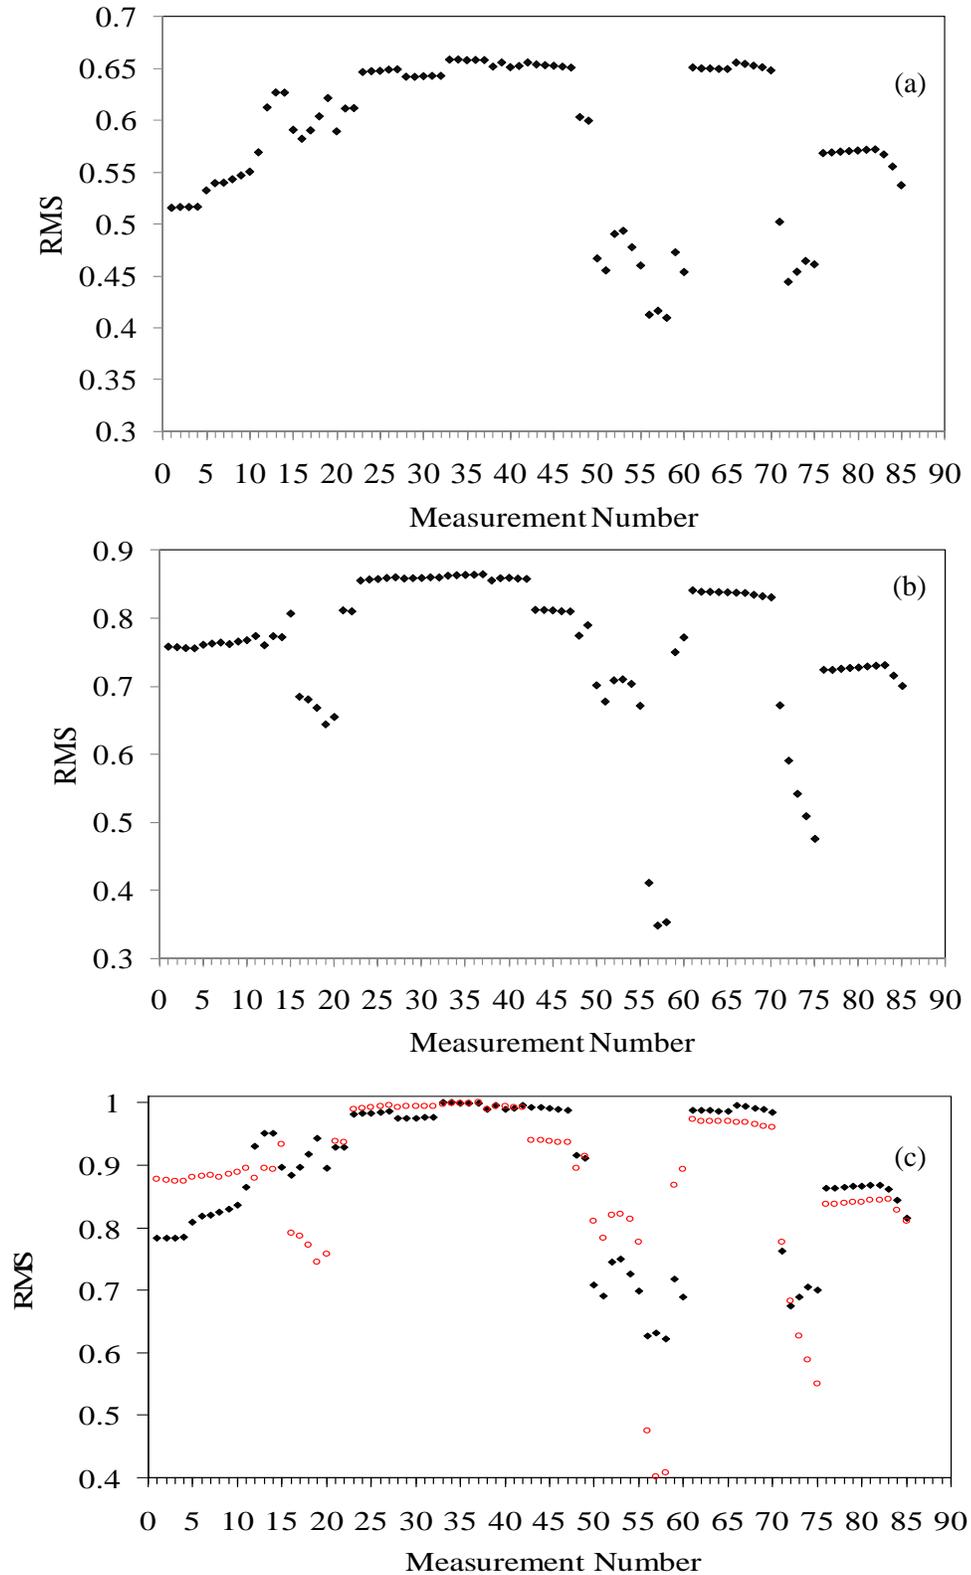
Figure 7.11 – Test 3. RMS for path: (a) S3=>S2; (b) S0=>S1; (c) Normalized RMS for S0=>S1 (red circles) and S3=>S2 (black dots).

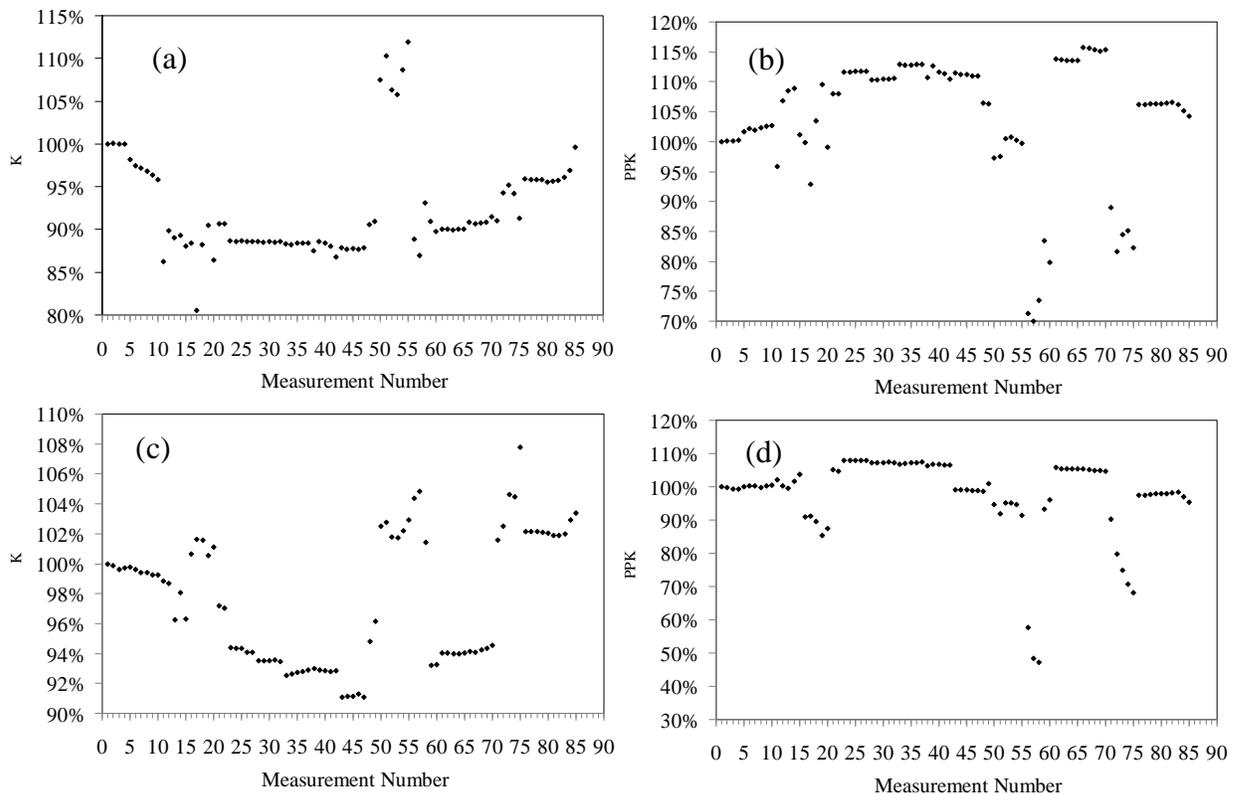
Figure 7.12 – Test 3. Path S3=>S2 (a) K-factor, (b) peak-to-peak. Path S0=>S1 (c) K-factor, (d) peak-to-peak.

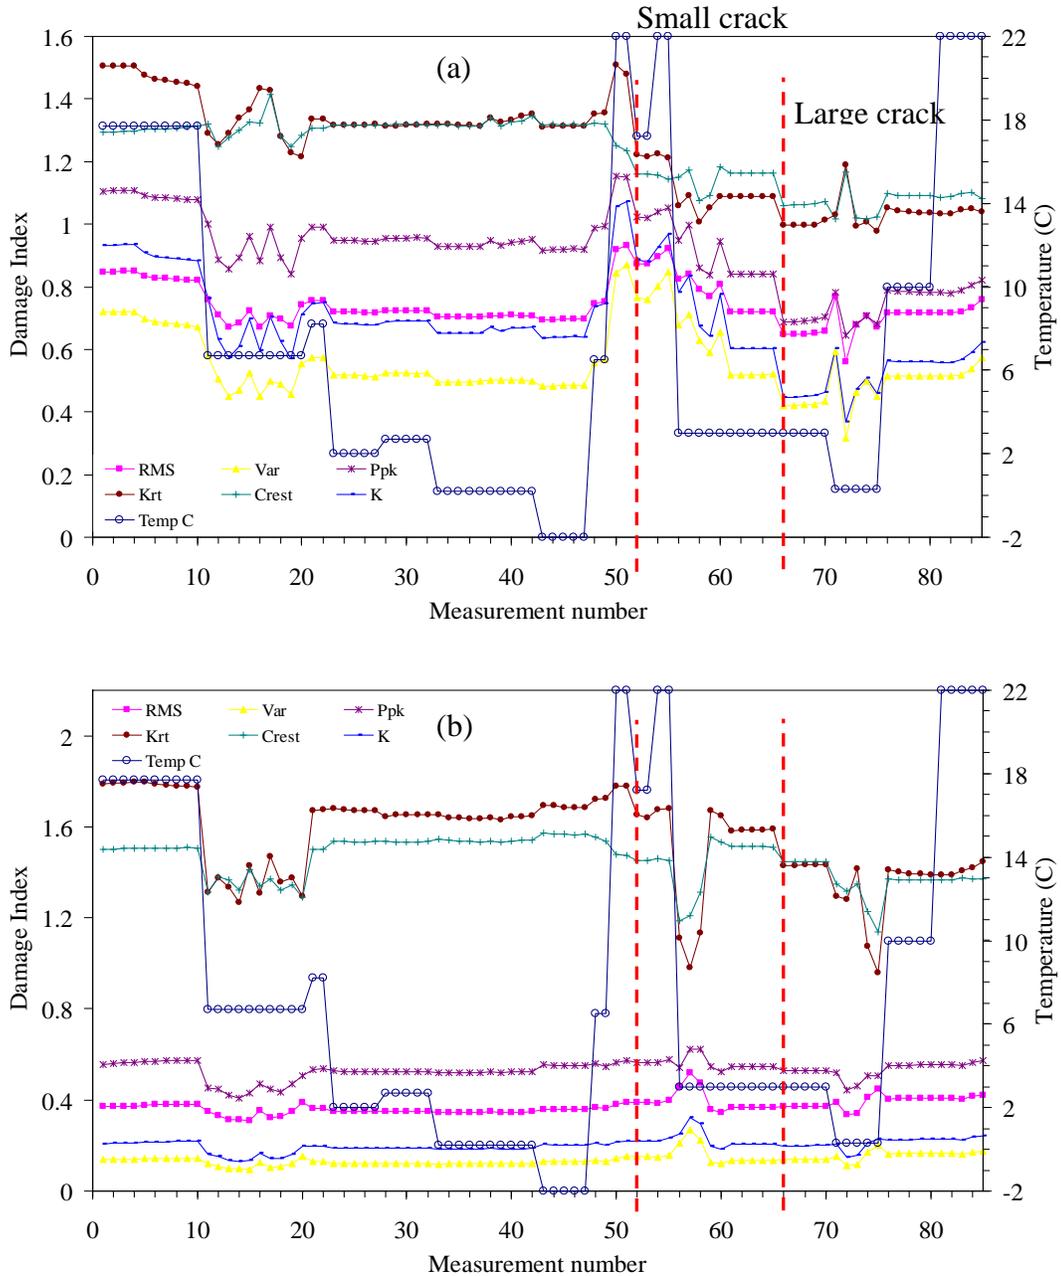
Figure 7.15 – Damage Index as a function of the measurement number associated with six features. (a) Ratio $S3 \Rightarrow S4 / S3 \Rightarrow S2$. (b) Ratio $S0 \Rightarrow S4 / S0 \Rightarrow S1$. The value of the temperature at each measurement number is scaled on the y-axis on the right.

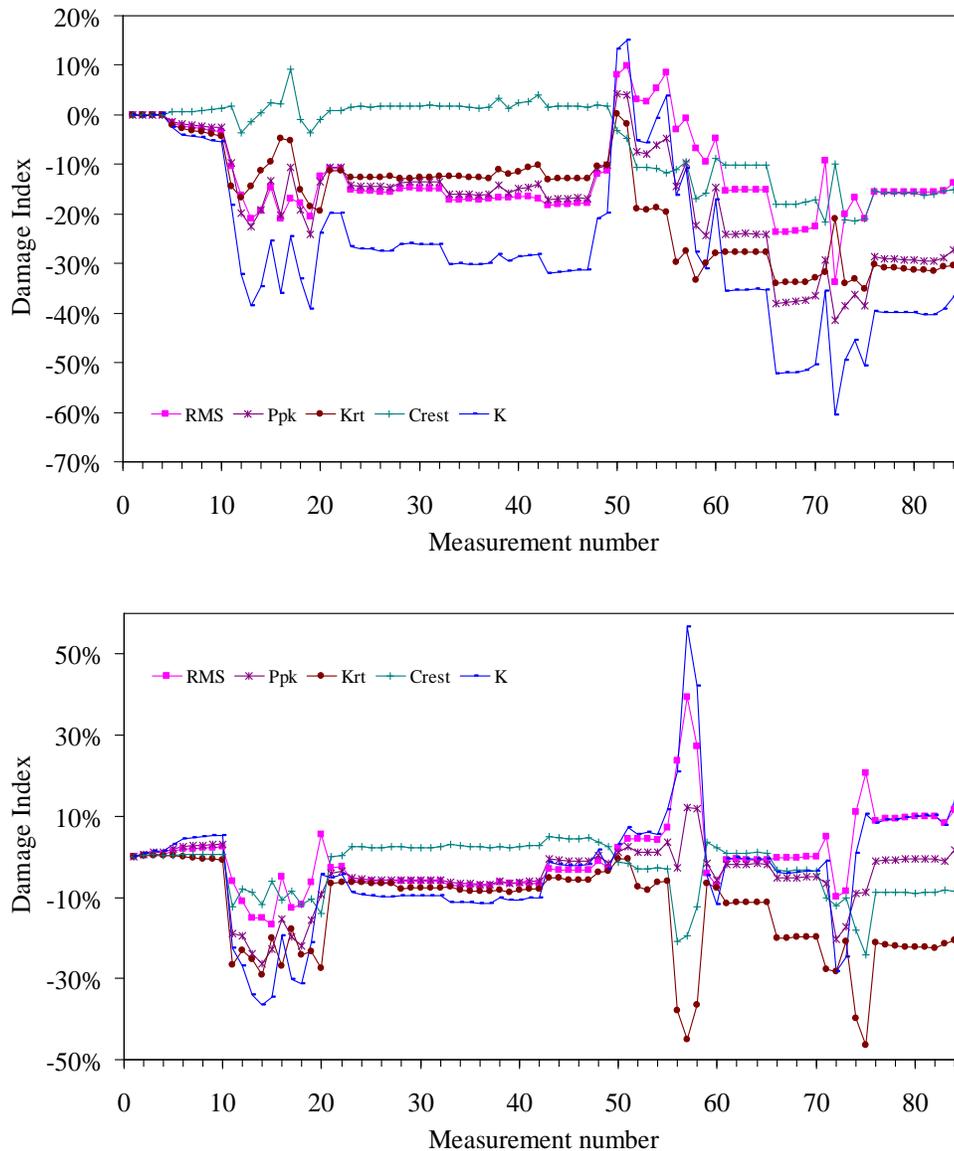
Figure 7.16 – Percentage variation of the damage index as a function of the measurement number associated with six features with respect to the value calculated during the first measurement. (a) Ratio $S3 \Rightarrow S4 / S3 \Rightarrow S2$. (b) Ratio $S0 \Rightarrow S4 / S0 \Rightarrow S1$. The value of the temperature at each measurement number is scaled on the y-axis on the right.

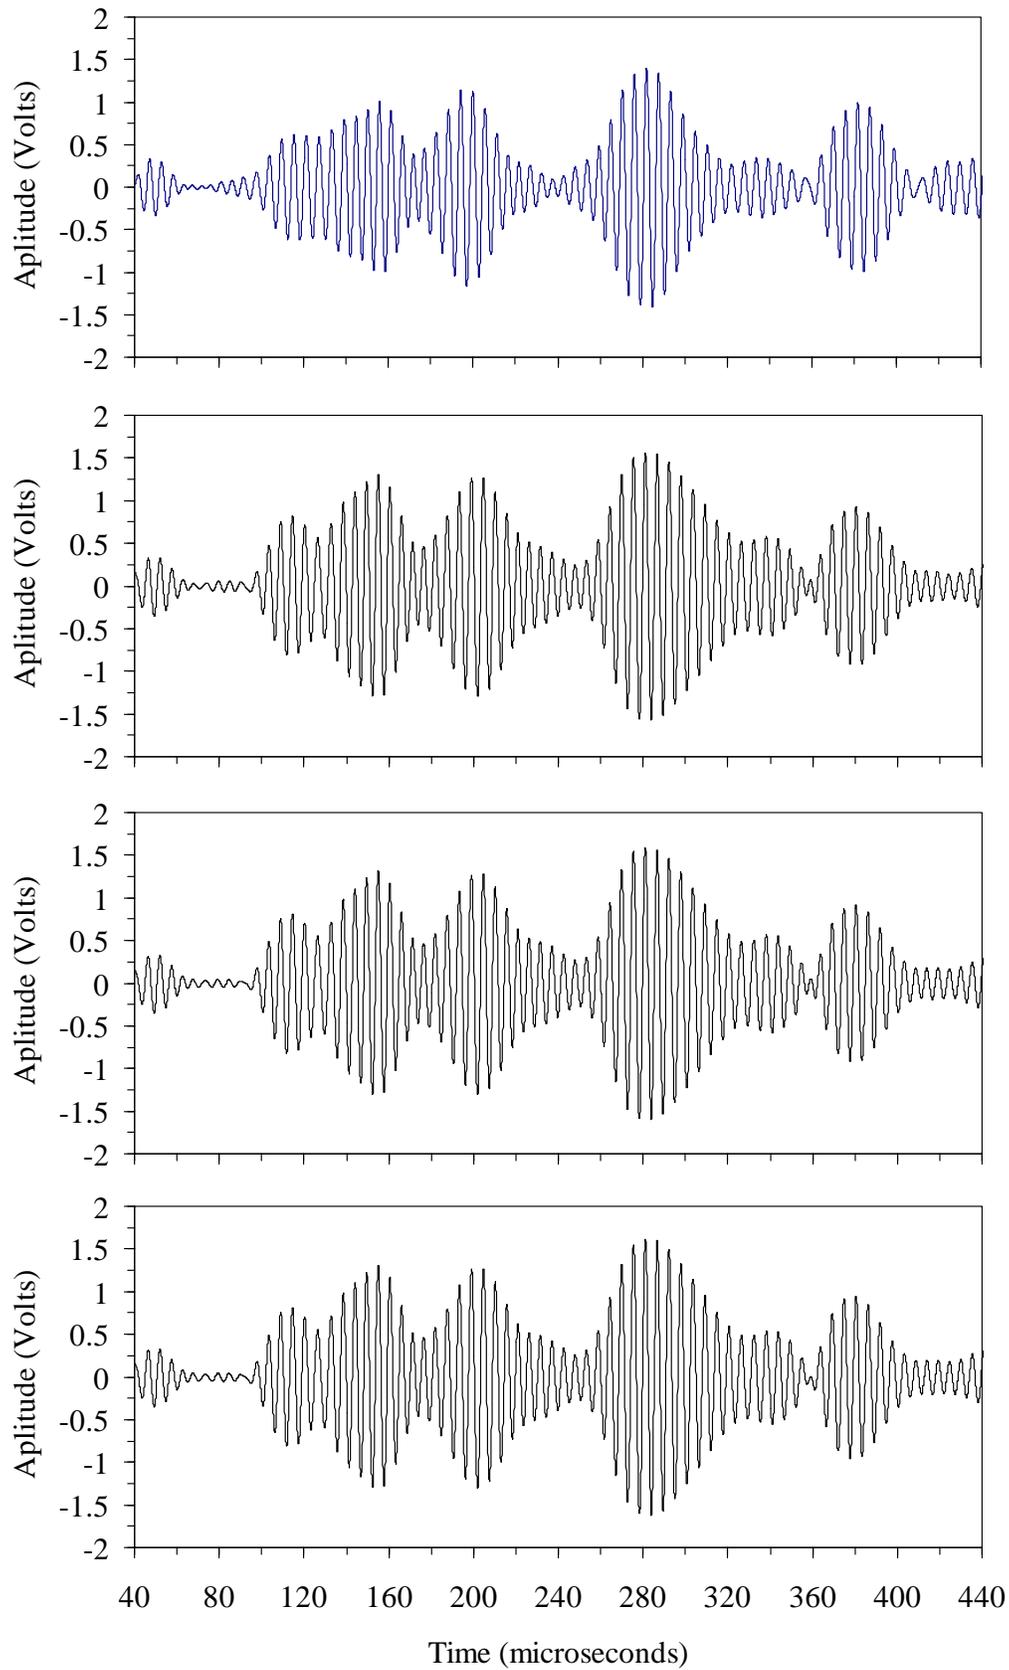
Figure 7.17 – Time waveforms generated by actuator S3 and sensor S2. From top to bottom: measurement number 1, 25, 61, 68.

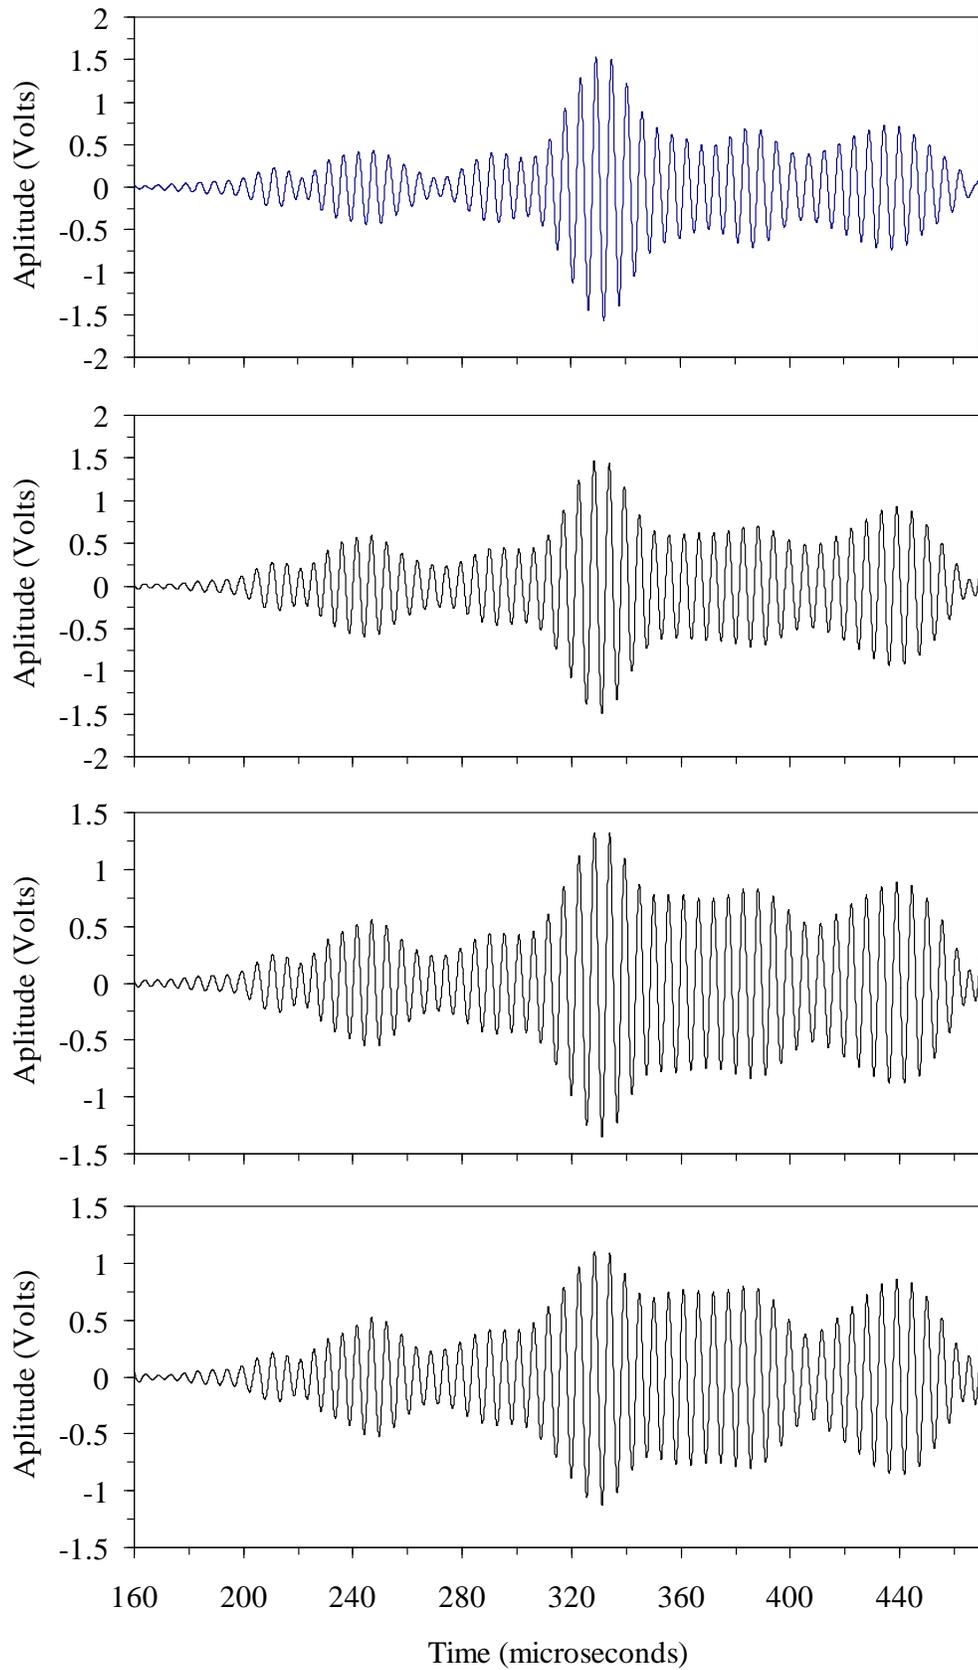
Figure 7.18 – Time waveforms generated by actuator S3 and sensor S4. From top to bottom: measurement number 1, 25, 61, 68.

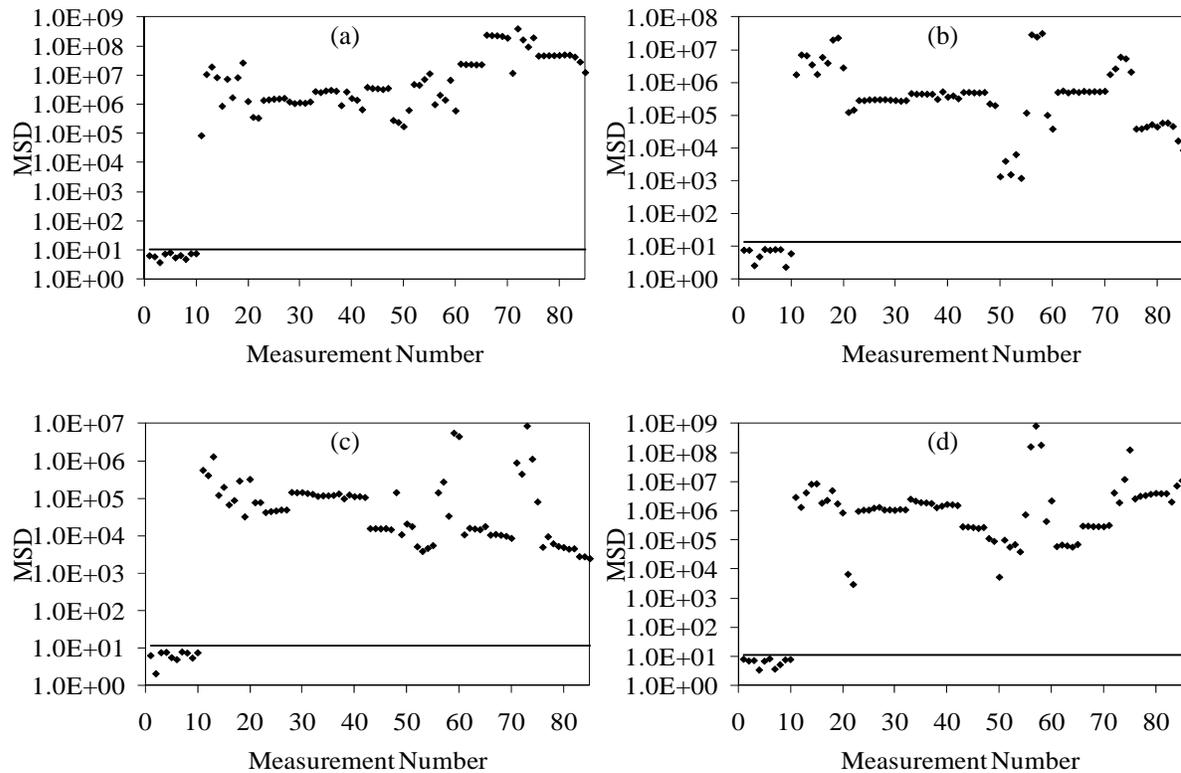
Figure 7.19 - Multivariate analysis. Mahalanobis squared distances as a function of the measurement number considering all seven features for the following: (a) $S3 \Rightarrow S4/S3 \Rightarrow S2$; (b) $S3 \Rightarrow S0/S3 \Rightarrow S2$; (c) $S0 \Rightarrow S3/S0 \Rightarrow S1$; (d) $S0 \Rightarrow S4/S0 \Rightarrow S1$.

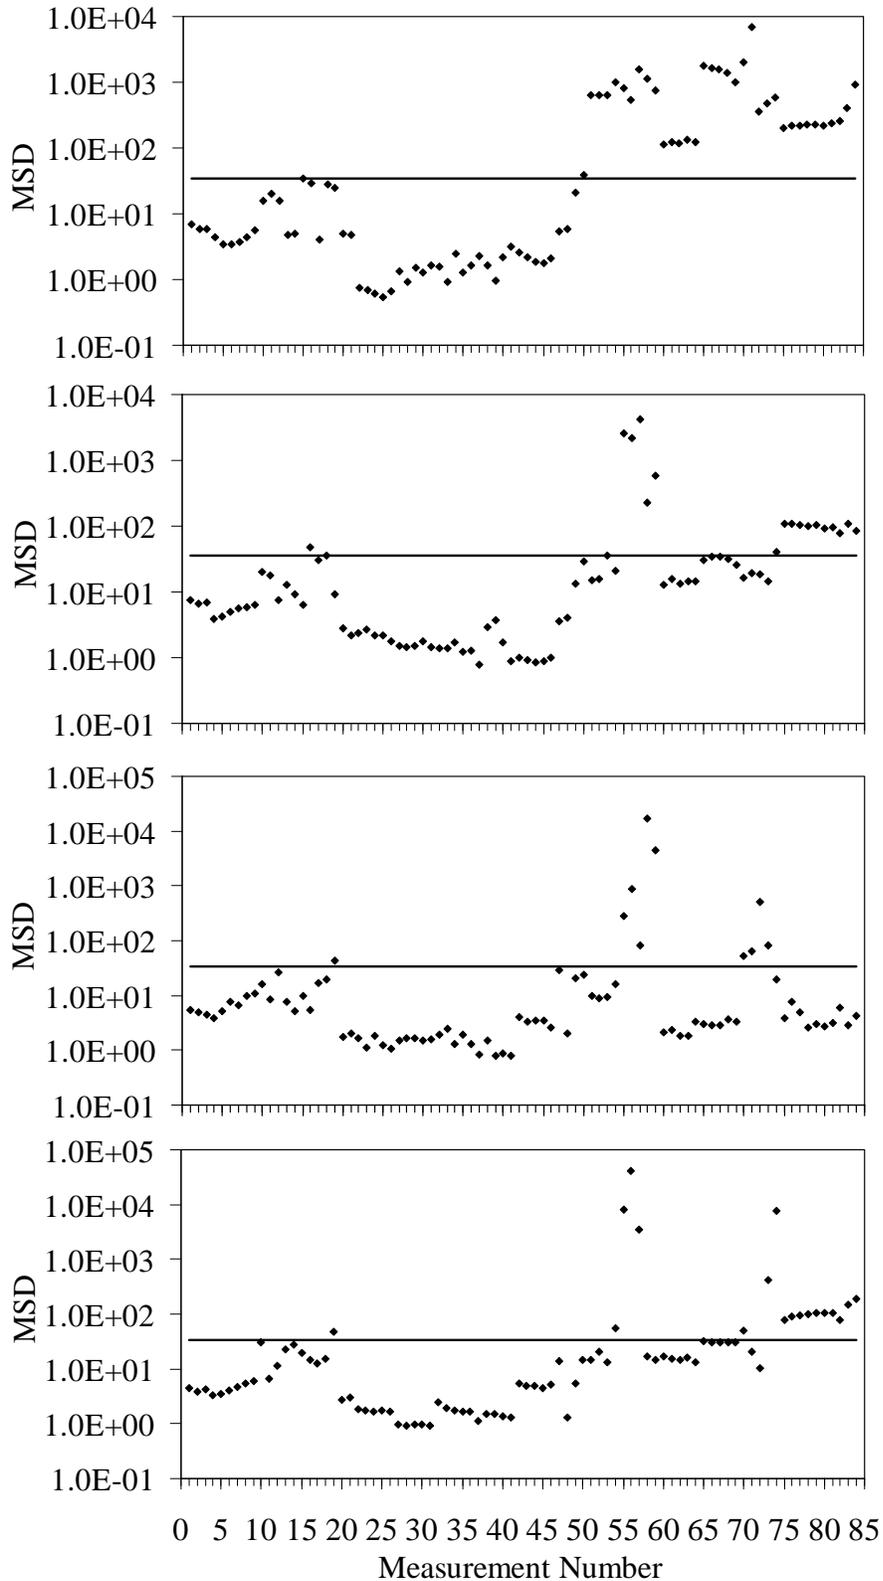
Figure 7.20 – MSD as a function of measurement number for paths (a) $C3 \Rightarrow C4/C3 \Rightarrow C2$, (b) $C3 \Rightarrow C0/C3 \Rightarrow C2$, (c) $C0 \Rightarrow C3/C0 \Rightarrow C1$, and (d) $C0 \Rightarrow C4/C0 \Rightarrow C1$. The first 51 measurements were considered a baseline.

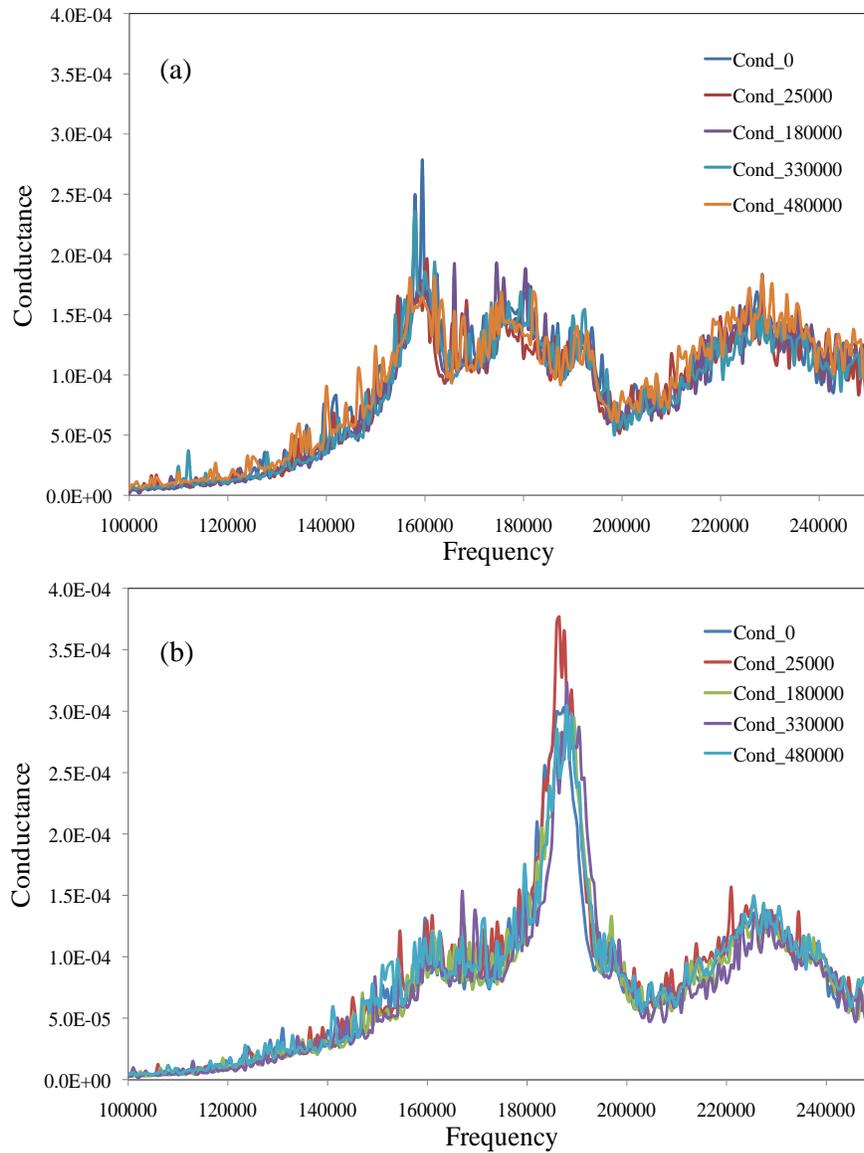
Figure 8.8 - (a) Conductance signature for EM1 resulted from PXI at 5 different periods; (b) Conductance signature for EM2 resulted from PXI at 5 different periods.

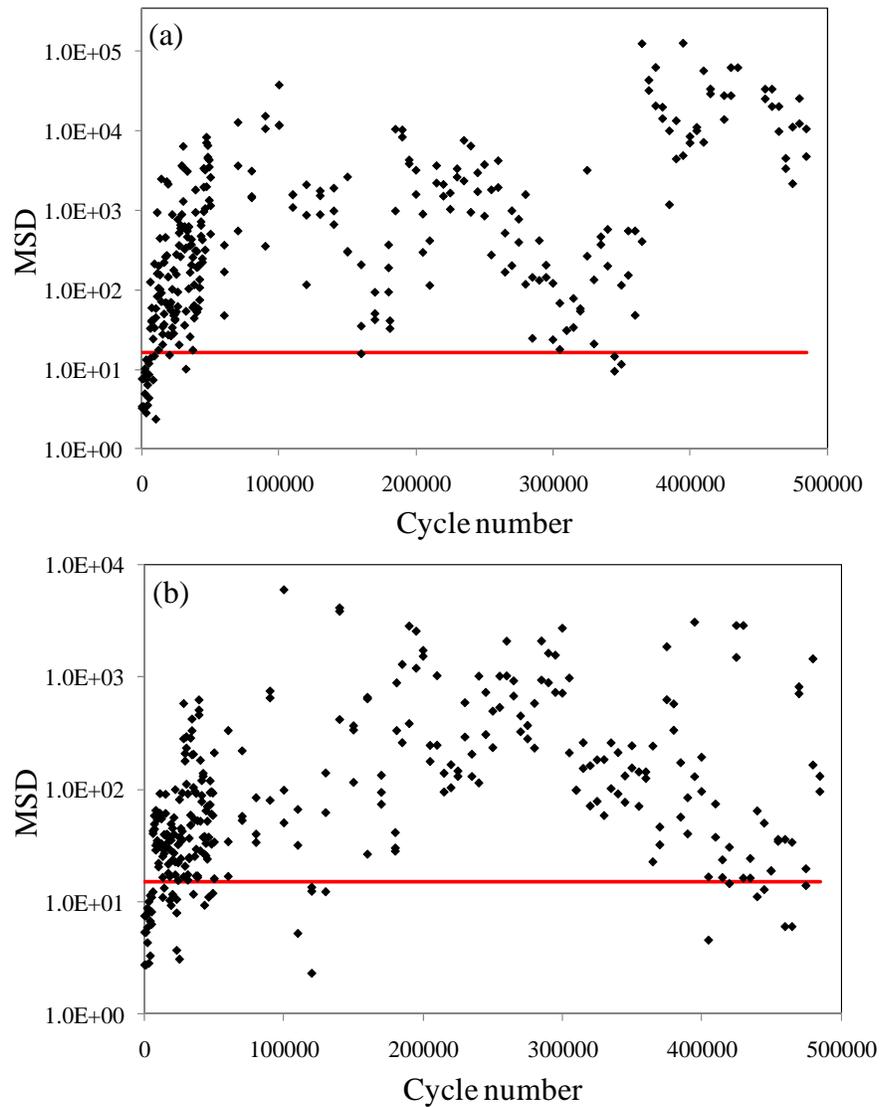
Figure 8.11 - Multivariate analysis. Mahalanobis squared distances as a function of the cycle number considering all seven features for: (a) EM1; (b) EM2.

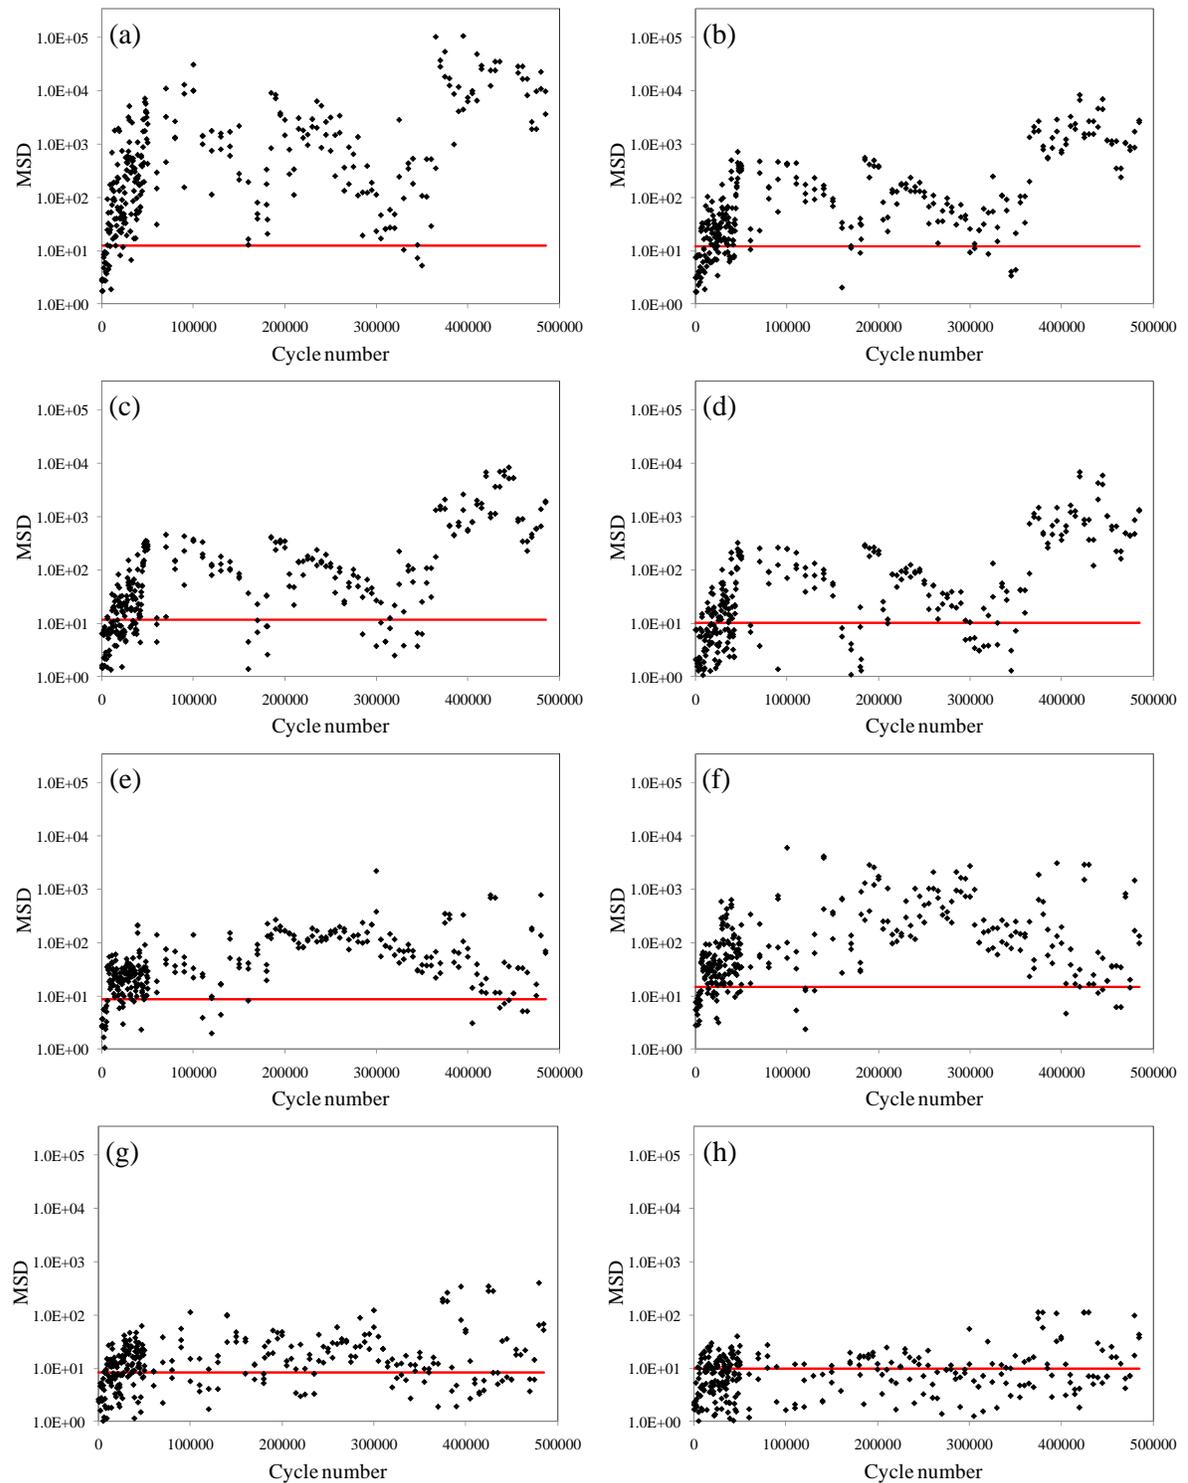
Figure 8.12 - Multivariate analysis. Mahalanobis squared distances as a function of the cycle number for: (a) EM1 with krt, rms, peak, area, skw, var and rmsd (b) EM1 with krt, peak, area, var and rmsd (c) EM1 with krt, rms, peak and skw (d) EM1 with peak, area and rmsd; (e) EM2 with rms, peak, area and skw; (f) EM2 with krt, rms, peak, area, skw, var and rmsd; (g) EM2 with peak, skw and var ; (h) EM2 with peak, area and rmsd.

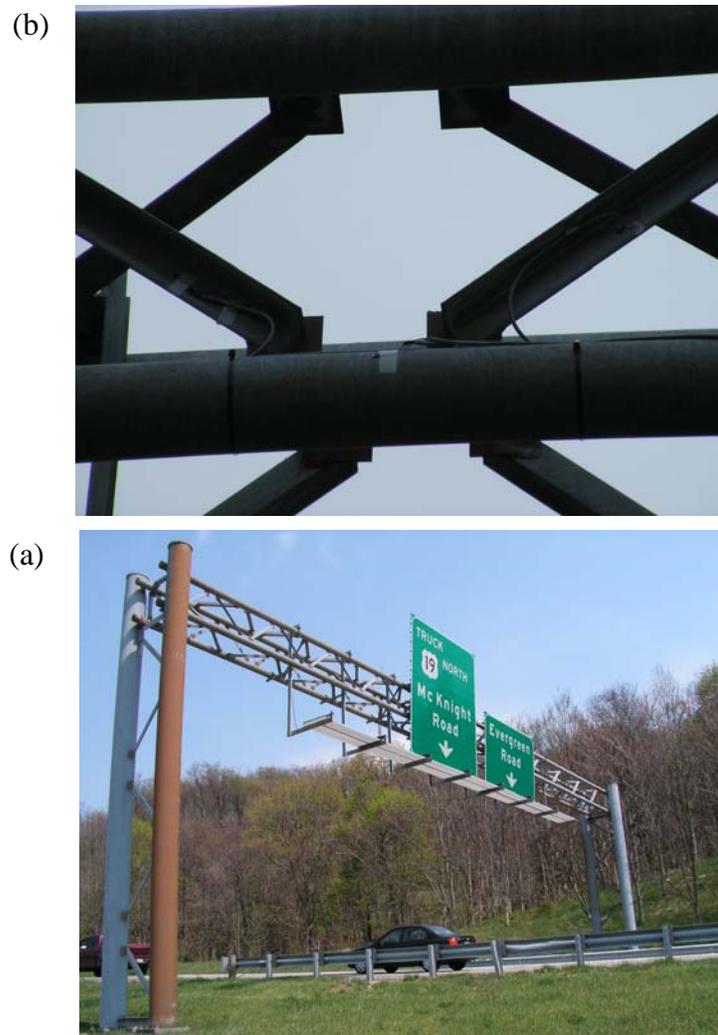
Figure 9.1 – (a) Photo of the first structure monitored in the field. (b) Particular of the welded connections instrumented with PZTs.

The main chords consist of tubular elements have 6.625 inches (168.275 mm) outer diameter and 0.432 inches (10.97 mm) thickness. Diagonal angular members (type 2.0 x 3.85) are welded to the structure. A zoom in view of one of these welded connections is shown in Fig. 9.1b.

The first field test was performed on the sign support structure shown in Fig. 9.1a. The structure is located on the Mc Knight Road ramp along Interstate 279 (40.49153,-80.009442) few miles north of downtown Pittsburgh, Pennsylvania. The structure is denoted as L.R.1021 3-C.

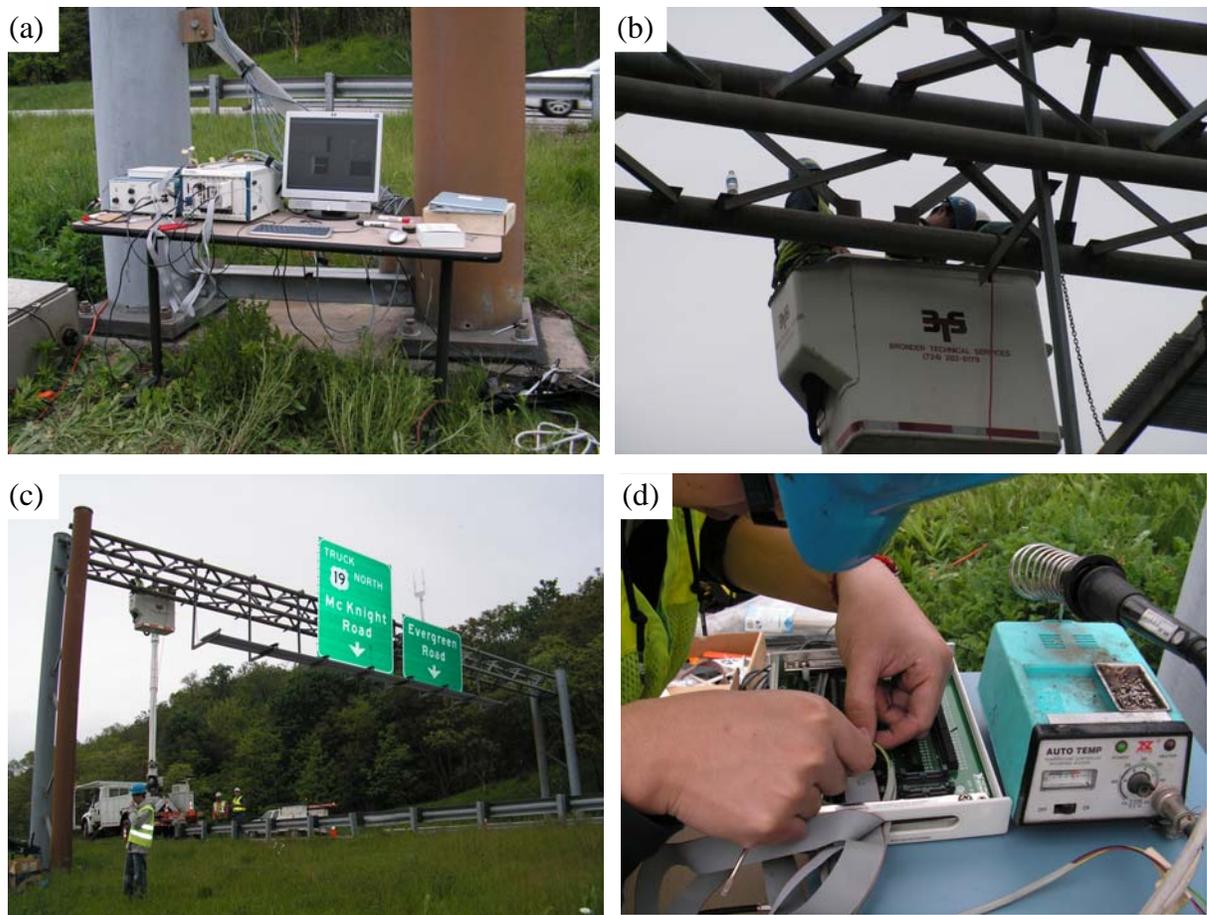
Figure 9.3 – Structure 1. (a) Data acquisition system. (b-c) Bonding the PZTs to the structure. (d) Connecting the coaxial cables to the screw terminal.

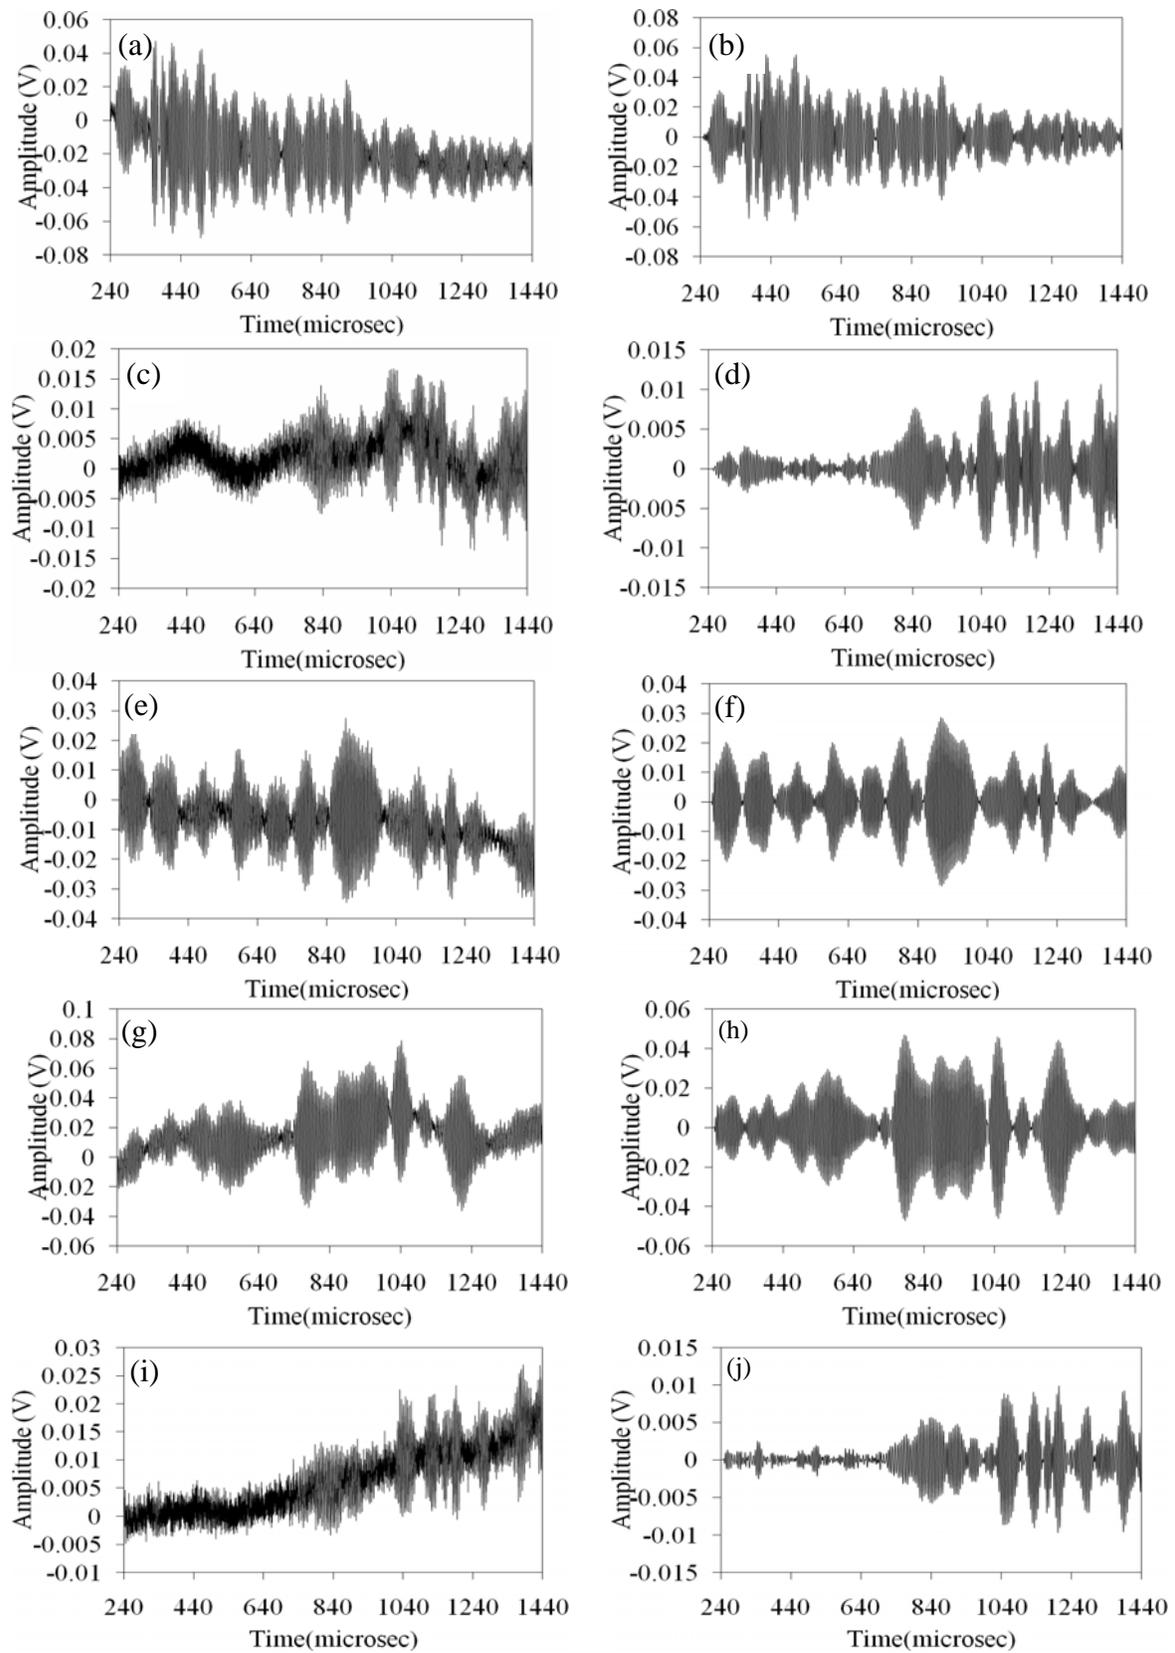
Figure 9.4 - Time waveforms recorded during May 17 and actuation frequency equal to 175 kHz. The left column shows original data. The right column shows the corresponding waveforms filtered using a Butterworth filter. (a,b) $S0 \Rightarrow S2$; (c,d) $S0 \Rightarrow S5$; (e,f) $S0 \Rightarrow S3$; (g,h) $S1 \Rightarrow S3$; (i,j) $S5 \Rightarrow S0$.

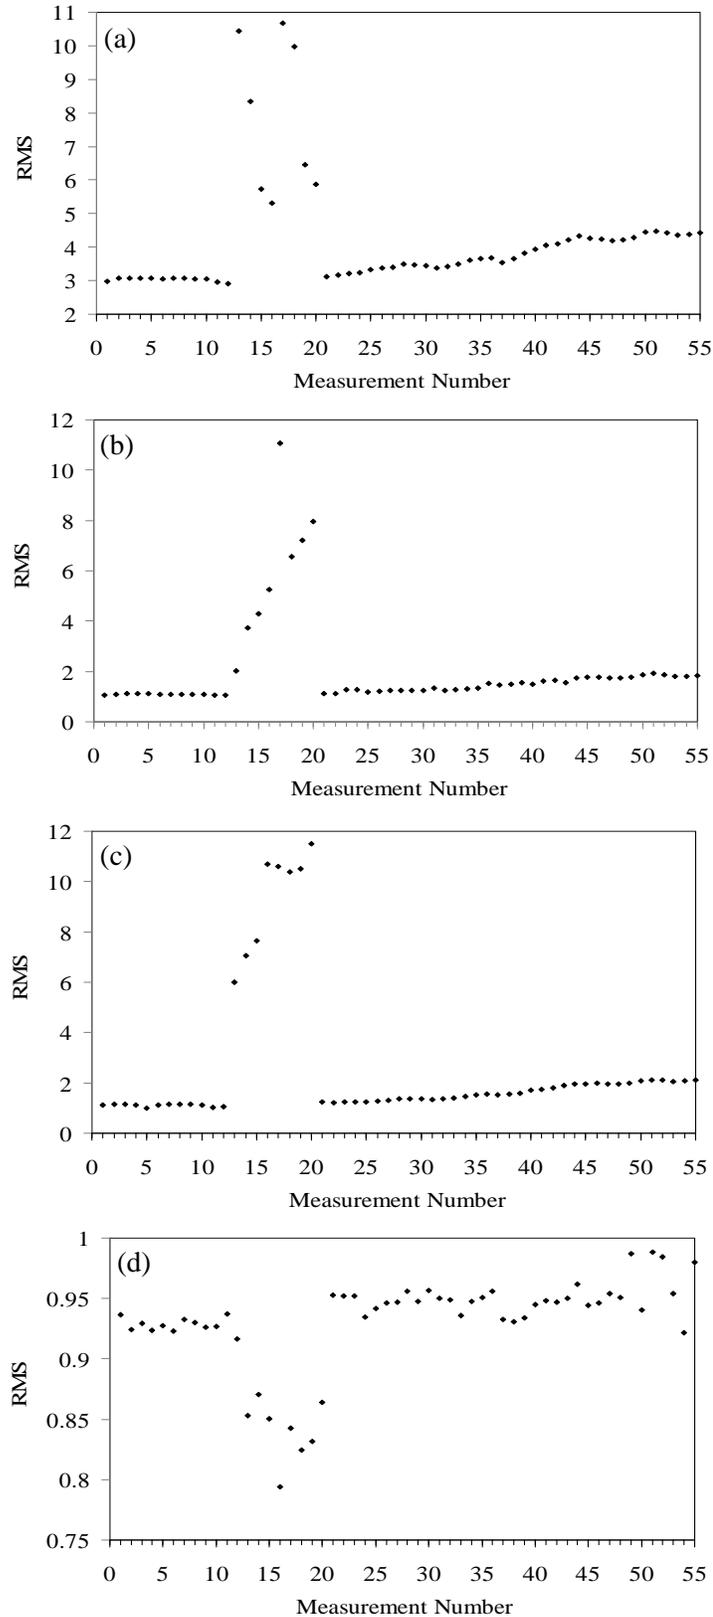
Figure 9.5 - Test 1, May. RMS – based damage associated to waveform paths: (a) $C0 \Rightarrow C2 / C0 \Rightarrow C5$; (b) $C0 \Rightarrow C3 / C0 \Rightarrow C5$; (c) $C1 \Rightarrow C3 / C0 \Rightarrow C5$ and (d) $C5 \Rightarrow C0 / C0 \Rightarrow C5$.

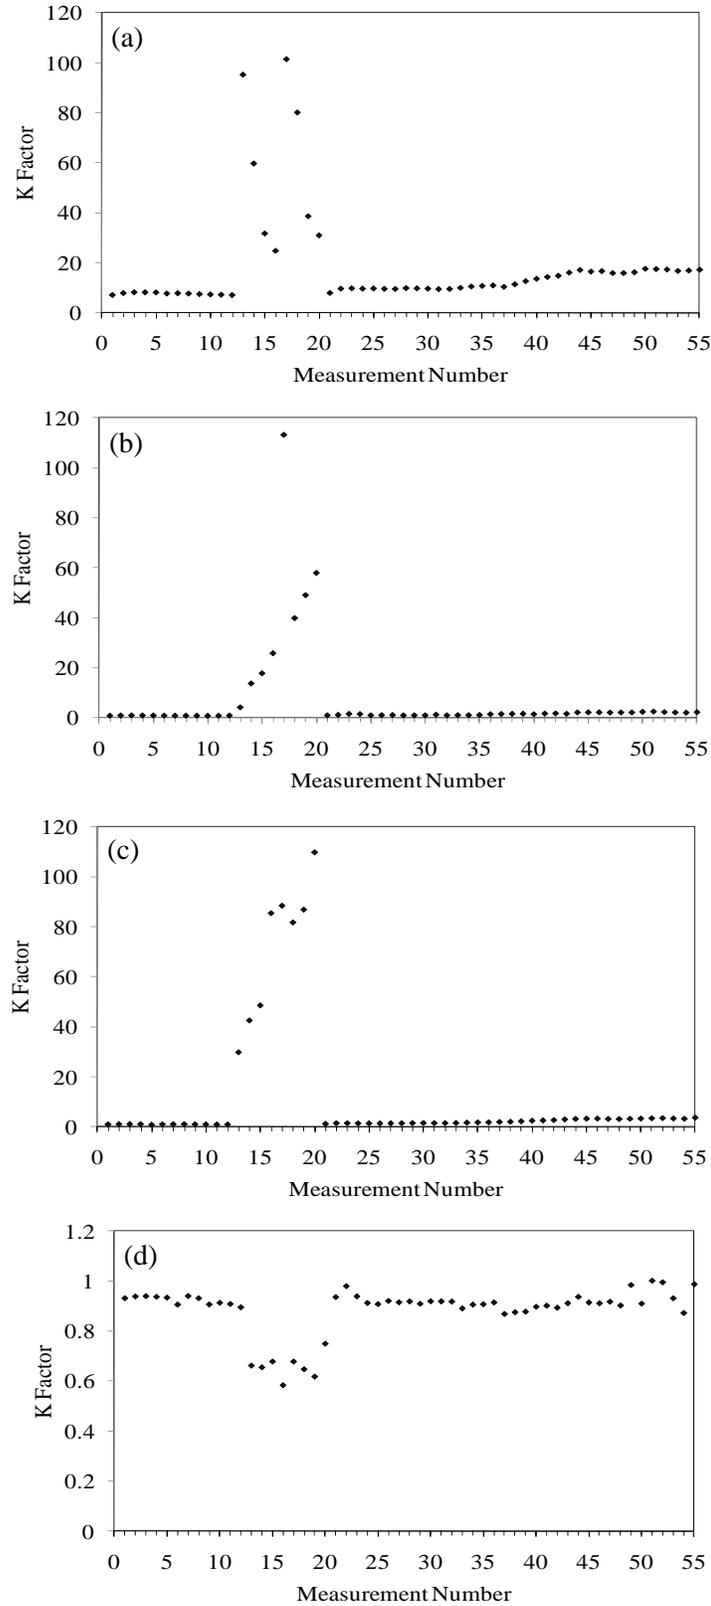
Figure 9.6 - Test 1, May. K factor – based damage associated to waveform paths: (a) $C0 \Rightarrow C2 / C0 \Rightarrow C5$; (b) $C0 \Rightarrow C3 / C0 \Rightarrow C5$; (c) $C1 \Rightarrow C3 / C0 \Rightarrow C5$ and (d) $C5 \Rightarrow C0 / C0 \Rightarrow C5$.

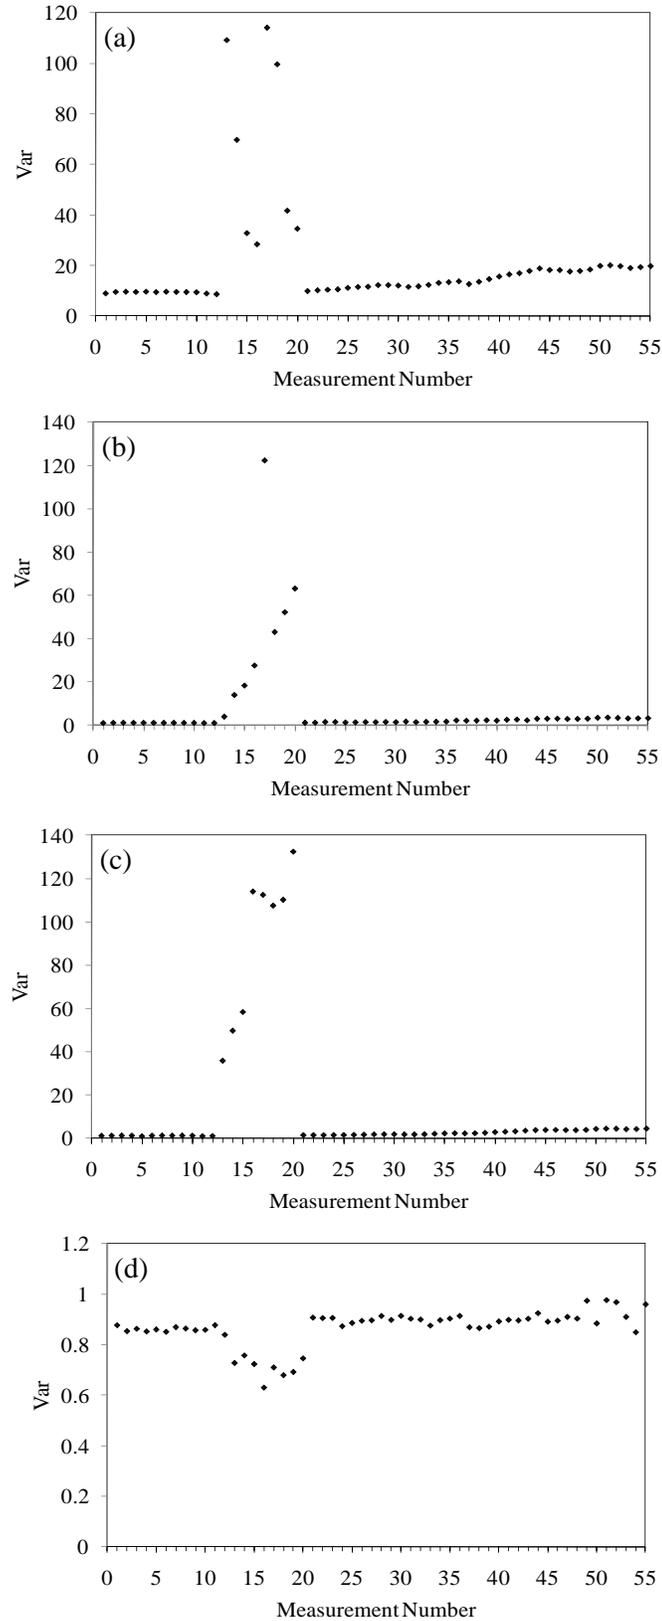
Figure 9.7 - Test 1, May. Variance – based damage associated to waveform paths: (a) $C0 \Rightarrow C2 / C0 \Rightarrow C5$; (b) $C0 \Rightarrow C3 / C0 \Rightarrow C5$; (c) $C1 \Rightarrow C3 / C0 \Rightarrow C5$ and (d) $C5 \Rightarrow C0 / C0 \Rightarrow C5$.
