Sensing Technology for Damage Assessment of Sign Supports and Cantilever Poles

FINAL REPORT

By Piervincenzo Rizzo and Xuan Zhu
University of Pittsburgh

COMMONWEALTH OF PENNSYLVANIA
DEPARTMENT OF TRANSPORTATION

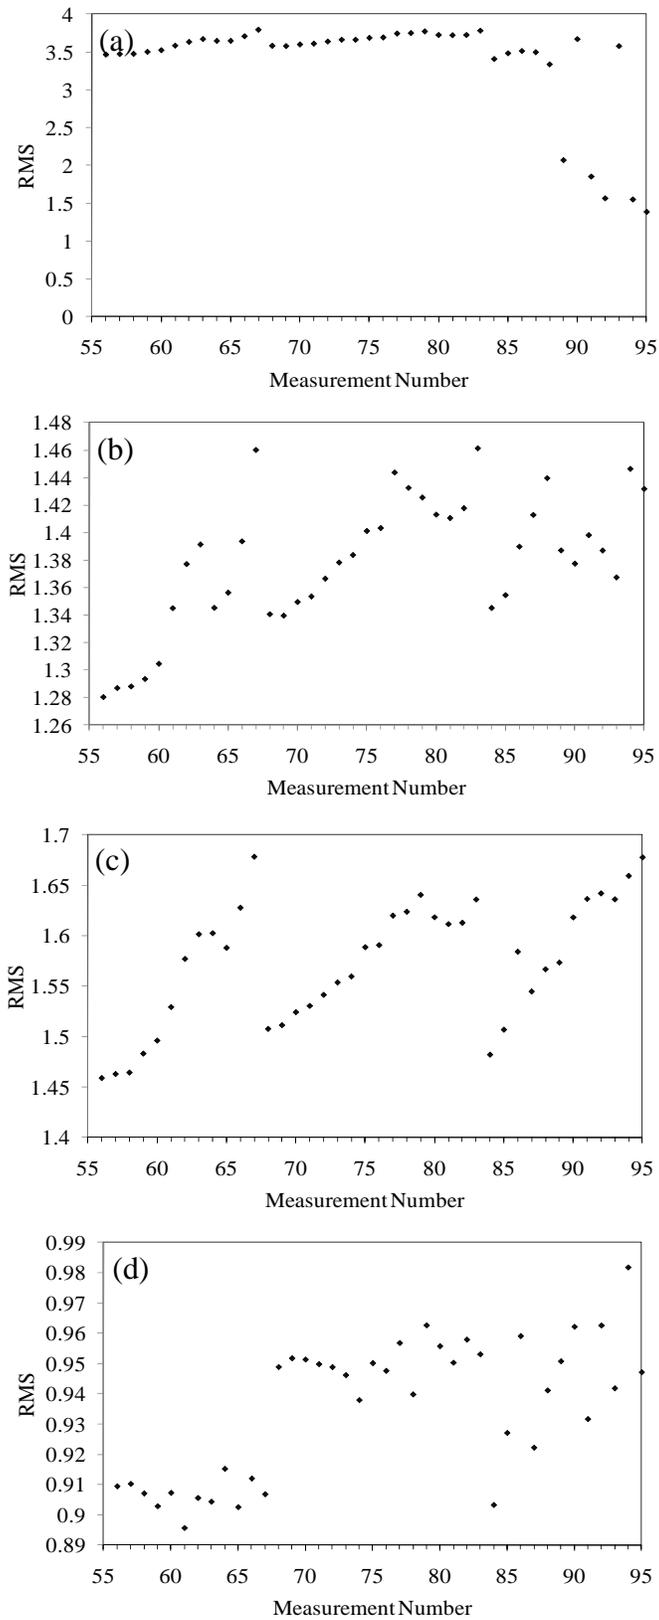
Figure 9.8 – RMS-based damage index from June data relative to paths: (a) $C0 \Rightarrow C2 / C0 \Rightarrow C5$; (b) $C0 \Rightarrow C3 / C0 \Rightarrow C5$; (c) $C1 \Rightarrow C3 / C0 \Rightarrow C5$ and (d) $C5 \Rightarrow C0 / C0 \Rightarrow C5$.

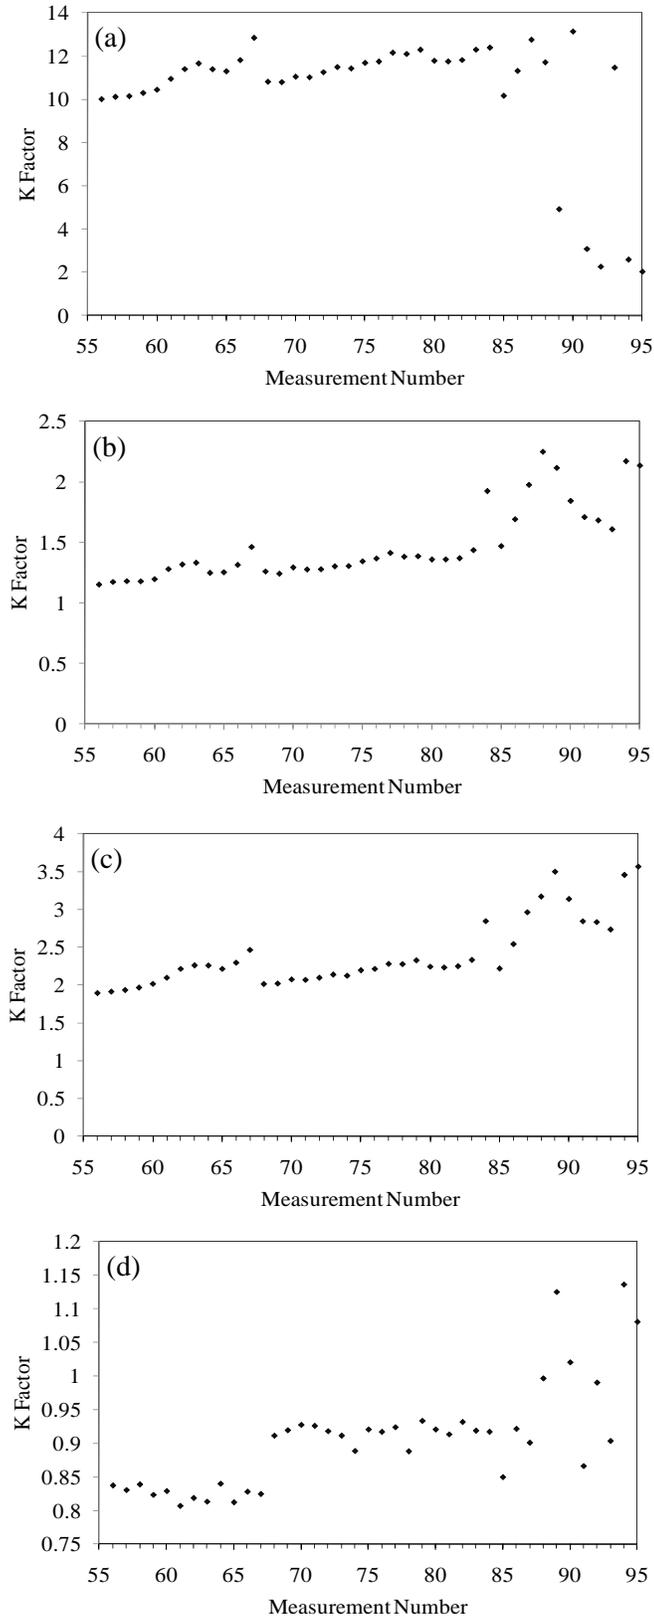
Figure 9.9 - K factor-based damage index from June data relative to paths: (a) $C0 \Rightarrow C2 / C0 \Rightarrow C5$; (b) $C0 \Rightarrow C3 / C0 \Rightarrow C5$; (c) $C1 \Rightarrow C3 / C0 \Rightarrow C5$ and (d) $C5 \Rightarrow C0 / C0 \Rightarrow C5$.

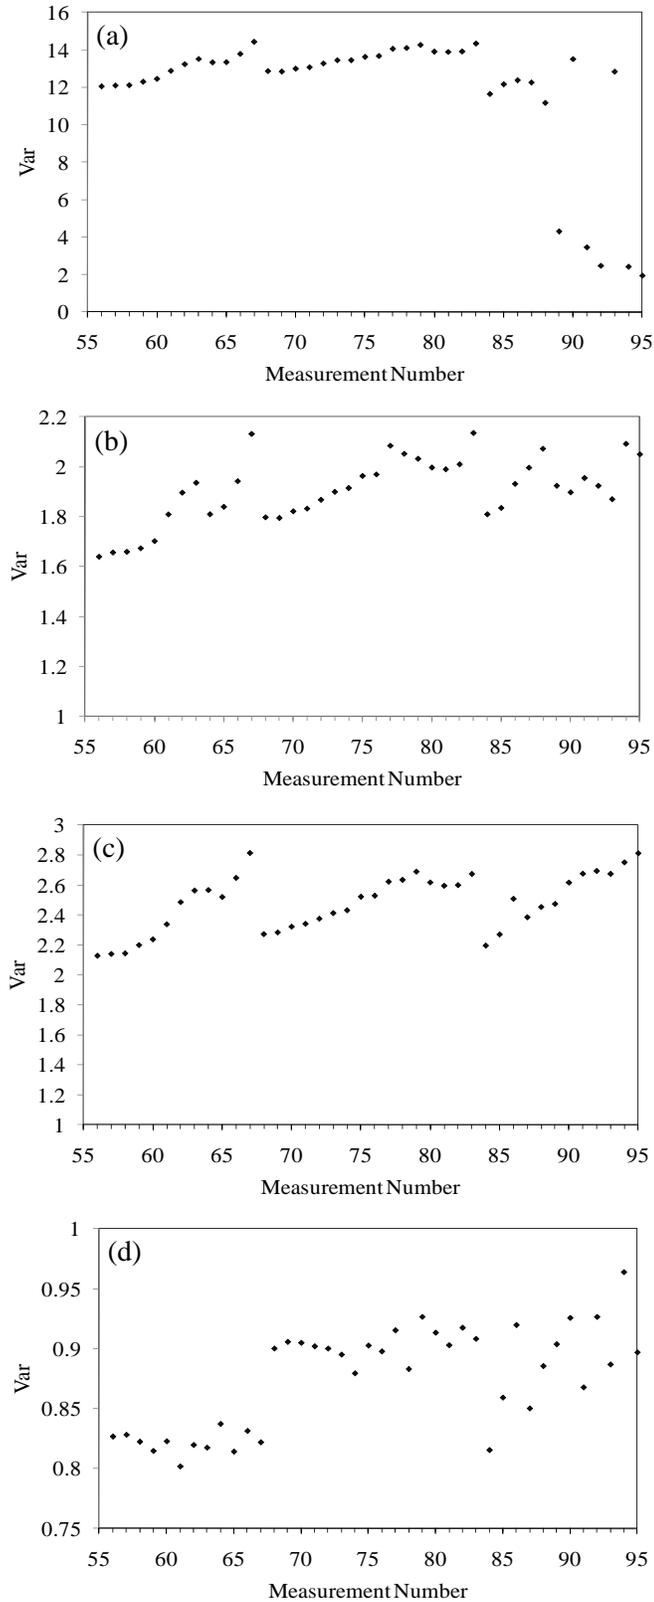
Figure 9.10 - Variance-based damage index from June data relative to paths: (a) $C0 \Rightarrow C2 / C0 \Rightarrow C5$; (b) $C0 \Rightarrow C3 / C0 \Rightarrow C5$; (c) $C1 \Rightarrow C3 / C0 \Rightarrow C5$ and (d) $C5 \Rightarrow C0 / C0 \Rightarrow C5$.

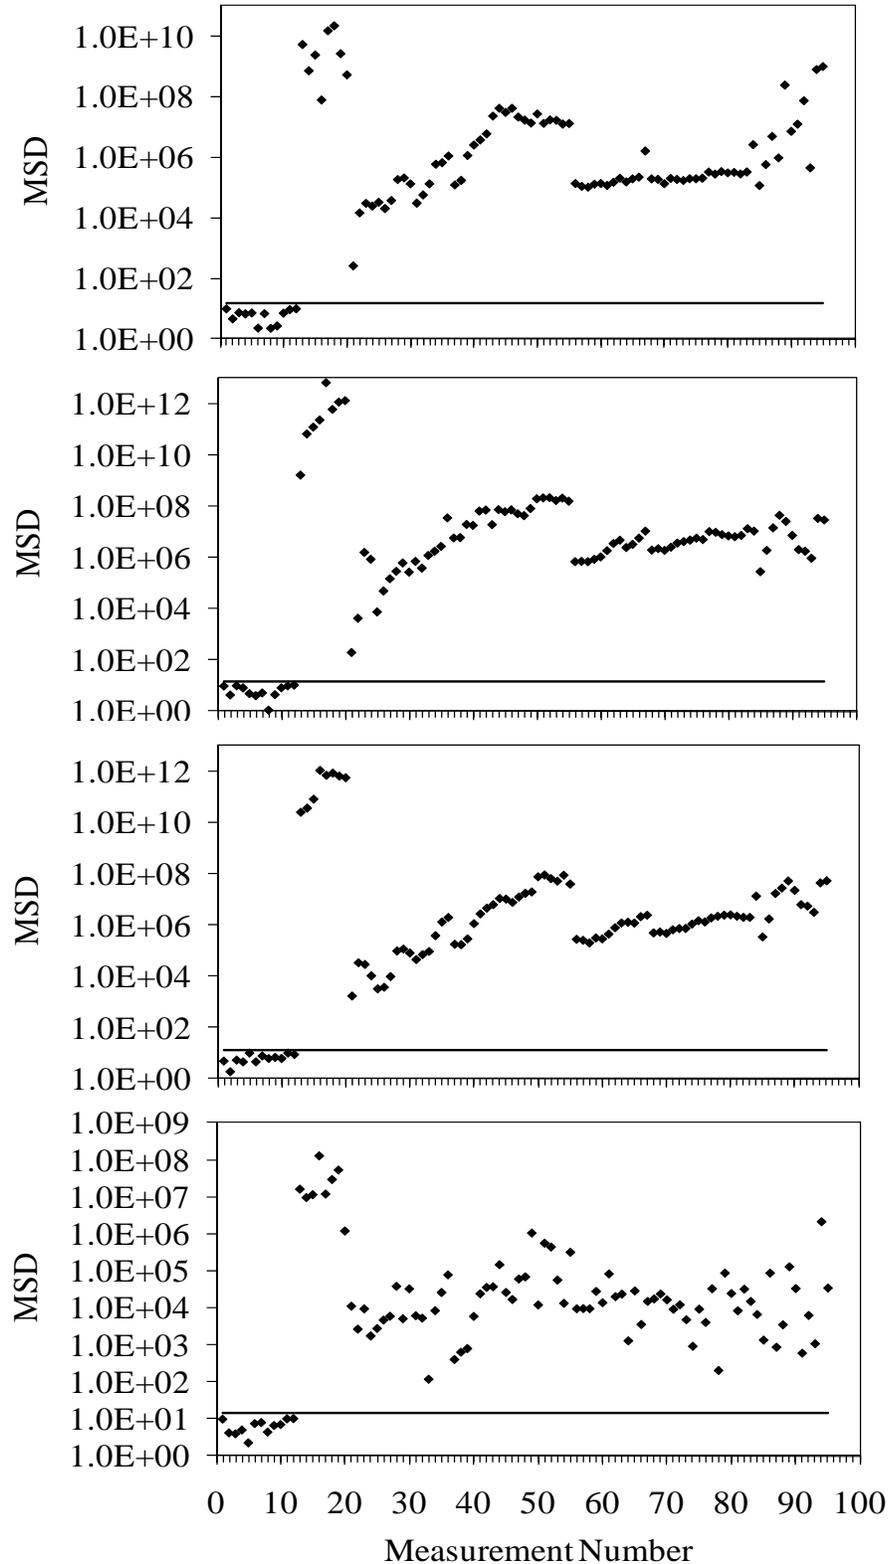
Figure 9.11 - MSD as a function of the measurement number. All seven statistical features and baseline from May 12 data considered. Paths: (a) $C0 \Rightarrow C2 / C0 \Rightarrow C5$; (b) $C0 \Rightarrow C3 / C0 \Rightarrow C5$; (c) $C1 \Rightarrow C3 / C0 \Rightarrow C5$ and (d) $C5 \Rightarrow C0 / C0 \Rightarrow C5$.

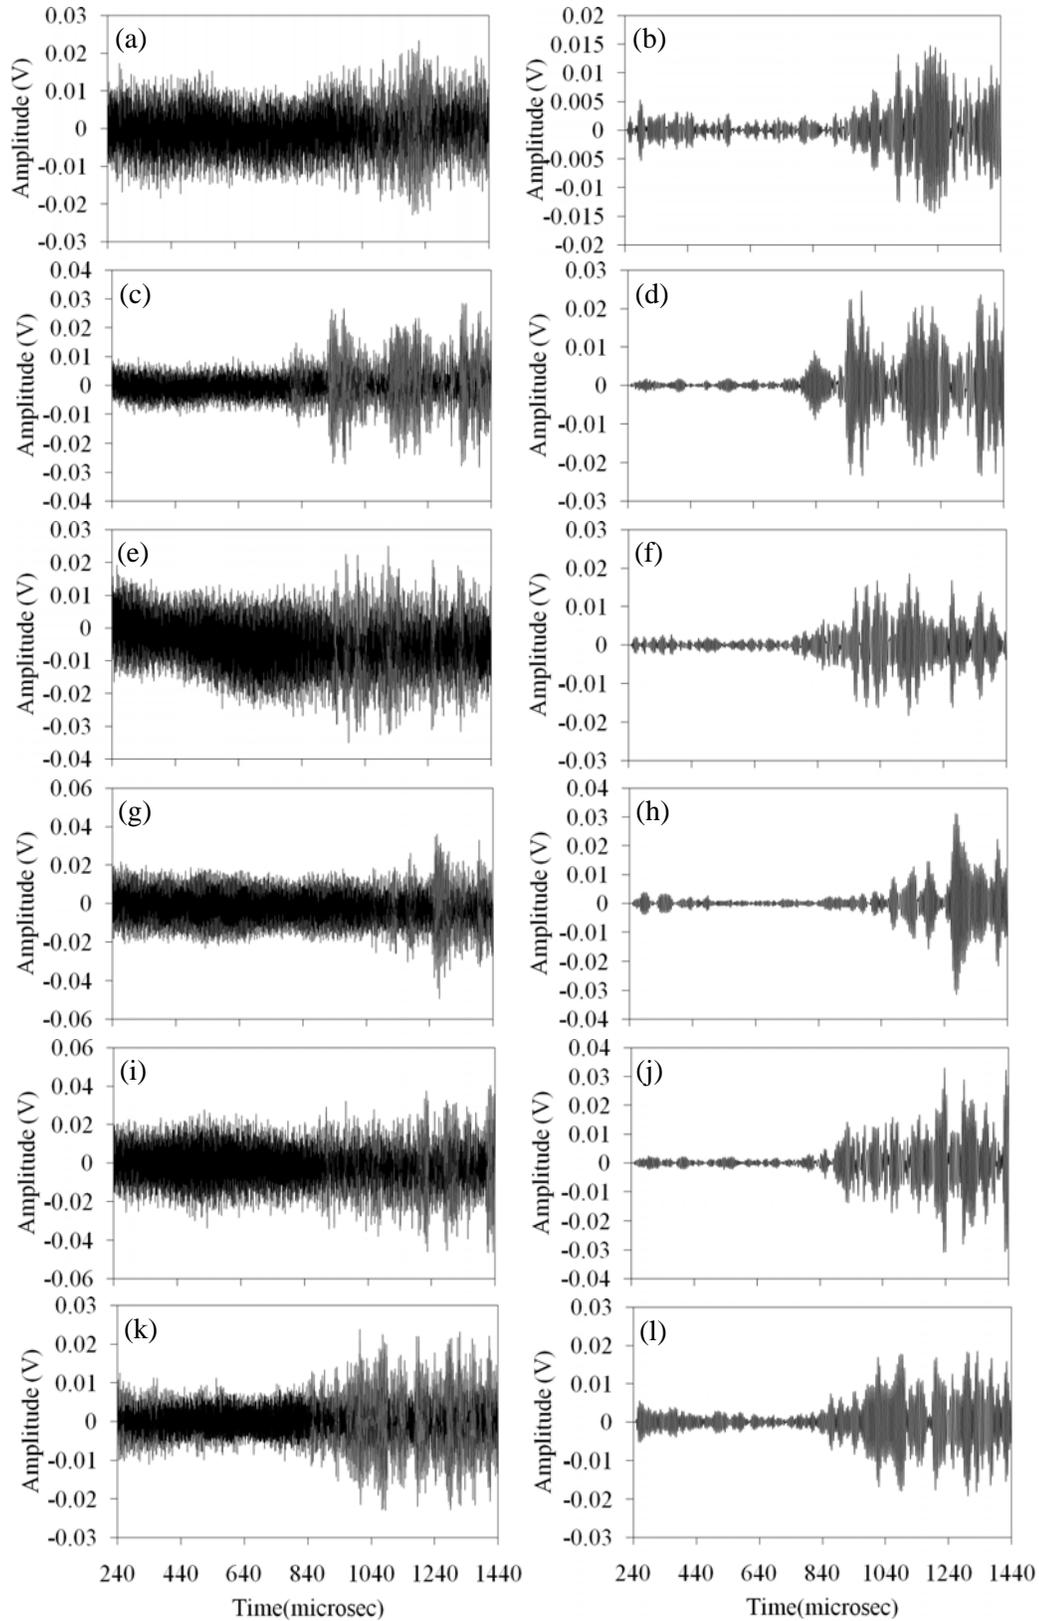
Figure 9.17 - Original time waveforms of 175 kHz for paths: (a) $S0 \Rightarrow S2$; (c) $S0 \Rightarrow S3$; (e) $S3 \Rightarrow S4$; (g) $S3 \Rightarrow S5$; (i) $S3 \Rightarrow S6$; (k) $S1 \Rightarrow S0$ and corresponding filtered waveforms of (b) $S0 \Rightarrow S2$; (d) $S0 \Rightarrow S3$; (f) $S3 \Rightarrow S4$; (h) $S3 \Rightarrow S5$; (j) $S3 \Rightarrow S6$; (l) $S1 \Rightarrow S0$ at the fourth measurement on June 17th.

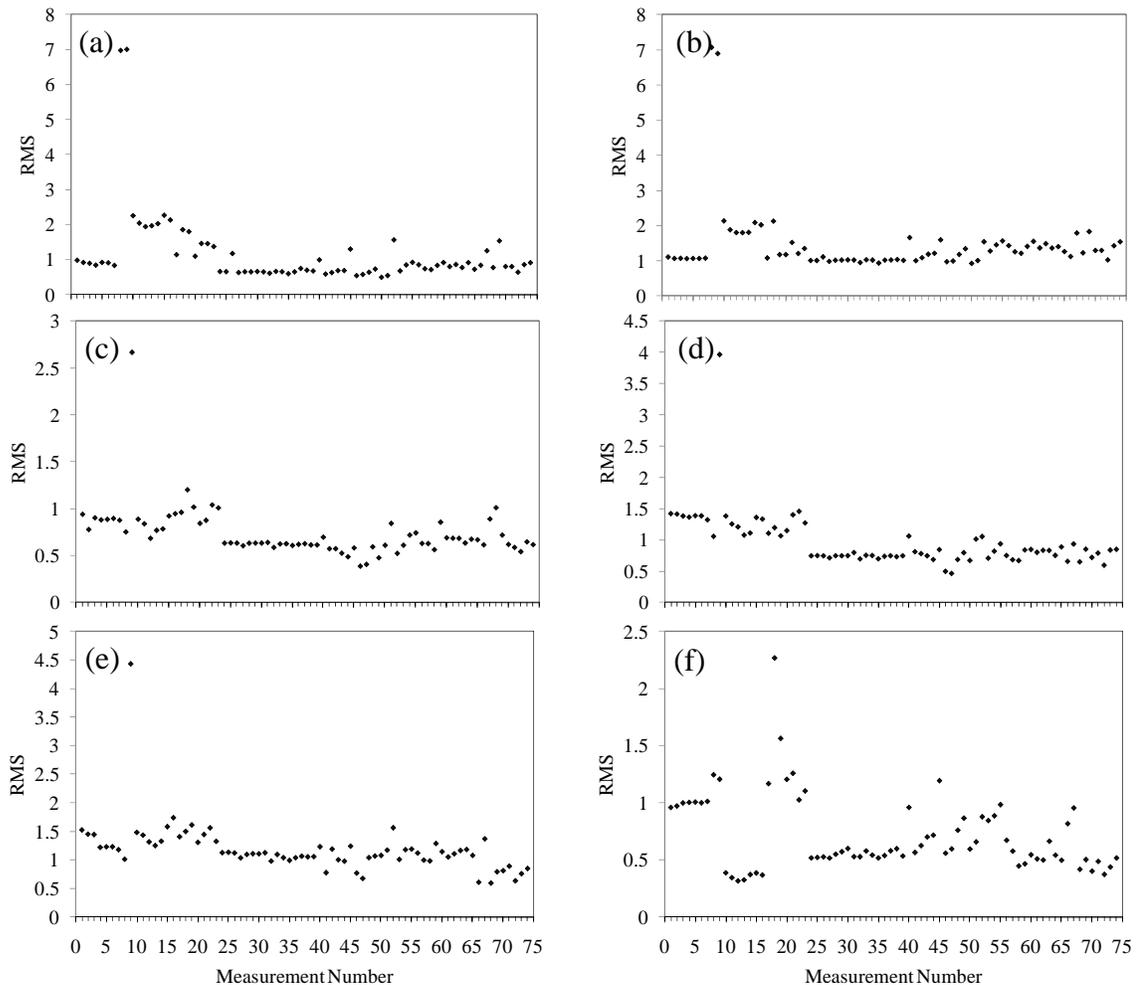
Figure 9.18 - Test 2. RMS-based damage index associated with paths: (a) $S_0 \Rightarrow S_2/S_3 \Rightarrow S_0$; (b) $S_0 \Rightarrow S_3/S_3 \Rightarrow S_0$; (c) $S_3 \Rightarrow S_4/S_3 \Rightarrow S_0$; (d) $S_3 \Rightarrow S_5/S_3 \Rightarrow S_0$; (e) $S_3 \Rightarrow S_6/S_3 \Rightarrow S_0$; (f) $S_1 \Rightarrow S_0/S_3 \Rightarrow S_0$.

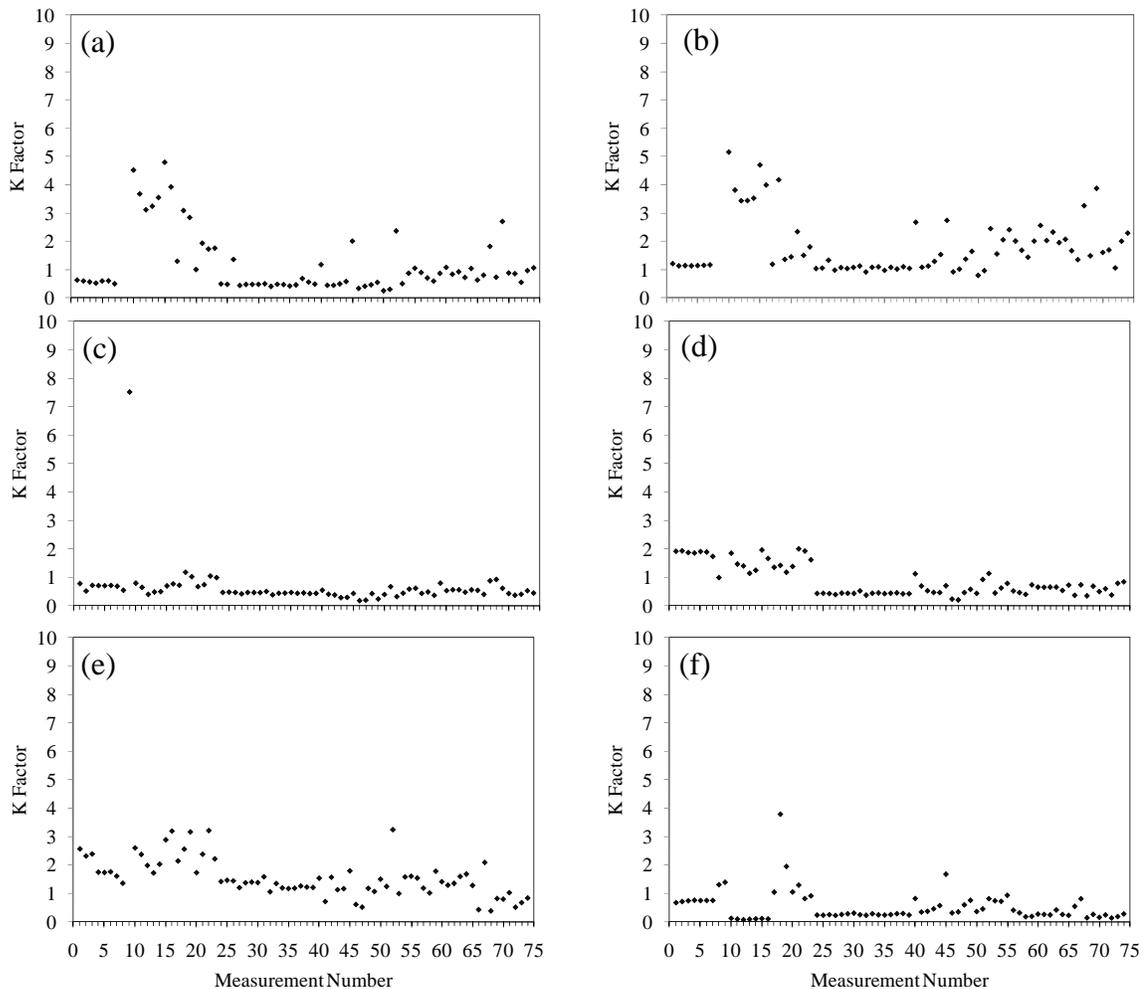
Figure 9.19 – Test 2. K-factor-based damage index associated with paths: (a) $S0 \Rightarrow S2/S3 \Rightarrow S0$; (b) $S0 \Rightarrow S3/S3 \Rightarrow S0$; (c) $S3 \Rightarrow S4/S3 \Rightarrow S0$; (d) $S3 \Rightarrow S5/S3 \Rightarrow S0$; (e) $S3 \Rightarrow S6/S3 \Rightarrow S0$; (f) $S1 \Rightarrow S0/S3 \Rightarrow S0$.
