FHWA-WY-11/03F

PERFORMANCE OF RECLAIMED ASPHALT PAVEMENT ON UNPAVED ROADS

Department of Civil and Architectural Engineering
University of Wyoming
1000 East University Avenue, Department 3295
Laramie, Wyoming

January 2012

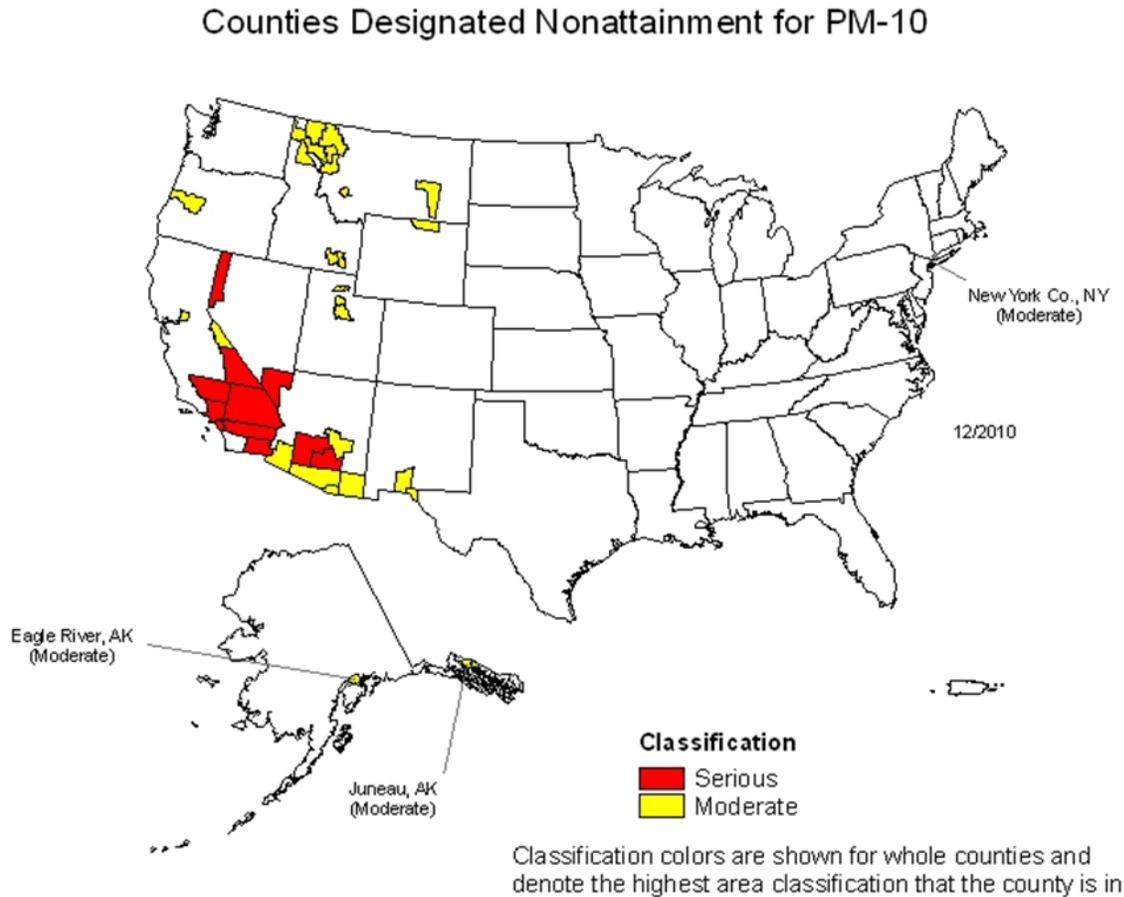
Figure 1.1 USEPA non-attainment areas for PM-10 particulate matter, December 2010 (USEPA 2011)

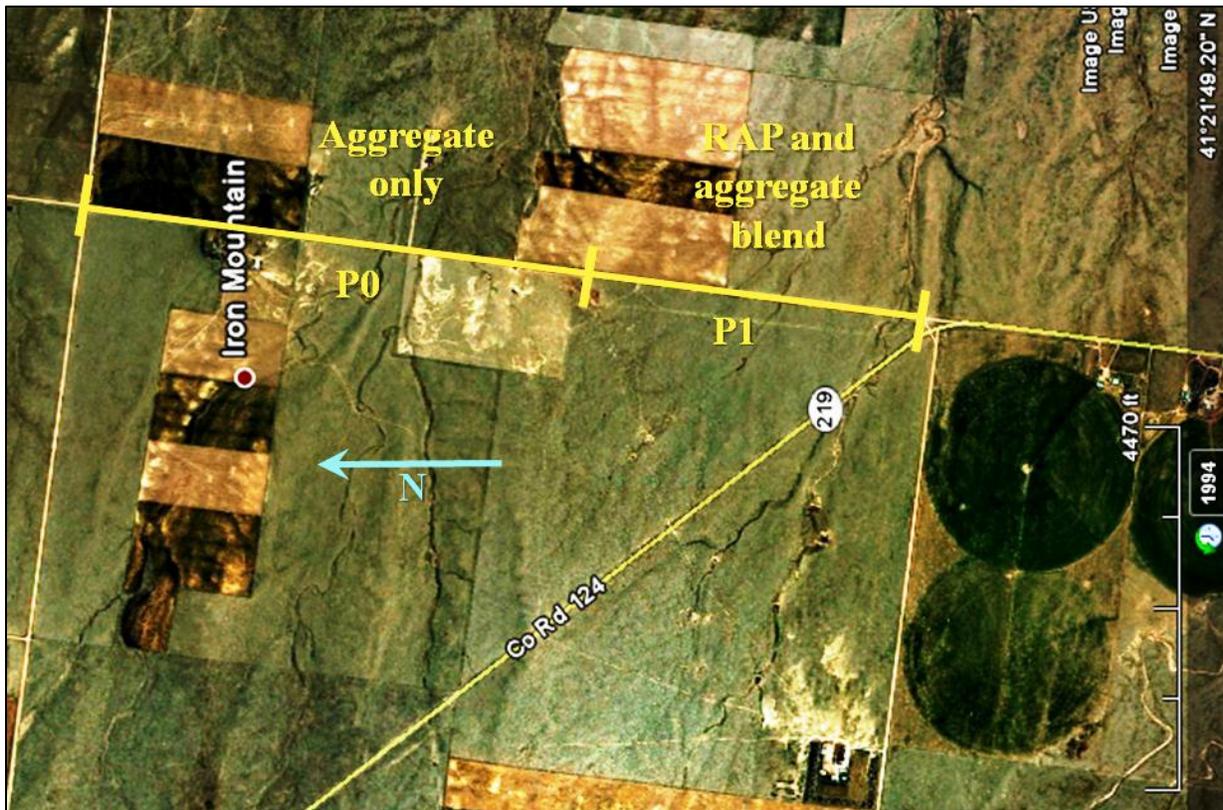
Figure 3.6 Laramie County Pry Road test sections.

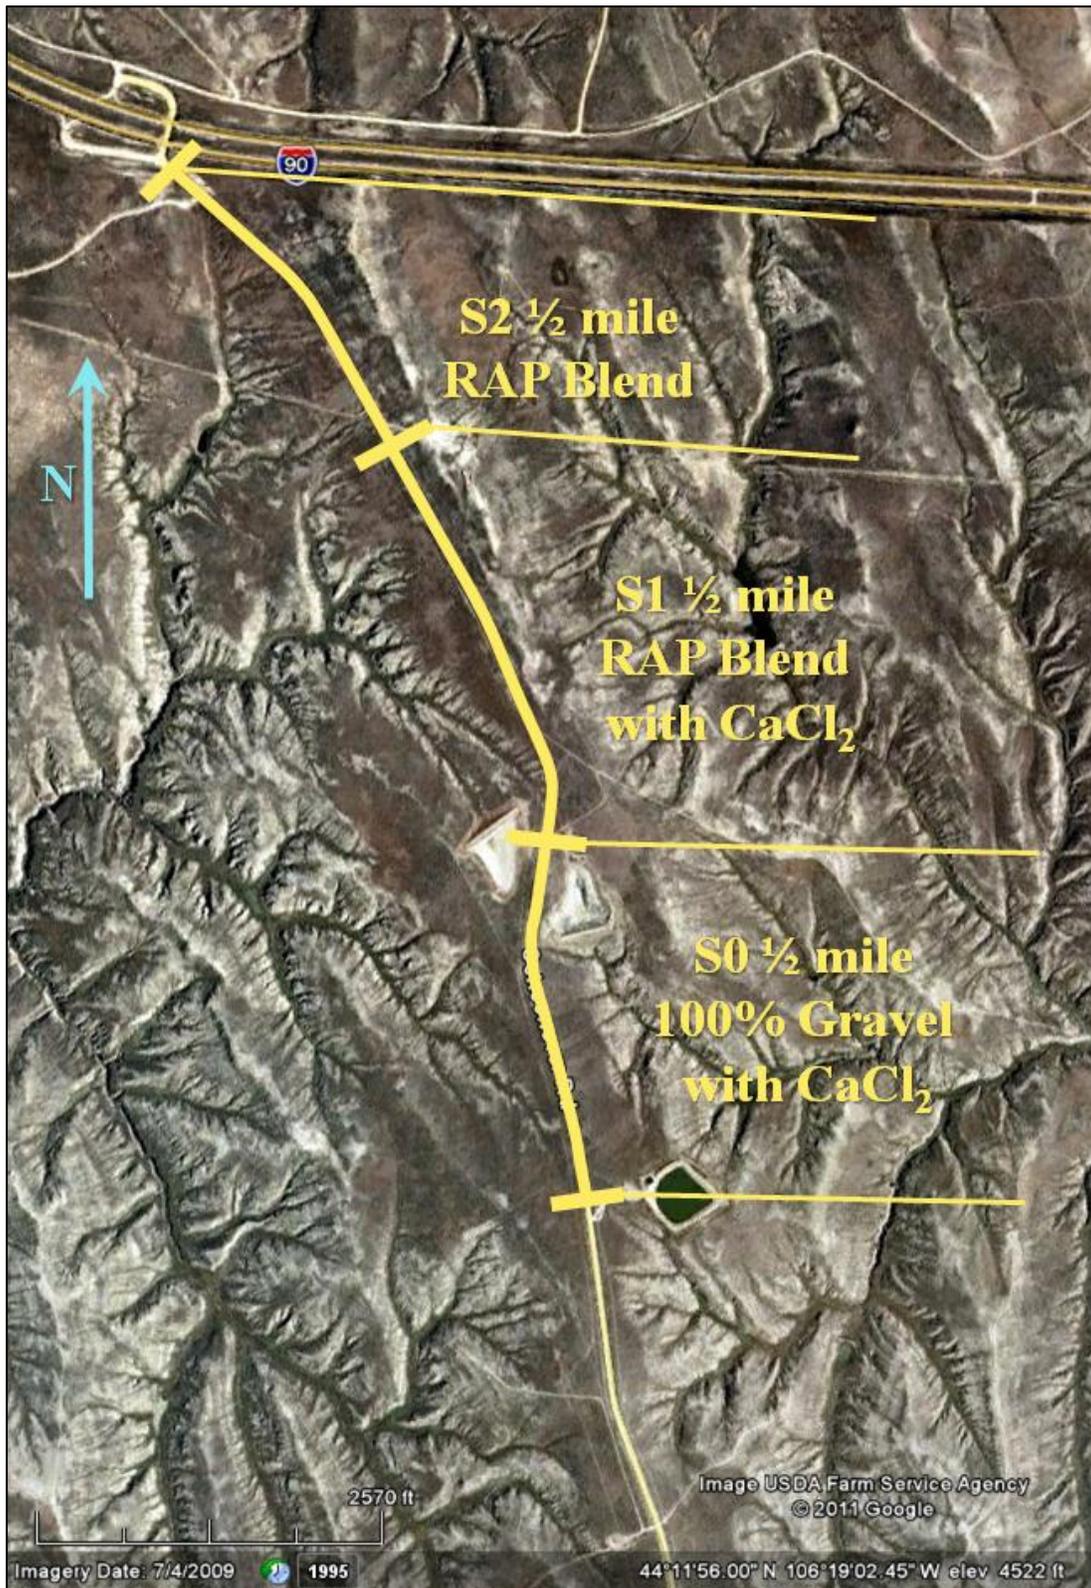
Figure 3.7 Johnson County test sections on Schoonover Road, JO CR 204B.

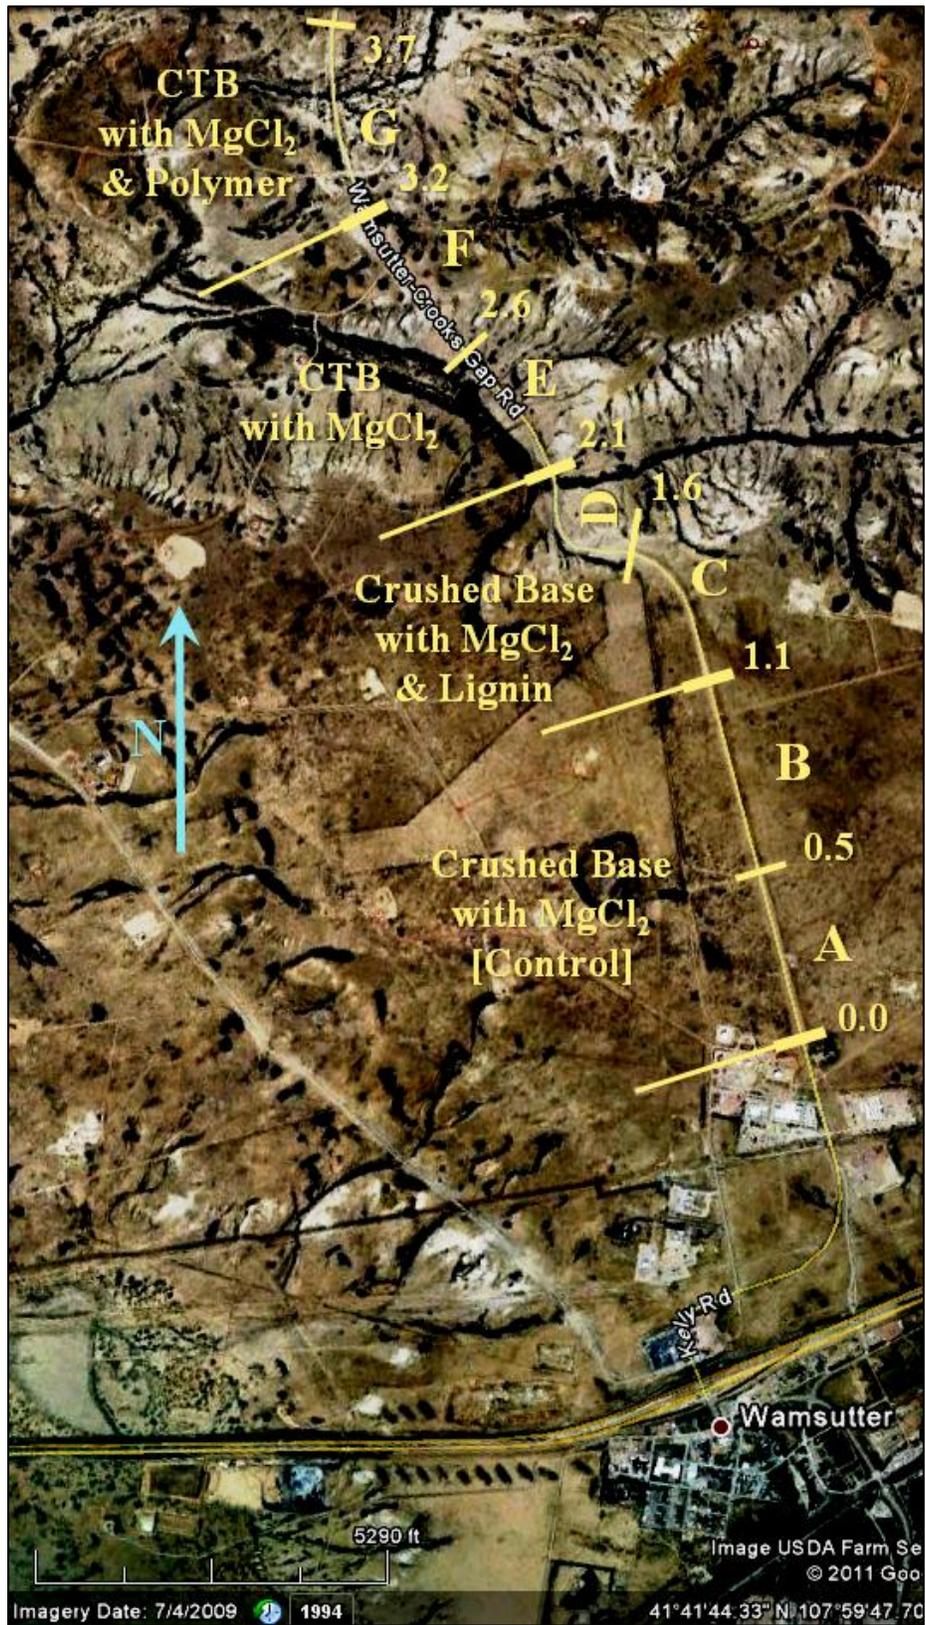
Figure 3.8 Sweetwater County test segments on Crooks Gap Road, SW CR 23, south end.

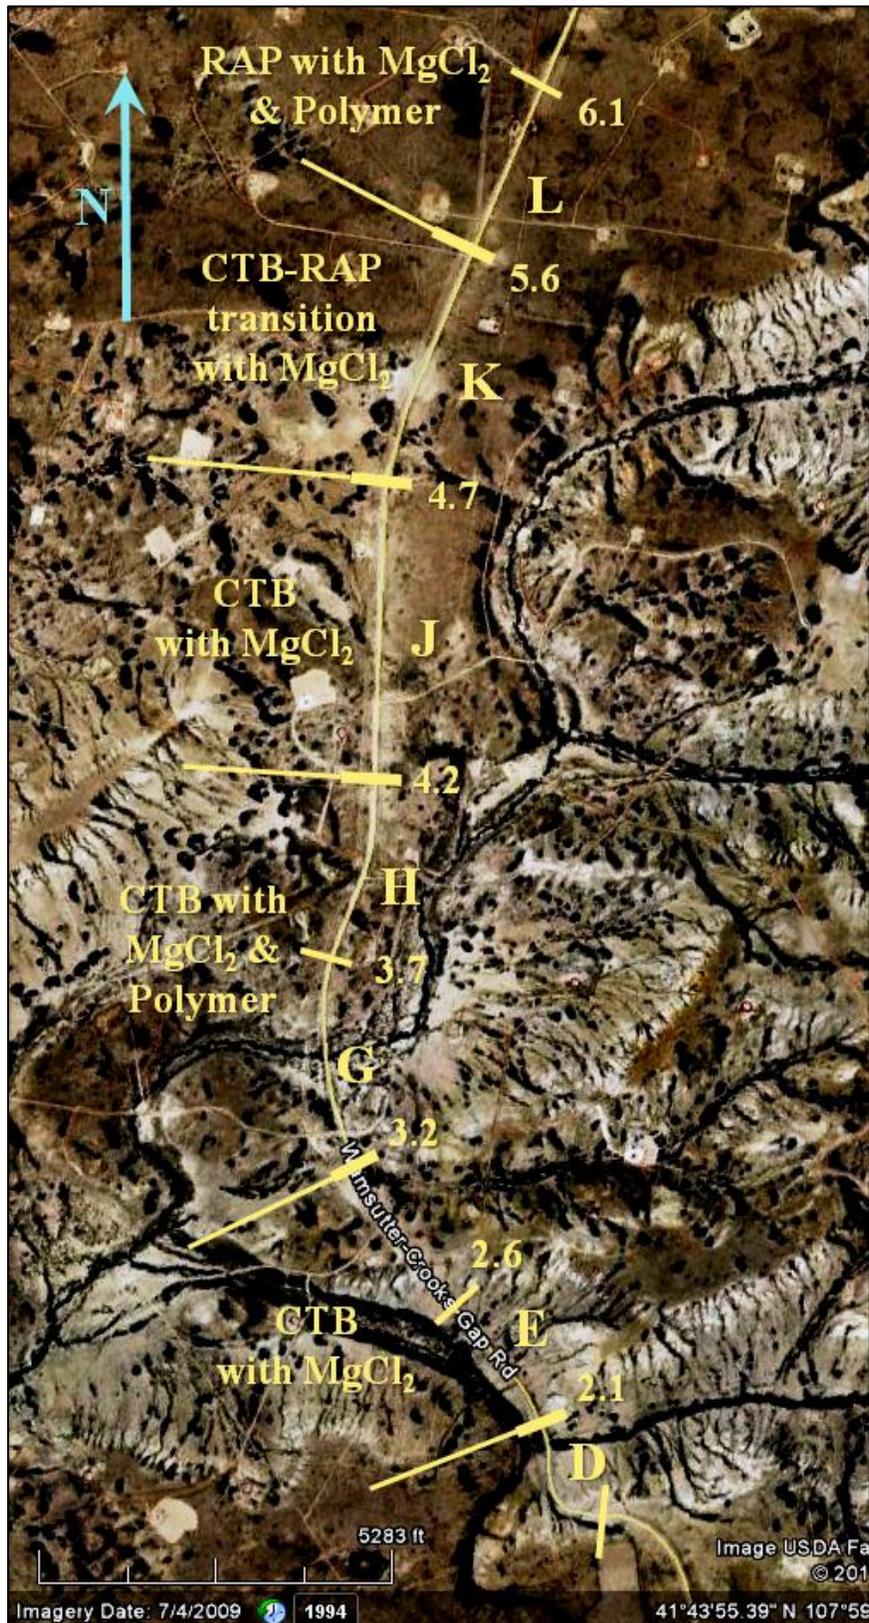
Figure 3.9 Sweetwater County test segments on Crooks Gap Road, SW CR 23, center.

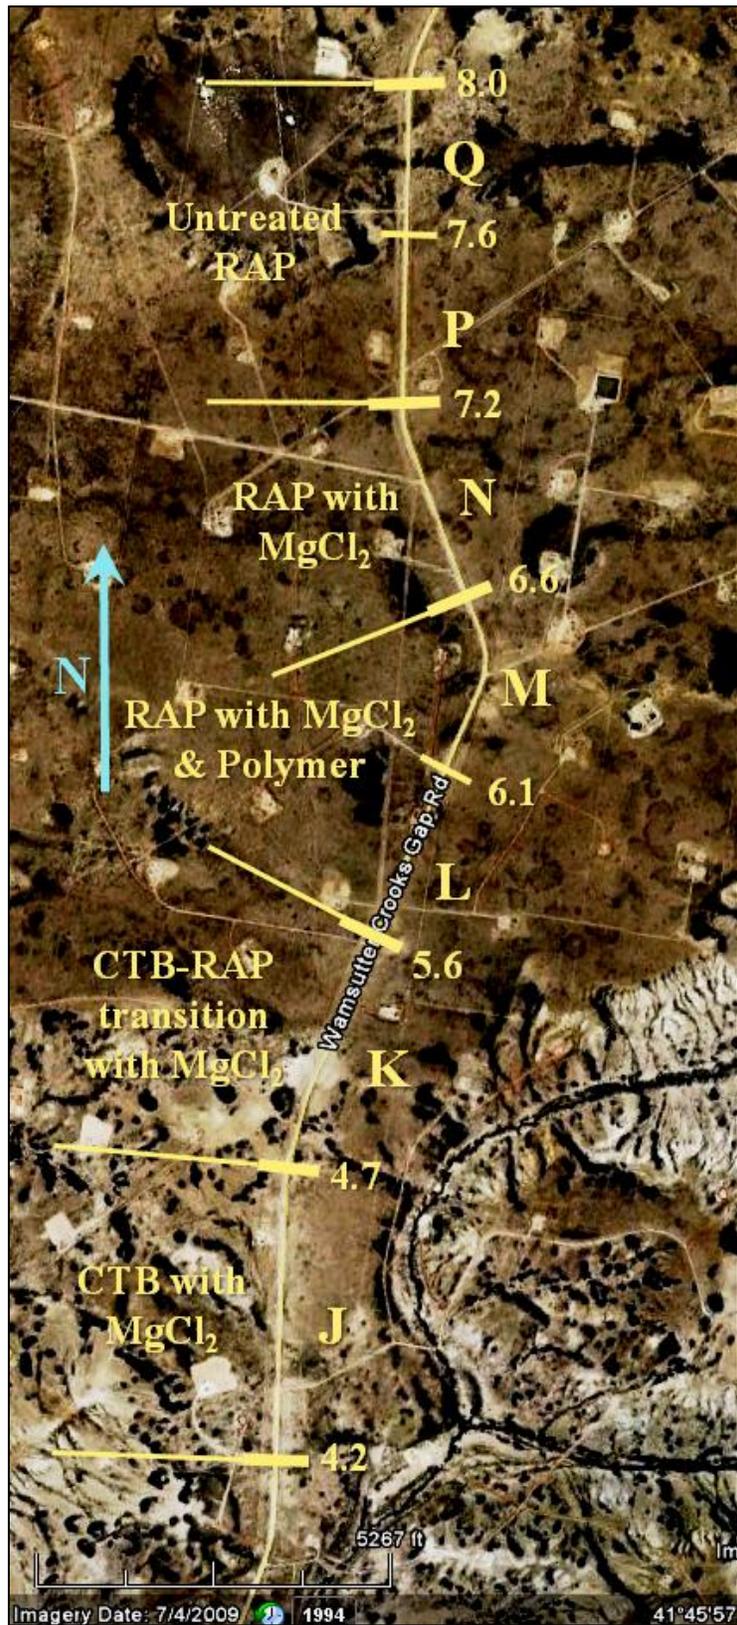
Figure 3.10 Sweetwater County test segments on Crooks Gap Road, SW CR 23, north end.

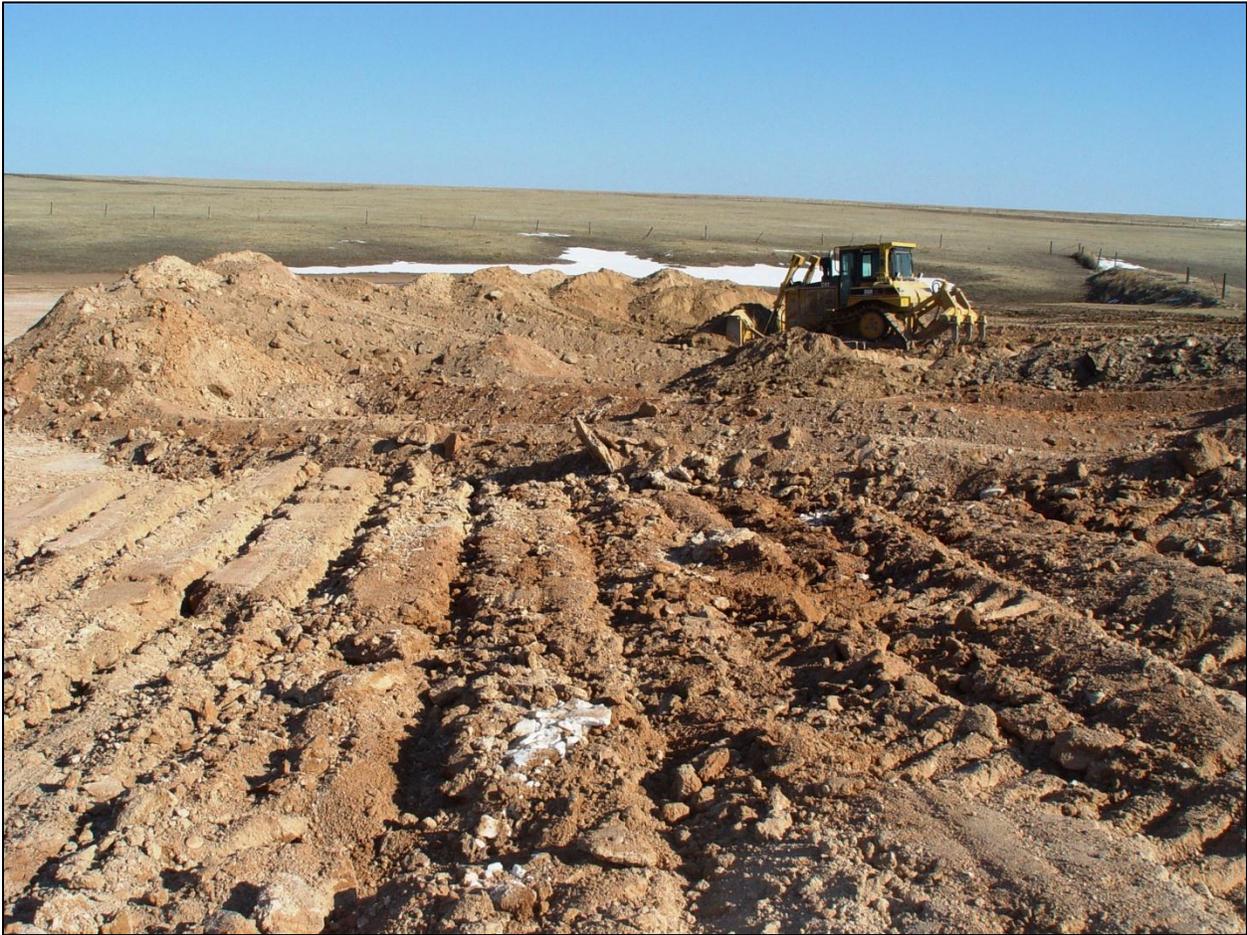
Figure 3.12 Blending of aggregate at Laramie County scoria pit near Atlas Road.

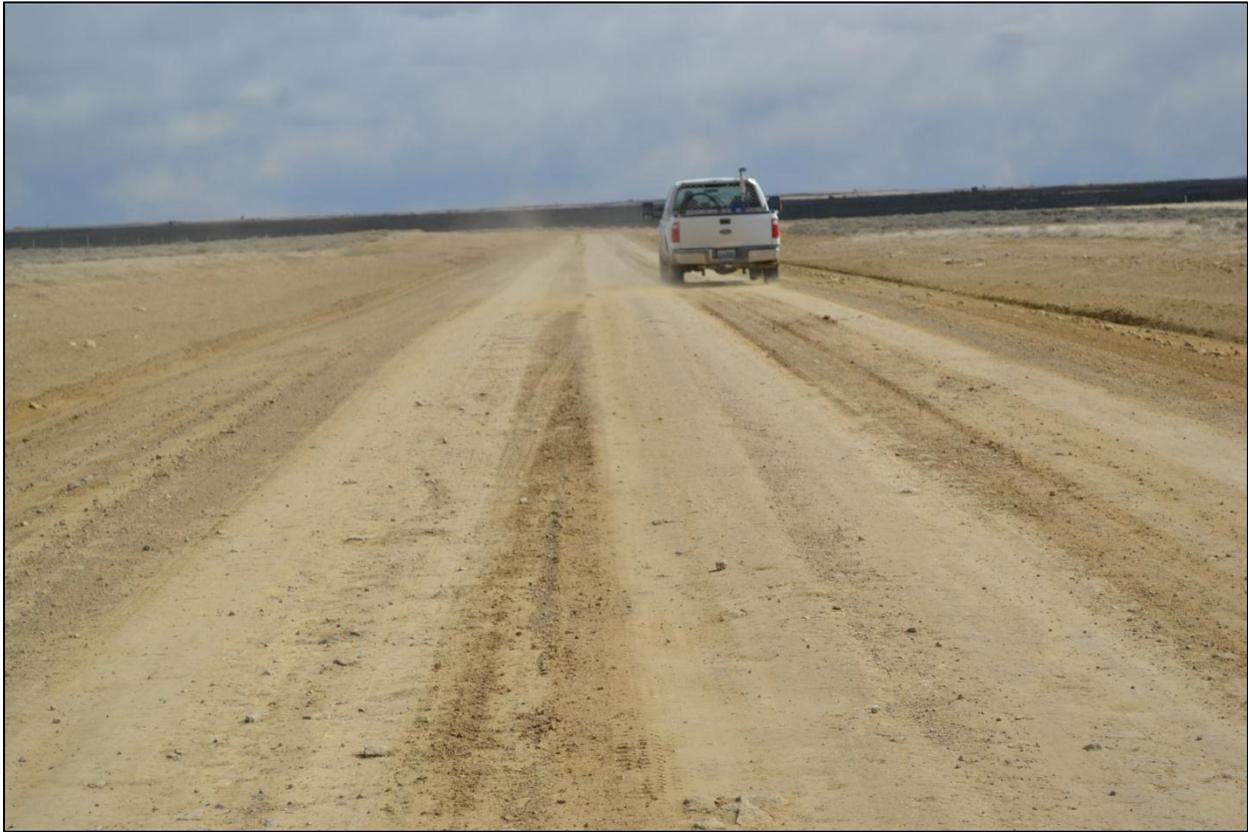
Figure 3.13 Crooks Gap Road north of the test sections showing the surfacing material typical of that which was blended with RAP or CTB on the Sweetwater County test sections.

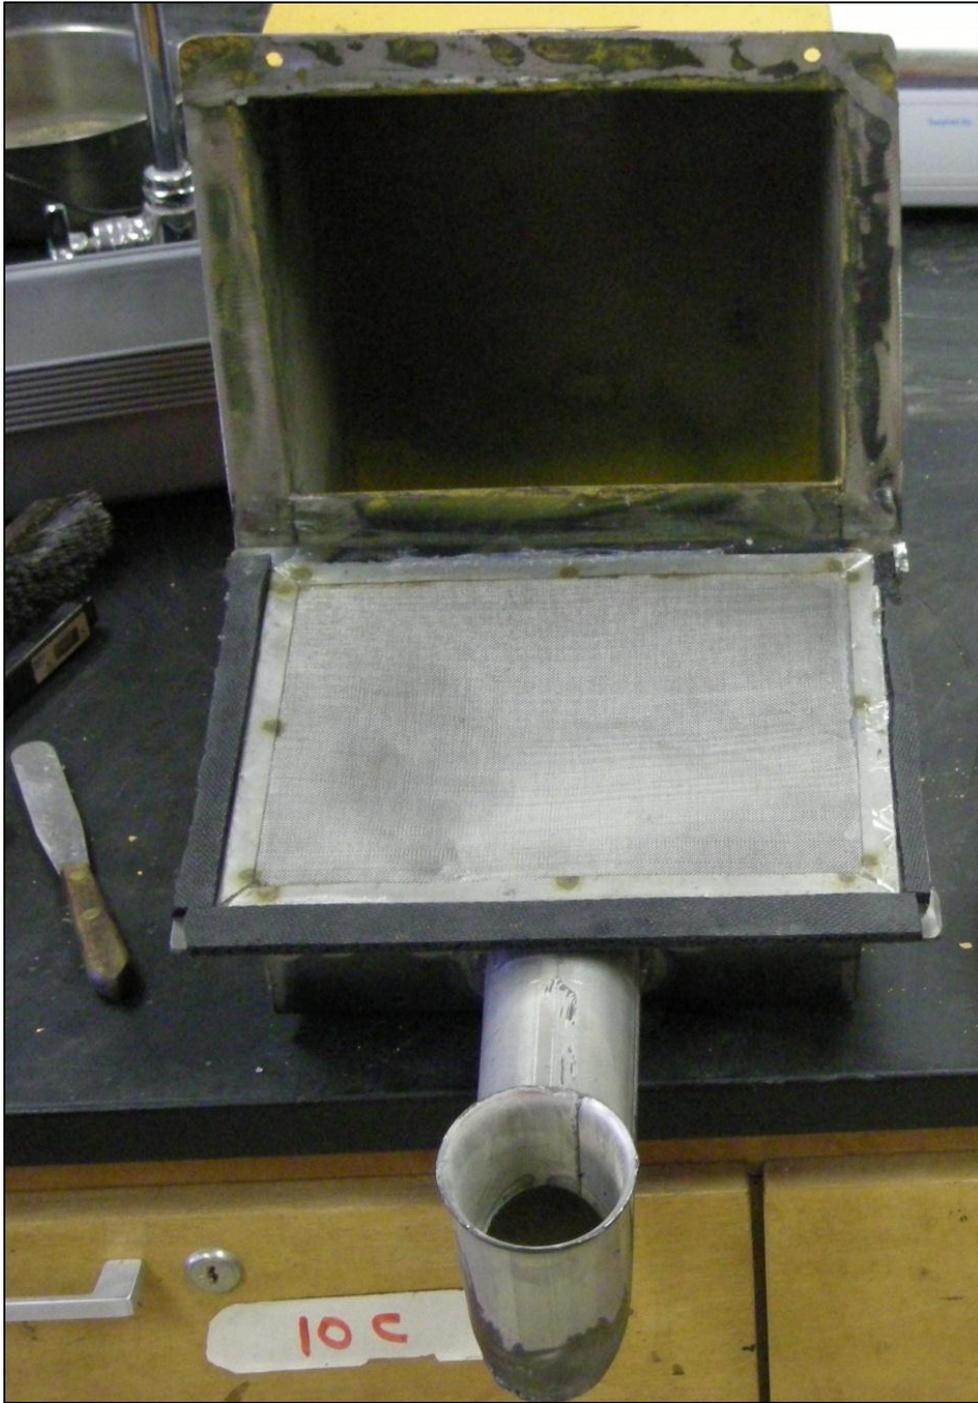
Figure 3.14 CSU dustometer with open filter box.

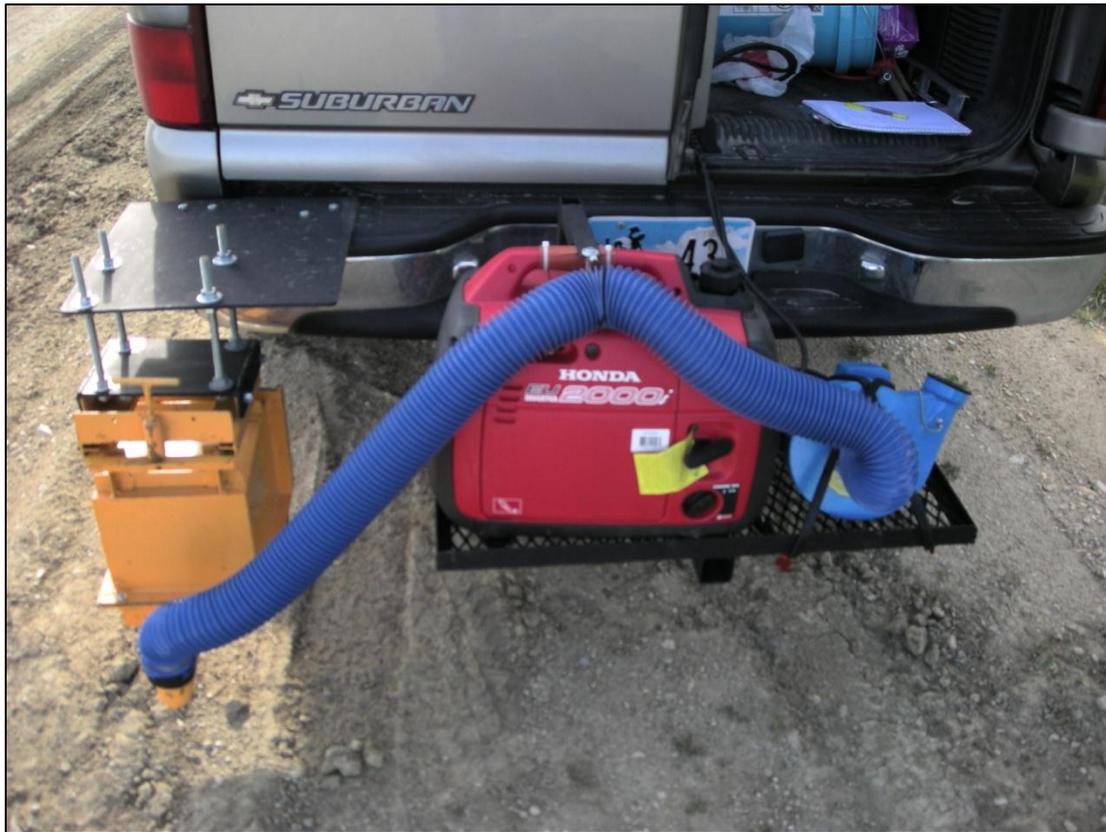
Figure 3.15 Dustometer setup with, left to right, the dustometer, generator and vacuum.

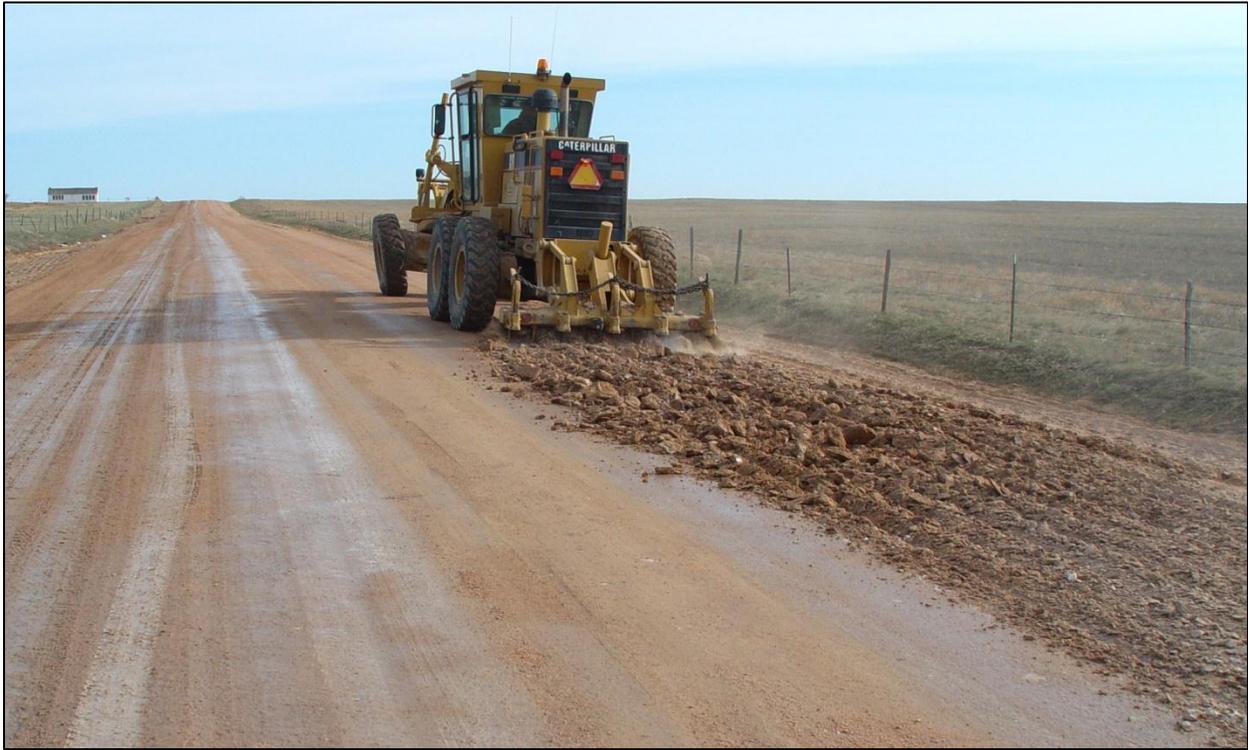
Figure 3.16 Scarifying Laramie County's Atlas Road prior to placement and blending of RAP.

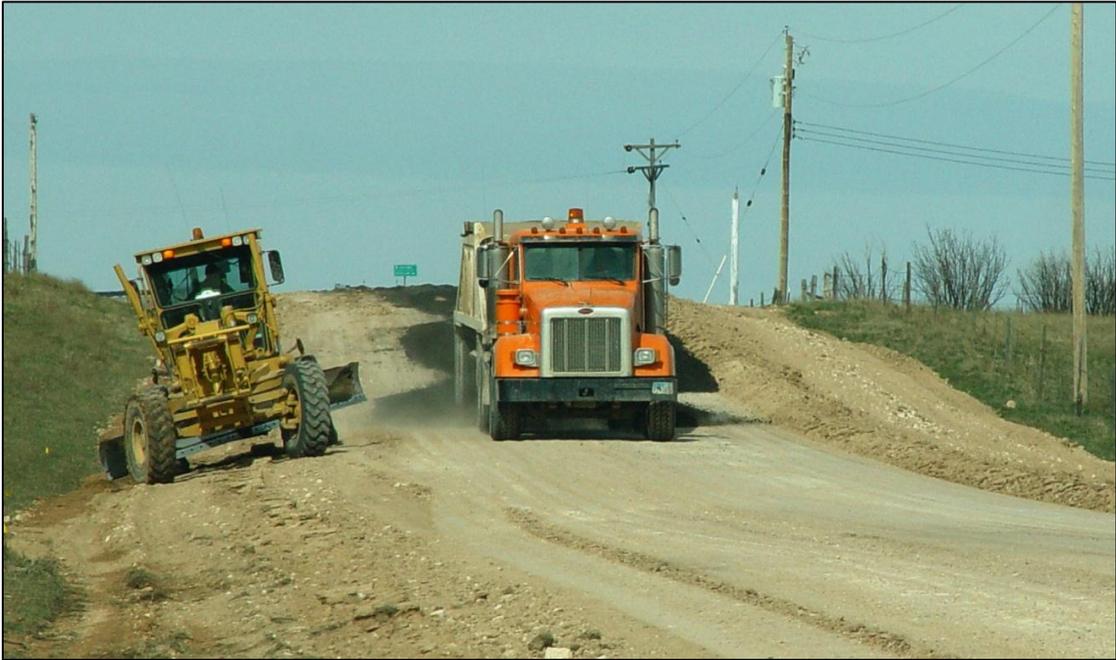
Figure 3.17 Placement of RAP windrow on Laramie County's Atlas Road with bottom-discharge haul trucks.

The original surfacing aggregate on Atlas and Pry Roads came from a nearby scoria pit [S^{1/2} of Section 13 T16N R67W (between Old Yellowstone Road SH 219 and Atlas Road CR 224, near their intersection)], while the reclaimed asphalt pavement (RAP) came from a roughly five-year old stockpile adjacent to and milled from I-25 (see Figure 3.11). The scoria was blended at the pit with a bulldozer (see Figure 3.12), hauled to the roadway with bottom-discharge trucks, and spread with a motor grader.

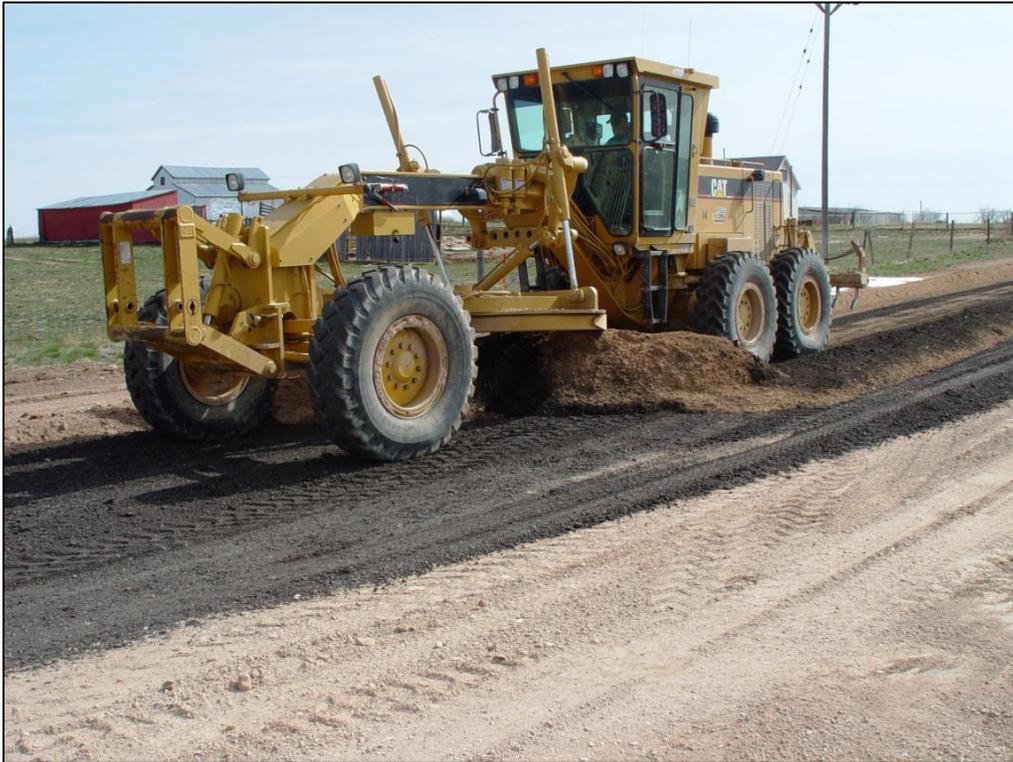
Figure 3.18 Blending RAP and existing, scarified aggregate on Laramie County's Atlas Road.

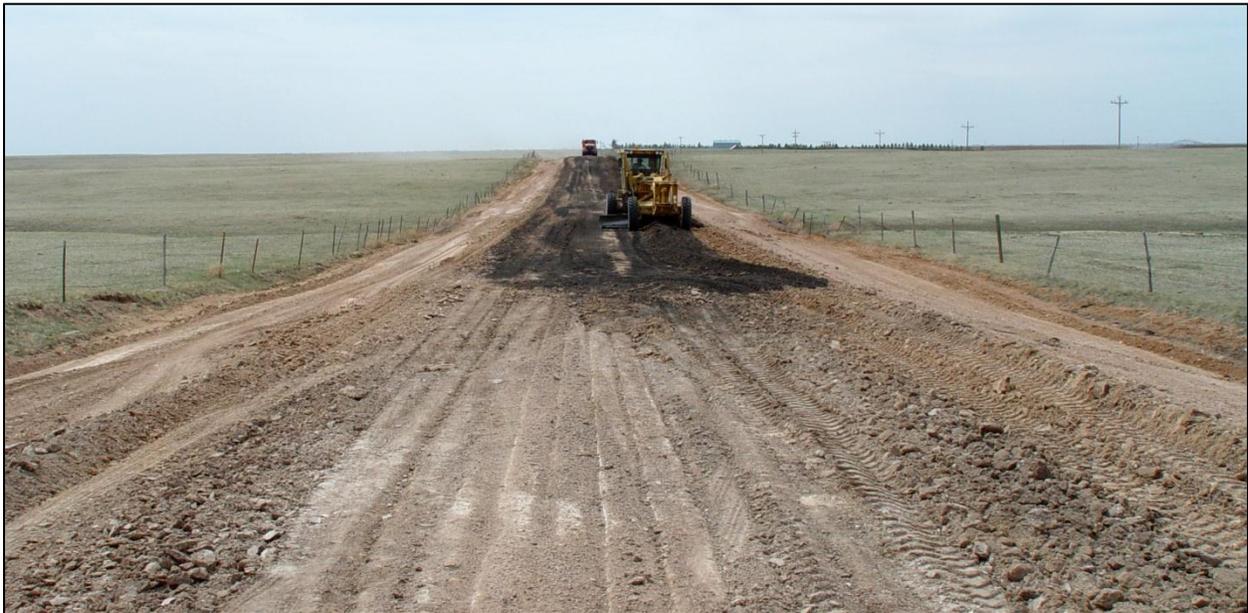
Figure 3.19 Blending and shaping RAP and existing, scarified aggregate on Laramie County's Atlas Road.

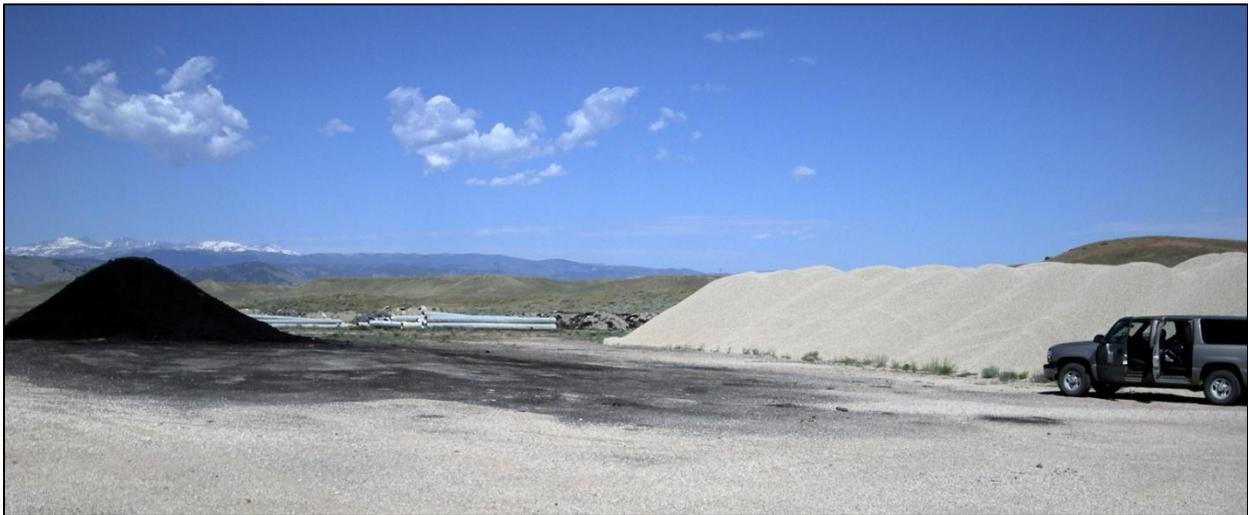
Figure 3.20 RAP and virgin aggregate stockpiles at Johnson County's Piney Creek stockpiles, June 2008.

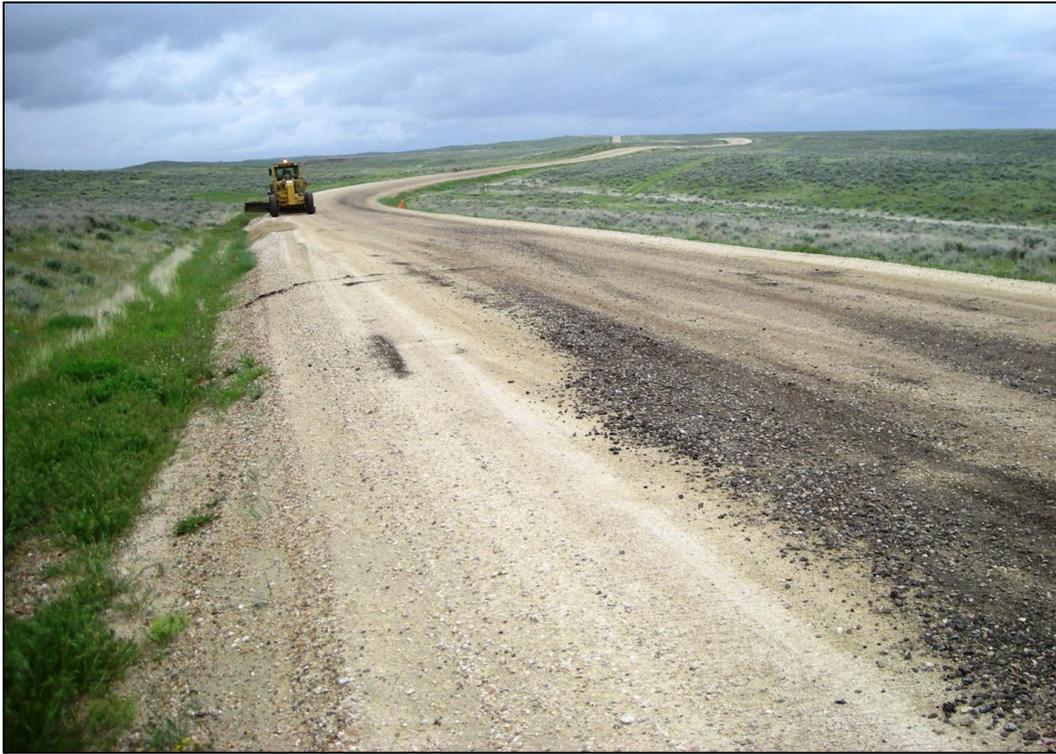
Figure 3.21 Initial shaping of Johnson County's Schoonover Road prior to placement of the blended RAP and aggregate, June 2008.

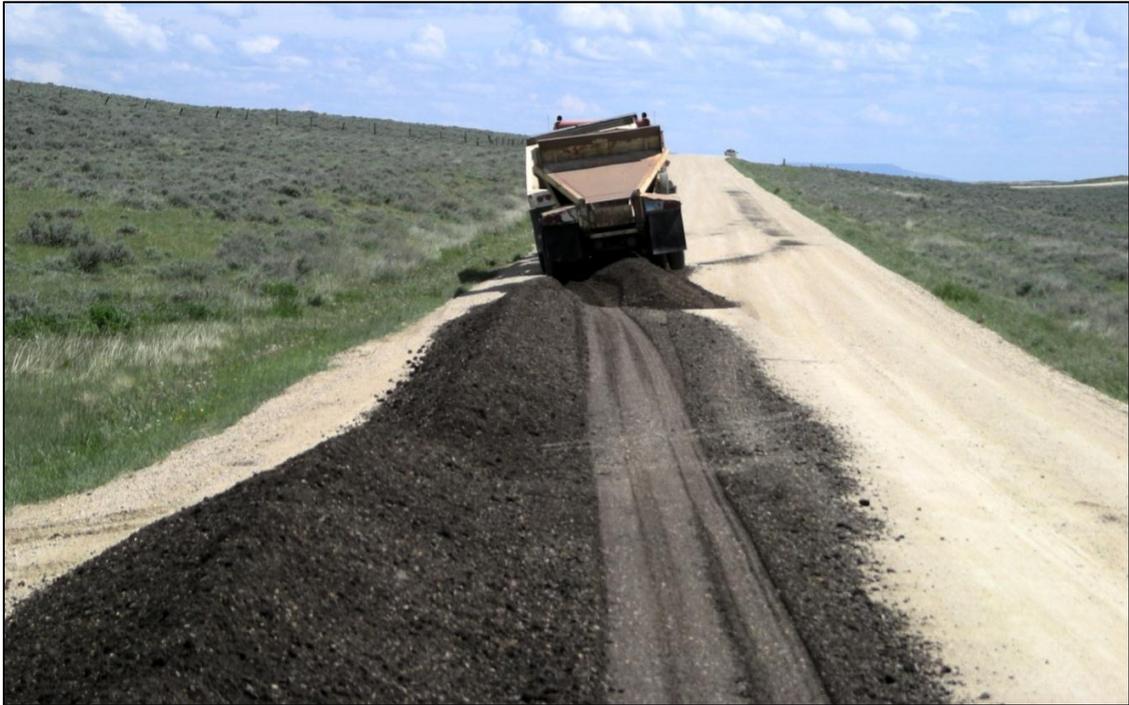
Figure 3.22 Placing RAP and aggregate blend on Johnson County's Schoonover Road, June 2008.

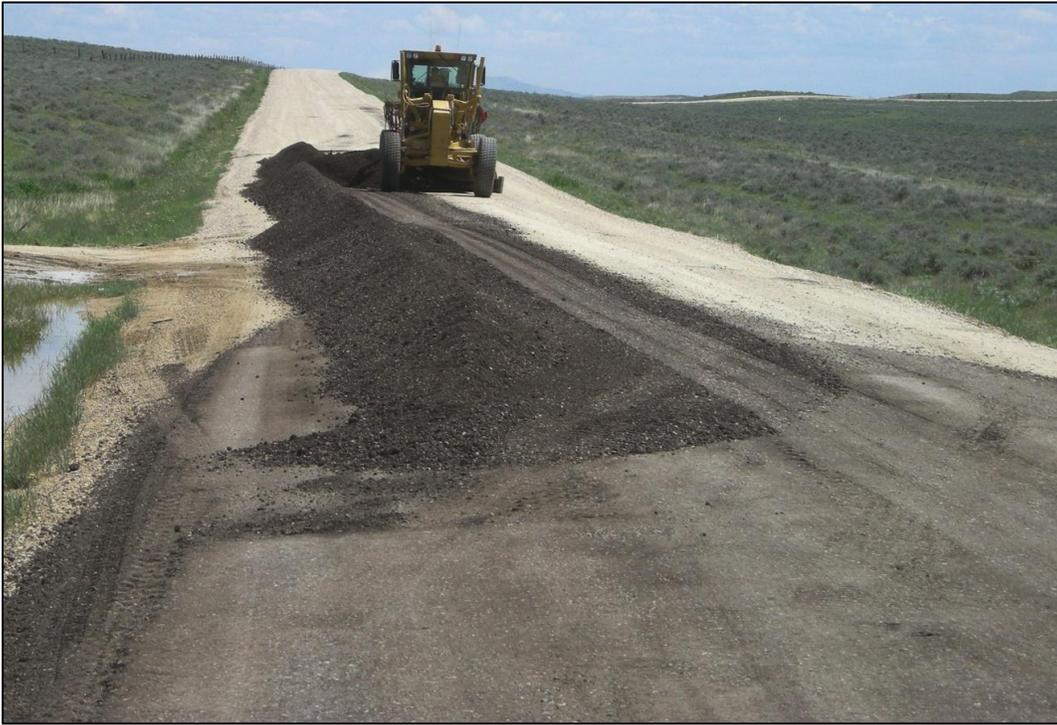
Figure 3.23 Shaping RAP and aggregate blend on Johnson County's Schoonover Road, June 2008.

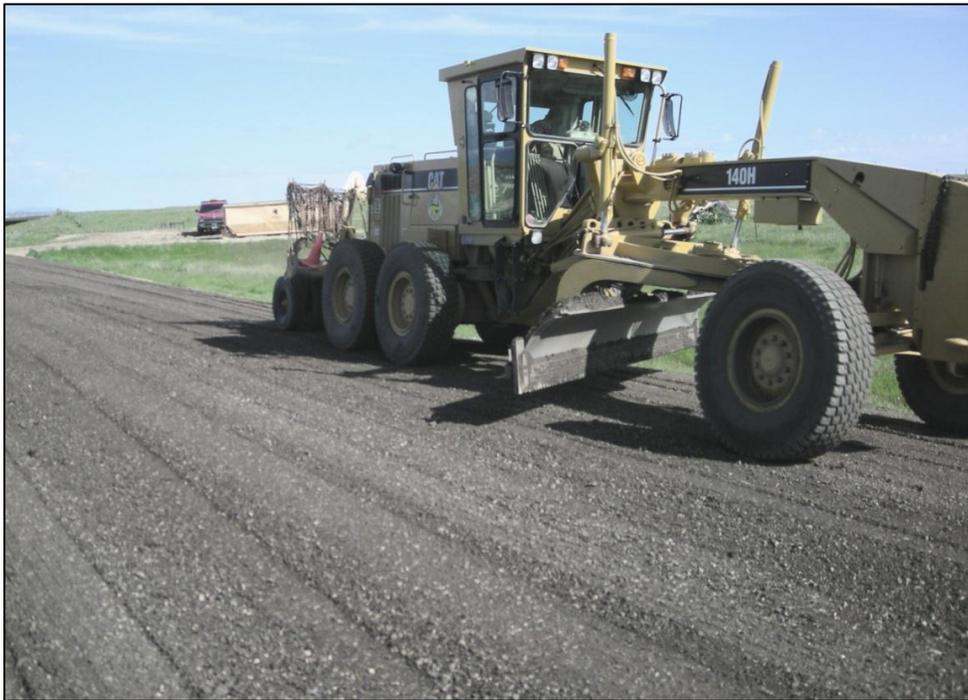
Figure 3.24 Compacting RAP and aggregate blend on Johnson County's Schoonover Road with pneumatic tire compactors mounted on the motor grader's ripper hydraulics, June 2008.

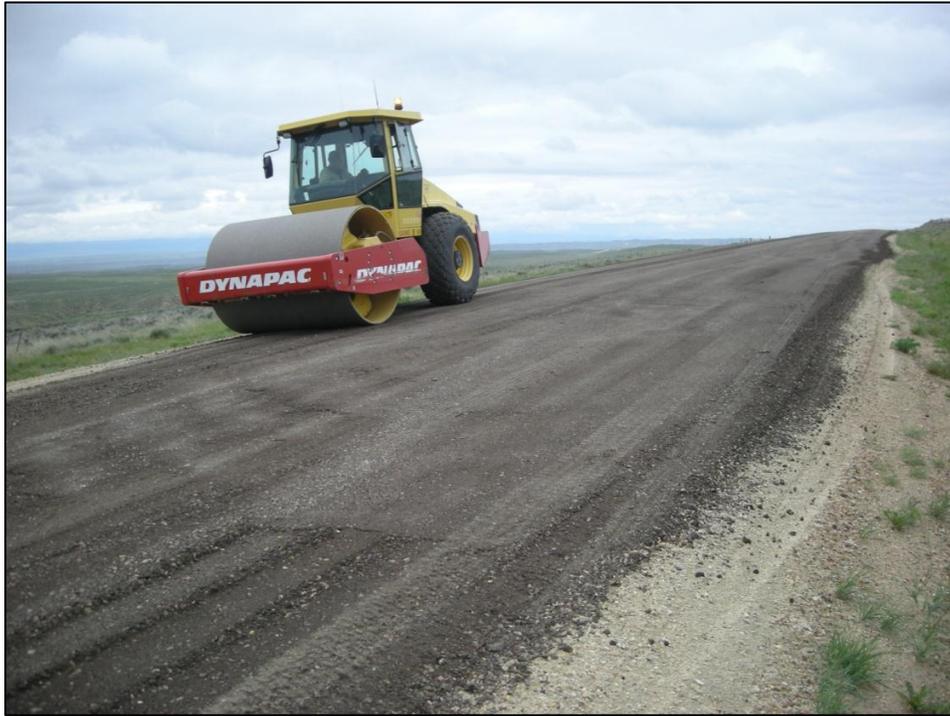
Figure 3.25 Final compaction of the RAP aggregate blend on Johnson County's Schoonover Road, June 2008.

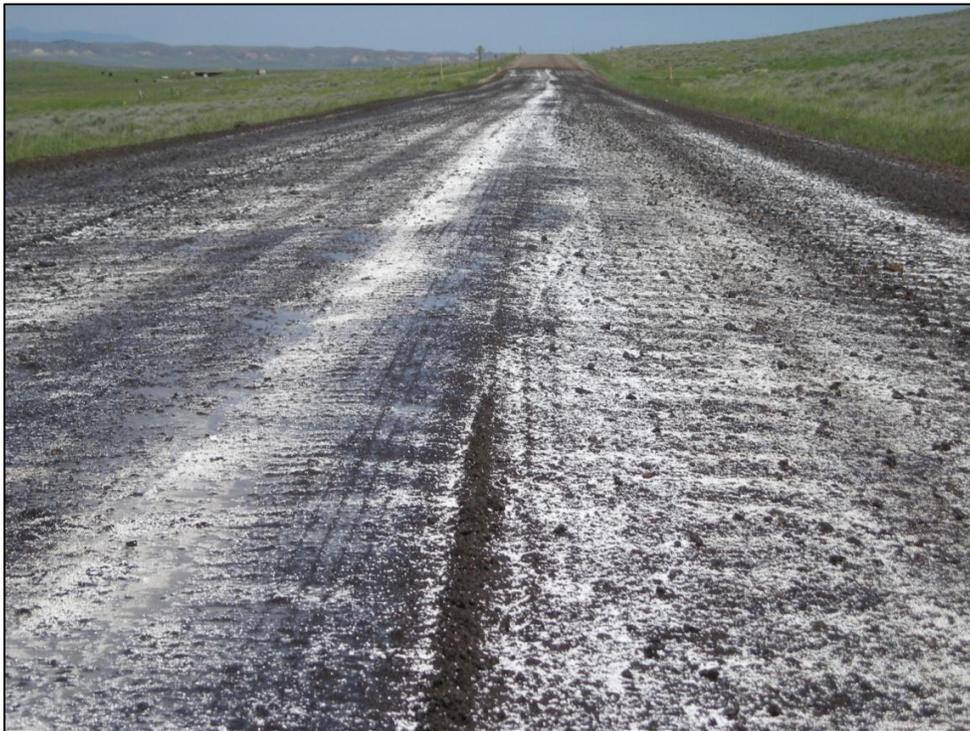
Figure 3.26 Calcium chloride flakes placed on damp RAP and aggregate blend on Johnson County's Schoonover Road, June 2008.

- 1) The roadway was dampened with a water truck.
- 2) Calcium chloride pellets were applied to the roadway (see Figures 3.26 and 3.27).
- 3) Additional water was applied to hold down the calcium chloride pellets.
- 4) Pellets worked into surface by traffic (see Figures 3.28 and 3.29).

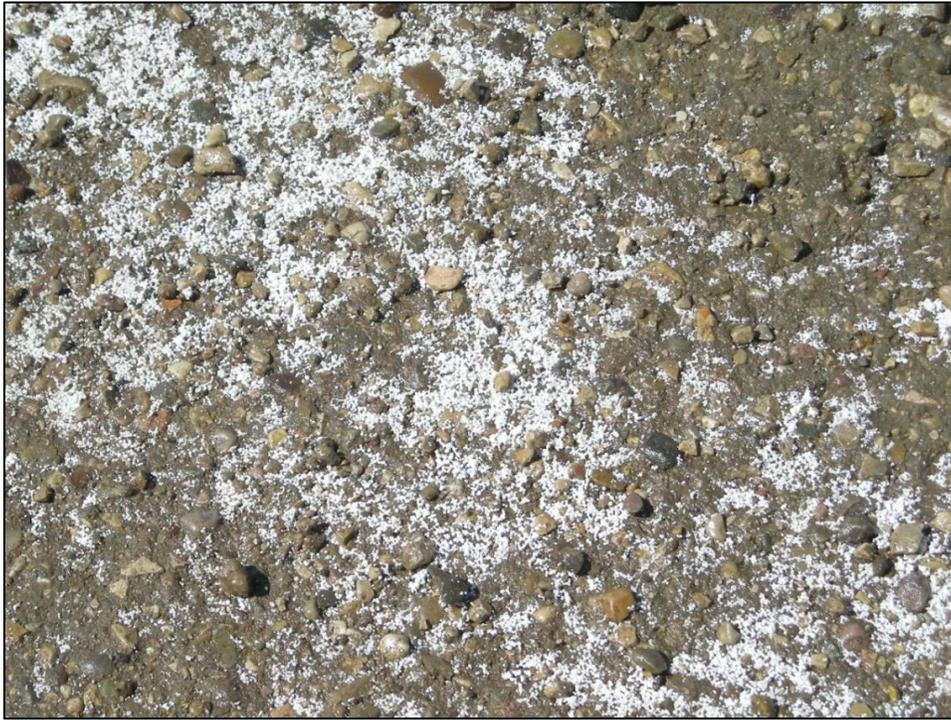
Figure 3.27 Close-up of calcium chloride flakes on Johnson County's Schoonover Road, June 2008.

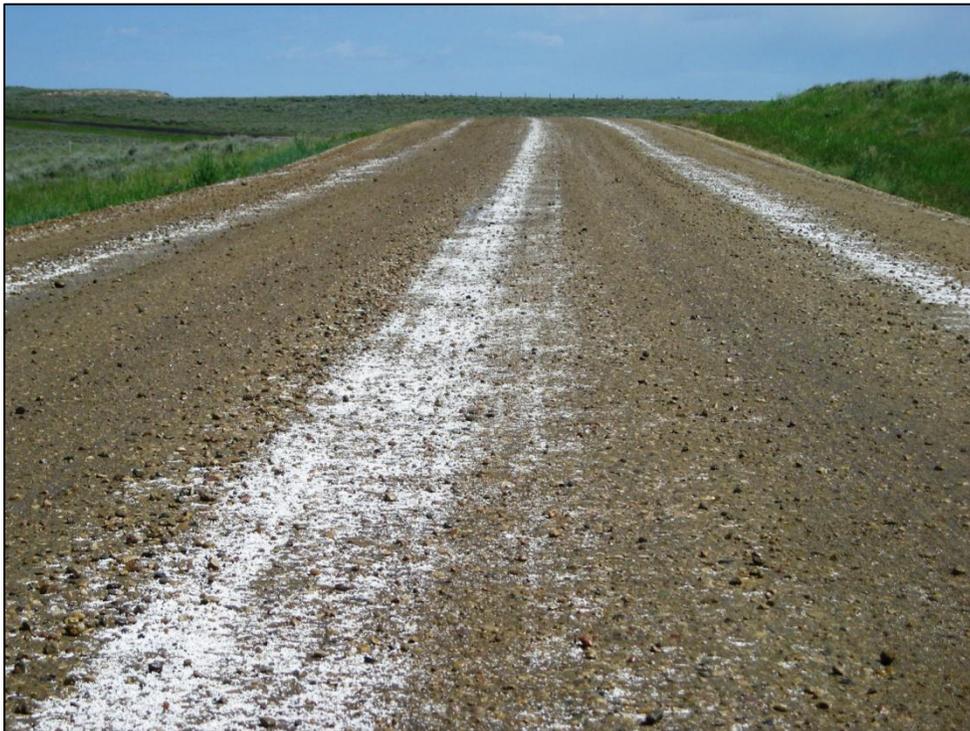
Figure 3.28 Calcium chloride flakes partially worked into the aggregate surface by traffic on Johnson County's Schoonover Road, June 2008.
