FHWA-WY-11/03F

PERFORMANCE OF RECLAIMED ASPHALT PAVEMENT ON UNPAVED ROADS

Department of Civil and Architectural Engineering
University of Wyoming
1000 East University Avenue, Department 3295
Laramie, Wyoming

January 2012

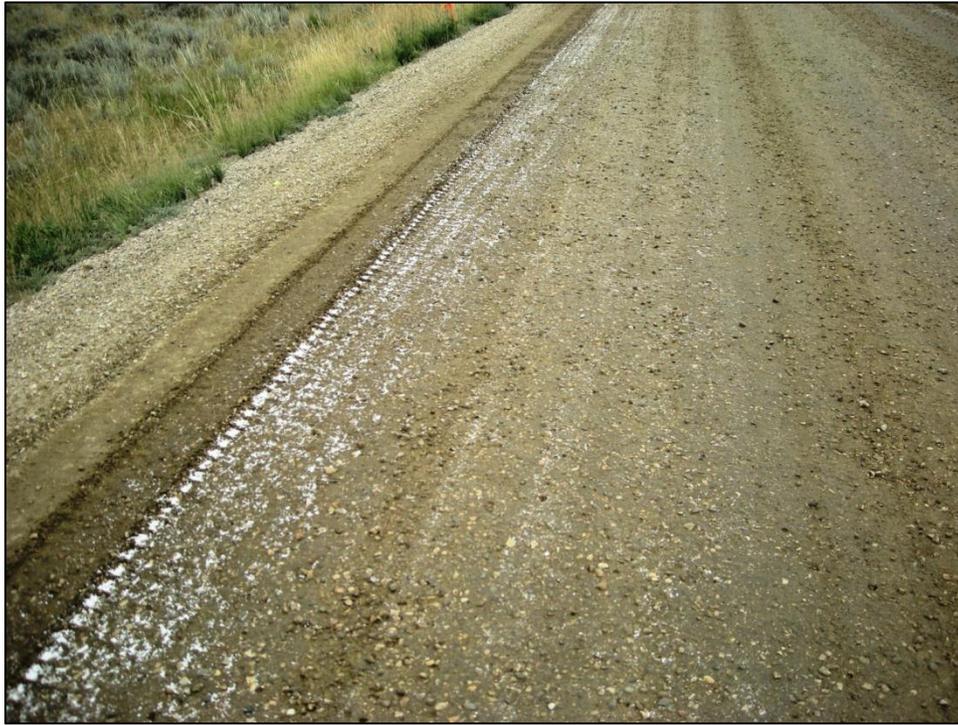
Figure 3.29 Calcium chloride flakes mostly worked into the aggregate surface by traffic on Johnson County's Schoonover Road, June 2008.

- 1) The roadway was dampened with a water truck.
- 2) Calcium chloride pellets were applied to the roadway (see Figures 3.26 and 3.27).
- 3) Additional water was applied to hold down the calcium chloride pellets.
- 4) Pellets worked into surface by traffic (see Figures 3.28 and 3.29).

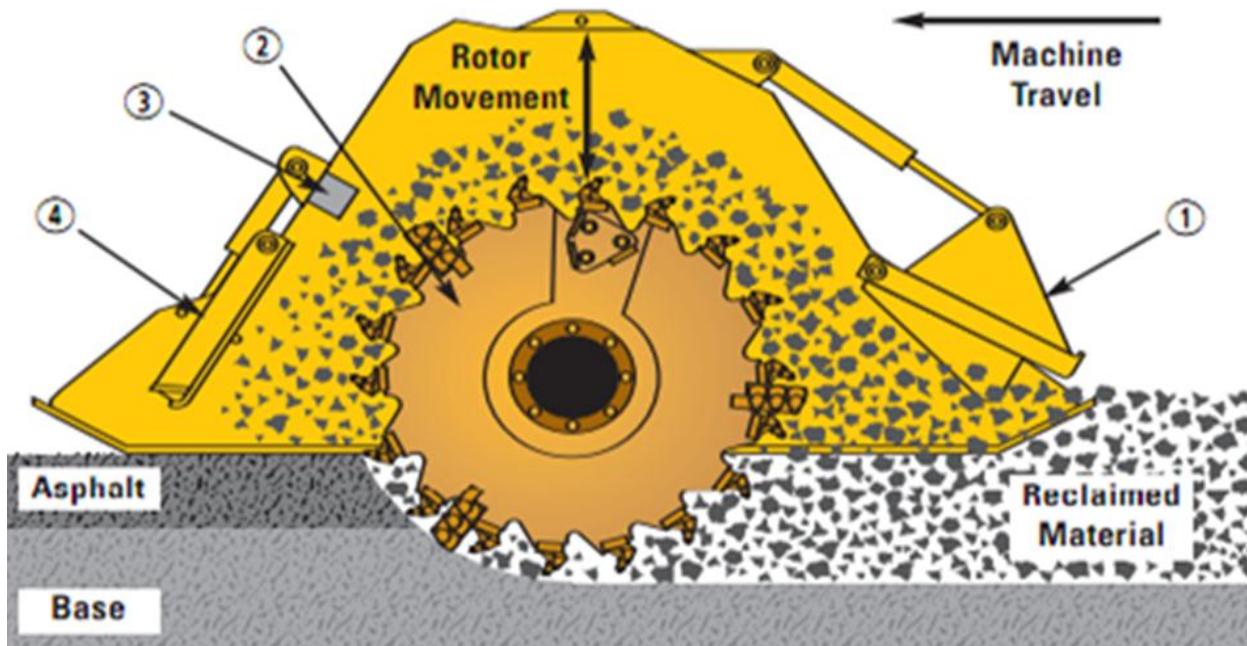
Figure 3.30 Operation of the reclaimer used to blend the underlying, existing surface with RAP or CTB on Sweetwater County's Crooks Gap Road. (1) Adjustable rear door. (2) Universal rotor. (3) Breaker bars. (4) Adjustable front door.

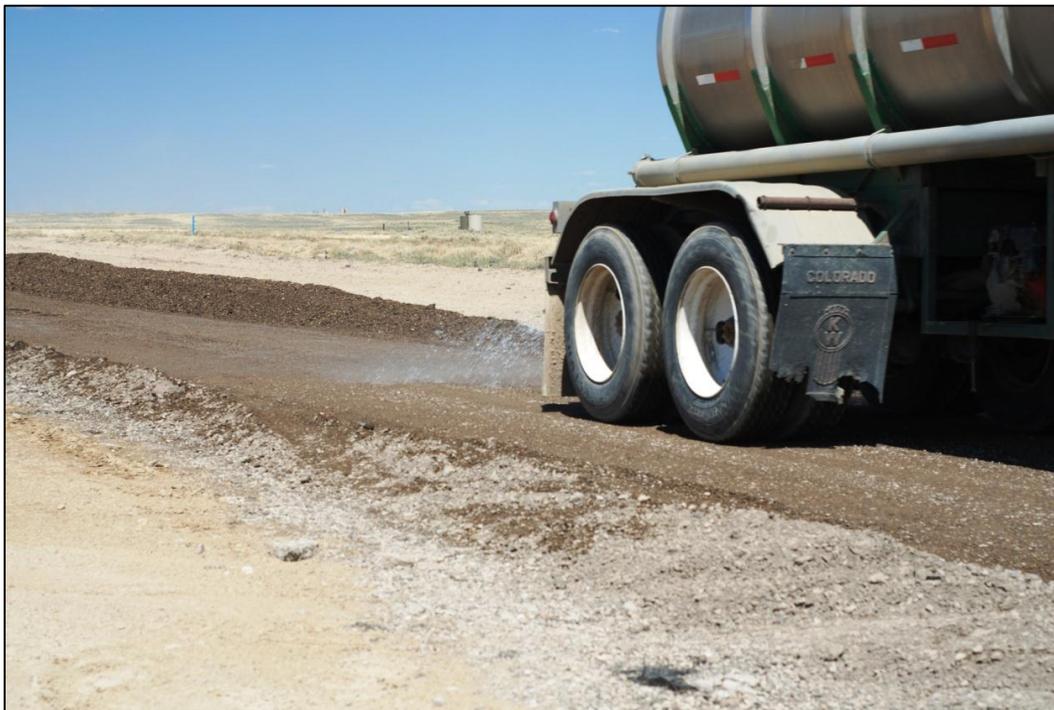
Figure 3.31 Applying water to the CTB and aggregate blend prior to final shaping and compaction on Sweetwater County's Crooks Gap Road, August 2010.

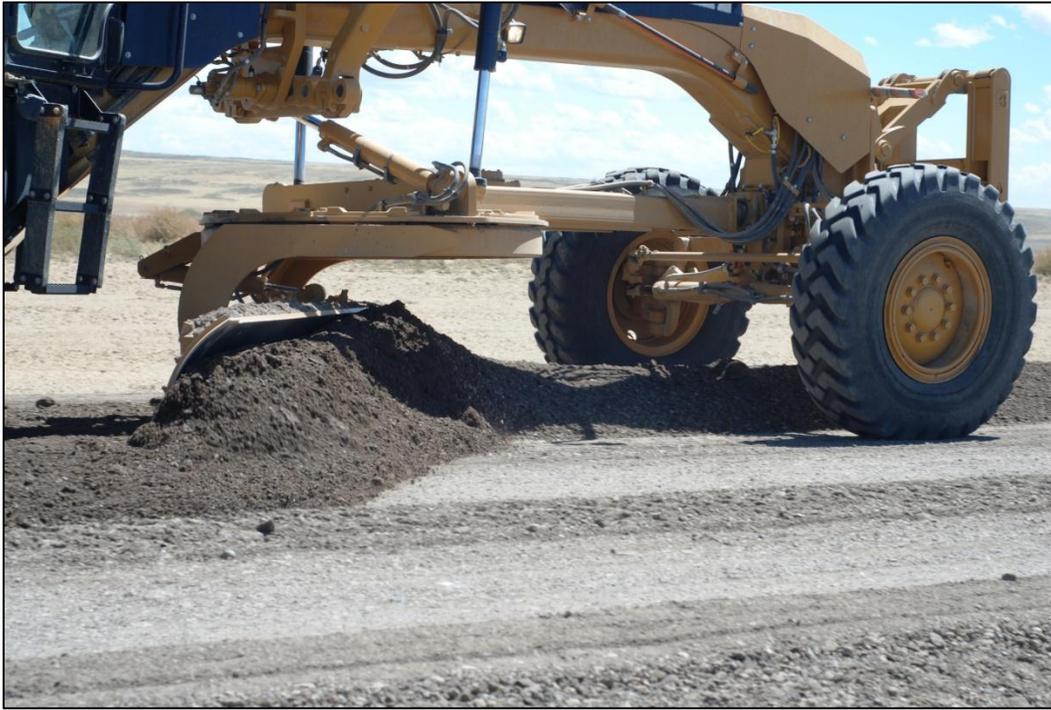
Figure 3.32 Blending and shaping the existing aggregate and CTB blend on Sweetwater County's Crooks Gap Road, August 2010.

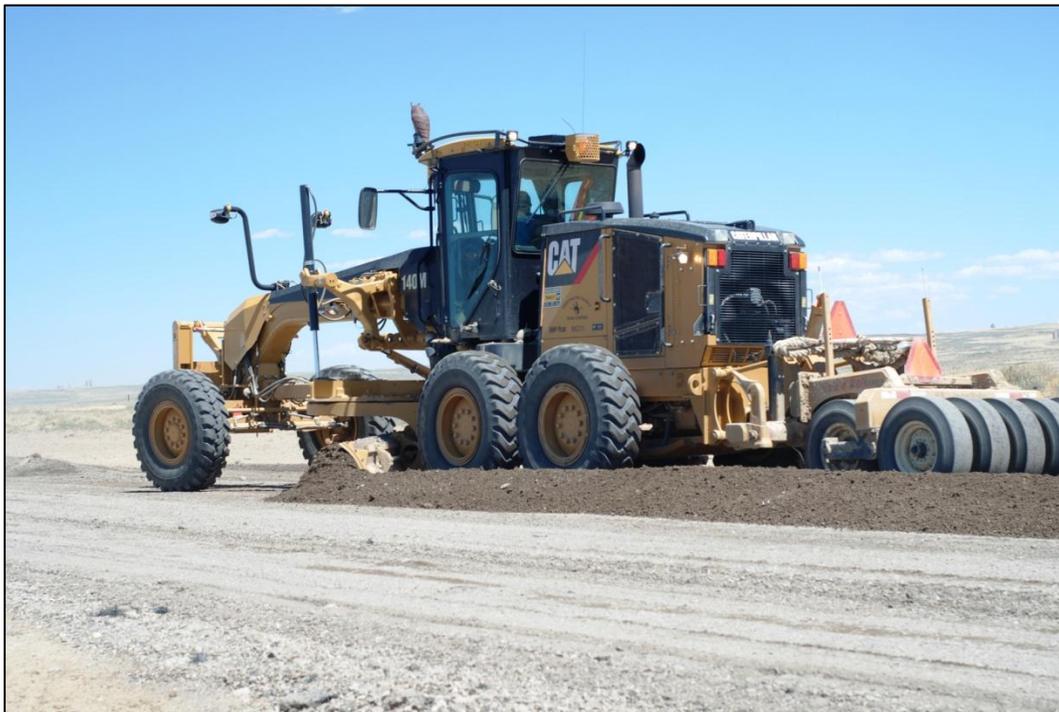
Figure 3.33 Final shaping and compaction of CTB and aggregate blend using a motor grader with pneumatic tire compactors mounted to its ripper hydraulics on Sweetwater County's Crooks Gap Road, August 2010.

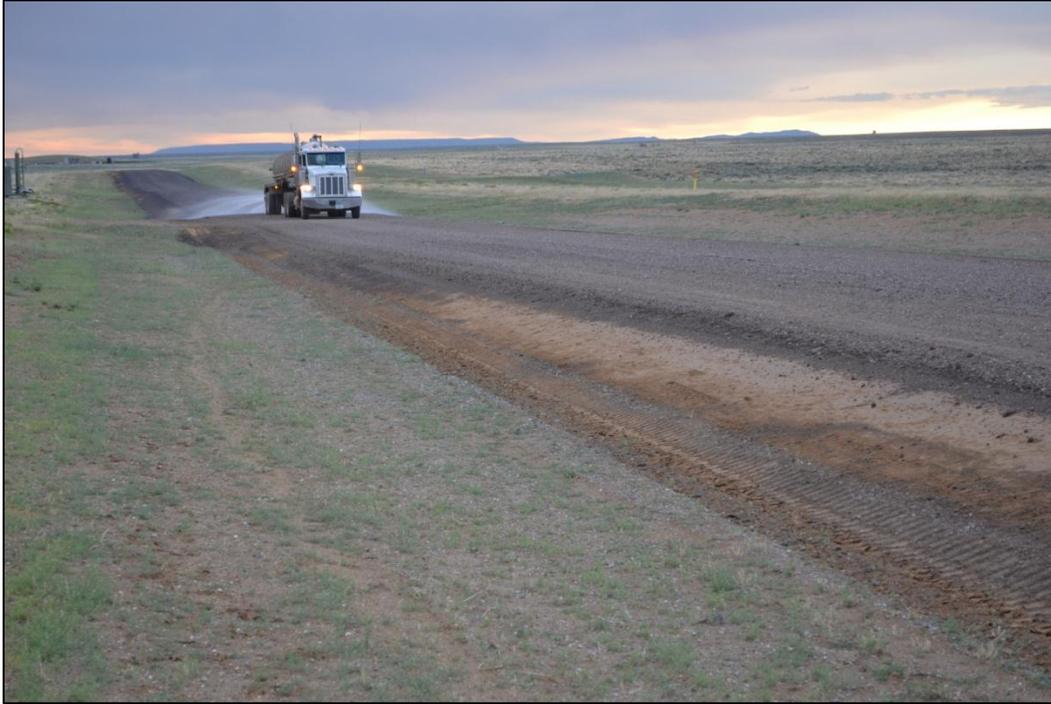
Figure 3.34 Pre-wetting RAP and aggregate blend at dawn prior to application of dust suppressants on Sweetwater County's Crooks Gap Road, July 2011.

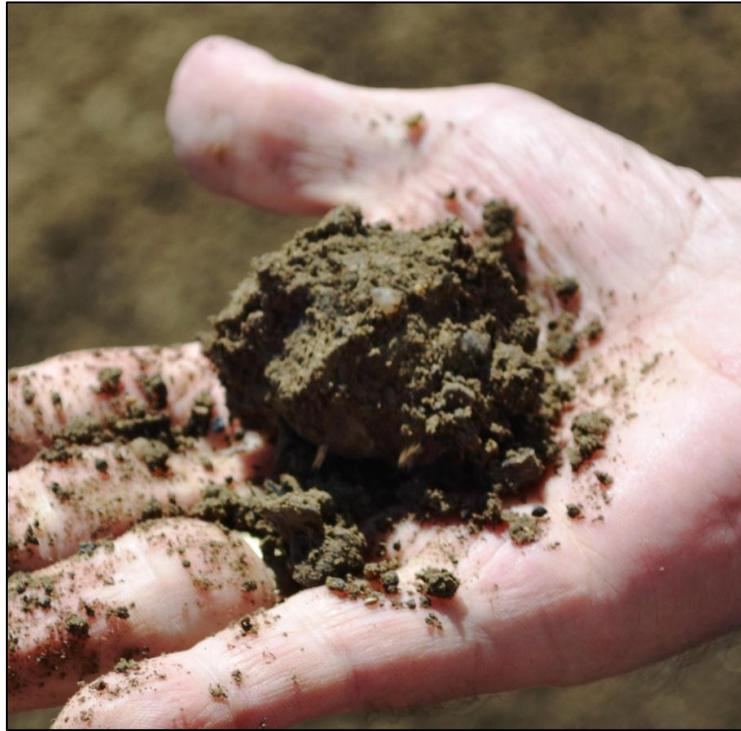
Figure 3.35 Dampened aggregate and RAP blend prepared for application of magnesium chloride and polymer dust suppressant on Sweetwater County's Crooks Gap Road, July 2011.

- 1) Surface was wetted (see Figure 3.34), with particularly heavy water application for the polymer-magnesium chloride blend (see Figure 3.35).
- 2) Surface was reshaped with a motor grader (see Figure 3.36).
- 3) Dust suppressant was sprayed at the prescribed rate (see Figure 3.37).
- 4) Dust suppressant was allowed to penetrate the surface (see Figures 3.38 and 3.39).
- 5) Compacted with a single steel drum compactor (see Figure 3.40).

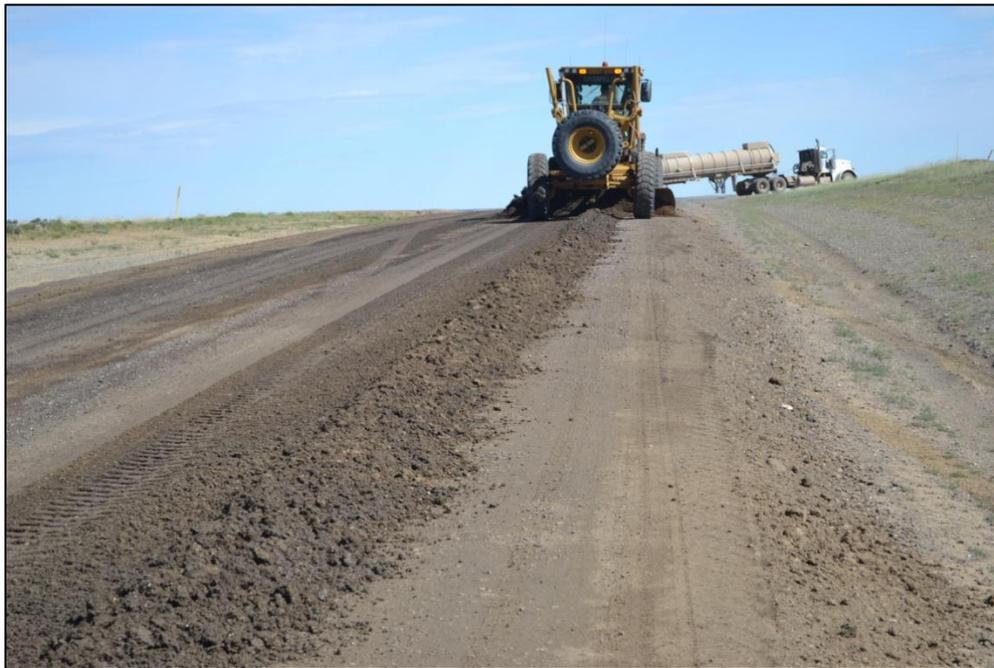
Figure 3.36 Shaping dampened RAP and aggregate blend in preparation for placement of dust suppressants on Sweetwater County's Crooks Gap Road, July 2011.

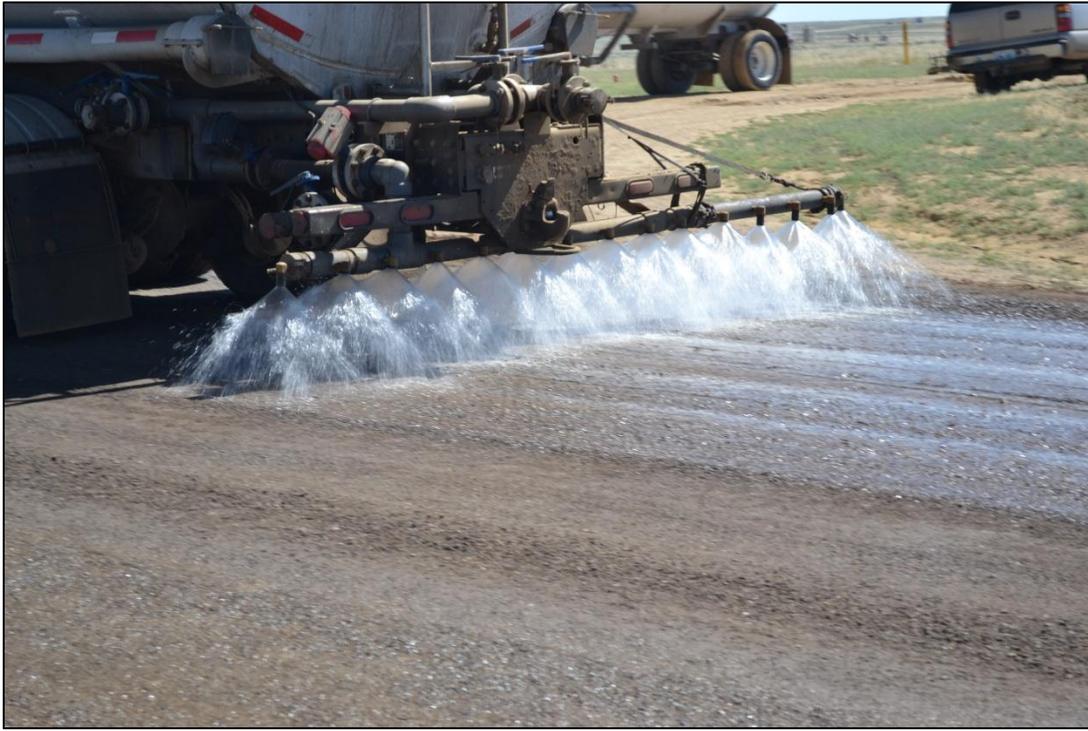
Figure 3.37 Applying dust suppressant brine to aggregate and RAP blend on Sweetwater County's Crooks Gap Road, July 2011.

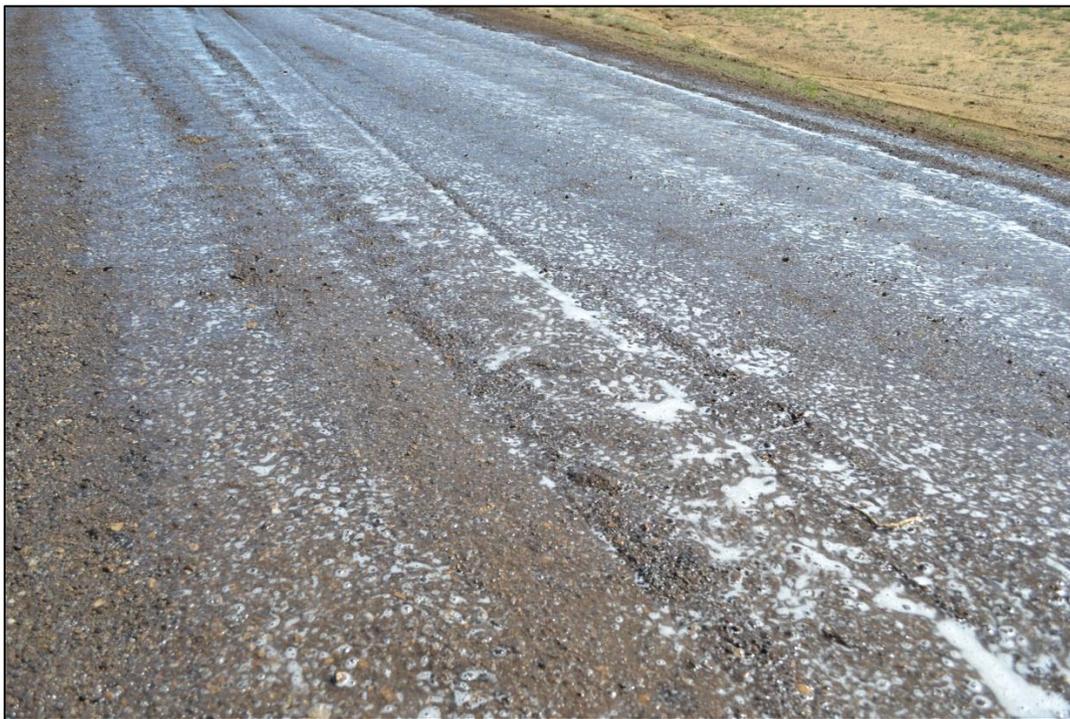
Figure 3.38 Recently applied magnesium chloride on the RAP and aggregate blend on Sweetwater County's Crooks Gap Road, July 2011.

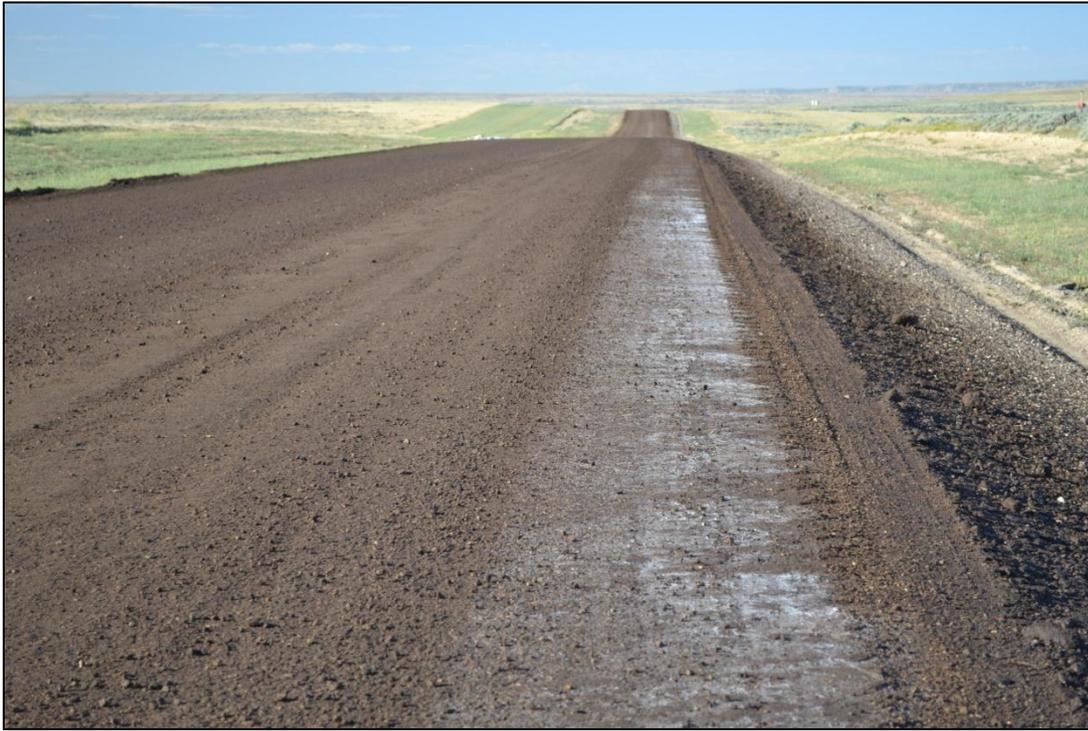
Figure 3.39 Magnesium chloride almost completely absorbed into the RAP and aggregate blend on Sweetwater County's Crooks Gap Road, July 2011.

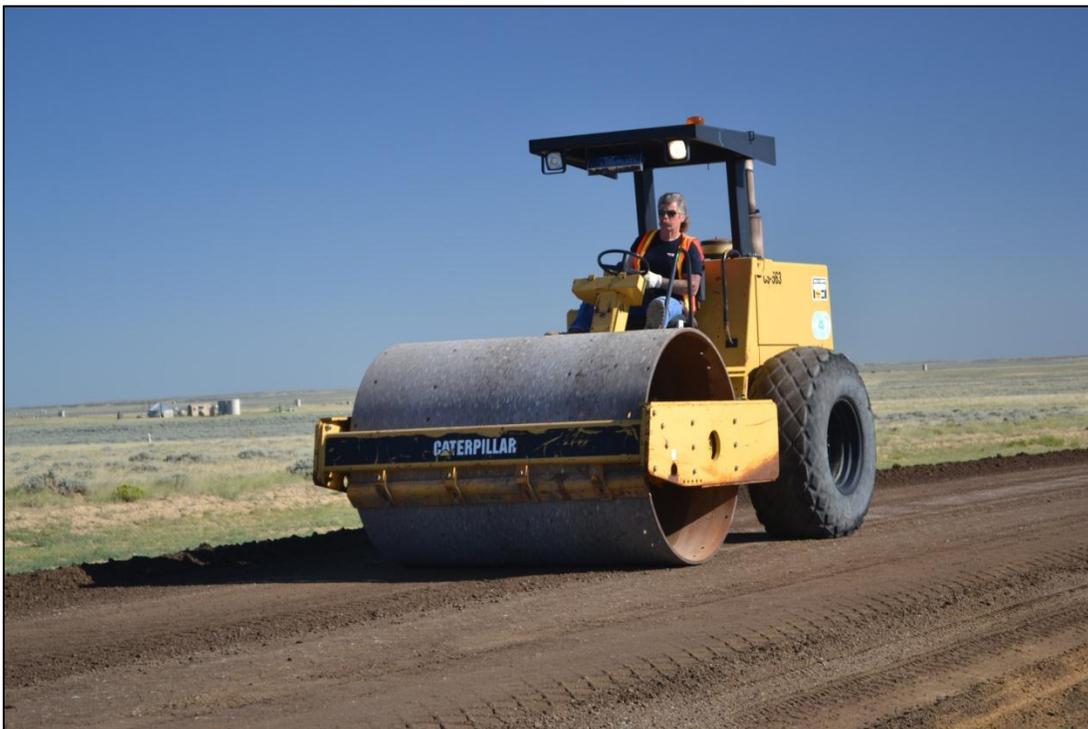
Figure 3.40 Compaction of the magnesium chloride-treated RAP and aggregate blend on Sweetwater County's Crooks Gap Road, July 2011.

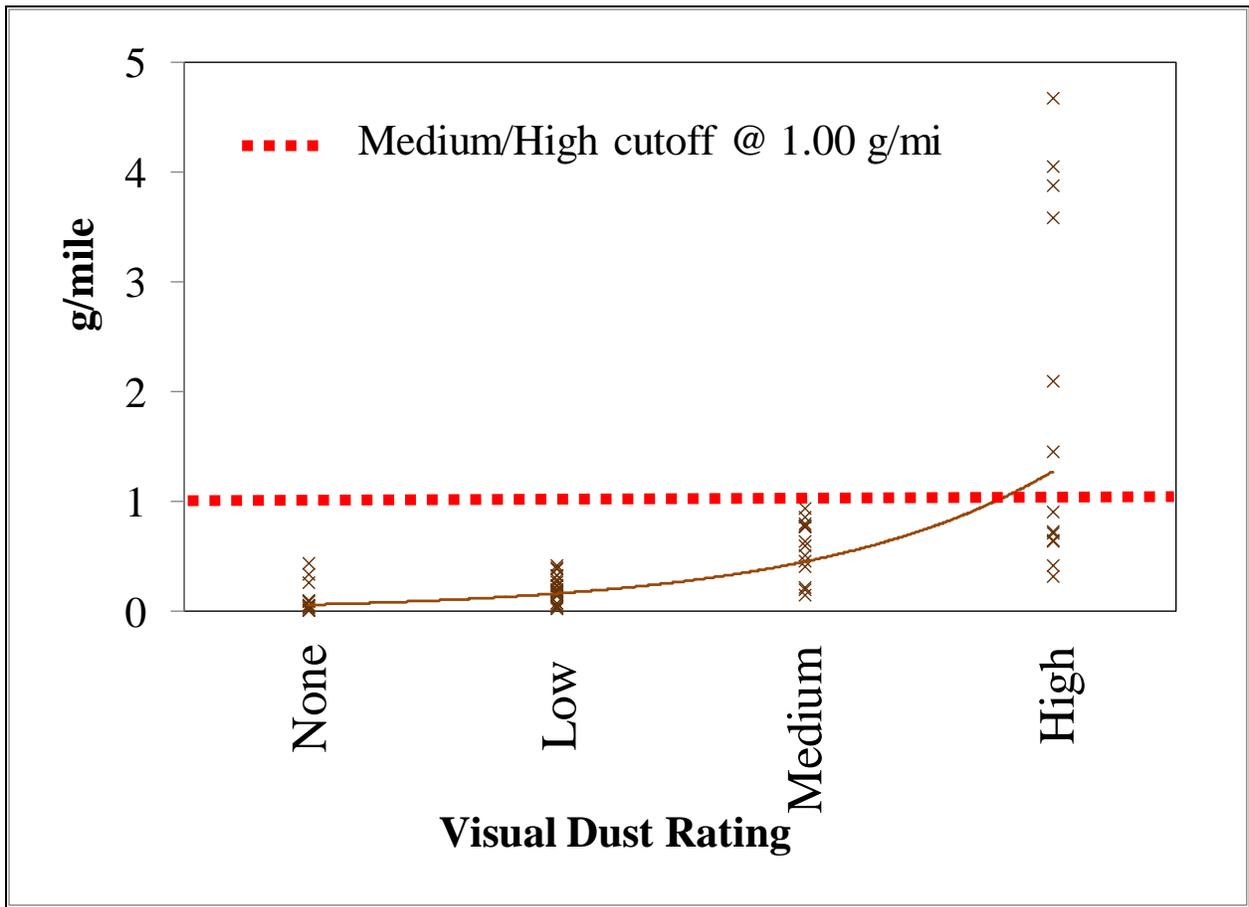
Figure 4.1 Dust measured with the dustometer as a function of subjective visual dust ratings, with a suggested numerical cutoff between Medium and High dust severity at 1.00 grams per mile.

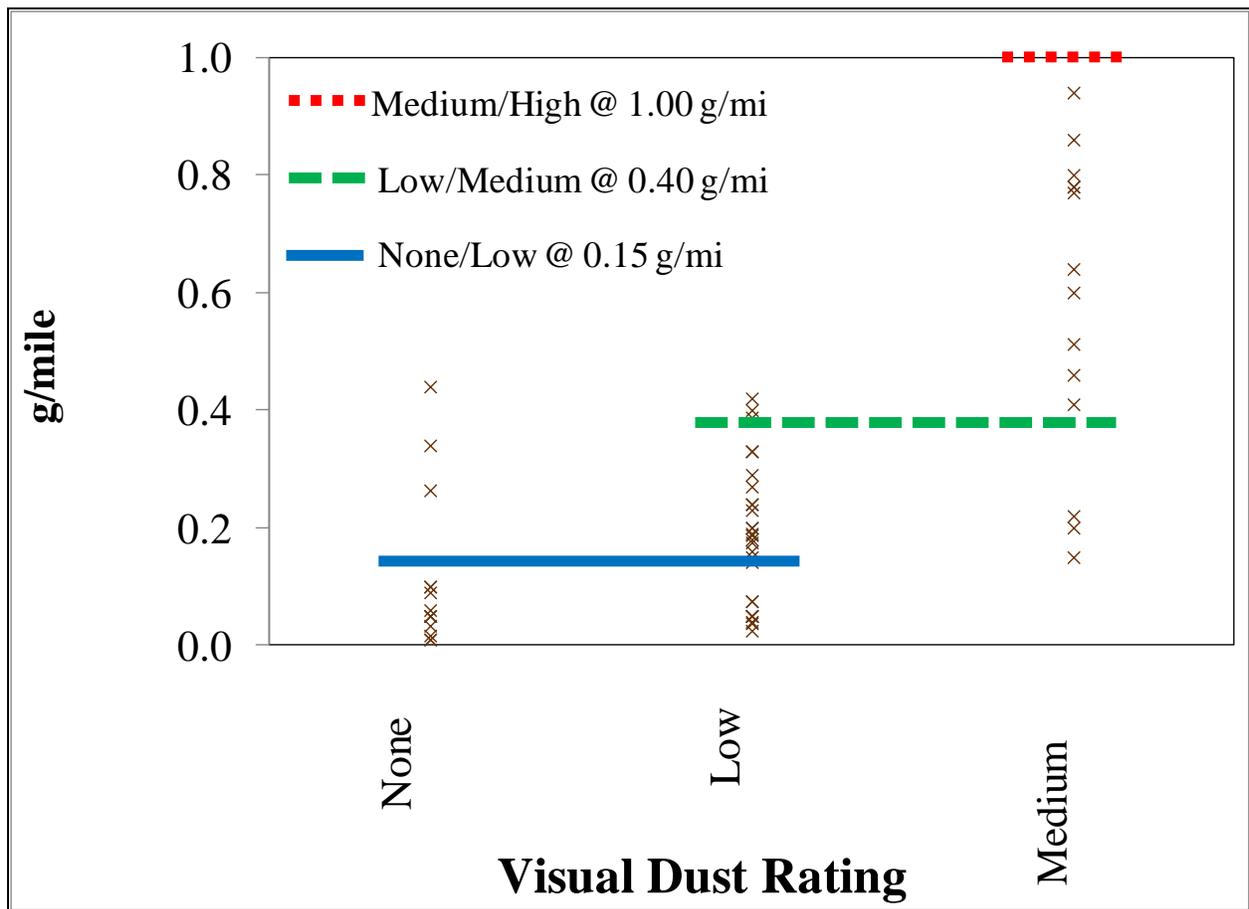
Figure 4.2 Dust measured with the dustometer as a function of subjective visual dust ratings, with suggested numerical cutoffs between High, Medium, Low and None dust severity.

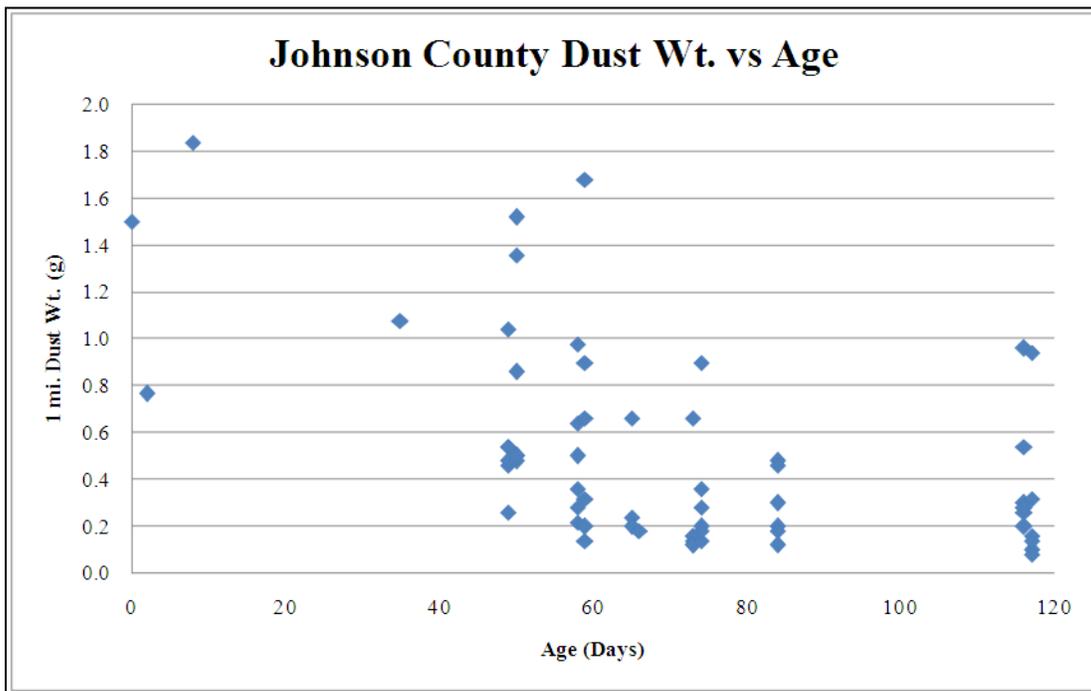
Figure 4.3 Measured dust as a function of road surface age on Johnson County's Schoonover Road.

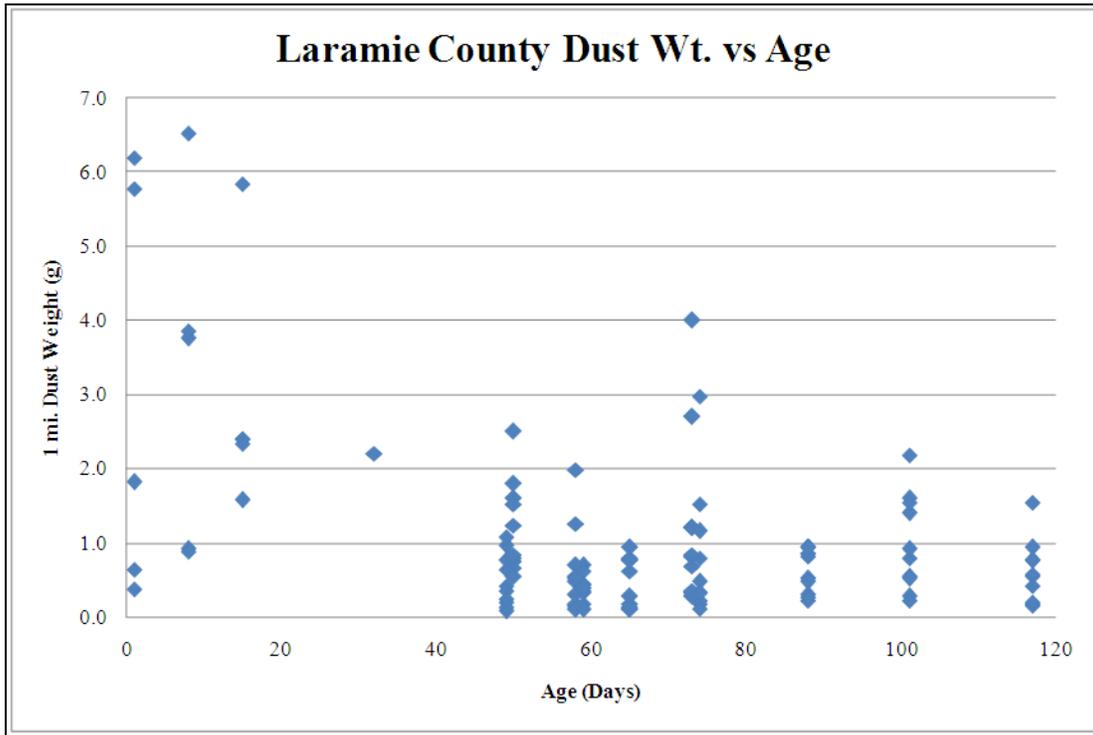
Figure 4.4 Measured dust as a function of road surface age on Laramie County's Atlas and Pry Roads.

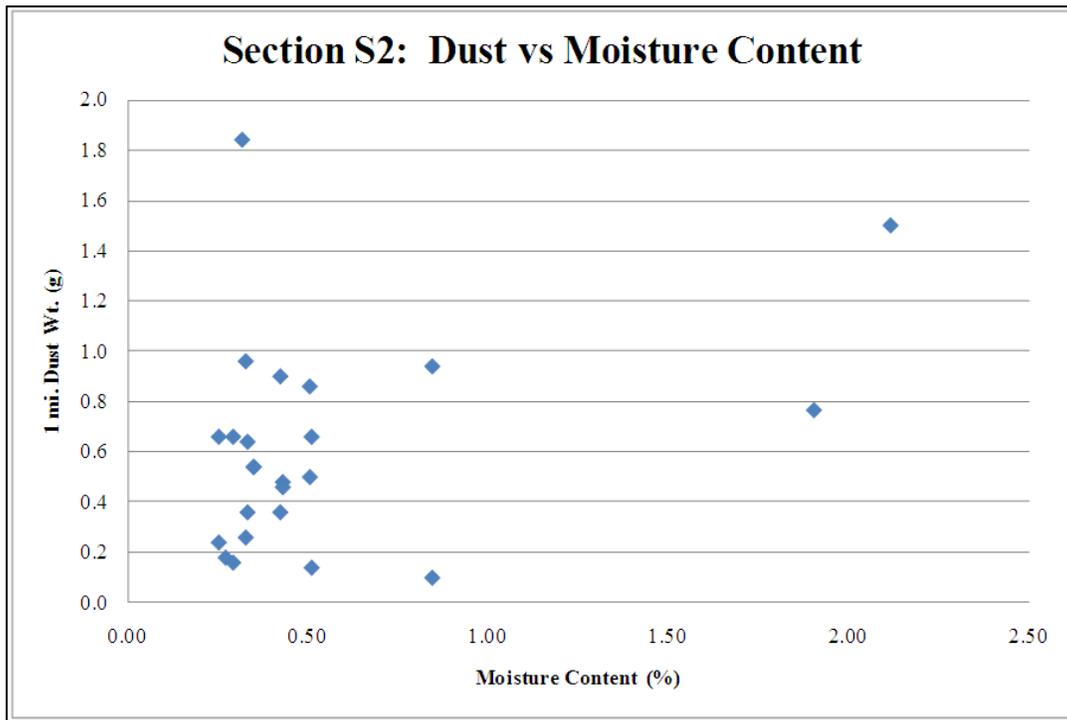
Figure 4.5 Measured dust as a function of moisture content on Johnson County's Schoonover Road, section S2 with RAP/aggregate blend and no calcium chloride.

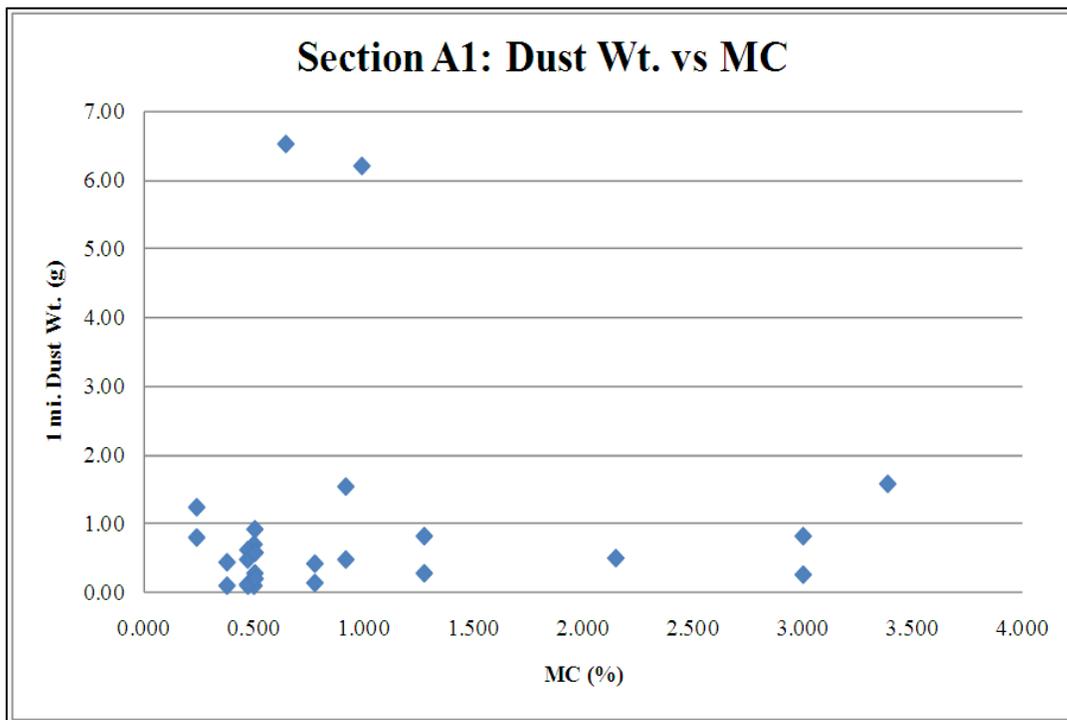
Figure 4.6 Measured dust as a function of moisture content on Laramie County's Atlas Road, section A1 with blended RAP and existing aggregate.

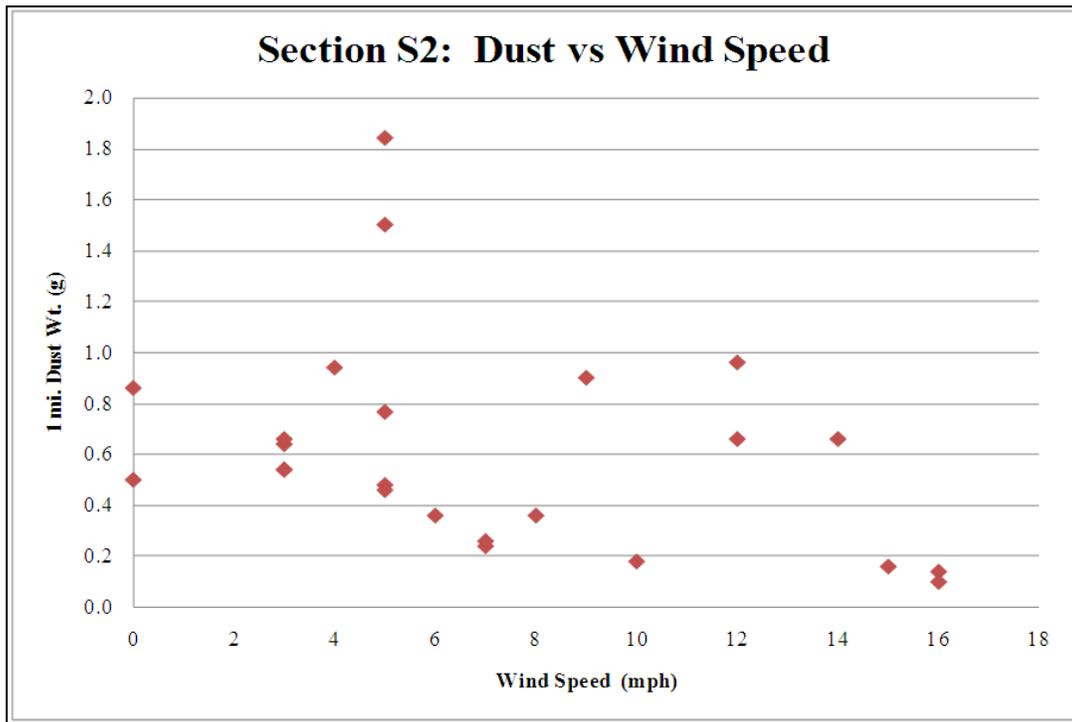
Figure 4.7 Measured dust as a function of wind speed on Johnson County's Schoonover Road, section S2 with RAP and aggregate surfacing but no calcium chloride.

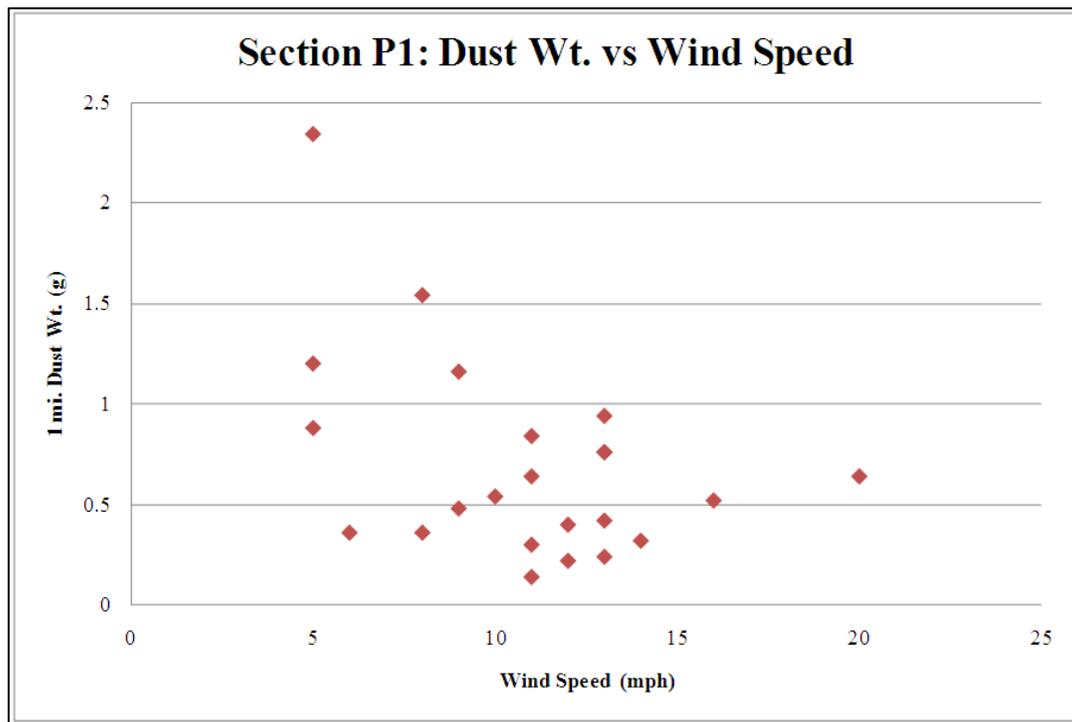
Figure 4.8 Measured dust as a function of wind speed on Laramie County's Pry Road, section S1 with blended RAP and existing aggregate.

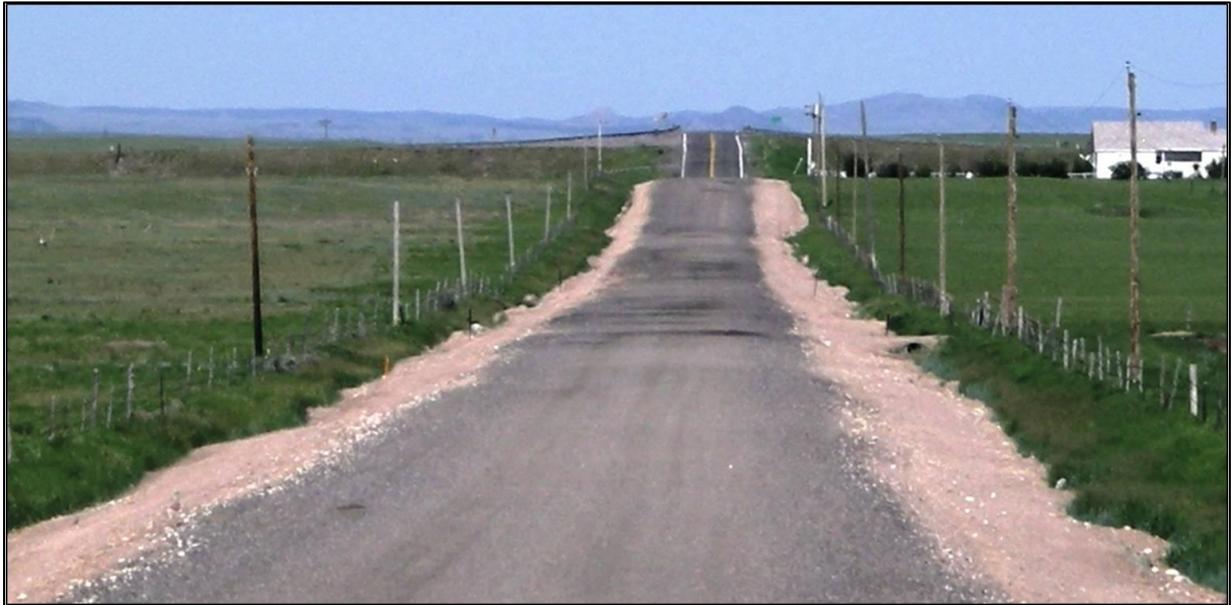
Figure 4.10 Segregation of RAP on Laramie County's Atlas Road in June 2008, two months after initial RAP application.

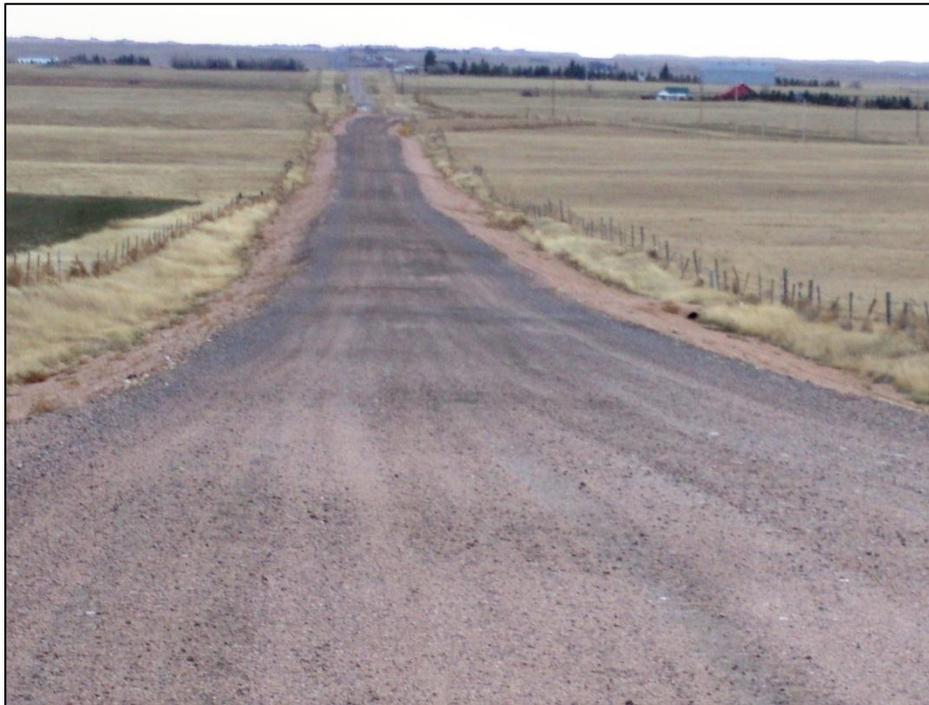
Figure 4.11 Segregation bands attributed to inadequate spreading of the windrows placed by the bottom-discharge haul trucks on Laramie County's Pry Road in November 2008, six months after initial application.

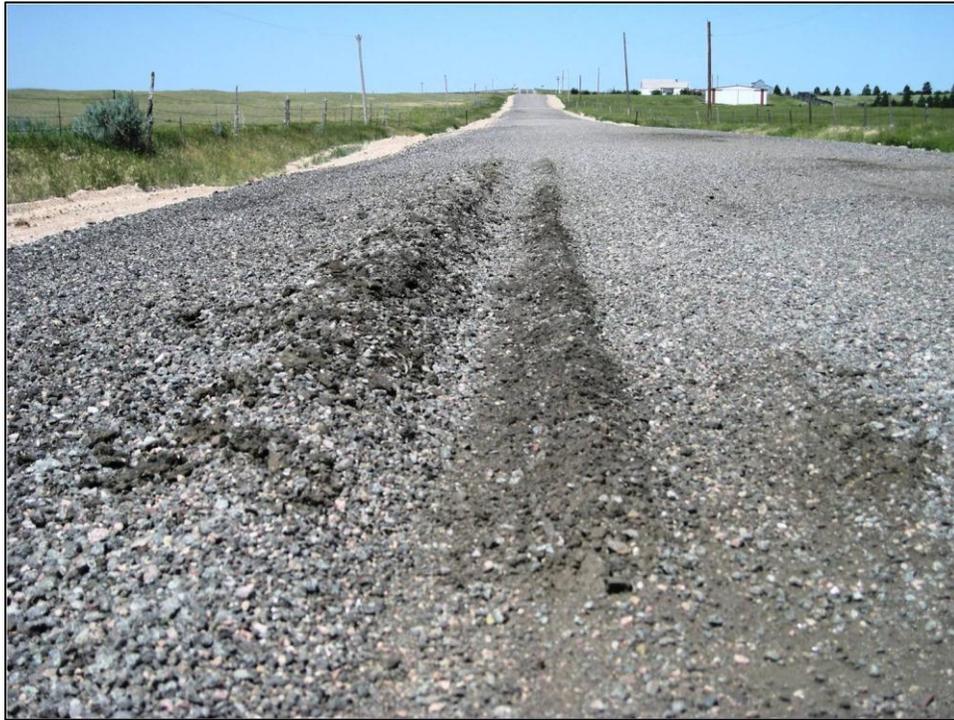
Figure 4.12 Nearly 100% RAP resulting in excessive loose aggregate on Laramie County's Atlas Road in June 2008, about two months after initial application.

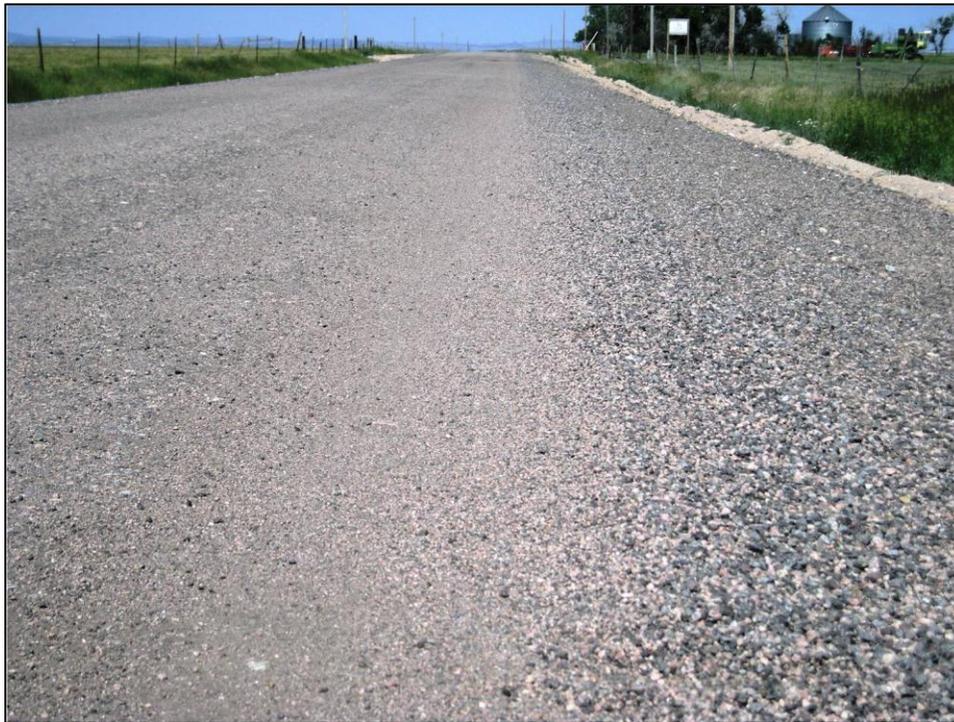
Figure 4.13 Well compacted, tight surface due to good blending on Laramie County's Atlas Road in June 2008, about two months after initial application.

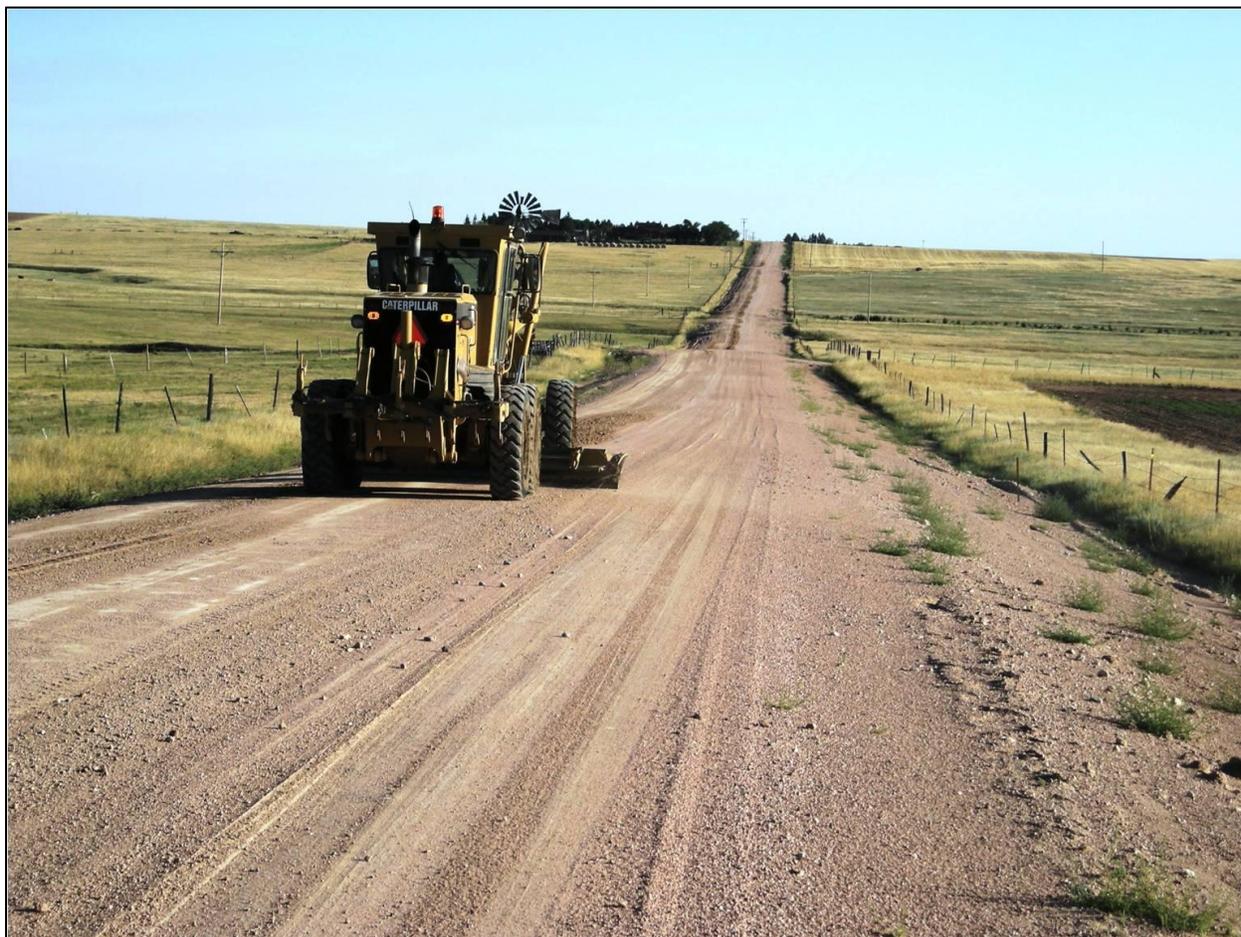
Figure 4.14 Re-working Laramie County's Pry Road in August 2008, four months after initial application, to correct segregation with additional blending and spreading.

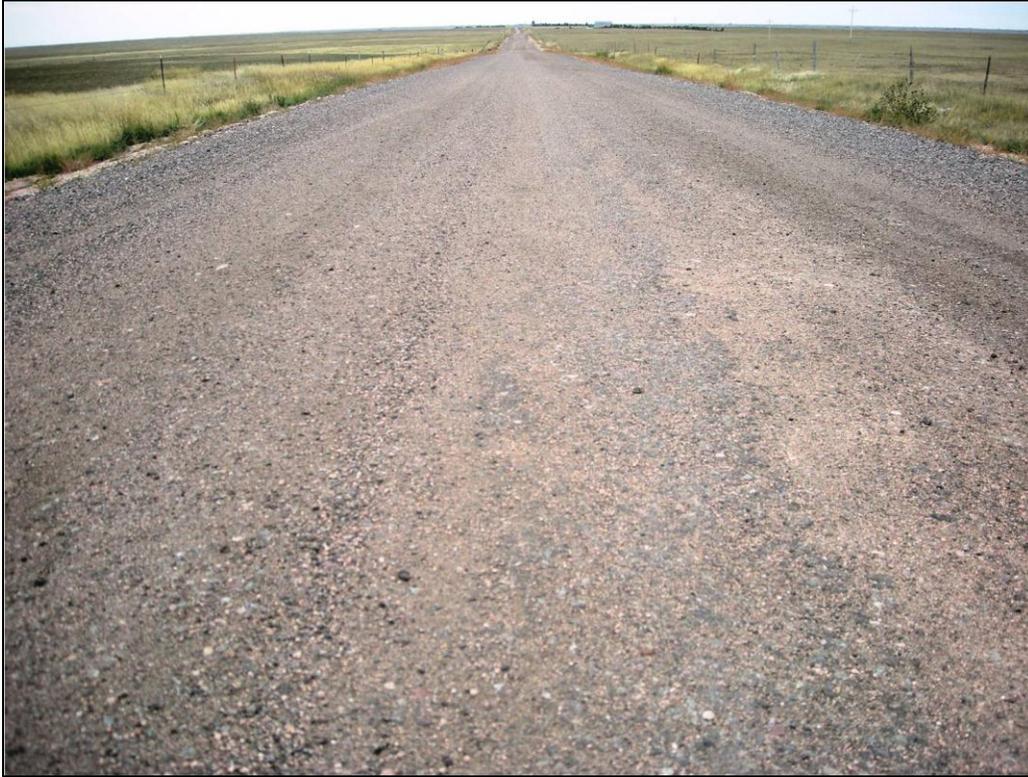
Figure 4.15 Good, tight surface on Laramie County's Atlas Road in October 2008, five months after initial application and two months after re-blending with motor grader.

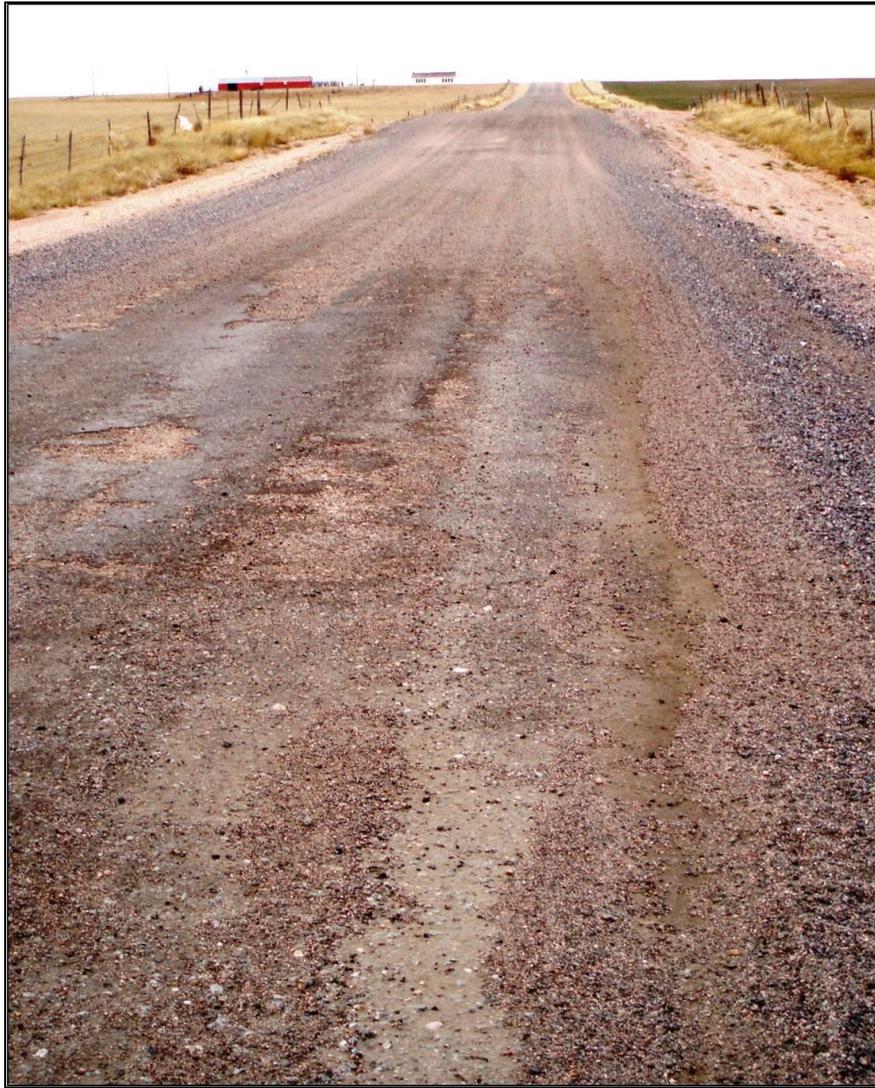
Figure 4.16 Variable densification under traffic due to incomplete blending and segregation of RAP and aggregate on Laramie County's Pry Road in November 2008, six months after initial compaction and three months after re-working.
