FHWA-WY-11/03F

PERFORMANCE OF RECLAIMED ASPHALT PAVEMENT ON UNPAVED ROADS

Department of Civil and Architectural Engineering
University of Wyoming
1000 East University Avenue, Department 3295
Laramie, Wyoming

January 2012

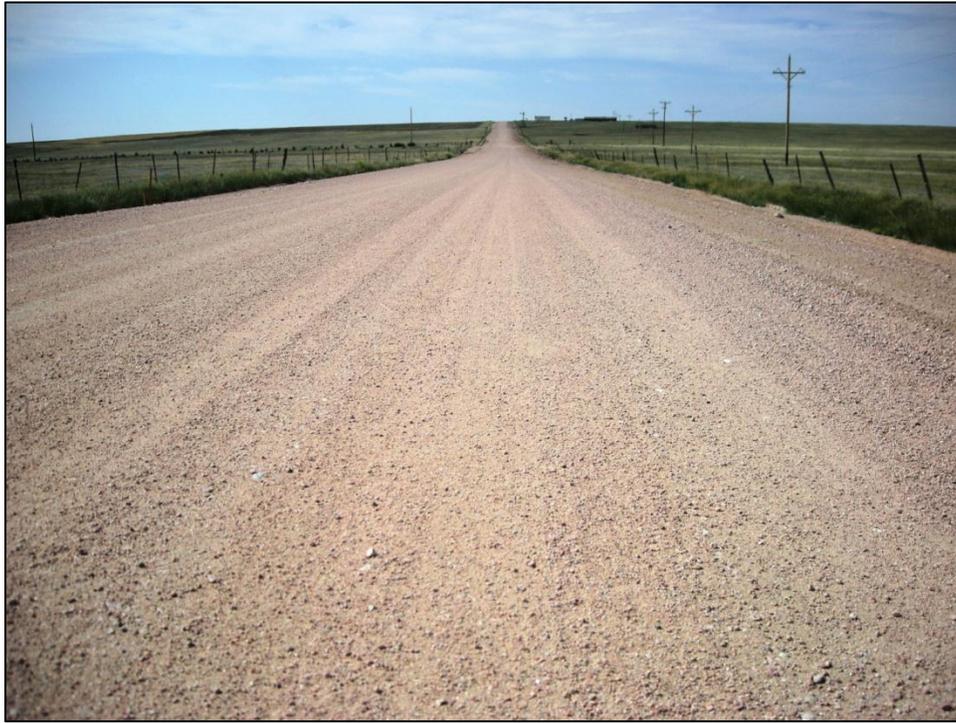
Figure 4.17 Aggregate only forming a good driving surface on Laramie County's Pry Road in July 2008, two months after shaping.

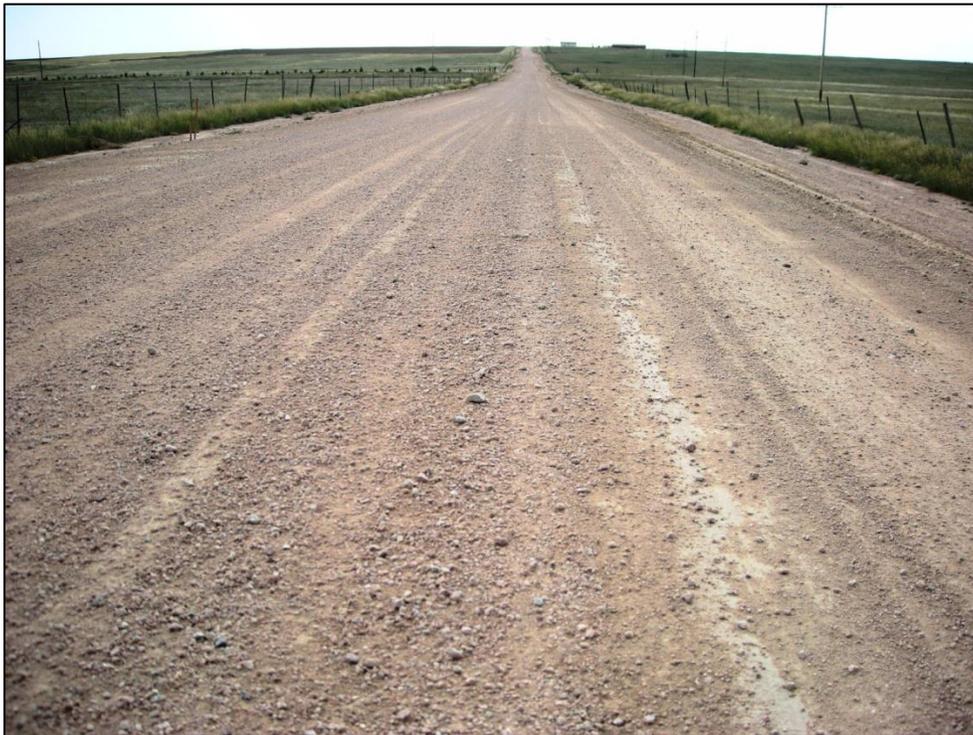
Figure 4.18 Aggregate only forming a good driving surface on Laramie County's Atlas Road in September 2008, four months after shaping.

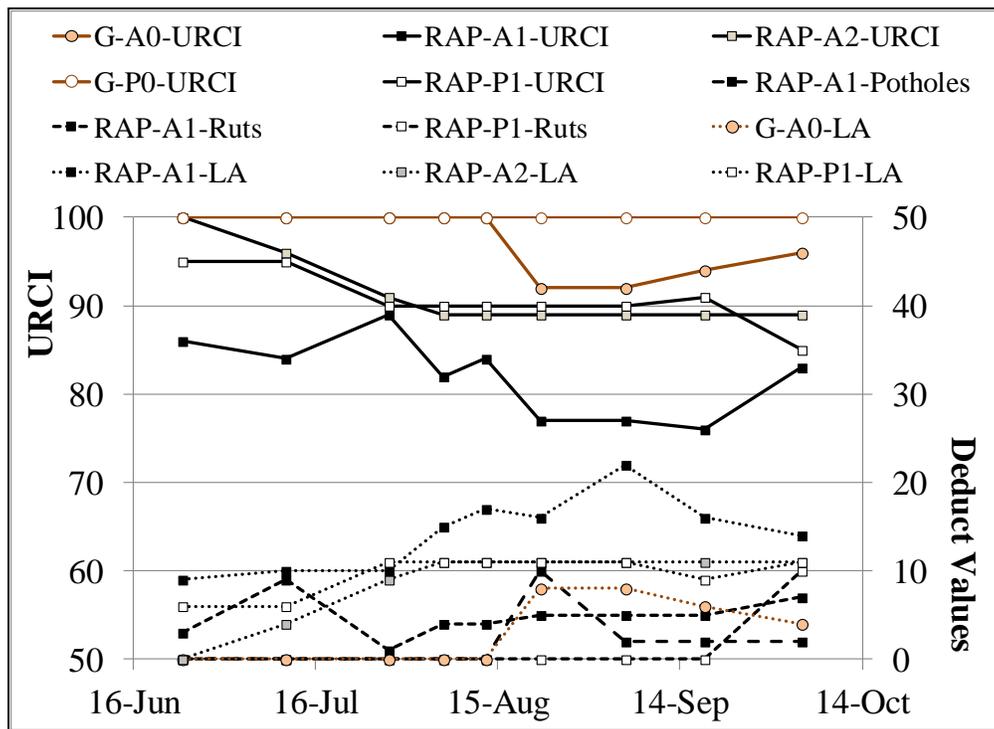
Figure 4.19 Laramie County unsurfaced road condition indexes (URCI) and deduct values for potholes, ruts and loose aggregate (LA).

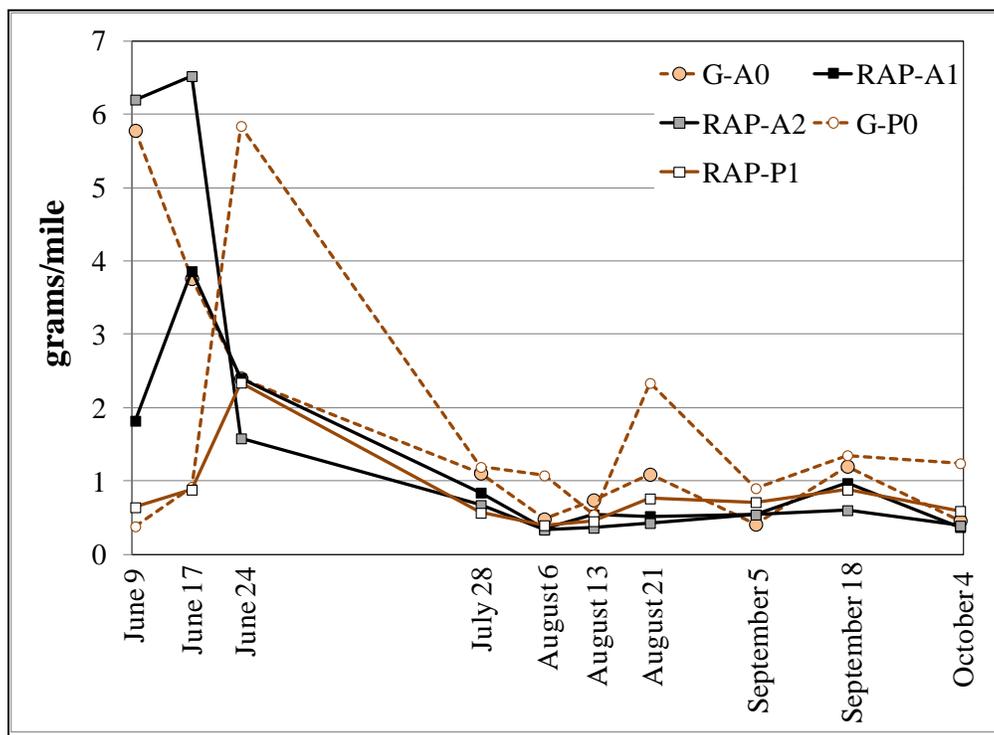
Figure 4.20 Dust measured with the dustometer on the Laramie County RAP blend and aggregate only (G) test segments.

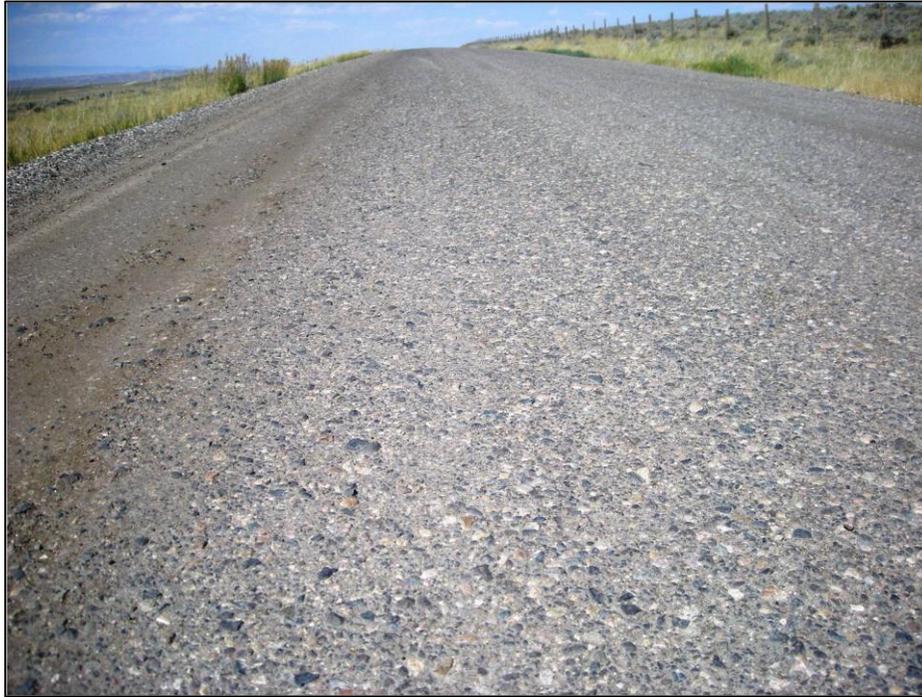
Figure 4.21 Road surface with some rutting on Johnson County's Schoonover Road, segment S1 with RAP and calcium chloride in August 2008, two months after RAP placement and one month after calcium chloride application.

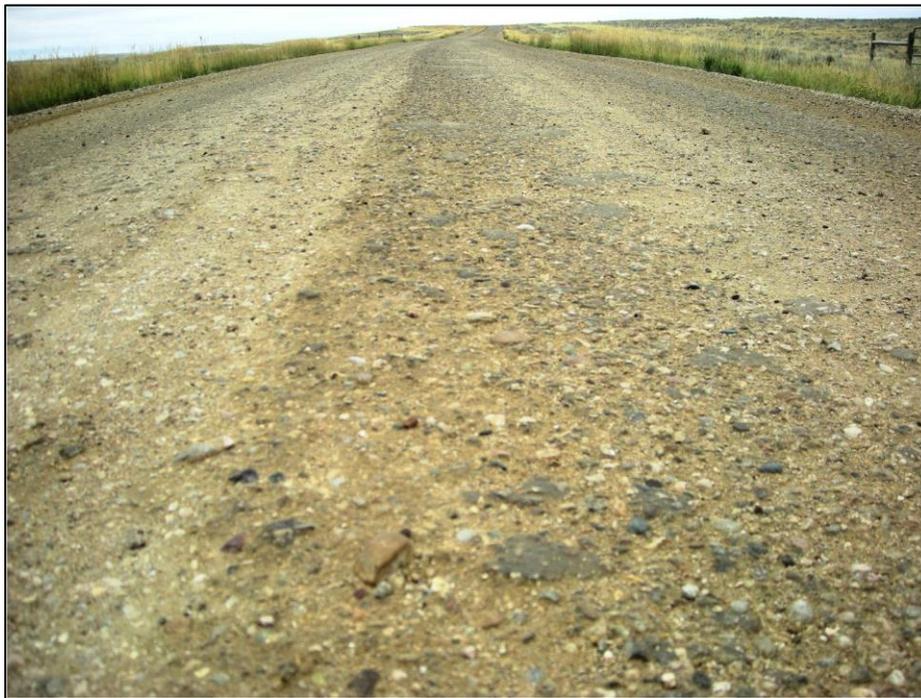
Figure 4.23 Road surface on Johnson County's Schoonover Road, segment S0 with aggregate and calcium chloride in September 2008, two months after calcium chloride application.

Figure 4.23 shows the virgin aggregate section with calcium chloride three months after resurfacing. A good crust formed, though some rutting developed.

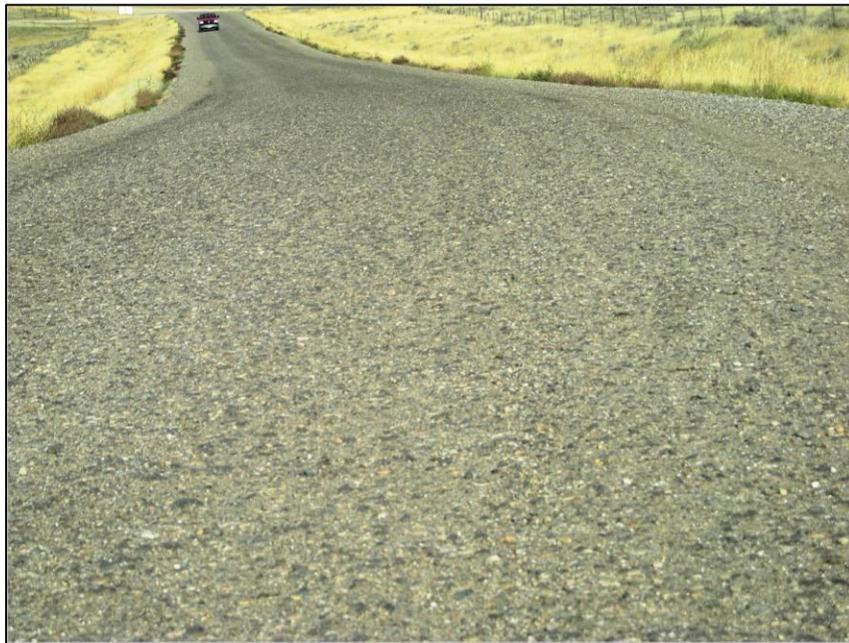
Figure 4.25 Road surface on Johnson County's Schoonover Road, segment S2 with RAP but no calcium chloride in October 2008, four months after RAP placement.

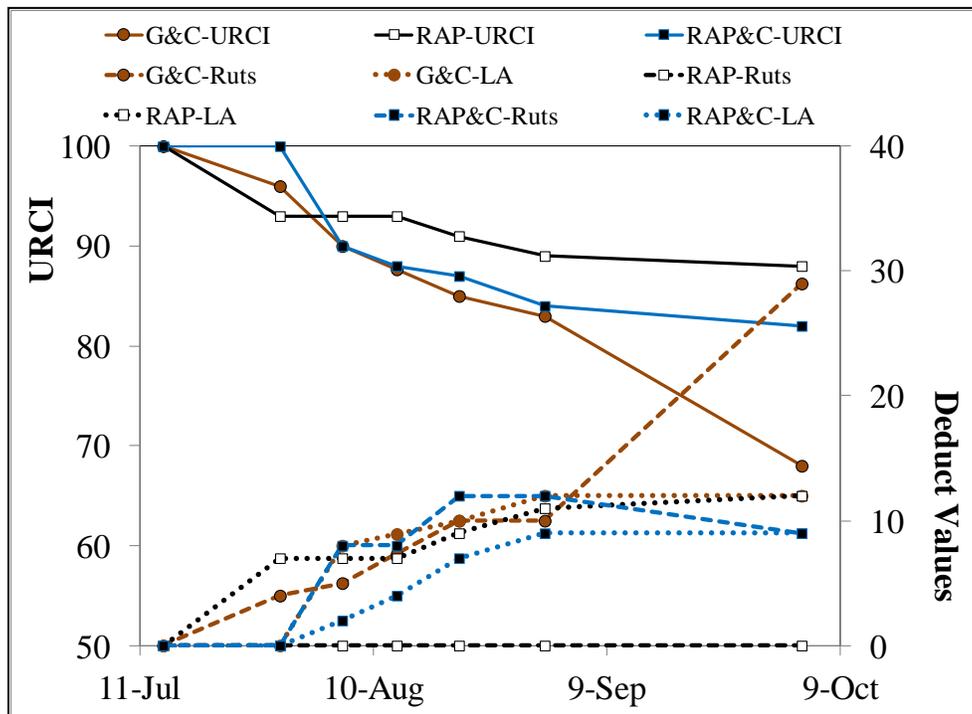
Figure 4.26 Unsurfaced road condition indexes and deduct values for ruts and loose aggregate (LA) on Johnson County's Schoonover Road for segments S0 with gravel and calcium chloride (G&C), S1 with RAP blend and calcium chloride, and S2 with RAP blend only.

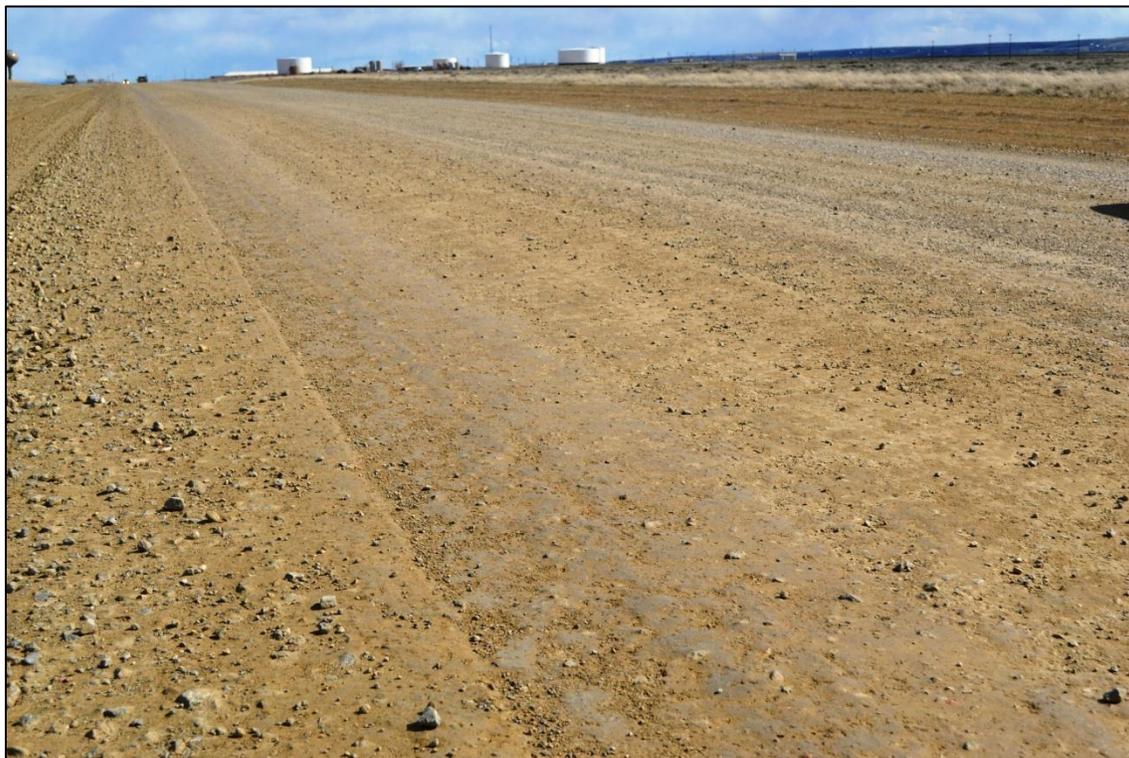
Figure 4.32 Road surface made of limestone crushed base treated with magnesium chloride on Sweetwater County's Crooks Gap Road.

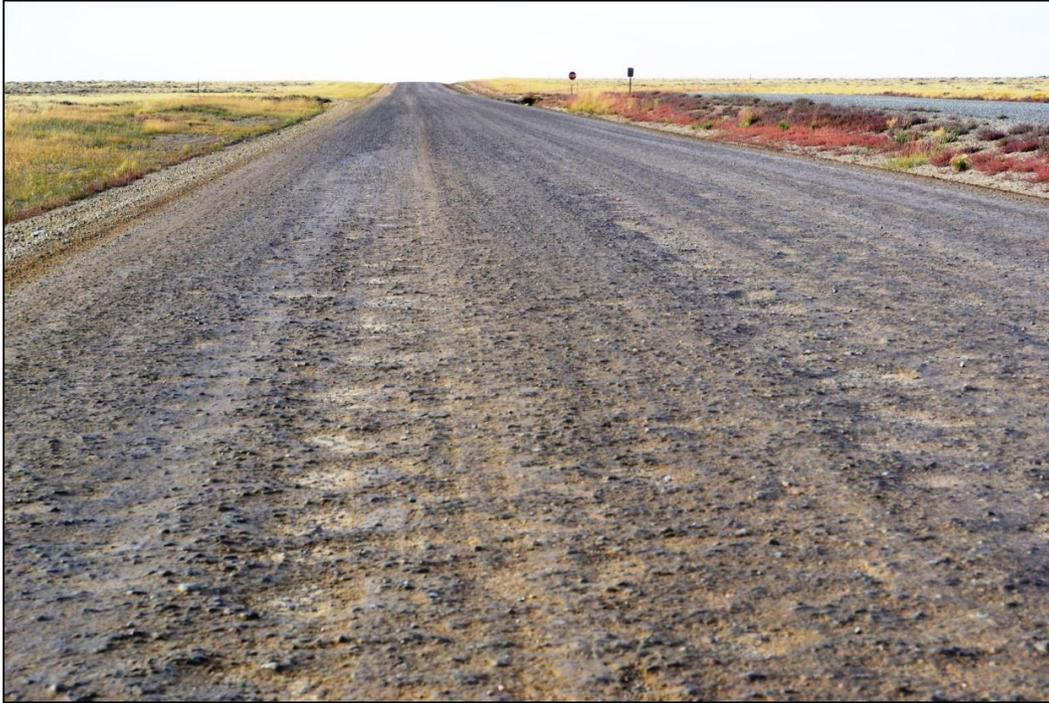
Figure 4.33 Road surface made of limestone crushed base treated with magnesium chloride on Sweetwater County's Crooks Gap Road showing small scale roughness.

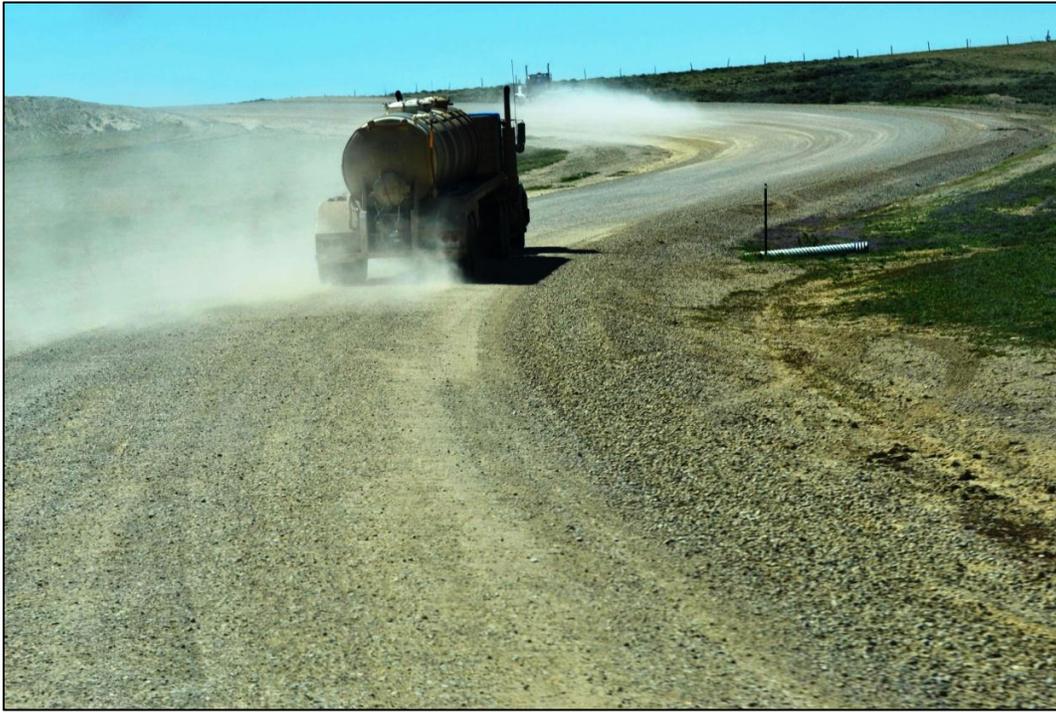
Figure 4.34 Dust from limestone crushed base before dust suppressant application on uphill, curved segment D of Sweetwater County's Crooks Gap Road in June 2011.

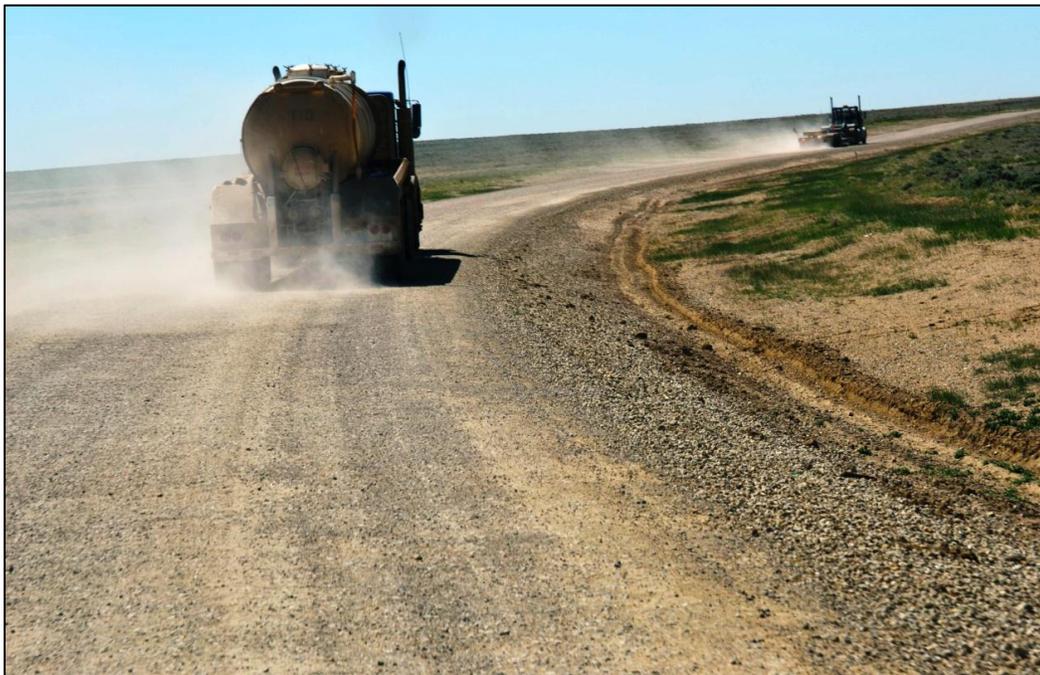
Figure 4.35 Dust from limestone crushed base before dust suppressant application on level, curved segment C on Sweetwater County's Crooks Gap Road in June 2011.

Before treatment, these sections were dusty since they had inadequate binder for untreated surfacing gravel. The dust on the uphill and downhill curves of section D (see Figure 4.34) was worse than on the flat curve of section C (see Figure 4.35).

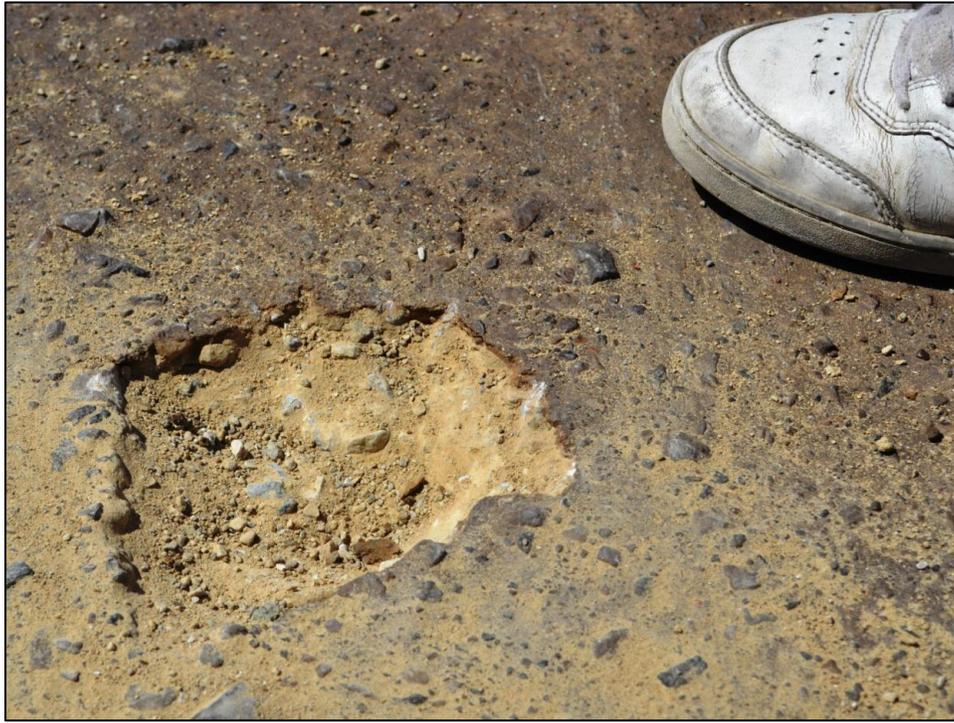
Figure 4.36 Crust formed by application of lignin and magnesium chloride dust suppressant applied to limestone crushed base on segment C of Sweetwater County's Crooks Gap Road in August 2011, three weeks after application of dust suppressant.

After treatment with the lignin sulfonate and magnesium chloride blend, a thin crust was formed (see Figure 4.36). Very little dust arose from these sections as long as this crust was intact (see Figure 4.37); it was very easy to see where the crust remained and where it had broken up (see

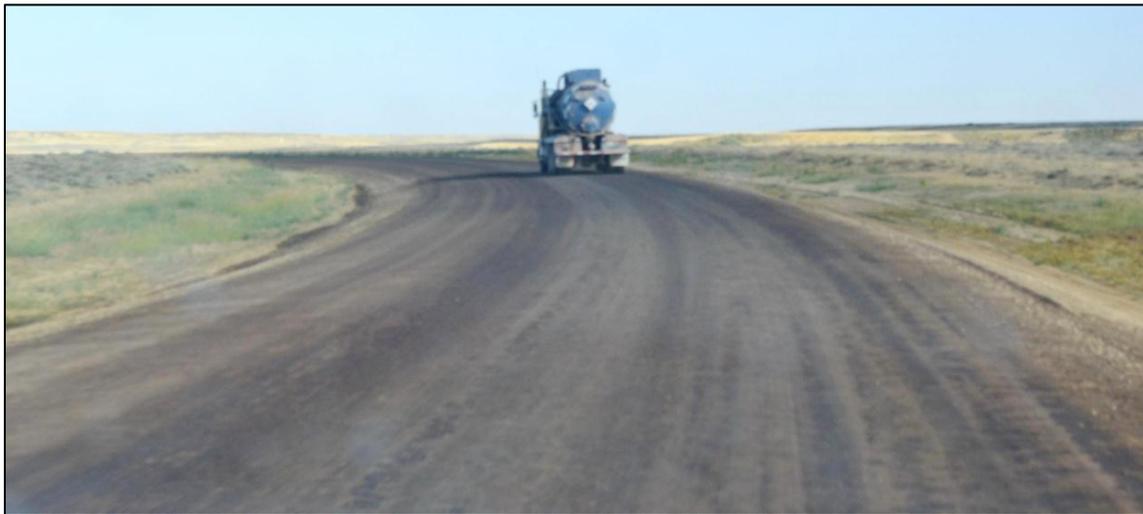
Figure 4.37 Road surface of limestone crushed base treated with lignin and magnesium chloride on uphill, curved segment D of Sweetwater County's Crooks Gap Road in August 2011, three weeks after application of dust suppressant.

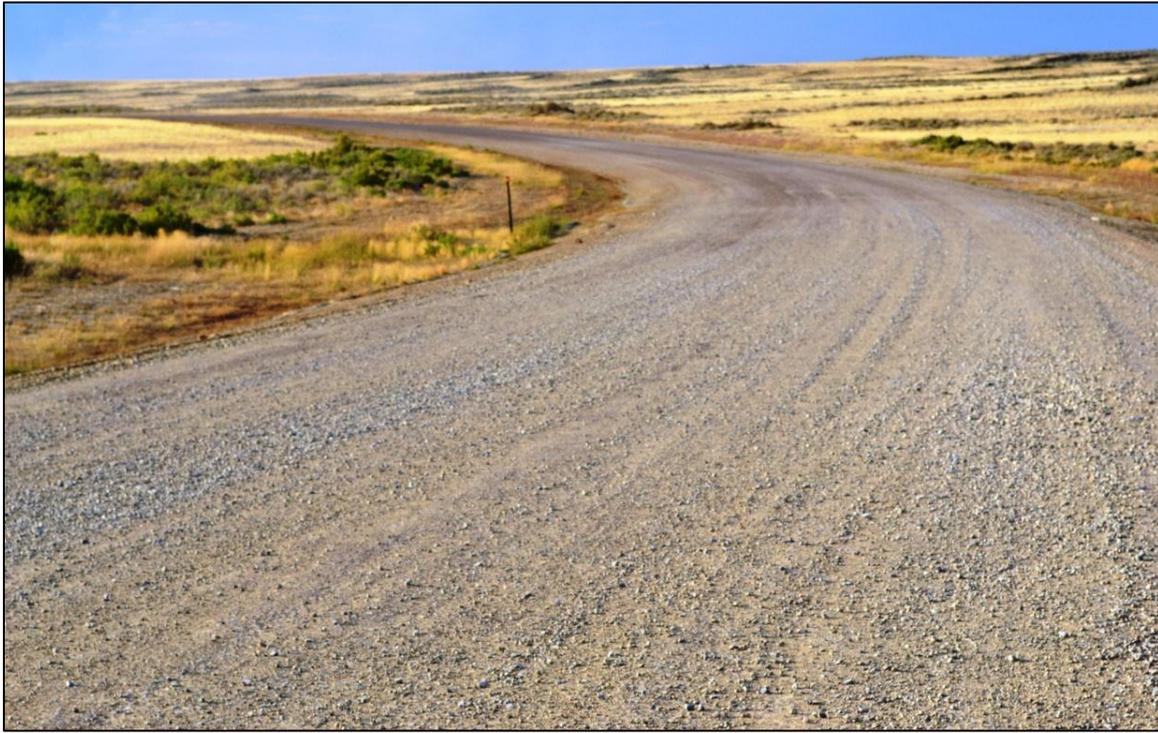
Figure 4.38 Broken up crust of limestone crushed base, foreground, and still intact crust, background, both treated with lignin and magnesium chloride on uphill, curved segment D of Sweetwater County's Crooks Gap Road in September 2011, eight weeks after application of dust suppressant.

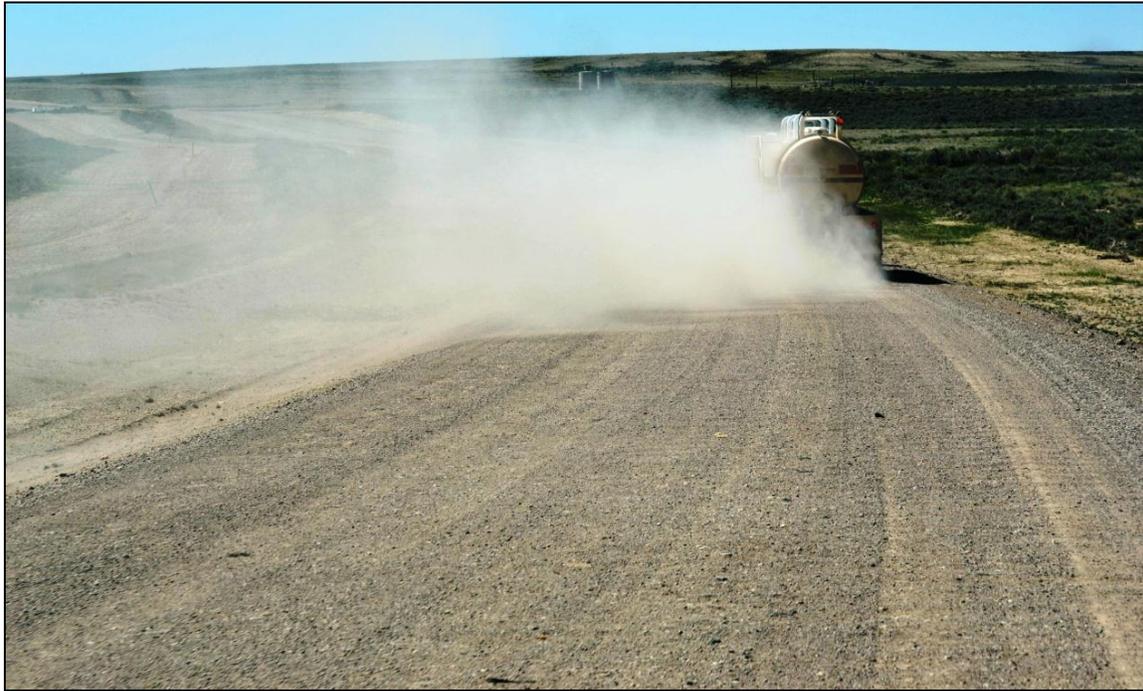
Figure 4.39 Dust from road surfaced with finer reclaimed cement-treated base on segment G of Sweetwater County's Crooks Gap Road in June 2011 before application of dust suppressant.

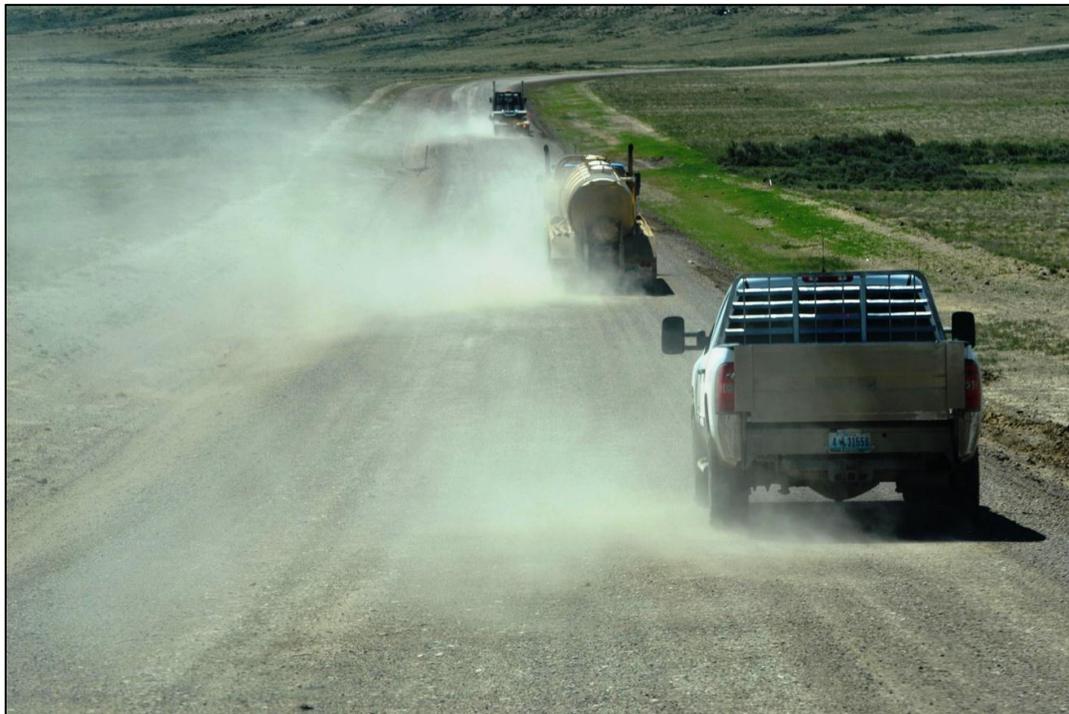
Figure 4.40 Dust from road surfaced with coarser reclaimed cement-treated base on segment E of Sweetwater County's Crooks Gap Road in June 2011 before application of dust suppressants.

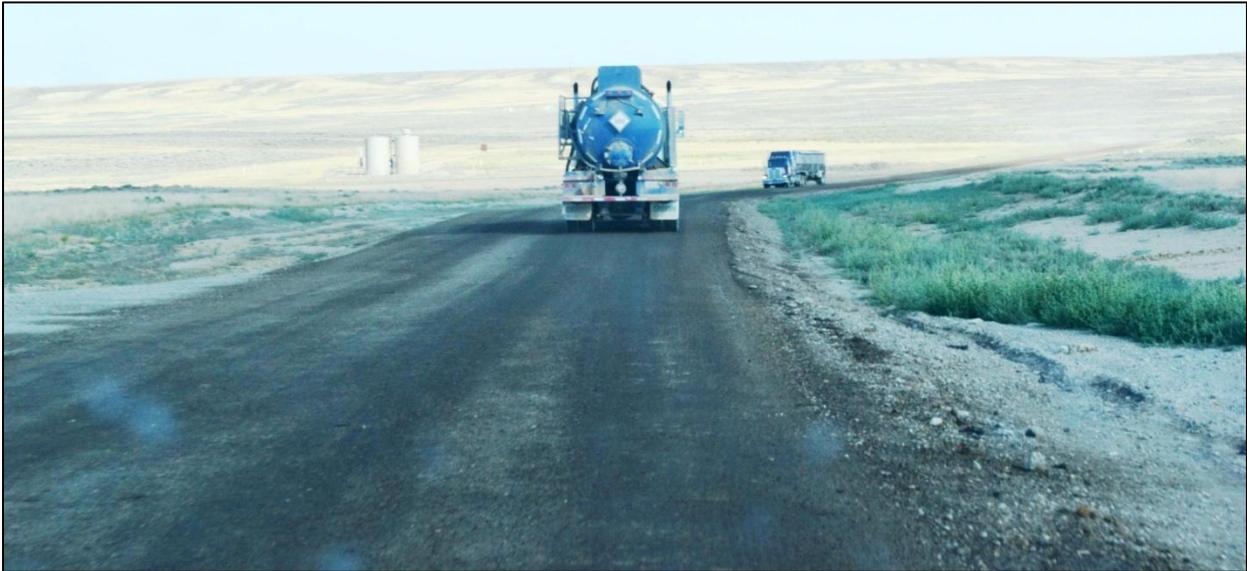
Figure 4.41 Road surface with good crust made of reclaimed cement-treated base treated with magnesium chloride on segment F of Sweetwater County's Crooks Gap Road in August 2011, three weeks after application of dust suppressant.

Shortly after treatment, there was very little dust arising from either the magnesium chloride sections (see Figures 4.41) or the magnesium chloride and polymer blend section (see Figure 4.42). However, as the crust was broken up, the dust became very thick (see Figure 4.43) on all the CTB sections.

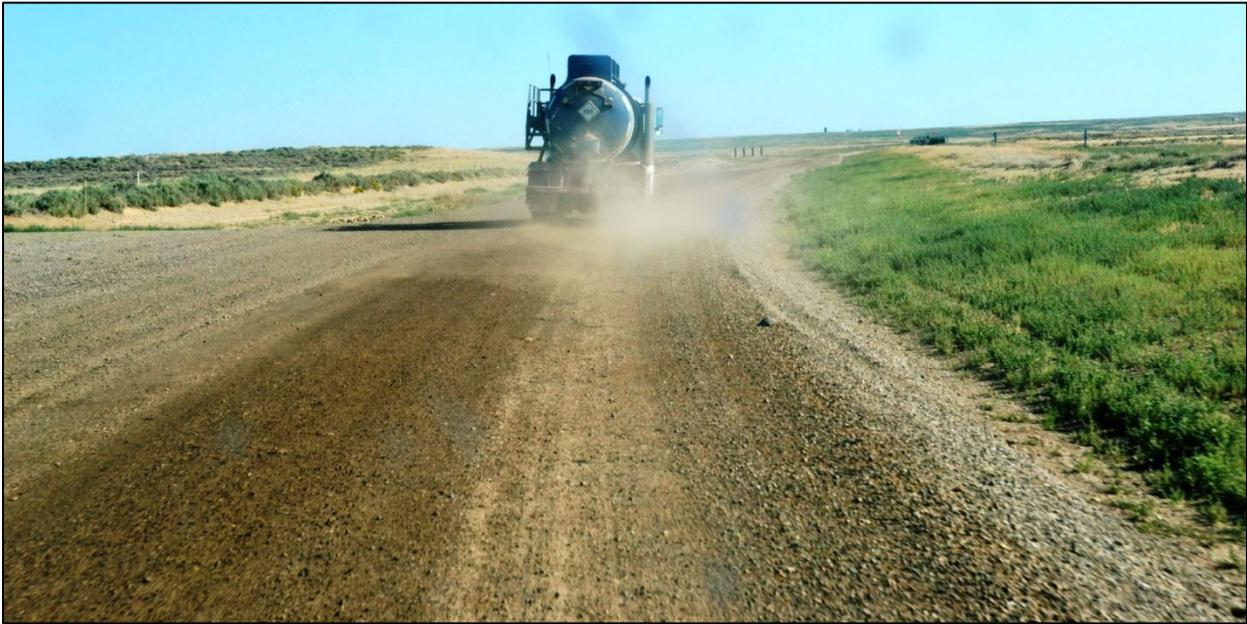
Figure 4.42 Road surface with good crust made of reclaimed cement-treated base treated with polymer and magnesium chloride on segment G of Sweetwater County's Crooks Gap Road in August 2011, three weeks after application of dust suppressant.

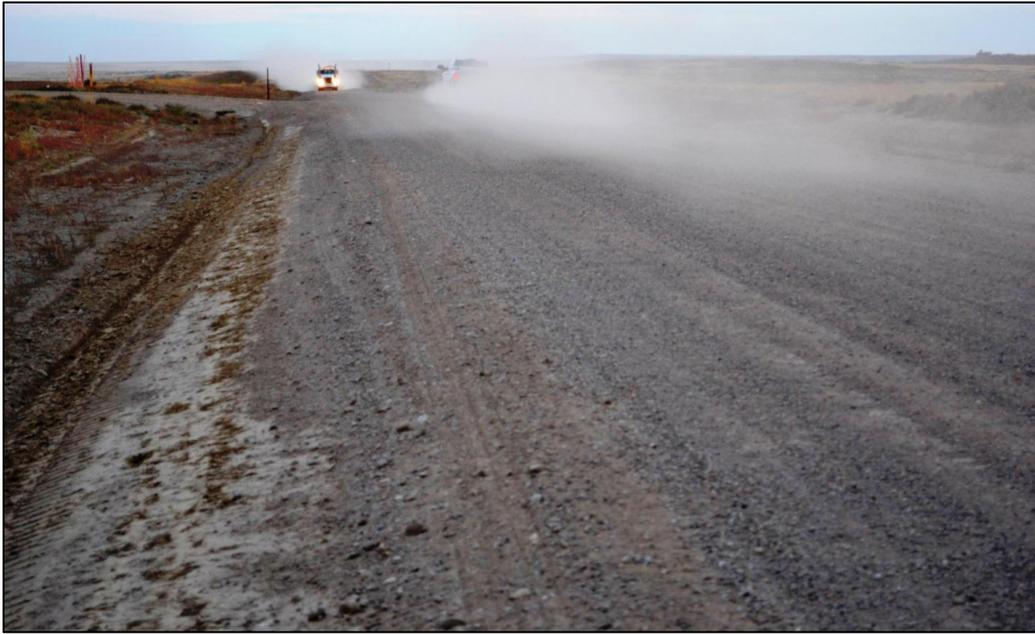
Figure 4.43 Dust from road surface made of reclaimed cement-treated base blended with existing aggregate and treated with magnesium chloride on segment J of Sweetwater County's Crooks Gap Road in September 2011, eight weeks after application of dust suppressants.

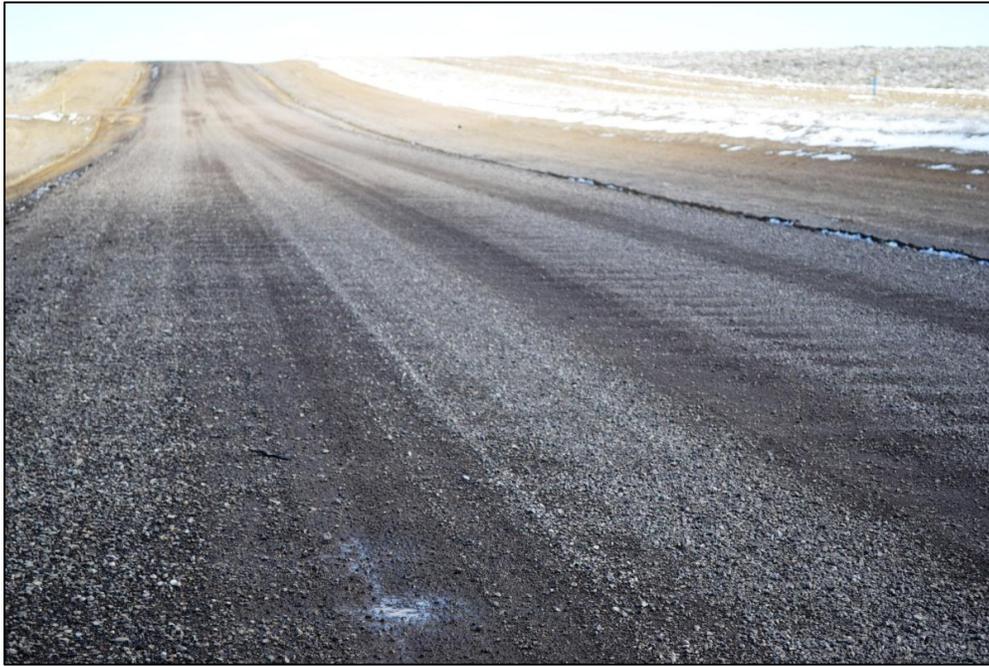
Figure 4.45 Road surface made from RAP blended with existing aggregate on segment K of Sweetwater County's Crooks Gap Road in April 2011, before application of dust suppressant.

4.5.2.4 Reclaimed Asphalt Pavement Treated with Polymer and Magnesium Chloride After initial construction, the reclaimed asphalt pavement (RAP) sections generally performed well. Early the following spring, the RAP sections had small amounts of dust and loose aggregate; the surface was in generally good condition (see Figure 4.44). Some areas had minor rutting and washboards (see Figure 4.45), and occasionally considerable loose aggregate (see Figure 4.46).

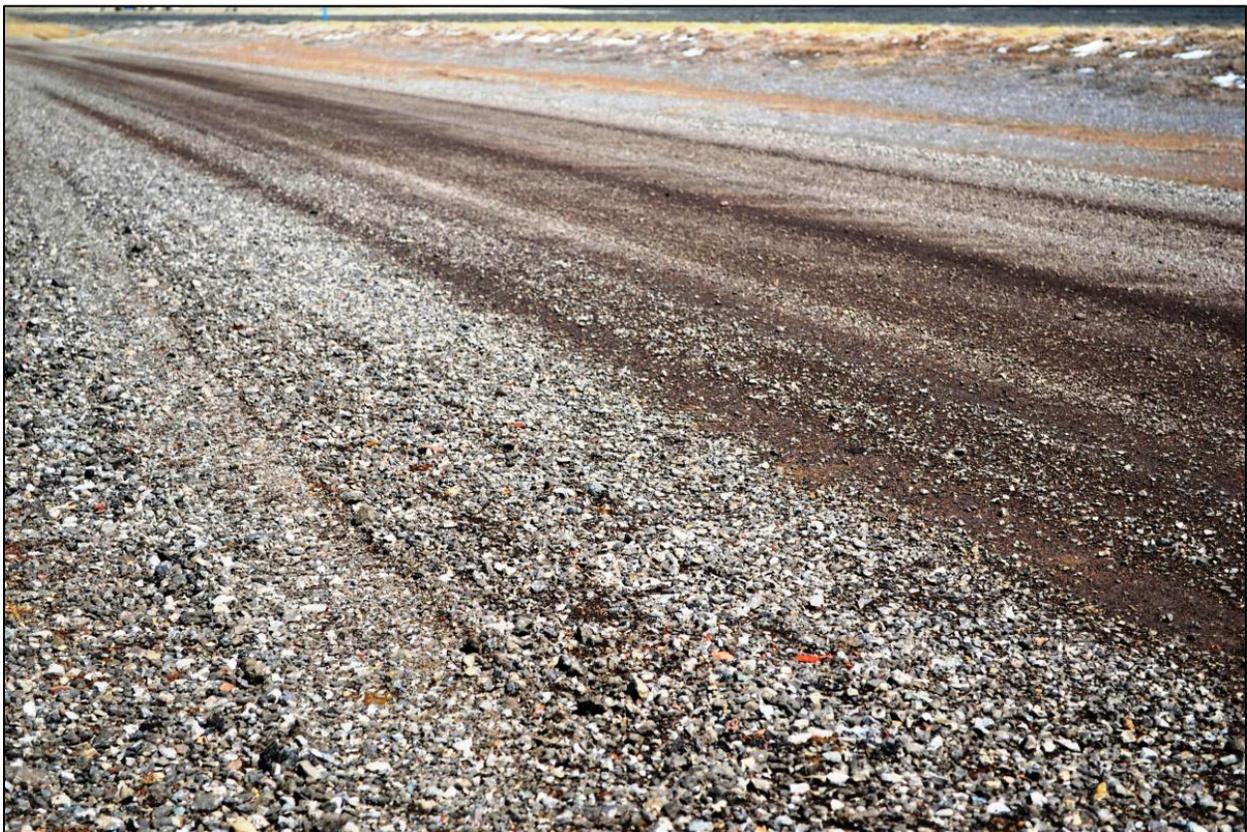
Figure 4.46 Road surface made from RAP blended with existing aggregate on segment Q of Sweetwater County's Crooks Gap Road in April 2011 without dust suppression agents.

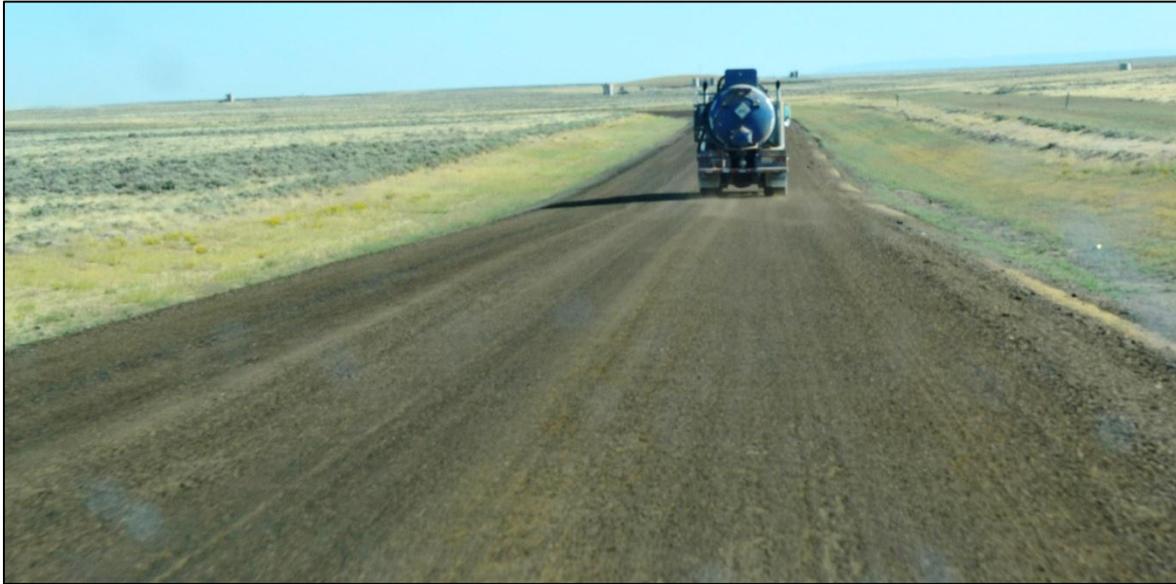
Figure 4.47 Road surface made from RAP blended with existing aggregate treated with magnesium chloride and polymer on segment M of Sweetwater County's Crooks Gap Road in August 2011, three weeks after application of dust suppressant.

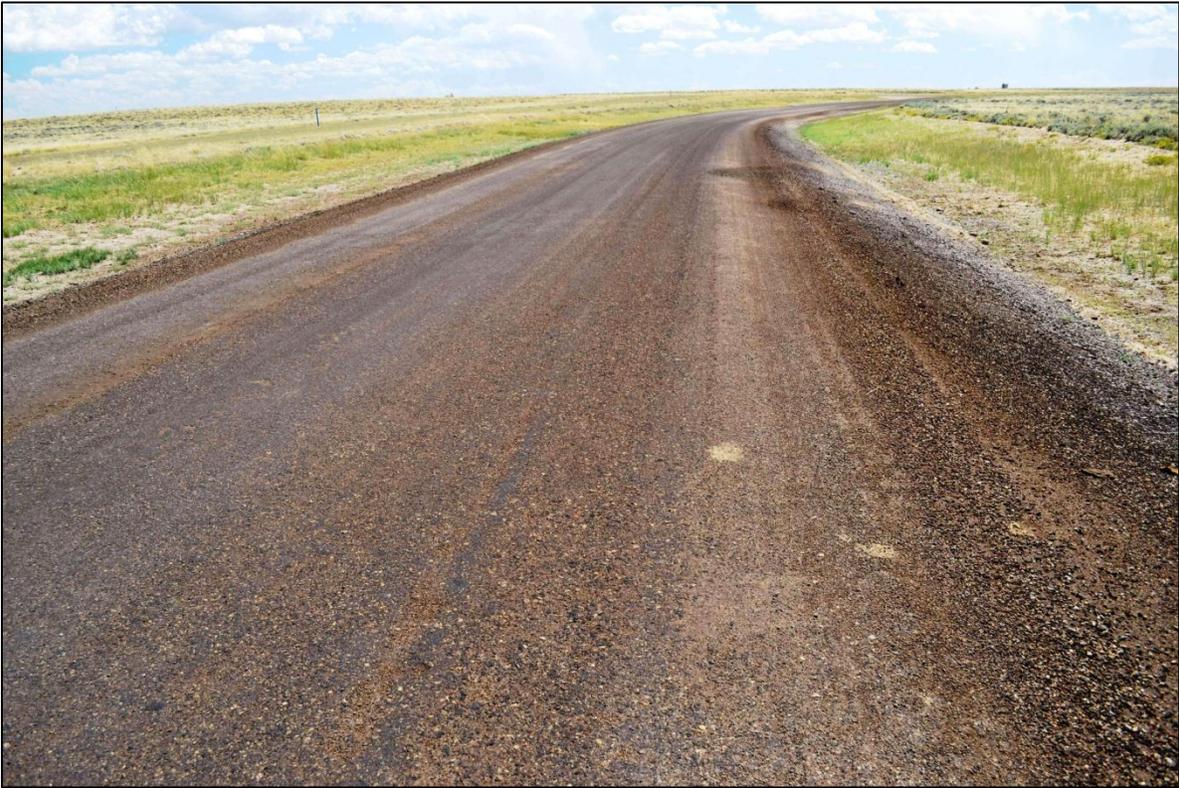
Figure 4.48 Road surface made from RAP blended with existing aggregate and treated with magnesium chloride on segment of Sweetwater County's Crooks Gap Road in August 2011, three weeks after application of dust suppressant.

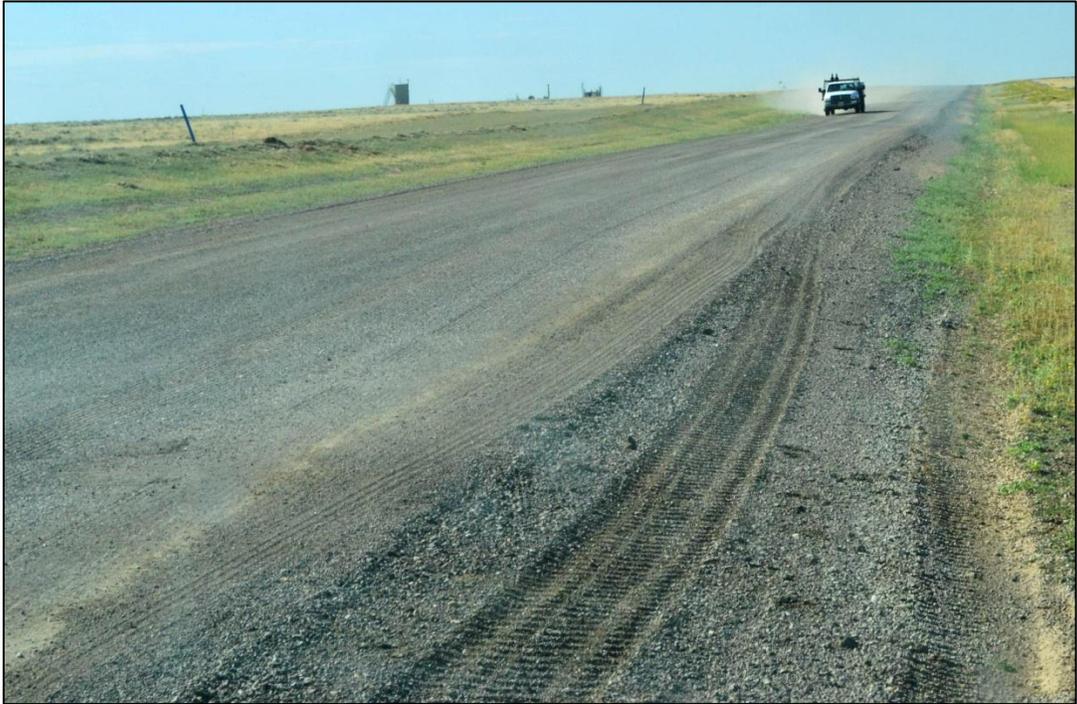
Figure 4.49 Road surface made from RAP blended with existing aggregate on segment P of Sweetwater County's Crooks Gap Road in August 2011.

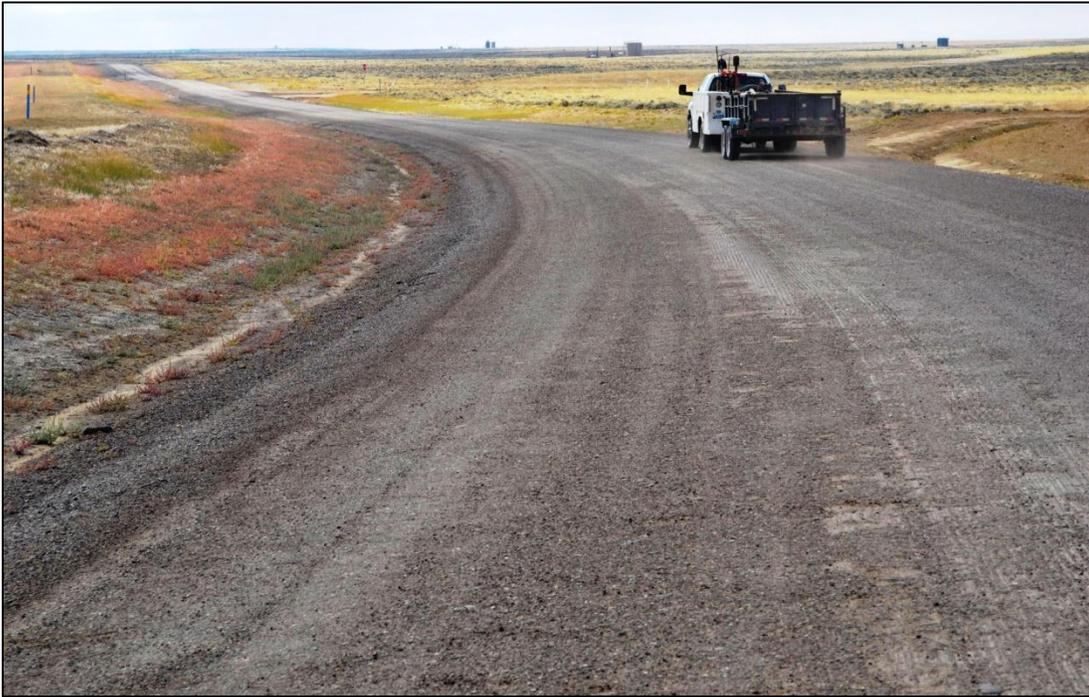
Figure 4.50 Road surface made with RAP blended with existing aggregate and treated with magnesium chloride on segment N of Sweetwater County's Crooks Gap Road in September 2011, eight weeks after application of dust suppressant.

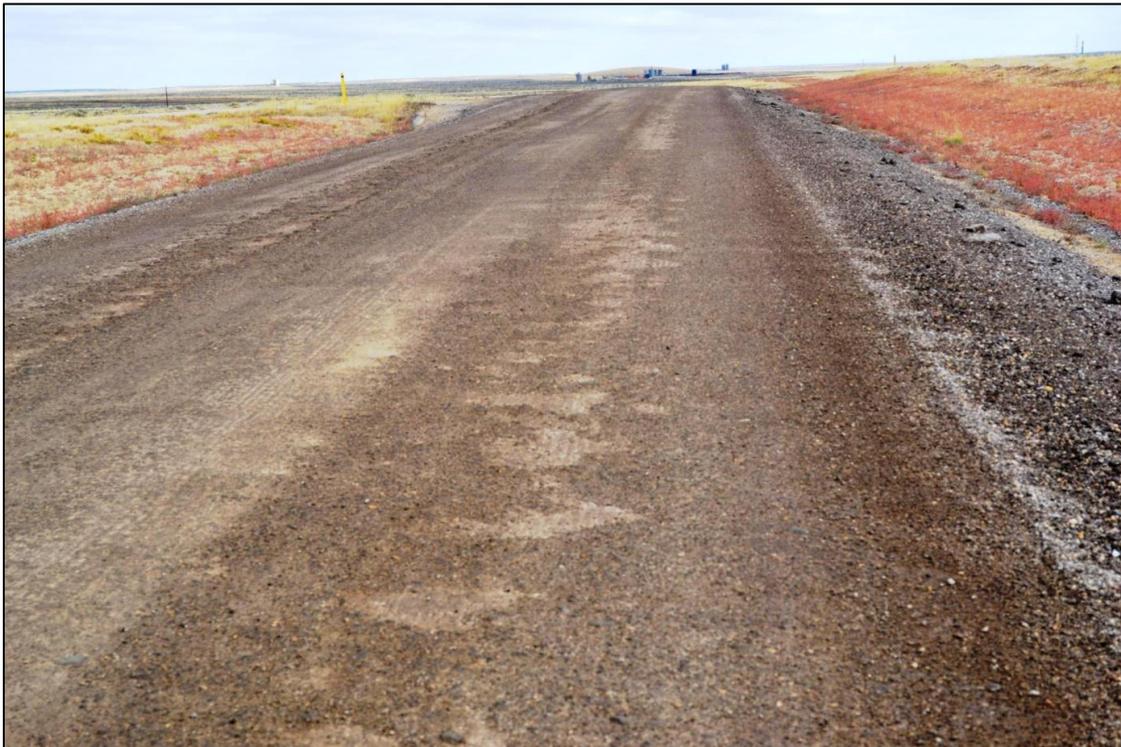
Figure 4.51 Road surface made with RAP blended with existing aggregate and treated with magnesium chloride and polymer on segment L of Sweetwater County's Crooks Gap Road in September 2011, eight weeks after application of dust suppressant.

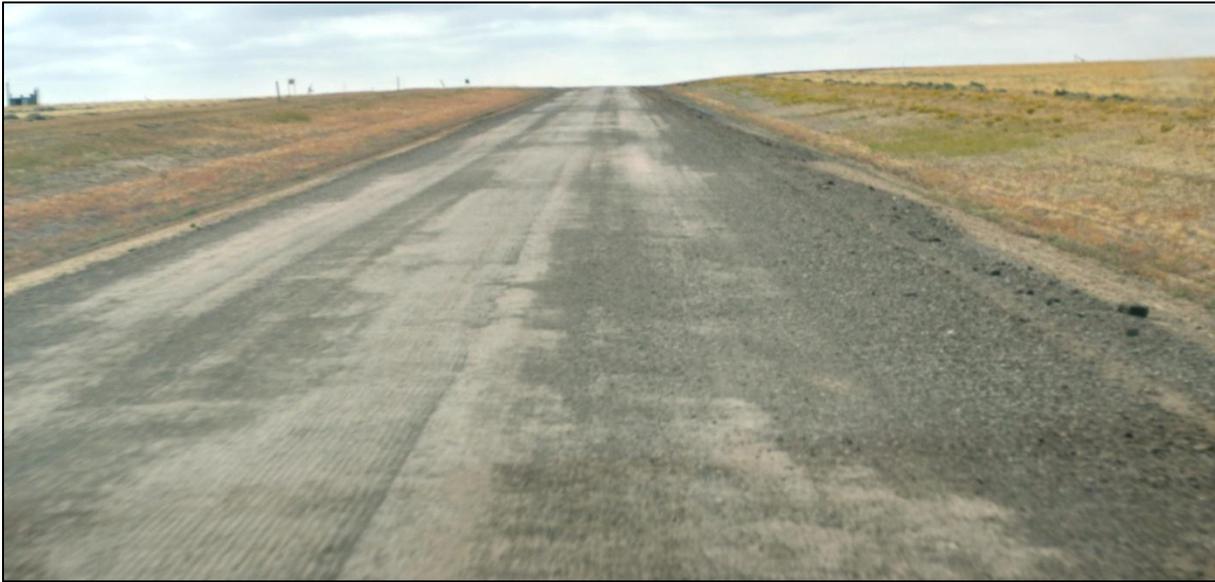
Figure 4.52 Road surface made with RAP blended with existing aggregate on segment P of Sweetwater County's Crooks Gap Road in September 2011.
