FHWA-WY-11/03F

PERFORMANCE OF RECLAIMED ASPHALT PAVEMENT ON UNPAVED ROADS

Department of Civil and Architectural Engineering
University of Wyoming
1000 East University Avenue, Department 3295
Laramie, Wyoming

January 2012

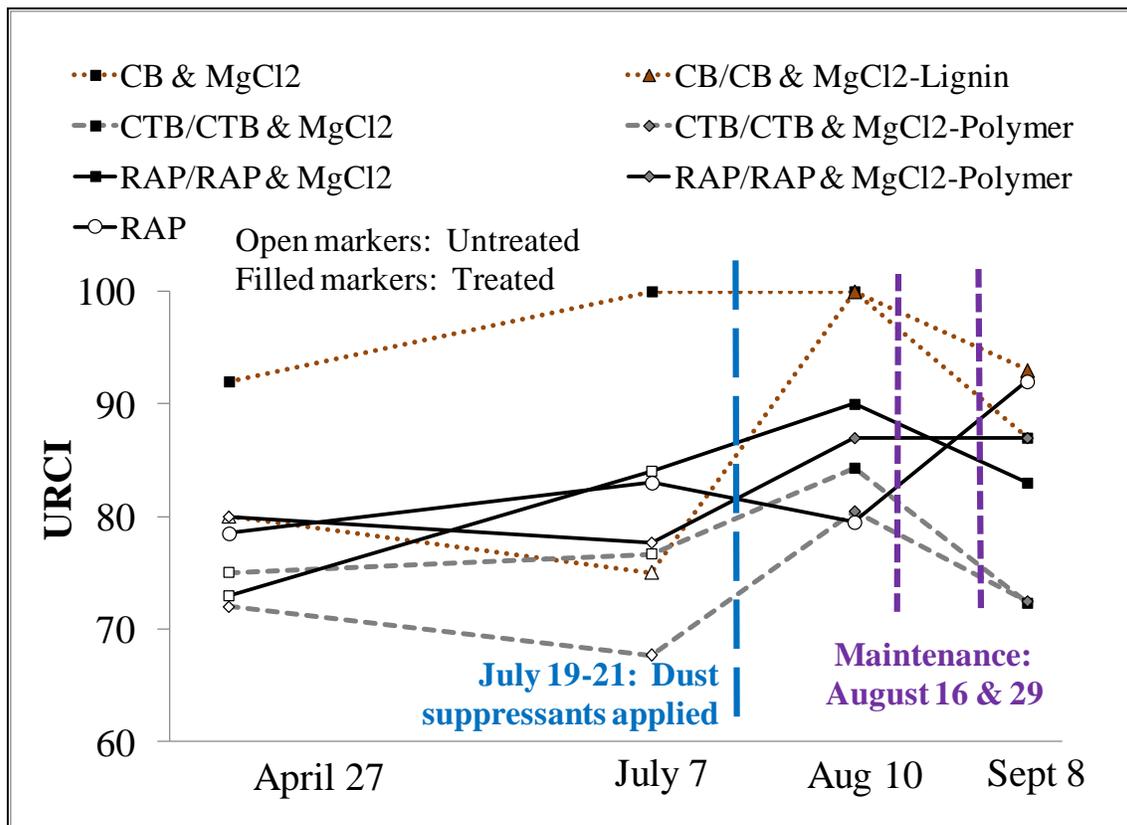
Figure 4.53 Average unsurfaced road condition indexes (URCI) for test segments on Sweetwater County's Crooks Gap Road in 2011.

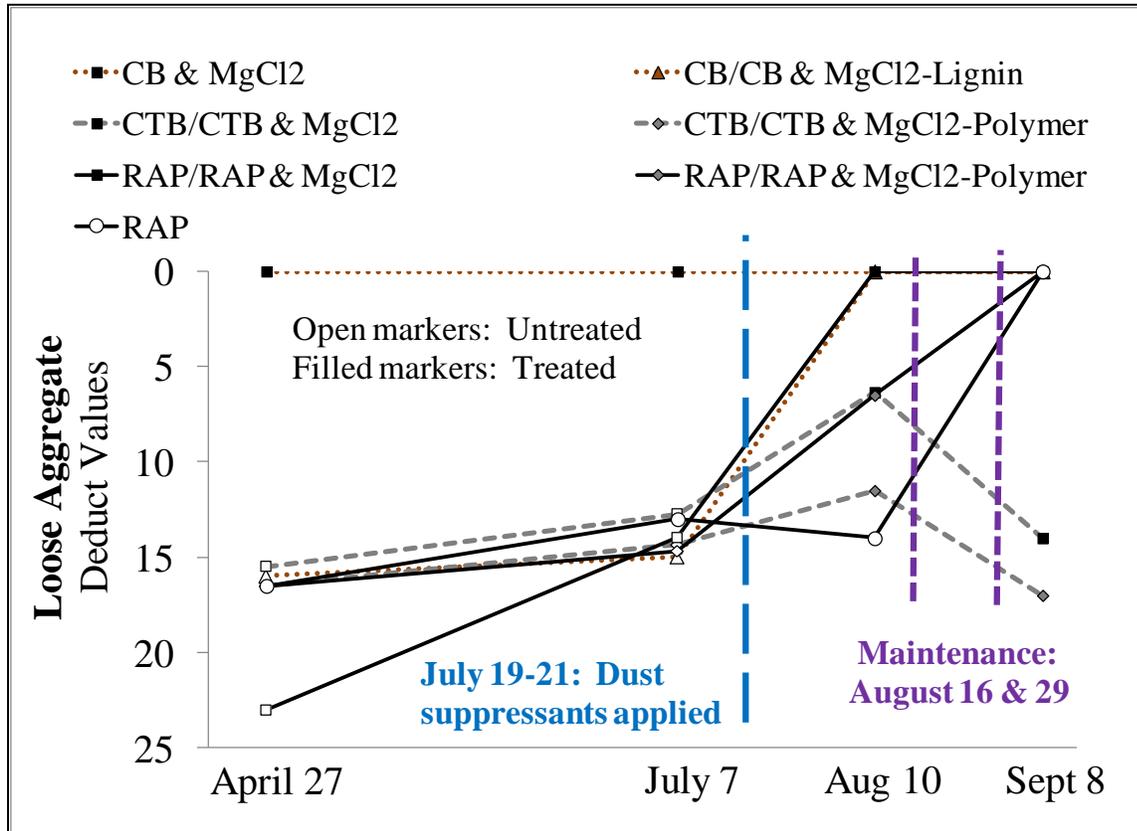
Figure 4.54 Average loose aggregate deduct values for test segments on Sweetwater County's Crooks Gap Road in 2011.

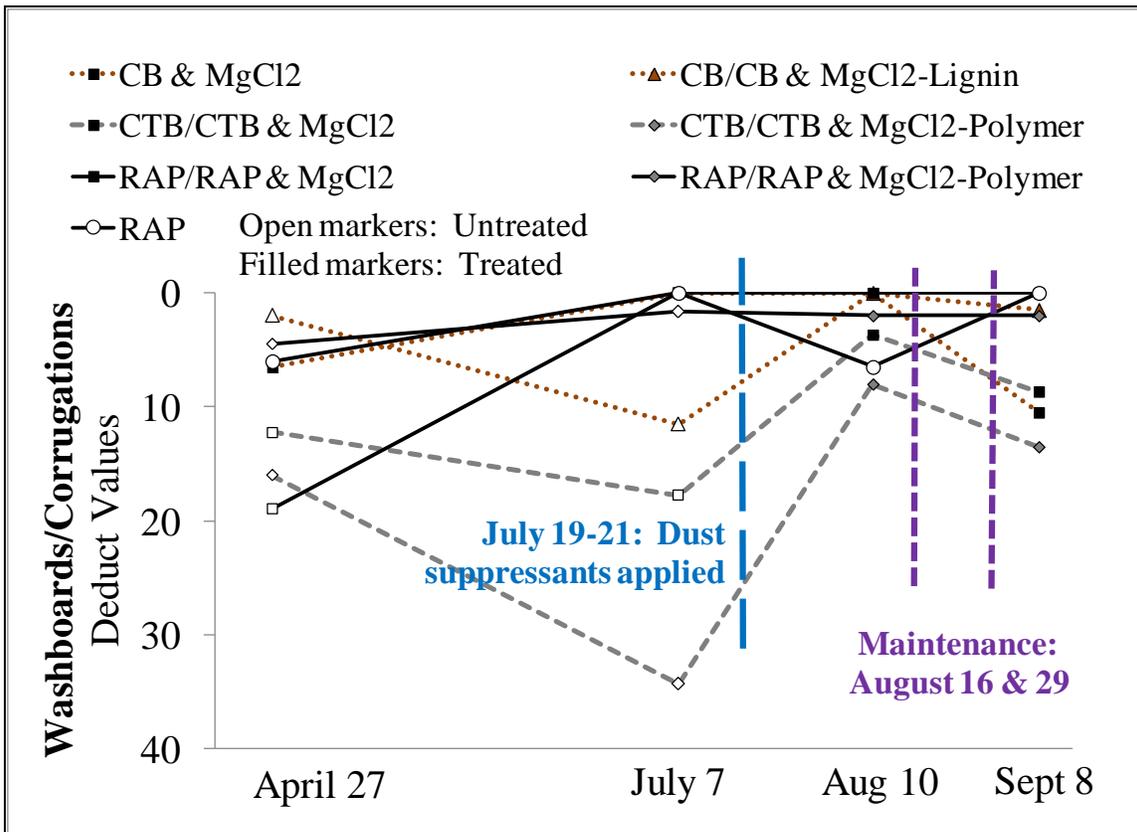
Figure 4.55 Average washboards/corrugations deduct values for test segments on Sweetwater County's Crooks Gap Road in 2011.

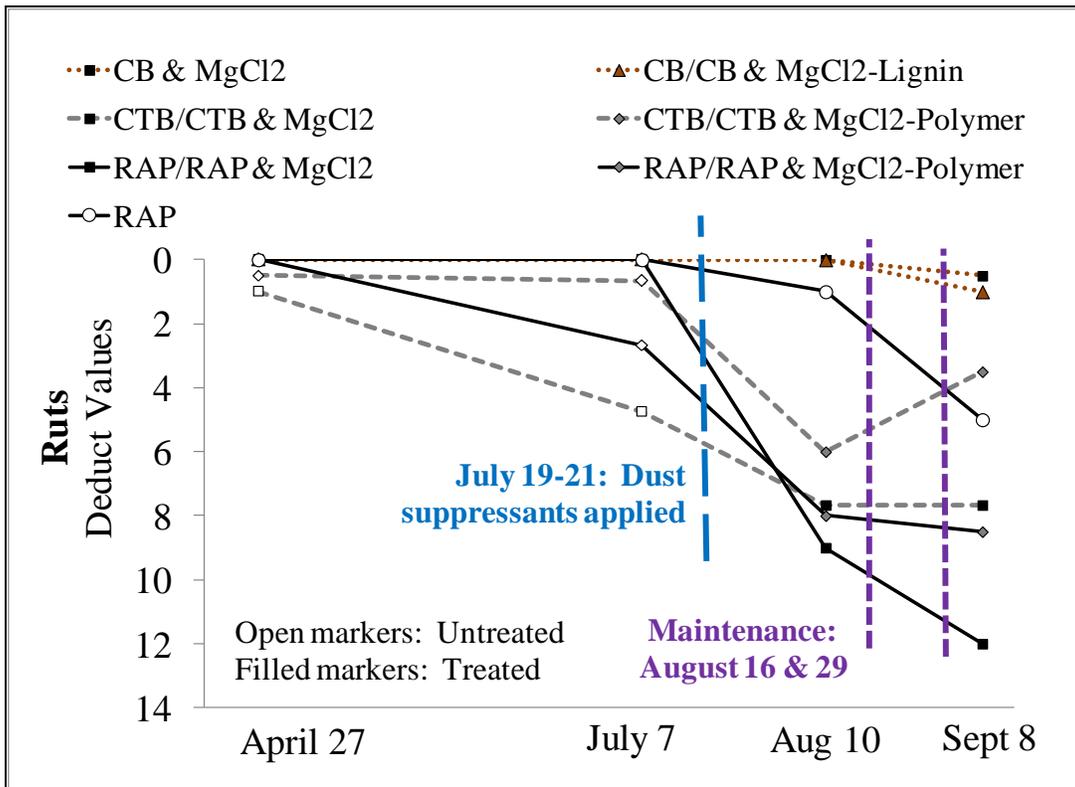
Figure 4.56 Average ruts deduct values for test segments on Sweetwater County's Crooks Gap Road in 2011.

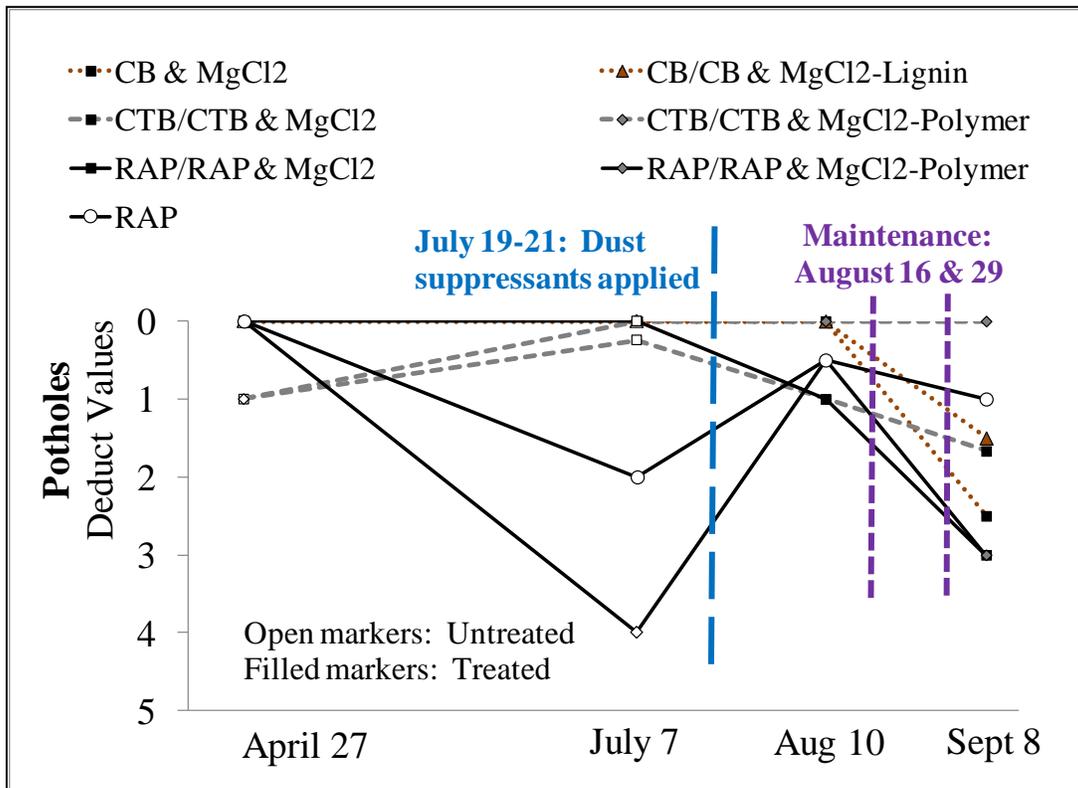
Figure 4.57 Average potholes deduct values for test segments on Sweetwater County's Crooks Gap Road in 2011.

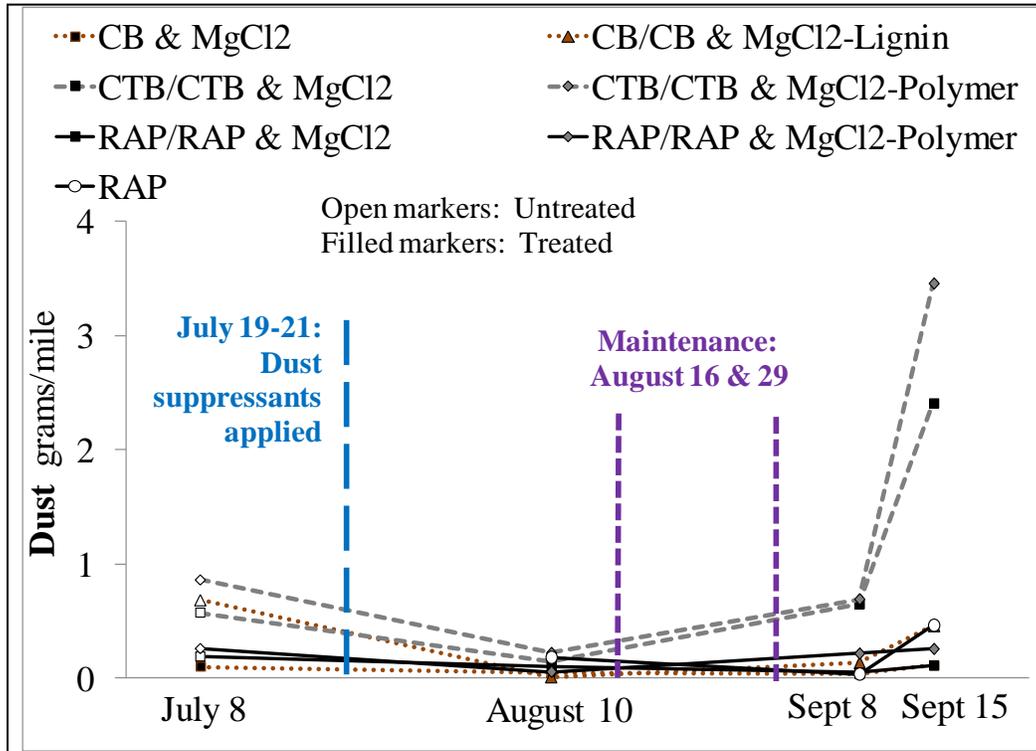
Figure 4.58 Average dust measured with the dustometer on test segments on Sweetwater County's Crooks Gap Road in 2011, full scale.

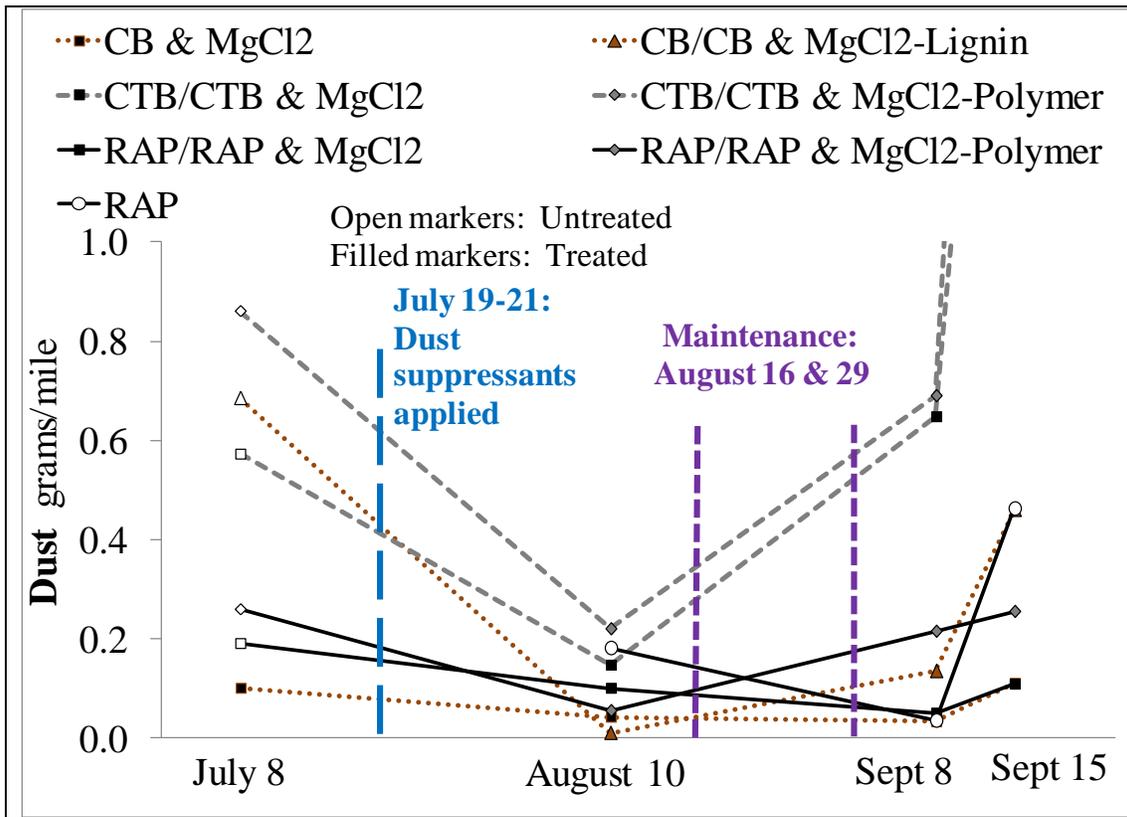
Figure 4.59 Average dust measured with the dustometer on test segments on Sweetwater County's Crooks Gap Road in 2011, partial scale.
