# FINAL REPORT

## FHWA-WY-11/02F

# EVALUATION OF MULE DEER CROSSING STRUCTURES IN NUGGET CANYON, WYOMING

September 2011

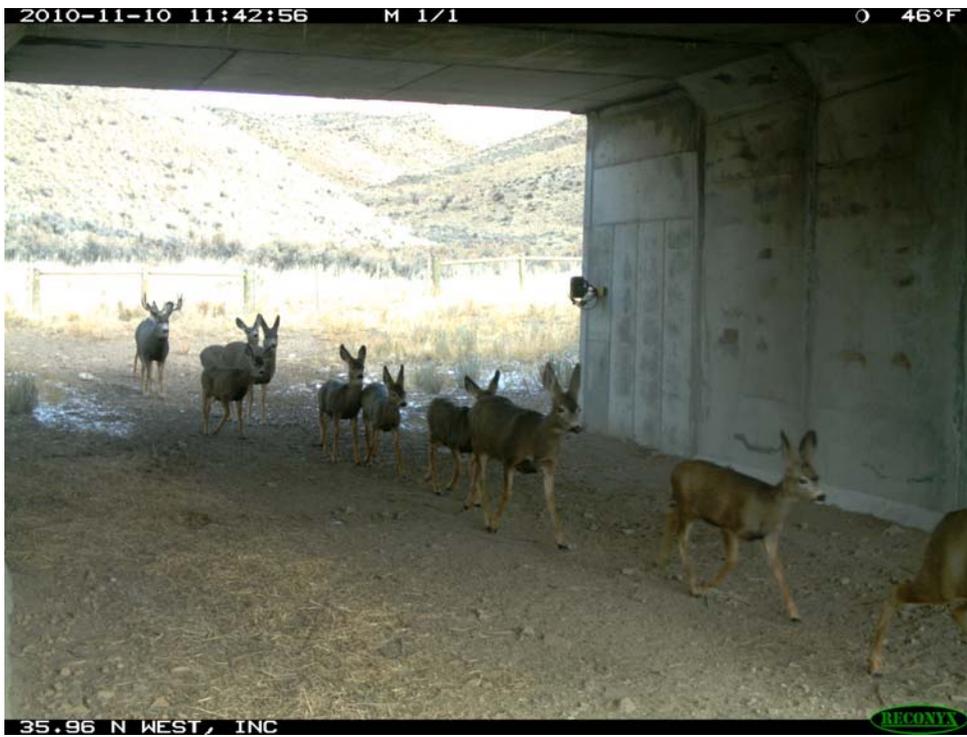
Plate 2. The underpass at milepost 35.96 was used by 14,012 mule deer and recorded 28% of all deer crossings.

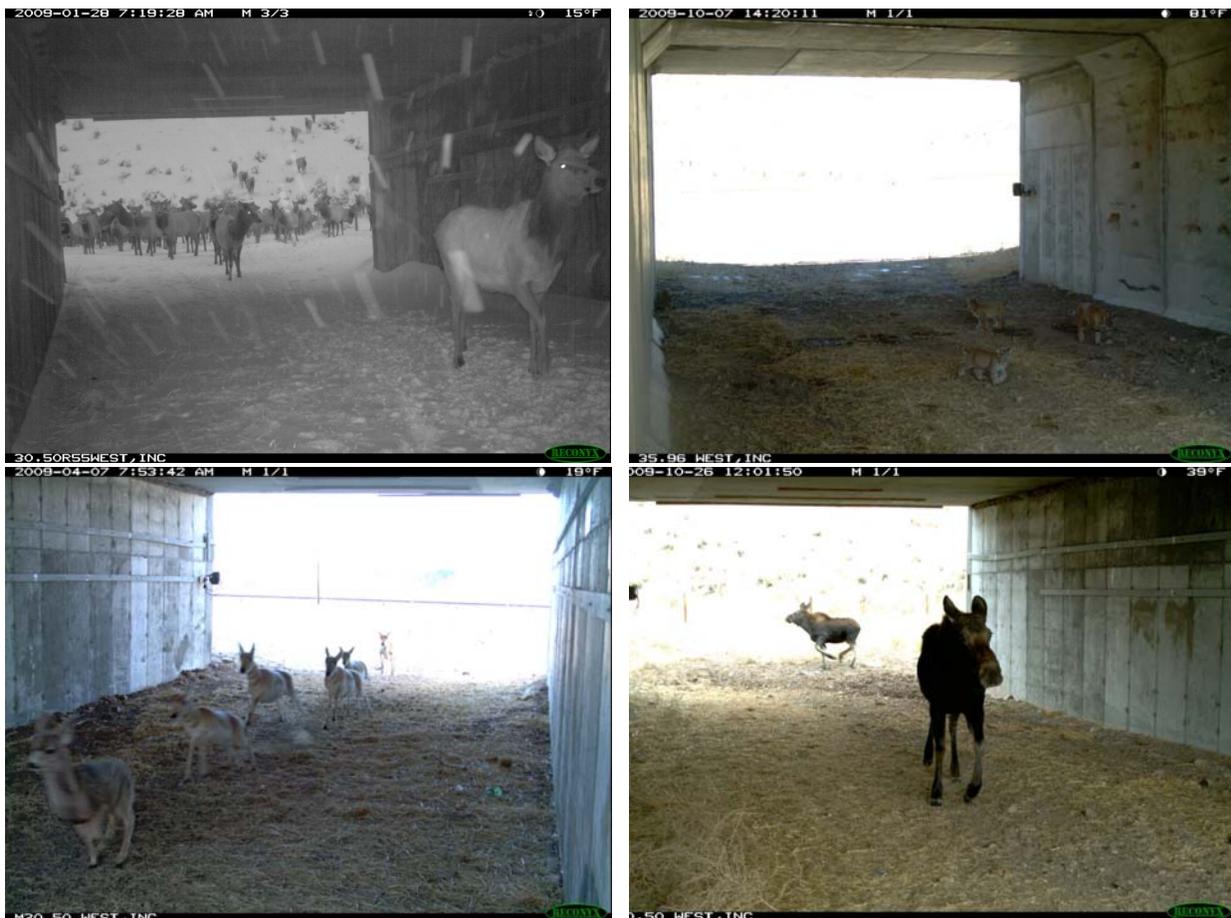
Plate 3. Photos of other wildlife, including elk at milepost 30.50 (top left), bobcats at milepost 35.96 (top right), mule deer and pronghorn at milepost 30.50 (bottom left), and moose at milepost 30.50 (bottom right).

Between December 2008 and May 2011, we recorded 1,953 elk (*Cervus elaphus*), 201 pronghorn (*Antilocapra americana*), 13 coyotes (*Canus latrans*), 77 bobcats (*Lynx rufus*), 9 badgers (*Taxidea taxus*), 13 moose (*Alces alces*), 3 raccoon (*Procyon lotor*), and 1 cougar (*Puma concolor*) move through the underpasses (Table 2; Plate 3). Most elk, moose, and pronghorn use occurred at the milepost 30.50 underpass.

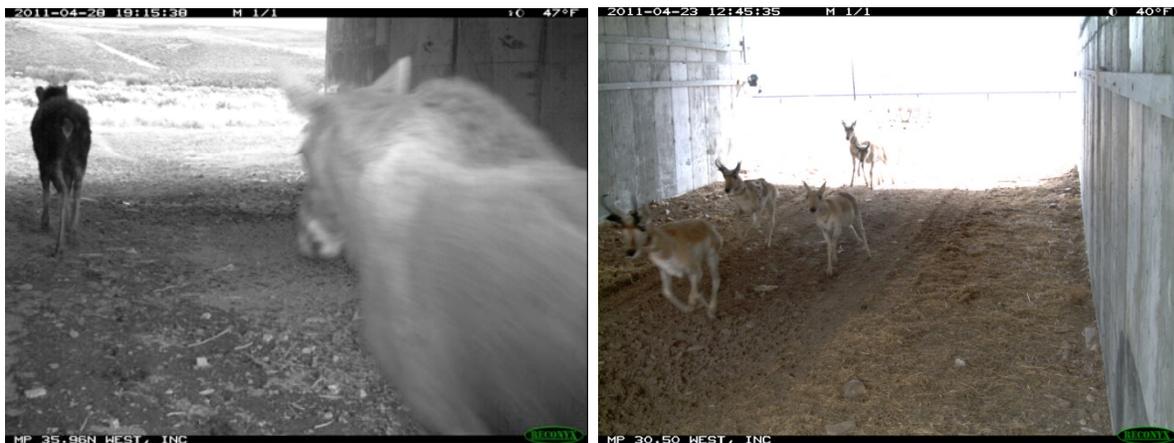
Plate 4. Moose (left) and pronghorn (right) move through underpasses at milepost 35.96 and 30.50, respectively.

The benefits of reduced vehicle mortality and safe passage across U.S. 30 were not limited to mule deer. We documented a variety of other animals that utilized the underpasses. Of particular interest was use by pronghorn, moose, and elk. Although pronghorn were documented using the underpass at milepost 30.50 shortly after construction (Plumb et al. 2003), underpass use by all three species is considered relatively rare (Foreman et al. 2003). Plate 4 includes additional photos of moose and pronghorn moving through the underpasses. A variety of small mammals (e.g., badger, raccoon) and carnivores (e.g., coyote, bobcat, cougar) also utilized the underpasses.

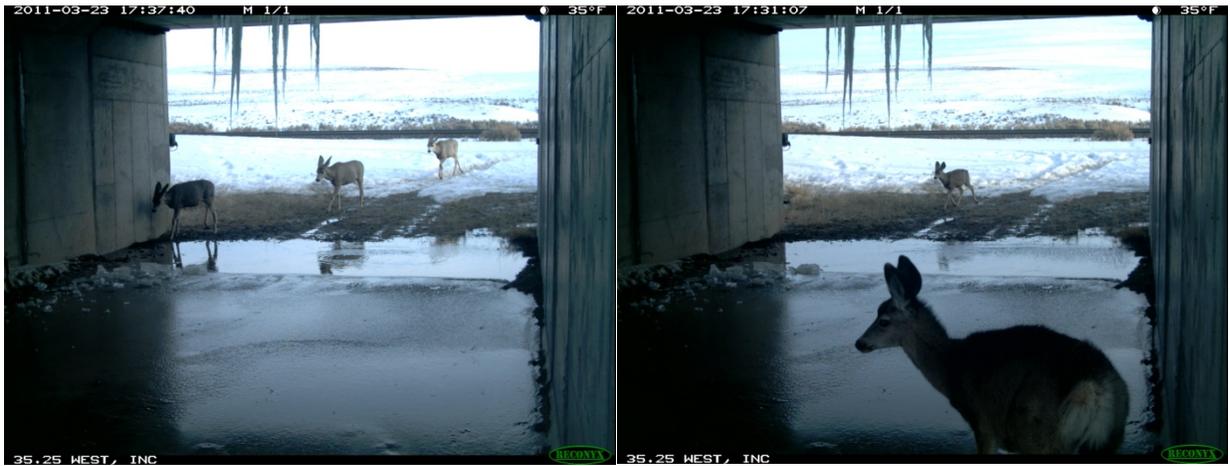
Plate 5. Mule deer attempt to walk around water and ice accumulation at milepost 35.25 underpass.

- Our results and others (e.g., Gagnon et al. 2011) illustrate the benefits of monitoring underpasses and evaluating their effectiveness. Aside from documenting animal use, the camera monitoring identified underpasses with potential snow drifting and drainage problems. For example, snow drifts and water accumulation were common at mileposts 35.25 and 40.62 (Plates 5 & 6). For cases where snow drifting is a problem, the effectiveness of the underpass could likely be improved by snow fencing or excavation work that minimizes drifting and improves drainage.

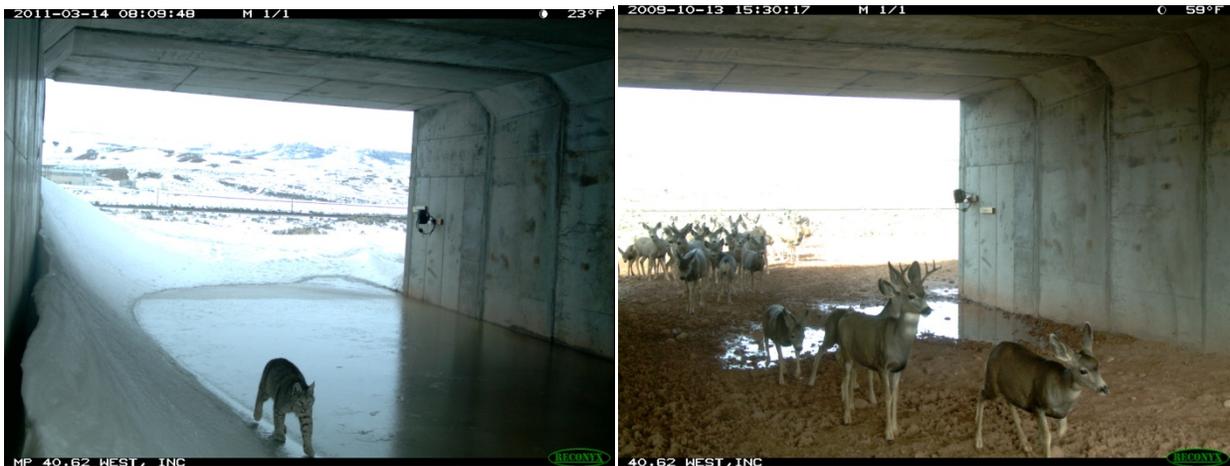
Plate 6. Bobcat (left) and mule deer (right) walk around water accumulation at milepost 40.62 underpass.
