# Verification of Rut Depth Collected with the INO Laser Rut Measurement System (LRMS)

Student Study  
Report No. FHWA/OH-2011/18  
State Job No. 134515

October 2011

Ohio Research Institute for  
Transportation and the Environment

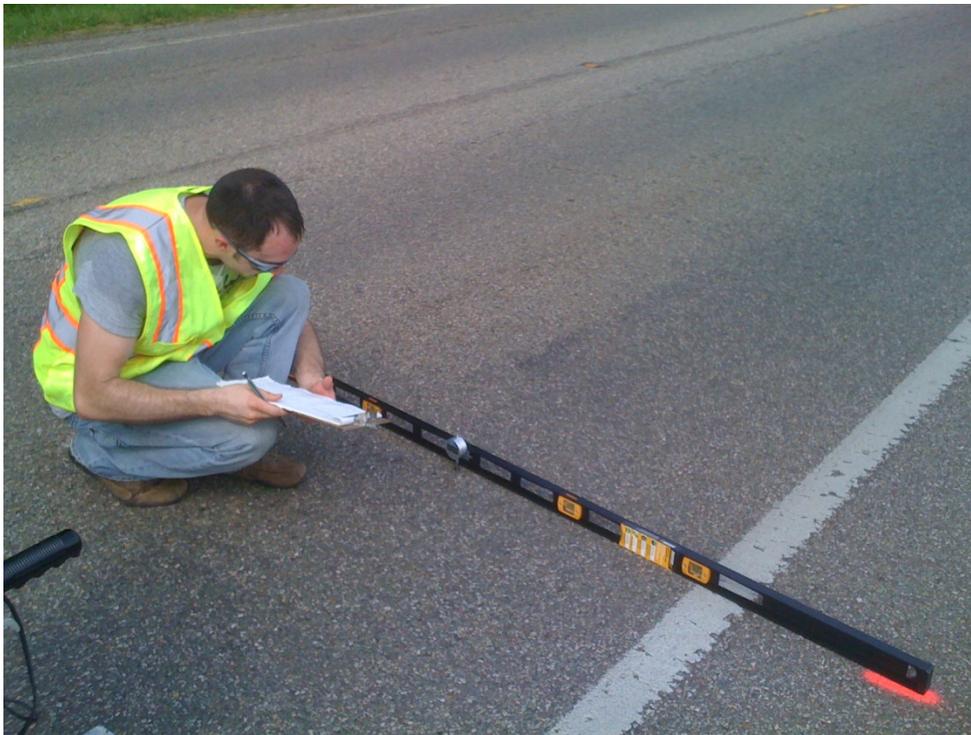
Figure 1. Measurement of rut using a straight edge and electronic dial gage

The most traditional technique for measuring rut depth is the straightedge method. This requires one to lay a straightedge across the wheel path perpendicular to the direction of traffic. The straightedge should contact the road at the two highest points on either side of the wheel path. The ASTM specification for this method requires that the straightedge be at least 1.73m (5.67ft) in length to ensure that it spans the entire width of the rut (ASTM E 1703/E 1703M, 1995). Using a gauge, several measurements along the length of the straightedge should be taken to find the deepest point in the rut. This method, while simple and accurate if proper technique is used, can be time consuming and difficult to perform especially with limited traffic control.

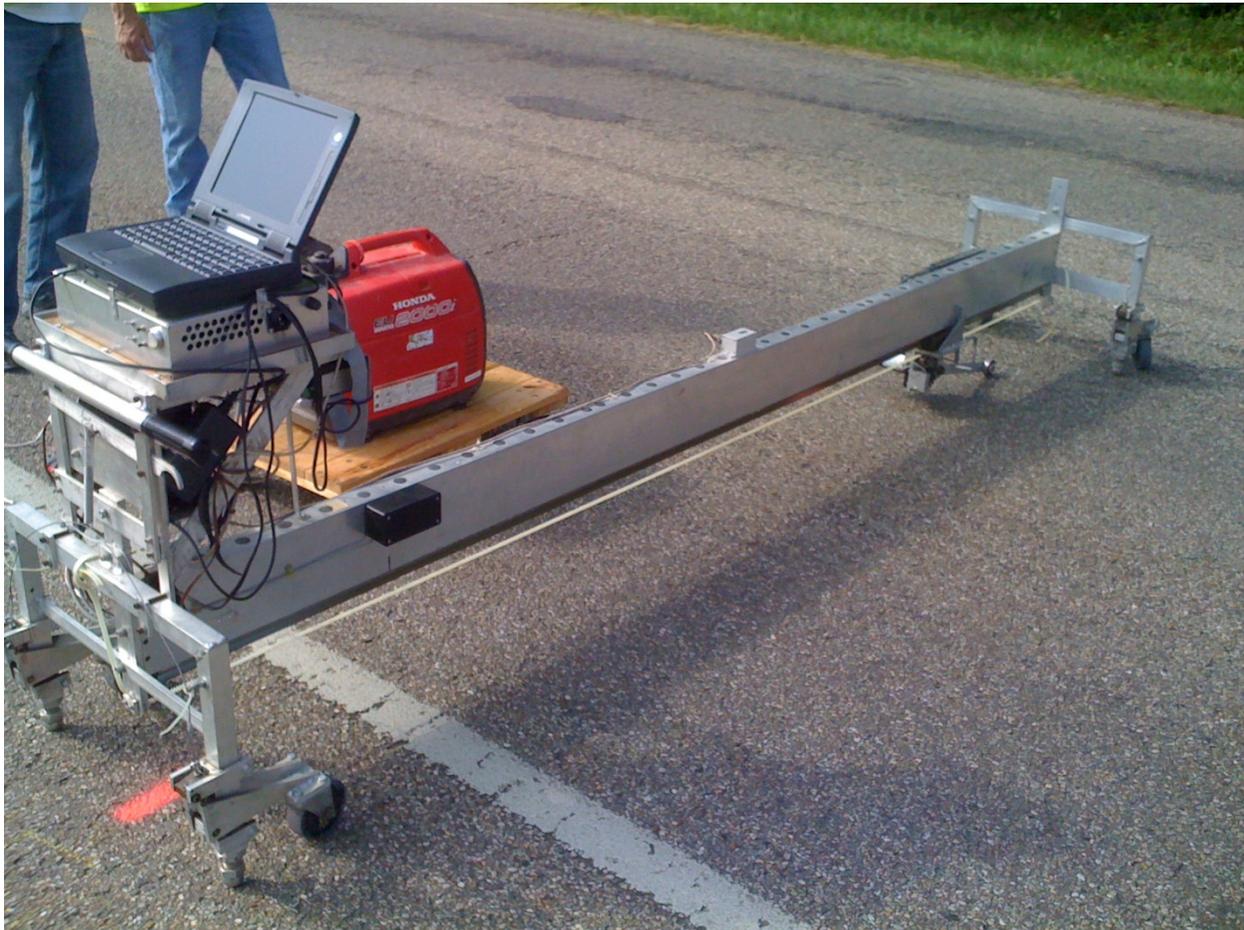
**Figure 2. ORITE Profilometer measuring a transverse profile on SR-682**

The Ohio Research Institute for Transportation and the Environment (ORITE) designed and constructed a mechanical profilometer for measuring surface deformation at the ORITE Accelerated Pavement Loading Facility. The device creates a profile by measuring the distance between the pavement surface and an aluminum beam that serves as a guide rail. A carriage hangs below the guide rail with a 12-in (30.5-cm) arm extending down to the pavement. A 2-in (5.08 cm) diameter wheel is connected to the end of the arm that allows it to roll over the pavement surface. The carriage is driven back and forth along the rail by an electric motor. Its movement is tracked using a quadrature rotary encoder. The angle of the arm changes as the

wheel travels over the uneven pavement. This angle is measured to a precision of 0.025 degrees using an incremental rotary optical encoder. A DOS program, written specifically for the ORITE Profilometer, uses the measured change in angle to calculate the tangential displacement of the wheel at the end of the arm. A change of 0.025 degrees measured by the rotary encoder would indicate approximately 0.005 inches (0.127 mm) of movement at the end of the arm. An inclinometer mounted at the center of the beam is used to measure the slope of the beam during each profile measurement. This allows profiles to be rotated or leveled to create a more accurate model of the pavement. The inclinometer makes it possible to level each profile in a series to produce an interpolated, three-dimensional profile of a segment of roadway (Richardson, 2003).

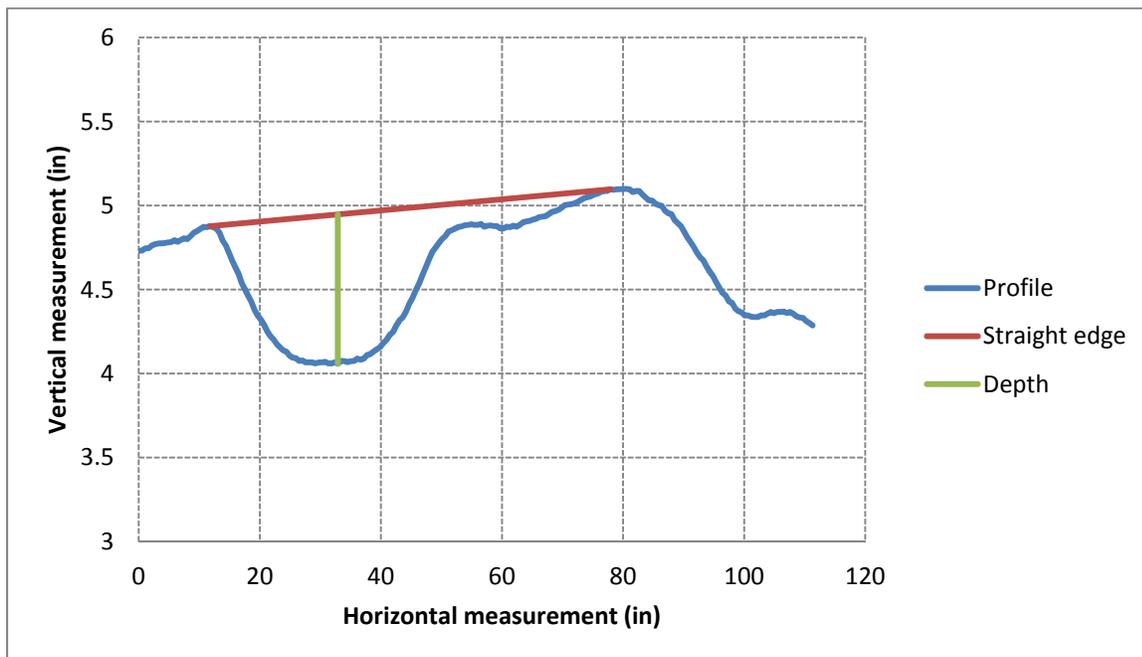
Figure 3. Typical virtual straight edge model using ORITE profilometer data from US-30 (1 in = 2.54 cm)

In order to measure the rut depth from the profilometer readings, a method for simulating a 2-m (6.56-ft) straight edge was developed using MATLAB. The MATLAB program begins at the leftmost point of the profile (the profilometer was run from right to left, which resulted in right and left being reversed) and draws a virtual line to every point within 2 m (6.56 ft). Each time a line is drawn, the depth is measured at every point in between its beginning and end. After the final line is drawn and depths are measured, the starting point is shifted one point to the right and the process of drawing lines begins again. This is repeated until the left end of the virtual straight edge is beyond the deepest part of the rut. The largest depth measured during this process is output as the rut depth for that profile. The rut width is recorded as well. This was done for each of the profiles collected in both wheel paths. An example of the resulting virtual straight edge created by the program is shown in Figure 3. Just like in the case of an actual straight edge measurement, the maximum possible depth is found when the virtual straight edge is tangent to the plotted curve at two points near the peaks on either side of the rut.

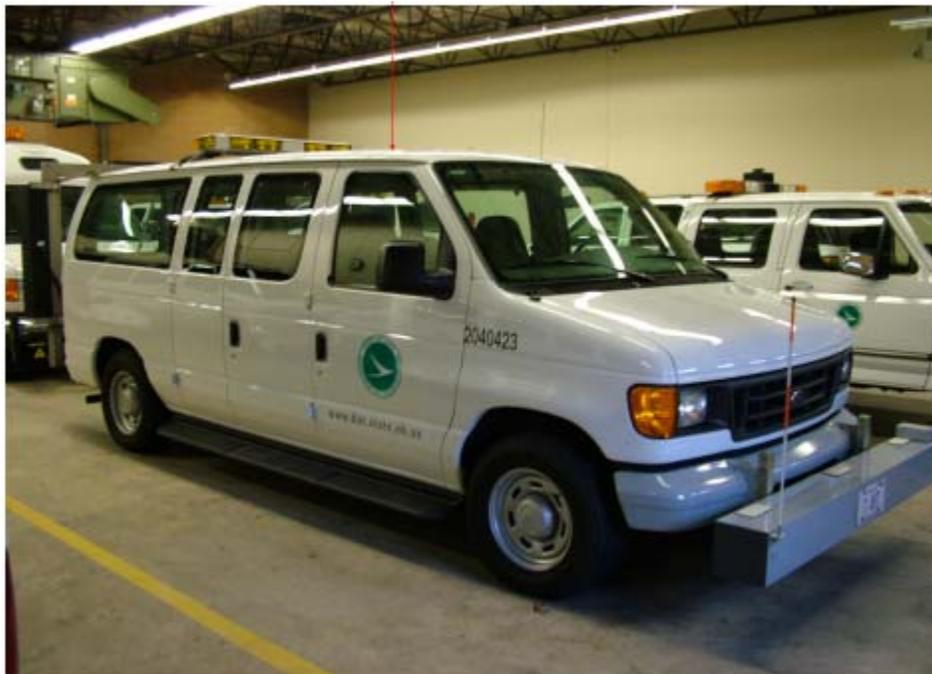
Figure 4. Front view of ODOT profiler vehicle

The INO laser rut measurement system used by ODOT utilizes two laser profilers mounted to the rear of a vehicle, as shown in Figure 4. Each profiler provides part of the overall field of view. The profilers use high-power pulsed infrared laser line projectors and specially designed cameras to create a transverse profile of the roadway surface. The LRMS system reads the vehicle odometer to determine the location of each profile reading and to ensure that measurements are taken at the user-specified intervals. The system is controlled from within the vehicle by a driver or passenger. The rut measurement data are analyzed and can be viewed in real time. In this study, the program RSPWin v2.6.8 from Dynatest was used. A list of specifications for the LRMS taken from the Pavemetrics website (<http://www.pavemetrics.com/en/lrms.html>) is shown below:

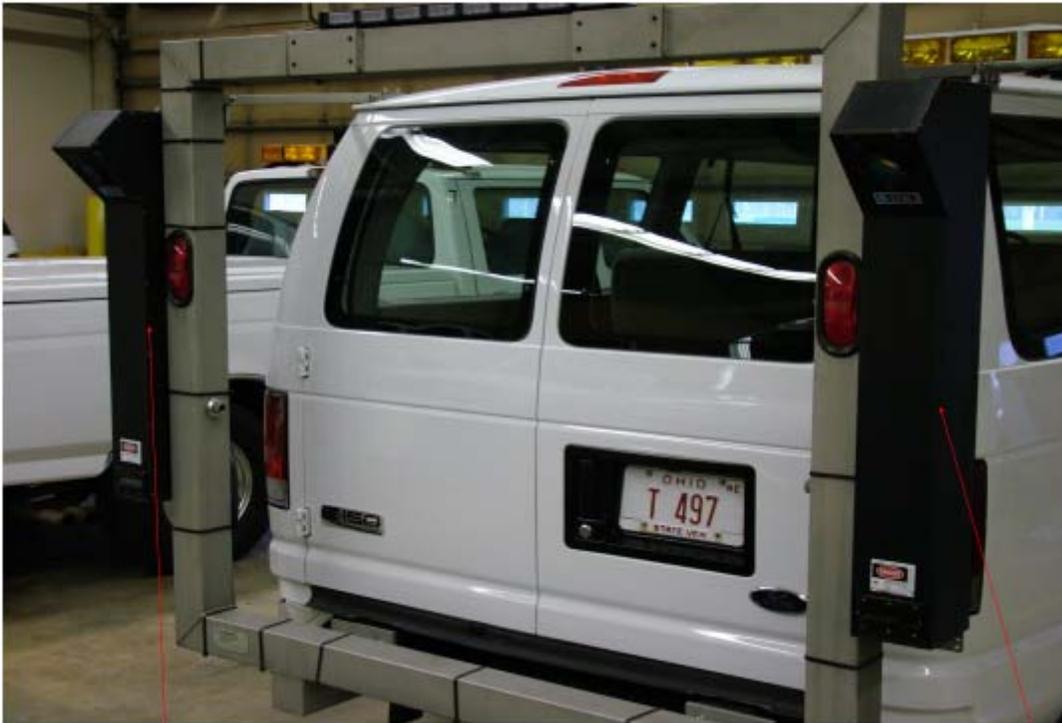
**Figure 5. Rear view of ODOT profiler vehicle showing attached INO Laser Rut Measurement System**

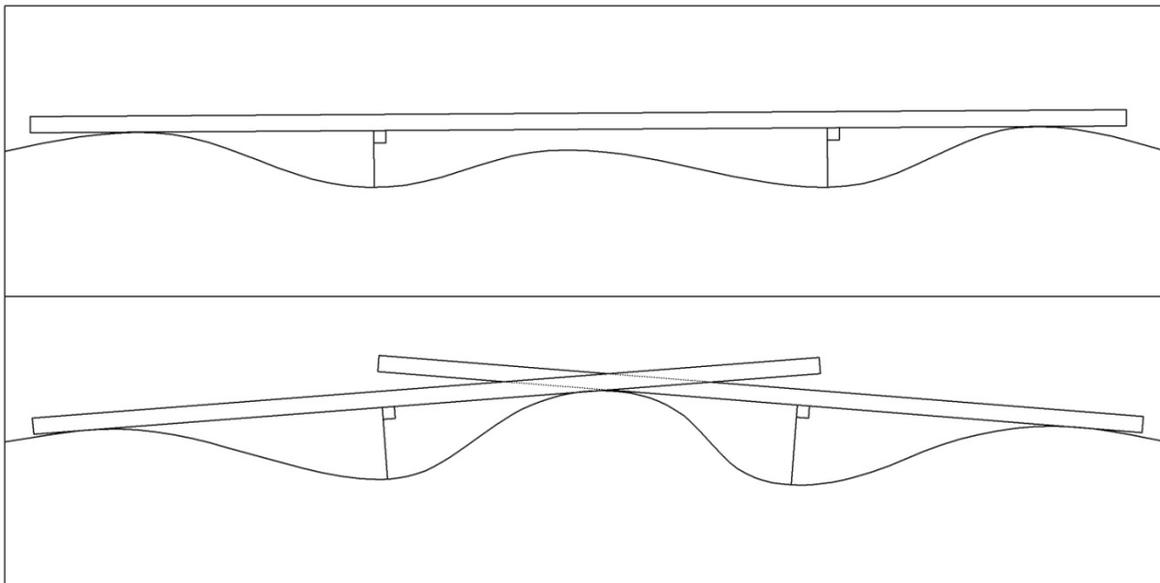
Figure 6. Virtual 2 m straight edge model

The straight edge model assumes a 2-m virtual straight edge bridging the rut which is created by connecting the two highest points on either side of a rut with a straight line (Figure 6). The depth is usually measured at a right angle to the straight edge. When this is not the case, the slope angle of the virtual straight edge is ignored as the effect is often negligible (Bennet Wang, 2002a). The 2-m virtual straight edge model is used by the LRMS system for calculating rut depth.

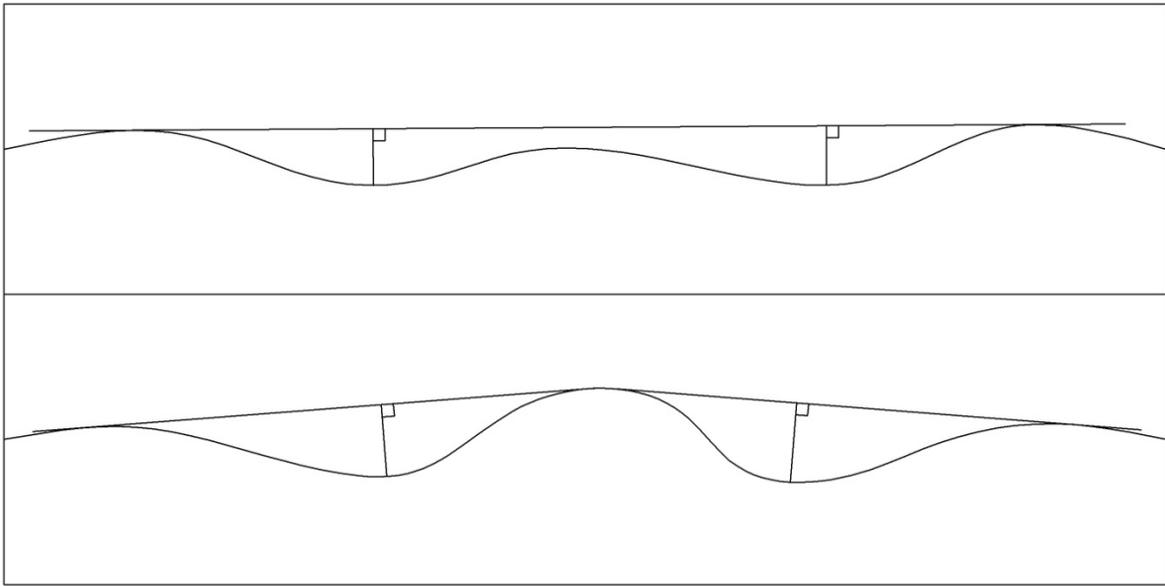
**Figure 7. Virtual wire model for measuring rut depth**

This model simulates a massless wire being stretched horizontally between the high points across the pavement. The wire begins at a high point to the left of the left wheel path and ends at another high point to the right of the right wheel path. The virtual wire may contact other high points and change slope as an actual wire would. In most cases, the wire model and the straight edge model would produce the same results. The only exception would be when the 2-m straight edge is too short to span the single or double rut (Figure 7) (Bennett Wang, 2002a).

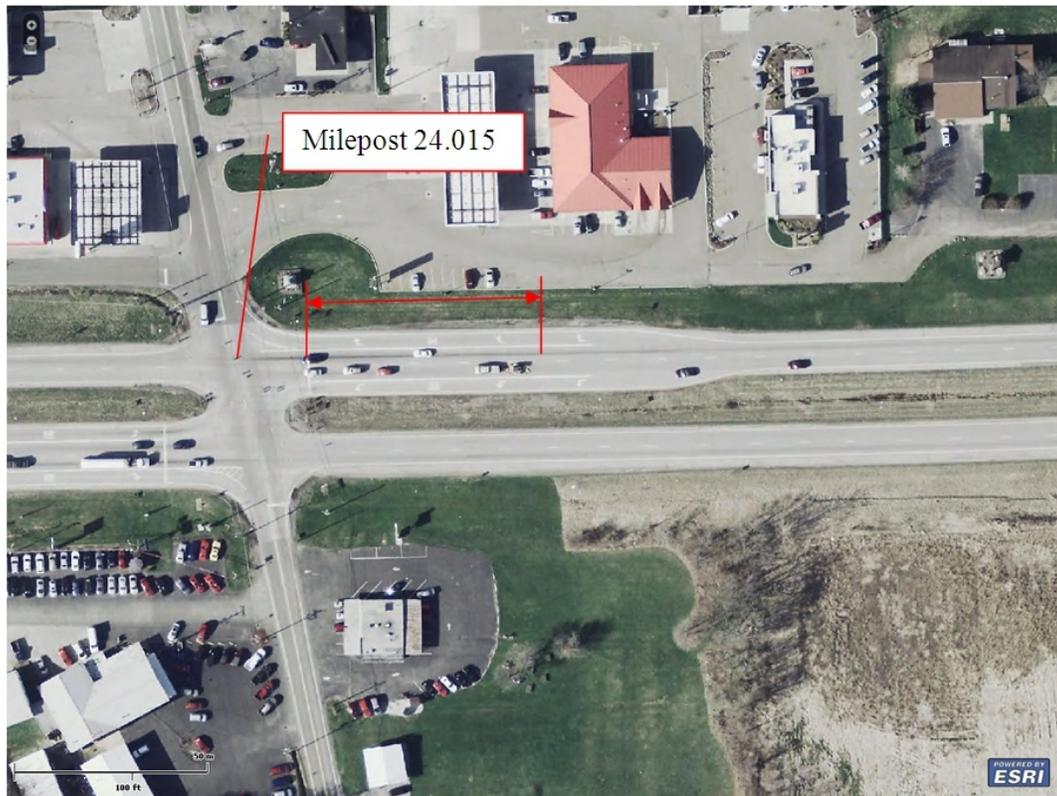
Figure 8. Test section at the intersection of US-30 and SR-94

A site was selected on US-30 near Wooster, Ohio for testing. The 200-ft (60.96 m) section was in the westbound approach to a stoplight at the intersection of US-30 and SR-94 (see Figure 8). This area receives a significant amount of large truck traffic. The stopped or slow-moving, heavily loaded trucks had produced a section of extremely severe rutting and upheaving. Areas away from the intersection were typically characterized by light or medium rutting.

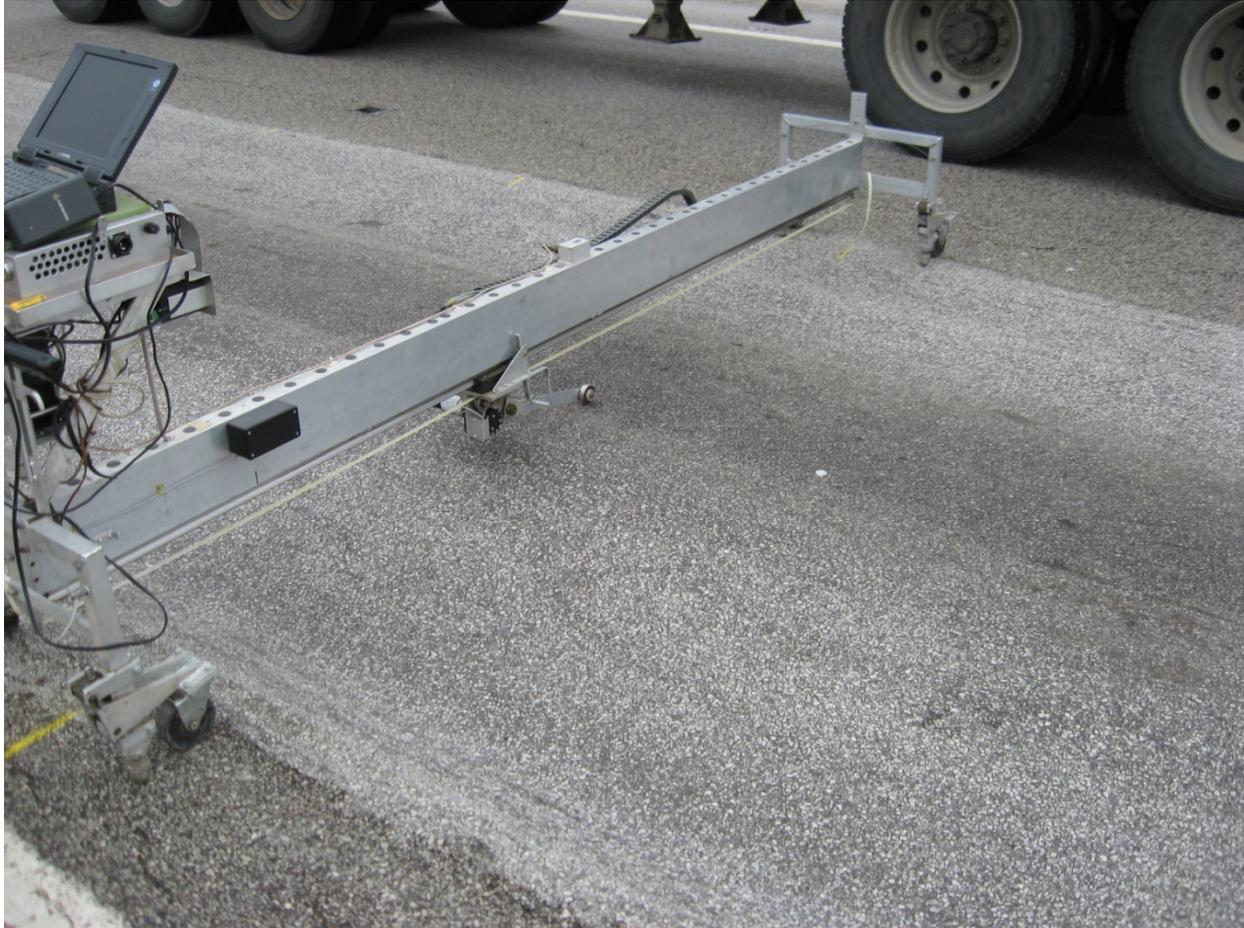
**Figure 9. Measuring rut depth on US-30 using the ORITE profilometer**

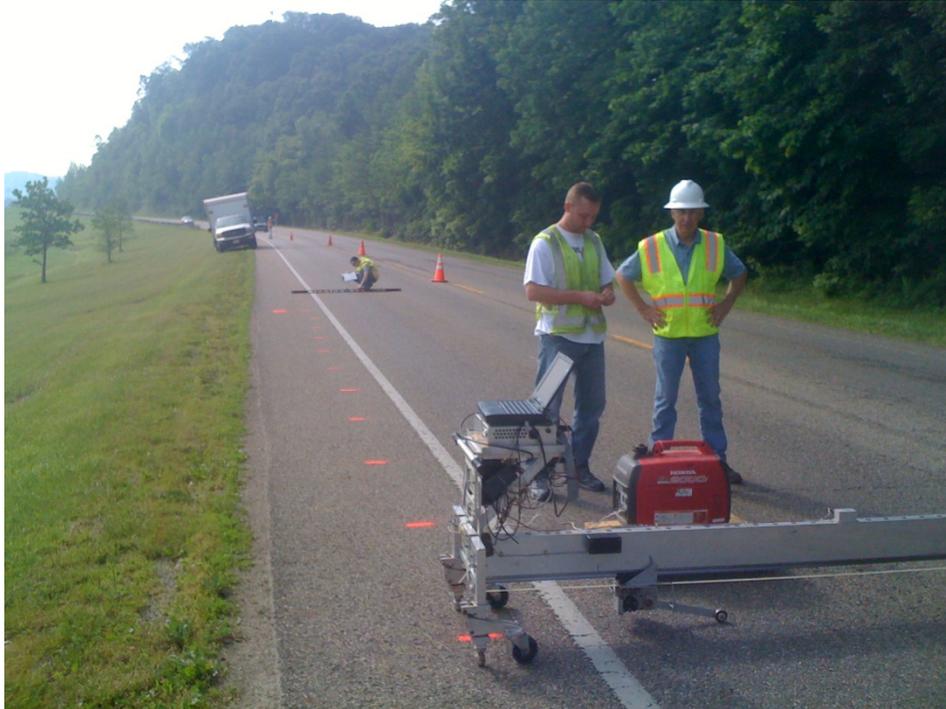
**Figure 11. Rut measurement on SR-682 using the profilometer and 8-ft S&G**

For this test, procedures similar to those used for the US-30 site were followed. A 200ft (60.96 m) section of pavement at approximately mile point 1.51 was measured and marked at five foot (1.52 m) intervals. Workers from the ODOT Infrastructure Management office made five runs with the Dynatest LRMS system. LRMS data was collected at five foot intervals beginning at milepoint 1 and ending at approximately milepoint 1.8, a distance of about 0.8 mi (1.3 km). As the vehicle approached the test section, rapid-fire mode was initiated, causing the system to record at 30 Hz intervals. Measurements were collected at 5-ft (1.52 m) intervals using the 4 ft straight edge, 8 ft straight edge, and profilometer on the 200-ft (60.96 m) section only. These measurements were then compared with the LRMS results.

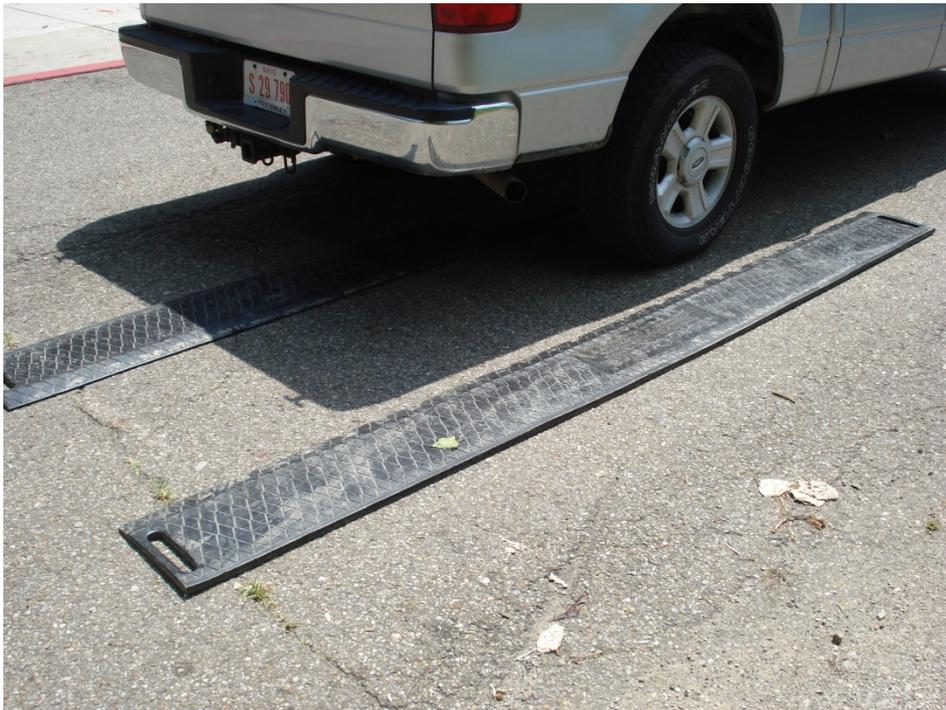
**Figure 12. Temporary rumble strips used to create an artificially deep rut to be used as a reference point in the LRMS data**

Unlike the US-30 test, there was no clearly defined section of severe rutting that could be used as a reference point for aligning data sets. To compensate, a reference point was created at the start of the 200-ft test section by creating a sort of artificial rut that would be easy to distinguish from other areas of the pavement. This was achieved by laying temporary rumble strips longitudinally in the road on both sides of the right wheel path. This artificially raised the sides of the wheel path to simulate a deeper rut and produced a spike in depth measurements that was used to align each set of data (see Figure 12).

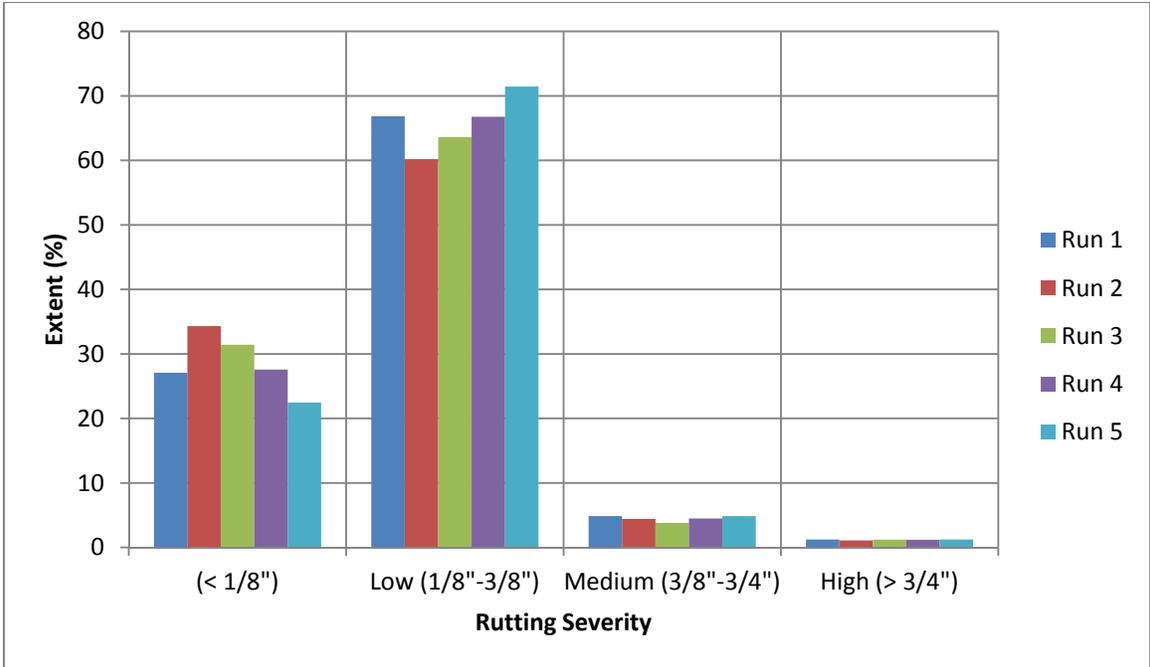
Figure 13. Distribution of rutting by severity on US-30 (LWP)

The Games-Howell test results suggest that the similarity between the five runs made with the LRMS system is fairly weak, especially in the left wheel path. However, the distribution of rutting, shown in Figure 13 and Figure 14, suggests that the five runs would have all produced the same score using the ODOT pavement rating system.

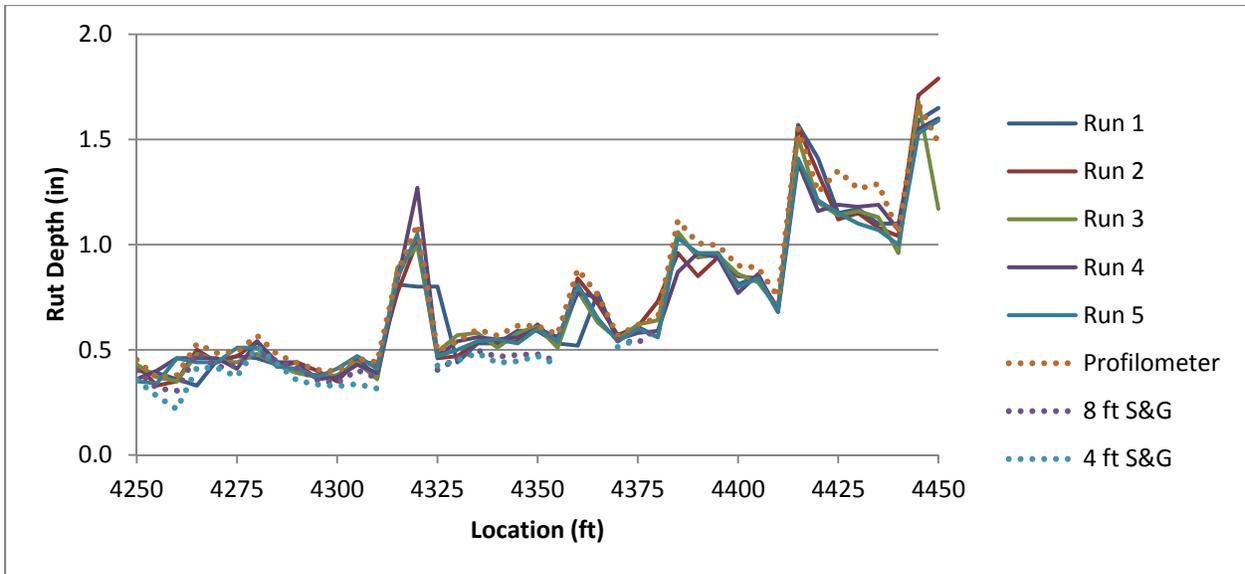
Figure 15. Rut depth measurements from 200 ft (60.96 m) test section on US-30 (LWP) (1 in = 25.4 mm)

The 200-ft (60.96 m) test section was extracted from the LRMS data and compared with the profilometer and S&G data gathered at the test section. S&G measurements could not be obtained at many of the 5-ft (1.52 m) intervals due to the extreme severity of rutting at these locations. The dial gage was not able to reach the bottom of the rut. The profilometer was able to gather data at each interval however. The same ANOVA and Games-Howell tests were used

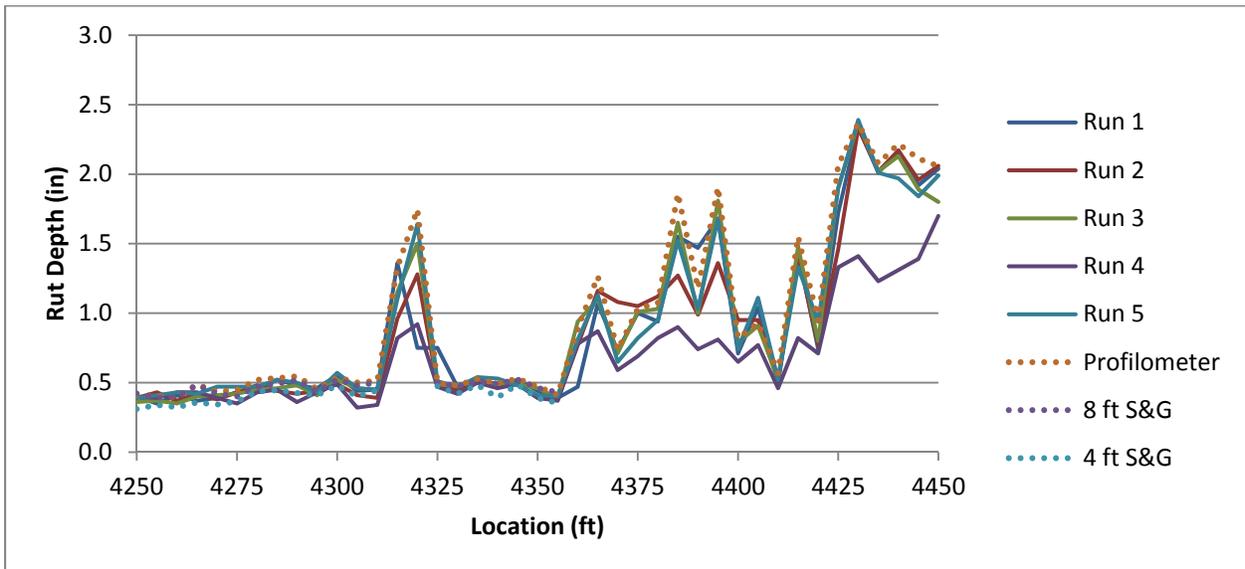
Figure 16. Rut depth measurements from 200-ft (60.96 m) test section on US-30 (RWP) (1 in = 25.4 mm)

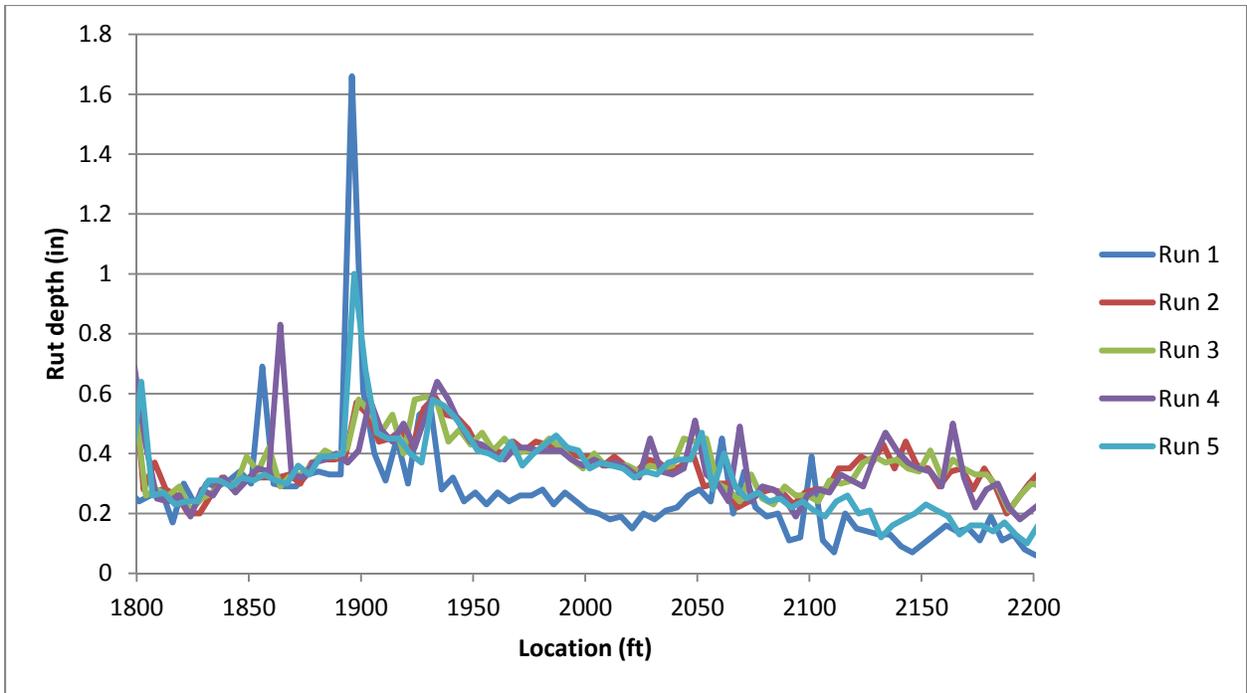
Figure 17. Rut depth measurements from LRMS in left wheel path on SR-682 (1800-2200 ft) (1 in =25.4 mm)

The Games-Howell test shows a strong statistical similarity between each set of data from the right wheel path; however the left wheel path data from Run 1 do not correlate with the other data sets. There are a few instances where the measured rut depths from Run 1 are slightly less than the other runs over a short distance (see Figure 17). In these segments, the measured rut widths in Run 1 are also significantly less than the widths measured in other runs. This may suggest that the vehicle had drifted from the center of the lane or the laser system was being influenced by pavement deterioration observed at the center of the roadway (see Figure 18).

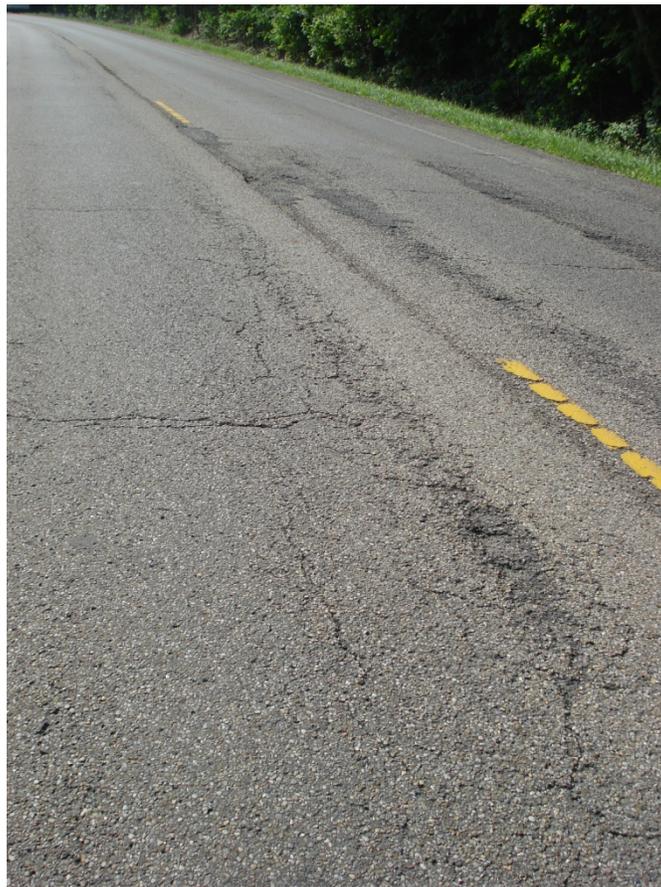
Figure 18. Pavement deterioration on SR-682

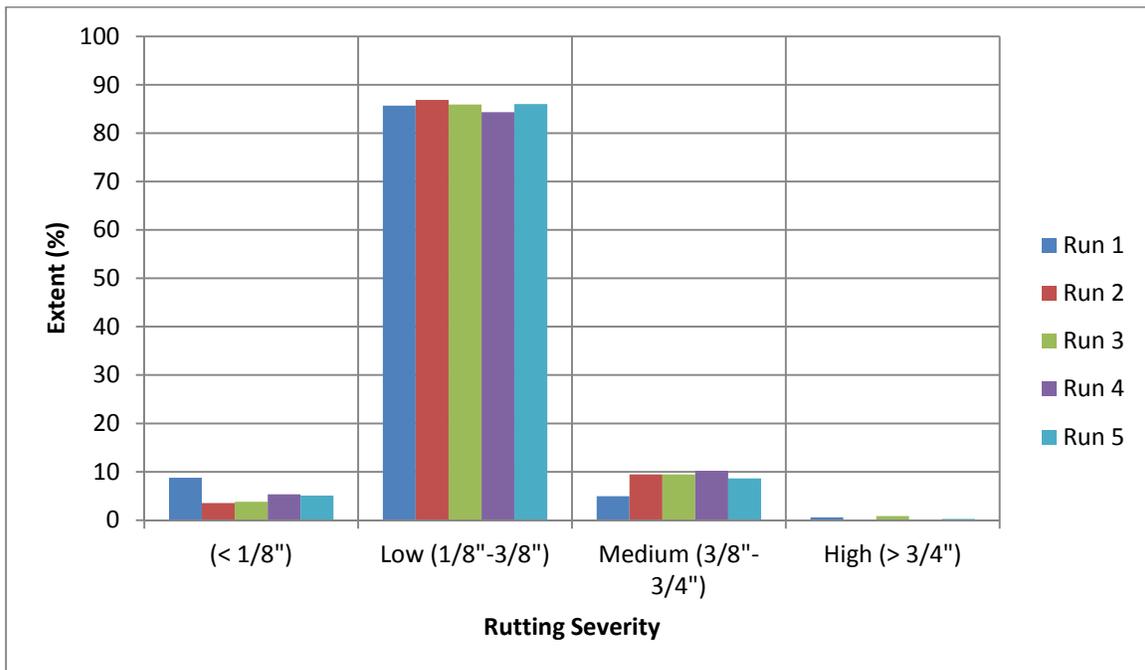
**Figure 19. Distribution of rutting by severity on SR-682 (LWP)**

Overall, the five runs show strong statistical similarity. There are some outlying data that created some dissimilarity in the first run; however, considering that these tests were run in an uncontrolled environment where the points do not align perfectly, pavement deterioration may influence measurements, and curves in the road may have influenced the driver's ability to remain at the center of the lane, the end results are convincing enough to deem the measurements repeatable. A distribution of data from SR-682 separated by PCR severity level is shown in Figure 19 and Figure 20. The distributions are similar between runs; however the inconsistency in the left wheel path data from run 1 is evident in Figure 19.

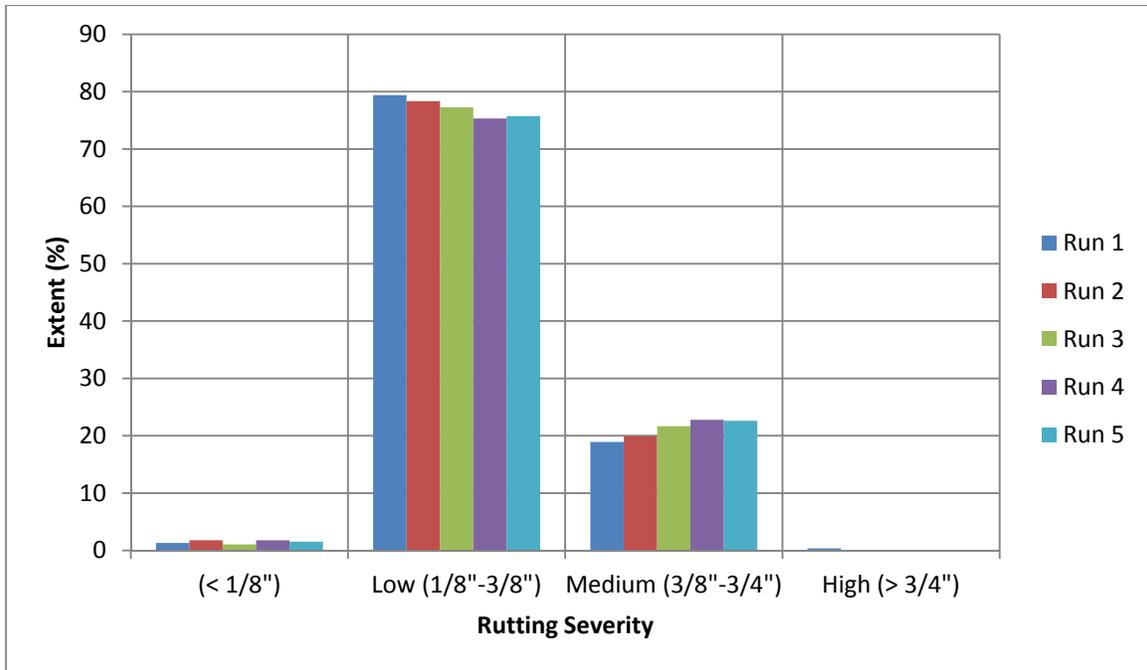
**Figure 20. Distribution of rutting by severity on SR-682 (RWP)**

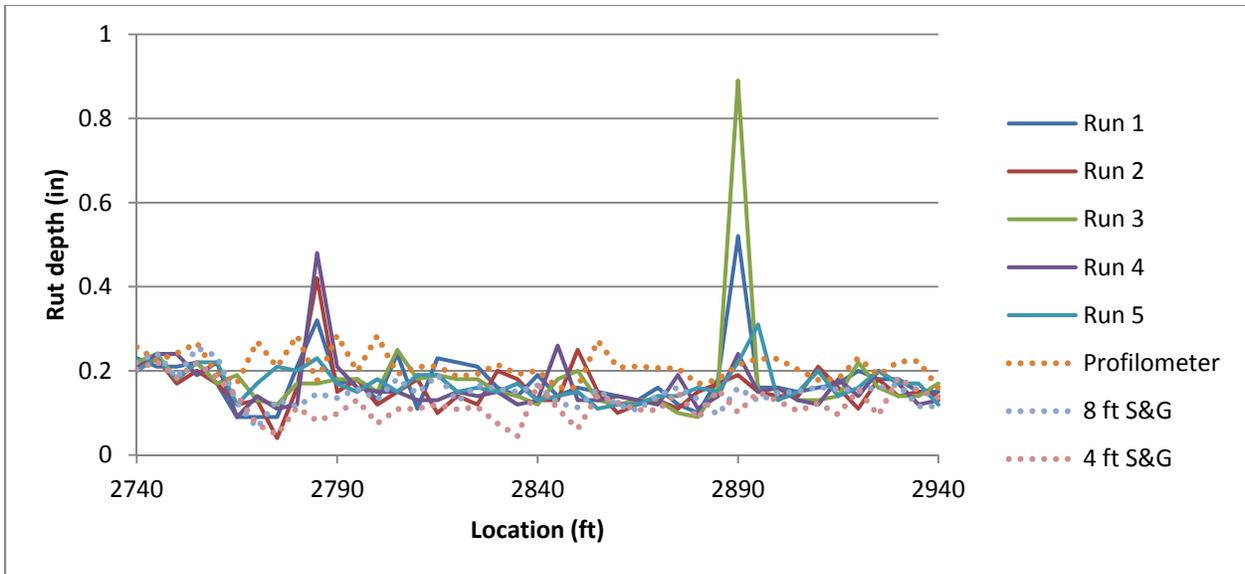
Figure 21. Rut depth measurements from the 200-ft (60.96 m) test section on SR-682 (LWP) (1 in = 25.4 mm)

The LRMS data correlate well with the 8 ft straight edge in all cases; however the profilometer measurements correlated with the LRMS readings only in the right wheel path. As one can see in Figure 21, the profilometer measurements are frequently higher than the other measurements. This is due to the deterioration in the left wheel path and near the centerline as shown in Figure 18. Small pits in the roadway surface are read by the profilometer wheel and create low points in the profile that are interpreted as the bottom of the rut by the rut depth algorithm discussed in Section 2.2. An example of this is shown in Figure 23. The LRMS system may not be influenced by this type of deterioration due to the shallow angle at which the laser hits the pavement surface. Its effects may also be diminished by the filtering used in the

Dynatest software. The data from the profilometer in the left wheel path of SR-682 is assumed to be flawed and is disregarded in the comparison of measurement methods.

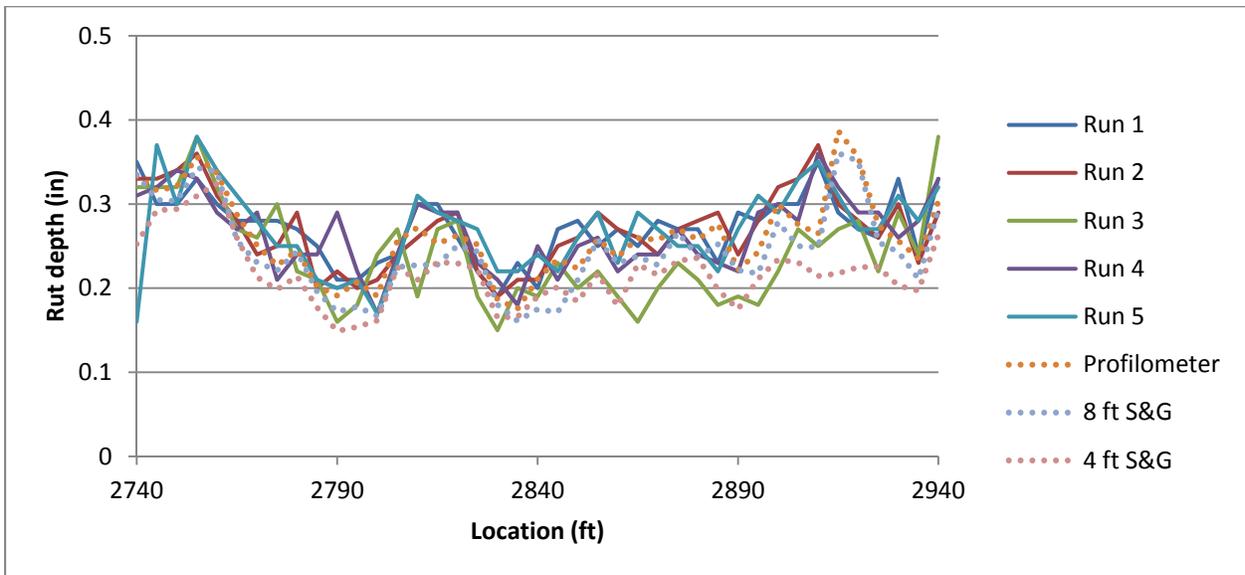
Figure 22. Rut depth measurements from the 200-ft (60.96 m) test section on SR-682 (RWP) (1 in = 25.4 mm)

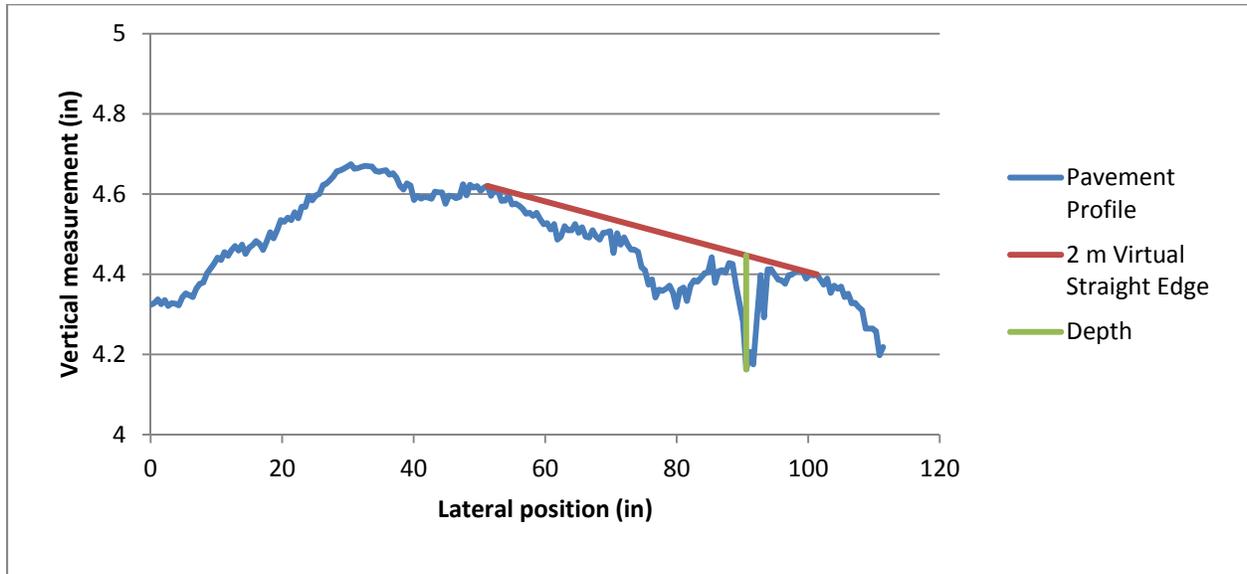
**Figure 23. Pavement profile from profilometer on SR-682 (LWP) where depth measurement was influenced by pavement deterioration (@ 2780 ft) (1 in = 25.4 mm)**

in the left wheel path that caused the rut depth algorithm to interpret pits in the pavement surface as the bottom of the rut. These data were considered invalid and were disregarded. The strong statistical similarity found in the results of the ANOVA and Games-Howell tests indicate that the LRMS produces accurate rut depth measurements. The 4-ft S&G however did not show strong similarity to the other measurement methods. The shorter length did not allow the straight edge to fully span the width of the rut in many cases. To prevent error and inaccuracy, the 4-ft S&G should be replaced with a device that meets the criteria listed in ASTM E 1703/E 1703M (1995).

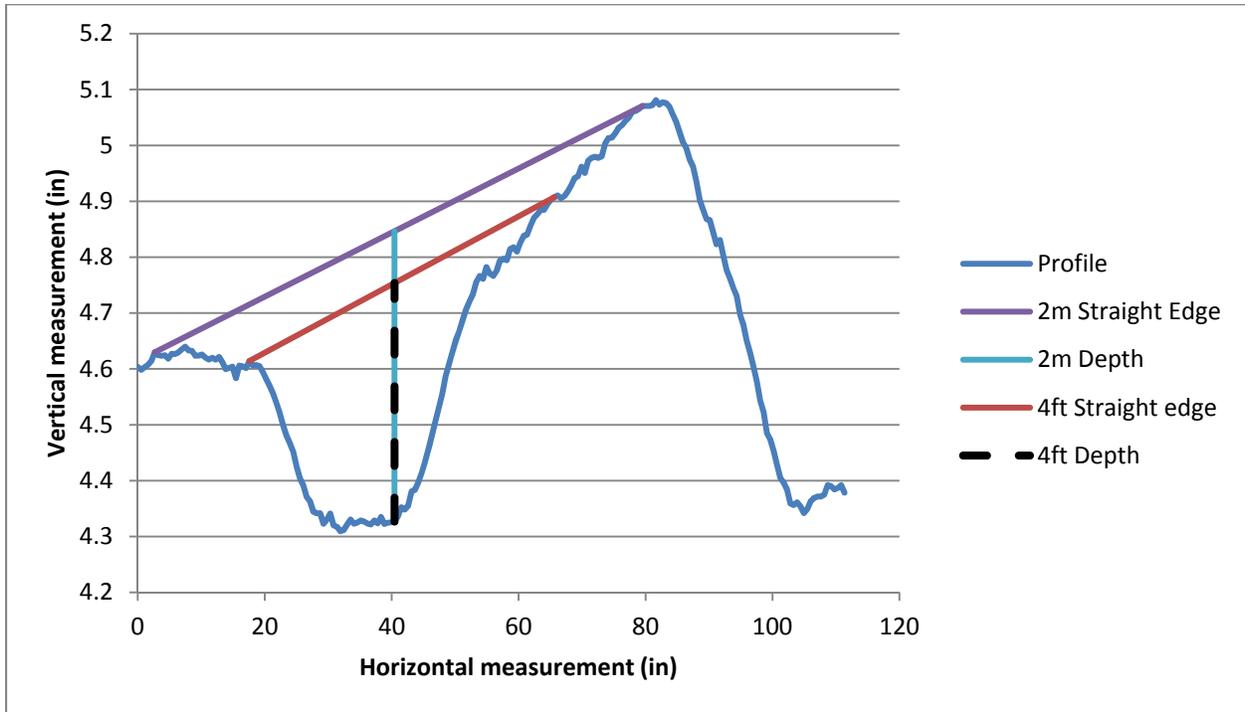
Figure 24. 2-m and 4-ft virtual straight edge models (1 in = 25.4 mm)

Measurements taken by the 4 ft straight edge during both tests were generally inconsistent with the profilometer and 8 ft straight edge. Figure 24 shows a profile of US-30 created by the profilometer with a 2 m virtual straight edge and a 4 ft virtual straight edge. The 4 ft straight edge is clearly unable to span the entire rut. This may not always be the case, since the validity of the 4 ft straight edge measurement is dependent on the width of the rut; however, because the potential for significant error exists when using this length of straight edge, its use should be discontinued.
