# SOIL STABILIZATION FIELD TRIAL

INTERIM REPORT

DEPARTMENT OF CIVIL ENGINEERING  
UNIVERSITY OF MISSISSIPPI

The University of Mississippi  
University, Mississippi  
April 2001

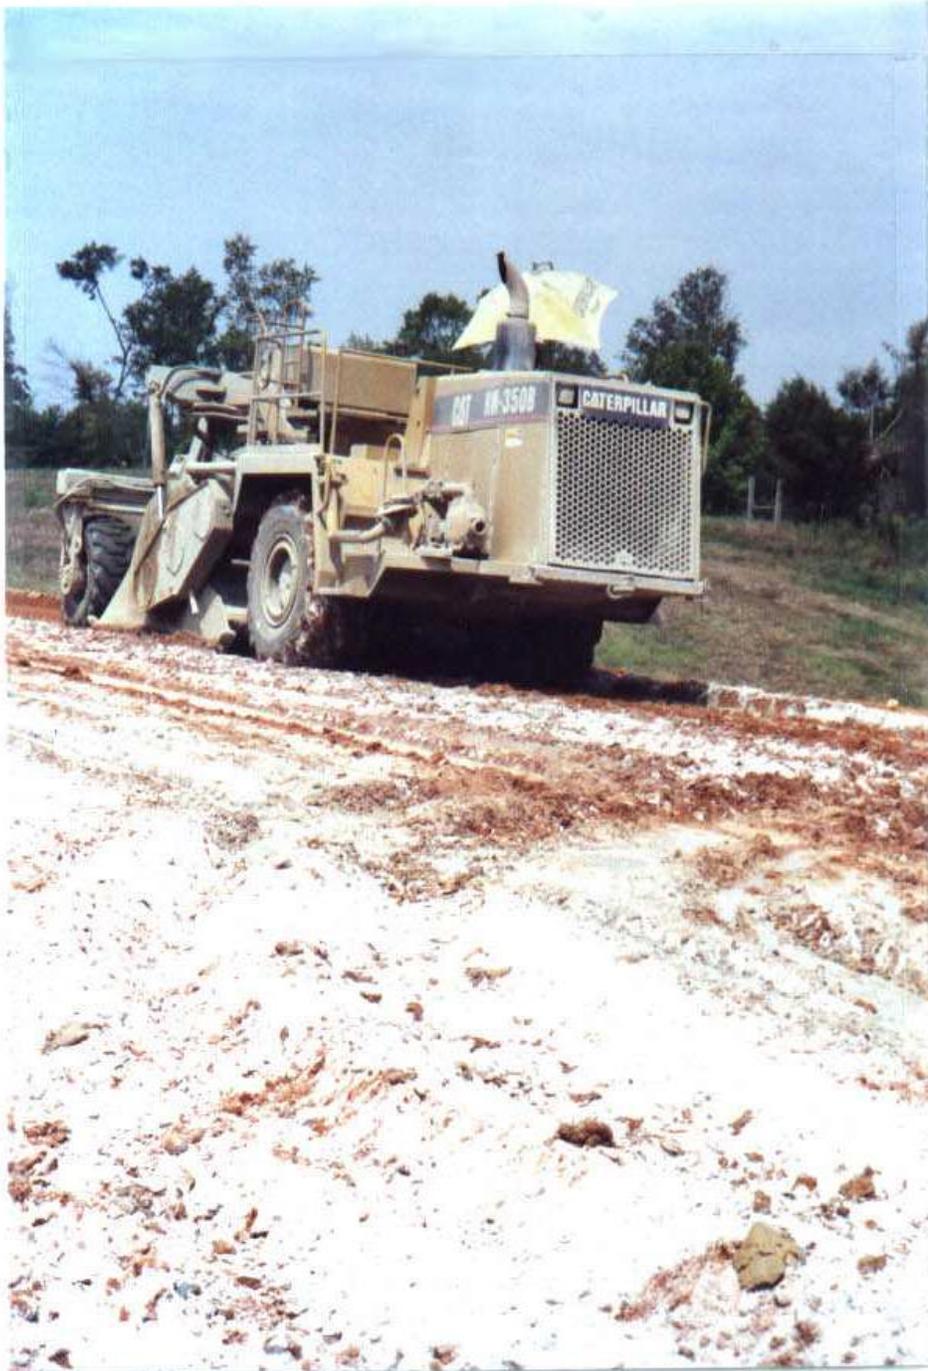
Figure 4.1 Dry mixing soil and lime employing a rotary mixer.

Step 1. One or two passes of dry mixing, employing a rotary mixer to incorporate the additive, such as cement (see Figure 4.1)

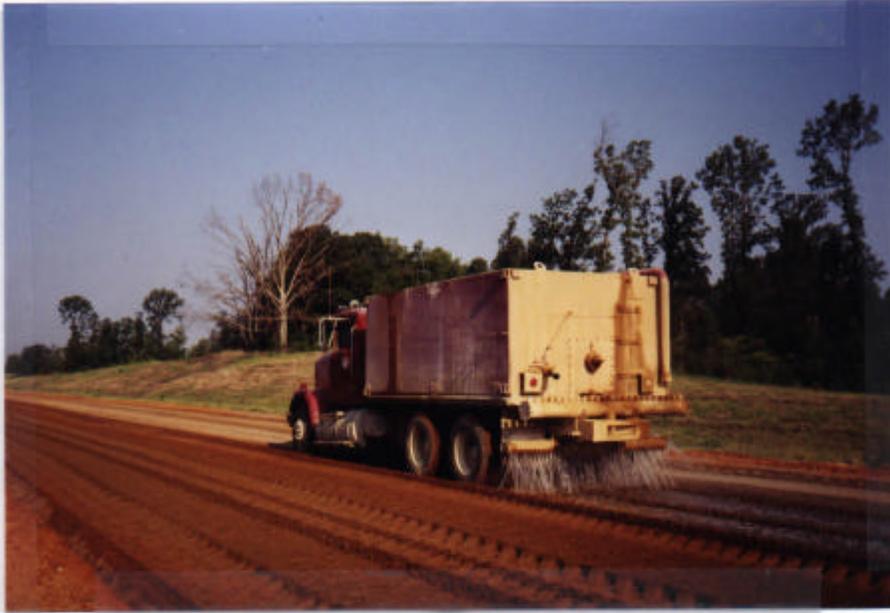
Figure 4.2 Water being added to the dry-mixed soil and additive(s).

Step 2. Water added (water quantity is approximated) (see Figure 4.2)

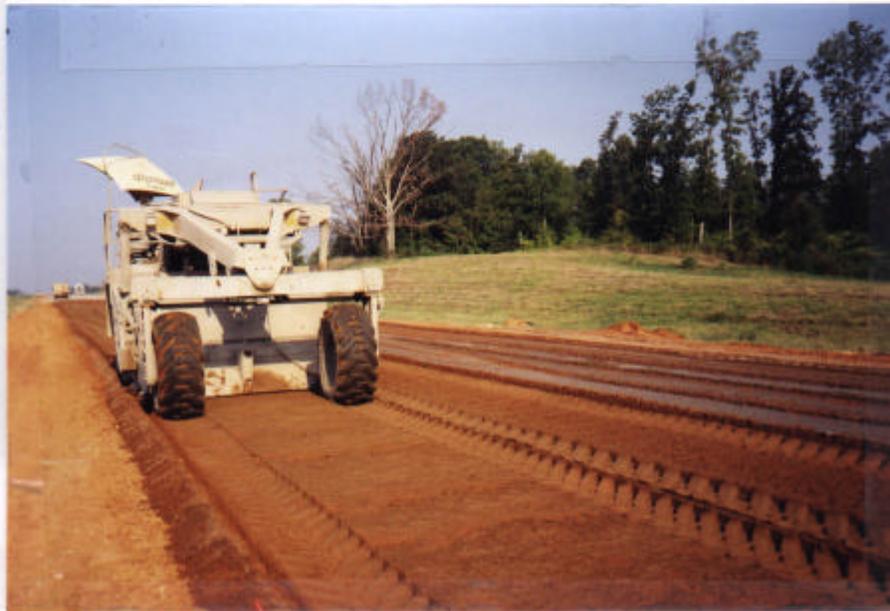
Figure 4.3 Wet-mixing of soil and additive(s).

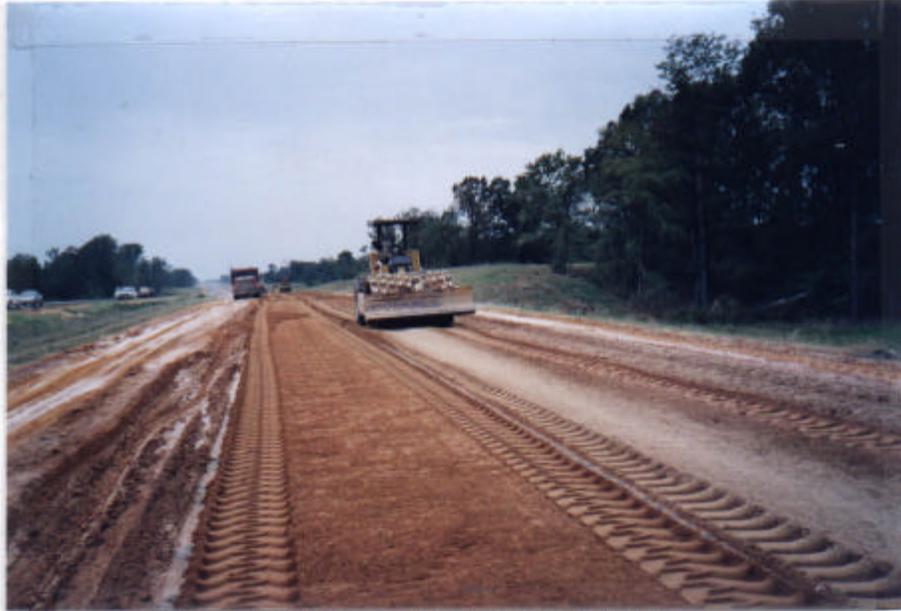
Figure 4.4 Initial compaction by sheeps-foot roller.

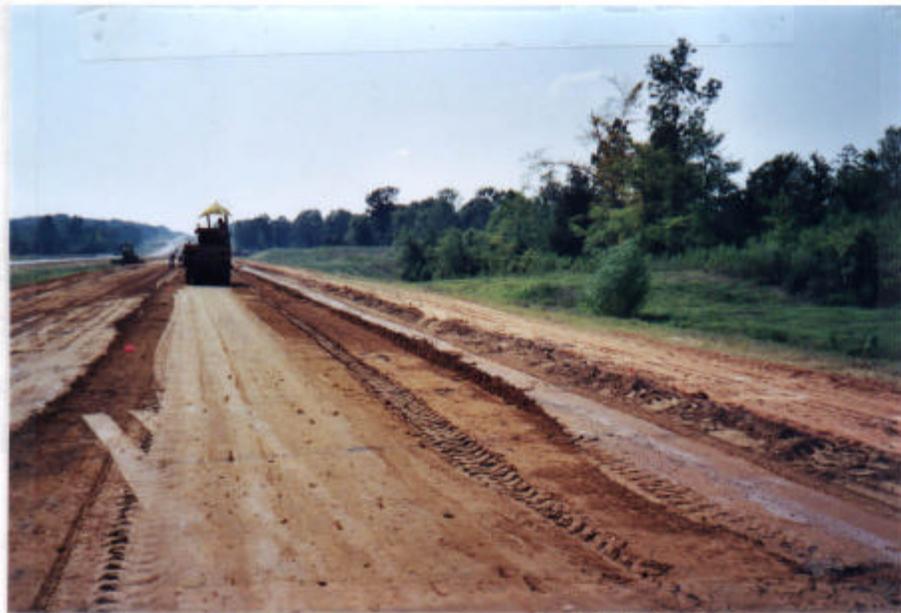
Figure 4.5 Finish-compaction by rubber-tired roller.

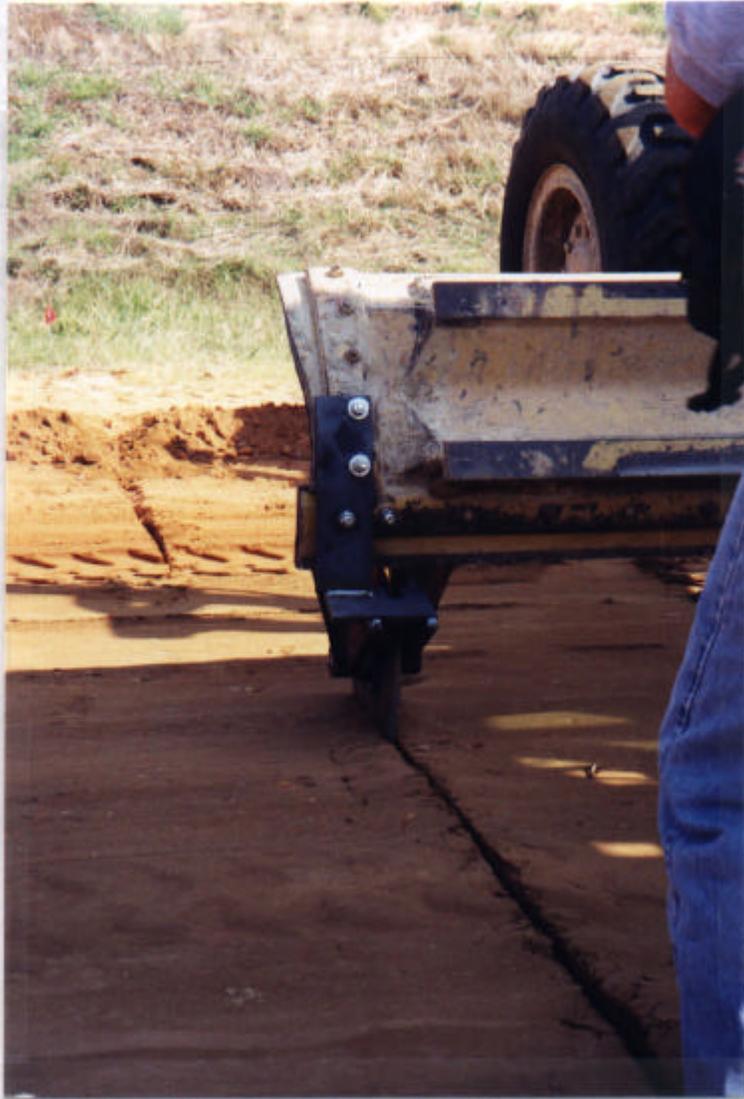
Figure 4.6 Grooves being cut in partially compacted layer employing a rotary blade.

The depth of the groove was controlled by the experienced motor grader operator. The groove width made with this device was somewhat in excess of 13mm (1/2 inch) at the top of the

groove, exceeding the desired groove width. Should this technique be adopted as a standard construction method, it is recommended to reduce the thickness of the rotary cutter.

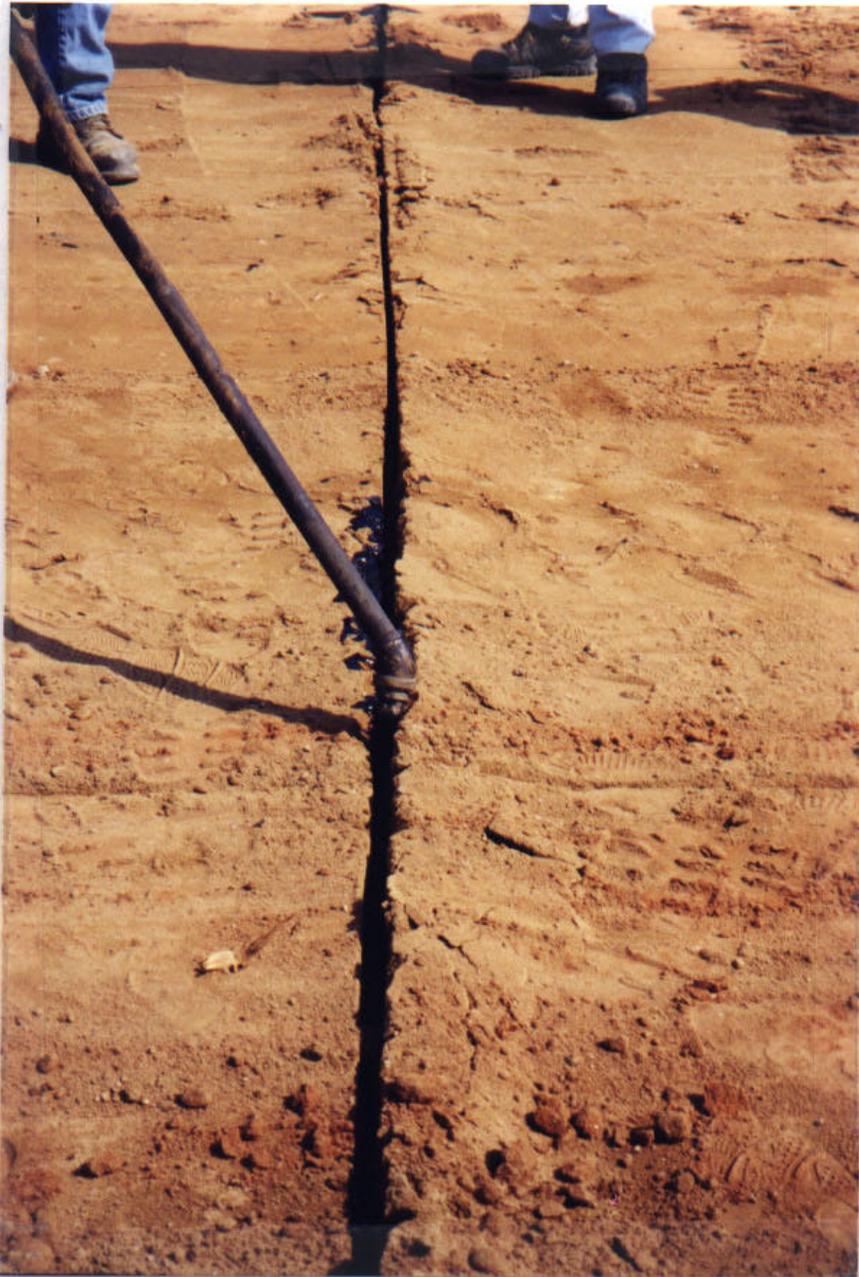
Figure 4.7 Grooves being filled with emulsion.

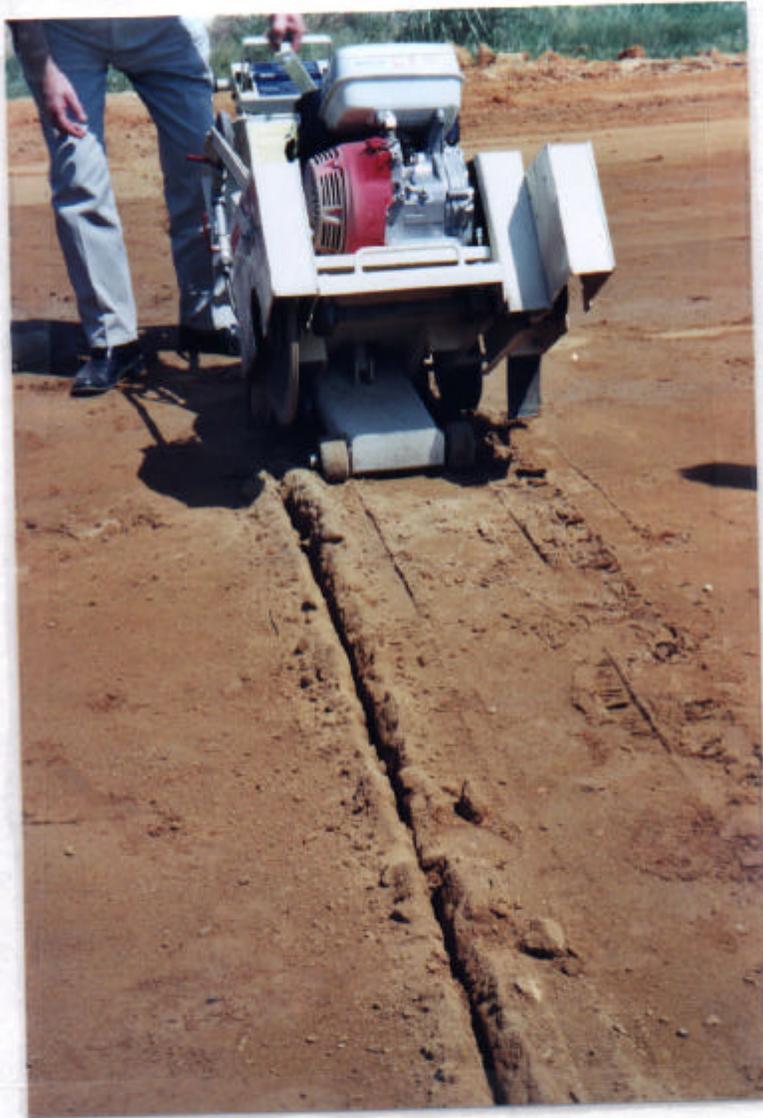
Figure 4.8 Grooves being cut in compacted layer employing a concrete saw.

This subsection was watered, mixed and fully compacted prior to attempting any precutting operation. The contractor attempted to use a concrete saw to cut the grooves (Figure 4.8). Two problems became apparent as the sawing operation proceeded which resulted in the termination of

this groove cutting technique. One problem was that the width of the grooves exceeded the 5mm (3/16 inch) requirement. The other problem was the length of time needed for the sawing operation. Based on the time required to cut several grooves with the concrete saw, it was estimated that more than two and one-half hours would be required to complete the sawing of this subsection. This would result in almost four hours elapsing between wet mixing to final rolling to close the grooves. Any closure of the grooves from final rolling that long after wet mixing would be detrimental to the stabilized material; therefore, attempts were discontinued to use this segment of road as a precut test subsection.

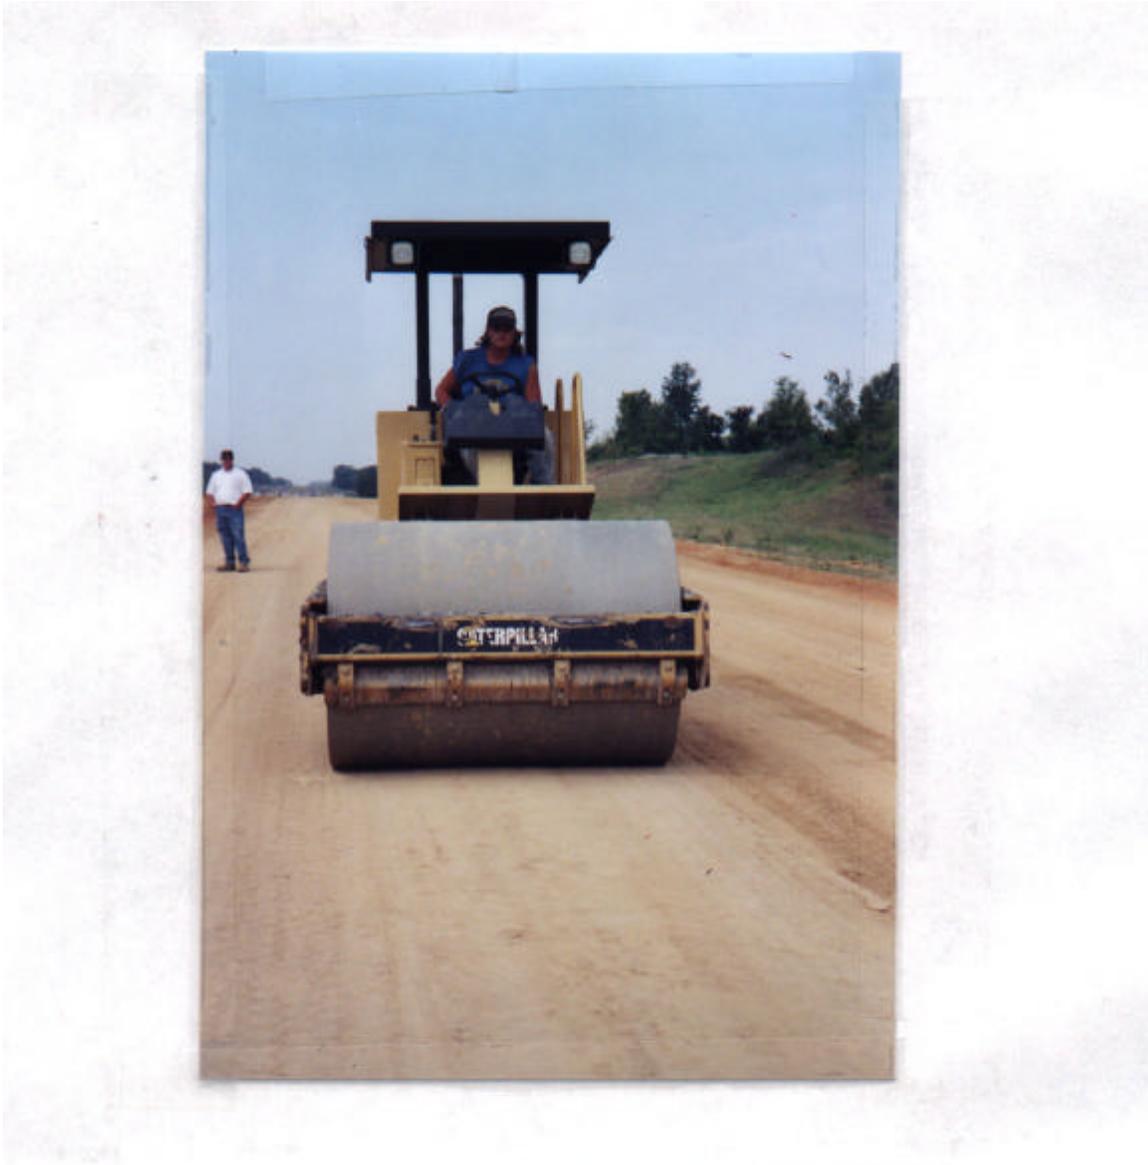
Figure 4.9 Vibration roller in operation precracking the layer after 24 hours.

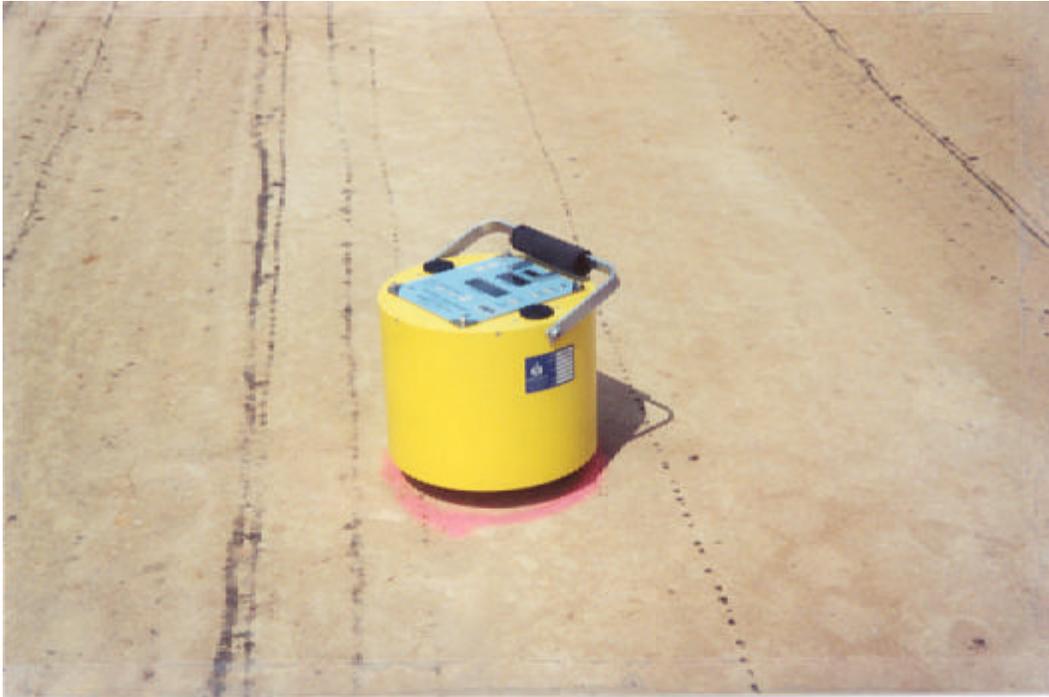
**Figure 4.11 Geogauge in operation evaluating modulus of layer in-place.**

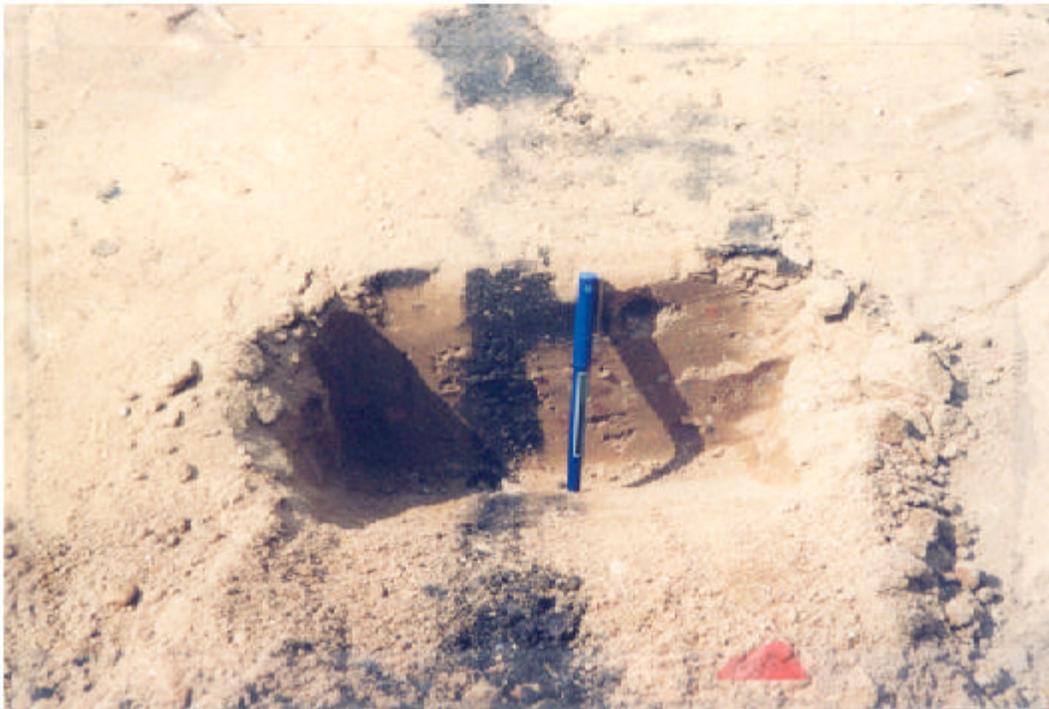
**Figure 4.12 Cross section through a precast joint filled with emulsion.**

A post-mortem examination (Figures 4.12 and 4.13) revealed that the joints were not adequately closed following this construction sequence. Two potential explanations include not blading the surface soon after filling the grooves with emulsion and the inadvertent addition of excess water before adequately closing the grooves with stabilized material. An overall view of the finished surface can be seen in Figure 4.14.

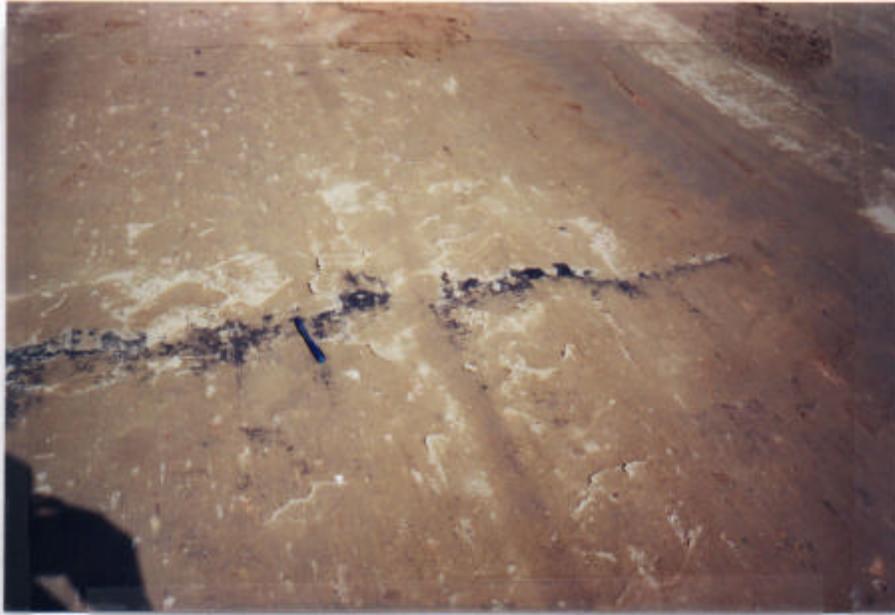
Figure 4.13 Close-up view of a precut joint.

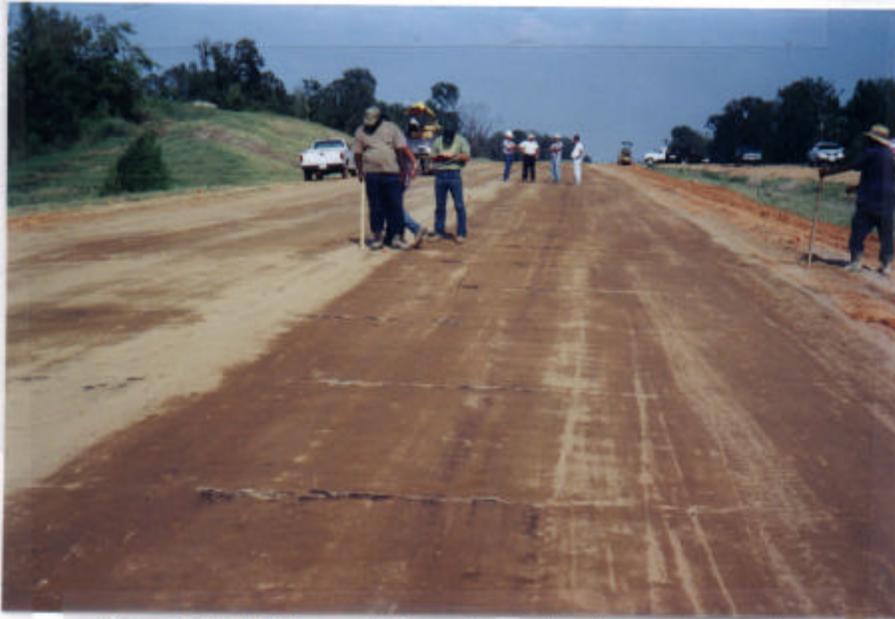
Figure 4.14 Visible precut joints after final grading and compaction.

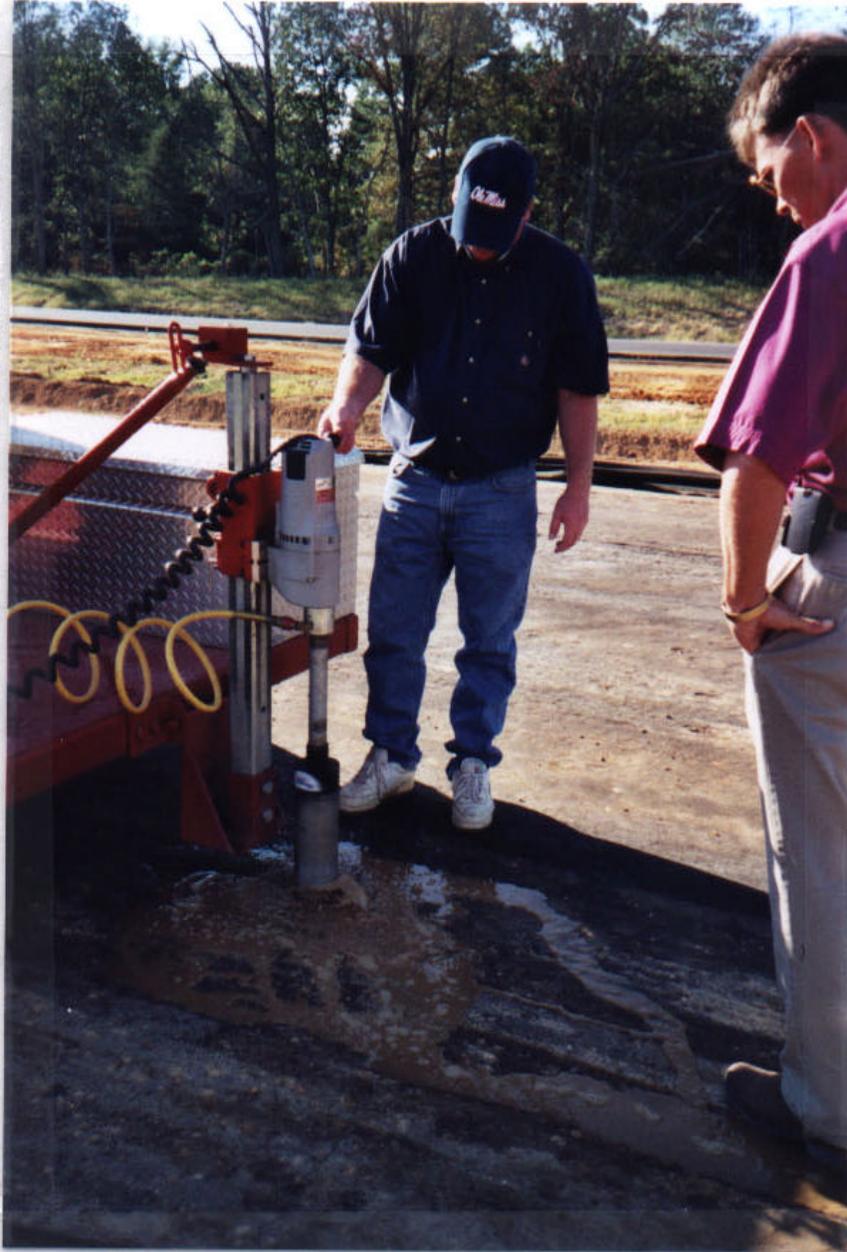
Figure 4.15 Core drill in operation.

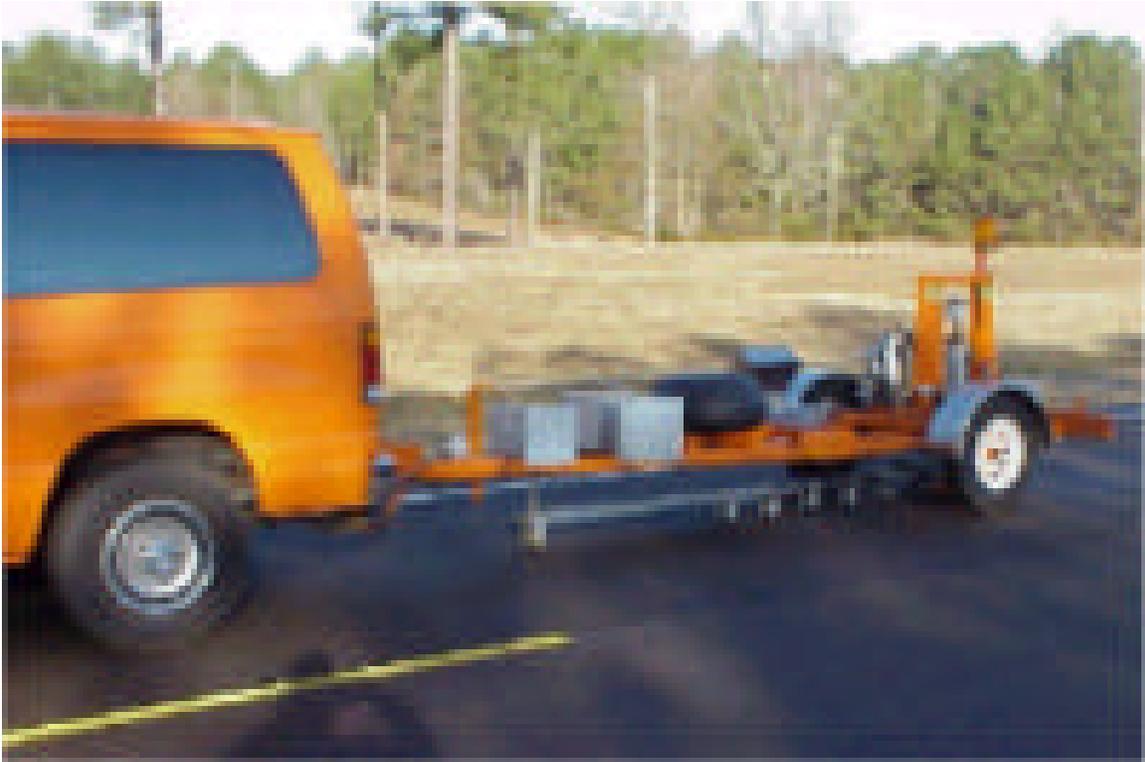
**Figure 4.16 Falling Weight Deflectometer in operation.**

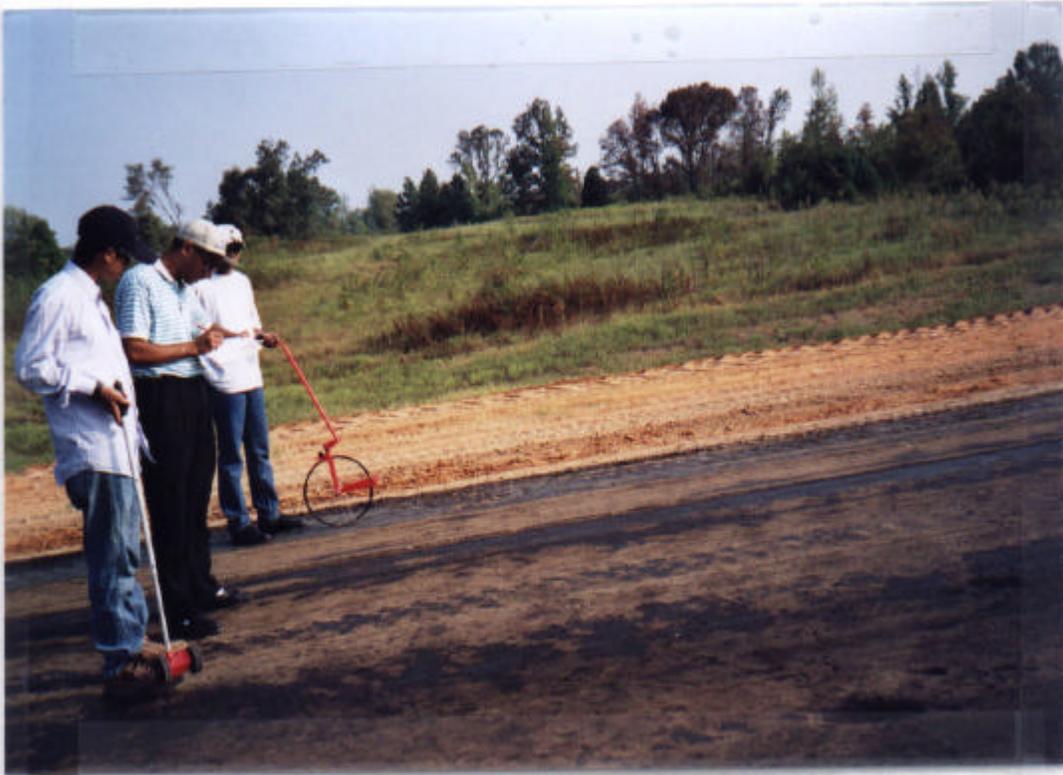
Figure 4.17 Survey crew measuring and mapping cracks.

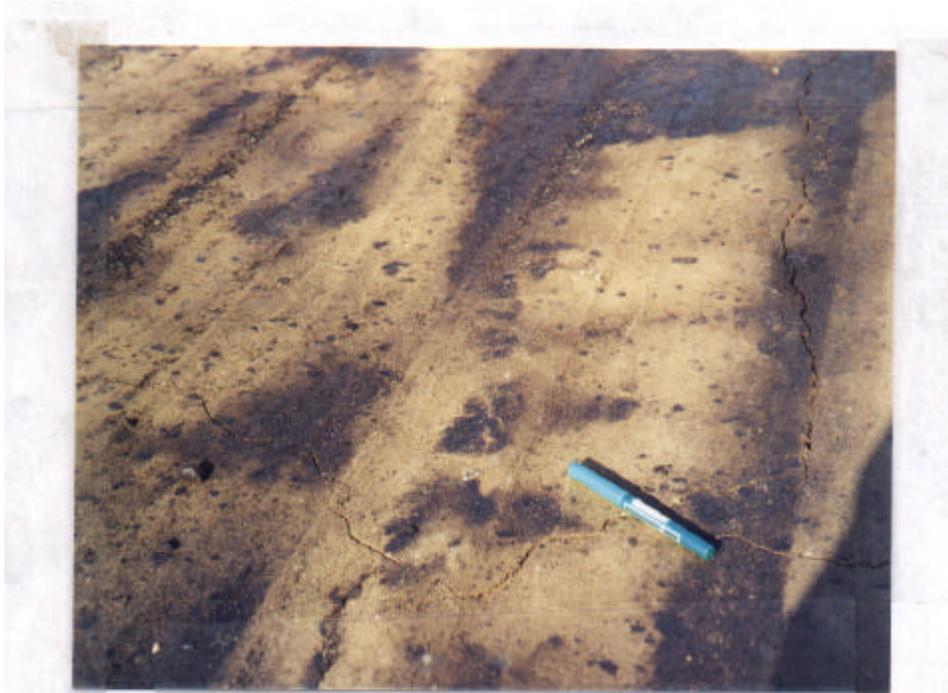
Figure 4.19 Medium severity cracks in section 1A, control cement, fourteenth day.

What follows is a series of pictures from the five sections captured during the 14-day survey. Random, medium severity cracks in the control cement subsection (190+00 to 195+00) can be seen in Figure 4.19. In Figure 4.20, the transverse crack is medium severity in comparison to low severity longitudinal cracks, again in Section 1A. In the Precut Section 1B (195+00 to 200+00), however, the cracks were predominately in the transverse direction with a few longitudinal cracks as well. Very few cracks appeared in the precracked section (200+00 to 210+00), as attested to by the almost crack-free surface in Figure 4.21. Again, random cracks,

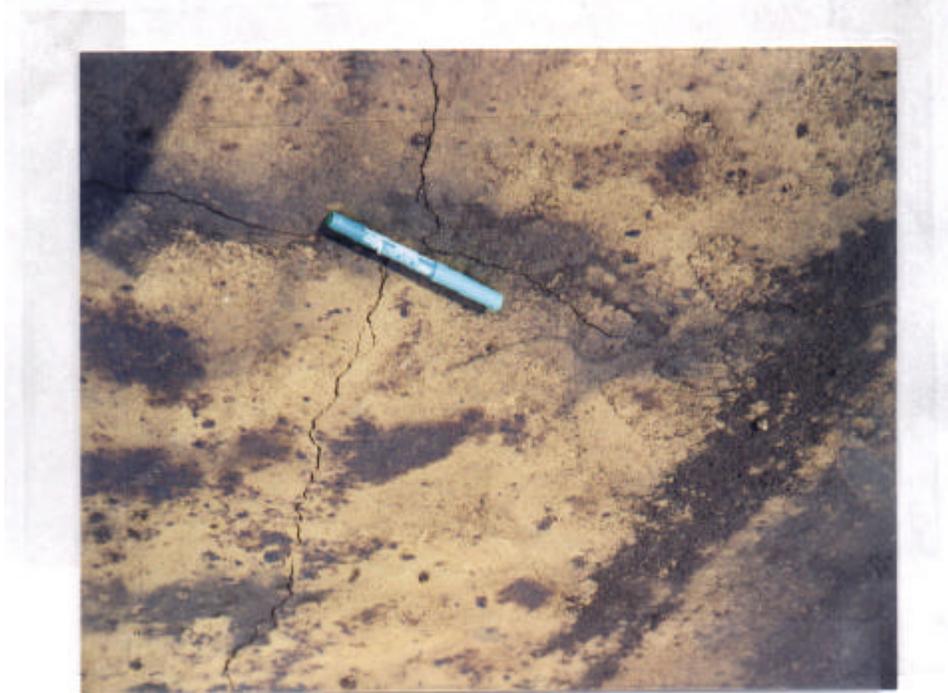
Figure 4.20 Medium transverse and low longitudinal cracks in section 1A, control cement, fourteenth day.

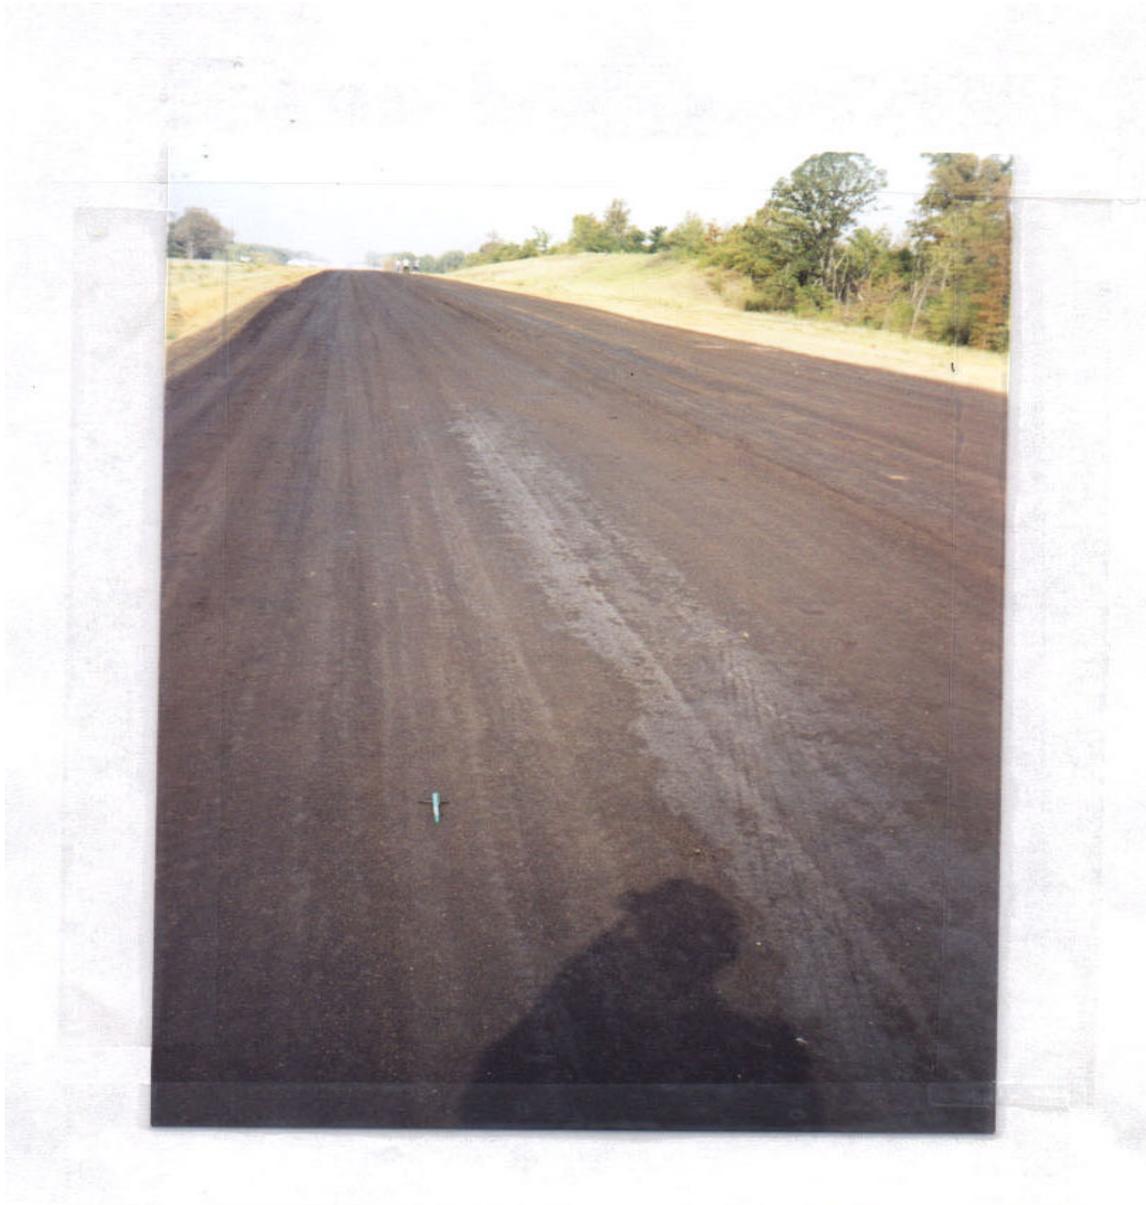
Figure 4.21 Crack-free surface of section 2 (precracked), fourteenth day.

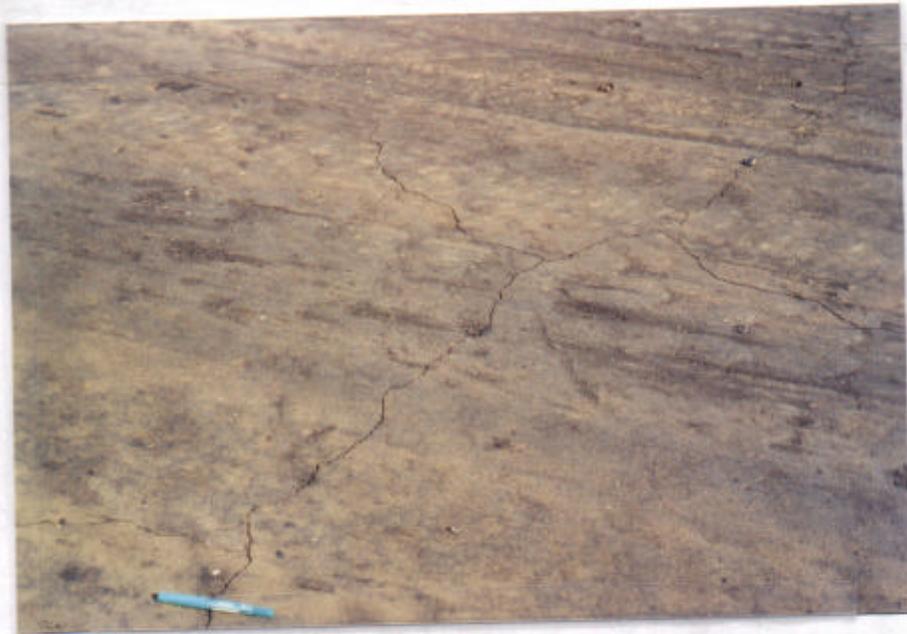
Figure 4.22 Random cracks in section 3A, control cement, fourteen day.

similar to those observed in section 1A, covered the complementary control cement, subsection 3A (200+00 to 205+00) (see Figure 4.22). For reasons not yet clear, the cracks in the cement-fly ash section appeared slightly more severe than those in the control cement section, as captured in Figure 4.23. Owing to excessive moisture during compaction, the first third of the LFA section (240+00 to 243+00) underwent severe cracking. What is shown in Figure 4.24 is typical block cracking observed in this segment of the LFA section. Typical cracks in the LFA section were of low severity and Figure 4.25 attests to this conclusion. With the cracks in the first third of the LFA section drastically different from what has typically been observed in the second half and also in adjacent LFA sections, a decision was made to substitute the first 152m (500 ft) by another segment of equal length, beginning at 250+00 and ending at 255+00. This 152m (500 ft) section is designated section 6 alternate. What is shown in Figure 4.26 is a view (westward) of the two subsections, constructed on two different days – the lighter surface in the background is the tail end of the original LFA section 6 (240+00 to 250+00) and the dark surface in the foreground portrays the new segment (245+00 to 250+00). Partly owing to better curing, the cracks in the well-cured half were much less than those observed in the poorly cured former half (background versus foreground). Based on this result, the author cannot overemphasize the importance of adequate curing in abating shrinkage cracks.

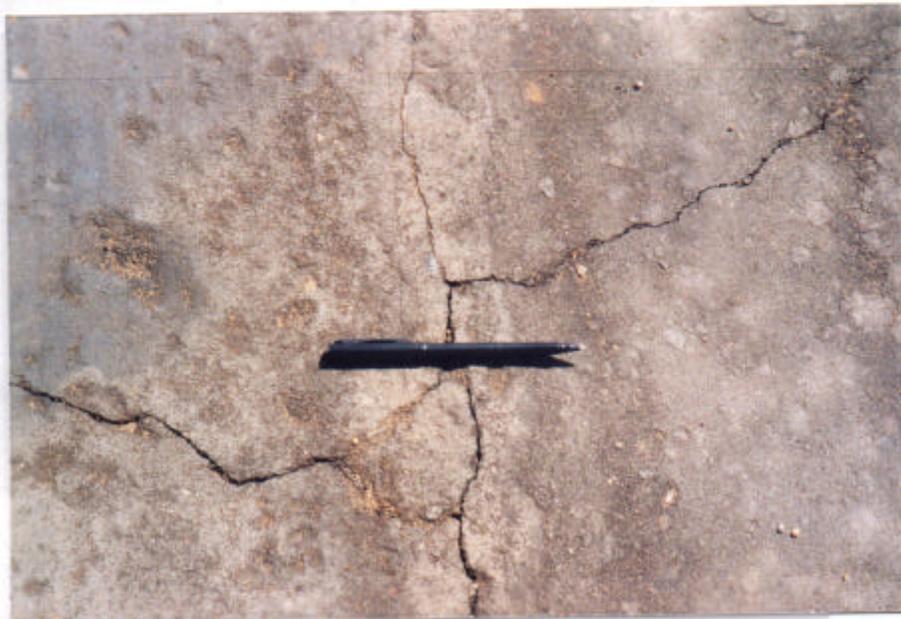
Figure 4.23 High severity cracks in section 4, cement-fly ash, twenty-eight day.

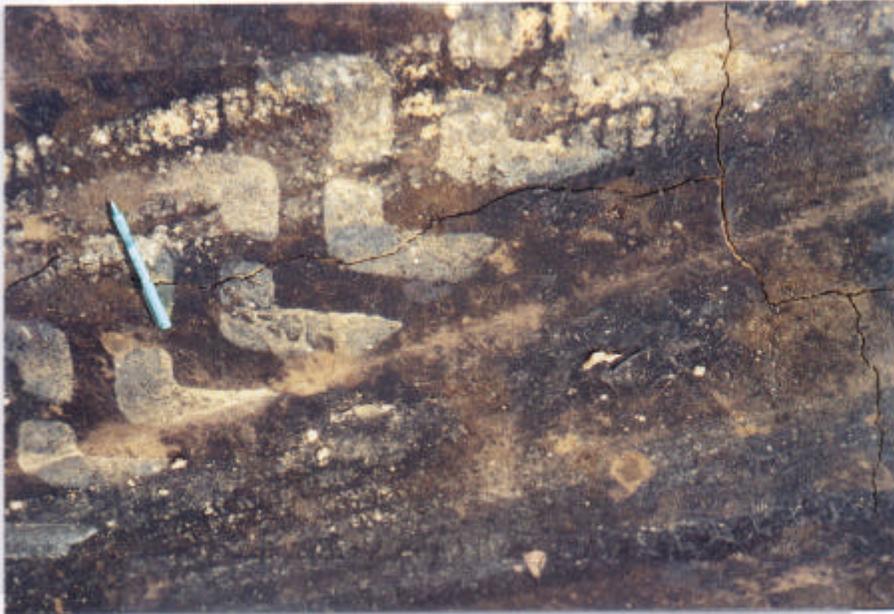
Figure 4.24 High severity cracks in section 6, lime – fly ash, 241 + 50, fourteenth day.

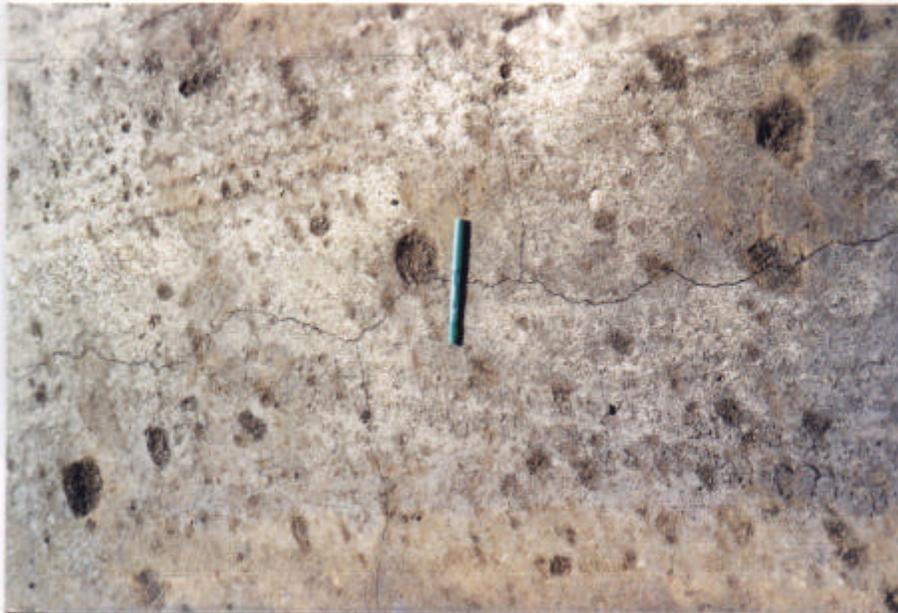
Figure 4.25 Typical crack in lime – fly ash section, 189 + 50, approximately twentieth day.

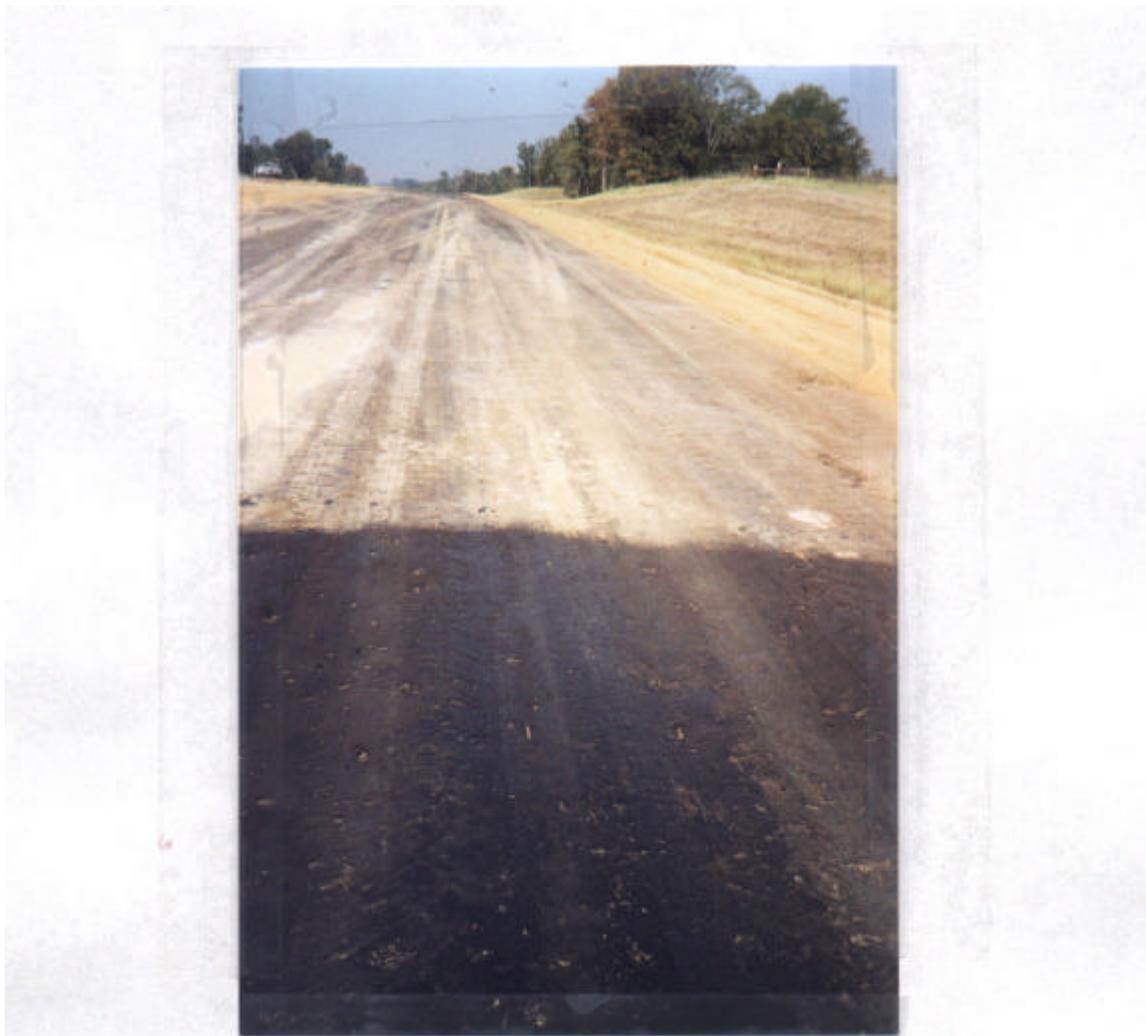
Figure 4.26 Comparison of emulsion retained, section 6 (alternate) in the foreground and section 6 in the background, fourteenth day.

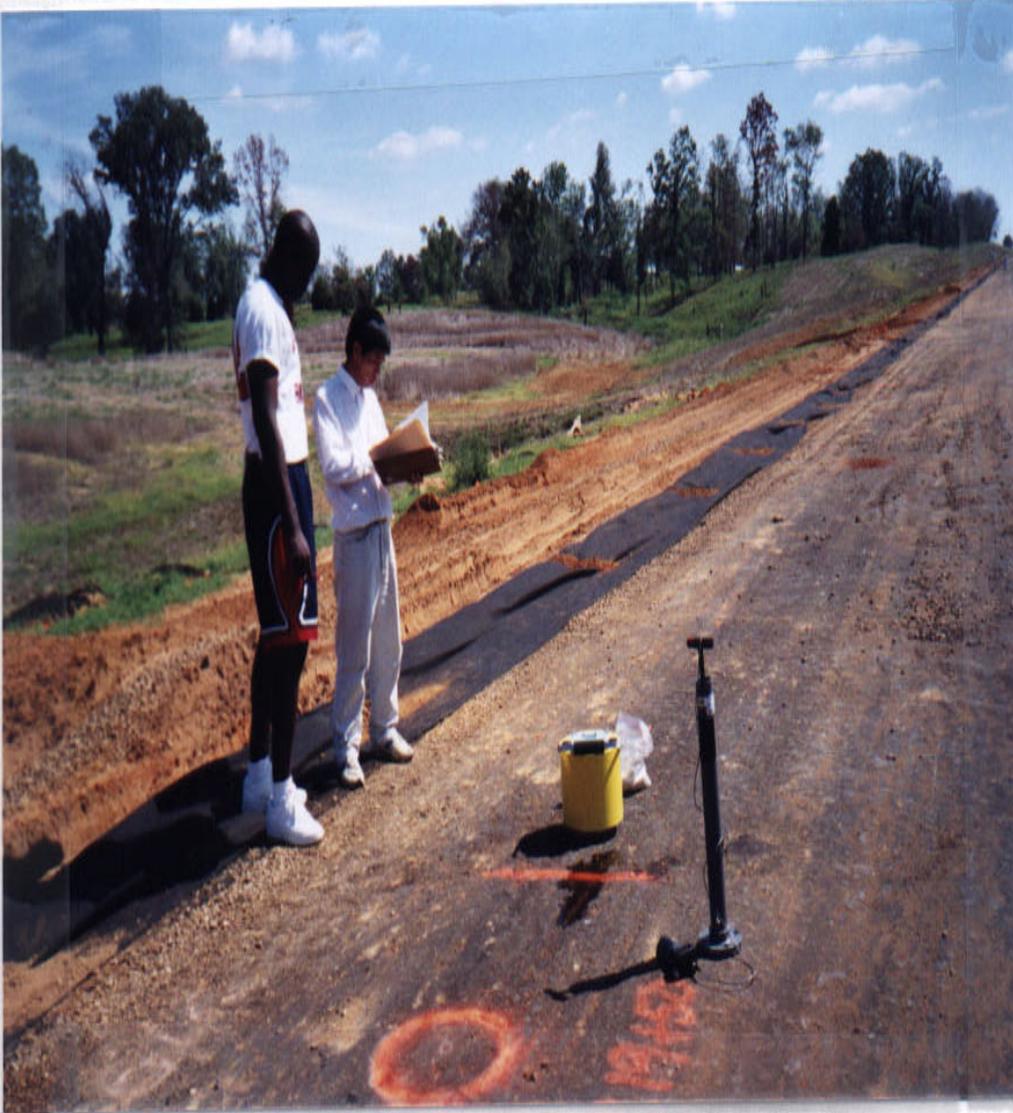
Figure 4.28 View of geogauge (left) and Clegg impact hammer (right).

presented in Figure 4.27 (31). Figure 4.28 is a view of the test in progress, with geogauge on the left and the Clegg hammer on the right. This impact-testing device, despite not being recognized as a standard test, was beneficial in evaluating the strength gain of stabilized material as time progressed. Note that at early stages, good cores could not be obtained. Clegg hammer strength values obtained at four, seven and 28 days are tabulated in Table 4.4.

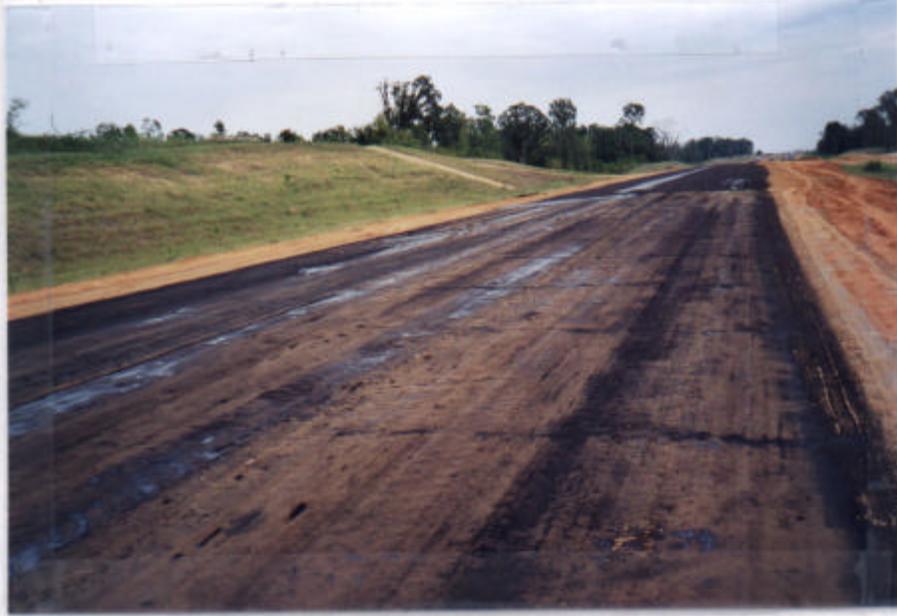
Figure B1 Section 1B (precut) in the foreground and section 2 in the background. Contrast in emulsion application.

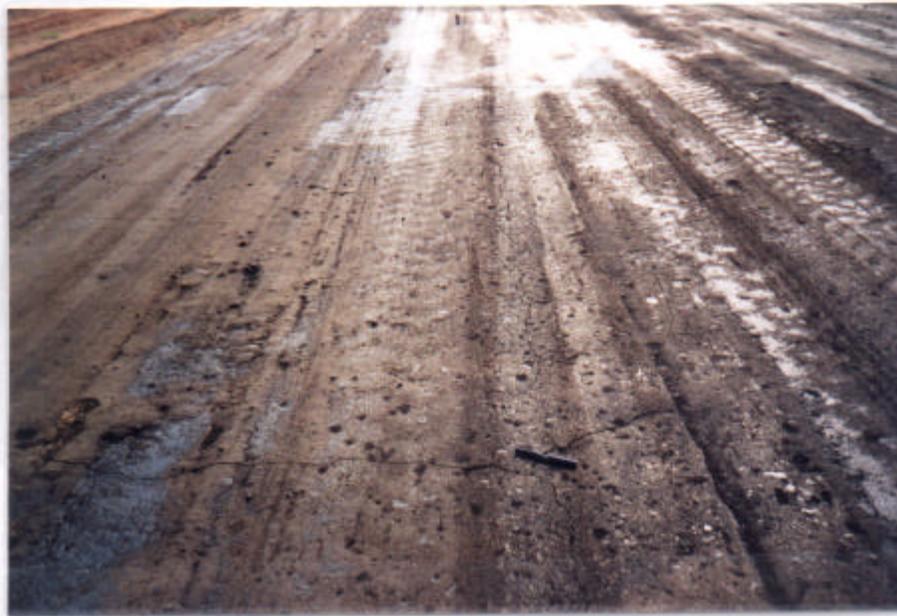
Figure B2. Medium severity crack in section 1A, control cement, nineteen days.
