# SOIL STABILIZATION FIELD TRIAL

INTERIM REPORT

DEPARTMENT OF CIVIL ENGINEERING  
UNIVERSITY OF MISSISSIPPI

The University of Mississippi  
University, Mississippi  
April 2001

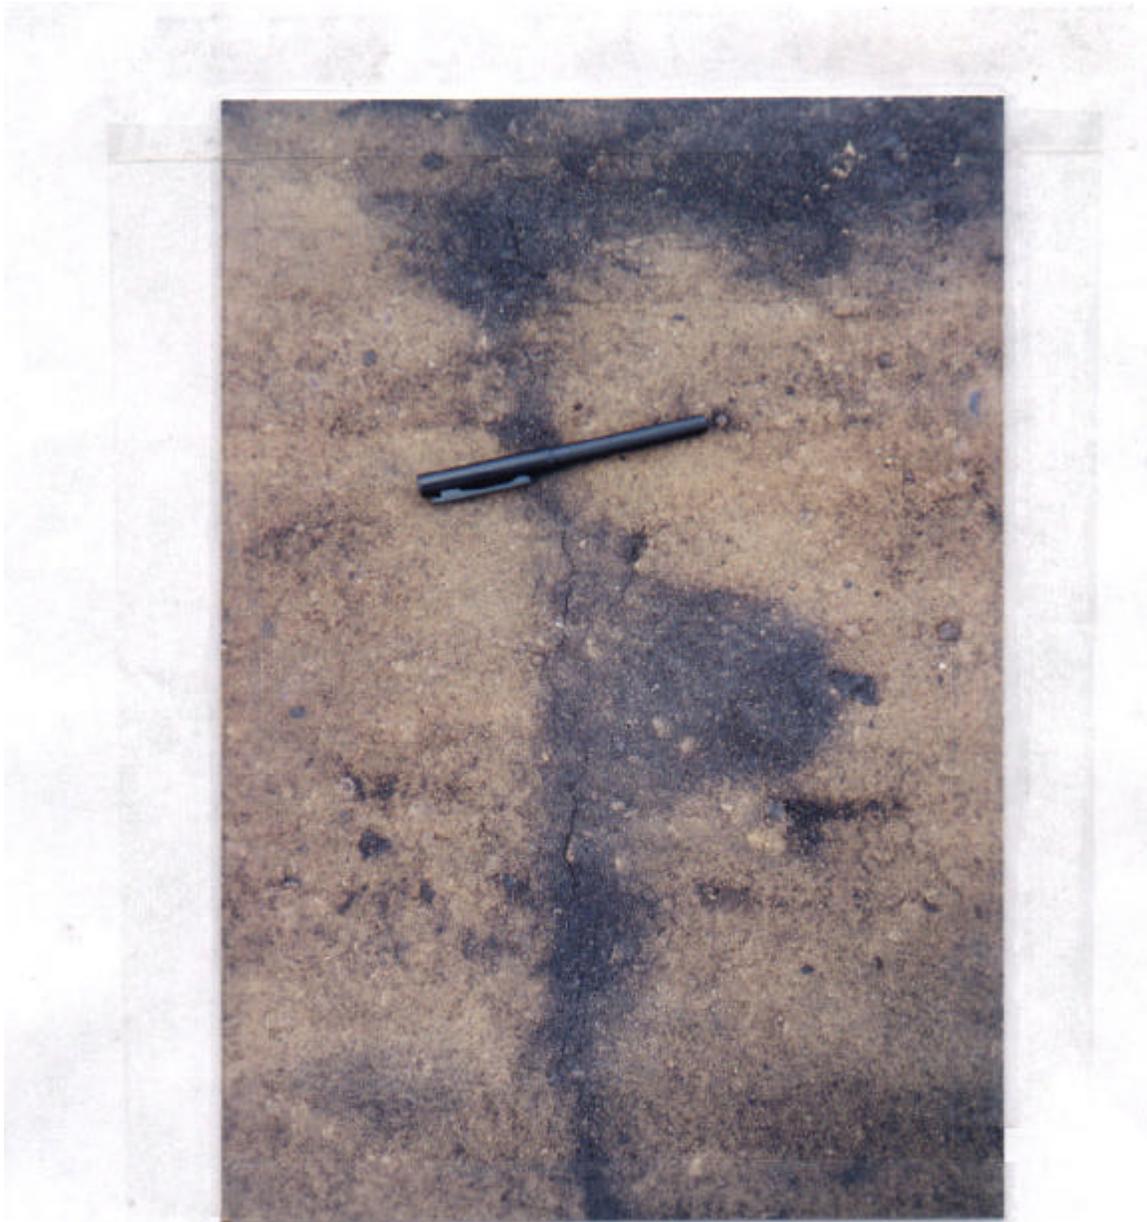
Figure B3 Transverse crack along a precut groove, section 1B, seventh day.

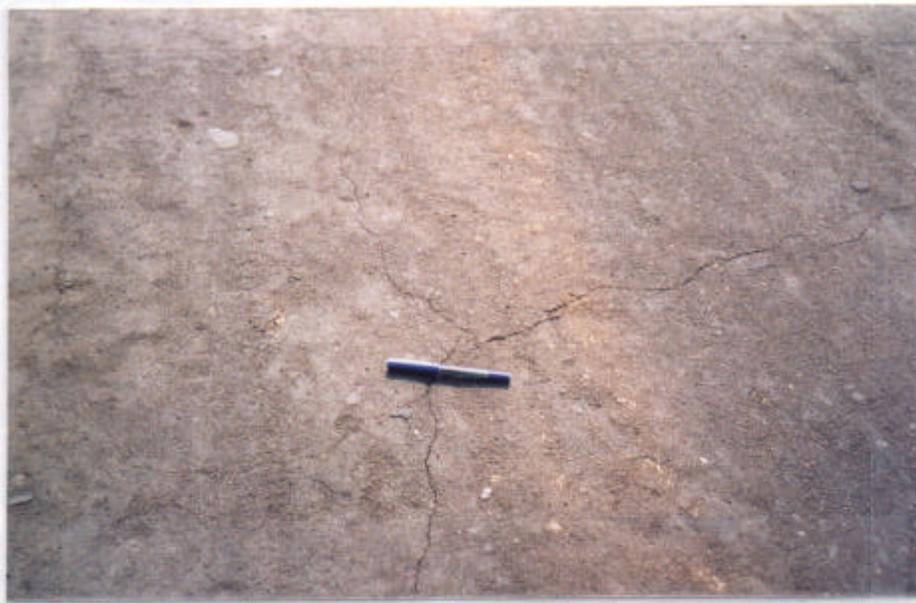
Figure B4 Transverse and longitudinal cracks in section 2 (precracked), nineteenth day.

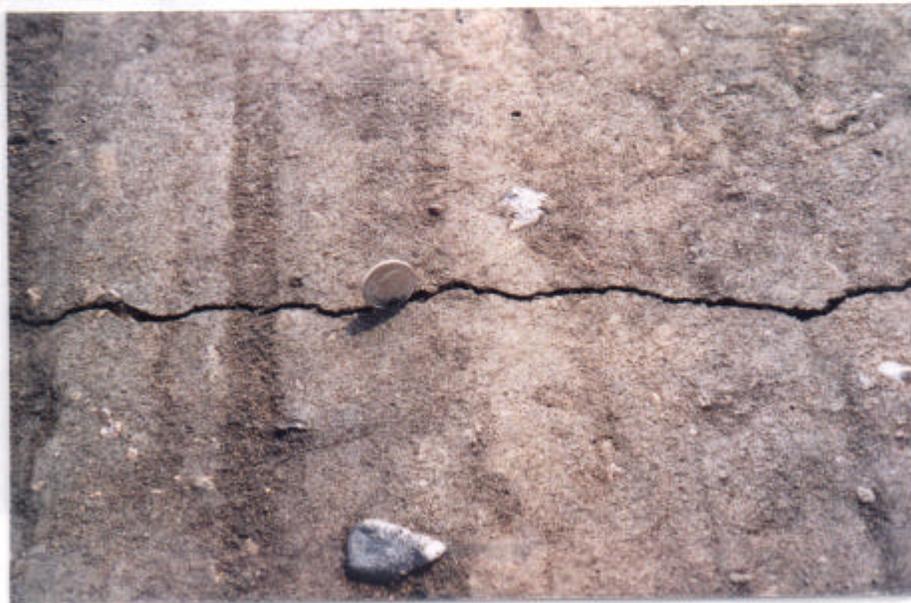
Figure B5 High severity longitudinal crack in section 4, cement – fly ash, 221 + 50, nineteenth day.

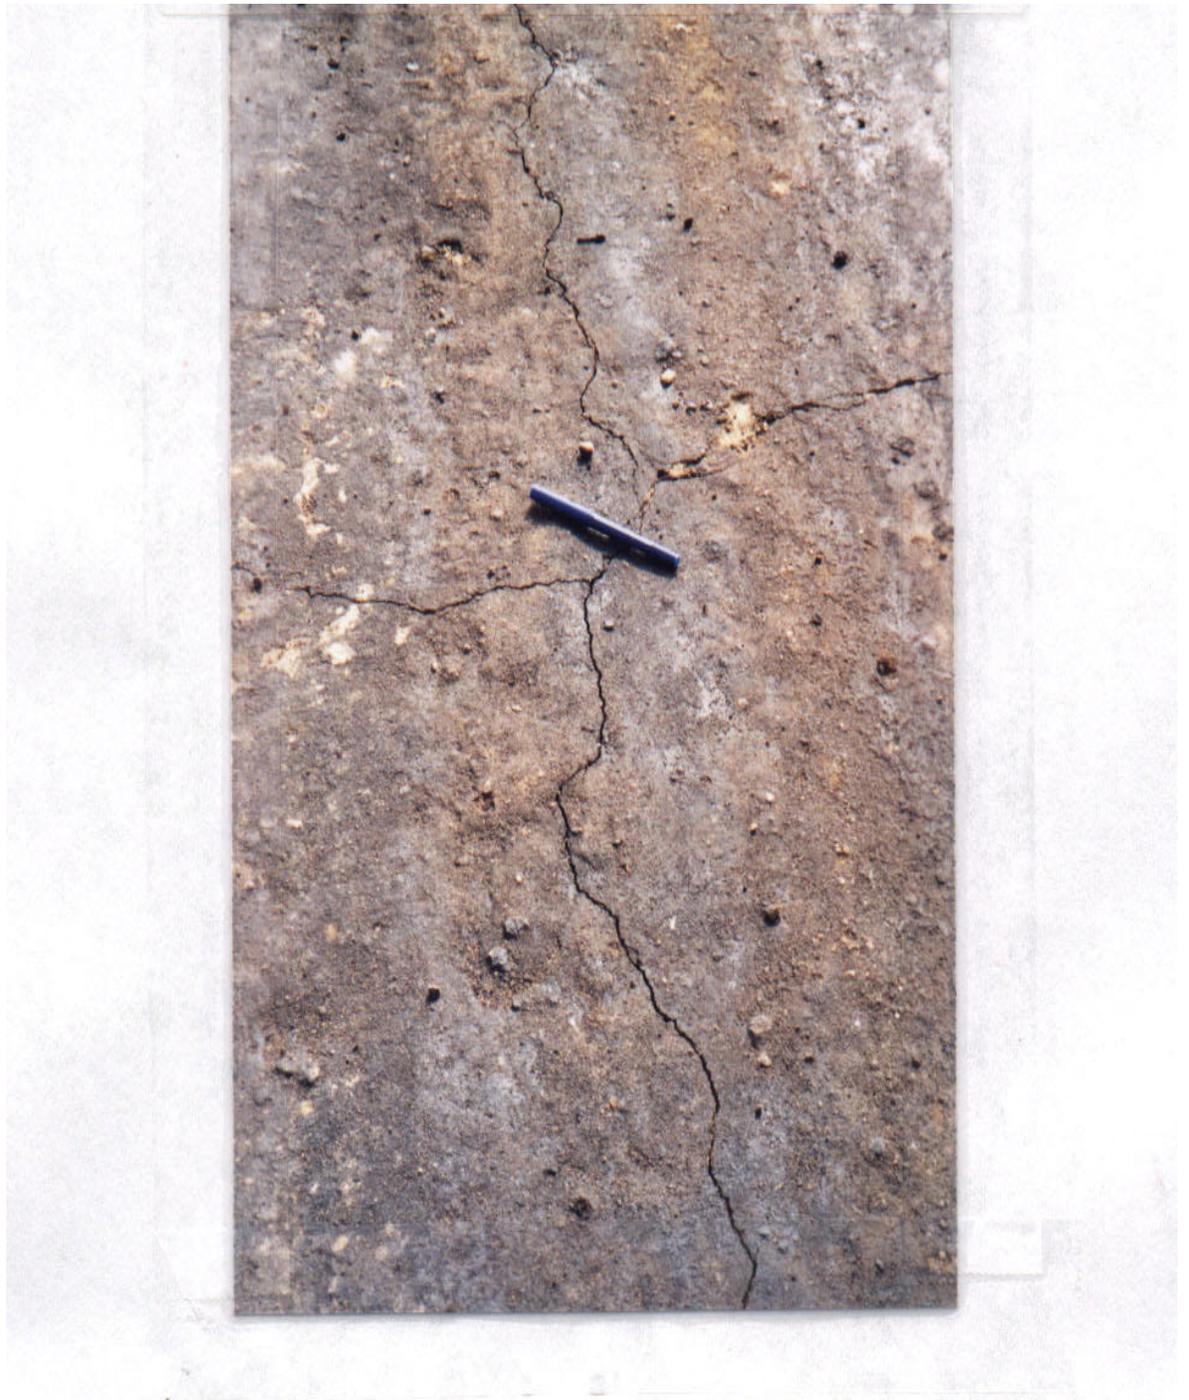
Figure B6. Medium severity crack in section 5, lime – GGBFS, nineteenth day. Curing compound completely vanished.

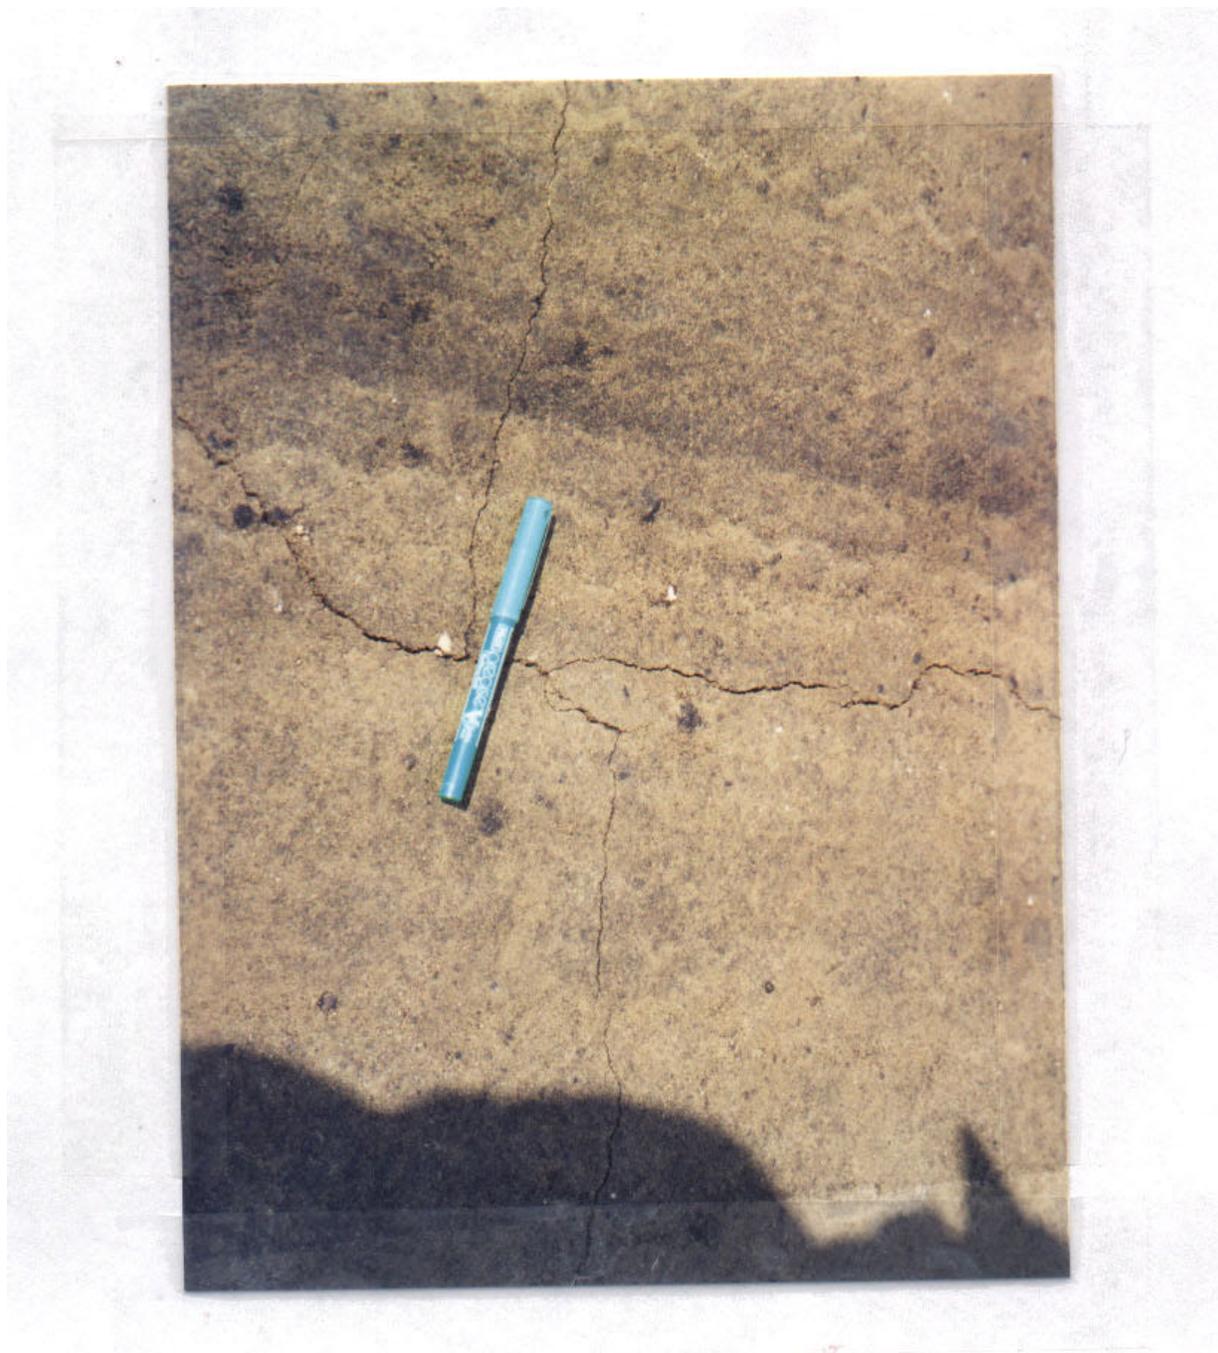
Figure B7. Meandering cracks in lime – fly ash section, 14 days.

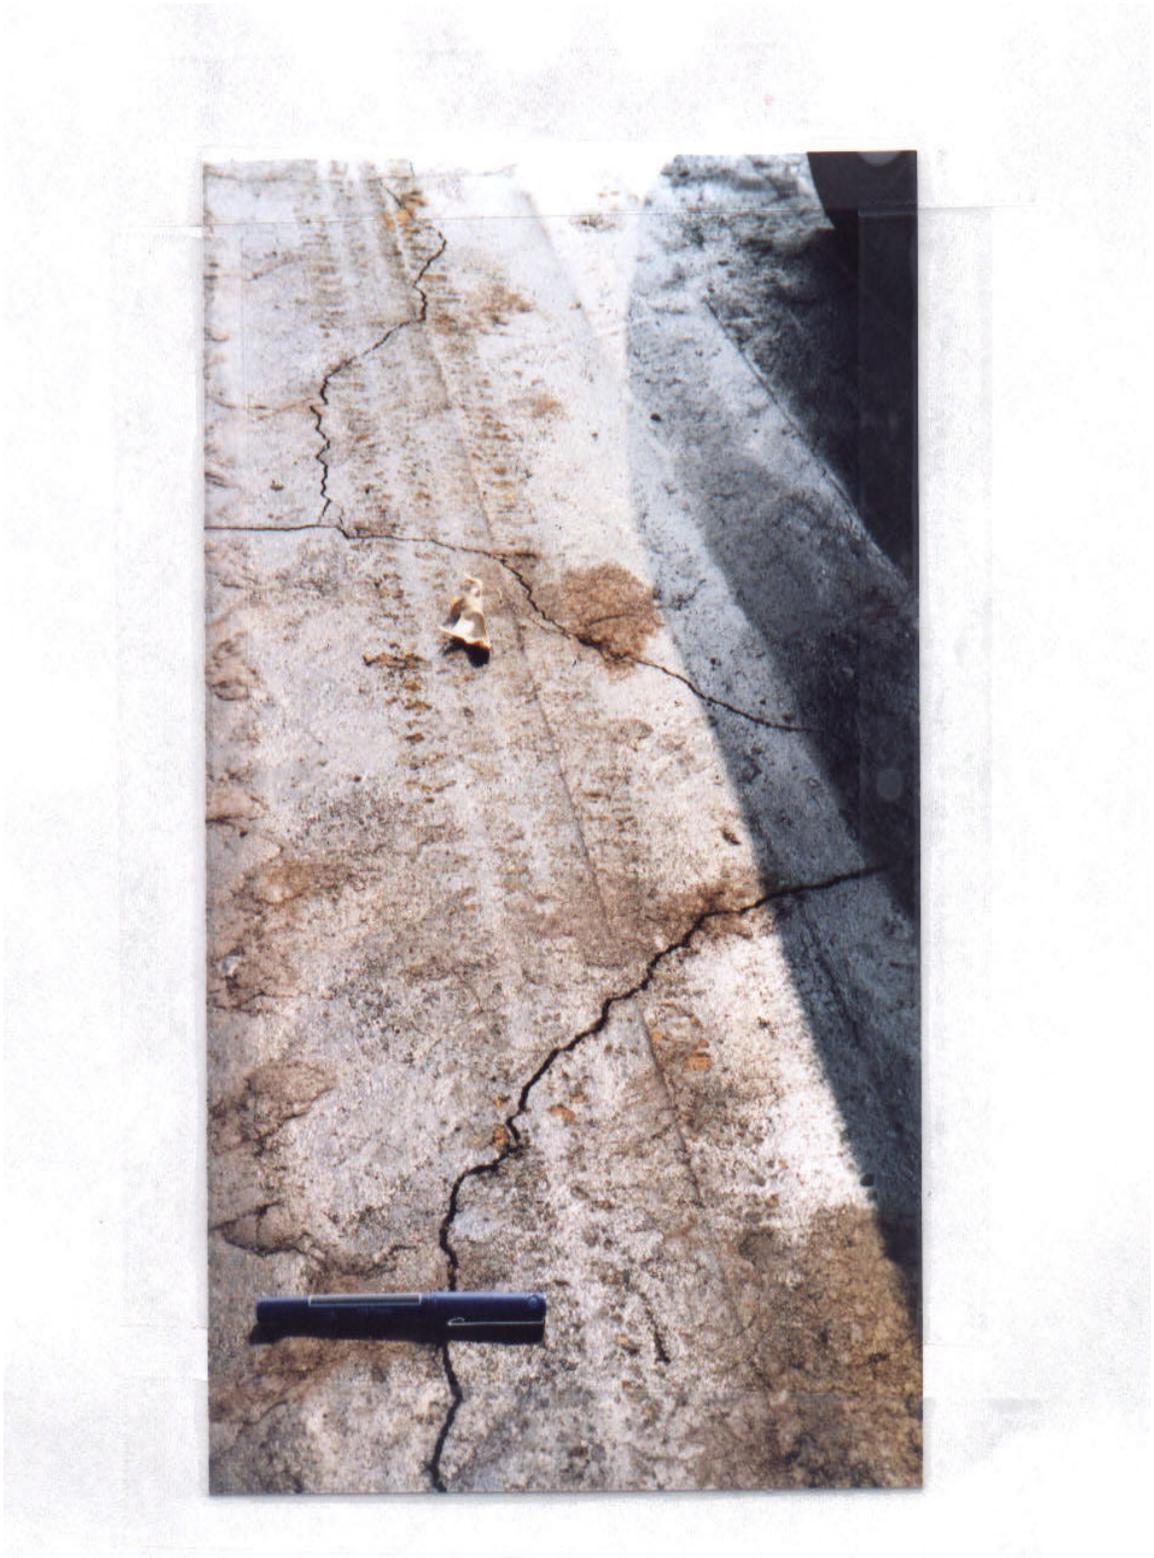
Figure B8. High severity cracks in lime – fly ash section, 241 + 50, nineteen days.

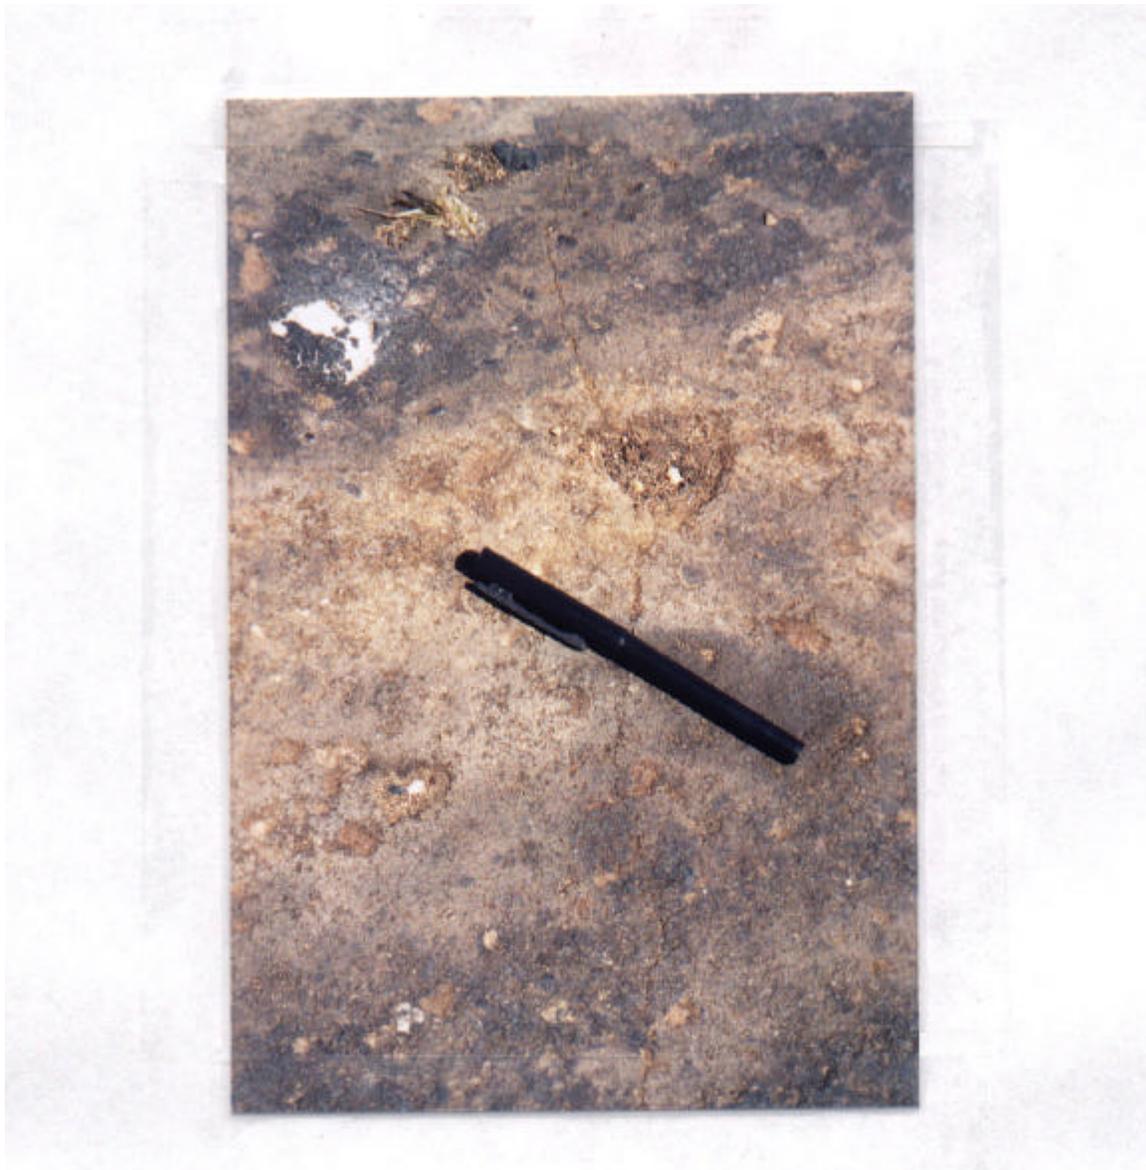
Figure B9. Fine crack in lime – fly ash section, section 6 (alternate), twenty eight days.
