Construction Monitoring of Paving Fabrics Systems to Reduce Reflective Cracking

INTERIM REPORT

Farshad Amini & Bradnado Turnquest
Department of Civil & Environmental Engineering
Jackson State University

August 2008

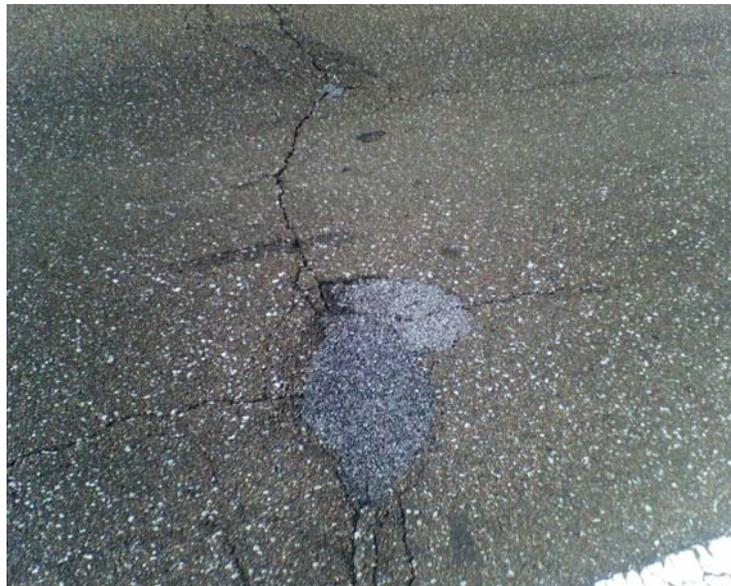
Figures 1 and 2 show typical transverse and longitudinal cracks in the pavement. This portion of roadway indicates many distresses in asphalt pavements including spalling and transverse cracking with the need for milling, sealing, and overlay. There were cracks of considerable lengths and widths, small pot holes, and sections with uneven roadway. These characteristics made this part of roadway a suitable location for research purposes.

Figure 1. Typical Cracks in the Pavement

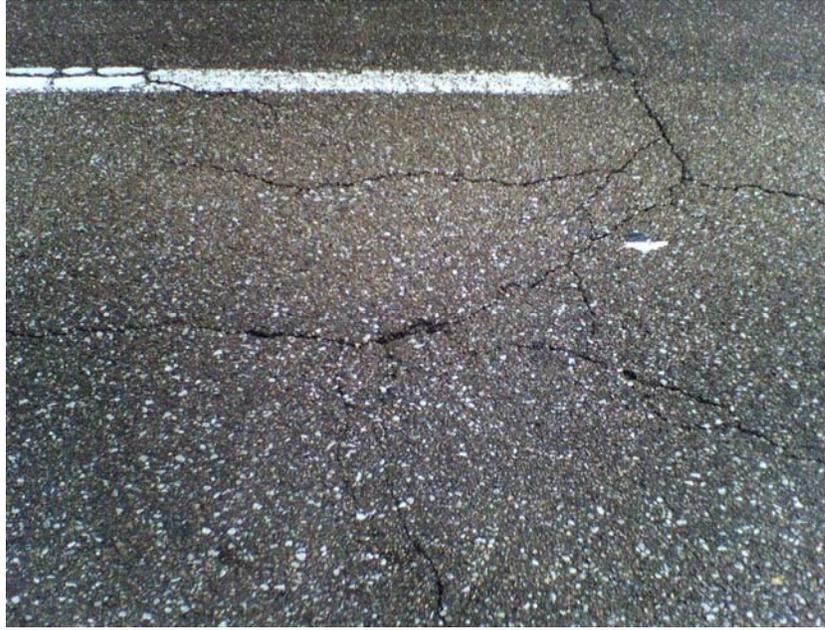
Figure 2. Typical Cracks in Pavement

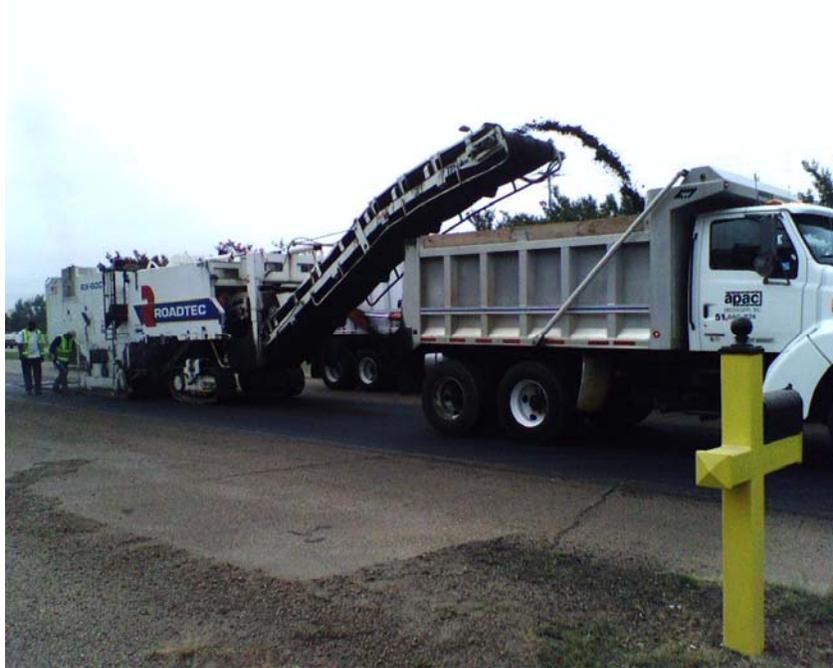
(shown in Table 2). The section was milled 1 ½-inch deep and approximately 12-ft wide. It was then brushed to remove all loose asphalt and excess dust. Figures 3, 4, and 5 show the milling process, brushing, and the complete milled test section, respectively. The specifications indicated a tack coating application rate between 0.22 to 0.30 gallons per square yard and the wrinkles in the fabric were less than ½ inch. However, all of the valves on the mobile truck used to apply the tack coat were not open, resulting in a non-uniform application which was not accepted by project engineers and inspectors. As a result, multiple runs on the section were performed to obtain uniformity. After a day of offsite testing, the problem was resolved and the adequate tack coating application rate, as determined on the test section, was 0.25 gallons per square yard. The construction daily reports are included in Appendix IV.

Figure 3. Milling of Test Section

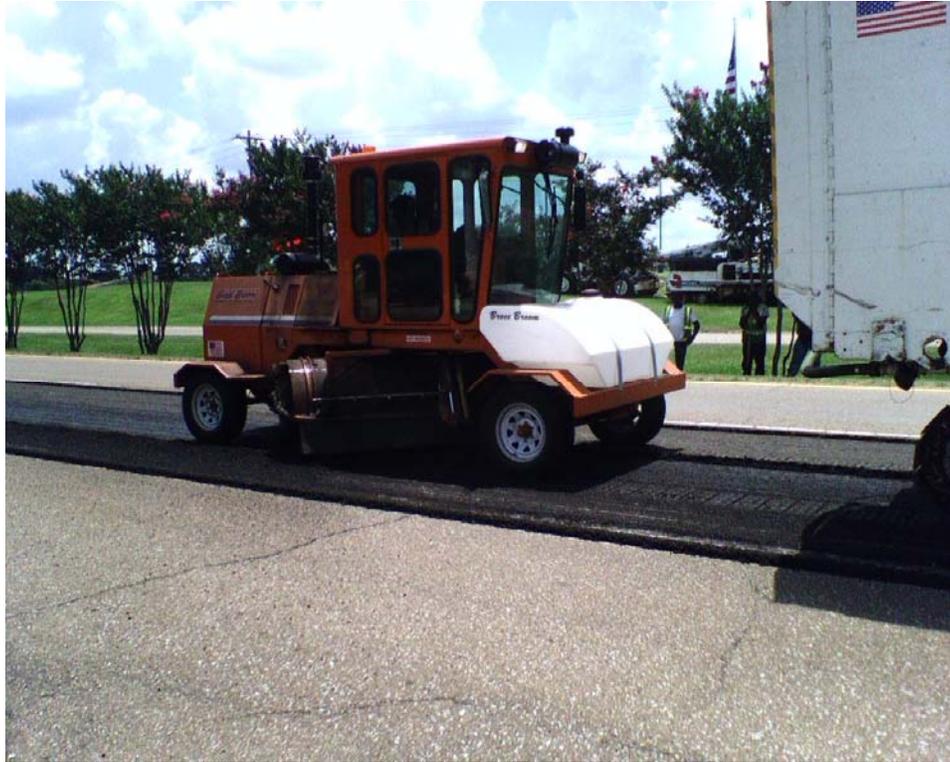
Figure 4. Brushing after Milling of Test Section

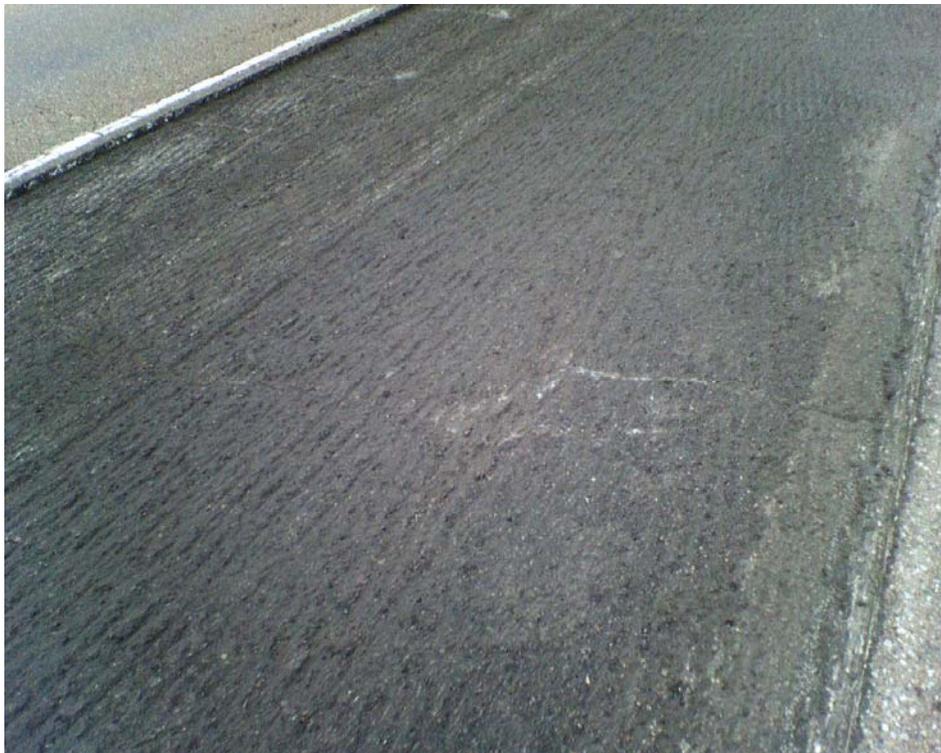
Figure 5. Milled Test Section

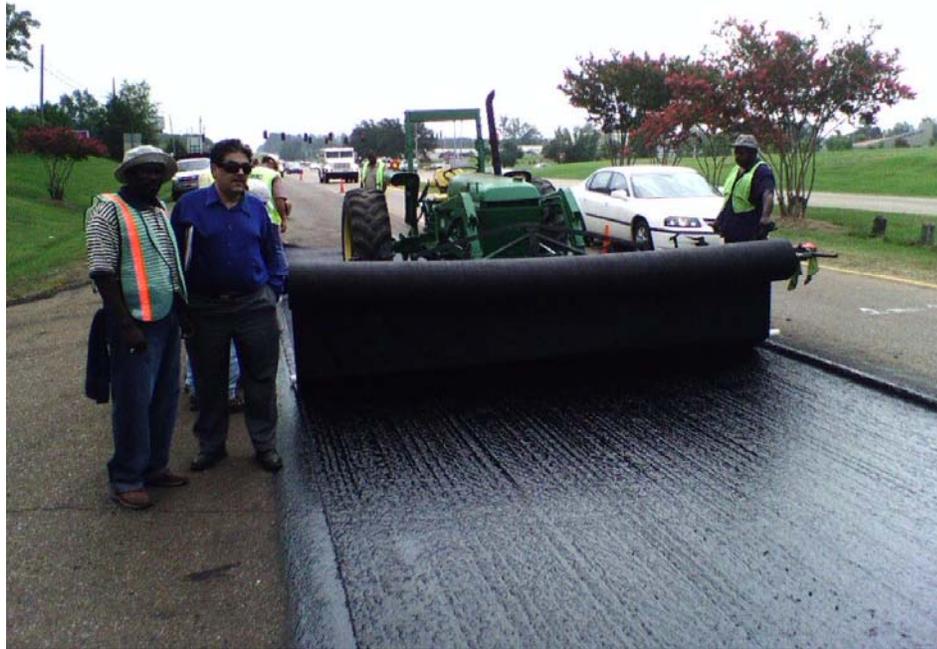
When placing the paving fabric, special care was taken to ensure that the wheels from the tractor, equipped with an attachment that allowed the placement of a roll of fabric on the road surface up to 12 ½-ft, did not damage the fabric. In addition, the fabric was inspected to ensure that there was not excess bleeding through the fabric from the tack coat (see Figures 6 through 9). For this to be accomplished, the driver kept the turning of the equipment wheel to a minimum and made sure that the fabric was kept in full tension during placement, to reduce wrinkles. After placement, all excess wrinkles were pulled out by hand, rolled with a steel roller and allowed to adhere to the tack coating before paving overlay could begin.

Figure 6. Placing Fabric on Test Section

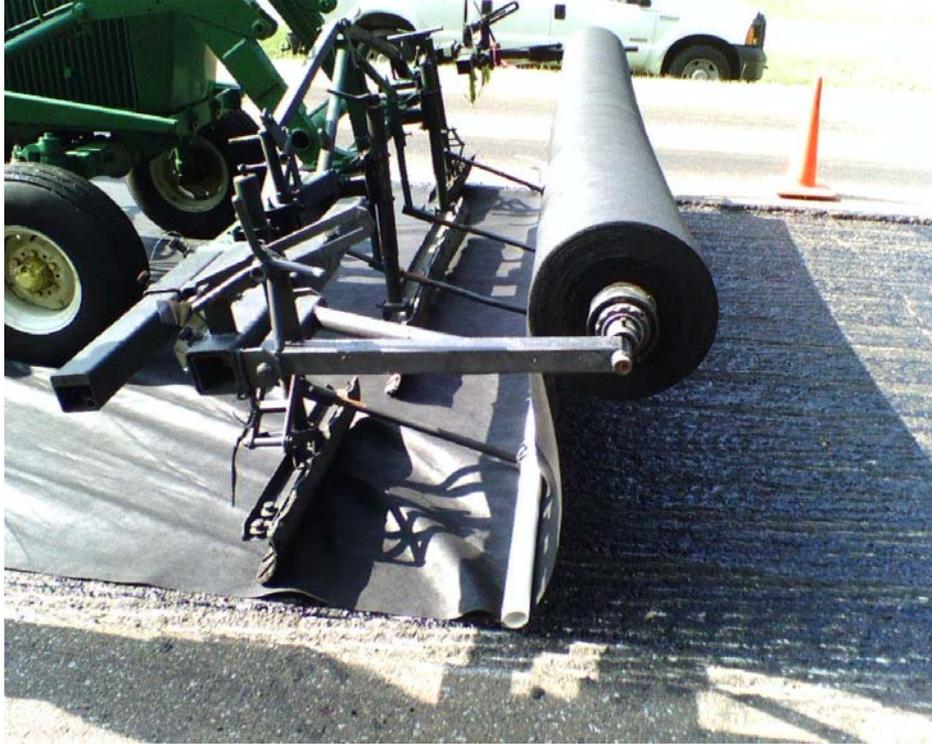
Figure 7. Placement of Paving Fabric

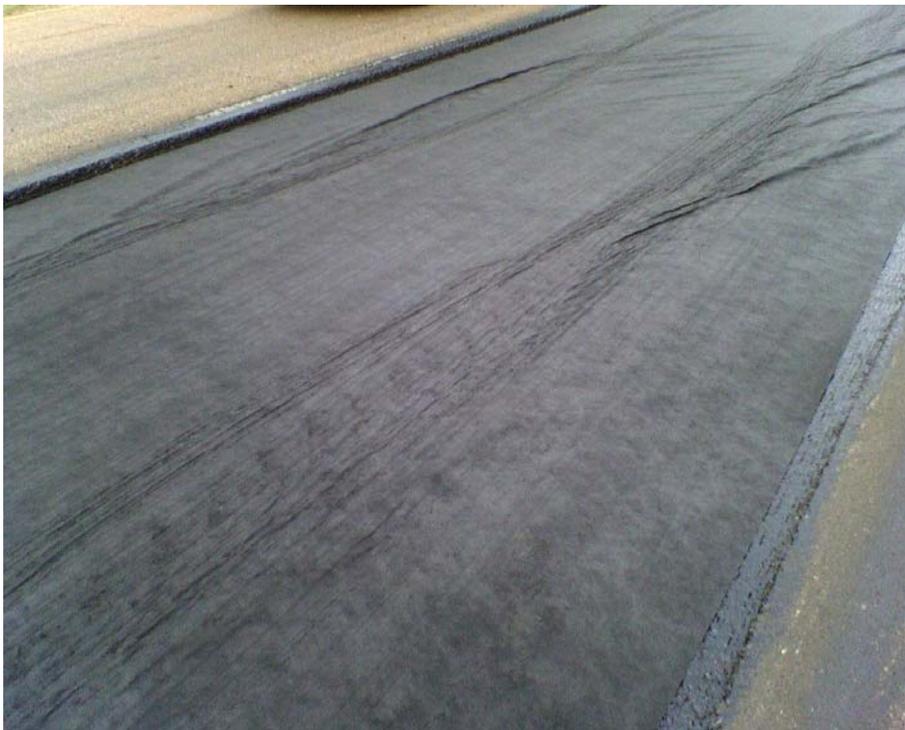
Figure 8. Wrinkles after Placement of Fabric

Second, it is always best to remove the wrinkles from the paving fabric during (preferred) or directly after placement of the fabric on the roadway, which will reduce the man power needed and time spent removing wrinkles. This process is very important, particularly in situations where the sections are long and there are only one or two workers assigned to this specific duty, as experienced on this project. Allowing the fabric to completely bond to the tack coating, particularly on the milled sections, poses significant problems in wrinkle removal, and ultimately results in damaging the fabric due to excess tensile stress. In situations where complete bonding becomes a problem, wrinkles have to be cut, which could create voids, and result in areas where cracks could propagate in the future.

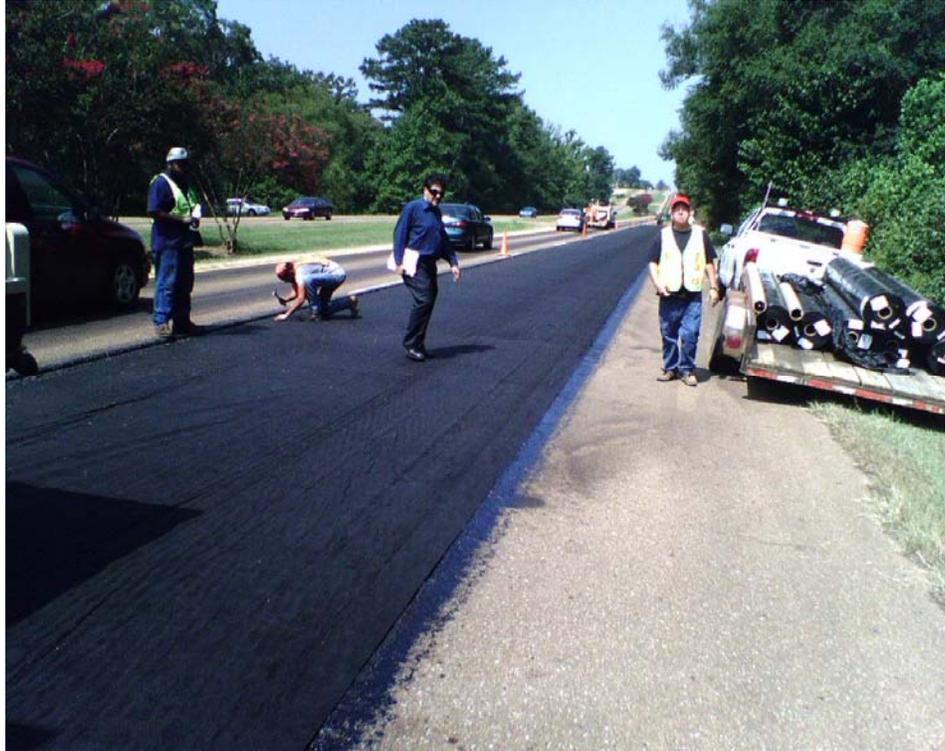
Figure 9. Engineer Inspecting of Fabric after Placement

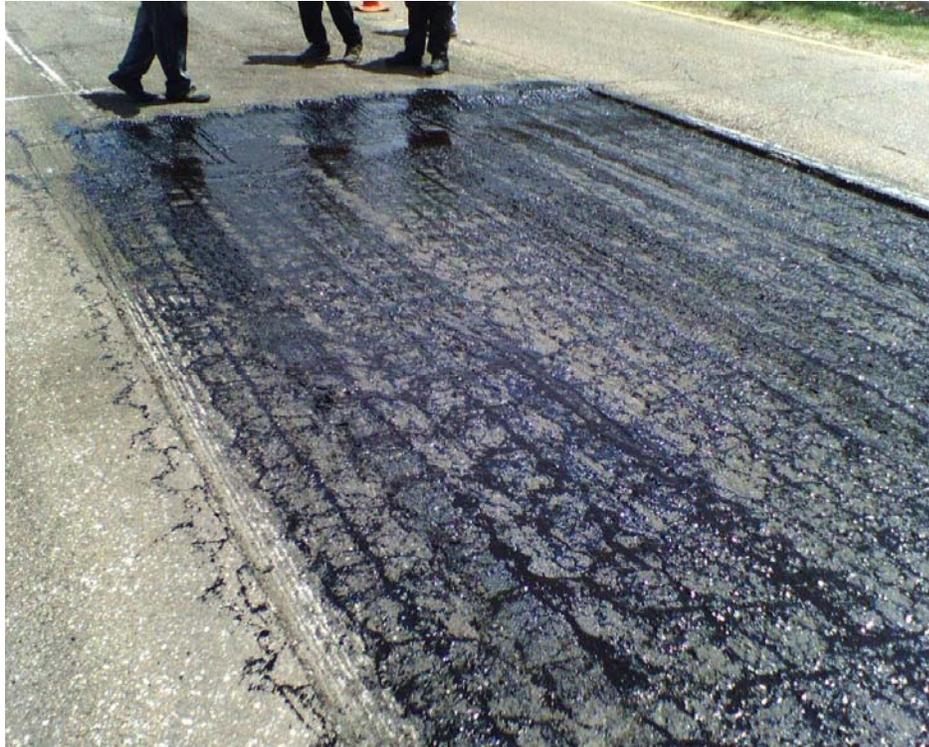
The test section was constructed with the same equipment, personnel, and application rate that will be used during construction. When the contractor demonstrated the ability to apply the tack coating and to place the paving fabric in the test section in accordance with the specifications, Burns Cooley and Dennis, Inc. cut cores in the test section, and the construction of the research sections commenced. However, when the contractor was unable to demonstrate the ability to install the tack coating and paving fabric, construction was not allowed to resume until the necessary adjustments were made (see Figures 10-12). Additional pictures are shown in Appendix V.

Figure 10. Non Uniform Tack Coat on Test Section

First, special care must be taken to ensure that there is uniform tack coating applied to the surface at an adequate rate so that the paving fabric adheres uniformly without any blotching or excess bleeding. Inadequate coating could result in loose fabric that does not perform as expected and allow cracks to propagate from the existing surface. In most cases, the tack coat application rate was less for non-milled pavement surfaces than that for milled surfaces. If the same rate is used on both surfaces there may be a problem with bleeding through the paving fabric, which ultimately will stick to equipment tires and further damage the fabric. Hence, for future projects it may be appropriate to construct two test sections for both milled and non-milled sections to determine the correct tack coating application rates. In addition, it was important to perform onsite measurements of the application rates to ensure that the readings and measurements from machines and equipments were correct.

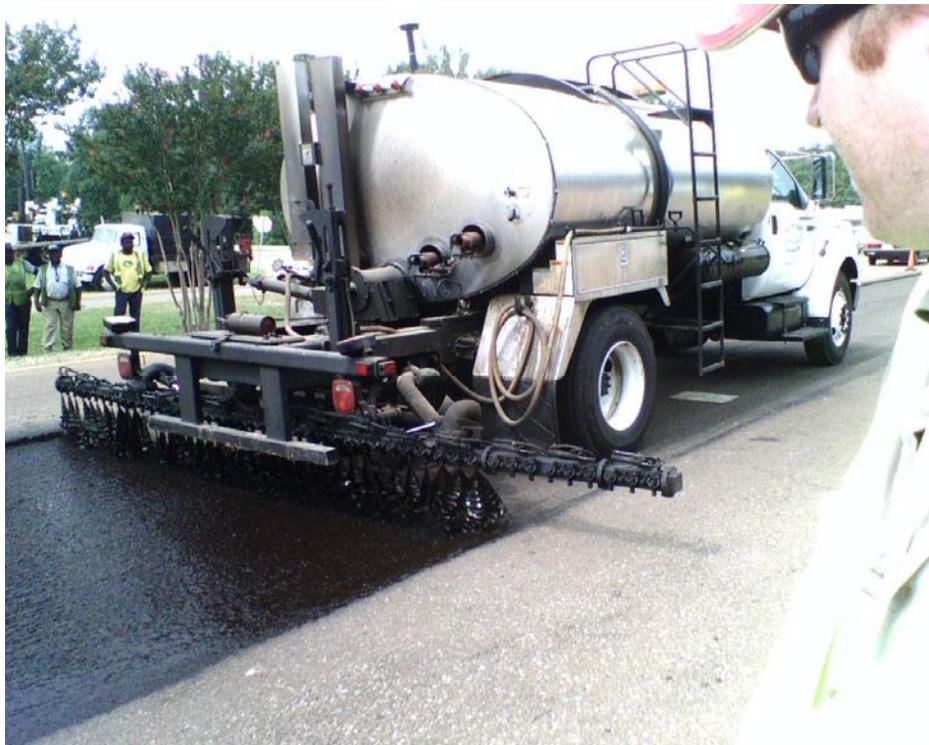
Figure 11. Applying Uniform Tack Coat on Test Section

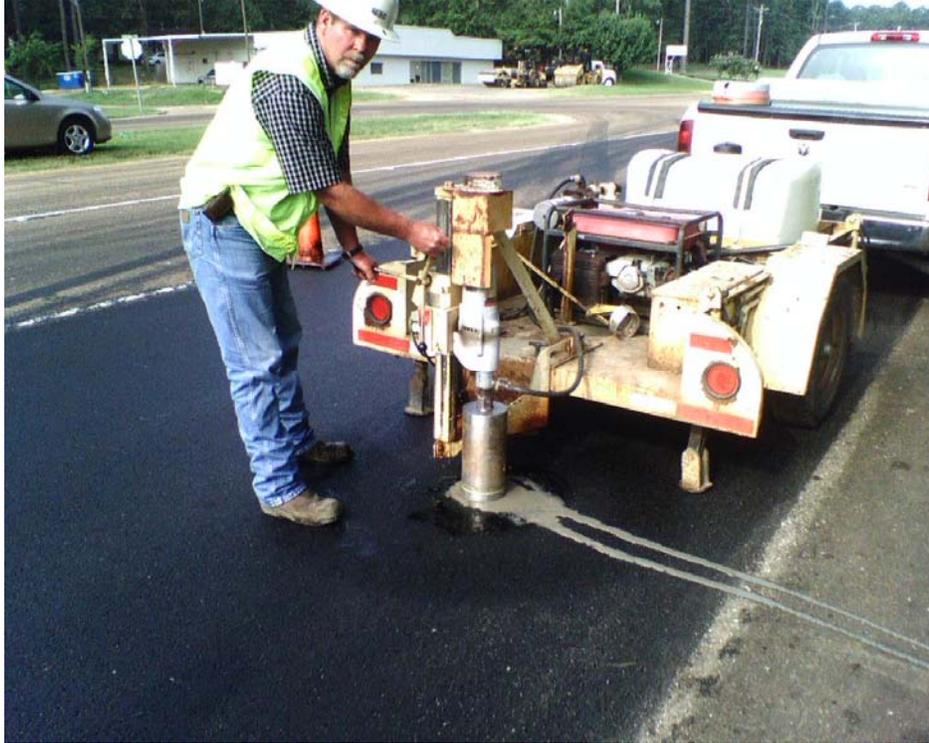
Figure 12. Cutting Core after Paving of Test Section

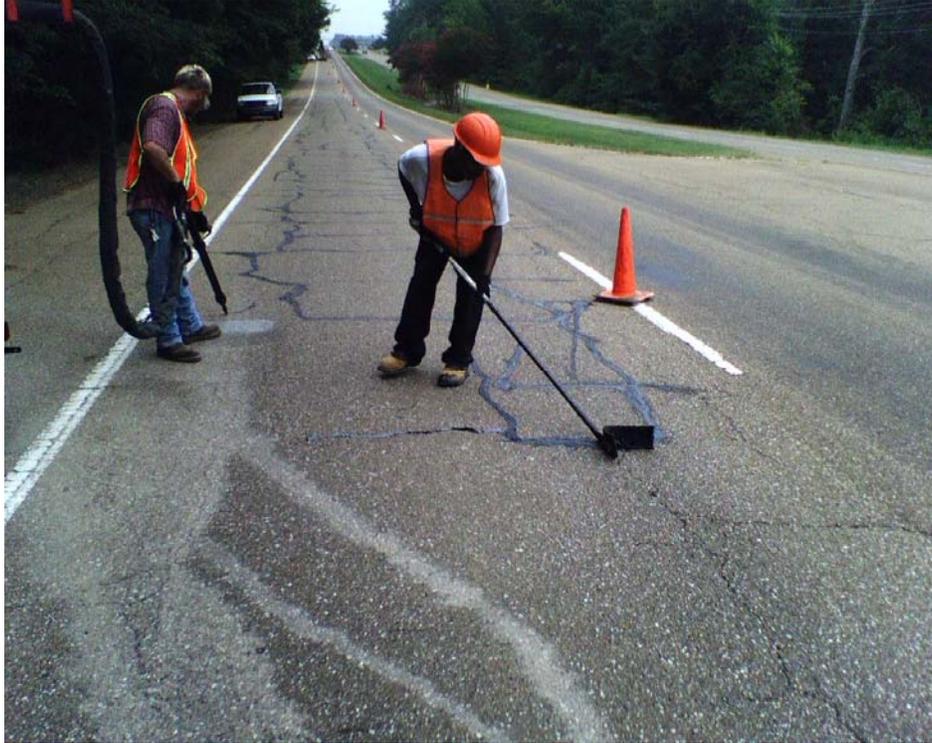
Measures of crack severity were studied and recorded prior to construction by MDOT. Some sections had more severe cracks than others (see Figures 1, 2 and 13). The engineers recorded the number and length of transverse cracks at the beginning and end of each research section. In sections requiring sealing, cracks were cleaned thoroughly using a high pressure blower by Sunbelt Sealing, Inc. before applying emulsion. A special metal tool was used to spread and compact the emulsion into the cracks to ensure uniformity (see Figures 14 through 16). Traffic was not allowed on the sealed cracks until they were properly dried.

Figure 15. Sealing Cracks in Section 9

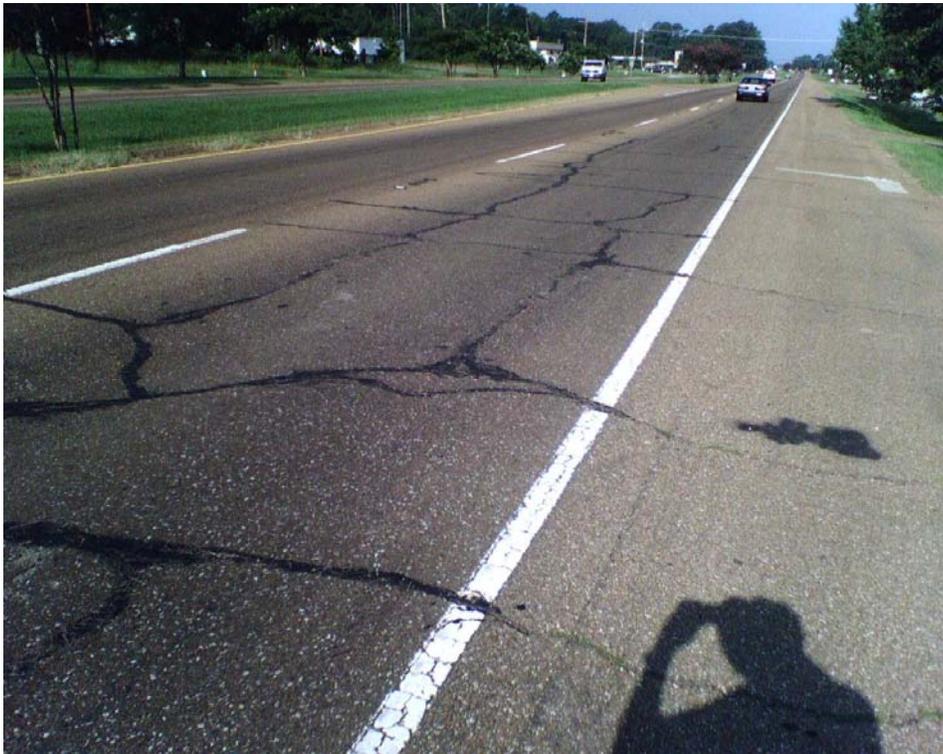
Figure 16. Completion of Sealing in Section 11

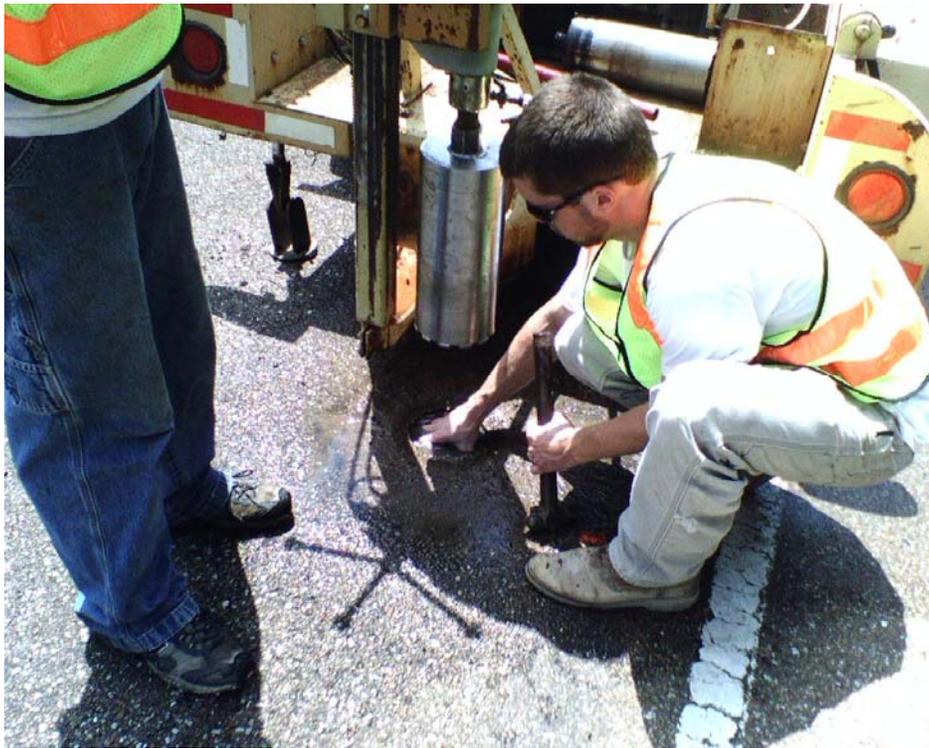
Figure IV-1. Cutting Cores in Section 7

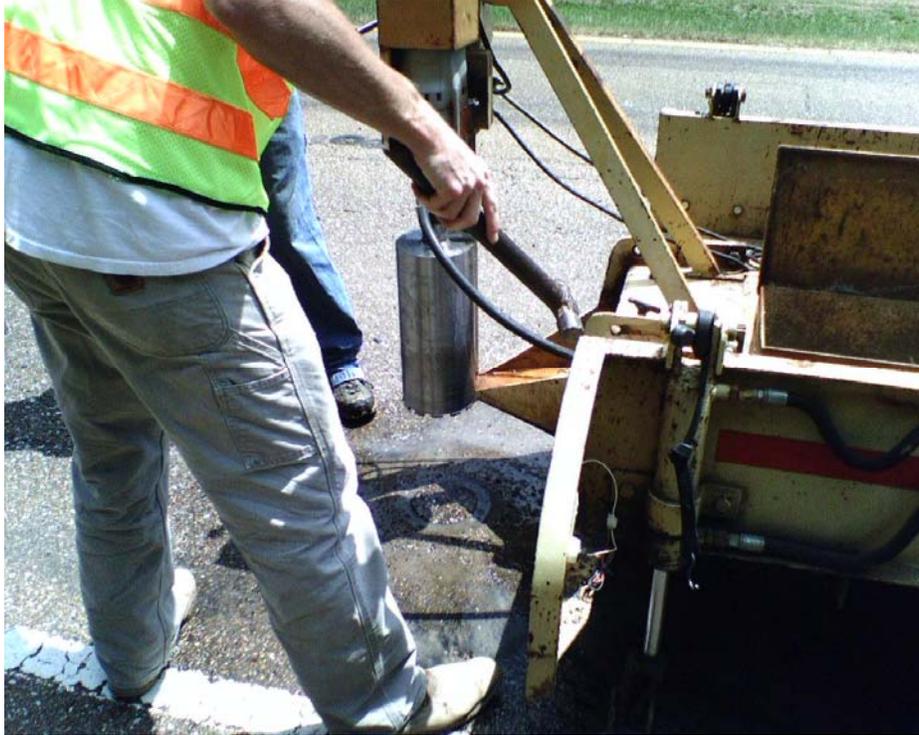
Figure IV-2. Core Cutting Machine

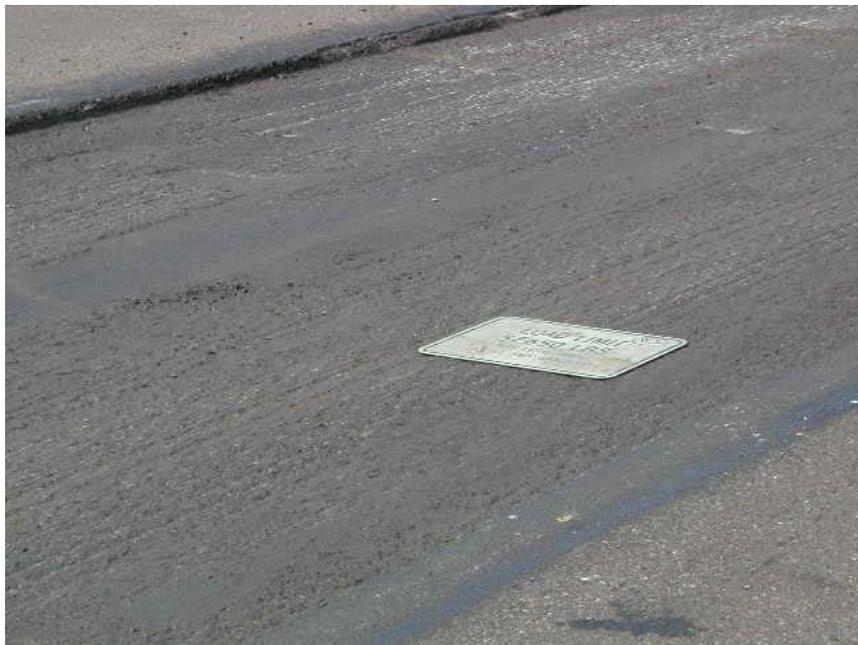
After closing the lane at 8:30am, Mississippi Paving Company milled the 300-ft test section once again as well as sections 1, 2, and 3, from station 295+00 to station 274+50. Before applying tack coat to the 300-ft test section, geotechnical engineers placed square pans with areas equal to 0.2431 square yards on the milled surface to measure the weight of the tack coat to ensure the correct application rate (see Figures 19 and 20). After applying the tack coat, the mass of the coating collected on the pan was 0.35lbs (0.039gals). The calculated rate was 0.16 gal/sq yd, and since the tack coating consisted of 60% emulsion and 40% water (dividing 0.16 by 0.60), the measured application rate was 0.25 gal/sq yd, which was the exact gage reading on the truck.

Figure IV-3. Dry Pan before Tack Coating of Test Section

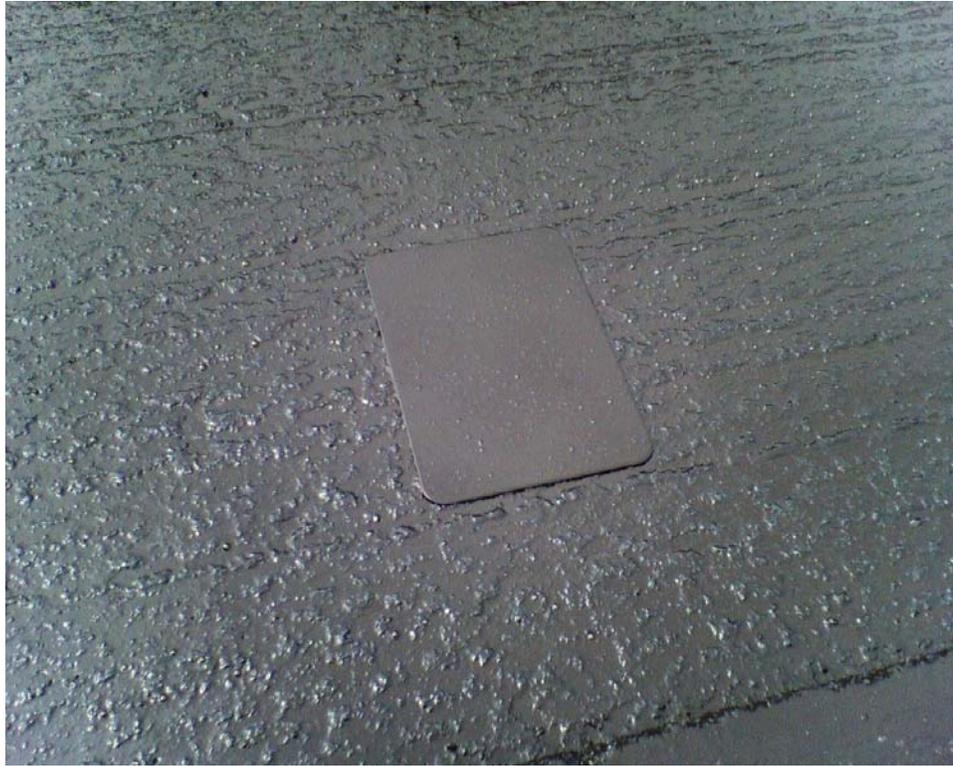
Figure IV-4. Pan used for Onsite Measurement of Tack Coating Application Rate after Tacking

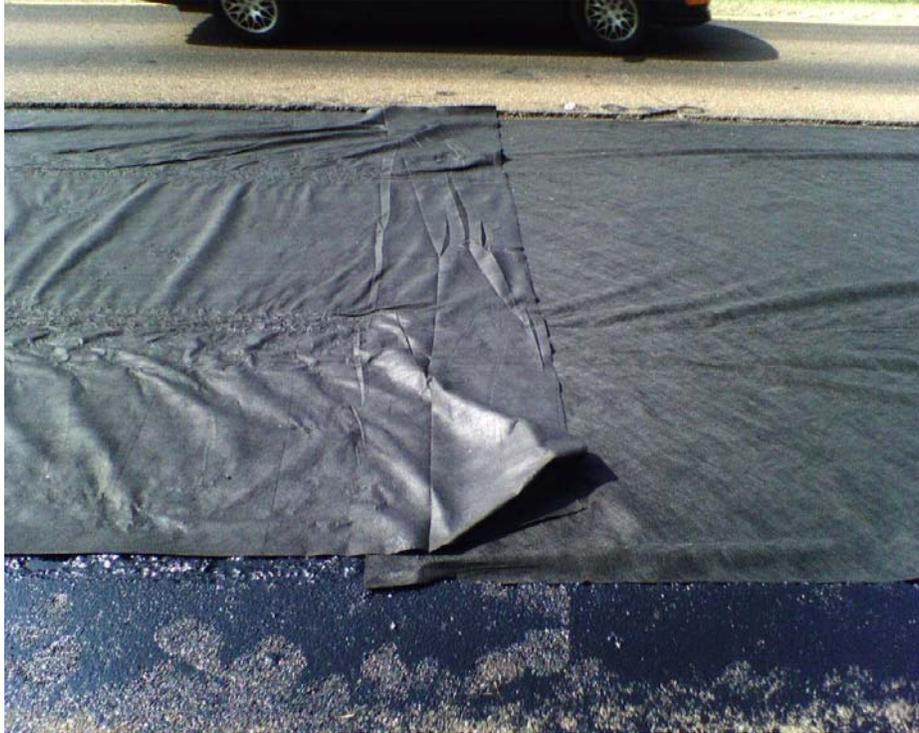
APAC Construction and Mississippi Paving Company removed the key joint at the end of section 1 at station 286+50 at 9:15am. Cheek's Construction then laid paving fabric from the end of section 1 at station 286+00, to the end of section 3 at station 274+50, all at once before paving took place. They then placed fabric in section 6 from station 263+00 to station 258+00. Figure 21 shows a 6" overlap of paving fabric placed from the end of one roll of fabric to the beginning of another.

Figure IV-5. Overlapping Fabric

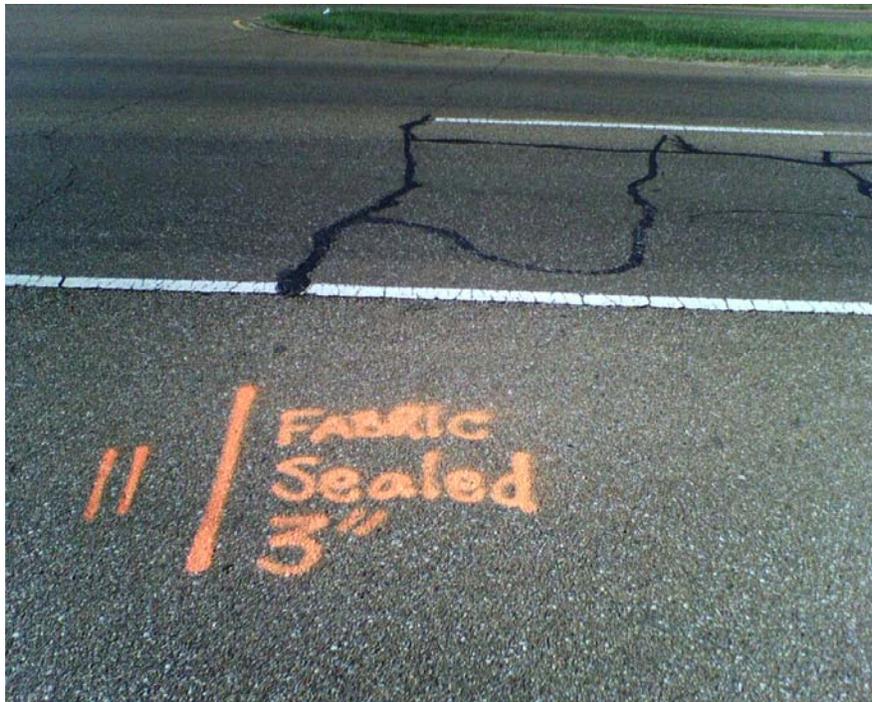
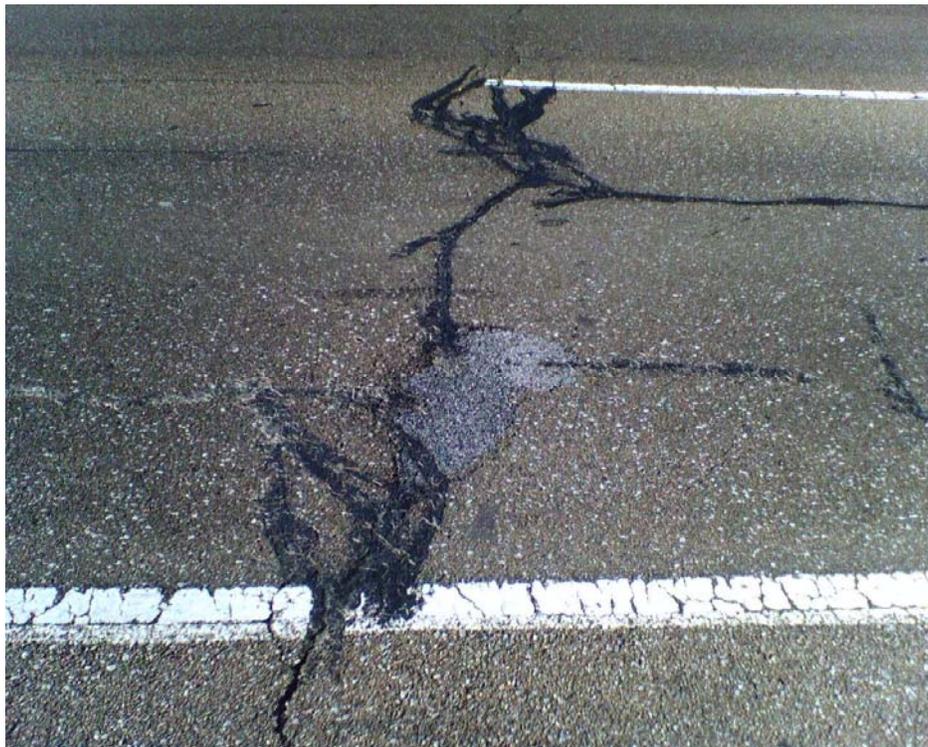
Figure V-1. Sealed Cracks in Section 11

Figure V-2. Sealed Cracks in Section 11

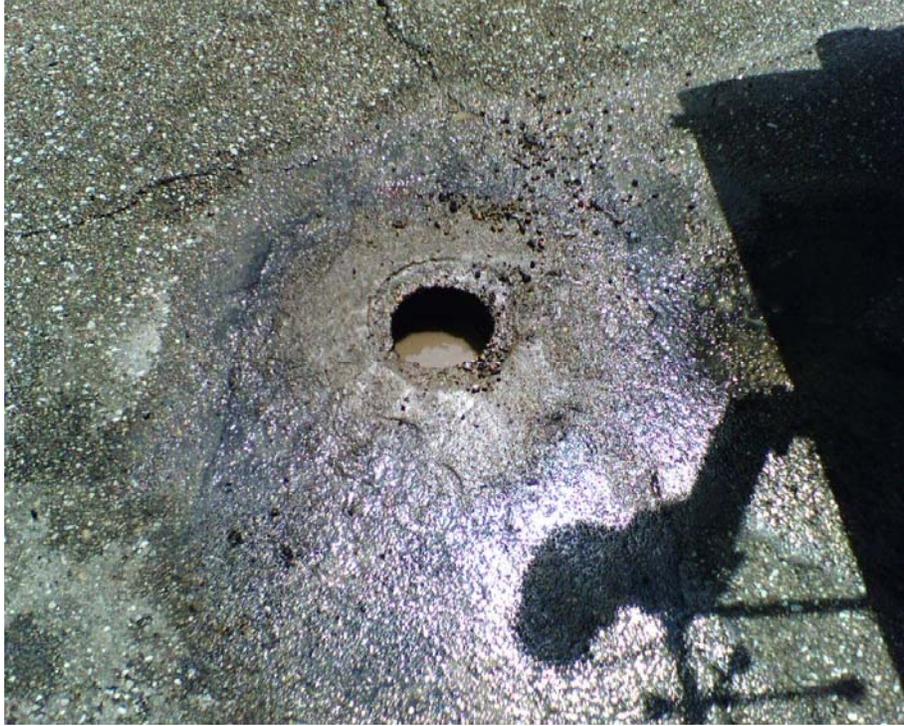
Figure V-3. Core Cut

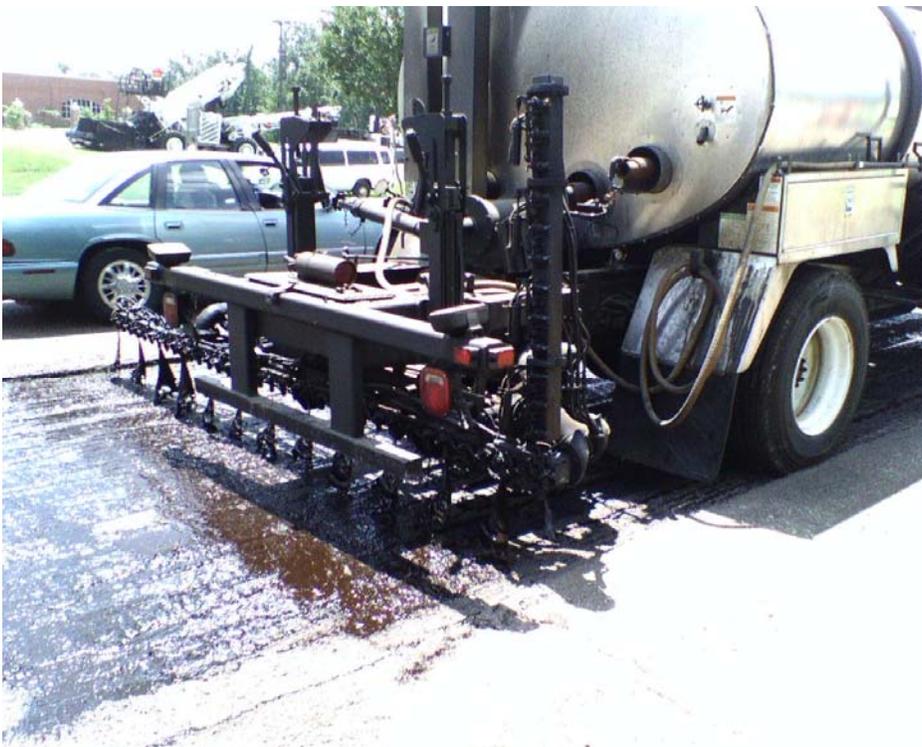
Figure V-6. Applying Tack Coat to Test Section

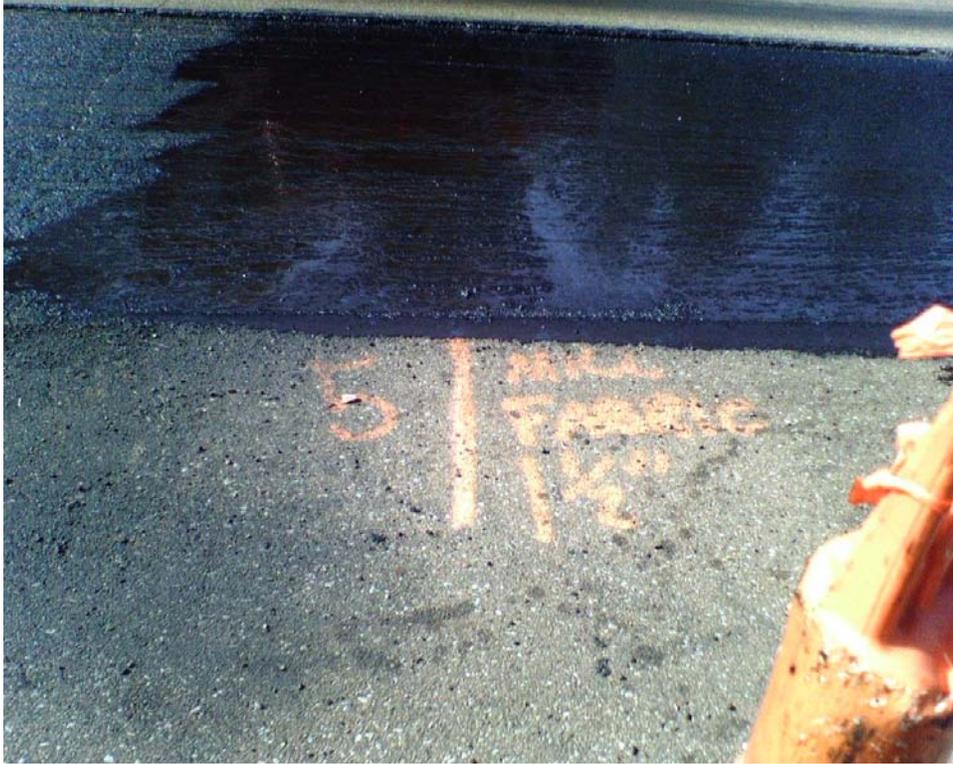
Figure V-7 Uniform Tackcoat on Section 5

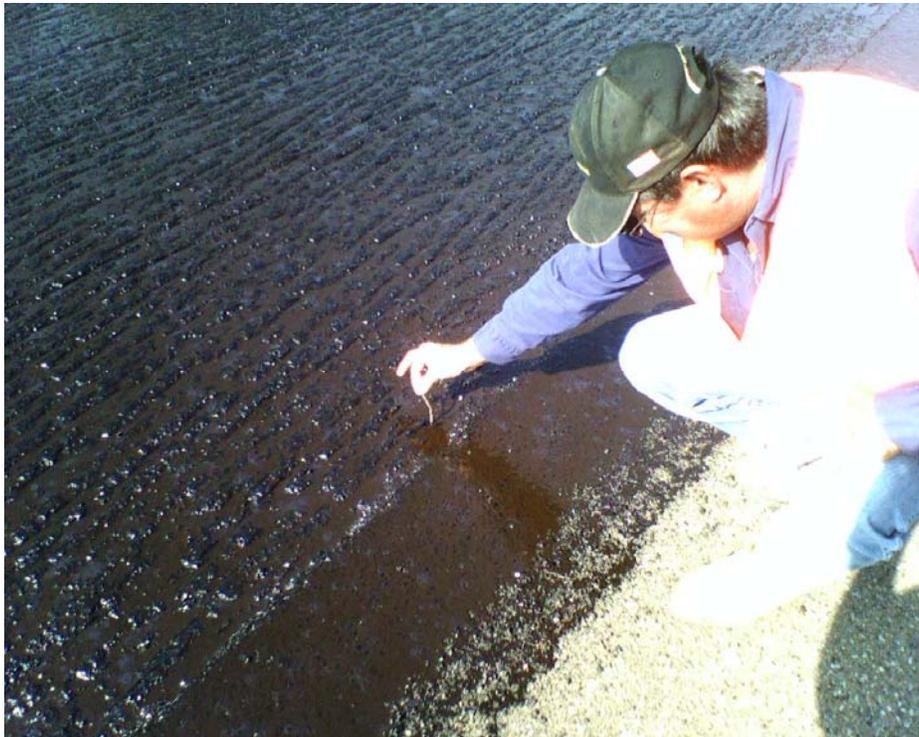
Figure V-8. Checking Thickness of Coating
