Evaluation of the Effectiveness Of Drainage Layers

FHWA/MS-RD-07-189

Mississippi State University

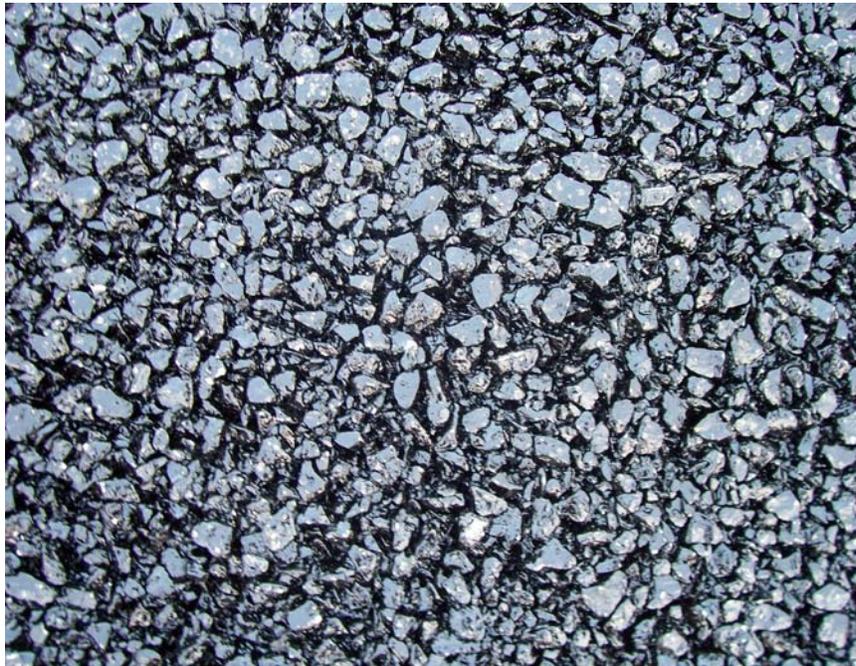
A highly permeable OGDL allows infiltrated water to drain into the longitudinal collector system and out of the pavement structure. Aggregate gradations of OGDL's vary and aggregate may be treated untreated or treated with Portland or asphalt cement. Treatment of aggregate stabilizes the drainage layer and aids in constructability. The Ontario Ministry of Transportation typically adds 1.8 percent asphalt cement (AC) to ensure constructability of OGDL's (4). An asphalt treated OGDL, as constructed on US 45 Alternate in Lowndes Co. (MS), is shown in Figure 2.1 below.

Figure 2.1 Asphalt Treated OGDL (US 45 Alt. Lowndes Co.)

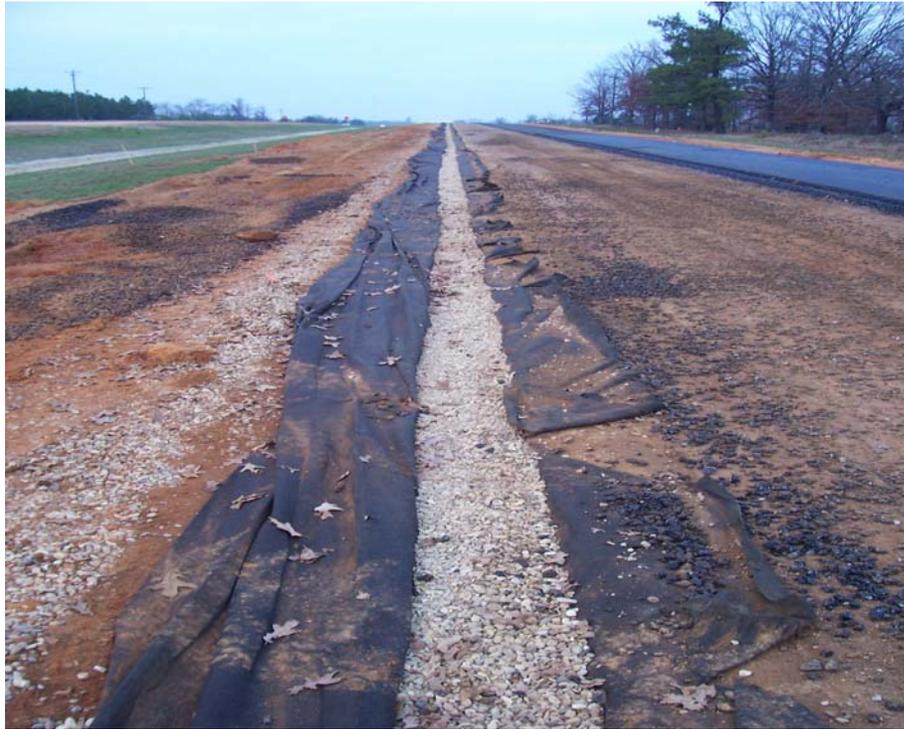
A longitudinal collector system intercepts free water flowing from the OGDL. Roadway sections containing a normal crown should have longitudinal collector systems along both sides of the roadway. When superelevations are present; longitudinal collectors must only be located on the low end. To construct a longitudinal collector system, trenches should first be cut along the roadway edge. These trenches should contain a perforated pipe that will collect free water and remove it from the pavement structure. Perforated pipes should be covered with aggregate and wrapped with fabric that will act as filter material to prevent the pipe from becoming clogged. Figure 2.2 shows a longitudinal collector system as built on US 45 Alternate in Lowndes Co. (MS). The figure shows a fabric lined trench with an aggregate covering the unseen perforated pipe.

Figure 2.2 Longitudinal Collector Trench (US 45 Alt. Lowndes Co.)

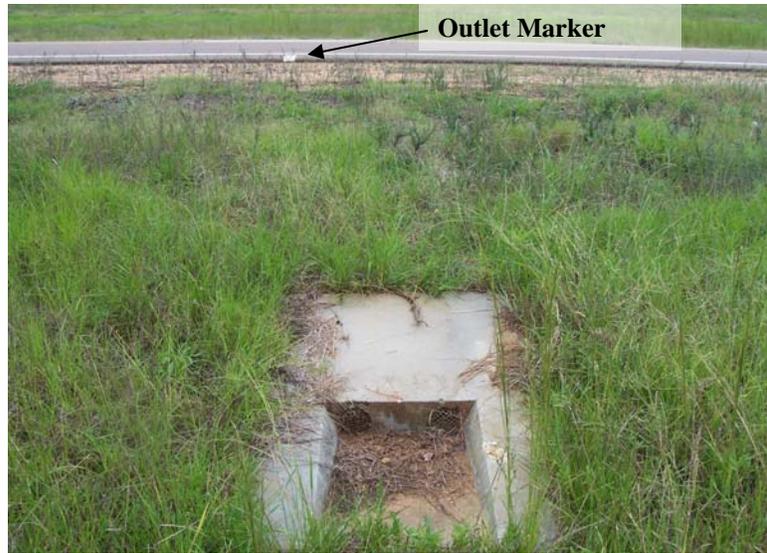
Some form of marker should be provided for each outlet. Markers are used for easy identification of outlet locations for maintenance and inspection crews. Common markers include signs on fences, reflector discs in the shoulder, or painted arrows on the shoulder (6). A piece of white tape serves as an outlet marker along the edge of pavement in Figure 2.3. Maintenance engineers in Mississippi have expressed a desire to have outlets marked with GPS coordinates. Maintenance crews are already provided handheld GPS units and could easily identify outlet locations for maintenance purposes.

Figure 2.3 Concrete Headwall and Outlet Marker

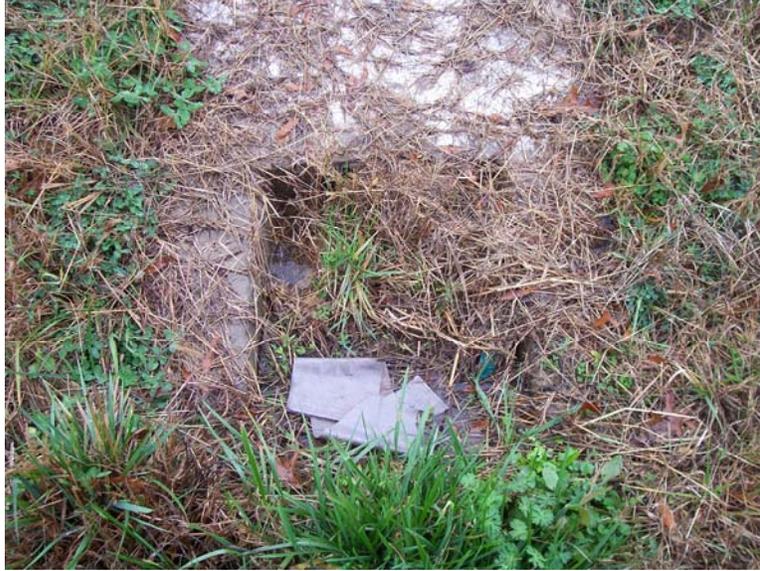
Once road construction is completed, proper mowing schedules should be practiced to ensure that vegetation will not impede the performance of the drainage systems. After mowing, grass clippings and other debris should be removed from the concrete headwalls or splash pads. Over time, debris can collect in front of the outlet and prevent water from exiting the system. This condition is shown in Figures 2.4 and 2.5, respectively.

Figure 2.4 Outlet Clogged With Grass Clippings

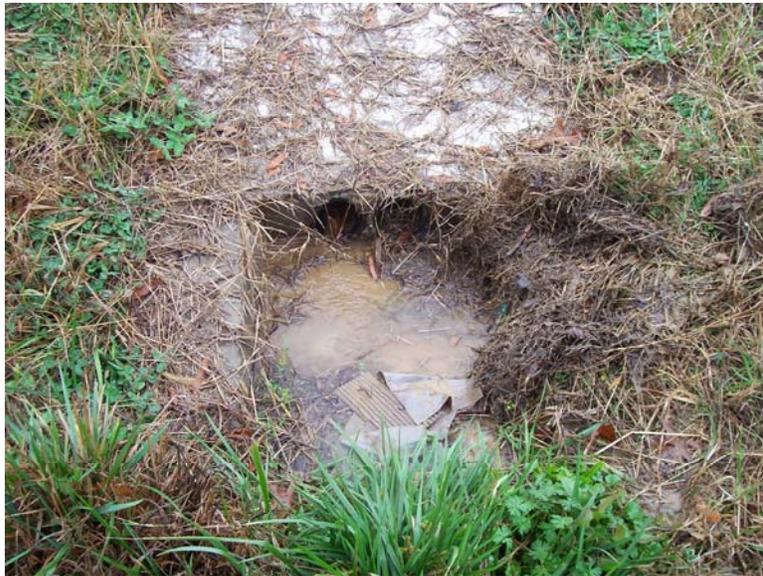
Figure 2.5 Water Flowing From Cleared Outlet

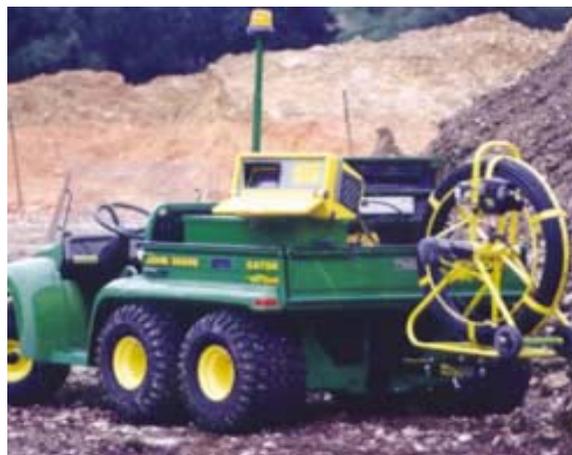
Employees from the engineering firm conducting the surveys, Fugro-BRE, suggested that video inspection equipment be mounted onto a utility vehicle (14). The request was granted, allowing technicians to drive to an outlet and feed the camera off the back end of the utility vehicle. The utility vehicle and video inspection equipment can be seen in Figure 2.7.

Figure 2.7 Video Inspection Vehicle (14)

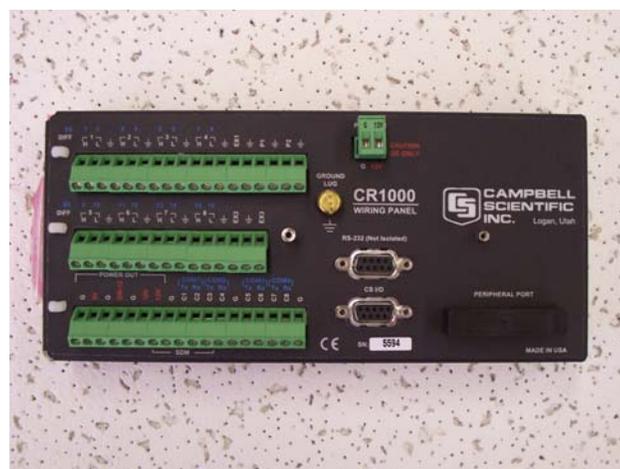
The view data tab will open downloaded files and display data in columns. This tab also has graphic capabilities, but due to the limitations of the software, data for this study was loaded into Excel and graphed. A CR 1000 Measurement and Control System is shown in Figure 3.1.

Figure 3.1 CR 1000

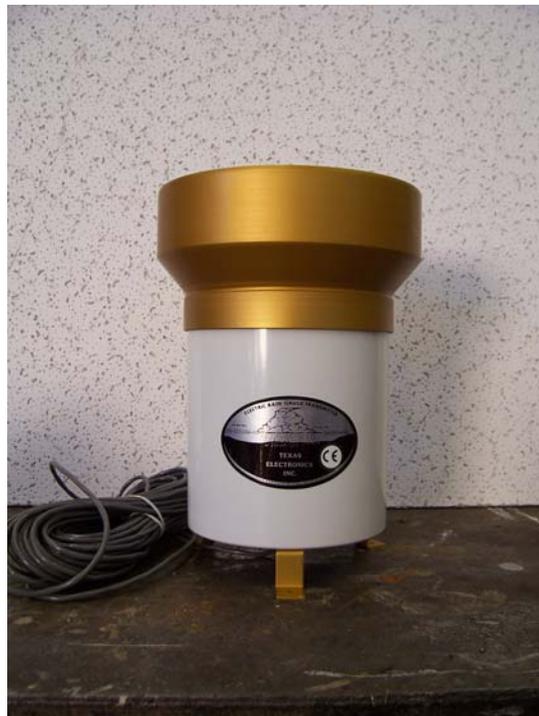
Rainfall events were recorded with a Texas Electronics Model TR-525USW tipping bucket rain gauge as shown in Figure 3.2. The rain gauge consists of a collector funnel, eight inches in diameter, which directs the water to a tipping bucket mechanism. A magnet attached to the tipping bucket actuates a magnetic switch causing a switch closure with each tip of the bucket. The rain gauge was factory calibrated so that each tip of the bucket accounts for 0.01 inches of rainfall with an accuracy of 1% for 1-inch of rainfall per hour or less (21).

Figure 3.2 Rain Gauge

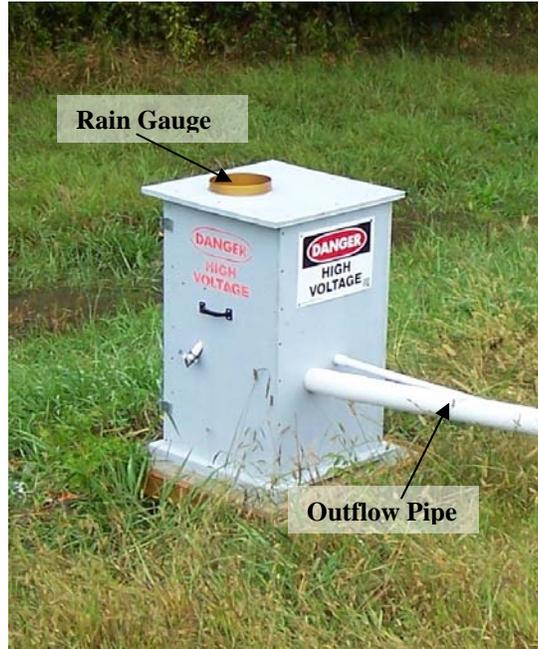
Enclosures were needed to protect the instrumentation from weather and tampering. To accomplish this, wooden boxes were constructed using $\frac{3}{4}$ " pressure treated plywood. Once constructed, the boxes were primed, painted, and caulked to protect from environmental damage. Locks and "High Voltage" signs were added to help reduce or prevent tampering while the equipment was in the field. Concrete pads were poured on the road embankment by MDOT maintenance personnel to provide a stable and level surface to mount the enclosures. A hammer drill was used to drill holes in the concrete pads and the enclosures were secured to the pads with concrete anchor bolts. Figure 3.4 shows an equipment enclosure mounted to a concrete pad.

Figure 3.4 Equipment Enclosure

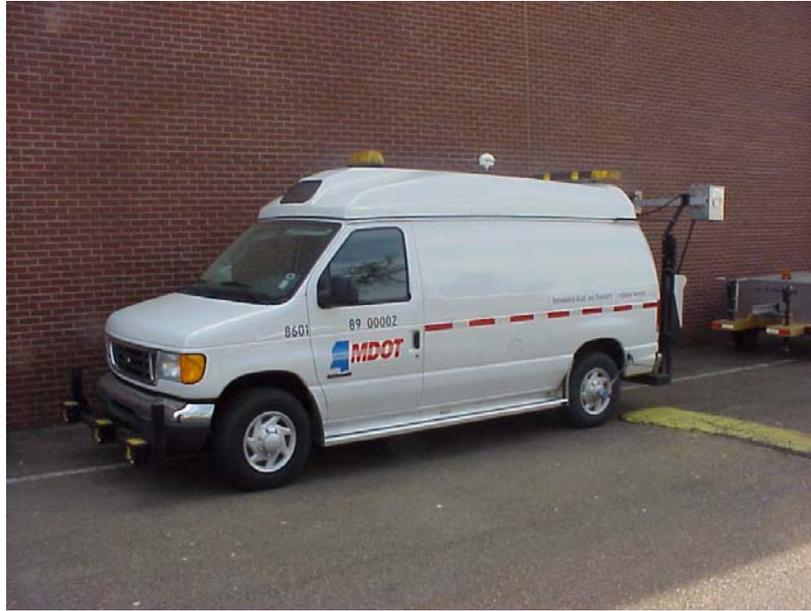
Actual distresses were quantified using video images of the pavement sections collected using MDOT's "Automated Road and Pavement Condition Surveys" van as built by Pathway Services, Inc. The van is shown in Figure 3.5. Collecting images took minutes and did not require traffic control since no people were required to be in the road.

Figure 3.5 MDOT Profiler Van

Once images were collected, they were brought into the office and analyzed using Path View II software from Pathway Services, Inc. Collected images were displayed on the computer screen and tools within the software were used to map and measure each distress. These measured distresses were used to perform the PCI calculations as described in ASTM D 6433-99.

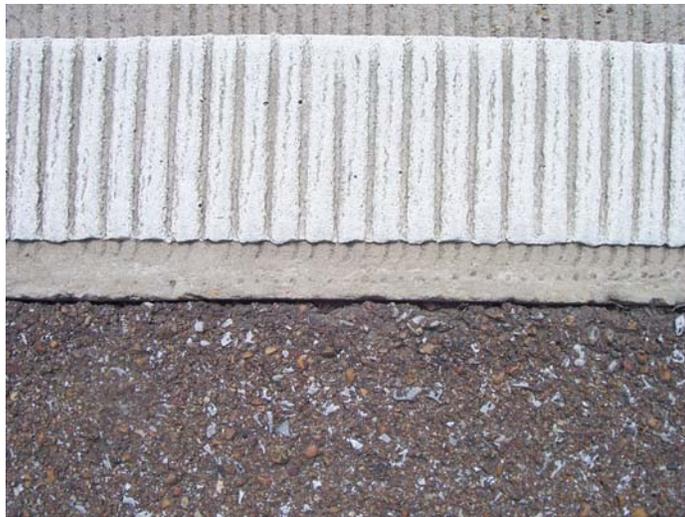
All infiltrated water removal percentages for the concrete test section were found to be less than 10%. Those values are significantly lower than the asphalt test section, despite receiving higher rainfall totals. Lower removal percentages are most likely attributed to the difference in pavement type. More specifically, the concrete is simply not as permeable as the asphalt. The concrete test section contains eleven inches of un-cracked concrete with a PCI of 100 and all joint sealant is in good condition. Very little, if any, water should be entering through the newly constructed concrete pavement. Knowledge gained from the review of literature suggests the most likely source for water entering the concrete pavement drainage system is through the unsealed edge joint between the concrete pavement and the asphalt shoulder. A concrete test section shoulder joint is shown in Figure 4.41 below.

Figure 4.41 Unsealed Edge Joint

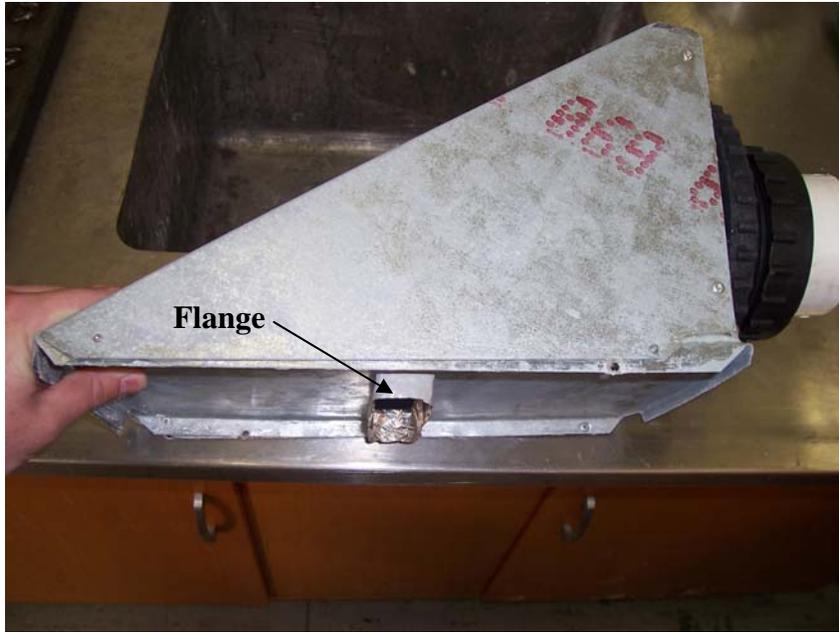
Figure A.3 Flange for Funneling Water
