TRINITY CABLE SAFETY SYSTEM

**Final Report
January 2007**

**Planning and Research Division
Oklahoma Department of Transportation
200 N.E. 21st Street, Room 3A7
(405) 522-3207
FAX (405) 521-6917**

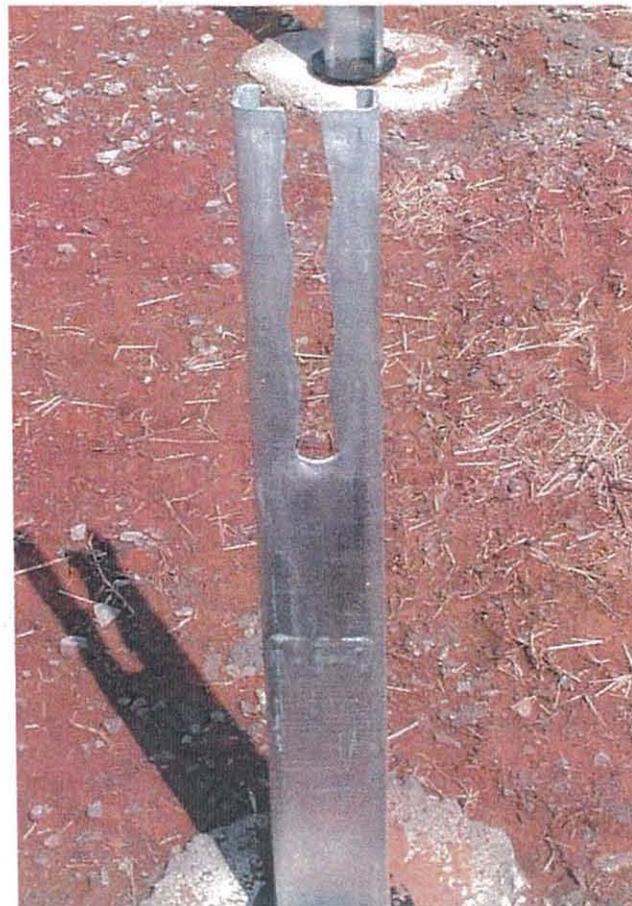
Figure 1: A post from Trinity Highway Safety Products, Inc. CASS™ Cable Safety System

CASS™ offers a unique design element in its wave-shaped slot which holds the cables in the post. The waves are said to create a longer period of friction before the cable comes out of the post during an impact. However, they still allow the cables to be released in the latter stages of impact. This prevents the cables from falling to the ground with the post, a situation which can permit the vehicle to cross the barrier.

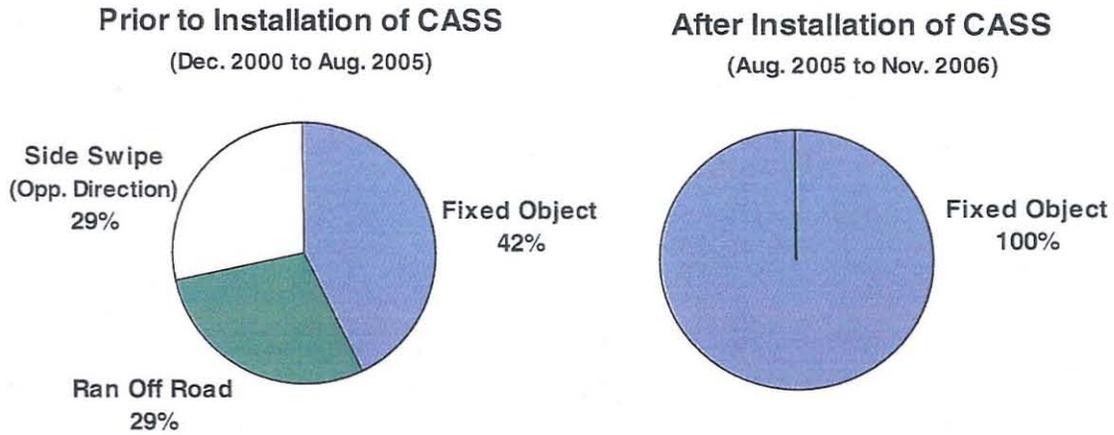
Figure 2: Cross-over collision types (CASS™ system)

Since the installation of the CASS™ system in August, 2005 through October, 2006, no vehicles have passed through the barrier. A total of 8 median barrier collisions were reported with no fatalities or injuries. As is graphically displayed in Figure 2, the presence of the barrier has reduced the likelihood of cross-over collisions dramatically. Since the installation, 100% of possible cross-over collisions have been associated with a fixed object (the cable barrier).

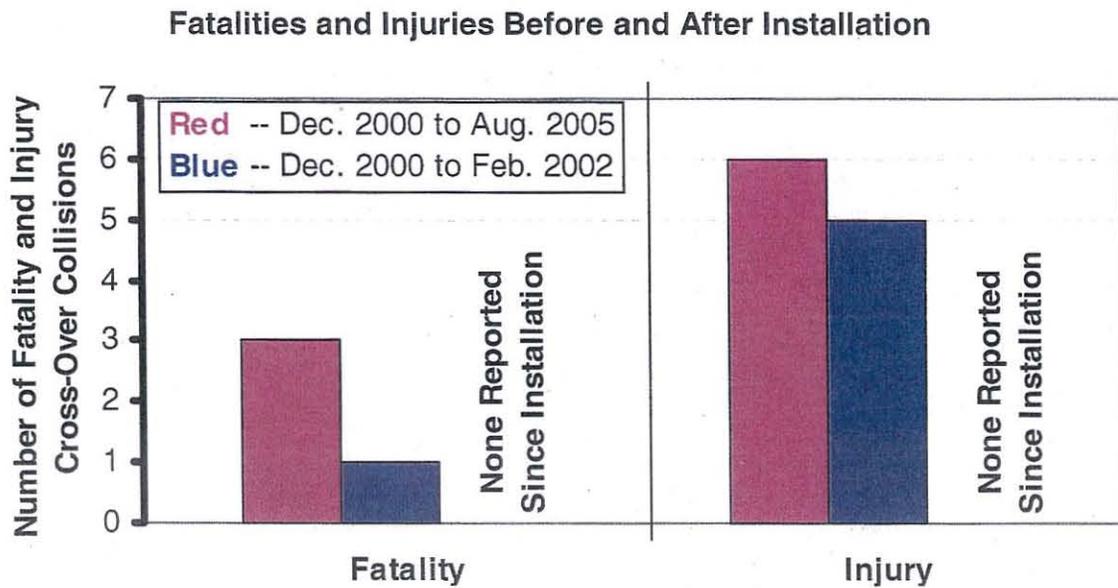
Figure 3: Fatalities and injuries before and after installation of CASS™ System

Figure 3 displays some of the most important data of all: fatalities and injuries. The red bars in the figure represent the entire period prior to the barrier installation back through December, 2000. The blue bars represent the worst 15 month period in this time frame. The 15 month period was selected for comparison with the 15 month period of data available after the CASS™ was installed. Three fatalities and six injuries were reported due to cross-over accidents since December, 2000, but thus far, none have occurred with the CASS™ barrier system in place.

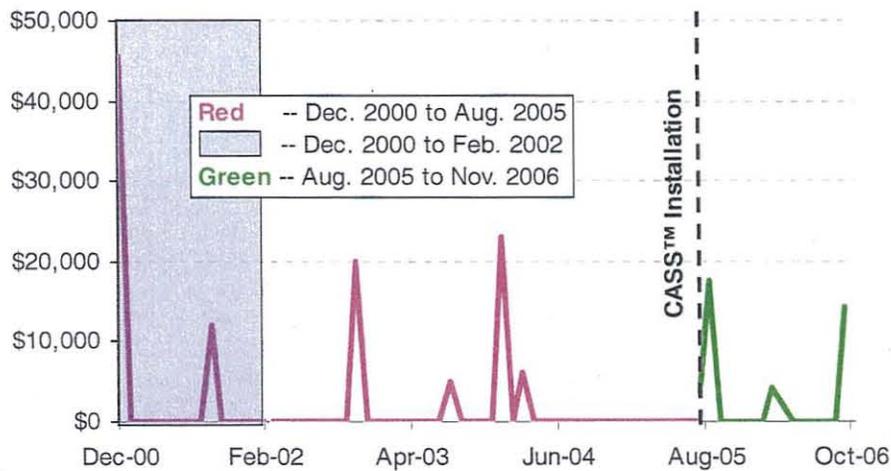
Figure 4: Property damage estimates by month (CASS™ system)

From the reported cross-over and barrier collision data, the estimated property damage time line and monthly average are displayed in Figures 4 and 5, respectively. These two figures show the data from December, 2000 up to the barrier installation in red, the data since installation in green, and the worst 15 month period before installation for comparison in blue.

Figures 4 and 5 show that property damage values have been at a high level since the installation of the cable barrier system. This is mainly due to the larger number of collisions occurring since the barrier installation. In the past, however, it is possible that accidents may not have been reported if little to no damage occurred to vehicles—for instance, when a car veered into the median but recovered successfully. The presence of the barrier has increased the likelihood of property damage, as well as reported collisions. On the other hand, associated with these increases is a notable absence of any fatalities or injuries.

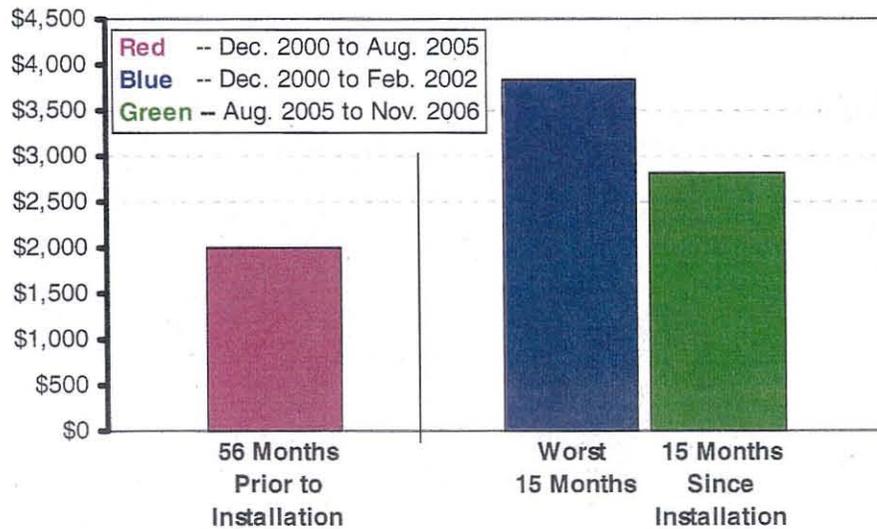
Figure 5: Monthly average property damage (CASS™ system)

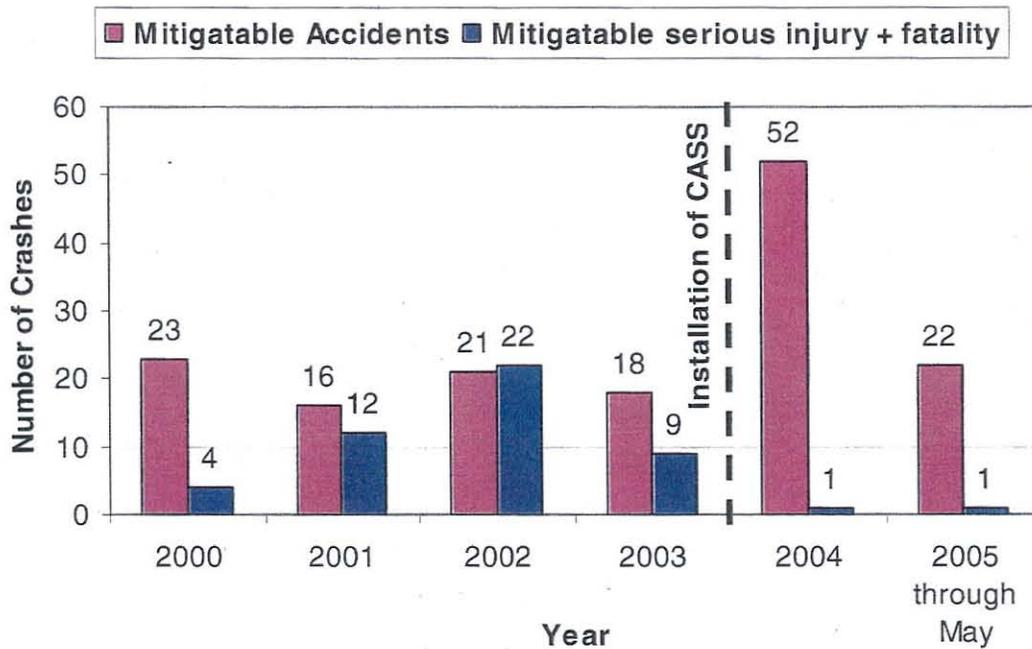
Figure 8: Accidents yearly before and after installation of CASS™ (Clayton, 2005)

As shown in Figure 8, the number of accidents rose significantly with the implementation of the CASS™ barrier system. However, the number of serious injuries and fatalities dropped dramatically. The average injury severity fell from 2.9 to 1.4. It is clear that this cable barrier system is very effective in reducing human injury.

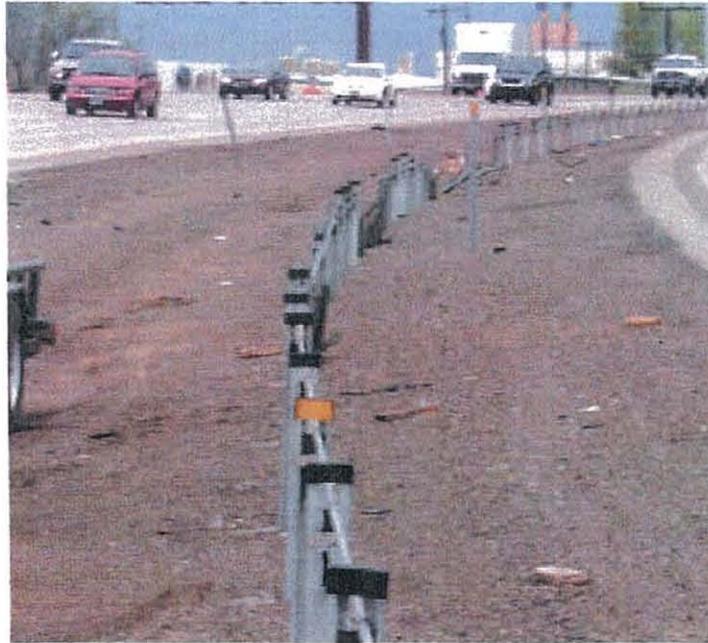
Figure 9: Utah CASS™ system after four cars hit it (Clayton, 2005)

Clayton lists several lessons Utah has learned. The CASS™ system is quite resilient, able to sustain a hit and remain effective even without repair. One instance is discussed where four cars hit the cable barrier in close proximity during a single hail storm, but the CASS™ system stayed effective throughout. Figure 9 shows the barrier after that event. The average repair consists of four to five posts replaced and 30 to 60 minutes repair time. Offsetting the barrier to one side of the median increased the accident rate from the lanes on that side (Clayton, 2005).

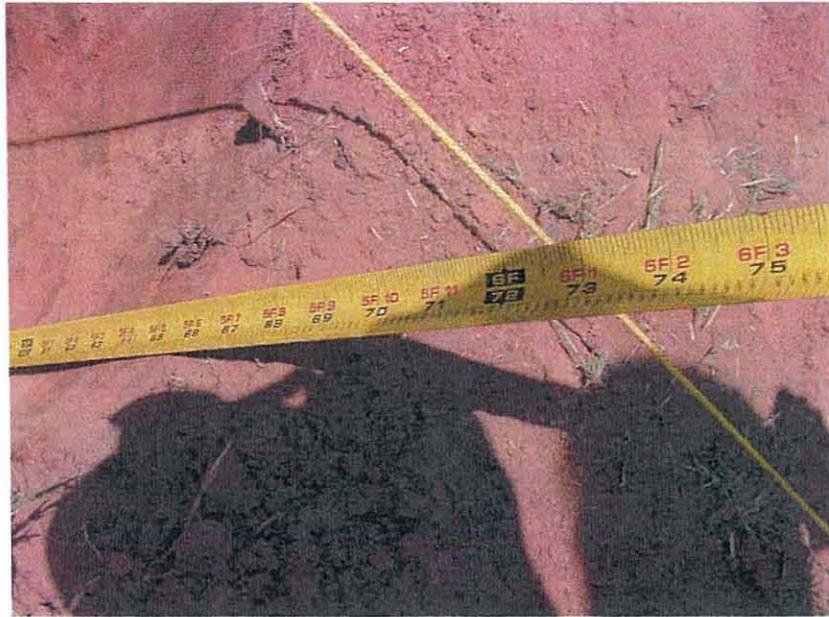
Figure A - 1: Anchor post base hole drilled to depth of 6 feet.

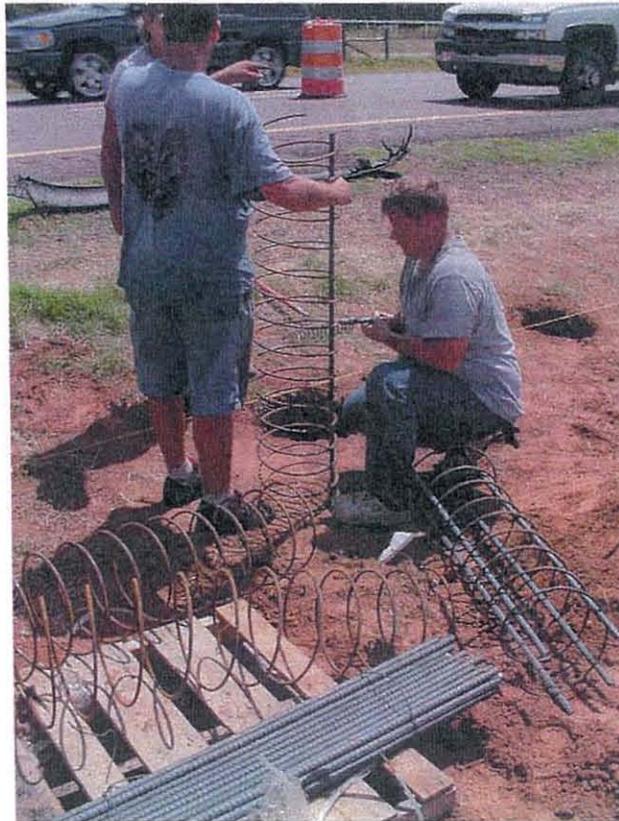
Figure A - 2: Construction of rebar cage for anchor post base.

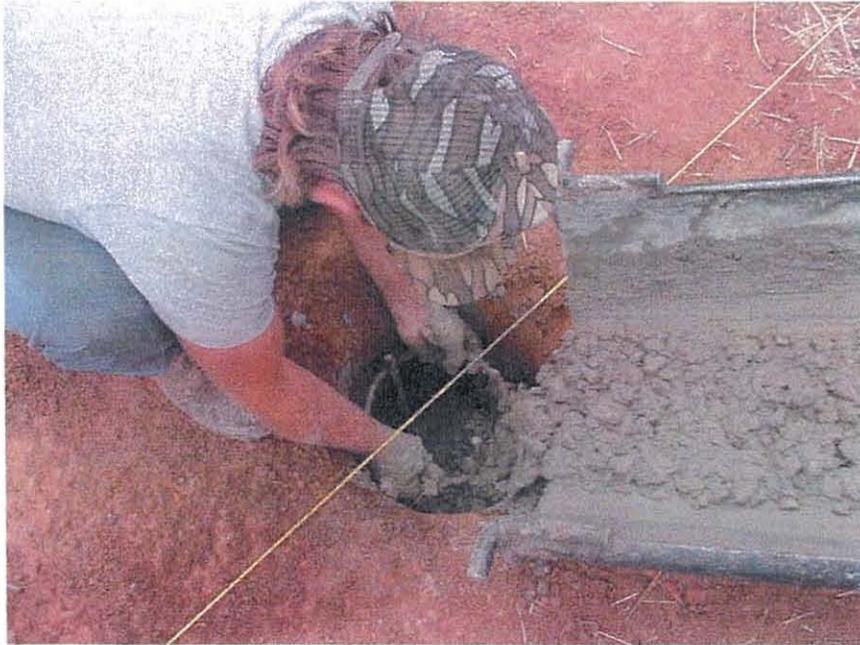
Figure A - 3: Insertion of rebar cage into drilled anchor base hole and concrete placement

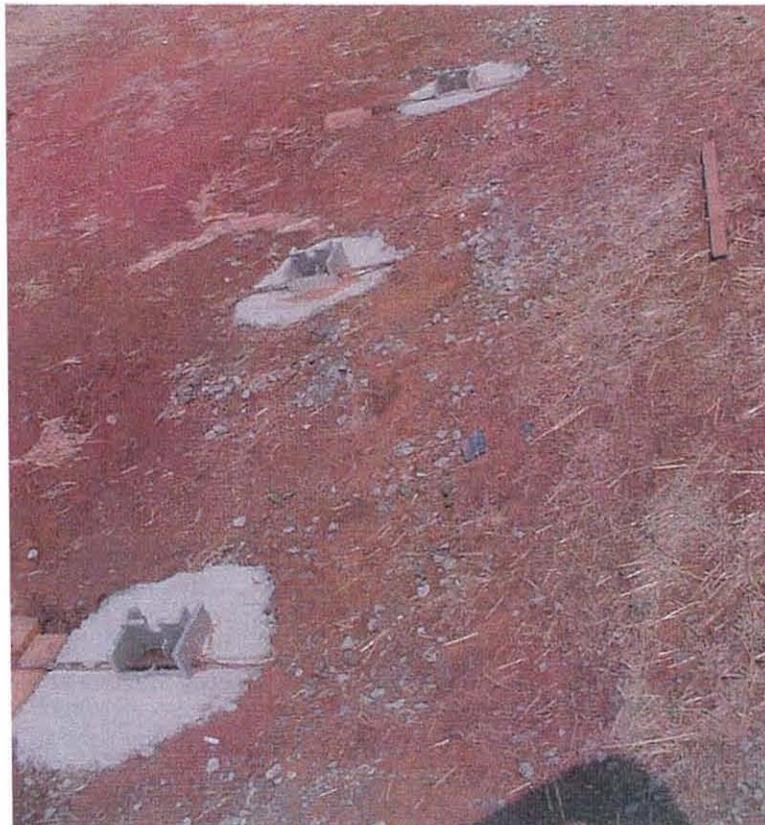
Figure A - 4: Finished anchor post bases.

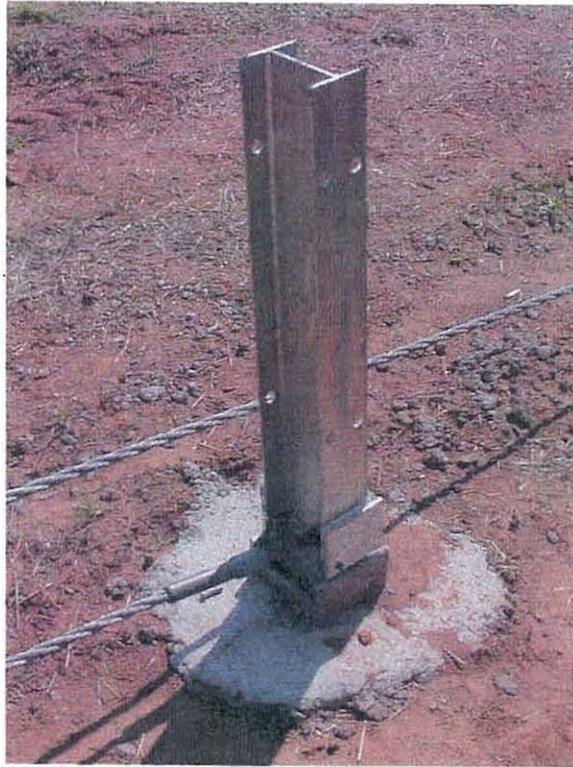
Figure A - 5: Anchor post installed

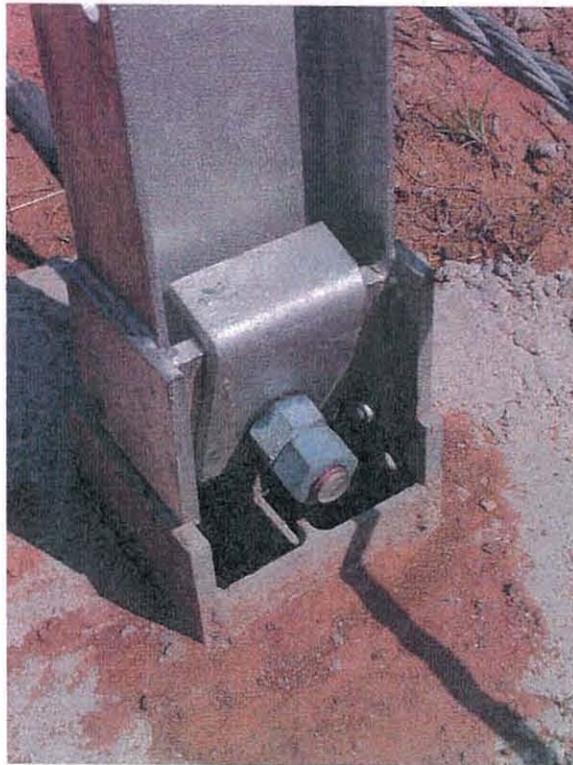
Figure A - 6: Anchor post end of cable connection

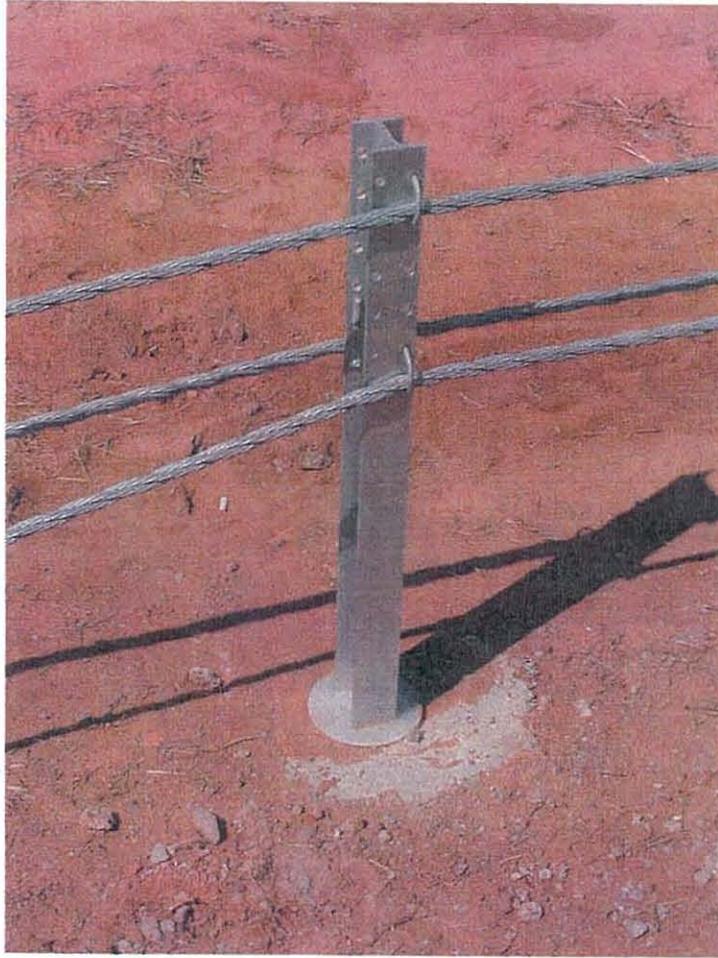
Figure A - 7: Installed post near anchors--note different cable-holding system

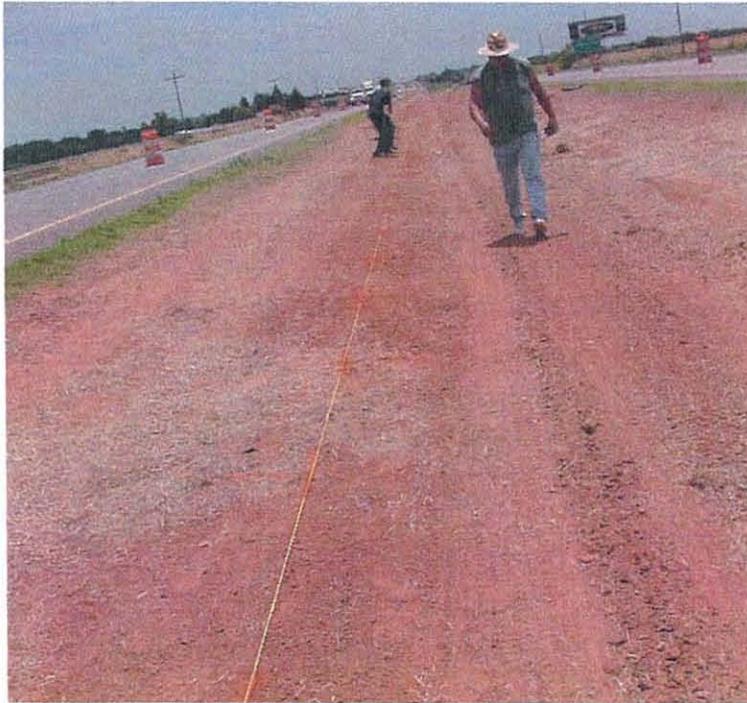
Figure A - 8: Laying out placement of barrier posts.

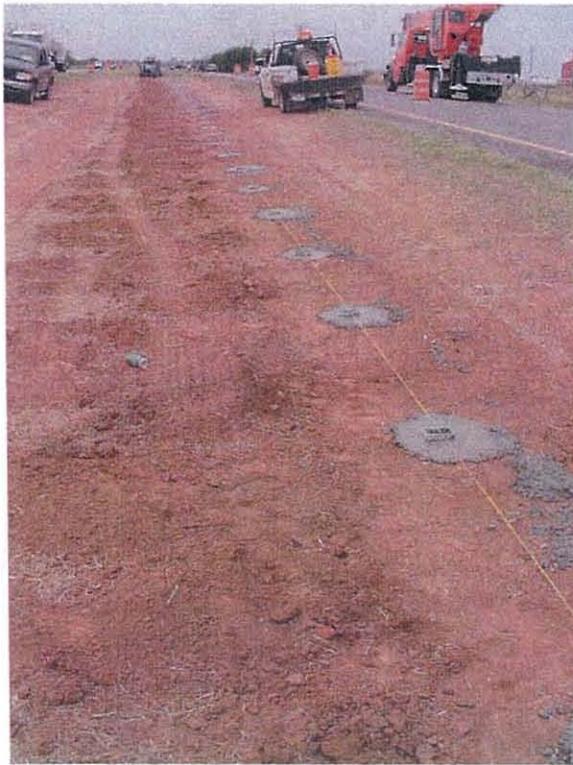
Figure A - 9: Completed barrier post bases.

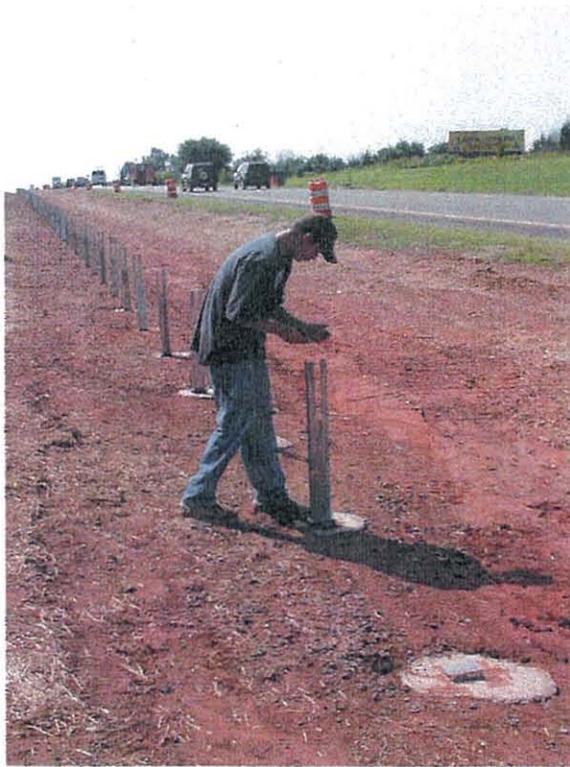
Figure A - 10: Installation of posts and base caps.

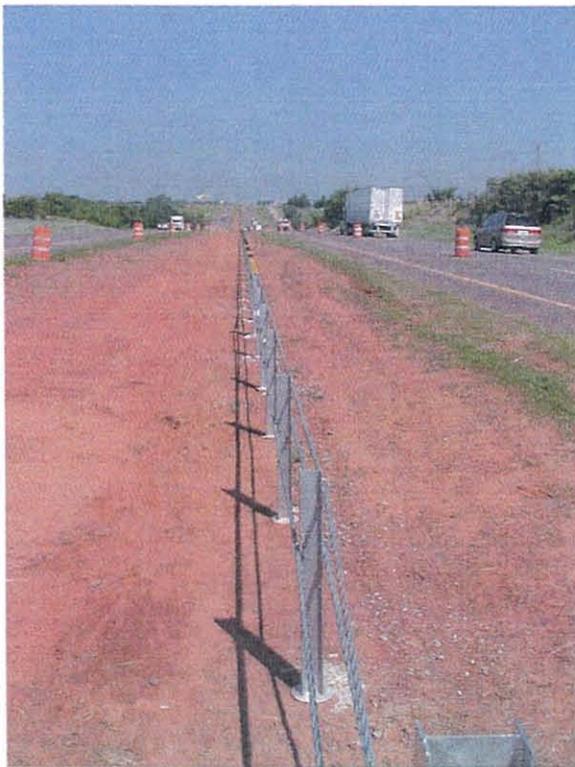
Figure A - 11: Finished cable barrier system.

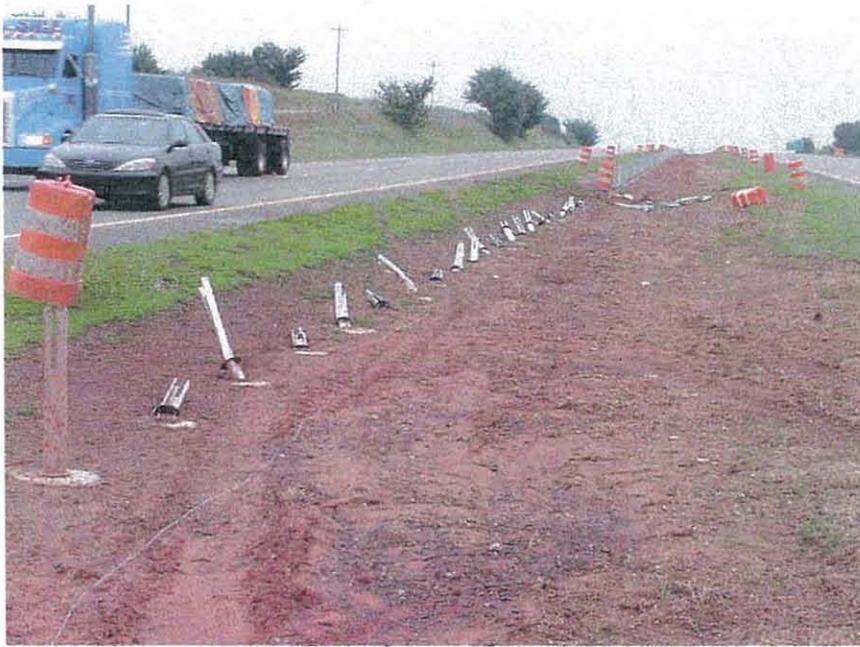
Figure A - 12: CASS™ system after impact.

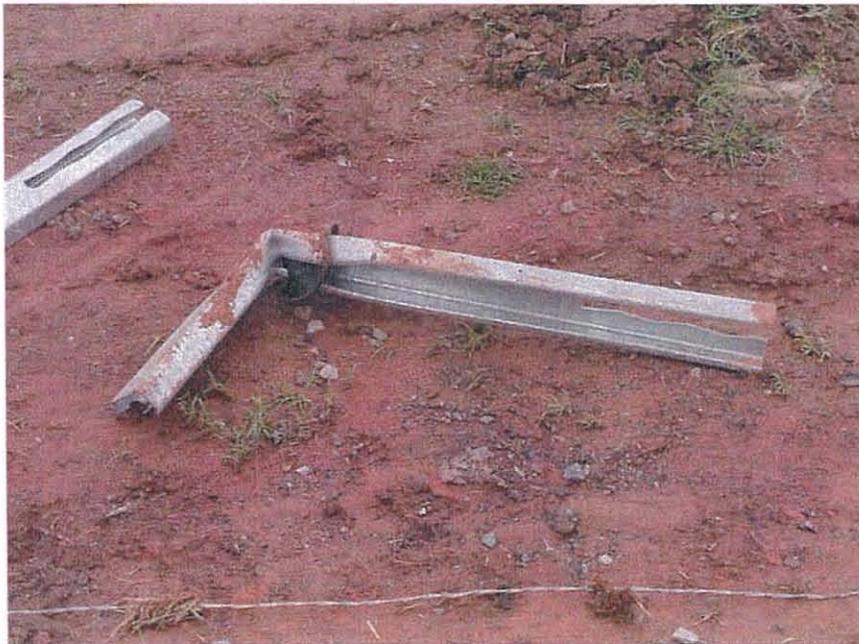
Figure A - 13: Barrier post after impact.
