U.S. Department  
of Transportation  
**National Highway  
Traffic Safety  
Administration**

DOT HS 812 045

# **Blind Spot Monitoring in Light Vehicles — System Performance**

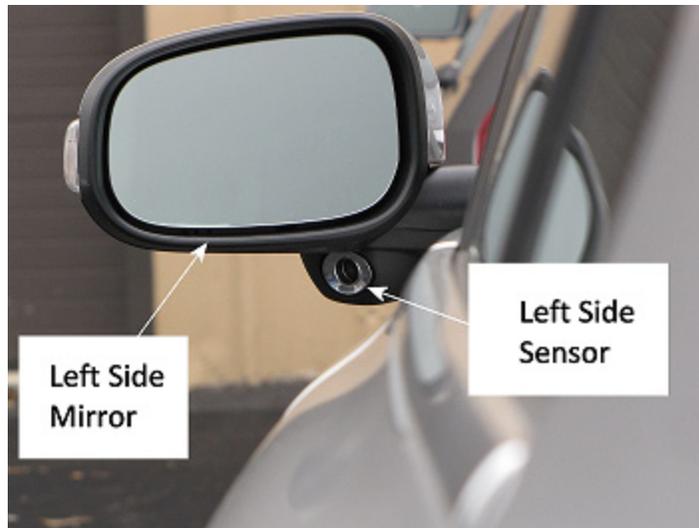
**Figure 3-1 Volvo Left BSM Sensor (Camera) Mounted Beneath Mirror (Viewed From Behind the Vehicle)**

**Figure 3-2 Volvo Right BSM Sensor (Camera) Mounted Beneath Mirror**

The Volvo was equipped with a vision-based system consisting of two sensors (cameras) mounted one under each side mirror; this is shown in Figures 3.1 and 3.2. The system covered an area of up to 3 meters out to the side, and up to 9.5 meters to the rear, of the mirror positions. It provided coverage at differential speeds of up to 6 mph when passing and 43 mph when being passed.

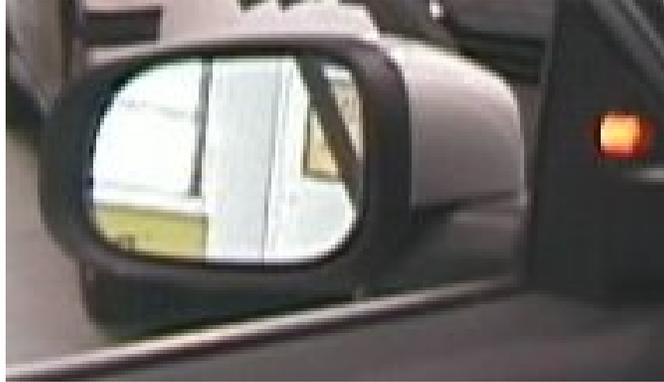
**Figure 3-3 Photograph of Volvo Left Side “Lighted” Alert Indicator on Inside of Front Door Frame**

The Volvo indicator of a vehicle within the blind zone consists of a 16 mm square LED in the door panel located just in front of the side window glass. Activating the vehicle's turn signal during an alert did not alter the lighted display. The driver's line of sight to the indicator display was just inboard, and on approximately the same horizontal plane as the side view mirror. The photographic image in Figure 3-3 shows the left lighted display for the Volvo.

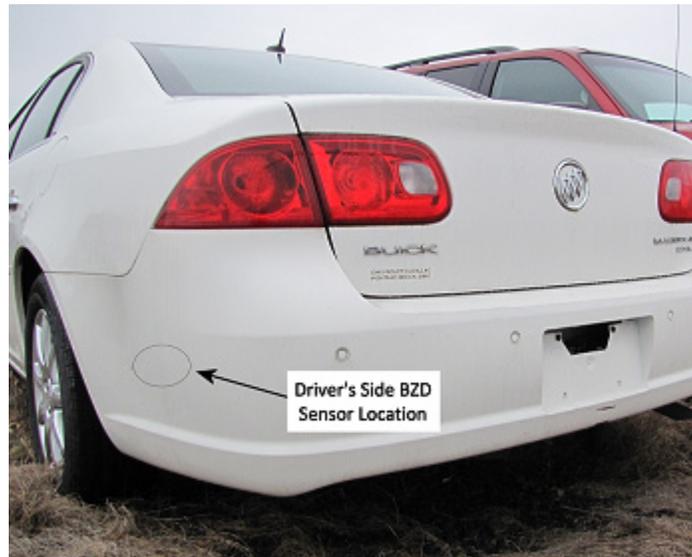
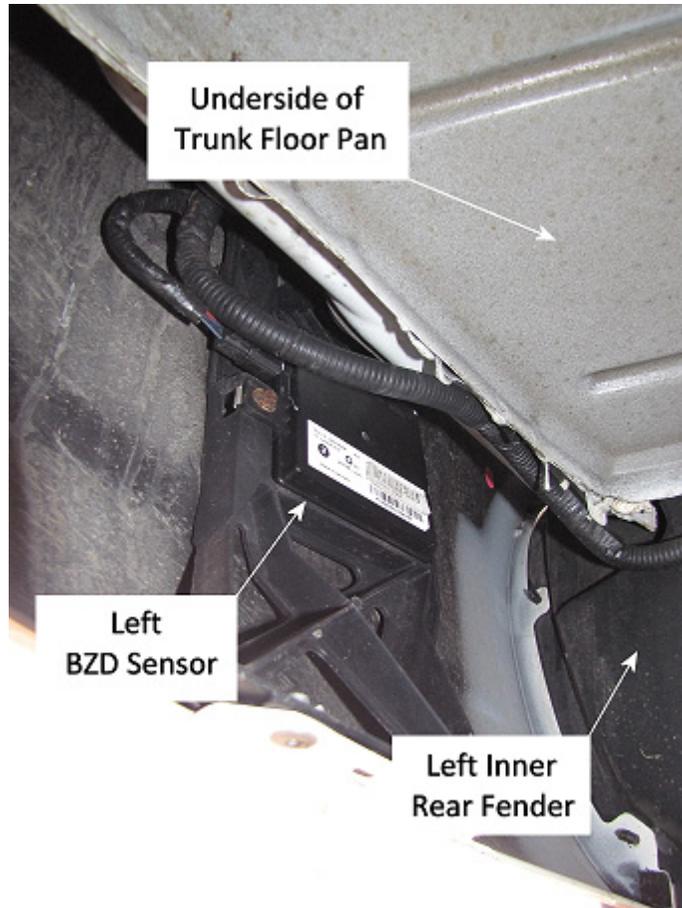
**Figure 3-4 Buick BSM Sensor Proximity**

**Figure 3-5 Buick Left BSM Sensor Behind Rear Bumper Wrap-Around**

**Figure 3-6 Buick Right BSM Sensor Behind Rear Bumper Wrap-Around**

The Buick was equipped with a radar-based system consisting of two sensors mounted one in each corner of the rear bumper, shown in Figures 3.4 through 3.6. The zone covered by the Buick system started at each mirror and went out to the side 3.5 meters and back 5 meters. A speed range was not listed in the Buick Lucerne’s Owner’s Manual.

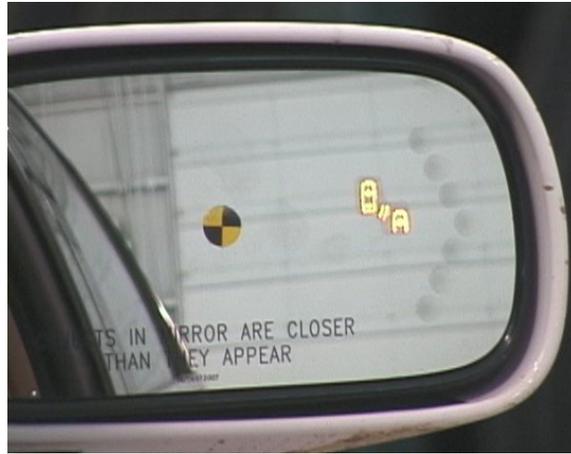
**Figure 3-7 Photographic Image of the Buick Lucerne Warning Icon on the Right Side Mirror**

The warning indicator for the Buick was an amber colored lighted icon, integrated into each side mirror's face depicting "a vehicle in the blind zone" scenario. The icon blinked if the turn signal was applied and the system sensed another vehicle. Length and width of the display was a square

about 19 mm on a side. The icon was located in the outer fourth of the mirror at the approximate vertical centerline. Figure 3-7 shows a photographic image of the lighted warning icon in the right side mirror on the Buick. The black and yellow dot in the figure marked the approximate center of the mirror.

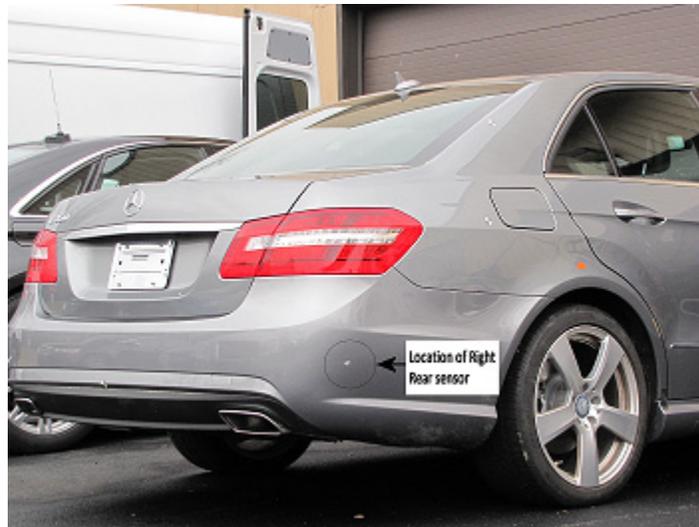
**Figure 3-8 Mercedes BSM Sensor Proximity**

**Figure 3-9 Mercedes Left BSM Sensor Behind Rear Bumper Wrap-Around**

The Mercedes was equipped with a radar-based system consisting of two sensors mounted one in each corner of the rear bumper as shown in Figures 3.8 and 3.9. The owner's manual indicated that the Mercedes system's range is 3 meters to the rear and to both sides of the vehicle at a speed range of greater than 30km/h (20mph).

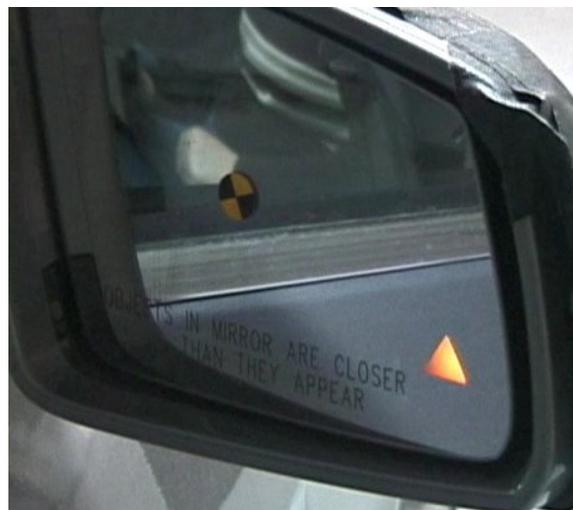
**Figure 3-10 Photograph of the Warning Indicator Integrated Into the Right Mirror of the Mercedes**

The warning indicator for the Mercedes was integrated into the mirror face. The lighted warning icon consisted of a red 9.5 mm high triangle located in the outboard lower quarter of the mirror which blinked when the turn signal was applied during an alert. The icon lit up an amber color when the vehicle was traveling at less than 18 mph, which indicated that the system was active but below the speed threshold. Figure 3-10 shows the right side lighted warning indicator for the Mercedes with the center of the mirror marked with a black and yellow dot.
