Evaluation of Effects of Fire on the I-465 Mainline Bridges—Volume I

Connor, R. J., A. H. Varma, S. Marcu, and R. J. Sherman. *Evaluation of Effects of Fire on the I-465 Mainline Bridges—Volume I*. Publication FHWA/IN/JTRP-2012/12. Joint Transportation Research Program, Indiana Department of Transportation and Purdue University, West Lafayette, Indiana, 2012. doi: 10.5703/1288284314975.

Report Number: FHWA/IN/JTRP-2012/12

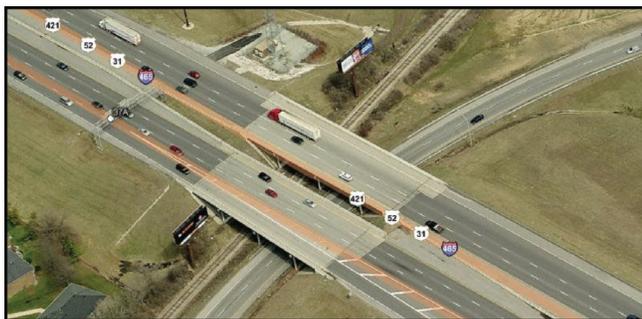
Figure 1.1 View of east and westbound bridges over the south ramp from I-69 (Microsoft 2010).

On October 22, 2009 a tanker truck carrying liquefied propane lost control and crashed beneath both I-465 bridges. The propane tanker was punctured during the crash, resulting in an explosion and fire. As a result of the fire, the steel superstructure was subjected to extreme temperatures; however, the duration of exposure and magnitude of these temperatures was not accurately established. Hence, the amount and extent of damage, if any, was unknown. To identify and document any short-term and long-term negative effects the fire may have had on the bridge a study was undertaken with the following three tasks described.

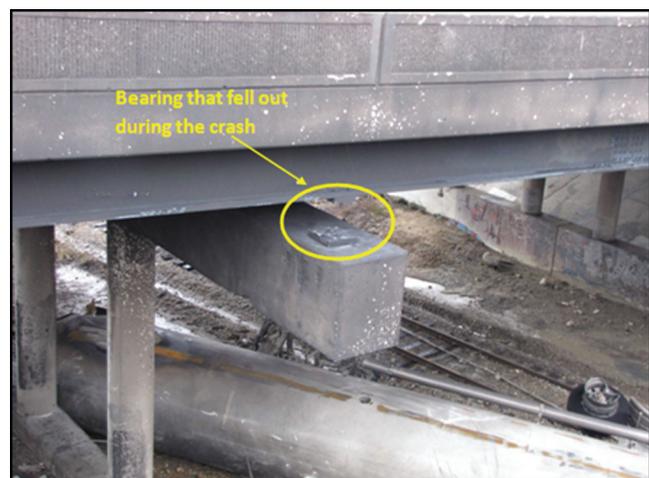
It is also noted that due to the damage to the west pier on the eastbound structure (Bent #3), the bearing of the exterior girder (Beam #12) on the north side of the bridge fell out (see Figure 1.2). As a result, the span length of this girder was significantly increased. Although the bearing was replaced when the pier was repaired, the amount of dead load that was put back into the exterior girder is unknown. Thus, the proportion of live load carried by this girder may not be as

Figure 1.2 Bearing that fell out during the crash (Beam #12; Bent #3) – Eastbound Bridge.

originally assumed in design if the repaired bearing is not operating as originally built.

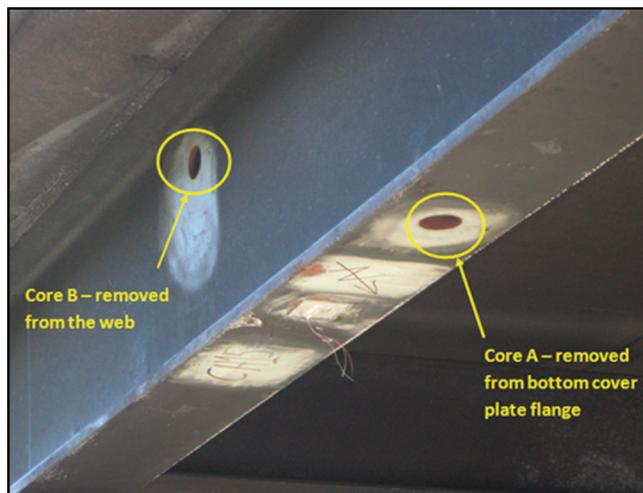
Immediately following the fire, steel samples were removed from both bridges for metallurgical investigation to determine if the extreme temperature exposure had any negative effects on the steel properties. Steel samples were cored from the web and cover plate of the girders to create Charpy V-Notch (CVN) impact specimens and perform hardness testing. Figure 2.1 is a photograph of cores removed from Beam #11 (Westbound Bridge). Additionally, bolts were removed from the web and flange splices at selected locations for specific tests: proof load, wedge tension and hardness. These tests were used to determine if the material properties of the fasteners were degraded due to uncontrolled heating and cooling, such as may have

Figure 2.1 Cores removed from the web and bottom cover plate (Beam #11) – Westbound Bridge.

Cores were taken from several girders in regions of high stress range in order to obtain steel samples for CVN specimens. At these regions, the condition at the cored hole could be classified as an AASHTO Category D fatigue detail (CAFL = 7.0 ksi). Since the original fatigue detail category at these locations was most likely Category B (CAFL = 16.0 ksi), the fatigue resistance of the detail has been significantly reduced. However, this reduction in fatigue category may not be significant if the actual in-service live load stress ranges are low. In the absence of field measured stress ranges, the effect of the cored holes on the fatigue performance of the bridge is unknown.

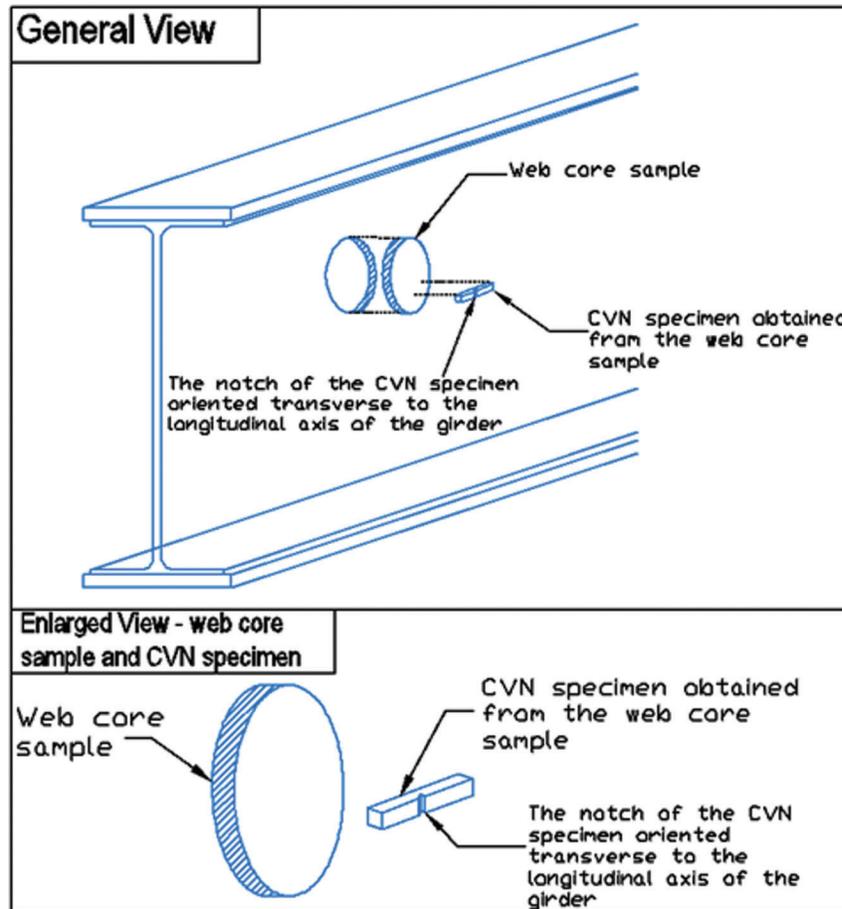
Figure 2.2 CVN specimen obtained from the web core sample.

A total of seven (7) web samples were tested. Four (4) samples were from regions exposed to fire and three (3) samples were from a region of the bridge nominally protected from the fire near the embankment. All measured data were well above modern AASHTO requirements for Zone II non-fracture critical applications as specified in ASTM A709. As stated above, the modern specification requires 15 ft-lbs @ 40F. For comparison, the *lowest* value measured from the samples removed was 94 ft-lbs. The data obtained are summarized in Table 2.2.

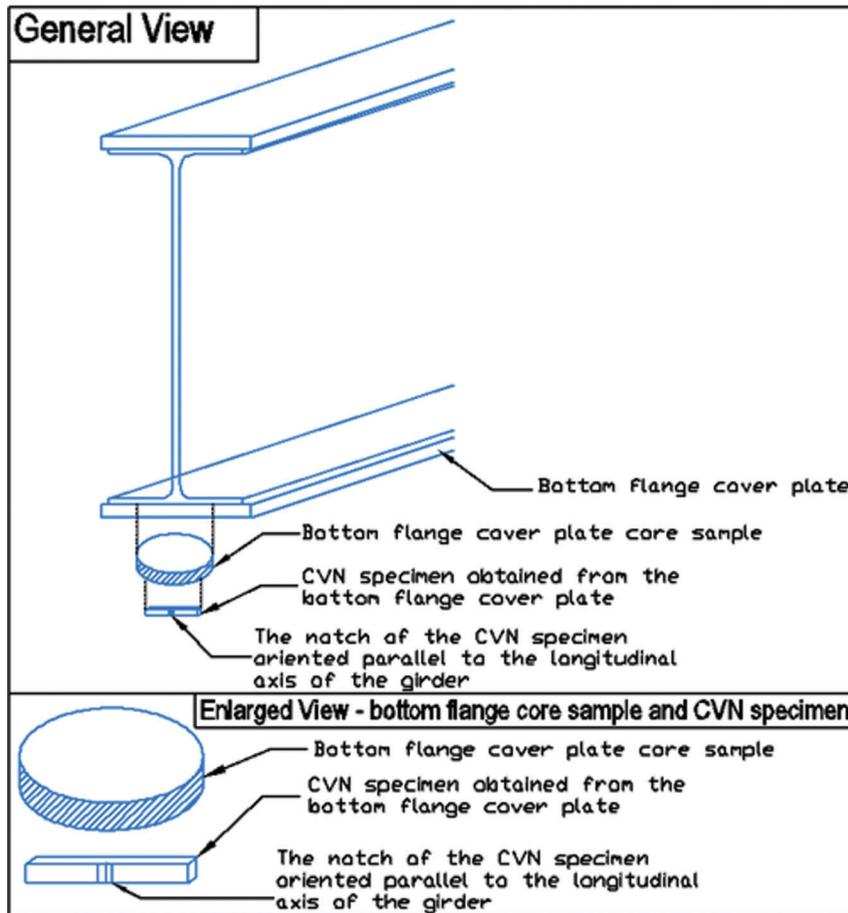
Figure 2.3 CVN specimen obtained from the cover plate core sample.

Like the web, seven (7) cover plate samples were tested: four (4) from the region exposed to fire and three (3) from the region nominally protected from the fire. The data obtained are tabulated in Table 2.3.

From Table 2.3 it can be observed that both sets of data contain results that are below the modern AASHTO Zone II non-fracture critical requirements for the *longitudinal* direction. However, these data were obtained from specimens oriented *transversely* and lower energy values would thus be expected. The longitudinal CVN impact energy values will be substantially greater than the transverse values measured. It should be noted that no specifications, modern or older, have ever had any transverse CVN requirements specified. Although the data are somewhat lower

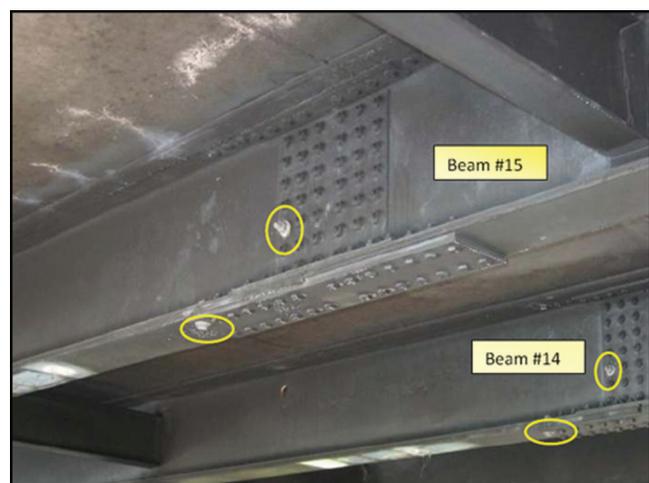
Figure 2.4 Bolts and nuts removed from Splice #2 - Beams #14 & #15 - Eastbound Bridge.

Figure 2.4, Figure 2.5, and Figure 2.6 are photographs of the replaced HS bolts and nuts on both bridges.

All fasteners were tested as a courtesy to INDOT by NUCOR Steel in Indiana. Dr. Victor Hong of INDOT Research witnessed the tests. The bolt test results are summarized in Table 2.4 and Table 2.5. The tests revealed that only one (1) bolt (Bolt #7) did not pass the proof load test requirements per ASTM A325. It should be noted that Bolt #8 failed the first proof load test but passed the second test with a 3% increased proof load. All other bolts passed the proof load tests.

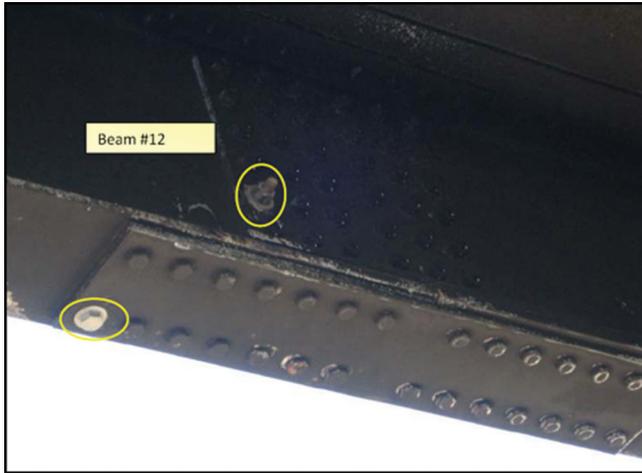
Figure 2.5 Bolts and nuts removed from Splice #1 – Beam #12 – Eastbound Bridge.

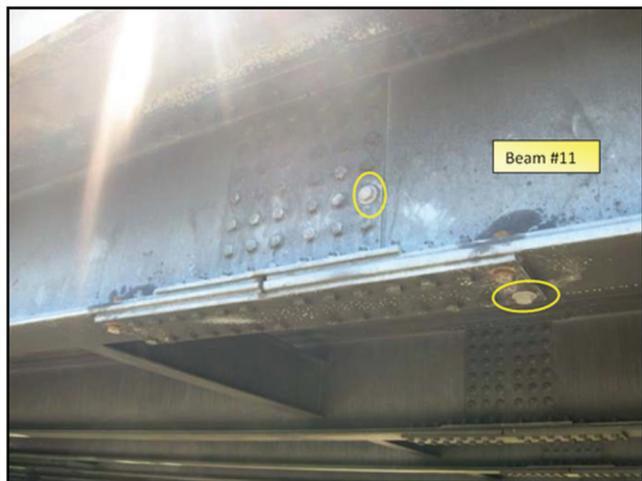
Figure 2.6 Bolts and nuts removed from Splice #1 – Beam #11 – Westbound Bridge.

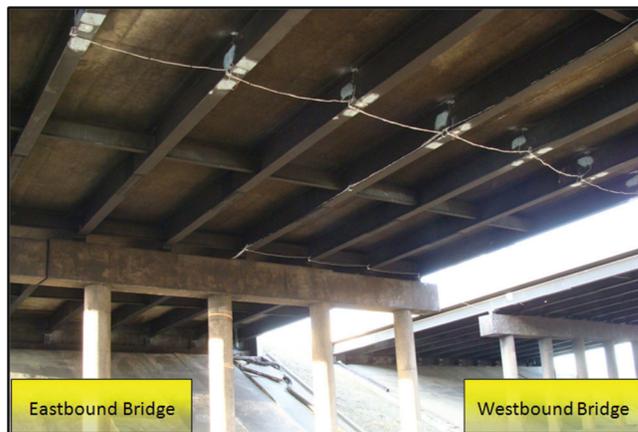
Figure 3.1 General view of strain gage locations.

Strain gages were installed to capture the local response of particular details, for example where core samples were removed from the bottom flange cover plate of the girders. Strain gages were also used to establish the global response of the bridge as a system. The particular strain gages installed on the steel girders of the I-465 bridges were produced by Vishay

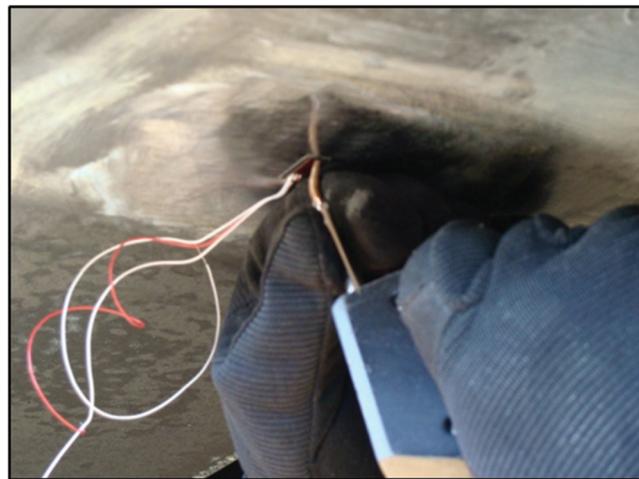
Figure 3.2 Weldable strain gage.

The strain gages come pre-bonded to a metal strip by the manufacturer. To attach them to the bridge in the field, multiple pinprick sized resistance spot welds are used as shown in Figure 3.2. The spot welds pose no concern with respect to fatigue. To prepare the surface for installation the metal is simply ground smooth and cleaned with degreaser. The final step in the installation process involves covering the strain gage with a proven multi-layer weatherproofing system to protect it against the extreme outdoor conditions. Figure 3.3 shows the

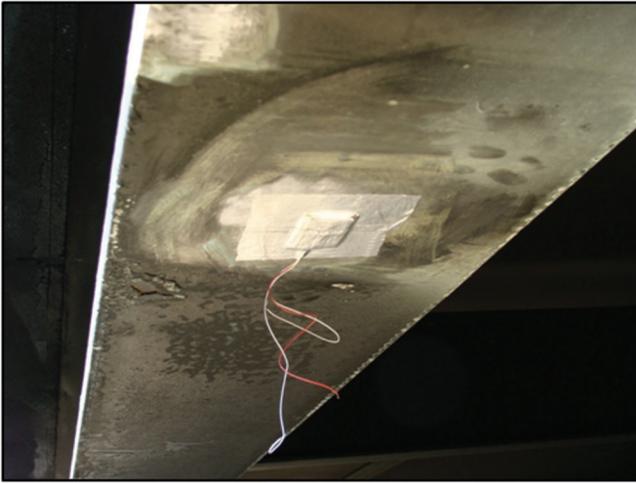
Figure 3.3 Strain gage in final installed condition.

final condition of the strain gage after installation and sealing.

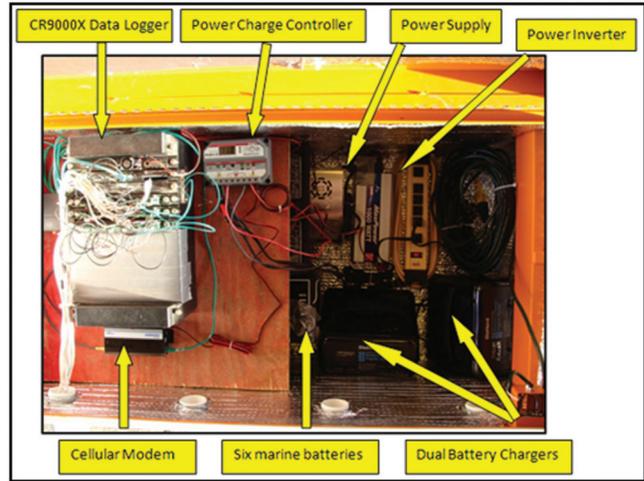
Figure 3.4 Data acquisition system.

The high-speed cellular modem installed serves several purposes. The first of which is to retrieve data remotely. Data is initially collected locally and stored onsite. Then using specialized software installed on a server residing at Purdue University the data are automatically downloaded at a predefined interval. Secondly, the cellular modem makes it possible to view live data in real time allowing the Research Team to verify the monitoring system is still functional without being onsite. One final attractive feature of the cellular modem is the ability to reprogram the data logger remotely through the cellular connection. This allows

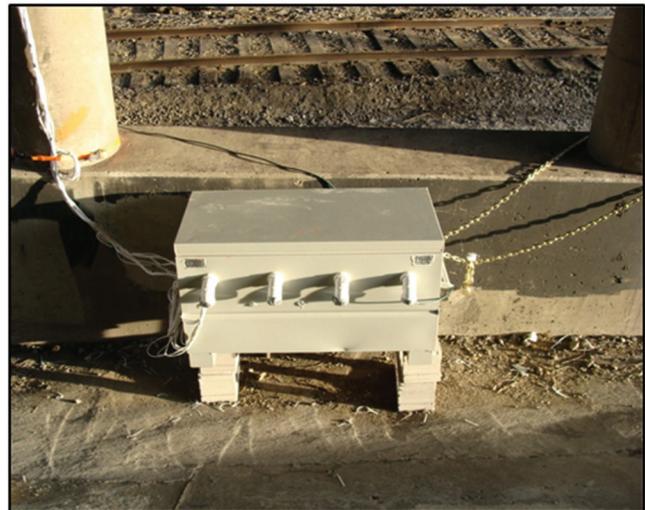
Figure 3.5 Weather-tight enclosure containing data acquisition system.

Power was provided from an electrical outlet installed near Bent #2 where the instrumentation box was placed. Power from the outlet was run to the box and connected to a surge protector powering two battery chargers. The two battery chargers were connected to a charge controller. A charge controller was used to ensure the six marine batteries maintained an optimal charge level. The charge controller also powered the cellular modem. Connecting the

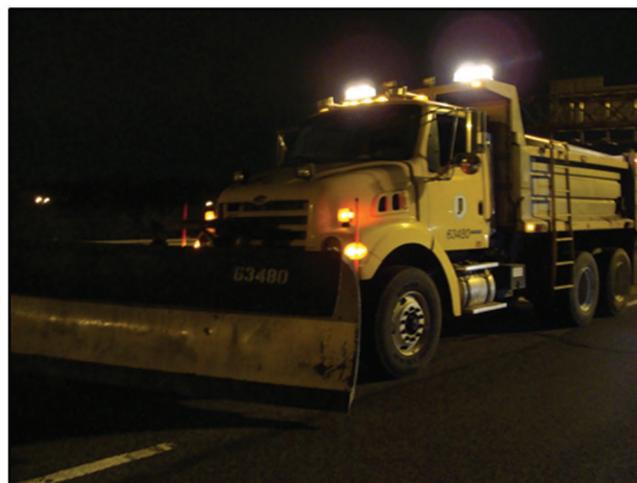
Figure 4.1 Test truck #63480 used in the control load testing.

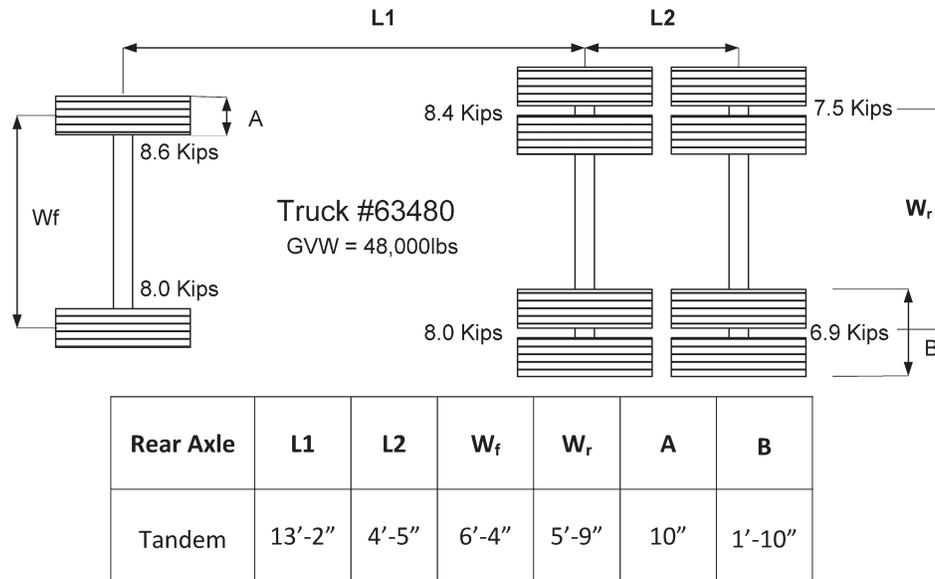
Figure 4.2 Geometry and tire load data for test truck #63480.

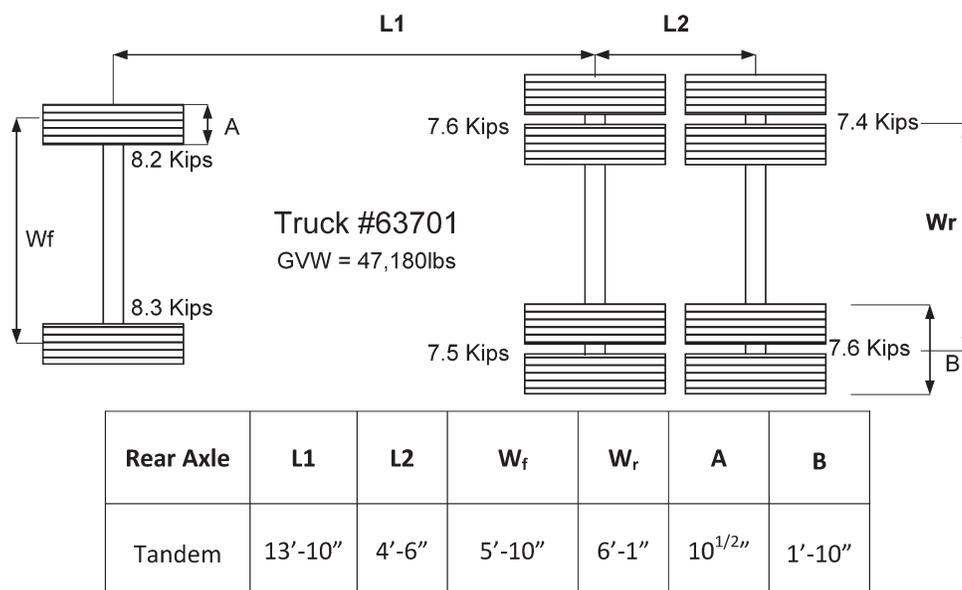
Figure 4.3 Geometry and tire load data for test truck #63701.

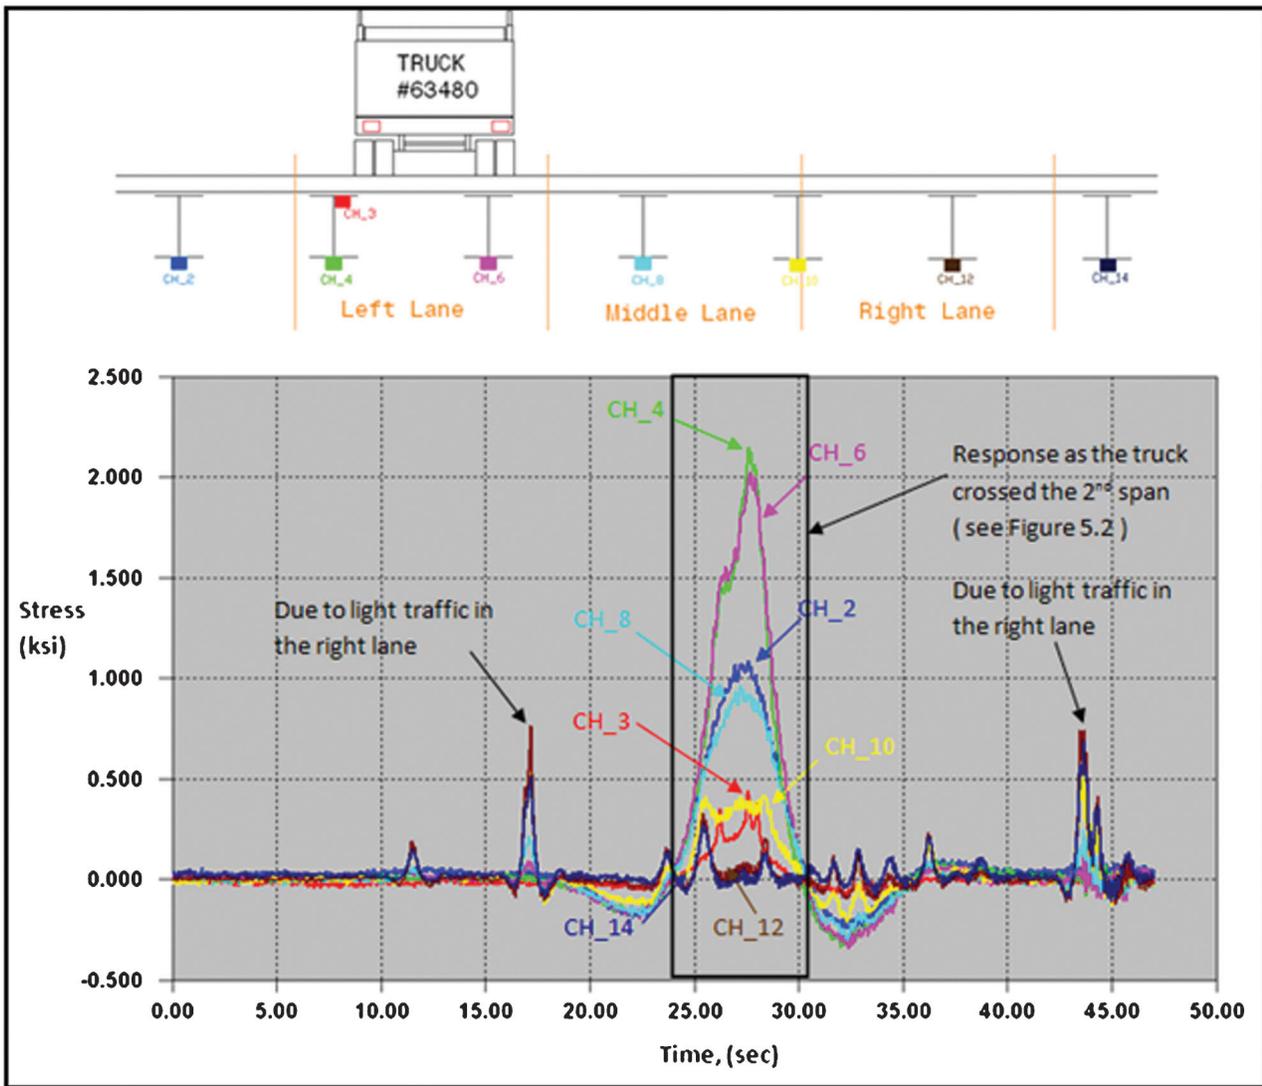
Figure 5.1 also shows good load distribution between the girders. The maximum response was observed in the girders closer to the test truck (CH_4 & CH_6) and a smaller response was observed in the girders further away from the test truck (CH_2, CH_8, CH_10, CH_12 & CH_14). This observation is very clear as the test truck passed over the second span as shown in Figure 5.1. As the truck passed over the other spans the load distribution becomes less clear. This is a

Figure 5.1 Response of strain gages installed at midspan (2nd span) – Crawl test: single truck in the left lane.

However, the effect of the second truck has little impact on the exterior girder. Comparing Figure 5.1 and Figure 5.14, the effect of a second truck in the middle lane has little influence on the stress in Beam #12 (CH_2). In other words, all the load of the truck in the middle lane was distributed out among the girders near the middle lane. This is best observed when comparing the stresses recorded during these two tests. In the first test (CRL_1.DAT), CH_2 recorded a maximum stress of approximately 1.1 ksi while in the second test (CRL_3.DAT) a maximum stress of 1.0 ksi was recorded. A similar response is also seen when looking at the first interior girder (Beam #13). Comparing the response of CH_4 for both truck configurations, only a small increase of approximately 0.5 ksi is observed when the second truck is added in the middle lane. A comparison of the maximum bottom flange cover plate stresses recorded for each of these

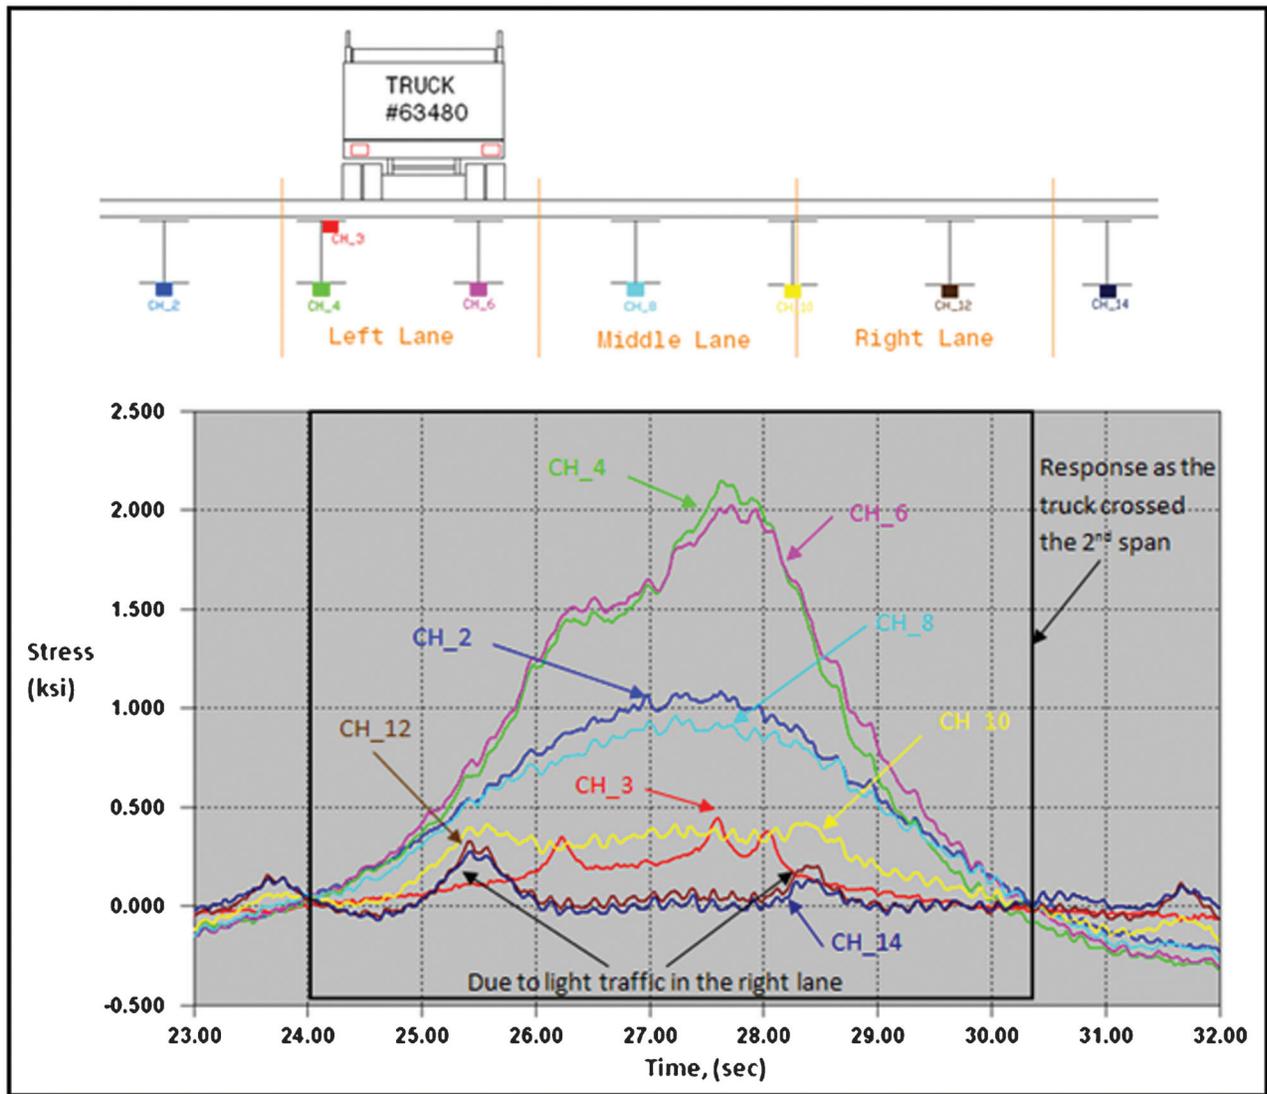
Often times the strain gages can also help to identify the number and type of vehicle(s) (i.e., number of axles) that cross the bridge. Figure 5.2 presents a zoomed in image of the boxed section of Figure 5.1. Using the response from strain gages installed on the top flanges of the girders, local bending effects can be observed that help identify the vehicle. For example, CH_3 in Figure 5.2 (red trace) clearly shows a vehicle having three (3) axles (i.e., a test truck). This is best exemplified with data collected from the controlled load test where the truck configuration was known; however, this same concept was used to identify vehicles in triggered time-history data.

Figure 5.2 Response of strain gages installed at midspan (2nd Span), as the test truck passes over the 2nd span.

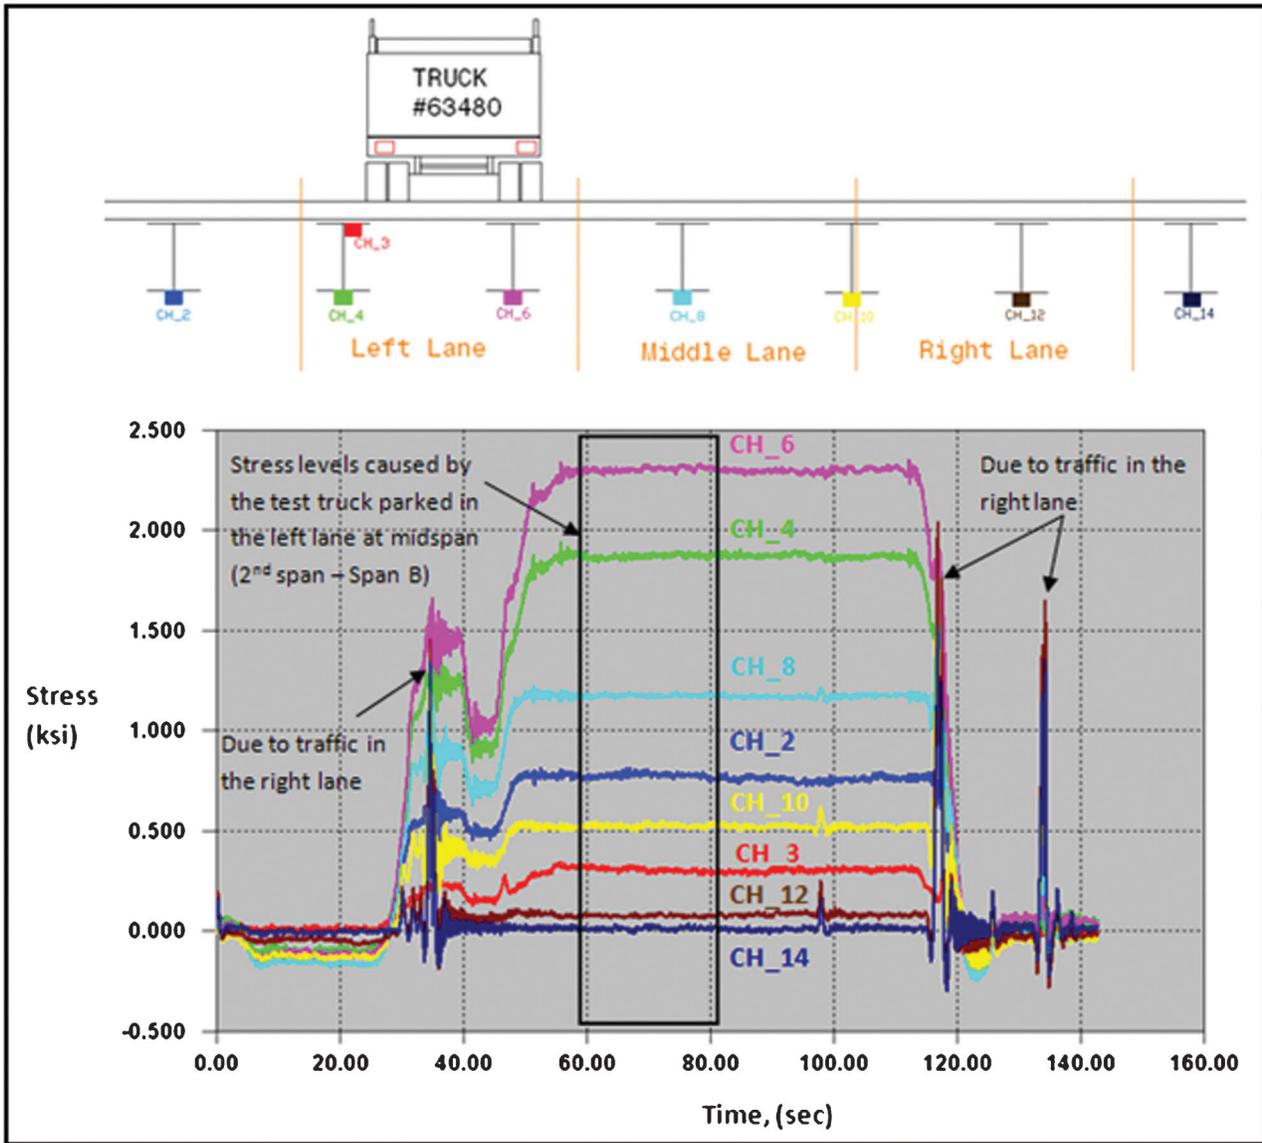
As it can be seen, the response of the static test (PARK_1.DAT) was relatively similar to that of the crawl test (CRL_1.DAT). The small difference between the two tests can be explained by the transverse location of the truck. During the crawl test (CRL_1.DAT) the truck did not pass through the exact transverse position as it was parked during the static test (PARK_1.DAT).

Figure 5.3 Response of strain gages installed at midspan (2nd Span) – Static test: single truck in the left lane.

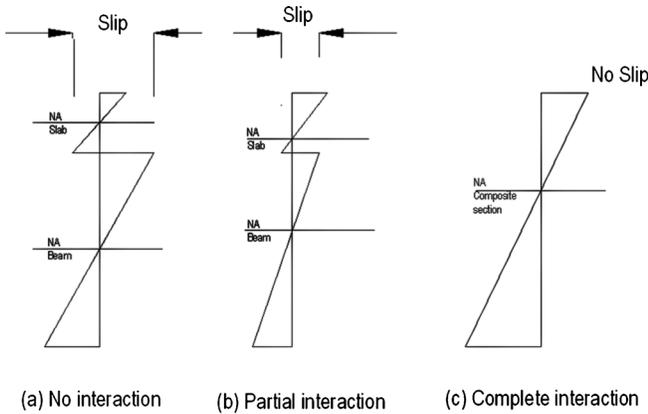
Figure 5.4 Strain variation in composite beams.

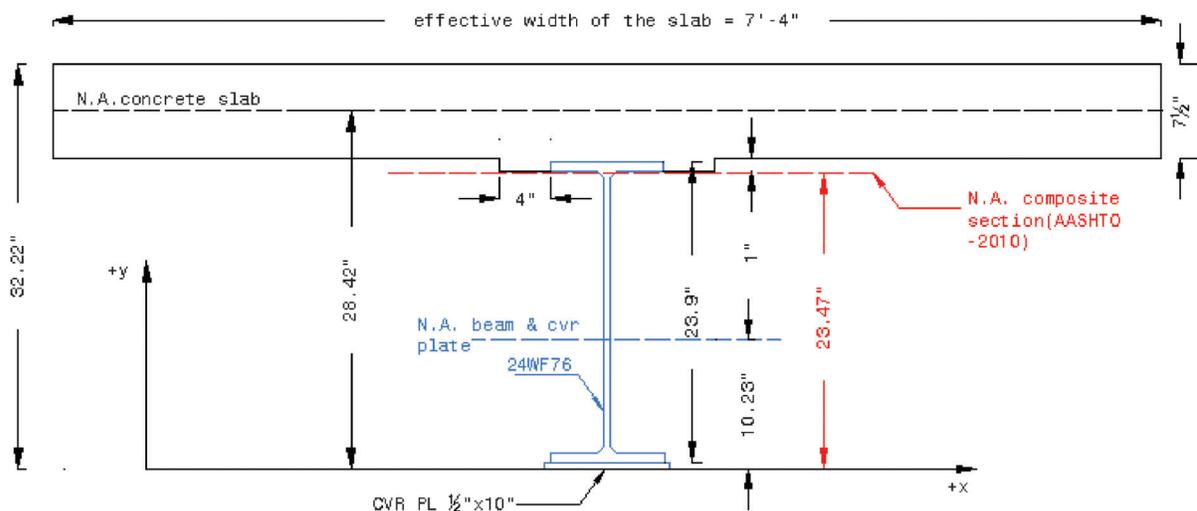
Figure 5.5 Neutral axis of the composite section – AASHTO 2010 (2).

1. Neutral axis of the composite section - AASHTO 2010 (2) (Figure 5.5)

The position of the neutral axis of composite section determined from the field measured stresses is above the position indicated by AASHTO 2010 (2) (see Figure 5.5), hence full-composite behavior is developed. As previously explained in section 5.1.3, this difference is not unusual since there are other factors (parapets and overlay surface) that contribute in the load distribution and composite action in turn influencing the position of neutral axis.

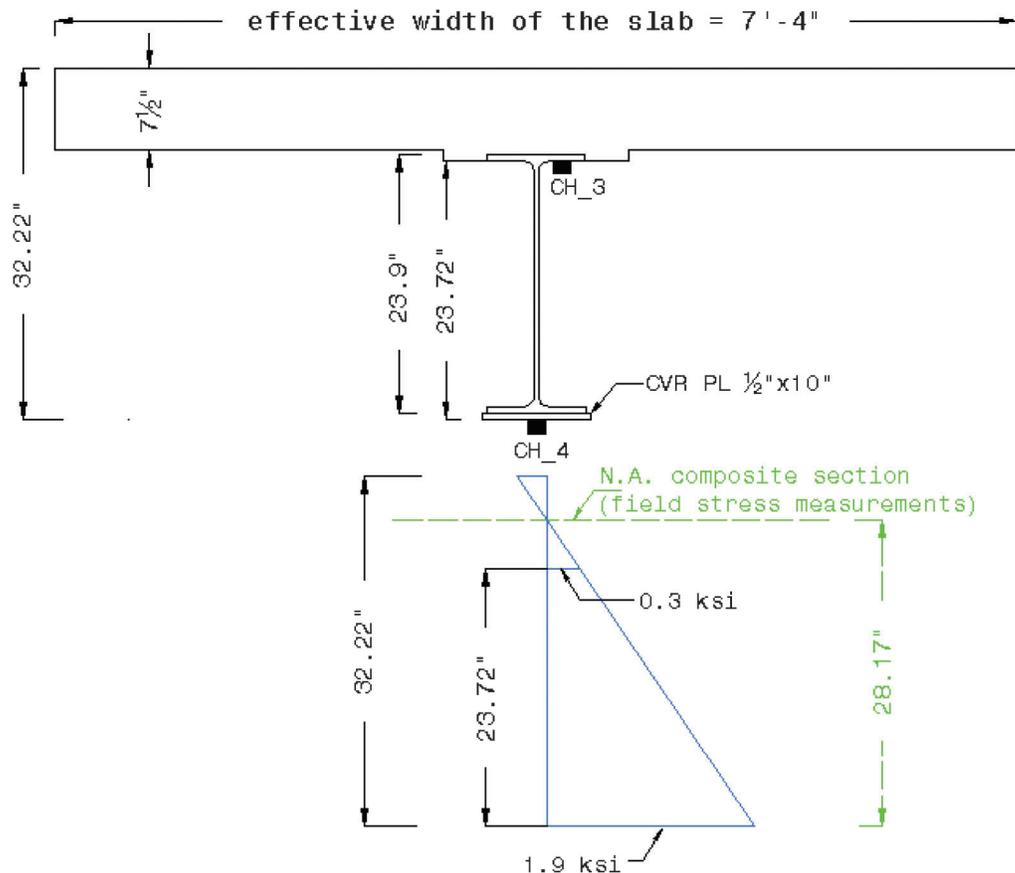
Figure 5.6 Neutral axis of the composite section – from stresses recorded in PARK_1.DAT.

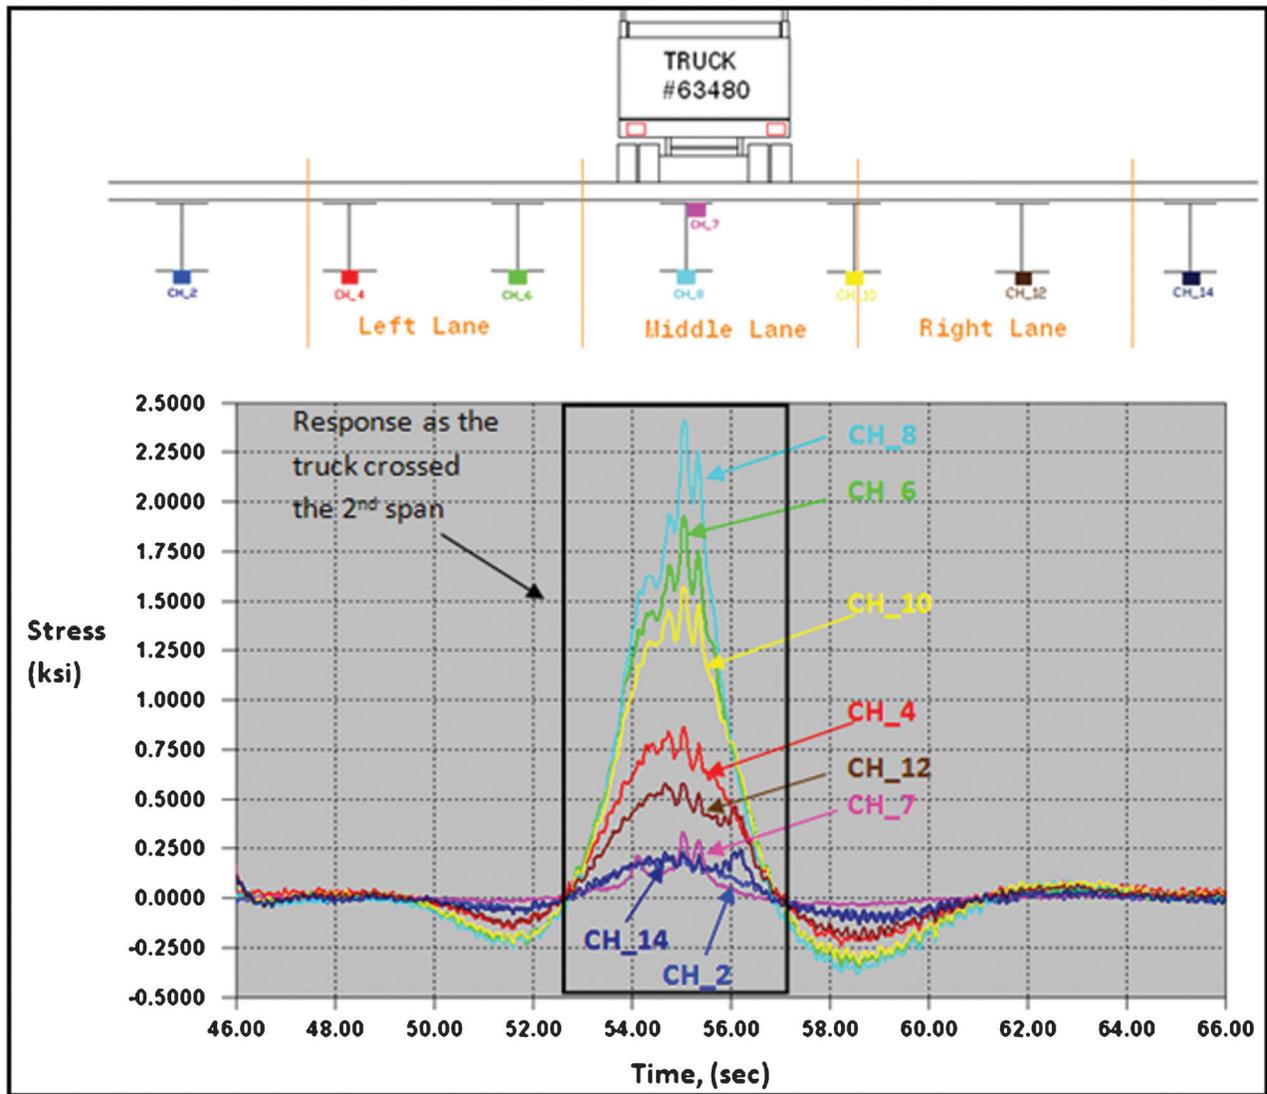
Figure 5.7 presents the response of CH_2, CH_4, CH_6, CH_7, CH_8, CH_10, CH_12 and CH_14 as the test truck (#63480) passed over the middle lane. The

response in all eight (8) channels is positive as the test truck passed over the second span (where the channels were installed). Negative moments were observed as the truck passed through the first and third spans. Also, as previously discussed in section 5.1.1, using the response from strain gages installed on the top flange of the girders, the type (number of axles) and number of vehicle(s) can be identified. This can be seen in CH_7 (pink trace) of Figure 5.7 where a tandem axle truck can be observed.

Figure 5.7 Response of strain gages installed at midspan (2nd Span) – Crawl test: single truck in the middle lane.

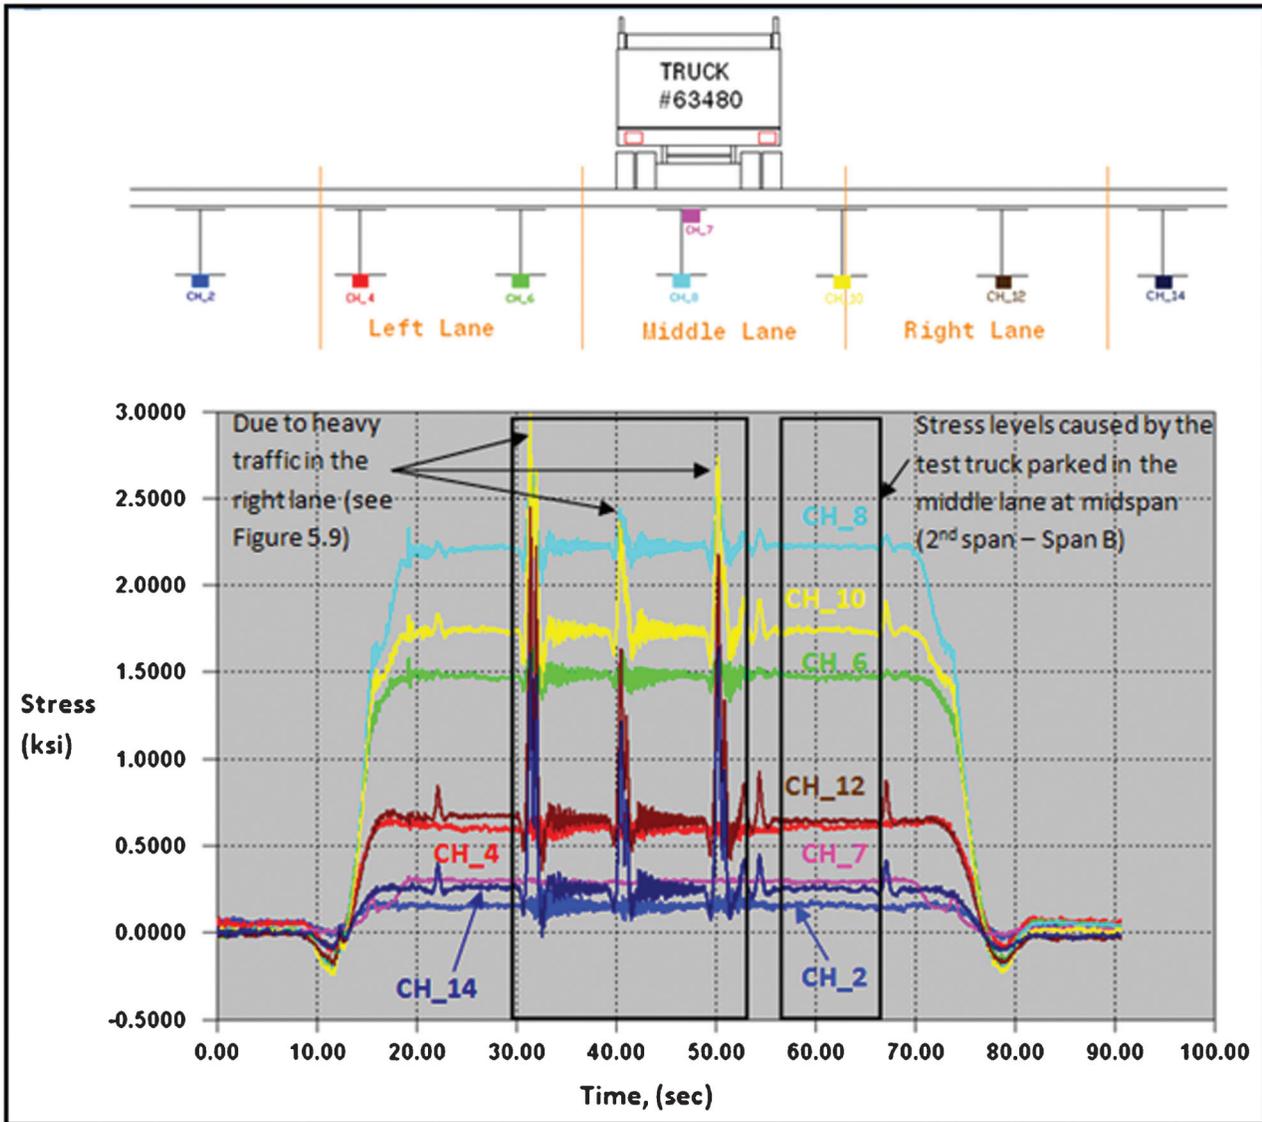
Figure 5.8 Response of strain gages installed at midspan (2nd Span) – Static test: single truck in the middle lane.

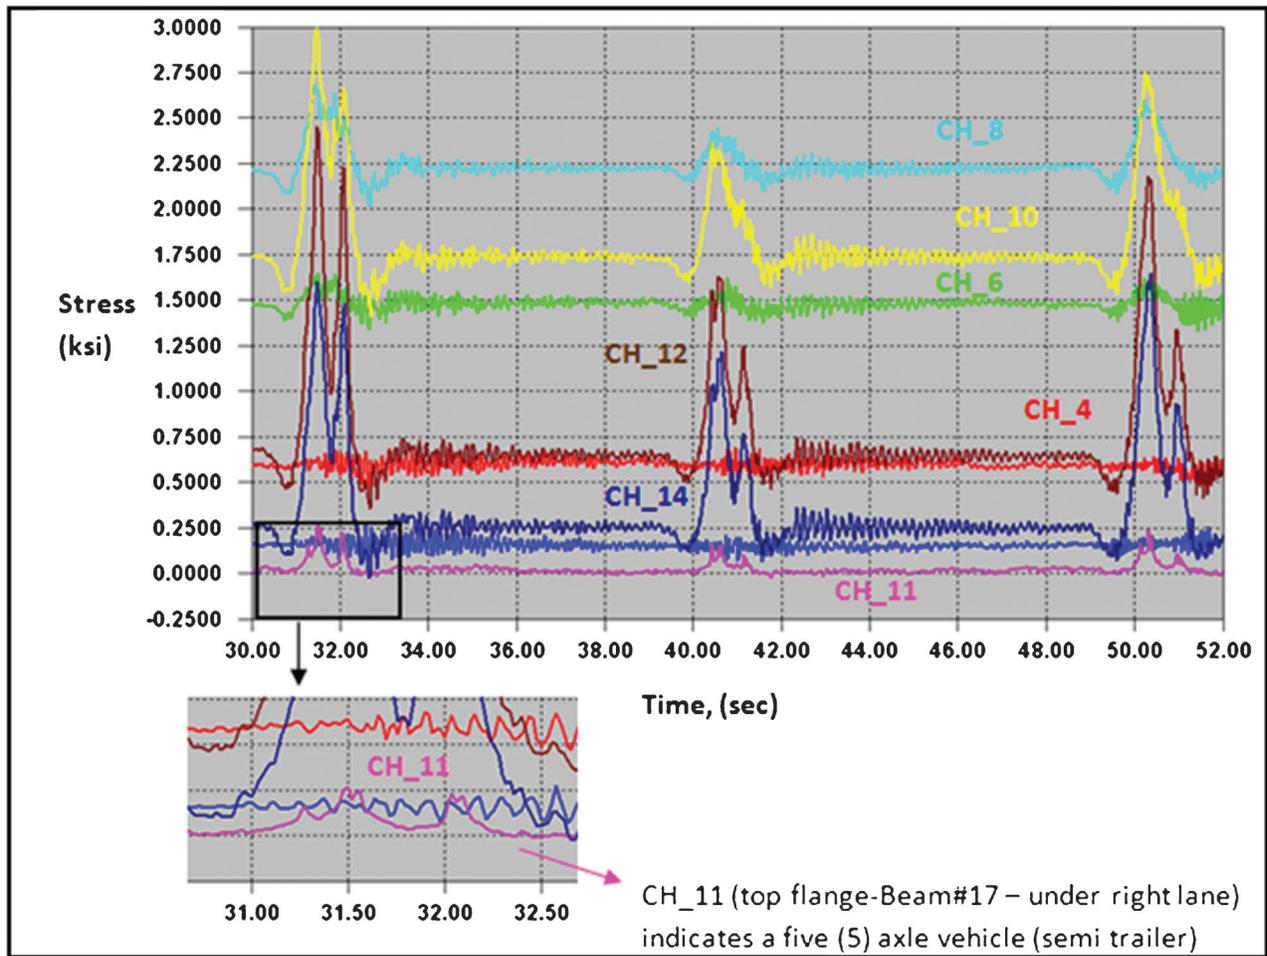
Heavy traffic was noted in the right lane during the static test (PARK_2C.DAT). Figure 5.9 shows the response of the strain gages to this heavy traffic. In the figure, CH_11 indicates three (3) semi-trailers passed back-to-back in the right lane. The semis were identified by the top flange response to the axles. An expanded view of the response to one of the semis exemplifies how they were identified.

Figure 5.9 Response of CH_11 indicates semis passing in the right lane during the single truck static test in the middle lane.

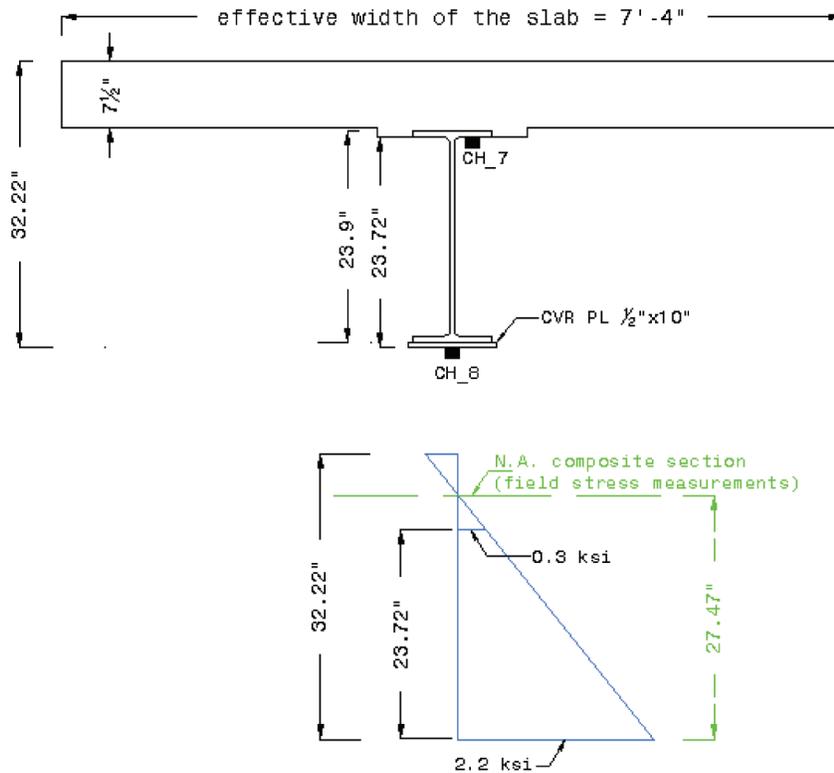
Figure 5.10 Neutral axis of the composite section – from stresses recorded in PARK_2C.DAT.

Using elastic section properties (linear stress-strain diagram) and similar triangles (Figure 5.10) the

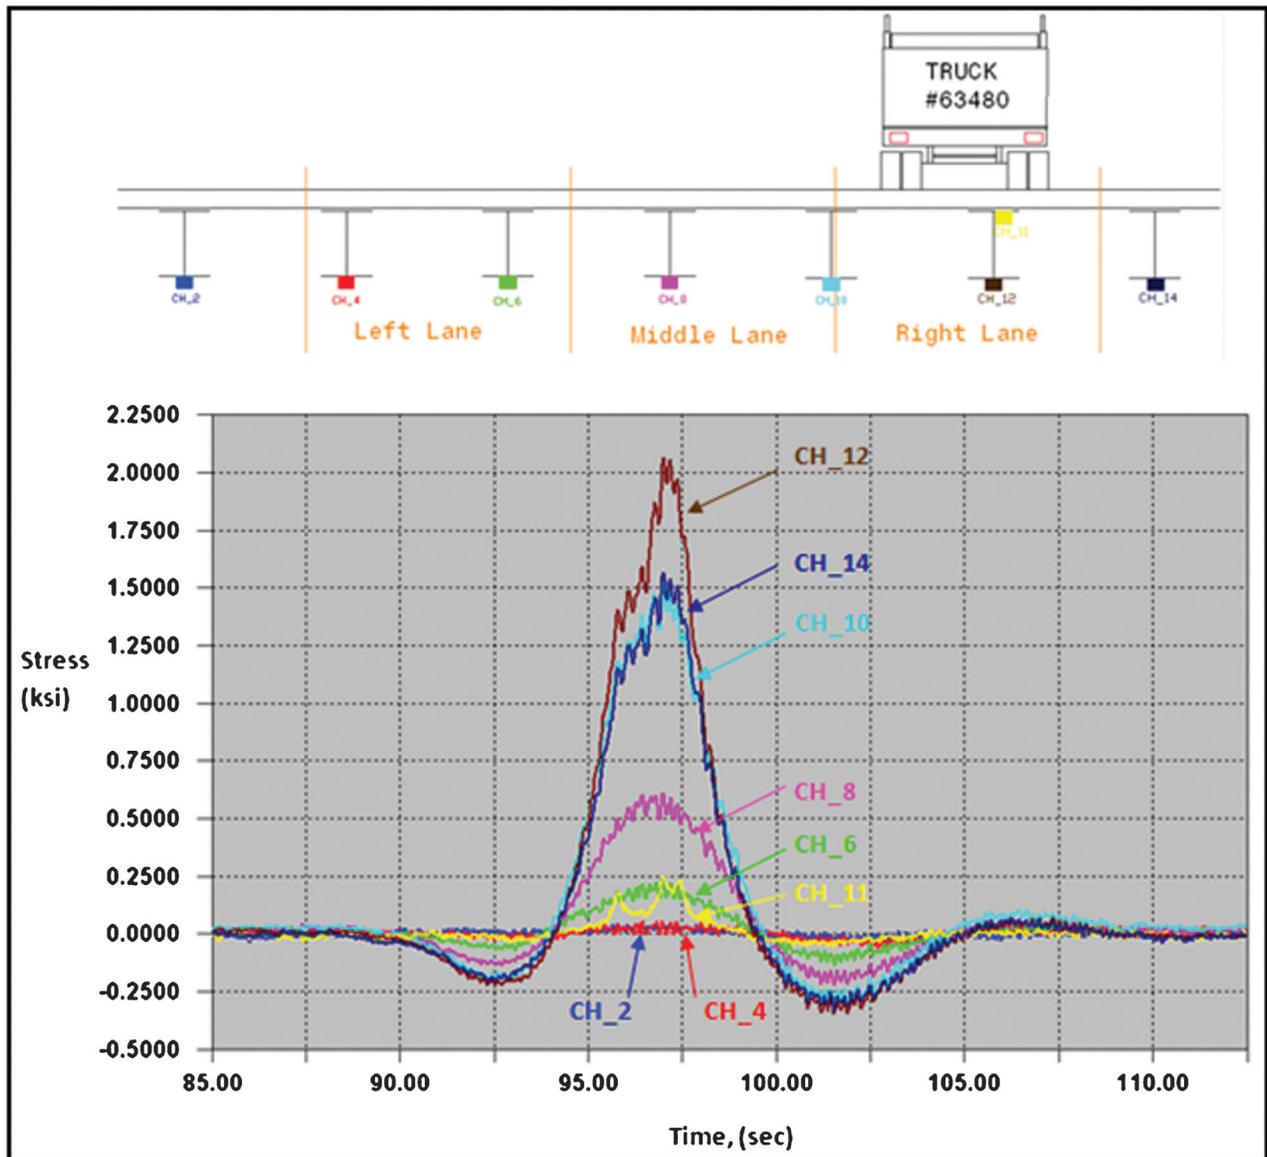
Figure 5.11 Response of strain gages installed at midspan (2nd Span) – Crawl test: single truck in the right lane.

When the controlled tests were performed in the right lane, the traffic on I-465 was stopped; thus, only the test truck was on the bridge. Figure 5.11 presents the response of CH_2, CH_4, CH_6, CH_8, CH_10, CH_11, CH_12 and CH_14 as the test truck (#63480) passed the bridge in the right lane. The response in all eight (8) channels is the same as in the previous single truck crawl tests: positive as the test truck passed over the second span (where the channels were installed) and negative as it passes through the first and third spans. Also, as for the previous two single truck positions, the
