Evaluation of Effects of Fire on the I-465 Mainline Bridges—Volume I

Connor, R. J., A. H. Varma, S. Marcu, and R. J. Sherman. *Evaluation of Effects of Fire on the I-465 Mainline Bridges—Volume I*. Publication FHWA/IN/JTRP-2012/12. Joint Transportation Research Program, Indiana Department of Transportation and Purdue University, West Lafayette, Indiana, 2012. doi: 10.5703/1288284314975.

Report Number: FHWA/IN/JTRP-2012/12

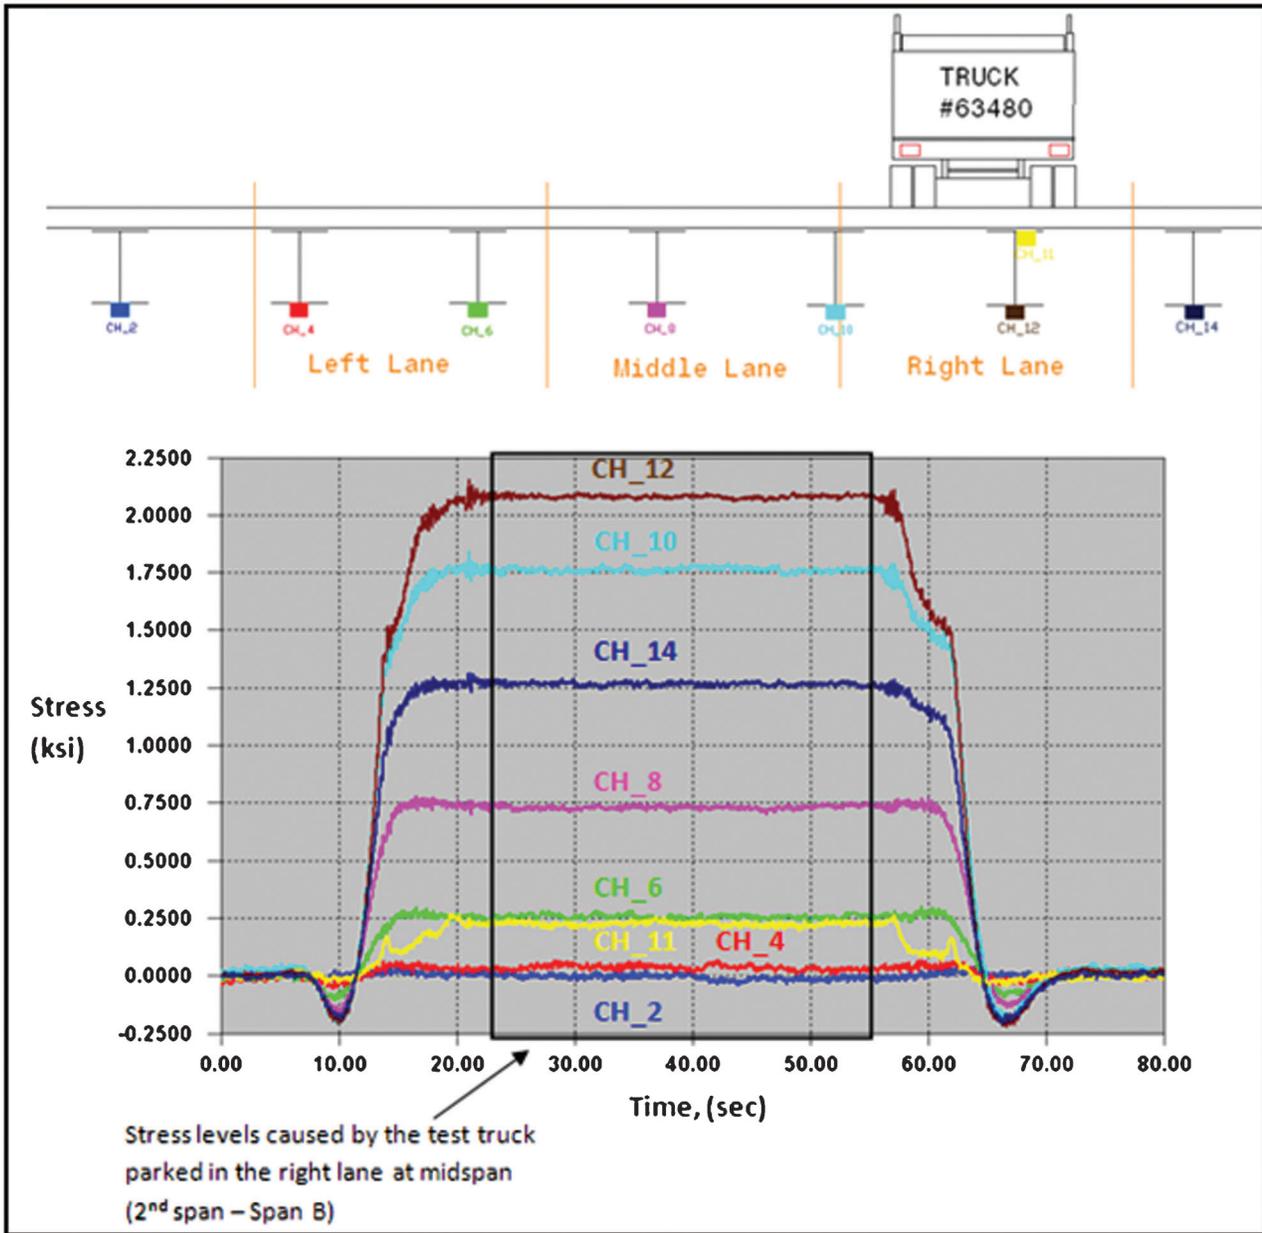
Figure 5.12 Response of strain gages installed at midspan (2nd Span) – *Static test*: single truck in the right lane.

The single truck right lane static test consisted of the test truck being parked at midspan (2nd Span) of the right lane for a short period of time while measurements were made. Figure 5.12 shows the response of the same channels considered in Figure 5.11 during the static test PARK_4.DAT. Maximum stress values obtained during the single truck tests in the middle lane are summarized in Table 5.3.

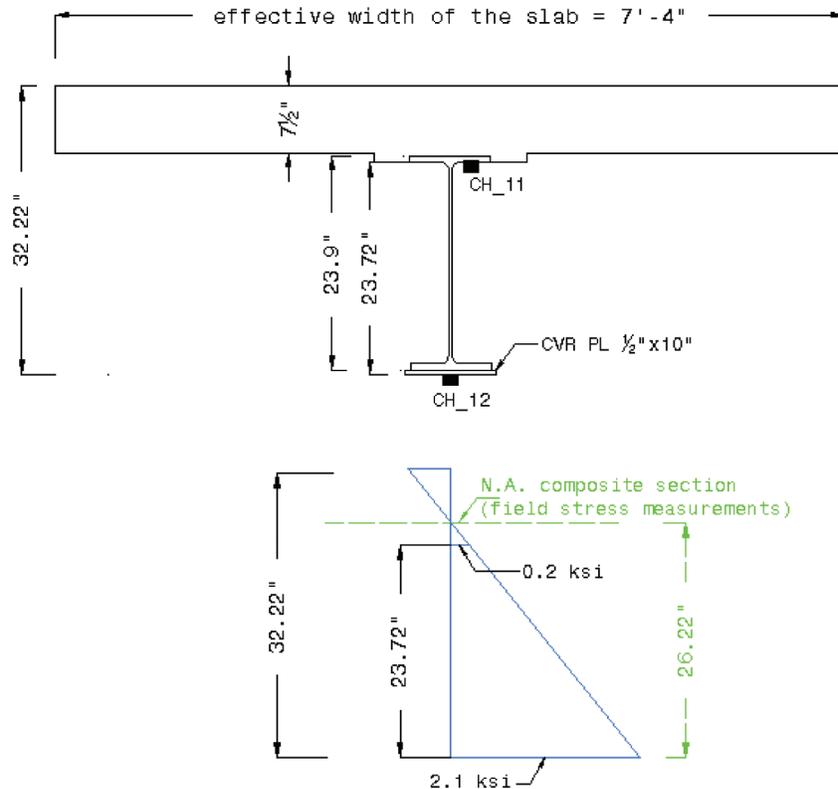
Figure 5.13 Neutral axis of the composite section – from stresses recorded in PARK_4.DAT.

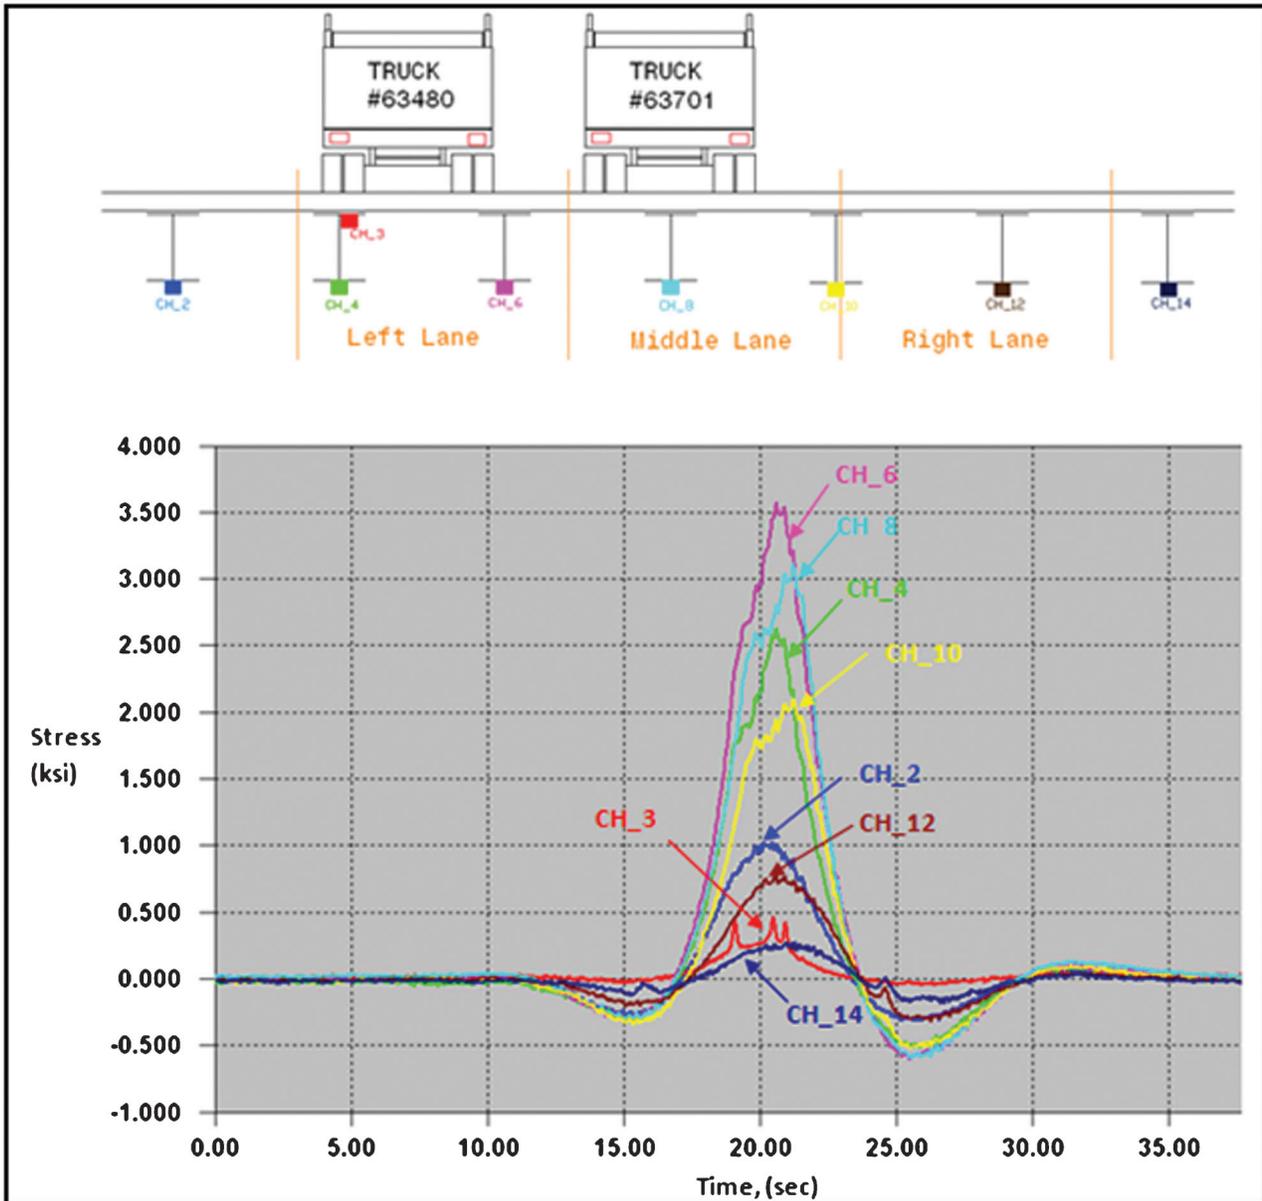
Figure 5.14 presents the response of CH_2, CH_3, CH_4, CH_6, CH_8, CH_10, CH_12 and CH_14 as both test trucks passed side-by-side over the bridge

Figure 5.14 Response of strain gages installed at midspan (2nd Span) – Crawl test: trucks side-by-side in the left and middle lanes.

However, the effect of the second truck has little impact on the exterior girder. Comparing Figure 5.1 and Figure 5.14, the effect of a second truck in the middle lane has little influence on the stress in Beam #12 (CH_2). In other words, all the load of the truck in the middle lane was distributed out among the girders near the middle lane. This is best observed when comparing the stresses recorded during these two tests. In the first test (CRL_1.DAT), CH_2 recorded a maximum stress of approximately 1.1 ksi while in the second test (CRL_3.DAT) a maximum stress of 1.0 ksi was recorded. A similar response is also seen when looking at the first interior girder (Beam #13). Comparing the response of CH_4 for both truck configurations, only a small increase of approximately 0.5 ksi is observed when the second truck is added in the middle lane. A comparison of the maximum bottom flange cover plate stresses recorded for each of these

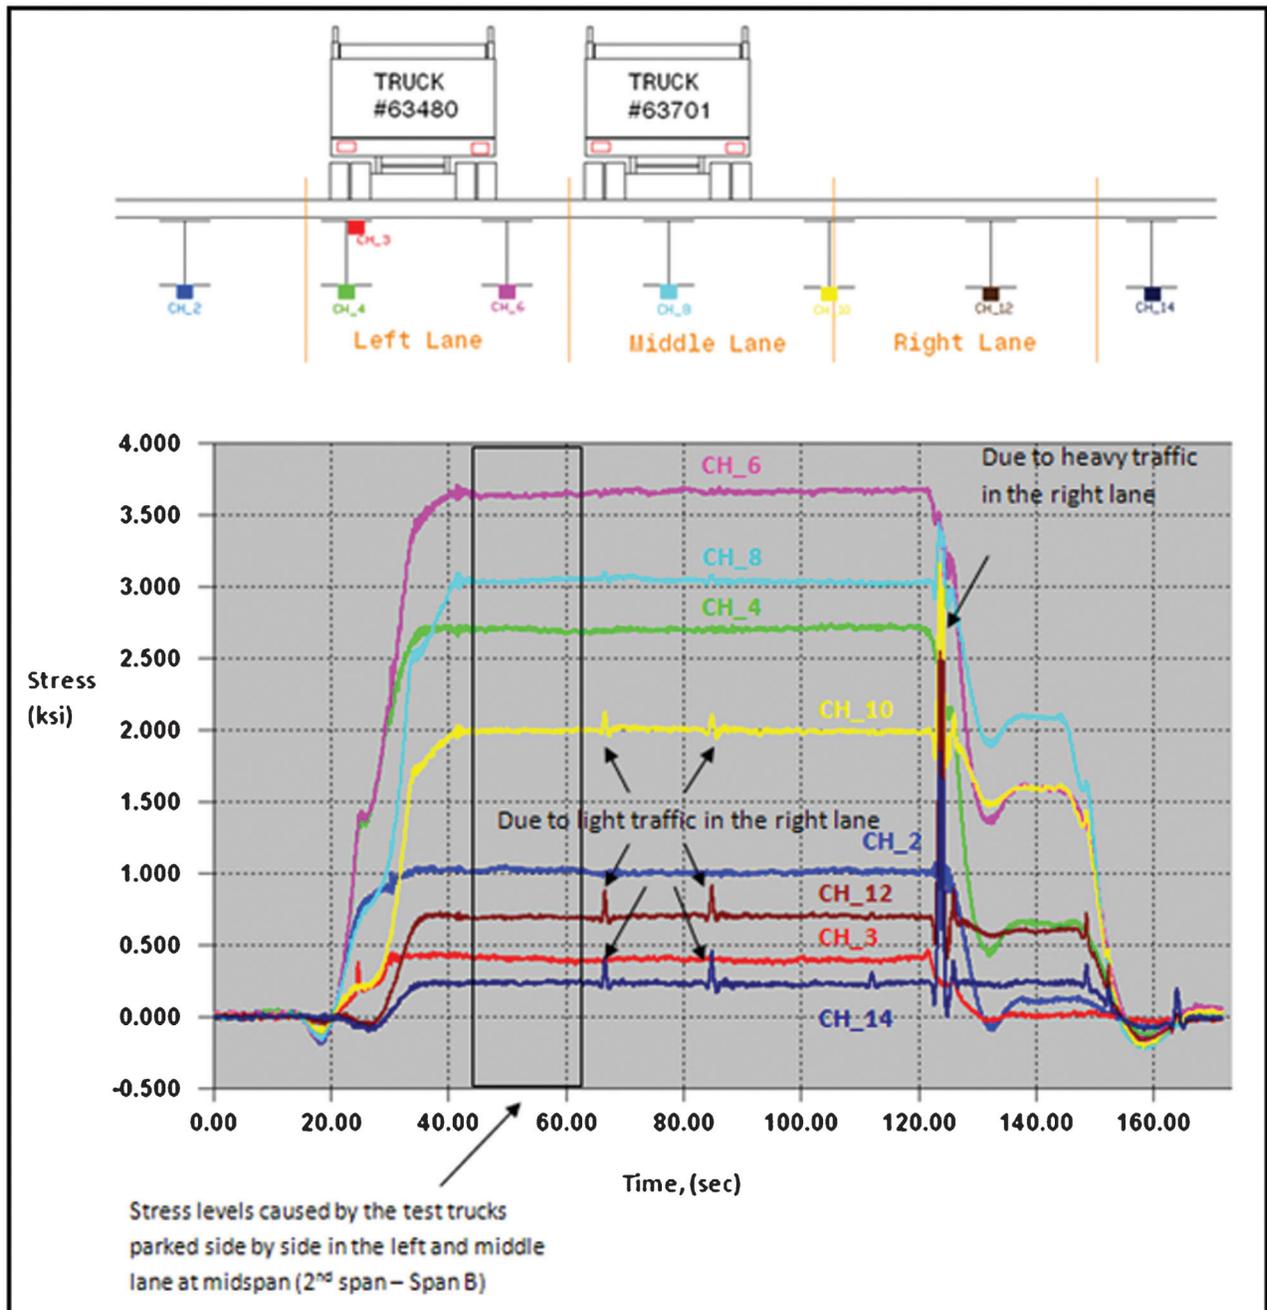
Figure 5.15 Response of strain gages installed at midspan (2nd Span) – *Static test*: trucks side-by-side in the left and middle lanes.

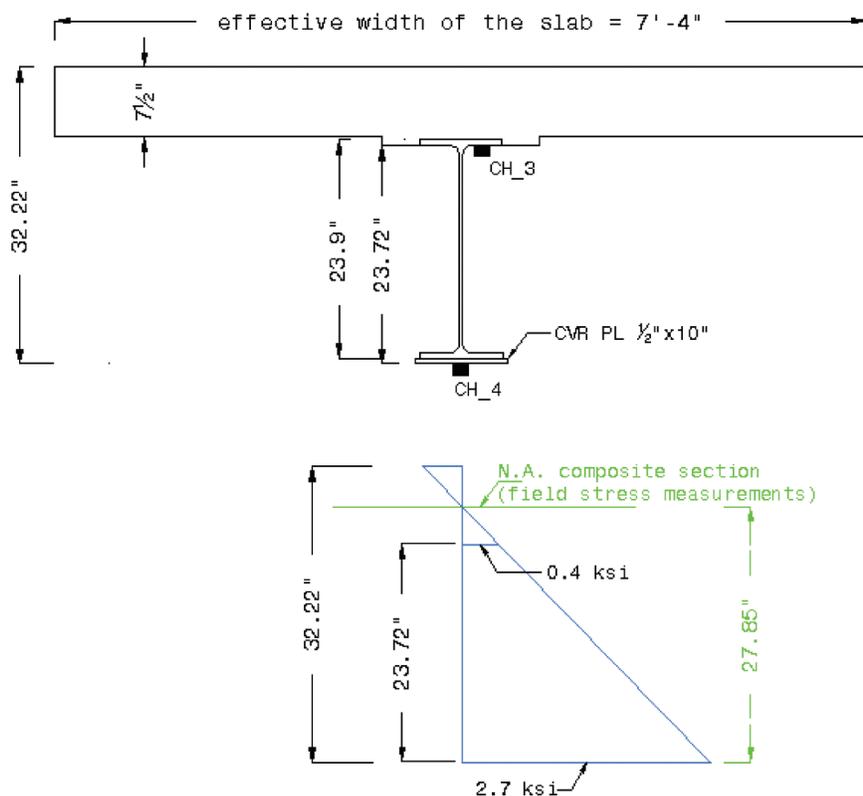
Figure 5.16 Neutral axis of the composite section – from stresses recorded in PARK_3.DAT.

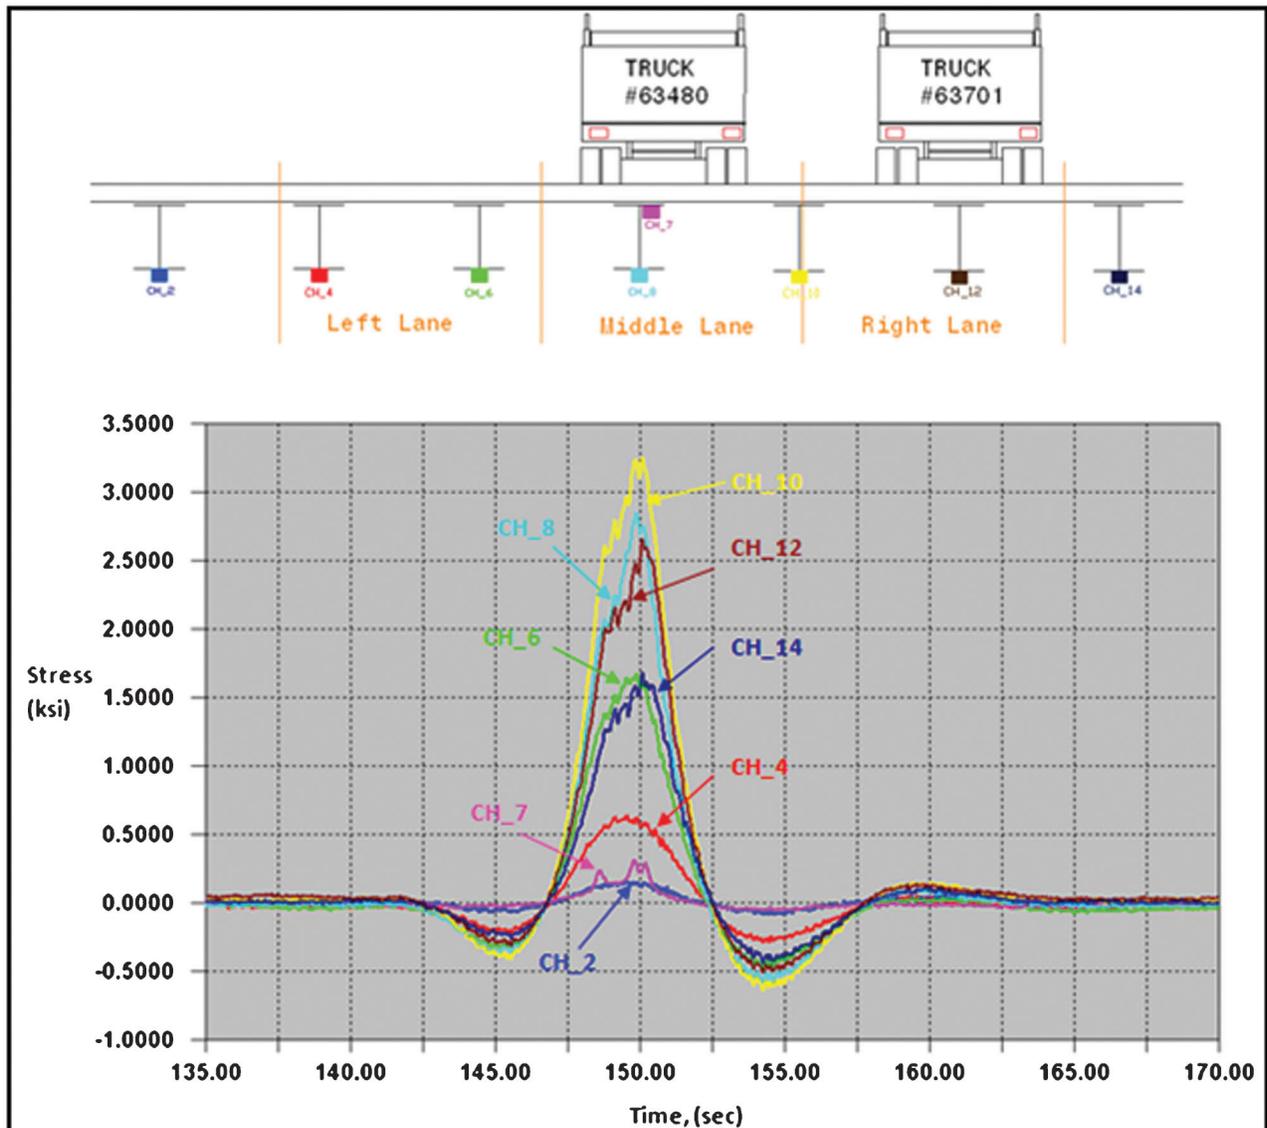
Figure 5.17 presents the response of CH_2, CH_4, CH_6, CH_7, CH_8, CH_10, CH_12 and CH_14 as

both test trucks passed side-by-side in the middle and right lanes in crawl test CRL_5.DAT. The same type of behavior (load distribution between the girders) is encountered in this crawl test (CRL_5.DAT) as presented in section 5.4.1. Maximum stresses were recorded in channels located on the girders nearest to the load. In this case CH_8, CH_10 and CH_12 recorded stresses of 2.8 ksi, 3.2 ksi and 2.6 ksi, respectively. Again, as seen in section 5.4.1, by comparing the response of CH_2 (Beam #12) and CH_4 (Beam #13) in both truck configurations (CRL_2.DAT & CRL_5.DAT) it is observed that the presence of a second truck in the right lane has little to no influence on these two (2) girders.

Figure 5.17 Response of strain gages installed at midspan (2nd Span) – Crawl test: trucks side-by-side in the middle and right lanes.

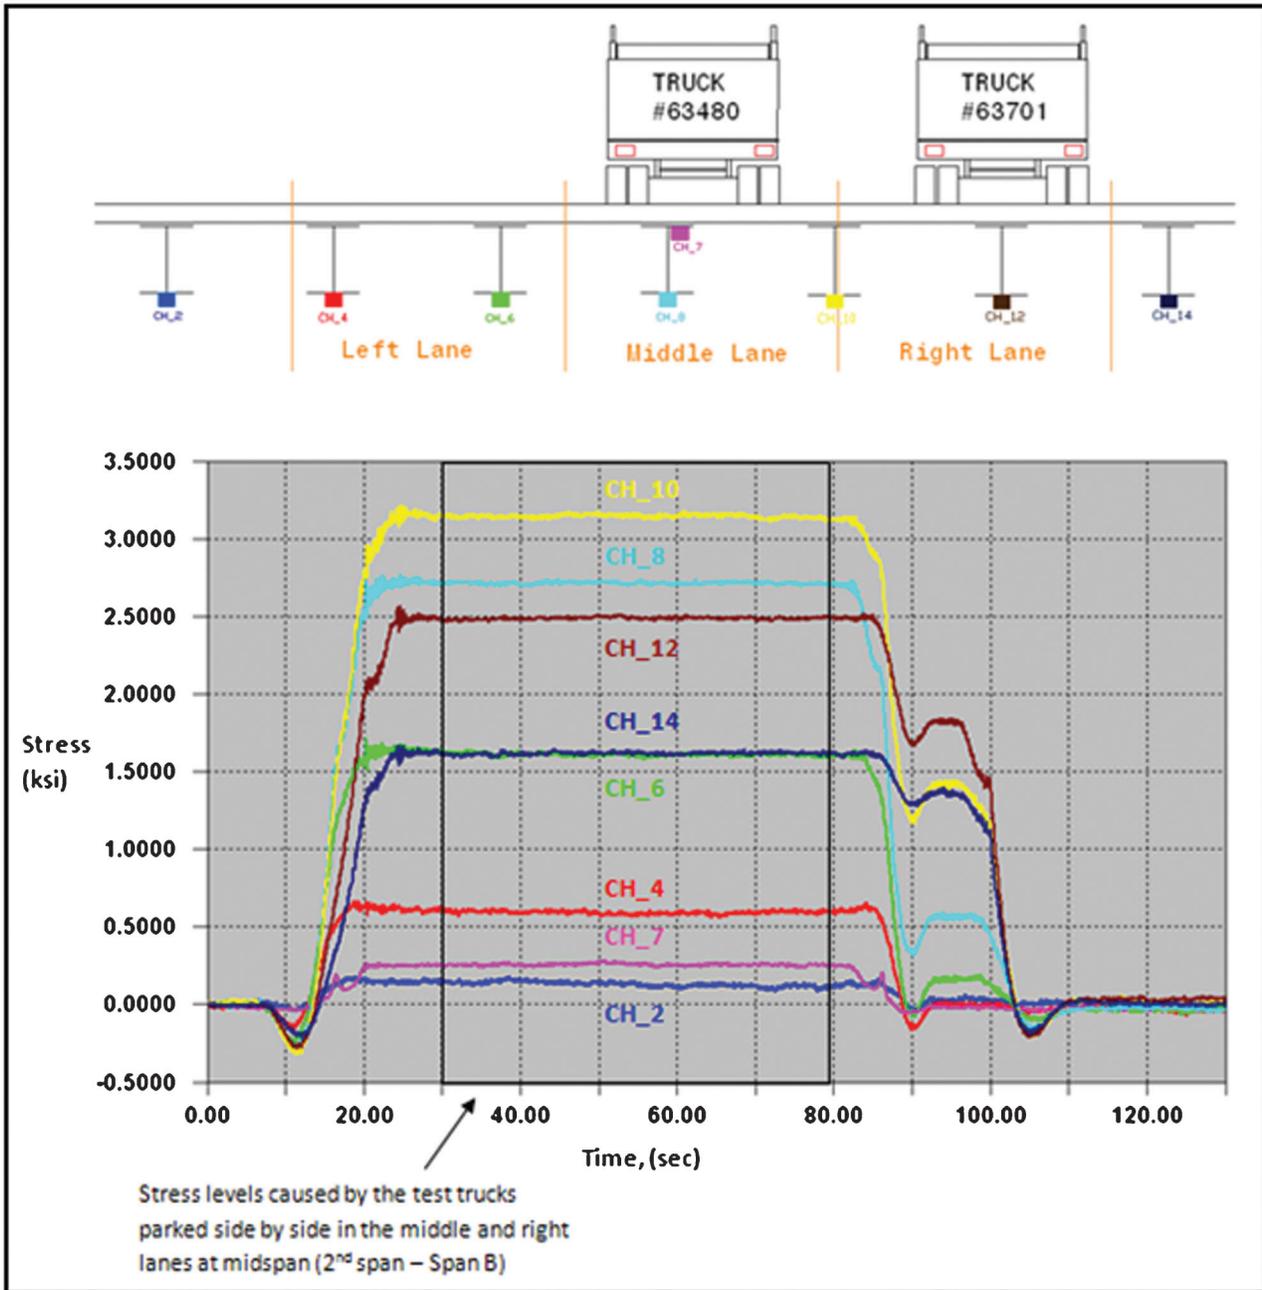
Figure 5.18 Response of strain gages installed at midspan (2nd Span) – *Static test*: trucks side-by-side in the middle and right lanes.

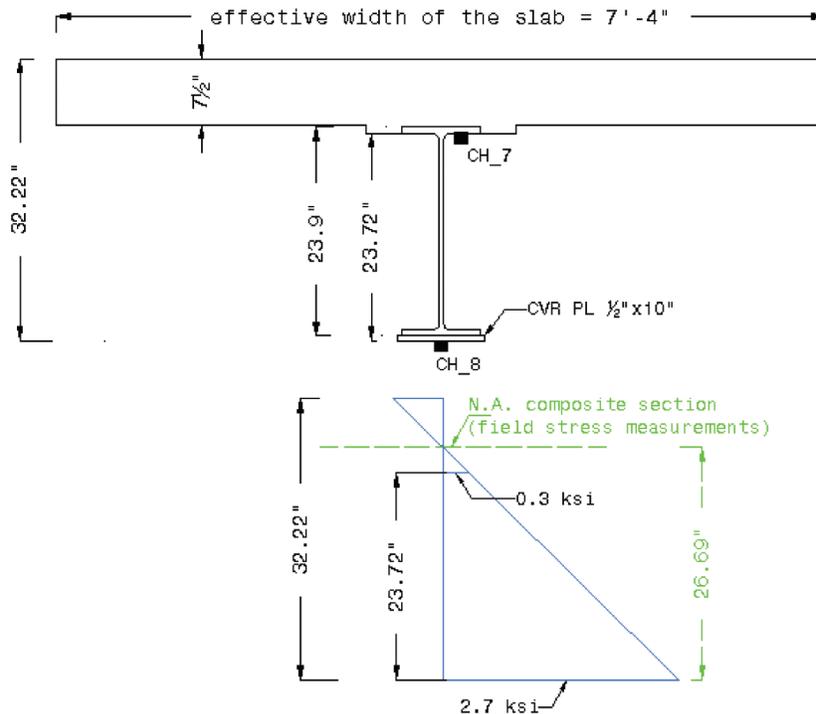
Figure 5.19 Neutral axis of the composite section – from stresses recorded in PARK_5.DAT.

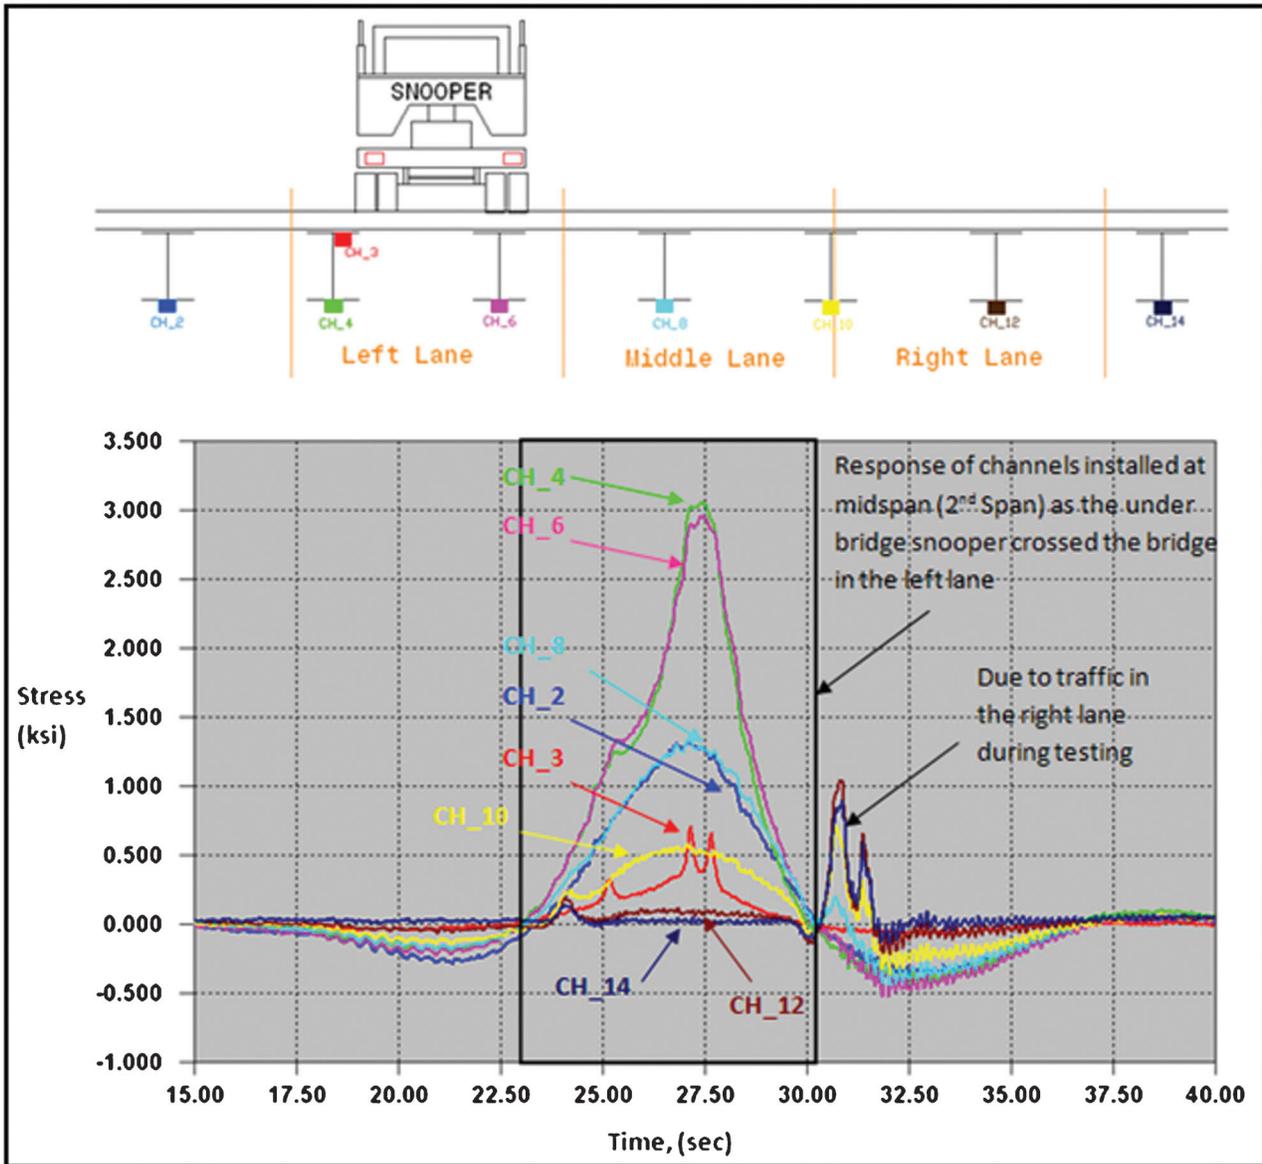
Figure 5.20 Response of strain gages installed at midspan (2nd Span) – Crawl test: under bridge snooper in the left lane.

The greatest stress values were recorded in CH_4 and CH_6 for both crawl tests (CRL_1.DAT and SNOOP.DAT). This was because the load was directly

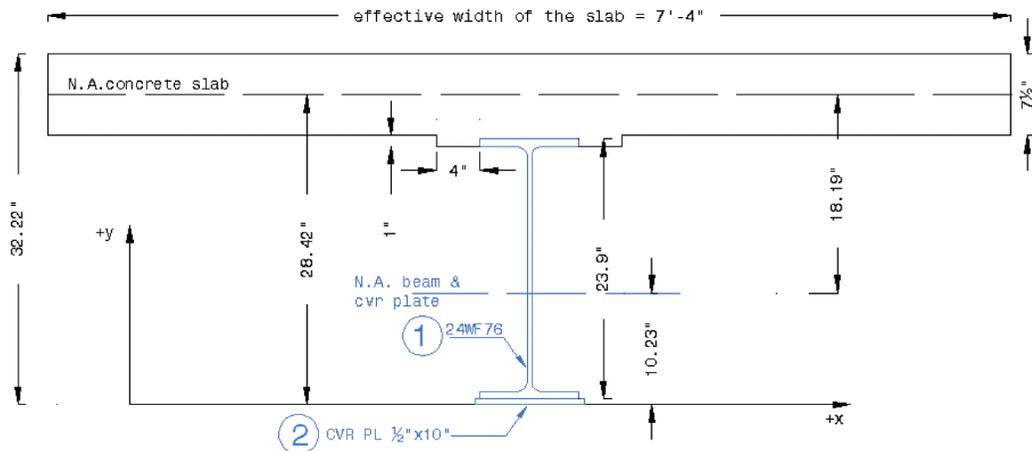
Figure 5.21 Sketch for determination of the longitudinal stiffness parameter K_g .

The longitudinal stiffness parameter K_g is determined as follows:

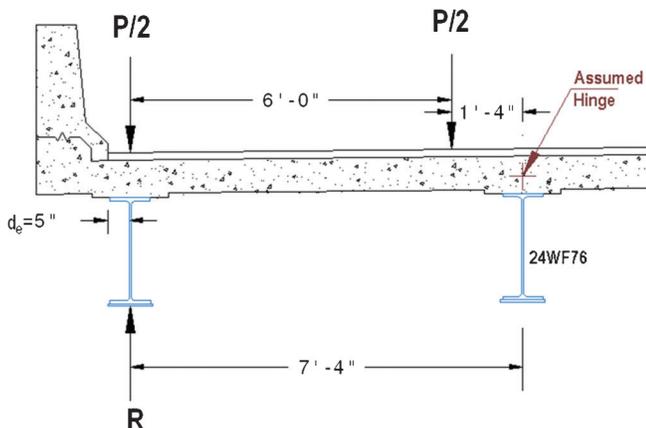
Figure 5.22 Distribution load factor – exterior longitudinal beam – Lever Rule.

The distribution factors (per lane) for moment in *exterior longitudinal beams* are determined according to Table 4.6.2.2d-1 as follows:

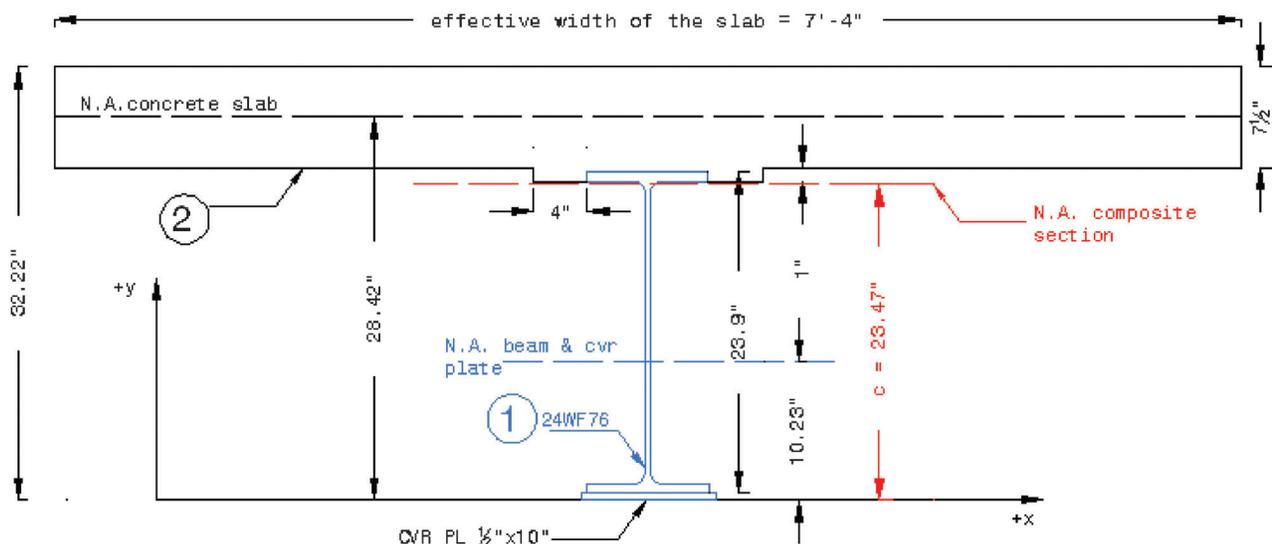
Figure 5.23 Section properties – composite section (interior beam case).

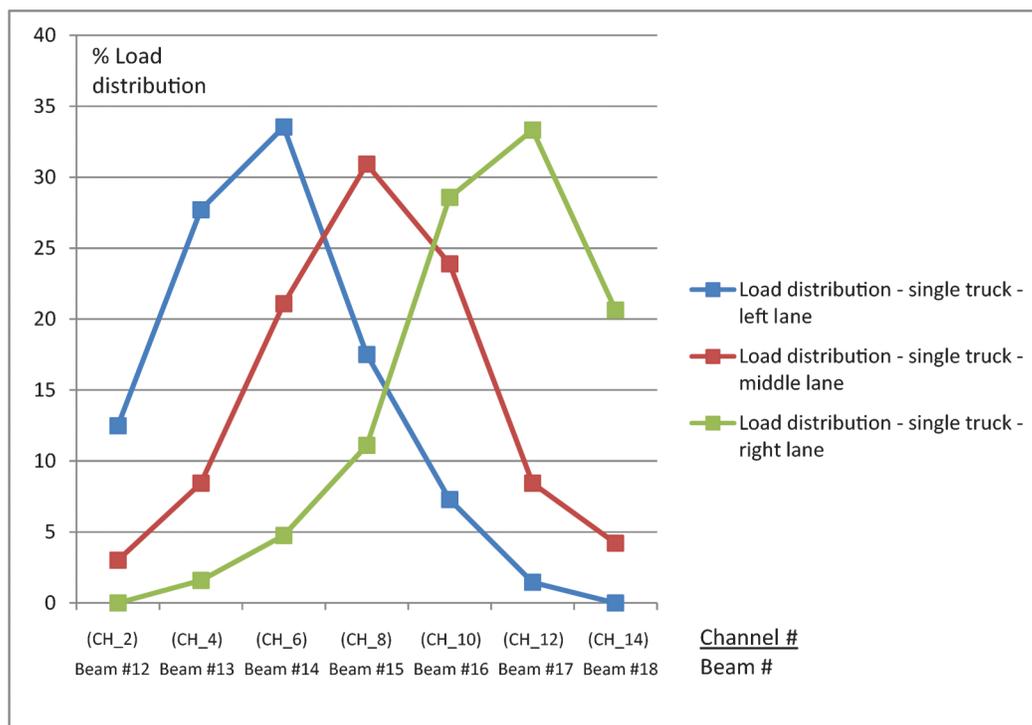
The data presented in Figure 5.26 show how the load was distributed among the girders during the single truck controlled load tests. When the test truck is parked in the left lane, the maximum percentage of the total load received by an interior girder, in this case Beam #14 - CH_6, is 34% (DF = 0.34). The maximum percentage of the total load received by the exterior girder, in this case Beam #12 - CH_2, is only 12 % (DF = 0.12). A comparison of these values with those obtained from AASHTO 1965 (1) and AASHTO 2010 (2) (see sections 5.8.1 and 5.8.2) shows the specification values being higher. This is expected since the load is also distributed longitudinally, while the specifications do not take this into consideration, offering a more conservative estimate of the portion of the load distributed to one of the

Figure 5.26 Load distribution between girders – single truck static tests.

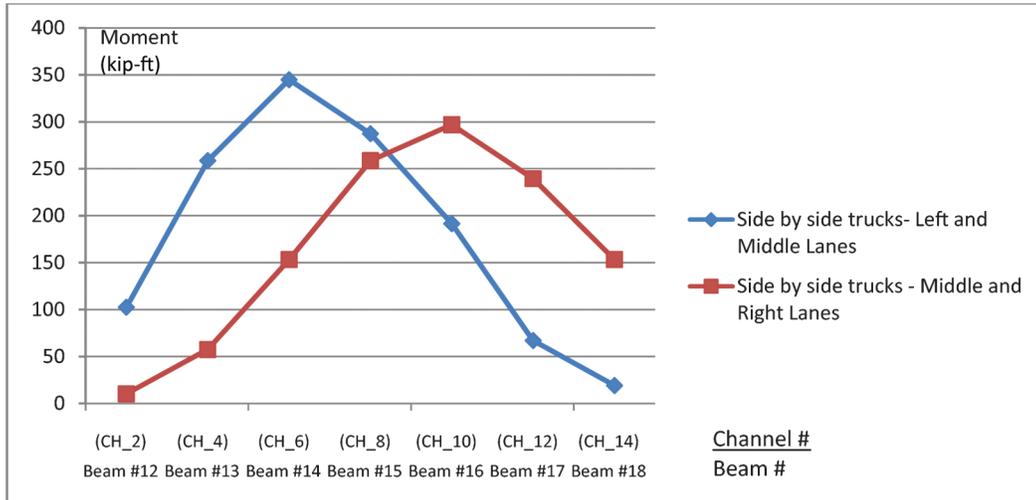
Figure 5.27 Moments determined from stresses recorded during side-by-side trucks static tests.

From Table 5.16 it is observed that the moments from the side-by-side tests are very close to those obtained from superposition of single truck tests. There are mainly two (2) reasons for the small differences outlined in column eight (8) of the table. First, there are small differences between the test trucks like: geometry (axle, wheel spacing) and weight (gross weight, axle weight). Figure 4.2 and Figure 4.3 from Chapter 4 are diagrams of the tests trucks and outline these geometric and weight differences. This is important since only truck #63480 was used in the single truck tests. Second, the transverse positions of the truck(s) during the parked tests were not identical. For example, during the single truck test in the left lane (PARK_1.DAT) the

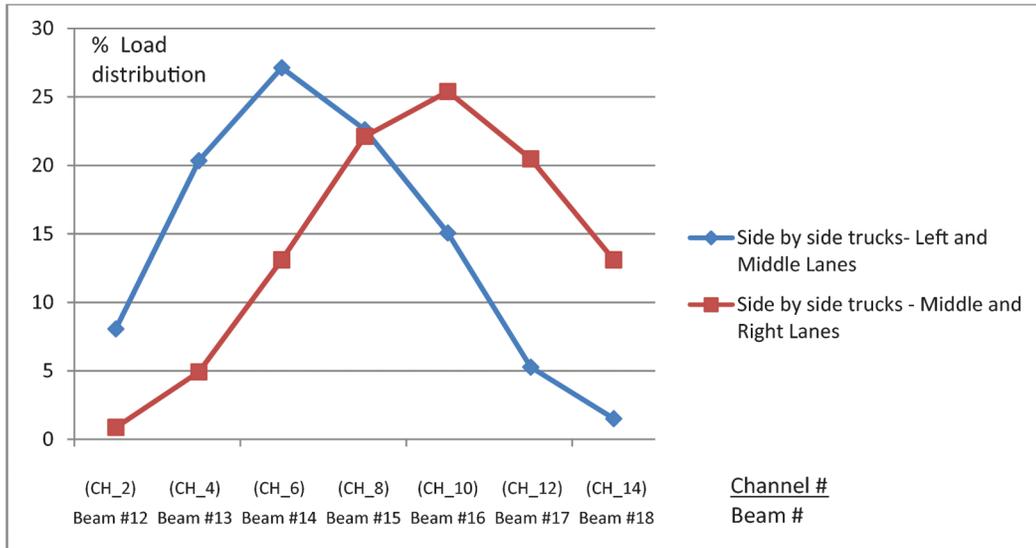
Figure 5.28 Load distribution between girders – trucks side-by-side static tests.

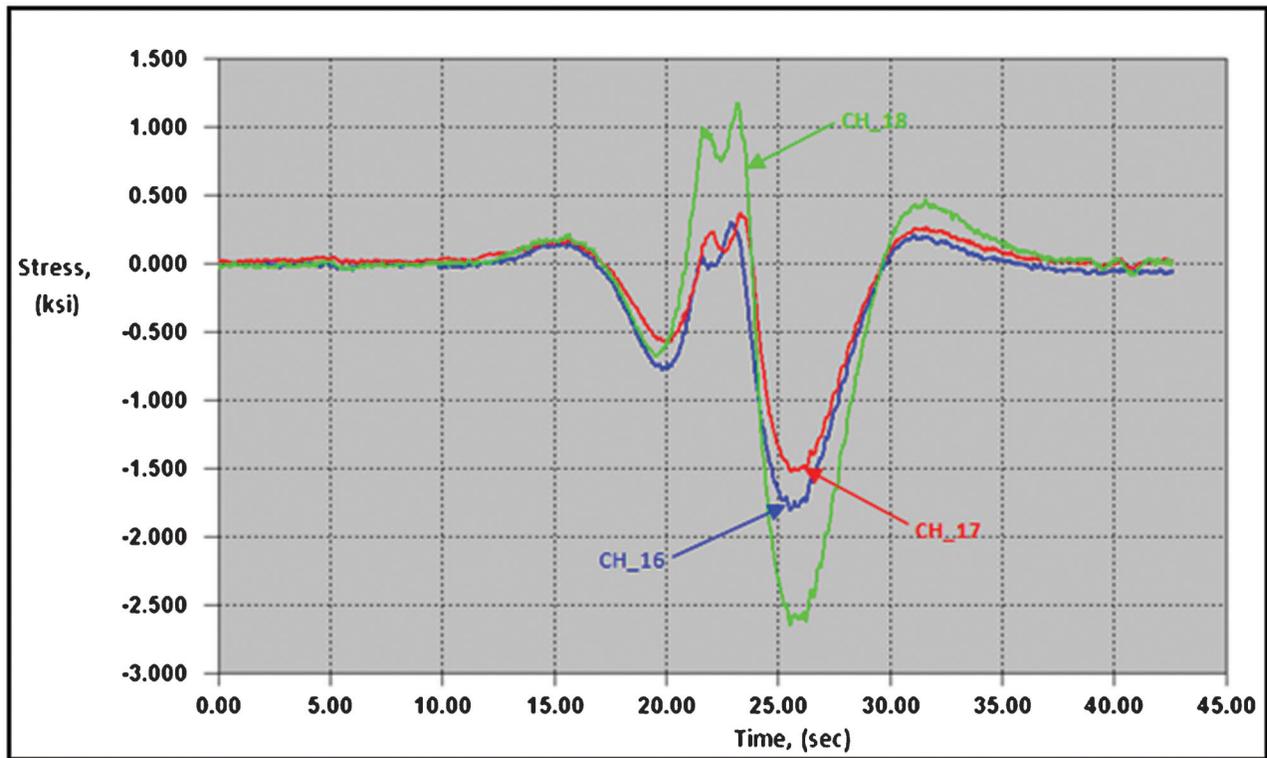
The maximum stress range observed for these three (3) channels (CH_16, CH_17 and CH_18) during the controlled load tests was only 3.8 ksi (CH_18 in test CRL_3.DAT). This is well below Category D fatigue detail (CAFL = 7 ksi). Figure 5.29 shows the response of these three (3) channels as both test trucks passed side-by-side over the bridge in the left and middle lane in crawl test CRL_3.DAT. Further discussion on the fatigue resistance of these locations will follow in Chapter 6.

Figure 5.29 Response of CH_16, CH_17 and CH_18 - *Crawl test*: trucks side-by-side in left and middle lanes.

A total of four (4) strain gages were placed near locations where cores were cut for metallurgical investigation to monitor the stress levels during the long-term monitoring and controlled load testing. At these regions, the condition at the cored hole could be classified as an AASHTO Category D fatigue detail (CAFL = 7.0 ksi). Prior to cutting the cores the fatigue detail category at these locations was most likely Category B (CAFL = 16.0 ksi). Thus, the fatigue resistance at this location has been significantly reduced. However, this reduction in fatigue category may not be significant if the actual in-service live load stress ranges at these locations are low.

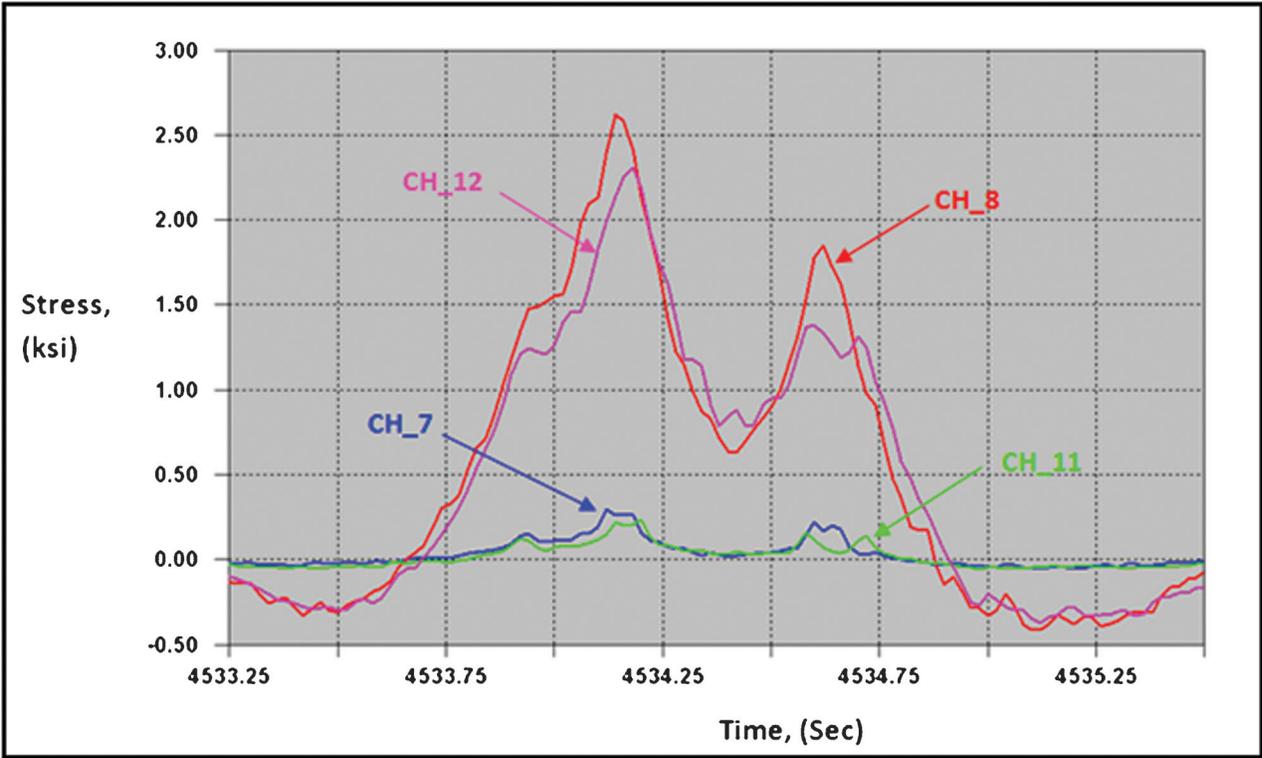
Figure 6.1 Typical trigger event: Two semi tractor trailers side-by-side in the middle and right lanes.

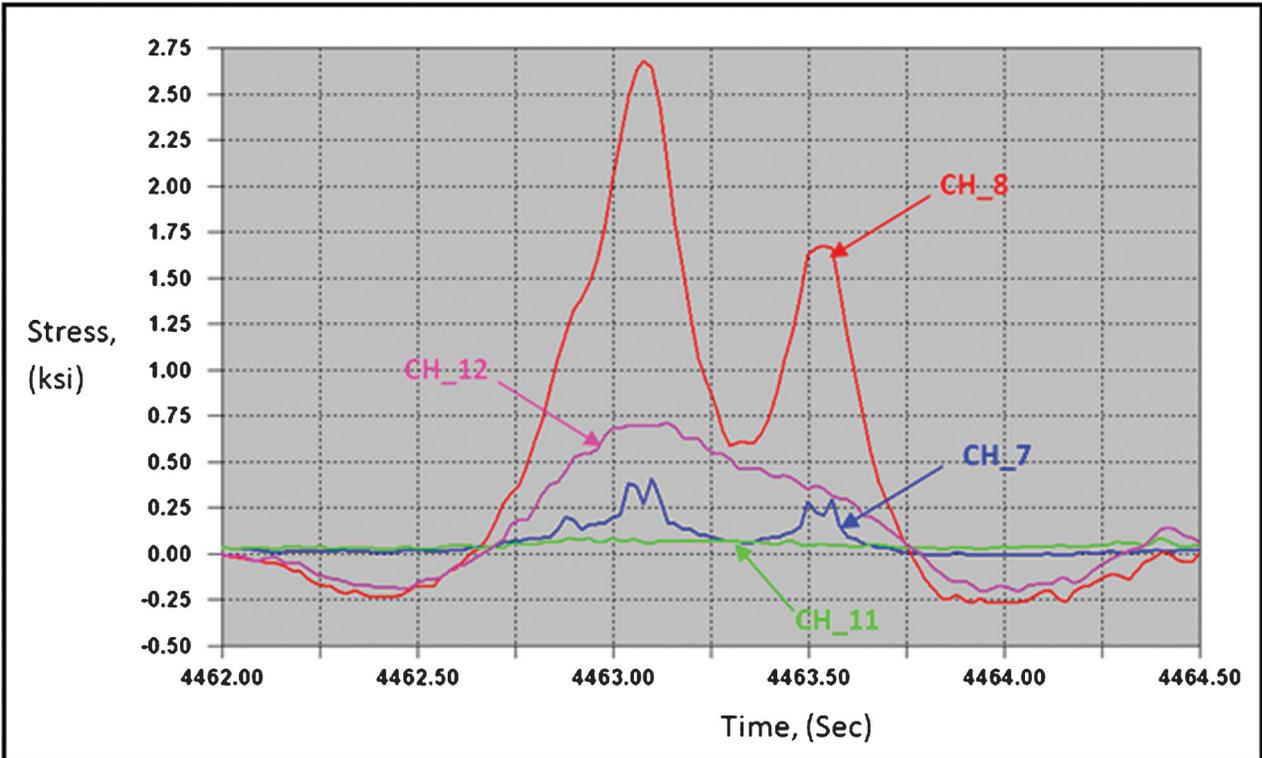
Figure 6.2 Typical trigger event: Semi tractor trailer in the middle lane.

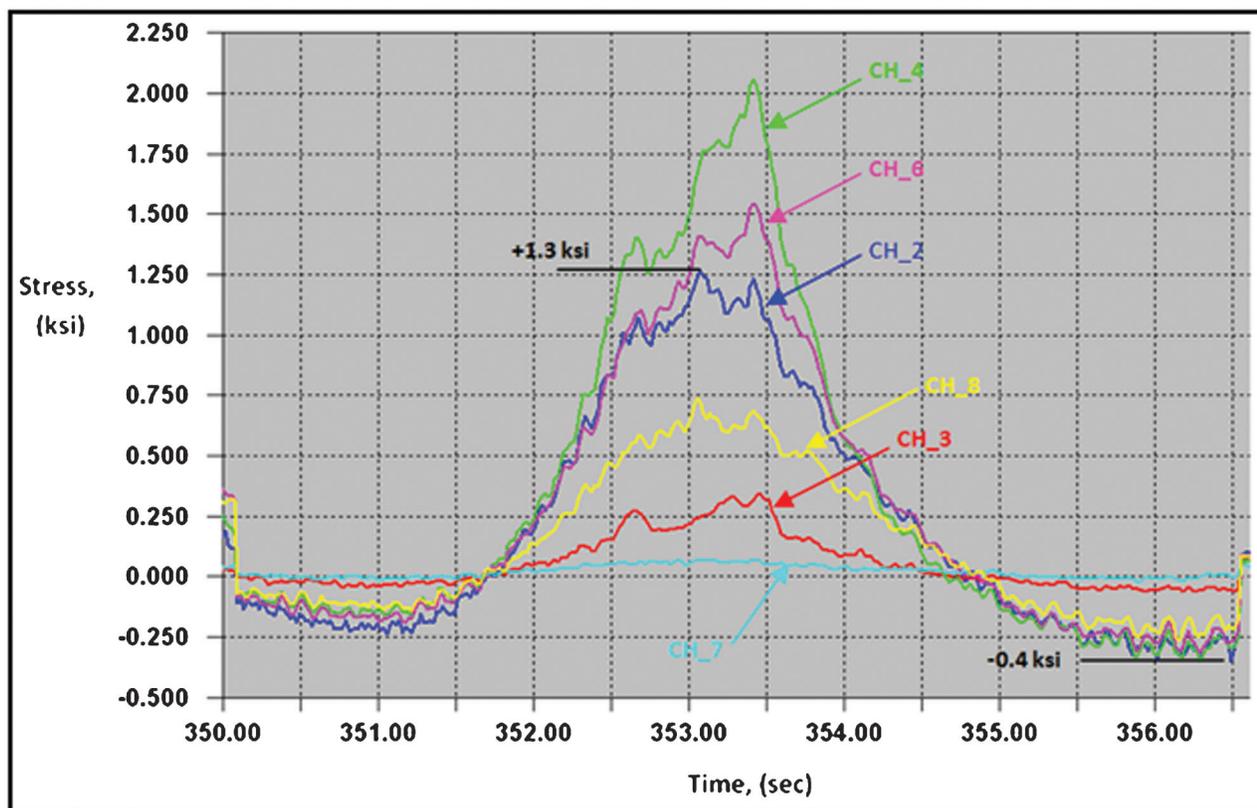
Figure 6.3 Maximum stress range recorded in CH_2 from triggered data.

MATLAB routines were created to search through the triggered data files and identify the maximum stress ranges for channels of interest. Table 6.3 summarizes these findings for the channels of interest located on the eastbound bridge. Figure 6.3 shows the maximum stress range event recorded by CH_2 on February 6, 2010. This event occurred while a tandem-axle truck crossed the bridge in the left lane. Plots of the maximum stress range events from triggered data for the remaining channels presented in Table 6.3 can be found in Appendix D.

Throughout the duration of monitoring no stress range cycles greater than the Category B CAFL (16 ksi)
