Signs on Concrete Median Barriers

Test Report 0-6646-1

**TEXAS A&M TRANSPORTATION INSTITUTE
COLLEGE STATION, TEXAS**

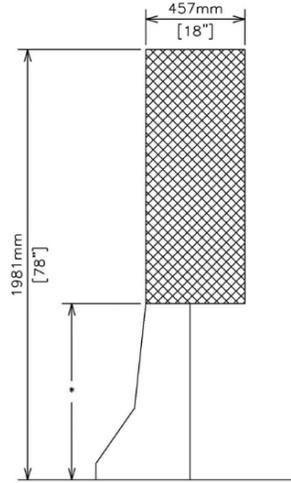
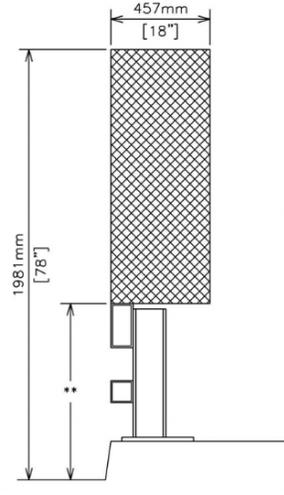
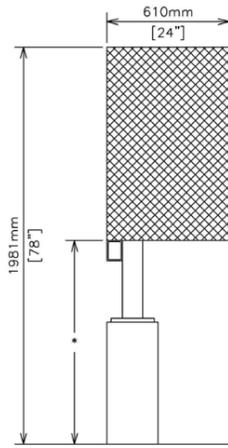
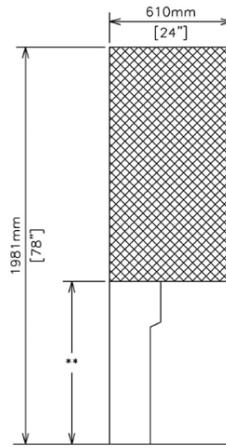
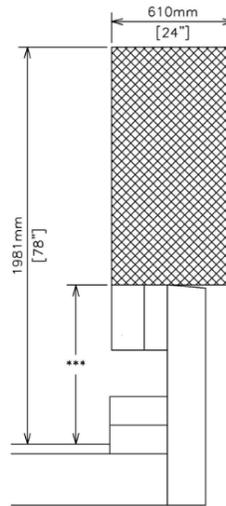
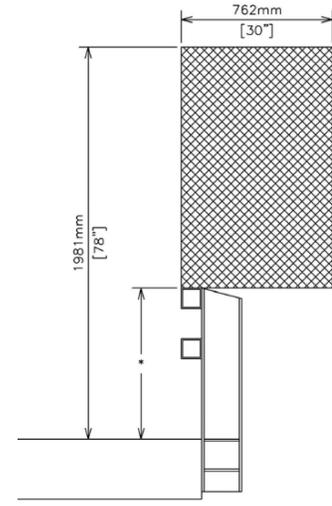
* Reviewed TL-3 sloped-faced concrete barrier heights fell in a range of 762 mm (30 in.) to 813 mm (32 in.)

** Reviewed TL-3 steel tubular barrier on curb (curb greater than 6") heights fell in a range of 813 mm (32 in.) to 864 mm (34 in.)

* Reviewed TL-3 combination barrier heights fell in a range of 889 mm (35 in.) to 1067 mm (42 in.)

** Reviewed TL-3 vertical concrete barrier heights fell in a range of 737 mm (29 in.) to 813 mm (32 in.)

*** The reviewed TL-4 timber barrier heights were 838 mm (33 in.)

Reviewed TL-3 steel tubular barrier (no curb or curbs 152 mm or less) heights fell in a range of 705 mm (27.75 in.) to 914 mm (36 in.)

**Figure 2.1. TL-3 Zone of Intrusions for
 (a) Sloped Face Concrete Barrier and Steel Tube Rail on Curbs > 6 inches;
 (b) Vertical Face Concrete Barrier and Combination Concrete and Steel Rail;
 and (c) Steel Tube Rail on Curbs > 6 inches (3).**

For TL-3, barrier classes were combined into three groups based on the size of intrusion extent: (1) sloped face concrete barrier and steel tube rail on 6-inch curb or greater; (2) vertical face concrete barrier, combination of concrete and steel rail, all timber rail; and (3) steel tube rails not on a curb or on less than a 6-inch curb. ZOIs for TL-3 identified by Keller et al. are shown in Figure 2.1. As can be seen, the intrusion zones for TL-3 sloped face concrete barriers with 30 inches to 32 inches in height consisted of an area above the barrier that is 18 inches wide and extends above the barrier to a height of 78 inches above the roadway surface. A 6-inch wide ZOI was recommended for the vertical face concrete barrier with 29 inches to 32 inches in height.

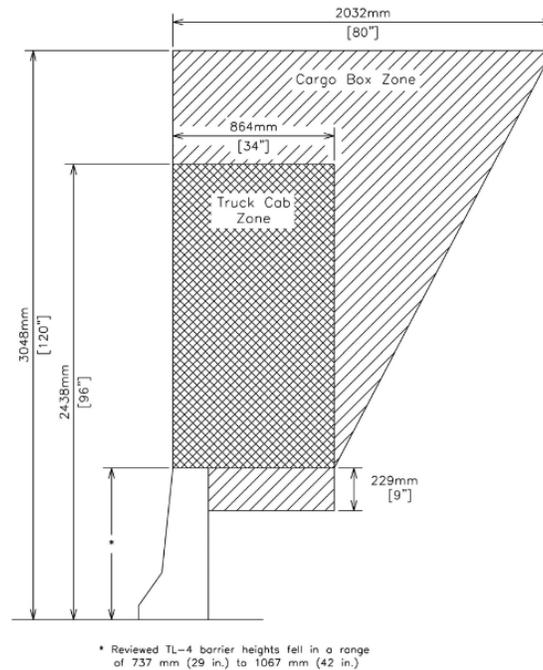
Figure 2.2. Zone of Intrusions for TL-4 Barriers (3).

Since, TL-4 barriers have little height variations, all of them exhibited similar intrusion number (3). Hence, only one ZOI was defined for TL-4 barriers. As shown in Figure 2.2, ZOI for TL-4 barriers with heights in the range of 28 inches to 42 inches was much wider at the top where the cargo box extended significantly beyond the front face of the barrier. Near the top of the barrier, ZOI for single unit trucks was similar to that of the pickup truck in TL-3 analysis. The truck cab ZOI extends 34 inches back from the front face of the barrier from top of the barrier to 8 ft above roadway surface. For cargo box, bottom of the intrusion zone was placed 9 inches below the barrier top and top of intrusion zone was placed 10 ft above the road surface.

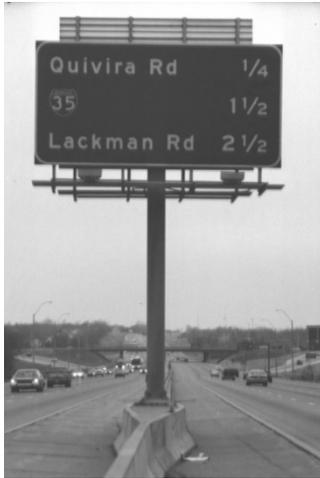
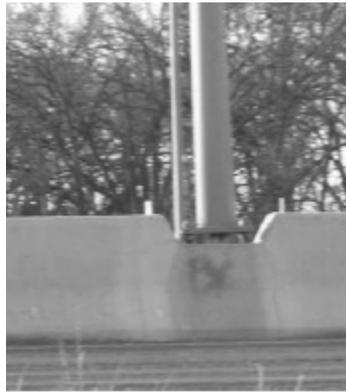
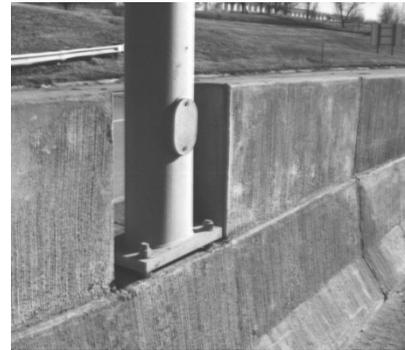
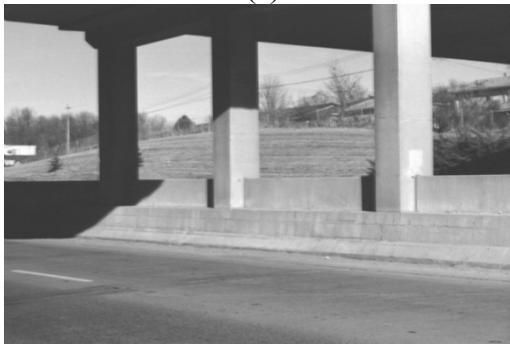
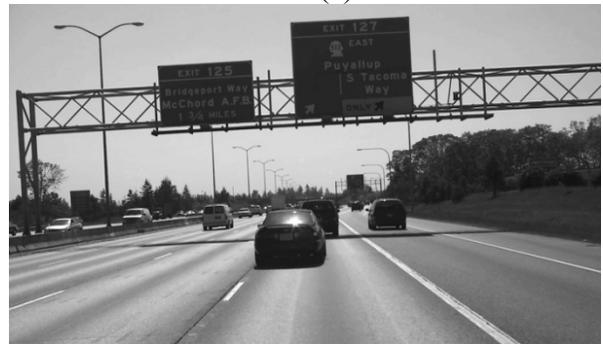
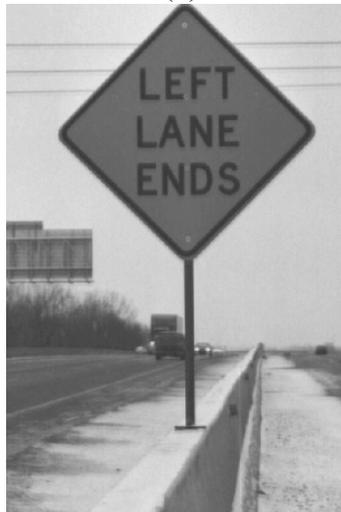
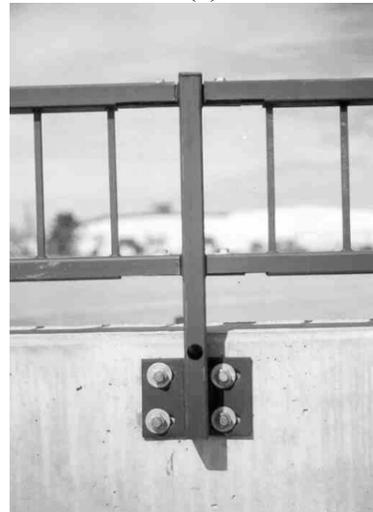
Figure 2.3. (a) Large Overhead Sign on Expanded Barrier (4); (b) Luminaire Pole on Lowered Barrier Top; (c) Luminaire Pole within Rigid Glare (4); (d) Bridge Pier on Top of Median Barrier (4); (e) Sign Bridges (5); (f) Medium Signs (3); (g) Minnesota Bridge Rail Breakaway Posts (3).

Figure 2.3 shows lists of barrier attachments used in the national highway. Keller et al. identified more than 125 traffic barrier attachments. Based on the size and method of connections to the barrier these were grouped as follows (3):

Non-rigid discrete attachments (e.g., light-gauge steel and aluminum posts and reflectors) contain minimal connection to the barriers, and hence have great potential to create debris problem when impacted by the vehicles. Performance of continuous attachments placed within ZOI, as shown in Figure 2.3(g) depends on post location and stiffness, geometry, continuity, and tensile capacity of longitudinal elements, transition at the attachment ends, and proximity to the pedestrian or vehicles that may be affected by debris (3).

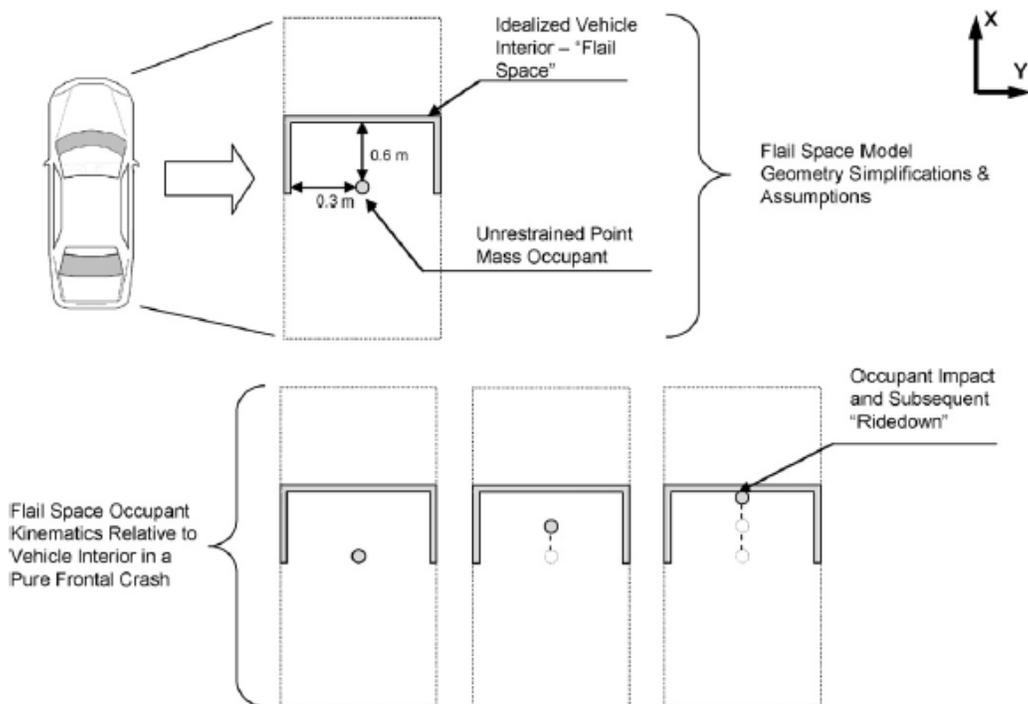
Figure 2.4. Flail Space Model Assumption and Simplifications as Described by Michie (8,9).

The occupant risk evaluates the degree of hazard to the occupant in the impacting vehicle. In 1981, Michie developed the flail space model to evaluate occupant risks in roadside safety hardware crash tests (7). The model assumes that the occupant injury severity is related to the velocity at which occupant impacts the interior and the subsequent acceleration experienced by the occupant. As shown in Figure 2.4, the occupant is allowed to flail 2 ft in longitudinal direction (parallel to the typical vehicle travel direction) and 1 ft in lateral direction before

impacting the vehicle interior. Difference in velocity between the occupant and vehicle interior at the instant the occupant reach either 2 ft longitudinally or 1 ft laterally is computed using measured vehicle kinematics (8). The largest difference in velocity, at the instant of occupant impact, is termed as occupant impact velocity (OIV). OIV in lateral and longitudinal directions are calculated independently. Once the occupant impacts the vehicle interior, the occupant is assumed to remain in contact with the interior and experience subsequent vehicular accelerations. The maximum 10-millisecond (ms) average of the acceleration (lateral and longitudinal directions are calculated independently) subsequent to the occupant impact is termed as ridedown acceleration. *MASH* prescribes threshold values, shown in Table 2.3, for both occupant impact velocity and occupant ridedown acceleration to minimize the risk of occupant injury. To pass the occupant risk criteria, occupant impact velocities and ridedown accelerations in both longitudinal and lateral directions obtained from a crash test must not exceed the maximum values specified. These maximum values correspond to serious but not life-threatening occupant injury (9).

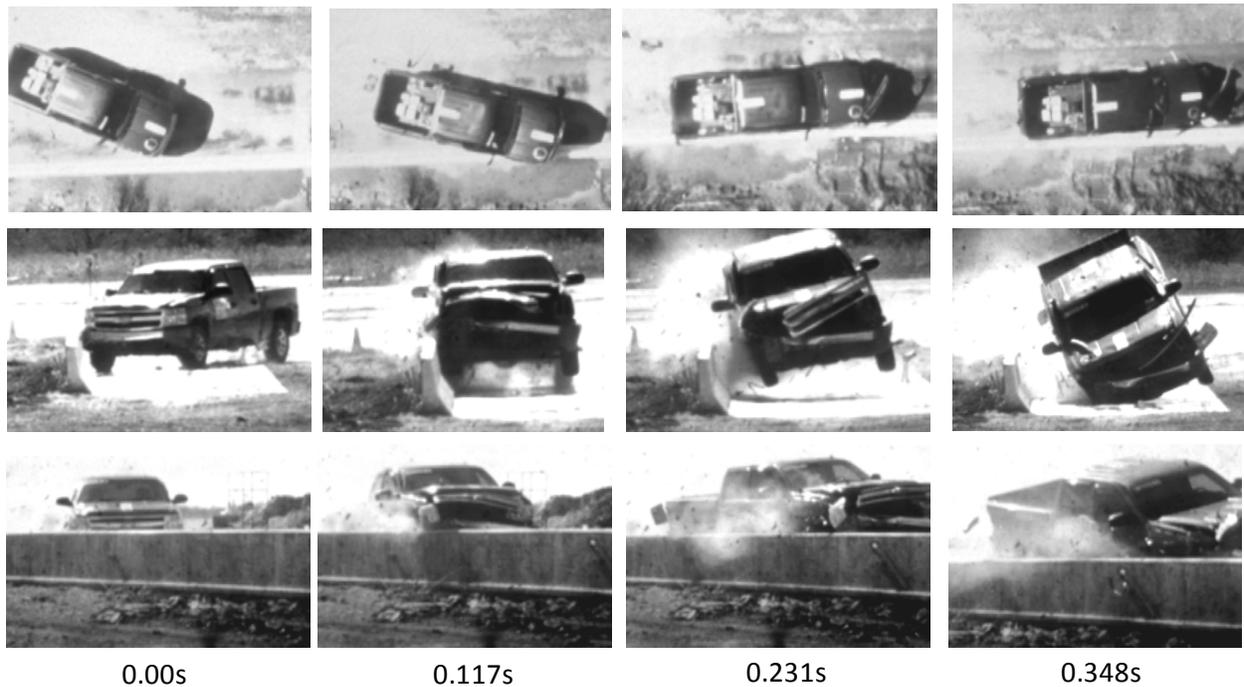
Figure 2.5. Sequential Photograph of Test Performed on New Jersey Safety Shape Barrier Following *MASH* Guidelines (10).

In 2010, a number of full scale crash tests were performed at TTI to understand and evaluate the consequences of adopting recommended changes in the new *MASH* guideline on existing roadside hardware. One of these tests involved a 2270P pickup truck impacting the 32-inch tall New Jersey safety shape concrete barrier at a speed and angle of 62.6 mi/h and 25.2 degrees, respectively (10). The vehicle was successfully contained and redirected by the barrier. Figure 2.5 shows sequential photographs of the test. As can be seen, the right front tire began climbing the barrier face at 0.066 s. The left tire became airborne at the same time. The vehicle became parallel to the barrier at 0.199 s. The left rear tire began to rise at 0.277 s and the right front tire contacted the ground surface at 0.282 s. The vehicle lost contact with barrier at 0.471 s. The maximum exterior crash to the barrier was 14 inches in the right front corner of the side panel at bumper height. Maximum occupant compartment deformation was 2 inches in the lateral area across that cab at right kickpanel (10). Table 2.4 summarizes the occupant risk factors obtained from the test. The New Jersey safety shape barrier performed acceptably in accordance to the safety evaluation criteria set forth in *MASH 3-11*.

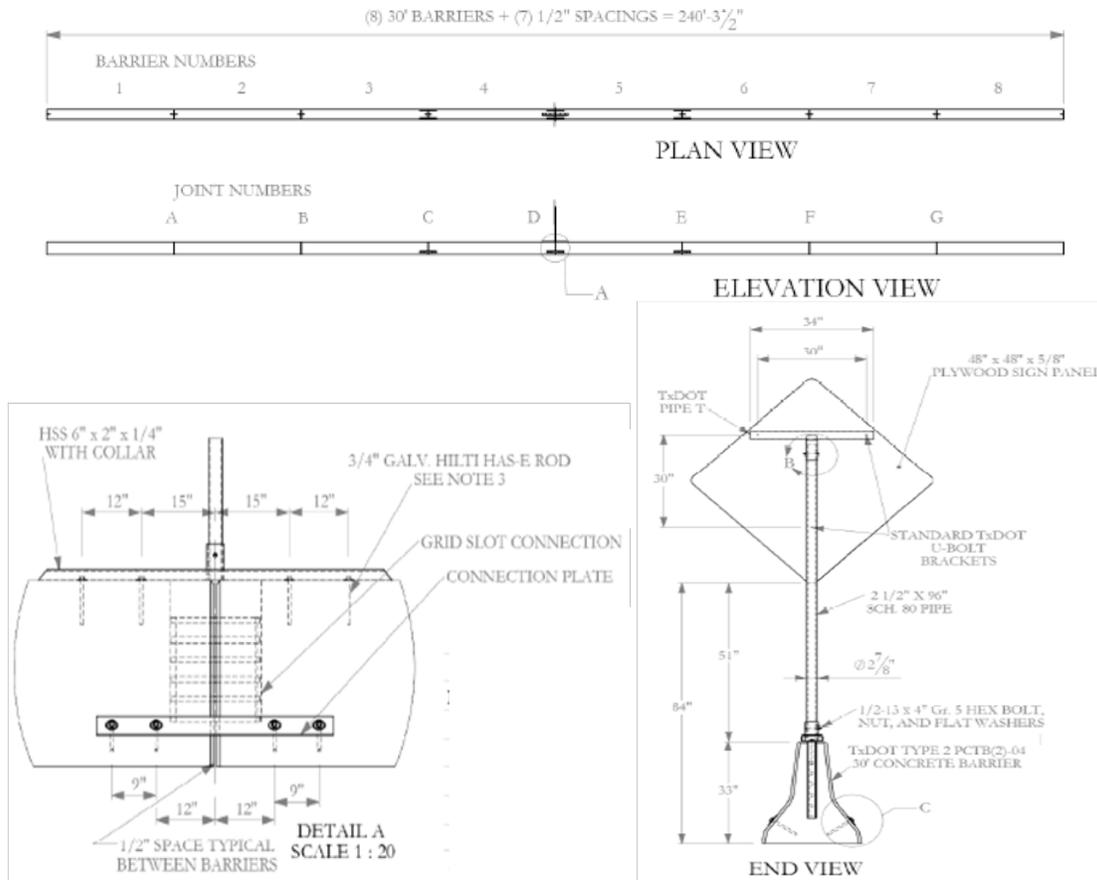
Figure 2.6. Details of PCTB Mounted Sign Support Assembly Used for TTI Test 466431 (II).

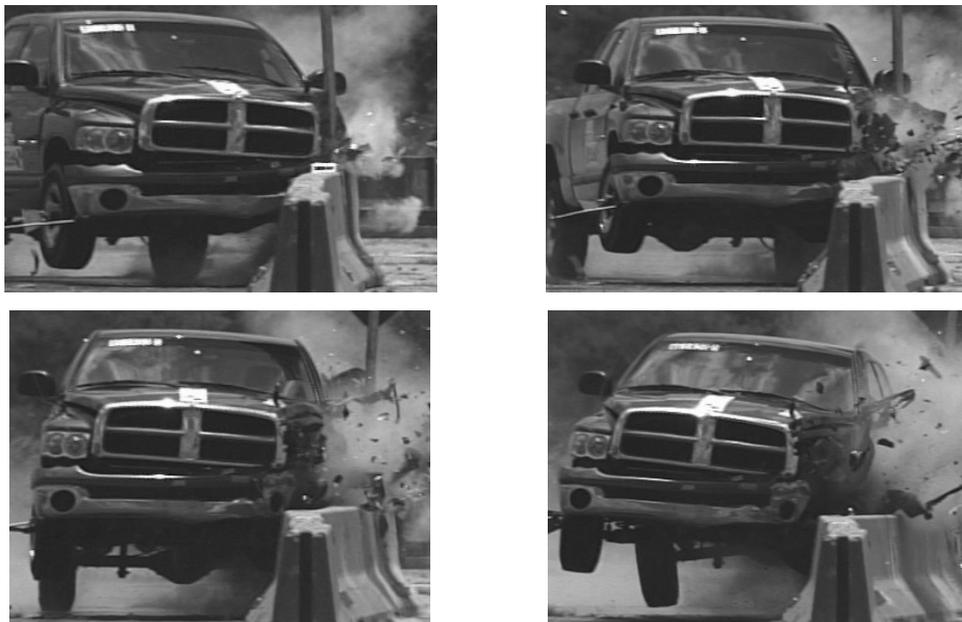
Figure 2.7. Sequential Photographs of TTI Test 466431 (II).

Researchers at TTI recently investigated the performance of a temporary concrete barrier with sign attachments mounted on top (11). The objective of the research was to develop a TxDOT standard for mounting traffic control signs and devices on concrete barrier in construction work zones. A crash test was performed on a TxDOT Type 2 portable concrete traffic barrier (PCTB) with a sign support assembly as per *MASH* test 3-11 (6). A crash test performed in 2001 on the modified TxDOT Type 2 PCTB with grid-slot connection and steel straps bolted to the base satisfactorily passed the evaluation criteria set forth in *NCHRP Report 350*. However, the connector strap was ruptured during the test. Hence researchers at TTI increased the strap thickness to 1/4 inch to improve the performance of the barrier. Sign support and sign mount connection was anchored on top of this modified concrete barrier in conjunction with the steel strap connections to three barrier joints as shown in Figure 2.6. A 2270P (5000 lb) Dodge Ram 1500 pickup impacted the test article at a speed and angle of 63.4 mi/h and 24.6 degrees, respectively. The test successfully passed the safety evaluation criteria set forth in *MASH* test 3-11.

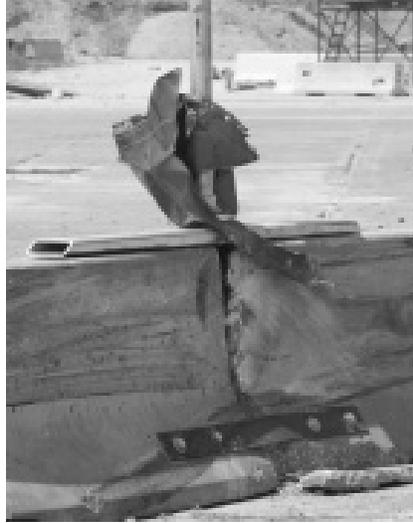
Figure 2.8. Sign Support Connection after the Crash Test (11).

The steel straps added to the barrier connection at sign mount connection and joints upstream and downstream of the sign mount connection minimized the intrusion of the vehicle over the barrier. This reduced the snagging of the vehicle on sign support and sign mount connection (11). The sign support connection developed and tested during this project was recommended for implementation and inclusion into the TxDOT standard specifications for sign supports used in construction zone.

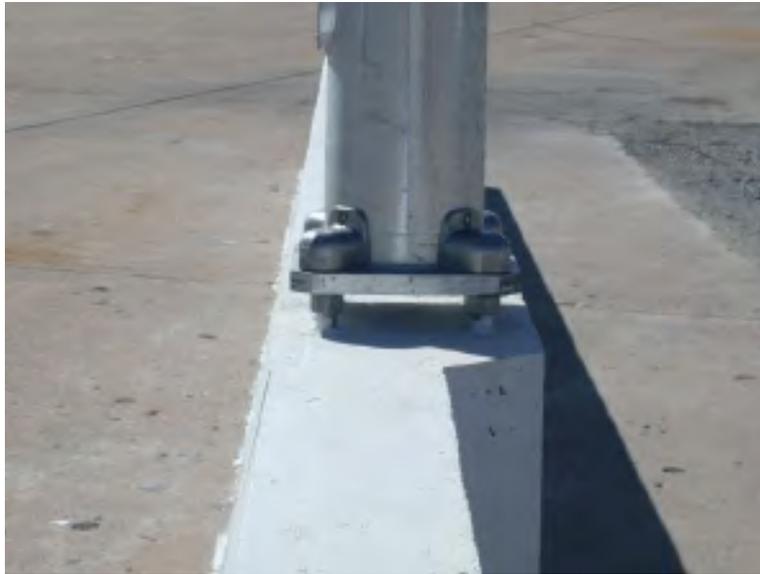
Figure 2.9. Luminaire Pole Attached to Single Slope Barrier for MwRSF Tests: ZOI-1 and ZOI-2 (12).

To evaluate the current practices for the placement of luminaire pole both on top and behind the concrete barrier, researchers at MwRSF performed several crash tests following *NCHRP Report 350* guidelines (12). For the first two tests, the test article consisted of a 37.5 ft long steel luminaire pole attached on top of an 32-inch tall single slope concrete barrier. As shown in Figure 2.9, a pedestal extended (6.6 inches backward) on backside of the barrier was built at the attachment location to fit the 10-inch wide luminaire pole base on 9.5-inch wide barrier top. In the first test (ZOI-1), a 17,605 lb single unit truck impacted a single slope concrete barrier with a luminaire pole mounted on top at a speed and angle of 50.4 mi/h and 15.6 degrees, respectively (12). Figure 2.10 shows the sequential images obtained from the crash test. It can be seen that the luminaire pole disengaged from the barrier and rotated downward to the truck as the front of the truck impacted the pole at 0.83 s. The dislodged pole landed directly behind the barrier and parallel to it. Researchers asserted that these results would not pose significant concerns for the median barrier applications as the pole would likely be within the shoulder and edge of the lane regions. The truck finally rolled to a 40 degree angle and left front corner of the truck contacted the ground at 1.984 s. The crash test, however, was determined to be acceptable according to the evaluation criteria of test designation 4-12 found in *NCHRP Report 350*. The second test (ZOI-2), performed according to test designation 4-11, involved a 4430-lb pickup truck impacting the single slope concrete barrier with luminaire pole attached on top at a speed and angle of 61.7 mi/h and 23.4 degrees, respectively (12). Test article successfully contained and redirected the 2000P vehicle. Figure 2.11 shows sequential photographs from the test. As can be seen, the vehicle did not penetrate or override the barrier and remained upright during and after the collision. The impact did not create any detached element or fragment that could show potential hazard to the occupant or other traffic. Occupant risk factors obtained from the test, as

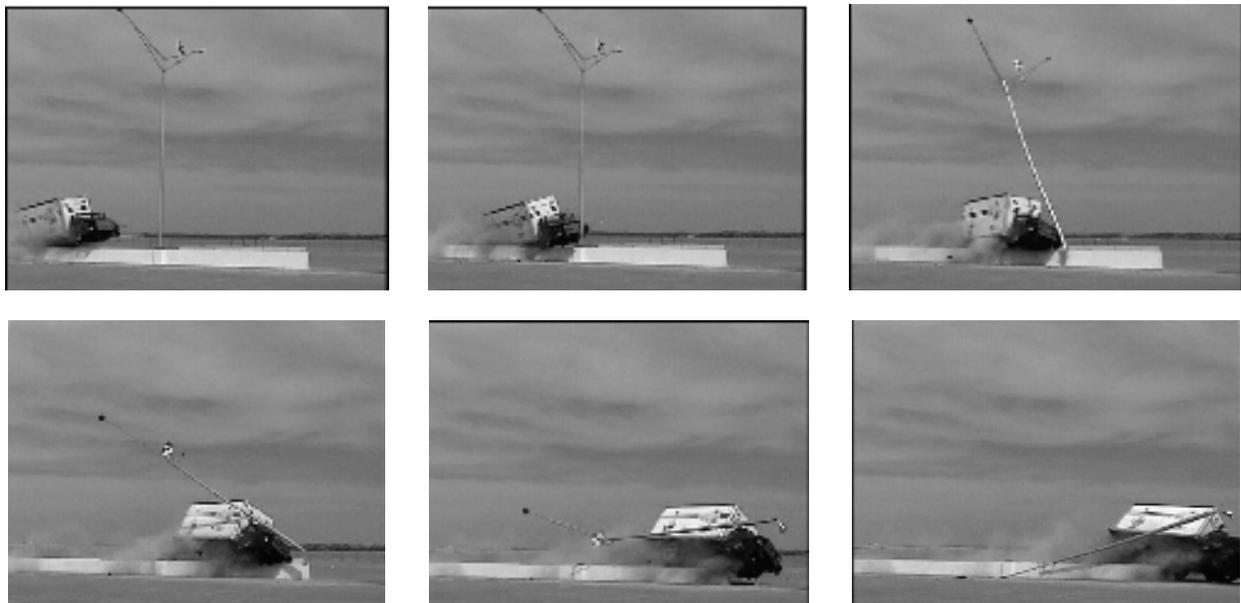
Figure 2.10. Sequential Photographs from MwRSF Test ZOI-1 (12).

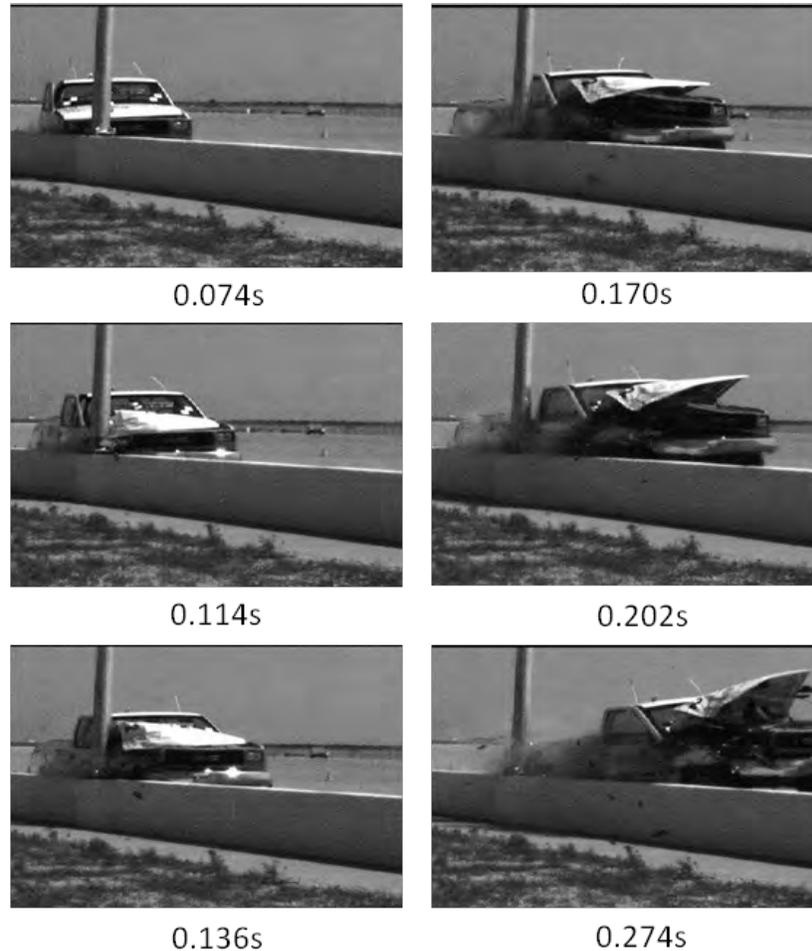
Figure 2.11. Sequential Photographs from MwRSF Test ZOI-2 (12).

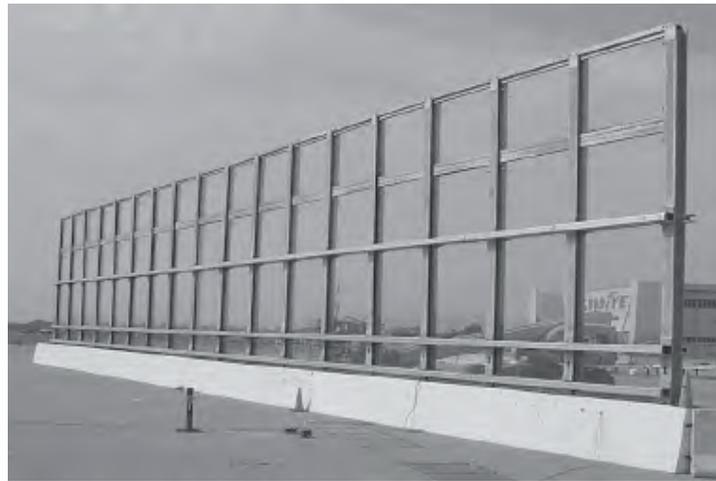
Figure 2.12. Noise Wall Barrier System Used in MwRSF Test (13).

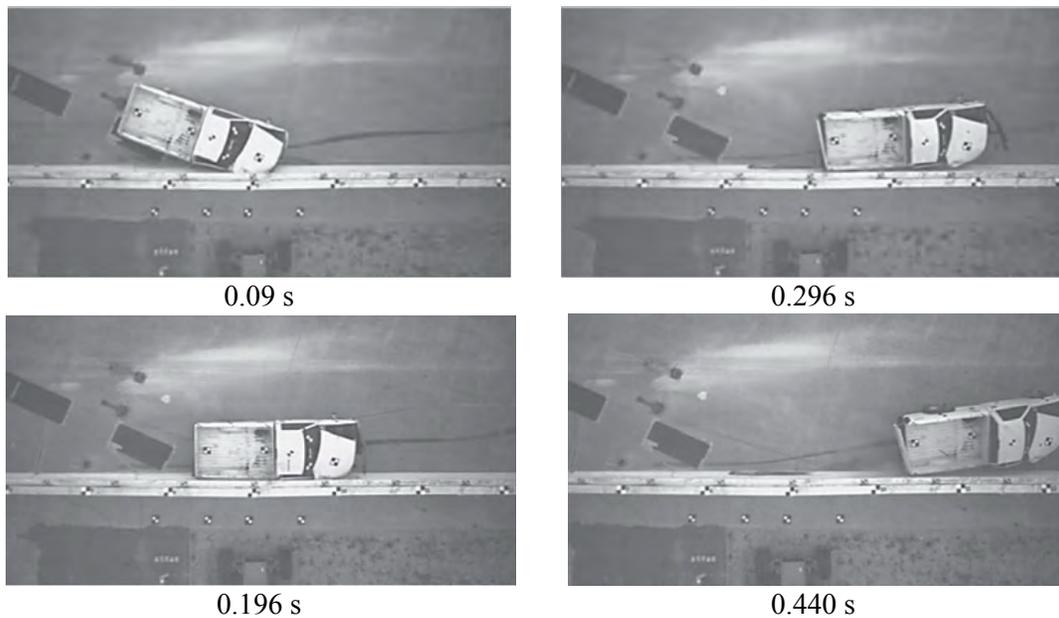
Figure 2.13. Sequential Photographs of Crash Test Performed on Noise Barrier Wall System (13).

To develop a noise barrier system for use on 32-inch tall single slope concrete barrier, researchers at MwRSF performed two full scale crash tests in accordance with requirements specified in *NCHRP Report 350 Test Level 4 (13)*. An 8000S single-unit truck and 2000P pickup truck were used in these tests. Both tests passed the safety evaluation criteria set forth in *NCHRP Report 350* test designation 4-12 and 4-11, respectively. The test article, as shown in Figure 2.12, consisted of 18 support posts spaced 6.5 ft on center anchored to the back-side vertical face of the concrete barrier. Two paraglass Soundstop GS CC panels occupied the span between each pair of posts. In the first test (CYRO-1), a 17,840-lb single unit truck impacted the noise wall barrier system at a speed and angle of 51.2 mi/h and 17.7 degrees, respectively (13). The vehicle was successfully contained and redirected by the system. Damage to the noise barrier wall was minimal. Exterior vehicle damage was moderate and occupant compartment deformation (OCD) to the right side and center of the floorboard was judged insufficient to cause serious occupant injury. In the second test (CYRO-2), a 4416-lb C2500 pickup impacted the test article at a speed and angle of 61.5 mi/h and 25 degrees, respectively. The barrier system successfully contained and redirected the pickup truck. Vehicle reached its maximum roll angle 24.8 degrees at 0.65 s before beginning to roll back and become stable. Figure 2.13 shows sequential photographs

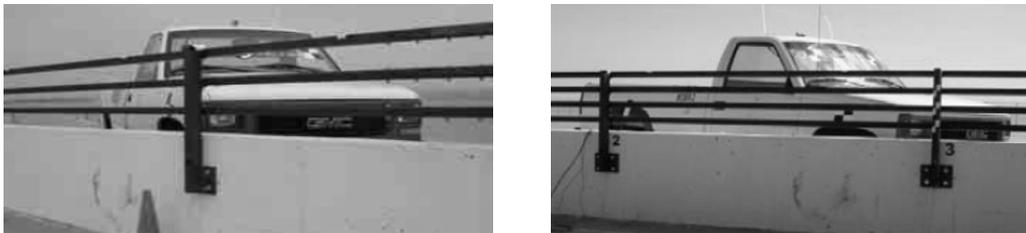
Figure 2.14. Setup for Crash Tests (MOBR1 and MOBR2) Performed on Two Combination Traffic/Bicycle Bridge Railing Systems Designed at MwRSF (14).

Researchers at MwRSF designed and tested two open traffic/bicycle bridge railing systems for use on a rigid, single-slope concrete barrier (14). One full scale crash test was performed for each system in accordance to test designation 4-11 set forth in *NCHRP Report 350*. The bicycle rail used in the first and second tests consisted of three and four longitudinal rails, respectively, mounted on steel posts as shown in Figure 2.14. In both systems, the bicycle rail was mounted to the back of the single slope barrier. In the first test (MOBR-1), a 4442-lb pickup truck impacted the system with three longitudinal rails at a speed and angle of 63.1 mi/h and 25.6 degrees, respectively (14). In the second test (MOBR-2), a 4493-lb pickup impacted the system with four longitudinal rails at a speed and angle of 63.8 mi/h and 25.6 degrees, respectively (14). In both tests, the open railing on top of the single-slope concrete barrier prevented the test vehicle from climbing the barrier allowing the vehicle roll during exit. Figure 2.15 show sequential photographs obtained from these tests. As shown in the figure, both systems failed to redirect the vehicle safely as it rolled over during the exit.

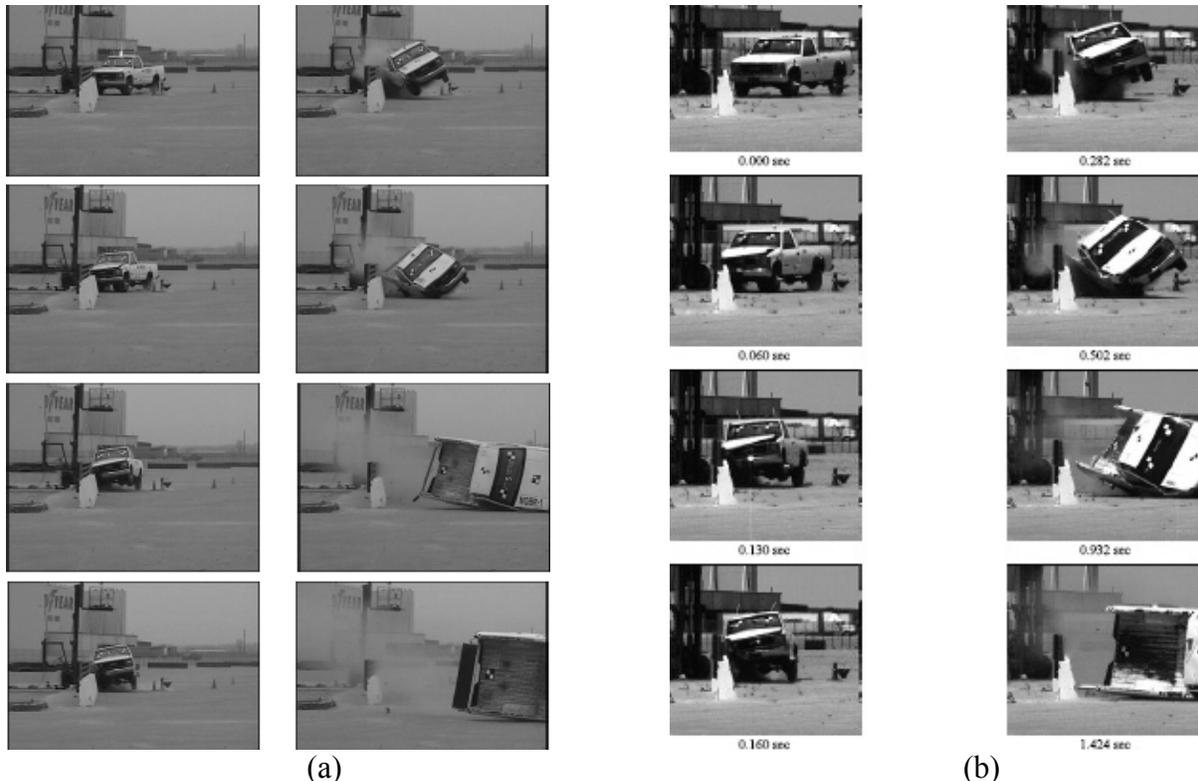
Figure 2.15. Sequential Photographs of Cash Test Performed on Combination Traffic/Bicycle Railing Systems (a) MOBR1 and (b) MOBR2 (14).

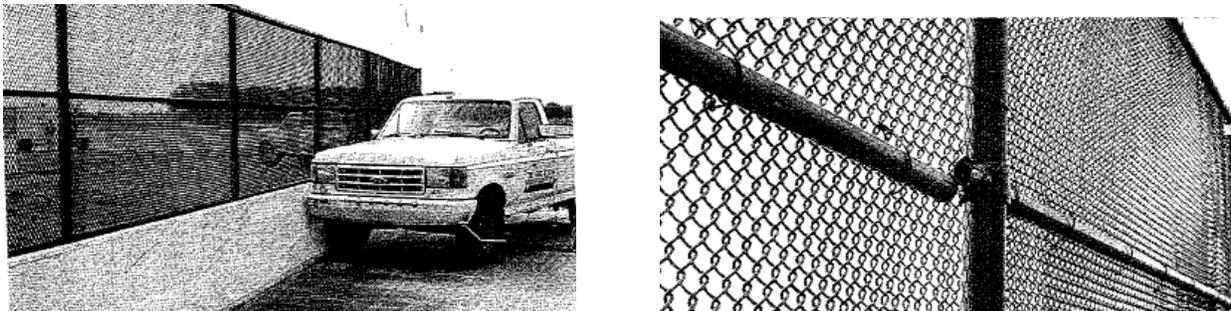
Figure 2.16. (a) Test Setup for New Jersey Shape Concrete Barrier with Vandal Protection Fence Mounted on Top (b) Longitudinal Rail Detached from Post 5 after the Impact (15).

In 1995, a full scale crash test, as shown in Figure 2.16(a), was performed at TTI on 31-inch tall New Jersey safety shape concrete barrier with vandal protection fence mounted on top following the AASHTO performance level 2 impact conditions (15). The thicknesses of the New Jersey shape barrier at the base and top are 15 inches and 6 inches, respectively. The vandal protection fence was mounted on 7.25-ft long \times 2.875-inch OD (schedule 40 pipe) straight posts mounted to the back of the barrier. A 5600-lb pickup impacted the test article at a speed and angle of 62.9 mi/h and 20.2 degrees. Contact with fence occurred at 0.032 s. As shown in Figure 2.16(b), the middle horizontal line rail pulled out of the connection at upstream side of post 5 at 0.089 s. Maximum deflection of the fence of 5.6 inches occurred at 0.11 s. The vehicle exited the system at 0.274 s and remained upright during and after the collision. Occupant risk factors obtained from the test, as shown in Table 2.5, were within acceptable values. Hence, the impact performance of the vandal protection fence on New Jersey safety shape bridge railing was considered satisfactory according to the guideline set forth in AASHTO (16).

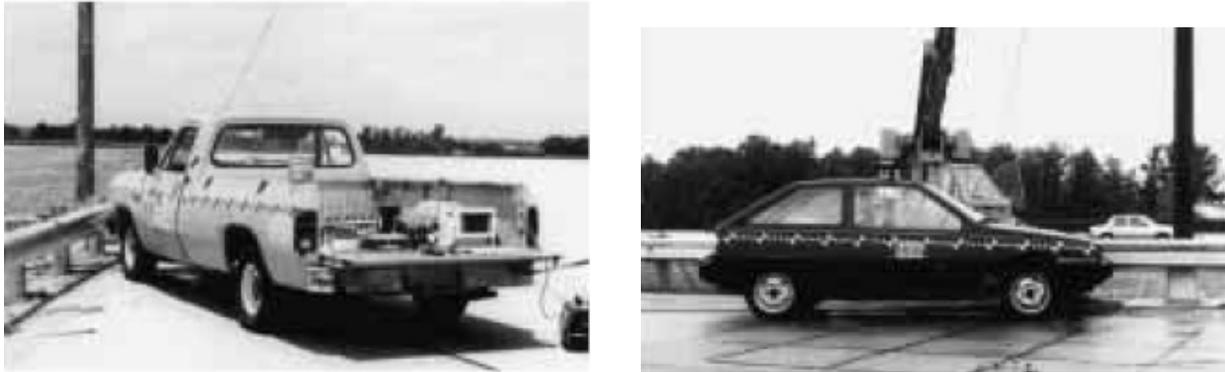
Figure 2.17. Setups for Two Crash Tests Performed at Ohio Transportation Research Center (17).

In the mid-1990s, a study was performed at Ohio Transportation Research Center (TRC) to determine the effect of light post on the redirecting performance of a roadside guardrail when installed within its deflection zone (17). Six crash tests involving two light pole base design (AT-A, and AT-X) and a typical Ohio Type 5 (W-beam) guardrail were performed following *NCHRP Report 350* TL-3 conditions. Basic difference in two aluminum bases was the dimension. While AT-X was almost constant in width and height, the wider AT-A was tapered with height. Figure 2.17 shows the crash test setup for two of these tests. Test 1 and 5 were performed to establish baseline performance of the guardrail and involved a 2000P truck and an 820C small car impacting the guardrail with no light pole. The guardrail performed satisfactorily as per *NCHRP Report 350* requirements. In test 2, a 2000P truck impacted a guardrail with a light pole installed on AT-X base at an approximate point of maximum guardrail deflection as determined in Test 1. This test was performed to provide worst case scenario for the vehicle to snag the pole. The vehicle, however, did not snag the pole and the pole did not breakaway. In the third and fourth tests, the 2000P vehicle impacted the guardrail with a light pole installed close to the impact point using AT-X and AT-A bases, respectively. The pole with a wider AT-A base was located farther from the back of the guardrail compared to the pole with AT-X base. For both tests the light pole did not cause vehicle snagging, but the pole did breakaway. The damage to the vehicle front end was more severe in test 4 compared to test 3, possibly due to the location of the pole farther back from guardrail. Due to the greater distance available, the vehicle in test 4

pitched downward before impacting the pole involving more of the hood and engine area. In the sixth test, 820C small car impacted the guardrail with light pole on AT-X base installed close to the impact point. The vehicle did not snag during the impact and light pole did not breakaway. All the four tests involving the light pole mounted behind the Type 5 guardrail passed the safety evaluation criteria set forth in *NCHRP Report 350*. Table 2.5 present the summary of these tests.

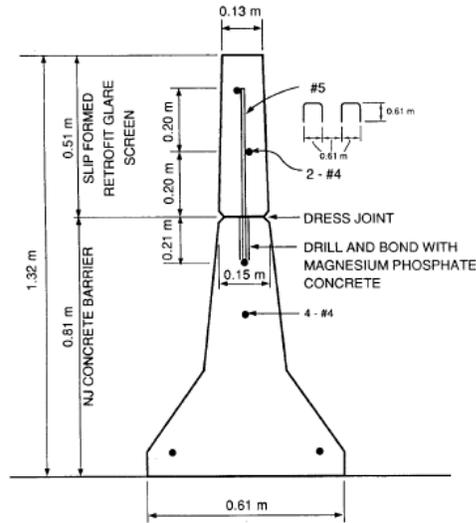
Figure 2.18. Cross Section of Concrete Median Barrier Retrofitted with Slipformed Concrete Glare Screen (17).

In the early 1990s, two crash tests were performed at Caltrans Dynamic Test Facility on a retrofitted concrete glare screen (CGS) slip formed on top of a 32-inch tall New Jersey safety shape concrete barrier (18). Table 2.5 summarizes these tests. Figure 2.18 shows detailed cross section of the test article. In the first test, a 5390-lb pickup truck impacted the test article at a speed and angle of 55.3 mi/h and 20 degrees, respectively. Lengths of the vehicle contact with the barrier and glare screen were 18.4 ft and 10.8 ft, respectively. The maximum height of the truck marks on the test article was 3.1 ft. The pickup did not show any tendency to snag or pocket and was upright throughout and after the collision. It was successfully redirected at an exit speed and angle of 45.7 mi/h and 6 degrees, respectively. There was no evidence of any structural distress of the CGS. The only damage to the barrier was a few scrapes and tire marks. In the second test, a 4363-lb heavy passenger car impacted the test article at a speed and angle of 56.2 mi/h and 25 degrees, respectively. The maximum height of the truck mark on the system was 2.6 ft. The vehicle was successfully contained and redirected without exhibiting any tendency to snag or pocket. However, the vehicle was severely damaged. Both the crash tests successfully passed the safety evaluation criteria set forth in *NCHRP Report 230* (19,20). Since an errant vehicle might be somewhat less likely to climb over a CGS-equipped barrier, researchers concluded that the additional height and strength of the CGS may cause some safety enhancements.

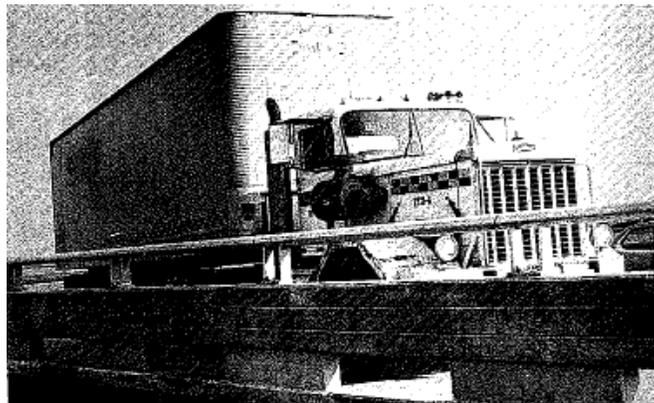
Figure 2.19. Crash Test Setup for 80,000 lb Van-Type Tractor-Trailer Impacting Concrete Safety Shape with Metal Rail on Top (21).

In the early 1980s, a crash test, as shown in Figure 2.19, was performed at TTI where an 80,000 lb van-type tractor-trailer impacted an 810 mm concrete safety shape with metal rail mounted on top (21). This study modified a 32-inch concrete safety shape to make an effective truck traffic rail. The combination rail selected for the test was a modification of the 32-inch tall Texas Type T5 traffic rail with an 18-inch tall modified Texas Type C4 metal rail mounted on top. The truck impacted the bridge rail 2.16 ft downstream of post 5 of the metal rail at a speed and angle of 48.4 mi/h and 14.5 degrees, respectively. Although the truck was contained and redirected, its tandem axles and trailer rolled 90 degrees and the truck came to rest on its side. The concrete parapet was not significantly damaged but the rail experienced damage between post 5 and 8. The threads were stripped from the anchor nuts of post 5 and 6. The maximum dynamic deflection of the metal rail was 11 inches. Table 2.5 summarizes the test. Although the truck rollover was not desirable, the bridge rail did meet the S20 criteria of *NCHRP Report 230*.

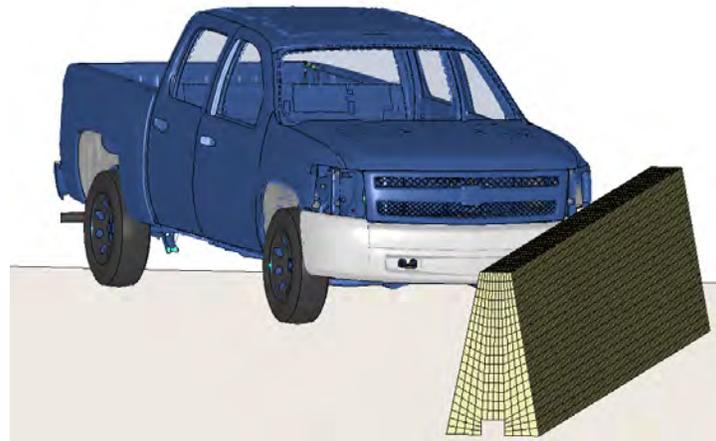
Figure 2.20. 5004 lb *MASH* Test Vehicle Impacting a Single Slope Concrete Barrier.

in LS-DYNA rather than using other assumed behavior models incorporated into some of the other codes. As shown in Figure 2.20, public domain finite element models of 2270P test vehicle, specified in the *MASH*, is already available in LS-DYNA. This vehicle model, developed by the National Crash Analysis Center (NCAC), will be used in this study to perform LS-DYNA simulations on barrier mounted hardware following the specifications set forth in the *MASH* test designation 3-11.

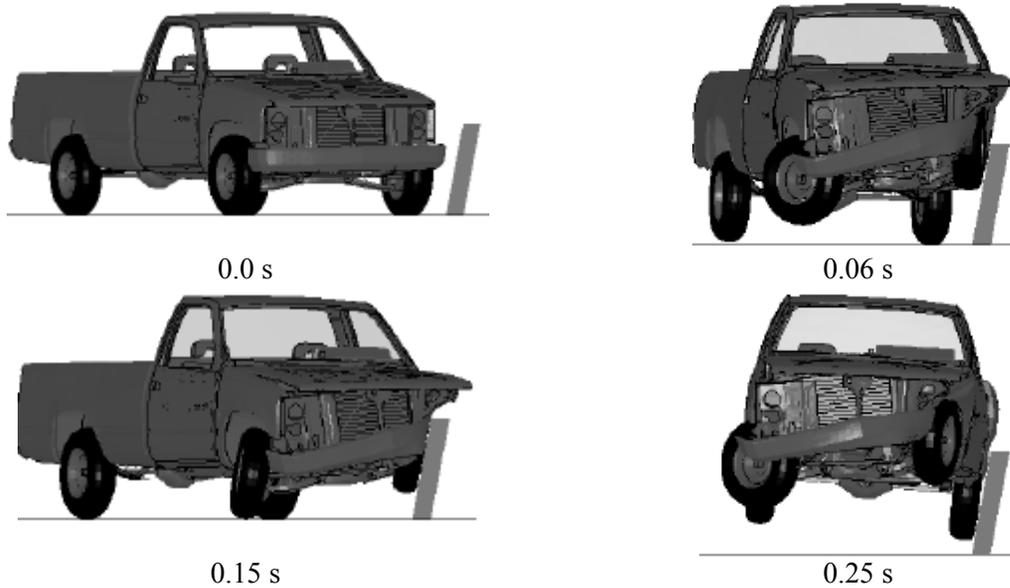
Figure 2.21. Sequential Images of the Simulation Performed on Single Slope Concrete Barrier Following *NCHRP Report 350 TL 3-11 (25)*.

Researchers at TTI performed several FE simulations to evaluate the performance of single slope concrete barrier under high speed impact conditions (25). FE simulations were performed with *NCHRP Report 350* specified 2000P pickup truck impacting the single-slope barrier, modeled using rigid material representation, at a speed of 62 mi/h and 85 mi/h. Figure 2.21 shows the sequential images obtained from the simulation where the 2000P pickup model impacted the single slope barrier at a speed of 62 mi/h and an angle of 25 degrees. As can be seen from the figure, the vehicle experienced substantial climb and instability. The intrusion zone for the vehicle hood and fender extended beyond two times the width of barrier top. In longitudinal direction, OIV and ridedown acceleration (RDA) obtained from the simulation were 21.3 ft/s and 8.4 Gs, respectively. In lateral direction, these values were 26.2 ft/s and 10.8 Gs, respectively. The vehicle, in the simulation, successfully passed the safety evaluation criteria set forth in *NCHRP Report 350*.

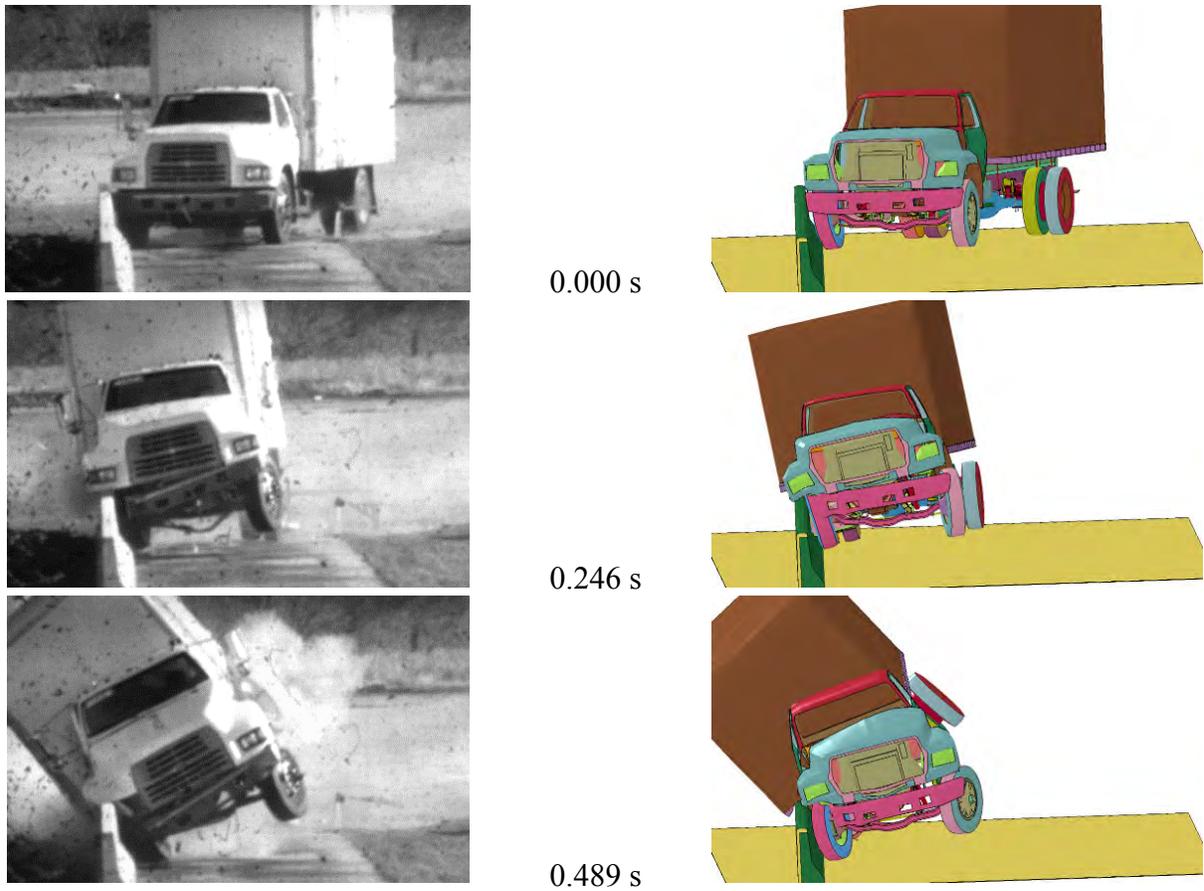
Figure 2.22. Comparison Front View Sequential Photographs for TTI Test 476460-1b (27) and Simulation (26).

The crash test used for this investigation was conducted at TTI using *MASH TL-4* impact conditions (27). A 32-inch New Jersey safety shape bridge rail was used in this test. The test vehicle was traveling at an impact speed of 57.4 mi/h and impacted the safety shape bridge rail 20 ft from the upstream end at an impact angle of 14.4 degrees. The full scale impact simulation was performed following the same impact conditions. Sequential photographs of the test and simulation were compared as shown in Figure 2.22. The vehicle in the crash test ended up rolling on top of the bridge rail. The simulation captured that dynamics from the beginning of rolling until 0.7 s (26). Occupant risk factors, vehicle yaw, pitch, and roll angles of both test and simulation were calculated using the Test Risk Assessment Program (TRAP) (28) developed by TTI. Figure 2.23(a) shows vehicle yaw, pitch, and roll angles obtained from the test and simulation. Figure 2.23(b) shows the longitudinal acceleration data obtained at vehicle C.G. for both test and simulation. The acceleration and angular rate data obtained from the test and simulation were compared using the Roadside Safety Verification and Validation (RSVVP) program developed by Mongiardin and Ray (29). A phenomena importance ranking table (PIRT), similar to the evaluation tables in *NCHRP Report 350* and *MASH*, was also developed to compare two cases. Both the qualitative and quantitative comparisons between results obtained from test and simulation showed good correlation and the modified SUT model was considered sufficiently validated to proceed with the impact simulations on various crash walls.

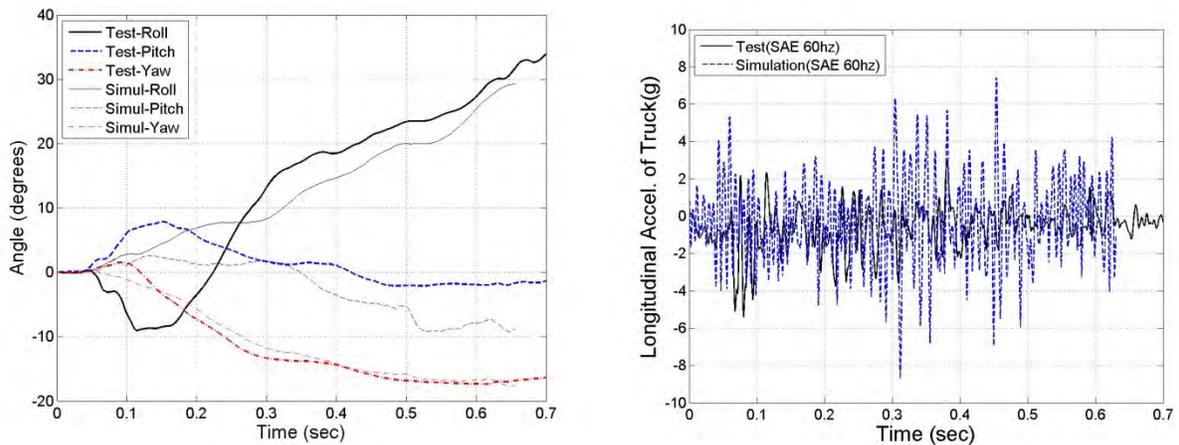
Figure 2.23. Comparisons of (a) Angular Displacements; and (b) Longitudinal Acceleration for Test and Simulation (26).

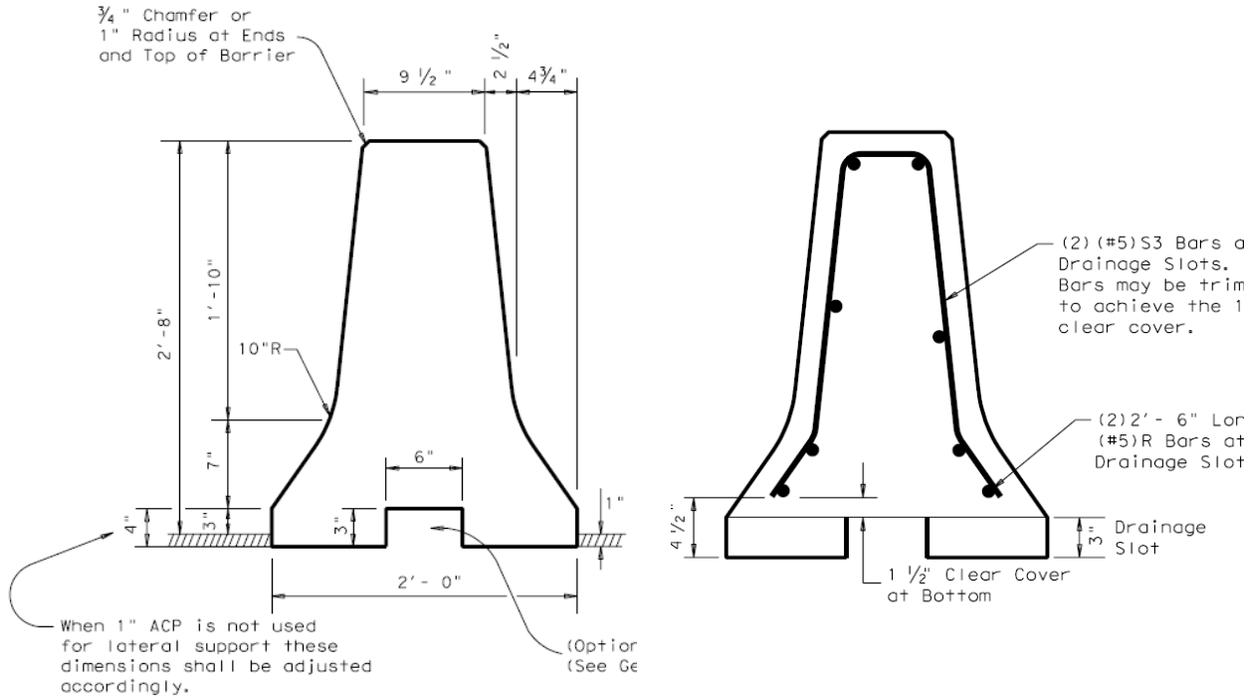
(a) Concrete Safety Barrier (F-shape) Type 1 CSB (1)-04 [34]

Figure 2.24. TxDOT Standards for the Commonly Used Permanent Concrete Median Barriers (34).

F-shape and single slope concrete barriers are the most commonly used permanent concrete barriers on Texas highways. Figure 2.24 shows the TxDOT standard drawings for a Type 1 concrete safety barrier (F-shape) and Type 2 single slope concrete barrier. Although the 42 inches single slope barriers are taller compared to the 32-inch F-shape barriers, a 1.5-inch wider barrier top can make the F-shape barrier better candidate for the attachments mounted on top. Hence, researchers in this study will investigate the methods and feasibilities to construct and mount a sign on top of both of these barriers.

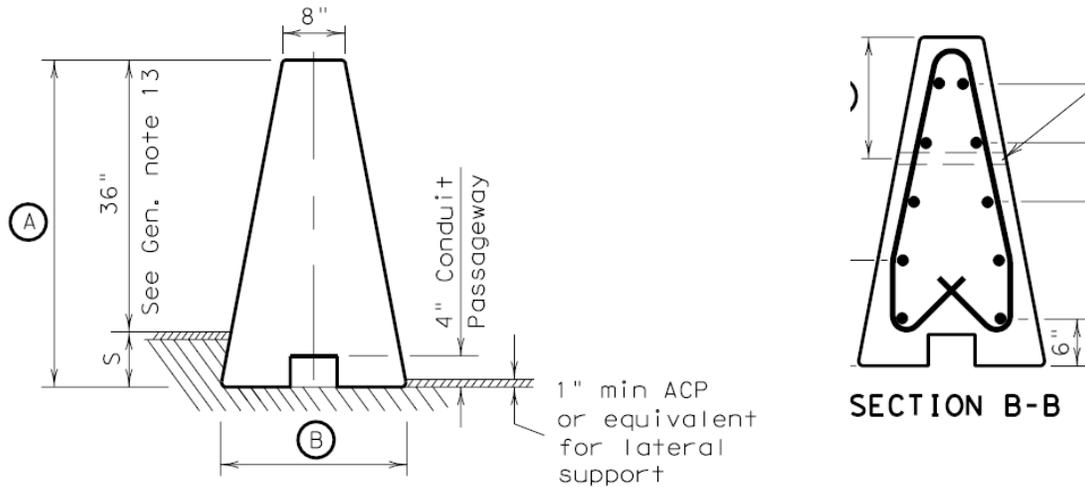
(b) Single slope concrete barrier Type 2: SSCB (2)-00A [34]
