Signs on Concrete Median Barriers

Test Report 0-6646-1

**TEXAS A&M TRANSPORTATION INSTITUTE
COLLEGE STATION, TEXAS**

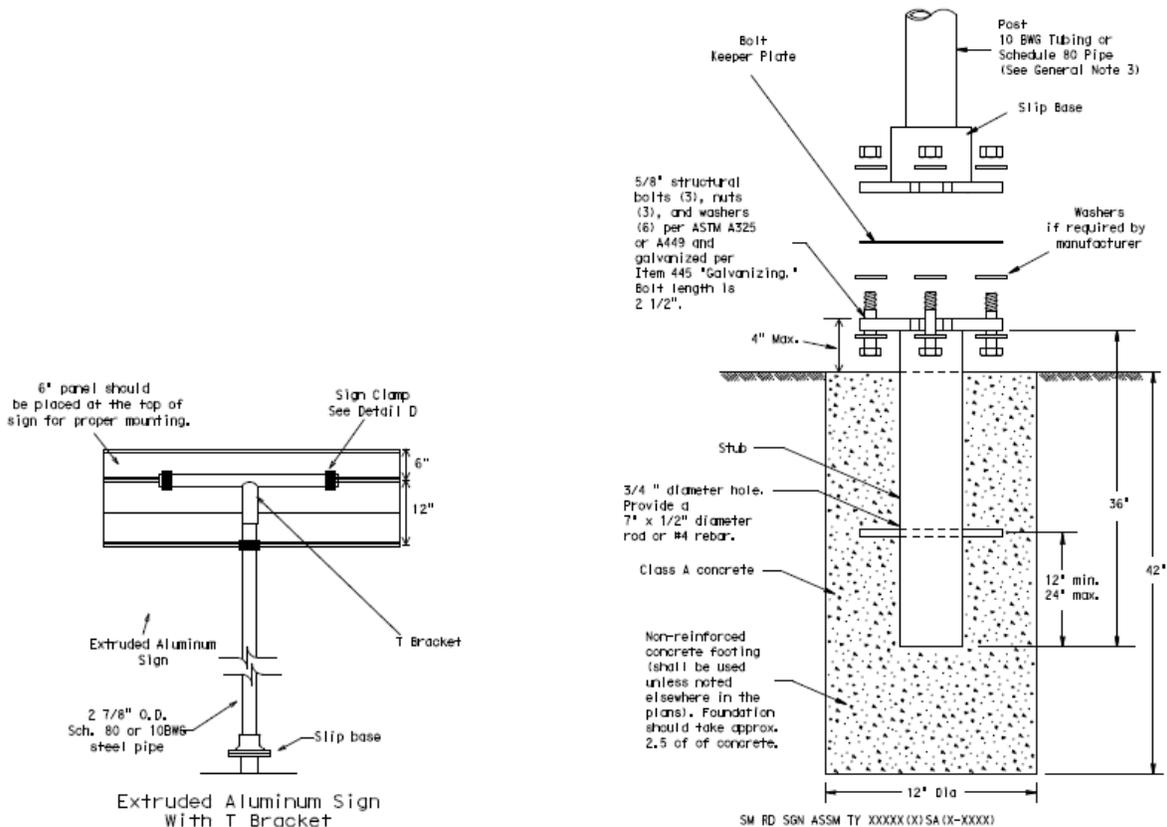
Figure 2.26. Sign Mounting Details Using Triangular Slipbase Anchor System: SMD (SLIP 1-3) (35).

Figure 2.25 shows sign support descriptive codes used in TxDOT standards. These codes indicate the types of anchors and types and number of posts used to construct sign support systems on state highways. Three types of anchors are generally used to mount the sign posts on top of a concrete base: triangular silpbase system, universal anchor system, and wedge anchor system. The slip base system, as shown in Figure 2.26, is considered unfit for barrier mounted hardware. This type of breakaway anchor allows the posts to detach from the base during a crash event. When used on median barriers, this breakaway mechanism, if activated, can cause potential debris hazard to the adjacent traffics. Both universal anchor system, shown in Figure 2.27, and wedge anchor systems, shown in Figure 2.28, are rigid type connections and can be used to mount a sign post on permanent concrete barriers. Researchers investigated the performance of using these anchor types to mount sign support systems on top of F-shape and single slope concrete barriers.

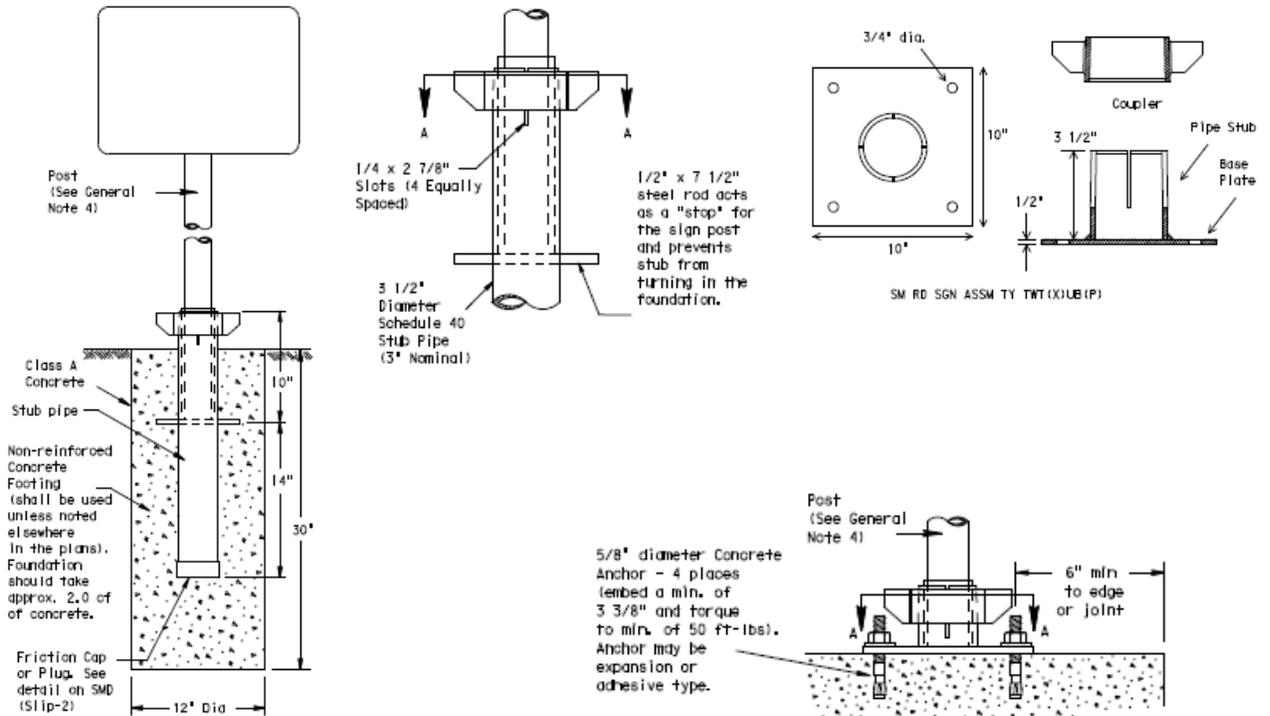
Figure 2.27. Sign Mounting Details Using Universal Anchor System SMD (TWT) (35).

The small signs used in Texas highways are generally supported by 10 gauge tubing or Schedule 80 pipe with 2.875 inches outside diameter, thin-walled tubing (TWT) with 2.375-inch outside diameter, and fiber reinforced plastic (FRP) pipe with 3-inch outer diameter. The 10 BWG tubing and Schedule 80 pipe are generally mounted on concrete base using slip base anchor systems. TWT posts that conform to 13 BWG tubing posts with 2.375-inch outside diameters are generally mounted using the universal anchor system and wedge anchor system. FRP pipes with 3-inch outer diameter are mounted using universal anchor systems.

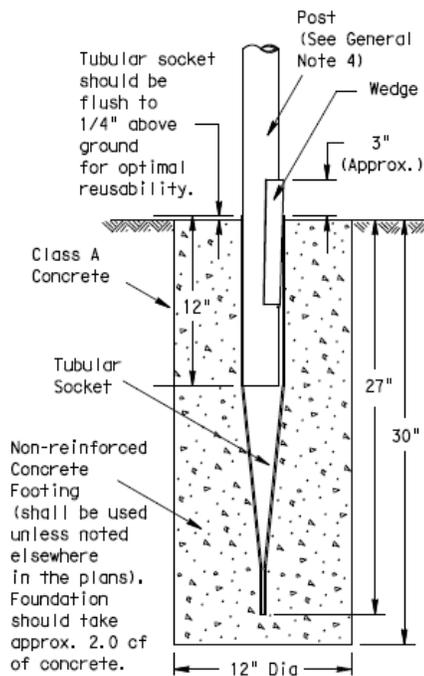
SM RD SGN ASSM TY TWT (X)WS (X)

Wedge Anchor Steel System

Figure 2.28. Sign Mounting Details Using Wedge Anchor System SMD (TWT) (35).

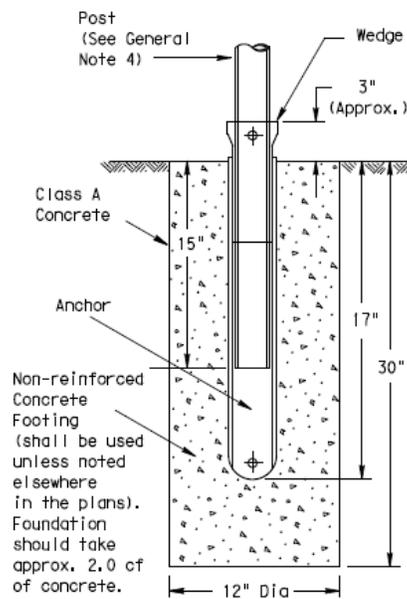
SMD RD SGN ASSM TY TWT (X)WP (X)

Wedge Anchor High Density Polyethylene (HDPE) System

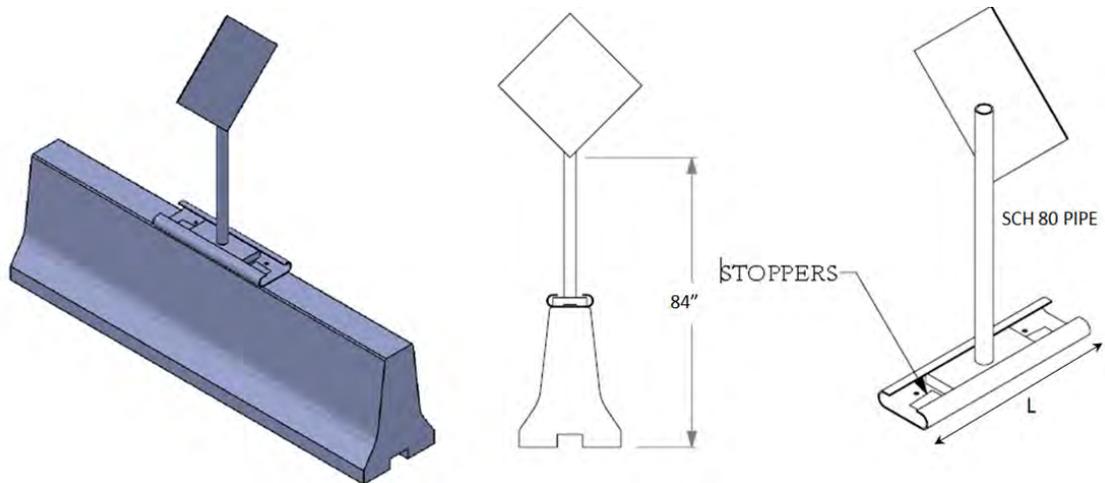
Figure 3.1. Concept 1: Chute Channel.

Several concepts were developed for mounting sign posts on median barriers. Figure 3.1 shows a concept where a sign post is mounted on a guiding channel attached to the top of the barrier. The post base is attached to the channel through clamped friction. The translation of the post base in longitudinal direction is further prevented by the stoppers at both ends of the channel. Figure 3.2 shows a concept where hinge and spring assembly is used to mount the sign post on top of a median barrier. The post is connected to the barrier using a hinge that allows the post to rotate about the lateral axis of the barrier. The springs connected on either side of the post would counter this rotation elastically by virtue of their stiffness. The objective is to allow the post to rotate toward the barrier top when impacted by a significant force along the longitudinal direction of a crash event. This would reduce the potential of post to vehicle snagging and allow a safer performance during a crash event. In the concept shown in Figure 3.3, the post is attached to the barrier using a bracket. The cable with shackle connecting the post and bracket is used to prevent the breakaway of the post if detached. A loose post flying free during a crash event may cause severe occupant injury. The shape of the bracket used on top of the barrier should match the shape of the barrier top. Hence same bracket cannot be used for all types of concrete barriers. Thus, this concept requires different mounting details for different barrier types. The concept shown in Figure 3.4 uses the same approach of using a bracket to mount the post on top of a barrier. The post here is attached to the two vertical steel plates welded on top of the bracket using a hinge and a sacrificial pin. The sacrificial pin is designed to fail during a crash event allowing the post to rotate toward the longitudinal barrier. This would reduce the post-to-vehicle engagements and allow safer performance during a crash event.

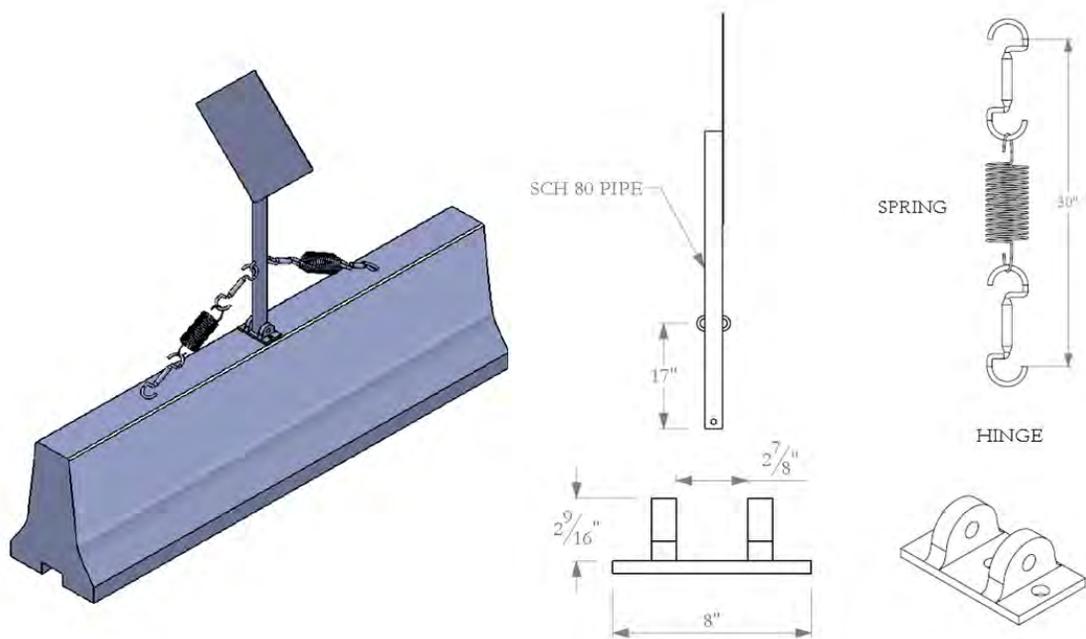
Figure 3.2. Concept 2: Hinge and Spring Assembly.

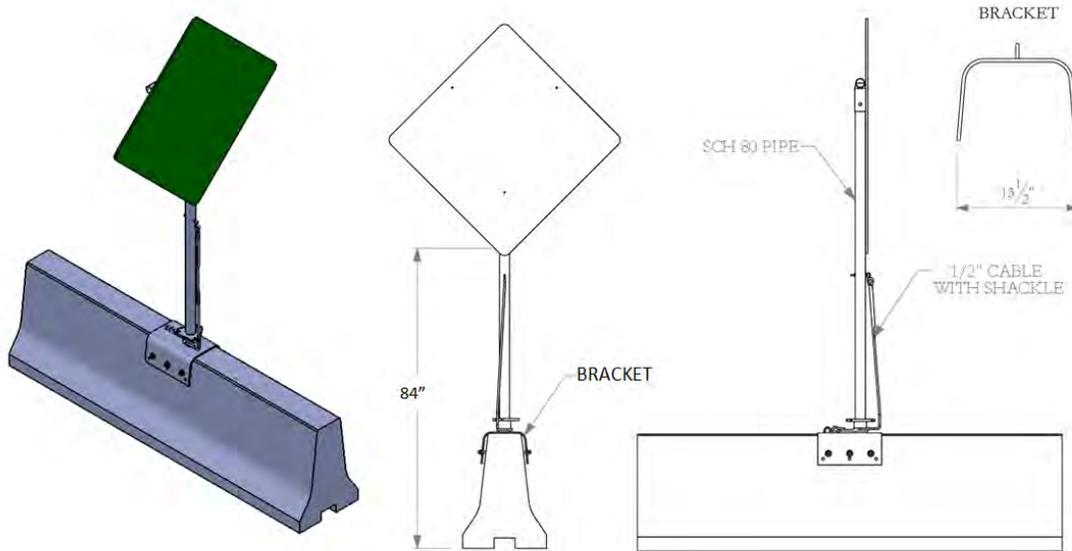
Figure 3.3. Concept 3: Bracket and Cable with Shackle Assembly.

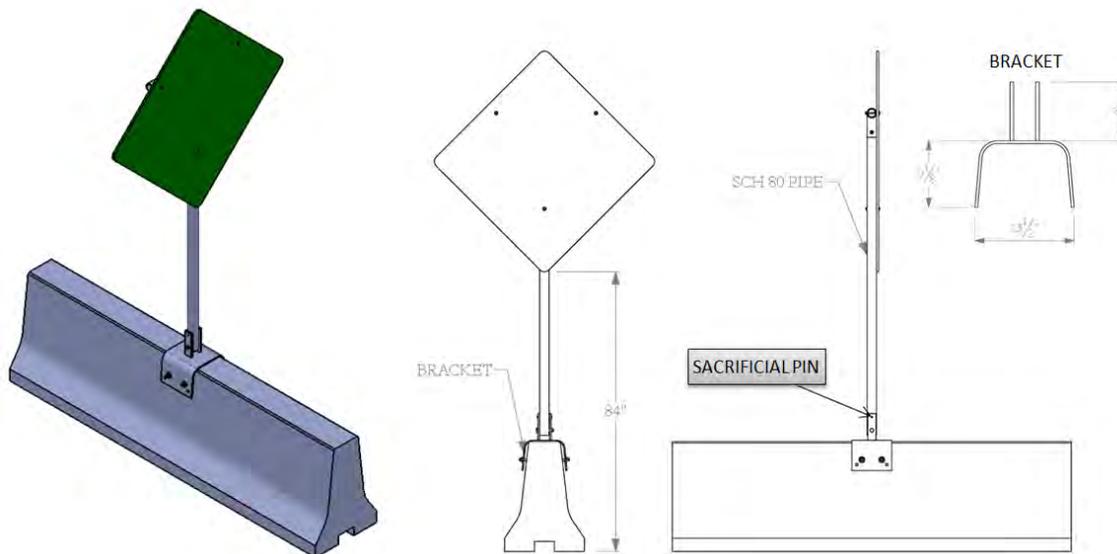
Figure 3.4. Concept 4: Bracket and Sacrificial Pin Assembly.

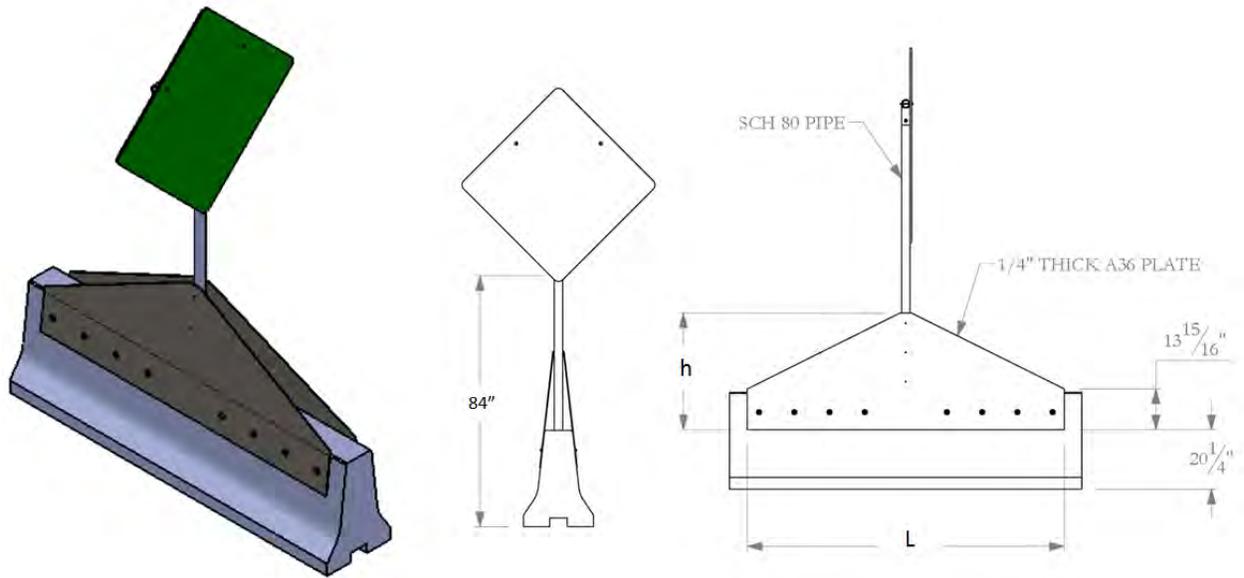
Figure 3.5. Concept 5: Triangular Plate to Shield Pole.

Figure 3.5 shows a concept where triangular side plates are used to shield the post from an impacting vehicle. The intention is to reduce the potential of post-vehicle snagging. The top of the plate should be high enough to effectively capture the fender of the airborne vehicle. Concept shown in Figure 3.6 uses a spread tube to mount the post on the barrier. One of the problems associated with mounting a post on top of a barrier using bolts is the limited space available for the connection in the direction of the width of the barrier (i.e., lateral direction). This can cause an insufficient moment capacity for the connection in lateral direction. Spread

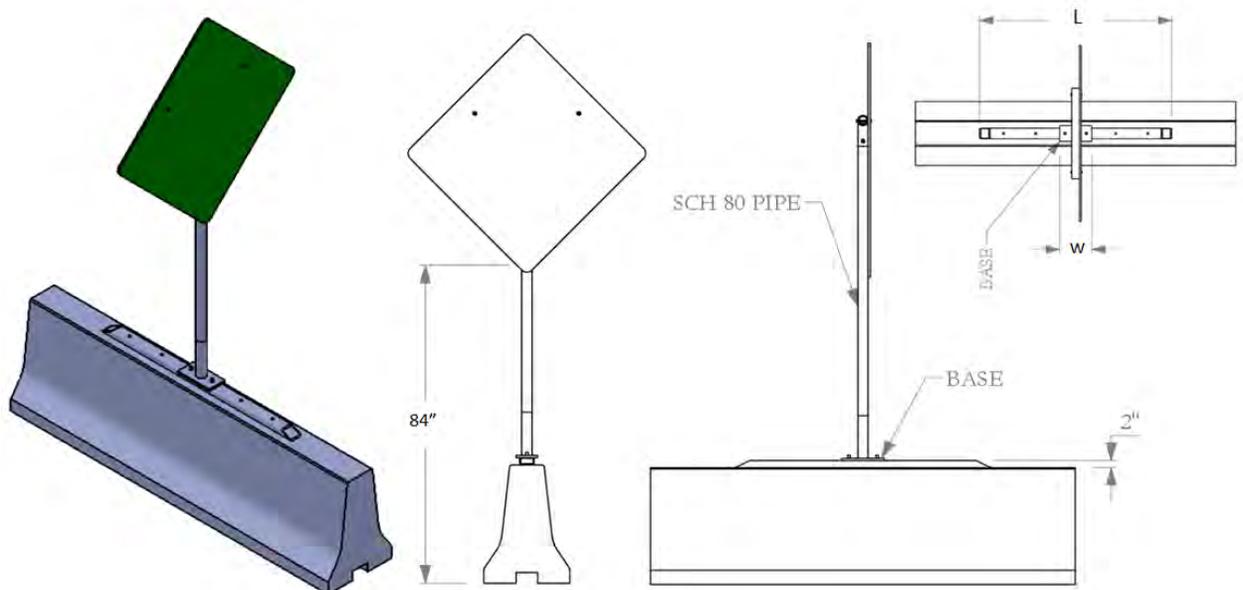
Figure 3.6. Concept 6: Spread Tube System.

tube, as shown in Figure 3.6, can be used to increase the stiffness of the connection in lateral direction and provide adequate bolting space along longitudinal direction.

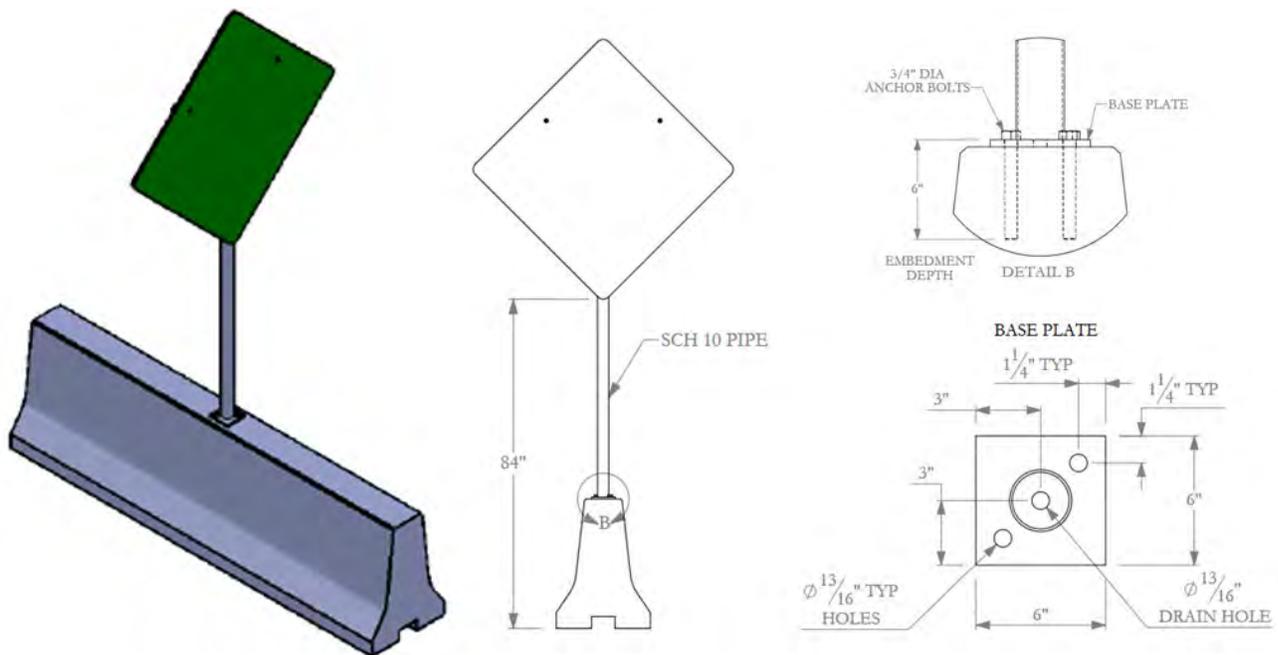
Figure 3.7 presents the details of a typical construction practice for mounting sign post on concrete barrier. As shown in the figure, the Schedule 10 sign pipe (2-1/2-inch outer diameter) was mounted on a 7/16-inch-thick base plate attached on top of the barrier. Two 3/4-inch bolts with 6-inch embedment lengths were used to attach the base plate on top of the concrete barrier. Performance issues of this connection must be identified for vehicle impact conditions specified in *MASH* test 3-11. For this task, the impact loads on a typical barrier mounted sign post was identified from an existing crash test data. The wind load on a typical 4-ft × 4-ft sign panel was also determined following AASHTO guidelines (36). Currently the engineering analyses are being performed to determine whether the connection shown in Figure 3.7 can withstand both the impact and wind loads.

Figure 3.7. TXDOT Type H4 (Dallas IH 35E) Sign Mount Details (37).

Engineering analyses were performed as shown in Figure 3.24 to determine the capacity of the bolts and the base plate used in the TXDOT Type H4 sign mount connection shown in Figure 3.7. It can be seen that the moment capacity of the connection based on bolt strength is 2.381 kip-ft. Also, bending capacity of the base plate used in the connection is 1.615 k-ft. This indicates that some bending of the base plate is likely to occur prior to the failure of the bolt at 2.38 k-ft moment.

As discussed in the previous sections, the maximum moments acting on a typical sign mounting connection due to the vehicular impact and wind load are 7.5 k-ft and 2.5 k-ft, respectively. Thus the bolts used in TxDOT type H4 connection shown in Figure 3.7 should fail at vehicular impact or severe wind load. In the next task of this study, conceptual sign mounting connections will be analyzed and recommended based on the results obtained from the analyses to be performed and TxDOT input.

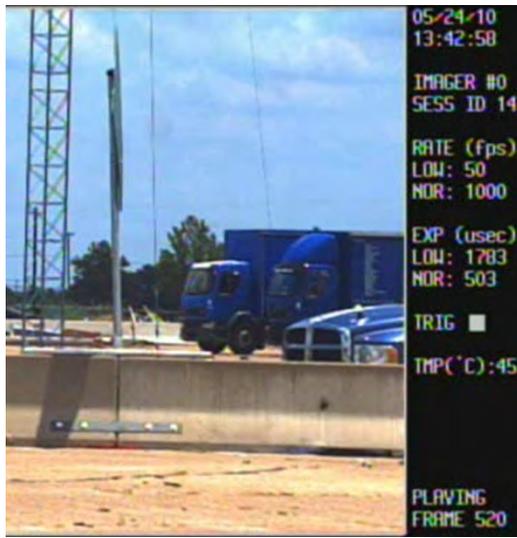
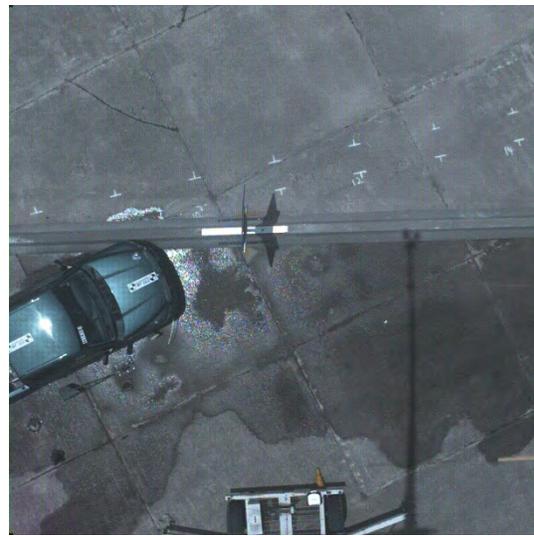
Video 1C (Frame 520)

Vehicle contacts barrier in Frame 520 (Video 1C). $t=0$ s

Figure 3.8. Film Analysis Results: MASH Test on TXDOT PCTB Sign Support Assembly (38).

A film analysis was performed to identify the sequential positions of the vehicle with respect to the barrier and the sign post during the crash test. Figure 3.8 shows the results obtained from the film analysis of TTI test 461430. As can be seen from the figure, the vehicle impacted the post at 0.081 s and lost contact with the post after 0.121 s.

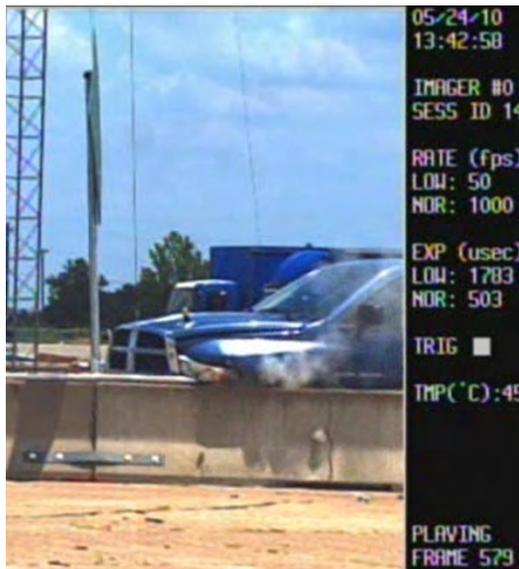
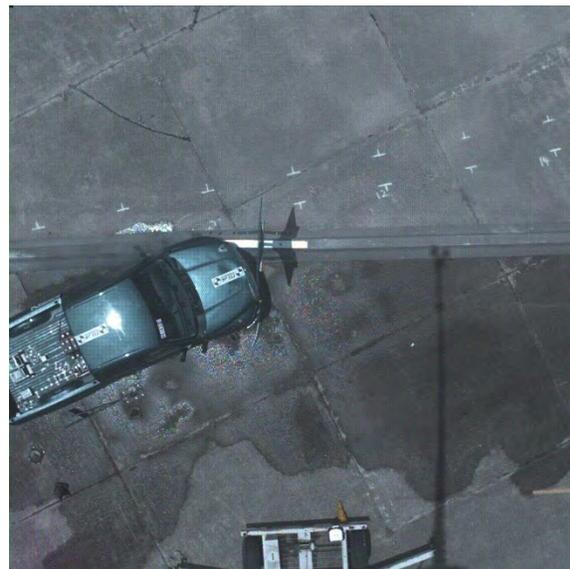
Video 1C (Frame 579)

Vehicle Impacts the base tube in Frame 579 (Video 1C). $t=(579-520)/1000=0.059$ s

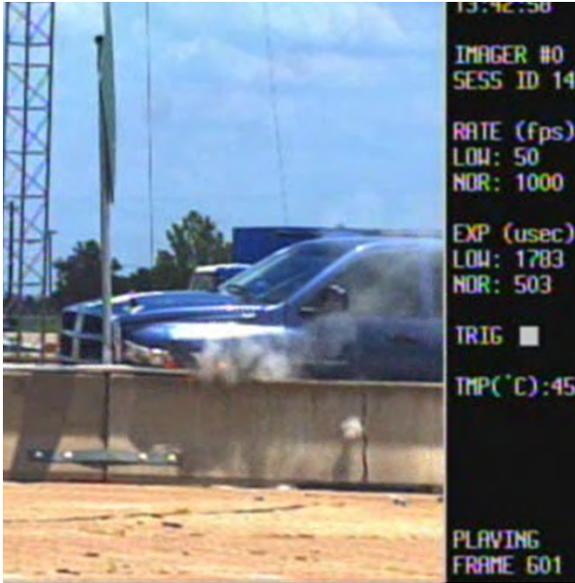
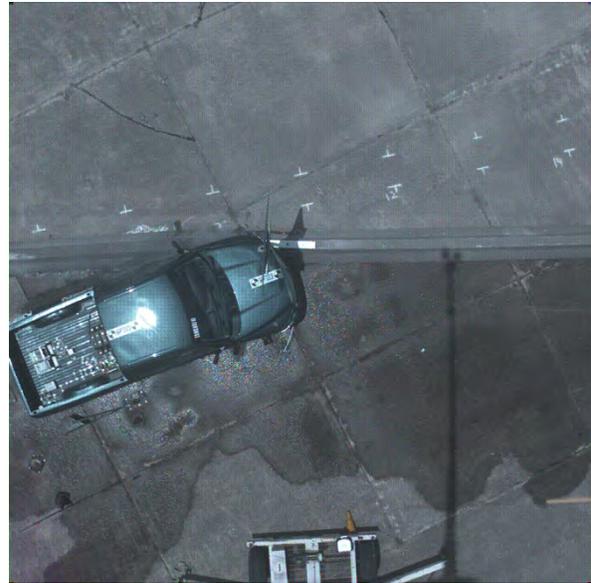
Video 1C (Frame 601)
 Vehicle Impacts the pole in Frame 601. $t=(601-520)/1000=0.081$ s

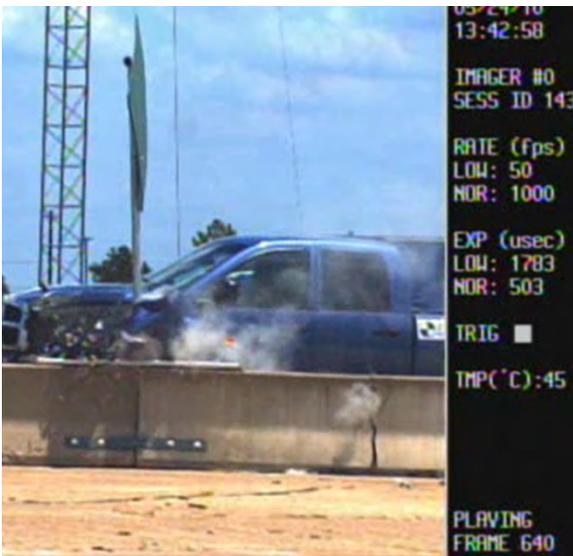
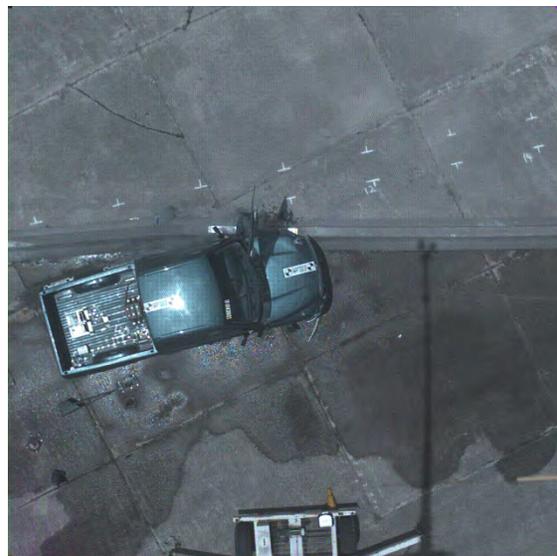
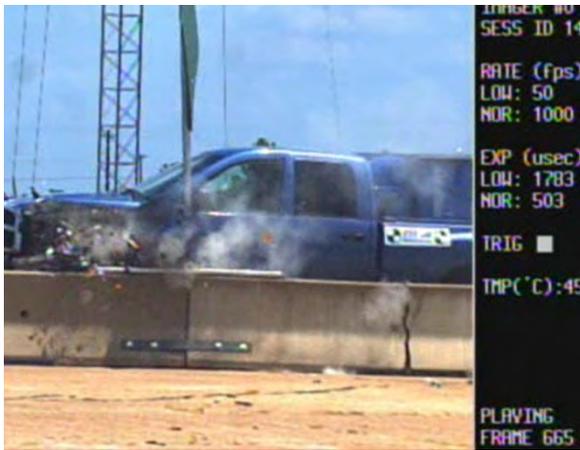
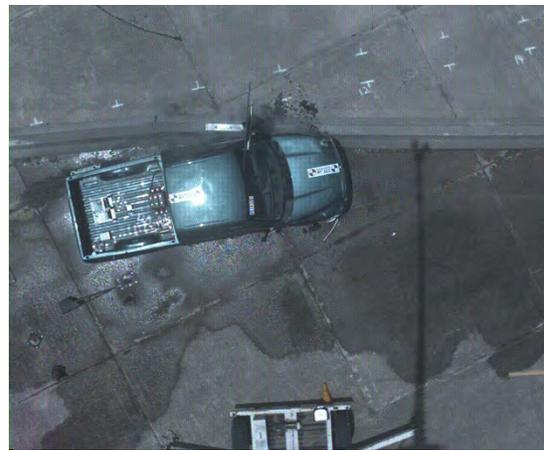
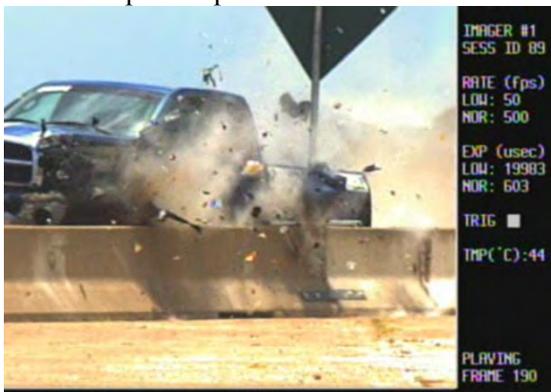
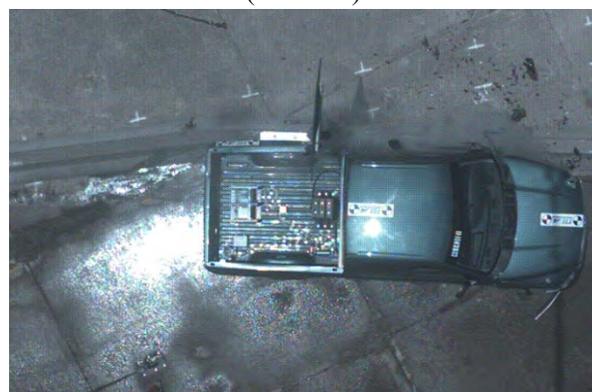
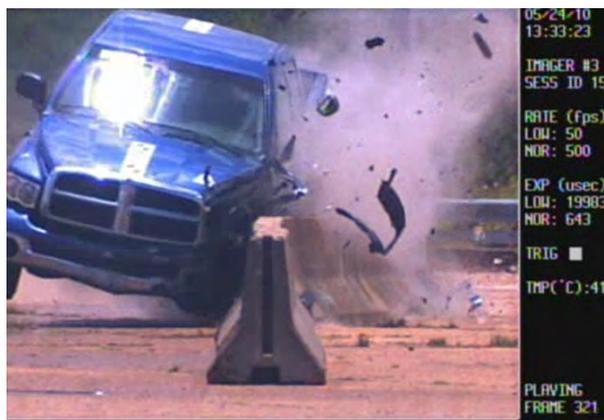
Figure 3.8. Film Analysis Results (continued).

Video 1C (Frame 640)
 Vehicle fender snags into the pole in Frame 641. $t=(640-520)/1000=0.121$ s

The pole impacts the vehicle side view mirror in Frame 665. $t=(665-520)/1000=0.145$ s

Rear of the vehicle contacts the barrier in Frame 190 (Video 1B). $t=(190-67)/500=0.24$ s

Front of the vehicle slap onto the barrier from Top in Frame 321 (Video 1A). $t=0.523$ s

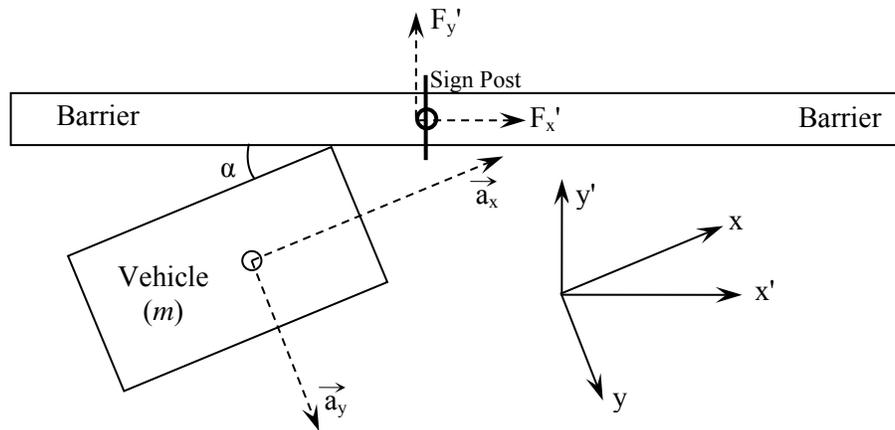
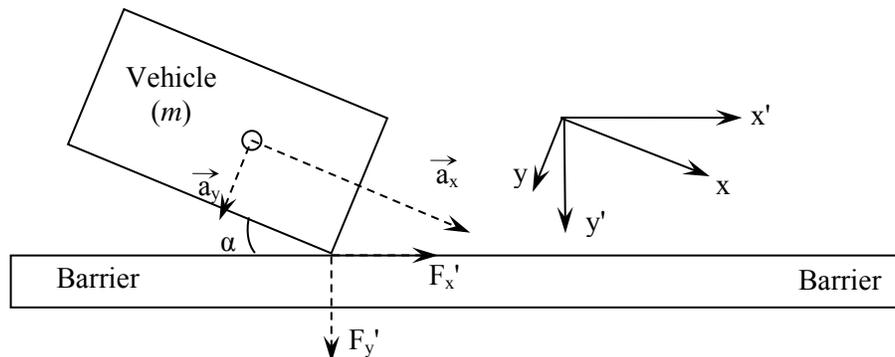
Figure 3.9. Coordinate Systems Used for the Vehicle and Sign Post/Barrier.

(a) Driver side of the vehicle impacting the barrier

The impact forces on the barrier and the sign post during the crash test were estimated using vehicle accelerometer data. The vehicle and the barrier co-ordinate systems used for the test are schematically shown in Figure 3.9(a). As can be seen from the figure, the driver side of

In the TTI test 44162-3 (39), the driver side of the Chevrolet 2500 pickup truck impacted the Texas grid-slot PCTB at a speed and angle of 62.5 mi/h and 25 degrees, respectively. Hence, as shown in Figure 3.9(a), the Equations 3.1 and 3.2 can be used to map the impact force components in barrier co-ordinate system. Using these equations, and the acceleration time histories and yaw angle data obtained at vehicle C.G. from the test, the impact force components in the barrier co-ordinate system were computed as a function of time as shown in Figure 3.14. As can be seen from the figure, the maximum 50-ms average impact forces acting on the barrier between times 0.082 s to 0.122 s (the vehicle-to-post contact period in TTI test 461430) were 10 kips and 40 kips in the longitudinal and lateral directions, respectively.

In the TTI test 476460-1 (10), the passenger side of the 5049 lb Chevrolet Silverado impacted a New Jersey concrete barrier at a speed and angle of 62.6 mi/h and 25.2 degrees, respectively. Hence, as shown in Figure 3.9 (b), the Equations 3.3 and 3.4 can be used to map the impact force components in the barrier co-ordinate system:

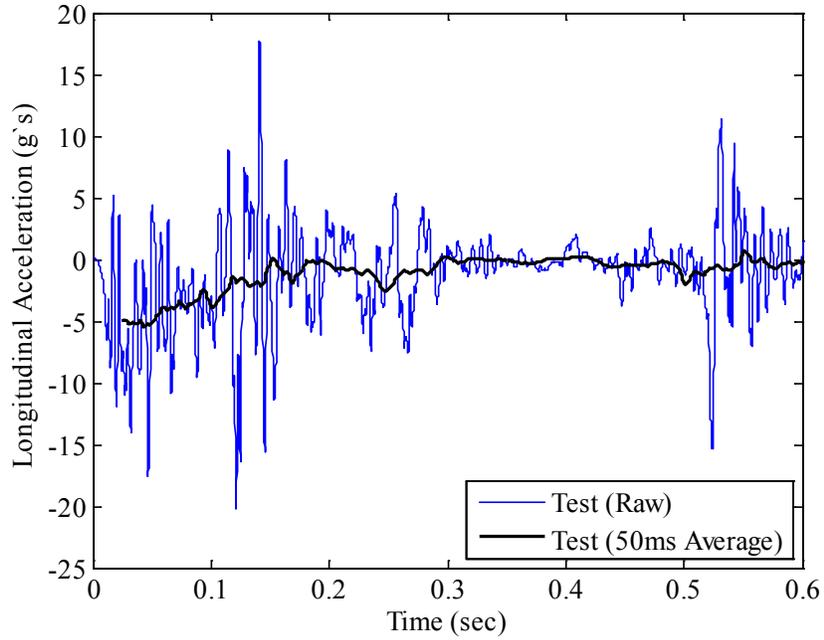
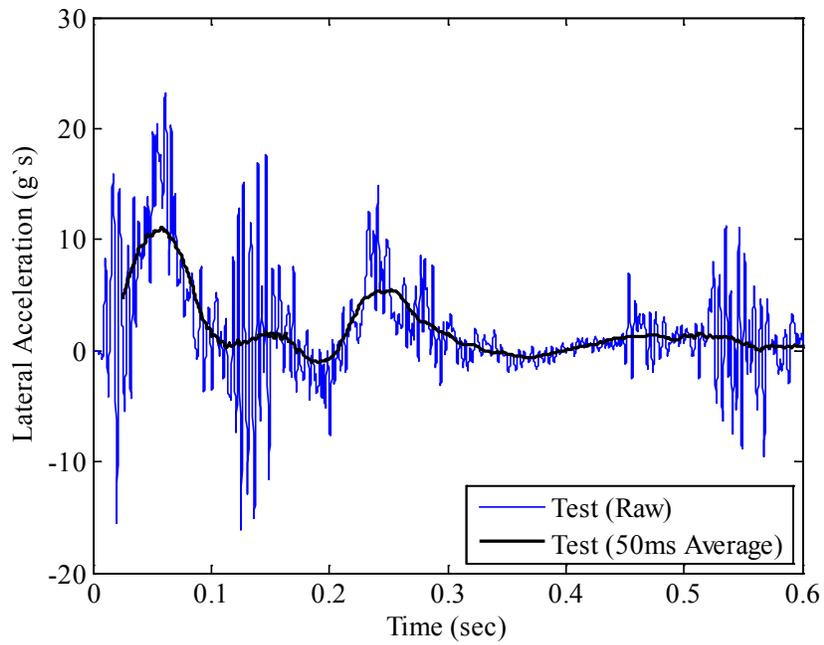
Figure 3.11. Accelerations of the Vehicle (TTI Test 461430) (4).

(a) Longitudinal Acceleration

(b) Lateral Acceleration

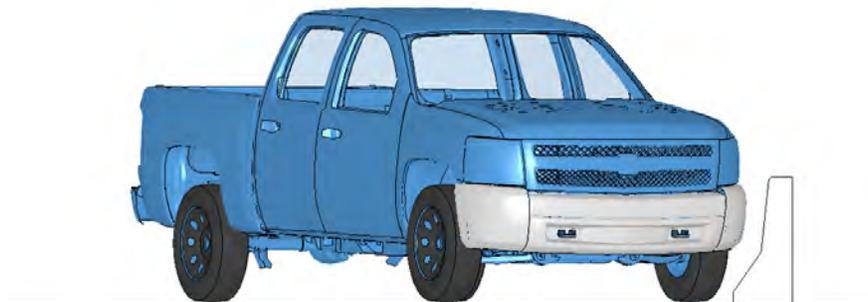
Figure 3.16. Simulation Setup for the *MASH* Test Performed on New Jersey Barrier.

Numerical simulation was used to evaluate the impact load acting on the sign post mounted on a permanent concrete median barrier. Finite element analyses were performed to simulate *MASH* 3-11 test conditions. A 251,241 elements Silverado pickup model developed by NCAC was used for these simulations. To assess the model fidelity, an impact analysis, as shown in Figure 3.16, was performed to simulate the *MASH* 3-11 test of the New Jersey barrier (10). The vehicle to barrier impact forces at the C.G. of the vehicle on the barrier coordinate systems were calculated using Equations 3.3 and 3.4 and the acceleration time histories and yaw angle data obtained at the C.G. of the vehicle from the simulation. Figure 3.17 compares the impact force components in the longitudinal and lateral direction obtained from the simulation and the test. As can be seen from the figures, the 50-ms average impact force obtained from the simulation closely matched the test result in the longitudinal direction. The impact force in the lateral direction obtained from the simulation, however, followed the forces obtained from the test until 0.15 s. In both the test and the simulation, the rear of the vehicle impacted the barrier at 0.15 s. The vehicle impacting a sign post, mounted on the barrier near the critical impact point, should lose contact with the post by the time the rear of the vehicle reaches the barrier. Thus impact forces after 0.15 s are resisted entirely by the barrier and are not important for the evaluation of the integrity of the post mounting connections based on this test/simulation analysis case.

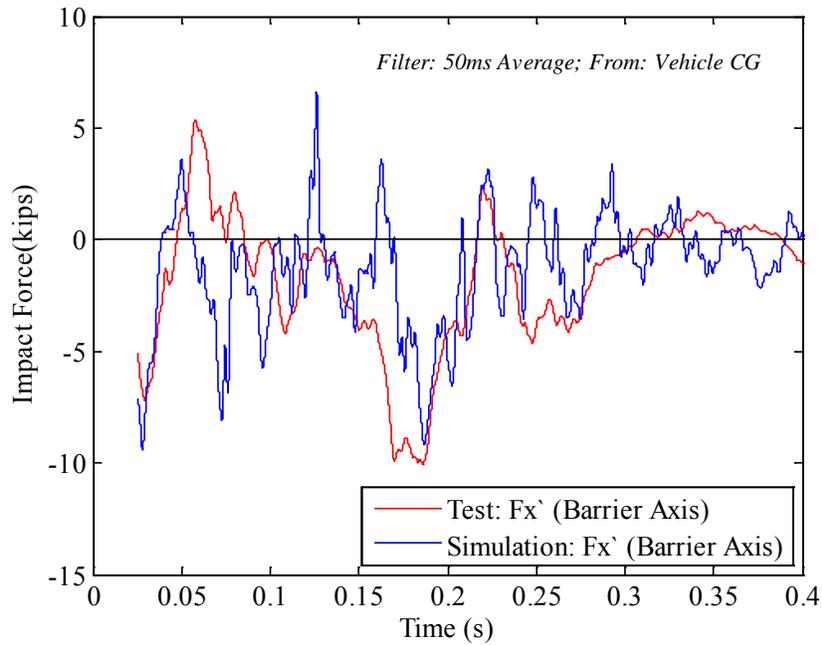
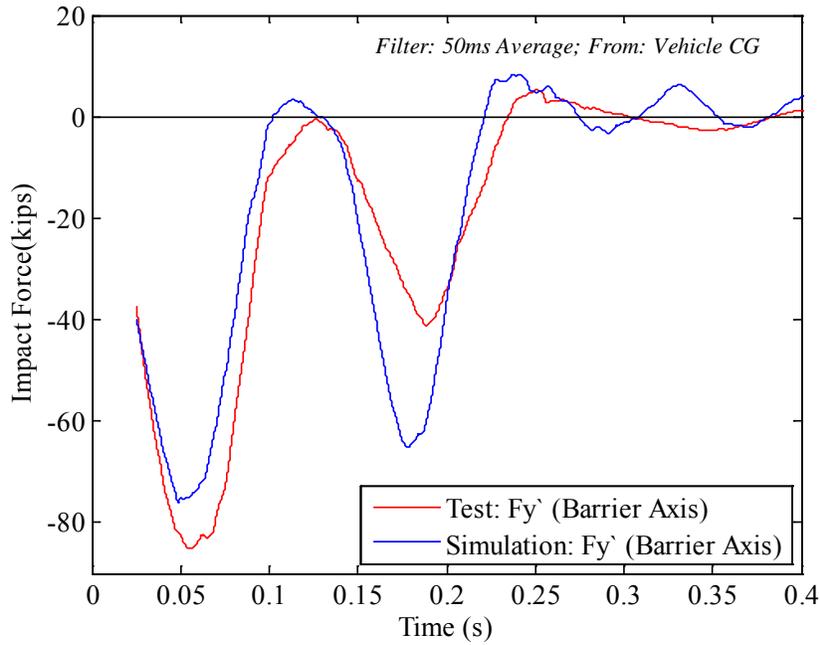
Figure 3.17. Impact Force Comparison between Simulation and Test 476460-1 (10).

(a) Longitudinal direction

(b) Lateral direction

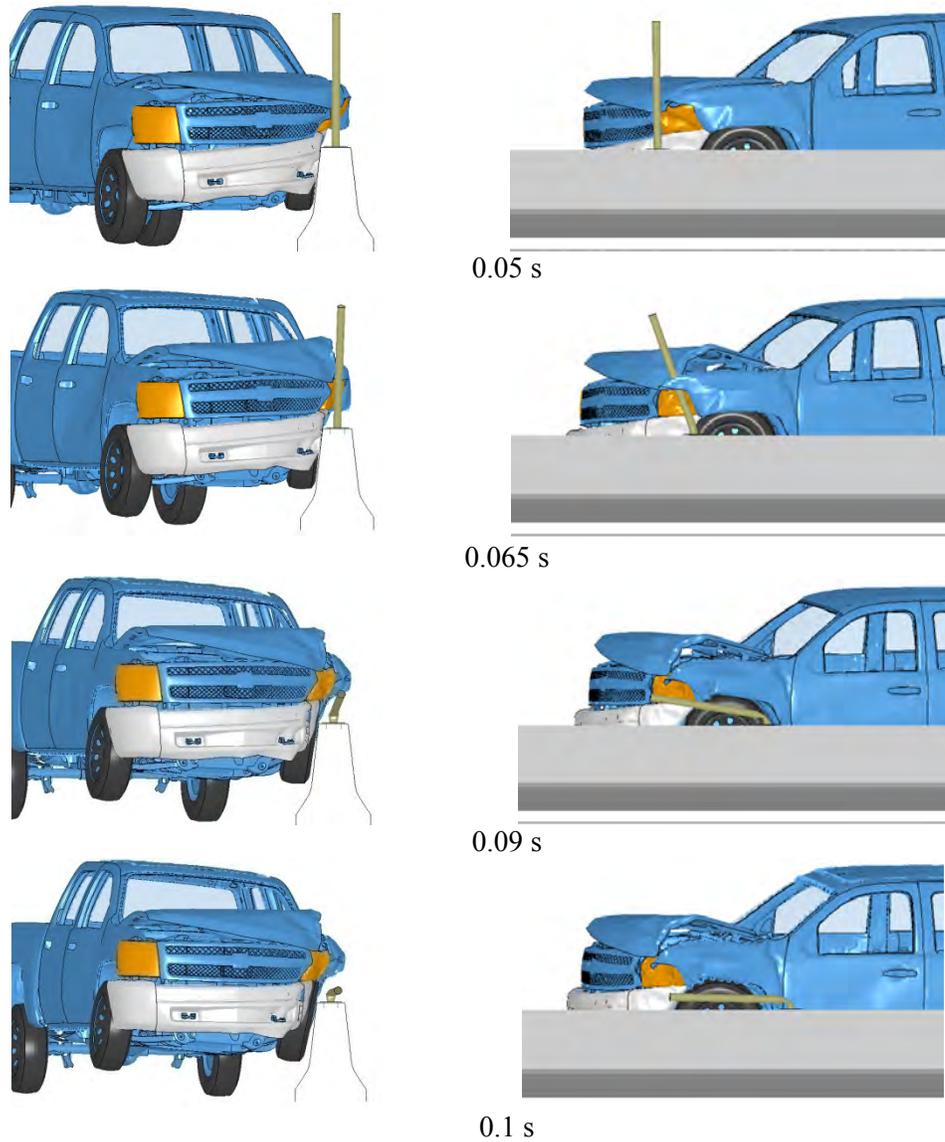
Figure 3.19. Sequential Photographs Obtained from the Simulation.

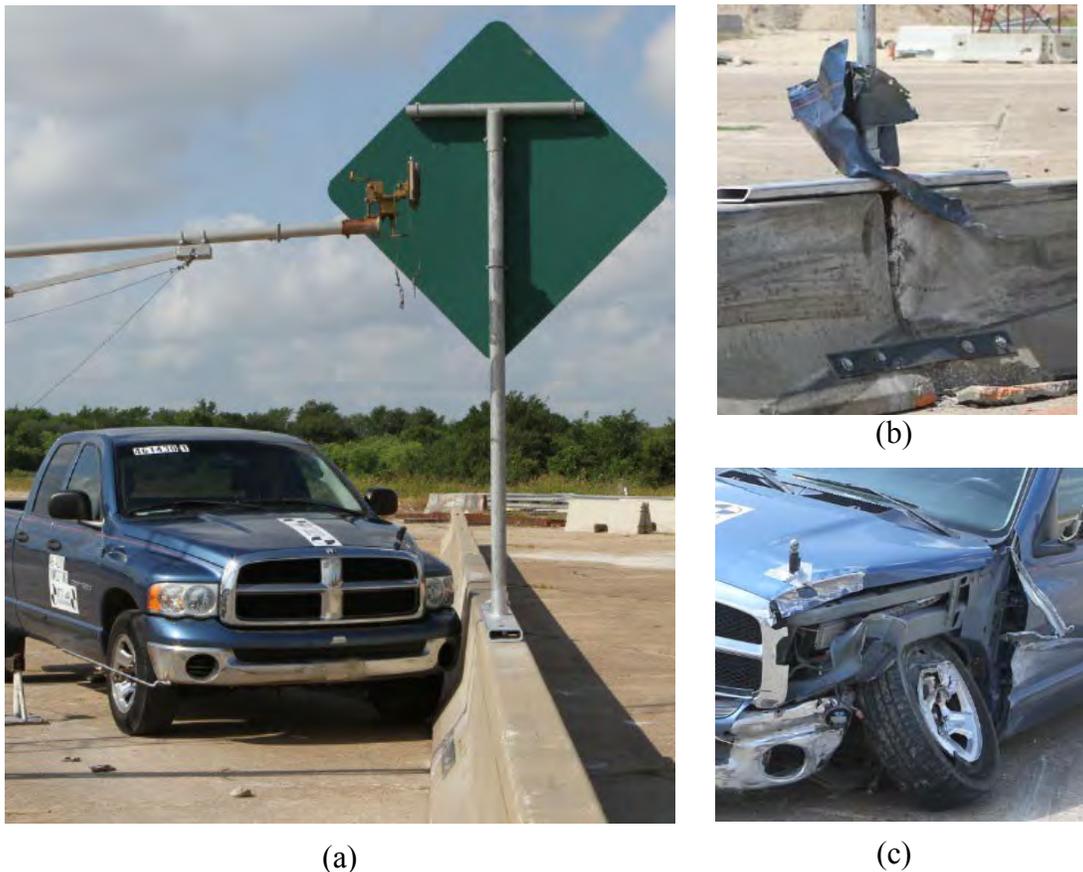
Figure 4.2. (a) Setup for MASH Test Performed on Temporary Concrete Barrier with Sign Post Mounted on Top; (b) Schedule 80 Sign Post after Test; (c) Exterior Fender Detached from Vehicle after Impact.

Researchers at TTI recently investigated the performance of a temporary concrete barrier with sign attachments mounted on top (38). A crash test of this barrier-sign configuration was performed using a 2005 Dodge Ram 1500 pickup truck. During the test, the exterior fender of the truck snagged into the Schedule 80 sign post and was detached from the vehicle as shown in Figure 4.2. An initial LS-DYNA simulation of the original (unmodified) Silverado model impacting the barrier mounted sign post showed that the vehicle model does not have any failure mechanism for the exterior fender connection. A subsequent investigation showed that there are distinct differences in the fender connection for a Dodge Ram and Silverado pick up. As shown in Figure 4.3, the exterior fender of a Dodge Ram is attached to the interior parts using bolts. In a Silverado pickup, on the other hand, the exterior fender is attached to the interior parts using both spot-welds and bolts. As shown in Figure 4.3(c), in the original Silverado model, the bolts were modeled using nodal rigid body (NRB) connections and no failure criteria was assign to the spot-weld connections. The fender elements near the edge of the door were merged/attached to the surrounding elements. Thus the exterior fender in the existing pickup model does not detach from the vehicle and can impart excessive force on the sign post once snagged during a side impact.

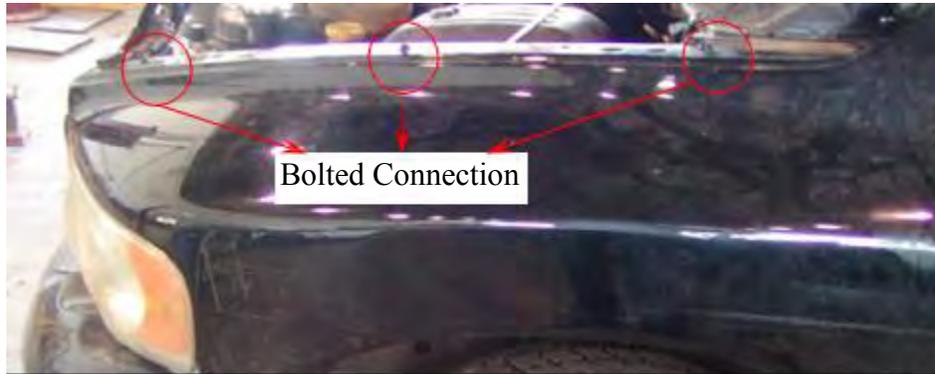
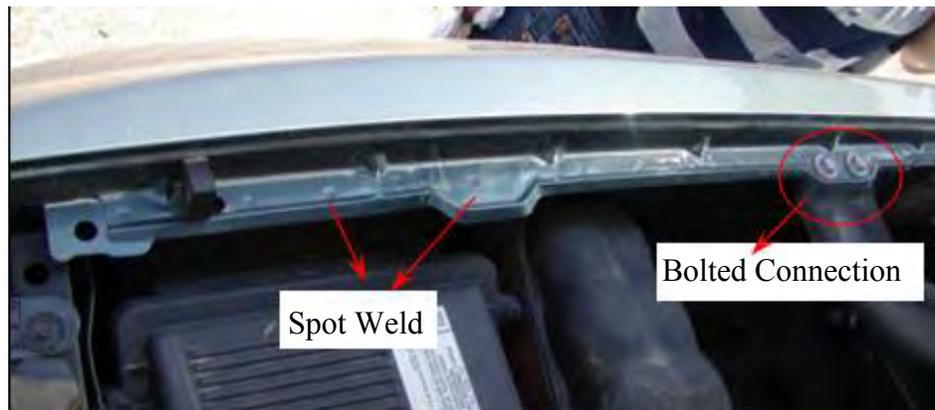
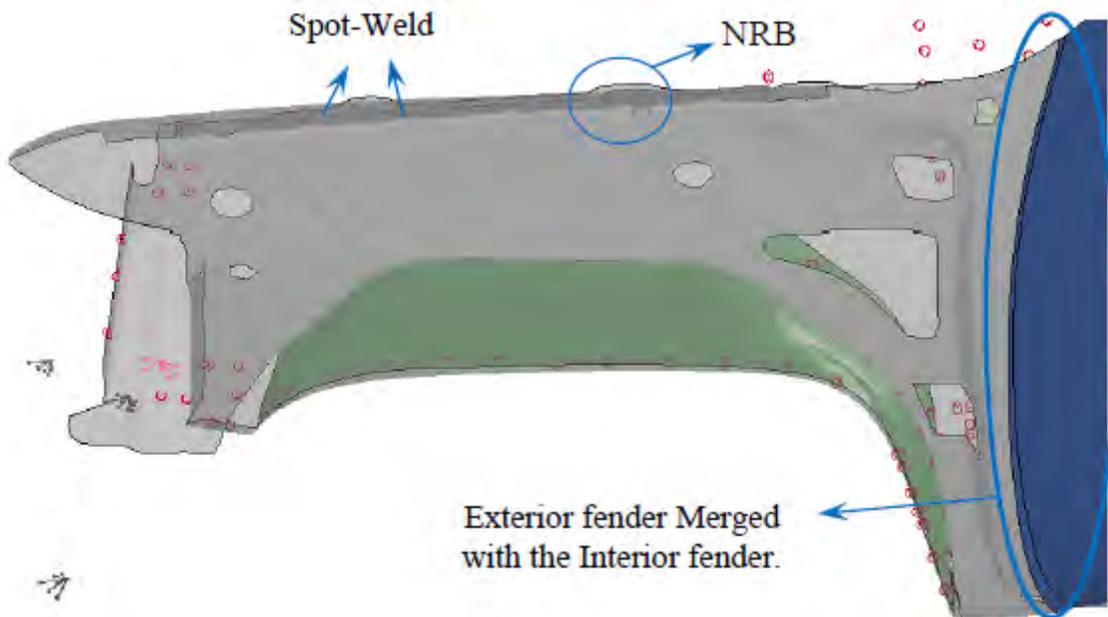
Figure 4.3. Exterior Fender Connection of (a) Dodge Ram 1500 Pickup; (b) Silverado Pickup; and (c) Silverado Pickup Truck Model.

(a)

(b)

(c)

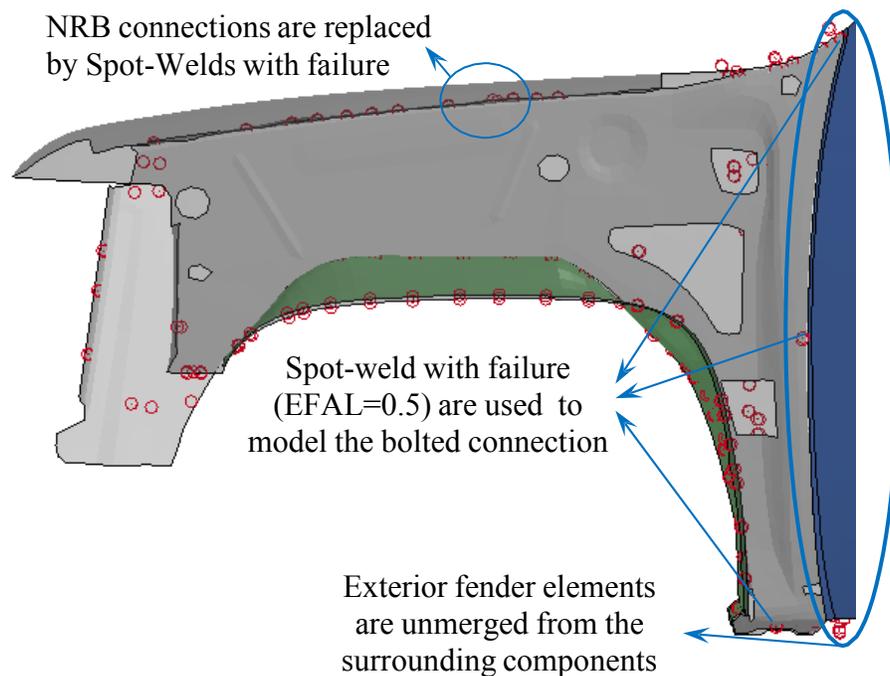
Figure 4.4. Modifications to Fender Connection of Existing Vehicle Model.

Dodge Ram pickup truck is generally used to perform *MASH* TL-3 tests at TTI and at other test labs. Hence, the research team modified the fender connection in the NCAC developed model to incorporate failure mechanism and match the fender connection in a Dodge Ram. As shown in Figure 4.4, the team removed the NRB connections and unmerged the exterior fender elements from interior parts at the edge near the door. Spot-weld representation was used to define the bolted connections. The research team used an effective failure strain of 0.3 to define the failure criteria for the spot-welds. Figure 4.5 shows the effect of these modifications on an impact simulation performed on a barrier mounted sign system. Figure 4.5(a) shows the result obtained from the simulation using the existing vehicle model. As can be seen in the figure, the spot welds near the fender region did not fail and the fender attached to the vehicle continued to impart high forces on the sign post producing excessive deformation of the Schedule 80 post. Exterior fender in the modified version of the vehicle model, as shown in Figure 4.5(b), on the other hand was detached from the vehicle imparting lower force on the post. Thus sign post in this simulation did not undergo large deformation due to this impact.
