Signs on Concrete Median Barriers

Test Report 0-6646-1

**TEXAS A&M TRANSPORTATION INSTITUTE
COLLEGE STATION, TEXAS**

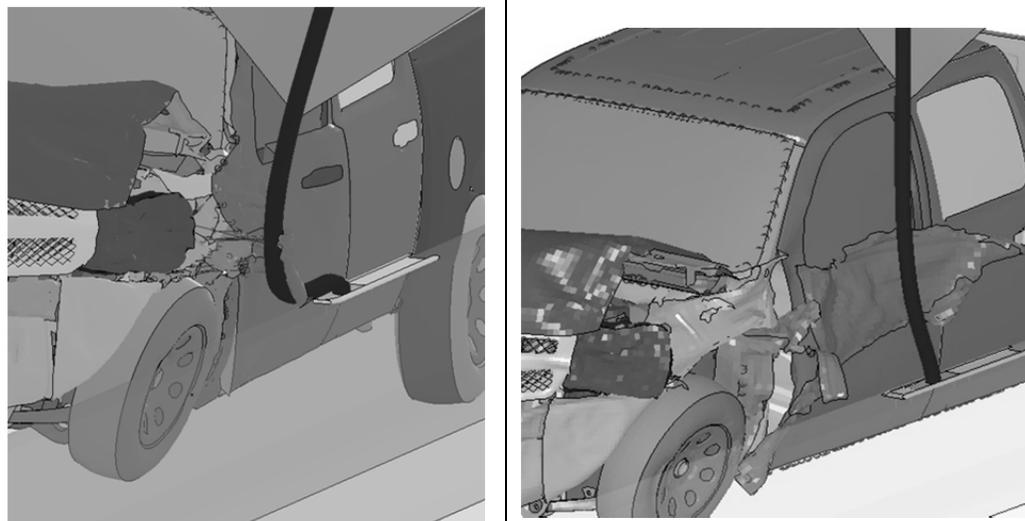
(a) Simulation using original version of the Silverado Model

(b) Simulation using modified version of the Silverado Model

Dodge Ram pickup truck is generally used to perform *MASH* TL-3 tests at TTI and at other test labs. Hence, the research team modified the fender connection in the NCAC developed model to incorporate failure mechanism and match the fender connection in a Dodge Ram. As shown in Figure 4.4, the team removed the NRB connections and unmerged the exterior fender elements from interior parts at the edge near the door. Spot-weld representation was used to define the bolted connections. The research team used an effective failure strain of 0.3 to define the failure criteria for the spot-welds. Figure 4.5 shows the effect of these modifications on an impact simulation performed on a barrier mounted sign system. Figure 4.5(a) shows the result obtained from the simulation using the existing vehicle model. As can be seen in the figure, the spot welds near the fender region did not fail and the fender attached to the vehicle continued to impart high forces on the sign post producing excessive deformation of the Schedule 80 post. Exterior fender in the modified version of the vehicle model, as shown in Figure 4.5(b), on the other hand was detached from the vehicle imparting lower force on the post. Thus sign post in this simulation did not undergo large deformation due to this impact.

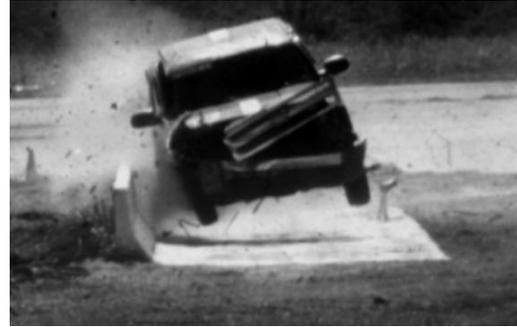
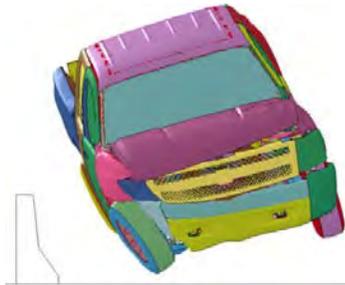
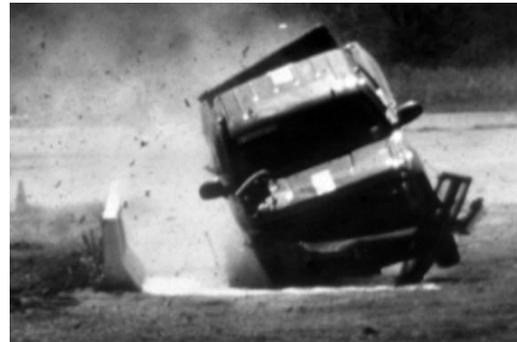
Figure 4.6. Comparison of Sequential Photographs.

0.23 s

0.46 s

Figure 4.6 compares the sequential photographs of simulation and test results. As can be seen, the vehicle in the simulation closely followed the trend observed in the crash test. Comparisons of longitudinal accelerations and lateral accelerations obtained at vehicle C.G. during crash tests and simulations are presented in Figure 4.7 (a). Vehicle's yaw, roll, and pitch angles are also compared in Figure 4.7 (b). A reasonable overall correlation between the test and simulation results was observed from these figures. As can be seen from Figure 4.7 (a), lateral accelerations (i.e., impact force) obtained from the simulation was slightly lower during the initial impact and higher during backslap compared to that obtained during the crash test. The accelerations in longitudinal direction closely matched the test results. The vehicle's yaw, roll, and pitch angles obtained from the simulation closely followed the test results.

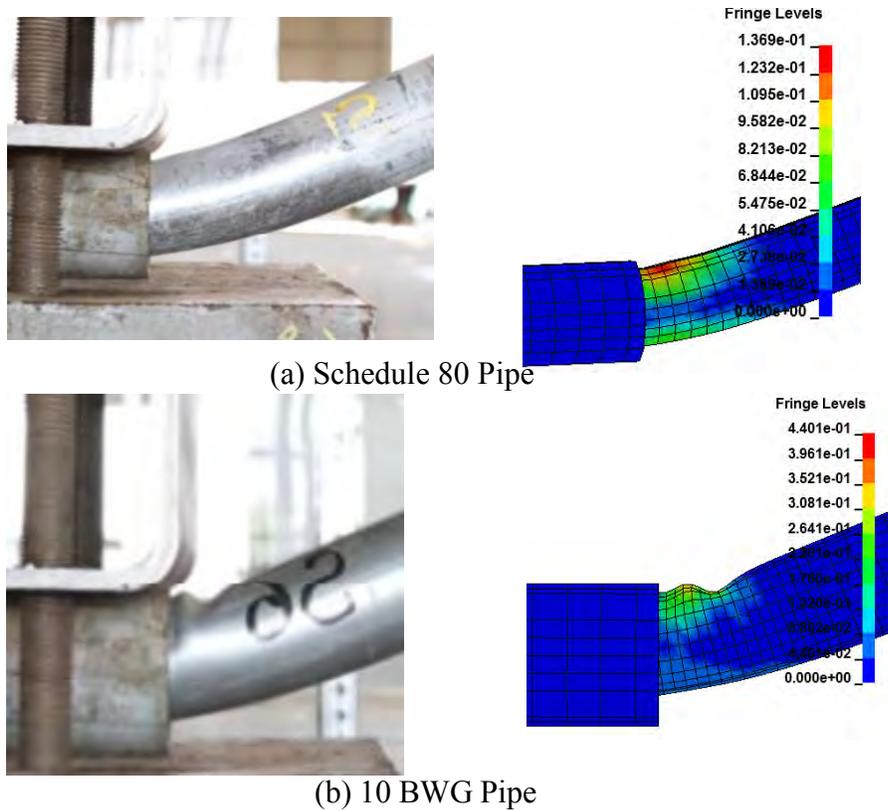
Figure 4.10. Bending of Pipe near Support Observed in Static Test and Simulation.

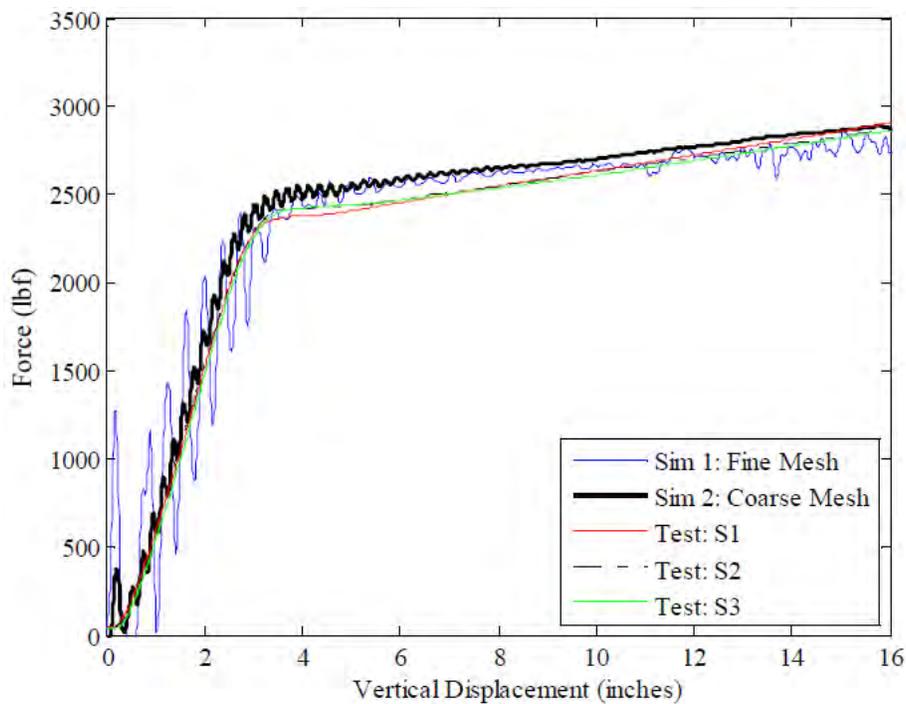
Figure 4.11. Load-Deflection Curves Obtained from Tests and Simulation Performed on Schedule 80 Pipe.

Figure 4.12 presents the data obtained from the tests and the simulations performed on the 10 BWG pipe. In each test, the 10 BWG pipe showed a nonlinear strain hardening followed by a nonlinear strain softening after the reaching yield point. One of the test specimens (S4), as presented in Figure 4.12, showed slightly lower load capacity. This specimen had slightly lower yield strength compared to the other 10 BWG pipes tested as reported in MTR shown in Table 3.3. In the simulation research team used the properties of the pipes used in test S5 and S6. As shown in Figure 4.12, load-deflection curves obtained from the simulations deviated from the test results after reaching the yield point. Slopes of the curves obtained from the simulations in the hardening and softening region were milder compare to those observed in the test. Hence, maximum load capacity of the pipe obtained from the simulation was lower than that observed in tests S5 and S6. The test specimens had slightly higher wall thickness compared to the nominal thickness for a 10 BWG pipe. Using wall thickness of the test pipe slightly increased the maximum capacity obtained from the simulation. However, the value was still slightly lower compared to that obtained from the test.

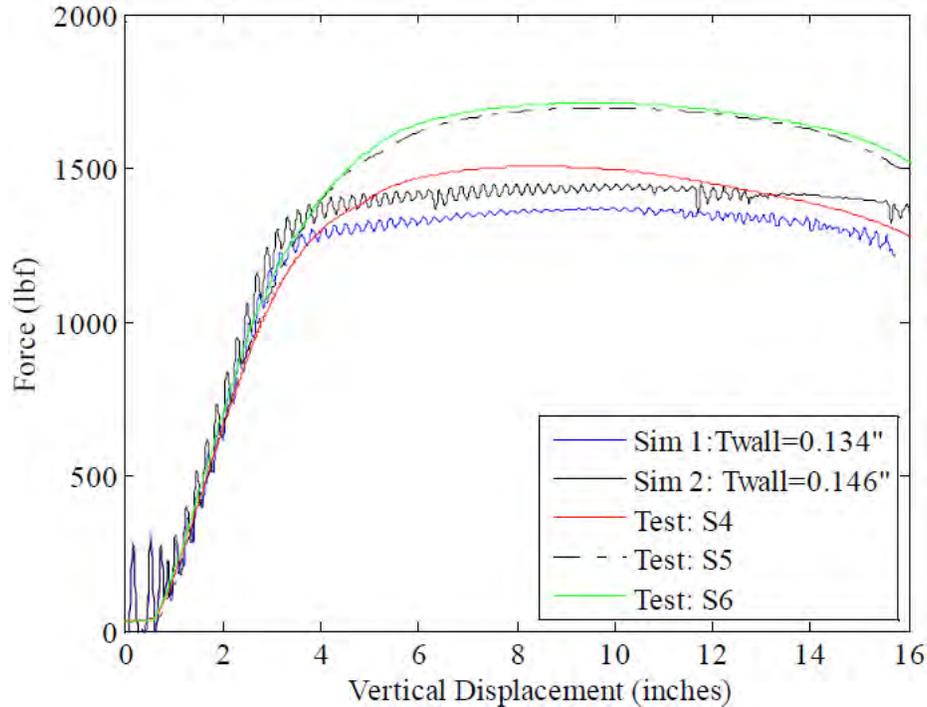
Figure 4.12. Load-Deflection Curves Obtained from Tests and Simulation Performed on 10 BWG Pipe.

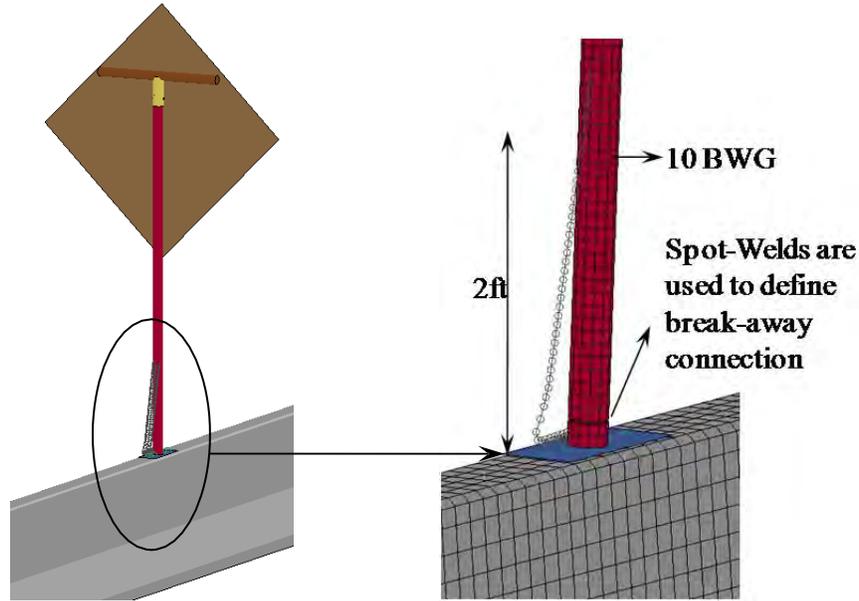
Figure 4.14. FE Model of Sign Mount Concept 3: Cable with Shackle Assembly.

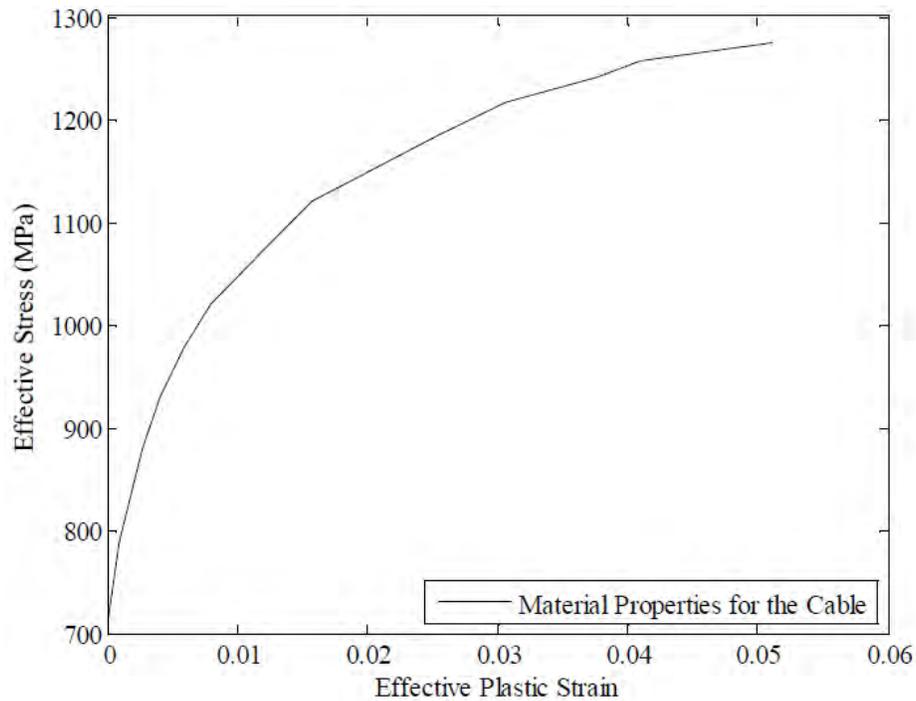
Figure 4.15. Material Properties (42) of Cable Used in FE Model of Sign Mount Concept 3.

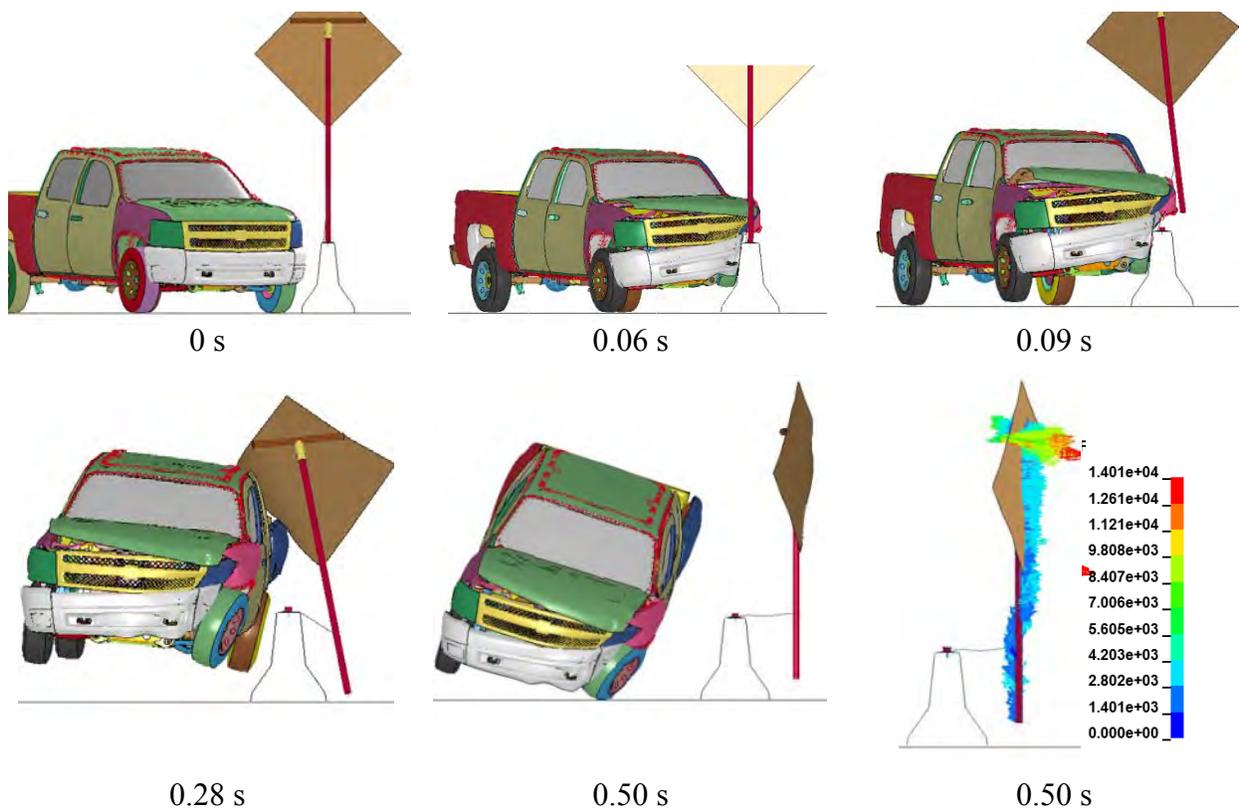
Figure 4.16. Sequential Images of MASH Simulation Performed on Sign Mounting Concept 3.

The sequential images obtained from the simulation are shown in Figure 4.16. It can be seen from the figure that the sign mount system, detached after the impact, traveled toward the opposing traffic lane producing a potential debris problem. The extent to which the sign system travels toward the oncoming traffic lane depends on the length of the attached cable and maximum length of the unsupported sign system. The top of a 4 ft × 4 ft sign panel extends 10-ft high above the barrier top. Based on the velocity of the detached sign post at 0.5 s, research team decided that the sign system can extend its fullest length into the opposing traffic lane at a later stage in this crash event. As can be seen in Figure 4.17, the impact forces on the post were insignificant. Axial force in the cable reached up to 4 kips when it stretched to its fullest length at 0.09 s.

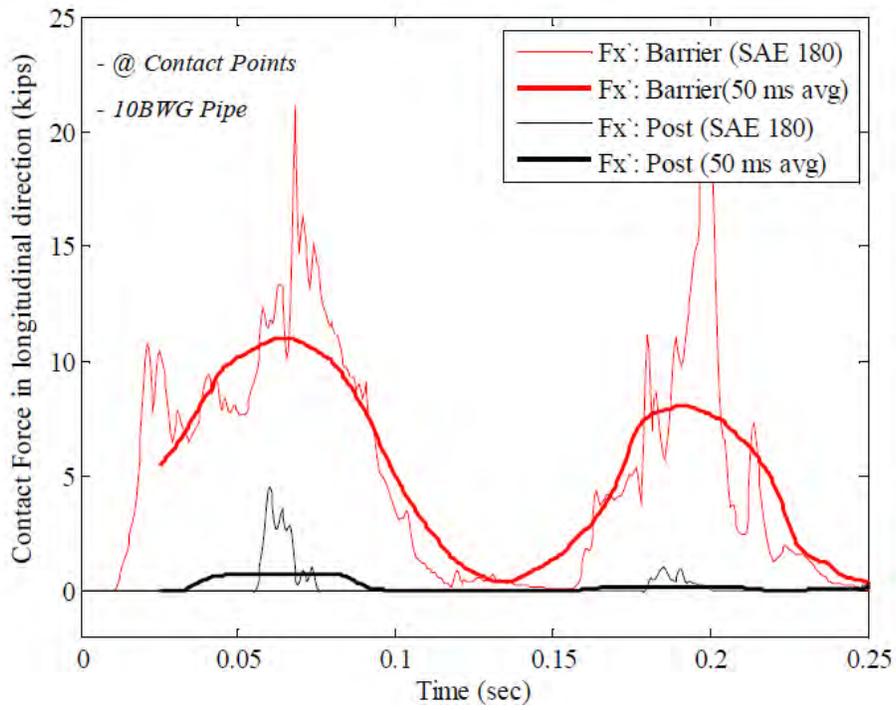
Figure 4.17. Impact Force on Barrier and Post in Direction Parallel to Barrier.

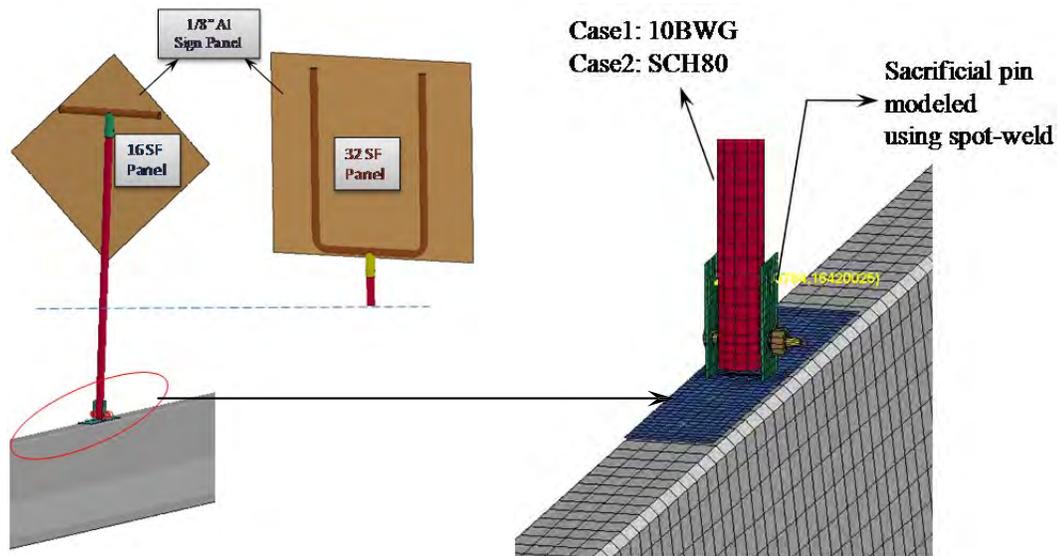
Figure 4.18. FE Model of Sign Mount Concept 4: Sacrificial Pin and Base Plate.

Simulation was performed for three cases. In the Case-1, the 16 SF panel was mounted using a 10 BWG pipe. In Case-2 the same panel was mounted using Schedule 80 pipe. In Case-3 a 32 SF sign panel was mounted using Schedule 80 pipe. Figure 4.19, Figure 4.20, and Figure 4.21 present the sequential images obtained from the three *MASH* simulations. For all cases, the post started to rotate about its hinge as the sacrificial-pin failed at 0.085 s due to the impact from the vehicle hood and fender. In each case, vehicle fender wrapped around the post and was detached from the vehicle at 0.15 s. The weaker 10 BWG post used in Case-1 rotated about the hinge with significant bending at the point of initial impact as shown in Figure 4.19. The stronger post used in Case-2 and Case-3, on the other hand, rotated about the hinge without any significant bending. In Case-2 the edge of the sign panel impacted the roof as the vehicle exited the system without causing any significant roof deformation. Due to the higher inertia, Schedule 80 post with the larger sign panel rotated at a slower rate allowing the vehicle to exit without any contact with the panel. As shown in Figure 4.22, the barrier resisted the entire impact force in the transverse direction. Lateral impact force acting on the post was insignificant for all cases. Major impact force acting on the post was in the direction parallel to the barrier. Longitudinal impact forces acting on the system for each simulation case are presented in Figure 4.23. As can be seen from the figures, maximum 50-ms average impact force acting on the 10 BWG sign post was 8.9 kips. The maximum force acting on the Schedule 80 pipe was 9.2 kips for both 16 SF and 32 SF sign panels. Thus the increase in sign panel did not have significant effect on the performance of the Schedule 80 pipe mounted on the barrier using sacrificial pin.

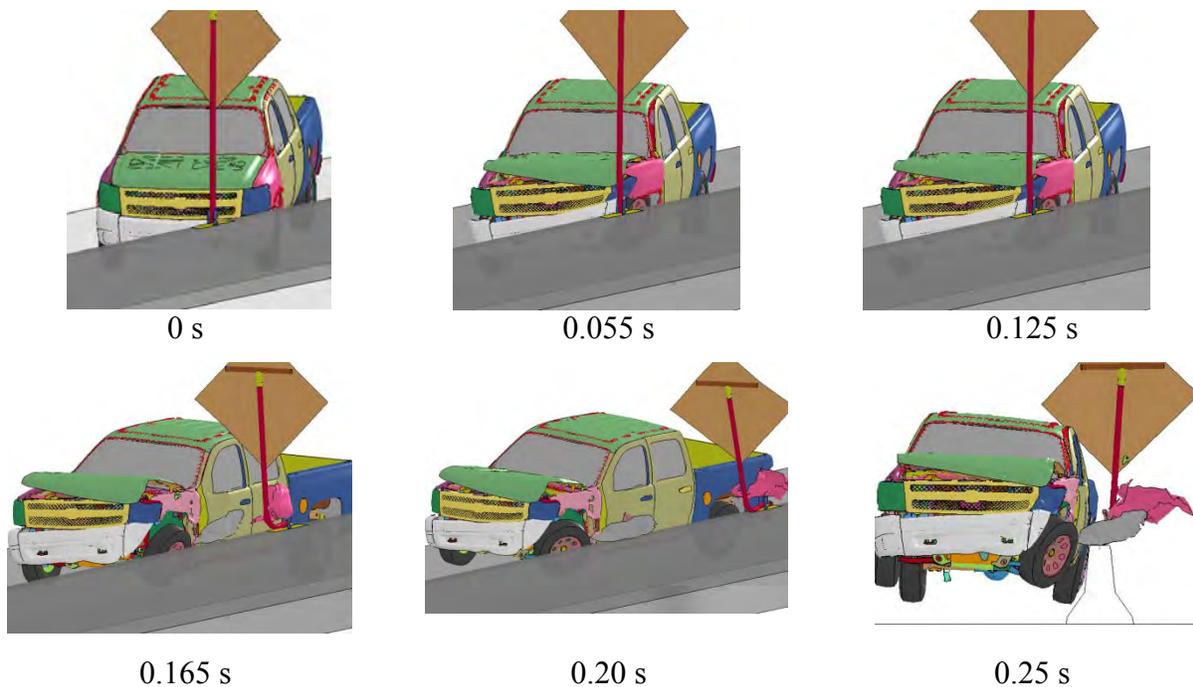
Figure 4.19. Sequential Images of *MASH* Simulation Performed on Sign Mounting Concept 4 with 16 SF Panel Mounted on a 10 BWG Pipe (Case-1).

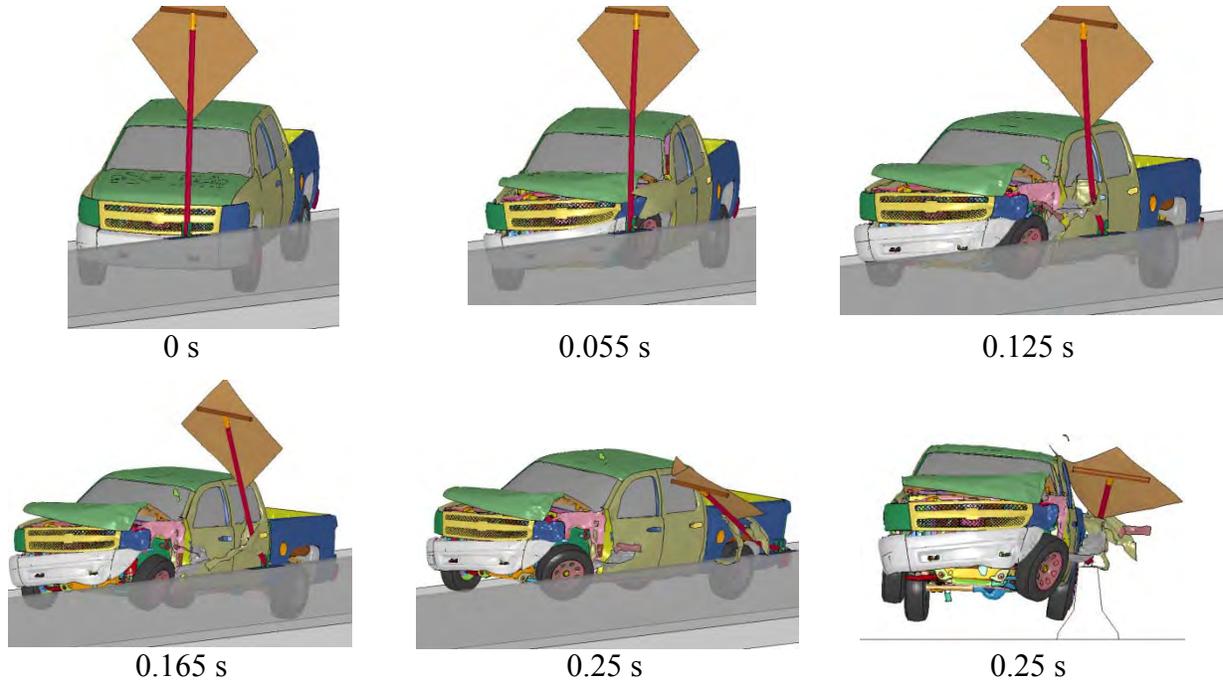
Figure 4.20. Sequential Images of MASH Simulation Performed on Sign Mounting Concept 4 with 16 SF Panel Mounted on Schedule 80 Pipe (Case-3).

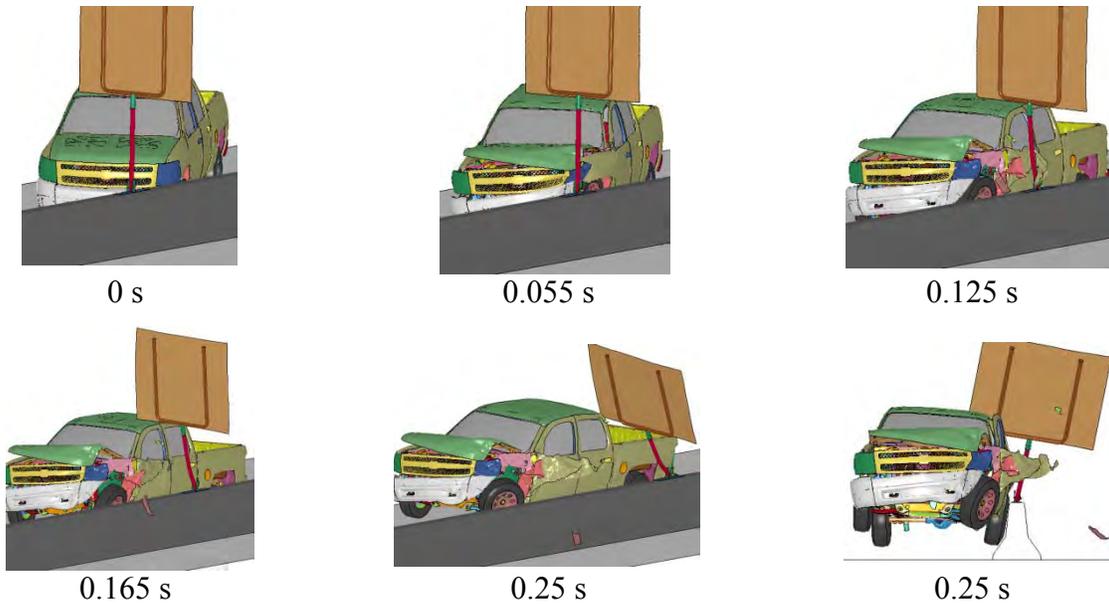
Figure 4.21. Sequential Images of MASH Simulation Performed on Sign Mounting Concept 4 with 32 SF Panel Mounted on Schedule 80 Pipe (Case-3).

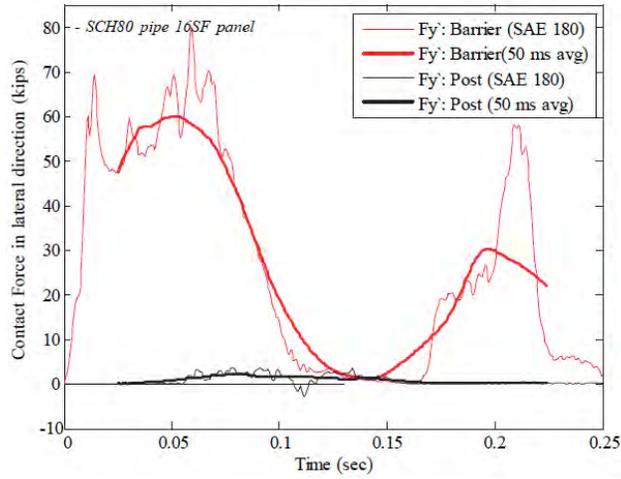
Figure 4.22. Impact Forces on Barrier and Post in Transverse Direction.

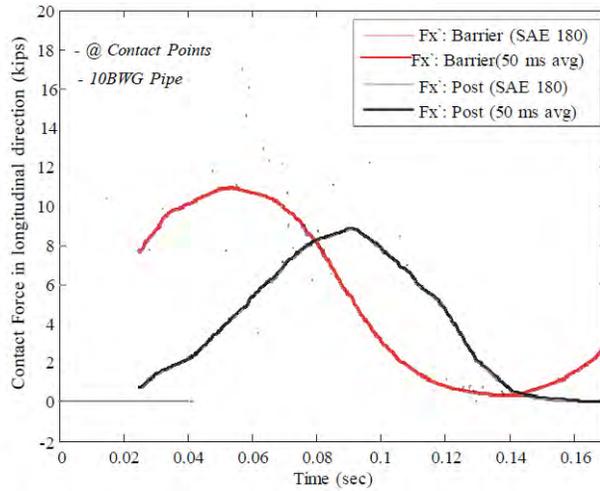
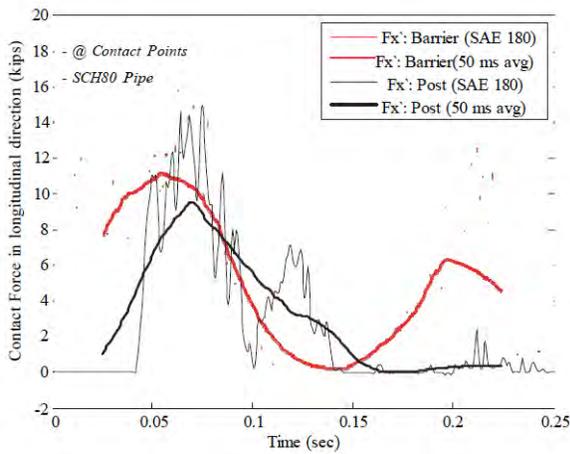
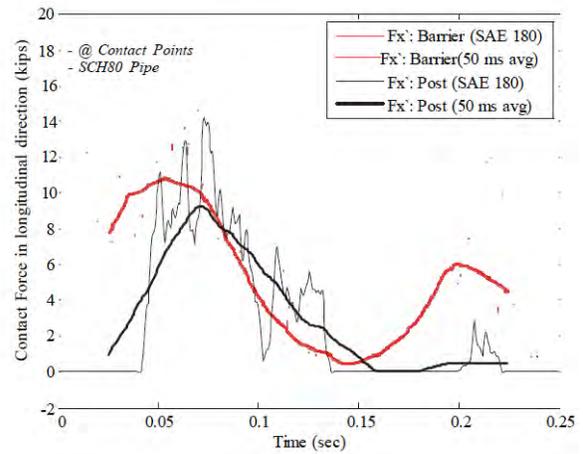
(a) Case-1 16SF panel on 10 BWG pipe

(b) Case-2: 16SF panel on SCH80 pipe

(c) Case-3: 32SF panel on SCH80 pipe

Figure 4.23. Impact Force on Barrier and Post in Direction Parallel to Barrier.

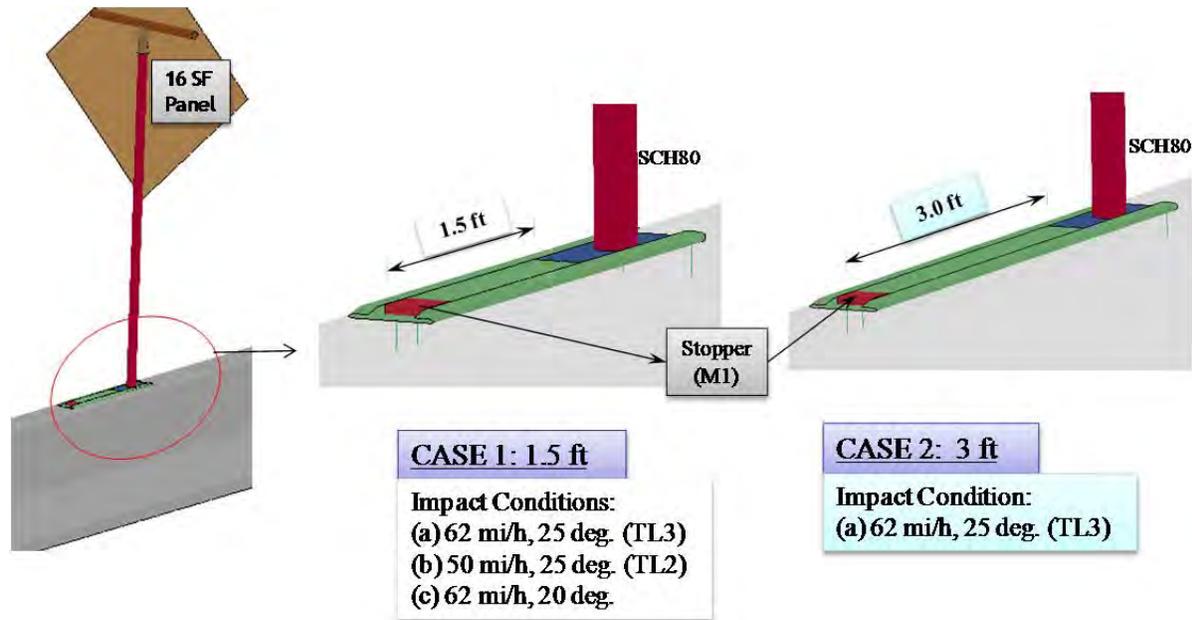
Figure 4.24. FE Model for Sign Mounting Concept 1: Chute Channel.

In Concept 1, the sign post was mounted on a base plate placed inside a guiding channel as shown in Figure 4.24. The channel was anchored on top of the barrier, and the base plate was allowed to travel inside the channel for a certain distance in the longitudinal direction before reaching a stopper. The idea was to allow the vehicle impact force to dissipate through sliding energy.

In the FE model, research team used piecewise linearly plastic material to model the chute channel. The base plate and the stopper was modeled using elastic material. Two cases with different base plate sliding distances were investigated. In Case-1, the sign system was allowed to slide through the channel 1.5 ft before reaching the stopper. In Case-2, this sliding distance was 3 ft. Sequential images obtained from the *MASH* TL-3 impact simulation for Case-1 and Case-2 are shown in Figure 4.25. As can be seen from the figure, as the vehicle hood impacted the post, the base plate traveled the allowed distance without any significant post deformation. Once the stopper stopped the plate movement at 0.085 s in Case-1 and 0.11 s in Case-2, the post started to bend due to the impact from the hood and fender. The fender lost contact with the post at 0.165 s in Case-1 and at 0.185 s in Case-2. In both cases, the post remained upright with minimum bending. Maximum dynamic deflection of the post relative to its base was 23.1 inches in Case-1 and 6.3 inches in Case-2. Figure 4.26 presents the impact forces acting on the barrier mounted sign system in longitudinal direction. The maximum 50-ms average impact force on the post in this direction was 12.2 kips for Case-1 and 13.2 kips for Case-2. The vehicle, in this case, lost 20 percent of its kinetic energy by the time the base plate translation was stopped by the stopper at 0.085 sec.

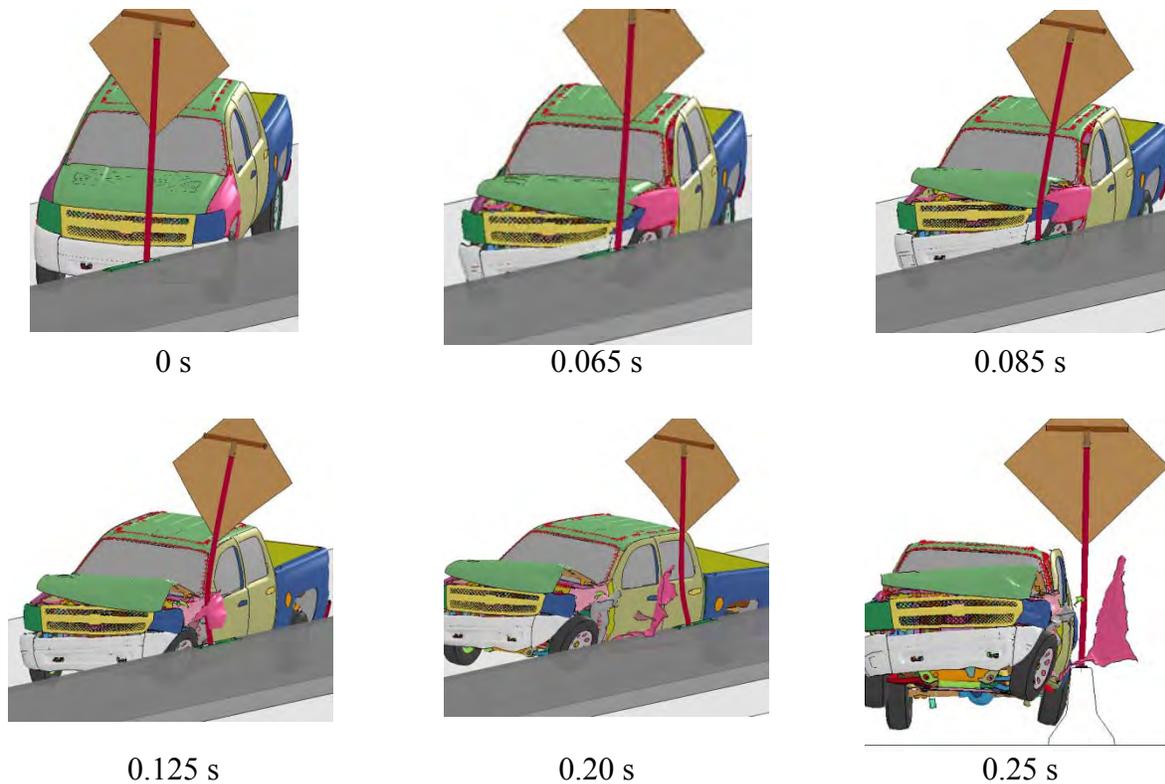
Figure 4.25. Sequential Images of *MASH* Simulation Performed on Sign Mounting Concept 1: Chute Channel.

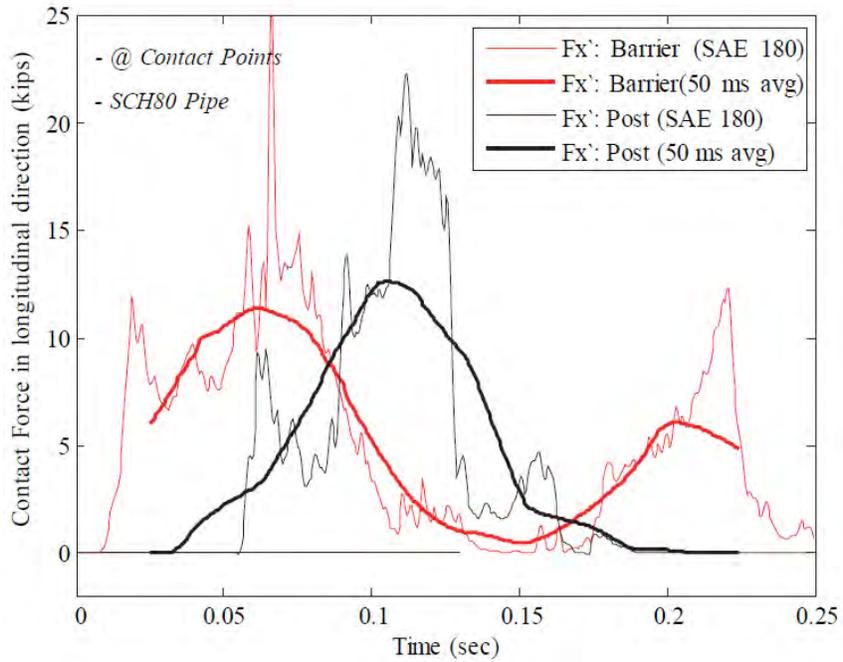
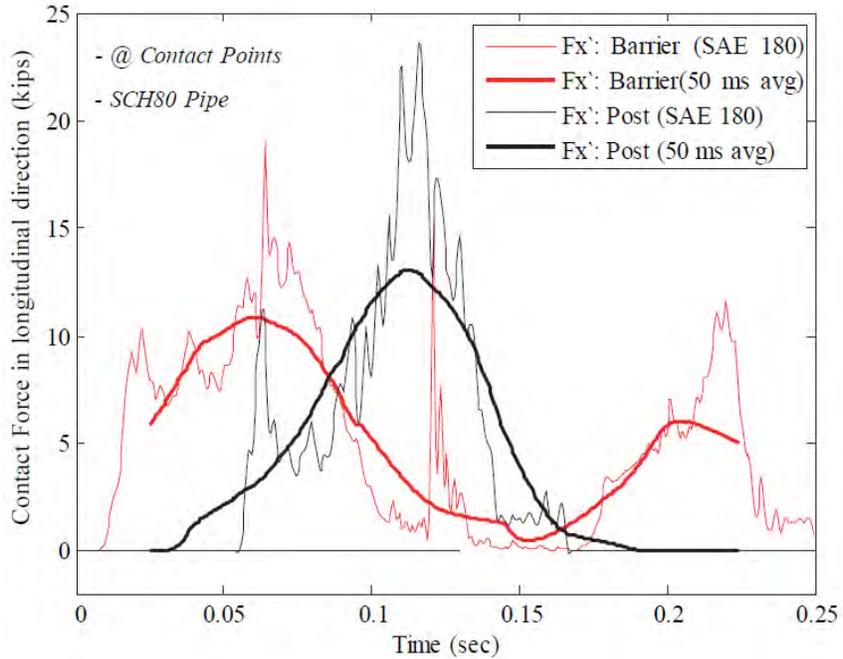
(a) Case-1a (1.5 ft Sliding Distance)

(b) Case-2 (3 ft Sliding Distance)

Figure 4.26. Impact Forces on Barrier and Post in Longitudinal Direction.

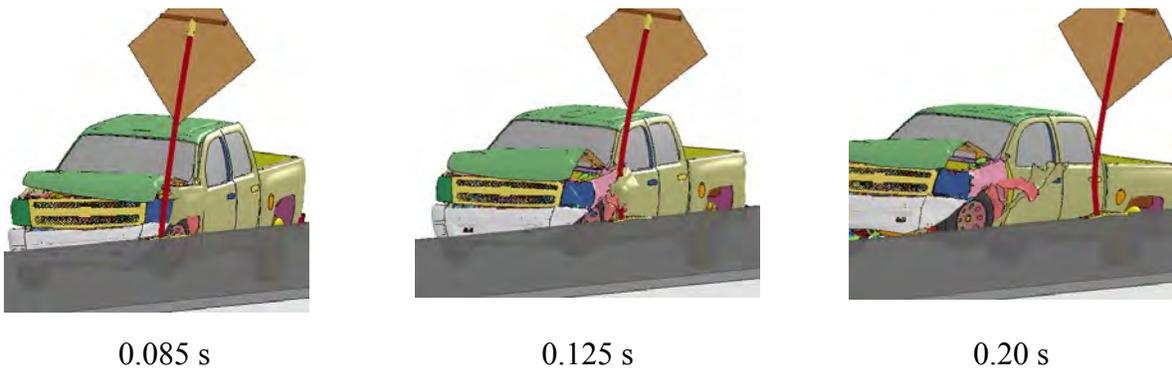
Case-1(c): Impact Speed=62.2 mi/h; Angle=20 degree

Figure 4.27. Sequential Images Obtained from Simulations Performed at Different Impact Conditions.

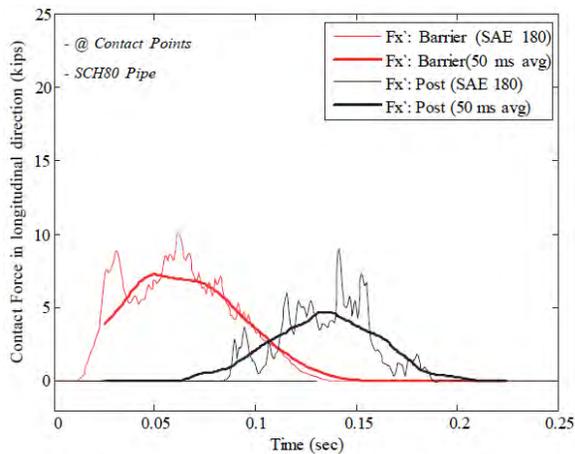
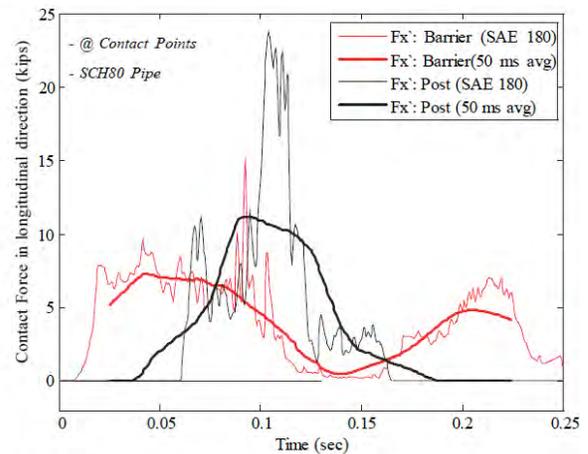
(a) Case-1(b): 50 mi/h; 25 degree.

(b) Case-1(c): 62.2 mi/h; Angle=20 degree

Figure 4.28. Impact Forces in Longitudinal Direction Obtained from Simulations Performed at Different Impact Conditions.

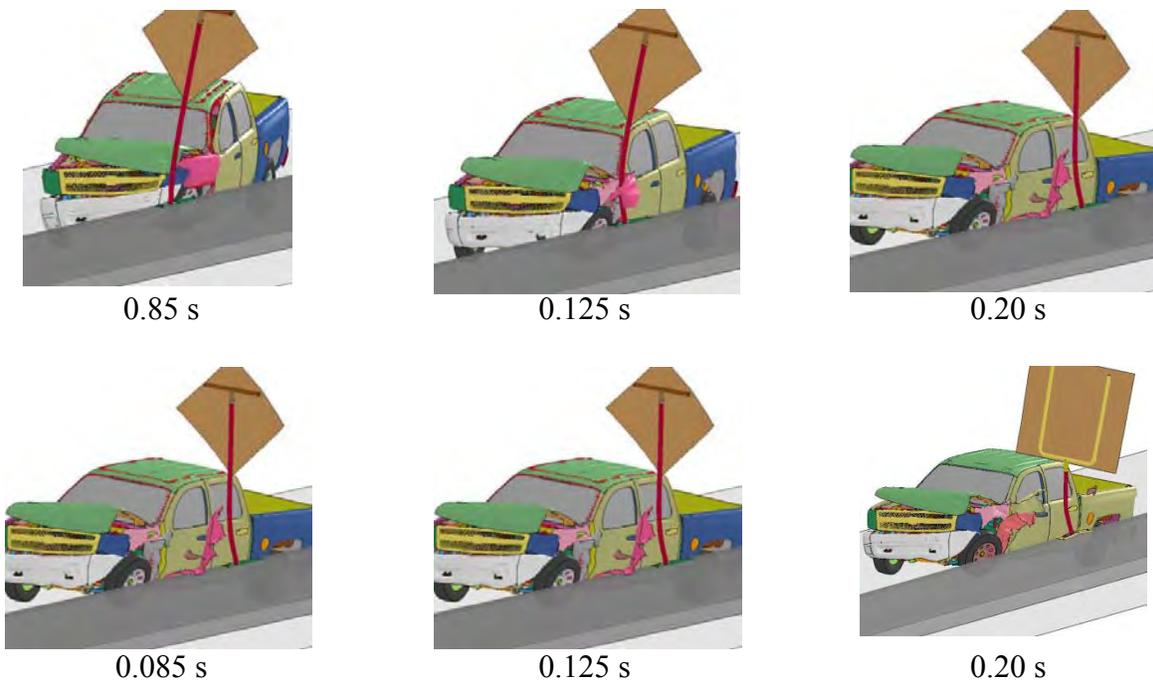
Figure 4.29. Sequential Images Obtained from Simulations Performed on Concept 1 with Different Sign Panel Sizes.

Effect of larger size sign panel was also investigated for sign mount Concept 1 with 1.5-ft sliding distance. Figure 4.29 compares the sequential images obtained from the *MASH* TL-3 simulations performed on different size sign panels mounted using chute channel concept. As can be seen, the post with larger sign panel slid through the channel at a slower rate due to its higher inertia. Post deformations were similar for both sign panel sizes. As shown in Figure 4.30, the impact force on the post was also similar for both 16 SF and 32 SF sign panel case.

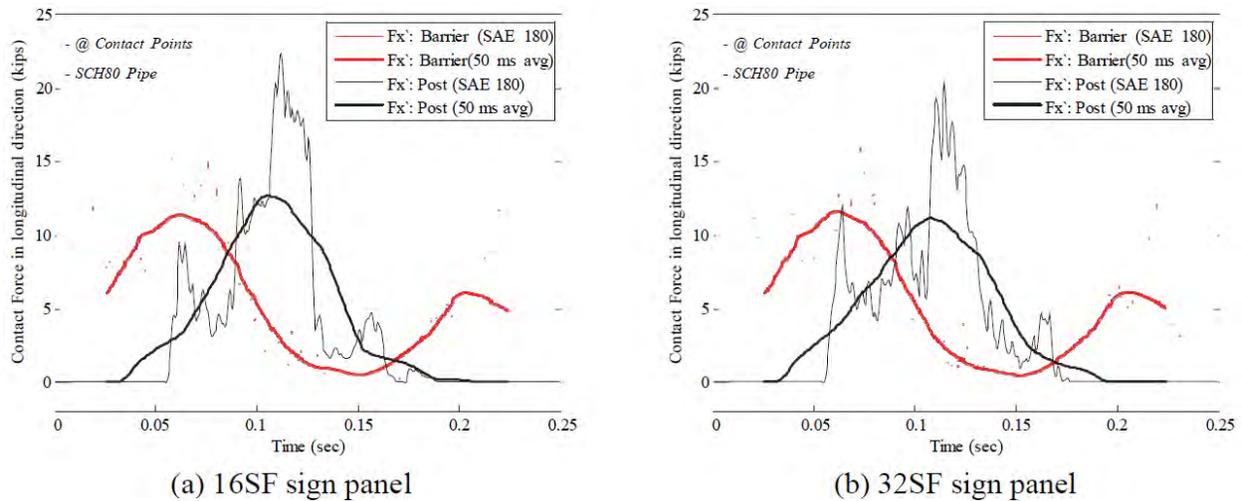
Figure 4.30. Effect of Sign Panel Size on Impact Forces Acting on Sign Mounted Barrier System.

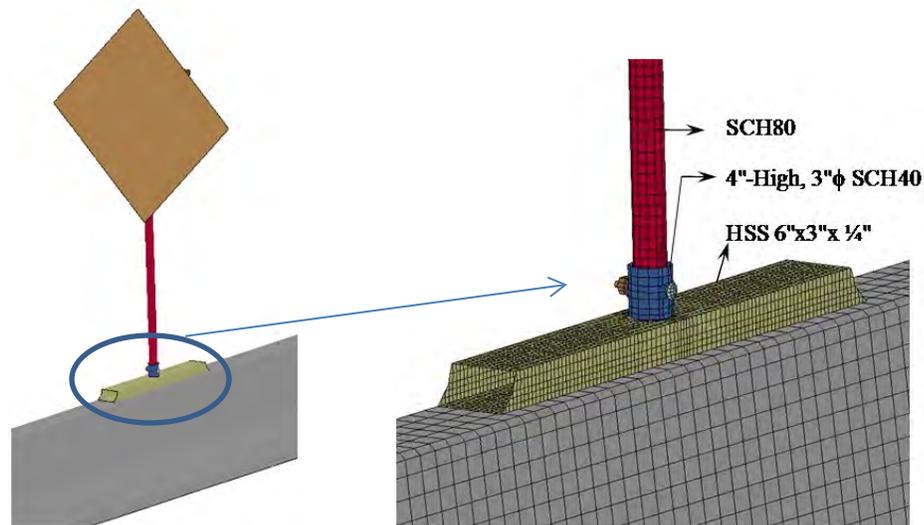
Figure 4.31. FE Model for Sign Mounting Concept 6: Spread Tube Assembly.

In the initial FE model for Concept 6, shown in Figure 4.31, the Schedule 80 post was attached to a 4-inch-high, 3-inch diameter Schedule 40 collar mounted on top of a 4-ft long 6-inch \times 3-inch \times 1/4-inch spread tube. Piecewise linearly plastic material was used to define the models for spread tube and Schedule 40 collar. The bolt was modeled using elastic beam elements surrounded by null shell elements attached to the beam using NRB. Figure 4.32(a) shows the sequential images obtained from the impact simulation performed on the model with 1/4-inch thick spread tube (Case 1). As can be seen from the figure, the fender of the errant vehicle during the simulation snagged into the post and caused the post and the material on top of the spread tube around the collar to yield. Yielding of the spread tube material can be prevented by increasing its thickness. The research team performed another impact simulation on the Concept 6 FE model with a 1/2-inch thick spread tube (Case 2). As shown in Figure 4.32(b), the tube material during this simulation did not yield and the post did not bend or deflect due to impact. Figure 4.33 shows the impact forces acting on the post for the two cases in a direction parallel to the barrier. The maximum 50-ms average impact force acting on the post with 1/4-inch thick spread tube was 18 kips. For the Schedule 80 post mounted on a 1/2-inch thick spread tube, this value was significantly low (13 kips). The bending of the post in the former case allowed it to remain engaged with the fender for longer period of time producing higher impact force.

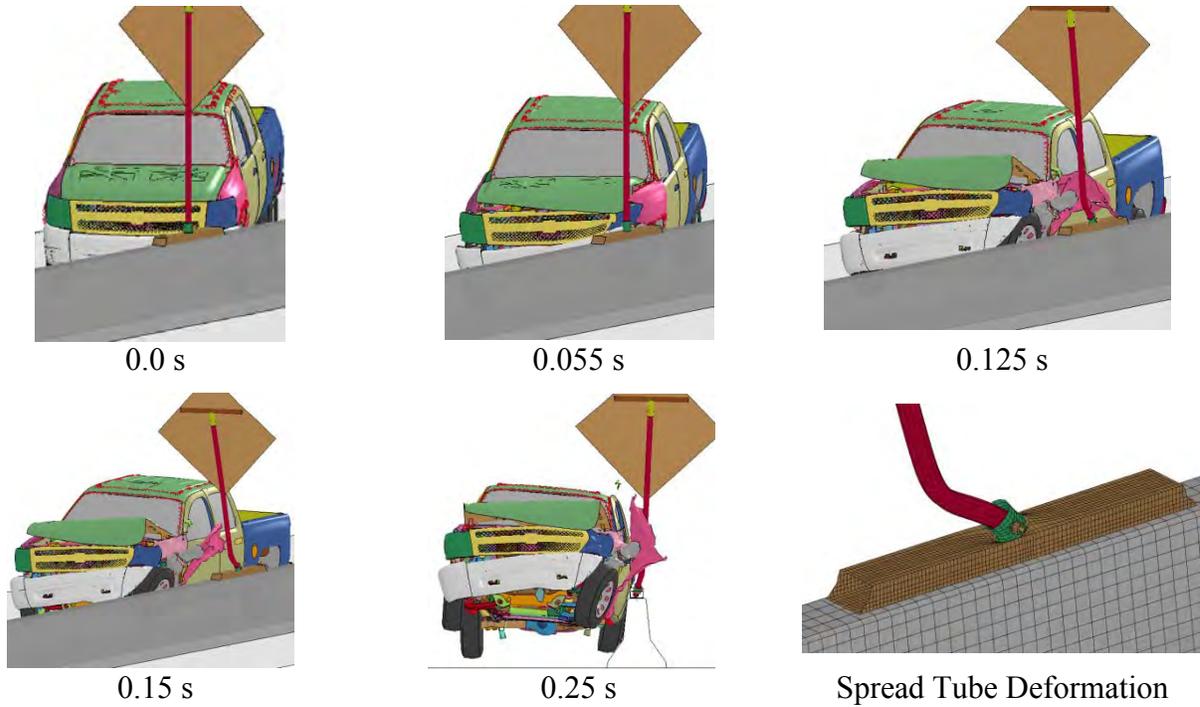
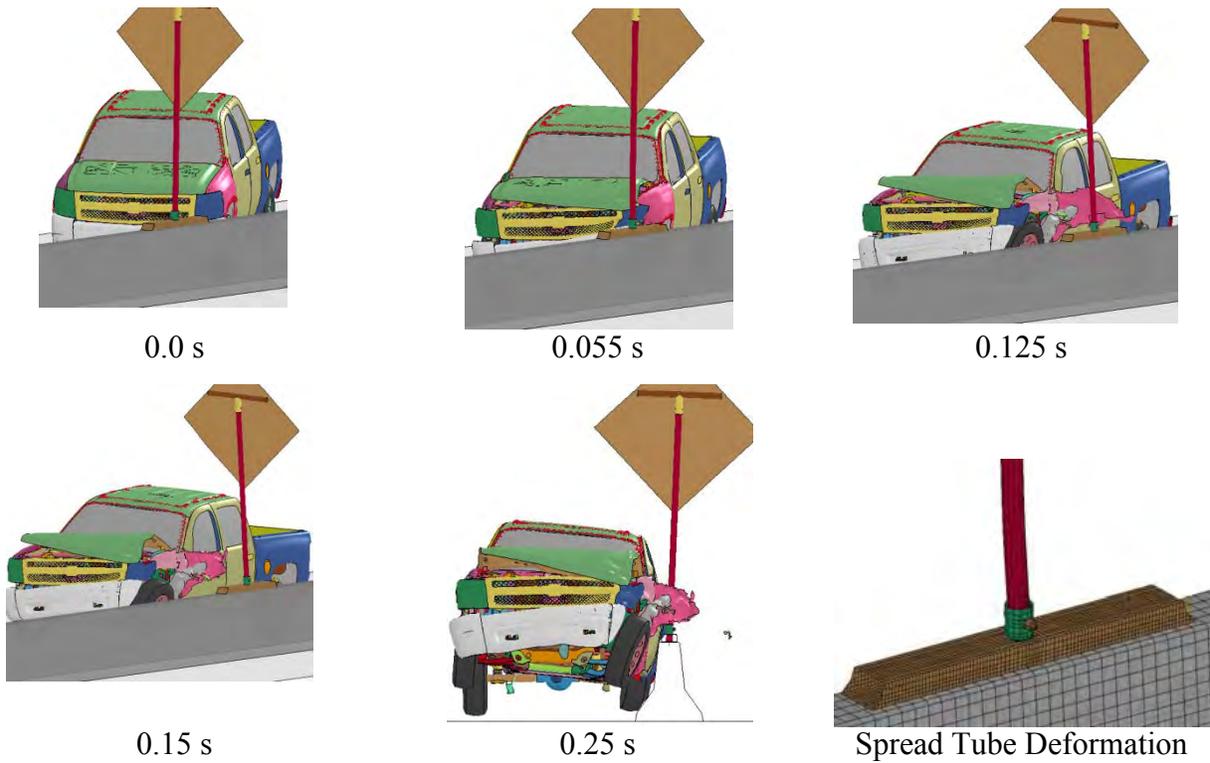
(a) Case 1: 1/4-inch thick spread tube; 16 SF panel

(a) Case 2: 1/2-inch thick spread tube; 16 SF panel

Figure 4.32. Sequential Images of MASH Simulation Performed on Sign Mounting Concept 6.

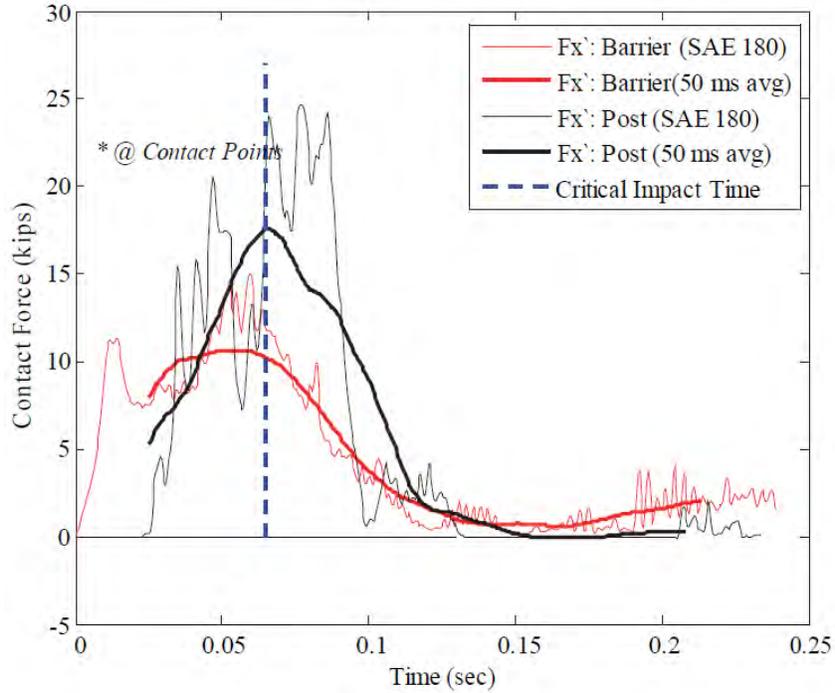
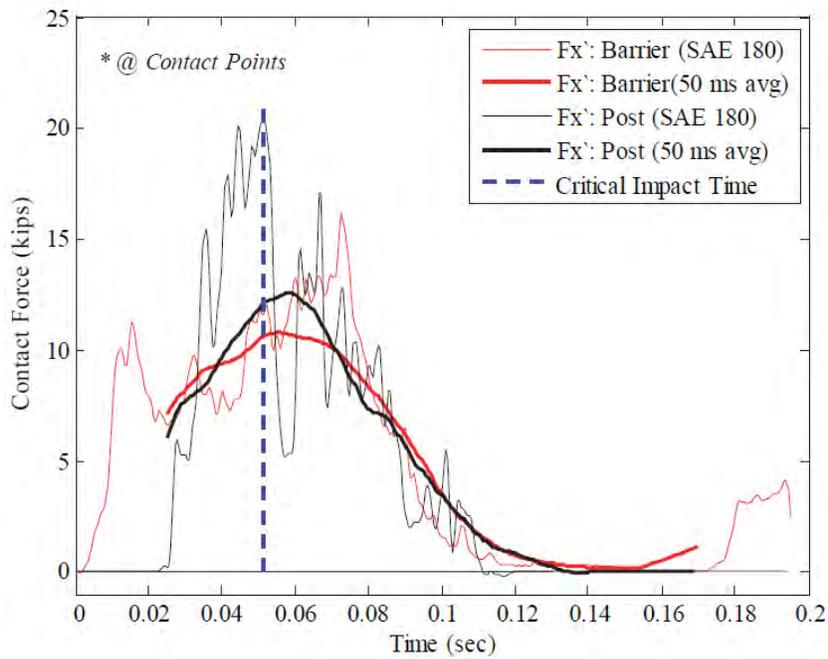
Figure 3.33. Impact Force on Barrier and Post with 16 SF Sign Panel in Direction Parallel to Barrier (a) Case-1: 1/4-inch Thick Spread Tube (b) Case-2: 1/2-inch Thick Spread Tube.
