Signs on Concrete Median Barriers

Test Report 0-6646-1

**TEXAS A&M TRANSPORTATION INSTITUTE
COLLEGE STATION, TEXAS**

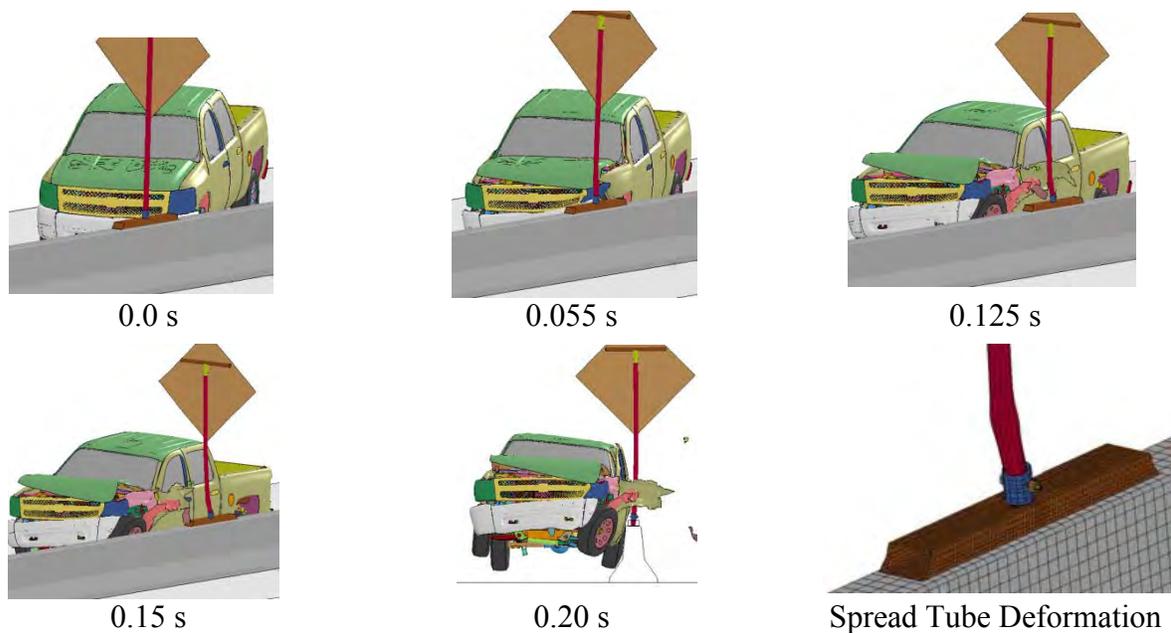
(a) Case 3: 6-inch \times 3-inch \times 1/2-inch spread tube; 10 BWG Pipe; 16 SF panel

Figure 4.34. (a) Sequential Images (b) Impact Forces in Longitudinal Direction Obtained from *MASH* Simulation Performed on Concept 6 with 10 BWG Sign Post.

Effect of post type was also investigated for Concept 6. An impact simulation was performed on Concept 6 model with 1/2-inch thick spread tube, Schedule 40 collar, 10 BWG pipe, and 16 SF sign panel (Case 3). Sequential images obtained from *MASH TL-3* impact simulation are shown in Figure 4.34(a). As can be seen from the figure, during the impact simulation, 10 BWG pipe deformed at a point 14 inches above the barrier top. The sign panel remained upright after the impact. As can be seen in Figure 4.34(b), maximum 50-ms impact force acting on the post was 10.8 kips, slightly lower than that observed during the impact on Schedule 80 pipe. Since a panel larger than 16SF cannot be mounted on a 10 BWG pipe and use of this pipe does not provide significant improvement to the sign mount system, a Schedule 80 pipe instead of a 10 BWG pipe was selected for the next analyses.

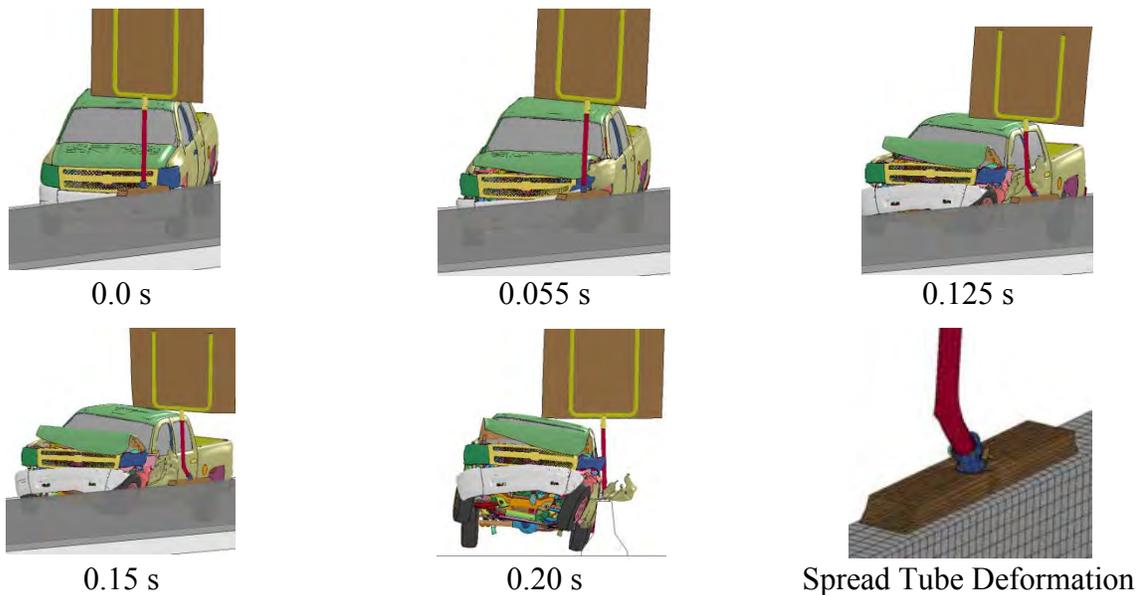
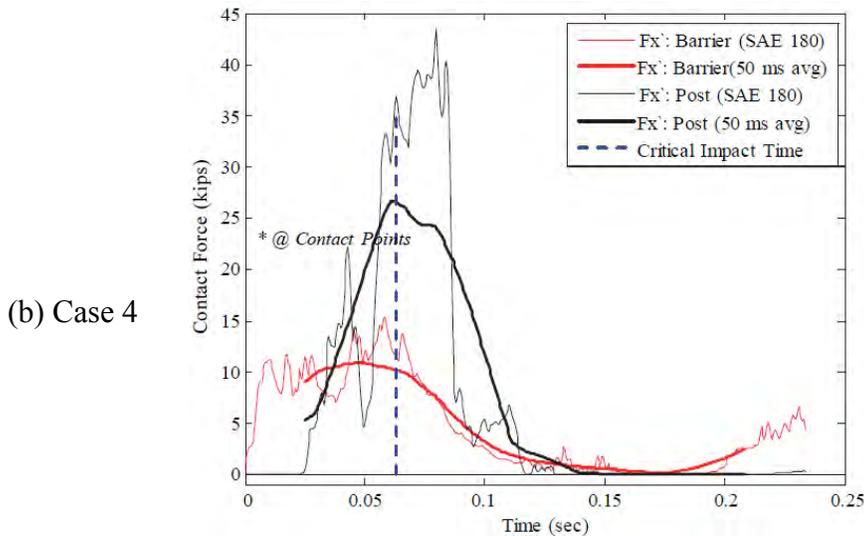
(a) Case 4: 6-inch \times 3-inch \times 1/2-inch spread tube; Schedule 80 Pipe; 32 SF panel

Figure 4.35. (a) Sequential Images (b) Impact Forces in Longitudinal Direction Obtained from *MASH* Simulation Performed on Concept 6 with 32 SF Sign Panel.

Research team also investigated the effect of large size sign panel mounted on a concrete barrier using Concept 6. *MASH* TL-3 impact simulation was performed on an FE model where a 32SF rectangular sign panel was mounted on an Schedule 80 pipe attached to an Schedule 40 collar mounted on top of the 1/2-inch thick spread tube attached to the New Jersey safety shape barrier (Case 4). Figure 4.35(a) shows sequential images obtained from the impact simulation. As can be seen from the figure, the fender of the errant vehicle during the simulation snagged into the post and caused the post and the material on top of the 1/2-inch thick spread tube around the collar to yield. As shown in Figure 4.35(b), impact force acting on the post with 32 SF panel was 26 kips, twice the force acting on the post with a 16 SF panel.

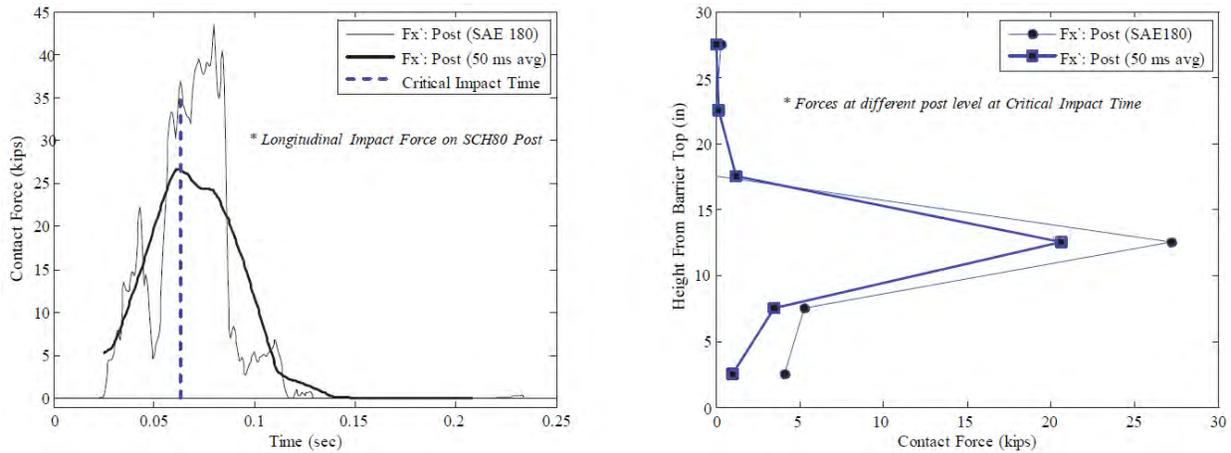
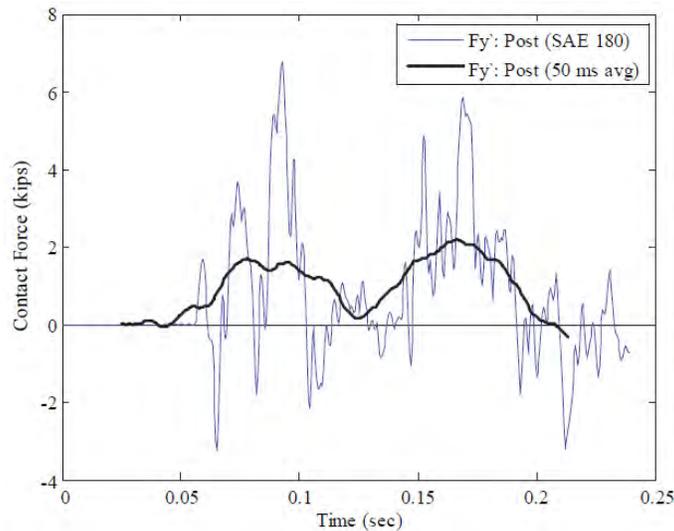
Figure 4.36. Concept 6-Case 4 (a) Longitudinal Impact Force and Impact Force Distribution along Post Height at Critical Impact Time; (b) Impact Force in Transverse Direction.

For the structural analyses of a connection, an accurate evaluation of the impact load and its location above the barrier top was necessary. The impact load on the sign system mounted on a rigid New Jersey safety barrier was evaluated using FE simulations. For 32 SF panel mounted using Concept 6, contact forces obtained from the simulation showed that the maximum 50-ms average force acting on the post in longitudinal barrier direction was 26 kips. To determine the average impact height for the post, forces at various impact heights above the post base at critical impact time were plotted as shown in Figure 4.36(a). It was found that at the critical impact time the maximum 50-ms avg. force was acting on the post 12.5 inches above the post base. This height can be considered as moment arm for the 26 kips impact load acting on

the post in the direction parallel to the barrier. As shown in Figure 4.36(b), maximum crash load acting on the post in transverse direction was 2 kips. Using these impact load values, engineering analyses were performed to develop post-barrier connection details for sign mount Concept 6. Figure 4.37 shows details of the connection. Appendix A shows the engineering calculations.

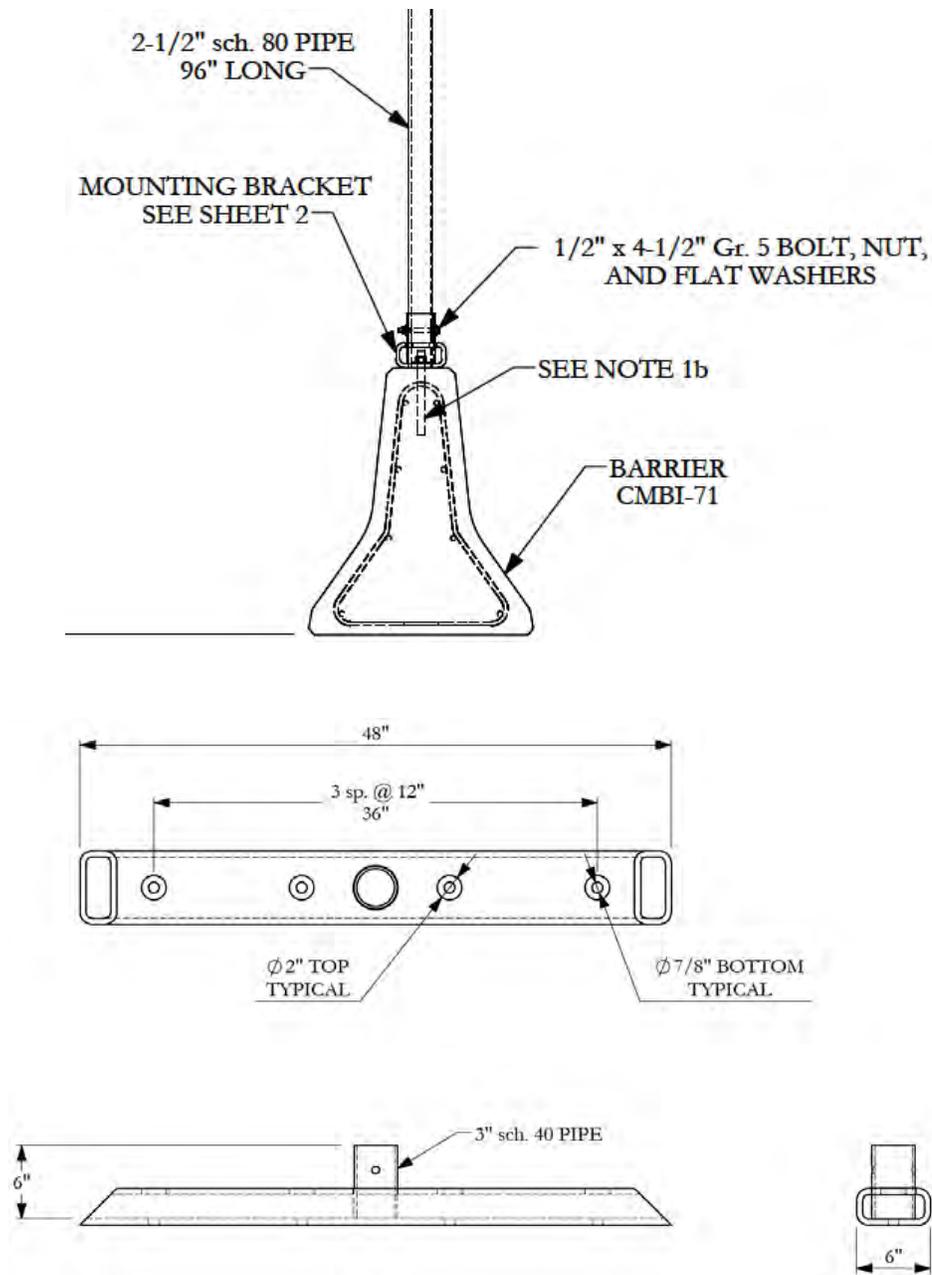
NOTE 1b: 3/4" galvanized Hilti HAS-E rods (x4), embedded 8" min., and secured with Hilti Hy 150 epoxy according to manufacturer's instructions.

Figure 4.37. Post to Barrier Connection Details for Concept 6: Spread Tube System.

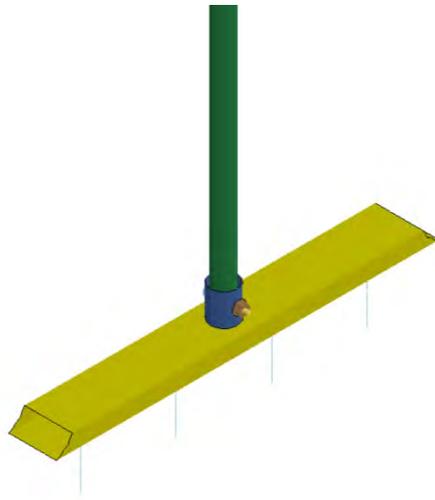
Figure 5.1. Model of Concept 6 Sign Mounting Design.

In this concept, the Schedule 80 sign post is rigidly mounted inside a schedule 40 collar pipe. The post is placed inside a 6-inch long, 3-inch diameter schedule 40 pipe that is built inside a 6-inch wide by 2-inch deep by ¼-inch thick steel tubing as shown in Figure 5.1. The post is secured to the pipe using a through bolt. The steel tubing spread is 48 inches long with 45 degrees tapers at each end and fixed to the top of the concrete barrier user four anchor bolts rods as shown in Figure 5.1. Figure 5.2 shows that the simulation predicts little yielding in the sign post and some slight damage to the sign post under truck impact.

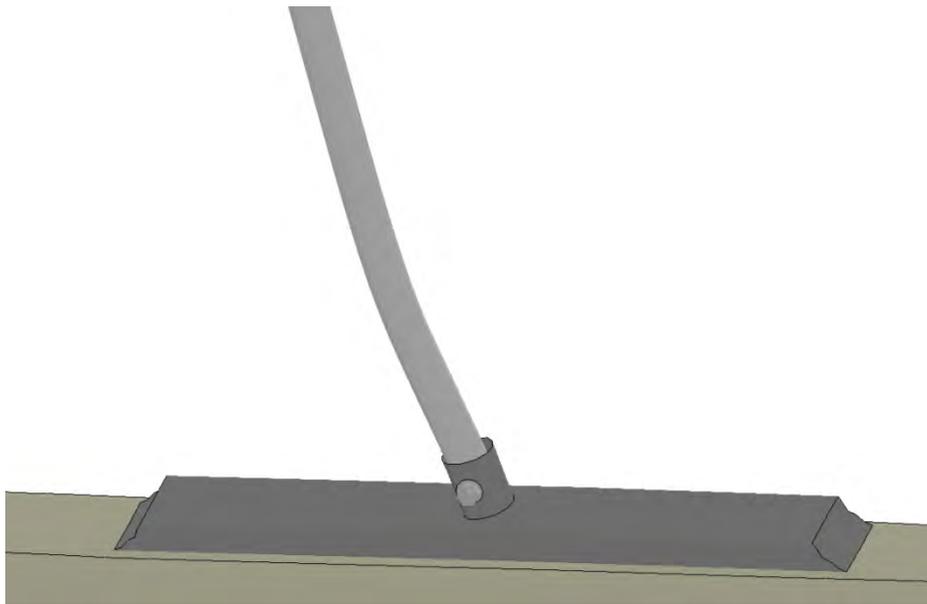
Figure 5.2. Damage to the Sign Post under Truck Impact.

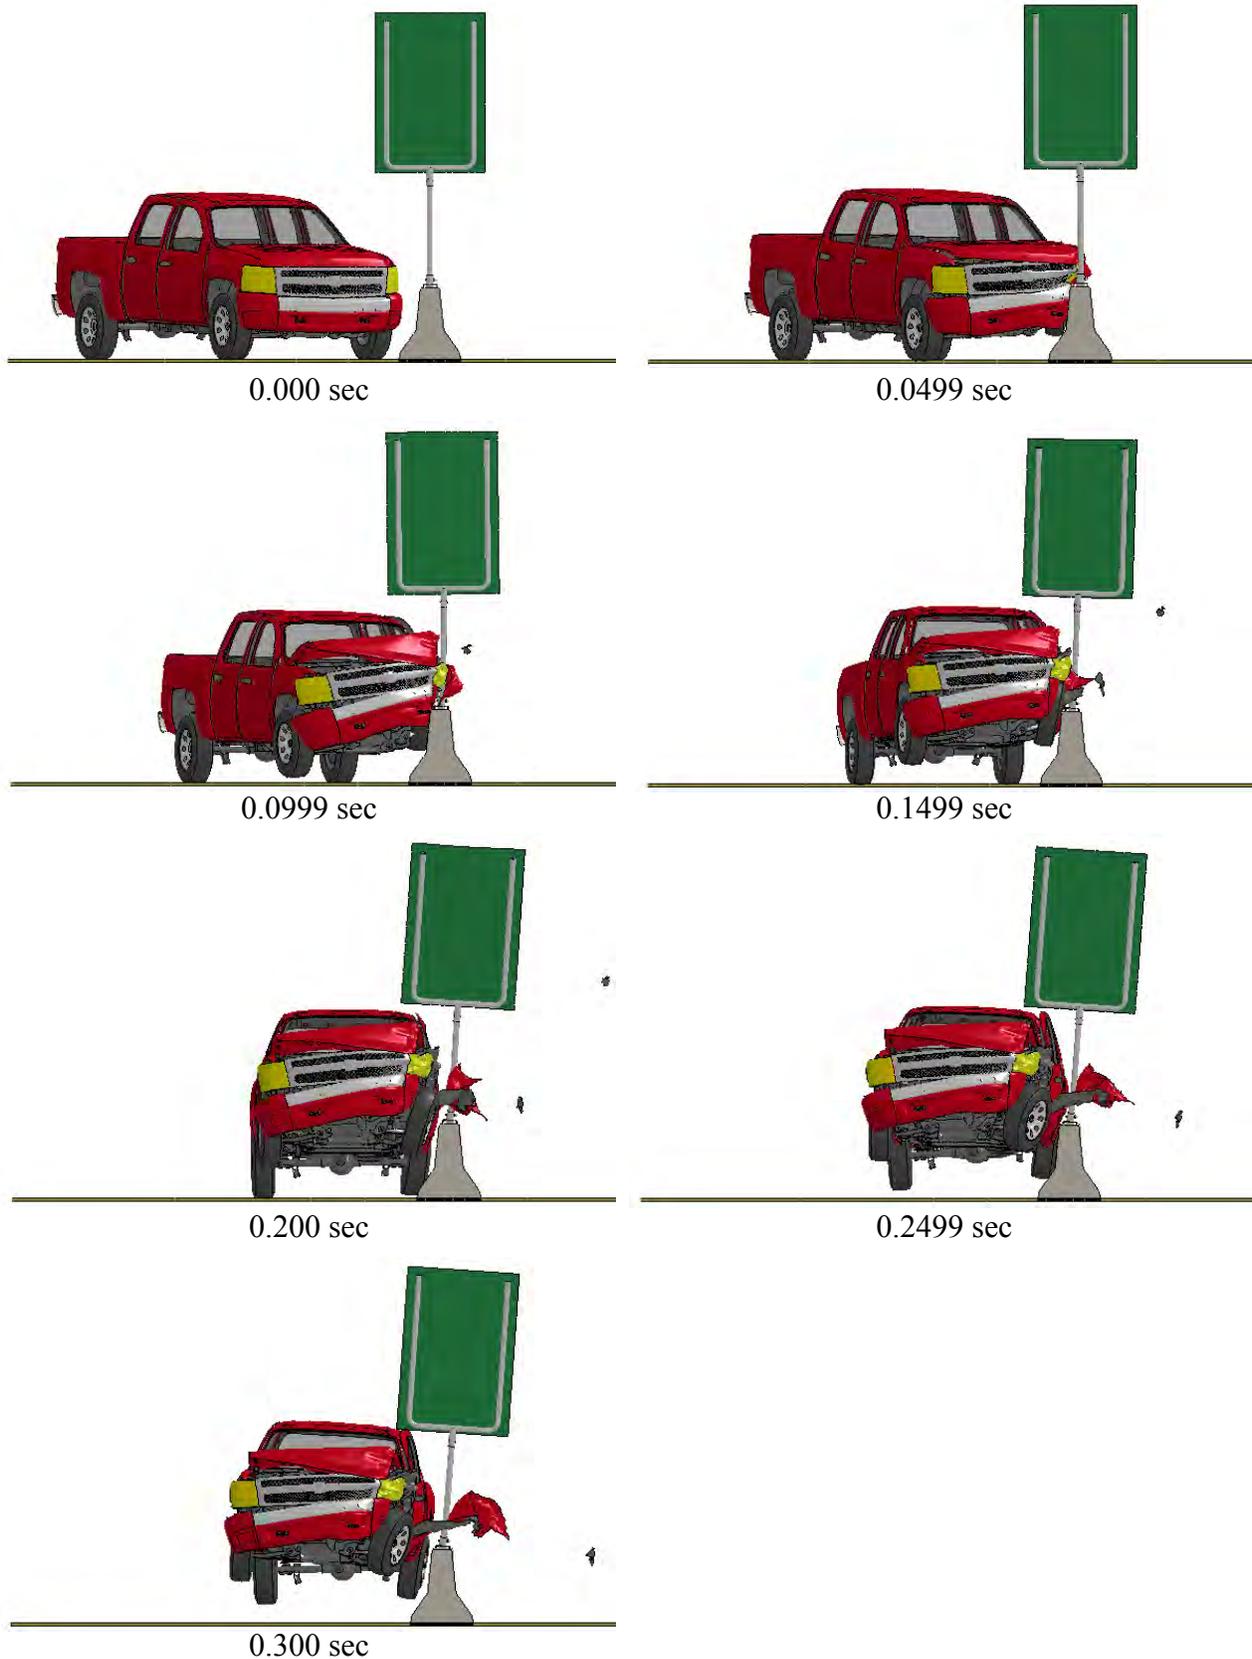
Figure 5.3. Impact View (Looking Upstream) Showing 5004-lb Test Vehicle Interacting with the Sign Post for Concept 6.

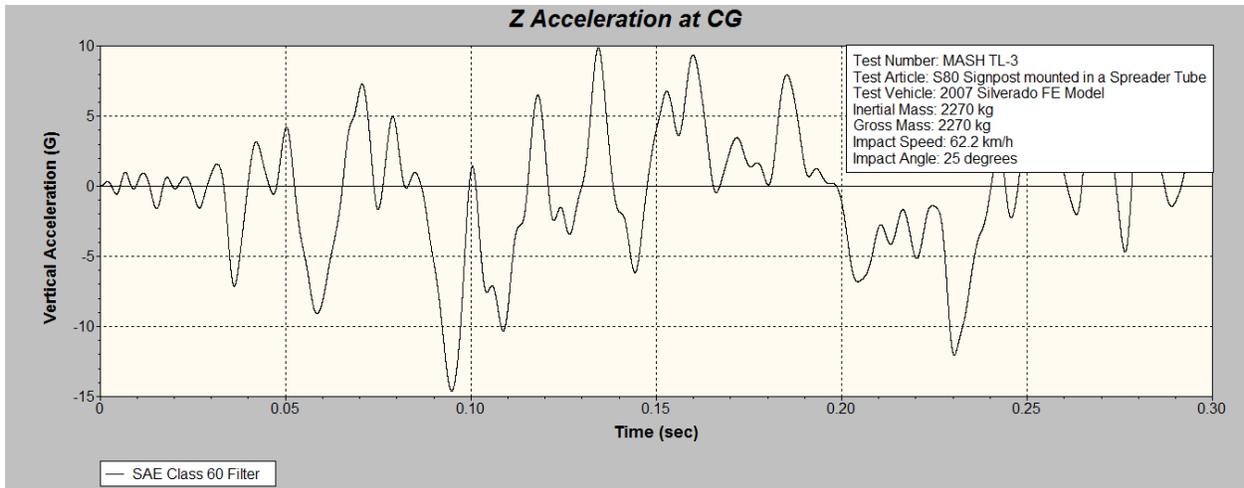
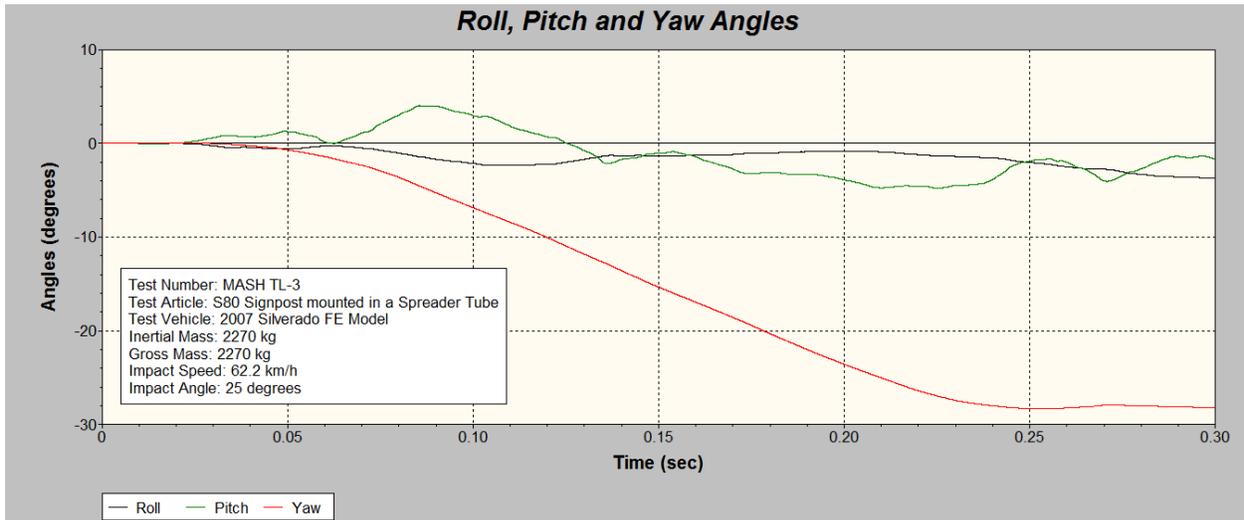
Axes are vehicle-fixed.
Sequence for determining orientation:

- 1.) Yaw.
- 2.) Pitch.
- 3.) Roll.

Figure 5.8. Vehicle Angular Displacement for Concept 6.

Occupant impact severity indices were all below the allowable limits of *MASH* evaluation criteria. The OIV was -24.61 ft/s (-7.5 m/sec) in lateral direction (preferred 30 ft/s [9 m/sec] and maximum allowable is 40 ft/s [12 m/sec]), while the ridedown acceleration was 11.0 Gs (preferred 15 Gs and maximum allowable is 20 Gs) in lateral direction, per the LS-DYNA simulation. Details of acceleration data are presented in Figure 5.4. Figure 5.5, Figure 5.6, and Figure 5.7 show the acceleration histories at the C.G. of the 5004-lb finite element model. The vehicular angular displacement, yaw, pitch, and roll rate are shown in Figure 5.8. Figure 5.9 presents other pertinent data from the simulation.

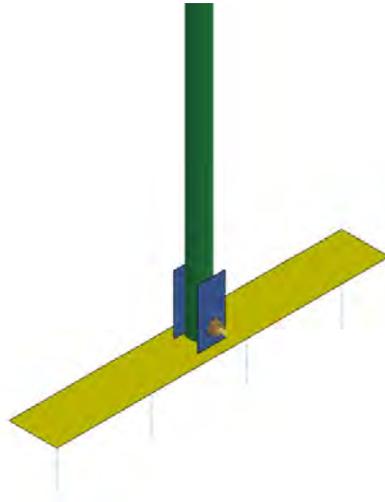
Figure 5.10. Model of Concept 4 Sign Mounting Design.

In this concept, the Schedule 80 post is held by two side plates utilizing a through bolt. The post and sign are prevented from rotating around the through bolt by adding a sacrificial pin above the pin. This pin is designed to be strong enough to withstand shear forces due to wind loads on the sign, but weak enough to release upon impact by the pickup truck. The two side plates are attached to a spreader plate that is mounted on the top face of the barrier using anchor bolts. Figure 5.10 shows the model, and Figure 5.11 shows activation of the sacrificial pin.

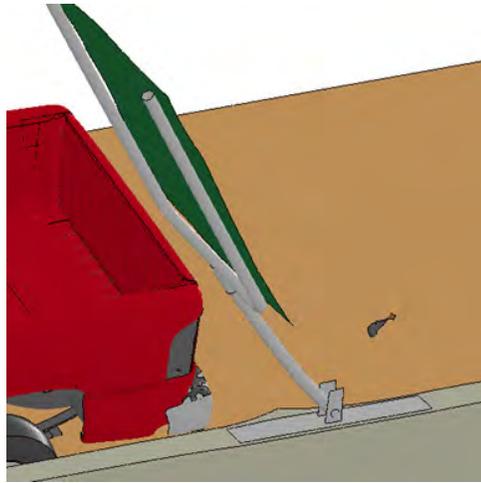
Figure 5.11. Sign Post Rotating around the Hinge Point after Impact.

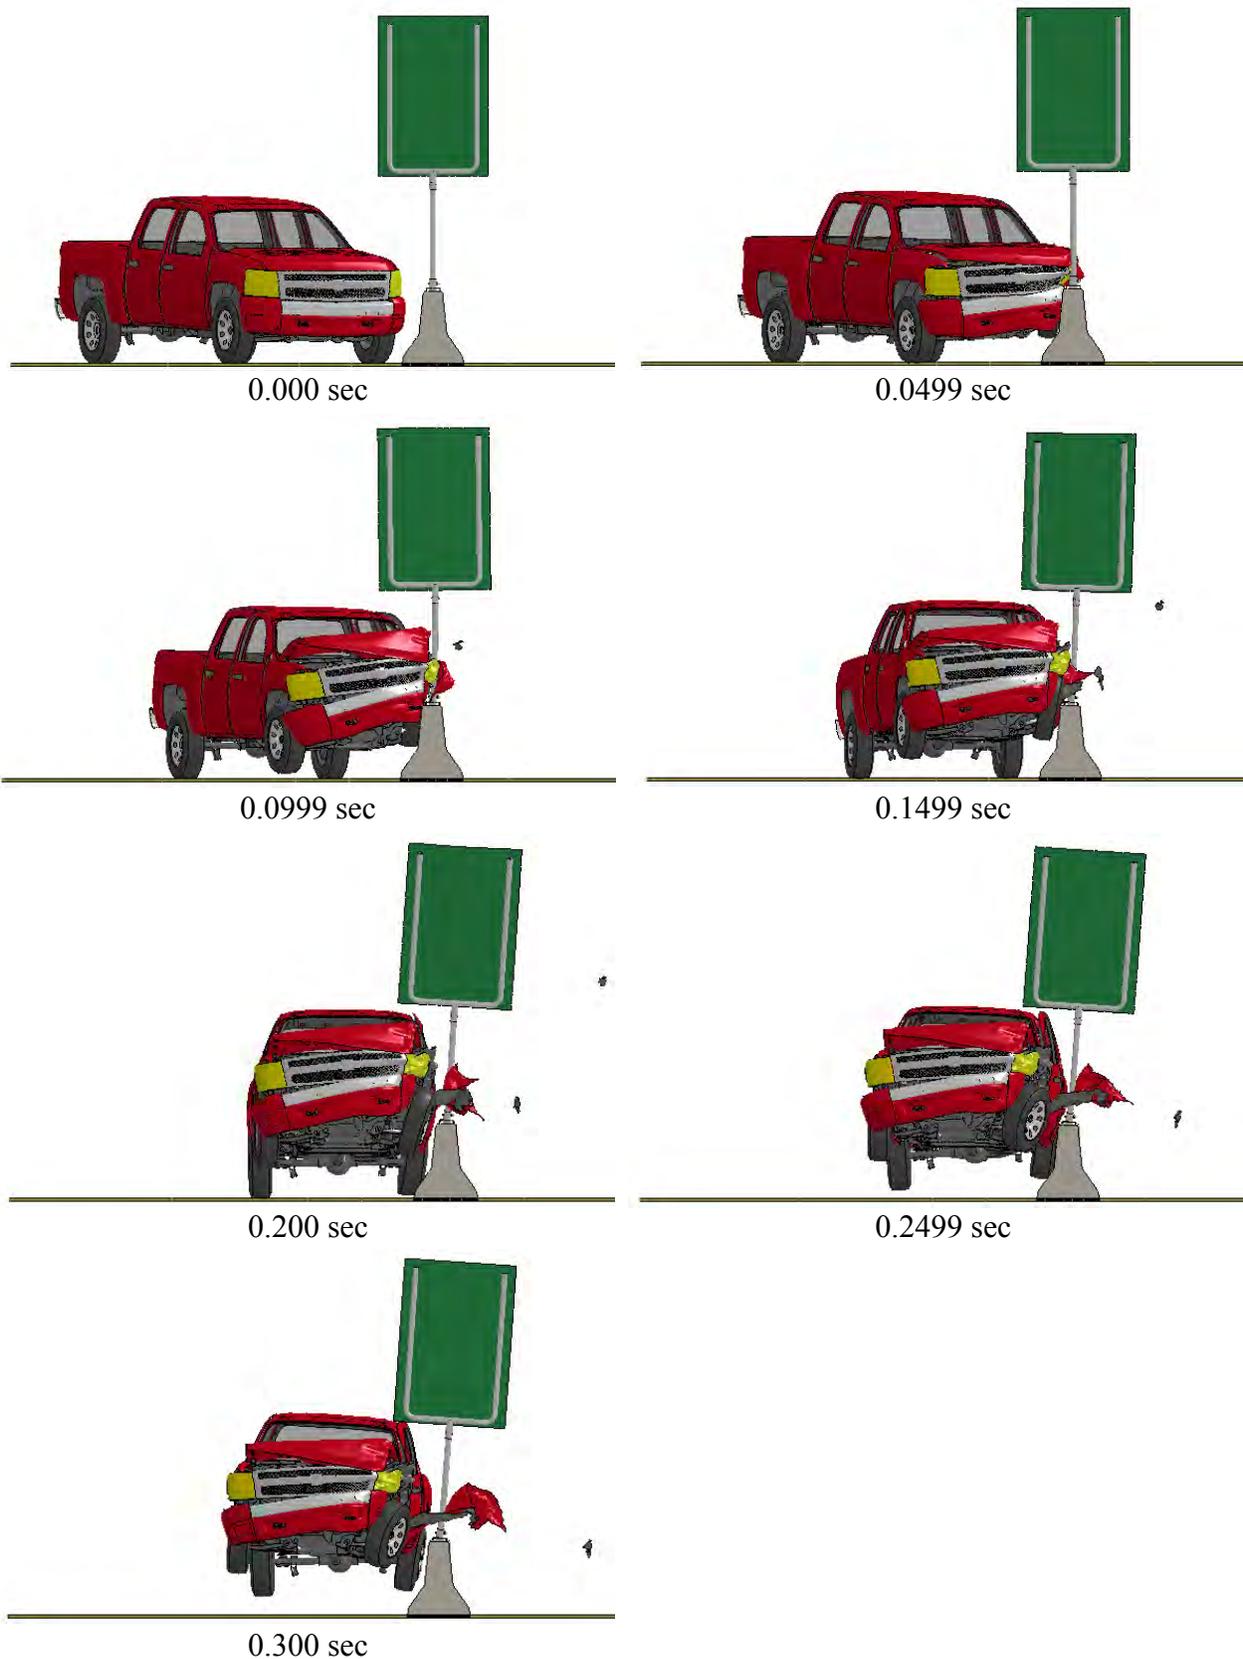
Figure 5.12. Impact View (Looking Upstream) Showing 5004-lb Test Vehicle Interacting with the Sign Post for Concept 4.

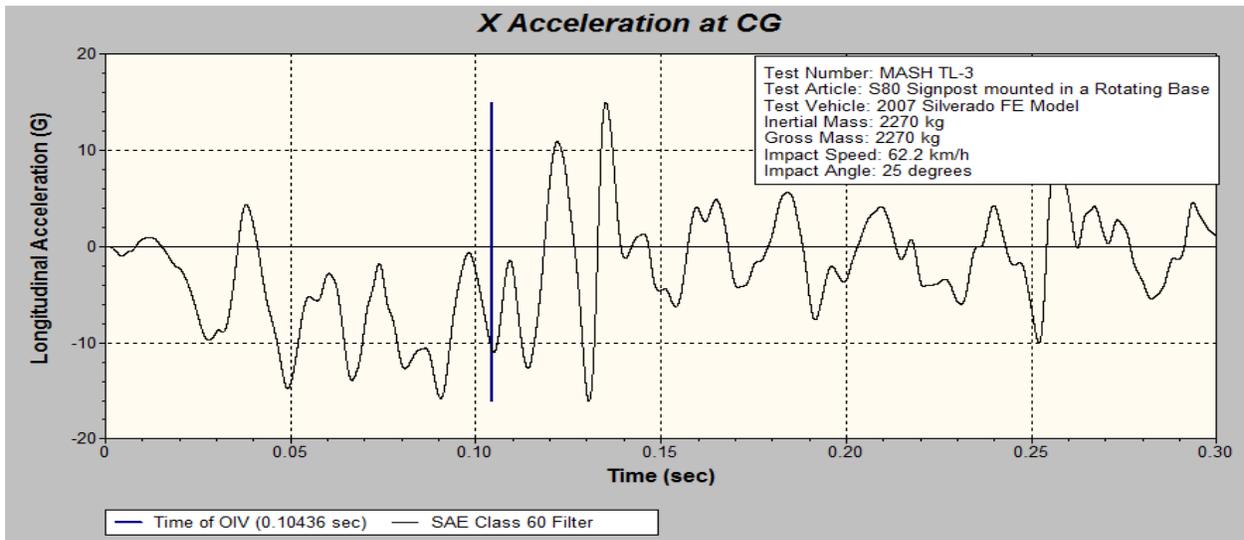
Figure 5.15. Lateral Acceleration History at C.G. for Concept 4.

Occupant impact severity indices were all below the allowable limits of *MASH* TL-3. The OIV was -25.59 ft/s (-7.8 m/sec) in lateral direction (preferred 30 ft/s [9 m/sec] and maximum allowable is 40 ft/s [12 m/sec]), while the ridedown acceleration was 13.1 Gs (preferred 15 Gs and maximum allowable is 20 Gs) in lateral direction per the LS-DYNA simulation. Details of acceleration data are presented in Figure 5.13. Figure 5.14, Figure 5.15, and Figure 5.16 show the acceleration histories at the C.G. of the 5004-lb finite element model. Figure 5.17 shows the vehicular angular displacement, yaw, pitch, and roll rate. Figure 5.18 presents a summary of pertinent data for the simulation on Concept 4.

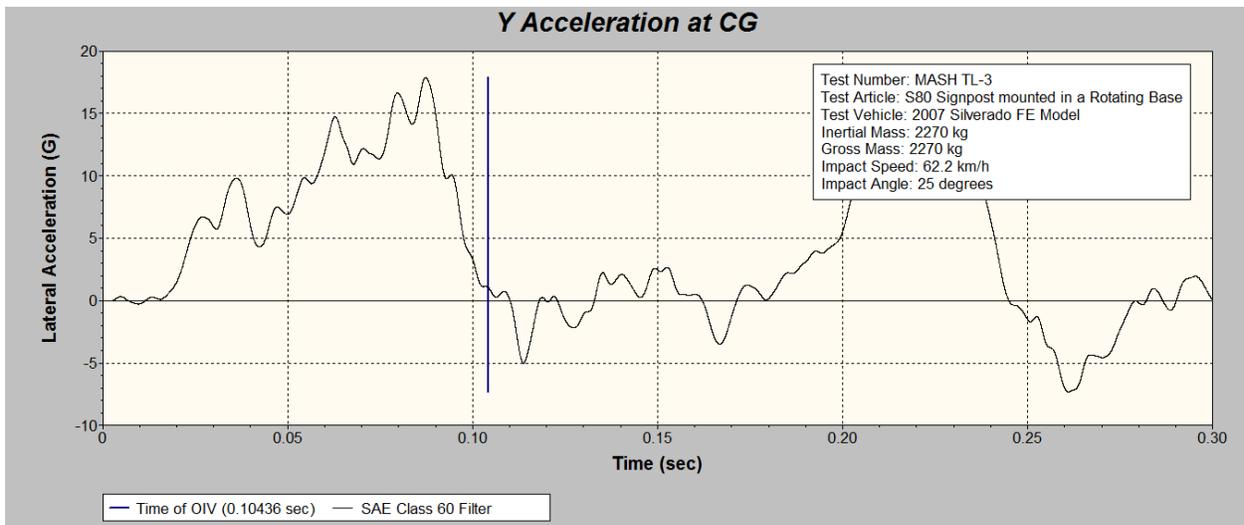
Figure 5.16. Vertical Acceleration History at C.G. for Concept 4.

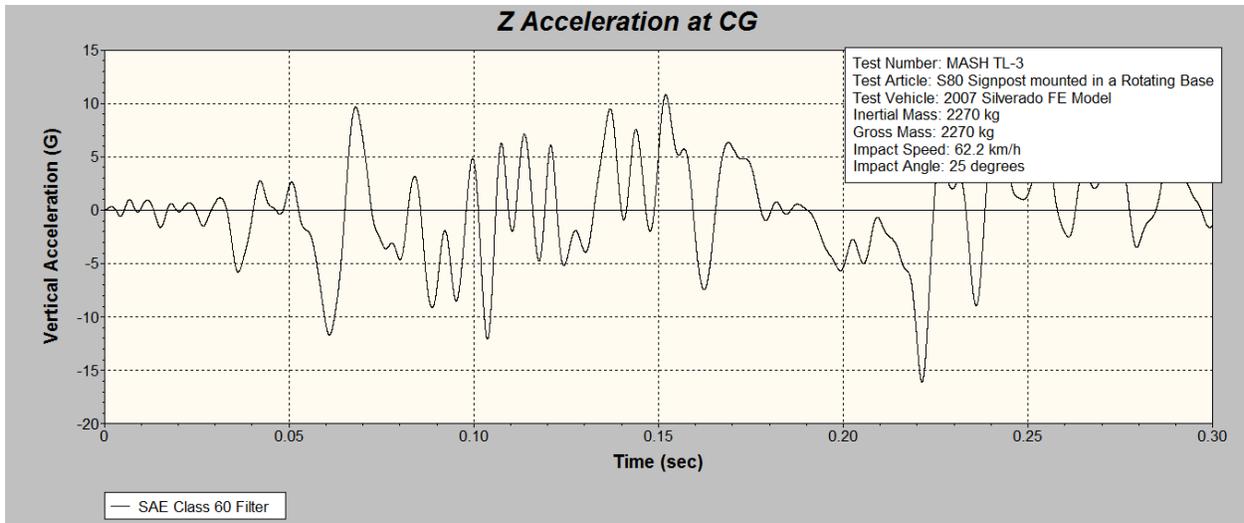
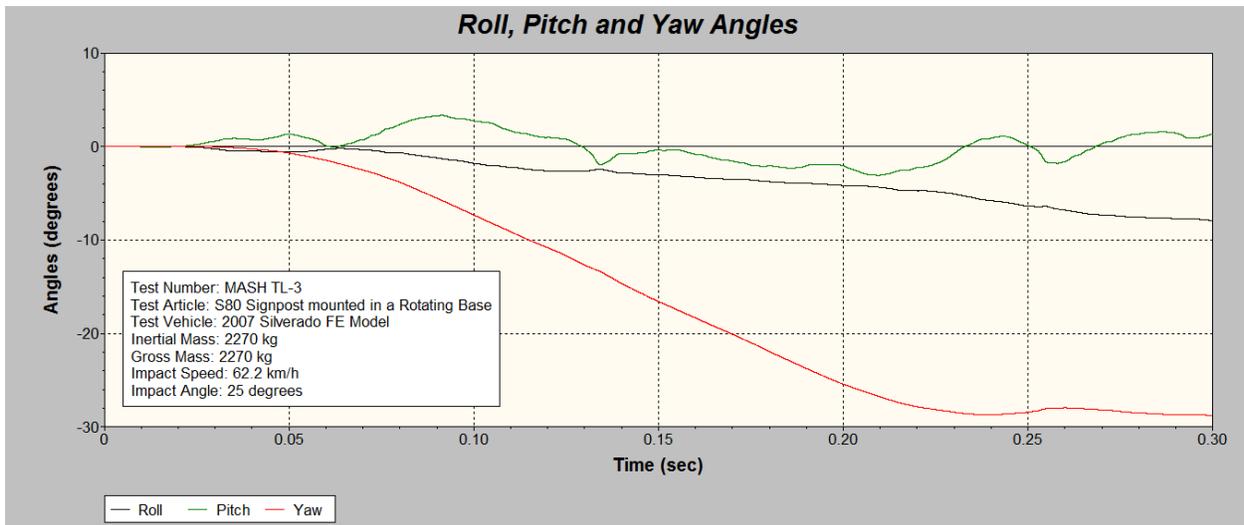
Axes are vehicle-fixed.
Sequence for determining orientation:

- 1.) Yaw.
- 2.) Pitch.
- 3.) Roll.

Figure 5.17. Vehicle Angular Displacement for Concept 4.

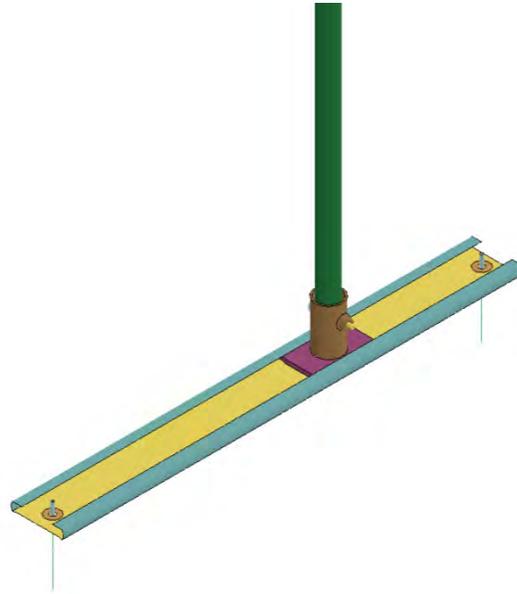
Figure 5.19. Model of Concept 1 Sign Mounting Design.

The idea of this concept is to allow the sign/post assembly to slide along the barrier top face upon impact. The Schedule 80 sign post is mounted inside a Schedule 40 collar pipe that is attached to a thick plate. The plate is inserted inside a steel chute so the plate can slide along the chute, but it cannot move sideways or up and down. Figure 5.19 shows the model of the sliding chute concept. The chute is mounted to the top of the barrier via two anchor rods at each end of the chute. Hence, they will act as end stoppers to prevent the post/sliding plate from exiting the chute.

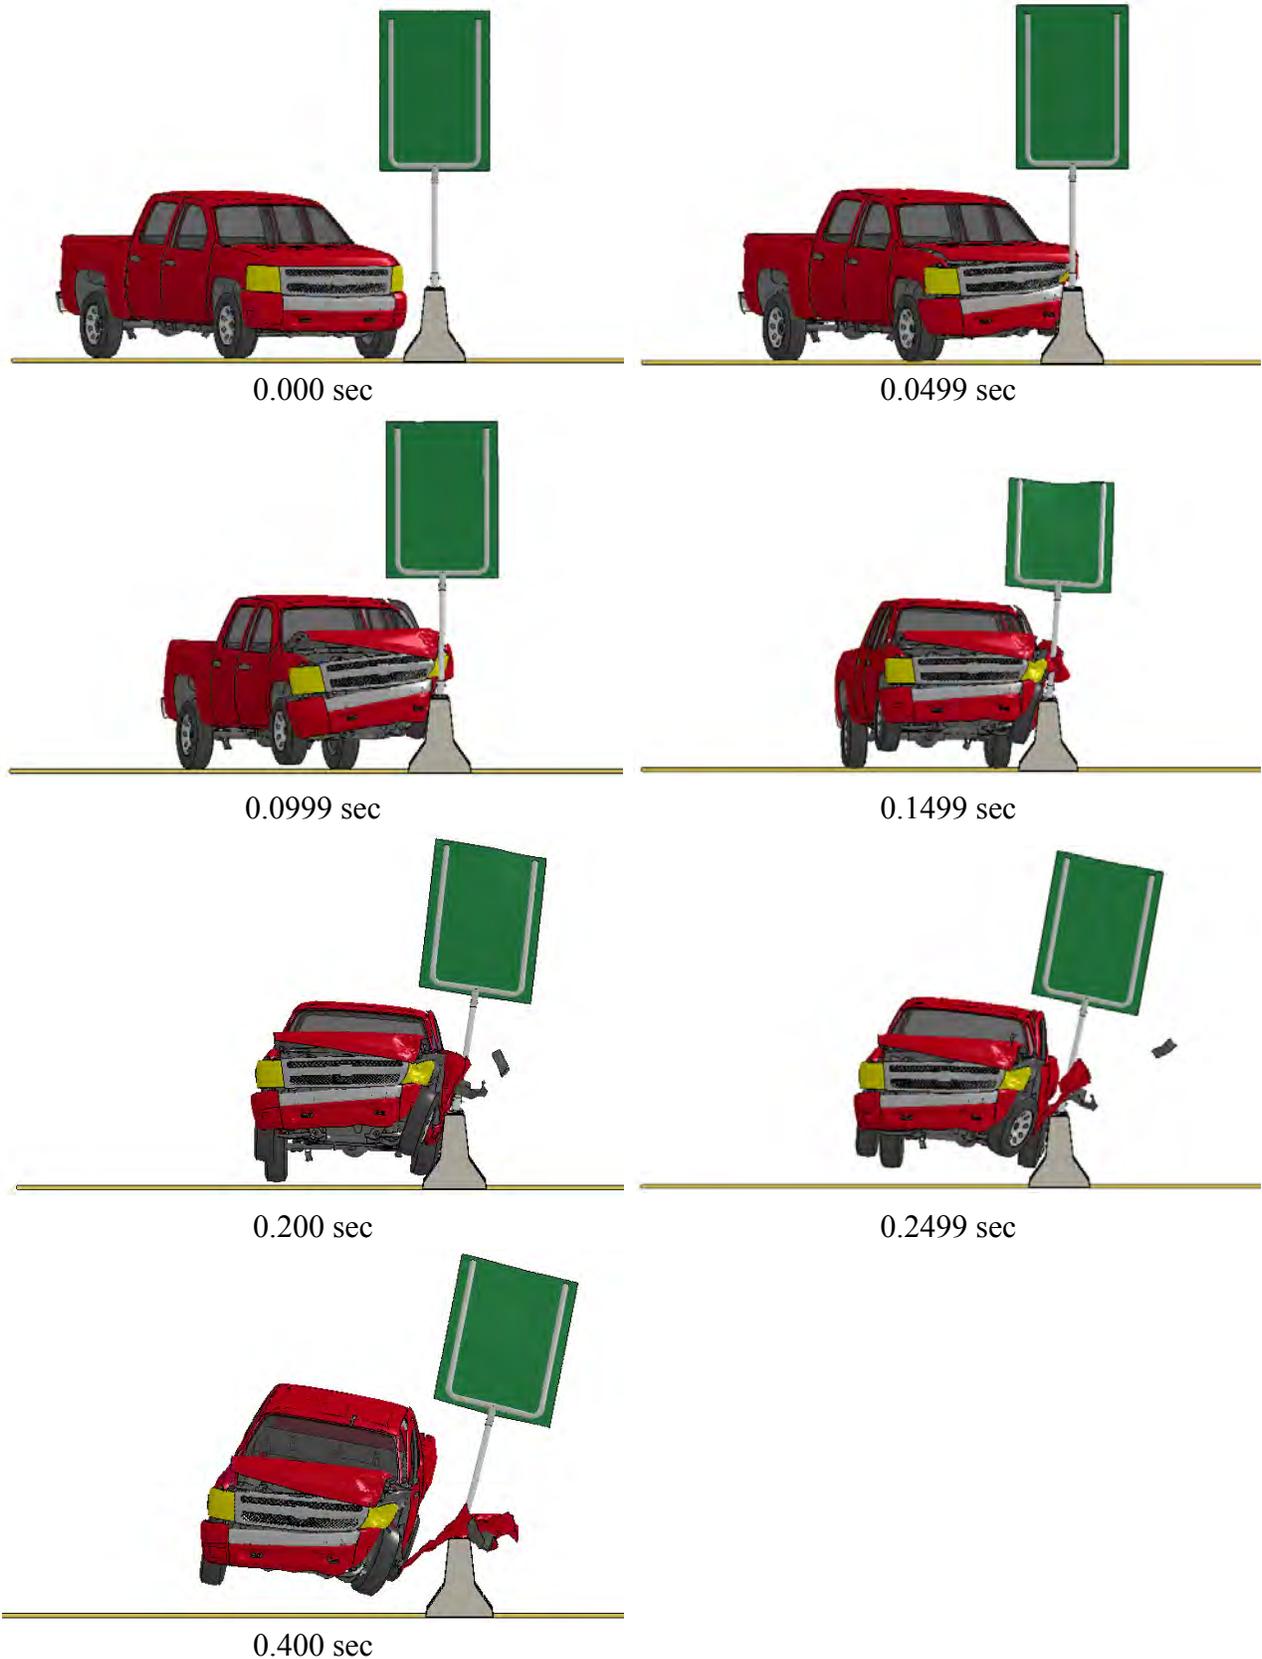
Figure 5.20. Impact View (Looking Upstream) Showing 5004-lb Test Vehicle Interacting with the Sign Post for Concept 1.

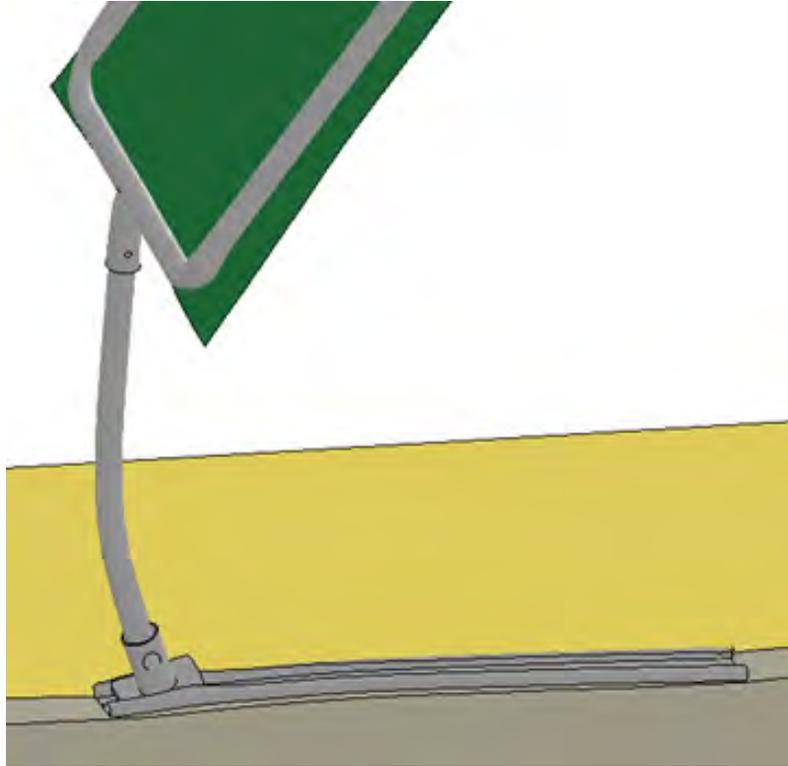
Figure 5.21. Displacement and Deformation of the Sign Post and Its Base for Concept 1.

Figure 5.20 shows sequential pictures of the truck model impacting into the barrier at 54 inches upstream of the base of the post. The new system with the chute was able to contain and redirect the vehicle very effectively. The base of the post slid in the chute as desired. There was very little pitch or yaw in the run. There was some vehicular rolling toward the end, -10.4 degrees, but it is still tolerable under the *MASH* evaluation criteria. This design kept the entire sign from going over across the barrier where it could be struck by oncoming traffic. Figure 5.21 shows the displacement and deformation of the sign post and base.

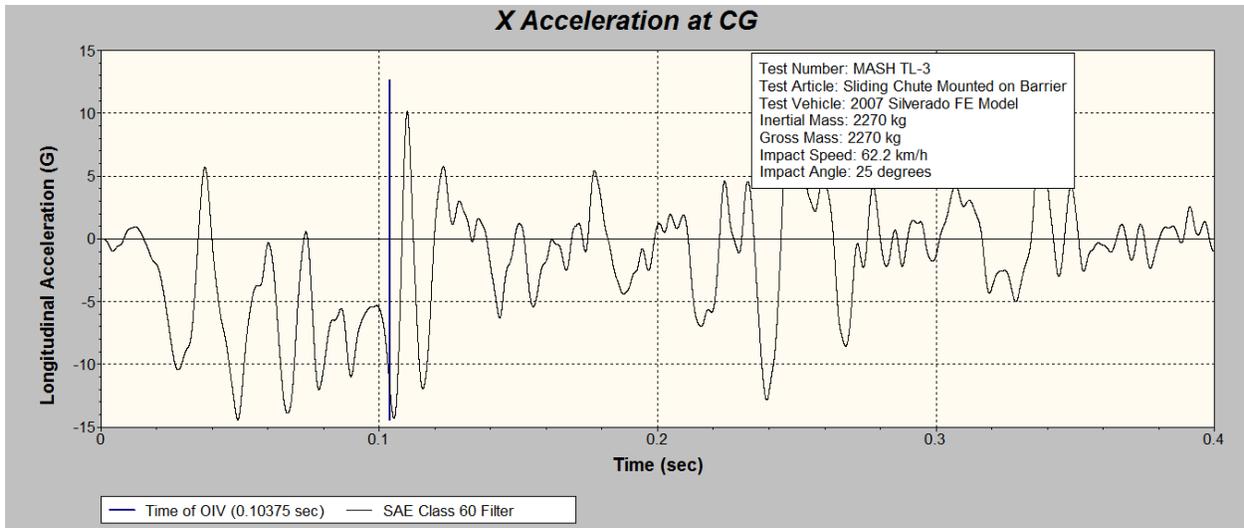
Figure 5.23. Longitudinal Acceleration History at C.G. for Concept 1.

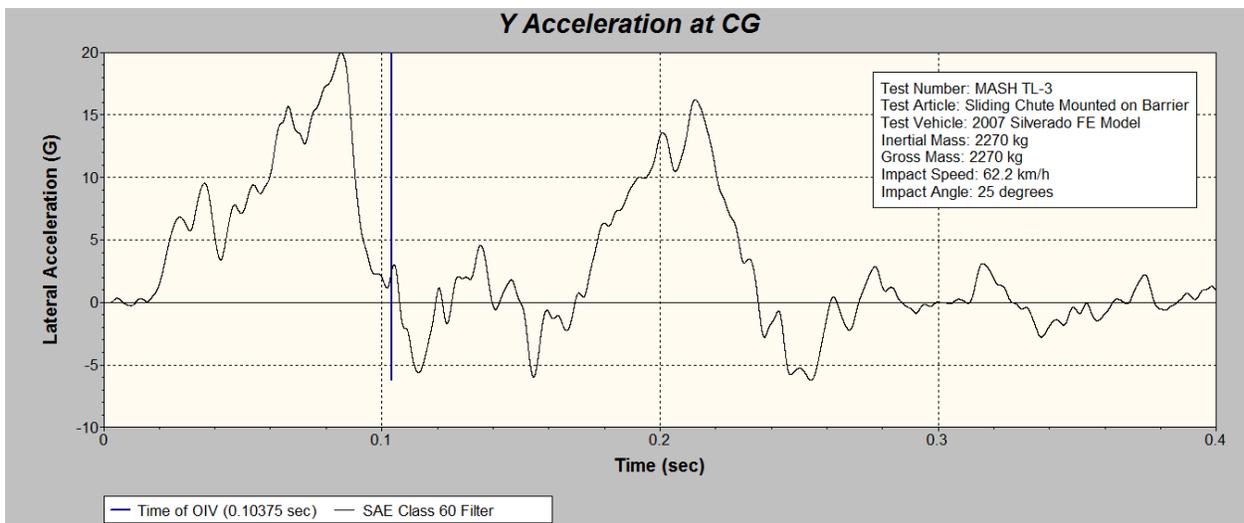
Figure 5.24. Lateral Acceleration History at C.G. for Concept 1.

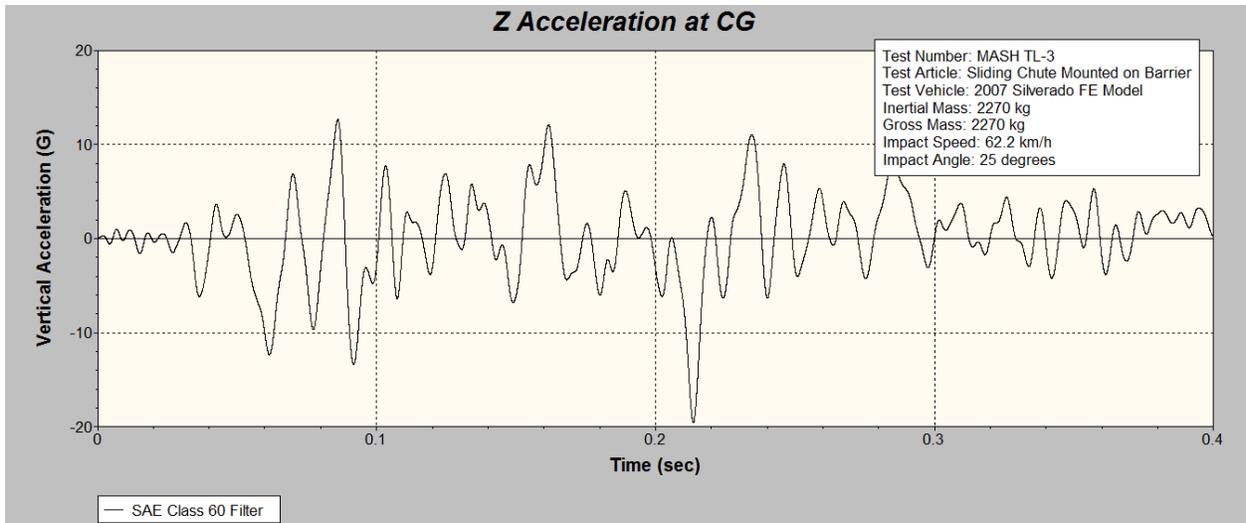
Figure 5.25. Vertical Acceleration History at C.G. for Concept 1.

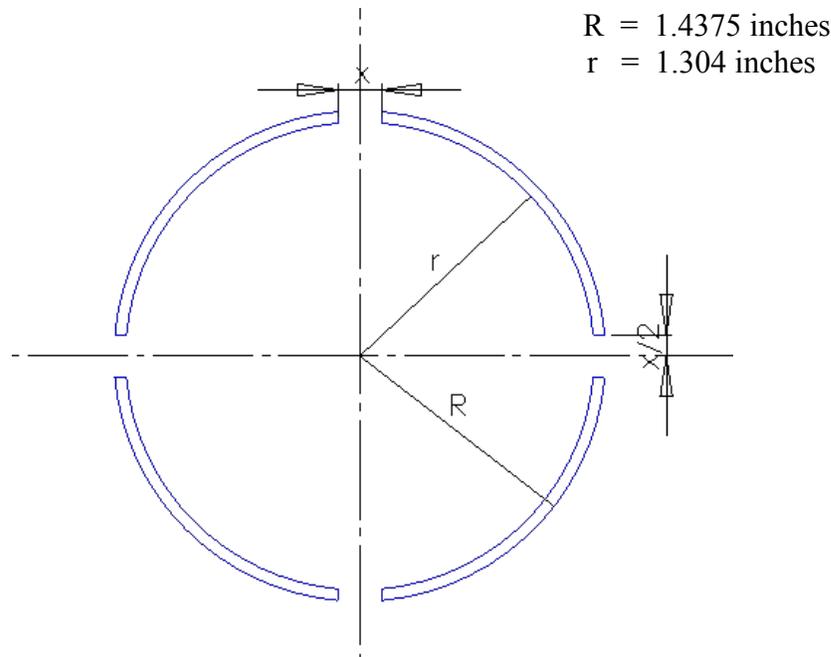
Figure 5.28 shows the cross section of a 2.5-inch 10 BWG (British Wire Gauge) pipe with arbitrary slot lengths cut out. The slots are present to weaken the strong axis, as well as the weak axis.

Figure 5.28. Cross Section of 2.5-inch 10 BWG Pipe.

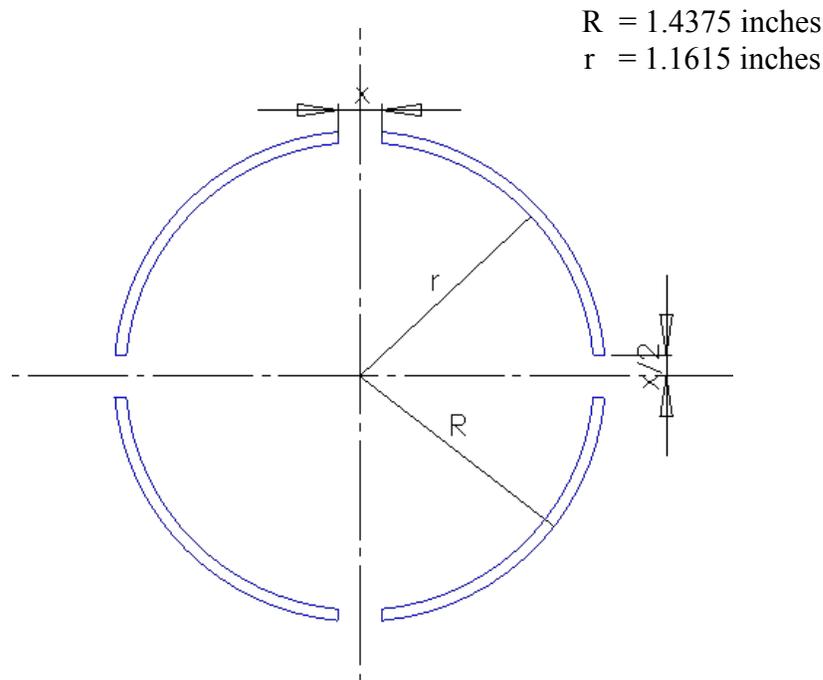
Figure 5.29 shows the same cross section as before, but this time the dimensions are for a 2.5-inch Schedule 80 pipe section.

Figure 5.29. Cross Section of 2.5-inch Schedule 80 Pipe.

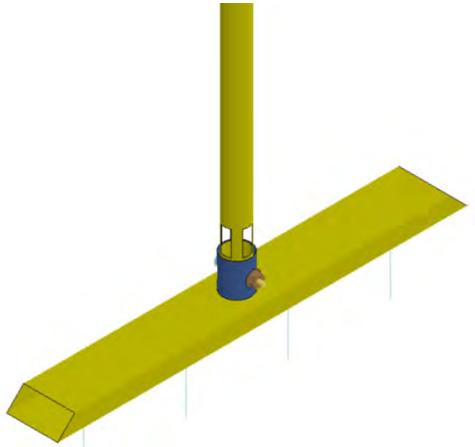
Figure 5.30. Model of Concept 8 Slotted 10 BWG Post (3-inch Slots).

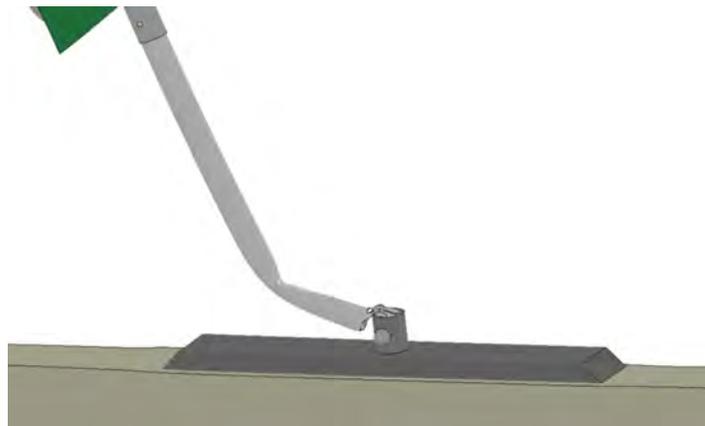
Figure 5.31. Bending of the Sign Post at the Slotted Section.
