Signs on Concrete Median Barriers

Test Report 0-6646-1

**TEXAS A&M TRANSPORTATION INSTITUTE
COLLEGE STATION, TEXAS**

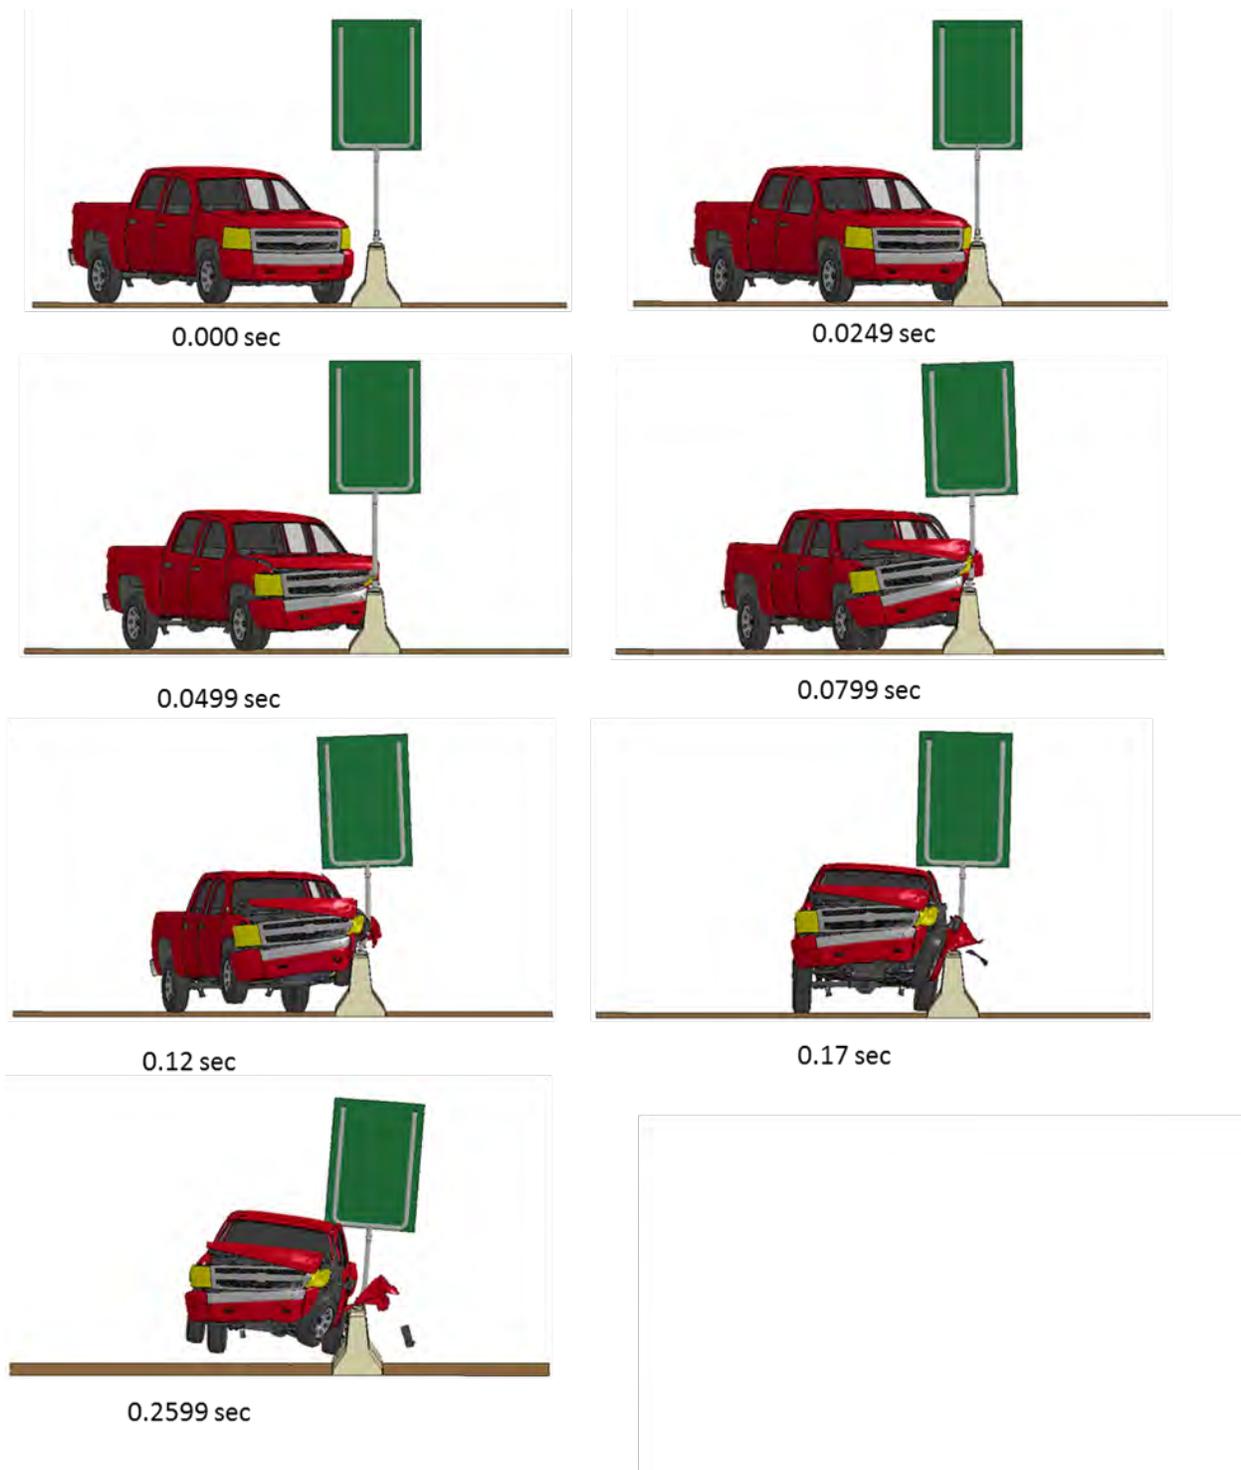
Figure 5.32. Impact View (Looking Upstream) Showing 5004-lb Test Vehicle Interacting with Sign Post for Concept 8 with 3-inch Slots.

Figure 5.31 shows predicted damage sustained by the sign post that indicates a collapse of the slotted section as intended. Figure 5.32 shows sequential pictures of the truck model impacting into the slotted 10 BWG sign post mounted on barrier at 42.5 inches upstream the base of the post. These sequential images show that the system was able to contain and redirect the vehicle as intended. The vehicle has a moderate roll angle of 13.3 degrees and smaller values for the pitch or yaw angles.

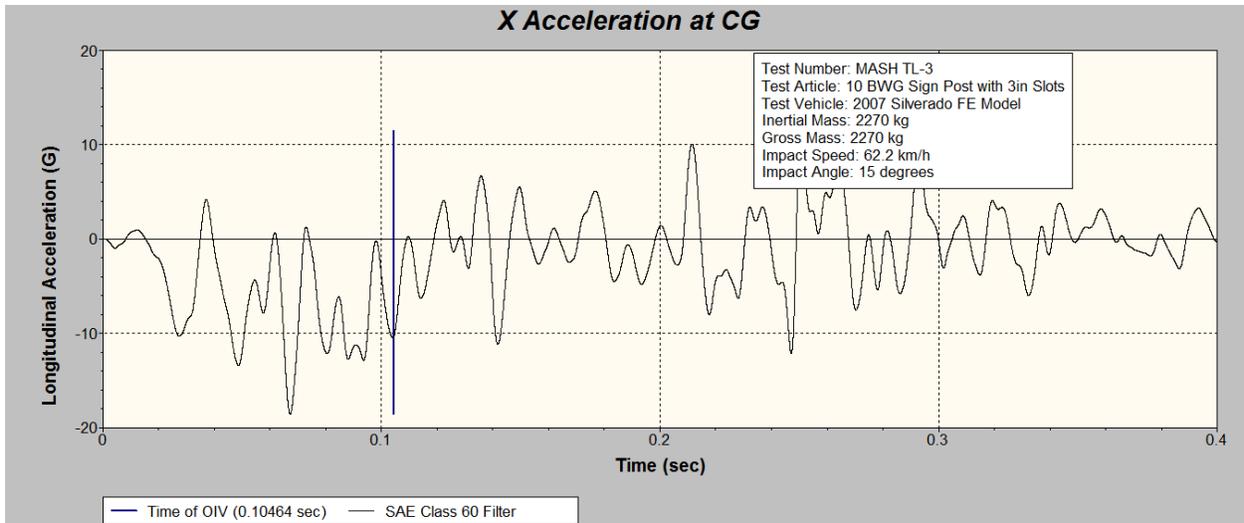
Figure 5.34. Longitudinal Acceleration History at C.G. for Concept 8 with 3-inch Slots.

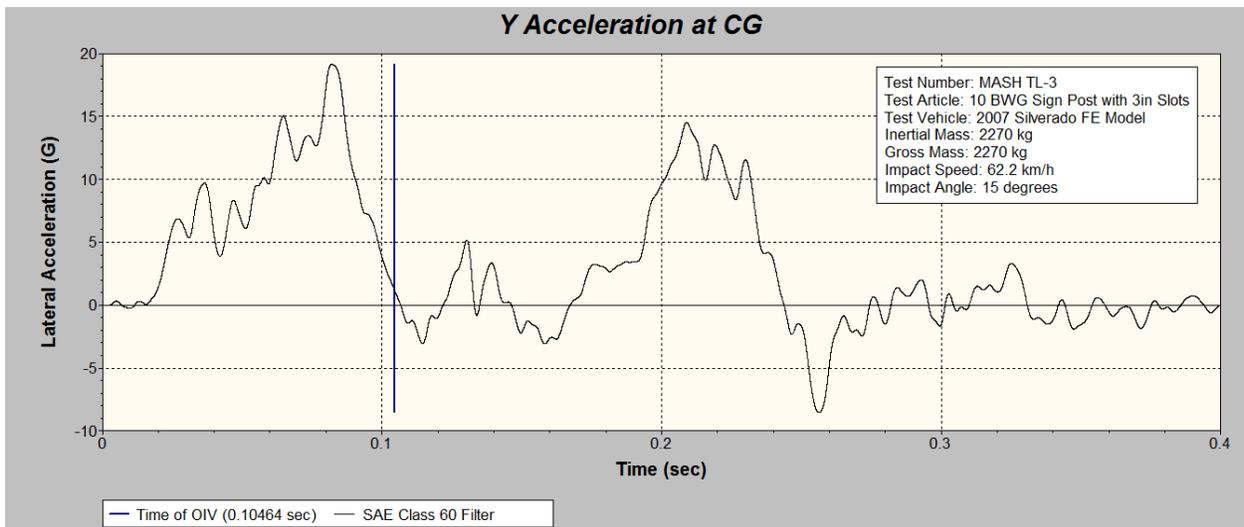
Figure 5.35. Lateral Acceleration History at C.G. for Concept 8 with 3-inch Slots.

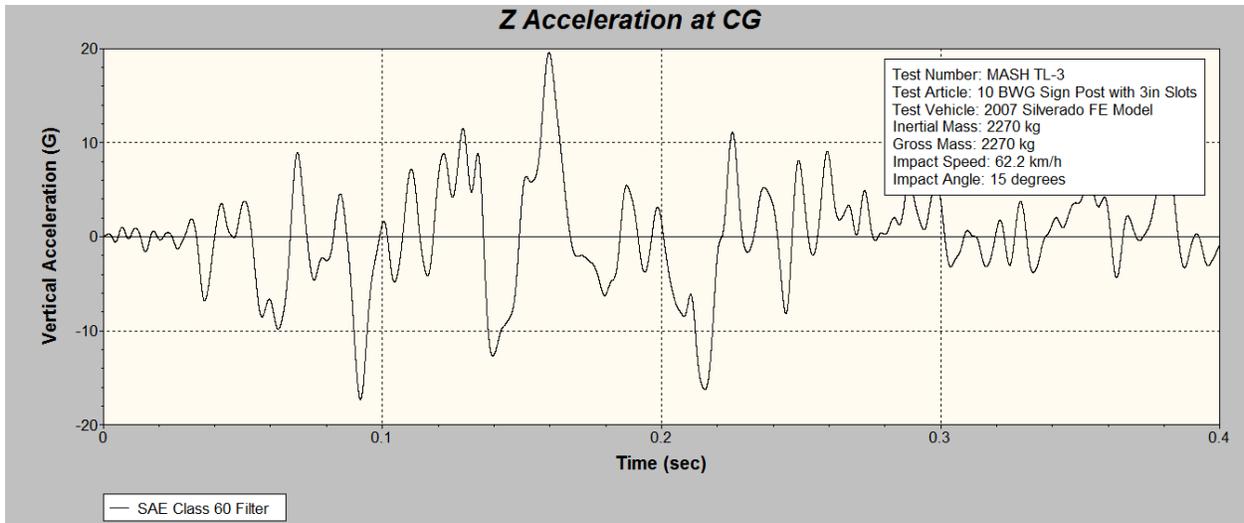
Figure 5.36. Vertical Acceleration History at C.G. for Concept 8 with 3-inch Slots.

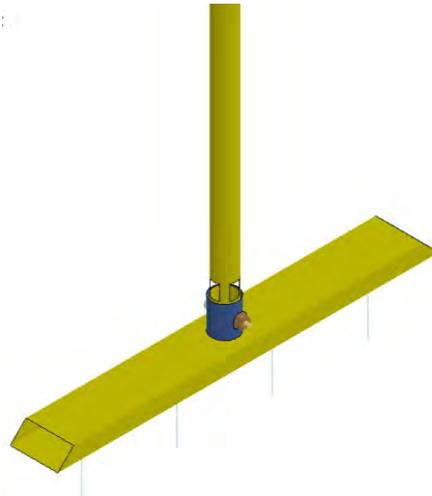
Figure 5.39. Model of Concept 8 Slotted 10 BWG Post (2-inch Long Slots).

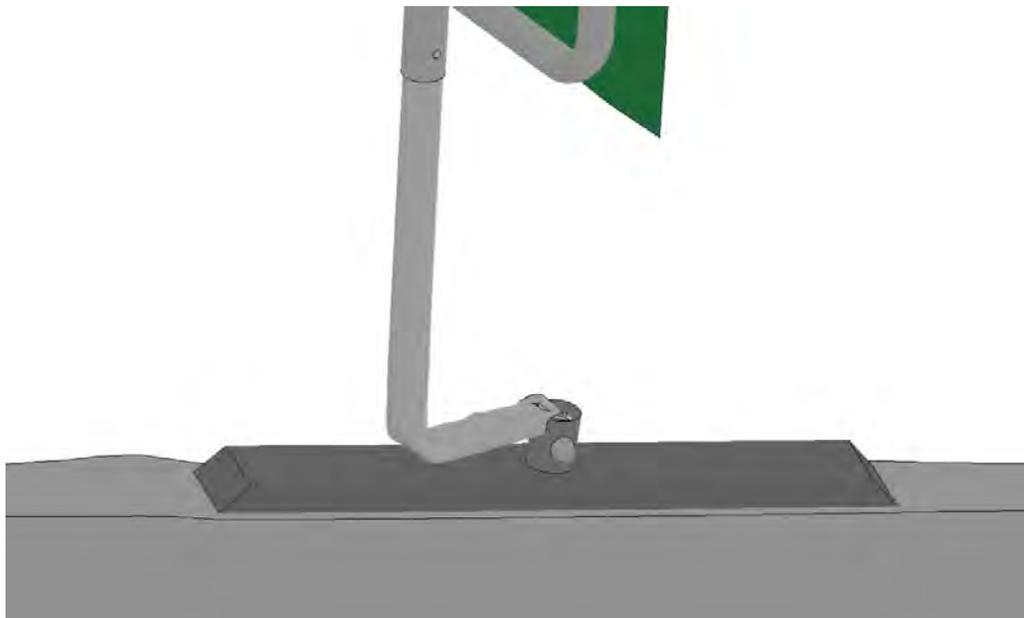
Figure 5.40. Bending of the Sign Post at the Slotted Section.

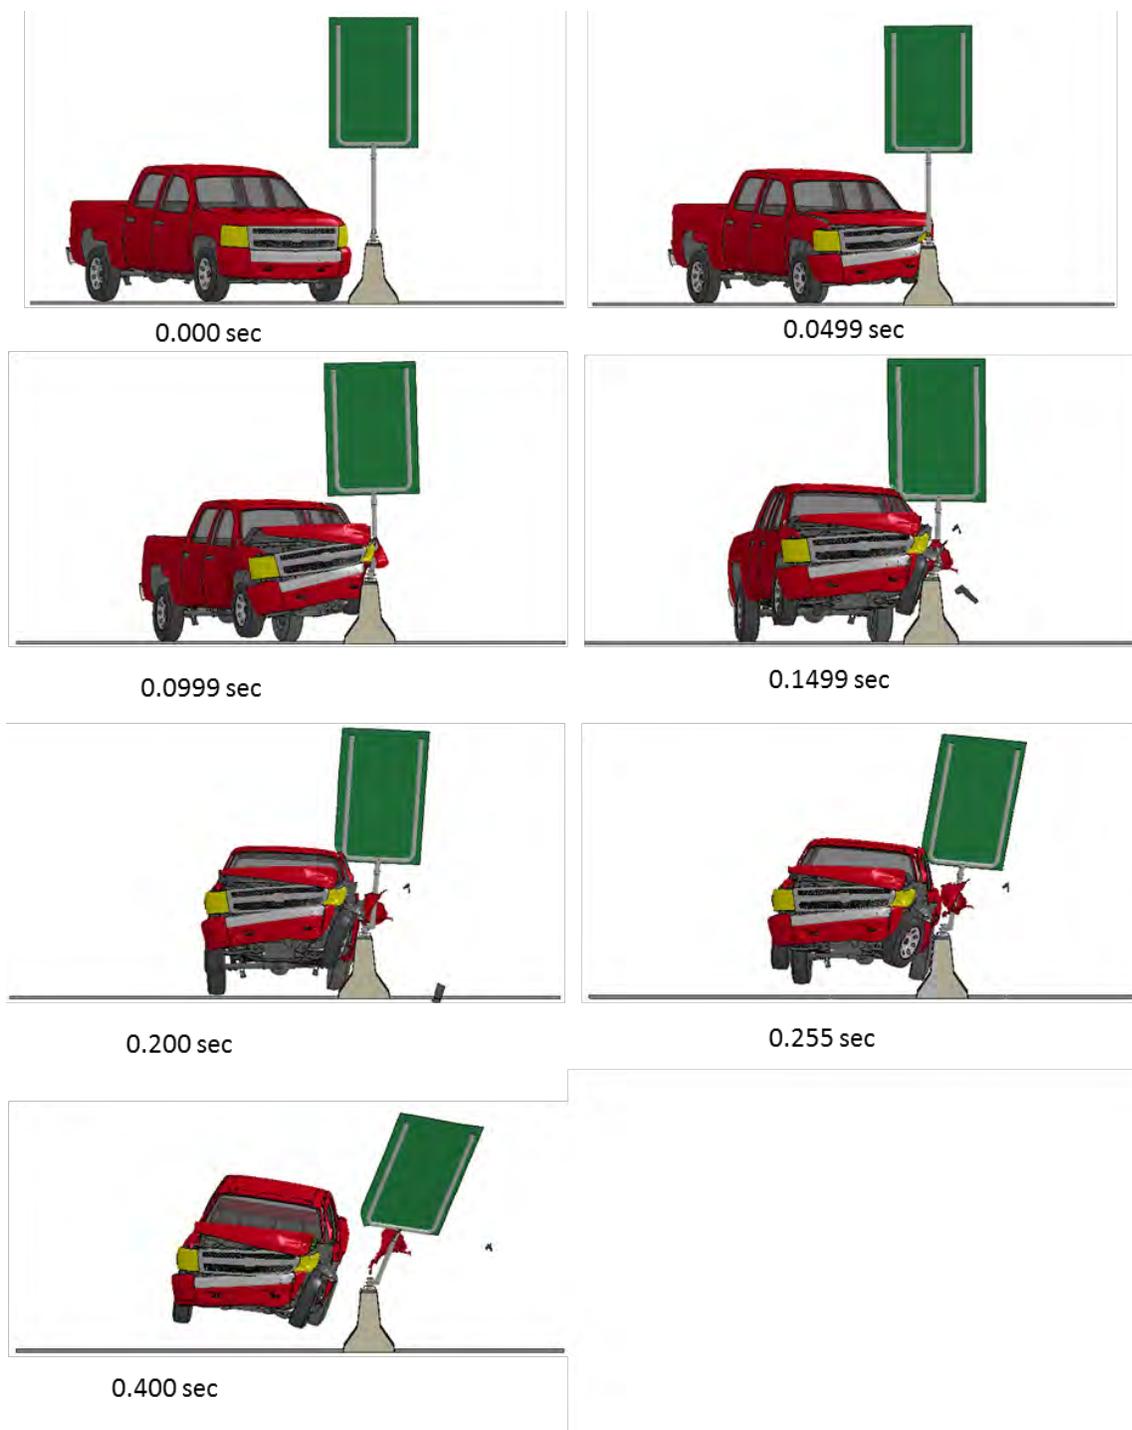
Figure 5.41. Impact View (Looking Upstream) Showing 5004-lb Test Vehicle Interacting with Sign Post for Concept 8 with 2-inch Slots.

The new system with the shortened slots was still able to contain and redirect the vehicle as shown in the sequential picture diagram. The vehicle had a moderate roll angle of 9 degrees and smaller values for the pitch or yaw angles.

Figure 5.40 shows predicted damage sustained by the sign post that indicates a collapse of the slotted section as intended. Figure 5.41 shows sequential pictures of the truck model impacting into the slotted 10 BWG sign post mounted on barrier at 42.5 inches upstream the base of the post. These sequential images show that the system was able to contain and redirect the vehicle as intended.

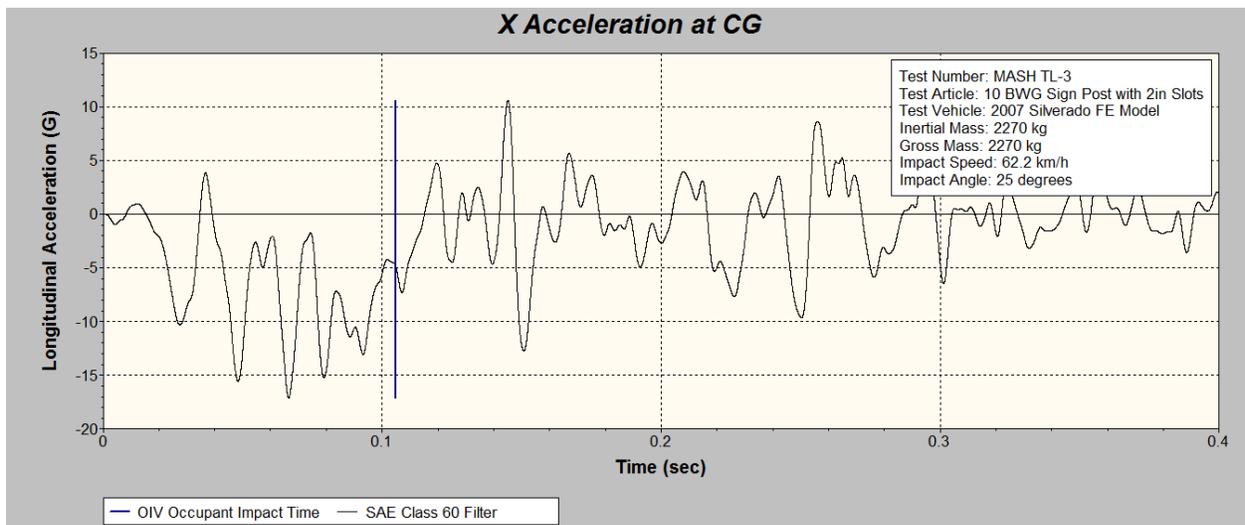
Figure 5.43. Longitudinal Acceleration History at C.G. for Concept 8 with 2-inch Slots.

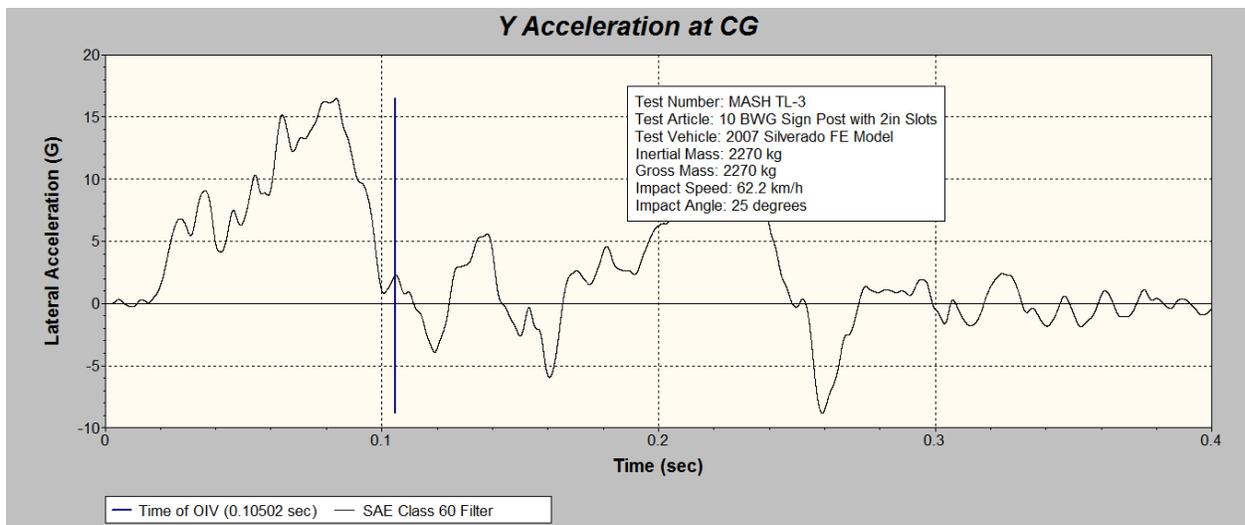
Figure 5.44. Lateral Acceleration History at C.G. for Concept 8 with 2-inch Slots.

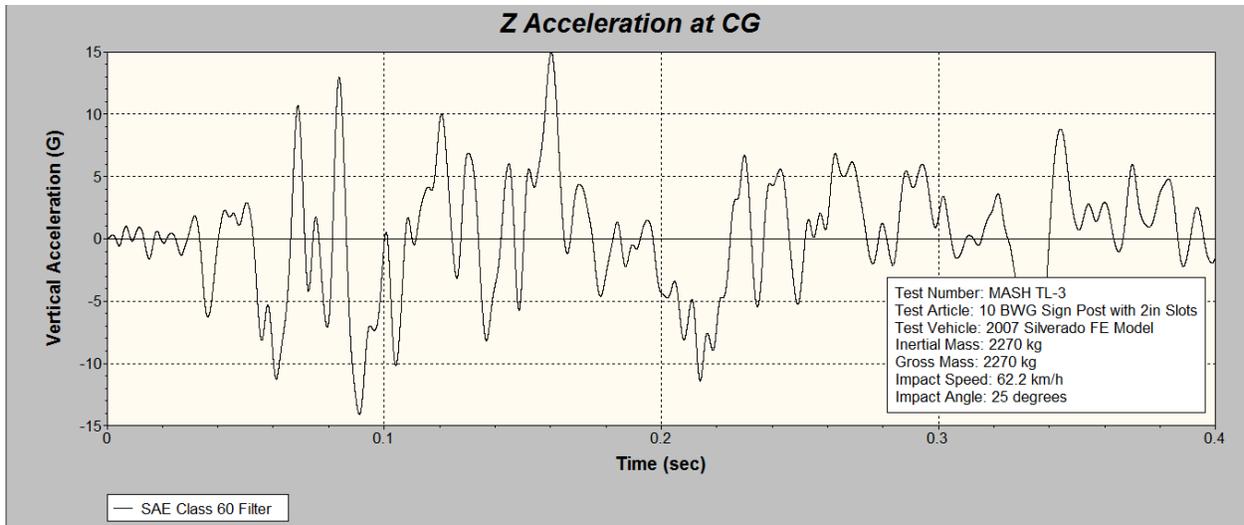
Figure 5.45. Vertical Acceleration History at C.G. for Concept 8 with 2-inch Slots.

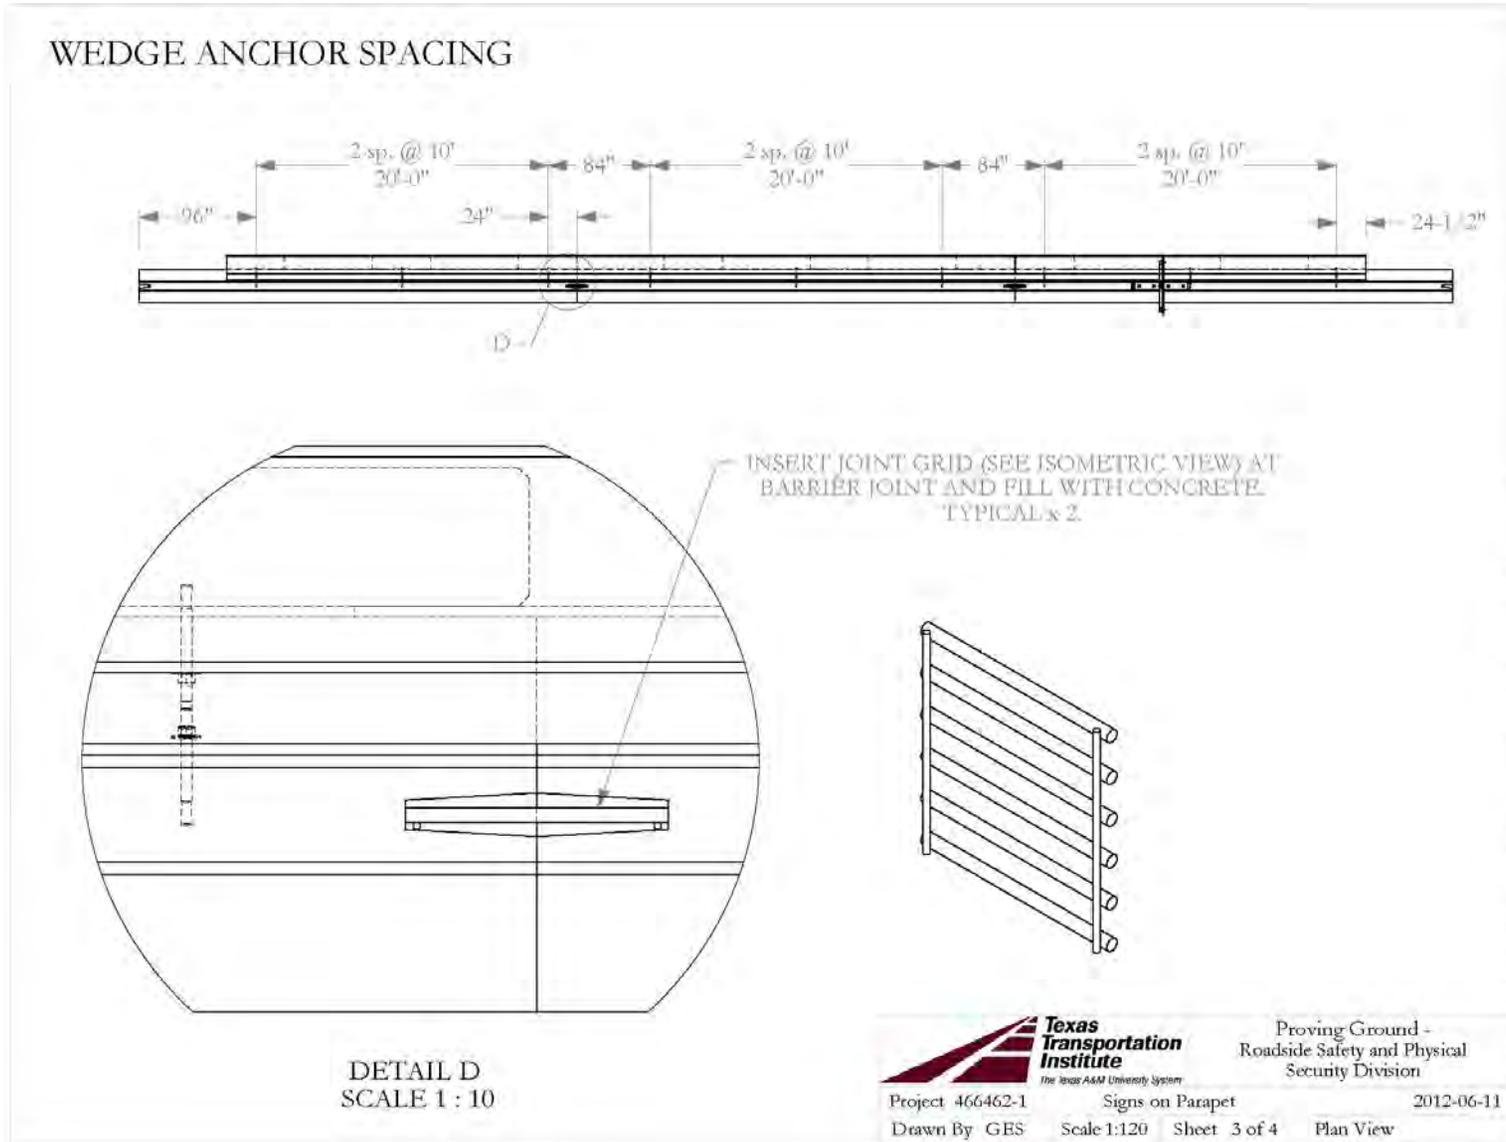
The same 32-inch height barrier assembly was used for all four tests conducted under this project. The barrier assembly consists of three TxDOT 30-ft New Jersey (NJ) shape CMB barriers that were placed longitudinally next to each other, which resulted in a 90-ft long NJ shape barrier. The 30-ft barriers were secured to each other via a steel grid inserted at their end openings, and the steel grid and the cavities were filled with concrete. Figure 6.1 shows the details of steel grid/concrete connection details. This 90-ft NJ barrier was placed against an existing TxDOT T223 bridge rail. The 90-ft NJ barrier was secured to the T223 bridge rail by using nine ¾-inch diameter wedge anchors and concrete to fill the gap between the NJ barrier and the T223 bridge rail as shown in Figure 6.2. Hence, the NJ barrier was fully secured and would respond as a permanent concrete barrier due to the aforementioned extensive anchoring schemes. Figure 6.3 shows the sign assembly, which consisted of a 48-inch × 72-inch × ½-inch aluminum sign with standard TxDOT U-bracket and hardware assembly.

Figure 6.1. Details of the Spread Tube Sign Support System on CMB for Test No. 466462-1.

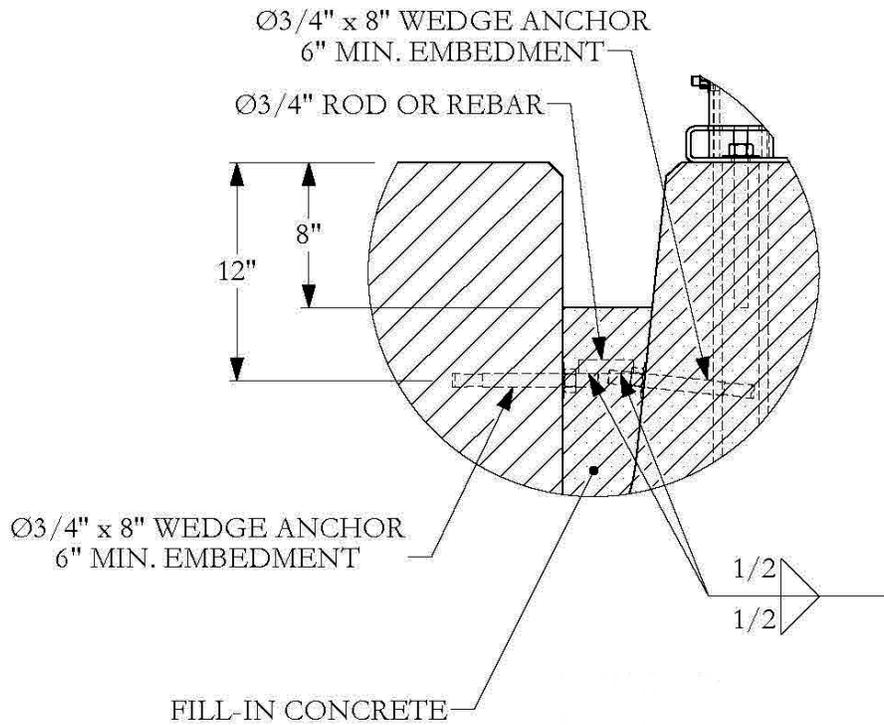
Figure 6.2. Gap between NJ Barrier and T223 Bridge Rail.

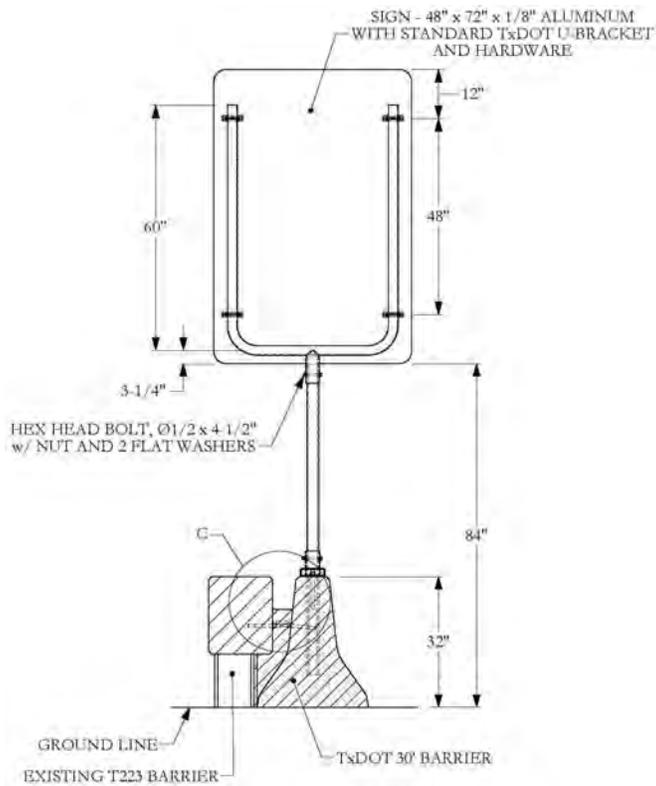
Figure 6.3. Sign and Post Assembly.

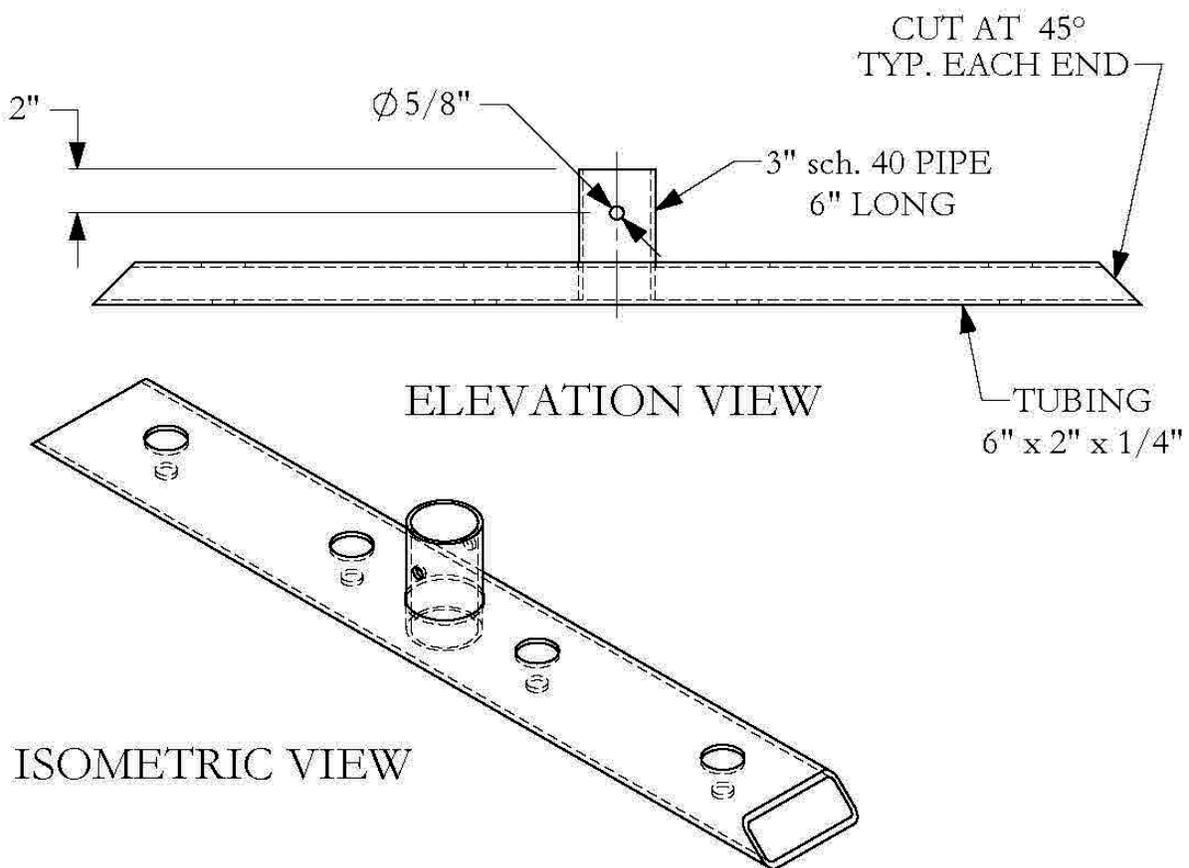
For test 466462-1, the sign post is a standard 2.5-inch diameter Schedule 80 post. Figure 6.4 shows the post is mounted inside a 6-inch long, 3-inch diameter schedule 40 pipe that is built inside a 6-inch wide \times 2-inch deep \times $\frac{1}{4}$ -inch thick steel tubing. The post is secured to the pipe using a $\frac{1}{2}$ -inch diameter through bolt. The steel tubing is 48 inches long with a 45-degree taper at each end and fixed to the top of the concrete barrier using four 8-inch long, $\frac{3}{4}$ -inch diameter anchor rods. Additional details for the installation are provided in Appendix C1 and C2. Figure 6.5 presents photographs of the completed test installation prior to the test.

Figure 6.4. Spread Tube Sign Support System on CMB.

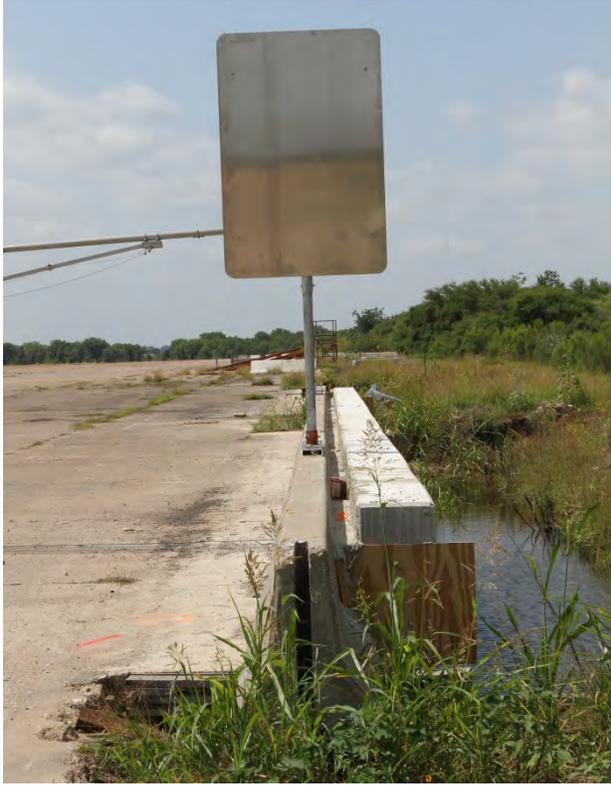
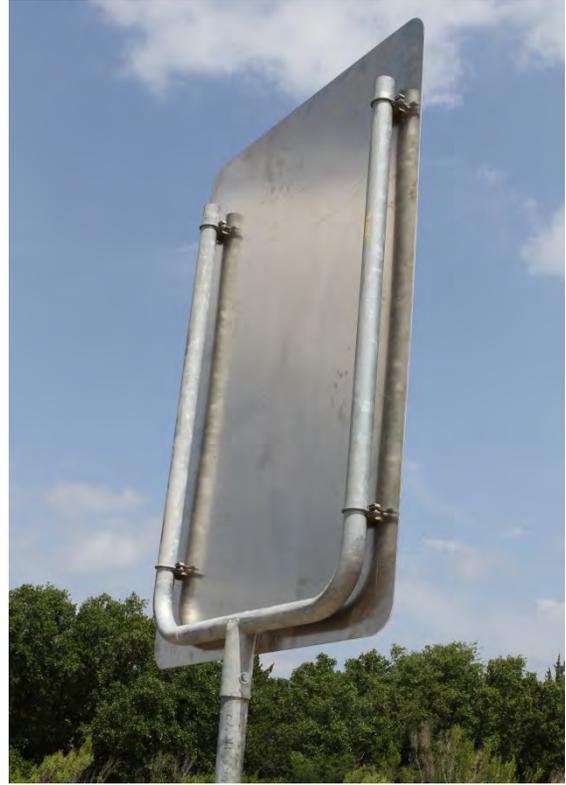
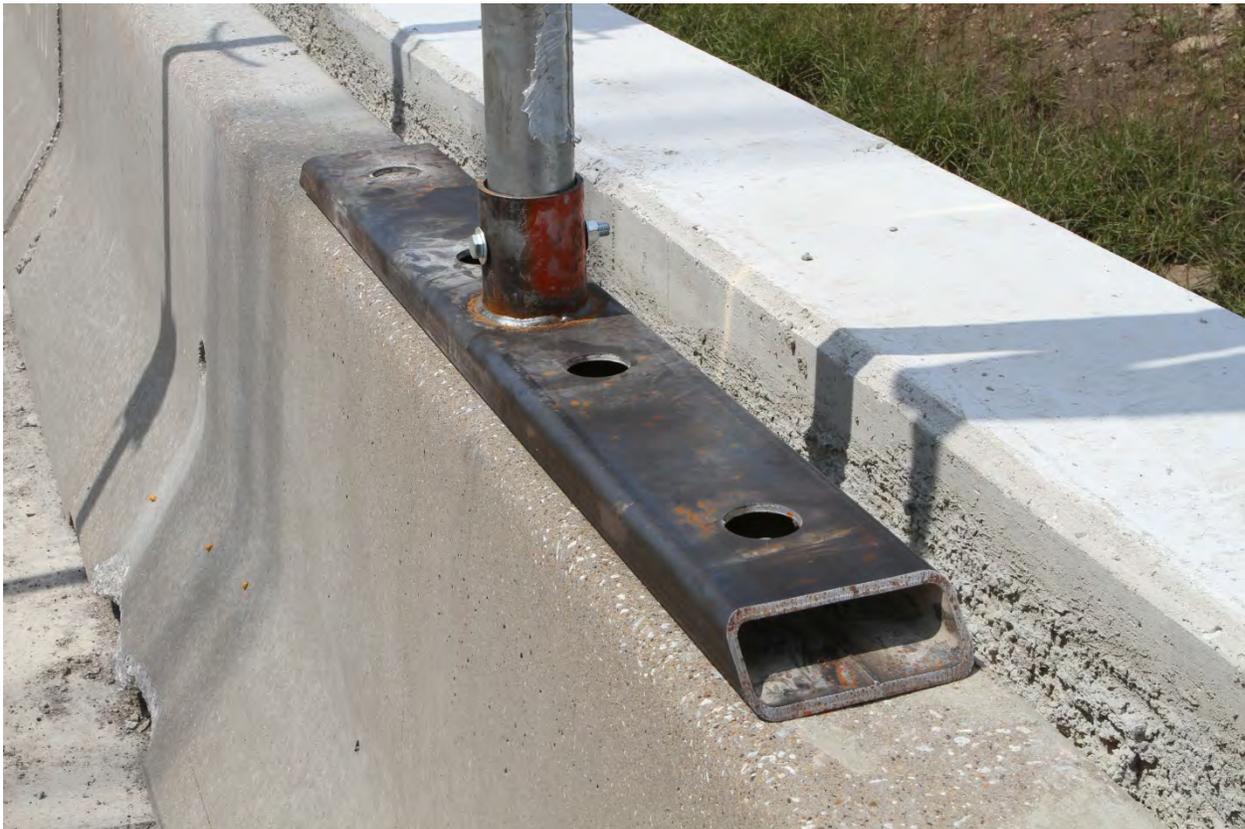
Figure 6.5. Spread Tube Sign Support System on CMB before Test No. 466462-1.

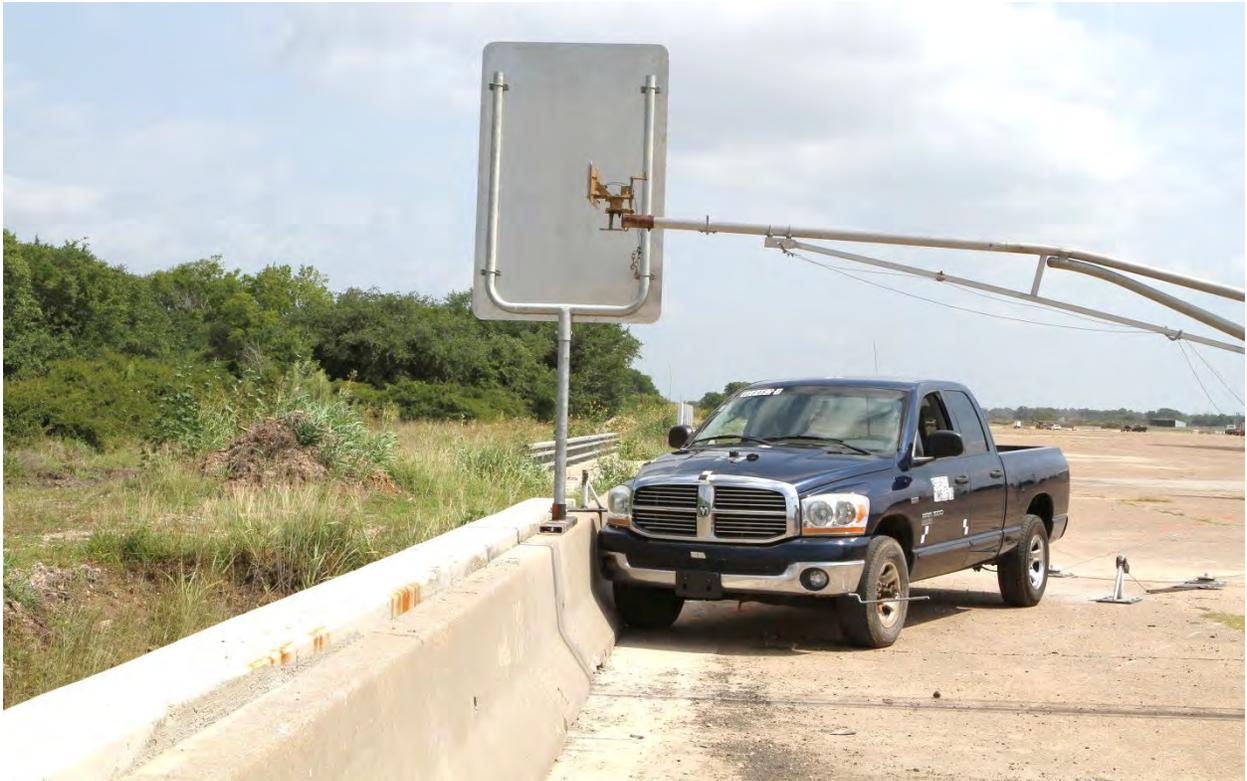
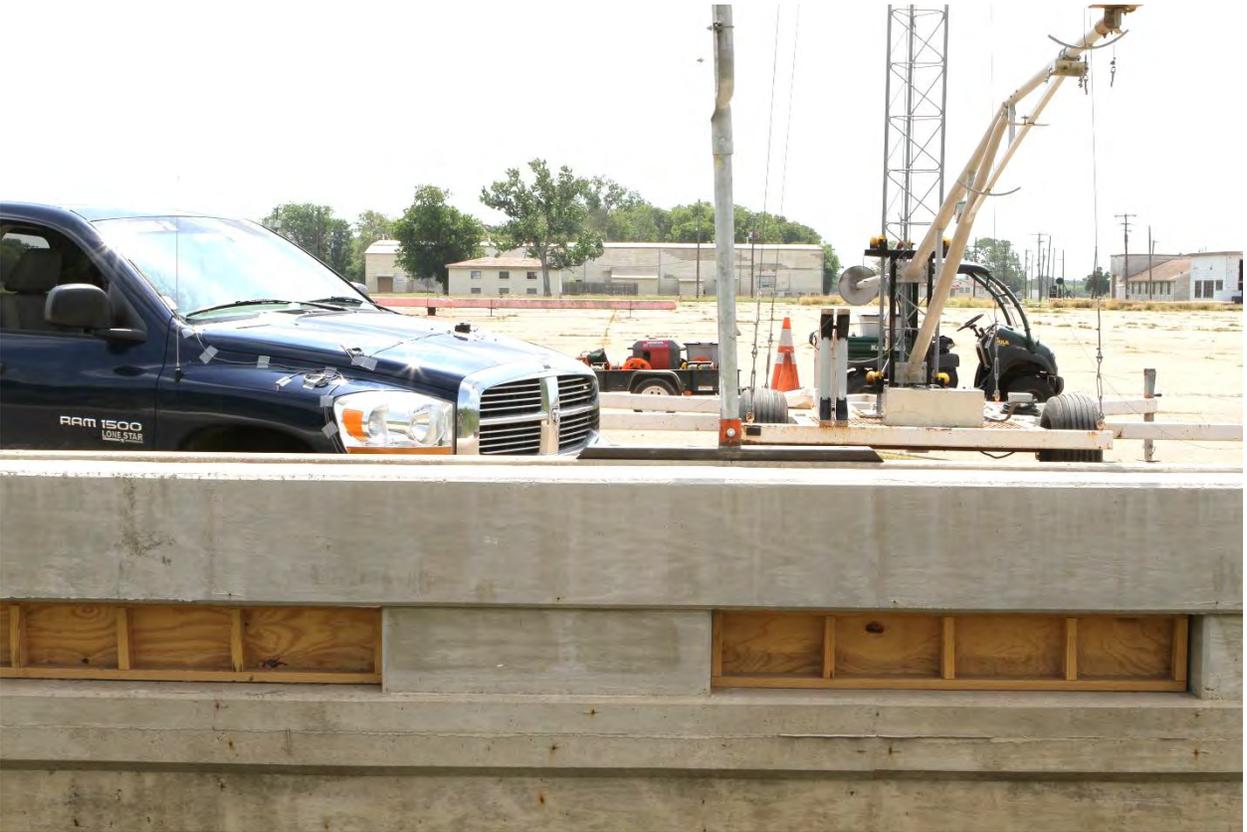
Figure 6.6. Vehicle/Spread Tube Sign Support System on CMB Geometrics for Test No. 466462-1.

A 2006 Dodge Ram 1500 pickup truck, shown in Figures 6.6 and 6.7, was used for the crash test. Test inertia weight of the vehicle was 5050 lb, and its gross static weight was 5050 lb. The height to the lower edge of the vehicle bumper was 13.75 inches, and it was 25.38 inches to the upper edge of the bumper. The height to the vehicle's center of gravity was 28.03 inches. Tables C1 and C2 in Appendix C3 give additional dimensions and information on the test vehicle. The vehicle was directed into the installation using the cable reverse tow and guidance system, and was released to be unrestrained just prior to impact.

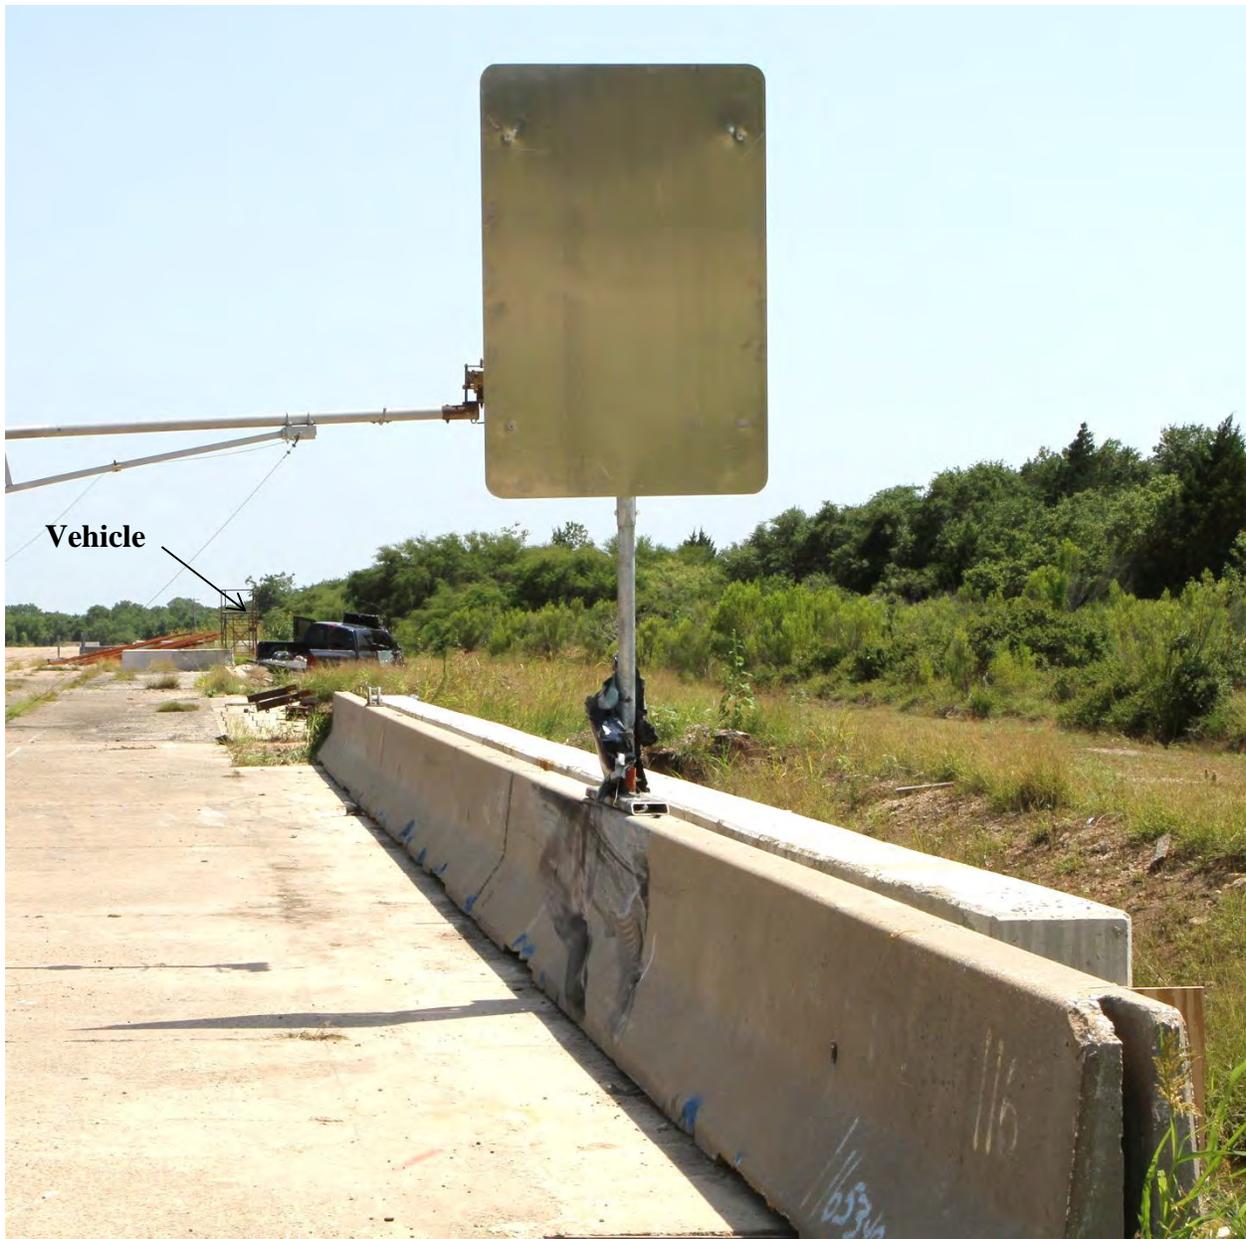
Figures 6.8 and 6.9 show damage to the spread tube sign support system and the barrier. The barrier face was marred with tire marks and scrapings. The sign support was leaning downstream and a piece of the sheet metal from the vehicle was wrapped around the lower portion of the support. The 2270P vehicle was in contact with the barrier 218 inches. Vehicle penetration (formerly working width) was 20.4 inches. No movement was noted in the barrier.

Figure 6.8. Vehicle/Spread Tube Sign Support System on CMB Positions after Test No. 466462-1.

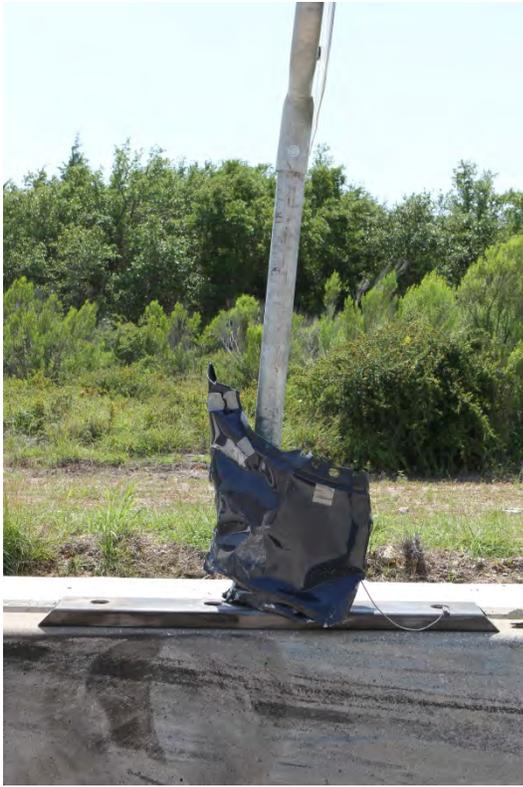
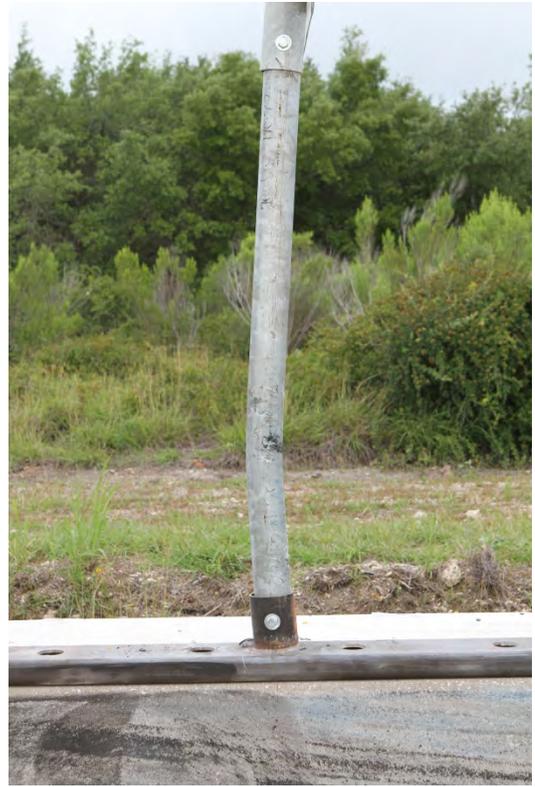
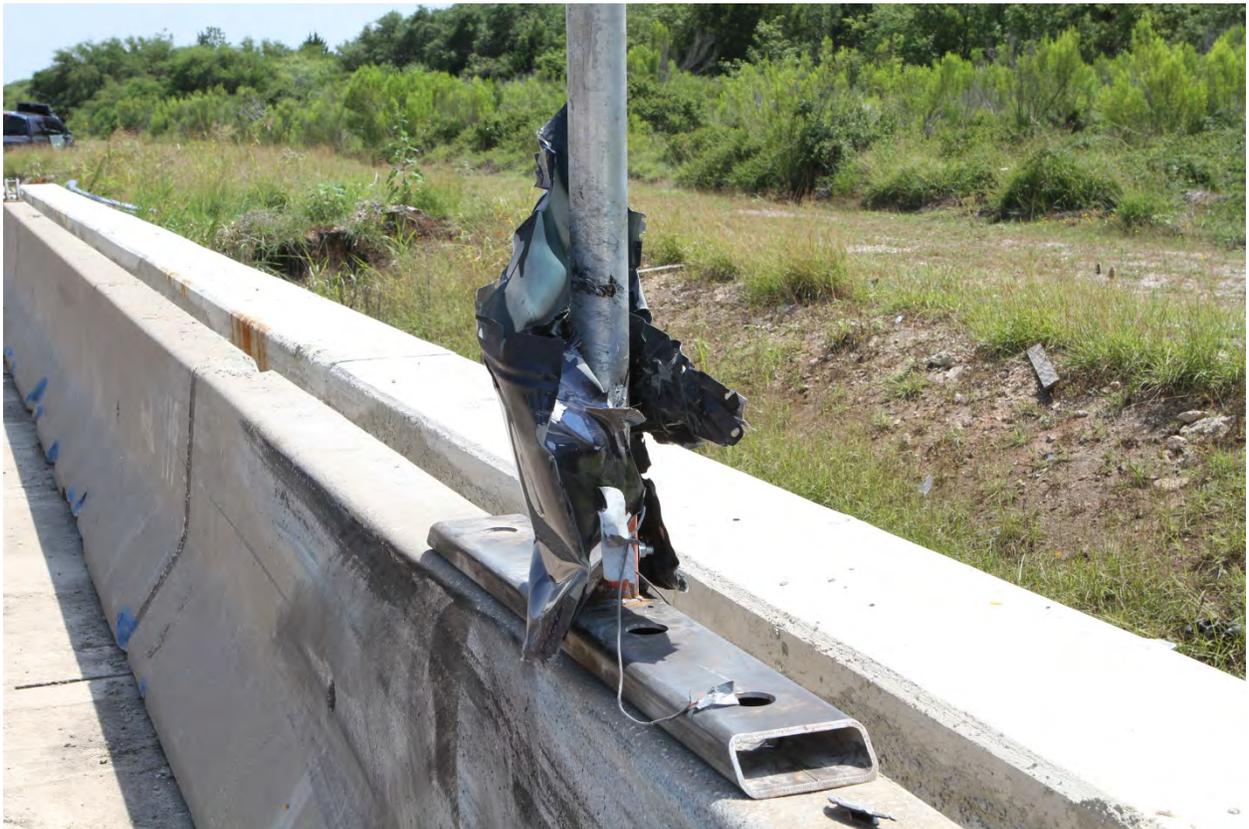
Figure 6.9. Spread Tube Sign Support System on CMB after Test No. 466462-1.
