Signs on Concrete Median Barriers

Test Report 0-6646-1

**TEXAS A&M TRANSPORTATION INSTITUTE
COLLEGE STATION, TEXAS**

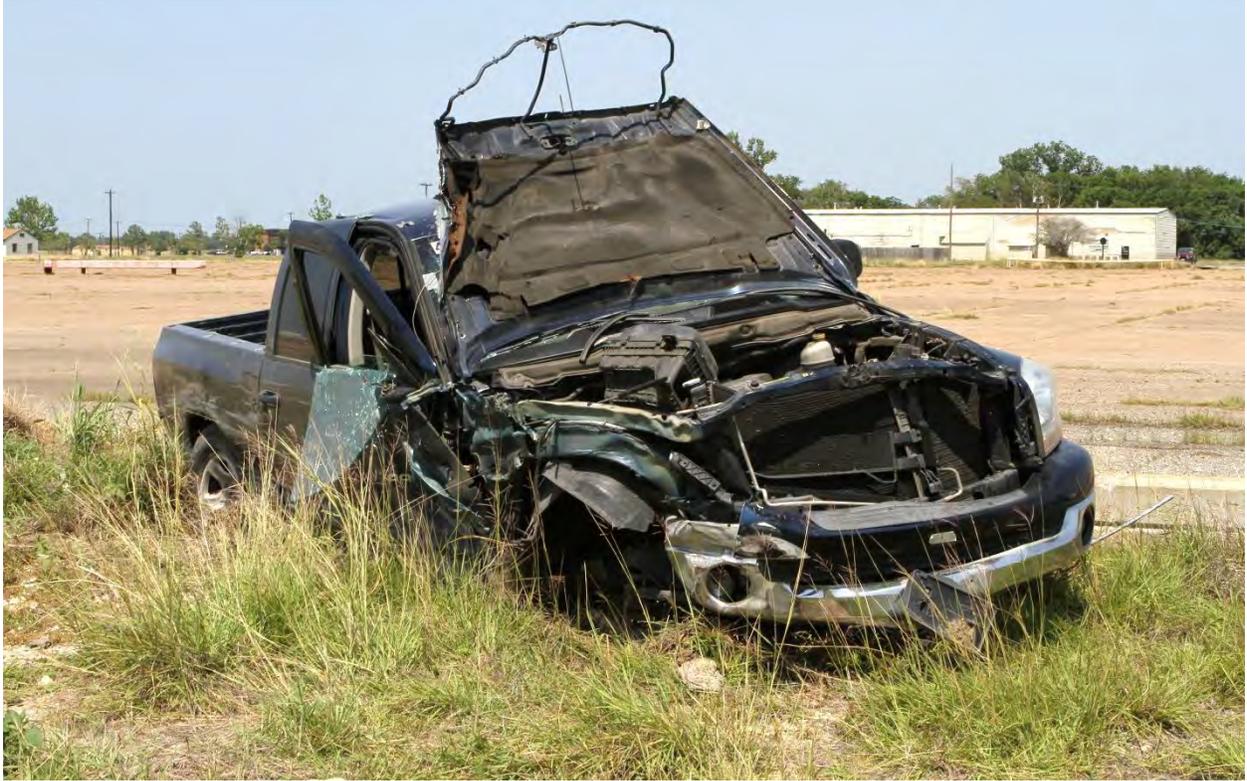
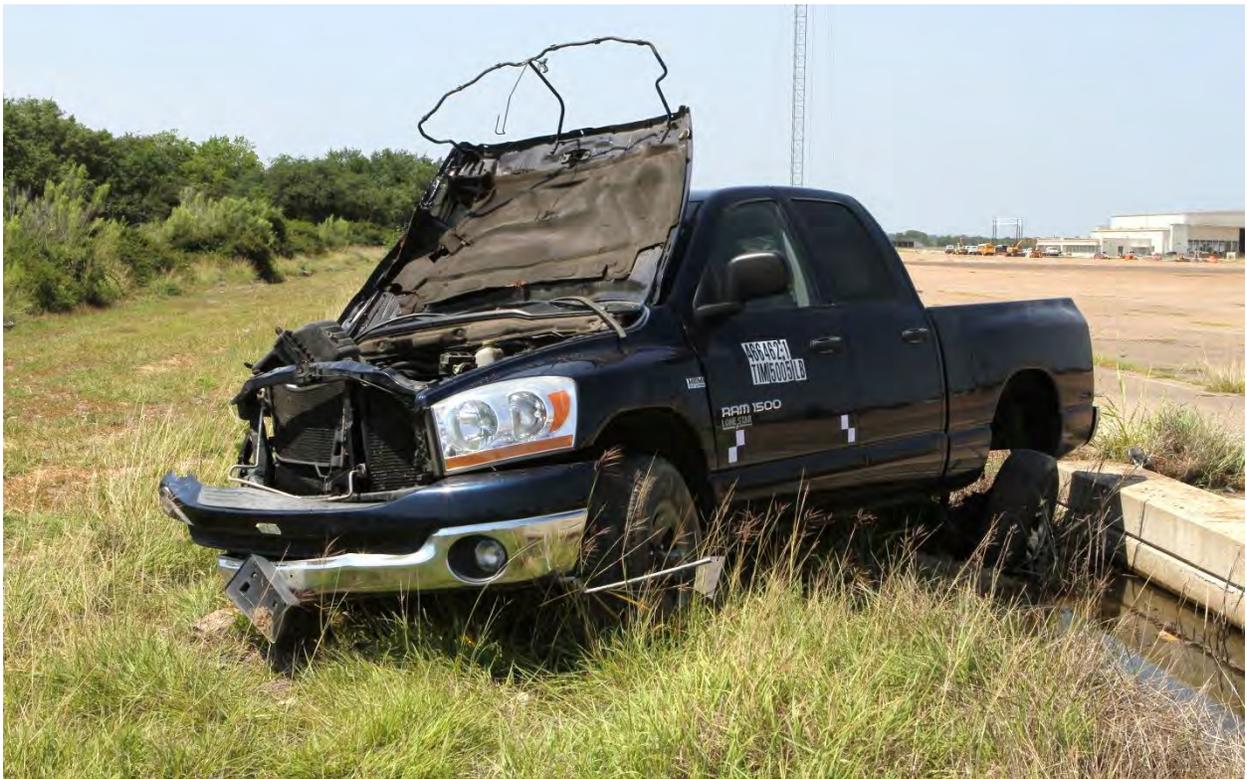
Figure 6.10 presents the damage sustained by the vehicle. The right upper and lower ball joints and A-arms, the right frame rail, left rear U-bolts, and drive shaft were deformed. The front bumper, hood, right front fender, right front door and door glass, right exterior bed, right rear door, right front tire and wheel rim, right rear tire and wheel rim, left rear tire and wheel rim, and rear bumper were also damaged. During the test, the windshield sustained stress cracks, and as the vehicle exited the barrier, the hood flew up and contacted the windshield and causing the windshield to break and deform. However, contact with the sign support and barrier did not cause the majority of the damage. Maximum exterior crush to the vehicle was 18.0 inches in the side plane at the right front corner at bumper height. Deformation of 7.5 inches was noted in the windshield; this was caused by the hood of the vehicle and not from interaction with the sign support or barrier. Maximum occupant compartment deformation caused by interaction with the sign support and barrier was 1.5 inches in the floor pan on the right side. Tables C3 and C4 in Appendix C4 provide maximum exterior crush and occupant compartment deformation of the vehicle.

Figure 6.10. Vehicle after Test No. 466462-1.

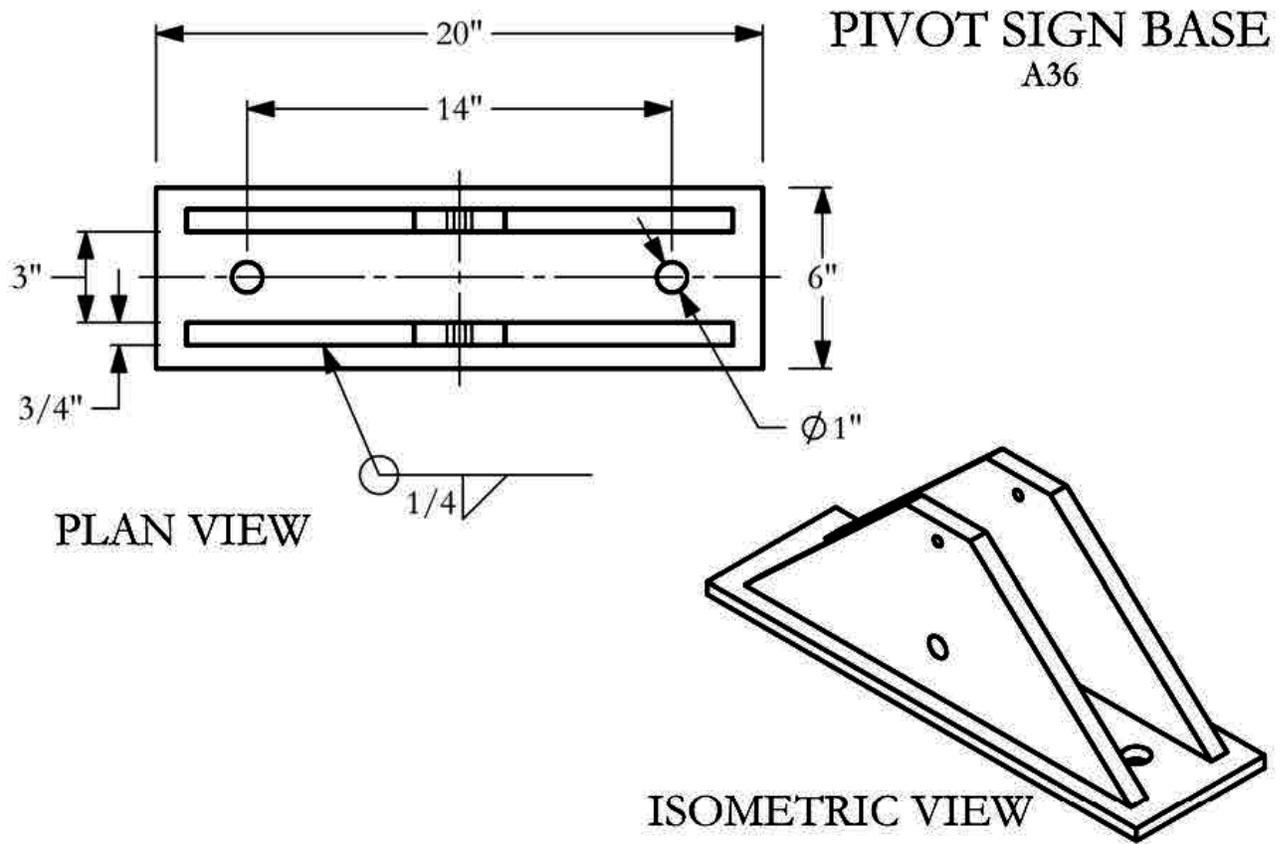
The design used for test 466462-2a consisted of the same sign assembly and post details used in test 466462-1. However, the sign post is mounted to the barrier by attaching it to two trapezoidal side plates. The 3/4-inch thick plates hold the post via a 3/4-inch diameter bolt and a 5/16-inch diameter sacrificial bolt. Both bolts are designed to keep the sign up under wind loading. However, the sacrificial bolt would break upon excessive longitudinal forces on the post due to impact. Hence, this the sign assembly would pivot around the 3/4-inch hinge bolt under excessive impact force. The bolts are secured to the side plates/base pivot assembly. The plates are welded to a 20-inch × 6-inch × 1/2-inch thick plate. This mounting assembly is attached to the top face of the barrier via two anchor rods; each is 8 inches long, 3/4-inch diameter. Figures 6.12 and 6.13 show the details of the mounting bracket, and additional details are provided in Appendix D1 and D2. Figure 6.14 presents photographs of the completed installation.

Figure 6.12. Isometric and Plan Views of the Bracket and Sacrificial Pin Sign Support.

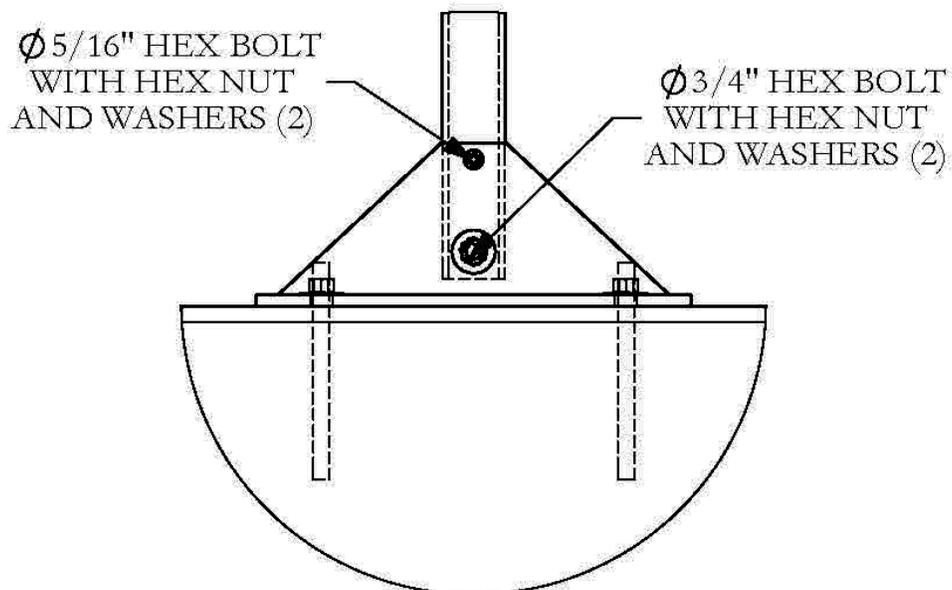
Figure 6.13. Mounting Assembly.

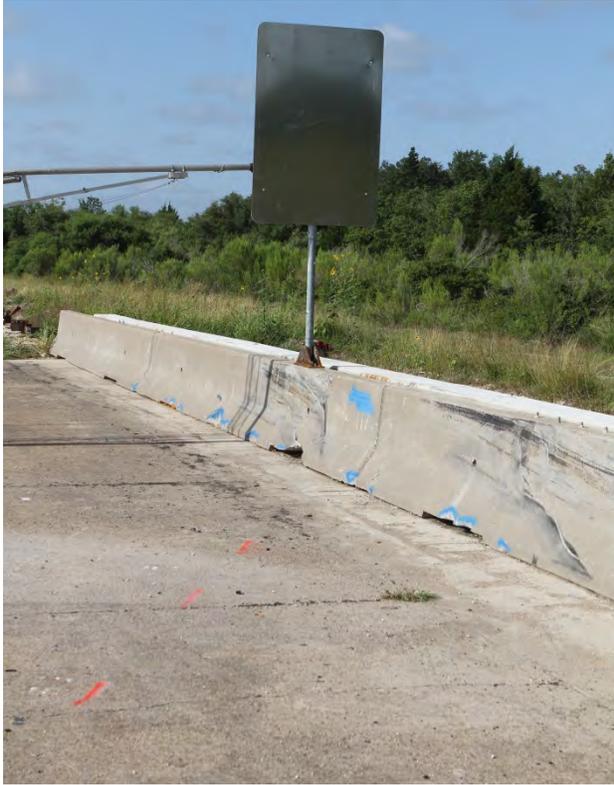
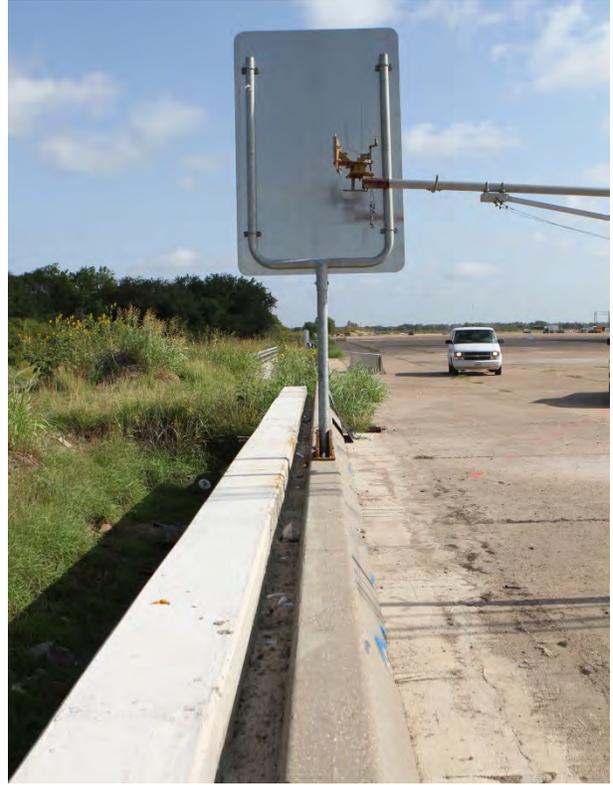
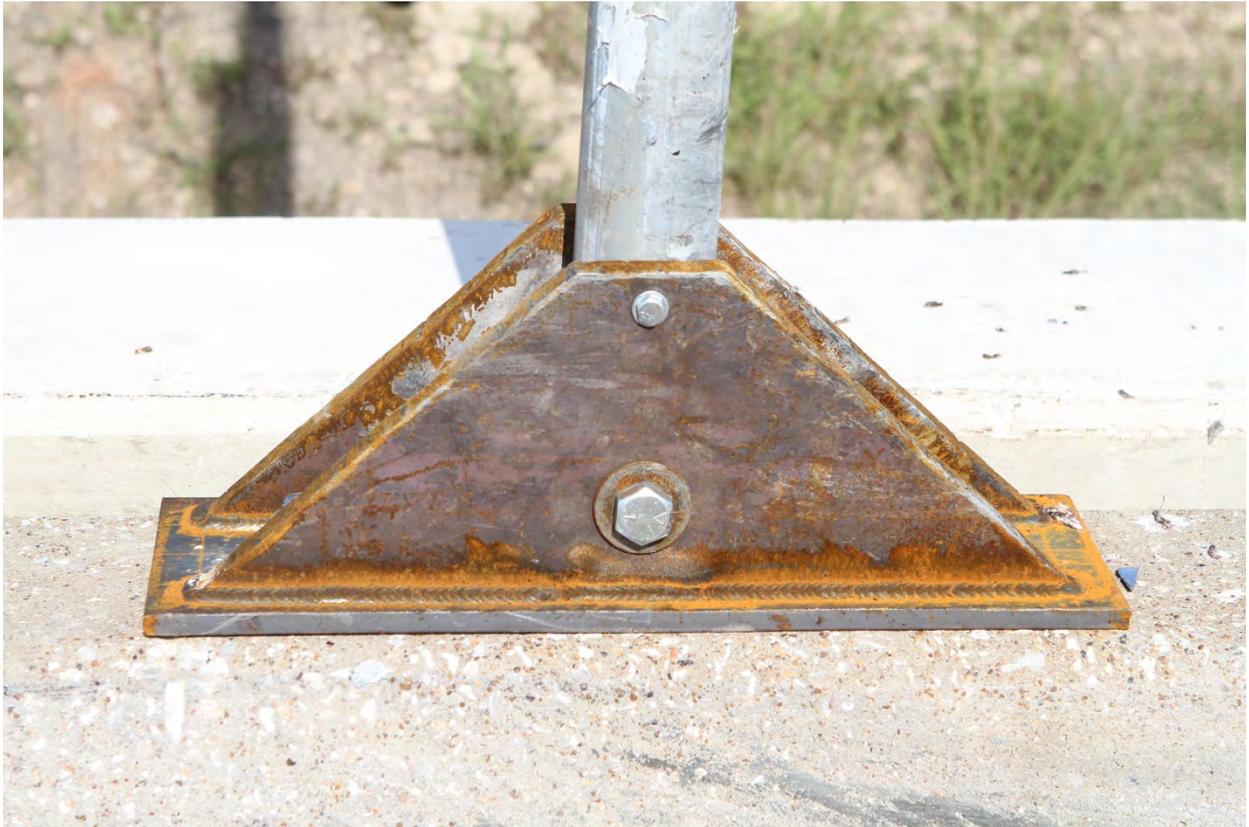
Figure 6.14. Bracket and Sacrificial Pin Sign Support on CMB before Test No. 466462-2a.

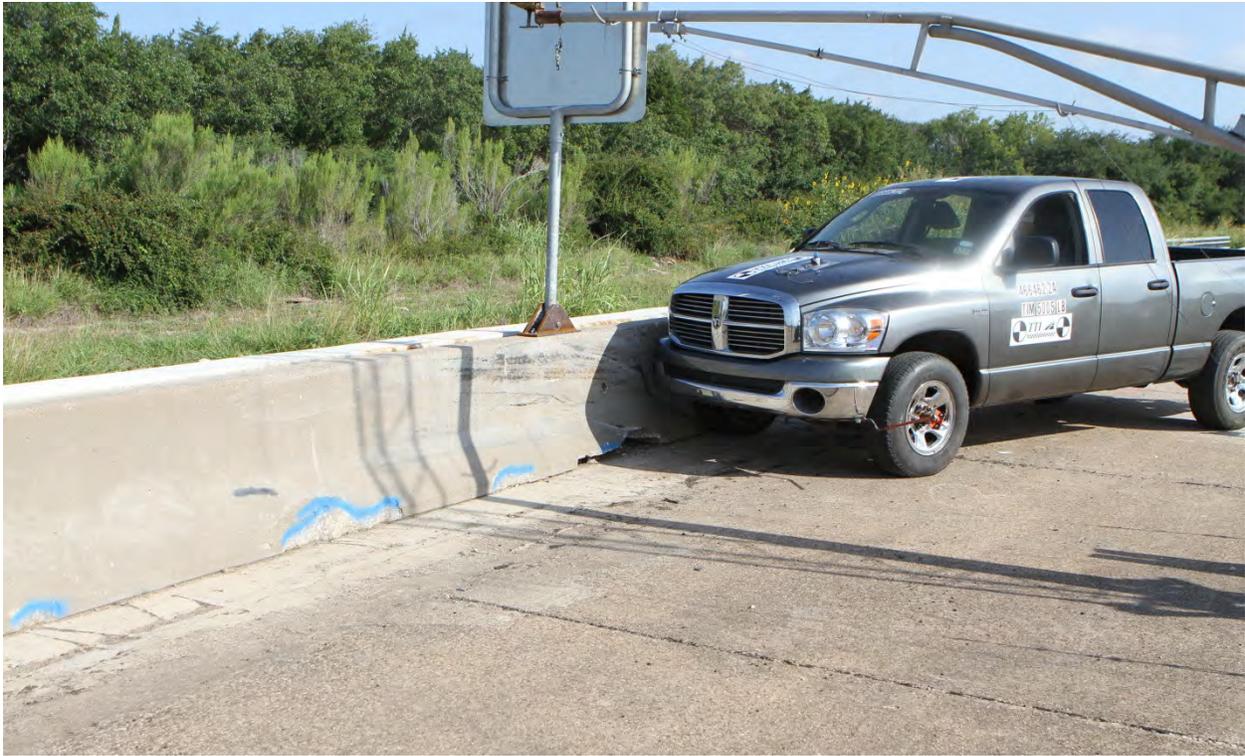
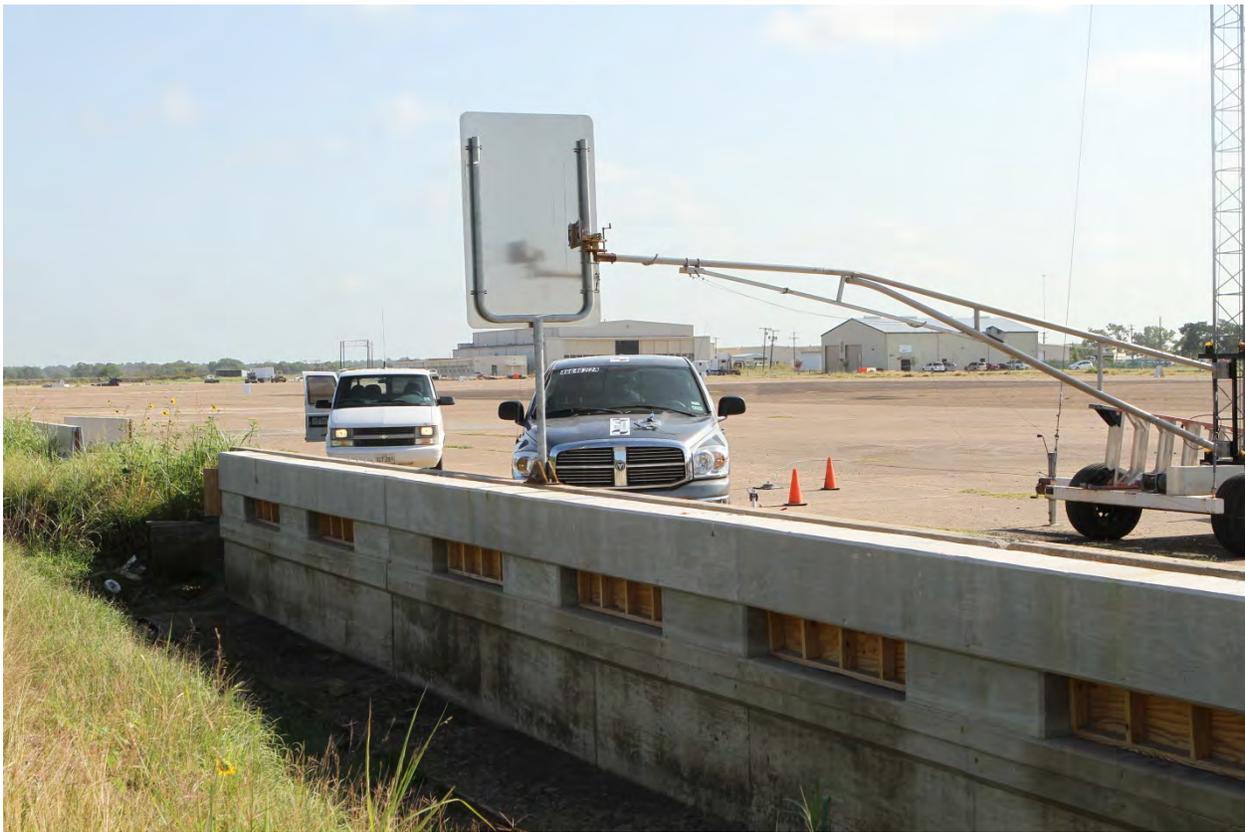
Figure 6.15. Vehicle/Bracket and Sacrificial Pin Sign Support on CMB Geometrics for Test No. 466462-2a.

A 2007 Dodge Ram 1500 pickup truck, shown in Figures 6.15 and 6.16, was used for the crash test. Test inertia weight of the vehicle was 4995 lb, and its gross static weight was 4995 lb. The height to the lower edge of the vehicle bumper was 13.75 inches, and it was 25.38 inches to the upper edge of the bumper. The height to the vehicle's center of gravity was 28.12 inches. Tables D1 and D2 in Appendix D3 give additional dimensions and information on the vehicle. The vehicle was directed into the installation using the cable reverse tow and guidance system, and was released to be unrestrained just prior to impact.

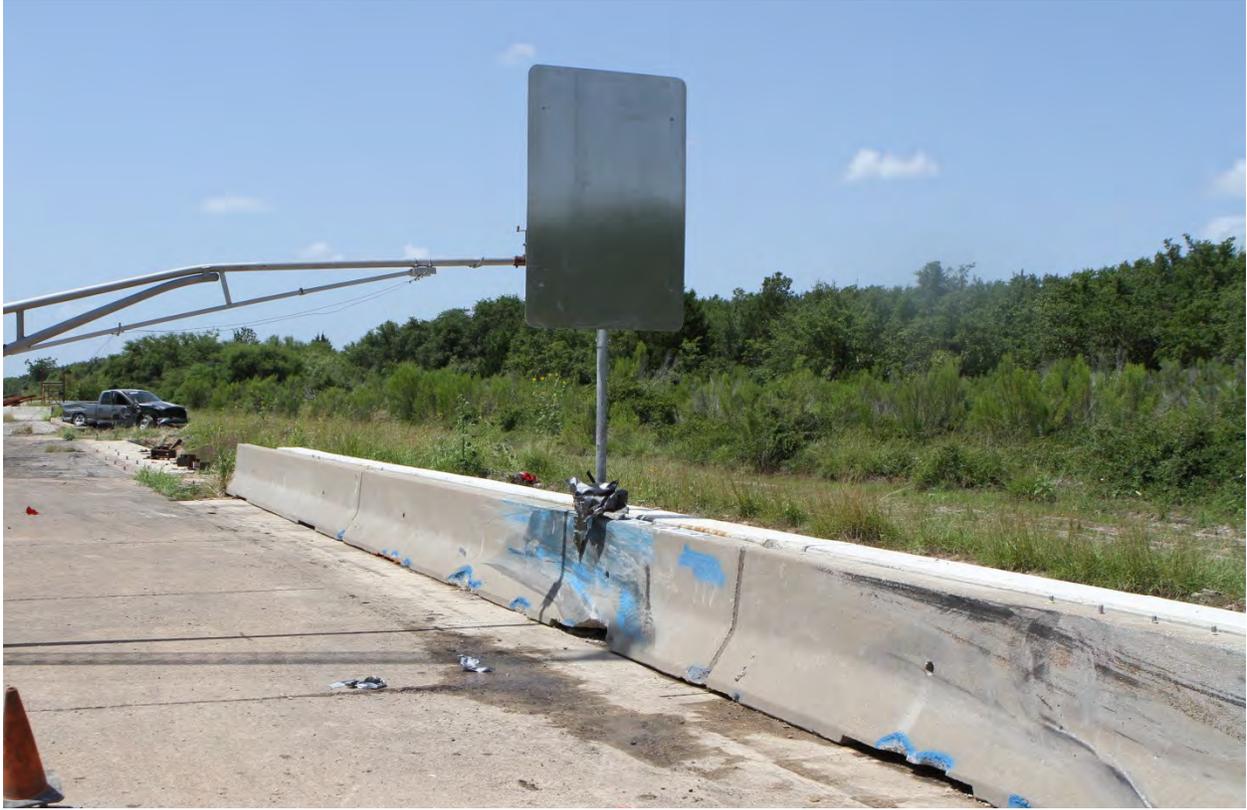
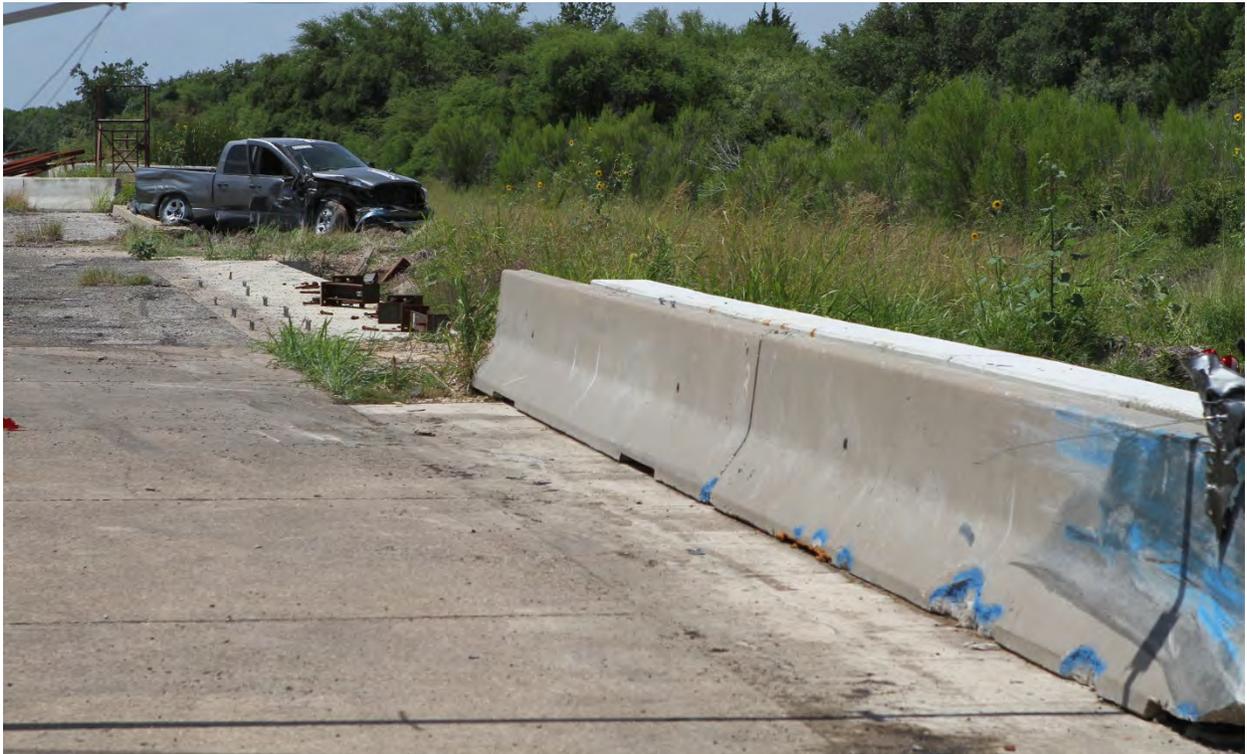
Figures 6.17 and 6.18 show damage to the bracket and sacrificial pin sign support and barrier. The barrier face was marred with tire marks and scrapings. The sign support was leaning downstream and several small pieces of the sheet metal from the vehicle were found in the pivot channel. The 2270P vehicle was in contact with the barrier 140 inches. Vehicle penetration (formerly working width) was 14.3 inches. No movement was noted in the barrier.

Figure 6.17. Vehicle/Bracket and Sacrificial Pin Sign Support on CMB after Test No. 466462-2a.

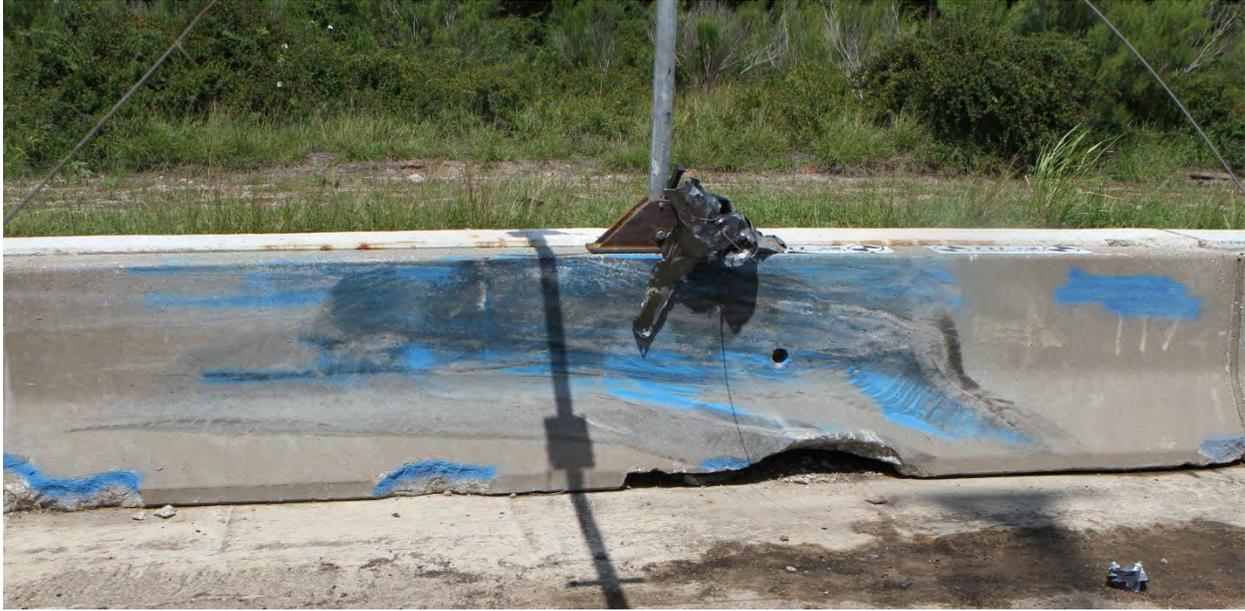
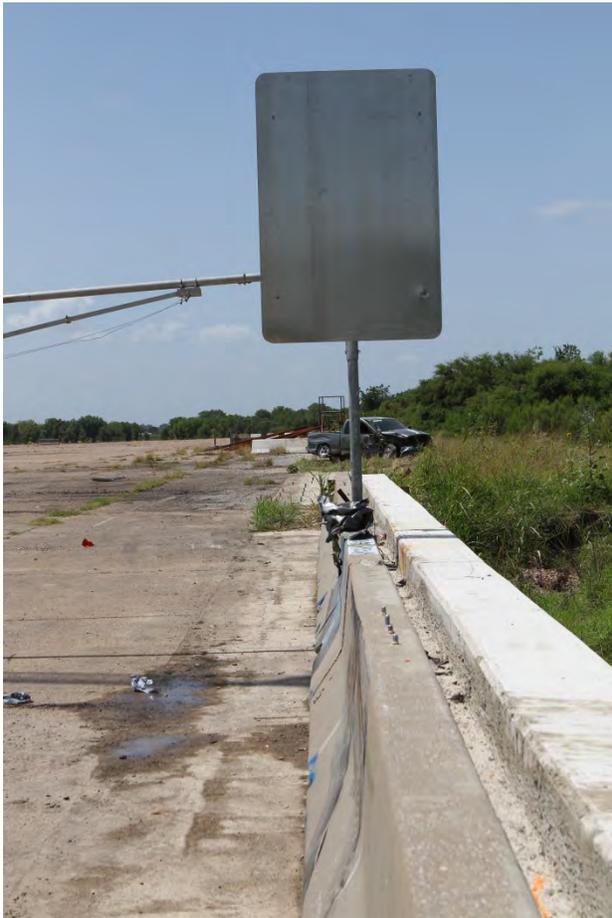
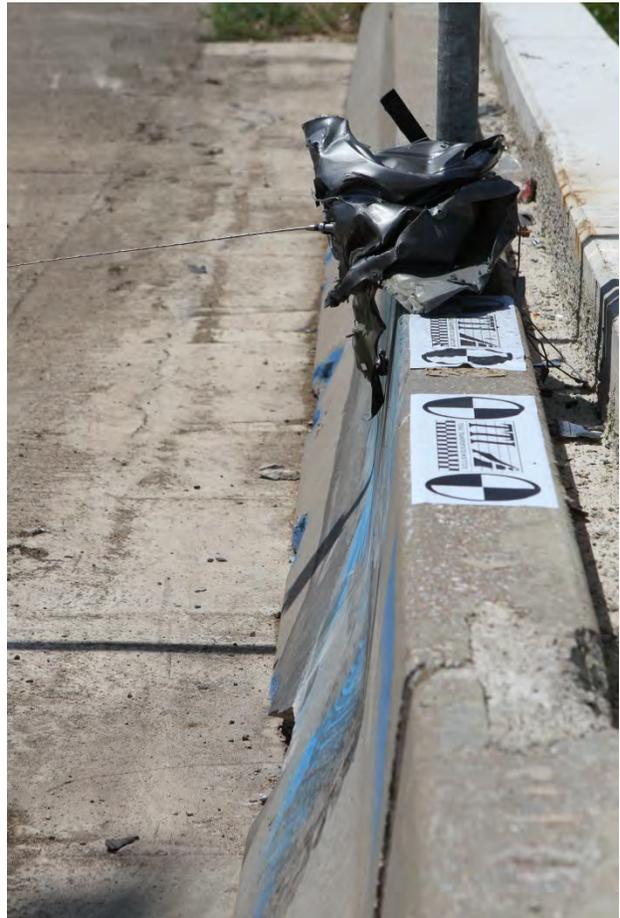
Figure 6.18. Bracket and Sacrificial Pin Sign Support on CMB after Test No. 466462-2a.

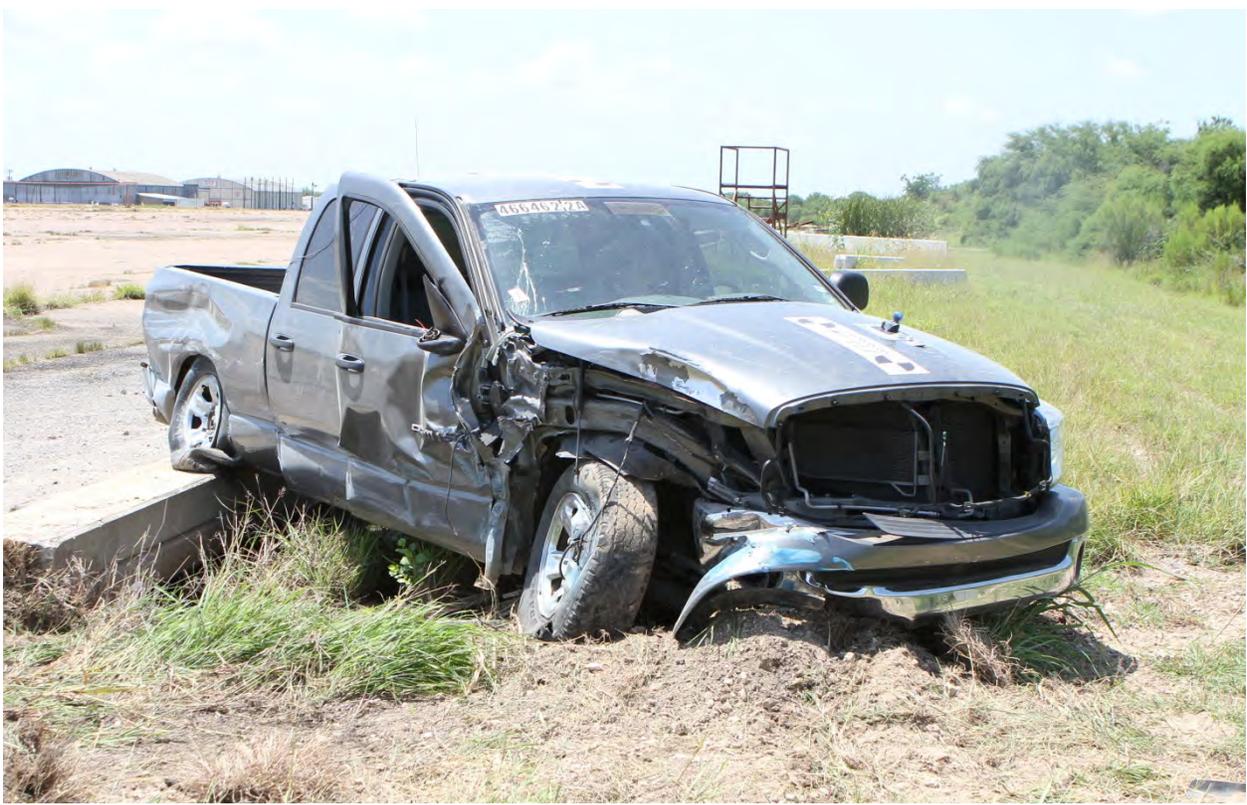
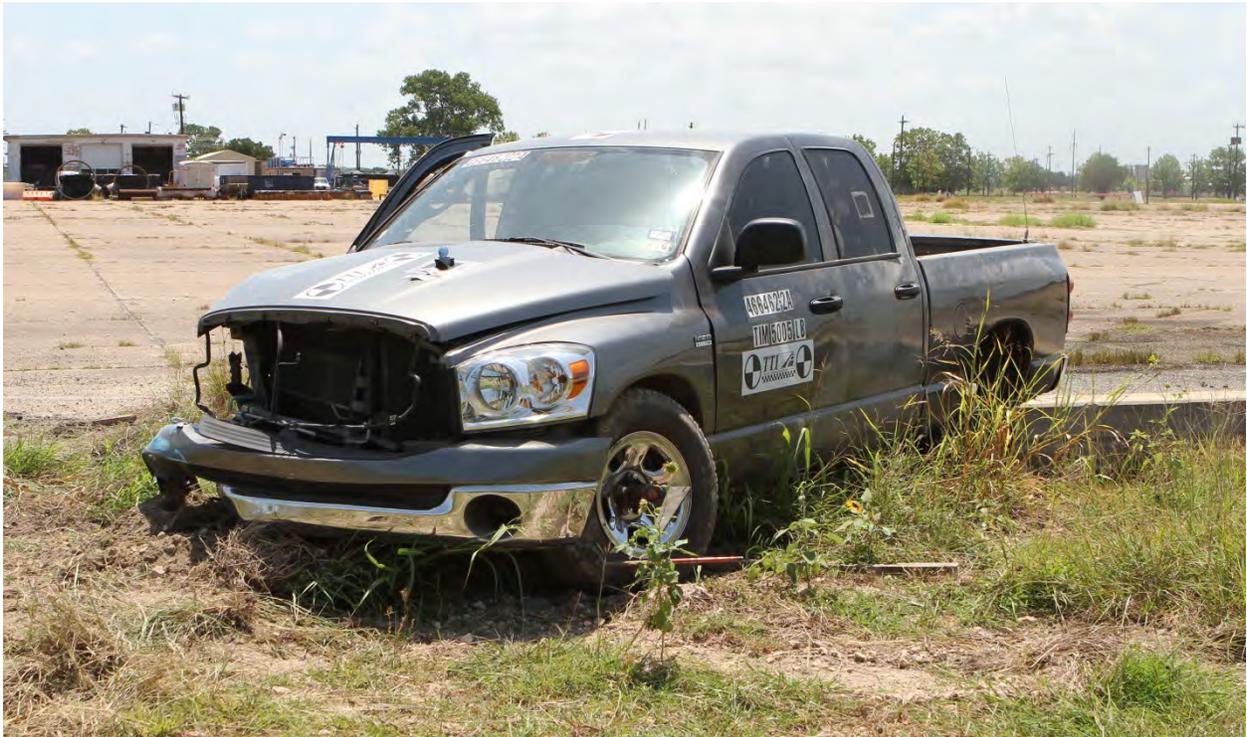
Figure 6.19 presents the damage sustained by the vehicle. The right upper and lower ball joints, right upper and lower A-arms, and the right frame rail were deformed. The front bumper, hood, right front fender, right front door and door glass, right rear cab corner right exterior bed, right rear door, right front tire and wheel rim, right rear tire and wheel rim, and rear bumper were also damaged. Maximum exterior crush to the vehicle was 13.0 inches in the side plane at the right front corner at bumper height. Maximum occupant compartment deformation caused by interaction with the sign support and barrier was 2.5 inches in the firewall area on the right side. Figure 6.20 show the interior of the vehicle. Tables D3 and D4 in Appendix D3 provide maximum exterior crush and occupant compartment deformation of the vehicle.

Figure 6.19. Vehicle after Test No. 466462-2a.

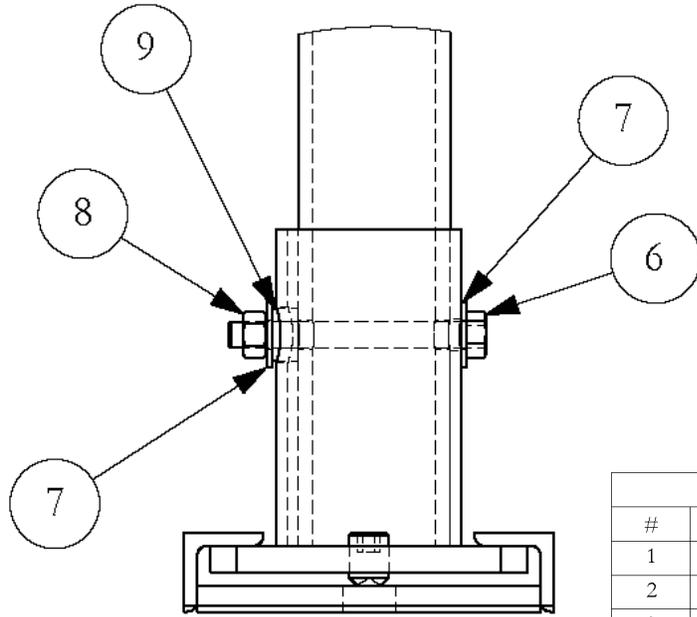
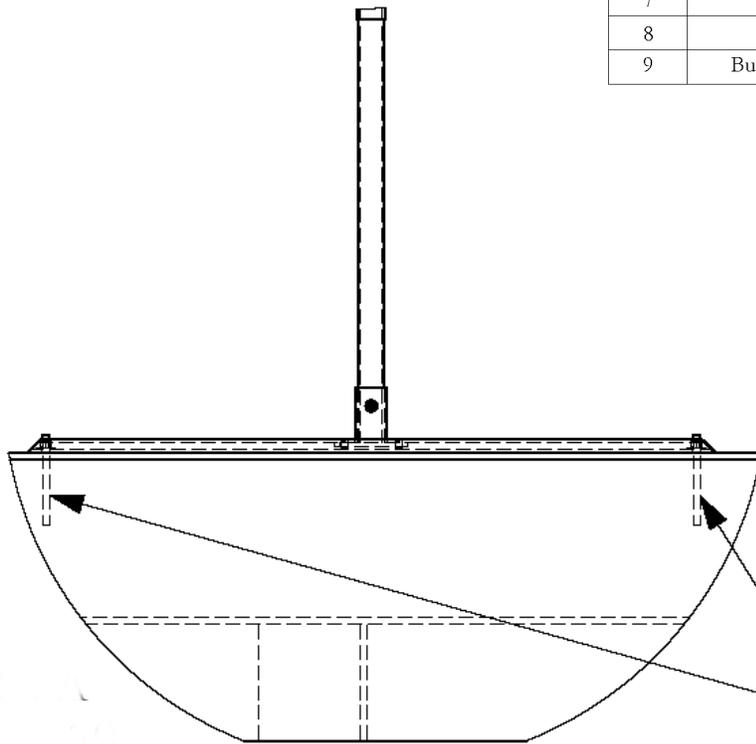
In the installation for test 466462-3, the sign post is mounted to a collar and slide assembly. The collar and slide assembly is placed in the middle of the 76-inch long chute with four screw sets to prevent it from sliding due to wind loading. The built up chute is mounted to the top face of the barrier using two anchor rods at each end; each is 8-inch long, 3/4-inch diameter. Figure 6.22 shows the collar and slide assembly and the chute details. Additional details are provided in Appendix E1 and E2. Figure 6.13 presents photographs of the completed installation prior to test 466462-3.

SIGN ASSEMBLY PARTS		
#	PART NAME	QTY.
1	Slide Assembly	1
2	Pipe, 2-1/2" sch. 80	1
3	Sign, 1/8" thick aluminum	1
4	U-Bracket	1
5	Sign Attachment Bracket	4
6	Bolt, 1/2 x 4-1/2 hex	2
7	Washer, 1/2 flat	4
8	Nut, 1/2 hex	2
9	Bushing, McMaster-Carr #92415A147	1

3/4-inch galvanized Hilti HAS-E rods (2), embedded 8 inches min., and secured with Hilti Hy 150 epoxy, according to manufacturer's instructions.

Figure 6.22. Details of the Chute Channel Sign Support on CMB.

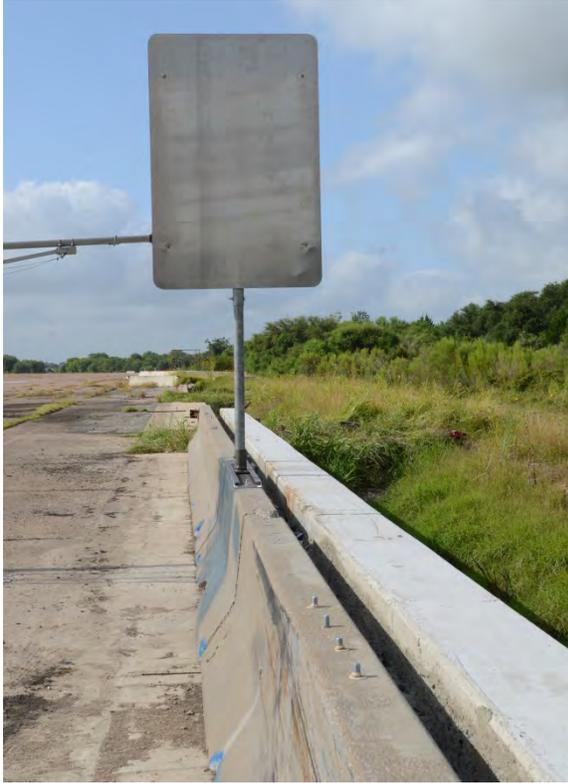
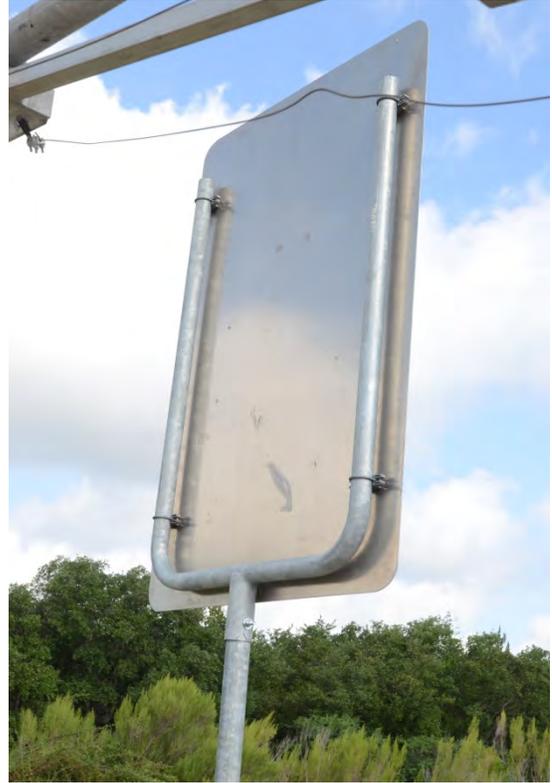
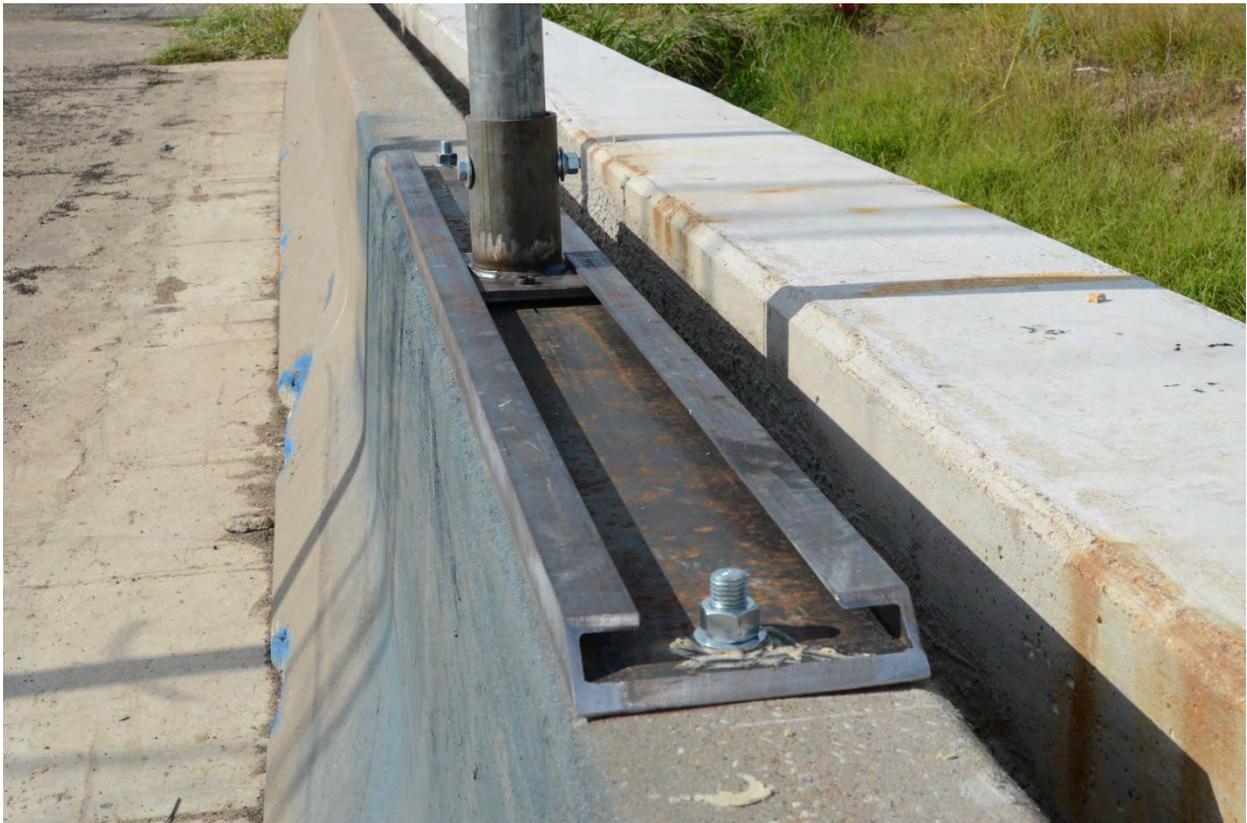
Figure 6.23. Chute Channel Sign Support on CMB before Test No. 466462-3.

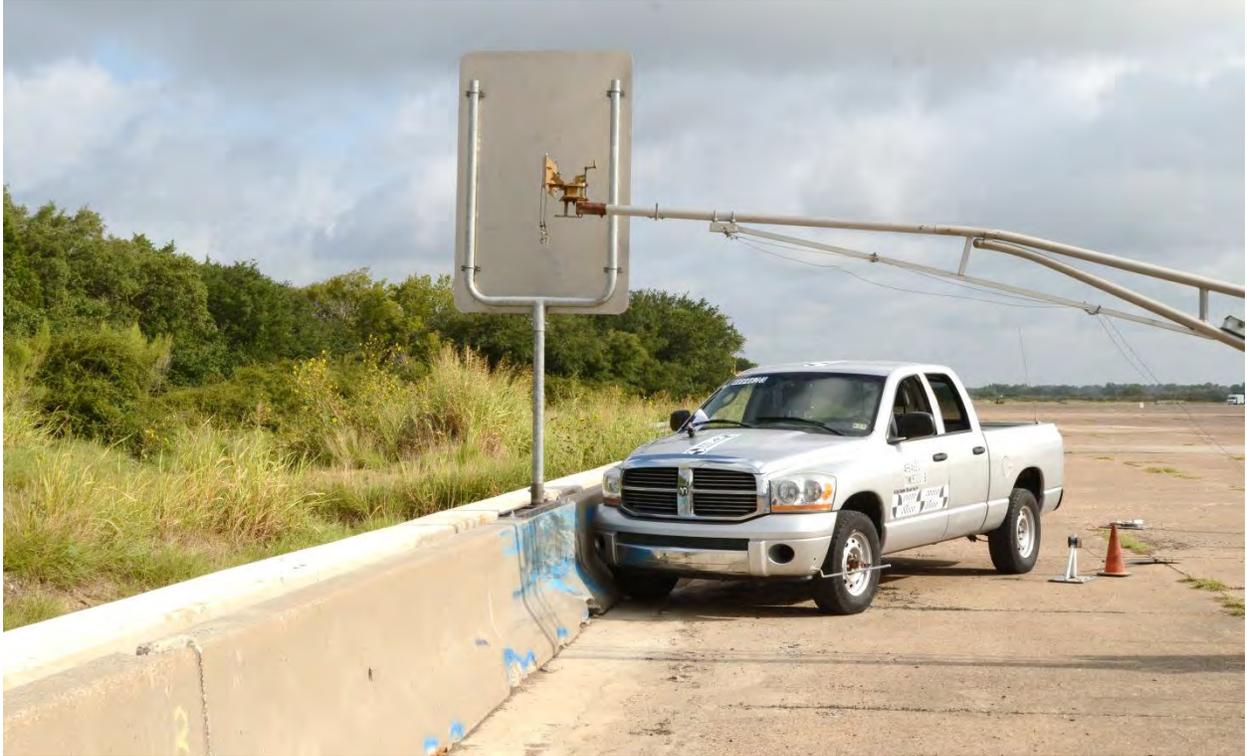
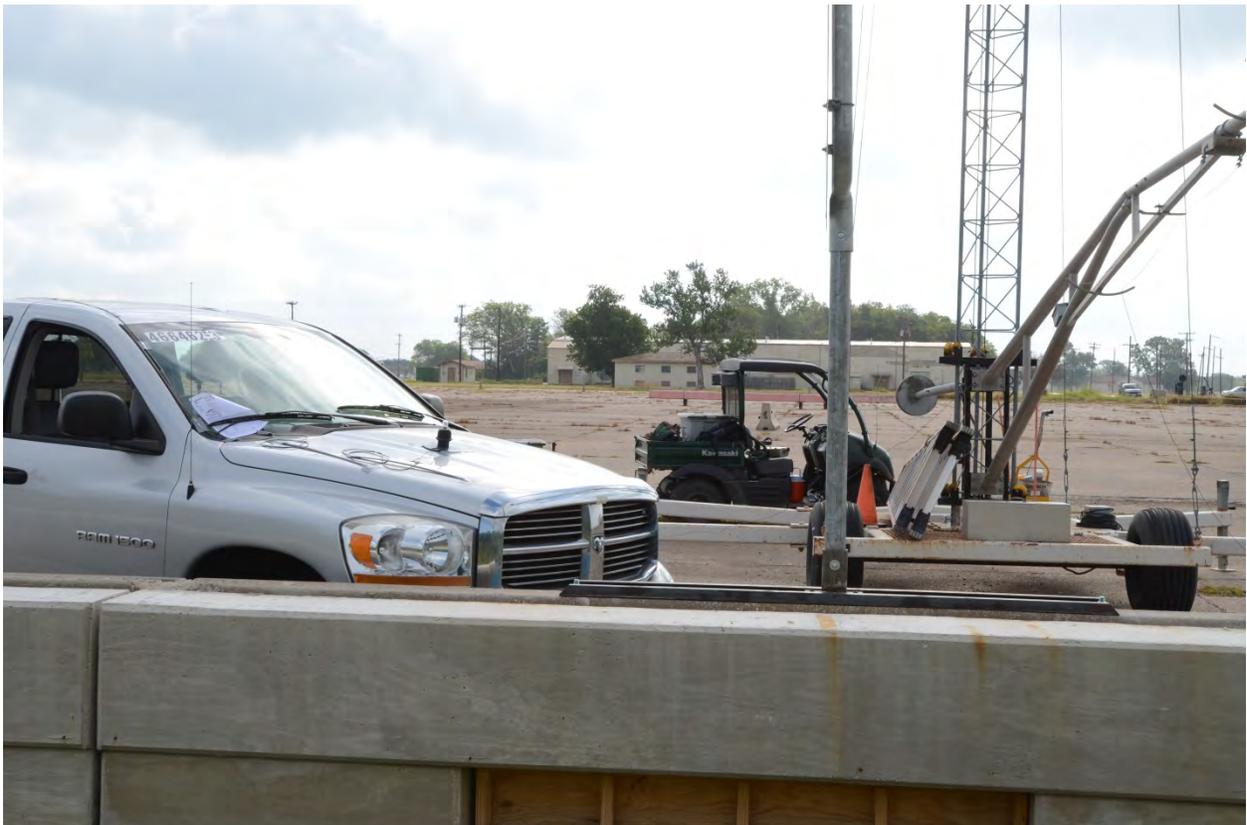
Figure 6.24. Vehicle/Chute Channel Sign Support on CMB Geometrics for Test No. 466462-3.

A 2006 Dodge Ram 1500 pickup, shown in Figures 6.24 and 6.25, was used for the crash test. Test inertia weight of the vehicle was 5029 lb, and its gross static weight was 5029 lb. The height to the lower edge of the vehicle bumper was 13.75 inches, and it was 25.38 inches to the upper edge of the bumper. The height to the vehicle's center of gravity was 28.19 inches. Tables E1 and E2 in Appendix E3 gives additional dimensions and information on the vehicle. The vehicle was directed into the installation using the cable reverse tow and guidance system, and was released to be free-wheeling and unrestrained just prior to impact.

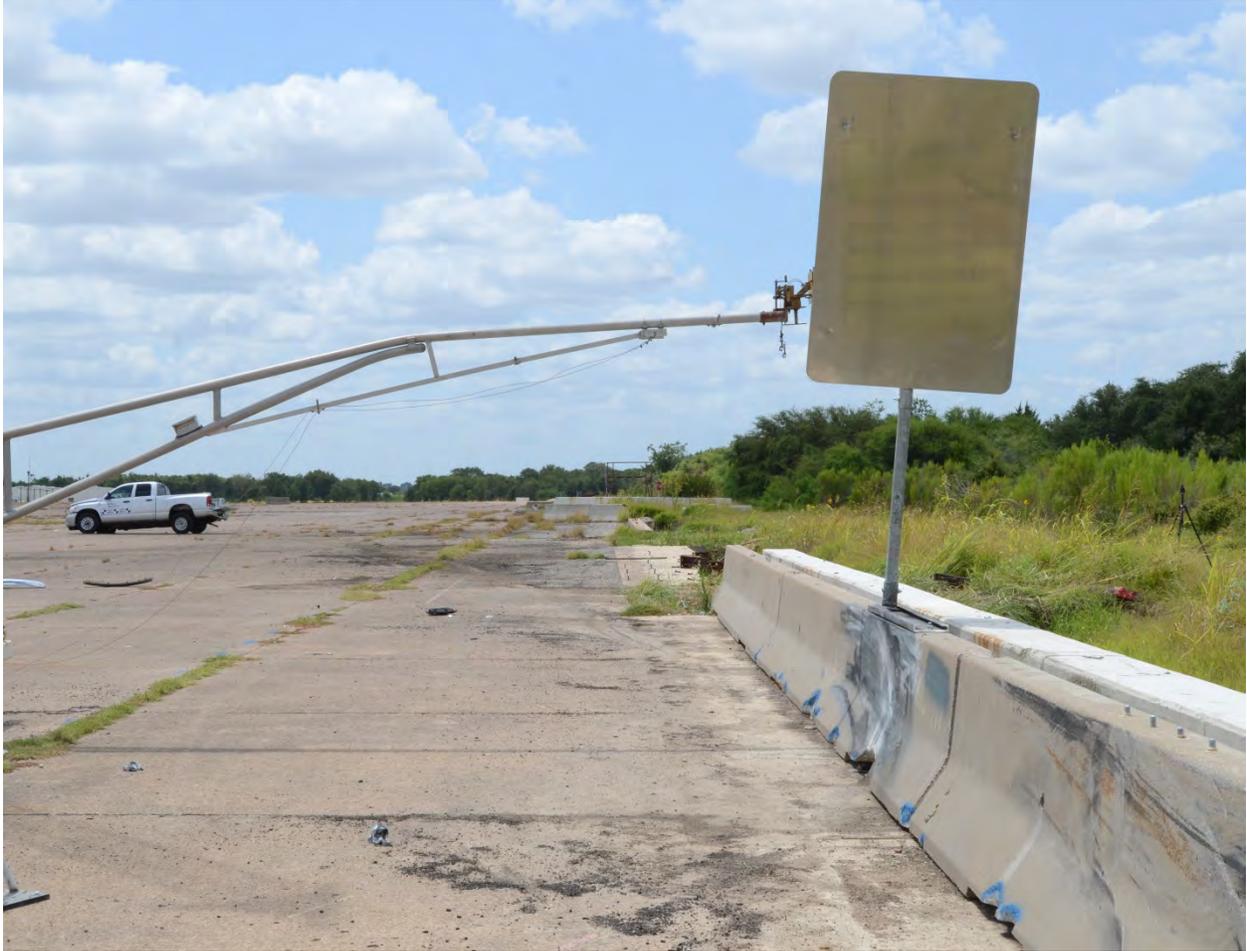
Figures 6.26 and 6.27 present the damage to the barrier and the chute channel sign support mounted on top the barrier. The sight support slid down the chute 27.6 inches, and the flange on the impact side of the chute was deformed upward 0.25 inch 18 inches downstream of centerline (see Figure 6.23). Vehicle penetration (formerly working width) was 25.9 inches. The vehicle was in contact with the barrier 148 inches.

Figure 6.26. Vehicle/Chute Channel Sign Support on CMB after Test No. 466462-3.
