Signs on Concrete Median Barriers

Test Report 0-6646-1

**TEXAS A&M TRANSPORTATION INSTITUTE
COLLEGE STATION, TEXAS**

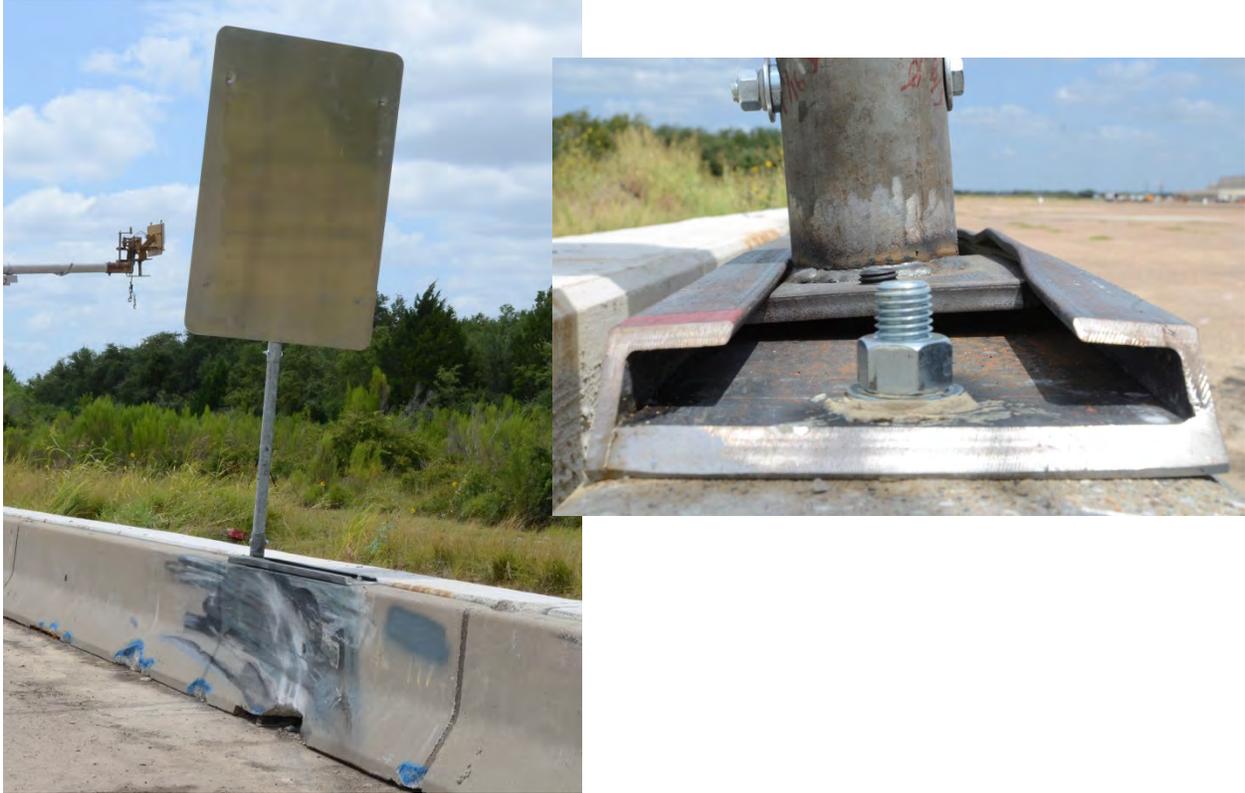
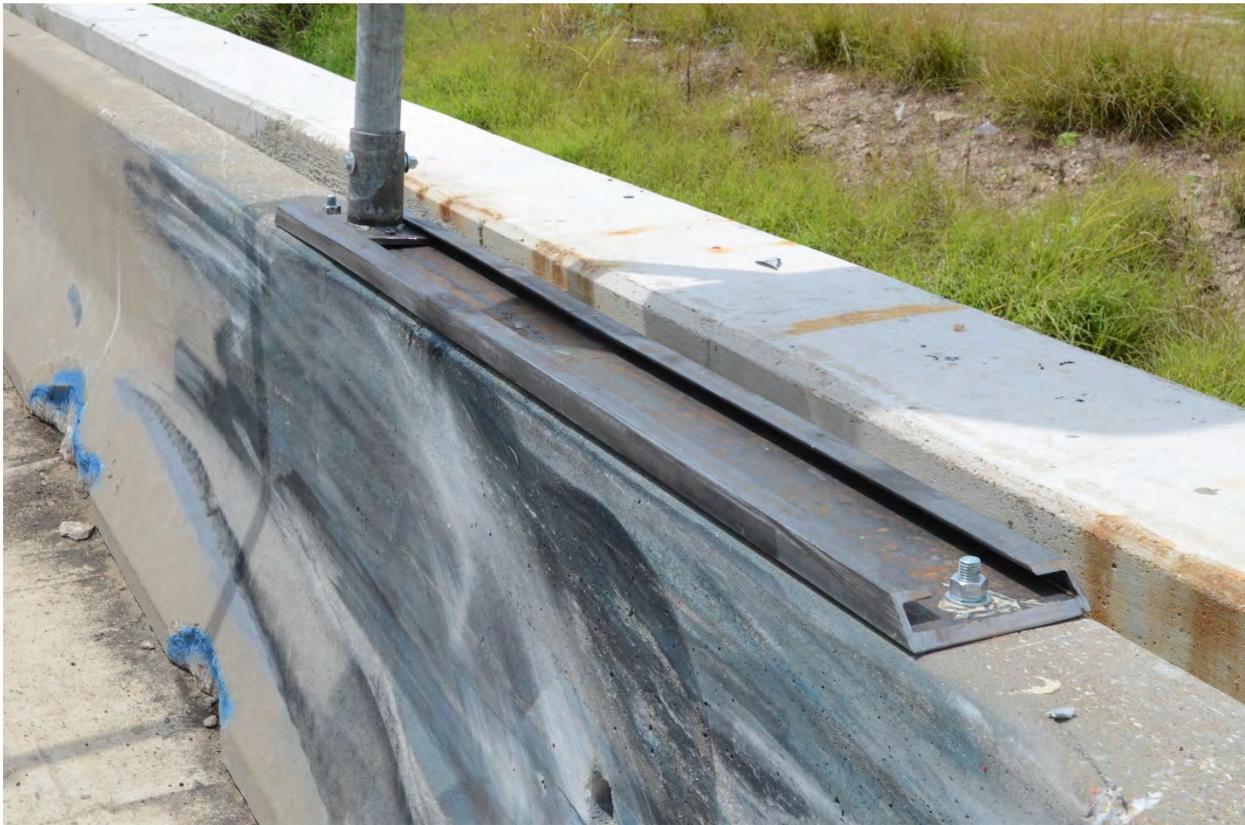
Figures 6.26 and 6.27 present the damage to the barrier and the chute channel sign support mounted on top the barrier. The sight support slid down the chute 27.6 inches, and the flange on the impact side of the chute was deformed upward 0.25 inch 18 inches downstream of centerline (see Figure 6.23). Vehicle penetration (formerly working width) was 25.9 inches. The vehicle was in contact with the barrier 148 inches.

Figure 6.27. Chute Channel Sign Support on CMB after Test No. 466462-3.

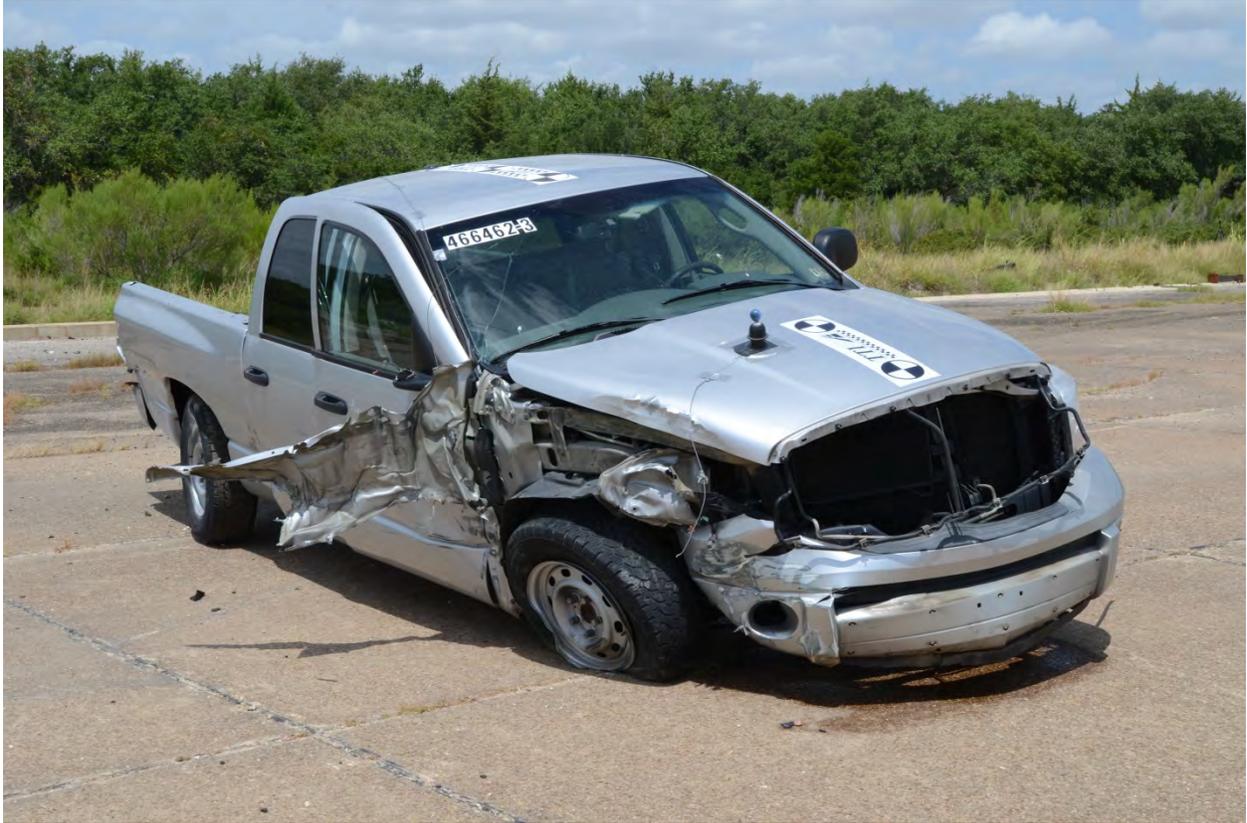
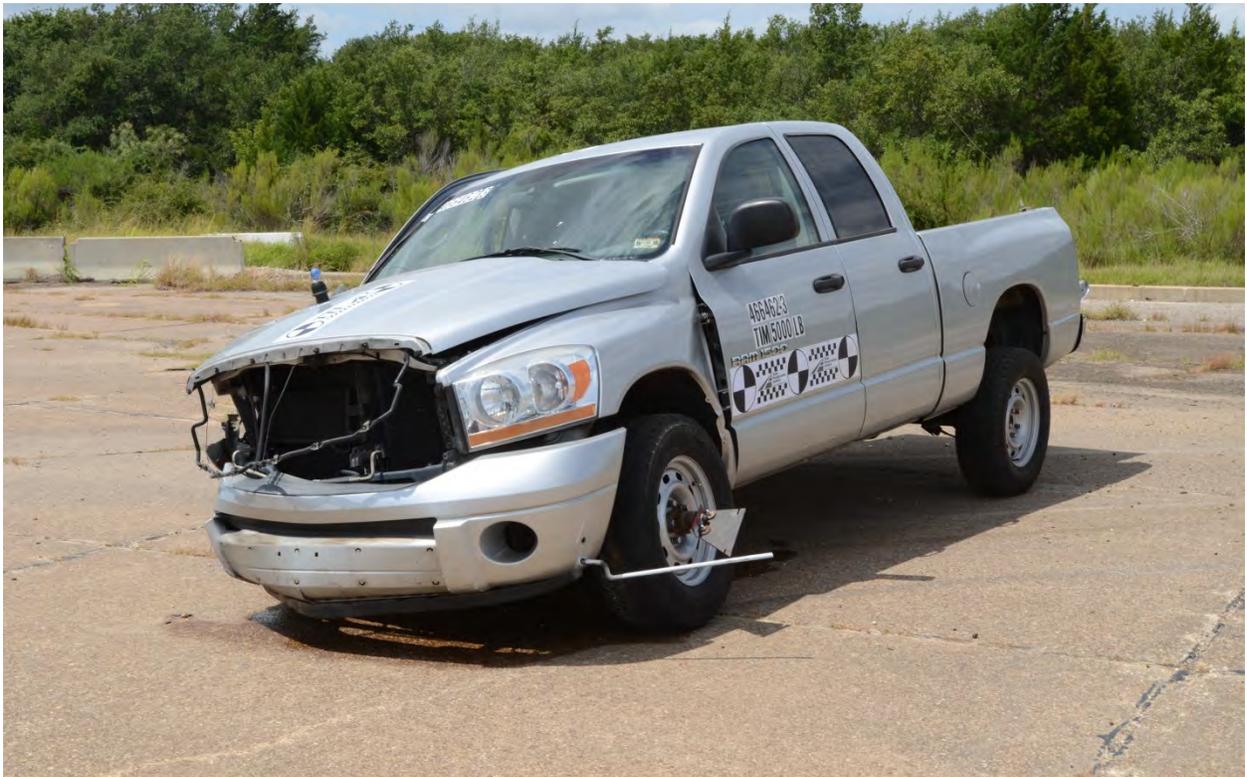
Figure 6.28 shows damage to the 2270P vehicle. The right front frame rail and right upper and lower A-arms were deformed. Also damaged were the front bumper, hood, right front tire and wheel rim, right front fender, right front door and door glass, right rear door, right rear corner of the exterior cab, right exterior bed, right rear wheel rim, rear bumper, and tailgate. The windshield sustained stress cracks in the right lower corner. Maximum exterior crush to the vehicle was 14.0 inches in the side plane at the right front corner at bumper height. Maximum occupant compartment deformation was 1.75 inches in the right side firewall area. Figure 6.29 presents the interior of the vehicle. Tables E3 and E4 in Appendix E3 provide maximum exterior crush and occupant compartment deformation of the vehicle.

Figure 6.28. Vehicle after Test No. 466462-3.

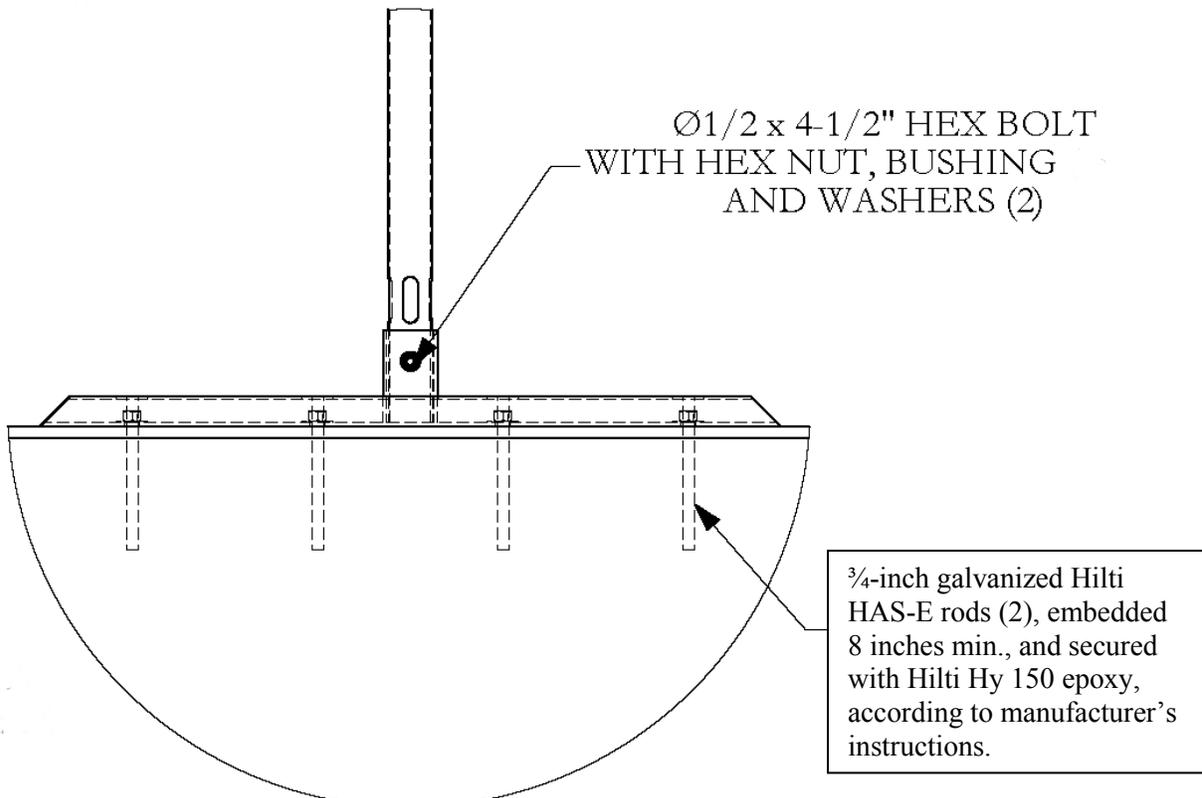
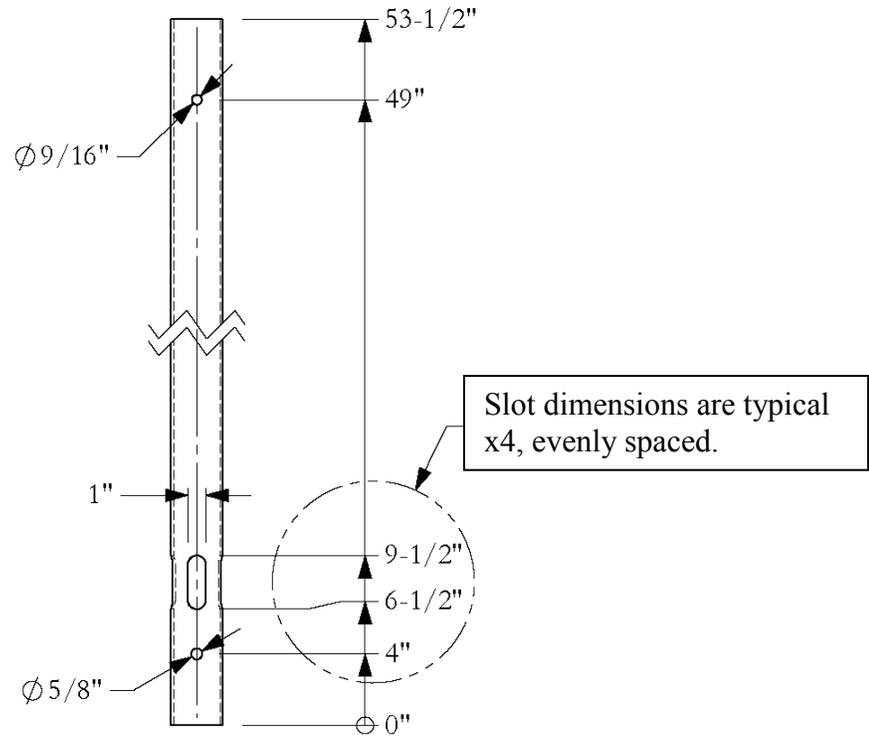
Figure 6.31. Details of the Slotted 10 BWG Sign Support.

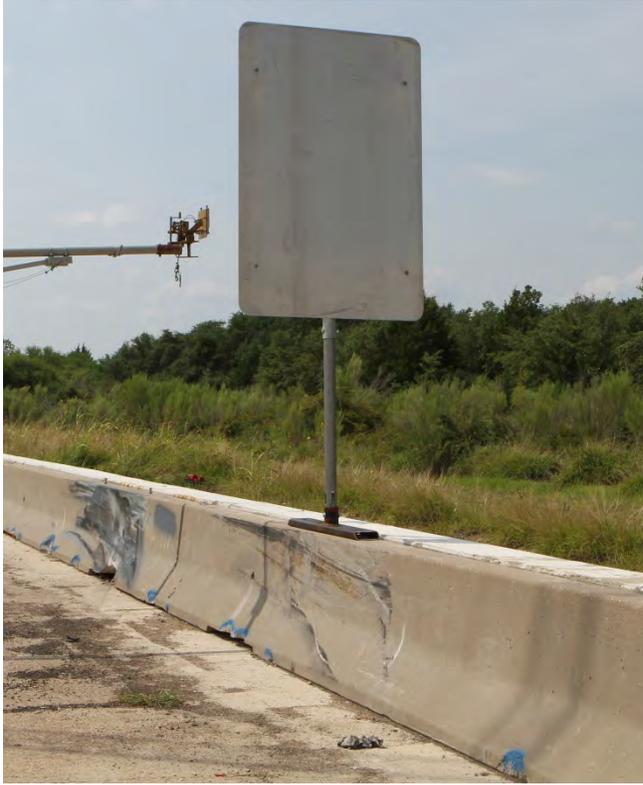
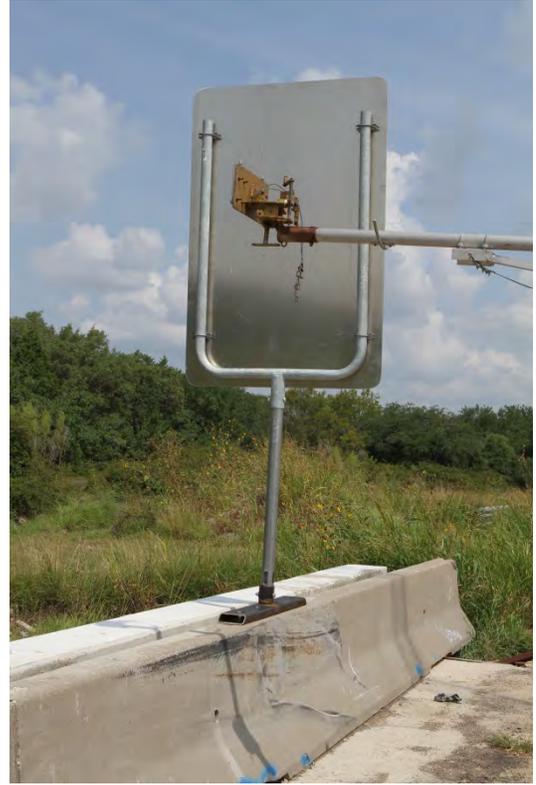
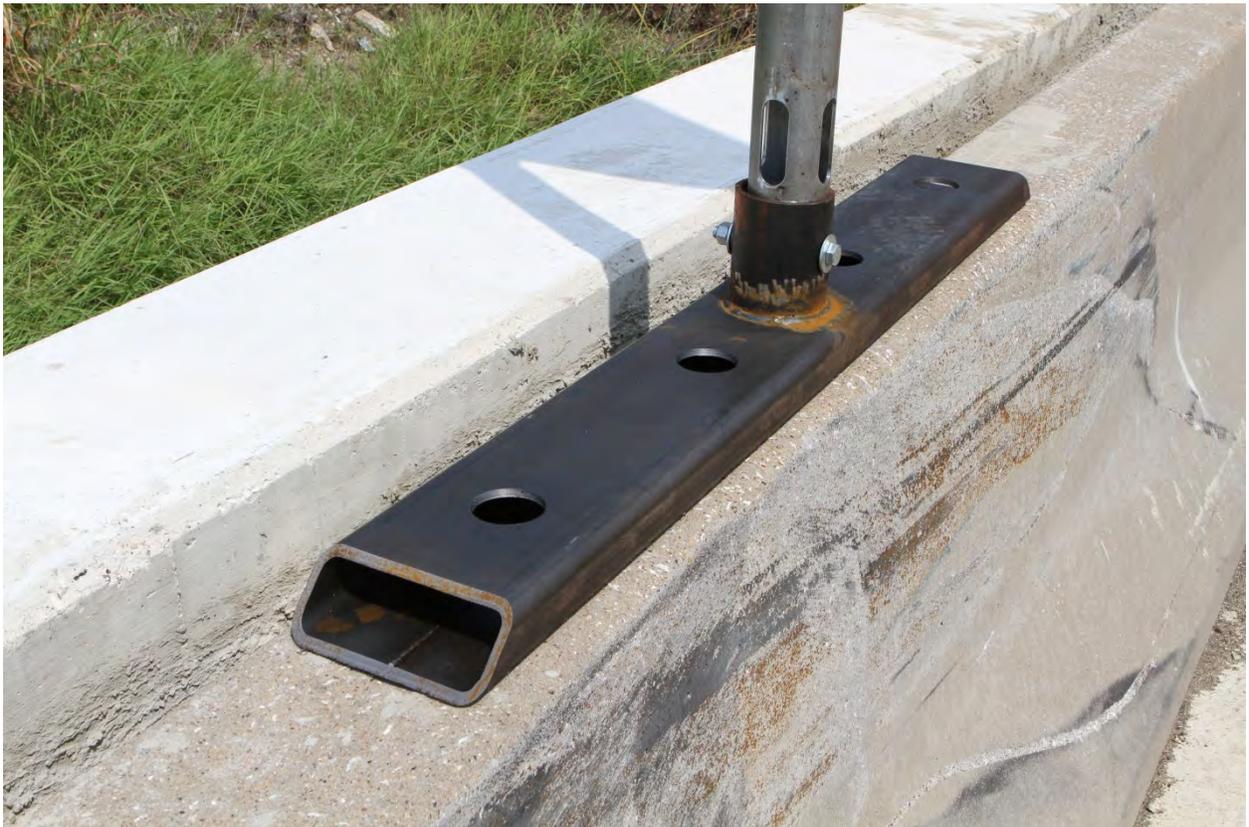
Figure 6.32. Slotted 10 BWG Sign Support on CMB before Test No. 466462-4.

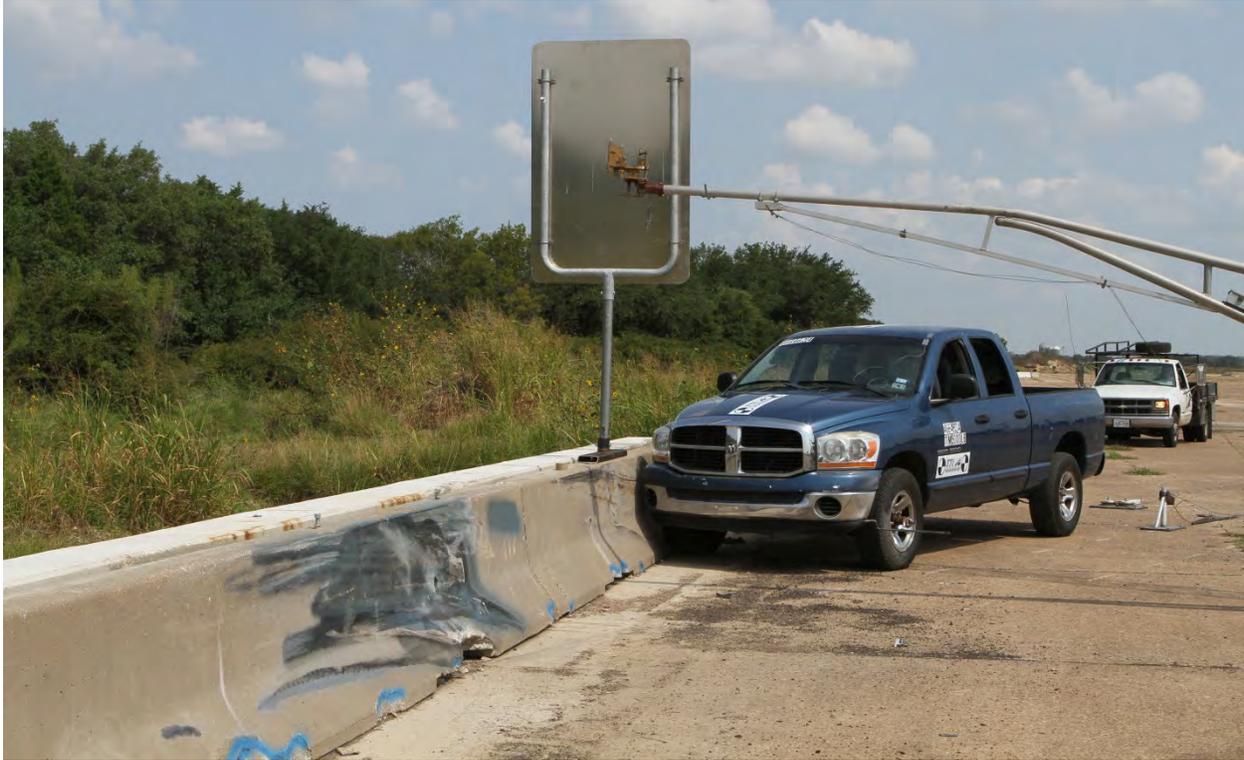
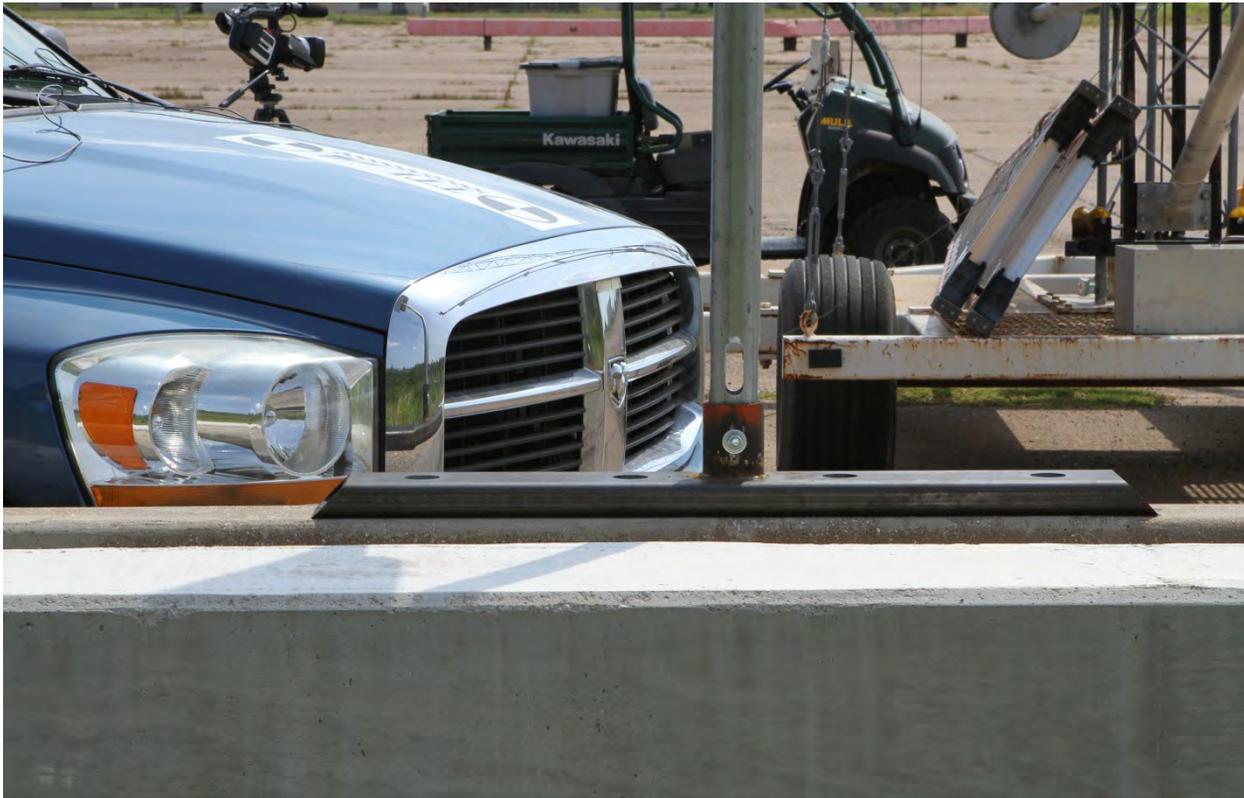
Figure 6.33. Vehicle/Slotted 10 BWG Sign Support on CMB Geometrics for Test No. 466462-4.

The 2006 Dodge Ram 1500 pickup truck, shown in Figures 6.33 and 6.34, was used for the crash test. Test inertia weight of the vehicle was 5011 lb, and its gross static weight was 5011 lb. The height to the lower edge of the vehicle bumper was 13.75 inches, and it was 25.38 inches to the upper edge of the bumper. The height to the vehicle's center of gravity was 28.50 inches. Tables F1 and F2 in Appendix F3 gives additional dimensions and information on the vehicle. The vehicle was directed into the installation using the cable reverse tow and guidance system, and was released to be free-wheeling and unrestrained just prior to impact.

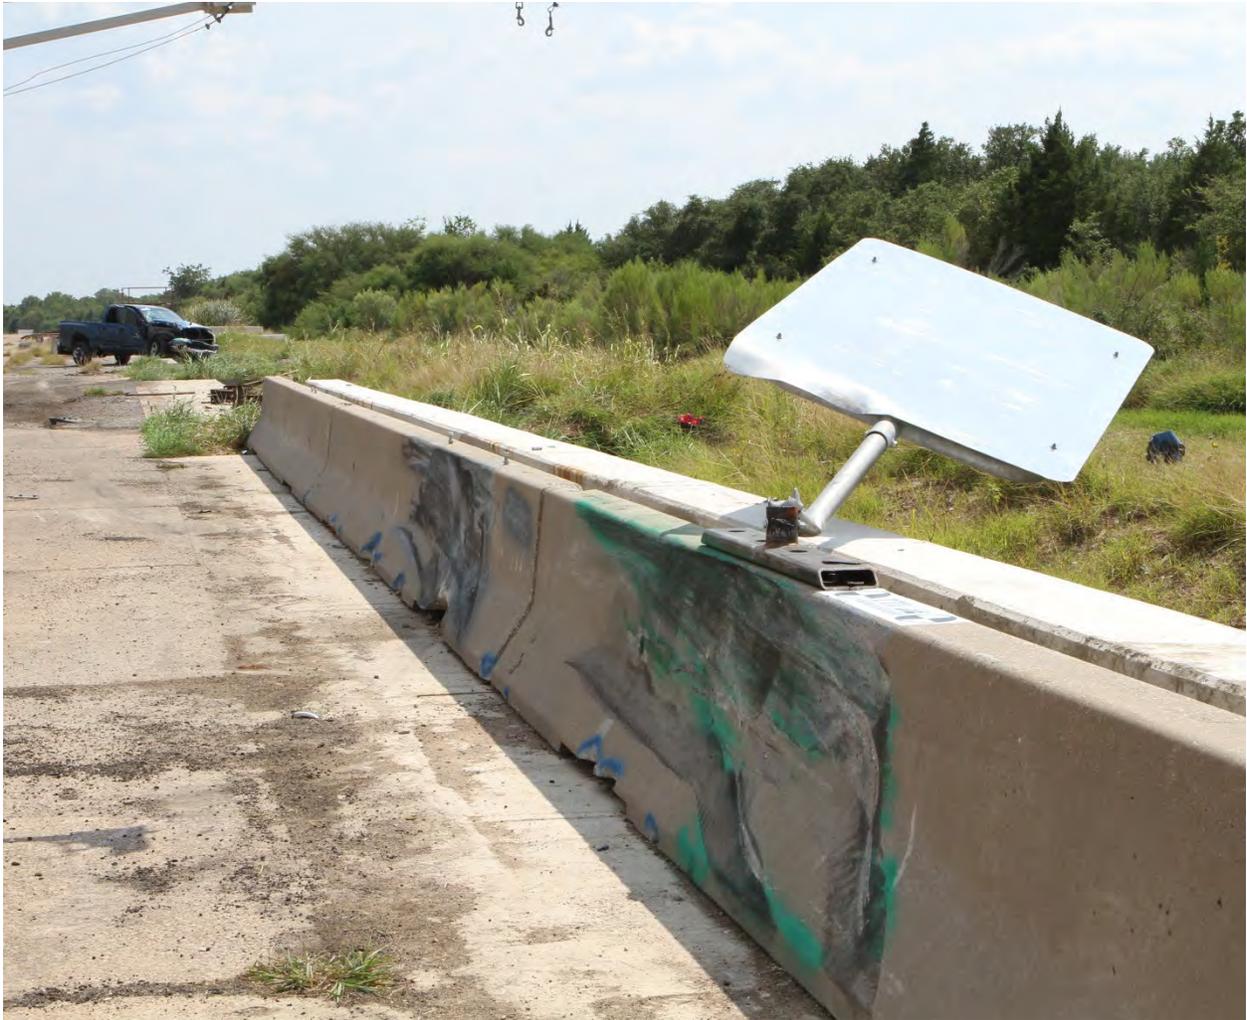
Figures 6.35 and 6.36 present the damage to the barrier and the slotted 10 BWG sign support mounted on top the barrier. The sign support was leaning downstream at 115 degrees and toward the field side 89.0 inches (working width). The 2270P vehicle was in contact with the barrier 164.5 inches. Vehicle penetration (formerly working width) was 20.6 inches. No movement was noted in the barrier.

Figure 6.35. Vehicle/Slotted 10 BWG Sign Support on CMB after Test No. 466462-4.

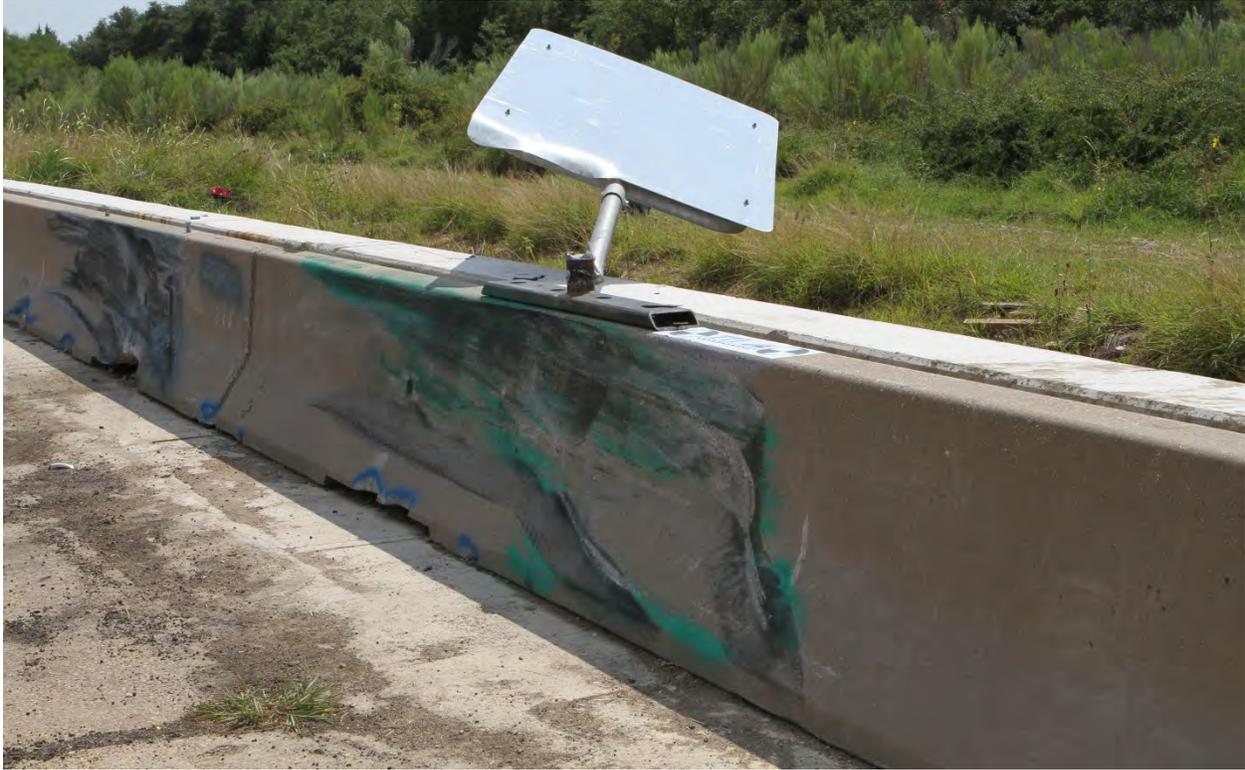
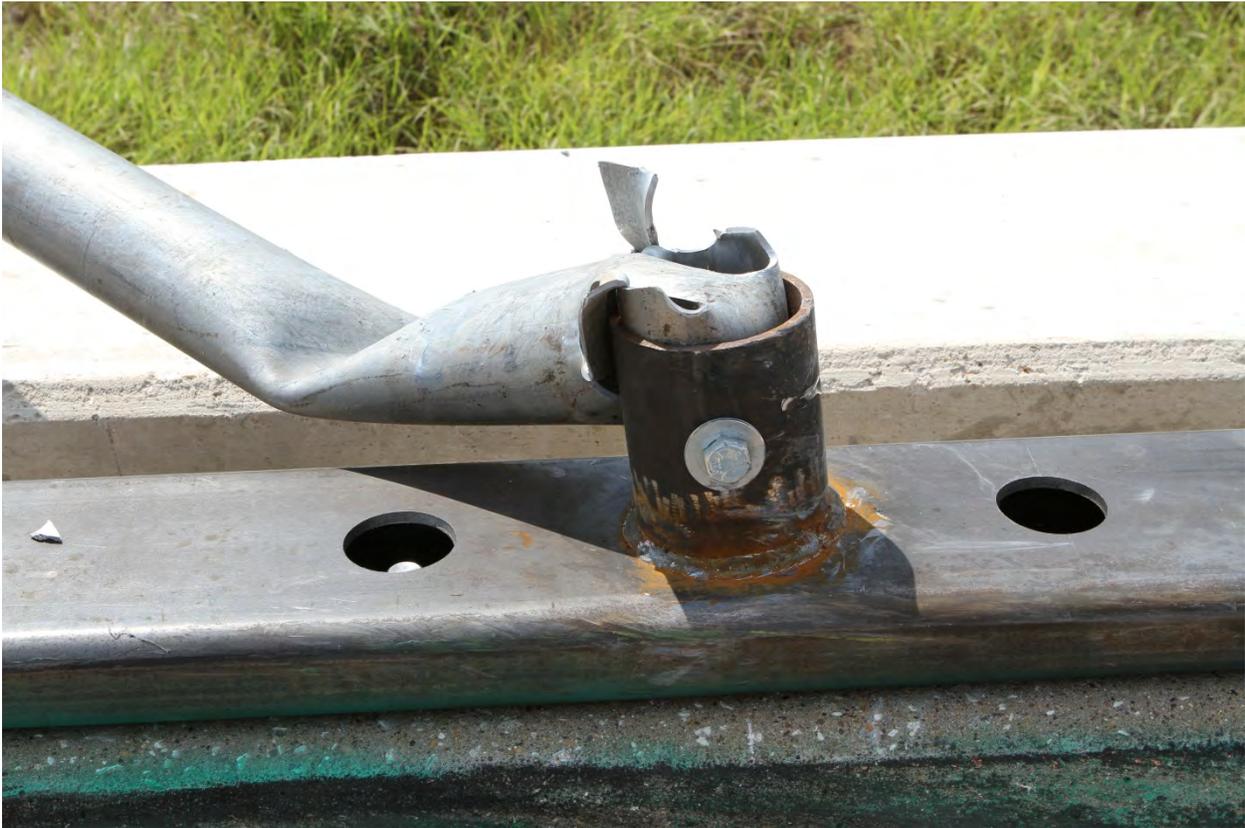
Figure 6.36. Slotted 10 BWG Sign Support on CMB after Test No. 466462-4.

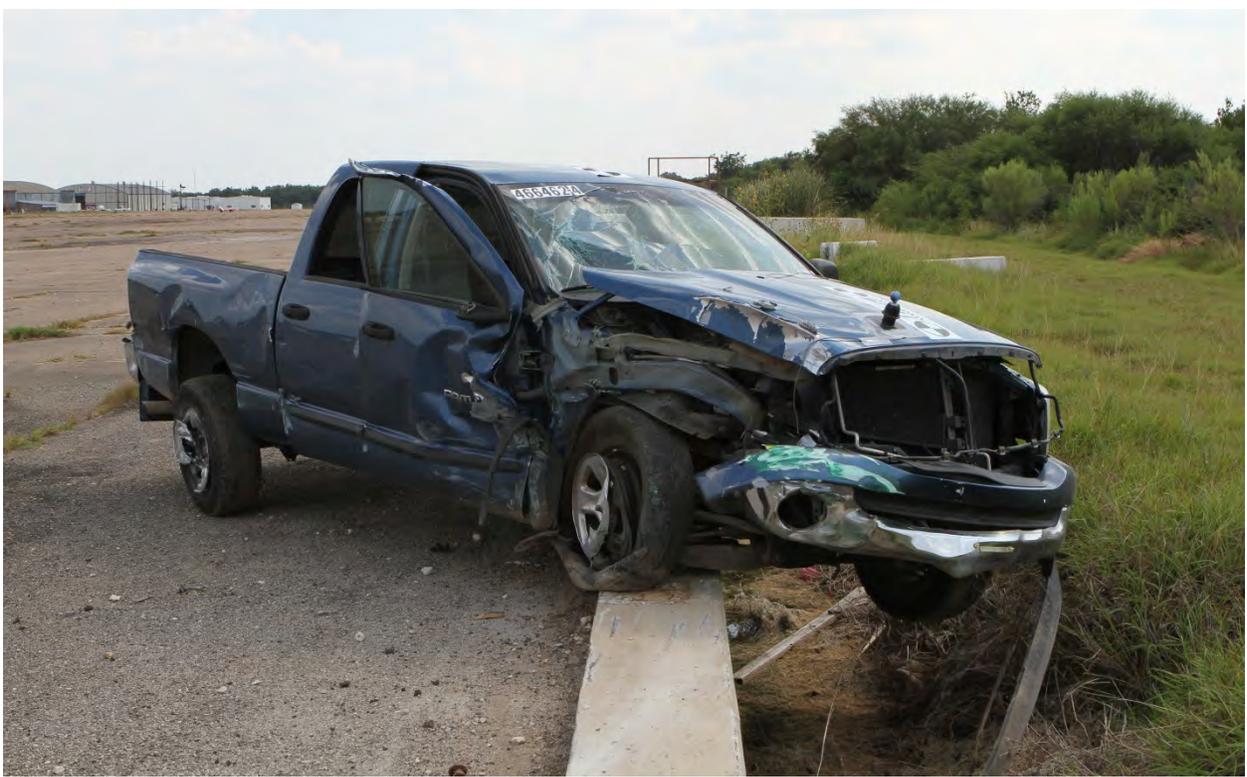
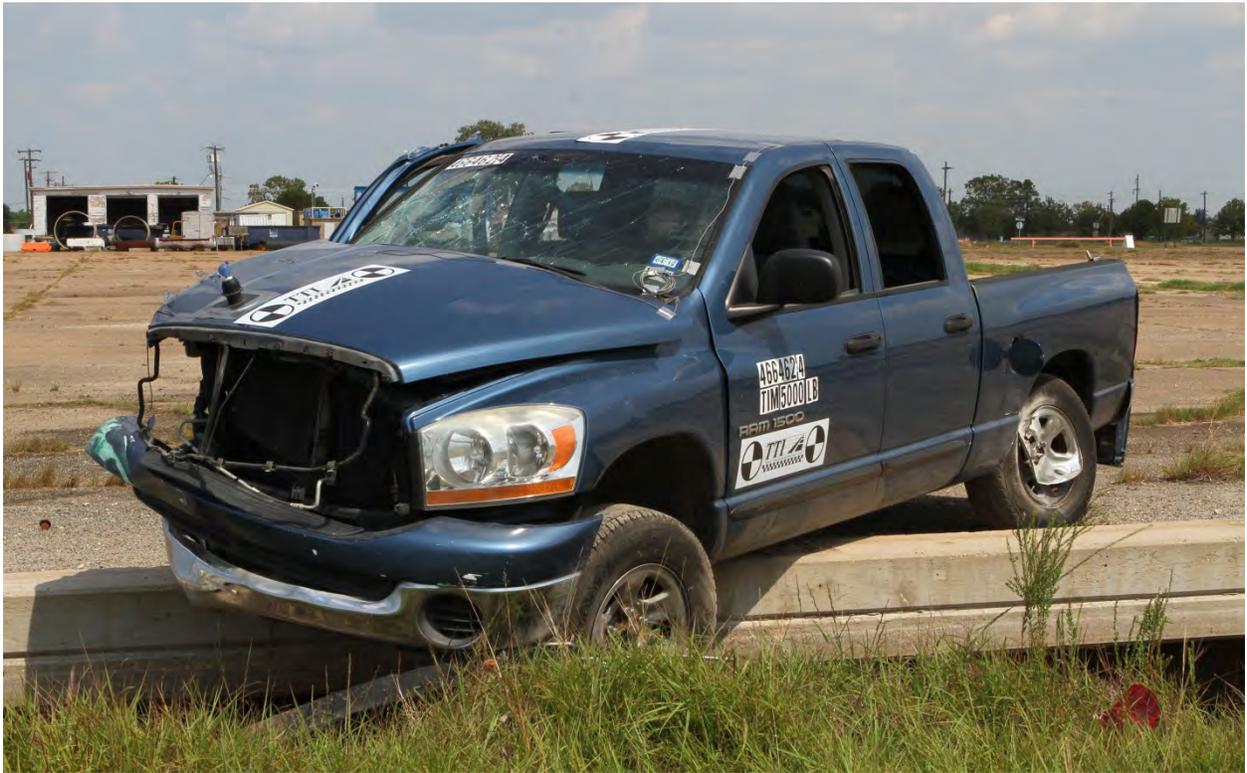
Figure 6.37 shows the damage sustained by the vehicle. The right front upper and lower A-arms and right frame rail were deformed. Also damaged were the front bumper, grill, radiator and supports, hood, right front tire and wheel rim, right front fender, right front and rear doors, right rear exterior bed, right rear wheel rim, rear bumper, and left rear wheel rim. Maximum exterior crush to the vehicle was 18.0 inches in the side plane at bumper height at the right front corner. Maximum occupant compartment deformation was 3.0 inches in the firewall on the right side. Tables F3 and F4 in Appendix F3 provide maximum exterior crush and occupant compartment deformation of the vehicle.

Figure 6.37. Vehicle after Test No. 466462-4.

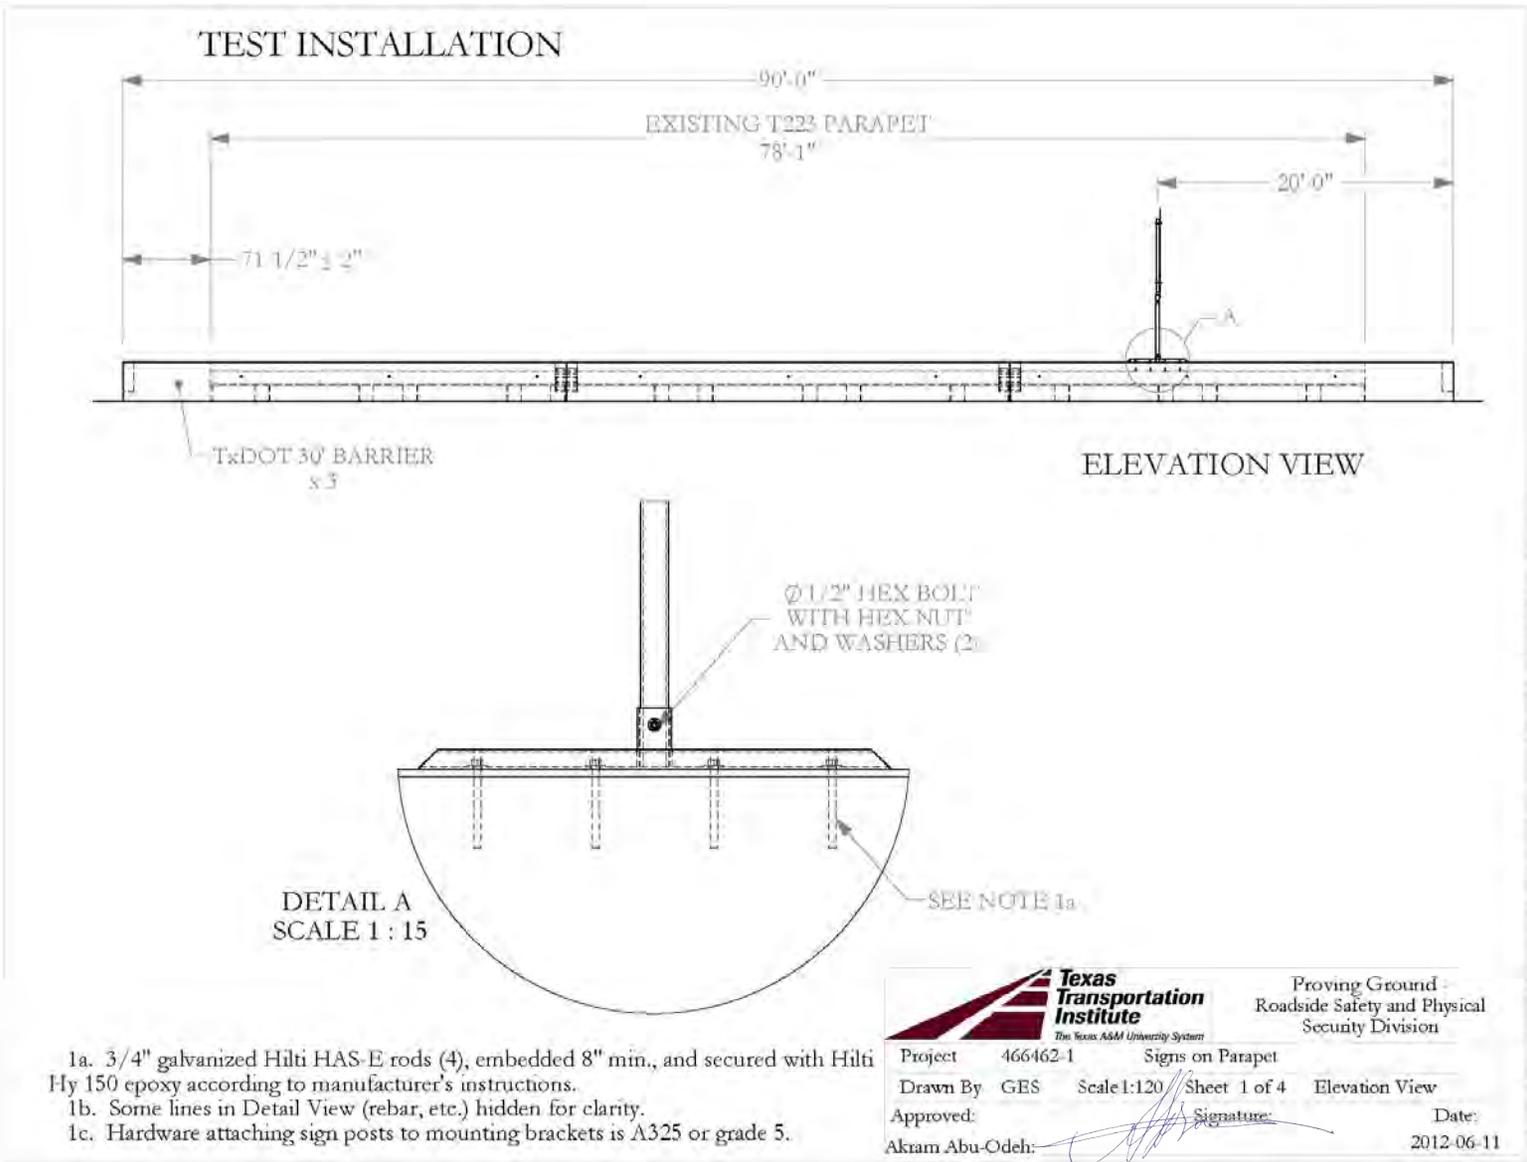
T:\2011-2012\Sign on-CPMB\Drafting\rev. 2012-06-08\466462-1 Drawing

C1. DETAILS OF THE TEST ARTICLE

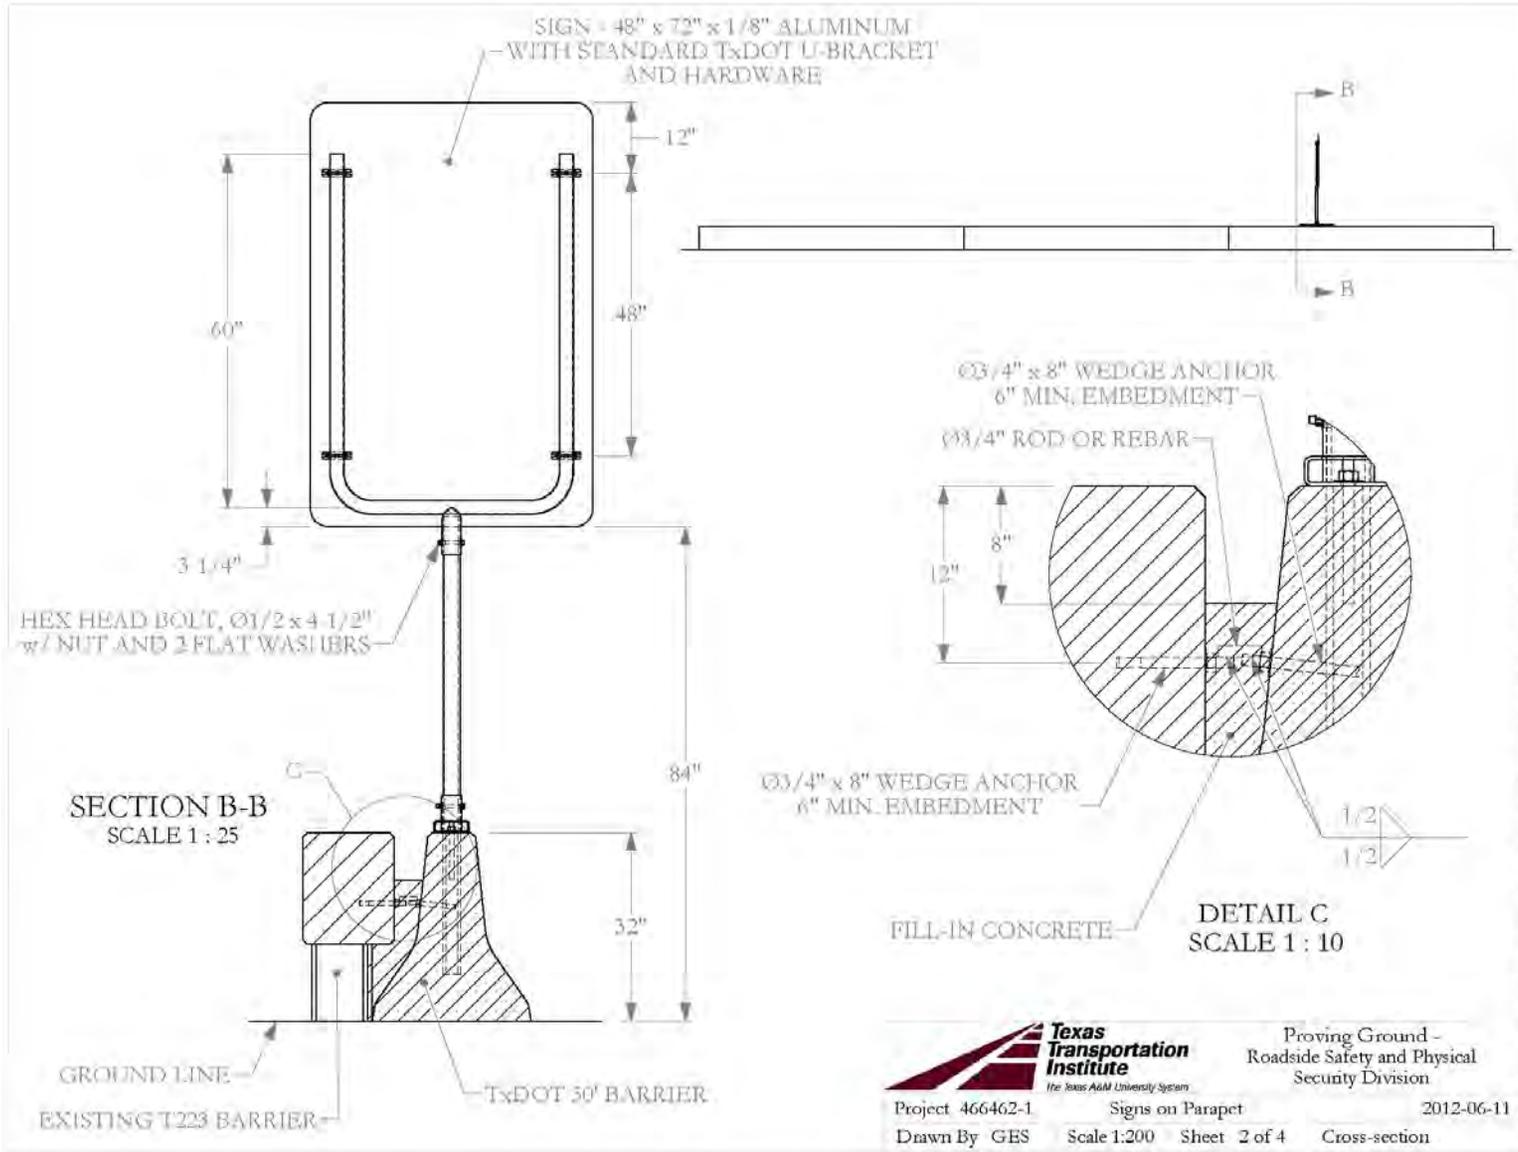
WEDGE ANCHOR SPACING

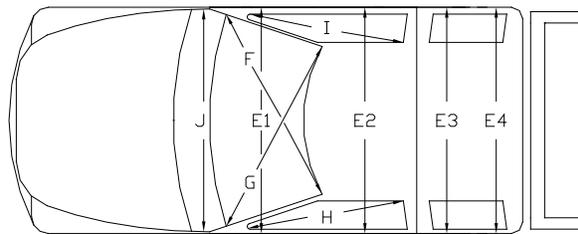
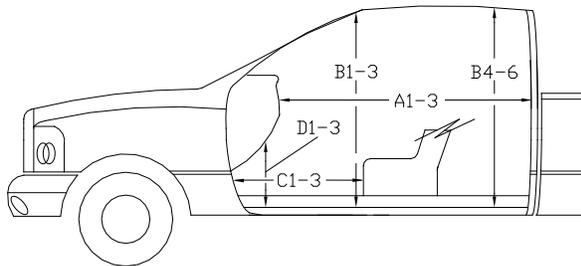
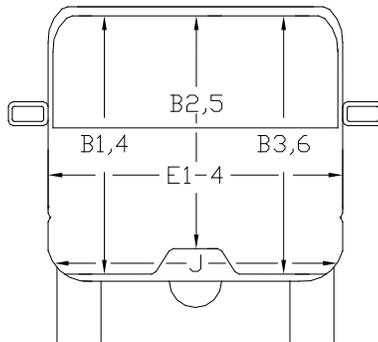
OCCUPANT COMPARTMENT DEFORMATION MEASUREMENT

Before (inches)	After (inches)
A1	64.50	64.50
A2	64.50	64.50
A3	65.00	65.00
B1	45.25	45.25
B2	39.00	37.75
B3	45.25	45.75
B4	42.12	42.12
B5	42.50	42.50
B6	42.12	42.12
C1	27.00	27.00
C2	----	----
C3	26.50	19.00
D1	12.75	12.75
D2	----	----
D3	11.62	12.00
E1	62.75	62.50
E2	64.50	65.50
E3	64.00	64.00
E4	64.38	64.38
F	59.50	59.50
G	59.50	59.50
H	39.00	39.00
I	39.00	39.00
J*	62.00	60.50

*Lateral area across the cab from driver's side kickpanel to passenger's side kickpanel.

<i>Deformations of, or intrusions into, the occupant compartment should not exceed limits set forth in Section 5.3 and Appendix E of MASH.</i>	Deformation of 7.5 inches was noted in the windshield; this was caused by the hood of the vehicle and not from interaction with the sign support or barrier. Maximum occupant compartment deformation caused by interaction with the sign support and barrier was 1.5 inches in the floor pan on the right side.	Pass

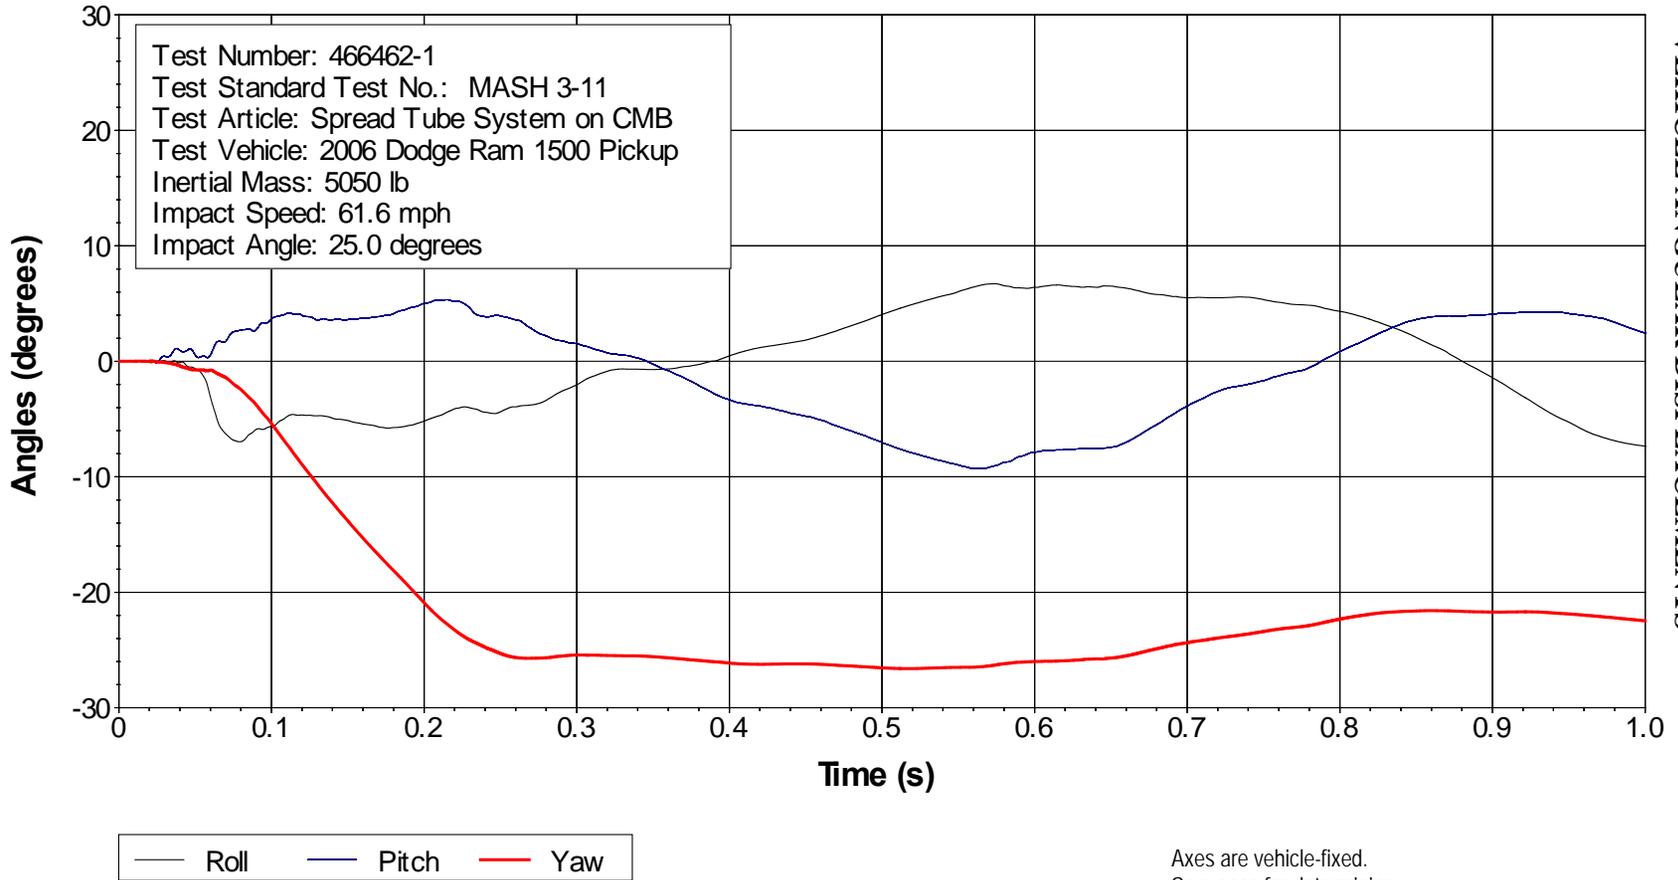
Figure C2. Vehicle Angular Displacements for Test No. 466462-1.

Axes are vehicle-fixed.
 Sequence for determining orientation:

1. Yaw.
2. Pitch.
3. Roll.

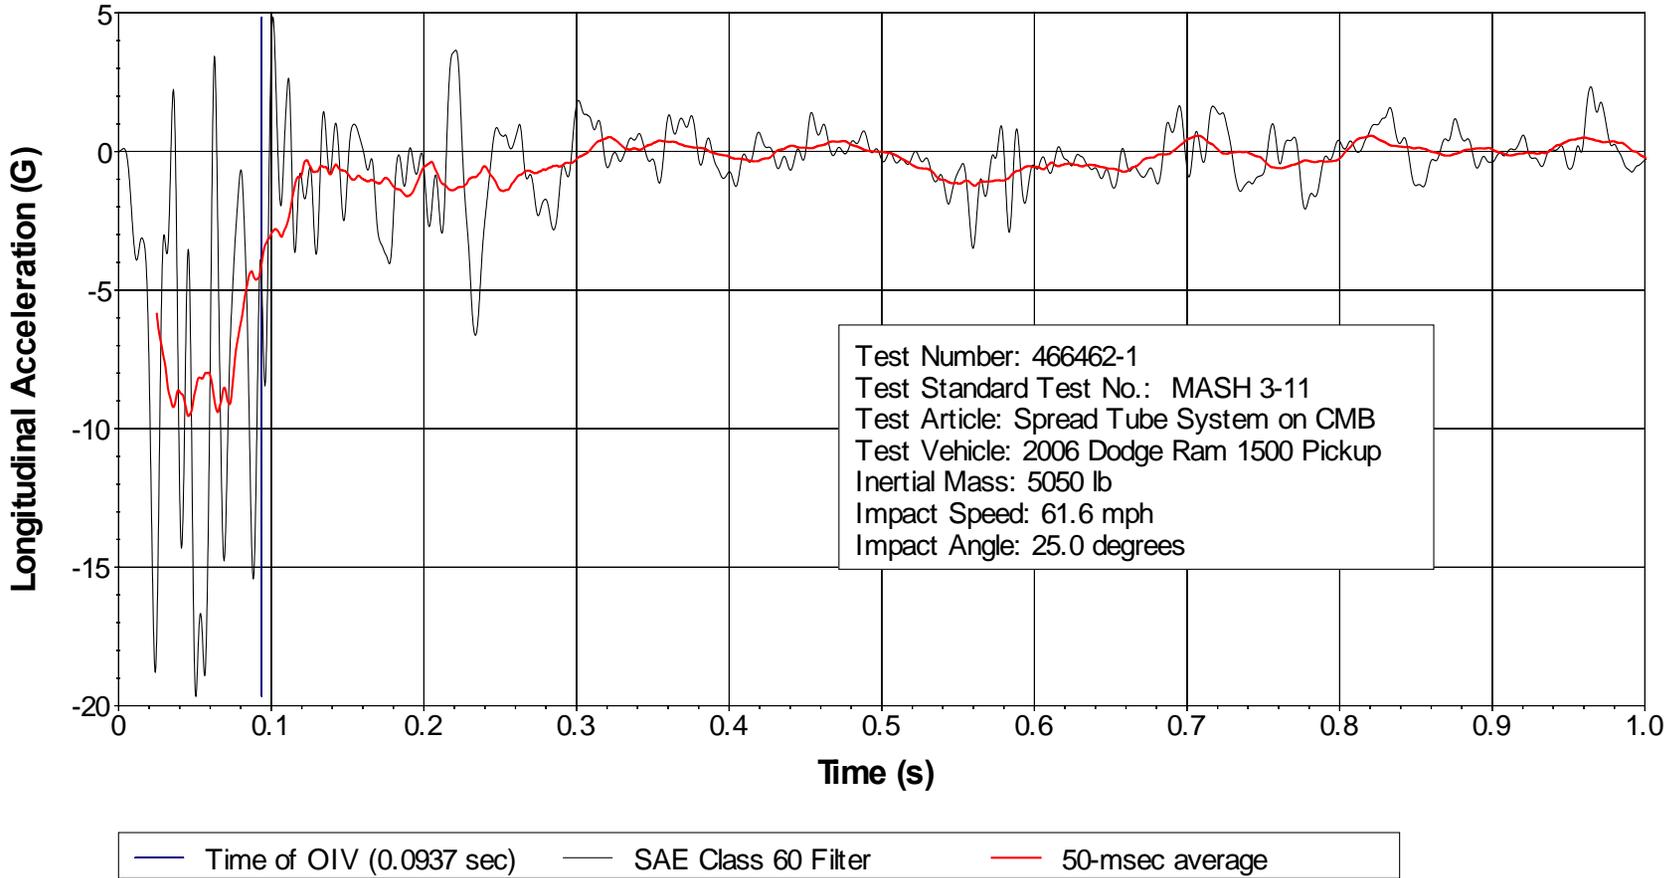
Figure C3. Vehicle Longitudinal Accelerometer Trace for Test No. 466462-1 (Accelerometer Located at Center of Gravity).
