Signs on Concrete Median Barriers

Test Report 0-6646-1

**TEXAS A&M TRANSPORTATION INSTITUTE
COLLEGE STATION, TEXAS**

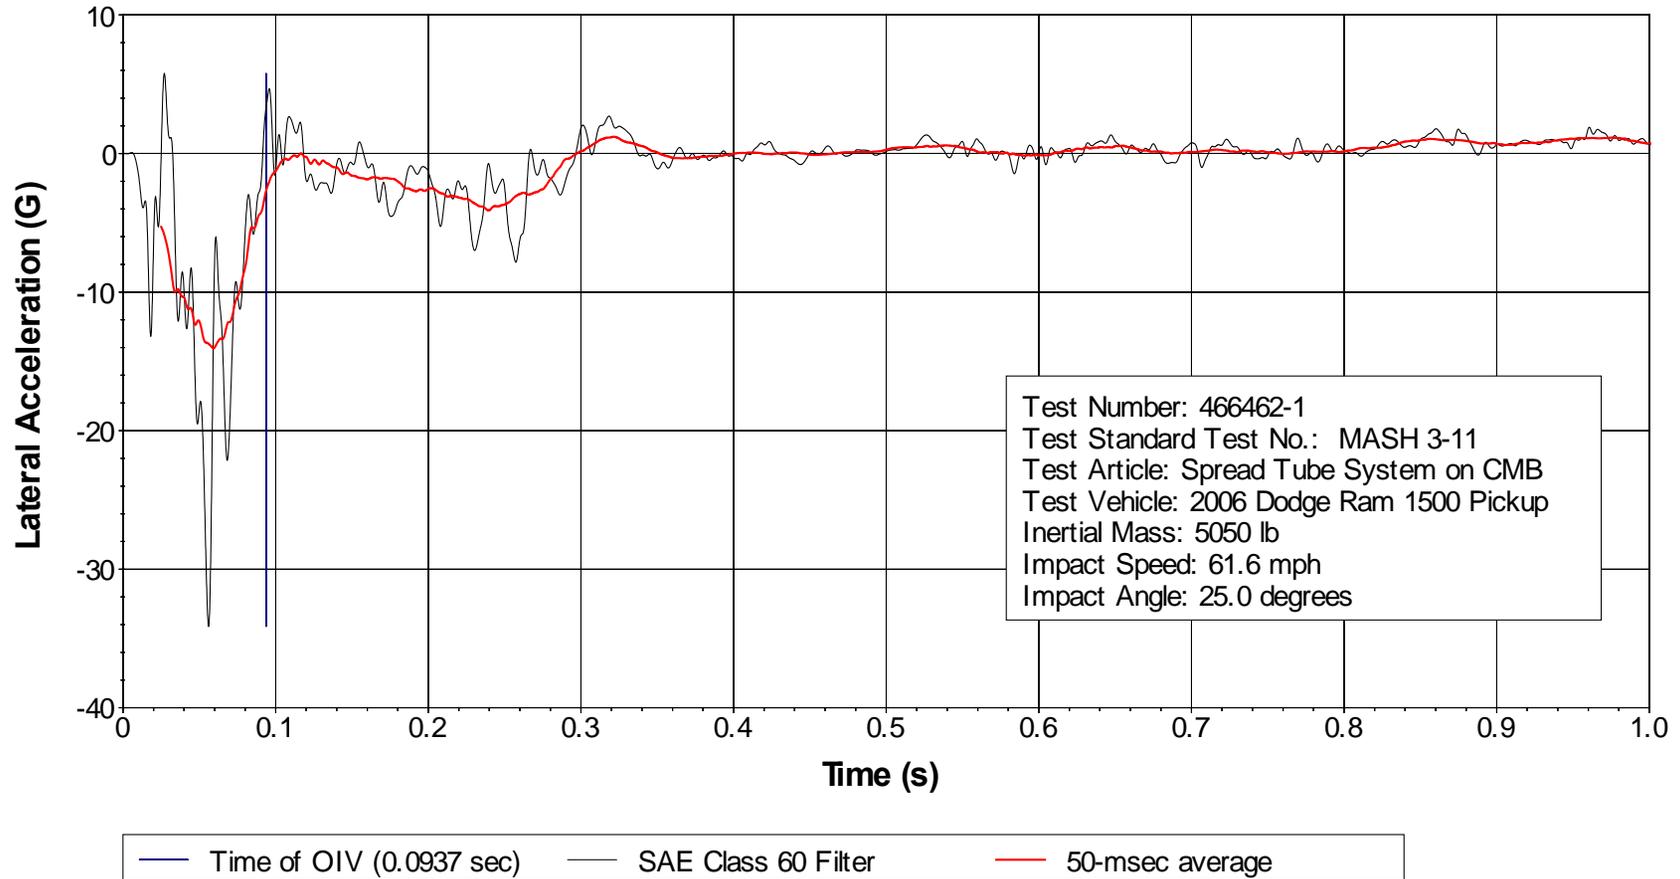
Figure C4. Vehicle Lateral Accelerometer Trace for Test No. 466462-1 (Accelerometer Located at Center of Gravity).

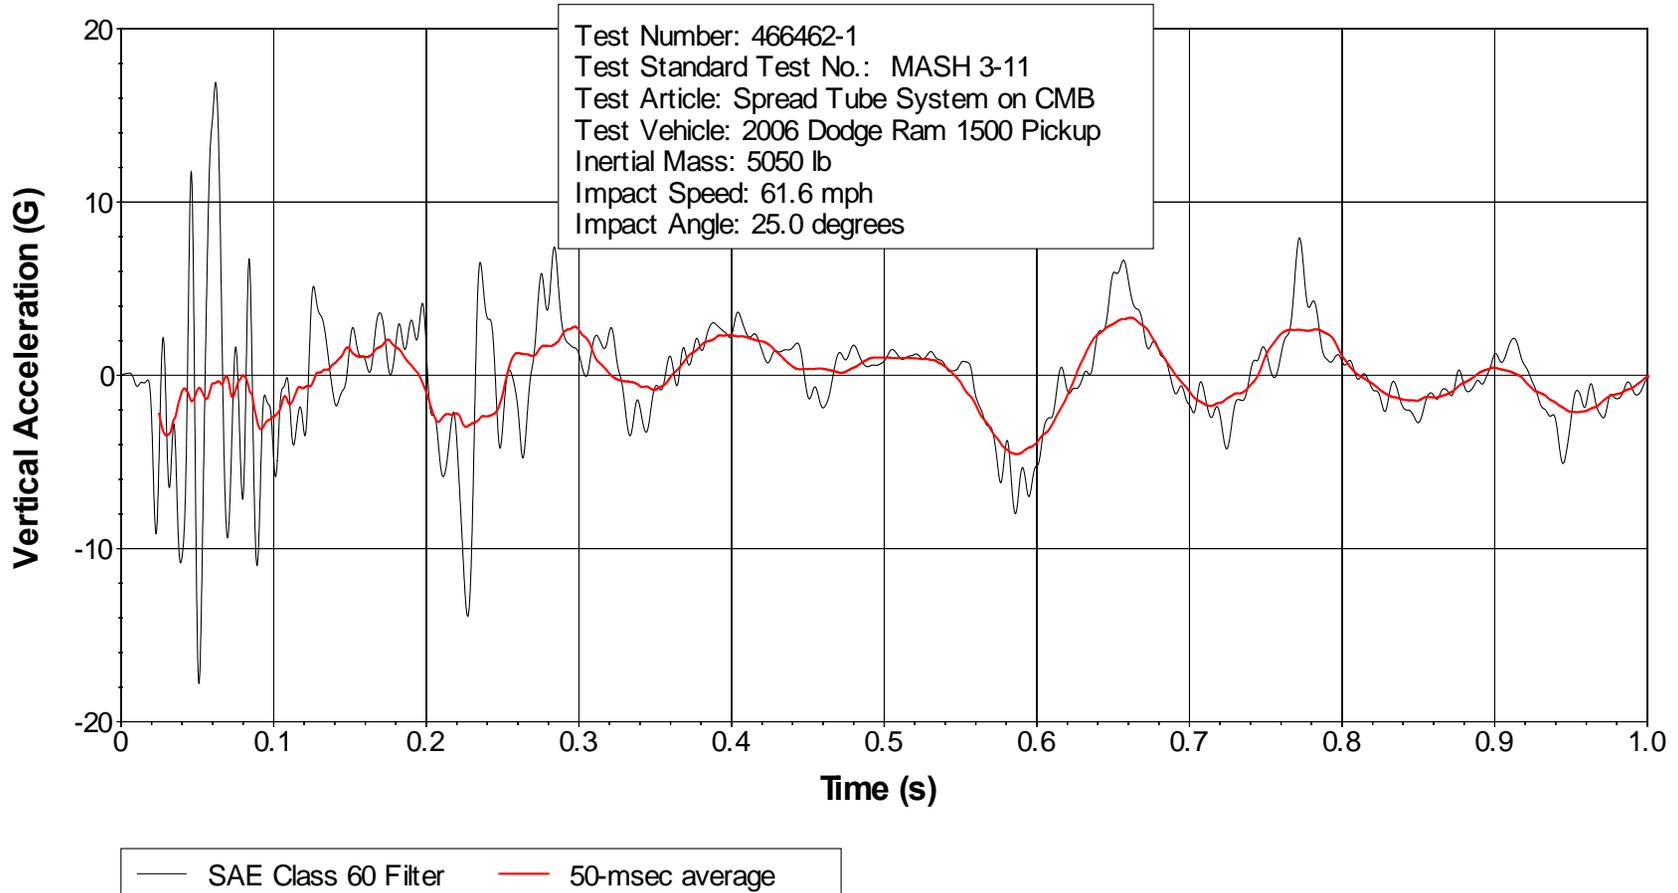
Figure C5. Vehicle Vertical Accelerometer Trace for Test No. 466462-1 (Accelerometer Located at Center of Gravity).

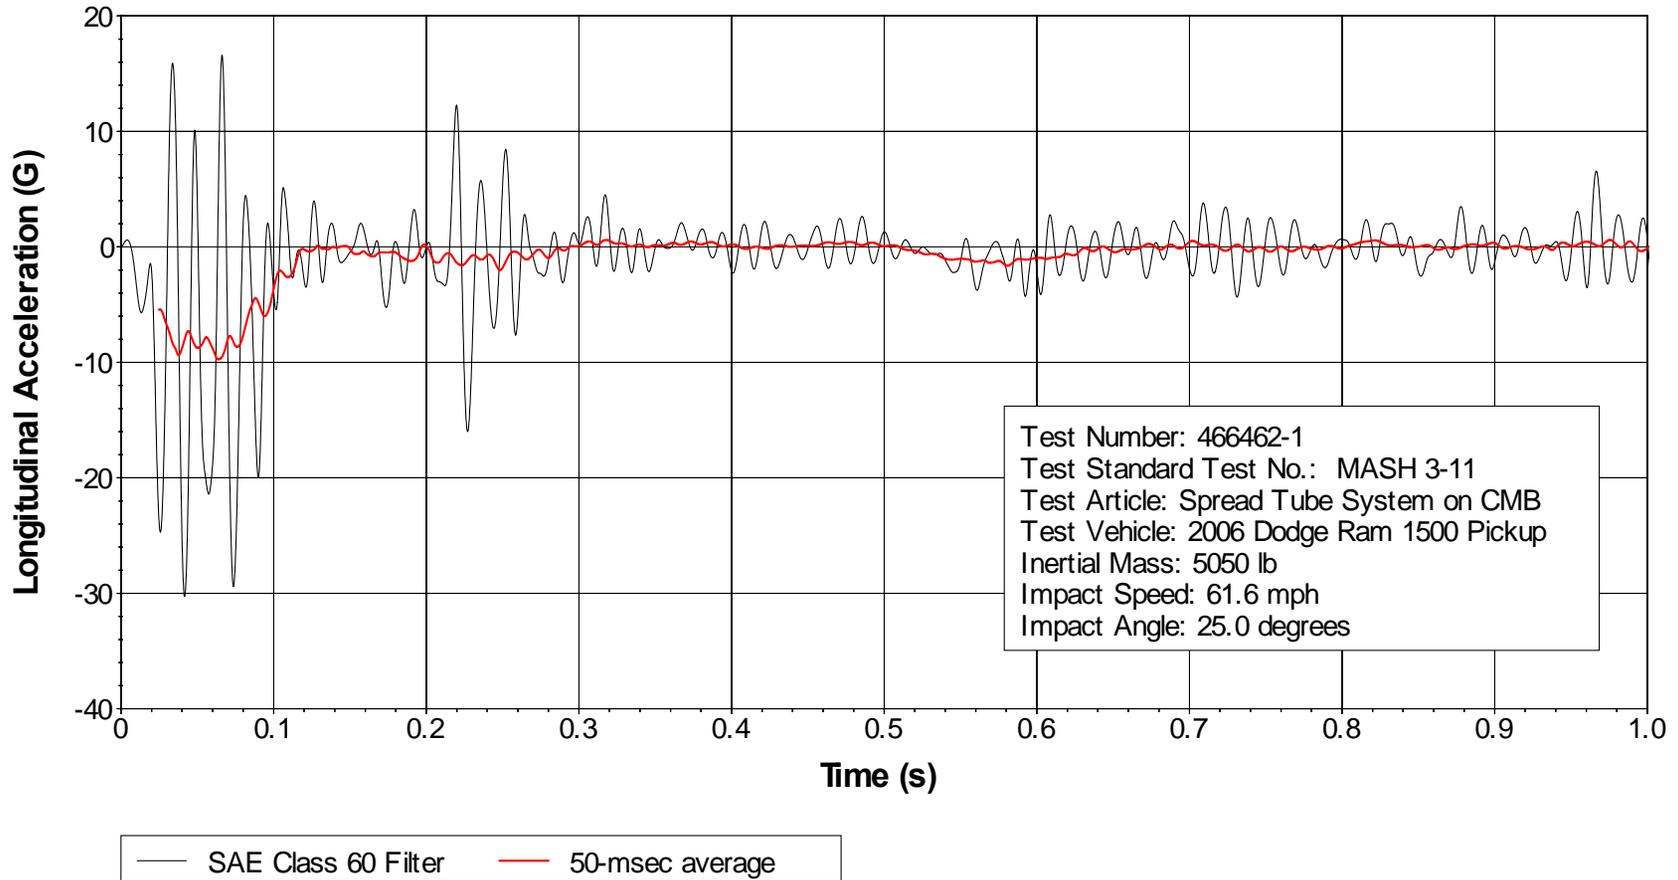
Figure C6. Vehicle Longitudinal Accelerometer Trace for Test No. 466462-1 (Accelerometer Located Rear of Center of Gravity).

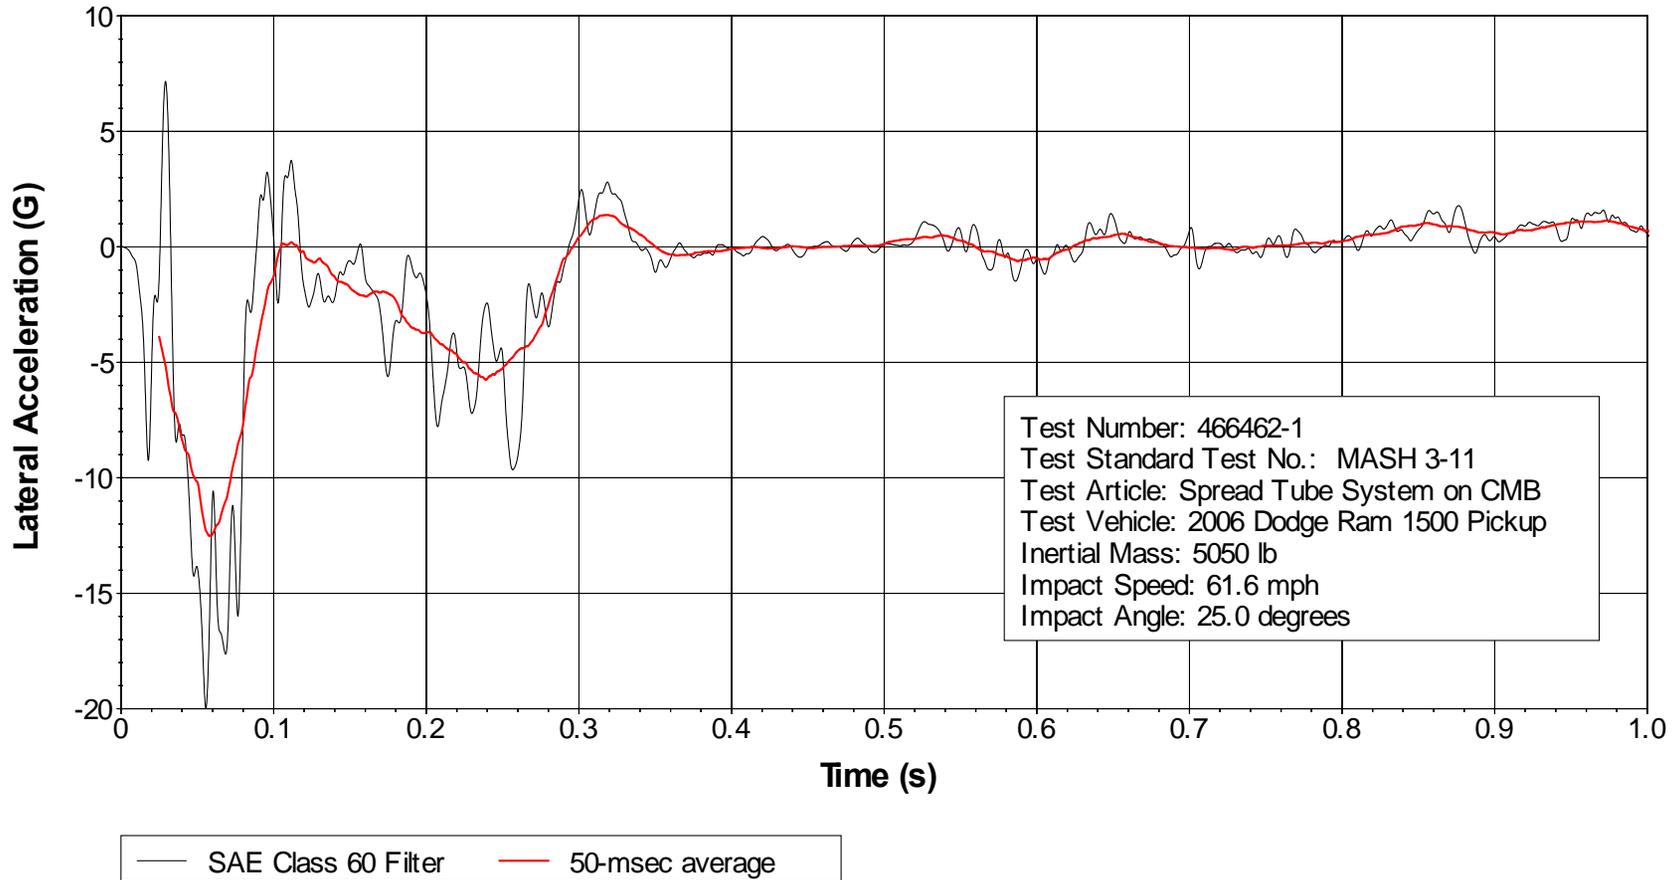
Figure C7. Vehicle Lateral Accelerometer Trace for Test No. 466462-1 (Accelerometer Located Rear of Center of Gravity).

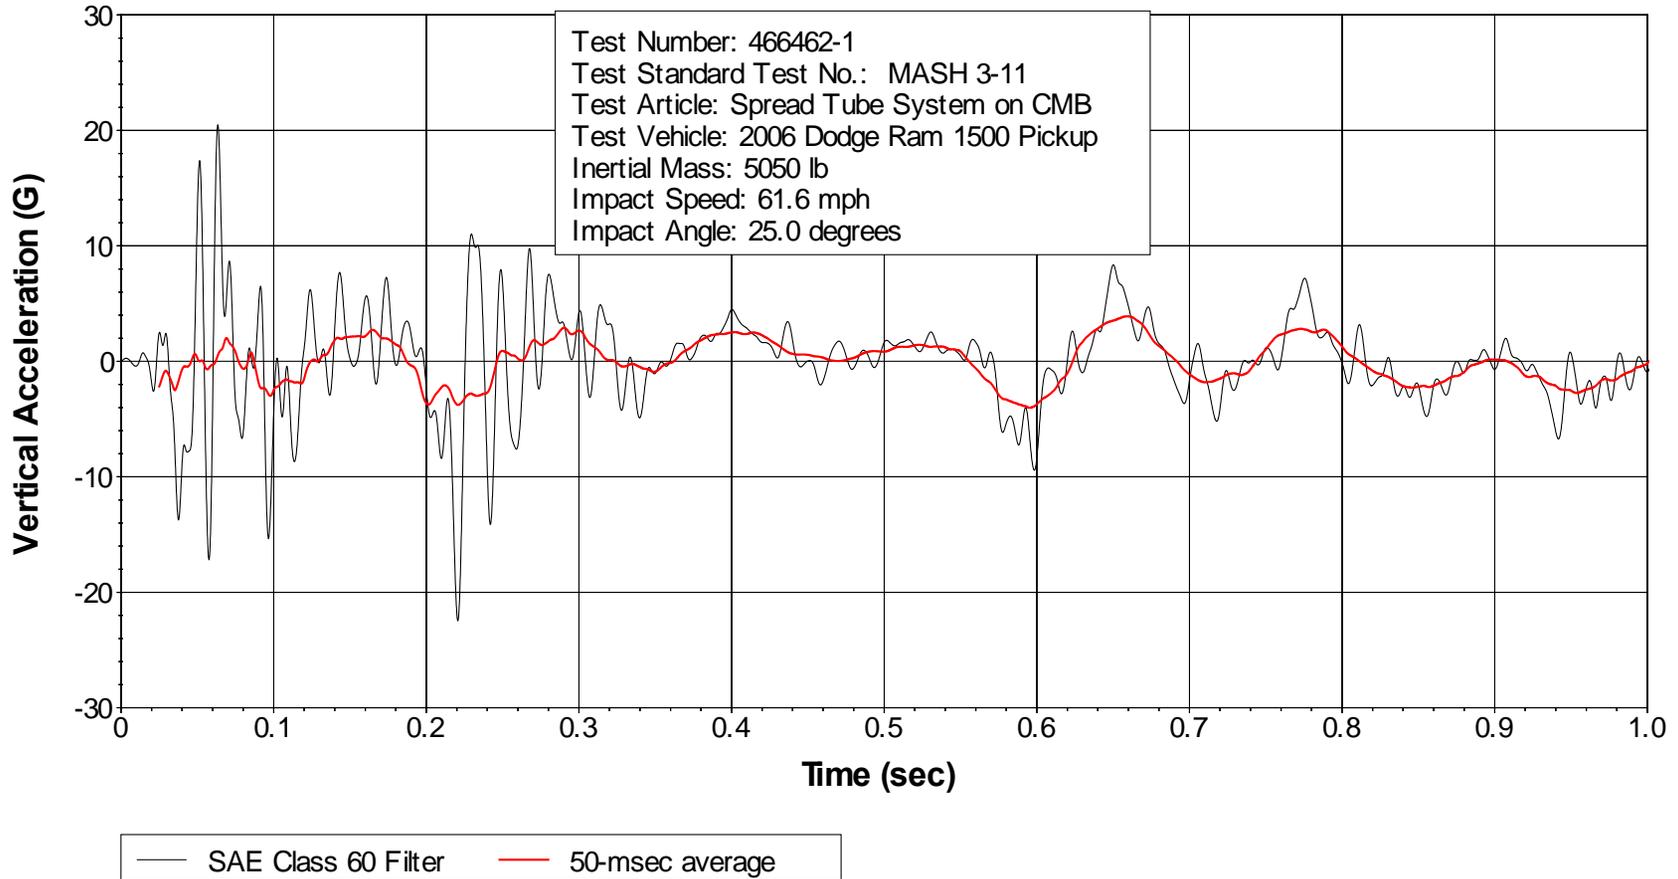
Figure C8. Vehicle Vertical Accelerometer Trace for Test No. 466462-1 (Accelerometer Located Rear of Center of Gravity).

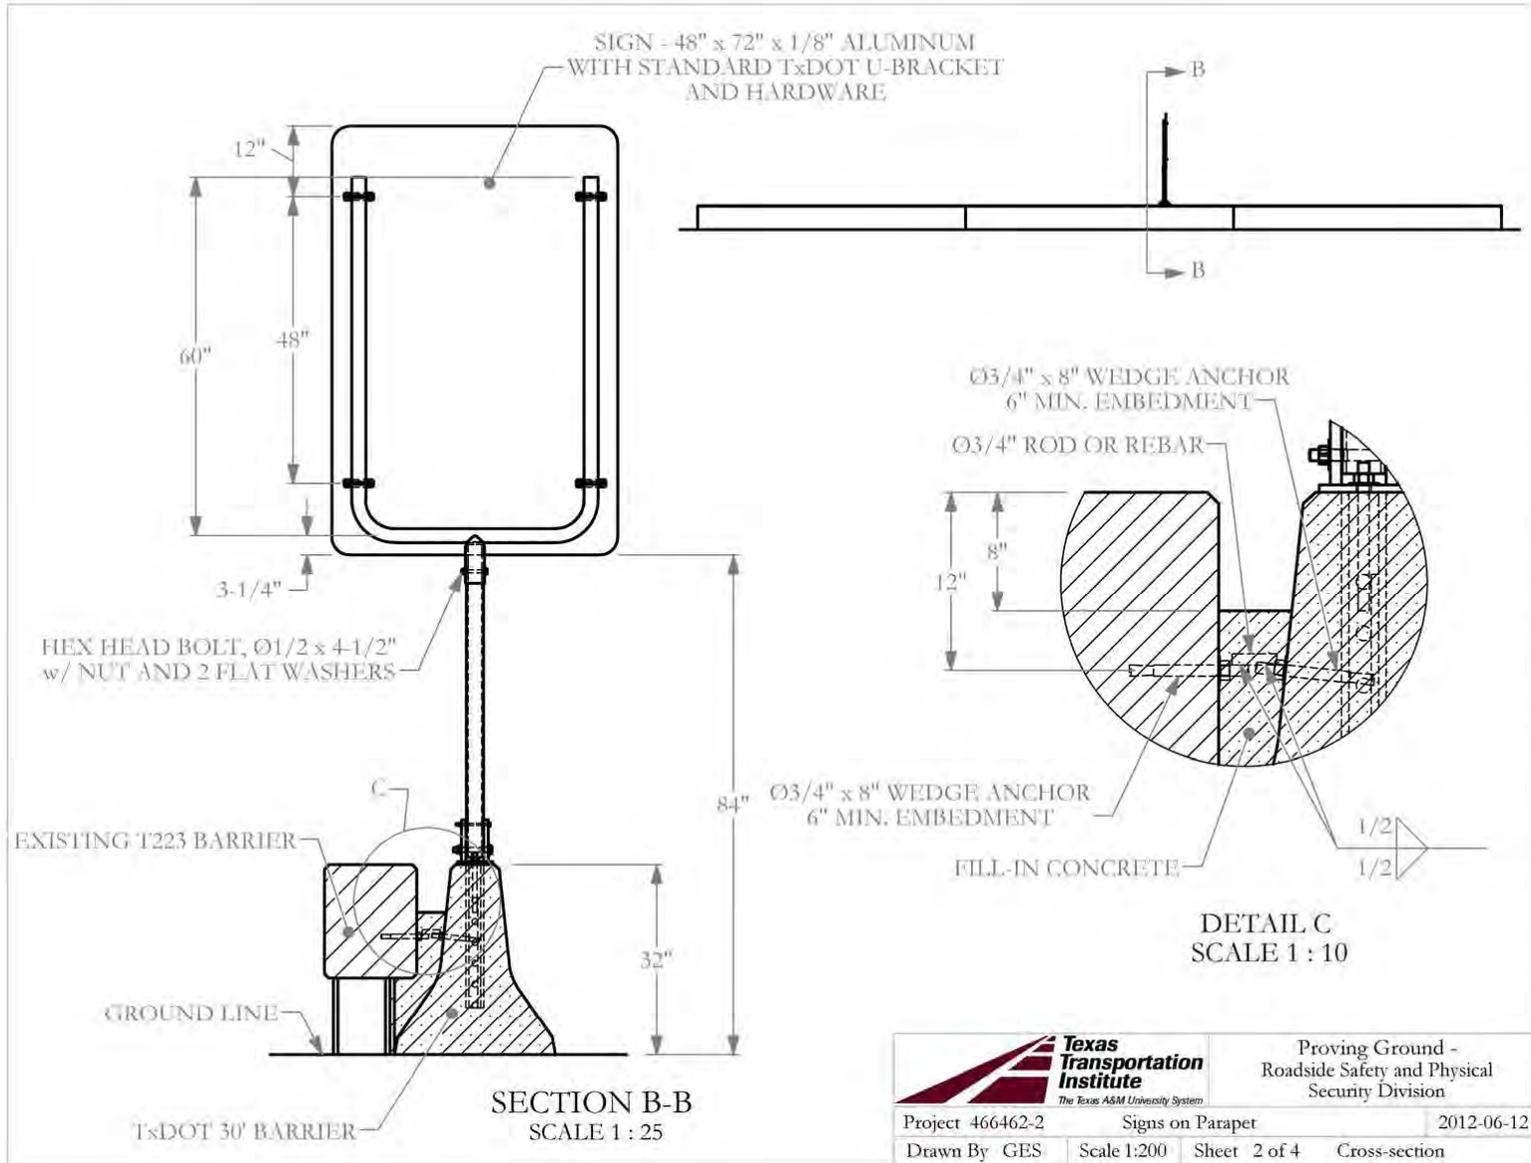
T:\2012\2012\Sign-on-Parapet\Drafting - tests 1 & 2\rev. 2012-06-08\466462-2 Drawing

WEDGE ANCHOR SPACING

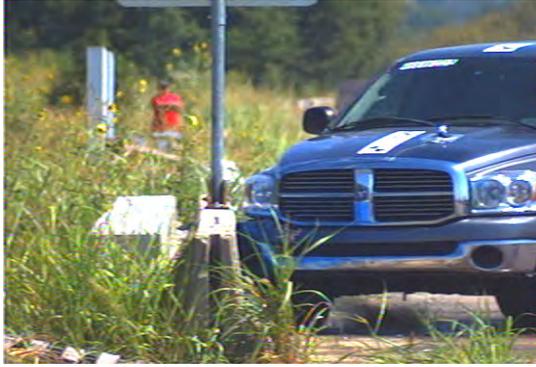
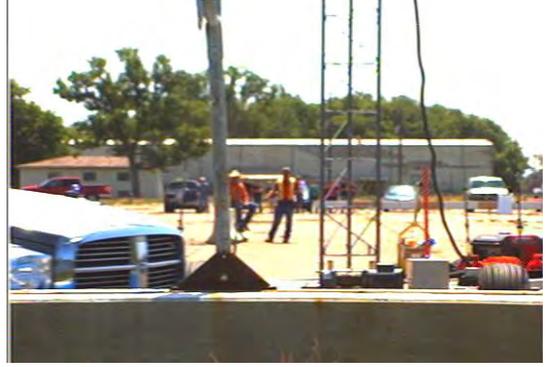
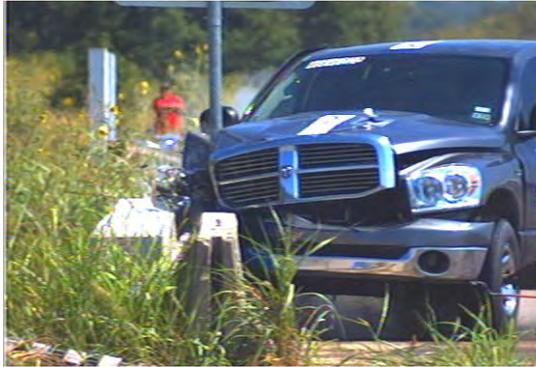
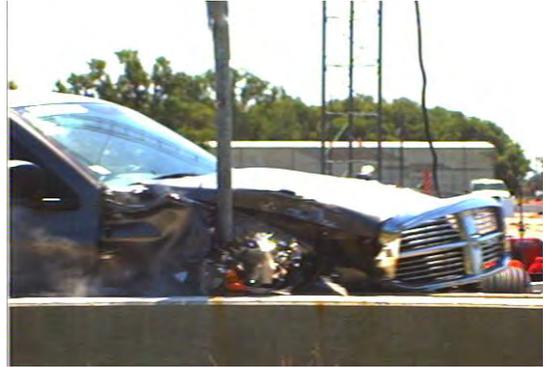
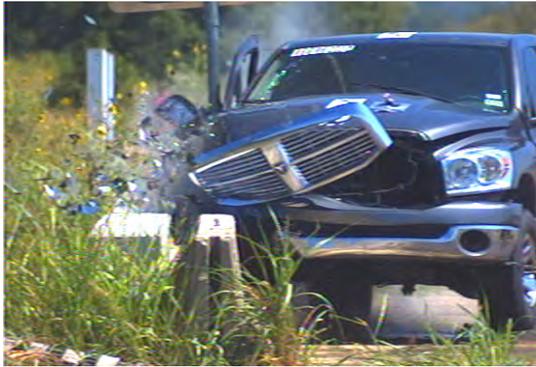
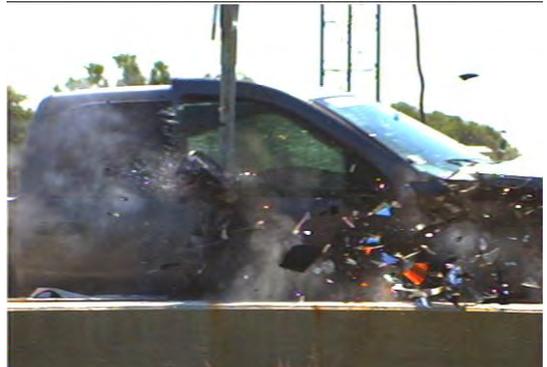
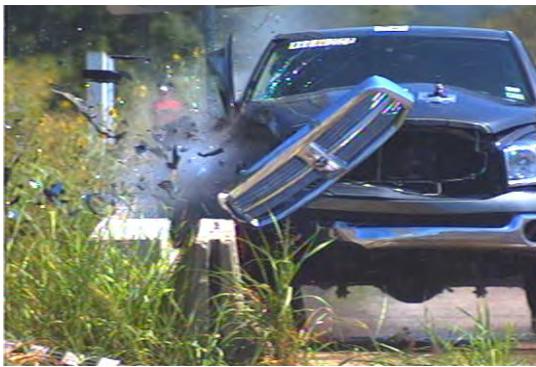
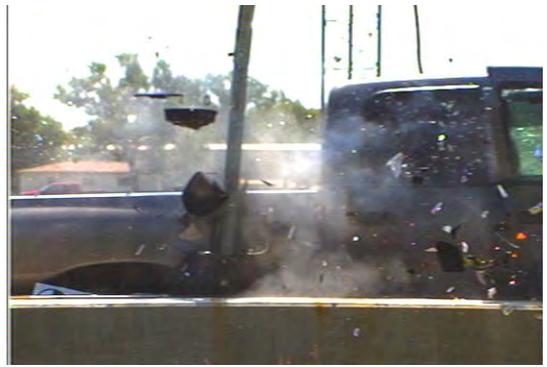
**Figure D1. Sequential Photographs for Test No. 46642-2a
(Frontal and Field Side Barrier Views).**

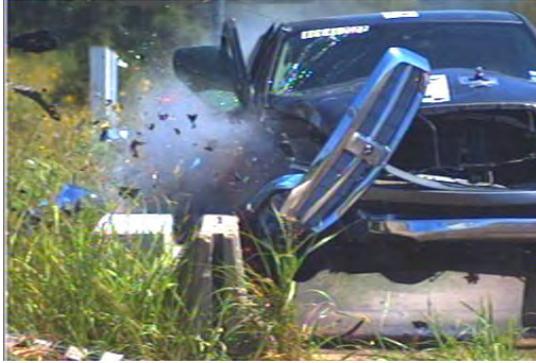
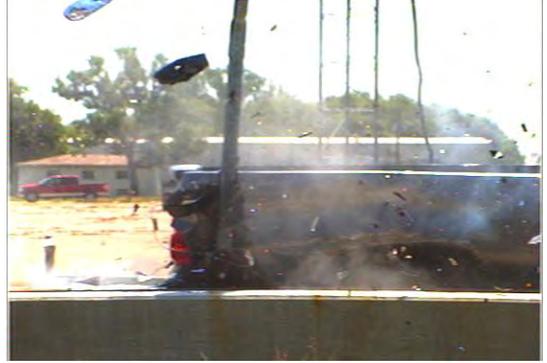
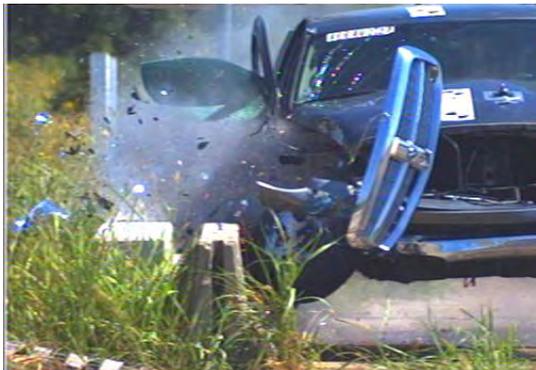
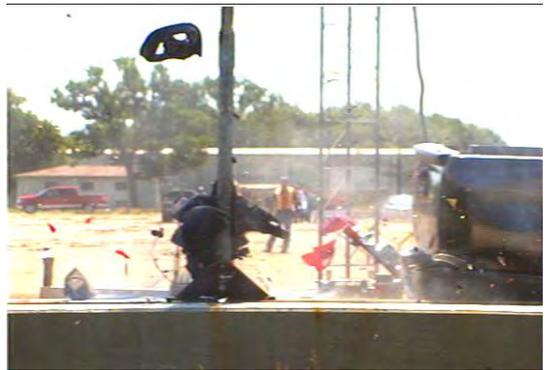
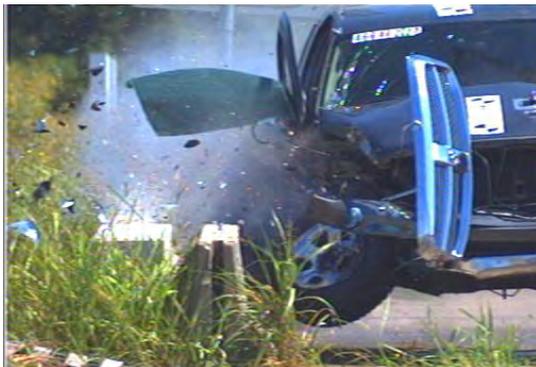
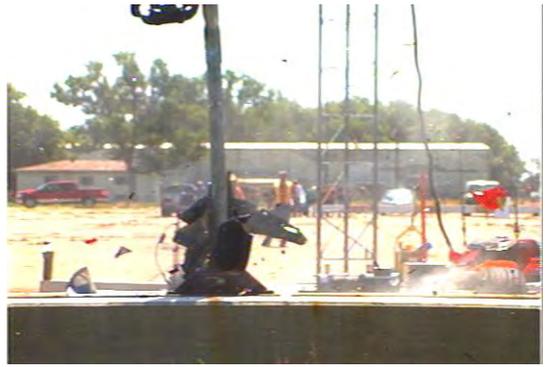
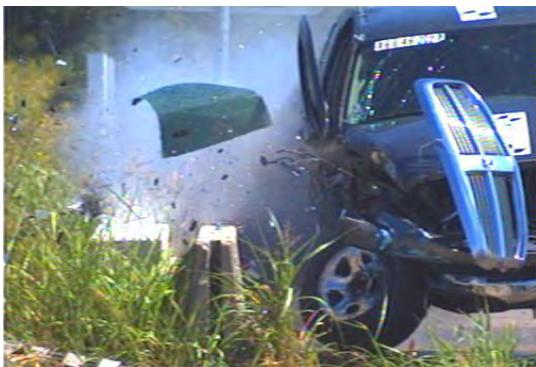
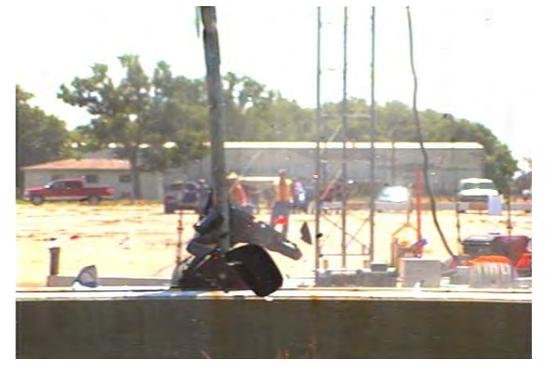
**Figure D1. Sequential Photographs for Test No. 466462-2a
(Frontal and Field Side Barrier Views) (continued).**

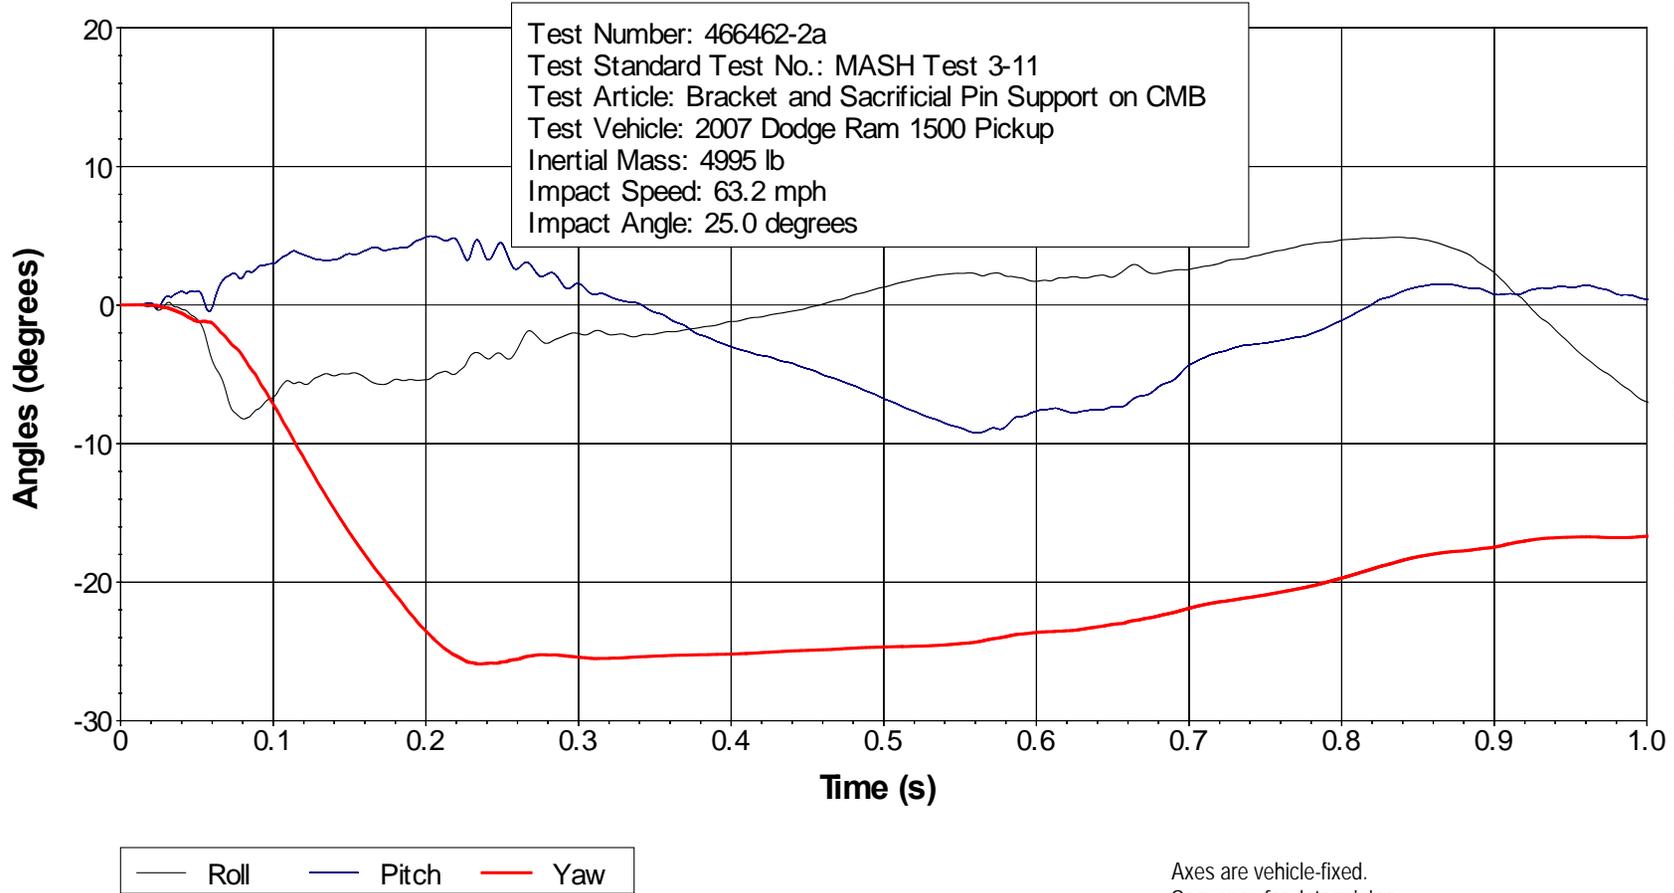
Test Number: 466462-2a
 Test Standard Test No.: MASH Test 3-11
 Test Article: Bracket and Sacrificial Pin Support on CMB
 Test Vehicle: 2007 Dodge Ram 1500 Pickup
 Inertial Mass: 4995 lb
 Impact Speed: 63.2 mph
 Impact Angle: 25.0 degrees

Figure D2. Vehicle Angular Displacements for Test No. 466462-2a.

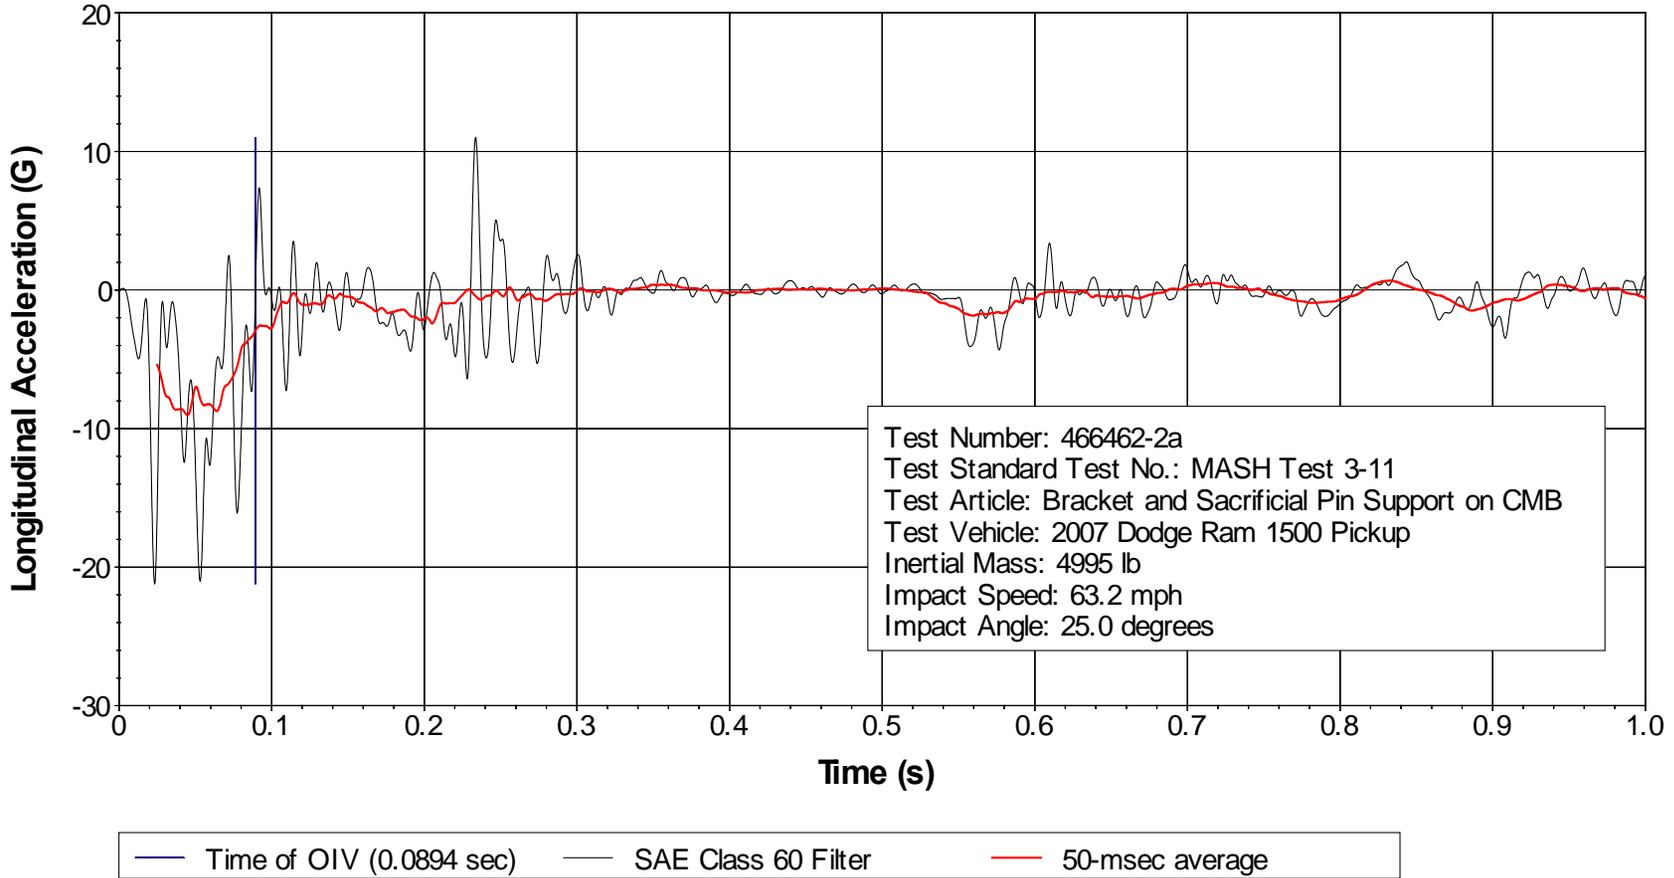
Figure D3. Vehicle Longitudinal Accelerometer Trace for Test No. 466462-2a (Accelerometer Located at Center of Gravity).

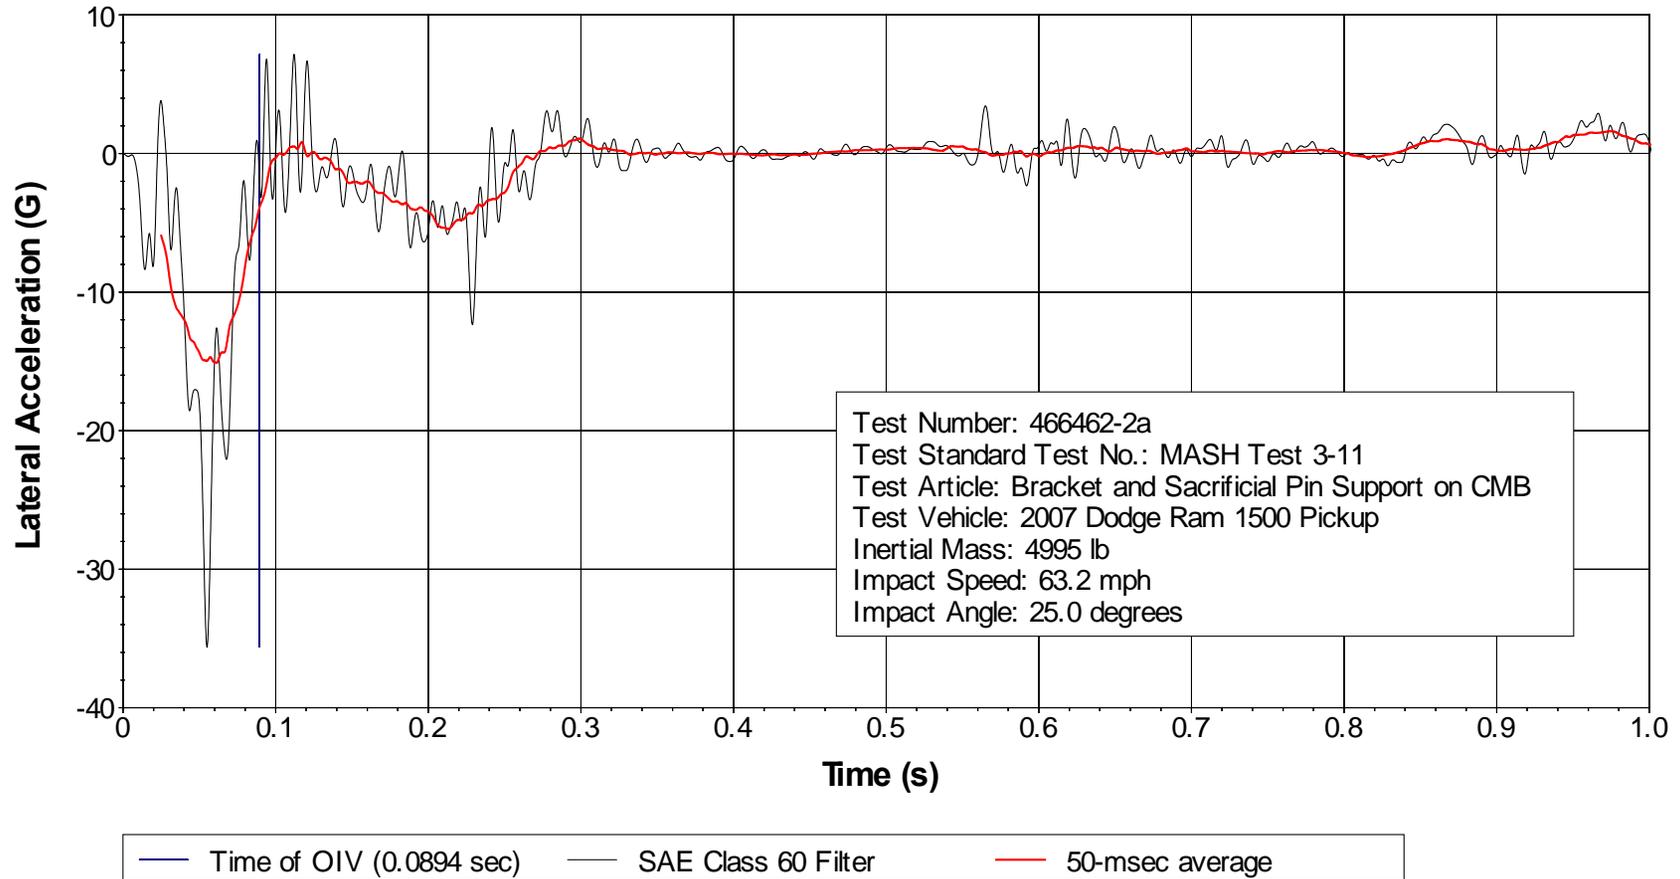
Figure D4. Vehicle Lateral Accelerometer Trace for Test No. 466462-2a (Accelerometer Located at Center of Gravity).

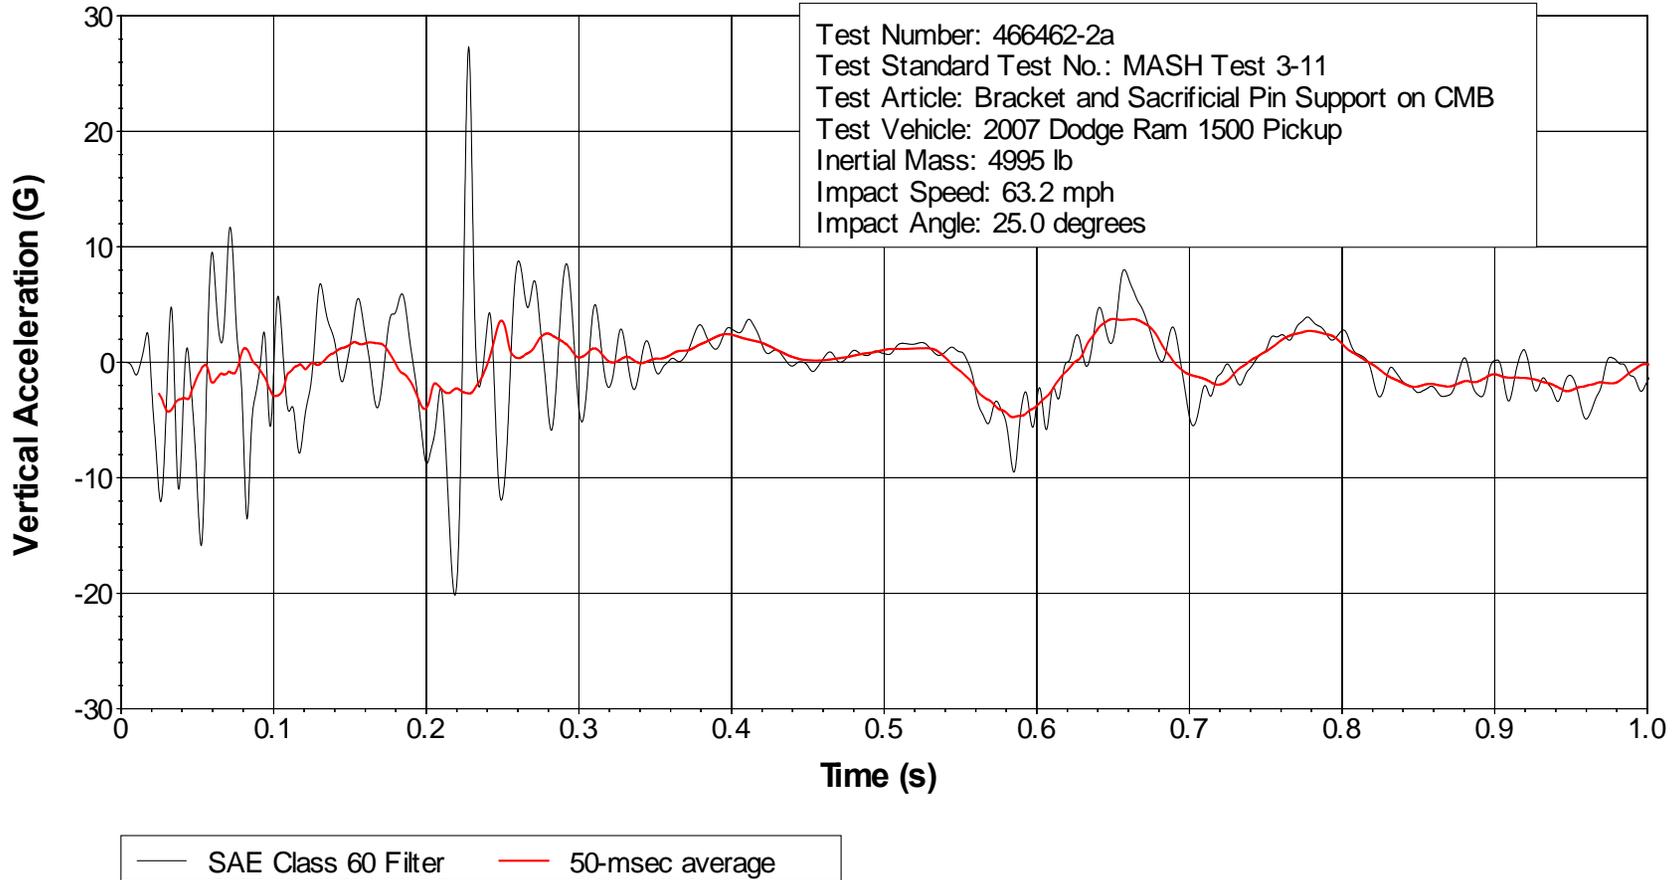
Figure D5. Vehicle Vertical Accelerometer Trace for Test No. 466462-2a (Accelerometer Located at Center of Gravity).

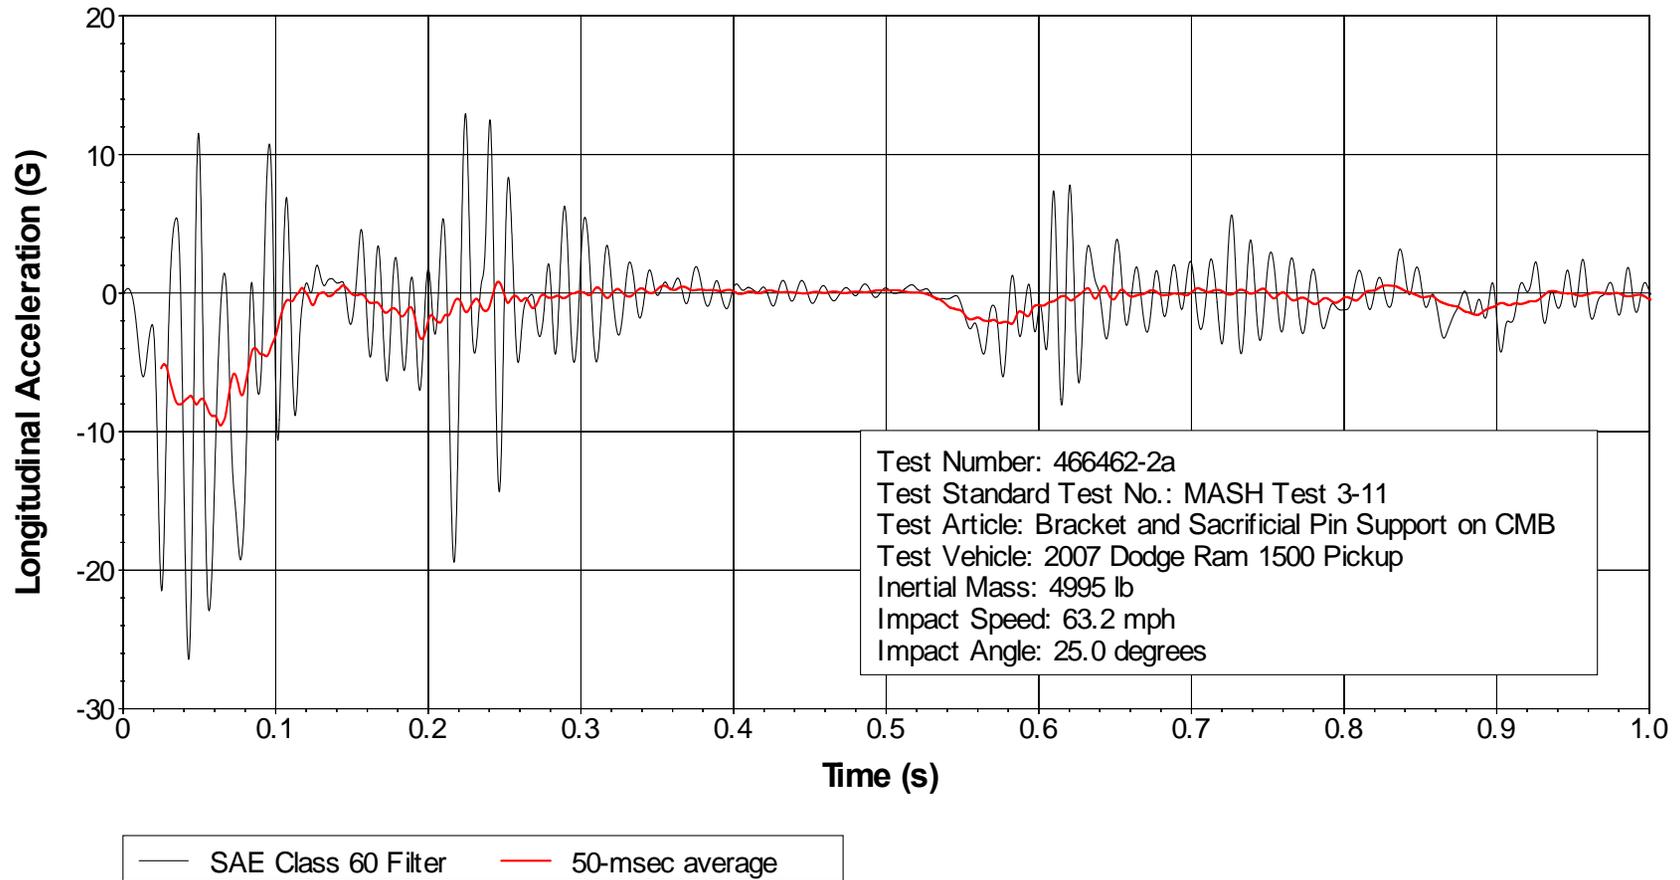
Figure D6. Vehicle Longitudinal Accelerometer Trace for Test No. 466462-2a (Accelerometer Located Rear of Center of Gravity).

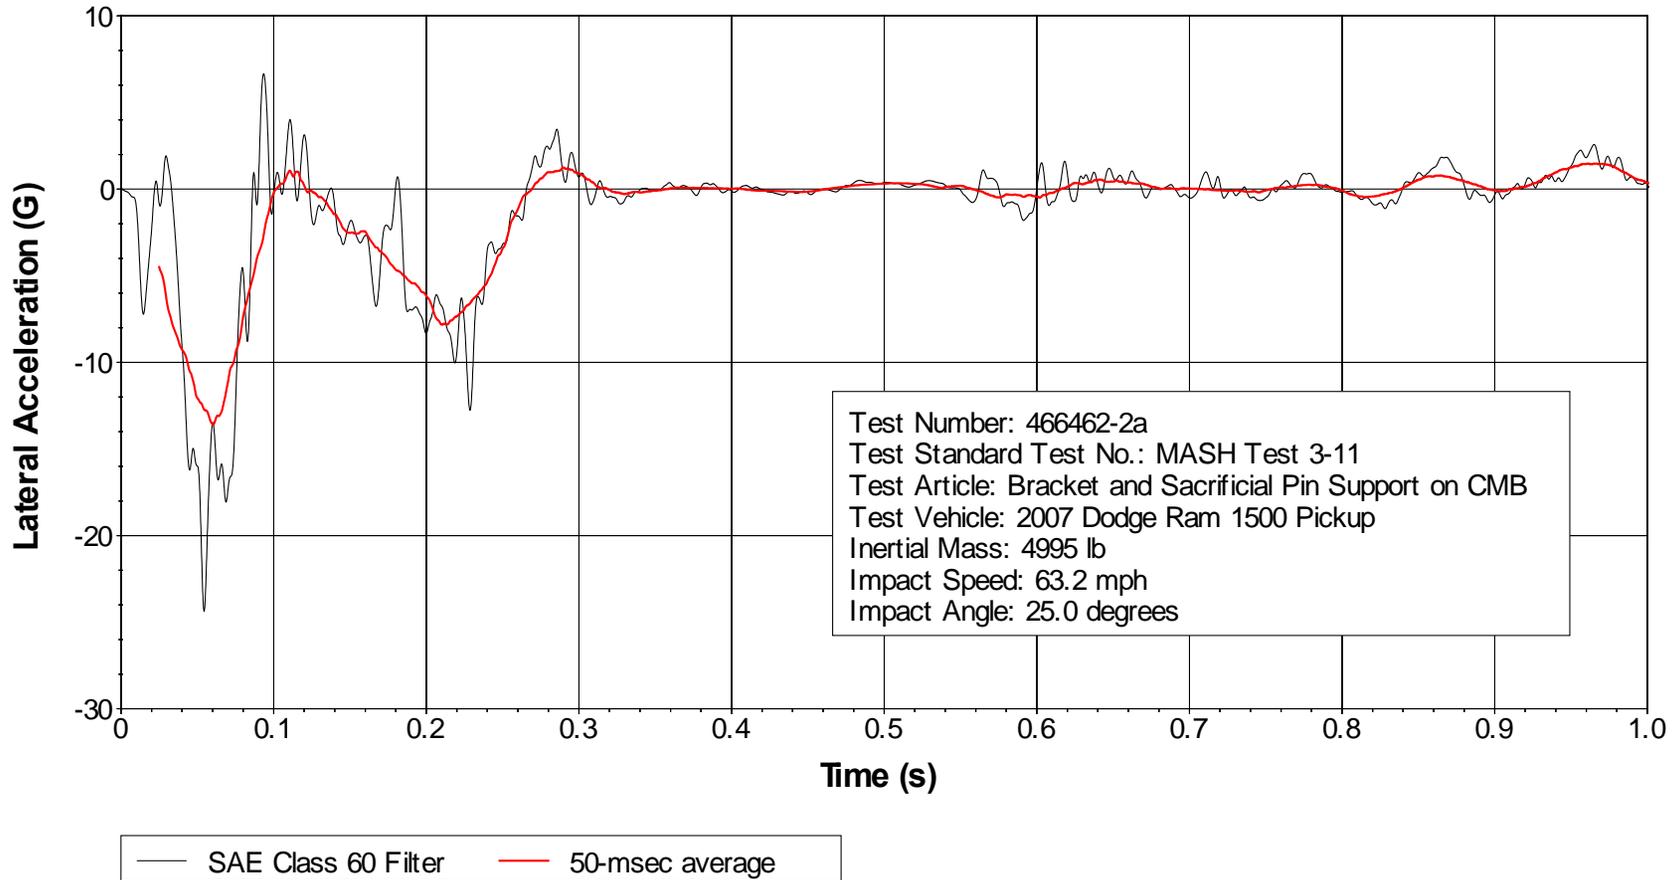
Figure D7. Vehicle Lateral Accelerometer Trace for Test No. 466462-2a (Accelerometer Located Rear of Center of Gravity).

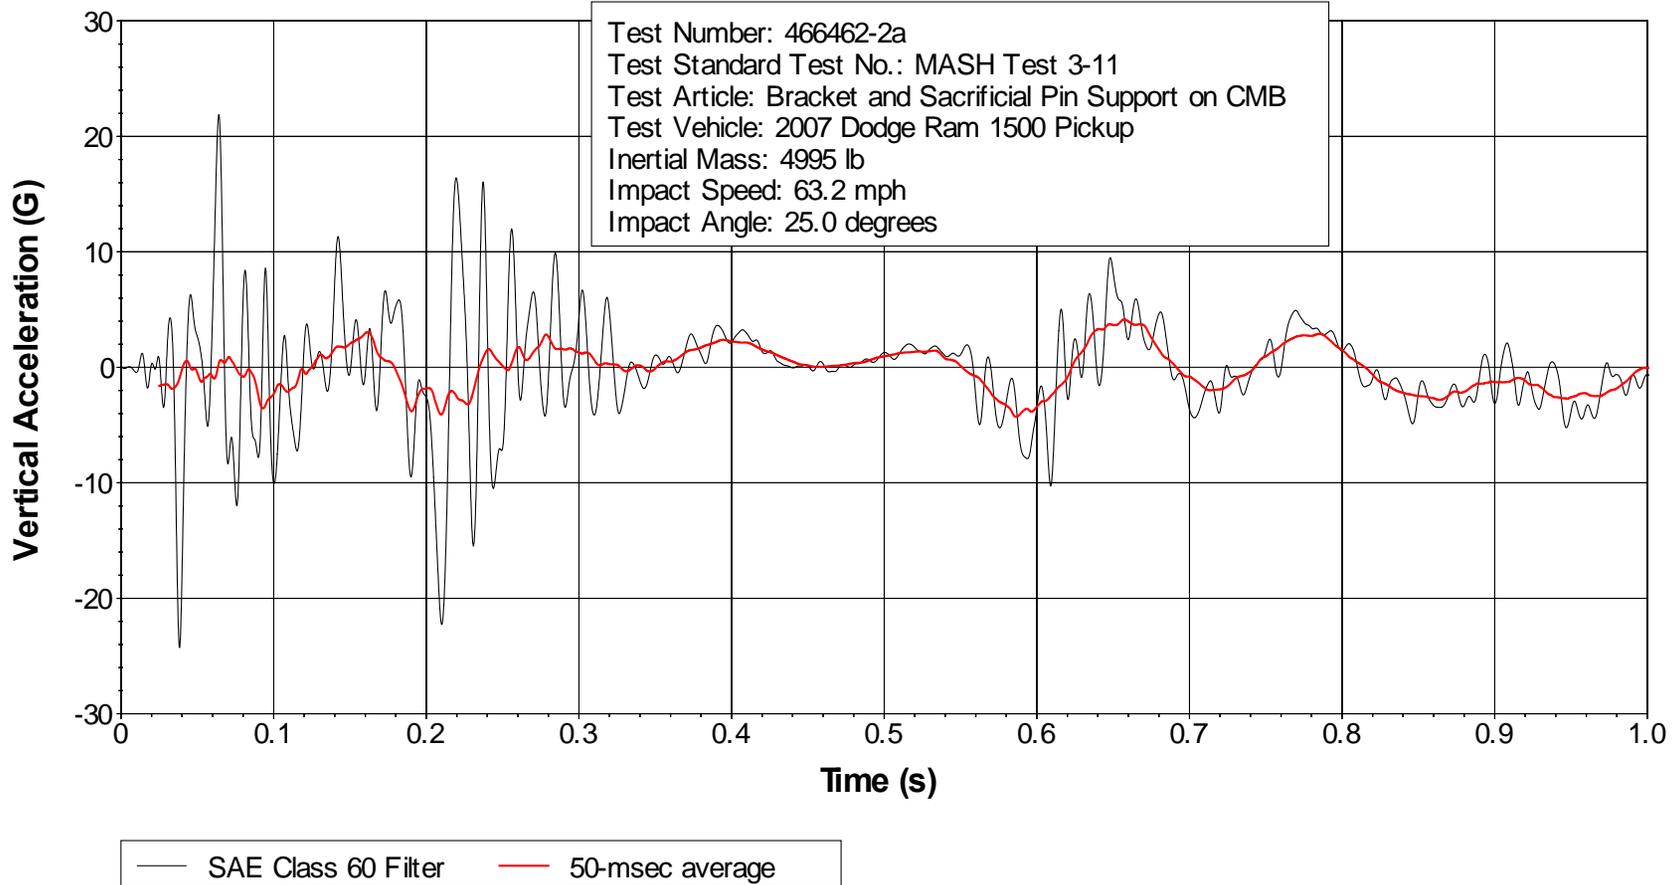
Figure D8. Vehicle Vertical Accelerometer Trace for Test No. 466462-2a (Accelerometer Located Rear of Center of Gravity).
