Signs on Concrete Median Barriers

Test Report 0-6646-1

**TEXAS A&M TRANSPORTATION INSTITUTE
COLLEGE STATION, TEXAS**

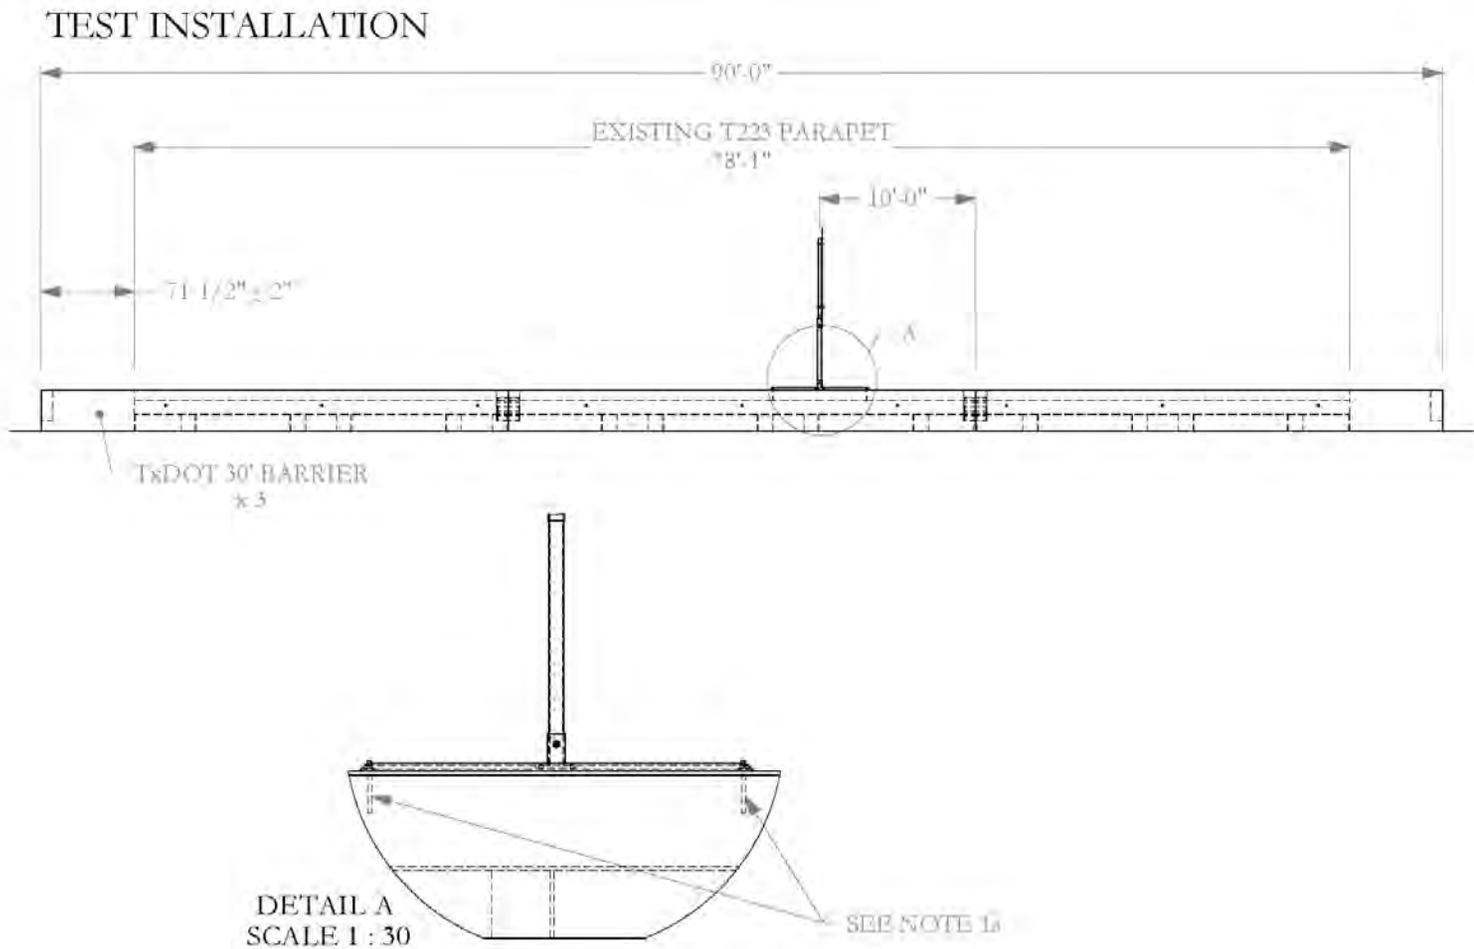
- 1a. 3/4" galvanized Hilti HAS-E rods (2), embedded 8" min., and secured with Hilti Hy 150 epoxy according to manufacturer's instructions.
- 1b. Some lines in Detail View (rebar, etc.) hidden for clarity.

Project	466462-3	Signs on Parapet	
Drawn By	GES	Scale: 1:120	Sheet 1 of 7
Approved:		Signature:	Date:
Akram Abu-Odeh:			2012-08-06

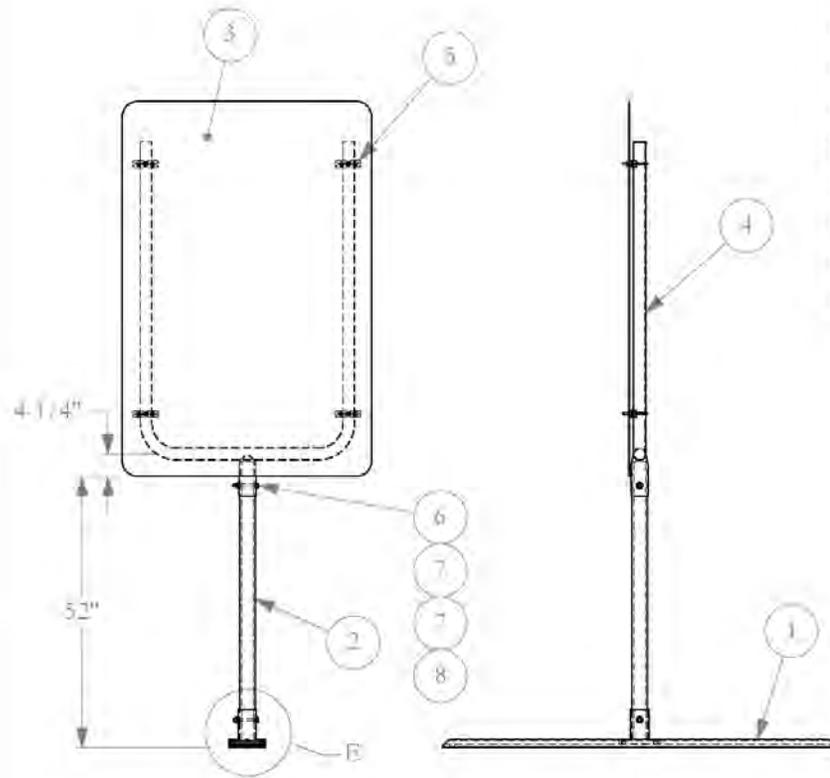
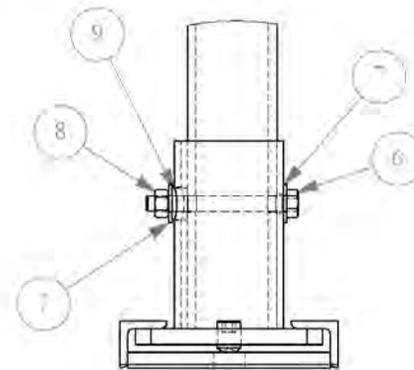
SIGN ASSEMBLY PARTS		
#	PART NAME	QTY.
1	Slide Assembly	1
2	Pipe, 2-1/2" sch. 80	1
3	Sign, 1/8" thick aluminum	1
4	U-Bracket	1
5	Sign Attachment Bracket	4
6	Bolt, 1/2 x 4 1/2 hex	2
7	Washer, 1/2 flat	4
8	Nut, 1/2 hex	2
9	Bushing, McMaster-Carr #92415A147	1

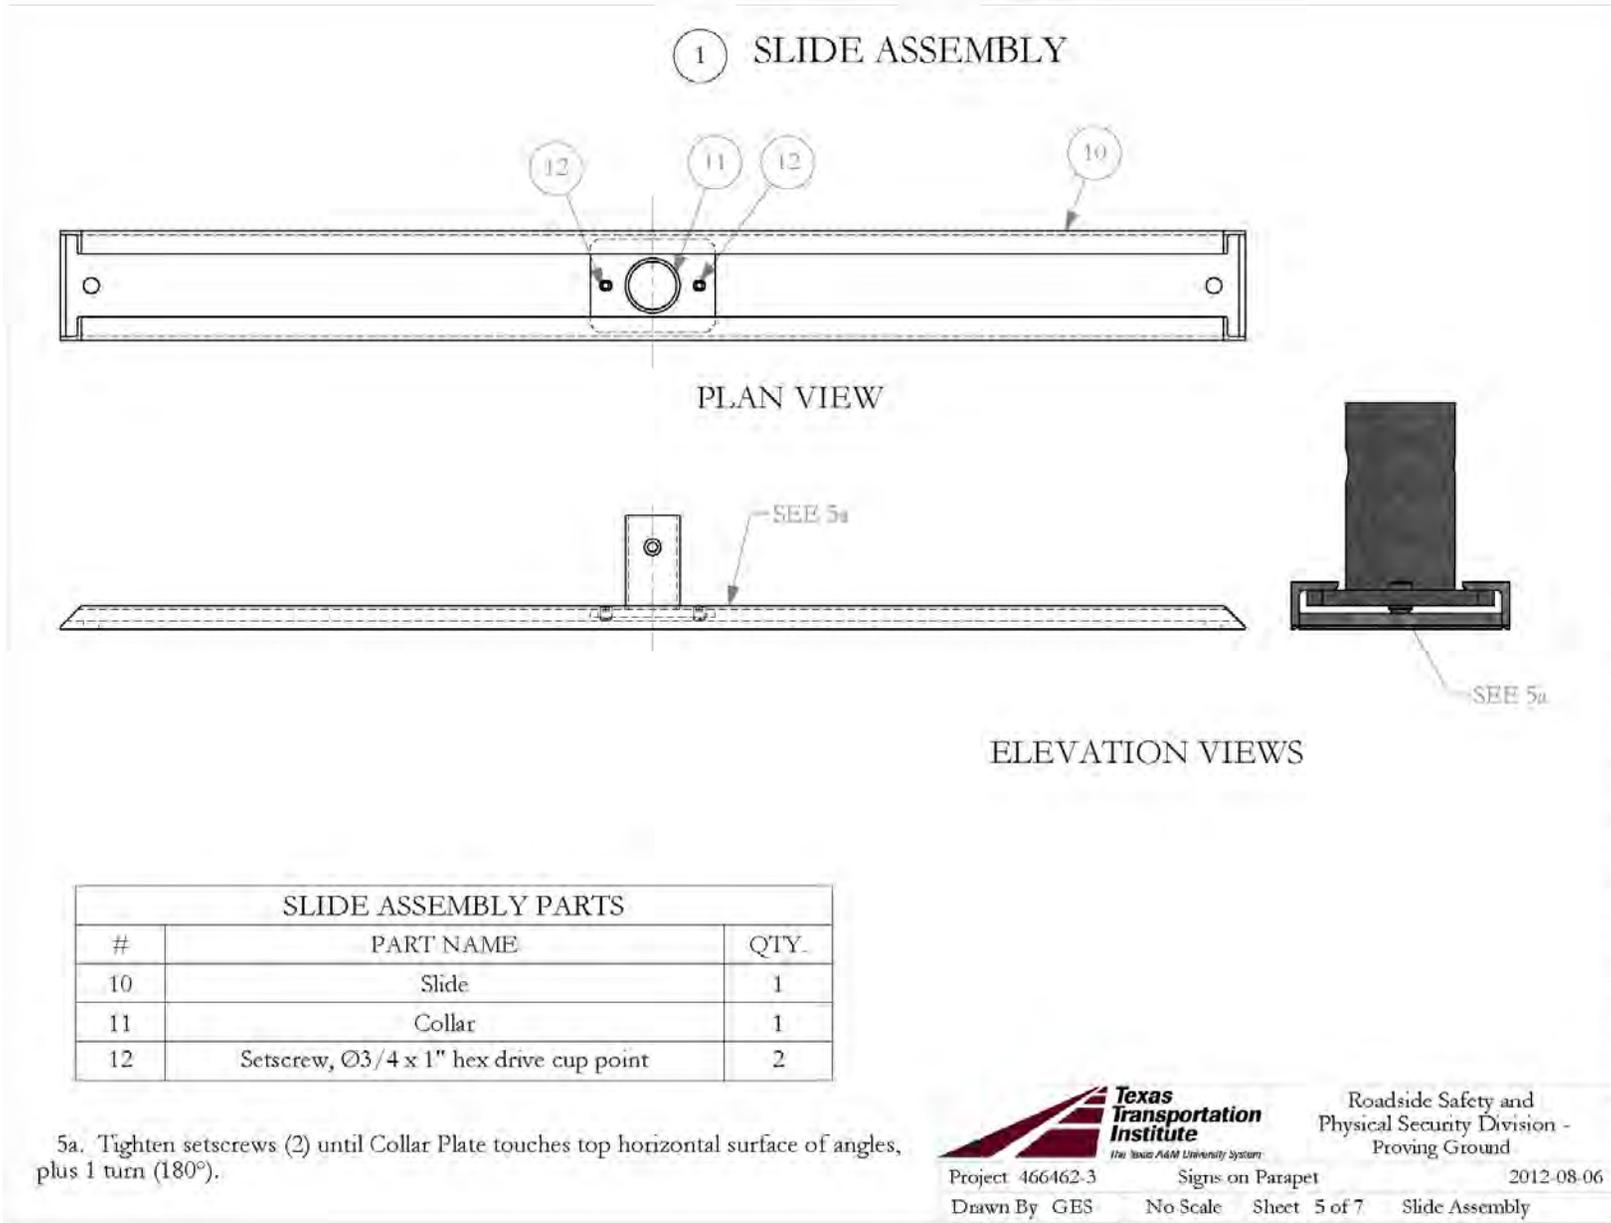
Project 466462-3 Signs on Parapet 2012-08-06
 Drawn By GES No Scale Sheet 5 of 7 Slide Assembly

SLIDE ASSEMBLY PARTS		
#	PART NAME	QTY.
10	Slide	1
11	Collar	1
12	Setscrew, $\text{O}3/4 \times 1$ " hex drive cup point	2

5a. Tighten setscrews (2) until Collar Plate touches top horizontal surface of angles, plus 1 turn (180°).

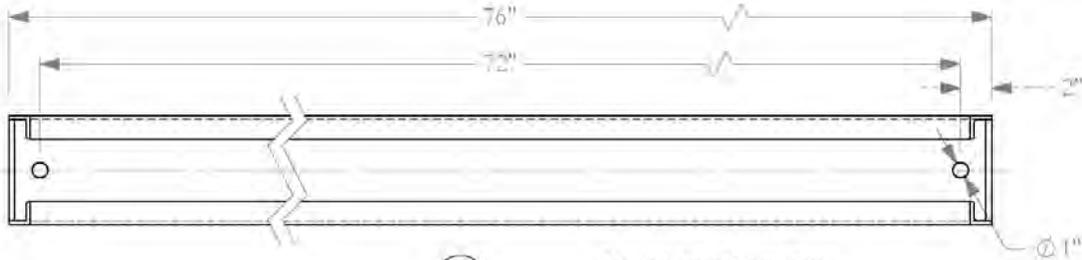
10 SLIDE PIECE
L1-1/2 x 1-1/2 x 1/4 ANDA36 STRAP

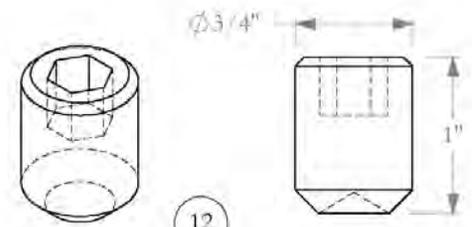
12 SETSCREW
THREADS NOT SHOWN FOR CLARITY

6a. Drill and tap $\phi 3/4"$ - 10 (NC) for setscrews.

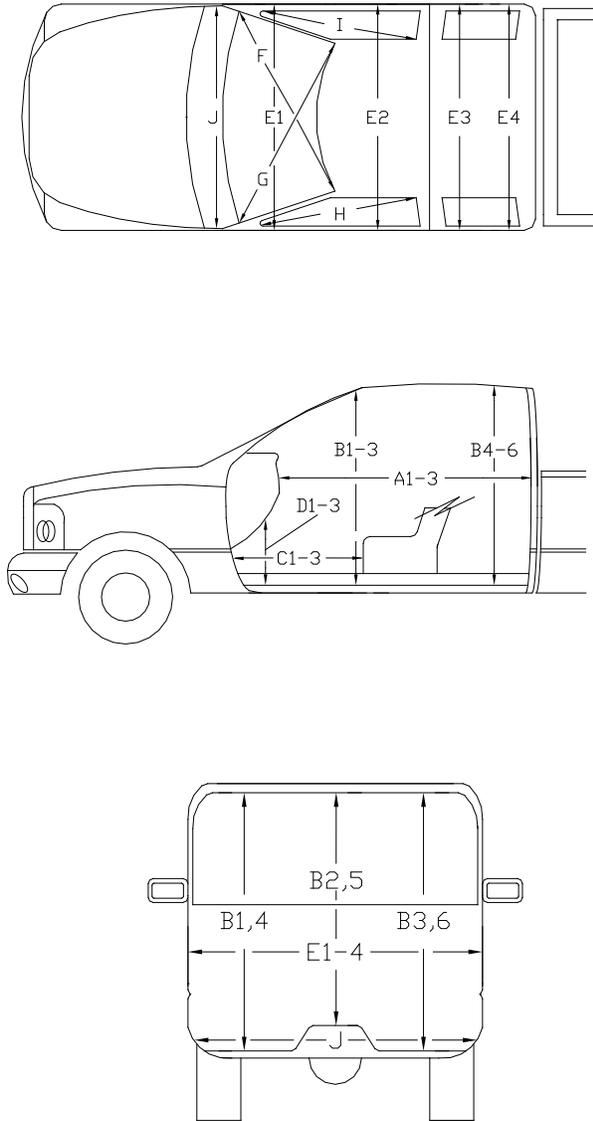
OCCUPANT COMPARTMENT DEFORMATION MEASUREMENT

Before (inches)	After (inches)
A1	64.50	64.50
A2	64.50	64.50
A3	64.50	64.50
B1	45.12	45.12
B2	42.50	42.25
B3	45.12	44.88
B4	42.12	42.12
B5	45.00	45.00
B6	42.12	42.12
C1	29.00	29.00
C2	----	----
C3	27.00	25.25
D1	12.50	----
D2	----	----
D3	11.50	12.00
E1	62.50	62.75
E2	64.50	66.00
E3	64.00	64.12
E4	64.12	64.12
F	60.00	60.00
G	60.00	60.00
H	39.00	39.00
I	39.00	39.00
J*	62.00	61.00

*Lateral area across the cab from driver's side kickpanel to passenger's side kickpanel.

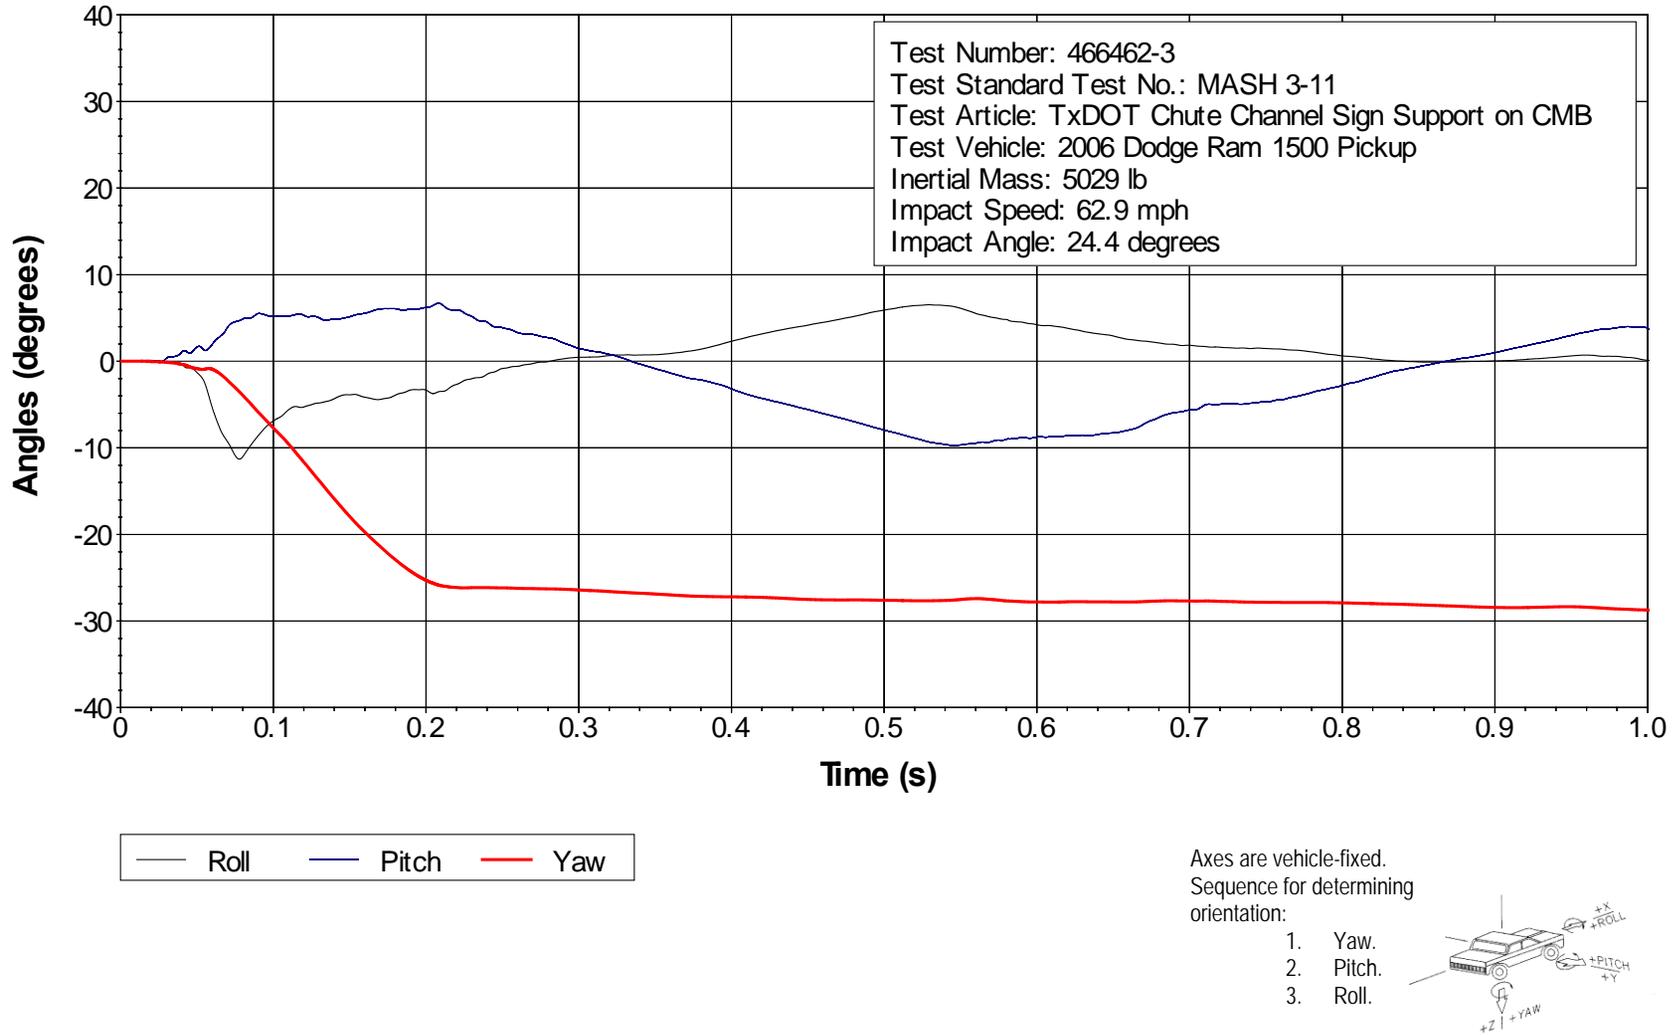
Figure E3. Vehicle Angular Displacements for Test No. 466462-3.

Roll, Pitch, and Yaw Angles

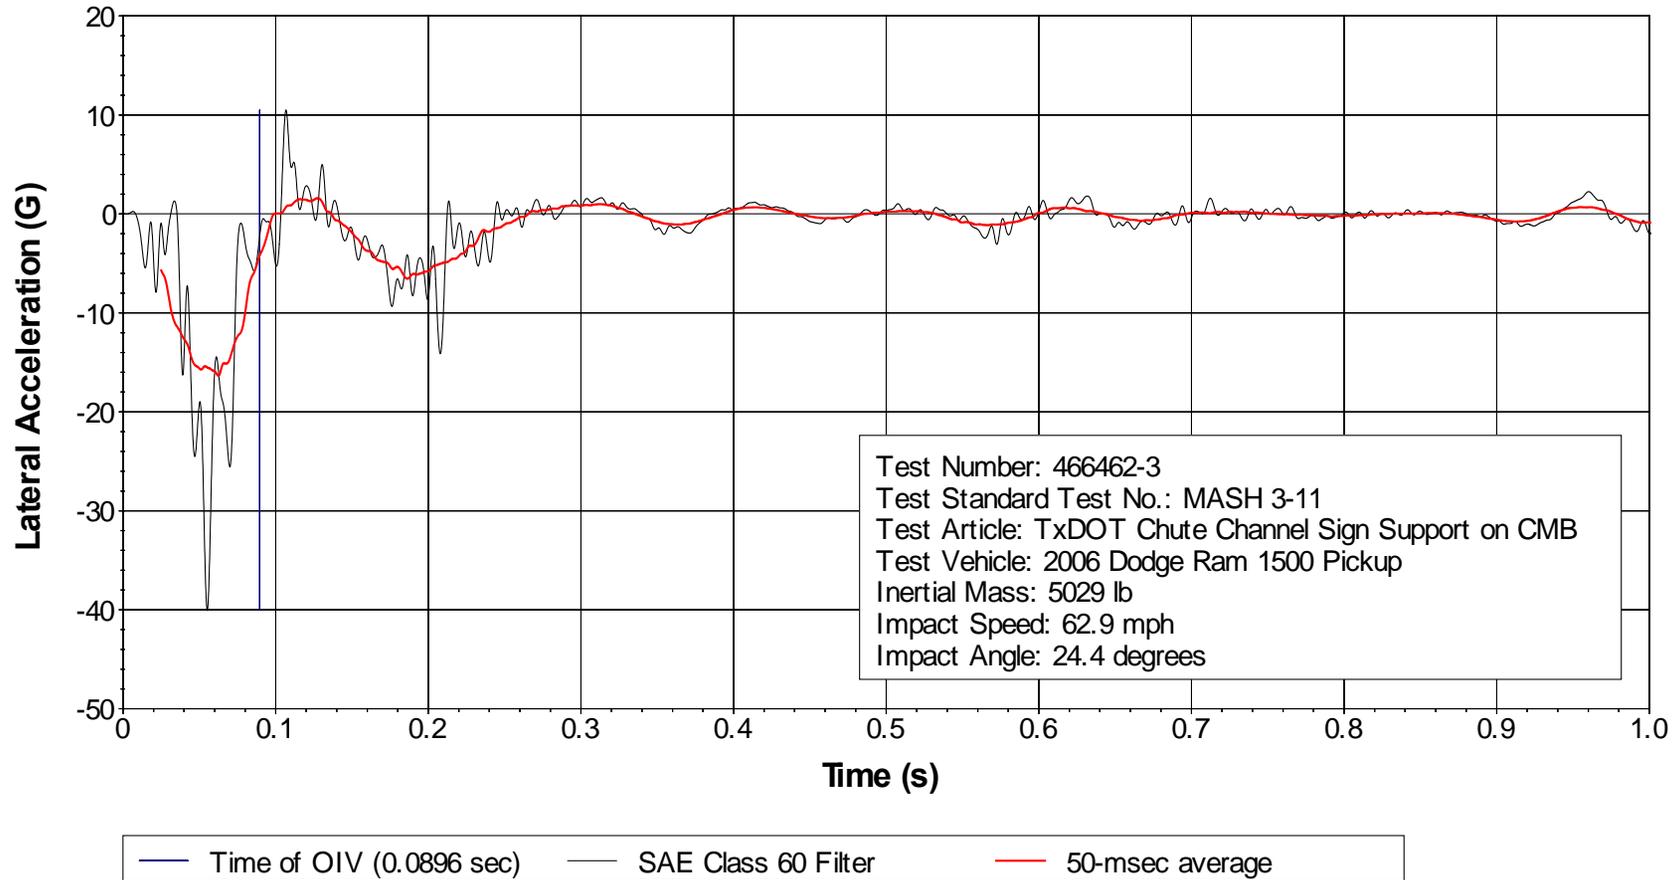
Figure E5. Vehicle Lateral Accelerometer Trace for Test No. 466462-3 (Accelerometer Located at Center of Gravity).

Y Acceleration at CG

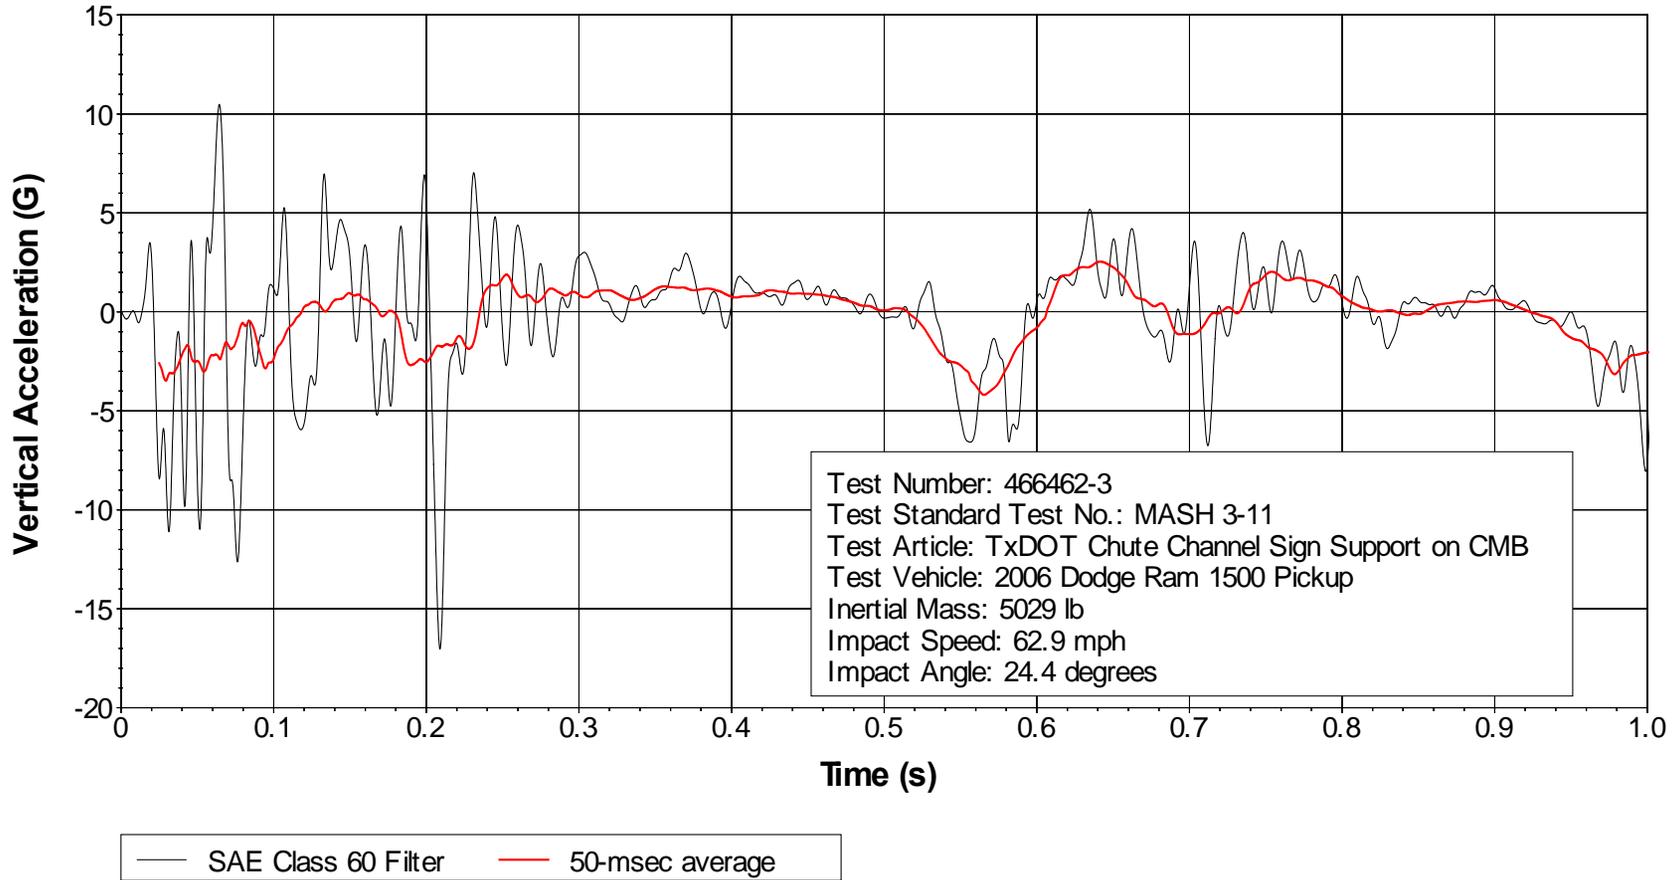
Figure E6. Vehicle Vertical Accelerometer Trace for Test No. 466462-3 (Accelerometer Located at Center of Gravity).

Z Acceleration at CG

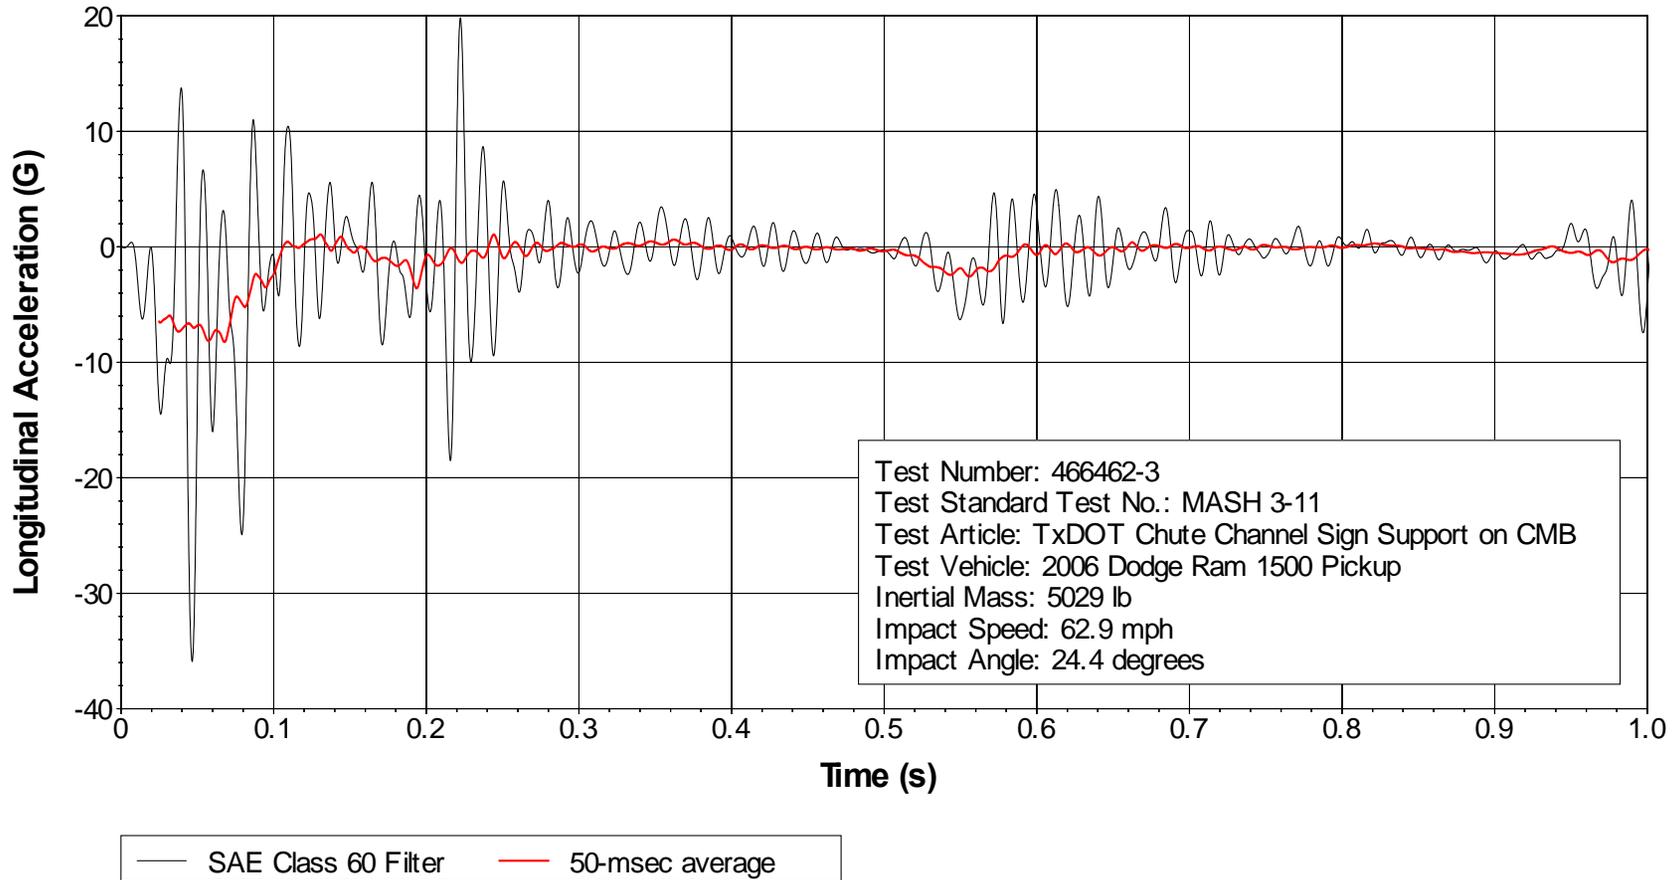
Figure E7. Vehicle Longitudinal Accelerometer Trace for Test No. 466462-3 (Accelerometer Located Rear of Center of Gravity).

X Acceleration Rear of CG

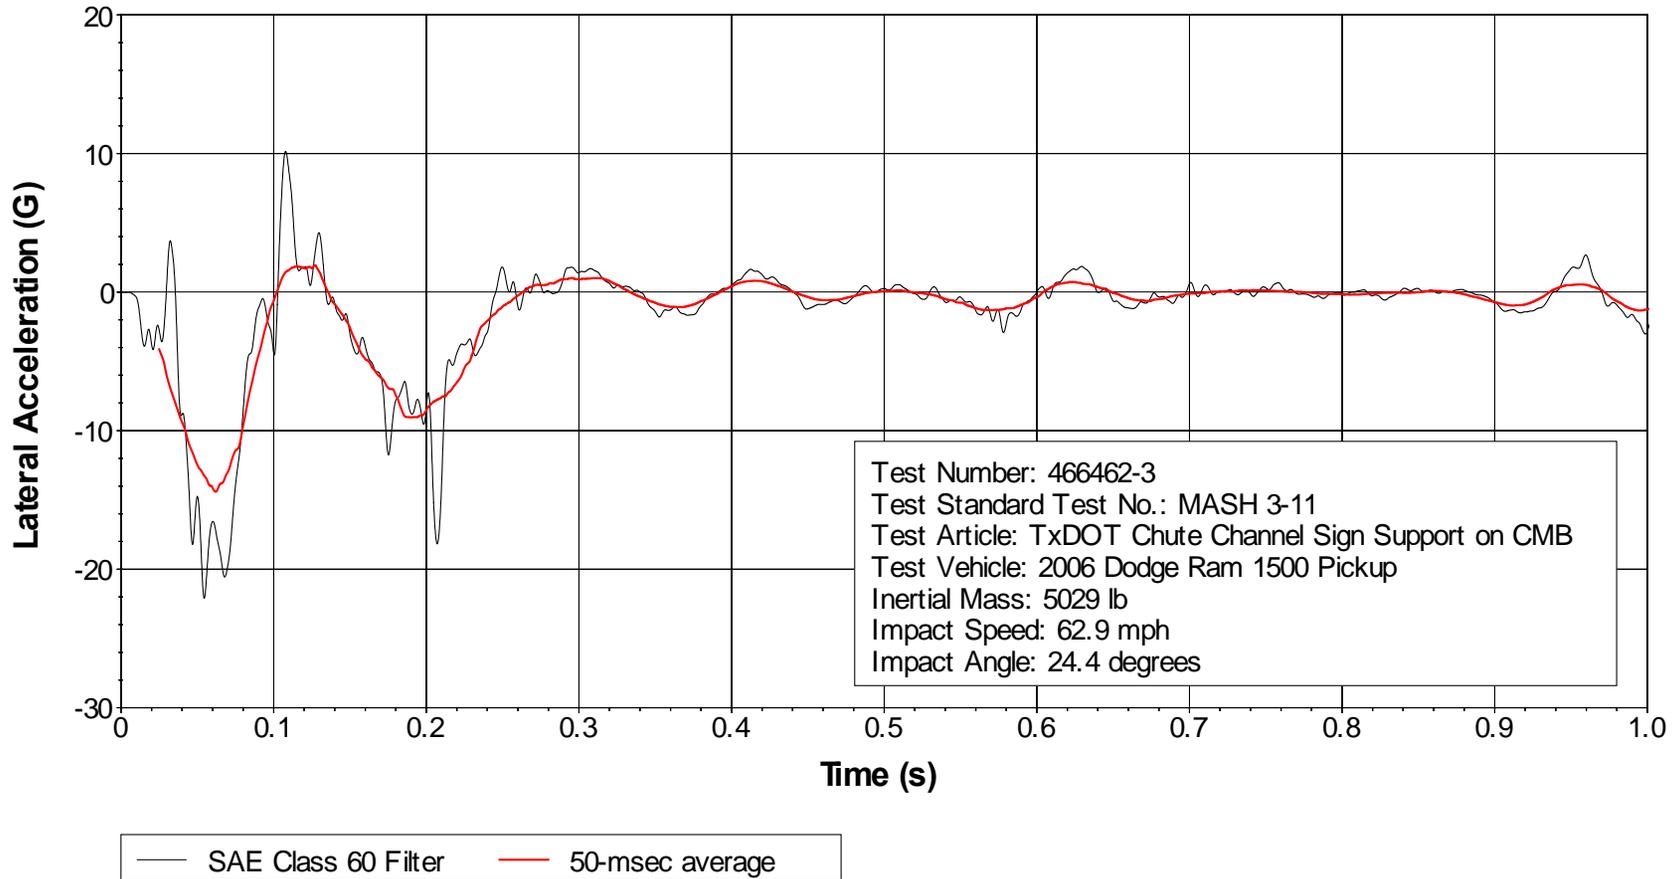
**Figure E8. Vehicle Lateral Accelerometer Trace for Test No. 466462-3
(Accelerometer Located Rear of Center of Gravity).**

Y Acceleration Rear of CG

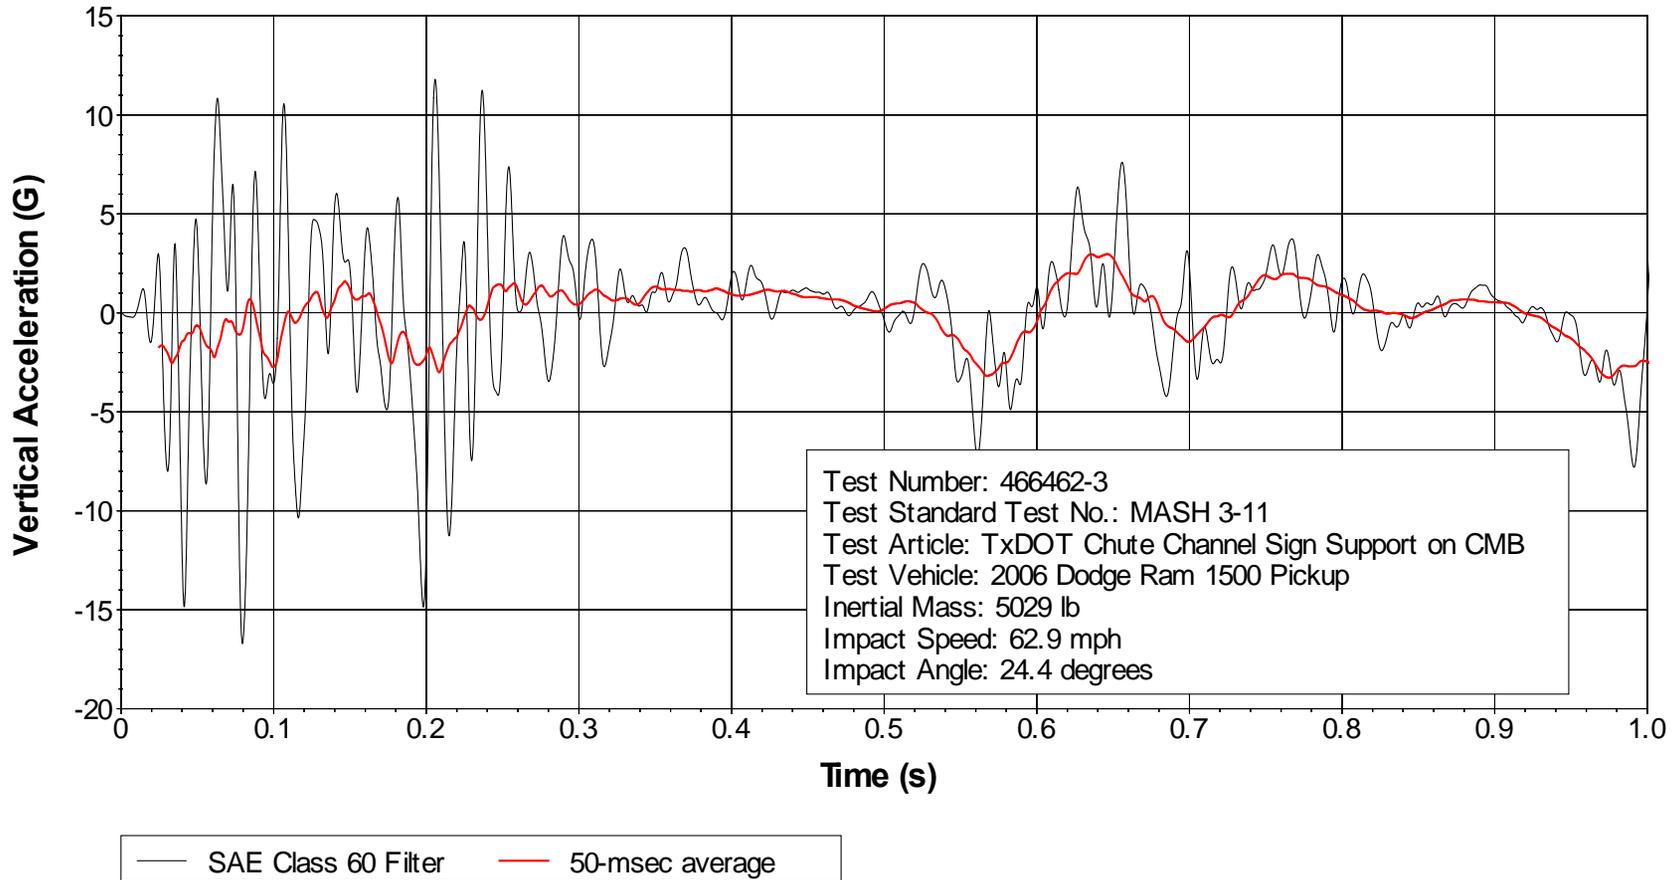
Figure E9. Vehicle Vertical Accelerometer Trace for Test No. 466462-3 (Accelerometer Located Rear of Center of Gravity).

Z Acceleration Rear of CG

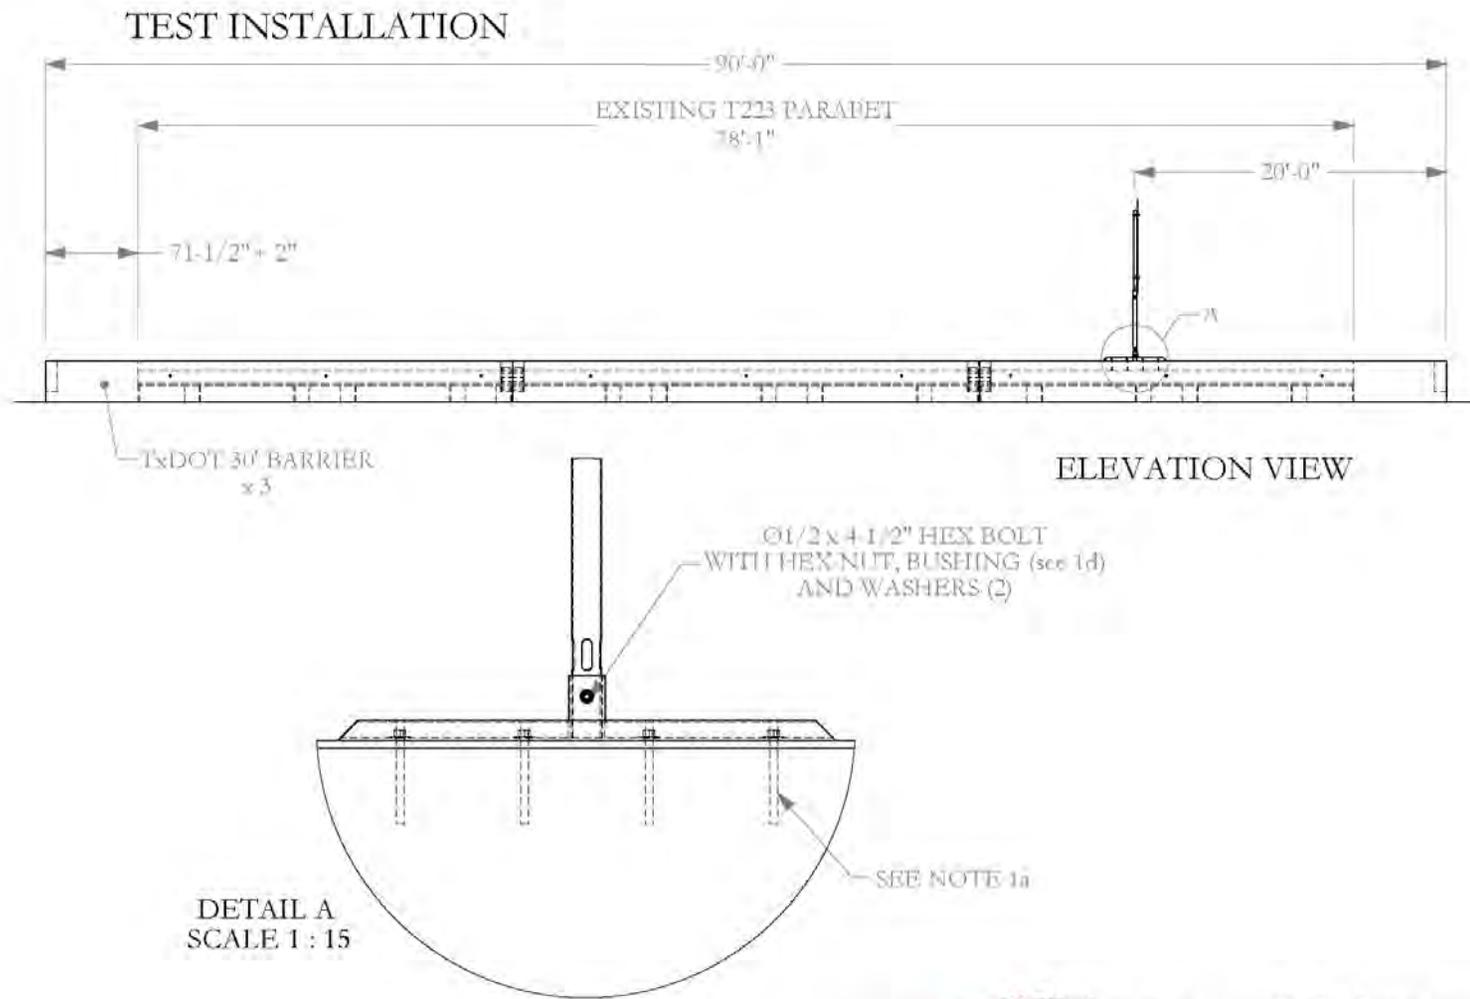
Project	466462-4	Signs on Parapet
Drawn By	GES	Scale 1:120 Sheet 1 of 4 Elevation View
Approved:		Date: 2012-08-27
Akram Abu-Odeh:

- 1a. 3/4" galvanized Hilti HAS-E rods (4), embedded 8" min., and secured with Hilti Hy 150 epoxy according to manufacturer's instructions.
- 1b. Some lines in Detail View (rebar, etc.) hidden for clarity.
- 1c. Hardware attaching sign posts to mounting brackets is A325 or grade 5.
- 1d. McMaster-Carr #92415A147

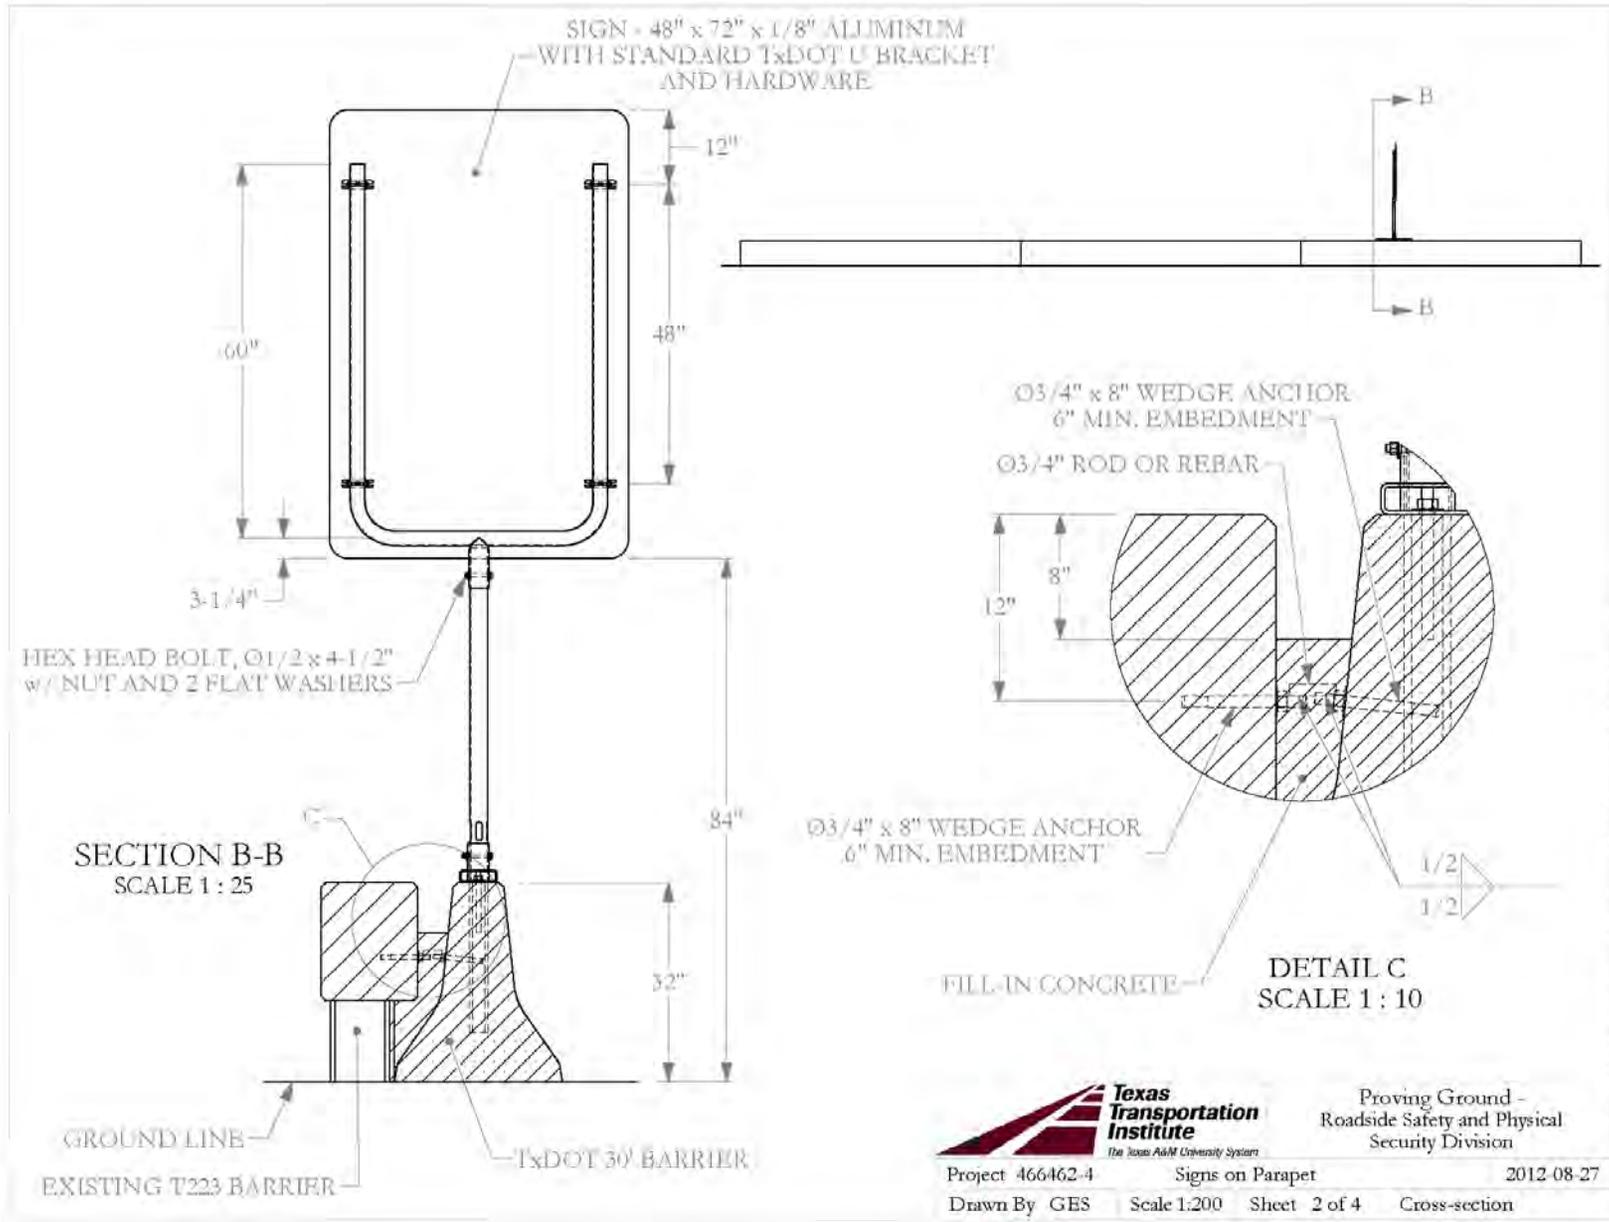
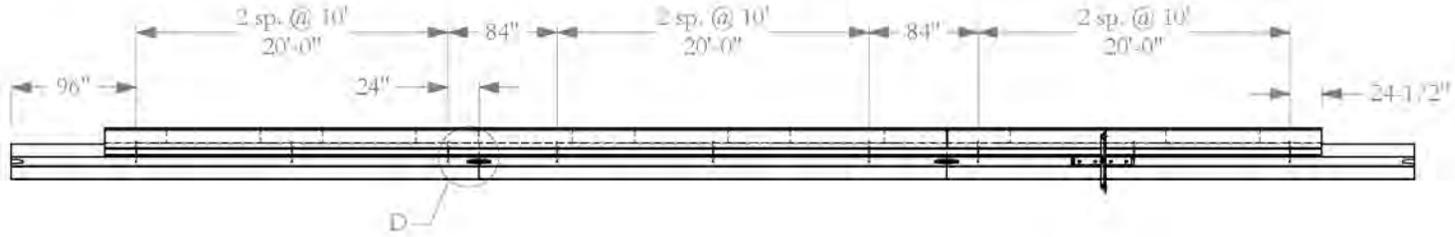
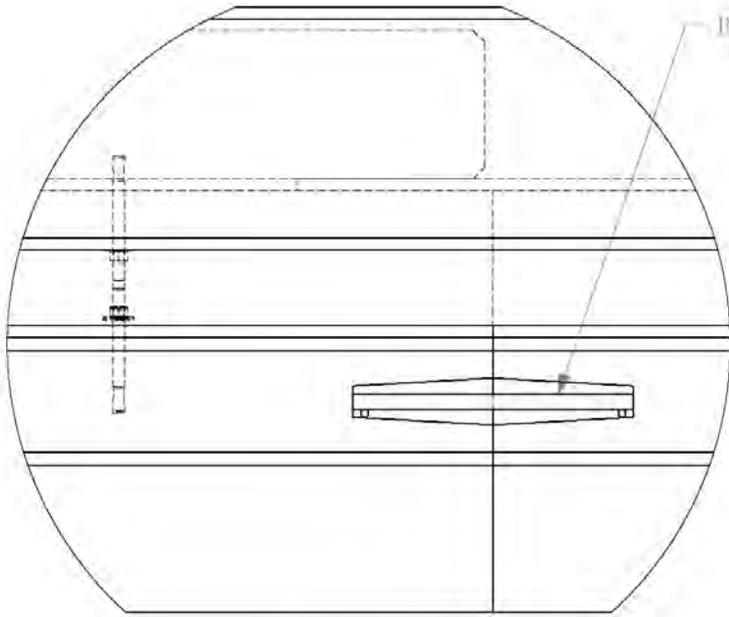
Project 466462-4 Signs on Parapet 2012-08-27
Drawn By GES Scale 1:120 Sheet 3 of 4 Plan View

WEDGE ANCHOR SPACING

INSERT JOINT GRID (SEE ISOMETRIC VIEW) AT BARRIER JOINT AND FILL WITH CONCRETE. TYPICAL x 2.

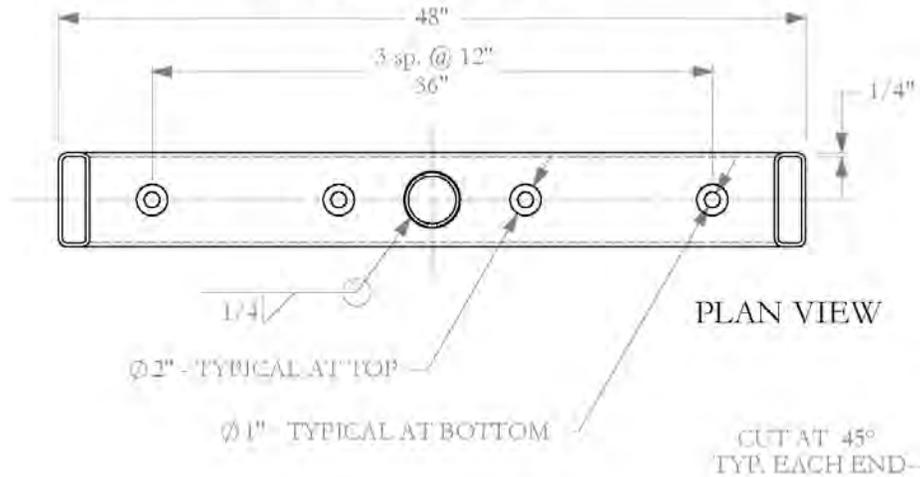
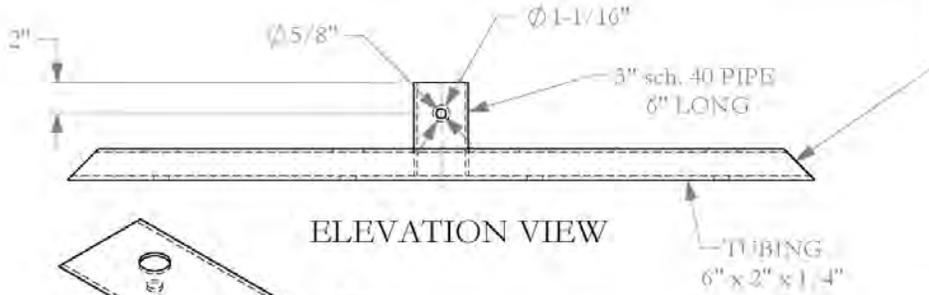
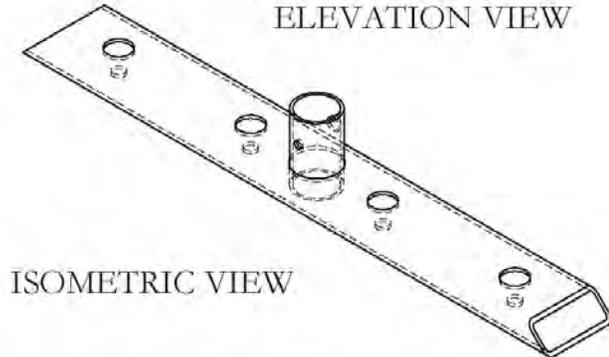
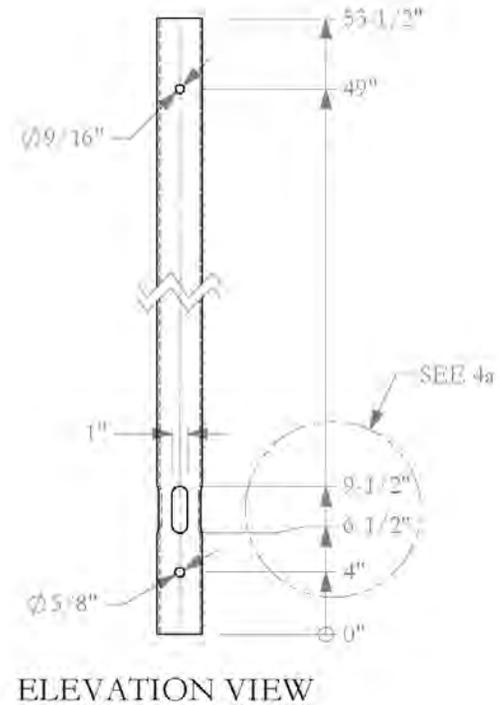
RIGID SIGN BASE

4a. Slot dimensions are typical x 4, evenly spaced.

POST

2-1/2" - 10 BWG PIPE

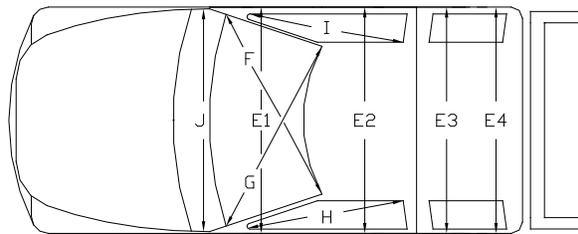
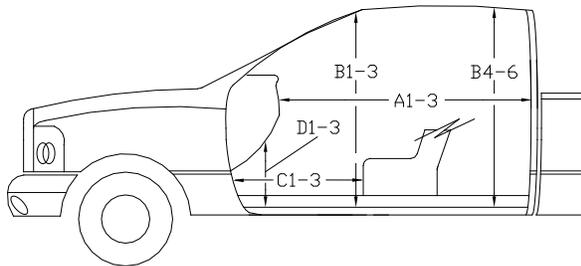
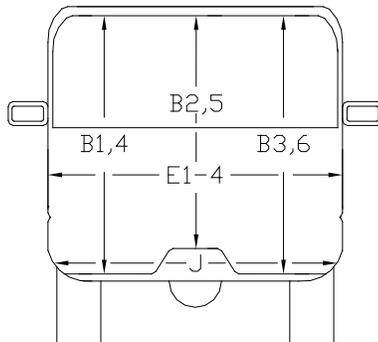
OCCUPANT COMPARTMENT DEFORMATION MEASUREMENT

Before (inches)	After (inches)
A1	64.50	64.50
A2	64.50	64.50
A3	65.00	64.00
B1	45.25	45.25
B2	39.75	39.25
B3	45.25	45.75
B4	42.25	42.25
B5	45.00	45.00
B6	42.25	42.25
C1	29.50	29.50
C2	----	----
C3	27.00	24.00
D1	12.75	12.75
D2	----	----
D3	11.50	11.75
E1	62.75	63.75
E2	64.50	66.12
E3	64.00	64.12
E4	64.12	64.25
F	60.00	60.00
G	60.00	60.00
H	39.00	39.00
I	39.00	39.00
J*	62.12	60.25

*Lateral area across the cab from driver's side kickpanel to passenger's side kickpanel.
