Signs on Concrete Median Barriers

Test Report 0-6646-1

**TEXAS A&M TRANSPORTATION INSTITUTE
COLLEGE STATION, TEXAS**

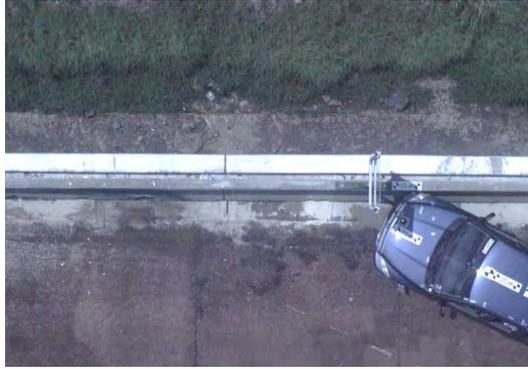
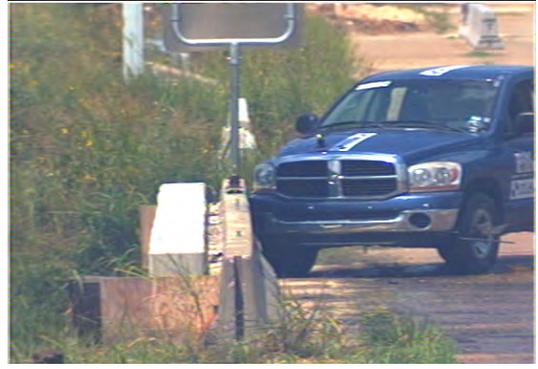
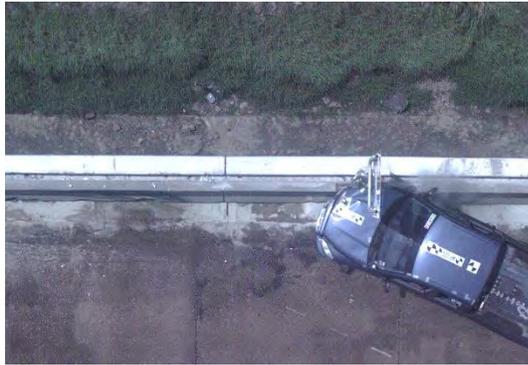
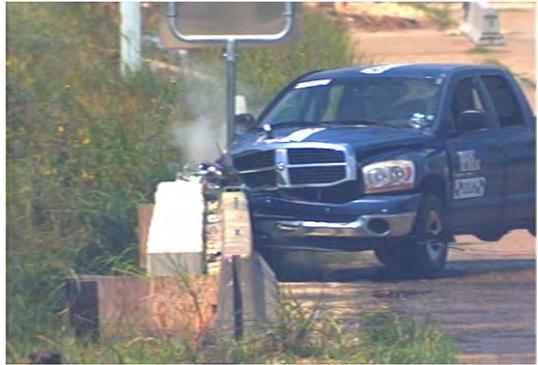
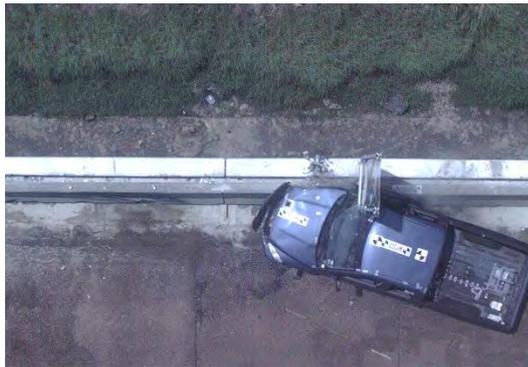
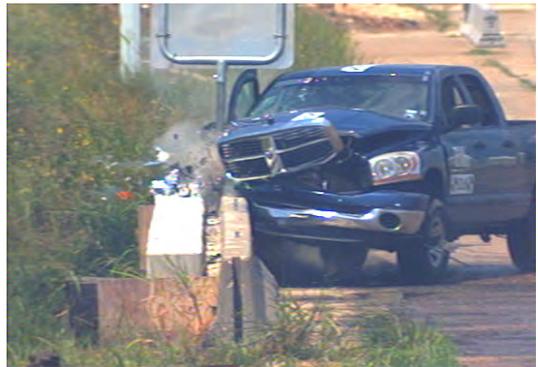
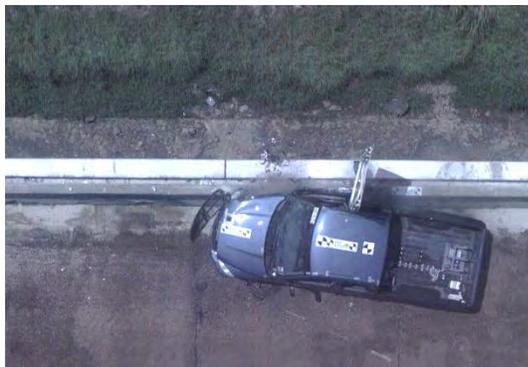
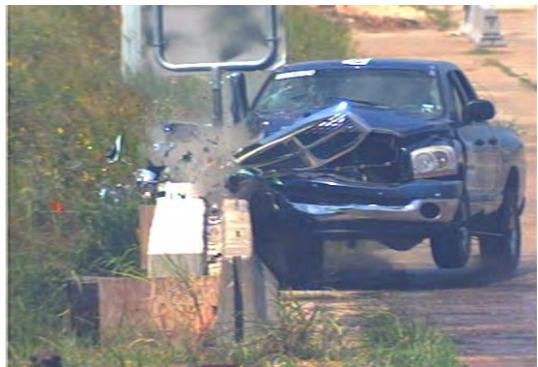
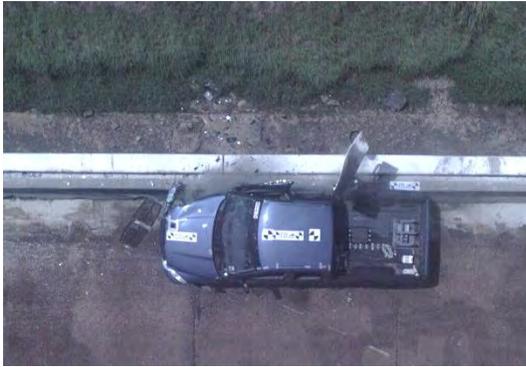
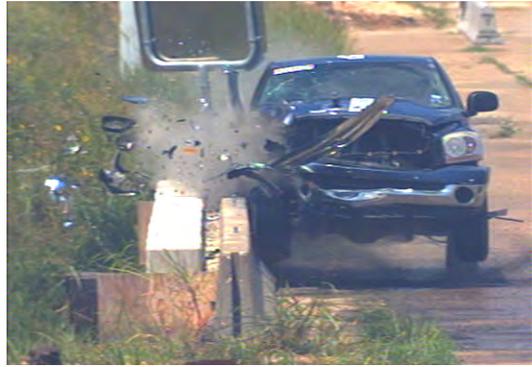
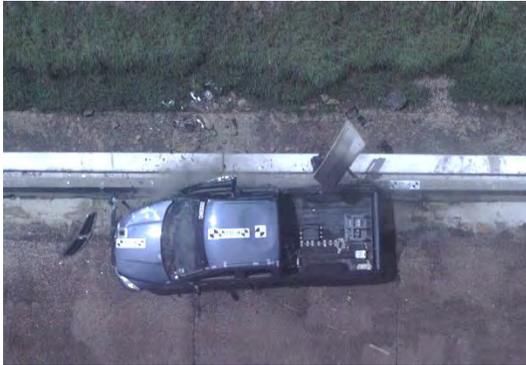
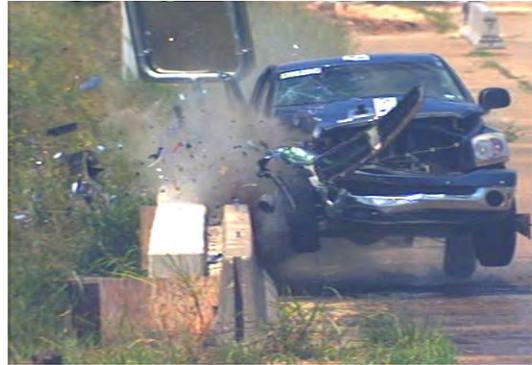
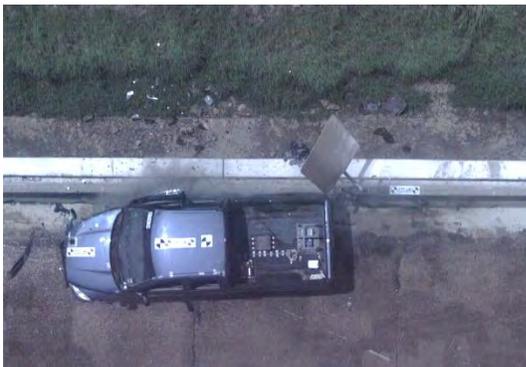
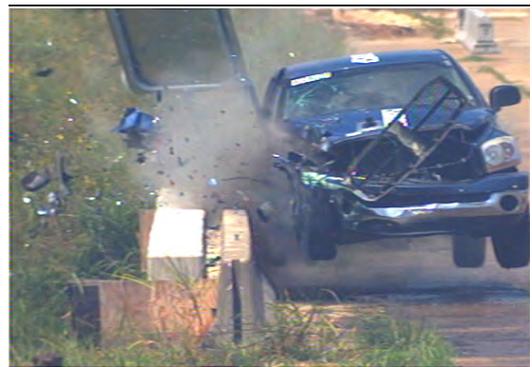
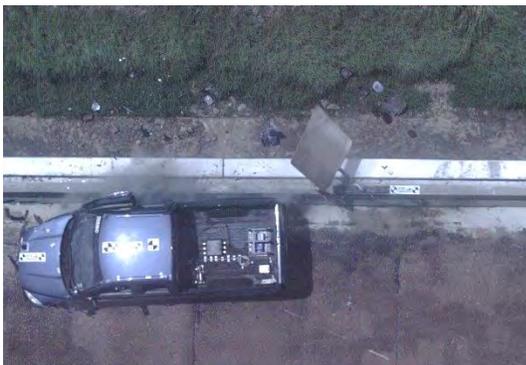
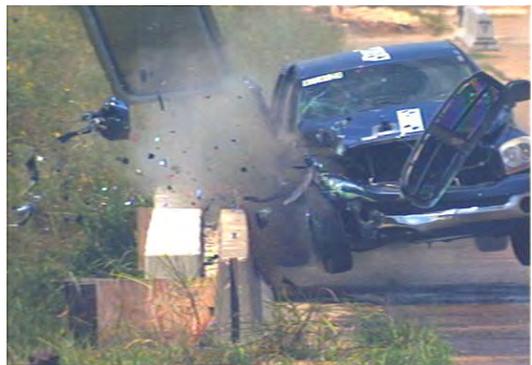
Figure F1. Sequential Photographs for Test No. 466462-4 (Overhead and Frontal Views).

Figure F1. Sequential Photographs for Test No. 466462-4 (Overhead and Frontal Views) (continued).

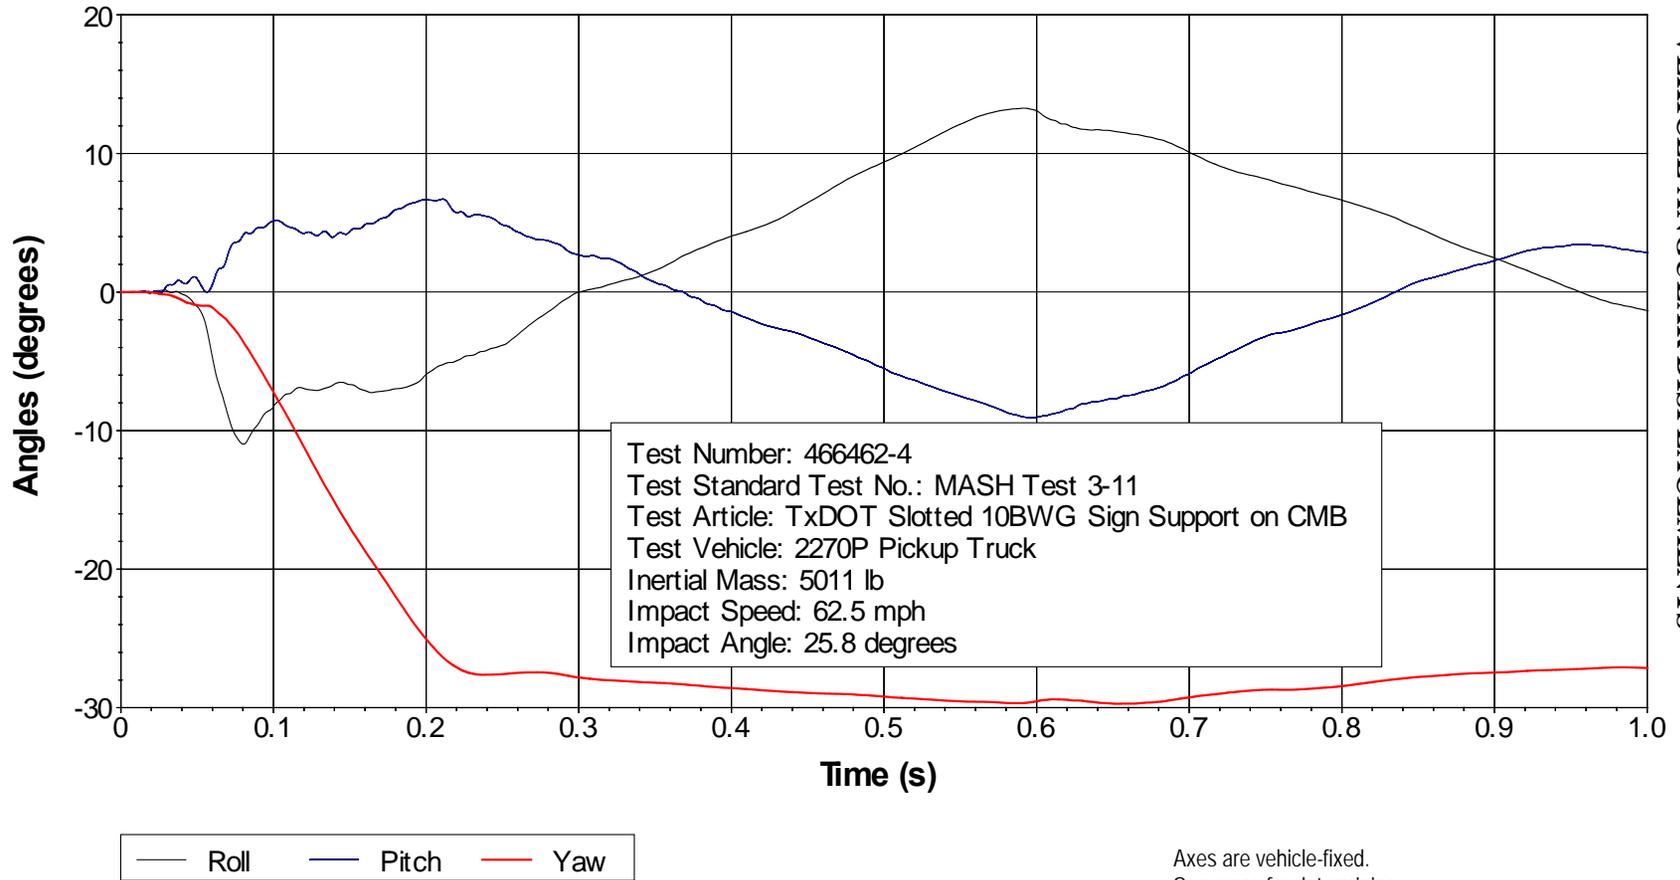
Figure F3. Vehicle Angular Displacements for Test No. 466462-4.

Axes are vehicle-fixed.
 Sequence for determining orientation:

1. Yaw.
2. Pitch.
3. Roll.
