Report No. C-10-06: Monitoring Functionality and Durability of the New York State Highway 30 Turtle Barrier and Adjacent Nesting Substrate

Final Report

Prepared for *New York State Department of Transportation*

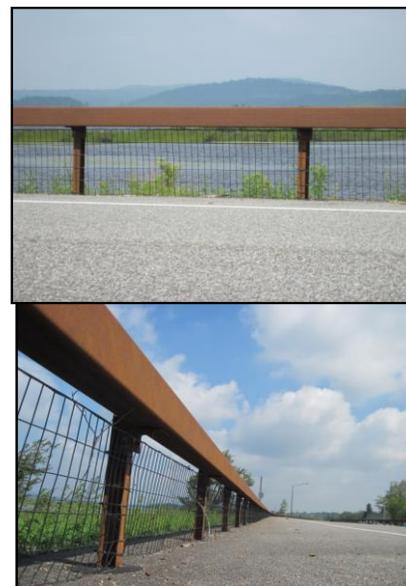
Fig. 2.1 b: NYS Highway 30 wildlife barrier, constructed of vinyl-coated steel mesh affixed to the road guard rail.

The design of the barrier is 0.6 m high, 5 x 10 cm mesh 12 gauge vinyl-covered wire fencing affixed to an existing steel guide rail post (Fig. 2.1 b). The fencing is affixed using heavy-duty, ultraviolet light-resistant cable ties (three per post). The base of the fence is flush with the road decking, and the top of the fence is flush with the guardrail (box beam).

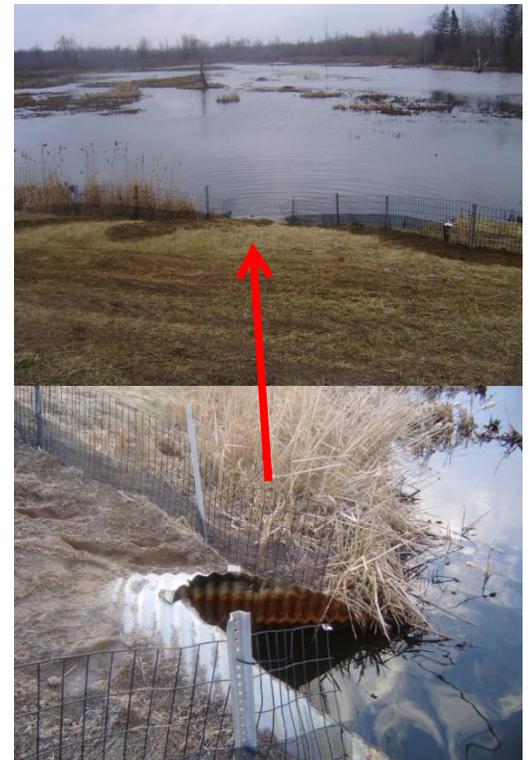
Design of Barrier: The site of the barrier was an elevated section of road with a steep verge. The east side, which included wire and wooden fence designs, was offset 6.5 m from the road. The length was 212 m, plus additional 7 m and 12 m wings on the ends of the barrier, oriented 45 degrees away from the road. The west side barrier, which was exclusively wire fencing, was 3 m from the road. The length was 213 m, plus additional 9 m and 12 m wings on the ends of the barrier, oriented 45 degrees away from the road. Wire fencing was used on each side to connect the fence to the water-equalization tube culvert (Fig. 2.2.1 b)

Fig. 2.2.1 b: Culvert connected to barrier fencing to serve as a passage.

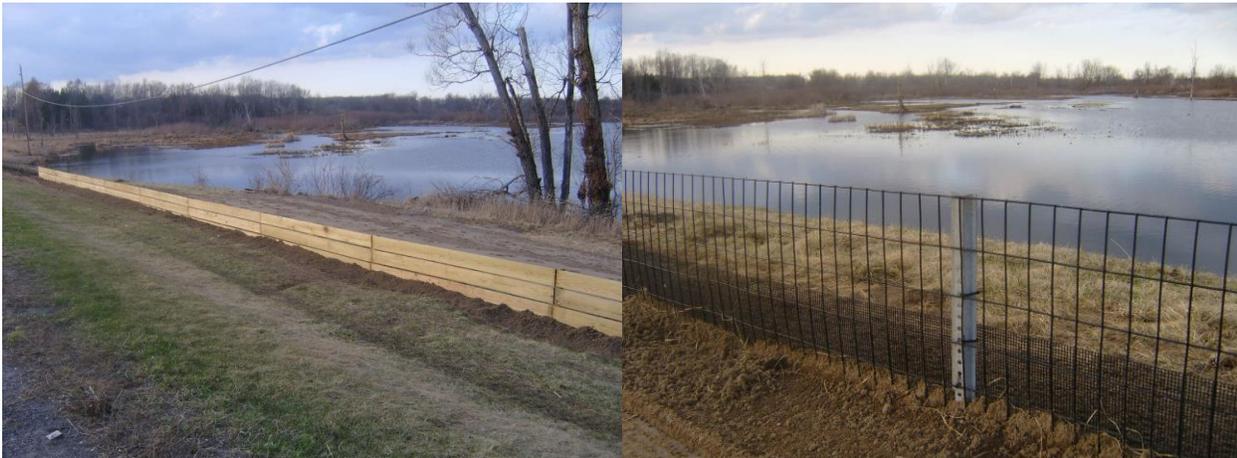
Fig. 2.2.1 c: Causeway Barrier 1 just after installation. (a) Wooden barrier. (b) Vinyl-coated metal barrier. Both barriers are 2 feet (54 cm) high.

Metal Fencing Barrier: The metal fencing barrier consisted of a base of 2 foot high (0.6 m) vinyl-coated over galvanized steel welded-wire metal fencing (Fig. 2.2.1 c). The fencing was affixed to metal posts (salvaged steel sign posts) using heavy-duty, ultraviolet light-resistant cable ties (three per post). The posts were spaced 6 feet (2 m) apart, and driven into the ground using a post-hole driver. A reflector was placed on every tenth post. When installing the fence, a trench a few inches was dug, and the bottom of the fence buried. Installation was fast (around 20 m / hr for a team of 5 men) and not difficult.

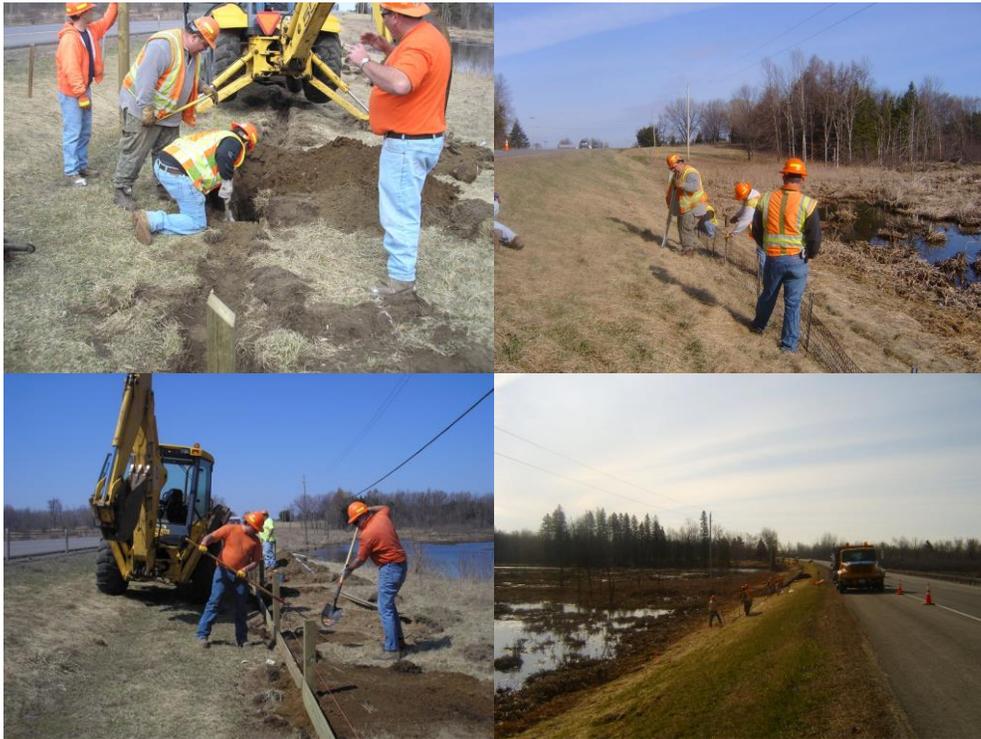
Site preparation required use of a backhoe and trencher (Fig. 2.2.1 d). It proved to be extremely difficult to dig the trench and post-holes, because the fill of the causeway, below a superficial layer of soil, was rock, including large boulders. These site conditions may be typical of causeways.

Fig. 2.2.1 d: Construction of Causeway Barrier 1. The left panel shows installation of the wooden barrier, and the right panel shows installation of the vinyl-coated metal fence.

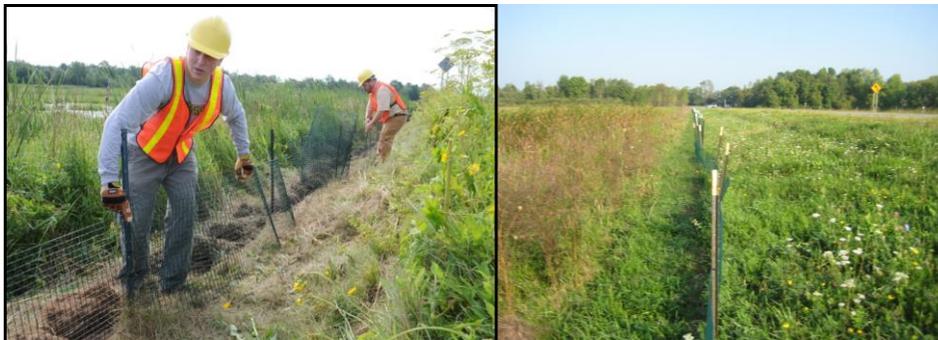
Fig. 2.2.2 b: Causeway Barrier 2 constructed of vinyl-coated wire fence.

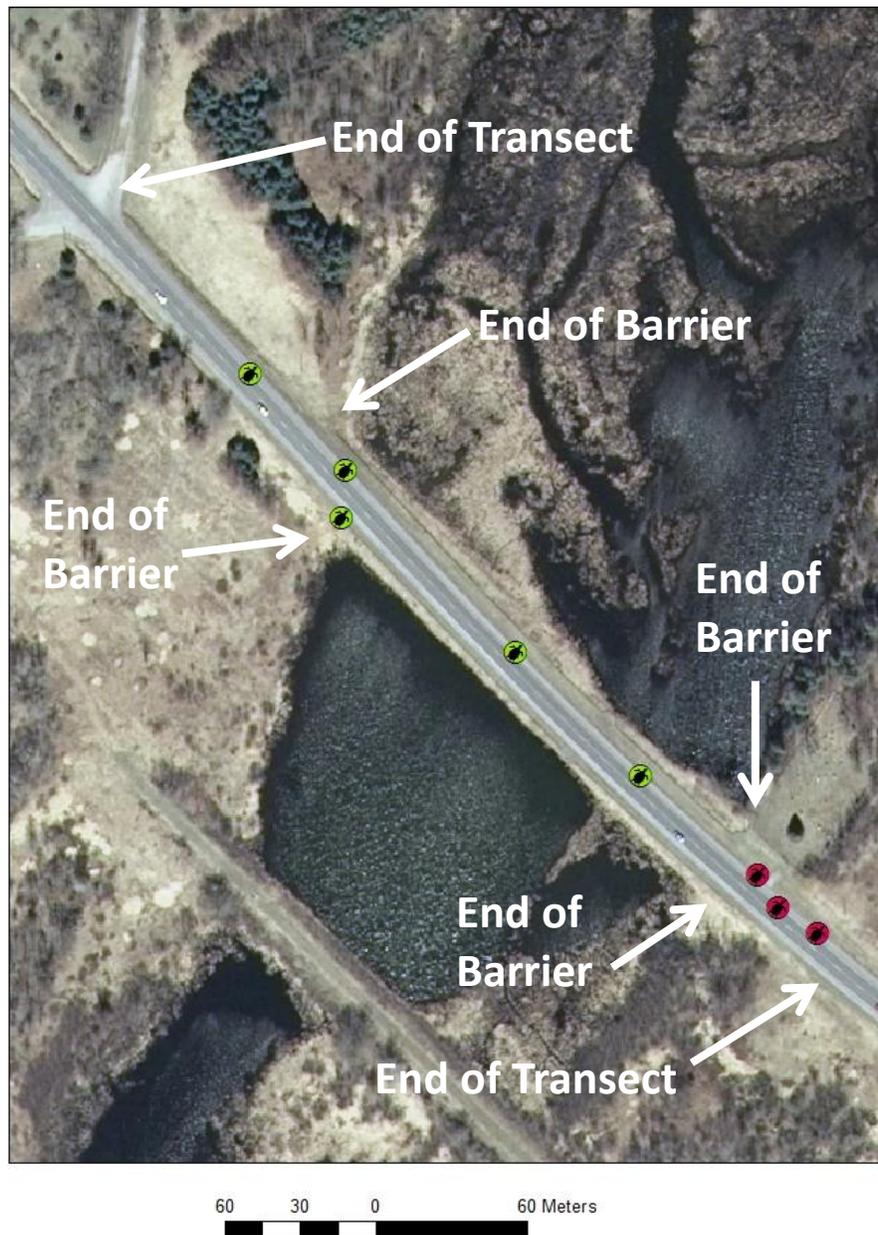
Fig. 4.3 b: *Locations of painted turtle (green) and snapping turtle (red) road-kill in 2010 and 2011 along the monitored transect of the ULL SWMA Highway 68 Turtle Barrier 1.*

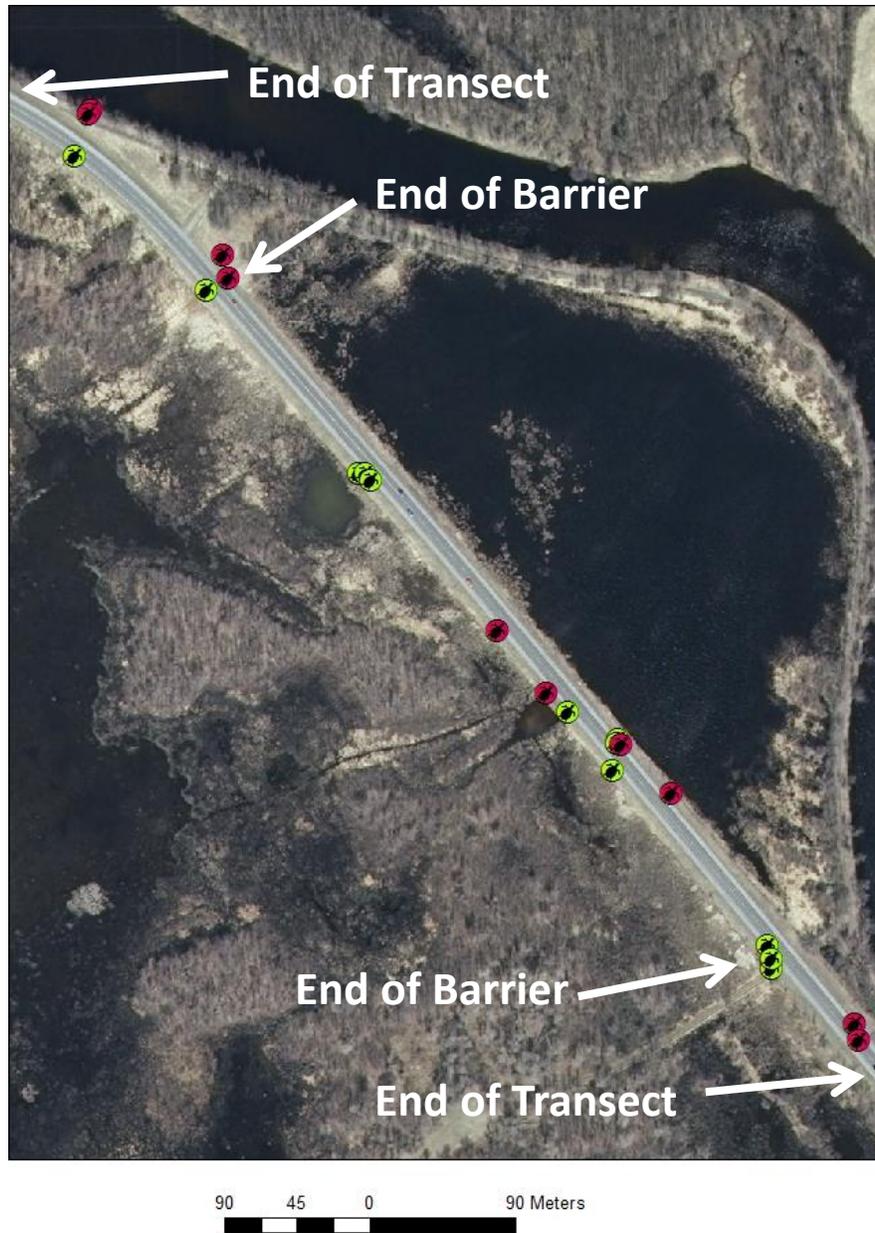
At the newer barrier (Highway 68 Barrier 2), a significant number of painted turtles were killed well-within the zone that was fenced (Fig. 4.3 c). In this case, it appears that turtles were finding gaps in the fence or (less likely) scaling it. Subsequent evaluation (after the monitoring season) indicated that a number of repairs were needed, caused by problems originating from the initial installation (which was done by BOCES Environmental Tech Students and St. Lawrence County Youth Bureau).

Fig. 4.3 c: *Locations of painted turtle (green) and snapping turtle (red) road-kill in 2011 along the monitored transect of the ULL SWMA Highway 68 Turtle Barrier 2.*

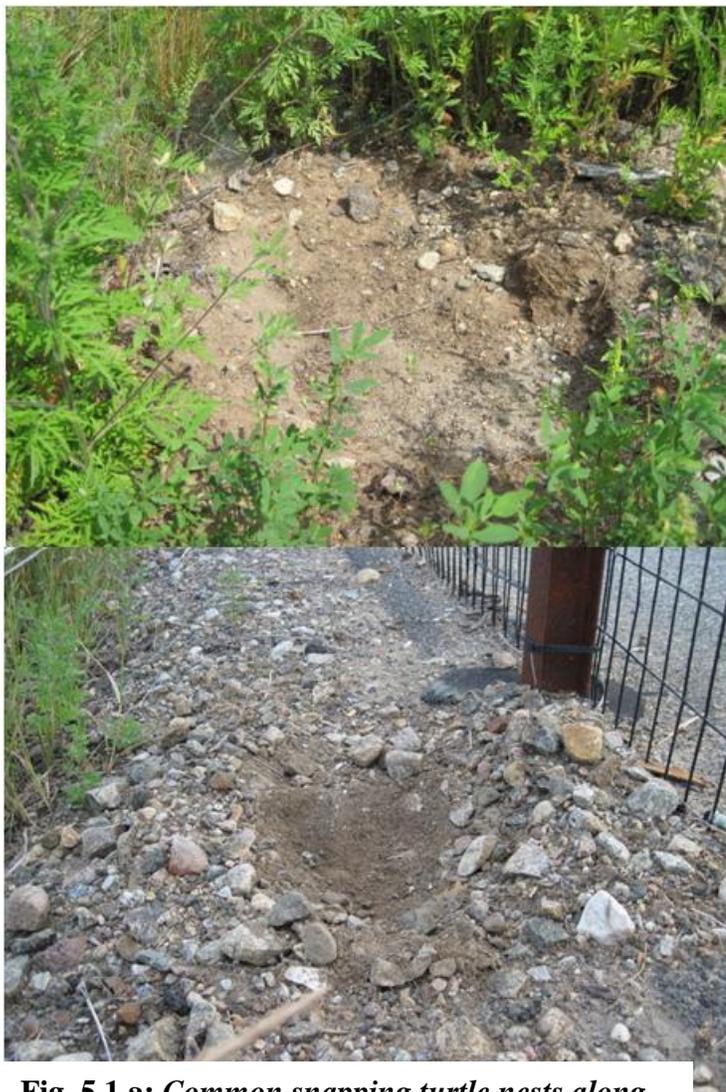
Fig. 5.1 a: *Common snapping turtle nests along the Tupper Lake Highway 30 Turtle Barrier.*

Nests were built immediately adjacent to the road pavement, and therefore adjacent to the turtle barrier. Nest placement was similar to that at the ULL WMA road segments (see Appendix 3: Langen 2009), and the two surveyed Adirondack ‘control’ road segments on Highway 30 and Highway 3. Nest predation rates were not measured for this study, but appeared to be low relative to other sites I monitored; relatively few nests were depredated (depredation is evident by excavation of the nest and discarded egg shells around the excavation site). My research at

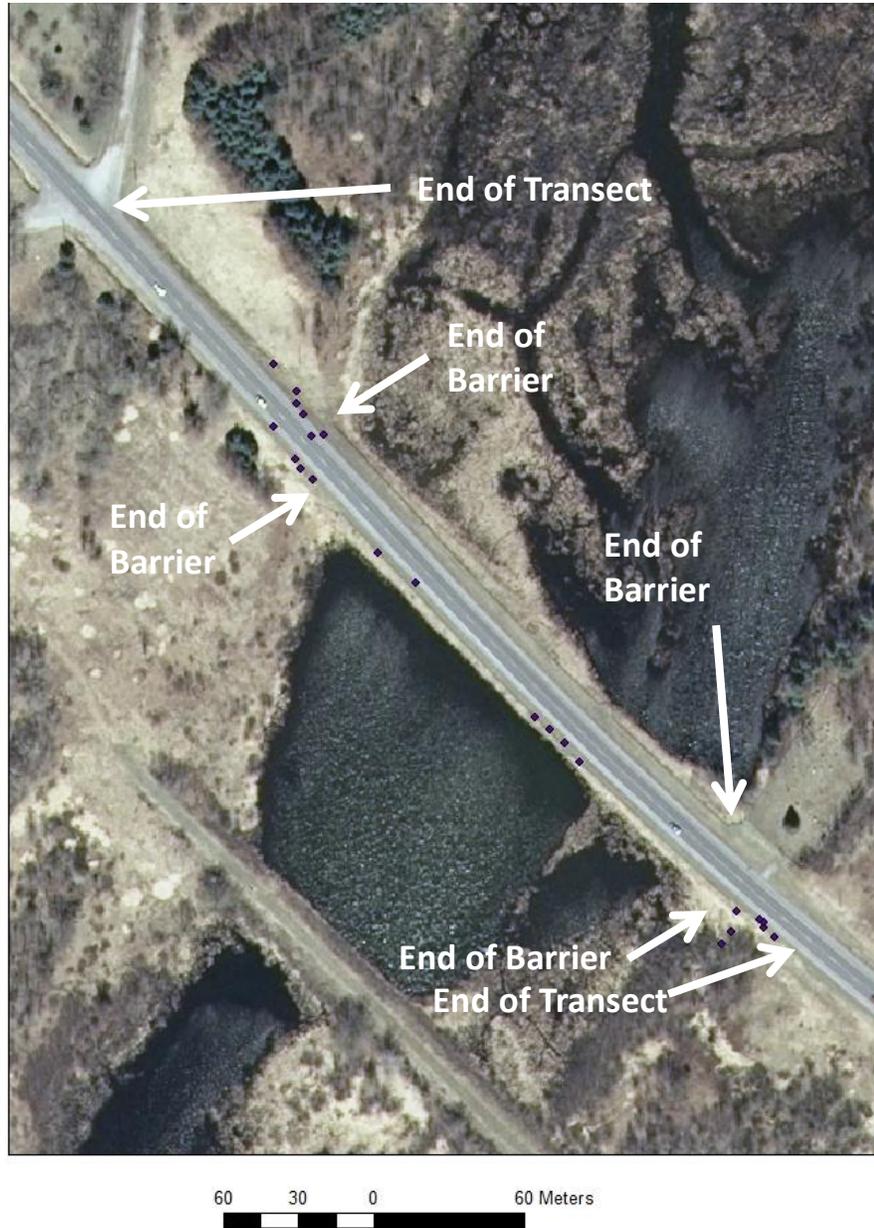
Fig. 5.1 c: *Locations of detected turtle nests in 2010 and 2011 along the monitored transect of the ULL SWMA Highway 68 Turtle Barrier 1.*

At both Upper & Lower Lakes SWMA Highway 68 Wildlife Barriers, nests were constructed all along the barriers, but many were clustered along the road outside of the fenced zone (Fig. 5.1 c, Fig. 5.1 d). This indicates that turtles were likely going around the wings of the fences, to gain access to the road edge for nesting (both fences are set back from the road, see sections 2.2.1 and 2.2.2). As one might predict, the ends of the fences were also hotspots of road-kill for turtles during this study (Fig. 4.3 b, 4.3 c).

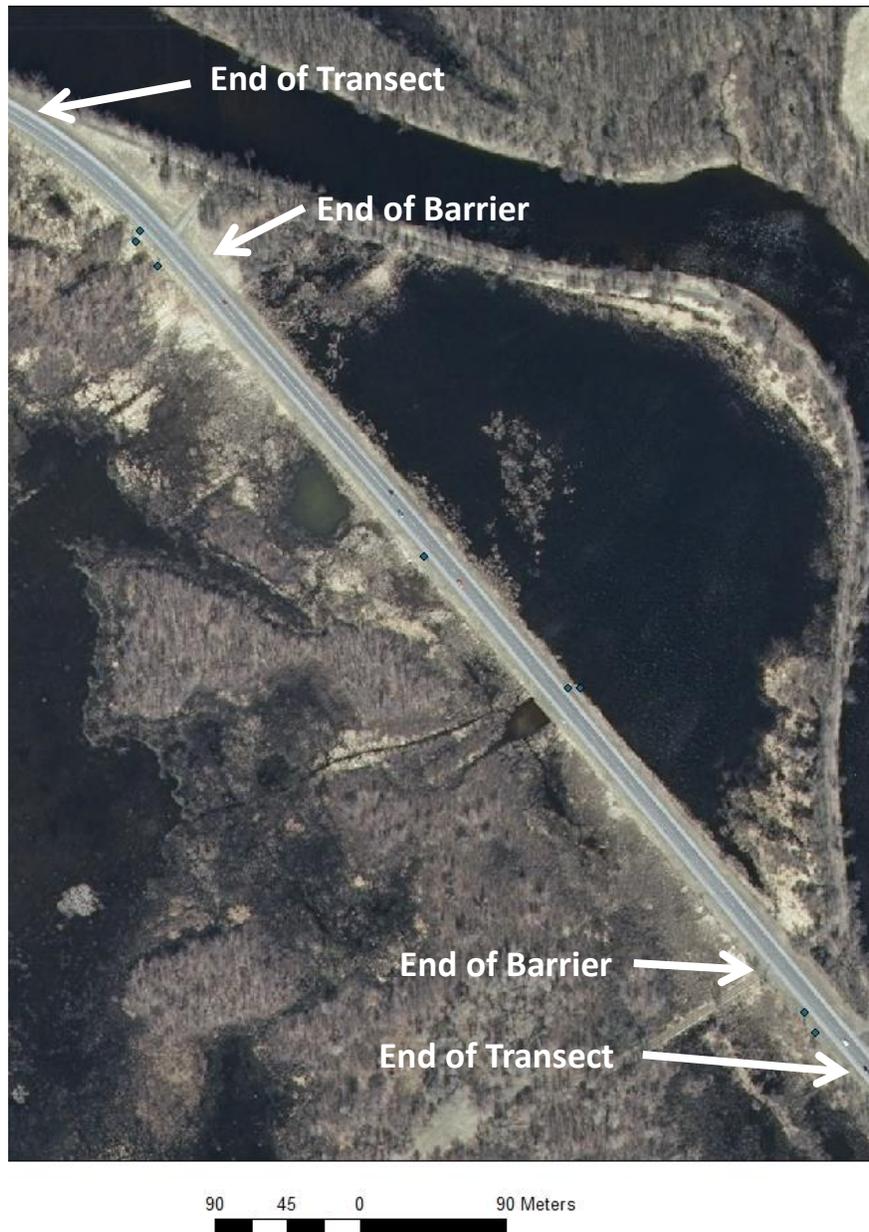
Fig. 5.1 d: *Locations of detected turtle nests in 2011 along the monitored transect of the ULL SWMA Highway 68 Turtle Barrier 2.*

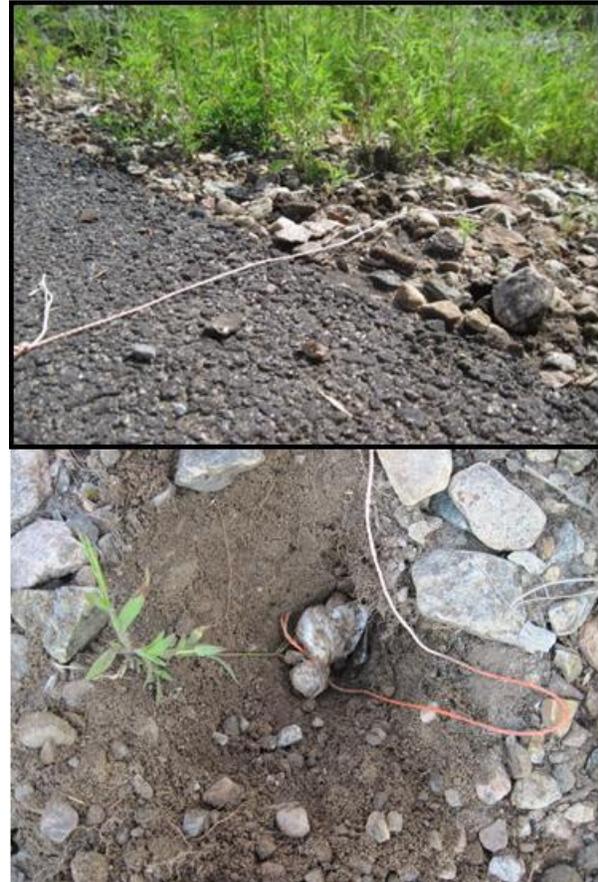
To record the temperature of the soil at depths relevant to egg and hatchling development in the nest, I planted iButton Thermocrons (Dallas Electronics) at a depth of approximately 20 cm (typical depth of incubating eggs). The sensors were placed in a plastic bag (to protect them from moisture), and a string was laced from the sensor to the surface to aid at relocating it (Fig. 5.2 a). The temperature sensors were programmed to record the temperature hourly. Locations included three evenly distributed sites adjacent to common snapping turtle nests along the Tupper Lake Highway 30 Turtle Barrier, on each side of the road (east and west facing) for a total of six sensors. Sensors were deployed in 2010 and 2011, and recorded data from early June to the beginning of August, spanning the critical period of development for turtle embryos (including sex determination).

Fig. 5.2 a: *Placement of thermocron sensors near road. The lower panel shows placement, but when deployed the sensor was buried.*

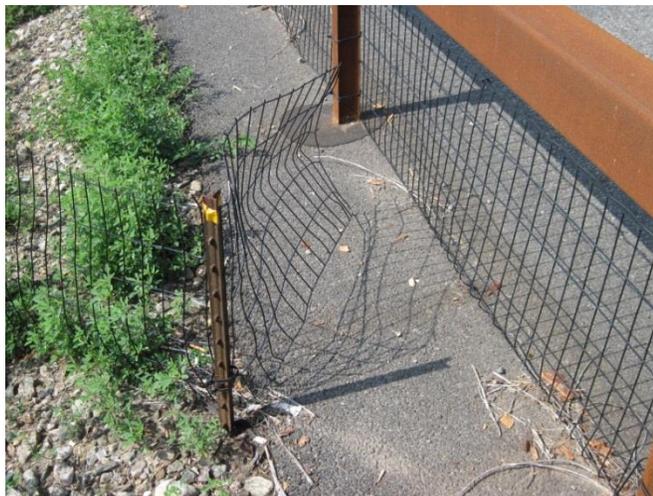
Fig. 6 a: *Fence break, likely caused by cutting.*

The most severe damage to the fences was caused by people intentionally cutting a section of fence to (presumably) make it easier to cross it (Fig. 6a). Less severe damage included two minor problems. First, some cable ties had to be replaced, having been broken or come undone. Second, the small fasteners that affixed the bottom of the fence, midpoint between support posts, to the asphalt broke in some places (Fig. 6b). In some cases, the gaps may have been large enough for smaller turtles (e.g. painted turtles, immature snapping turtles) to enter the roadway. In one instance, fill around a post shifted during the winter caused a post to lean.

To remain functional, the Tupper Lake Highway 30 Turtle Barrier will need annual inspection and maintenance. This should be done, minimally, each year in early May, before turtles become active on land. A repair kit should include packets of 10 inch UV-light resistant cable ties, some 1 m lengths of vinyl-coated fencing for patching major fence breaks (the same type as used in the installed barrier), wire cutters, pruning shears, pliers, and a post driver. Based on my experience, repairs can be completed within two worker-hours.

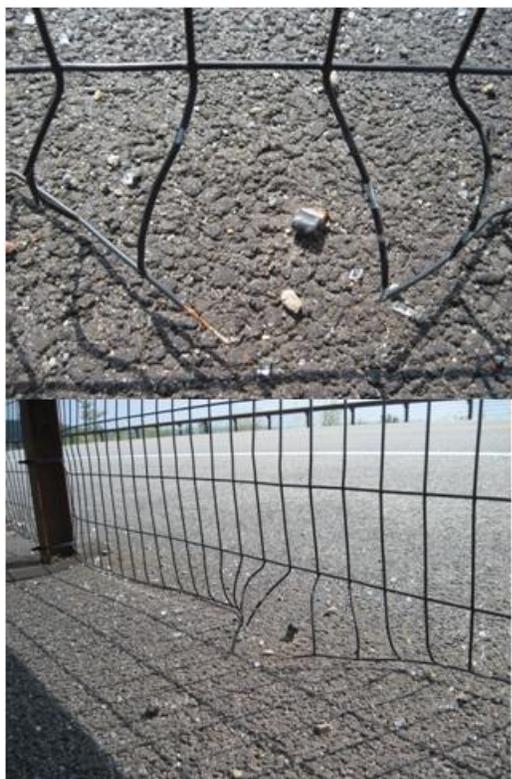
Fig. 6 b: *Break of fence at a bottom fastener.*
