# National Conference on Preservation, Repair, and Rehabilitation of Concrete Pavements

St. Louis, Missouri  
April 22–24, 2009

*Proceedings*

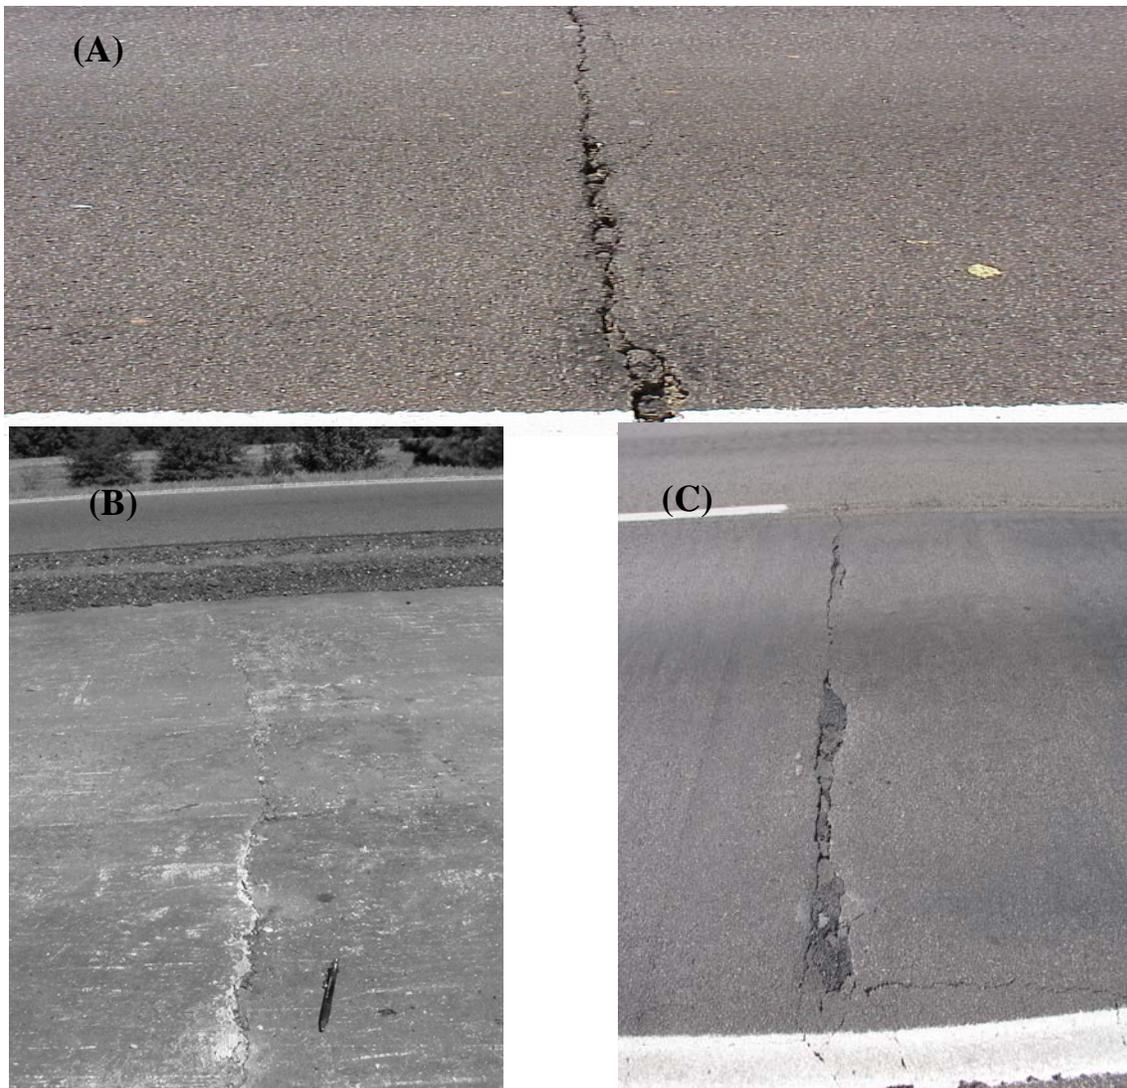
Figure 4 illustrates the pavement condition before milling, after milling, and 1 year after the 100-mm AC overlay. Even though there were significant vertical movements, no full-depth repairs were performed at this location, and cracks reflected through within 1 year. In fact, numerous reflective cracks were observed on IH-20 after only a few days. The lab results on the cores taken from IH-20 indicated that the 100-mm AC overlay was stiff and rut resistant, but had relatively poor crack resistance. Under the Hamburg Wheel test, the AC overlay had rutting of less than 12.5 mm after 20,000 cycles at 50C. The AC cores were tested with the OT, and it only took 2 cycles to fail the specimens. This means the AC overlay is very brittle and prone to crack. After traffic resumed, numerous locations like those shown in Figure 4 were observed, and many patches had to be placed in 25 months or less. The distress condition survey indicated that there were 90 locations (63 reflected cracks plus 27 patches) with distress after 25 months.

Figure 4. Pavement conditions along IH-20 (A) before milling, (B) after milling and before overlay, and (C) with reflected cracks 1 year after overlay.

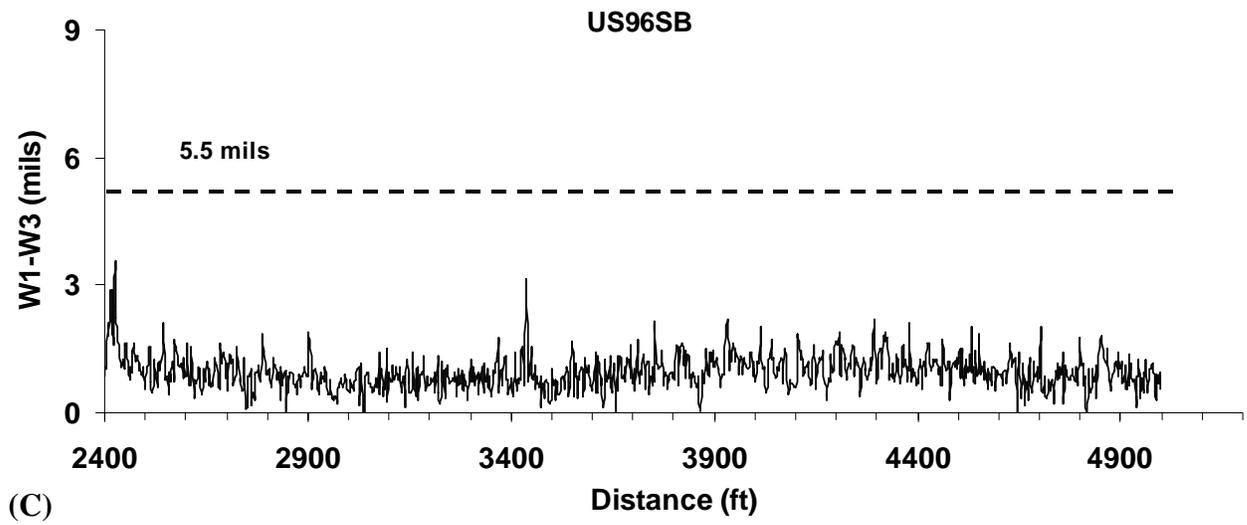
A 40-year-old CRCP on US-96 was being considered for major rehabilitation for the first time. Extensive spalling of the original CRCP near the transverse cracks was evident. The spalling was found to be limited to the top 50 mm. The pavement consists of 8 in. (203 mm) of CRCP and 4 in. (102 mm) of CTB. The roadway condition before rehabilitation is shown in Figure 6A. A candidate rehabilitation strategy proposed by the District consisted of placing an SMA overlay, 3 in. (76 mm) thick. The main concern with the placement of the overlay was the potential for reflective cracking. Since the reflective cracking is highly related to movement of the slabs at the cracks, the District requested an RDD survey to assess the support under the slabs at the cracks, as shown in Figure 6B. The continuous deflection profile collected by the RDD at this site is shown in Figure 6C. In view of Figure 6C, it was found that no cracks had  $W1-W3$  deflection exceeding 5.5 mils, indicating good load transfer and little reflective cracking potential.

**Figure 6. (A) Pavement condition of US-96 before rehabilitation with severe cracking and spalling; (B) rolling dynamic deflectometer testing (RDD); (C) RDD continuous deflection profile (on top of exposed concrete surface) for southbound direction.**

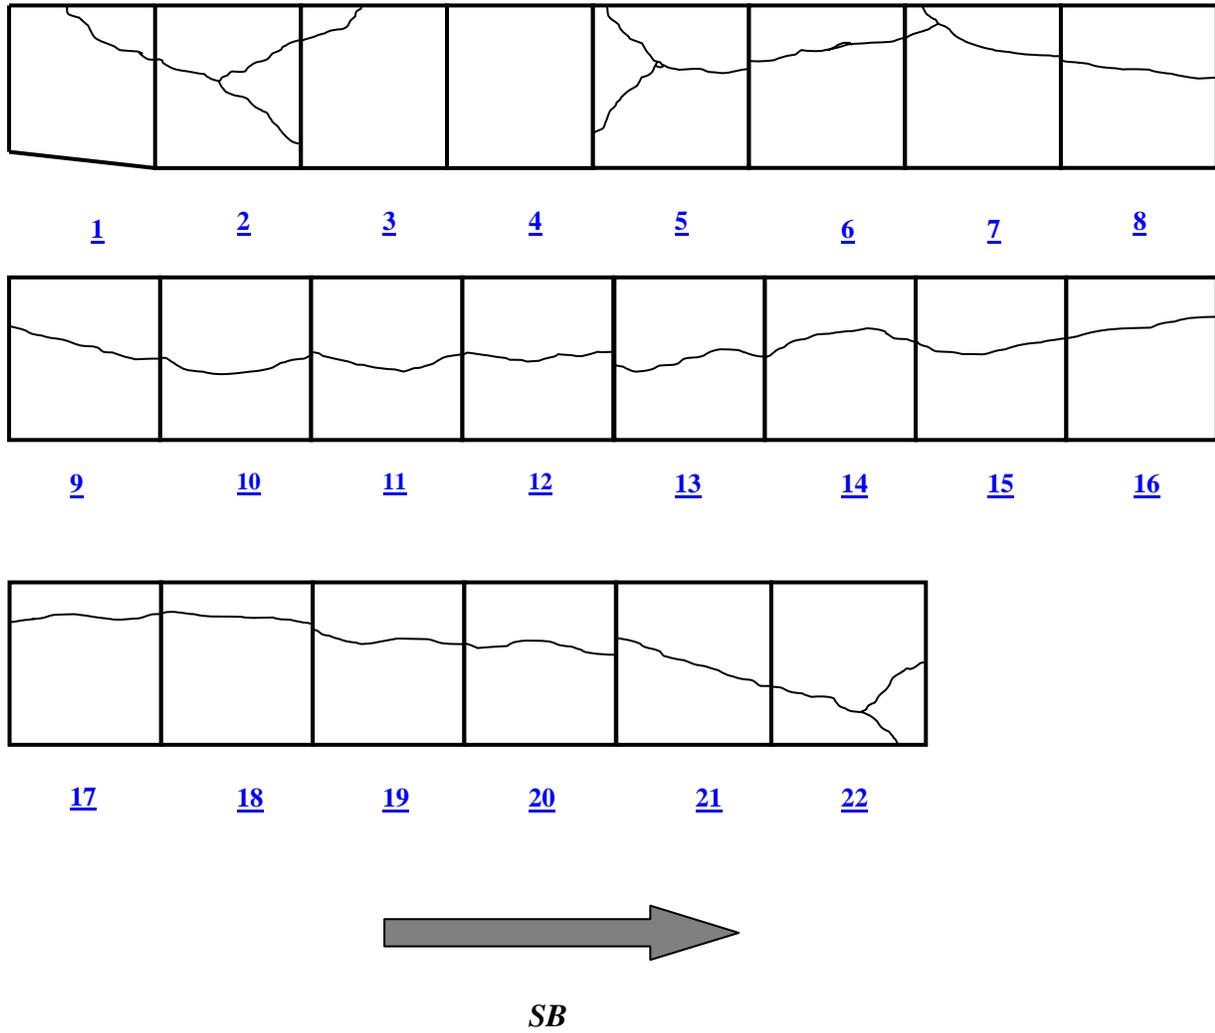
Twenty-one of 22 panels in the turning lane developed some form of cracking. The cracking pattern is detailed in Figure 3: 15 panels had a single longitudinal crack running from transverse joint to transverse joint; 4 panels had multiple cracks emanating in a Y-shape; 2 panels had corner cracks. The crack widths remained fairly tight, yet some displayed obvious faulting, which became the primary concern of the field investigation. Project office personnel said that the crack initiated at the southern end and propagated northward along the entire length.

Figure 3. Route 94 turn-lane cracked panel diagram.

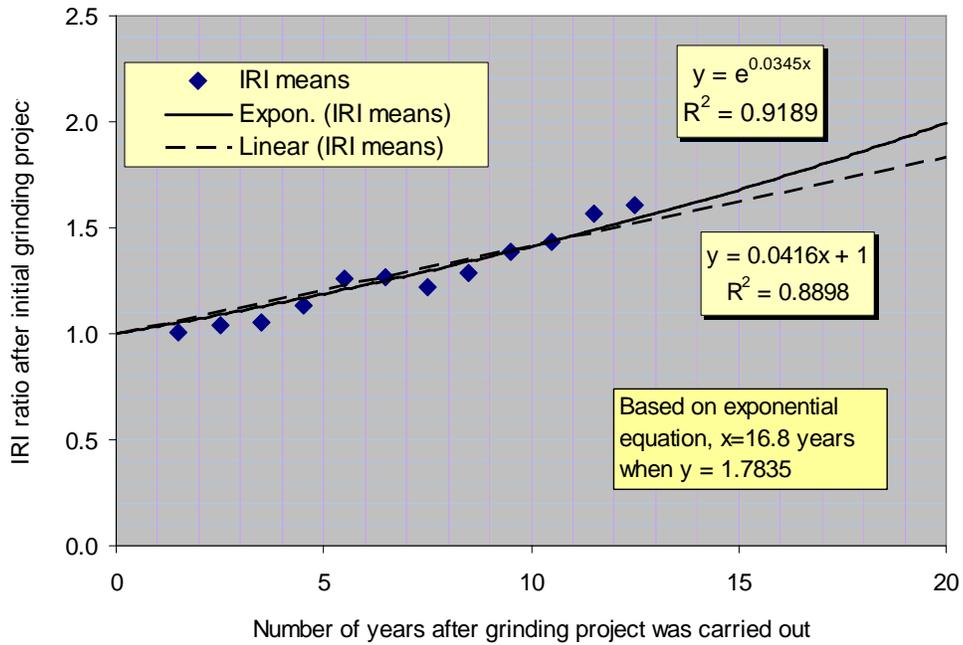
**Figure 1. Change in the ratio of IRI over time as a function of the initial IRI after grinding (2).**

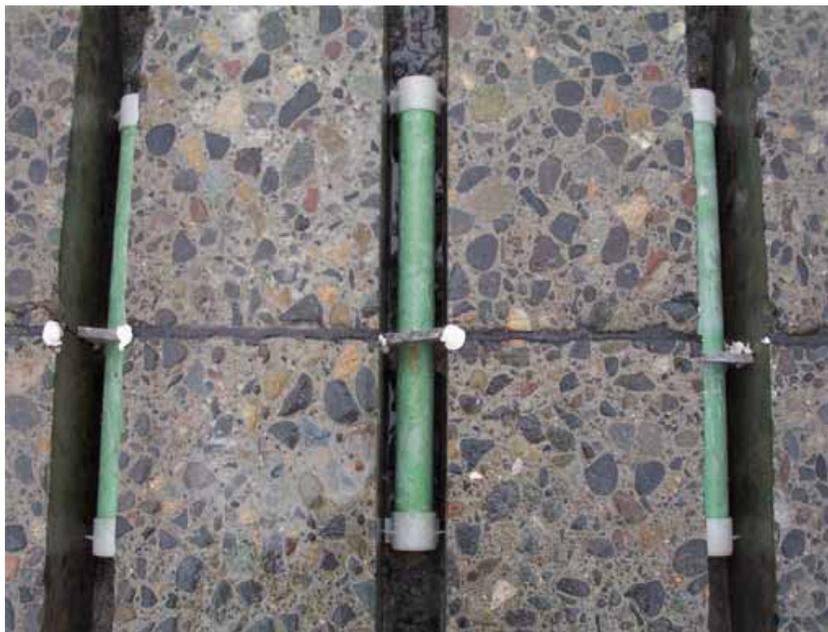
Poor load transfer across transverse joints was listed above as one of the factors that should preclude the use of diamond grinding. Dowel bar retrofit (DBR) rectifies poor load transfer and can be used in combination with diamond grinding. DBR (see Figure 5)—if properly carried out—can be a very effective pavement preservation strategy. This approach can be used to remedy poor joint load transfer, thus rendering a diamond grinding project feasible—barring any other precluding conditions in the above list.

**Figure 5. Dowel bar retrofits at a transverse joint (8).**

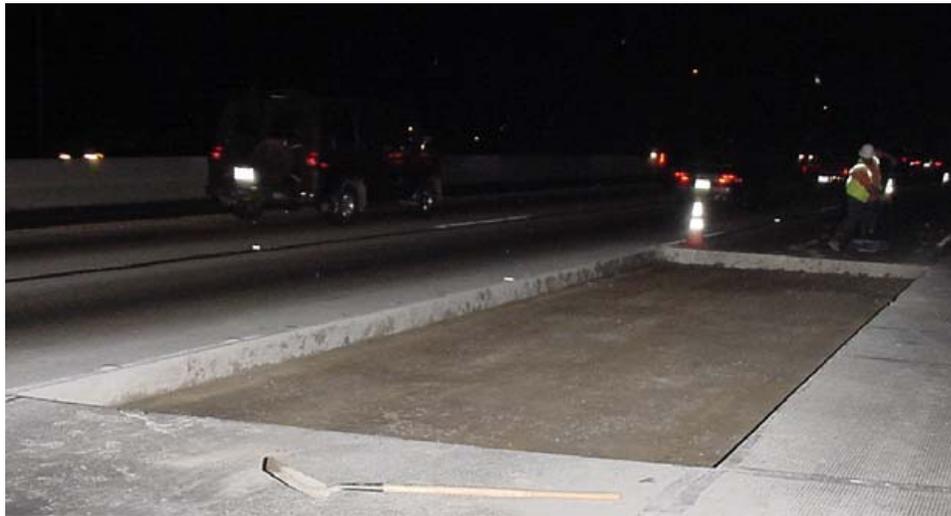
Full depth slab repair involves full-depth and -width slab removal followed by cast-in-place replacement of slabs (or partial-length slabs) in an existing pavement. Typically the minimum length requirement is 6 ft (1.8 m); however, when repair areas are closely located it may be more cost effective to substitute a larger area—usually the full length of the original slab. Guidelines associated with full-depth slab repairs, such as reestablishing joints, etc., are detailed in the Caltrans *Slab Replacement Guidelines* document (11).

**Figure 8. A full-depth concrete slab replacement project (11).**

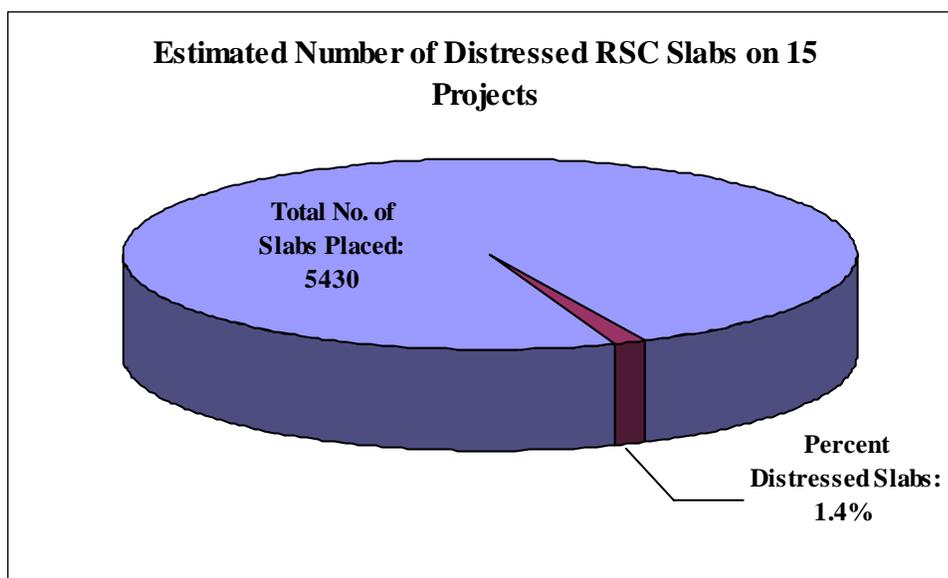
RSC cement mixtures have performed very well in California, indicating both excellent concrete design and construction practices (13). A total of 15 statewide projects were surveyed by Caltrans recently for premature distresses on RSC slab replacements. The results were excellent (see Figure 9), with less than 2 percent of the surveyed slabs showing any significant surface distresses. Where distresses were observed, shrinkage cracks were the most prevalent distress type.

**Figure 9. Percent distressed slabs on surveyed RSC projects (13).**

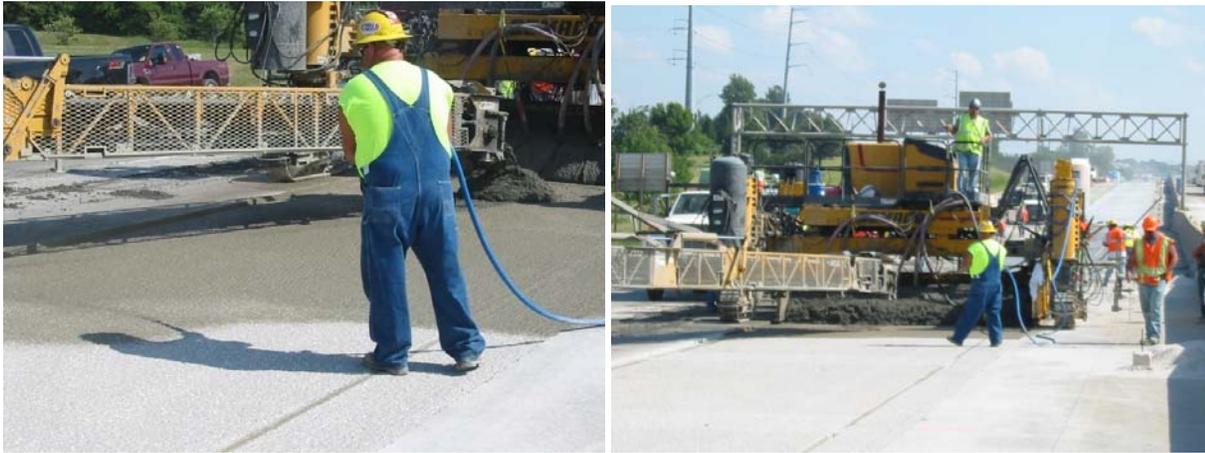
**Figure 4. Slurry application and concrete placement.**

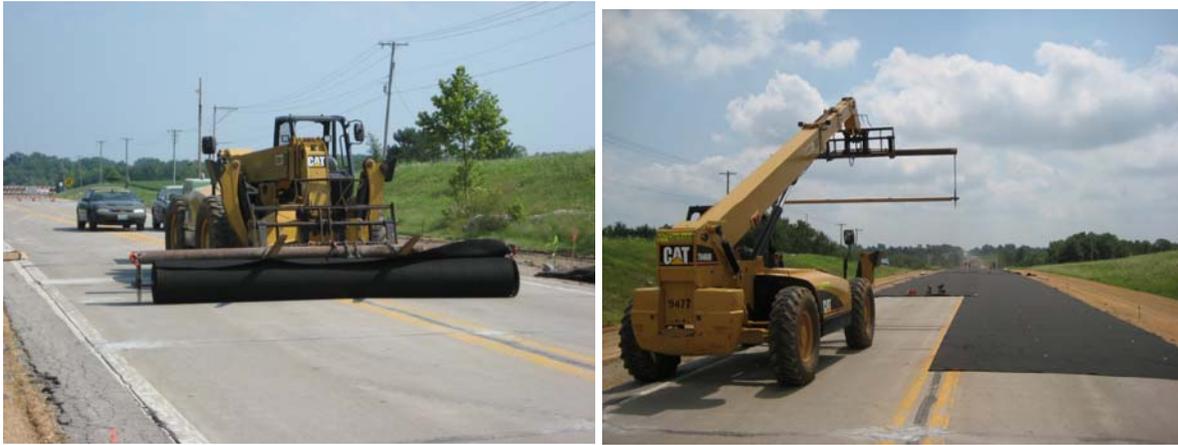
**Figure 6. Geotextile fabric placement.**

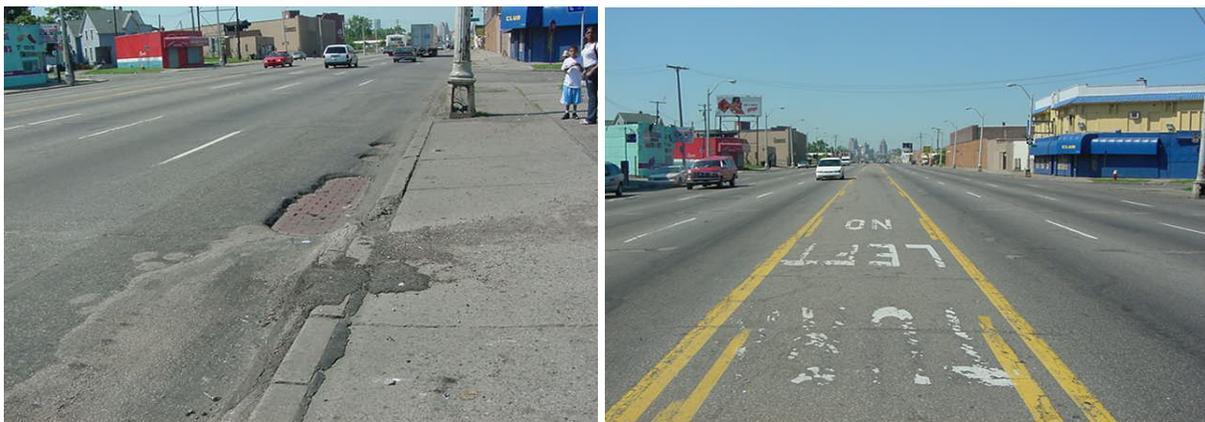
immediate site review was conducted to determine the extent of potential support problems. Figure 8 shows the condition of the composite pavement.

**Figure 8. Condition of existing composite pavement.**

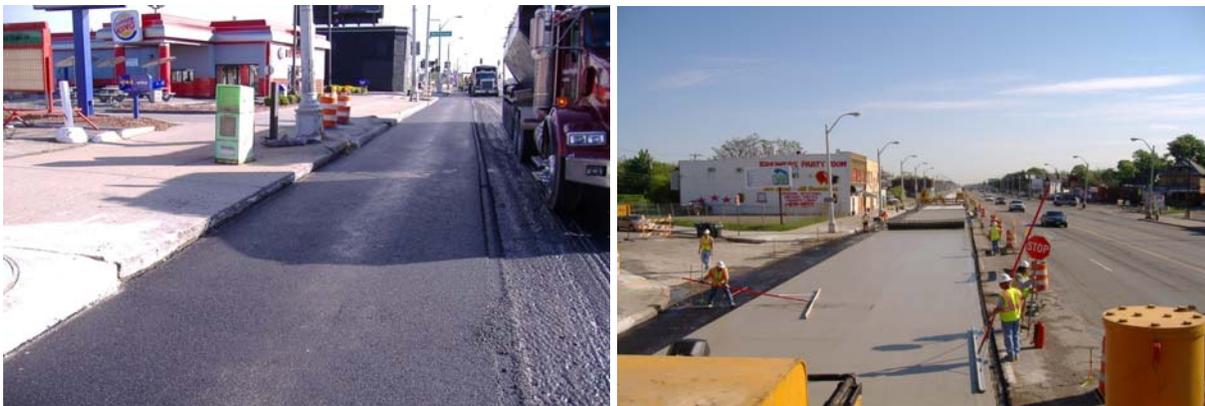
**Figure 10. AC interlayer and concrete placement.**

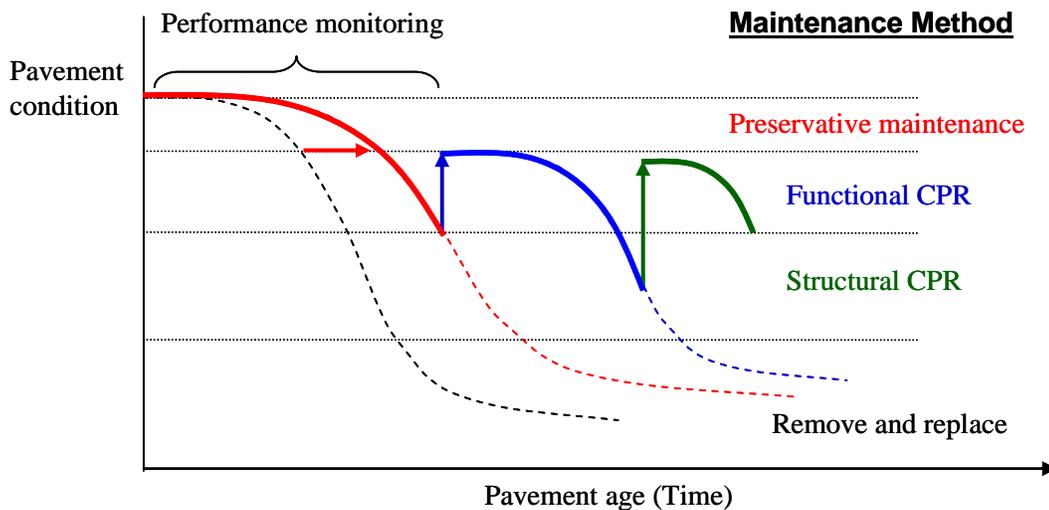
**Figure 1. Pavement condition and maintenance stages.**

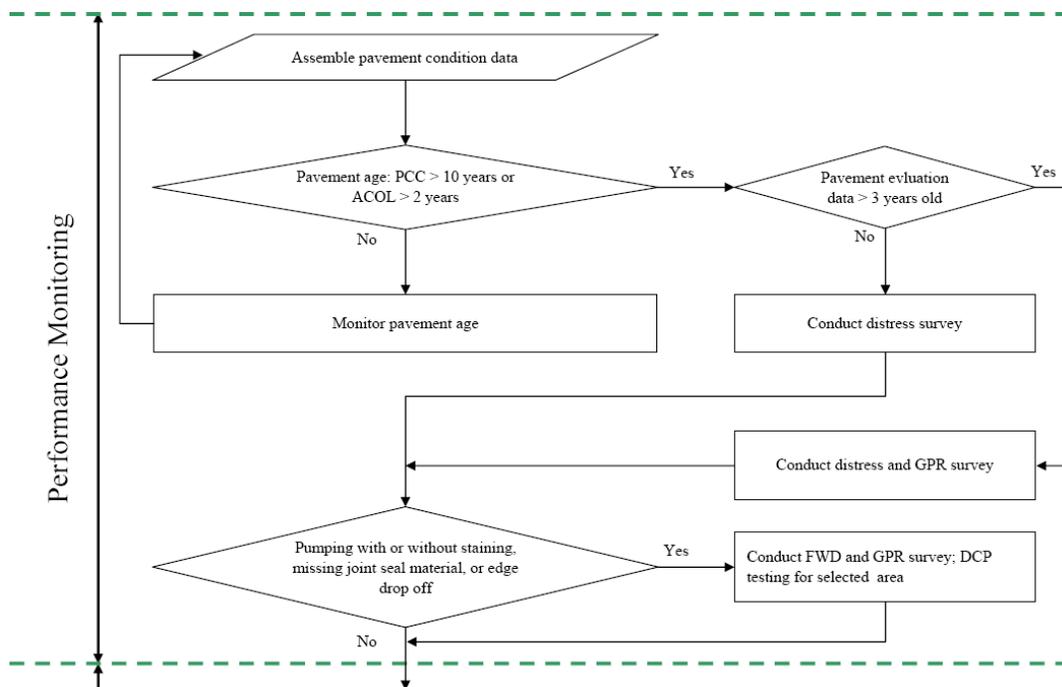
Figure 3. Routine Maintenance Decision Flowchart – Performance Monitoring.

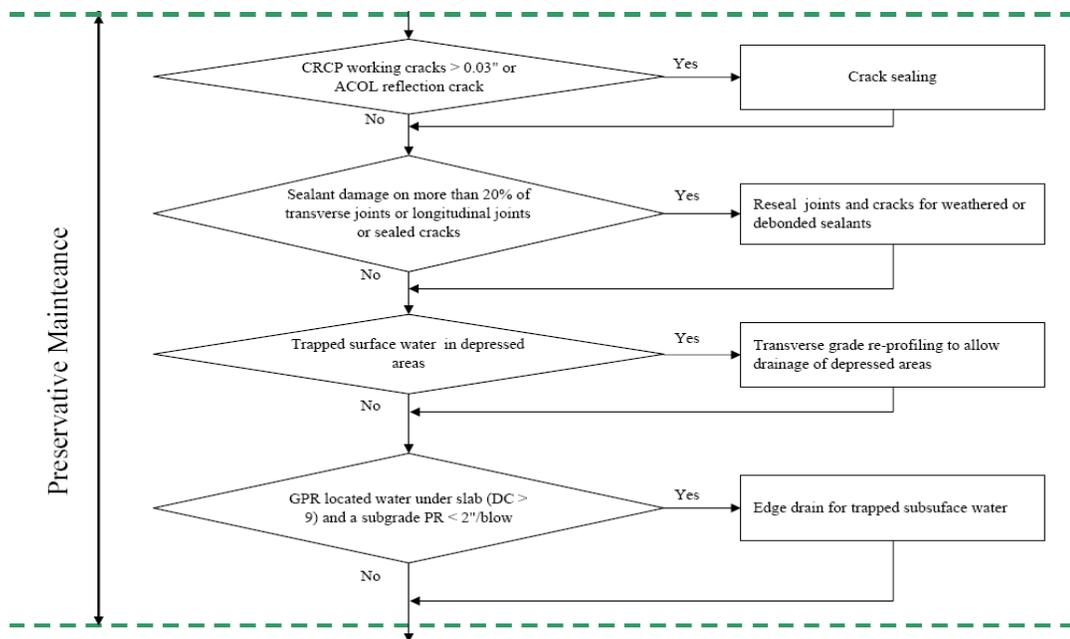
Figure 4. Routine Maintenance Decision Flowchart – Preservative Maintenance.

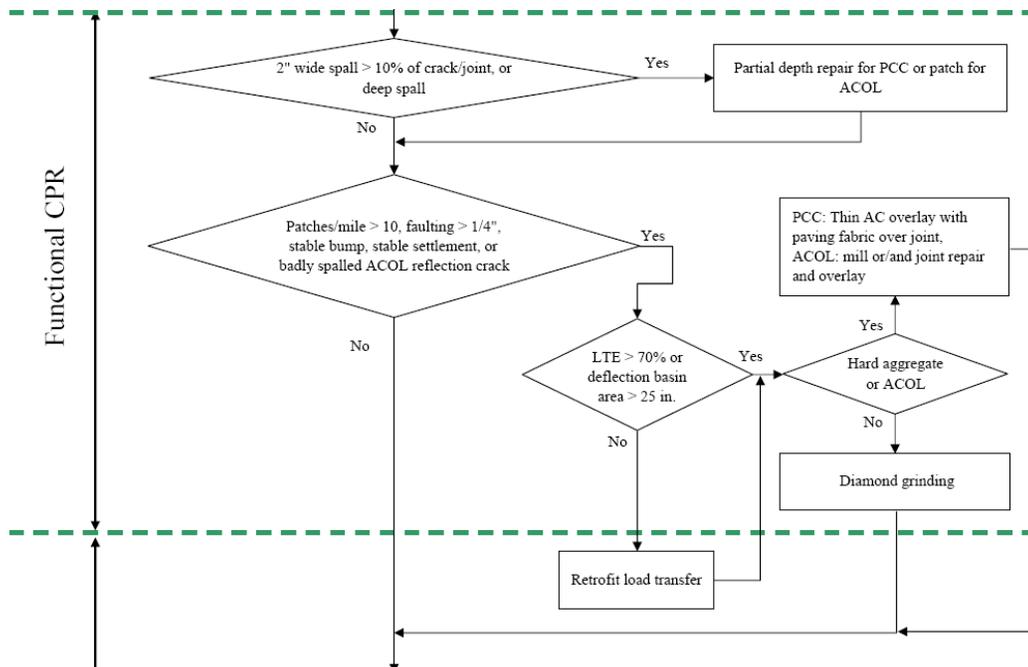
Figure 5. Routine Maintenance Decision Flowchart – Functional CPR.

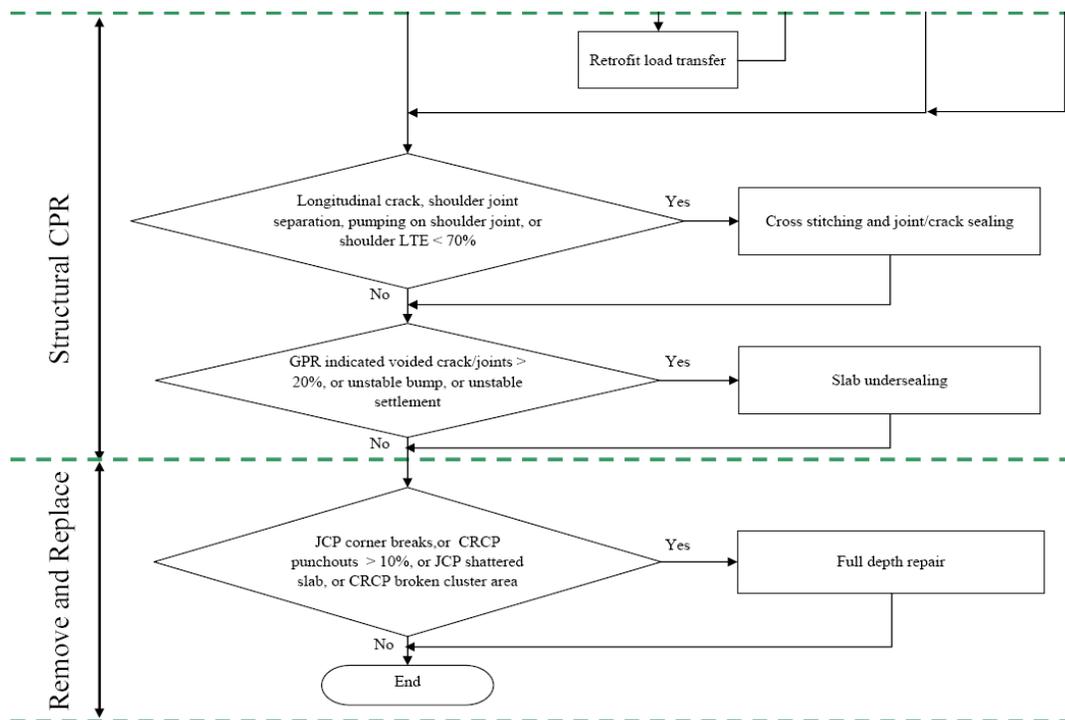
**Figure 6. Routine Maintenance Decision Flowchart – Structural CPR and Replace.**

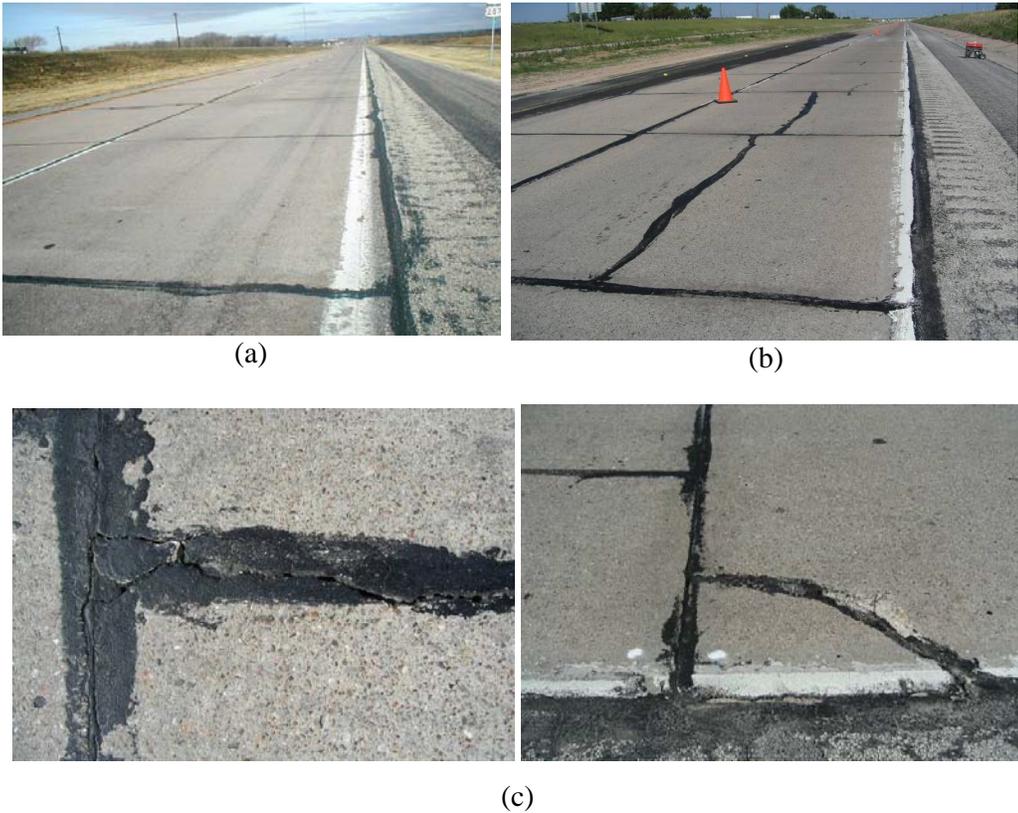
finer were detected, and the erosion depth was about 1 to 1.5 in. (25 to 28 mm) in the poor condition section. Since the aggregate type of the poor condition section is river gravel, the crack/joint opening with a higher curling effect may have contributed to pumping and erosion damage to the subbase material. The good condition section showed a smaller depth of erosion. As feasible maintenance means, joint resealing, slab undersealing, and edge drainage may be needed to fill voids under the slab and reduce further moisture damage to the base and subgrade.

**Figure 7. Test sections in Vernon: (a) good condition, (b) poor condition, (c) crack and deteriorated joint sealing in poor condition section.**

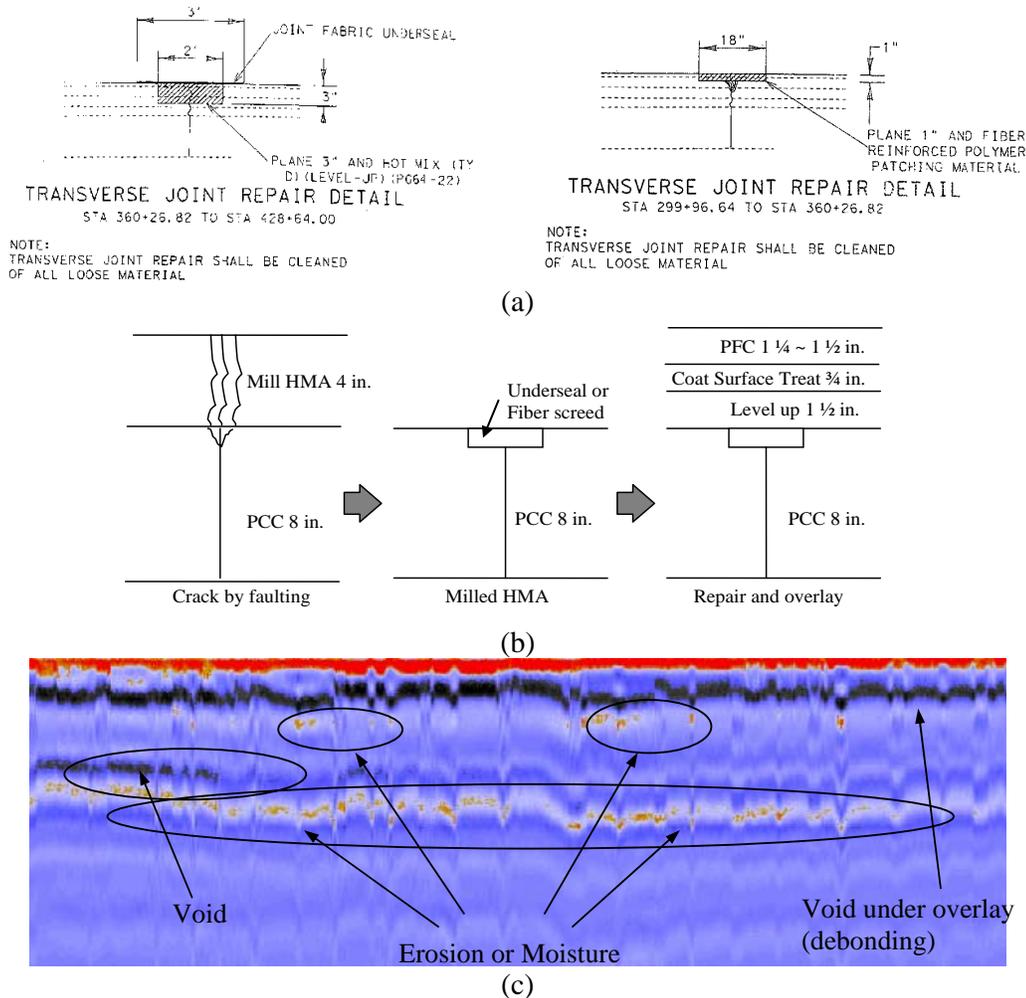
AC-overlaid JC pavement on US-59 in Legget, Texas, was tested using rolling dynamic deflectometer (RDD) and GPR. Interesting repairs were under taken during rehabilitation work carried out in 2002 consisting of the replacement of an existing AC overlay where the joints in the JC pavement were repaired using two different materials: fiber-reinforced polymer and HMA with a fabric underseal, as shown in Figure 9 (9). The pavement surface condition was visually good, and there was virtually no distress over the repair section after 5 years of service. However, the first section showed an LTE of 65 percent, while the second section showed an LTE of 81 percent based on RDD results as well as a high possibility of debonding and moisture presence between the overlay and the jointed pavement in the GPR image (shown in Figure 9-c). Moreover, eroded or wet conditions under the PCC slab were detected by the GPR. According to the decision criteria, these sections should be monitored routinely for reflection cracking and sealed in a timely manner as preservative maintenance to prevent rapid joint deterioration.

Figure 9. US-59 ACOL joint repairs: (a) standard plans, (b) repair steps, (c) GPR image.

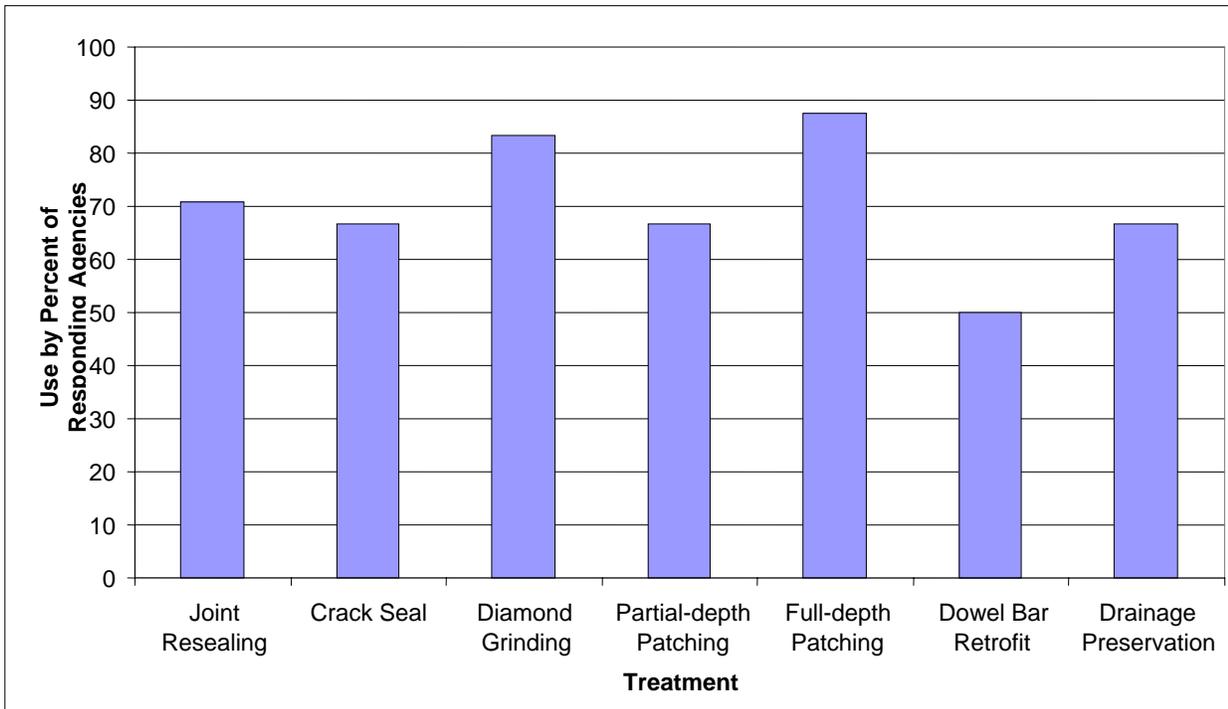
**Figure 1. Percent of agencies reporting treatment use on rural high volume traffic PCC roadways ( $\geq 5,000$  ADT).**

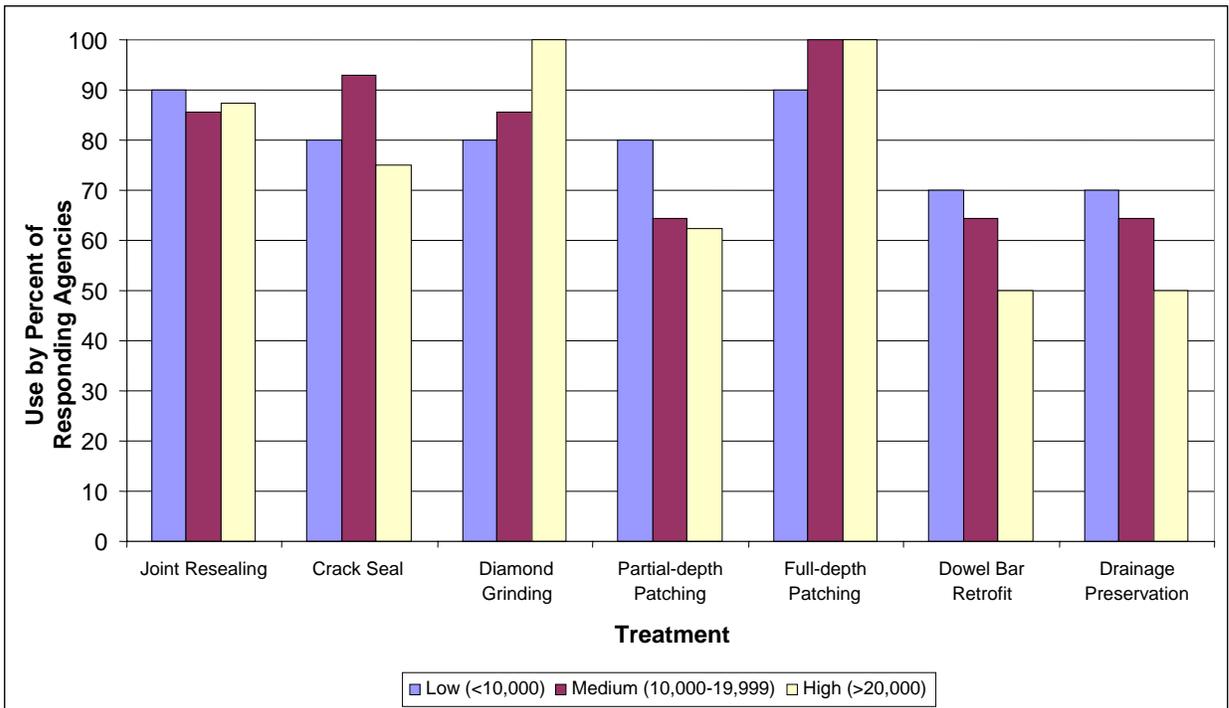
However, as shown in Figure 4, when different ranges of traffic volumes were considered for urban roadways, some differences did emerge. For example, as traffic volumes increase, the more likely an agency was to use diamond grinding and full-depth patching. Similarly, as traffic volumes increased, the less likely agencies were to use partial-depth patching, dowel bar retrofit, and drainage preservation.

**Figure 4. Percent of treatment use on urban PCC roadways for different ranges of high traffic volumes.**

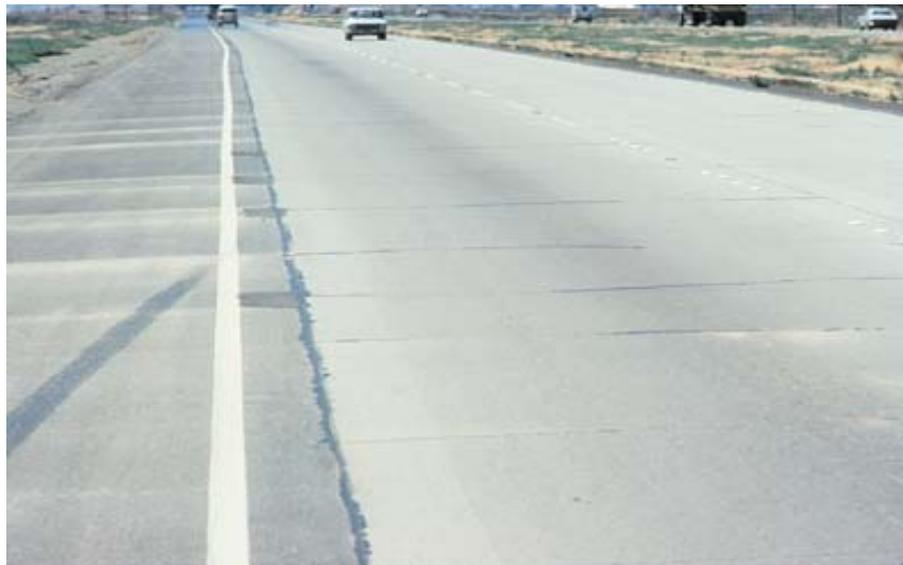
certain design features are not addressed regarding free water intrusion, serious problems can develop. These problems became quite apparent in the 1970s in California and other States as truck traffic increased (see Figure 1).

**Figure 1. Typical pumping and erosion of jointed plain concrete pavement with no dowels.**

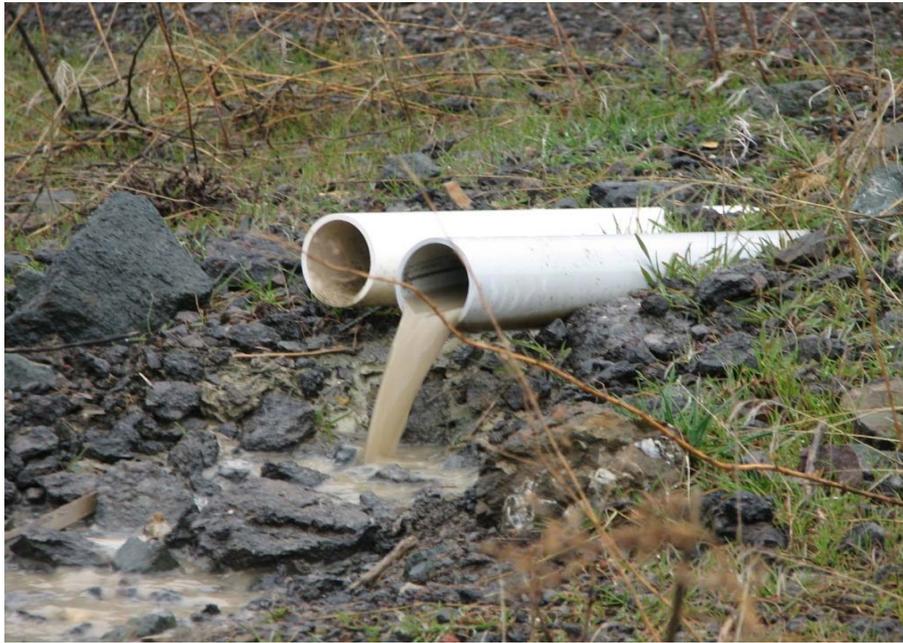
Only a few (< 30 percent) of the edge drains investigated were operating in an acceptable manner (see, for example, Figure 4). The properly operating edge drains were generally in areas of higher rainfall, especially in the upper foothill and mountainous areas, where the natural materials were coarser and noncohesive in nature. Considering this fact, it can be assumed that the volume and velocity of water drained from these pavement sections prevent the fines from settling and clogging the drainage pipes.

**Figure 4. Flowing water from edge drain outlets on northbound I-5 in Siskiyou County.**

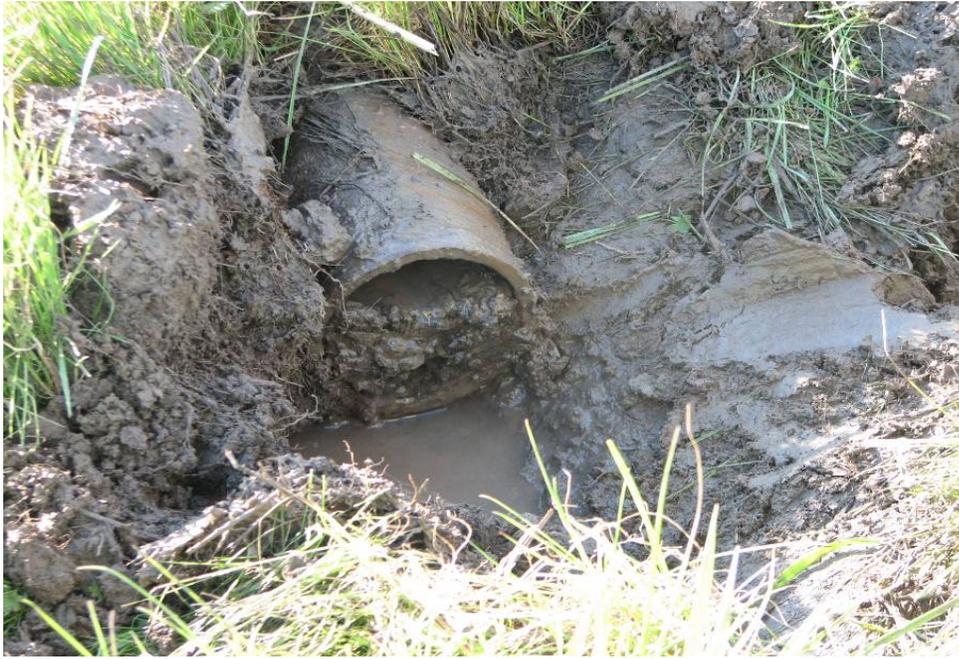
**Figure 5. Clogged edge drain outlet pipe on northbound I-5 in Sacramento County.**

Many of the pavement sections investigated with retrofit edge drains were more than 30 years old. Maintenance is badly needed to preserve the structural integrity of the edge drain structure and prevent further accumulation of fines in the drain pipes. Also, a majority of the outlet pipes have no end wall protection, which can cause clogging. The use of end walls reduces (but does not eliminate) the need for maintenance.

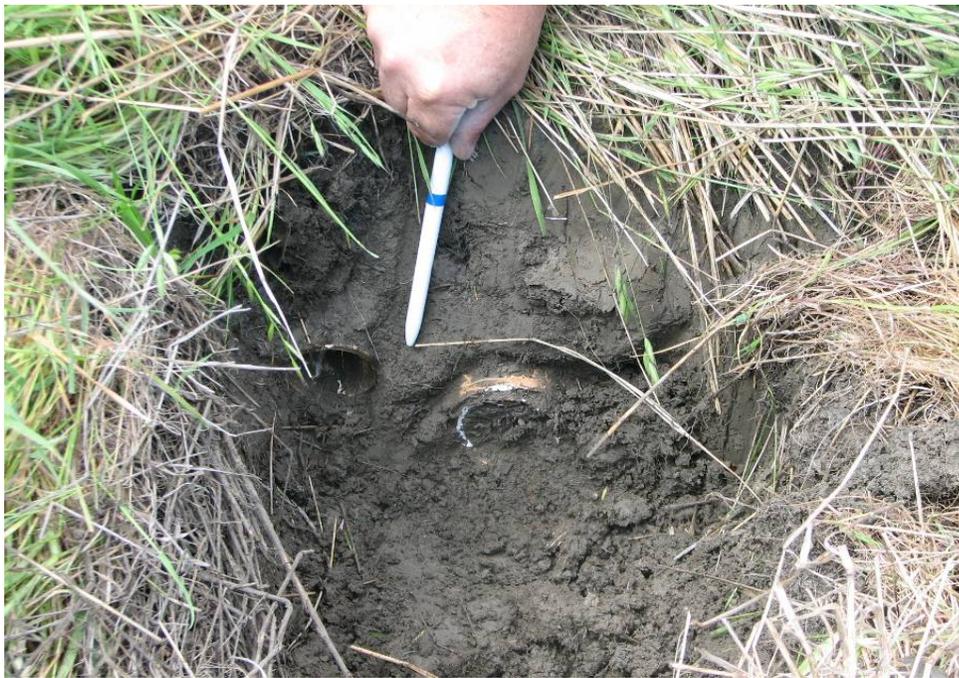
**Figure 6. Clogged and buried edge drain outlet pipe on northbound I-5 in Tehama County.**

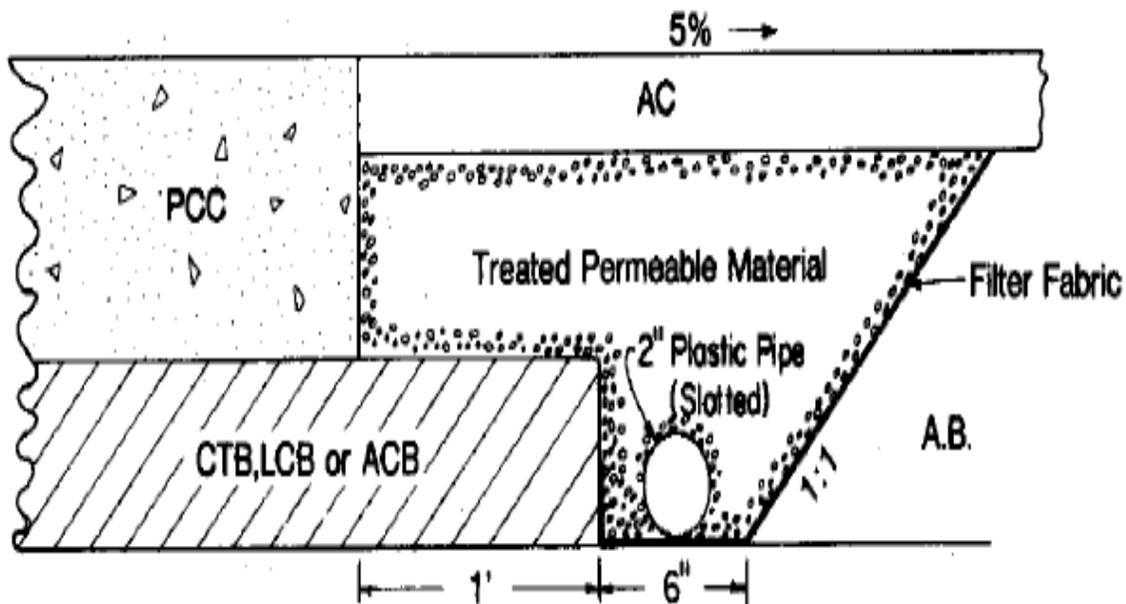
Figure 7. Edge drain design on southbound I-15 in San Diego County (5).

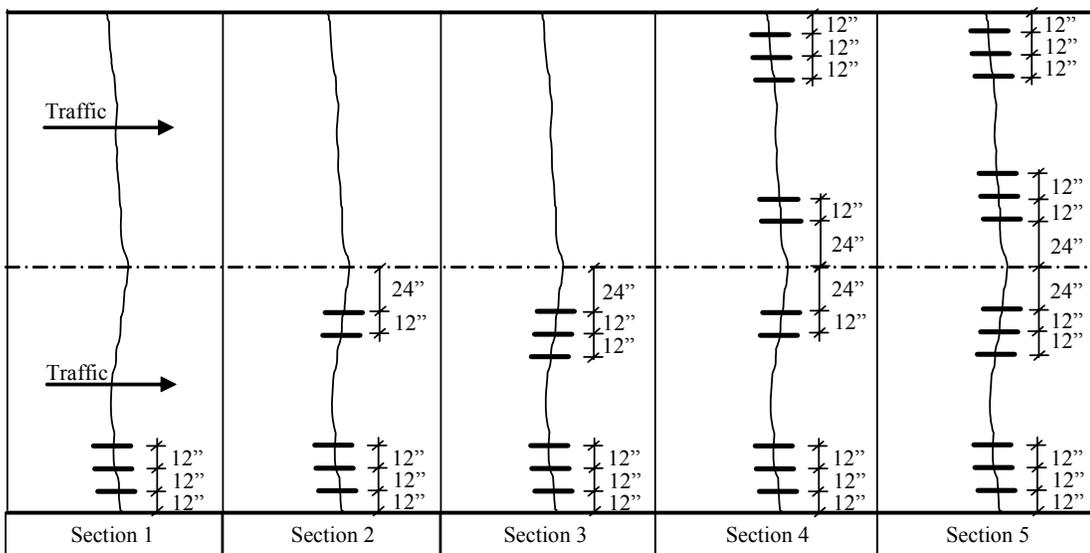
Figure 1. TH 52 test section retrofit dowel bar patterns.

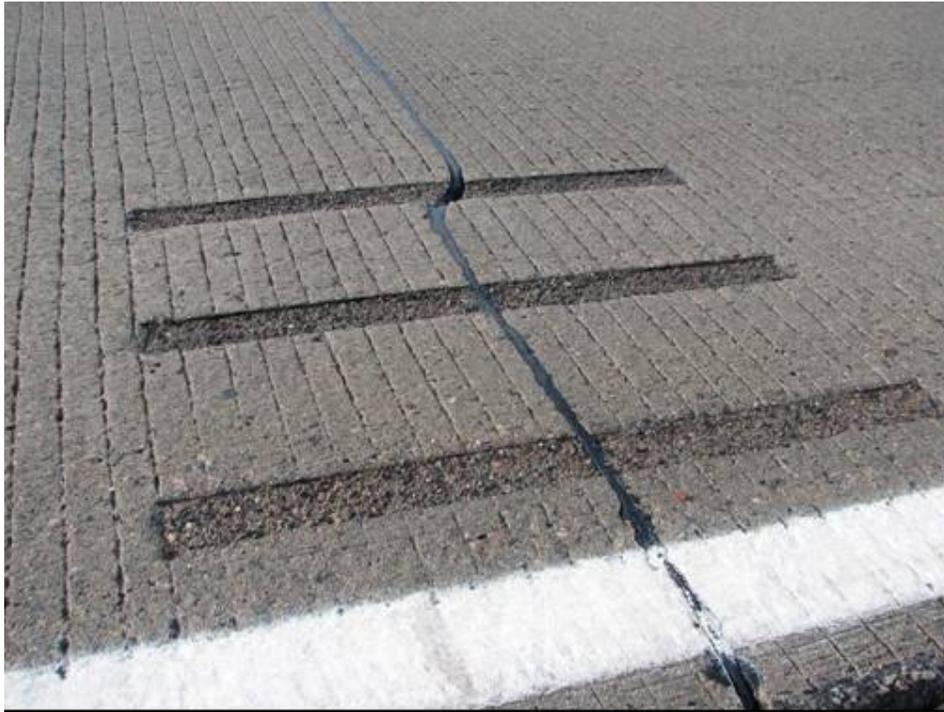
**Photo 3. Loss of PMQP mortar near surface of slots on TH 52.**

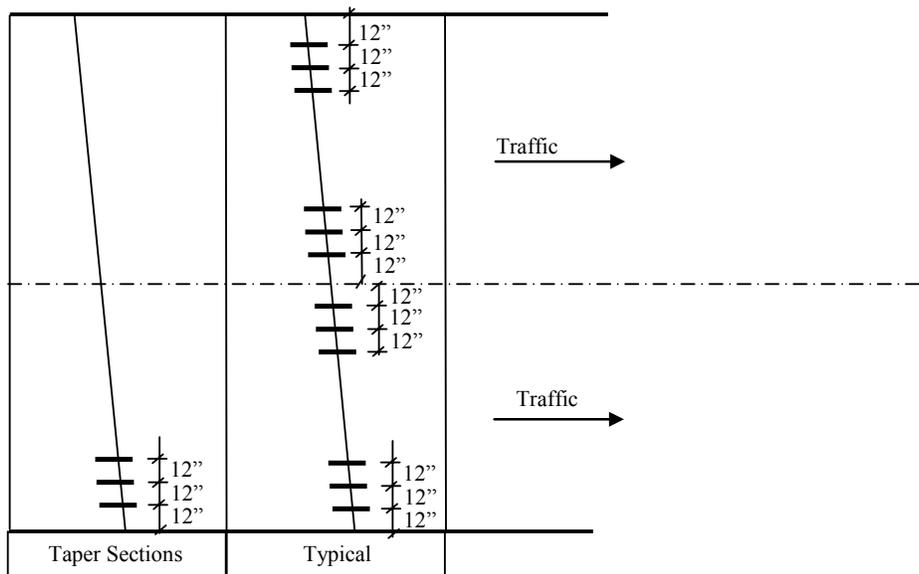
**Figure 2. TH 12 test section retrofit dowel bar patterns.**

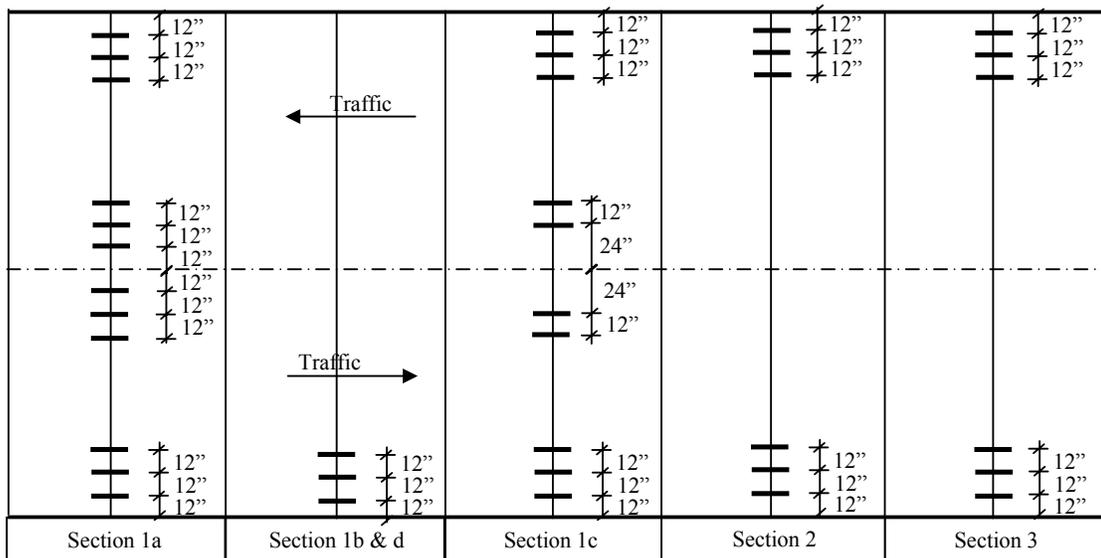
**Figure 3. TH 23 test section retrofit dowel bar patterns.**
