# National Conference on Preservation, Repair, and Rehabilitation of Concrete Pavements

St. Louis, Missouri  
April 22–24, 2009

*Proceedings*

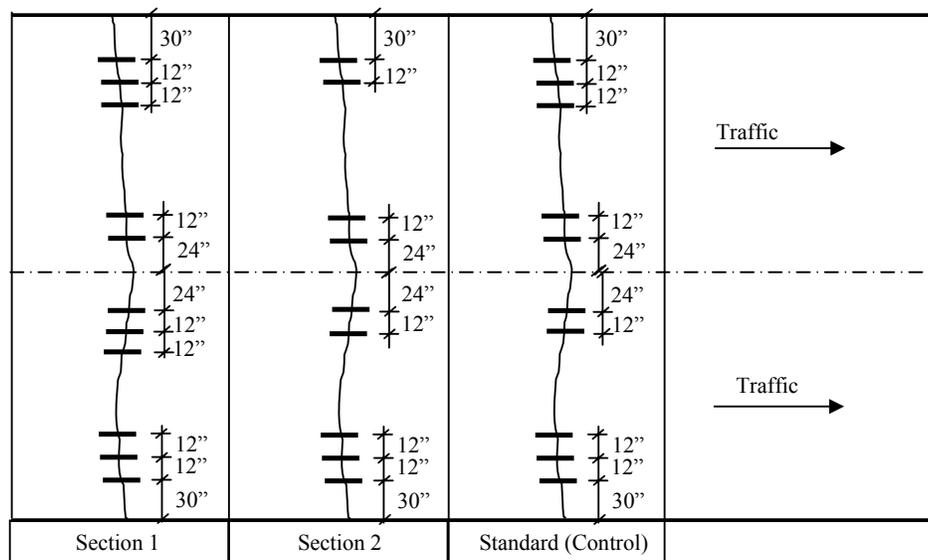
**Figure 4. I-90 Test section retrofit dowel bar patterns.**

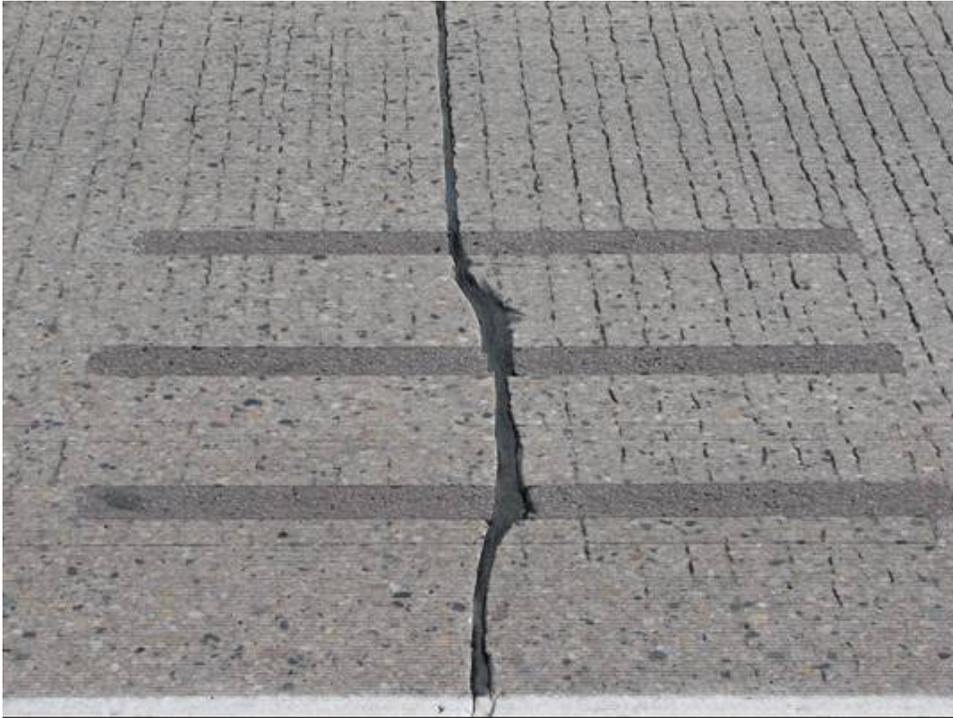
**Photo 7. Typical condition of I-90 slots with PMQP backfill mortar after 7 years.**

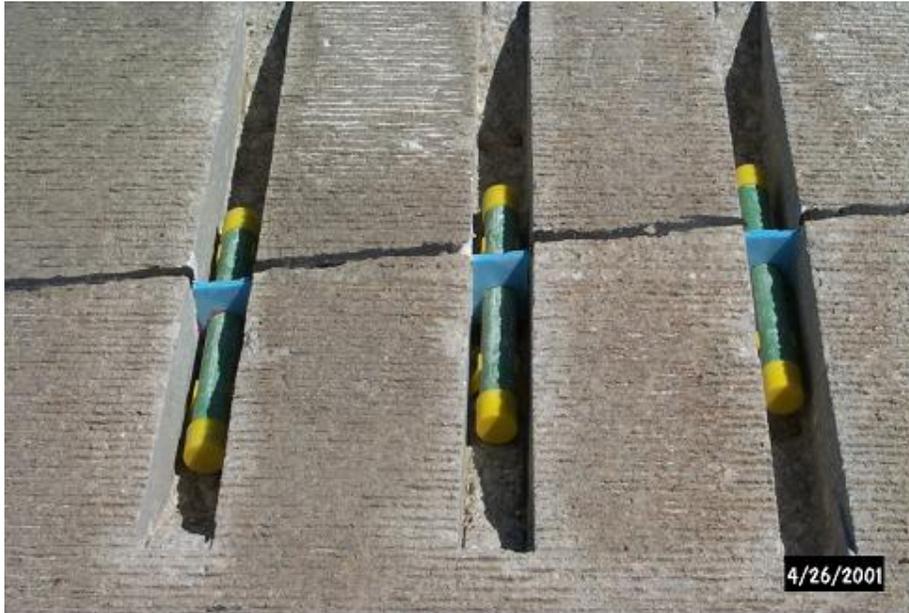
**Photo 10. Retrofit dowel assemblies placed in the slots prior to backfilling.**

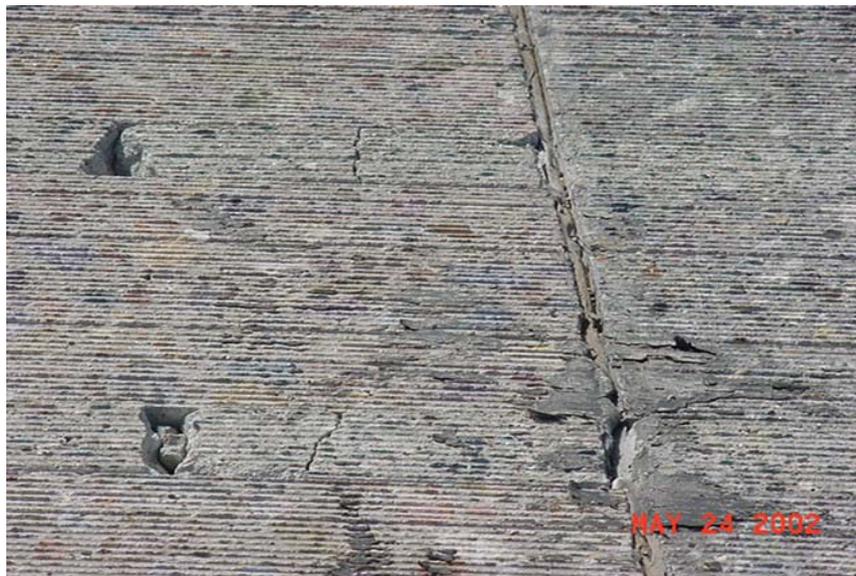
**Figure 13. Failure of dowel bar patching material (23).**

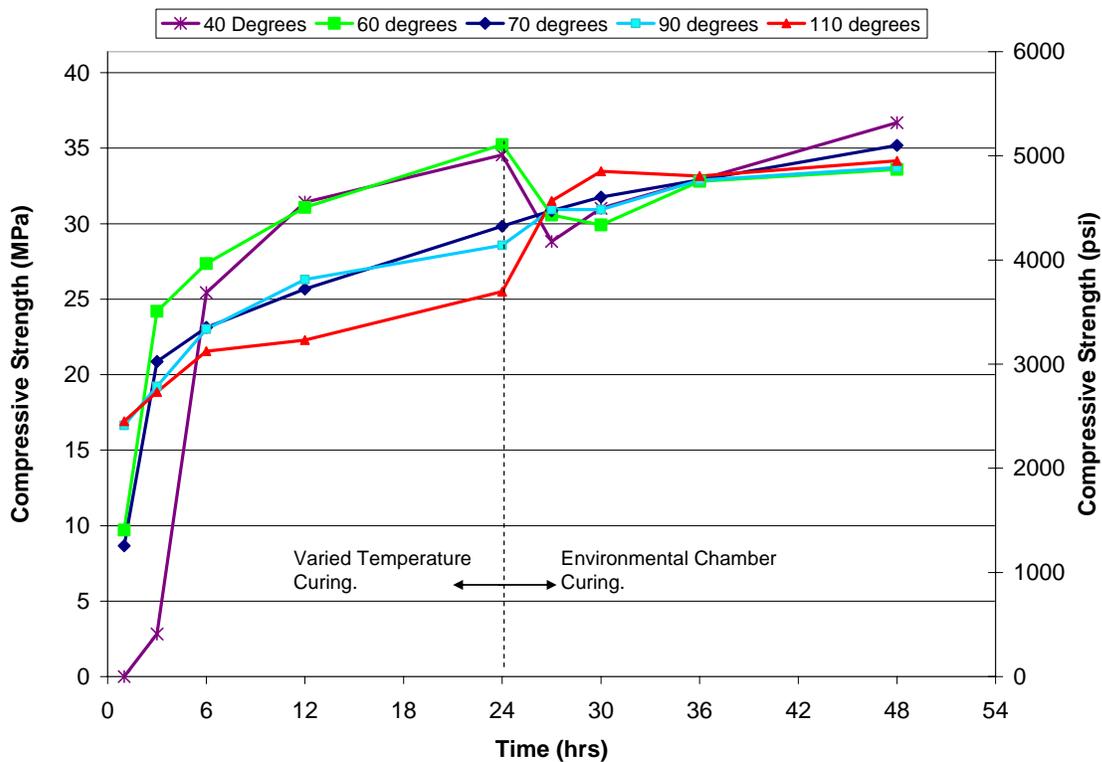
**Figure 1. Early age strength gain for very early strength calcium sulfoaluminate concrete with changes in temperature.**

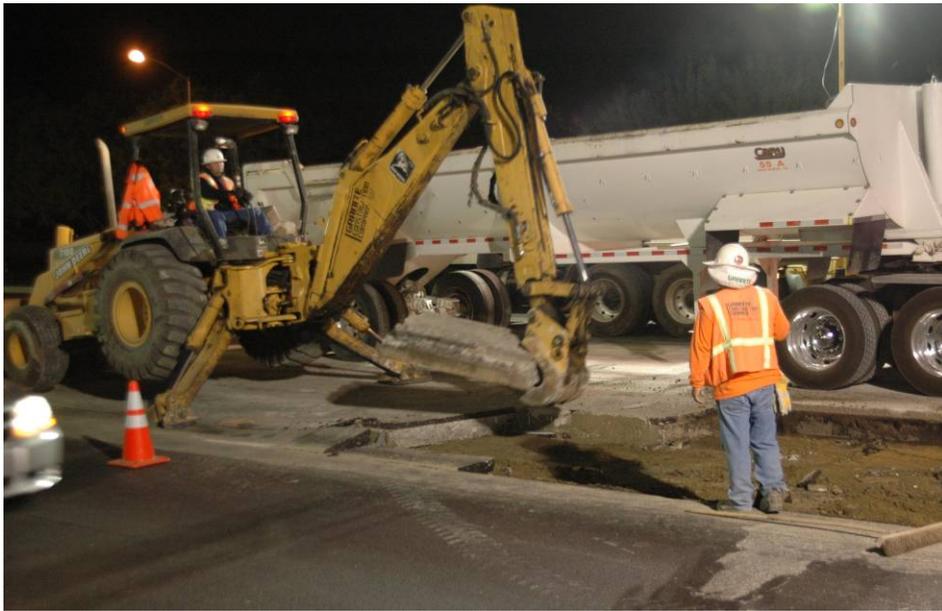
**Figure 2. Damaged highway panel being removed.**

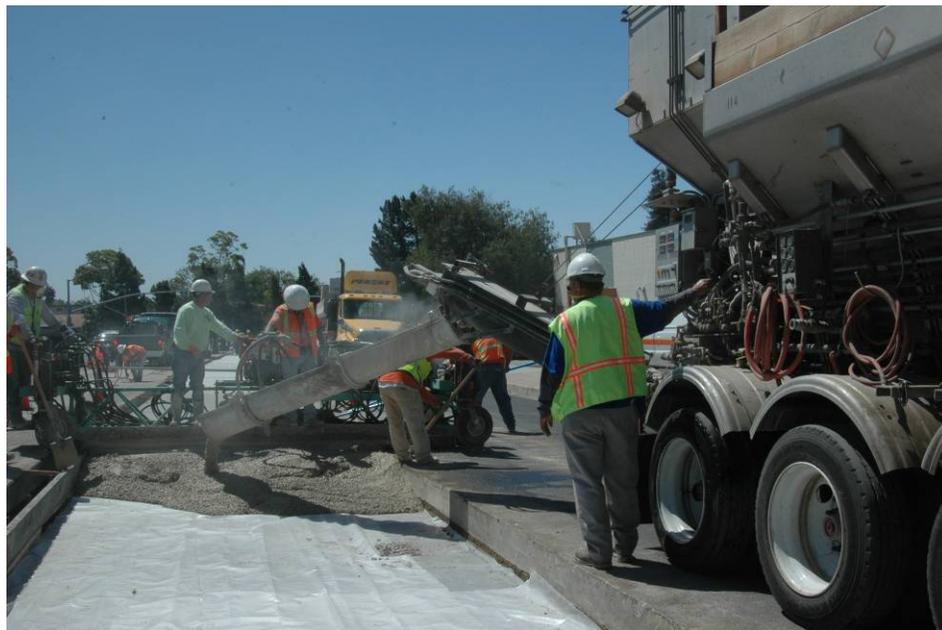
**Figure 3. Mobile Mixer placing very early strength (VES) concrete.**

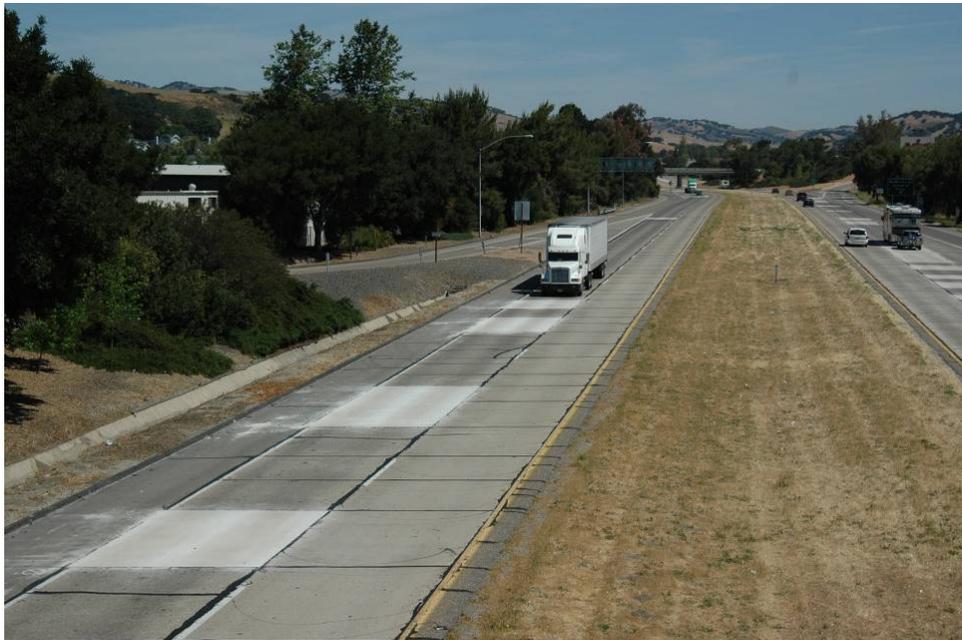
**Figure 5. Panels open to traffic.**

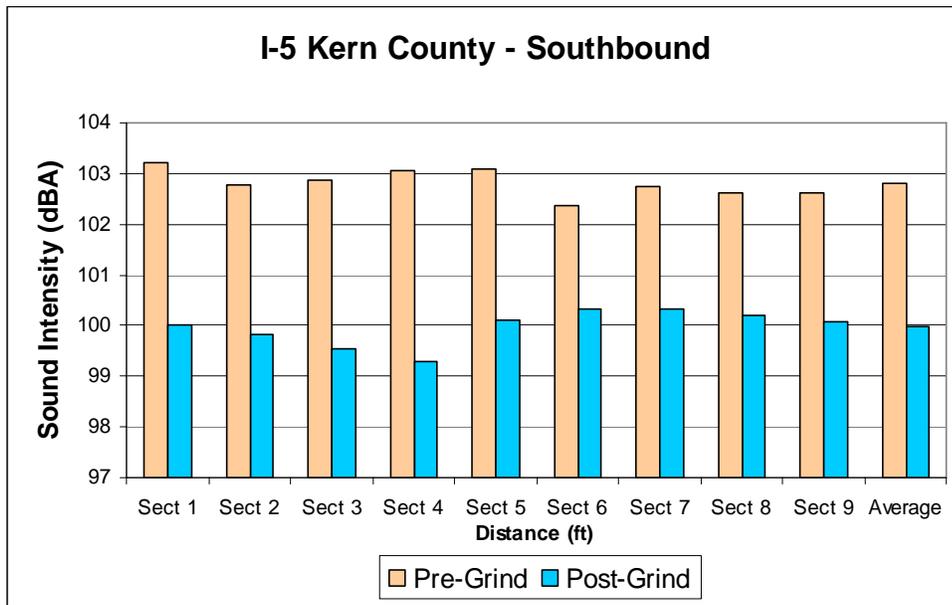
Figure 4. A-weighted SI levels averaged over four runs for southbound I-5 in Kern County.

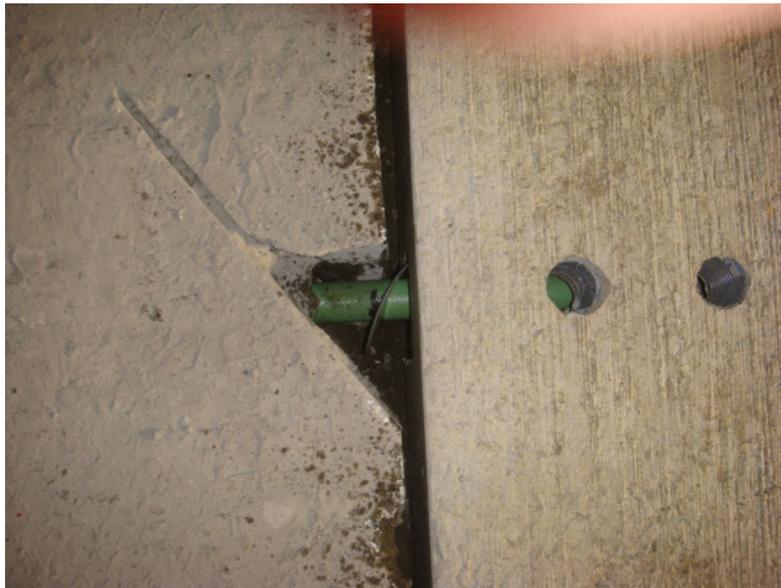
**Figure 15. Holes for grouting dowels and a section of damaged concrete that was filled with grout.**

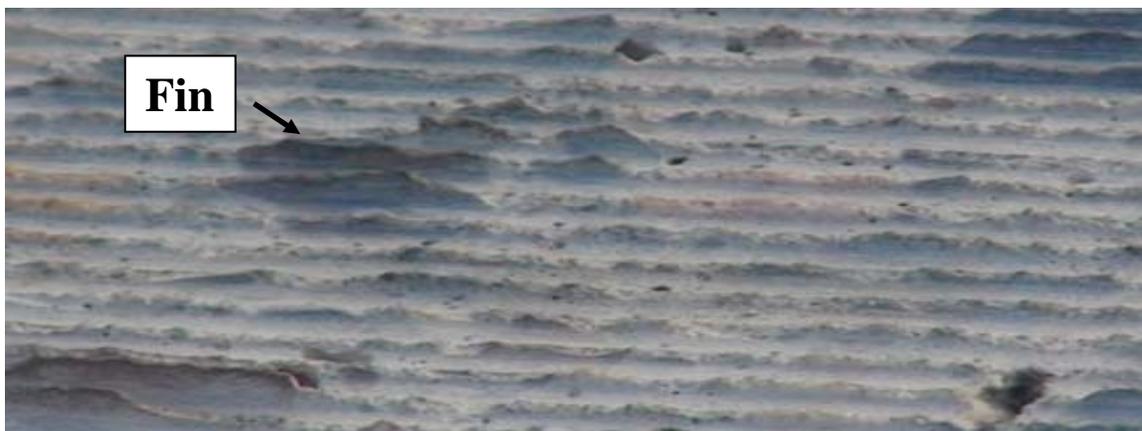
**Figure 3. Variability of fin profile on conventional diamond-ground surface on MnROAD I-94.**

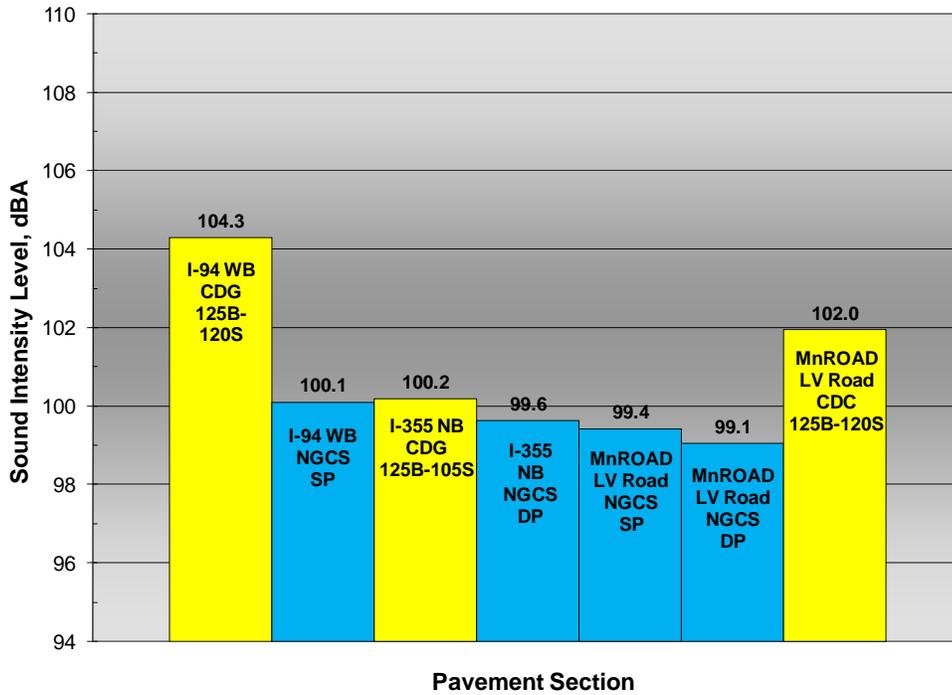
Figure 6. ACPA OBSI results for MN I-94 and IL I-355 sections.

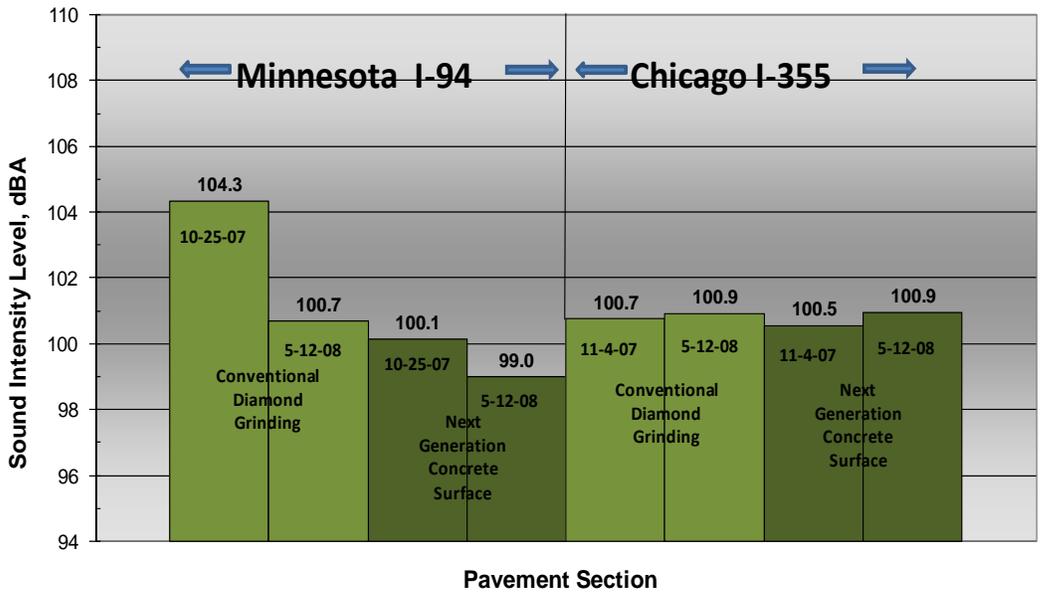
Figure 10. Comparison of CDG to NGCS OBSI levels through May 15, 2008.

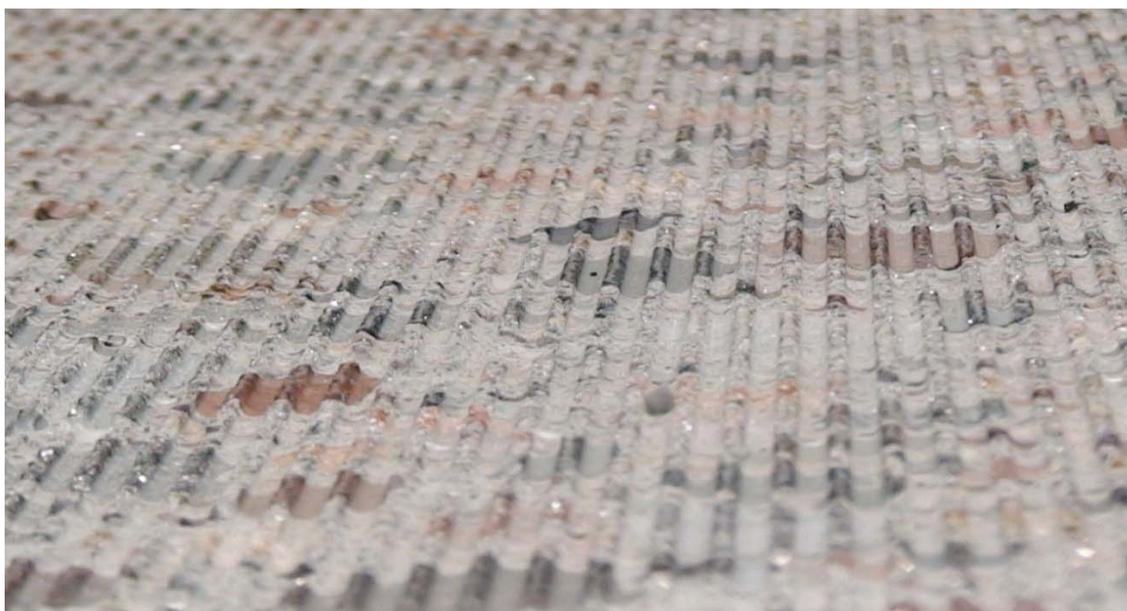
**Figure 12. MnROAD I-94 conventional diamond-ground texture after 5 months of traffic.**

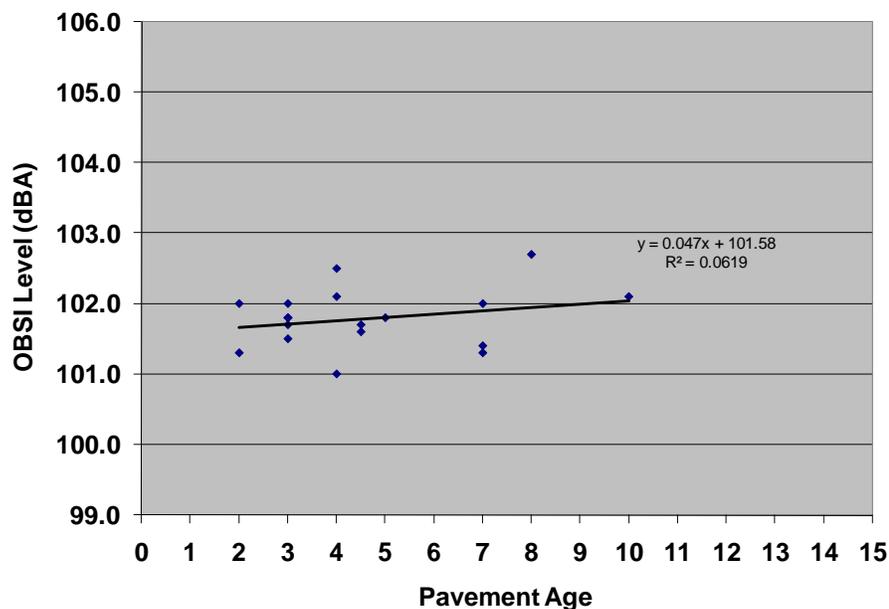
Figure 14. Acoustic durability of conventional diamond-ground projects in Kansas.

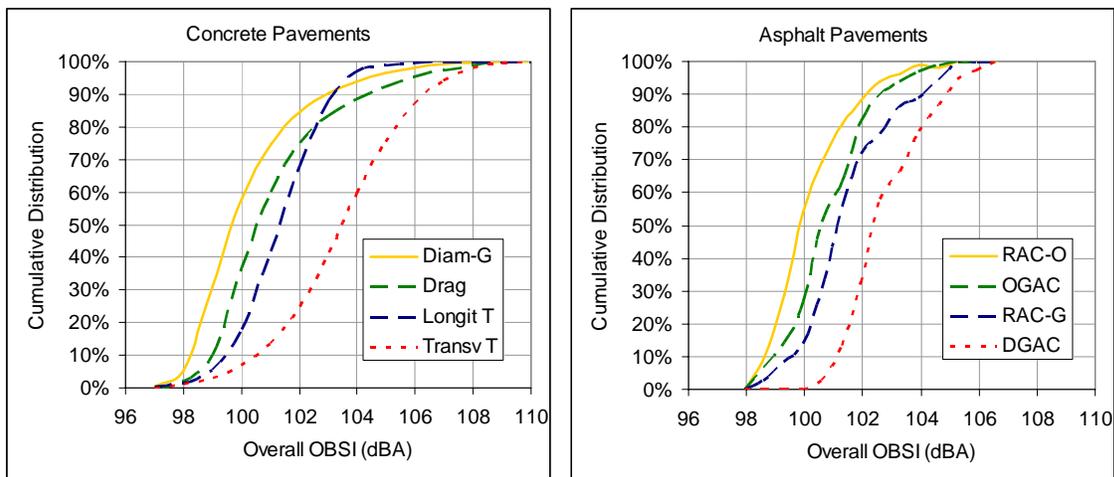
**Figure 9. Cumulative distributions of OBSI levels for concrete pavements (CP Tech Center data) and asphalt pavements (UCPRC data).**

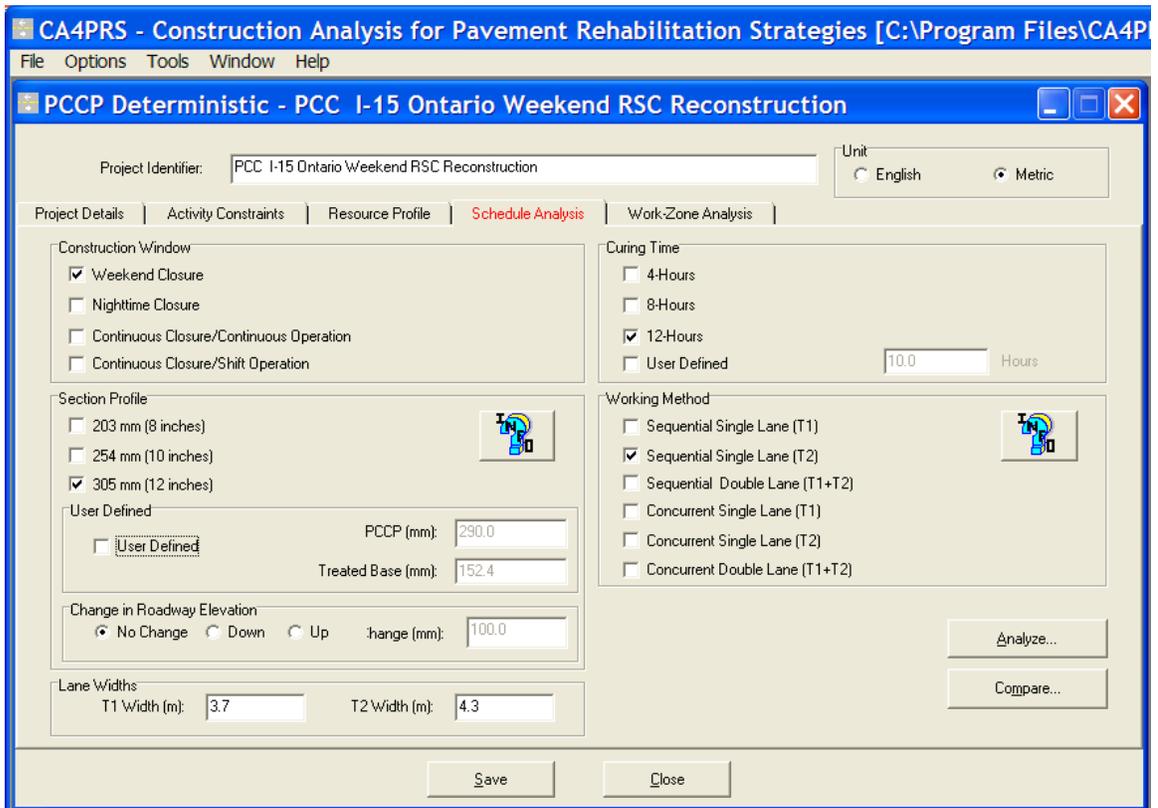
**Figure 6. Input window of CA4PRS software used in the preconstruction analysis of the I-15 Ontario project to compare schedule, traffic, and cost between the rehabilitation alternatives.**

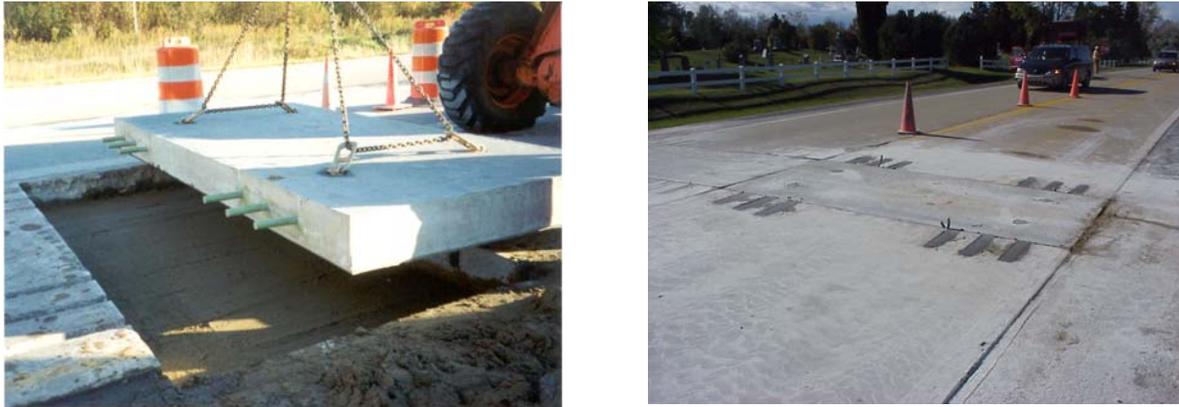
**Figure 3. The full-depth precast repair system (Michigan installation).**

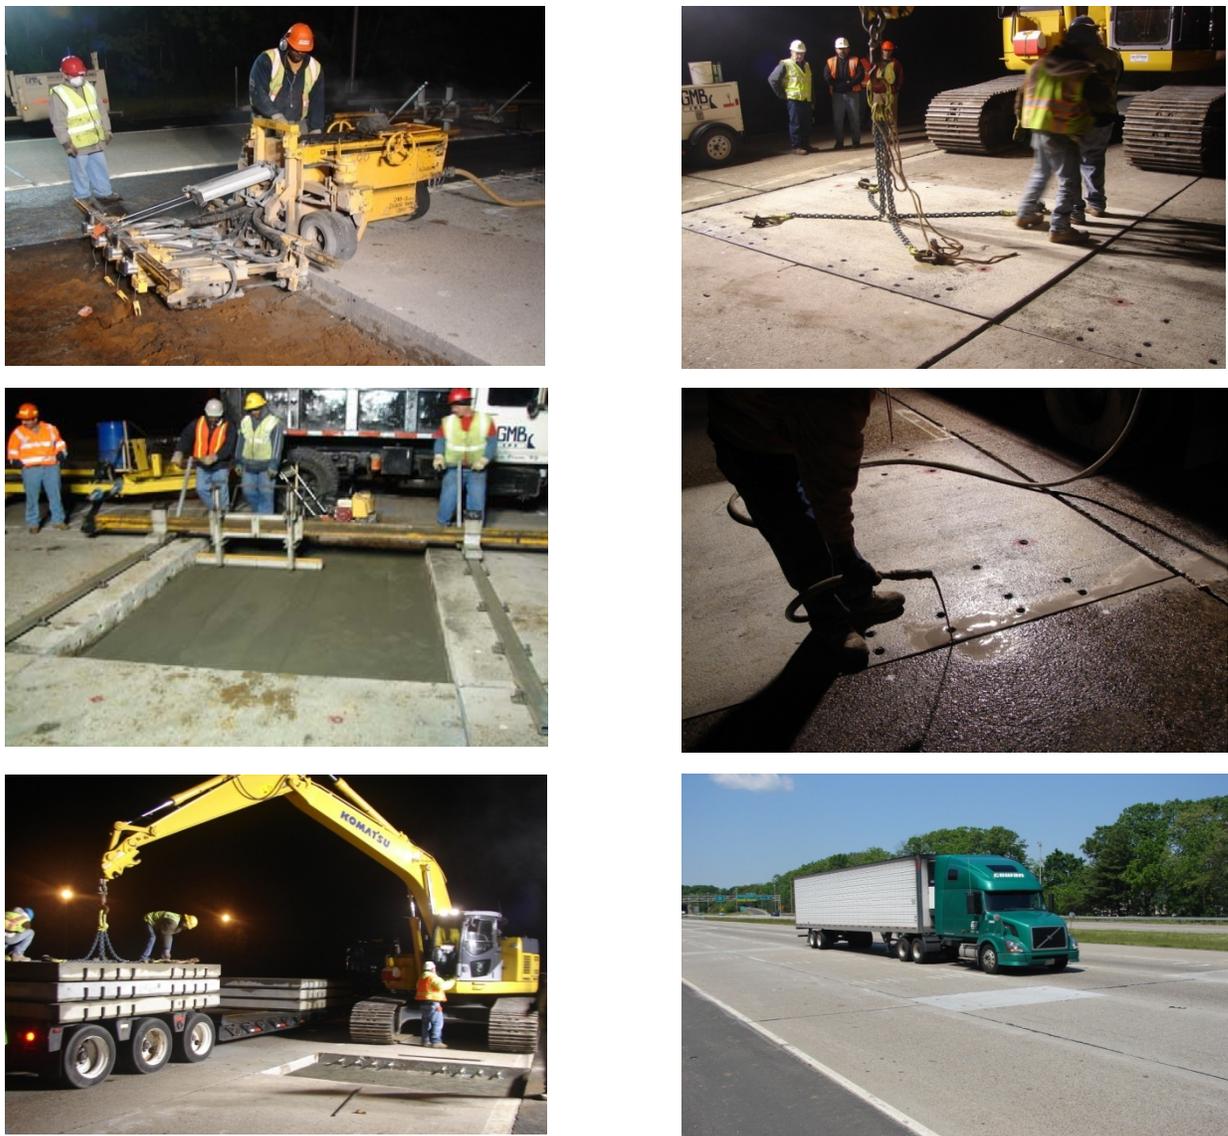
**Figure 6. I-295 precast panel installation.**

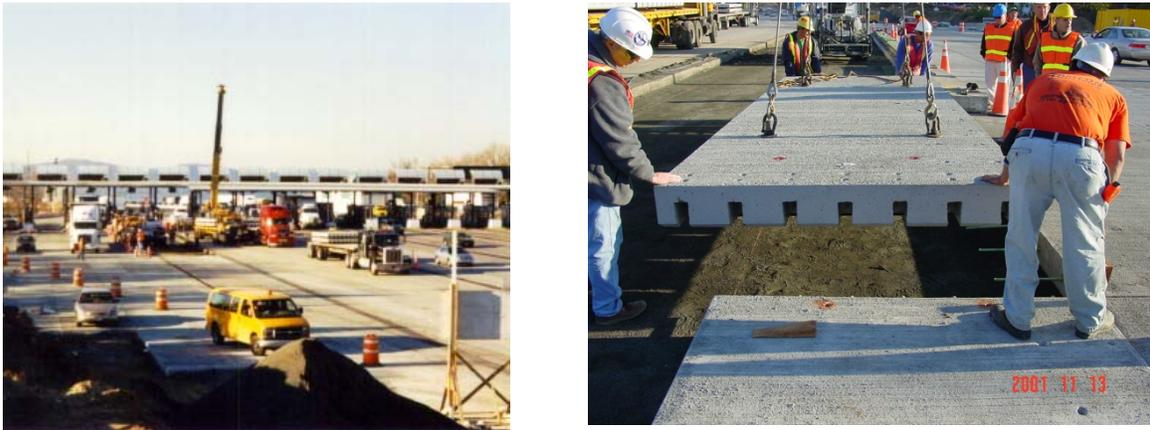
**Figure 7. Precast panel installation at the Tappan Zee Toll Plaza.**

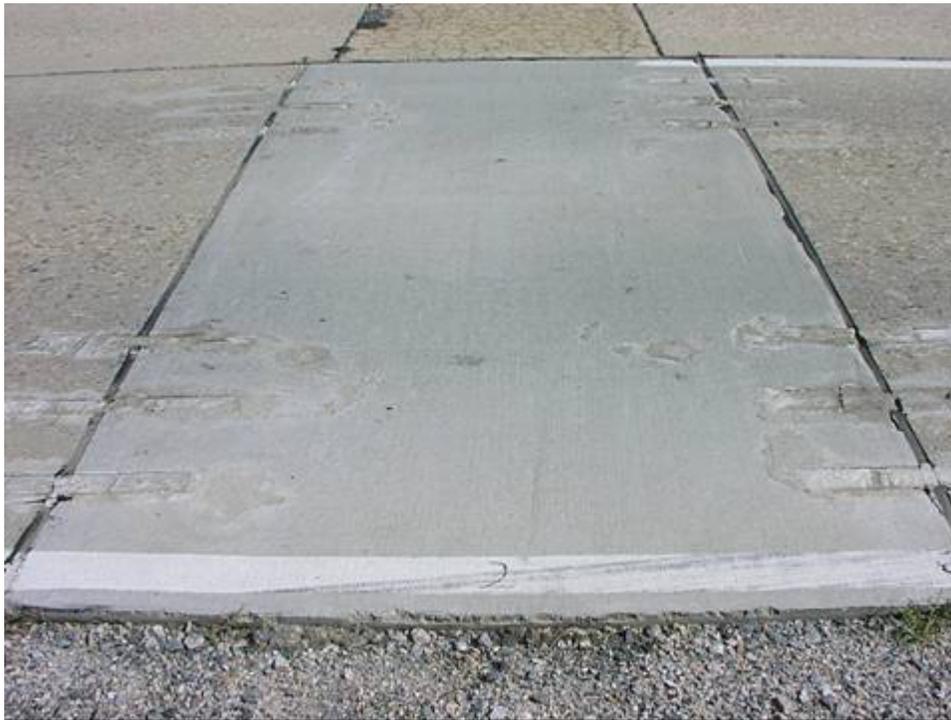
**Figure 1. Discontinuous joint at dowel retrofit.**

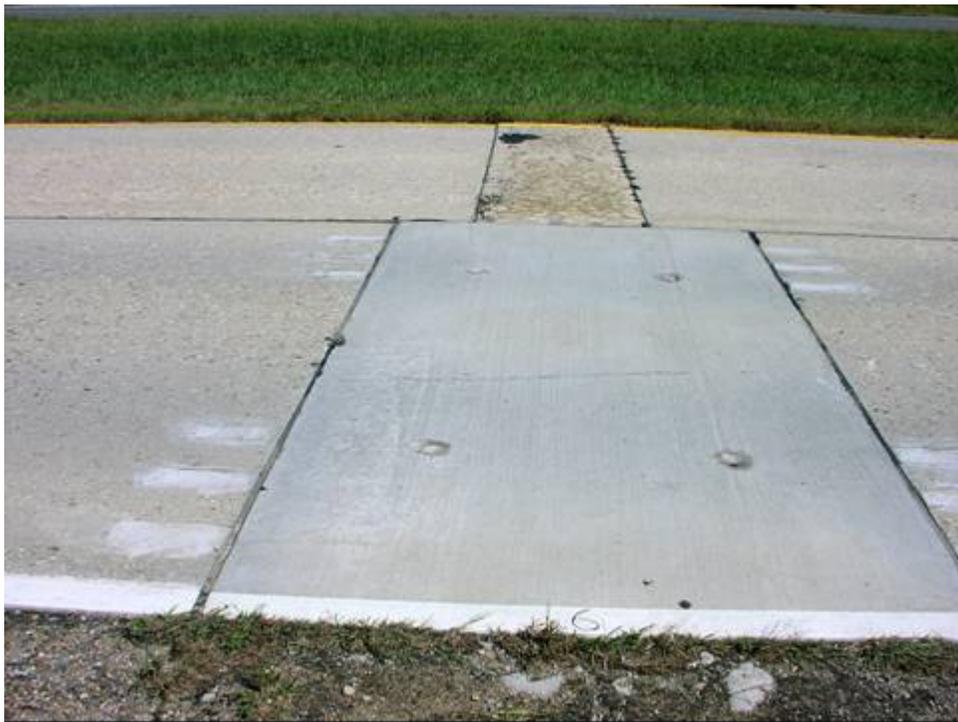
**Figure 4. Crack propagating between wheelpaths in patch with cast-in dowel.**
