Summary Report on the Performance of Open-Graded Friction Course Quieter Pavements

I-5 Lynnwood, SR-520 Medina, I-405 Bellevue

WA-RD 817.1

Summary Report

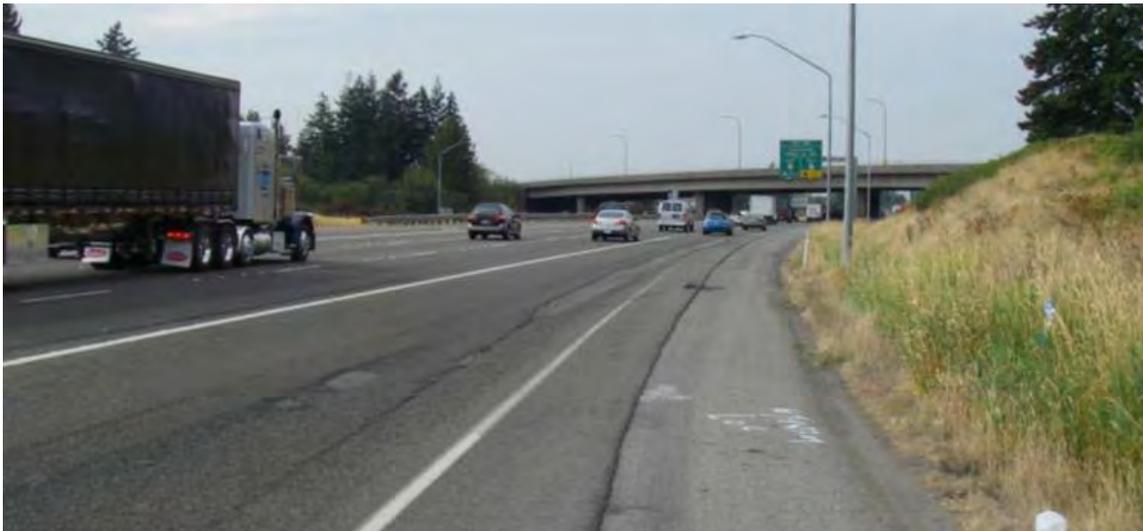
The OGFC-AR test section on the Lynnwood project was removed in the fall of 2010 after only four years of service due to safety concerns with vehicles having to cross the deep ruts during shifts of traffic necessary for the construction of new ramps for the Alderwood Mall interchange. The rutting in the OGFC-AR (Figure 16) was a result of wear and raveling and not the result of deformation of the pavement due to compaction or shoving as evidenced by the accumulation of aggregate on the shoulder (Figure 17).

Figure 16. Wear in OGFC-AR near Lynnwood. (Photo date 2010.)

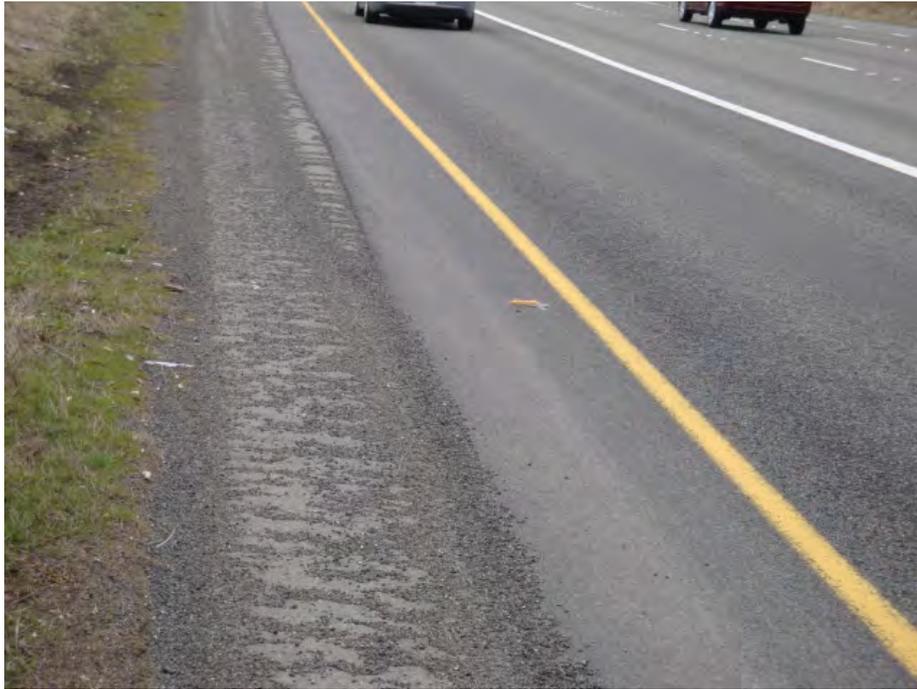
Figure 17. Accumulation of aggregate on the shoulder in the OGFC-AR section. (Photo date 2010.)

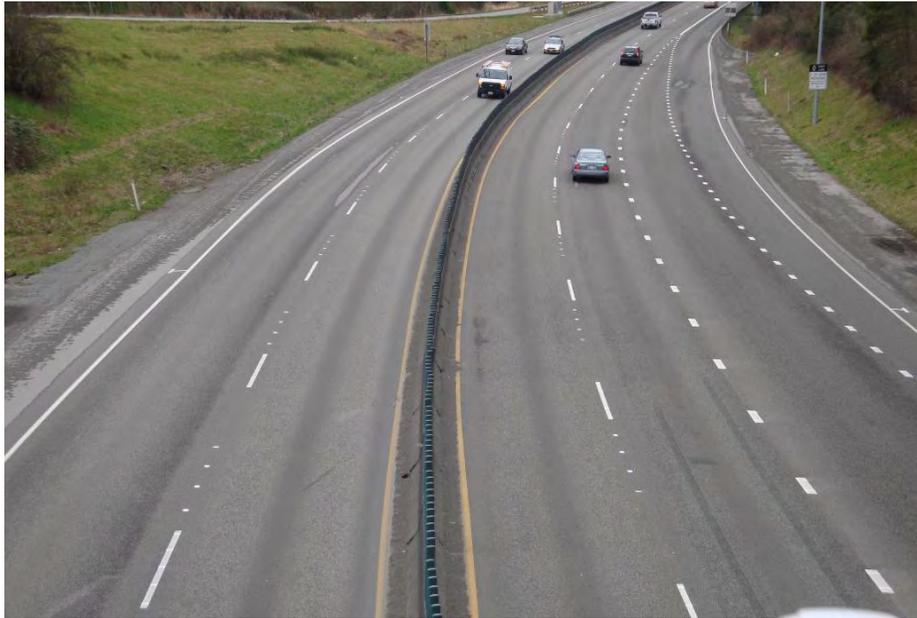
The performance of the OGFC-AR section on the Bellevue project matched that of the Lynnwood project with wear and raveling exceeding the depth of the overlay in the wheel paths as shown in Figure 18.

Figure 18. Rutting in EB Lane 1 (far left lane in photo) of OGFC-AR test section on SR 520. (Photo date February 2011.)

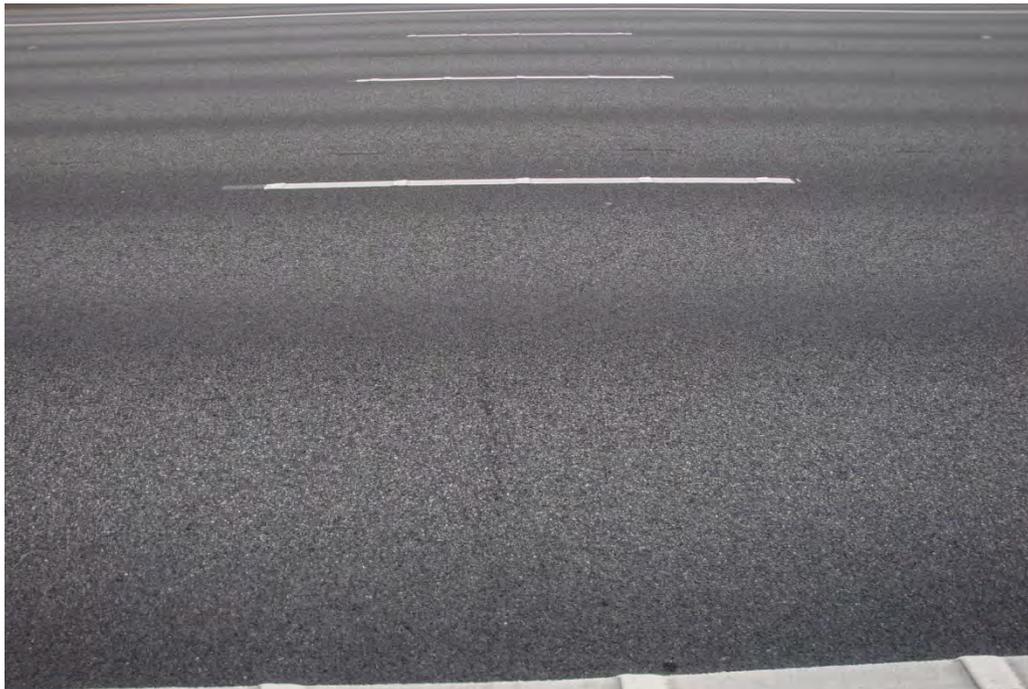
The wear/rutting on the Bellevue sections have not exceeded the depth of the pavement which is 1 inch as compared to the other two projects that were only 3/4 inch in thickness. However, the 2012 pavement condition data for the project shows that the OGFC-AR section is not performing as well as the OGFC-SBS section. Table 9 shows the type and extent of the distress for both sections. The distress noted for the OGFC-AR includes a minor amount of low severity alligator and longitudinal cracking but a significant number of low severity transverse cracks and sealed transverse cracks. In contrast, the data for the OGFC-SBS section shows only a few low severity transverse cracks (Figure 19). The 82 transverse cracks reflecting through the OGFC-AR overlay from the underlying concrete pavement accounts for 33 percent of the possible cracks as contrasted with the 5 cracks in the OGFC-SBS overlay which equates to 5 percent. The underlying concrete pavement ranged in age from 42 to 50 years with a length weighted average of 44 years. This would indicate that all of the transverse cracks throughout both the AR and SBS sections would be wide and worn by traffic and very prone to reflect through an HMA overlay. The amount of cracking in the OGFC-AR as compared to the OGFC-

SBS section indicates a weaker pavement that is less resistance to this type of cracking. Pavement condition data for the HMA control section is not presented because it is not underlain by concrete pavement.

Figure 19. Transverse reflection crack in OGFC-AR section. (Photo date February 2011.)
