Bridge Approach Slabs for Missouri DOT

Field Evaluation of Alternative and Cost Efficient Bridge Approach Slabs

Final Report Prepared for Missouri Department of Transportation
2013 November

Report cmr 13-010

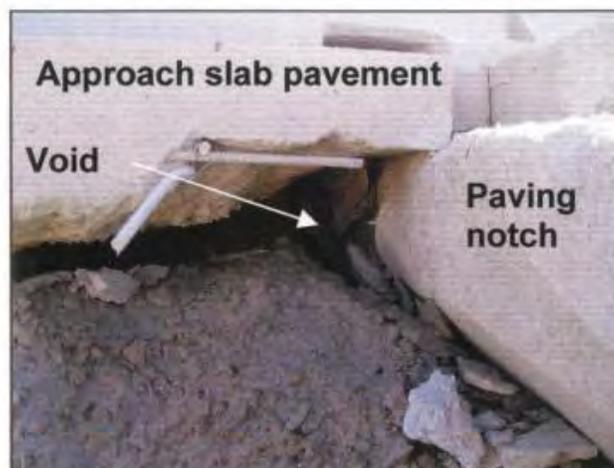
Figure 2-2 Erosion of Soil at the BAS and Abutment Joint [3]

Some geotechnical factors that affect the performance of BASs include settlement of the embankment soil and primary and secondary compression of the foundation soil under the abutments [7]. The embankment fill has a significant impact on the performance of a BAS. Three factors that affect the performance of embankment fills is the type of soil, the density at which it is compacted, and if the fill is susceptible to erosion [8]. Figure 2-2 shows a void formation under the BAS near the abutment, due to infiltration of water. The California Department of Transportation (Caltrans) performed a BAS study which indicated erosion and settlement of the soil to be the two main issues with BAS failure. A recommendation to help mitigate water infiltration was to extend the BAS over the wingwalls [9].

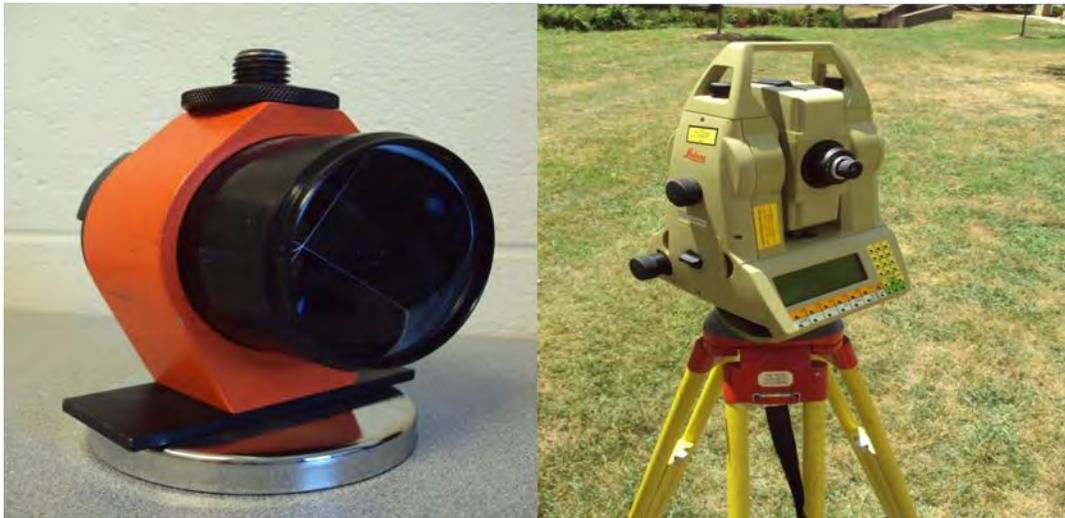
Figure 3-1 Surveying prism (left) and the Total Station (right)

One method used to evaluate the performance of the new BAS designs was to monitor the deflections of the slabs over time. Elevations of 6 points on the newly constructed BASs were determined relative to a point on the abutment using a high precision TCA 2003 Total Station manufactured by Leica Geosystems. The abutments were assumed to provide a stable benchmark since they were supported by pile foundations. The initial readings were used as a reference to determine if the BASs were deflecting due to various reasons such as water infiltration and loss of support or due to settlement of embankment soils. The Total Station was placed off the roadway roughly 50 to 100 ft. from the BAS to provide a wide line of sight to the selected points on the BAS. The total station rested on a tripod placed firmly in the soil to eliminate any movement when readings were being taken. Surveying prisms were placed on the selected 6 points of the BAS and on the abutment to perform the surveying. Figure 3-1 shows a surveying prism and the TCA 2003 Total Station. The surveying prisms had to be placed on a smooth and flat surface to collect accurate readings unlike the concrete surface of the BAS. Therefore monitoring plates were installed on the BASs at the selected 6 points. Detailed information on the monitoring plates is provided in the following sections.

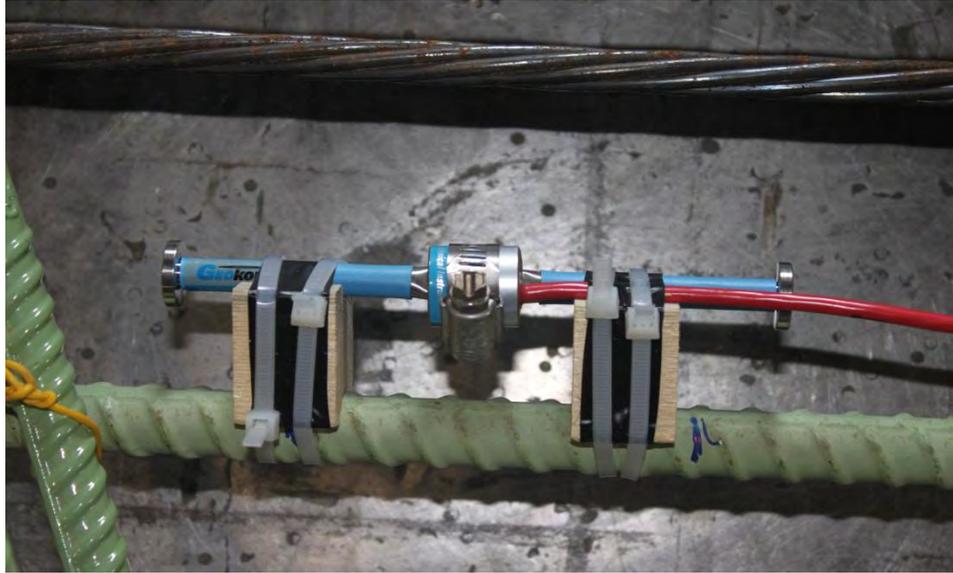
Figure 3-6 VWSG attached to the reinforcement

VWSGs can be placed in concrete members in a variety of ways; they can be directly embedded in concrete by pre-attaching the gauges to rebar or tensioning cable, they can be precast into a concrete briquette that is subsequently cast into the concrete member, or they can be placed into the boreholes and grouted. In this study VWSGs were attached to reinforcement prior to casting of the PCPS panels at the precast plant as shown in Figure 3-6. Wooden spacers notched on both sides were used to attach the VWSGs to the reinforcement and to ensure that they will remain parallel to the reinforcement during pouring of concrete. VWSGs were attached to the wooden spacers using electrical tape and these assemblies were attached to the reinforcements at the precast plant using zip lock ties. The wires of VWSGs were also tied to the rebar at every 3 feet using a zip lock tie to prevent damaging and entanglement of wires during concrete pouring. The VWSGs were installed on July 6, 2011 at Coreslab Structures, Inc. prior to the casting of the PCPS panels. A total of 11 VWSGs were installed in the PCPS panels that made up the east side BAS of the bridge A7767. Detailed information on the location and direction of the VWSGs is provided in Chapter 4 that describes the construction of the BASs.

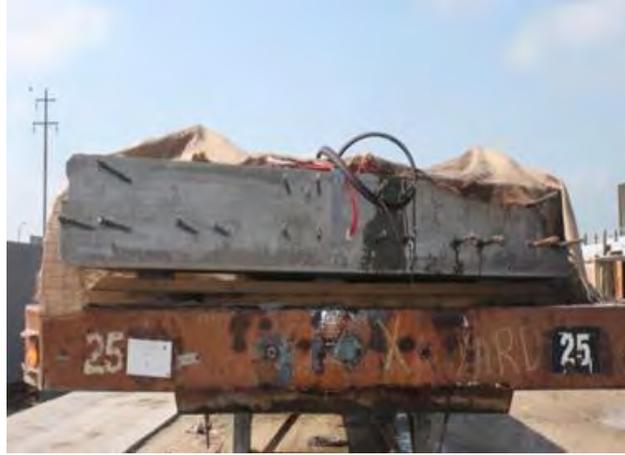
Figure 3-17 Curing of PCPS slabs

The first of two concrete pours were for four panels each. The four panels were laid out longitudinally. The prestress tendons were anchored at one end and stressed at the other end of the four panels. The prestress tendons between two panels were cut after the concrete was hardened and gained minimum strength. For the first pour, the data logging of the gauges was stopped before the prestress tendons were cut. For the second pour the data logging was stopped after the prestress tendons were cut to record any changes in concrete strain. The cables were carefully handled during removal of formwork and anchored to the slab panel top surface using zip lock plastic bags and tape. The curing was done using wet burlap. The cables were protected from being wet as they were housed in zip lock plastic bags (see Figure 3-17).

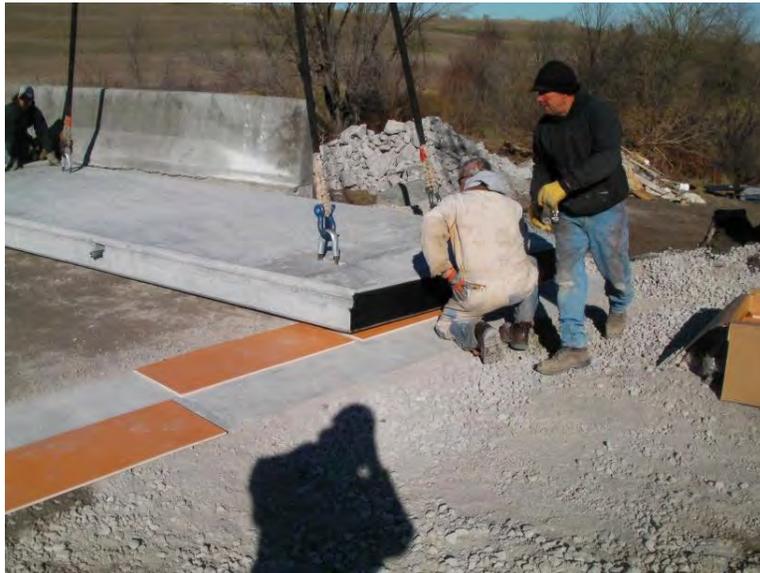
Figure 4-21 Placement of First PCPS Panel on US136 on Bearing Pads on Sleeper Slab

After completion of the compaction of the aggregate base the contractors recommended the use of sand or lime to make it easier to level. The large aggregate made it difficult to form a flat surface and the addition of a finer material would help. After the base was level, rubber fabric pads were placed on the sleeper slab and along the bridge deck and wingwall to provide for expansion as seen in Figure 4-21.

Figure 4-21 shows the laying of the first panel at the east end of the bridge. No polythene sheets were specified for this bridge. Figure 4-22 shows placement of the middle panel and Figure 4-23 shows the placement of the last panel. These panels were connected using the shorter transverse tie rods that connect two adjacent panels. It was observed that the construction crew had a difficult time trying to reach in between the panels in order to tighten the nut of the tie rods.

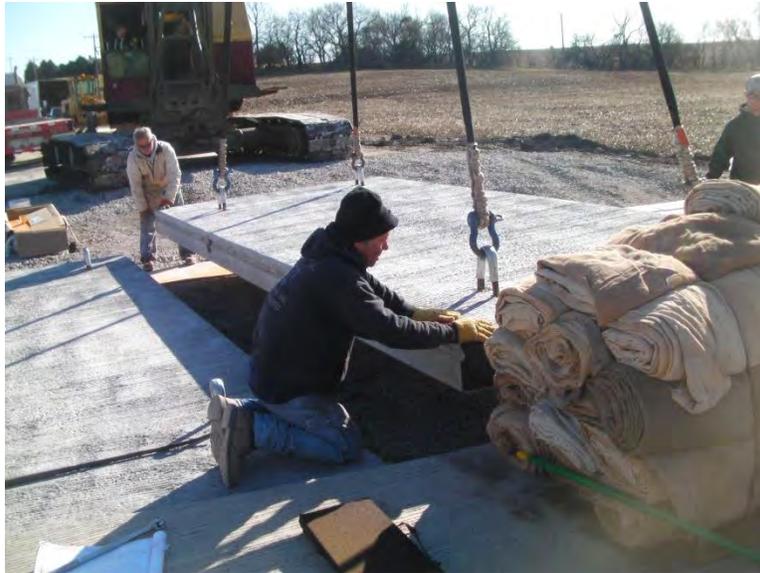
Figure 4-22 Placement of a Central PCPS Panel on Bridge on US136

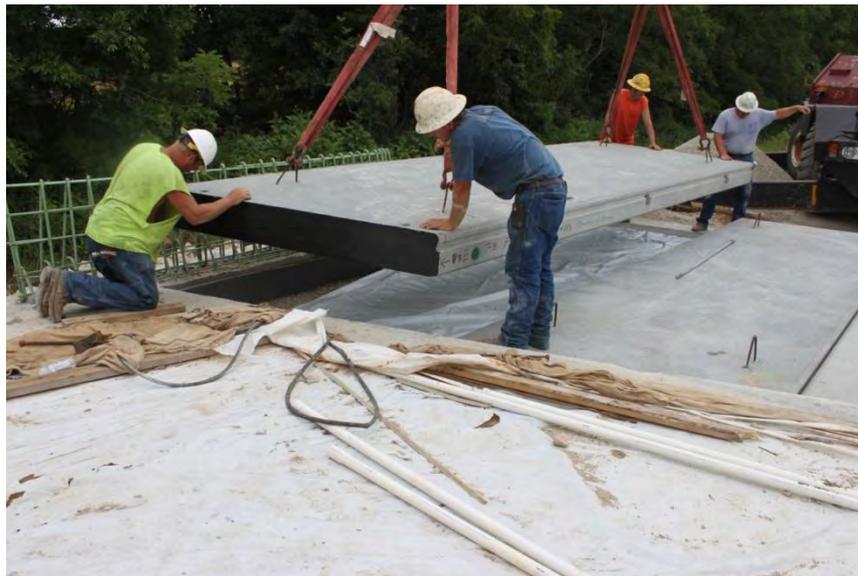
Figure 5-2 PCPS Panel placement on Bridge A7767

The BASs of bridge A7767 are skewed 30° and they are 30 ft. wide consisting of five 6 ft. wide PCPS panels on each end of the bridge. The PCPS panels were produced at CORESLAB's Marshall Plant in Missouri and delivered to the site on flatbed trucks. The PCPS panels were placed using a 33 ton rough terrain crane with a 92 ft. boom directly from the truck to the aggregate base covered with polyethylene sheeting. Figure 5-2 shows placement of PCPS panels. Placement of the panels had to be stopped on the east side after the placement of the first panel because of uneven support caused by high spots in the aggregate base. The panel and polyethylene sheeting were removed and the aggregate base was re-leveled using a 2x6 between the abutment and sleeper slab. During the placement of panels on the west end, the south side wing wall had to be chipped to fit the panels between the wing walls.

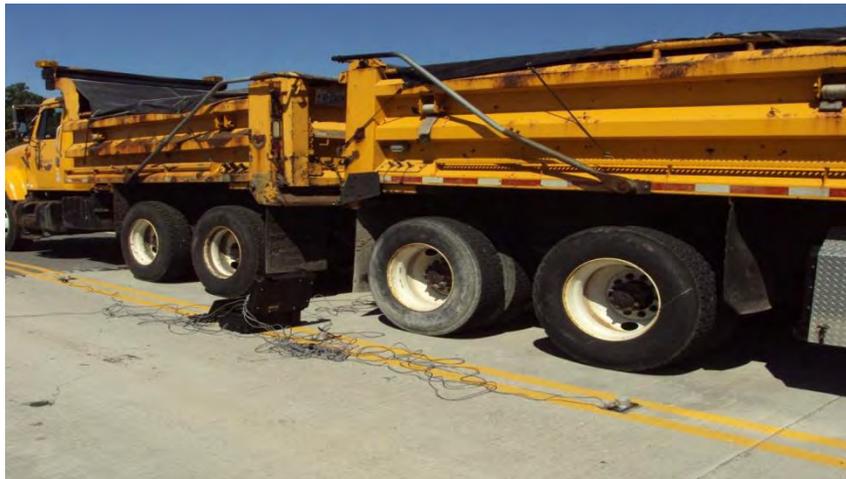
Figure 6-2 Overloading left lane for the BAS on Bridge A7890

The load test was conducted using two HS20 MoDOT dump trucks as shown in Figure 6-2 and Figure 6-3. Each load test occurred in the lanes where the BASs experience service loading. This provided a uniform test between all three (3) slab designs and represented actual load locations once the bridge was opened to traffic.

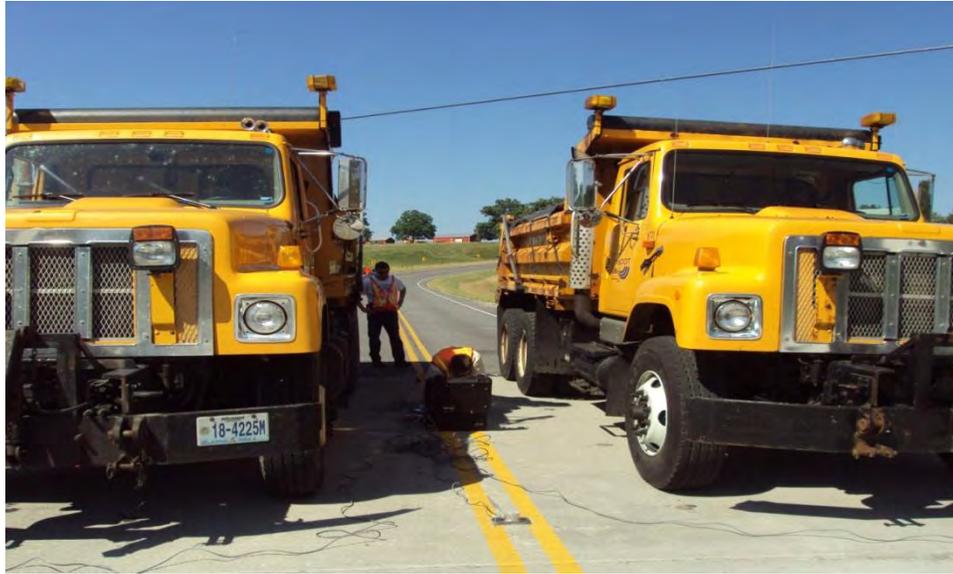
Figure 6-3 Tandem loads placed near the flexible pavement on Bridge A7890

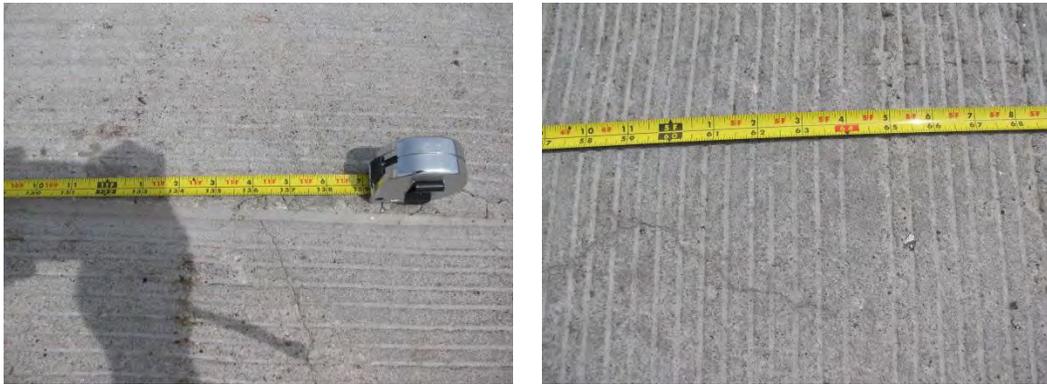
Figure 6-45 Longitudinal Crack at West End of PCPS on MO38 – 11’4” distance from the wing wall (left) and 5’4” crack (right)

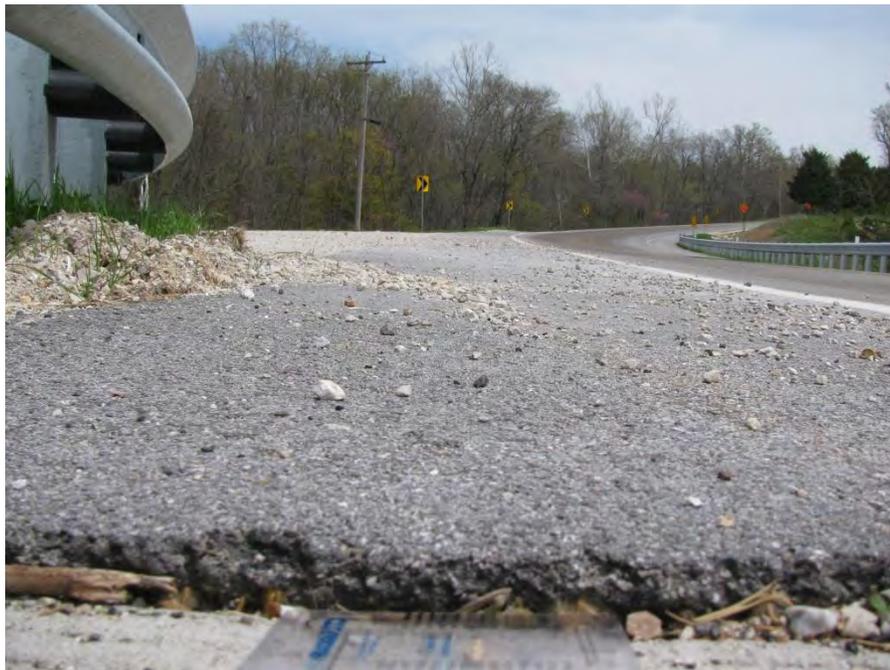
Figure 6-46 Shoulder asphalt level above the CIP BAS on MO38

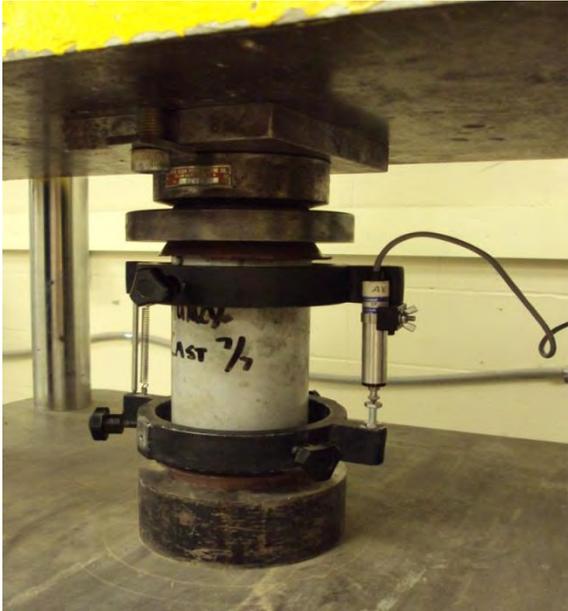
Figure 7-1 Test setup for compressive strength in the Tinius-Olsen

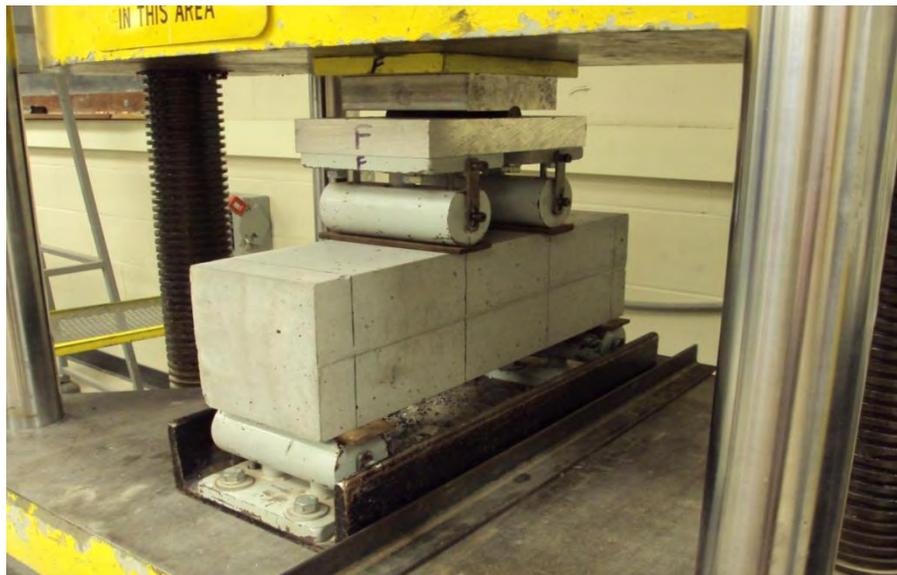
Figure 7-4 MOR Test Setup

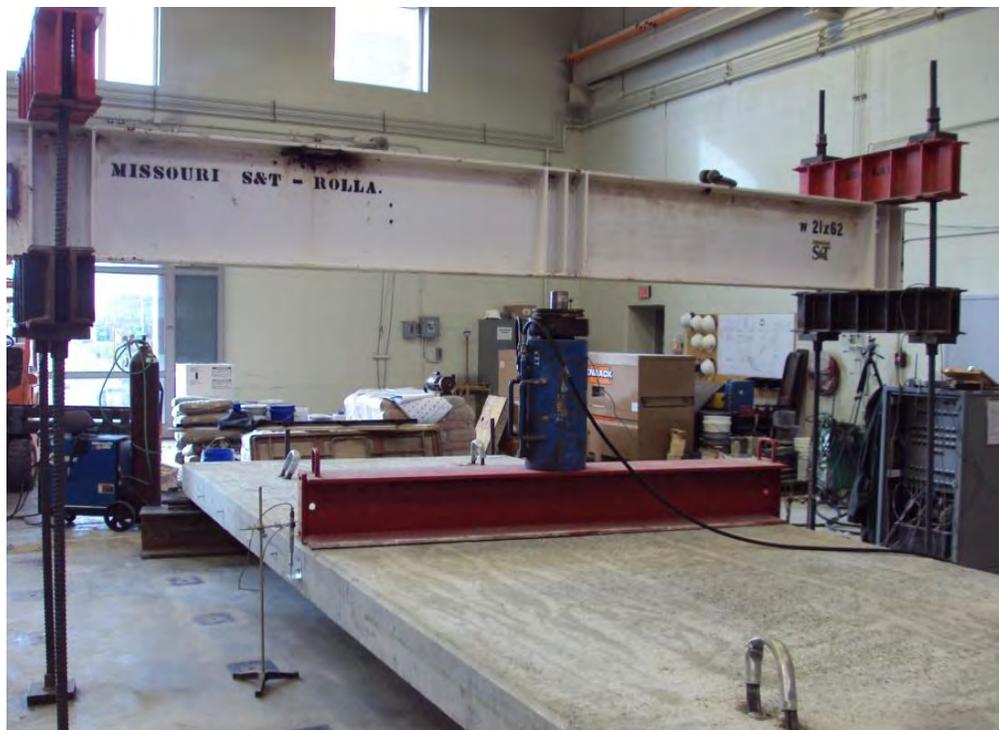
Figure 7-22 Testing Apparatus for Testing Panel to Failure

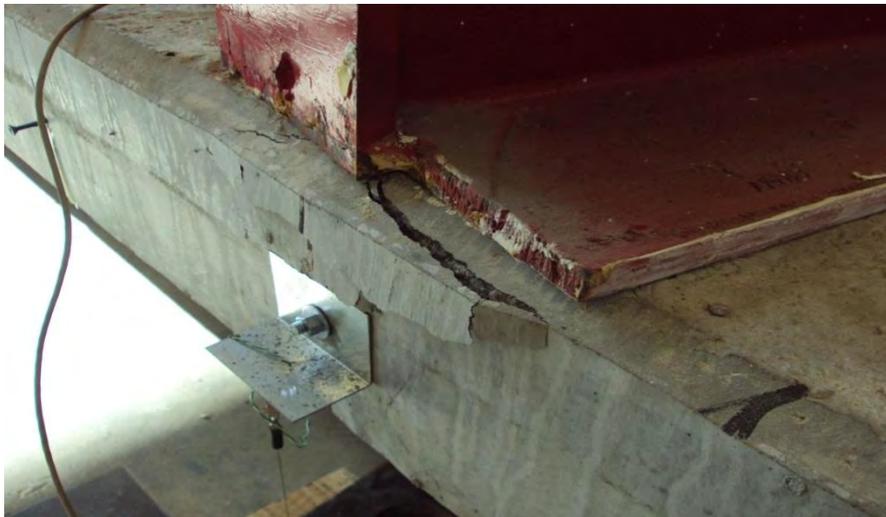
Figure 7-24 Localized Failure Due to Non-Uniform Pressure of Line Load
