PIG MOUNTED TRIALS FOR INTERNAL
CORROSION MONITORING FLUIDIZED SENSORS
(PROJECT #277)

REPORT No TAOUS811-EP00168

DNV USA

FINAL REPORT

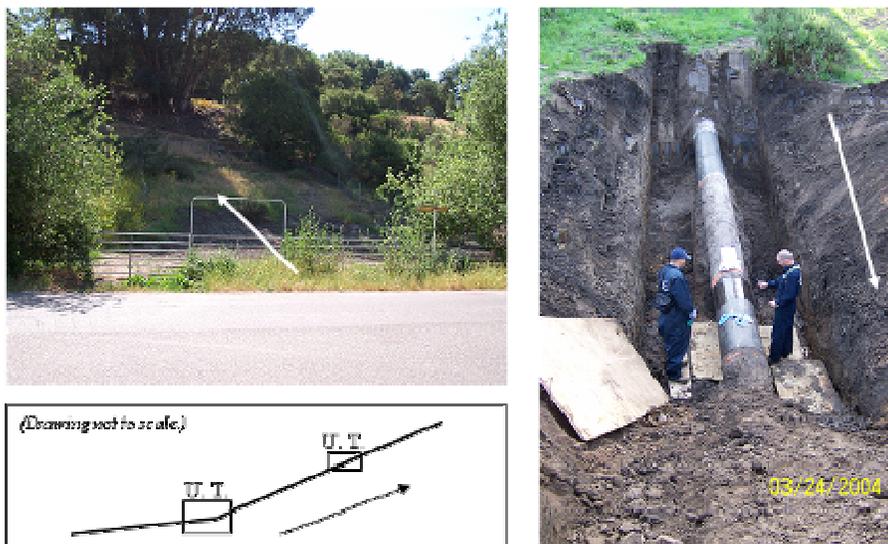
Figure 1. Uncertainty in the extent of pipe to be excavated for ICDA

Internal Corrosion direct Assessment (ICDA) was developed for wet and dry gas and liquid hydrocarbon transmission lines. For pipelines that normally carry dry gas but may suffer from short term upsets of liquid water, the ICDA methodology relies on established multiphase flow principles to predict locations of water accumulation. For these nominally dry gas lines, a simple correlation was developed that calculates the critical angle of inclination for water accumulation that can be compared to the actual angle of inclination of the pipe (measured by digital elevation data and depth of cover). Once critical angle sites are identified, the pipe is excavated and one or more direct examination techniques (e.g., ultrasonic inspection) are used to determine whether internal corrosion is present. This is illustrated in Figure 1.

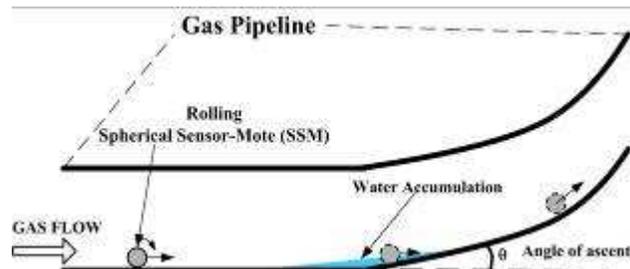
Figure 2. Illustration showing fluidized sensor motion

Because of the uncertainties related to ICDA and constraints making some pipelines unpiggable in the traditional sense, other technologies and alternative methods for pipeline inspection have been examined. In a previous PHMSA funded research project, prototype small wireless sensors that can travel inside the pipeline were developed. These sensors took advantage of recent advances in computational and wireless communication technologies. This concept is illustrated in Figures 2 and 3.

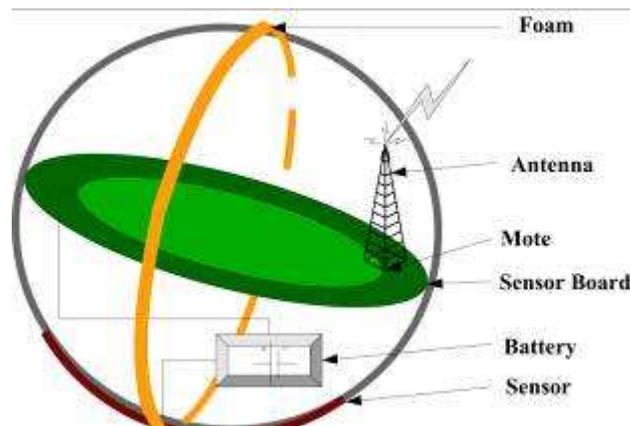
Figure 3: Illustration of spherical sensor.

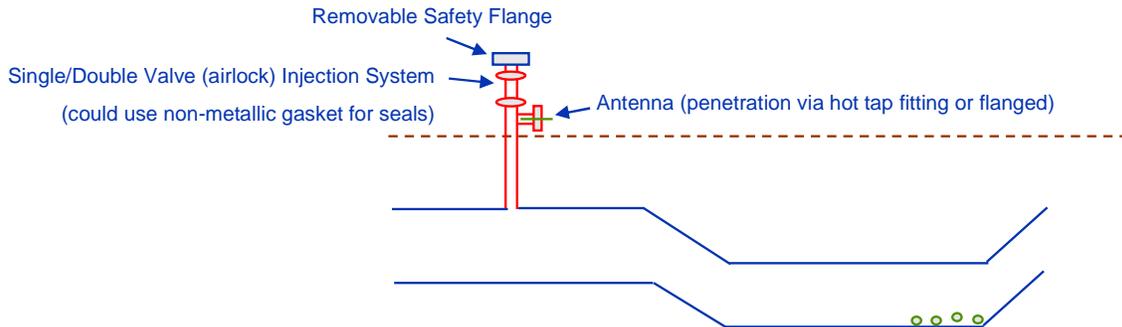
Figure 4: Schematic of "leave in place" configuration.

During the course of the previous research project, two operational conceptual design alternatives emerged based on pipeline operator inputs. The first, which was the original intent of the project, was to create a "leave in place" sensor system. In this configuration, multiple sensors will be injected into a transmission pipeline to monitor for water accumulation at a specific location of interest (e.g., road crossing, critical incline, etc.). A schematic diagram of this configuration is shown in **Error! Reference source not found.** As part of the internal corrosion monitoring scheme, the sensors will be injected upstream of the location of interest (preferably

within 300-1000'; likely closer). Once on station, the sensors would be left in place for a period of up to perhaps several years. Once the sensors were no longer functional, the plan would be to use a cleaning pig to sweep them out.

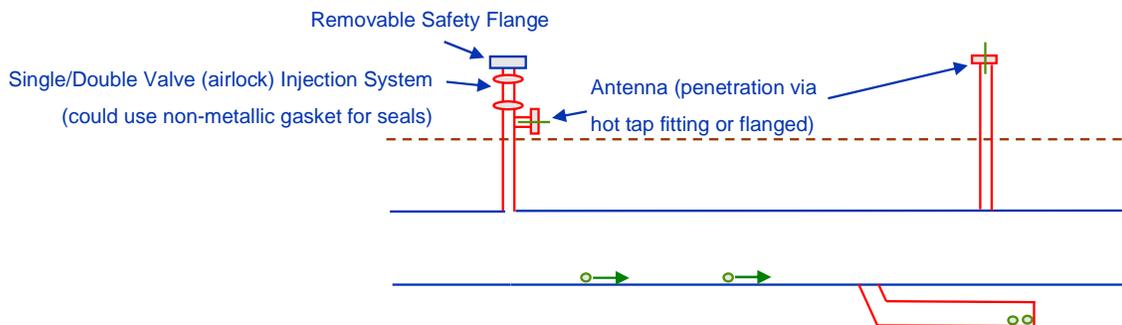
Figure 5: Schematic diagram of flow through field validation test on gathering line using a drip to collect the sensors.

The second configuration design concept that was envisioned was a “once-through” type system. In this configuration, a mobile version of the sensor system would be used. These sensors will be injected upstream of a location of interest and would flow to a suitable location downstream. Between the injection and retrieval points, the sensors would be continually flowing, collecting data, and storing the data in memory, which will be accessed after completing the run. A schematic diagram of this arrangement wherein the sensors would be collected at a downstream drip is shown in **Error! Reference source not found..**

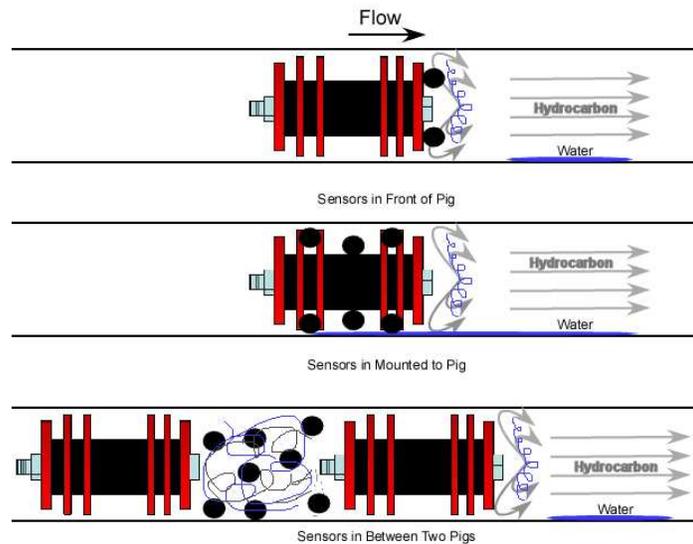
Figure 6: Schematic diagram of different possible pig-sensor combinations.

Based on the discussions, it was decided that focusing on mandrel pigs normally used in cleaning and dewatering applications would be a logical first step. The mandrel pig is a good choice because its stackable-disk geometry offers flexibility of sensor placement and it is the preferred pig of the operators. The sensor can be placed in front of the pig, incorporated into the pig, or placed between two pigs. These scenarios are depicted in Figure 6.

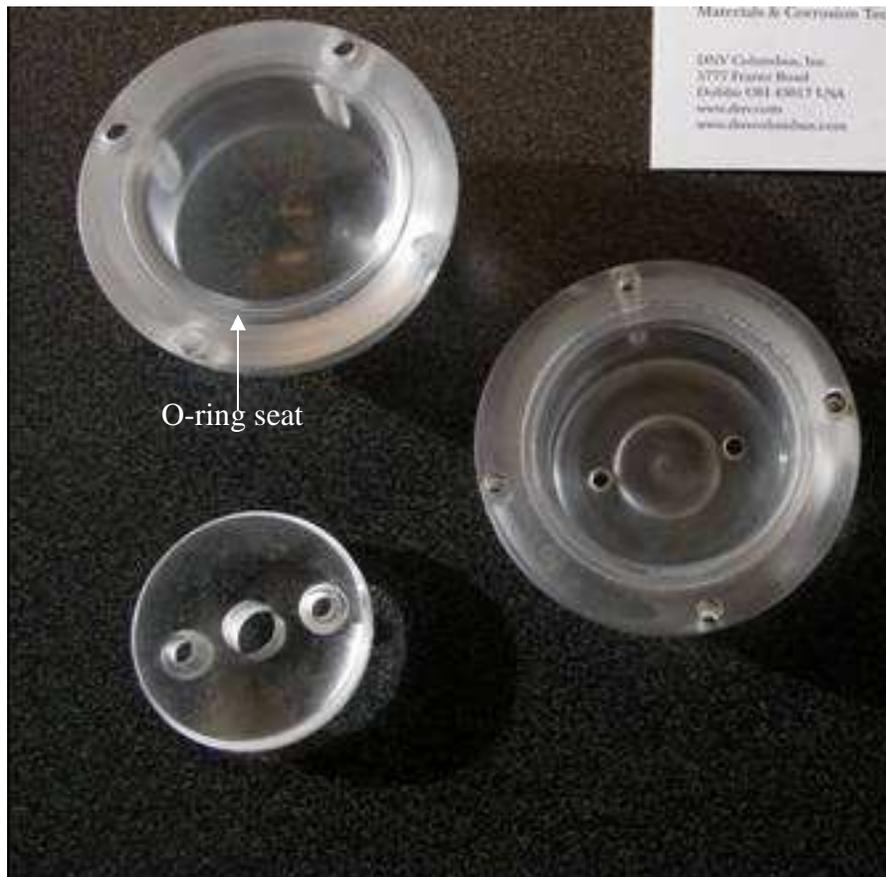
Figure 7: A photograph of an alternate packaging design using mechanical fasteners.

A photograph of a sensor that is joined using mechanical fasteners is shown below. The design shown contains the same internal elements as the previous sensor.

Several attempts were made using the sensor packaging design shown in Figure 7. In this design, an o-ring seal was combined with mechanical fasteners (bolts and nuts) in order to create an effective sealing system. This approach, however, was found to not provide the robustness needed to

withstand multiple impacts that the sensor would encounter when used in service. In addition, this approach proved to be ineffective at pressures above approximately 400 psi at which point leaking occurred.

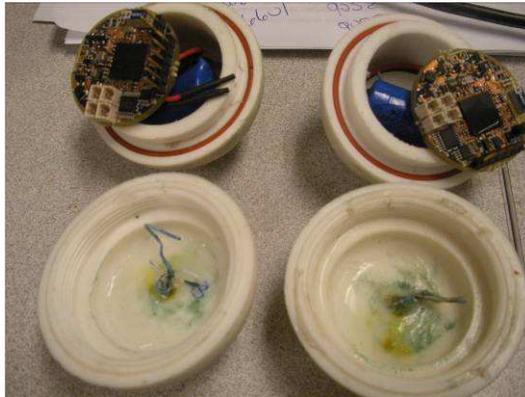
Figure 8: Photo of duplicate Teflon package trials using threaded connection and gasket. Note water inside.

Alternative approaches using both Teflon and polycarbonate spherical assemblies with differing wall thicknesses were then tried. Different sealing surface geometries were also attempted, including threaded joints, threaded joints that included a base o-ring gasket, epoxy sealed joints, silicone sealed joints, and other combinations of the above. Photographs of different test systems are shown below. Initial testing of these approaches showed that they could withstand impacts as well as high pressures. Manufacturing the two halves of the sensor housing to have mating threads provided a strong mechanical integrity platform. Then combining this with the different sealing methods of o-rings and other seals provided a viable packaging option.

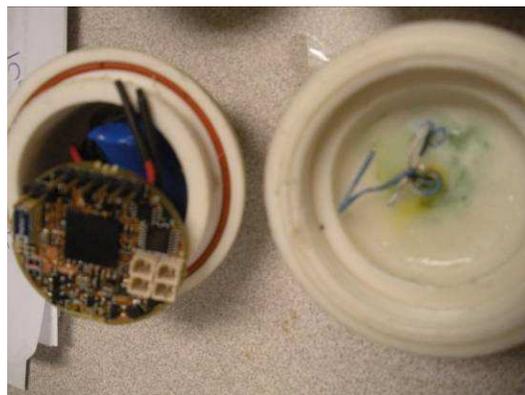
Figure 9: Photo of thin wall Teflon package that failed due to deformation at 1000 psi.

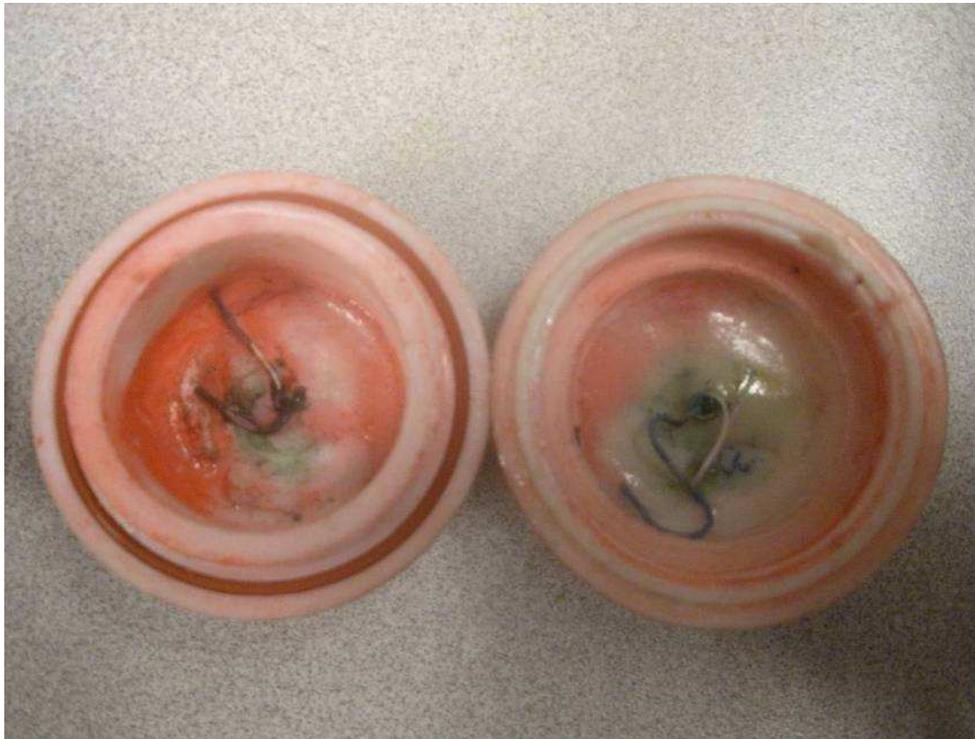
Figure 10: Photo showing that dye is inside the sensor package after testing at 1000 psi indicating a leak at the main seal.

Because of uncertainty regarding the location of possible leaks (i.e., is the leak at the main thread joint or is it from the sensing elements and leads), another set of tests was performed that included a red dye in the water. Four main combinations were examined in this test:

Results from some of the tests are shown below. Note that in these tests only two sensor elements were mounted on the package housing. Because the tests that were performed were destructive, it was decided to limit the number of sensor elements that would be destroyed. Thus, only a single sensor element in each hemispherical half was installed. In practice, multiple sensor elements would typically be used in each half to maximize the resolution and sensitivity of the sensor ball.

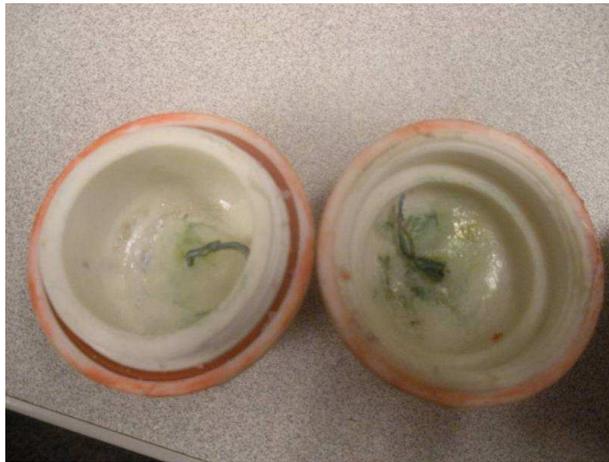
Figure 11: Photo showing no dye inside sensor package after testing to 1000 psi indicating that the main joint was effectively sealed.

Based on the testing conducted, two viable packaging options are available. For low pressure systems (~ 500 psi), a Teflon based design using threaded joint, a gasket, and silicone is effective and functional over long time periods. To withstand higher pressures, the wall thickness necessary for Teflon results in the sensor ball being too heavy for effective flow and movement. Thus, a polycarbonate design using a threaded, gasketed, and sealed joint was evaluated and found to function well over long time periods.

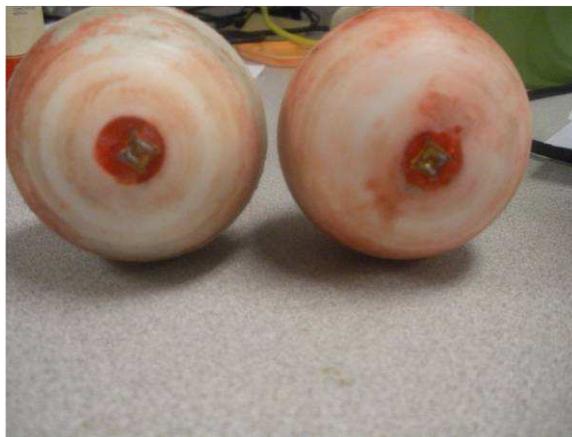
Figure 12: Photo of sensing elements after testing.

Additional testing showed that using small wires bonded to the sensing element that is then bonded to the spherical package resulted in poor performance. Shown below is a photo of damage that was noted after testing. Based on several iterations of sensing element packaging, testing has shown that the incorporation of the sensing element in a Teflon or polycarbonate plug that is then bonded to the sphere produces results that are superior to those observed when the wires/leads penetrate the package and are then bonded externally.

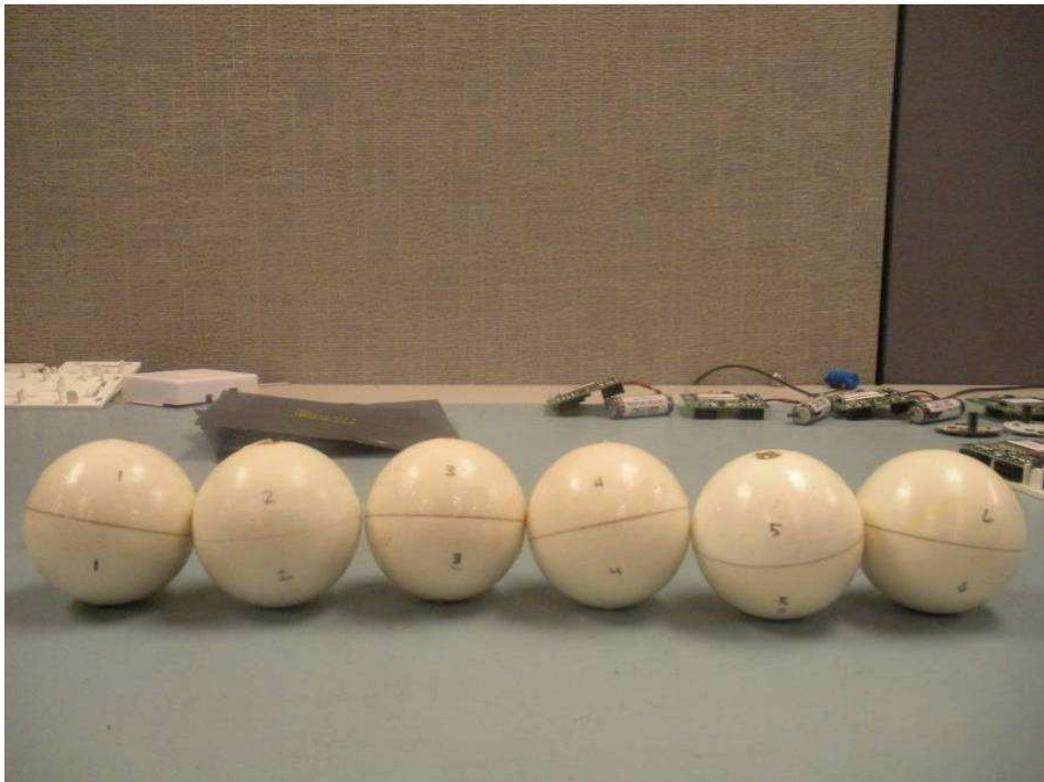
Figure 13: Photograph of six replicates used for packaging final design evaluation.

Several attempts were made using both Teflon and polycarbonate spherical assemblies with differing wall thicknesses. Different sealing surface geometries were also attempted. These included threaded joints, threaded joints that included a base O-ring gasket, epoxy sealed joints, silicone sealed joints, and other combinations of the above. The final identified and tested solution is a heavy wall Teflon sphere that combines epoxy, silicon sealants, and threaded O-ring joints. This configuration withstood both deformation and leak testing at pressures up to 1500 psi for a period of 3 weeks. Several pre- and post-test photographs of the tested packages are shown below. In all cases, package evaluation was conducted using six separate, identical replicates. Replicates were used to help give confidence in the results obtained. In this final configuration, all six replicates passed all aspects of the testing.

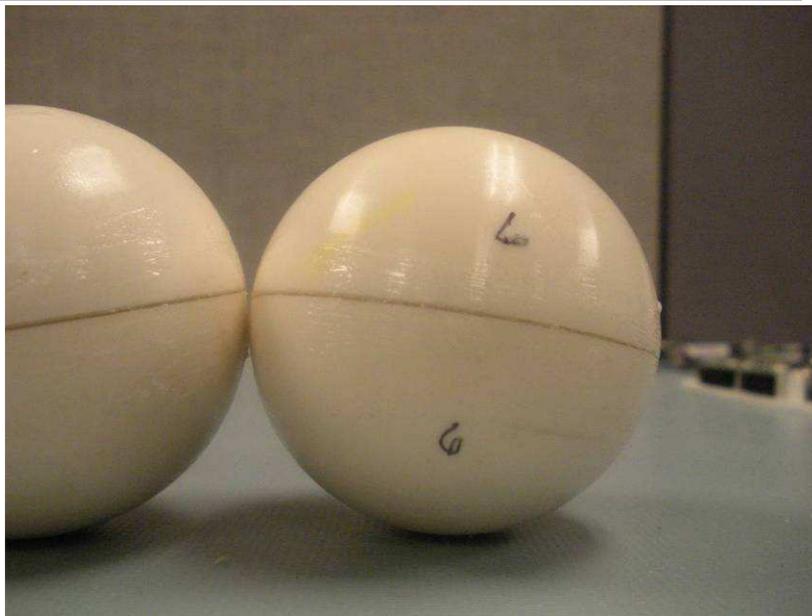
Figure 14: Close up photograph of replicate #6 prior to testing the final packaging design.

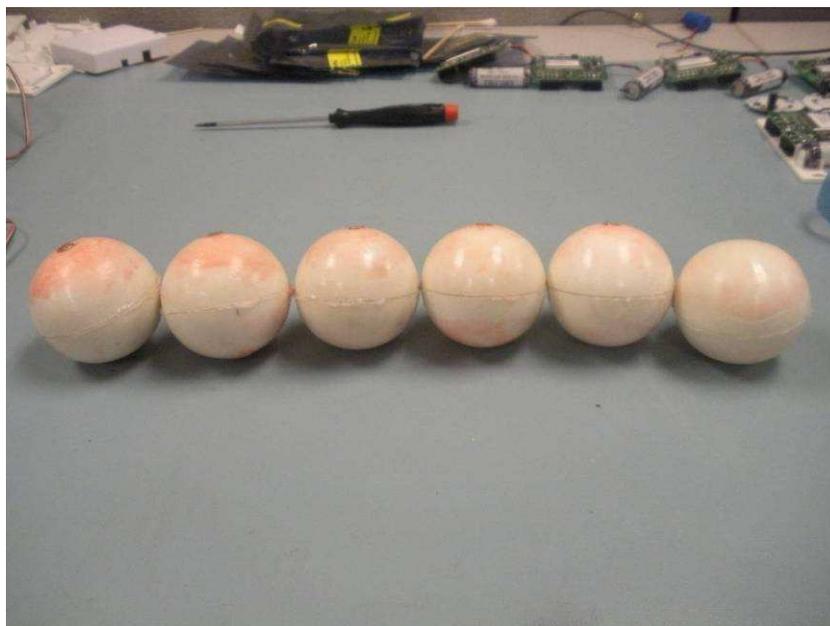
Figure 15: Post-test appearance of all six replicates for final packaging design. Note that the red color is from the dye used to facilitate post-test leak inspections.

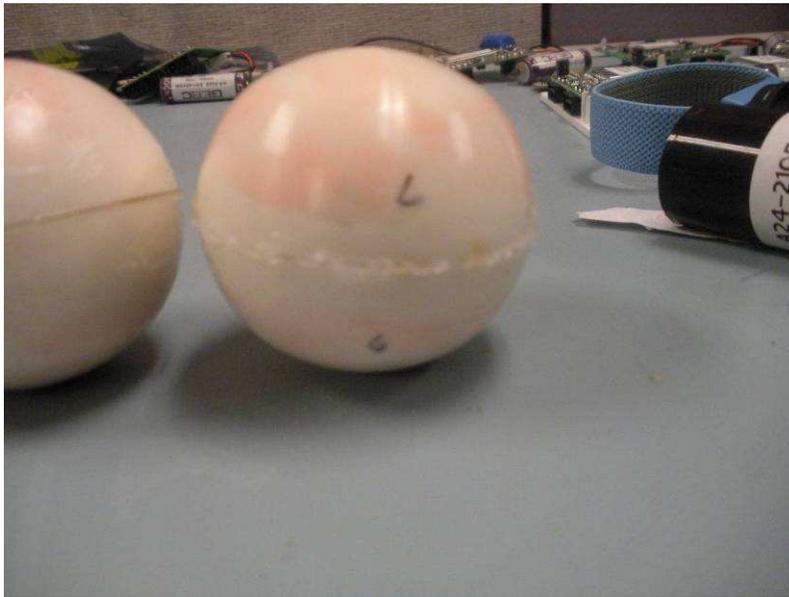
Figure 16: Close up appearance of replicate #6 after testing. Note that the red color is from the dye used to facilitate post-test leak inspections.

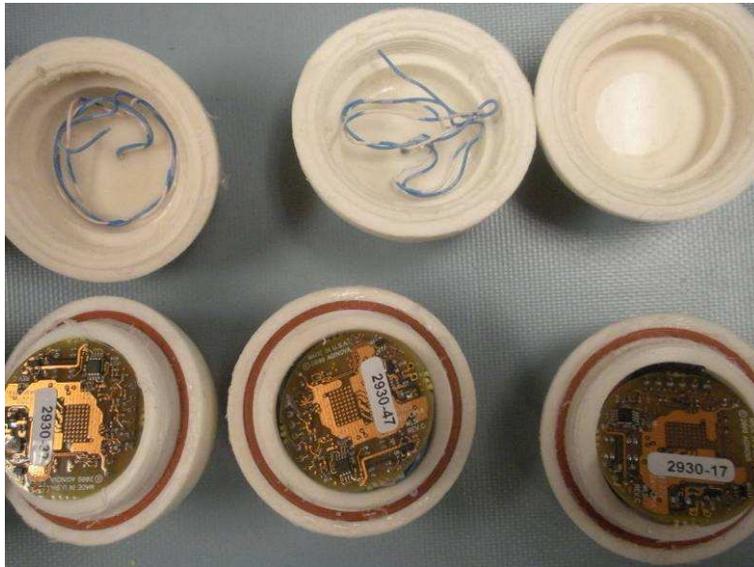
Figure 17: Post-test interior inspection of replicates 1-3. Note that no red color is evident inside the package indicating that no leaks occurred.

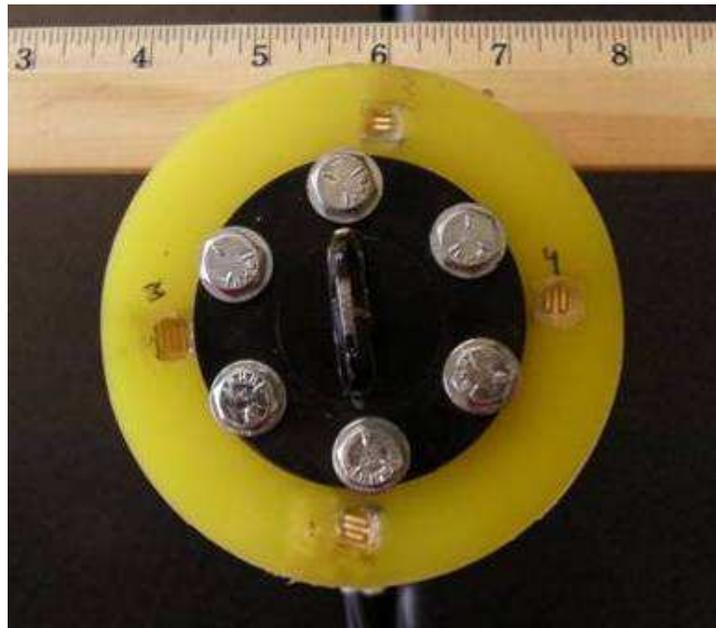
Figure 18: Front face of cleaning mandrel pig showing sensing elements at the 3, 6, 9, and 12 o'clock positions.

The new sensing head design is based on creating a circumferential ring around the front face of the pig rather than making measurements at four discrete locations (Figure 18). The operating principles of the new head design are illustrated in Figure 19 – 23. In this new design, the resistance of the entire ring is monitored. The ring is composed of alternating segments of steel and non-conductive polymer. Each steel element is connected to the next steel element via a $100\text{ k}\Omega$ resistor. Using a resistor of this size enables the elements to remain essentially isolated from each other until a conductive liquid (condensed or entrained water) creates a short. Once the short is created by the presence of the water, then the effective resistance decreases. The final installed ring on the front of the mandrel pig is shown in Figures 24 and 25. The ring is electrically connected to the electronics by passing through the annulus of the mandrel pig (as was done in the original design). The electronics are housed in the spherical package mounted in the rear of the pig.

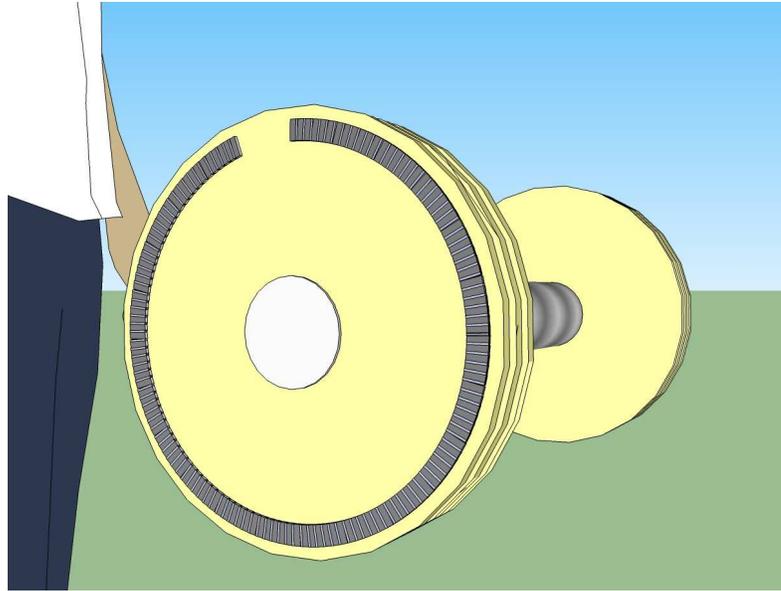
Figure 19: Schematic drawing of improved sensing head design.

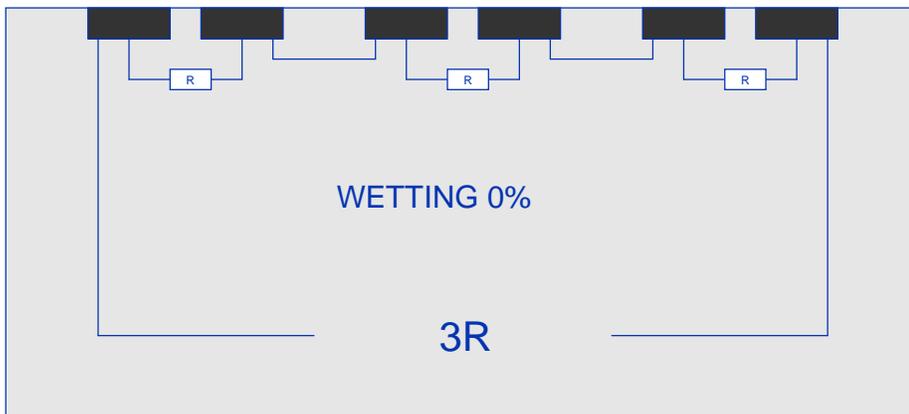
Figure 20: Schematic illustration of the operating principle of the improved sensing head design when no liquid is present.

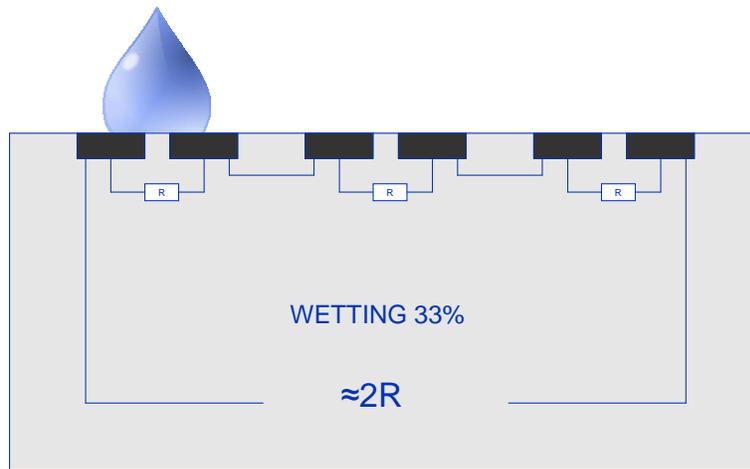
Figure 21: Schematic illustration of the operating principle of the improved sensing head design when enough liquid is present to create a short across only a single set of the elements in the head.

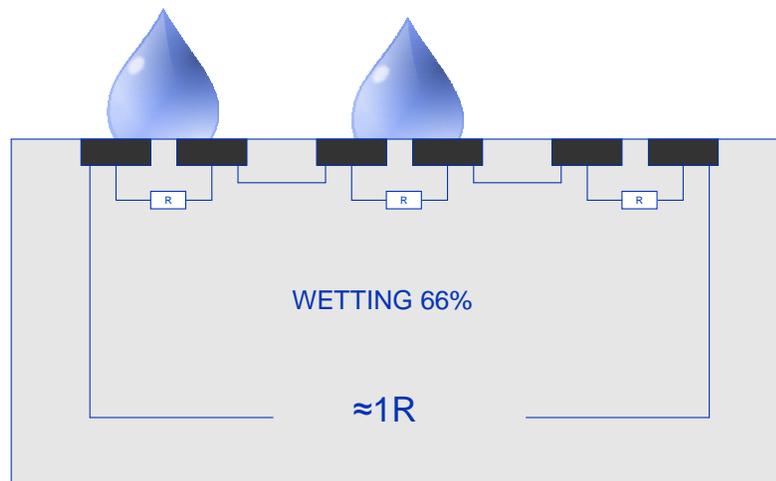
Figure 7: Schematic illustration of the operating principle of the improved sensing head design when enough liquid is present to create a short across only two sets of the elements in the head.

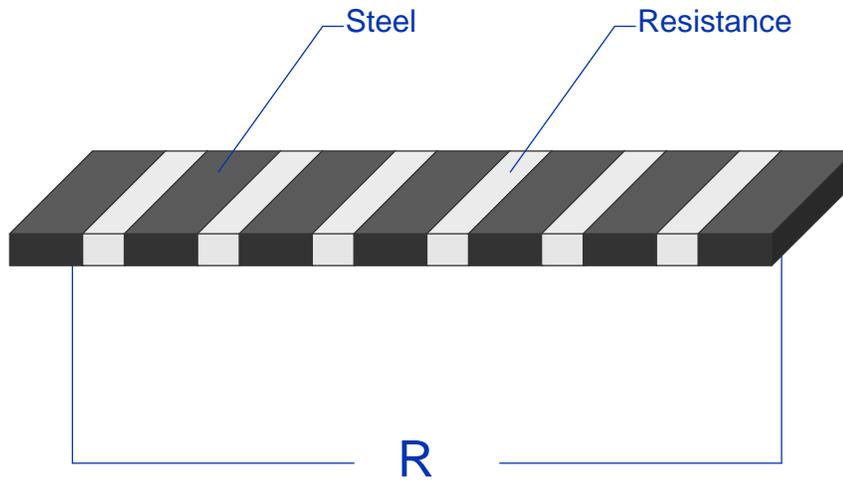
Figure 23: Overall conceptual design schematic of sensing ring.

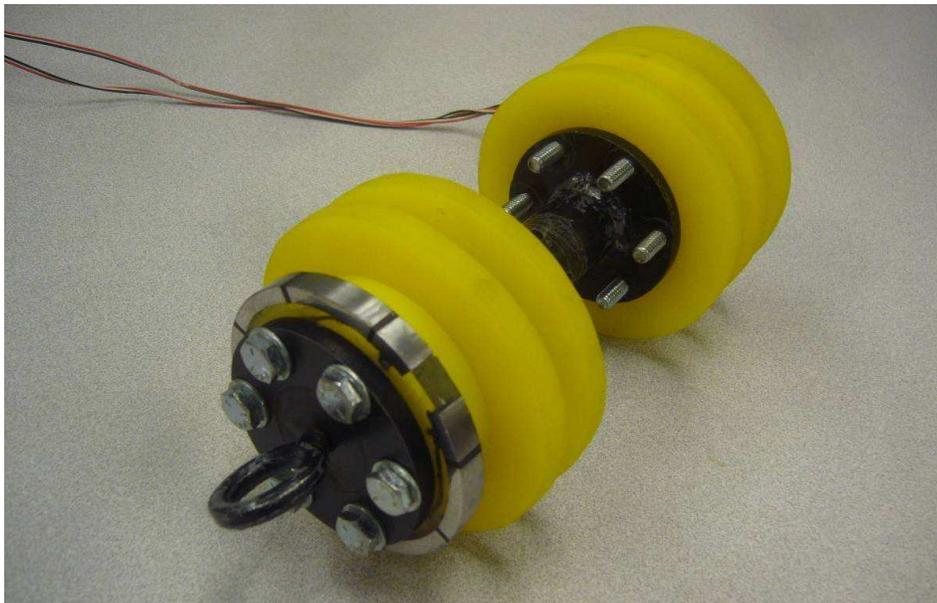
Figure 24: Overall view of the new pig. The metallic ring in the front is the new sensing element.

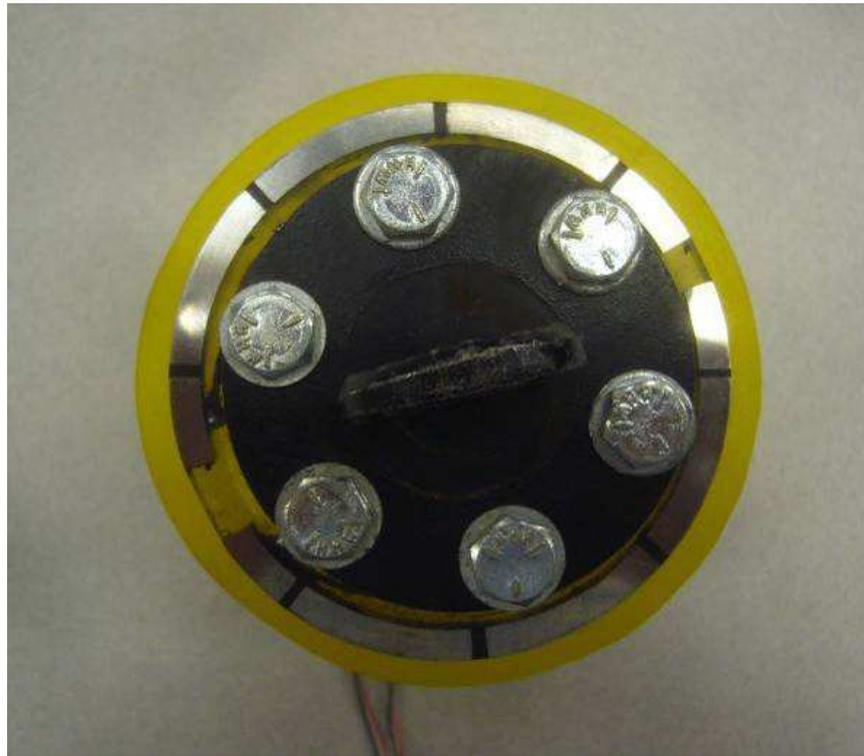
Figure 25: Photograph of front face of the mandrel pig showing the sensing head.

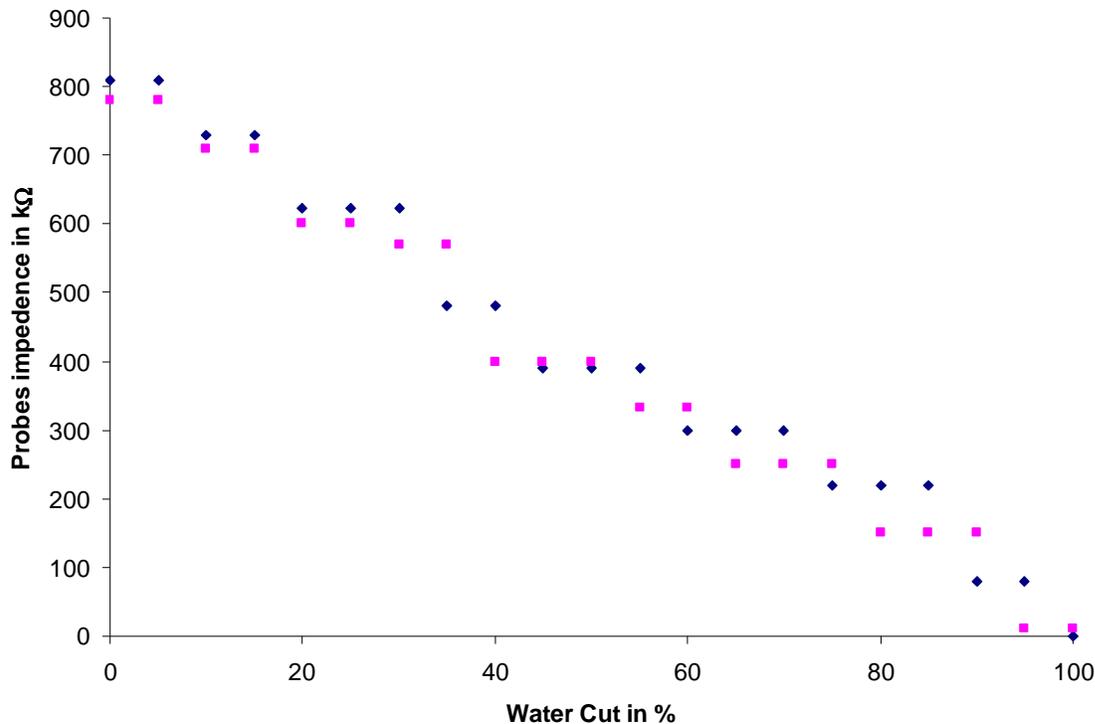
Figure 26: Evolution of the total impedance function of the water cut (original experiment in blue, repeat in pink)

A series of test runs with the modified pig design were conducted in mineral oil with different water cuts. The water contained 0.5 wt% NaCl to try to represent produced water. The results for replicate runs at different water cuts are shown in Figure 26. As can be seen, the replicate runs show very good agreement in resistance measurements. Furthermore, the improved design also demonstrates that differences in water cut can also be determined. Tests using the previous head design showed only a marginal ability to detect differences in water cut (as will be discussed in Section 3.3 below). Thus, the new sensor design provides sensitivity to distinguish between water and liquid hydrocarbons and mixtures in between with a resolution of a few percent. The capability to detect the percent water cut was identified as of key interest by pipeline operators.

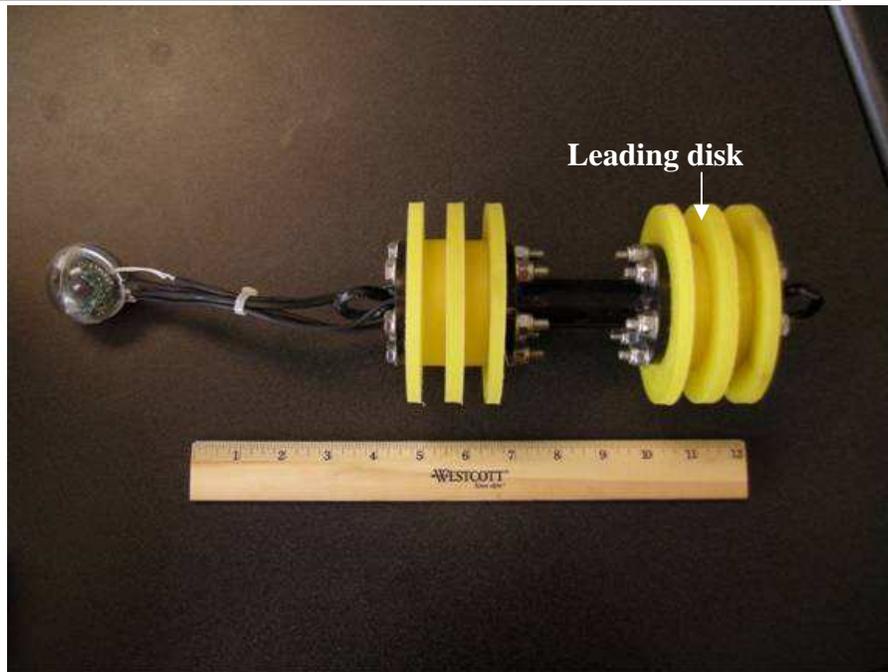
Figure 27: Photograph of mandrel pig with tethered sensor ball attached.

Initial lab-scale testing consisted of incorporated four sensors into the leading disk on the mandrel pig as shown in the figures below. Figure 27 is a photograph of a sensor-equipped pig. The photograph shows the mandrel pig, a collection of wires coming from the back of the pig, and the data acquisition / communication (DAQ / COMM) module. The DAQ/COMM module is a hollow acrylic sphere that opens into two halves. The Aginova electronics inside the sphere measure the sensor outputs and transmit the data wirelessly to a nearby to a laptop computer via wireless router.

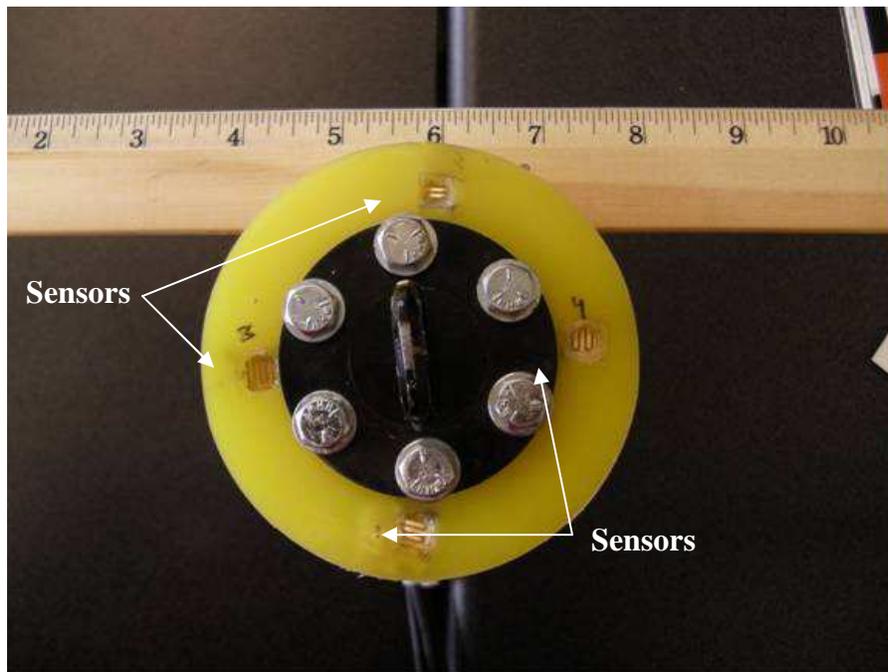
Figure 28: Photograph of front face of the mandrel pig showing water detection sensor installation locations.

Figure 28 is a photograph of the leading disk on the mandrel pig. Sensors are embedded in the disk at approximately ninety-degree intervals about the disk circumference, and positioned near the bolted flange rather than close to the disk edge. Each sensor has two electrically isolated traces printed on the surface. A voltmeter was used to test sensor function following assembly. The sensor was functioning properly if the voltmeter read open (or infinite) resistance when the sensors were dry. Copper traces were chosen for the lab scale testing, and may be changed to a different metal or alloy in the future, if necessary. The wiring for each sensor was routed through the hollow center of the mandrel pig. The wires exited the pig through four holes drilled in the rear flange.

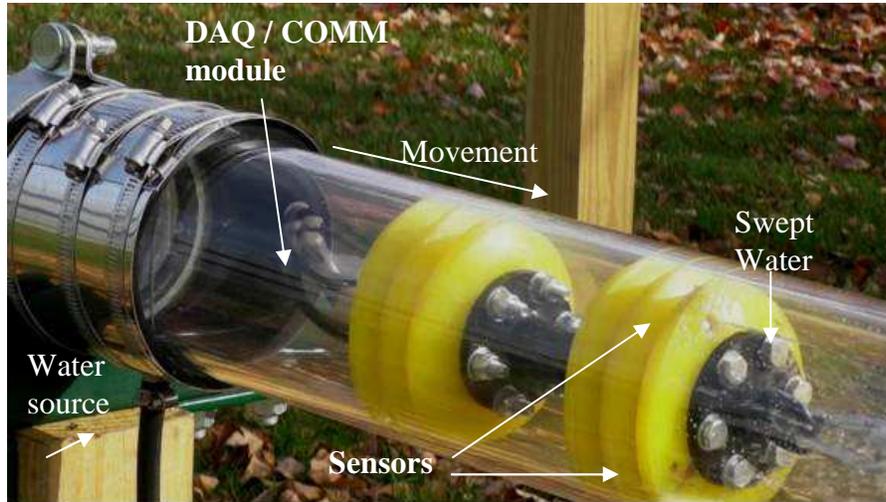
Figure 29: Photograph of pig trial run.

Figure 29 shows a sensor-equipped pig travelling through transparent acrylic pipe during a test. Several labeled white arrows are present in Figure 29. The white arrows point to the water source, the instantaneous position of the DAQ/COMM module, the direction of movement of the pig, the visible sensors, and the swept water in front of the pig inside of the pipe. The water source is a 1/4" diameter rubber hose fed by a peristaltic pump operating at approximately 50 mL per minute. The pig is travelling through the pipe at approximately 5 meters/second, or about 11.5 miles per hour. The test was filmed using a high-definition digital camcorder that has the capability to save still screen images during playback.

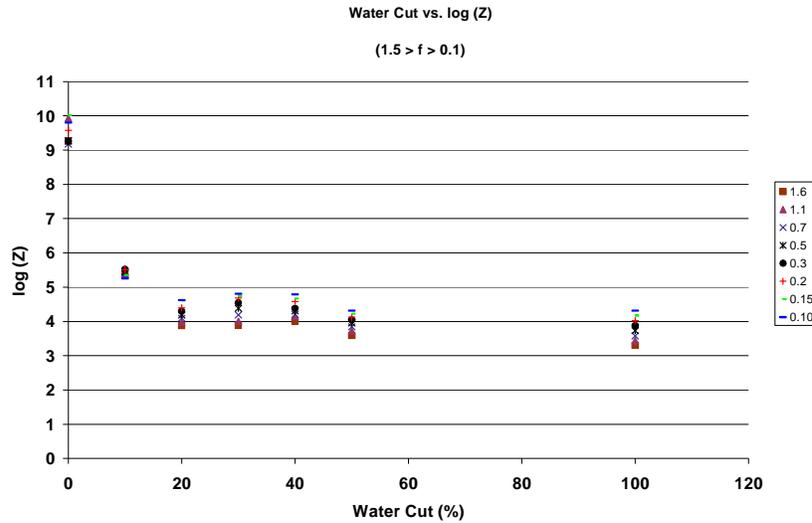
Figure 30. A plot of WC versus log (Z) in the frequency range 0.1 Hz to 1.6 Hz.

The results of the water-cut analysis using an AC induced signal are shown in Figures 30 – 35. Analysis of the AC impedance data indicated that the sensors can determine the difference between 0WC, 10% WC, 20% WC, 50% WC, and 100% WC at frequencies below 900 Hz. The

magnitude of the impedance did not vary significantly between 20% WC and 40% WC using the initial sensor design. Because the sensor elements of the original design are small, it was easy for them to become oil-wet thereby making subsequent measurements suspect and challenging to obtain accurate information. At this point, the alternative ring approach discussed in Section 3.2 was developed and tested.

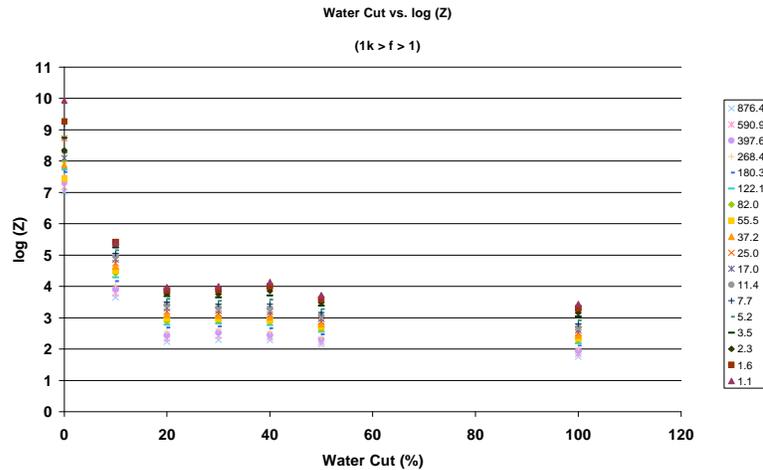
Figure 31. A plot of WC versus log (Z) in the frequency range 1.1 Hz to 876.4 Hz.

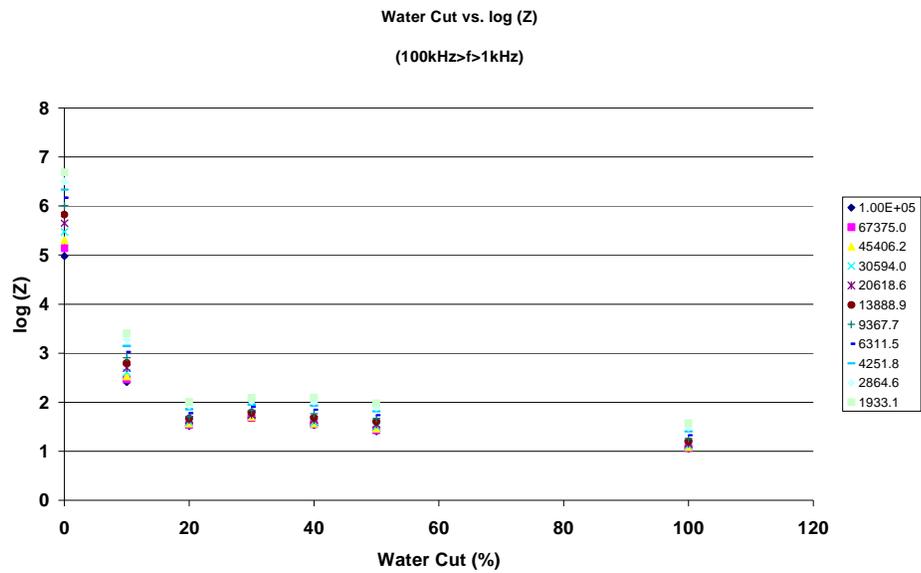
Figure 32. A plot of WC versus log (Z) in the frequency range 1933 Hz to 100 kHz.

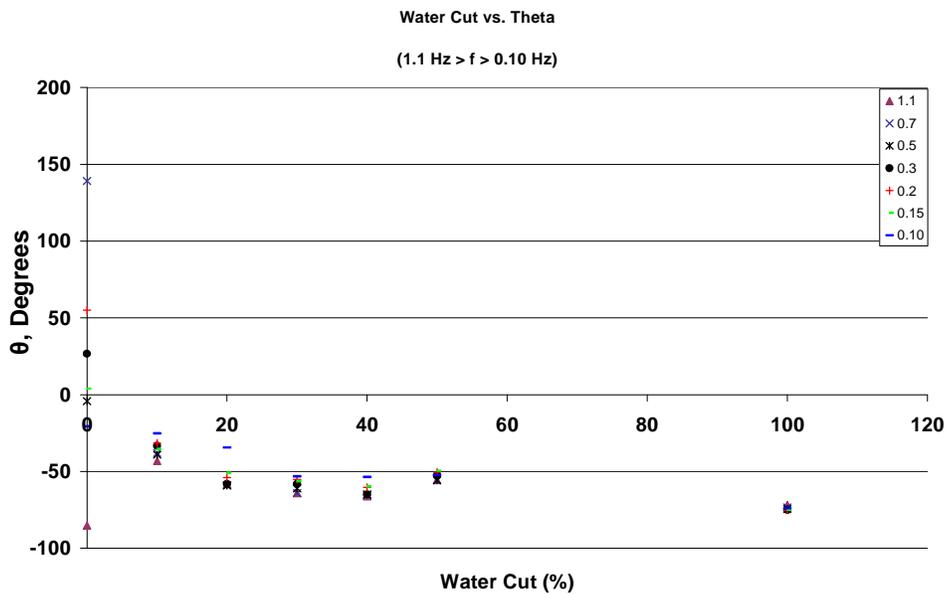
Figure 33. A plot of WC versus the phase angle (θ) in the frequency range 0.1 Hz to 1.1 Hz.

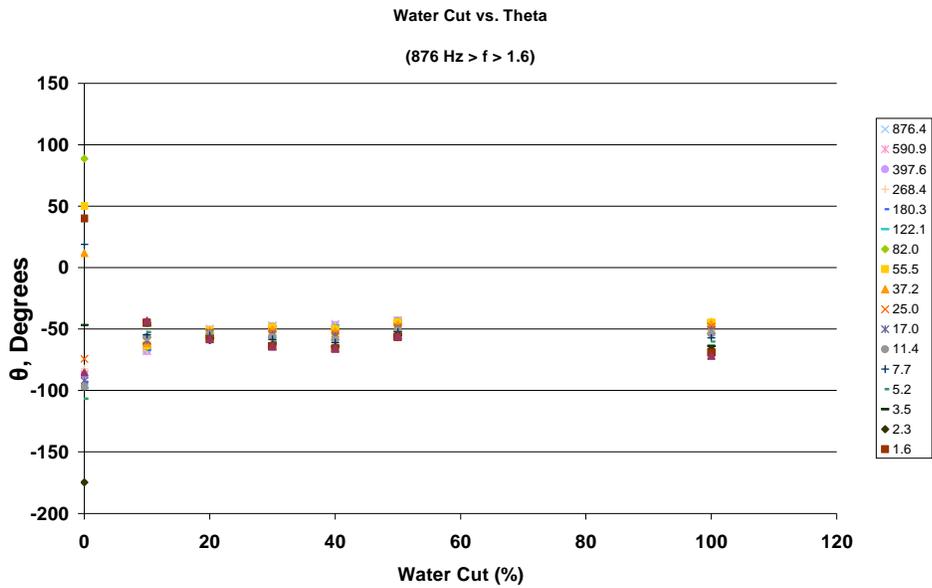
Figure 34. A plot of WC versus the phase angle (θ) in the frequency range 1.6 Hz to 876.4 Hz.

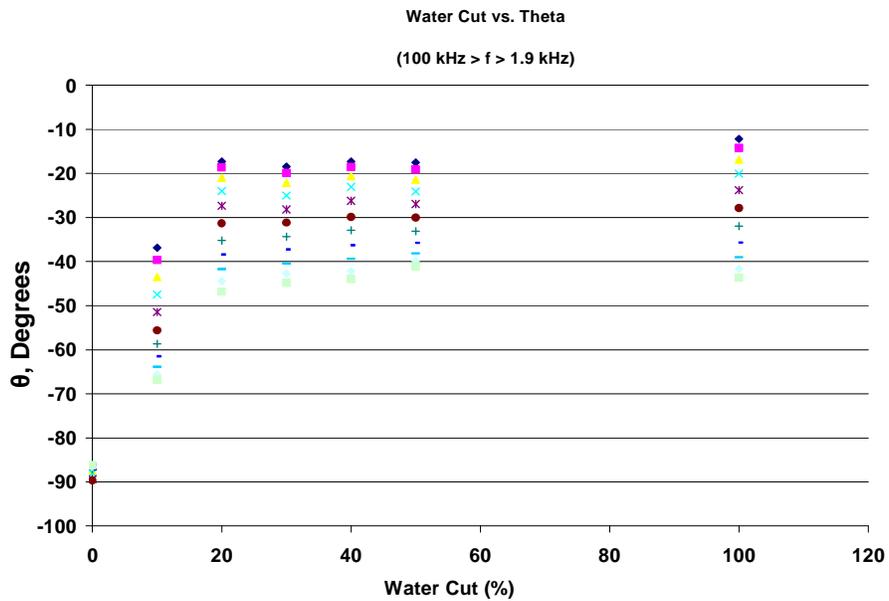
Figure 35. A plot of WC versus the phase angle (θ) in the frequency range 1933 Hz to 100 kHz.

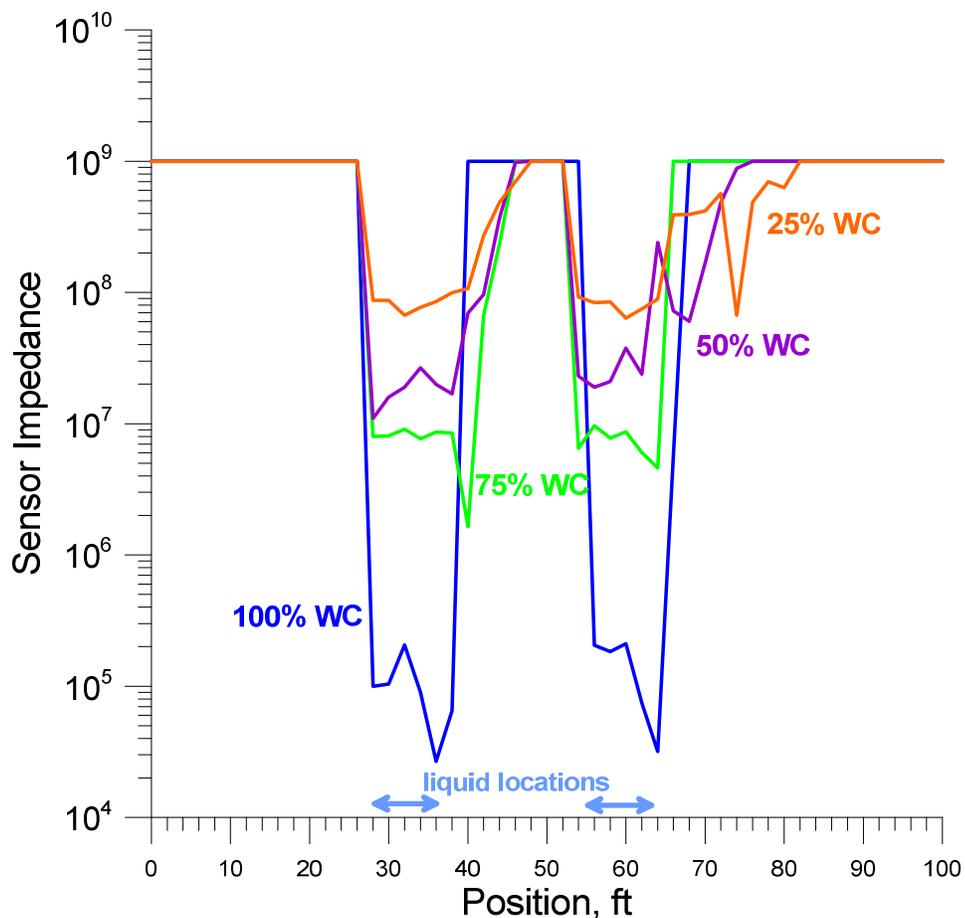
Figure 36. A plot of sensor impedance as a function of position in 100' test flow loop at different water cut levels.

Using the alternative pig ring-sensor design, a series of flow loop tests were conducted with different water cuts. The results are shown in Figure 36. From these results, it is clear that different WCs can be distinguished to at least 25% resolution. Furthermore, it is also evident that when liquid accumulation is at two different locations, these can be distinguished provided that the liquid volume is not so large that the pig is constantly pushing a puddle. In addition, it is also clear that some smearing and/or sluicing of entrained liquids occurs for some distance past the accumulation points before dissipating and thinning out. That is, once the pig encounters liquid this liquid is then pushed forward along the pipe. Due to lack of ovality or damage to the pig such that a tight seal is no longer maintained, the liquid becomes smeared out and thinned causing the sensor to detect the liquid beyond the end point of the accumulation.

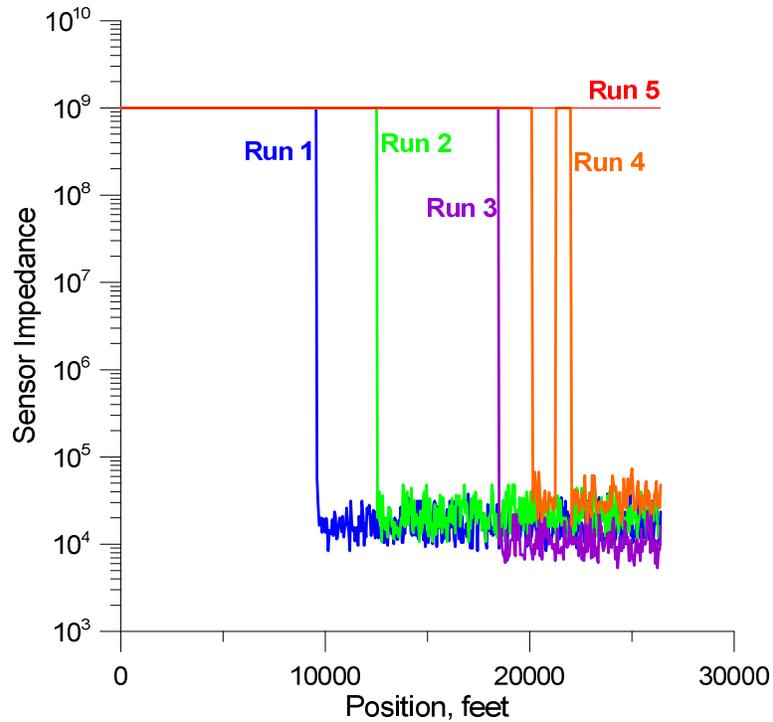
Figure 37. Sensor impedance measurements for an instrumented de-watering pig during subsequent pig runs.

A field trial using the pig-mounted ring-sensor was conducted in an operating side stream. The total pipeline length investigated was approximately five miles. The line was hydrotested as a part of the overall integrity management plan. After the hydrotesting, an instrumented de-watering pig was run through until no water was detected by the sensors. As shown in Figure 37, it took 5 pig runs to remove all the water. The first run encountered water approximately 9,600' and then continued to see water the rest of the distance as the pig pushed water out of the line. In the second run, water was encountered farther downstream than the first run at approximately 12,500'. Subsequently, the third and fourth runs also progressively showed the pig encountering water farther downstream. In the fifth run, no water was detected over the distance it was run. These results are very encouraging and demonstrate that the concept will work. As a result, Petrobras has entered into contract negotiations to conduct a long-length pipeline investigation using this technology as well as individual stand-alone sensors.
