# **SmartPark Technology Demonstration Project**

U.S. Department of Transportation  
**Federal Motor Carrier Safety Administration**

**October 2013**

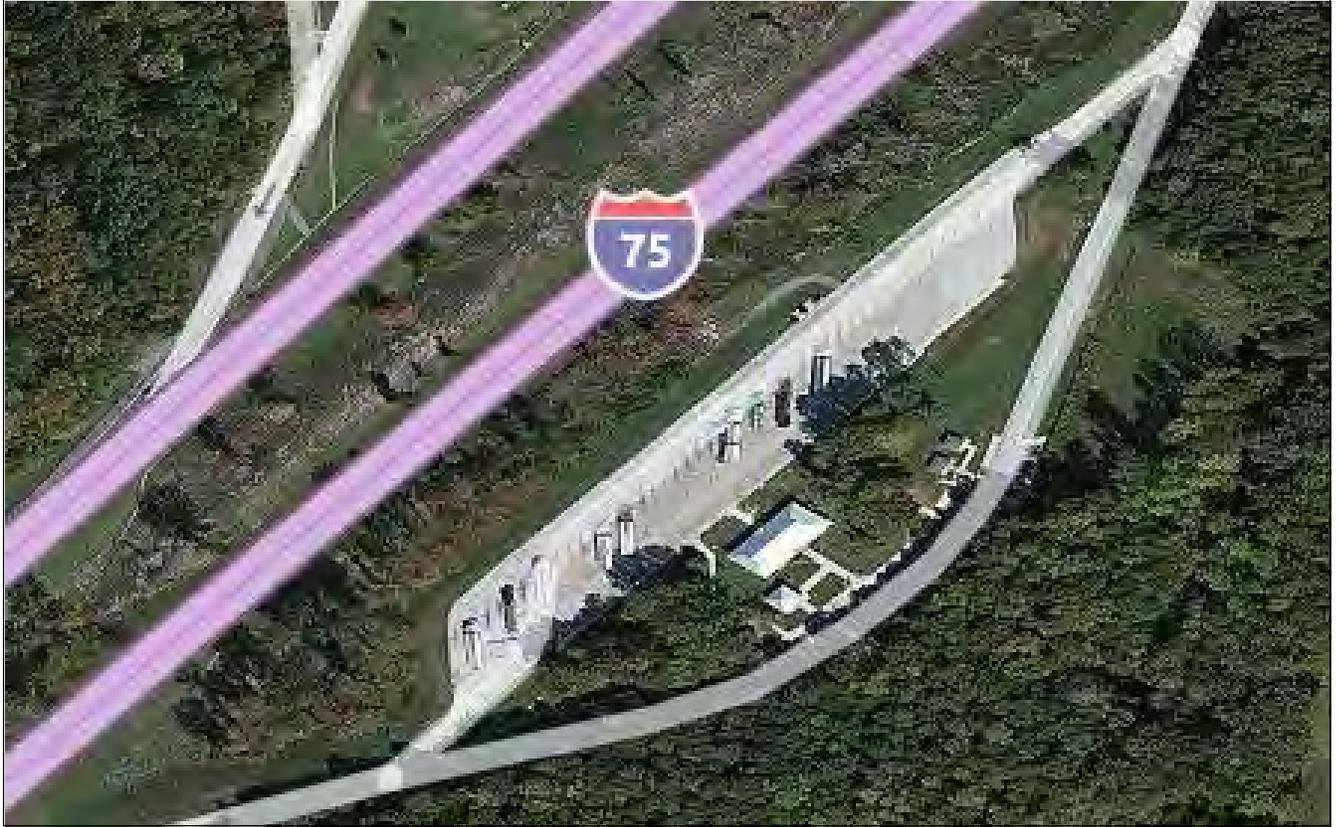
The site and most of its features are clearly visible in the satellite view provided in Figure 4. The two parking areas at the rest stop are visible in the image. The area to the right of rest stop building is for smaller vehicles only, while the truck parking area can be seen to the left and above the rest stop building and is the larger of the two parking areas.

**Figure 4. Photo. SmartPark Phase I test site aerial photograph.**

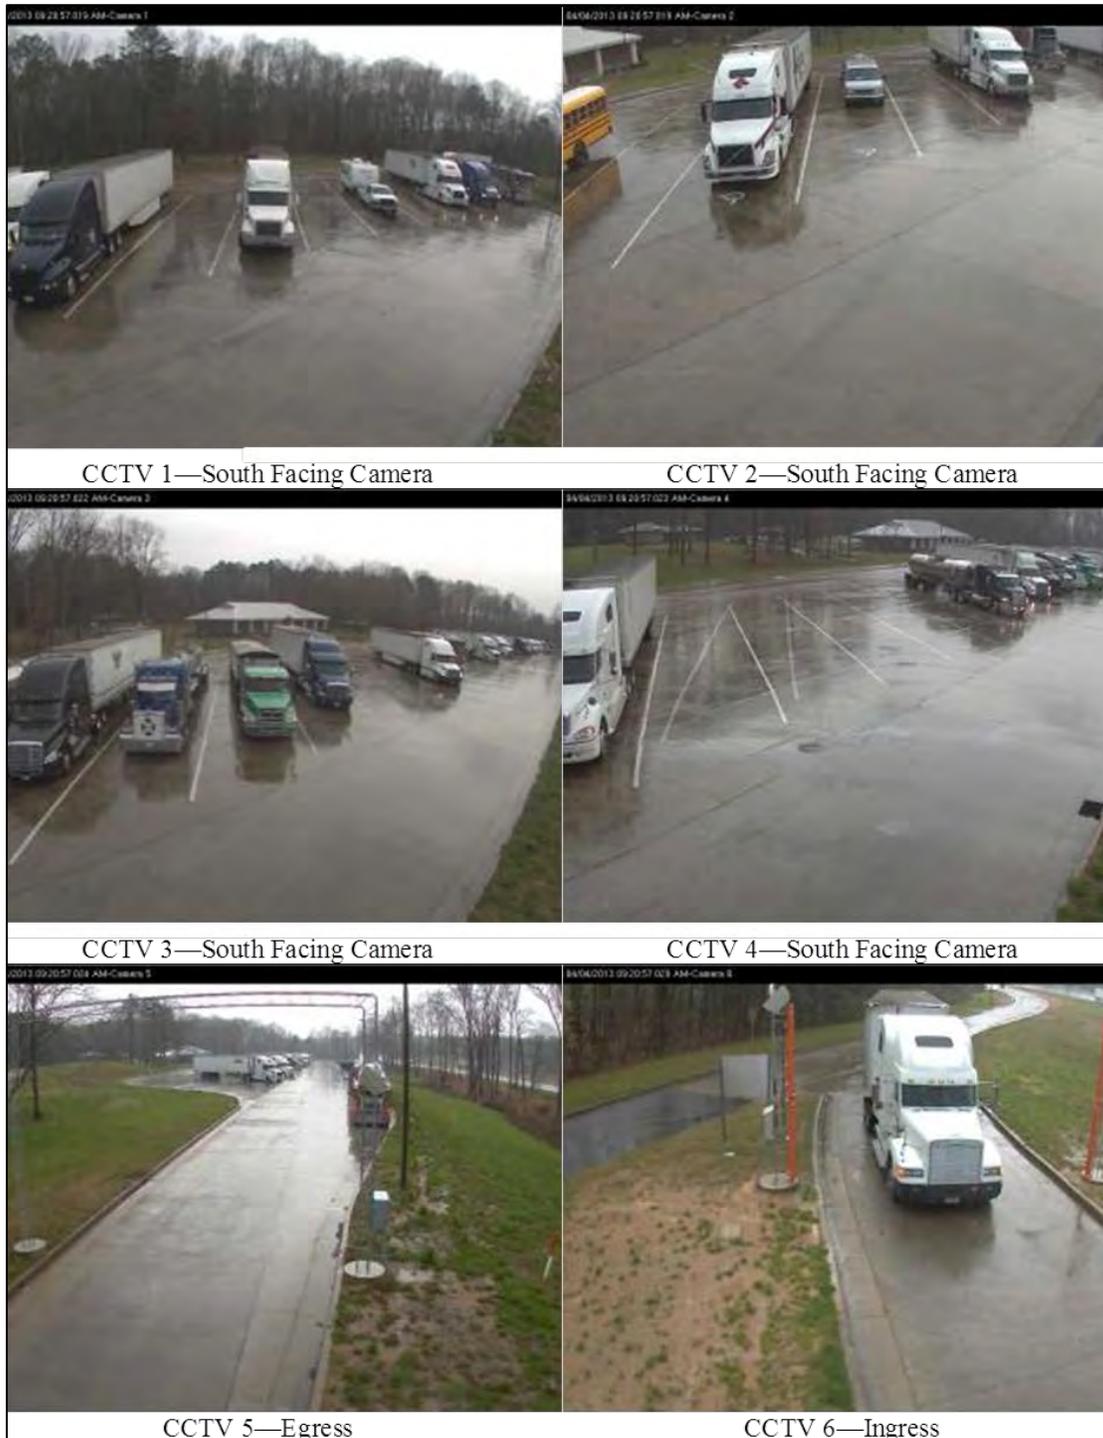
**Figure 12. Grouped photo. CCTV camera images for cameras 1–6.**

Each of the CCTV cameras was linked to the central server located onsite in the rest area equipment room. From this room, the cameras were viewable, one at a time, using the Internet and the project Web site. Viewing from the project Web site was limited to a single camera at a time due to bandwidth limitations. The field of view for each of the seven cameras is displayed through snapshots in Figure 12 and Figure 13.

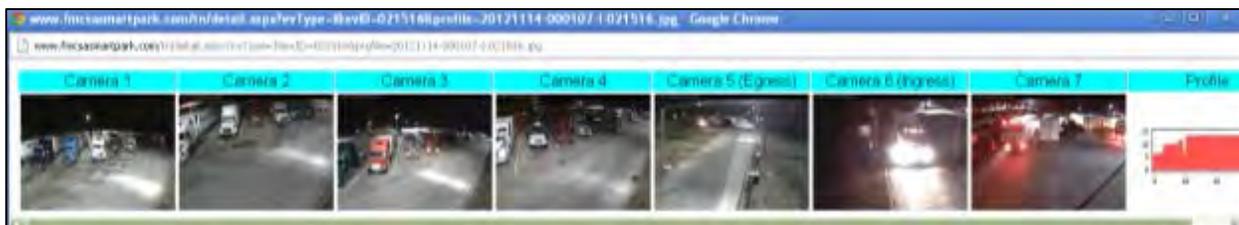
**Figure 16. Screenshot. Typical SmartPark database image catalog.**

The Web site has been uniquely configured to provide the project team with as much information as possible regarding each event (i.e., ingress or egress). A critical aspect of monitoring the system is the ability to observe any errors in parking space availability. The CCTV cameras utilized at the site provide viewing capability for real-time streaming and corrections. However, the CCTV cameras also capture still images of the entire project area every time an event occurs. These images are associated with the unique vehicle/event ID and are stored in the data retrieval database. They can be recalled by clicking on the profile image for a data retrieval entry. Using these still images, a user can view activity and occupancy within the lot and compare it to the vehicle count and availability as described by the system. This provides a unique method of reviewing historical accuracy, identifying errors encountered throughout the life of the system, and identifying the causes of system errors. Sample images of typical database images are displayed in Figure 16.
