FHWA-WY-13/04F

State of Wyoming
Department of Transportation

EVALUATION OF ASR POTENTIAL IN WYOMING AGGREGATES

October 2013

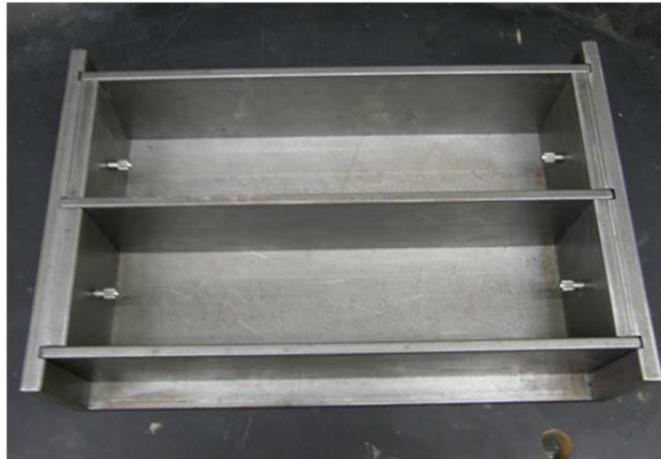
Figure 4. Mold for ASTM C1293 with four measurement pin inserts.

After the slump and air content were measured the concrete was placed in the ASTM C1293 molds (Figure 4) and in 102 x 203 mm (4 x 8 in.) cylinders for later compression testing. WD-40 was used as the debonding agent and was applied before the measurement gage studs were screwed into place to avoid weakening the bond between the studs and the concrete. Concrete was placed in the molds in two equal layers, and each layer was rodded 33 times. After the concrete was placed, the ends and corners of the molds were tapped with a rubber mallet to aid in the consolidation process. The surface of the mold was struck off flush and finished.

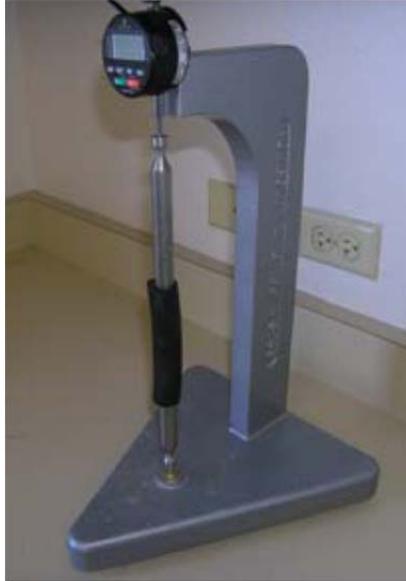
Figure 5. Length comparator with reference bar.

The specimen was placed in the comparator and then spun gently, and when the measurement settled on a number it was recorded. Each specimen was labeled with a name and an arrow to ensure that it was measured with the same end up every time. The specimens were measured at 1, 7, 28, and 56 days, and 3, 6, 9, and 12 months. After each measurement the specimens were stored with a different end facing up to limit alkali migration.

When the concrete had cured for 24 hours from the time that water was mixed with the cement, the CPT specimens were removed from their molds and measured using the comparator shown in Figure 5.

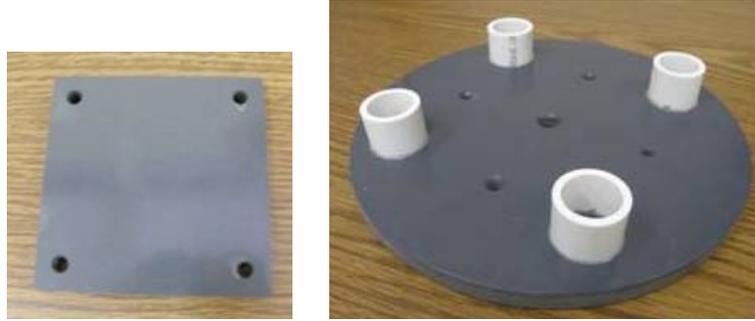
Figure 6. Top portion of rack (left) and bottom portion of rack shown upside-down (right).

The requirements for the storage environment are specified by ASTM C1293. In fulfillment of the standard, 1.01 kg (2.3 lbs) of water was added to each 18.9 liter (5 gallon) bucket to provide slightly less than 25.4 mm (1 inch) of water in the bottom. Wicking material, needed to aid in moving moisture throughout the storage container, was then placed around the edge of the bucket. A rack to elevate the specimens above the water was placed in the bucket which can be seen in Figure 6.

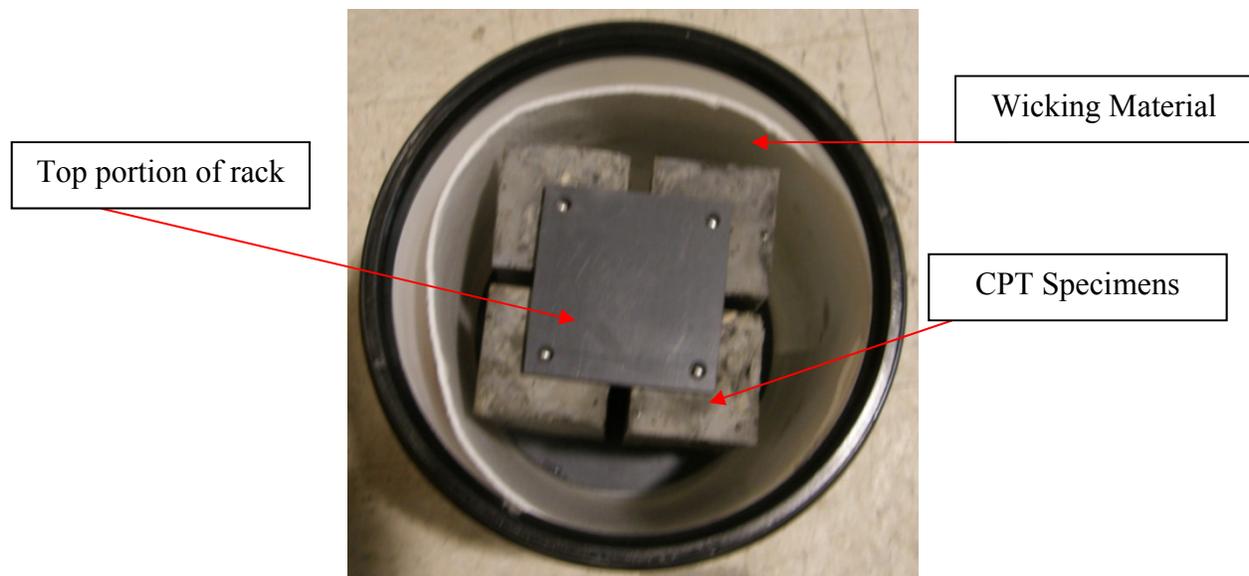
Figure 7. CPT storage environment without lid.

Once the specimens were placed on the rack, a top piece was added to ensure separation between them. The storage environment without the lid is shown in Figure 7.

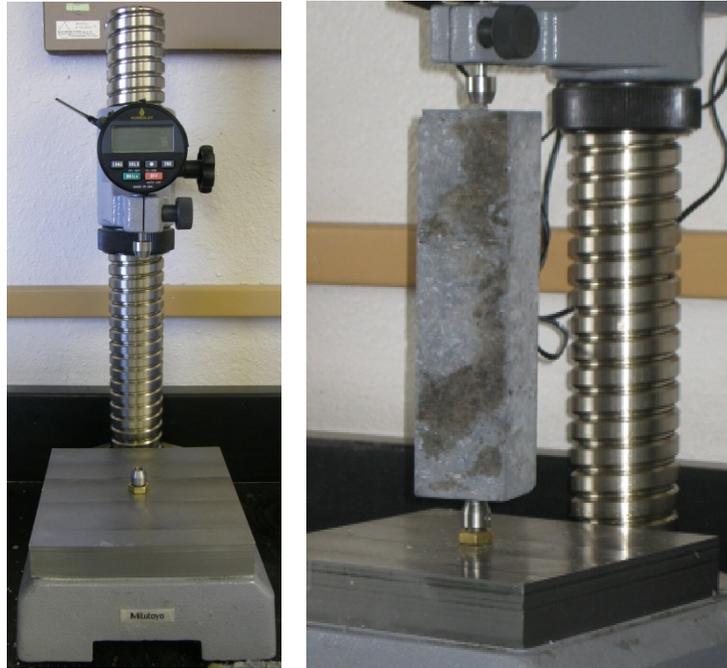
Figure 13. Length comparator setup (left) and specimen in measurement position (right).

To measure the length of a specimen, a single bar was removed from the container with silicone tipped tongs and toweled dry. Then it was placed in the length comparator (Figure 13) and spun gently.

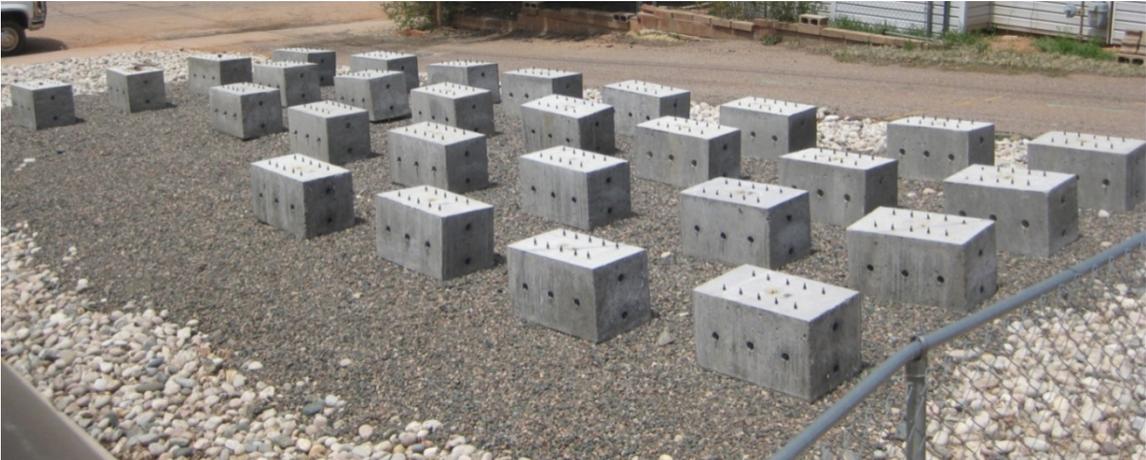
Figure 15. Outdoor exposure site.

An outdoor exposure site, shown in Figure 15, was constructed on a bed of 4 in. minus rock to coarsely level the area and ensure proper drainage, and 3/4 in. minus angular gravel was then placed on top of the rock for fine leveling. To date, a total of 28 field specimens have been transported to the site for outdoor exposure.

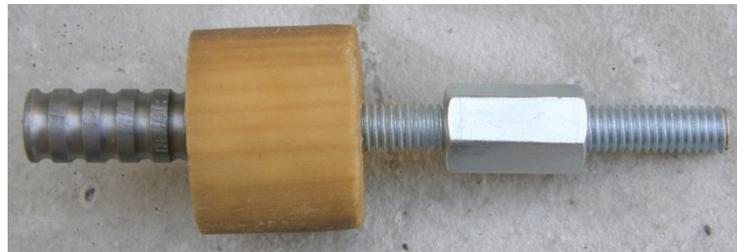
Figure 16. Threaded steel insert assembly.

Forms for the 380 x 380 x 660 mm (15 x 15 x 26 in.) specimens were constructed using standard lumber and plywood. The bottom, sides, and ends were all constructed separately to be assembled at the time of casting which allowed for efficient construction and stripping of the forms. Both inside corners and edges of the formwork were caulked to prevent moisture loss during curing, and a debonding agent was sprayed on the inside of the form. To secure the measurement studs into the concrete block, a threaded steel insert assembly was bolted to the inside of the form after the debonding agent was applied to ensure a good bond between the insert and the concrete. This assembly (Figure 16) consisted of the steel insert, a threaded rod, a wooden spacer, and a nut. The insert and the wooden spacer were placed on the inside of the forms and the nut was placed on the outside as shown in Figure 17. Ten of these assemblies were installed in the forms: three on each side and two on each end.

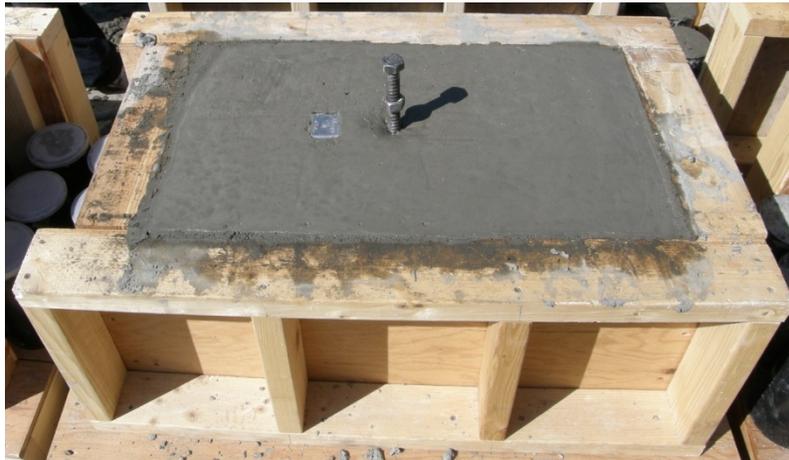
Figure 18. Field specimen immediately after casting.

consolidated using an internal concrete vibrator, paying special attention to ensure that the concrete was completely consolidated near the corners of the form and around the insert assemblies. When enough concrete had been placed in the form the top was struck off flat and then finished with a magnesium float. An aluminum name plate, a steel lifting insert, and the top measurement pins (except for pins that were installed by drilling after the concrete cured) were installed in the concrete. The specimens were then covered with plastic to limit the moisture loss during curing. A field specimen after casting is shown in Figure 18 before measurement pins are installed and before the block is covered with plastic for curing.

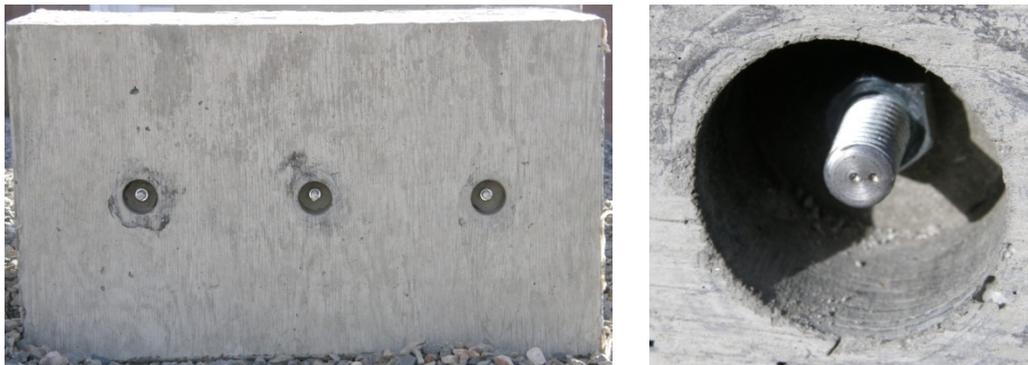
Figure 20. Side of field specimen (left) and close up of installed measurement stud (right).

To install the side measurement studs into the field specimens the studs were screwed into the threaded steel inserts that were cast into the block. The orientation of the stud was critical due to its effect on the location of the drilled offset hole. To control this orientation, a hex nut was screwed onto the stud before the stud was installed in the block. Once the stud was screwed into the threaded insert and the orientation of the offset hole was chosen, the hex nut was tightened against the block to lock the stud orientation in place. It was helpful to use a hollow socket when tightening the hex nut so the location of the offset hole could be monitored. An example of the installed measurement stud can be seen in Figure 20.

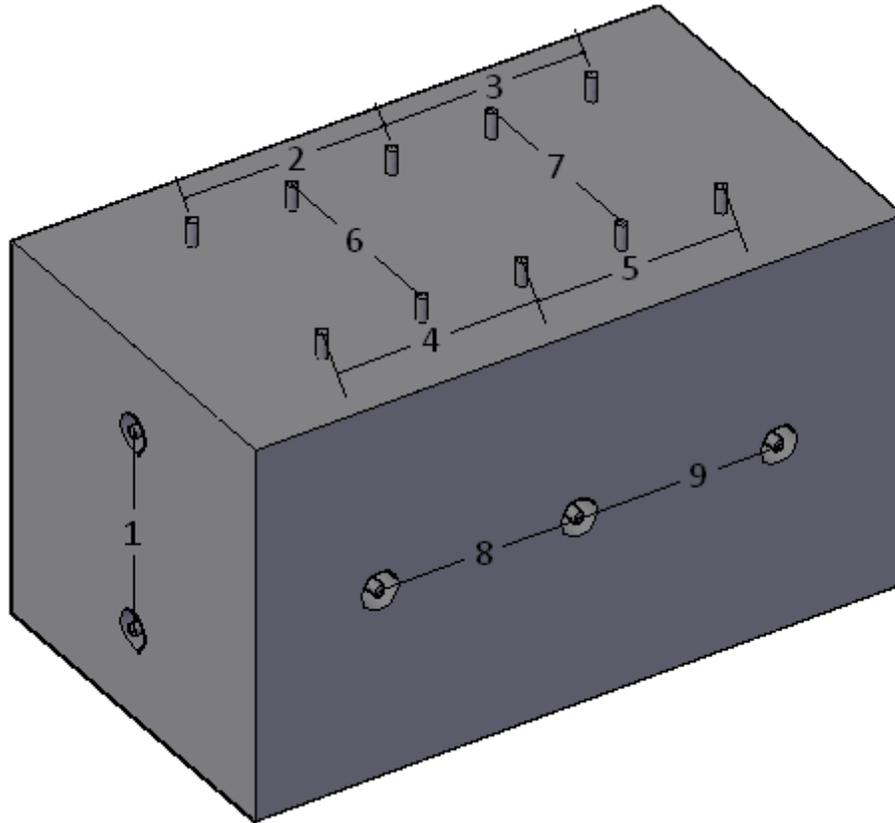
Figure 21. Field specimen diagram showing the layout of the measurement locations.

To monitor the expansion, twelve locations on each block were measured. There were four longitudinal measurements on the top, and two longitudinal measurements along each side. In addition, there were two transverse measurements on top and one vertical measurement on each end. All measurements had an approximate gage length of 203.2 mm (8 in.). Figure 21 shows the typical measurement location layout for each field specimen where 9 of the 12 measurements are shown.

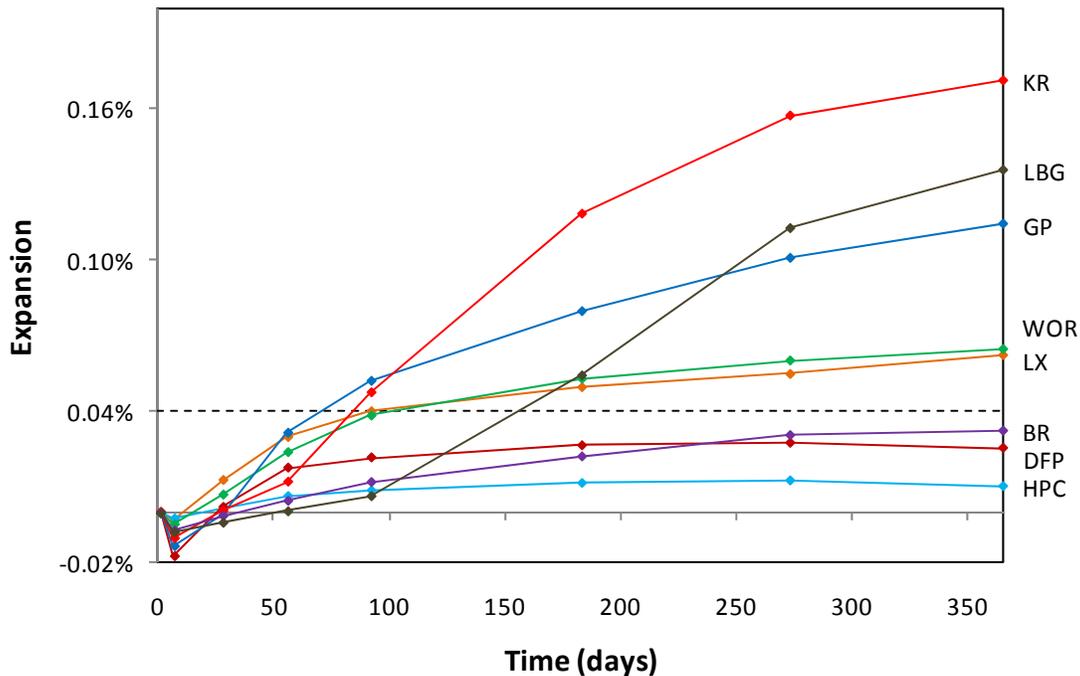
Figure 26. Average expansion for eight aggregates subjected to the CPT.

The average measured expansions of the concrete prisms cast with each aggregate are presented in Figure 26. Figure 27 illustrates the average one year expansion with error bars showing \pm one standard deviation. Complete coefficient of variation data is given in Appendix C.

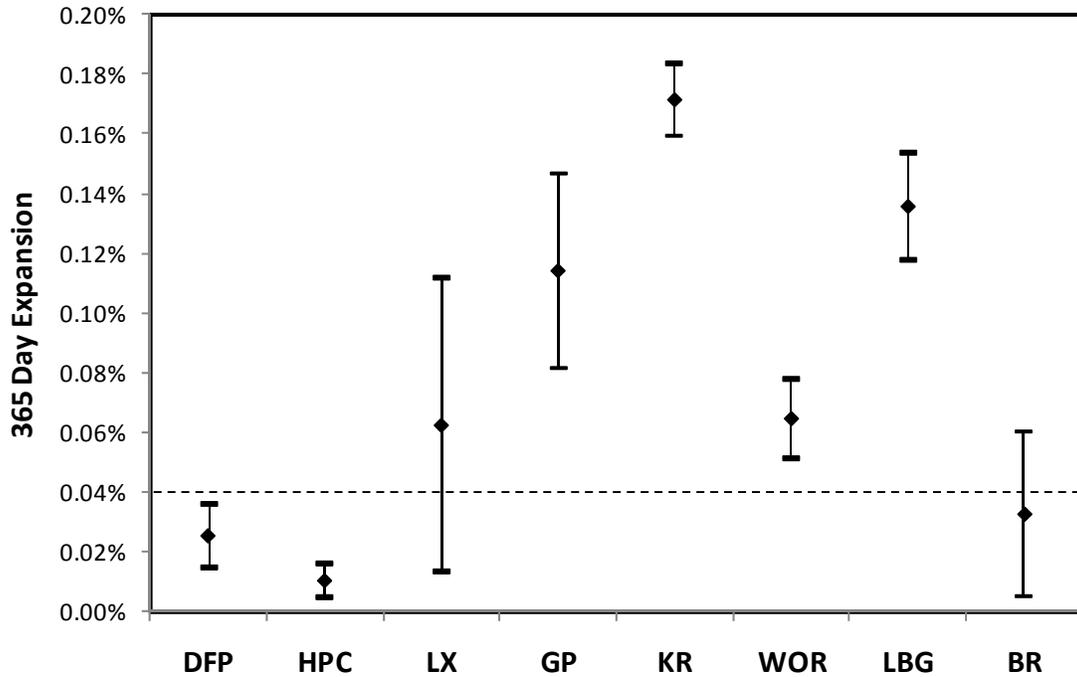
Figure 27. Average one year expansion in the CPT with error bars showing standard deviation.

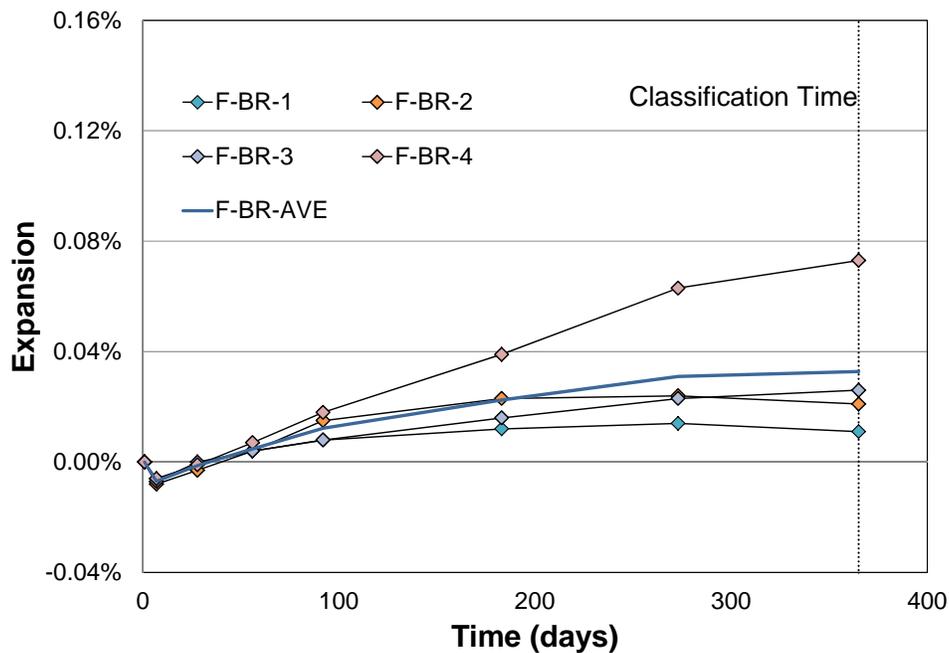
Figure 28. ASTM C 1293 Black Rock Test Results (Fertig 2008).

A summary of the original Black Rock data is illustrated in Figure 28 and the average is indicated by a solid blue line without markers. Although, the average expansion of all four Black Rock specimens was below the ASTM limit, one specimen had over twice the measured expansion of the other three specimens cast at the same time. Because this one specimen exceeded the ASTM limit by a factor of 1.8, additional testing was conducted.

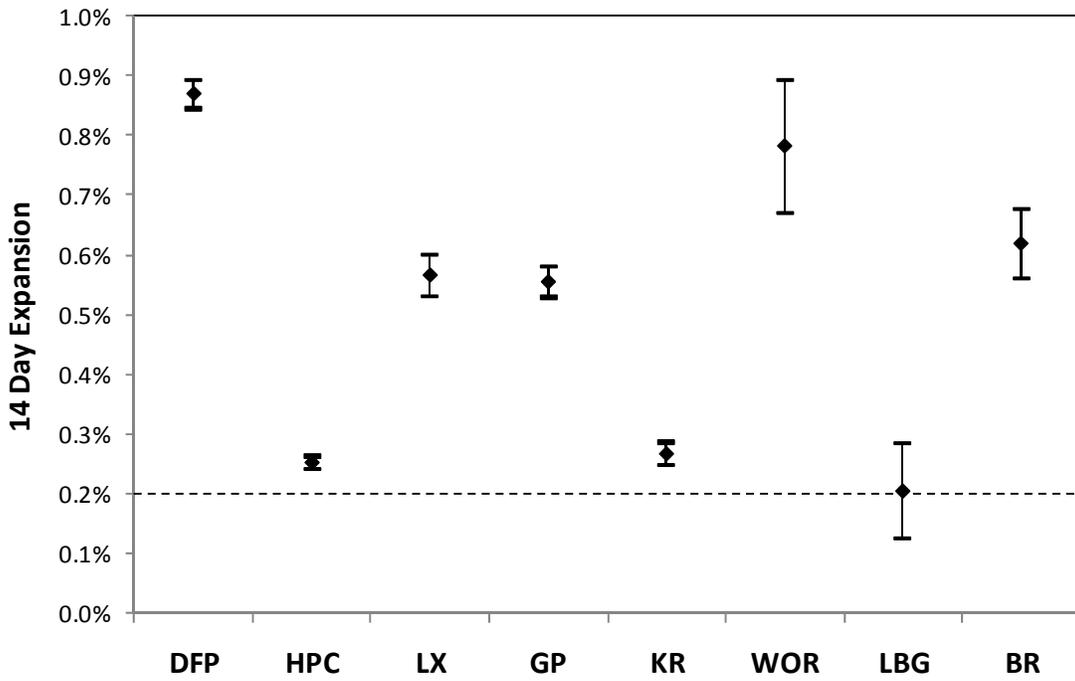
Figure 31. Average 14 day expansion in the AMBT with error bars showing standard deviation.

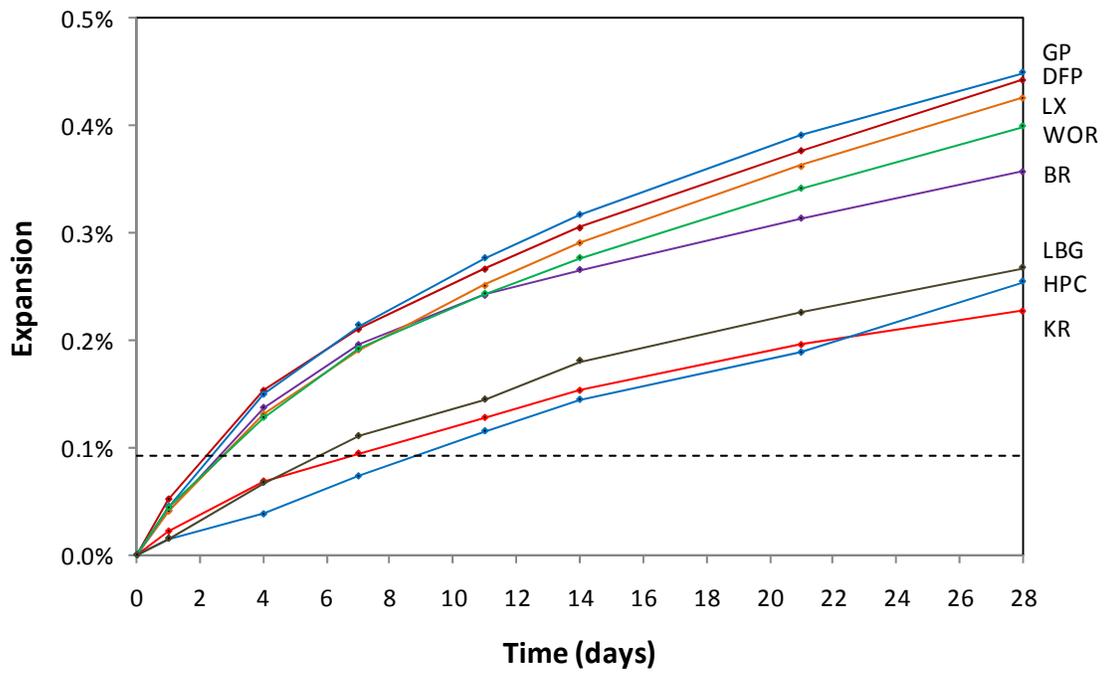
Figure 33. Average expansions for eight aggregates subjected to the modified CAMBT.

The average expansions of all the mortar bars cast with each aggregate are shown in Figure 33. The average 14 day expansion is shown in Figure 34 with error bars designating plus or minus one standard deviation.

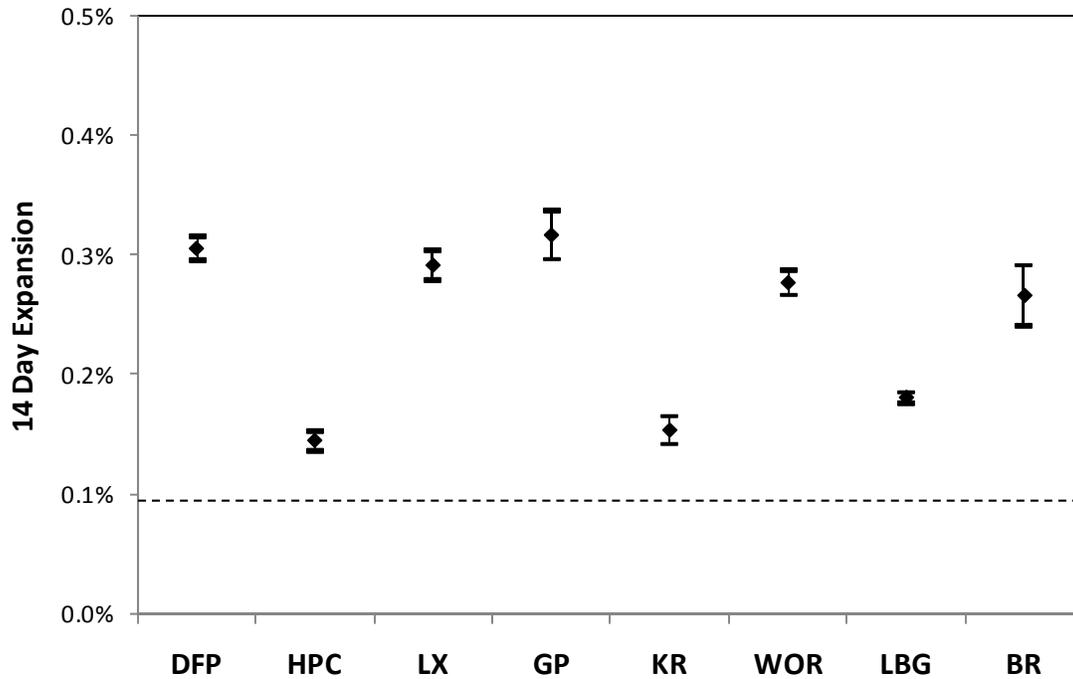
Figure 34. Average 14 day expansion in the CAMBT with error bars showing standard deviation.

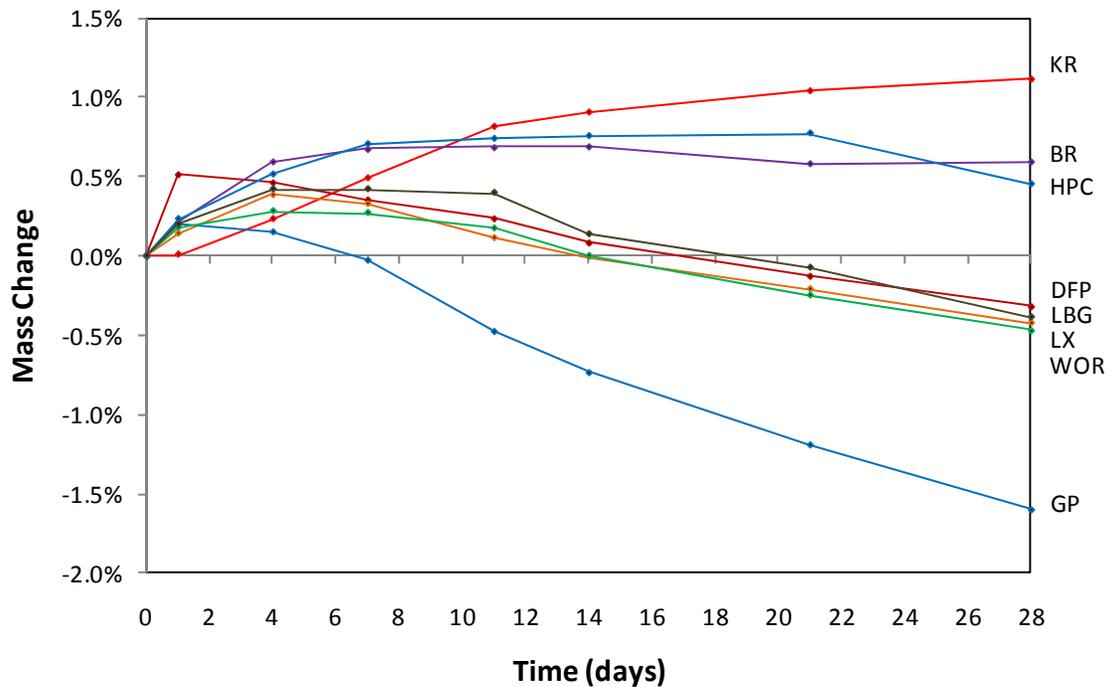
Figure 35. Average mass changes for eight aggregates subjected to the modified CAMBT.

The mass change data is presented in Figure 35, and although the curves are slightly more erratic than the expansion data, there are two distinct mass signatures.

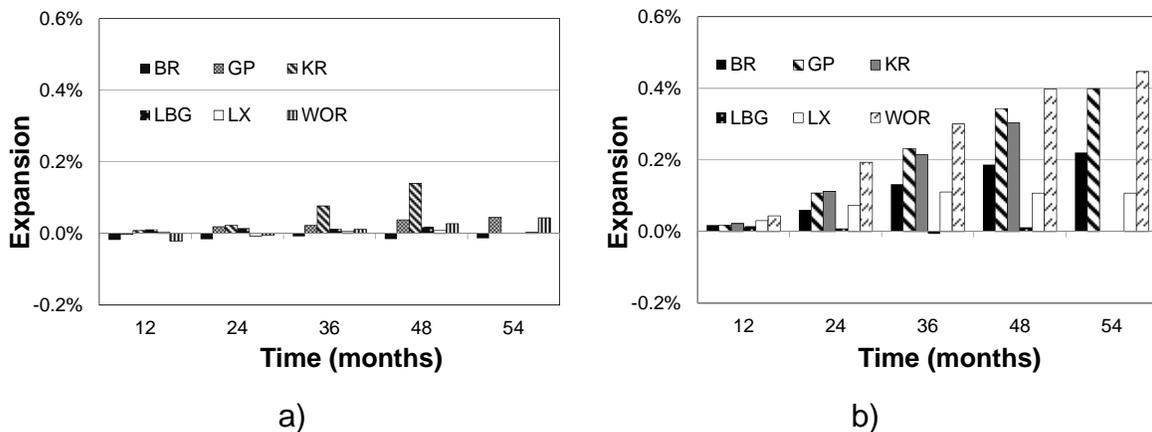
Figure 36. Potentially Reactive Aggregates – a) Unboosted b) Boosted.

Potentially reactive aggregates have greater expansions. In Figure 36, boosted expansions are consistently higher than unboosted. Classifications are based on the unboosted state. All specimens will continue to be monitored.

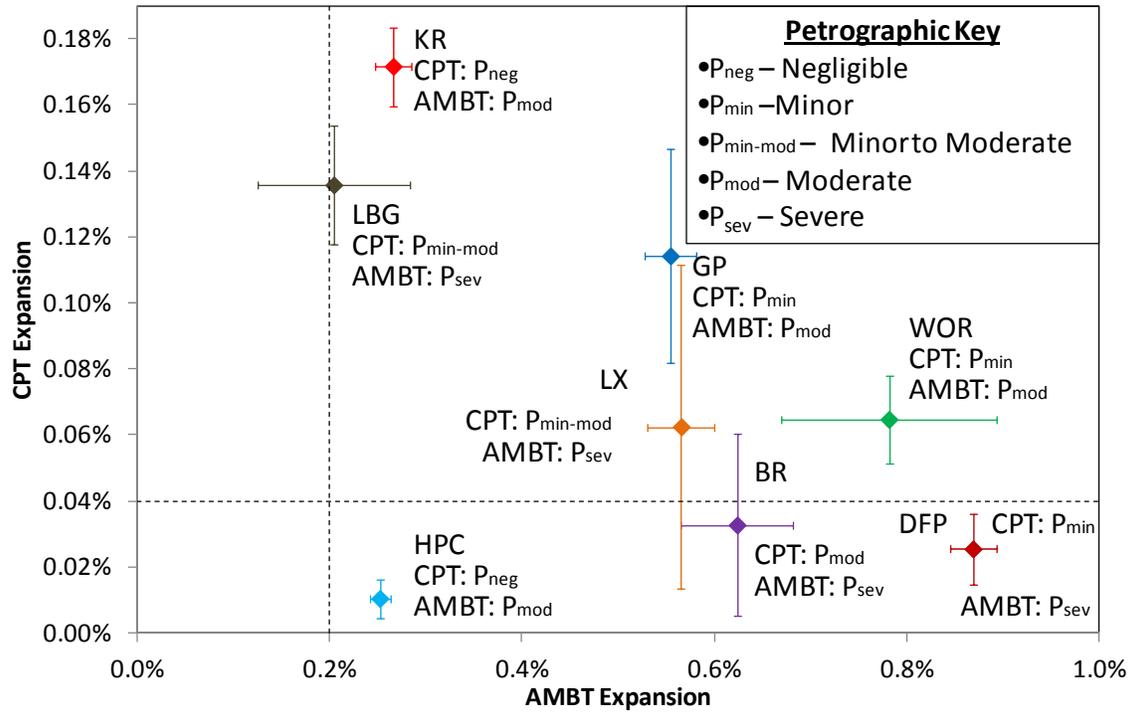
Figure 38. Comparison of the CPT and the AMBT expansions with error bars for each aggregate.

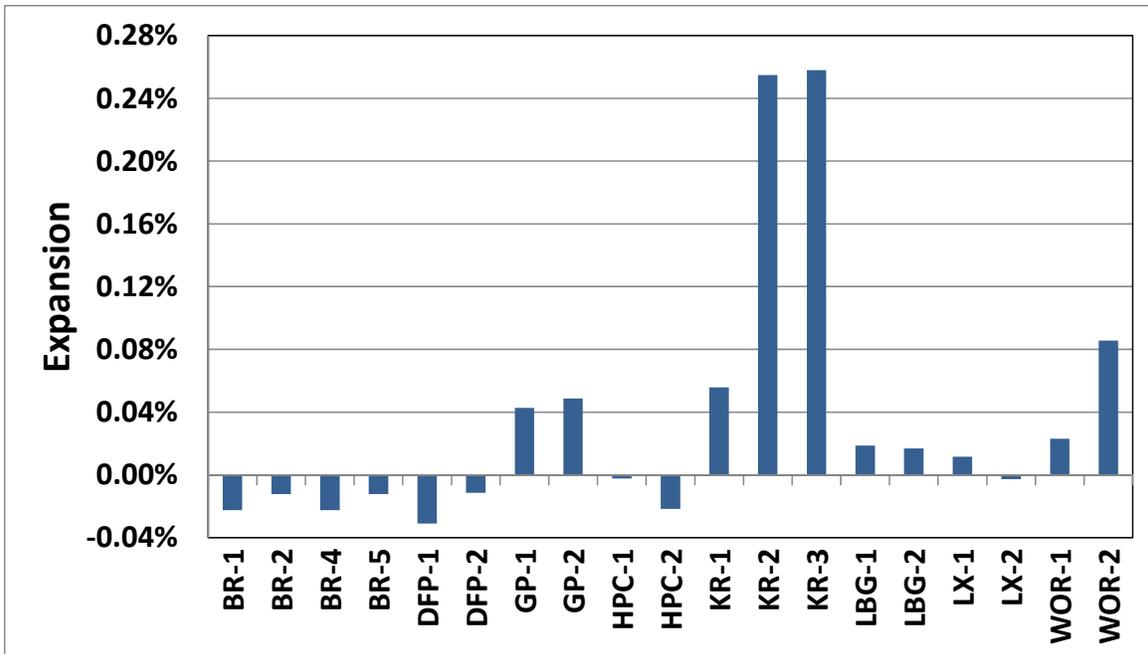
Figure 41. Expansion to date of unboosted field specimens.

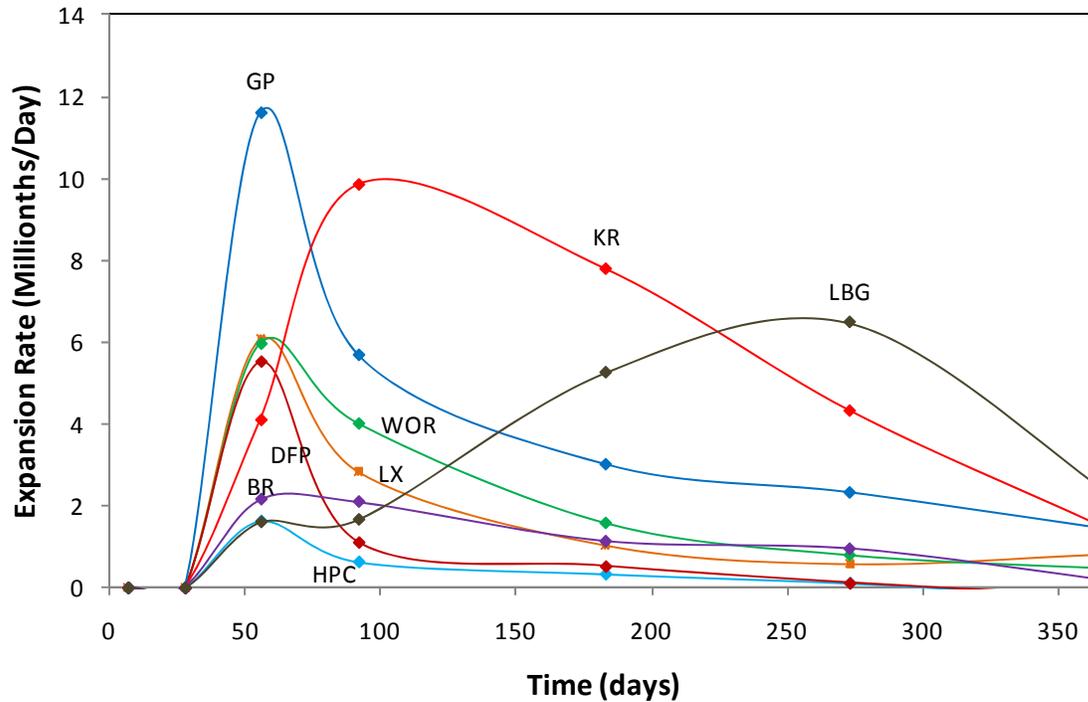
Figure 42. Expansion rates for eight aggregates subjected to the CPT.

The research team knows of few studies related to rate of reaction. As a result, rate calculations and comments are presented herein. Although the CPT reactivity classification is based solely on the total expansion at one year, the behavior of the aggregates during the course of the test can also offer valuable information. Figure 42 shows the expansion rates for the tested aggregates, neglecting the expansion behavior before day 28 because of the variability associated with the CTE that resulted in negative expansion values for this period. Smooth lines were used in the plot to aid in readability, but they are not meant to represent any assumptions made about the data. The vertical axis represents the instantaneous expansion rate, given in units of relative expansion times 10^6 per day.

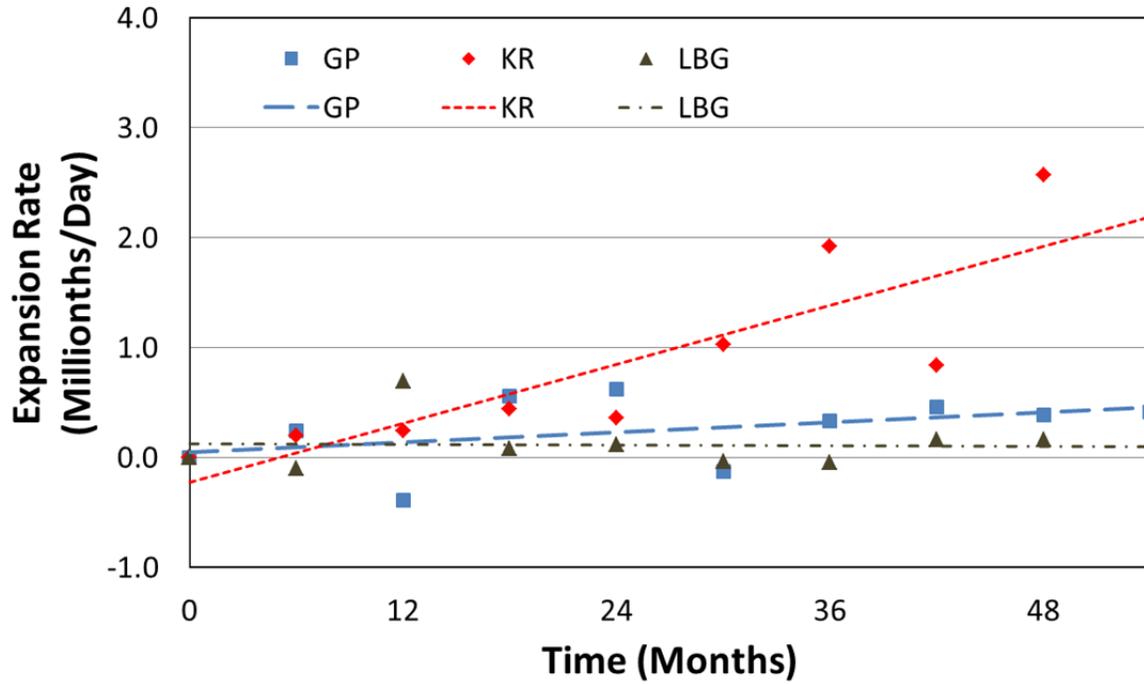
Figure 43. Rate of expansion for unboosted field specimens.

Because GP, KR and LBG may be slowly reacting aggregates based on CPT expansions, a similar analysis was performed for field specimen expansions. The rate of change of expansion is illustrated in Figure 43. Positive trend lines indicate that the specimens are continuing to expand. The research team will continue to monitor this data.

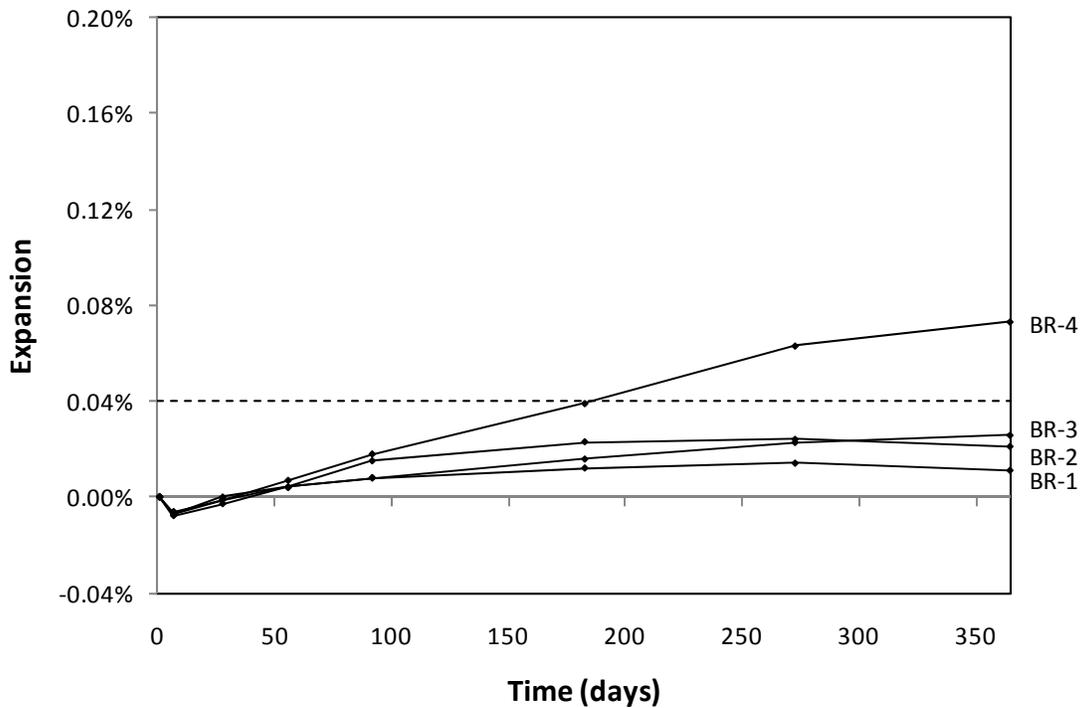
Figure 47. ASTM C1293 results for Blackrock aggregate.

Figure 47 shows the concrete prism expansion with respect to time.

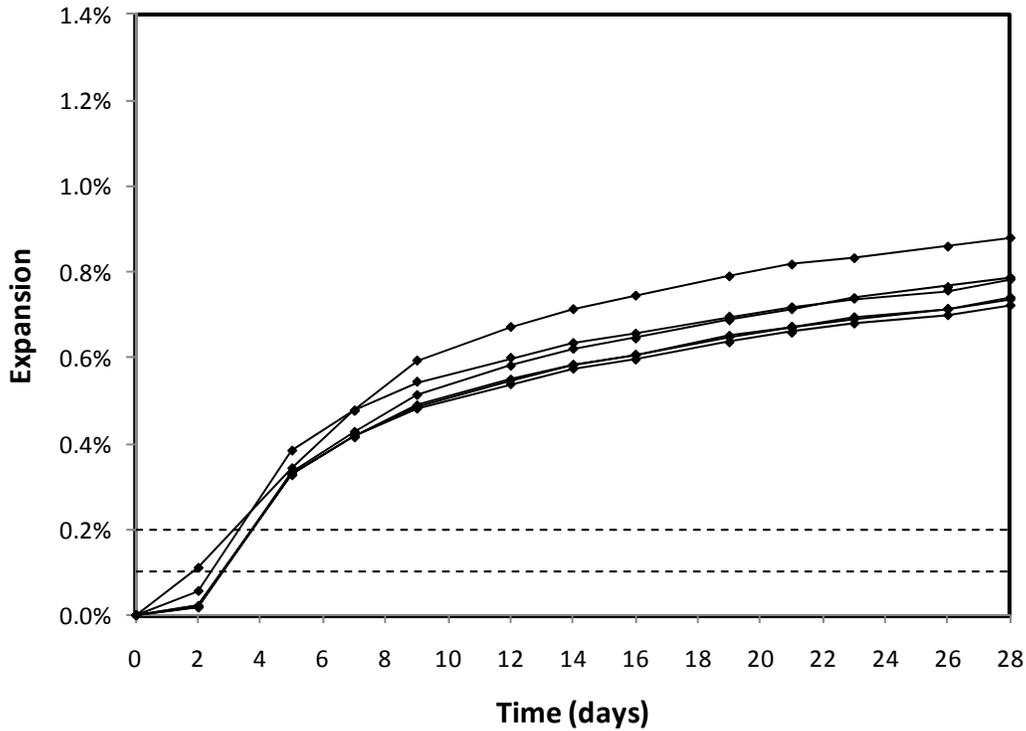
Figure 49. ASTM C1260 average Blackrock mortar bar expansion.

The average expansions for the three mortar bars in each set are shown in Figure 49.

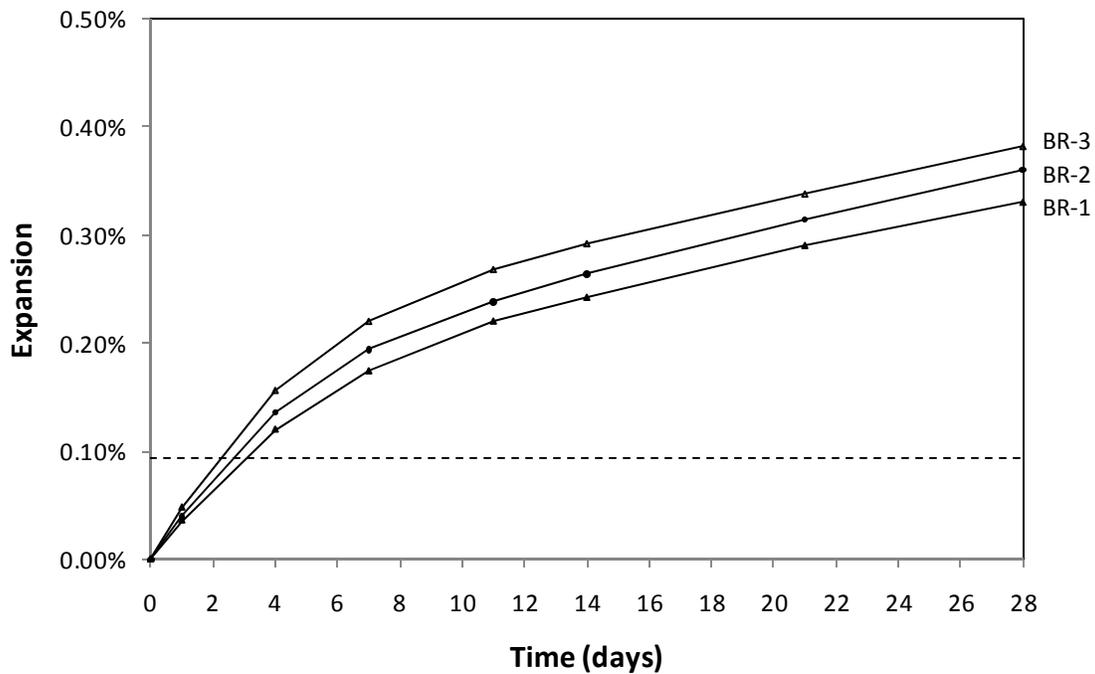
Figure 51. Modified CAMBT mortar bar expansion for Blackrock.

There was excellent agreement among the expansions of all three mortar bars which can be seen in Figure 51.

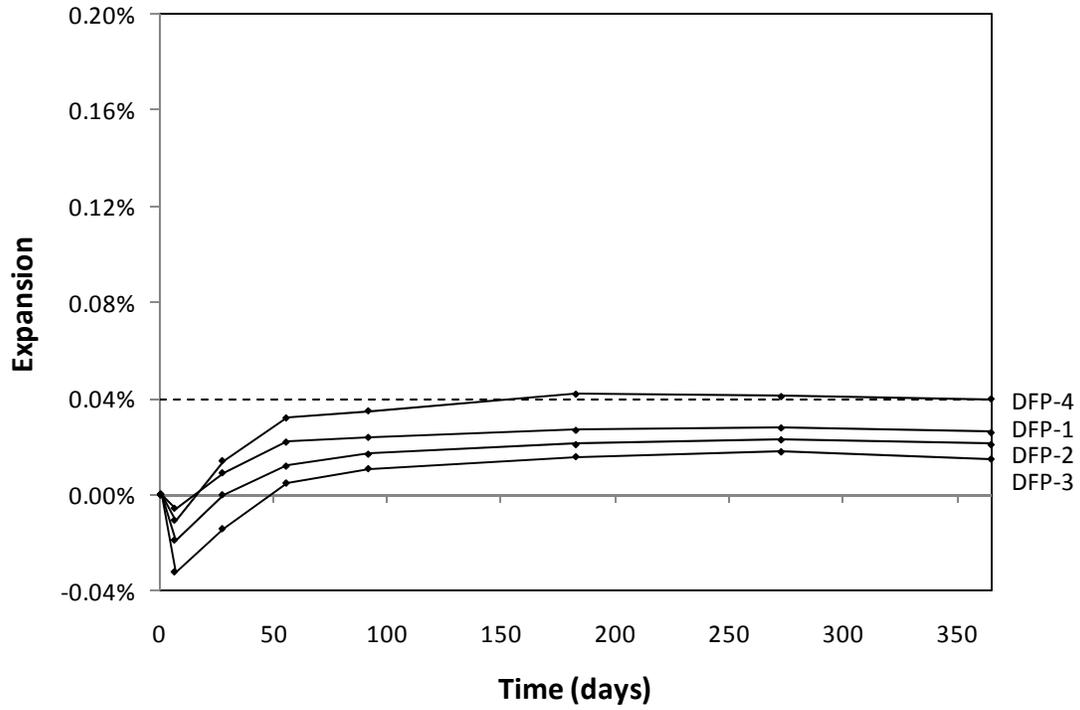
Figure 53. ASTM C1293 results for Devries Farm aggregate.

The figure below shows specimen expansion with respect to time.

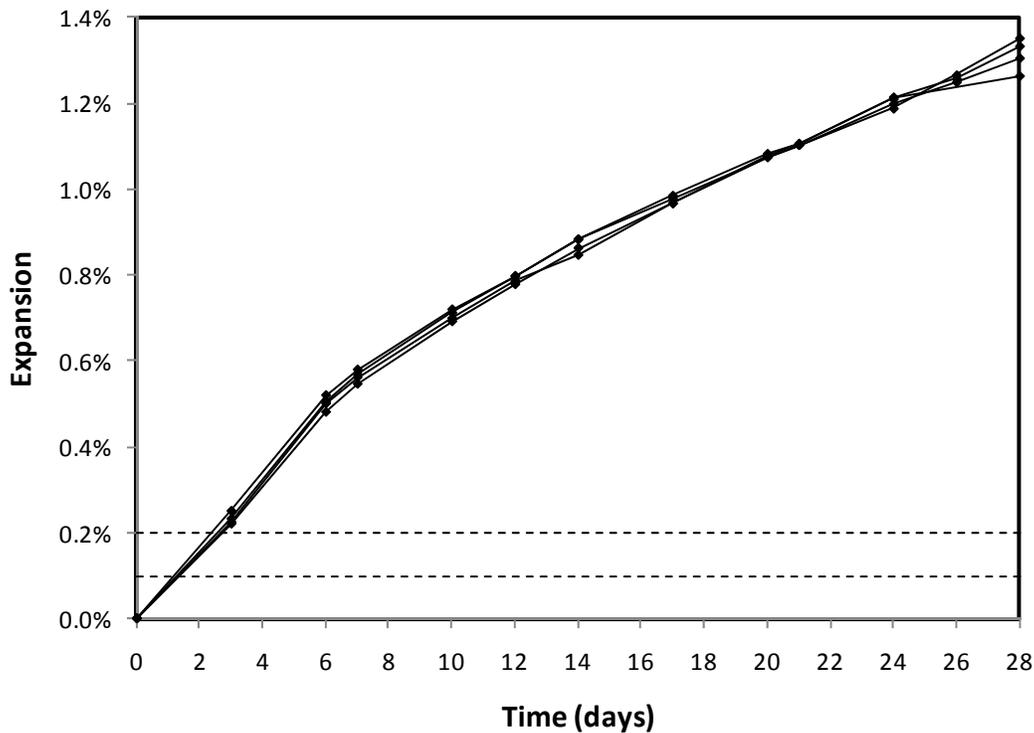
Figure 54. ASTM C1260 average Devries Farm mortar bar expansion.

The average expansions for the three mortar bars in each set are shown in Figure 54. As can be seen from the graph, there was good correlation between all sets of mortar bars.

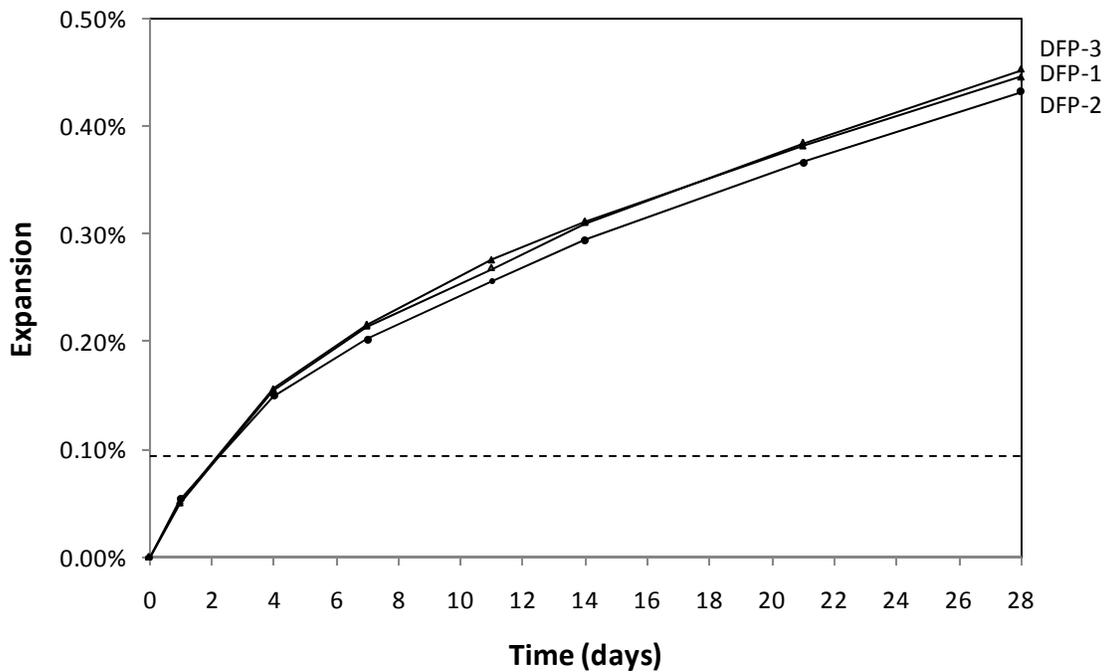
Figure 56. CAMBT Mortar bar expansion for Devries Farm.

There was excellent agreement among the expansions of all three mortar bars. The graph of their expansions can be seen in Figure 56.

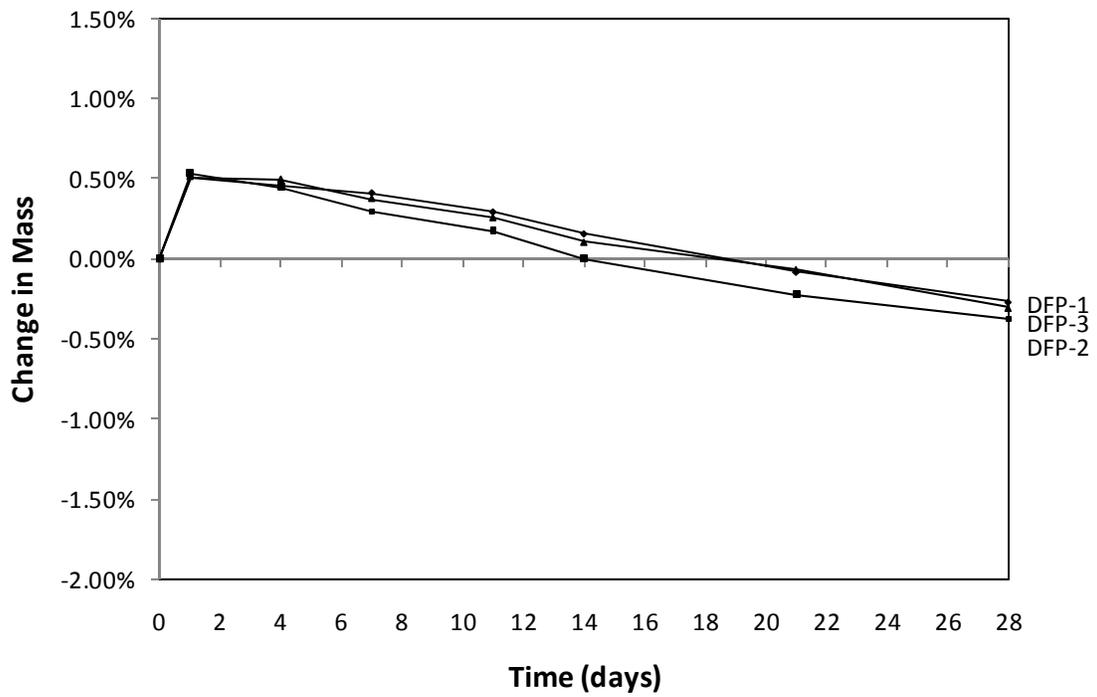
Figure 57. Mass change (%) for Devries Farm mortar bars in the modified CAMBT.

Figure 57 shows that the mass of the bars increased only during the first day in the NaOH solution and then declined steadily. At the end of 28 days the mass of the specimens were 0.3 to 0.4 percent less than when they entered the NaOH solution.

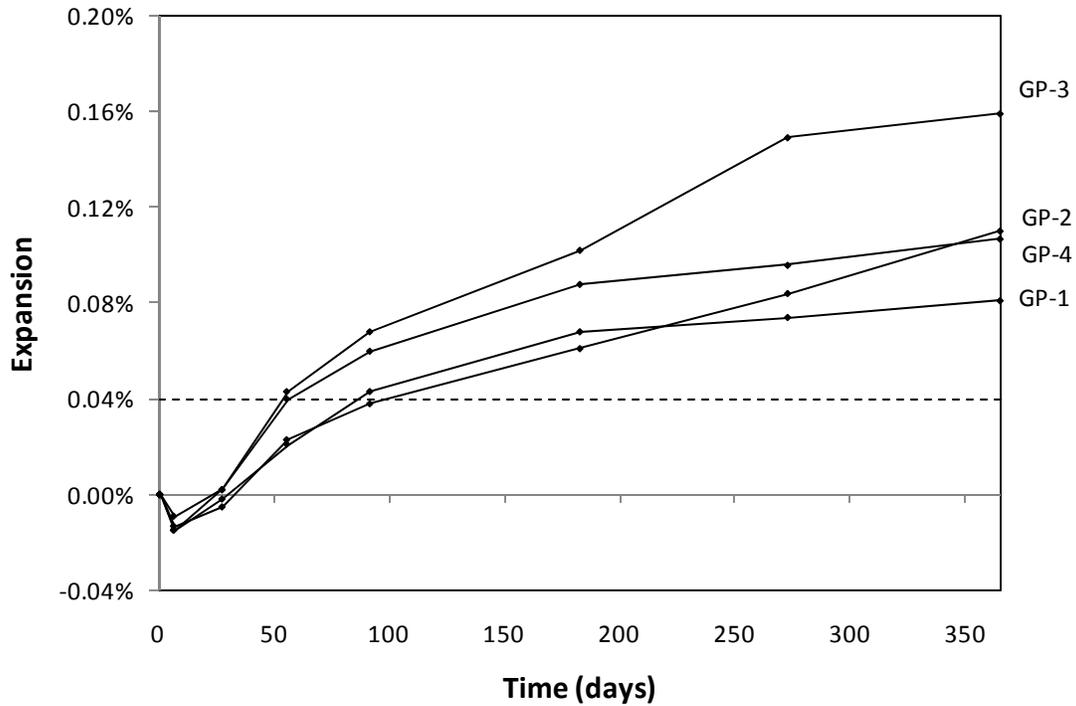
Figure 59. ASTM C1293 results for Goton aggregate.

The expansion curves for the Goton specimens are more spread out than other aggregate specimens as can be seen in the figure below.

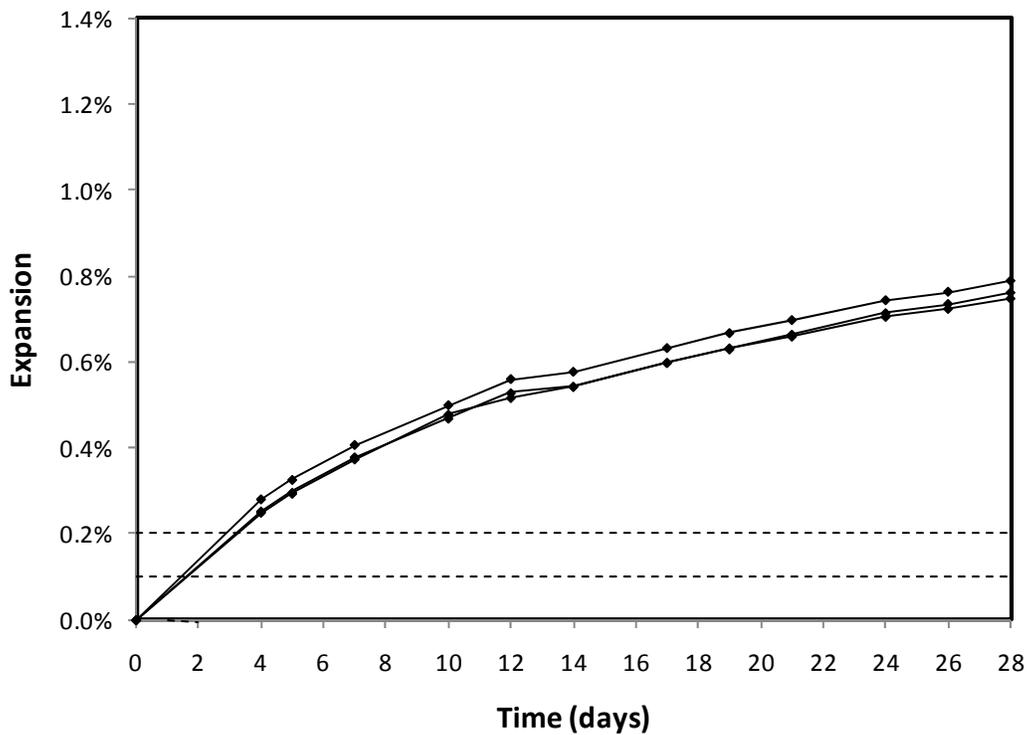
Figure 60. ASTM C1260 average Goton mortar bar expansion.

The average expansions for the three mortar bars in each set are shown in Figure 60. As can be seen from the graph, expansion data correlated well in all sets of mortar bars.
