FHWA-WY-13/04F

State of Wyoming
Department of Transportation

EVALUATION OF ASR POTENTIAL IN WYOMING AGGREGATES

October 2013

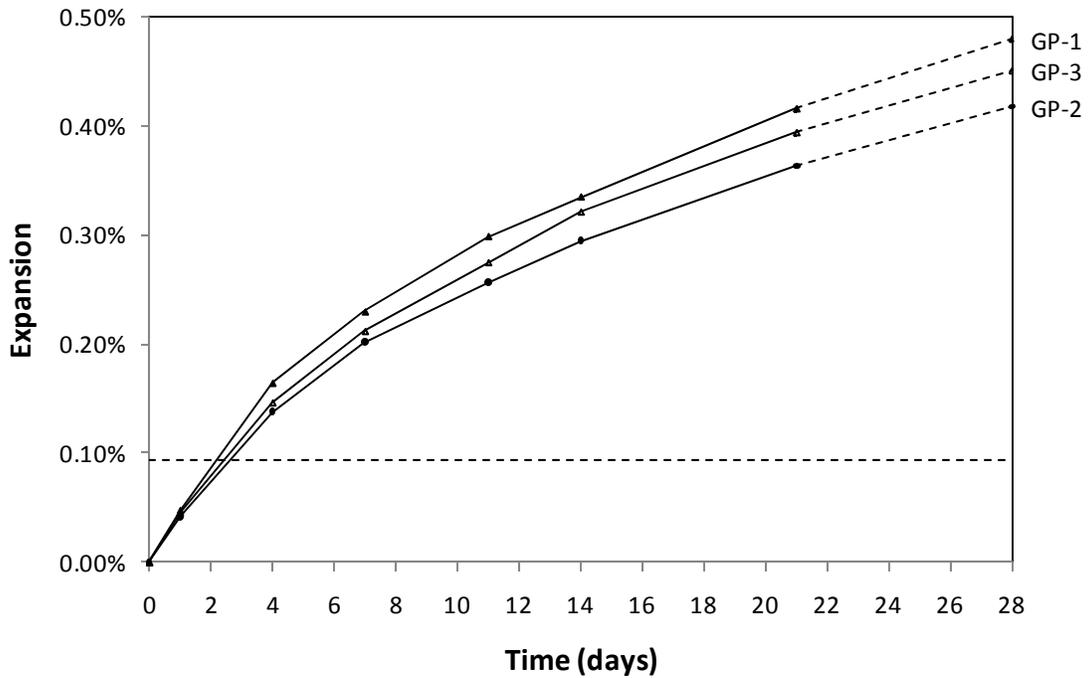
Figure 62. CAMBT Mortar bar expansion for Goton.

Measurement was stopped at day 21 for this test, so the 28 day values shown for expansion and mass change (Figure 63) are linear extrapolations of the previous data with some decay included. The accuracy of these extrapolations does not affect the reliability of the test because aggregates are evaluated at day 14. The graph of the mortar bar expansions can be seen in Figure 62.

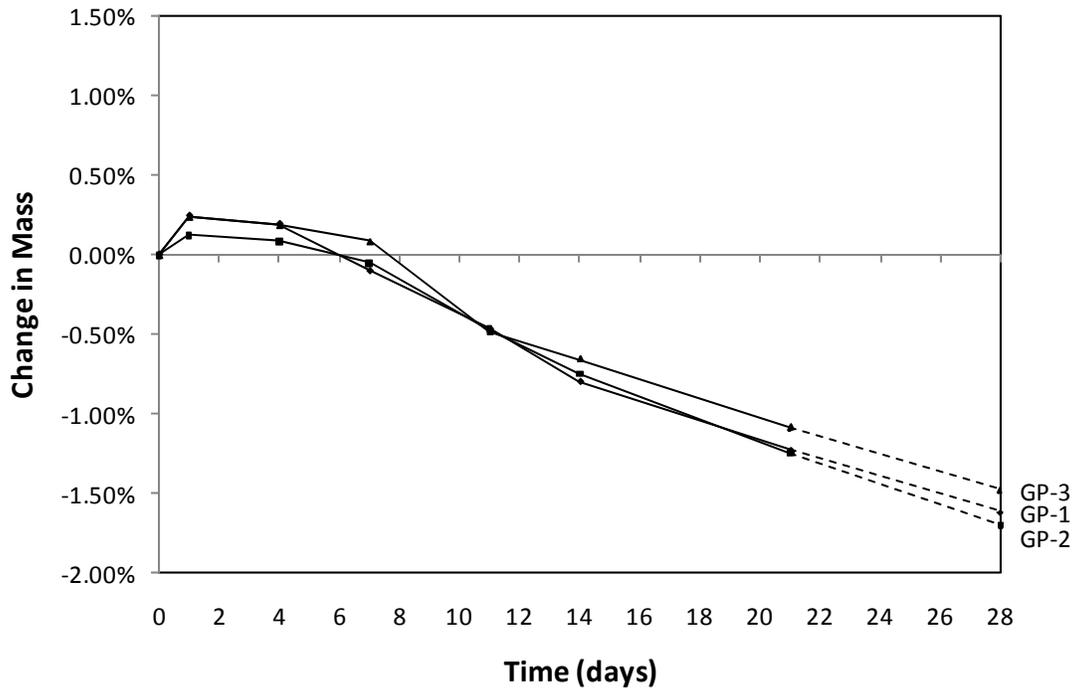
Figure 63. Mass change (%) for Goton mortar bars in the modified CAMBT.

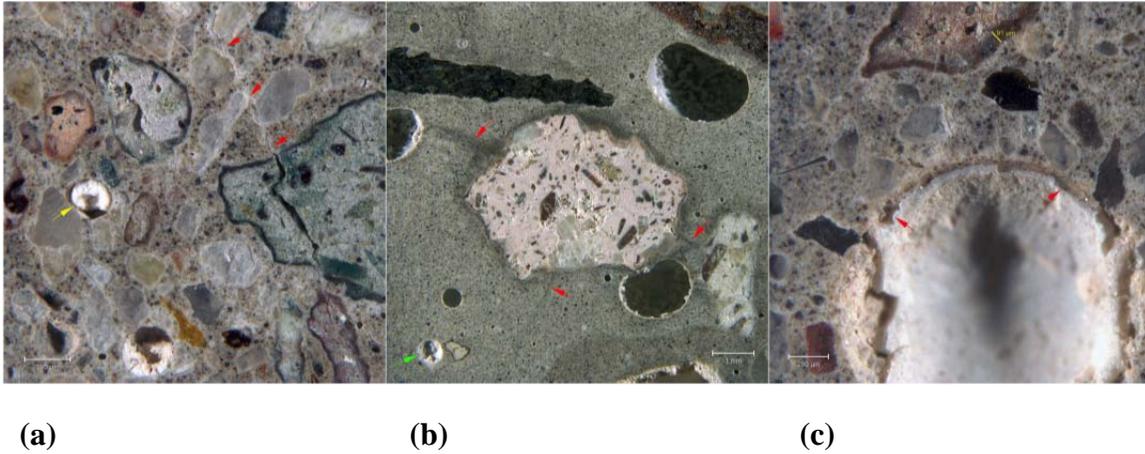
Figure 96. Devries Farm Pit exposure test samples. Reflected light photomicrographs of polished surfaces. Gel-filled microcracks (red arrows) on (a) C1260 mortar bar and (b) CAMBT bar. The yellow and green arrows in (a) and (b), respectively indicate voids lined with gel. In (c) the red arrows indicate gel lining a void and the yellow bar measures a reaction rim on a rhyolite particle on the C 1293 concrete prism.

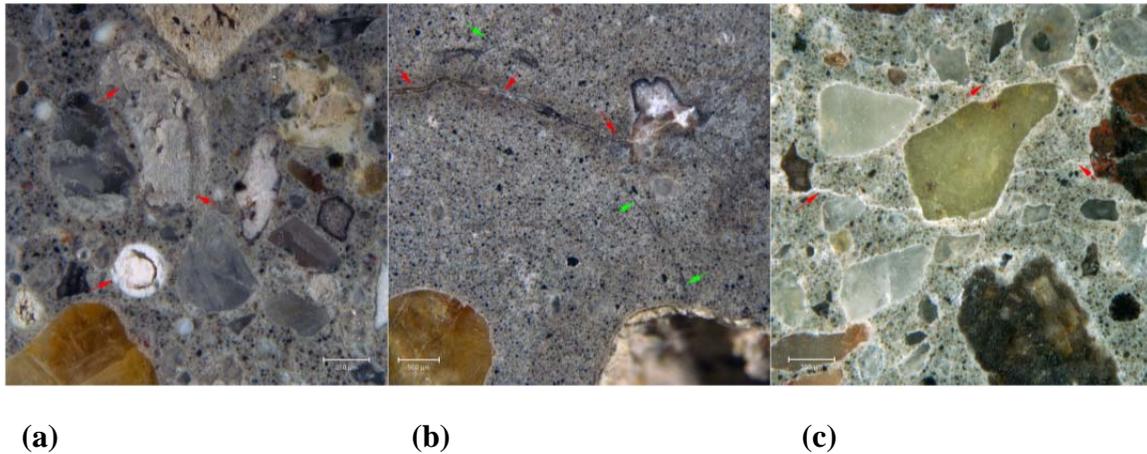
Figure 97. Goton Pit exposure test samples. Reflected light photomicrographs of polished surfaces. (a) Gel in void (red arrows) on C1260 mortar bar. (b) Hairline crack (red arrows) and microcrack (green arrows) filled with gel on CAMBT bar. (c) Microcracks (red arrows) on C1293 prism.

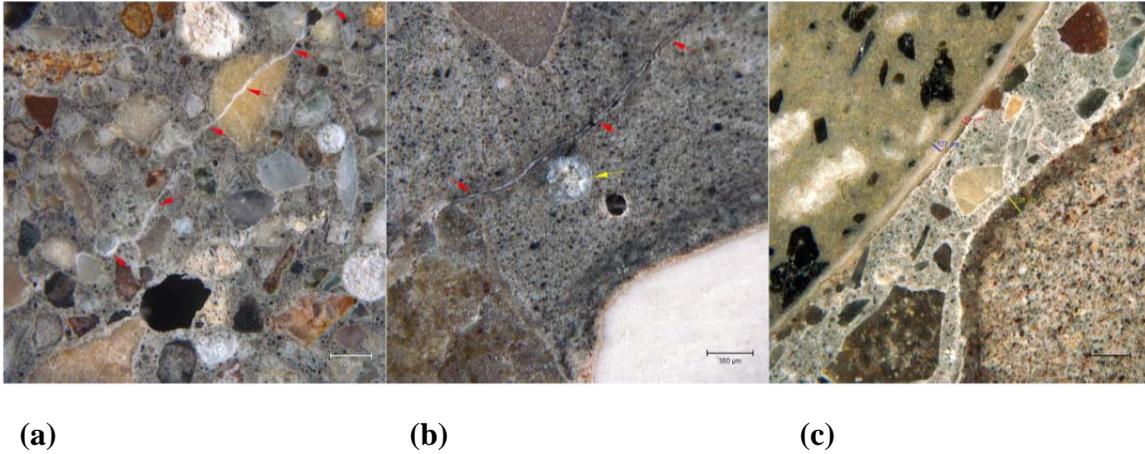
Figure 98. Harris Pit exposure test samples. Reflected light photomicrographs of polished surfaces. (a) Gel in microcracks (red arrows) on C1260 mortar bar. (b) Microcrack (red arrows) and void (yellow arrow) filled with gel on CAMBT bar. (c) Reaction rims on aggregate on C1293 prism.

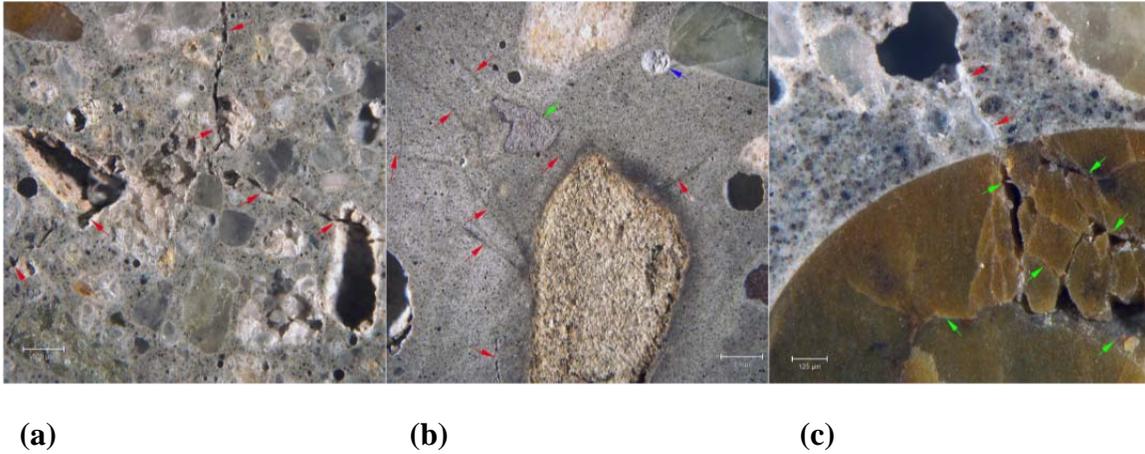
Figure 100. Labarge Pit exposure test samples. Reflected light photomicrographs of polished surfaces. (a) Gel in microcracks (red arrow) radiating from aggregate particle on C1260 mortar bar. (b) Microcracks (red arrows) filled with gel radiating from pitted quartzite particle on CAMBT bar. (c) Microcrack filled with gel (red arrows) on C1293 prism.

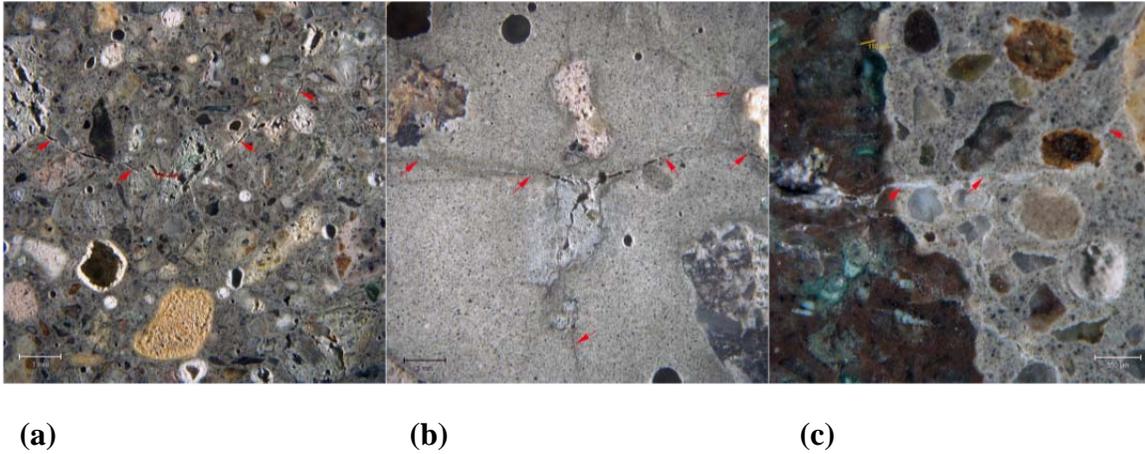
Figure 101. Lamax Pit exposure test samples. Reflected light photomicrographs of polished surfaces. (a) Gel in microcracks (red arrow) radiating from rhyolite particle on C1260 mortar bar. (b) Microcracks (red arrows) filled with gel radiating from rhyolite particle on CAMBT bar. (c) Microcrack filled with gel (red arrows) cutting from rhyolite particle into the paste on C1293 prism.

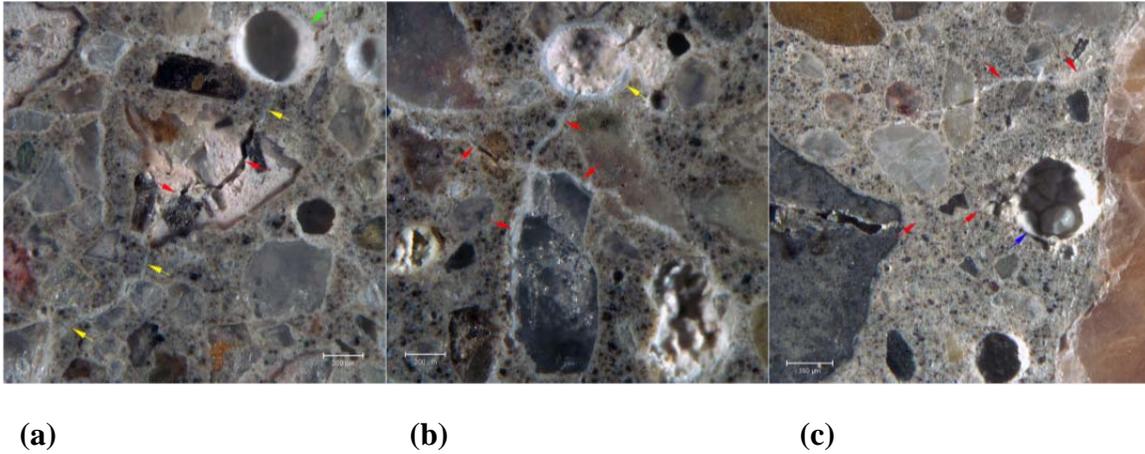
Figure 102. Worland (BLM) Pit exposure test samples. Reflected light photomicrographs of polished surfaces. (a) Microcracks (yellow arrows) radiating from rhyolite particle on C1260 mortar bar; the red bars show internal microcracks in the particle. (b) Microcracks (red arrows) filled with gel cutting through the paste on CAMBT bar. The yellow arrow highlights deposit of gel rimming a void. (c) Microcracks filled with gel (red arrows) cutting from rhyolite particle into the paste on C1293 prism. Blue arrow highlights void with gel.
