JOINT TRANSPORTATION RESEARCH PROGRAM

Alternatives to Raised Pavement Markers (RPMs)

This technical report summarizes the project background and development of CLRS specifications, provides detailed photos of a fall 2013 deployment, and summarizes the post-construction close-out meeting held on December 4, 2013.

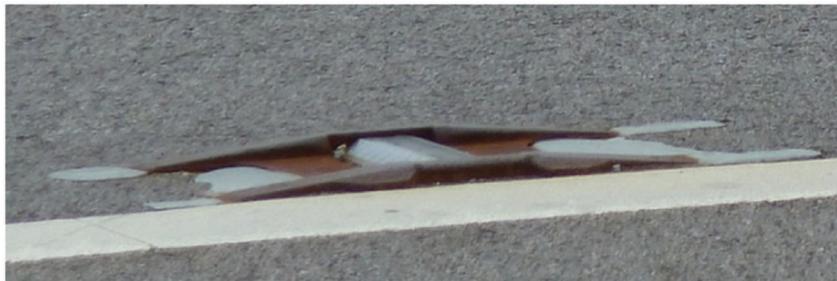
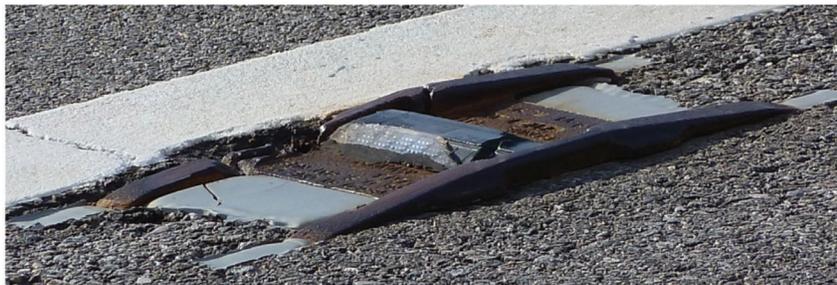
(a) New RPMs

(b) Damaged RPM

Figure 1.1 RPMs installed fall 2010 along SR 25 near Shadeland, Indiana. Several were damaged prior to the plow season, November 2010.

RPMs can become damaged (Figure 1.1b) or occasionally dislodged (Figure 1.2) from snowplow operations or heavy vehicle traffic. The intent of the study was to identify an alternative to Raised Pavement Markers (RPMs) (Figure 1.1a) and develop an implementation plan. Any proposed RPM alternative needs to provide similar or better safety performance on rural routes and be cost effective to construct.

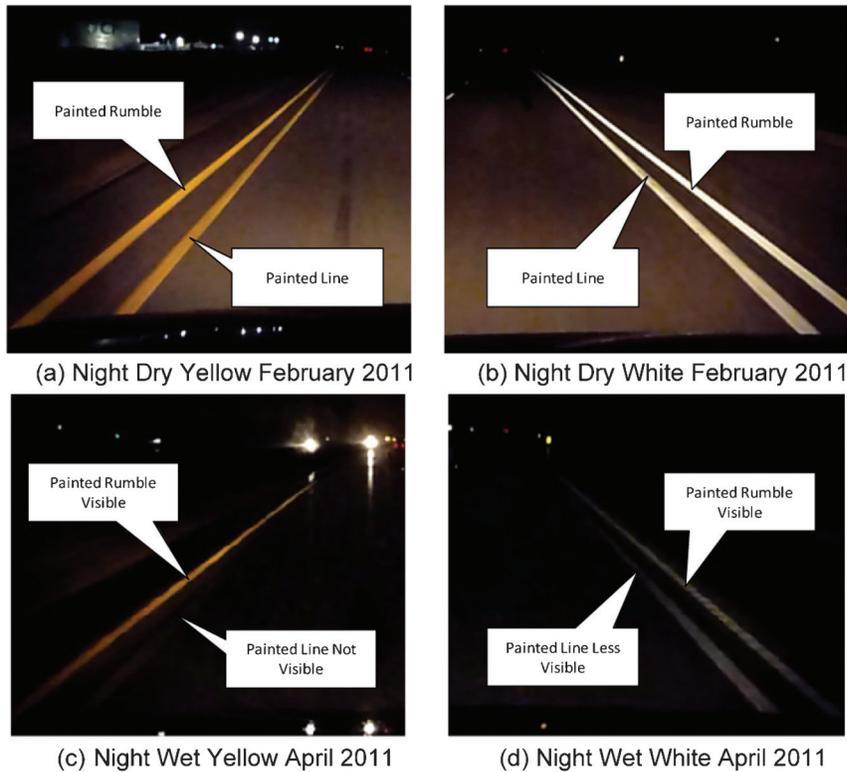
Figure 1.3 SR 28 Screen Images from driving videos in test zone with standard INDOT pavement marking with glass beads. Photos courtesy Alex Hainen and Steve Remias, Purdue University.

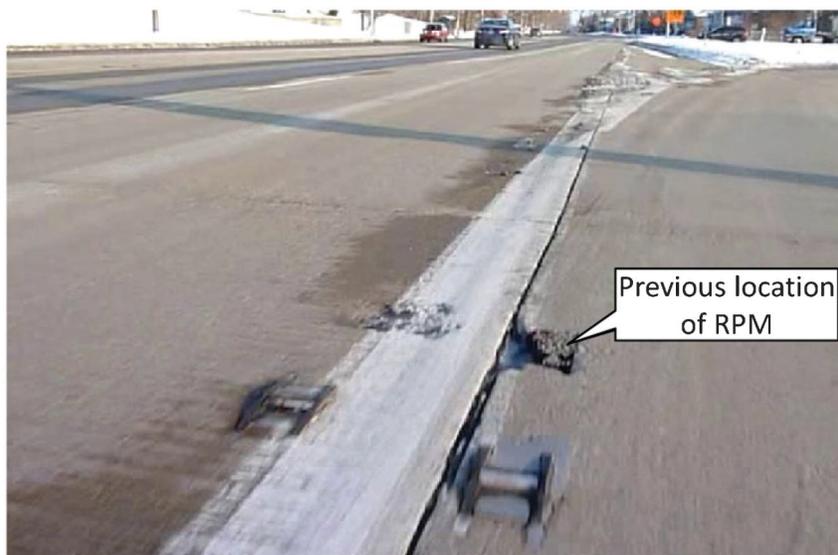
(a) Area of missed snow removal

(b) Replaced RPM

Figure 2.1 RPM impact on US 231 on ramp in West Lafayette, Indiana. January 2011. Photos courtesy Alex Hainen, Purdue University.

Many crashes occur on rural roads as a result of lane departure related crashes (2,5,6–8). Many two-lane and four-lane rural roads lack medians and are not lighted. Although FHWA suggests retroreflectivity standards for painted pavement markings, studies show that additional measures can be taken to reduce lane departure crashes (7,9). RPMs are one common technology used in conjunction with painted lines. Concerns with using RPMs include expensive installation, high maintenance costs and susceptibility to dislodgement as the roadway degrades (3,9–11). RPMs also impact winter snowplow operations by causing the plow blade to jump, as shown in Figure 2.1a, and consequently missing the snow directly behind the RPM. While some snowplow operators cite the RPMs as helpful indicators of lane presence, this impact is likely damaging to the plow, RPM, and surrounding pavement.

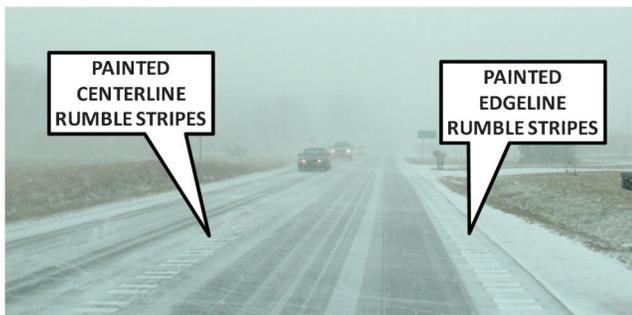
Figure 2.5 Examples of snow event that may cause lane departure (US 231 north of Crawfordsville in 2012).

Federal Highway (FHWA) reports CLRS can reduce target crashes by 45% and ELRS can reduce target crashes by 35% (2,5), in large part by effectively alerting drivers and providing them an opportunity to correct their course before crossing the centerline or leaving the roadway (18). The corrugation can be particularly effective during periods of decreased visibility and/or adverse weather conditions (Figure 2.5, Figure 2.6).

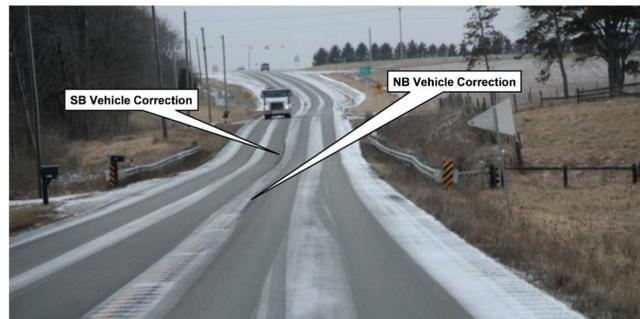
Figure 2.6 Example of vehicle correction after hitting the centerline rumble strip, located on US 231 north of Crawfordsville, Indiana, after a light snow, 2012.

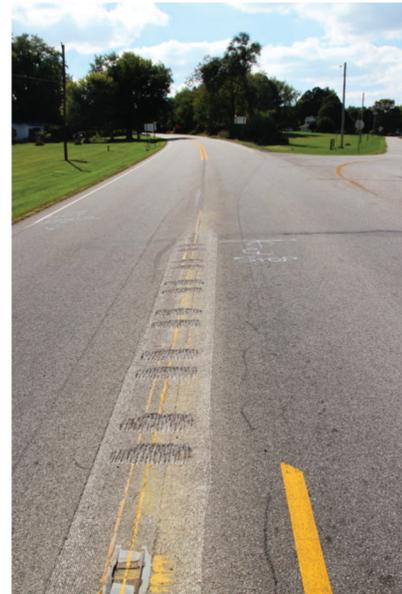
Figure 4.1 Dripline placed between centerlines before centerlines are ground off.

1. Contract documents should include an item for placing a drip line (Figure 4.1) along the center joint and/or between the centerline to provide horizontal control for placing the centerline rumble after the centerline markings are ground off.
2. Contract documents should include an item for placing a drip line to provide horizontal control for placing edgeline rumble.
3. Providing proper fog seal coverage was a challenge (Figure C.28 to Figure C.32). Further dialog is needed to

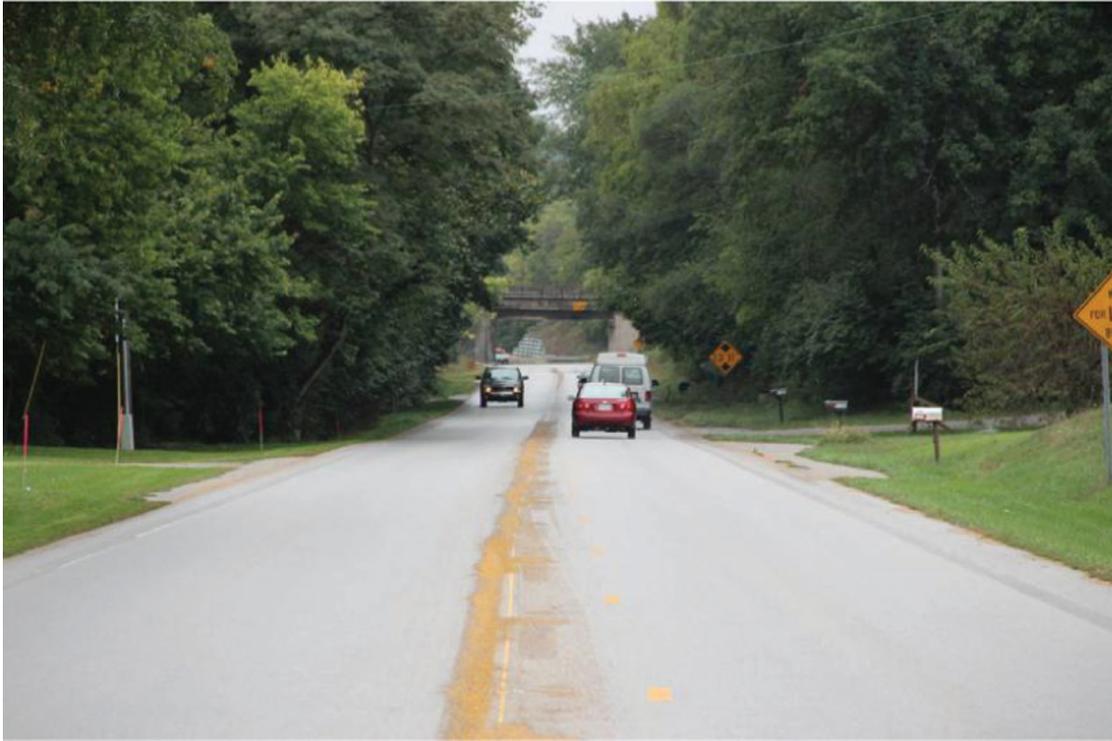
Figure C.3 Centerline and edgeline markings ground off (but centerline debris not removed).

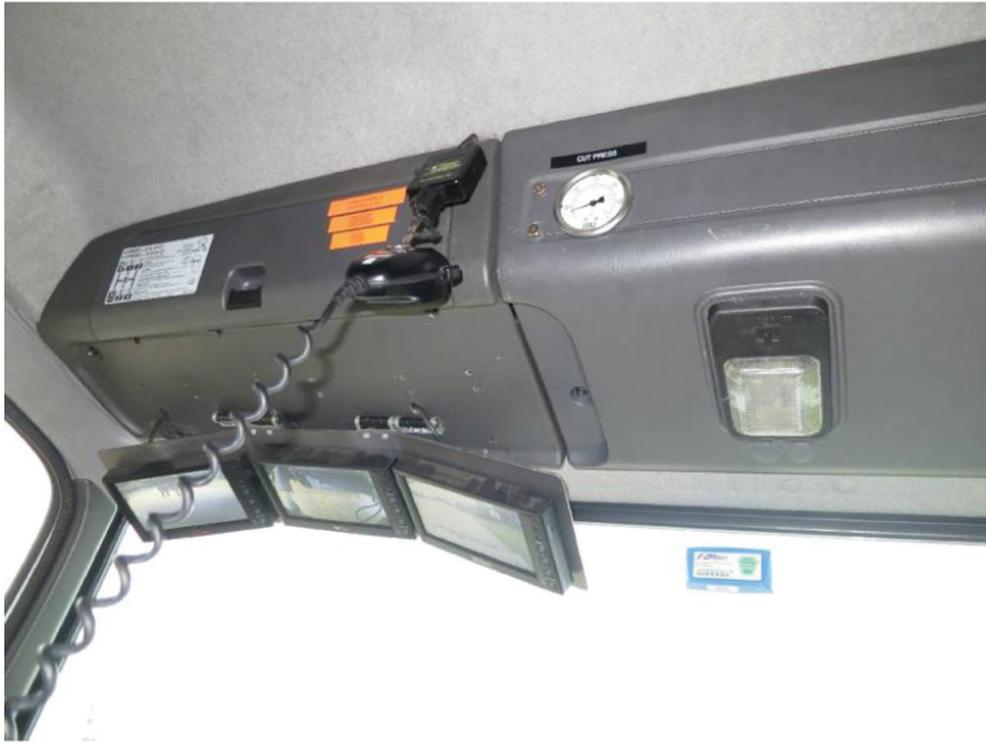
Figure C.5 Cab of milling truck, note three monitors on visor.

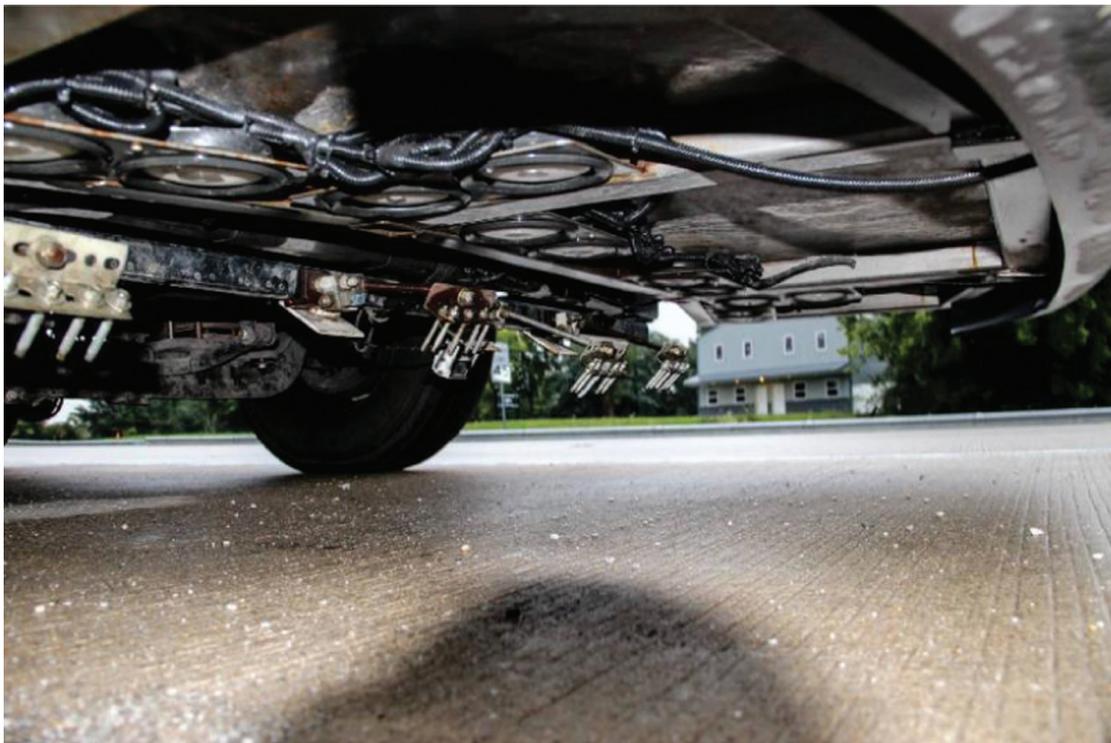
Figure C.6 Camera mounted under milling truck.

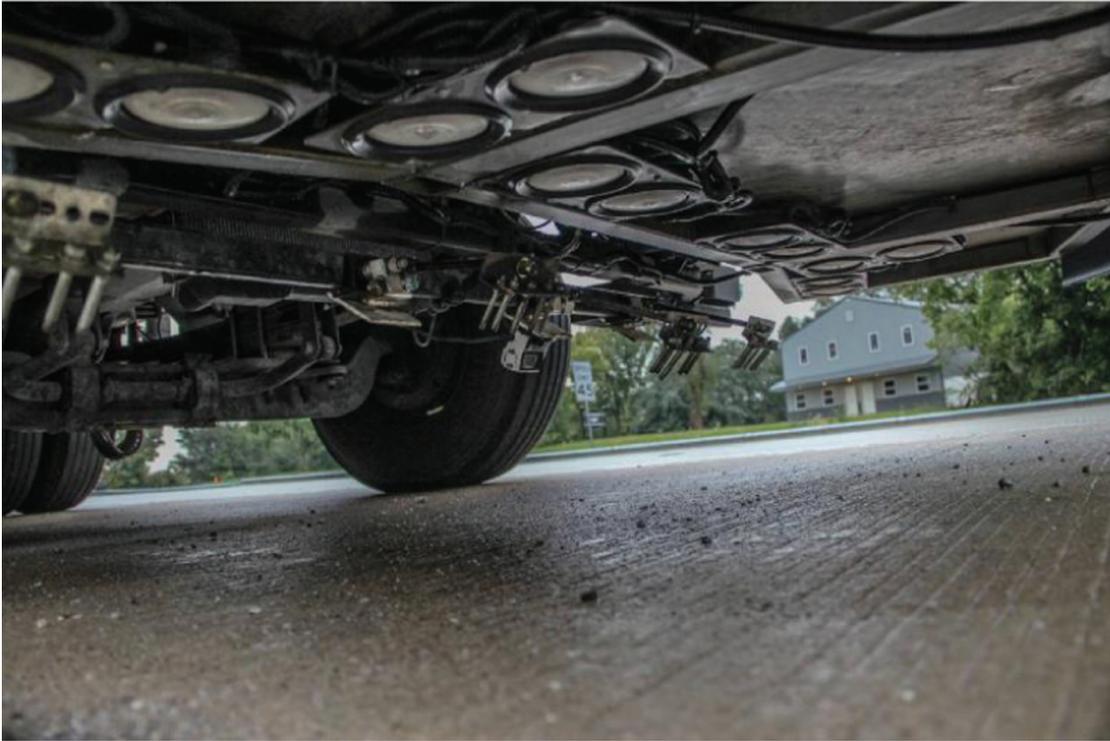
Figure C.7 Cameras mounted under milling truck.

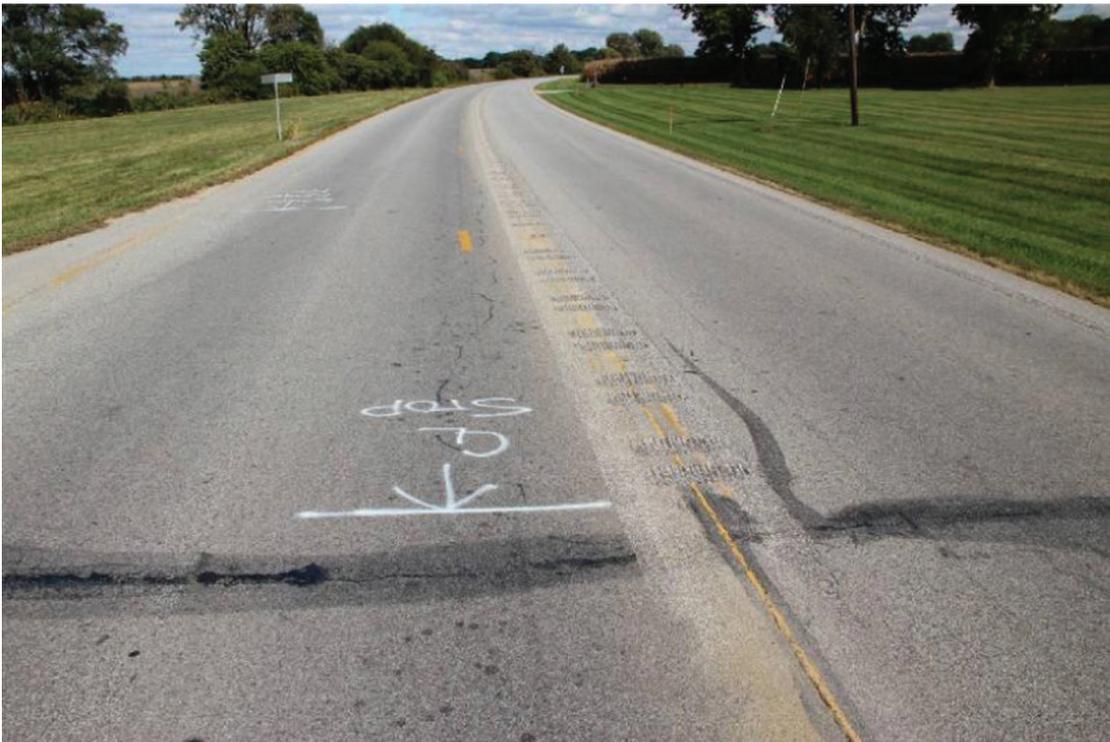
Figure C.8 Markings to indicate stop of centerline (CL) rumble.

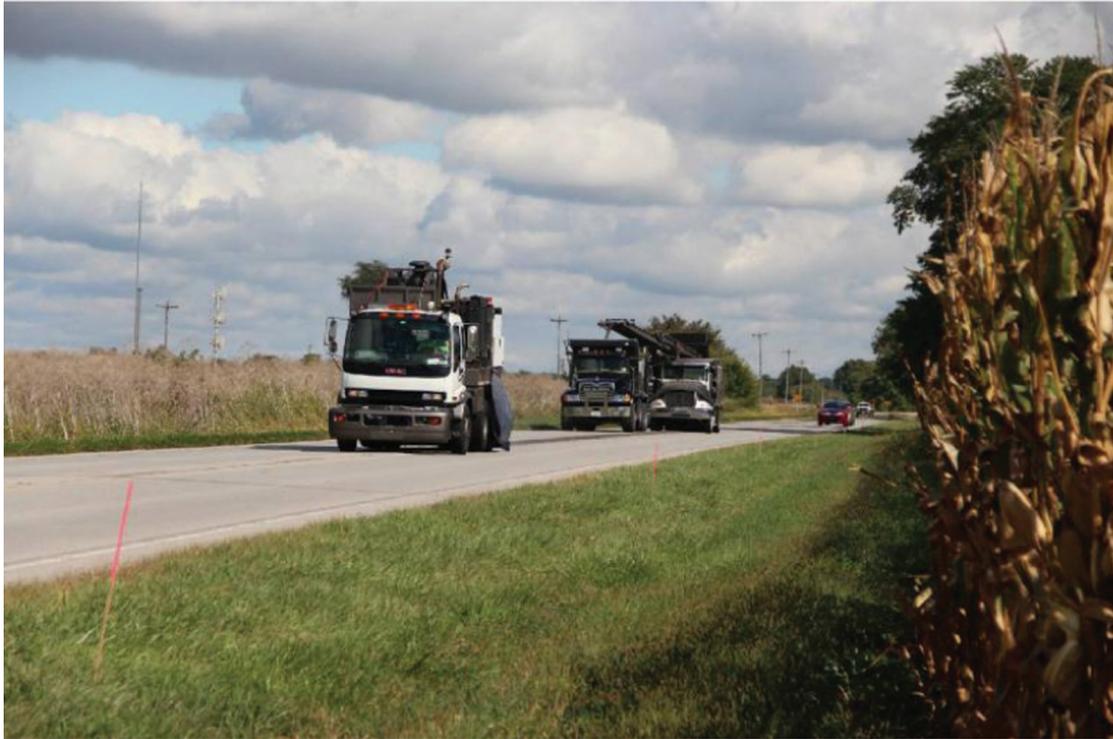
Figure C.17 Rumble stripe convoy (milling, dump truck, sweeper).

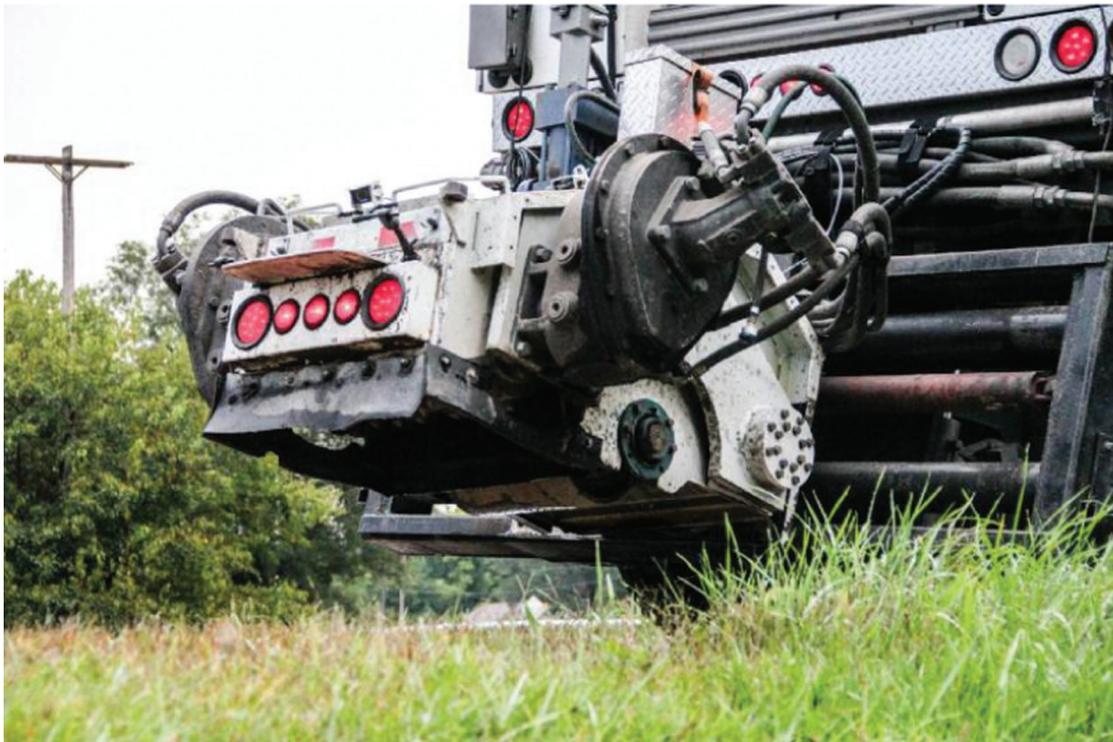
Figure C.18 Rumble milling truck, milling head close up.

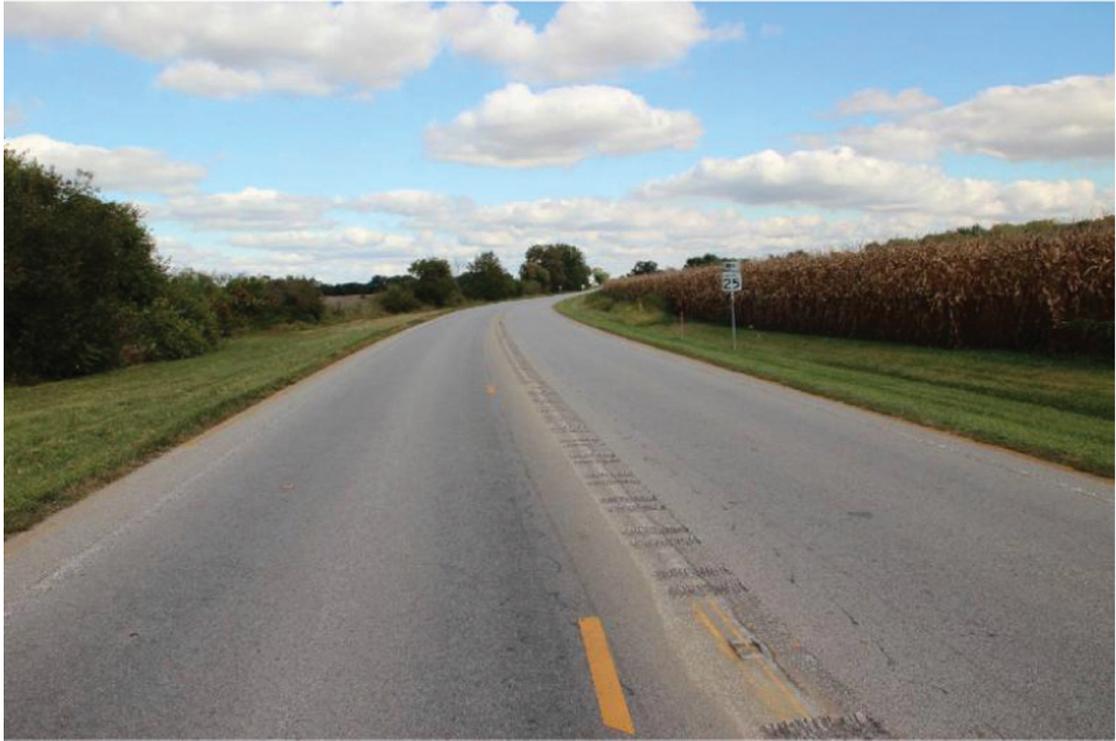
Figure C.21 Freshly milled rumbles, drip line visible.

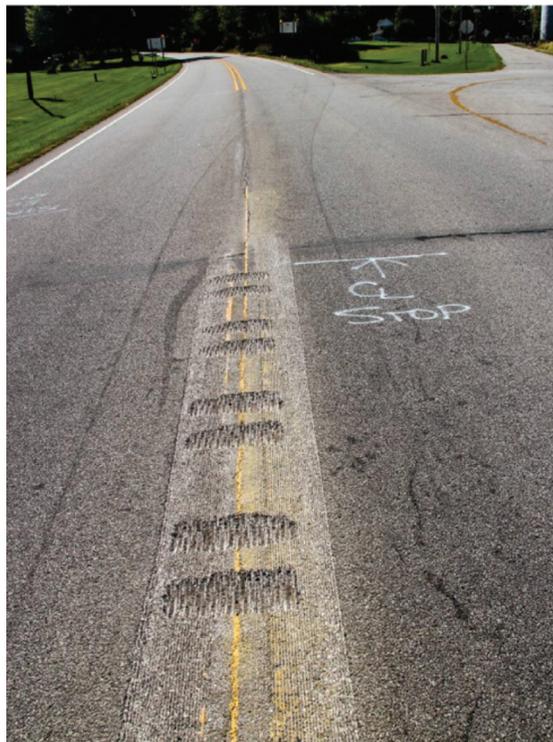
Figure C.22 Freshly milled rumbles, drip line visible.

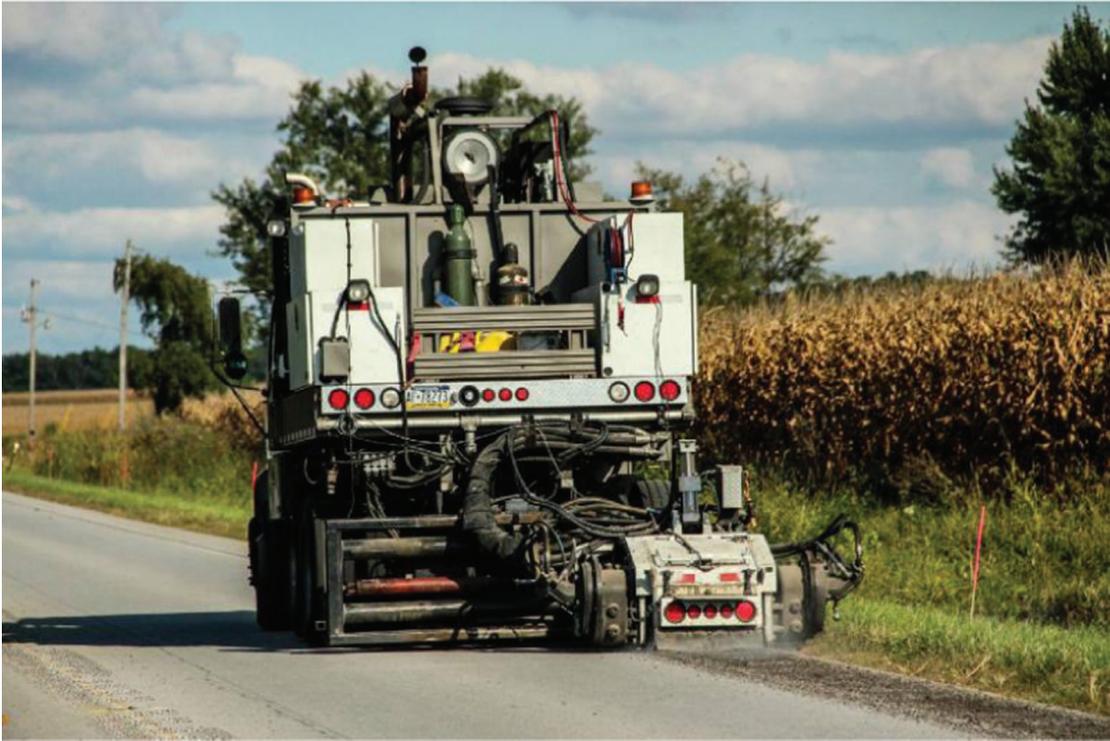
Figure C.23 Edgeline rumble milling.

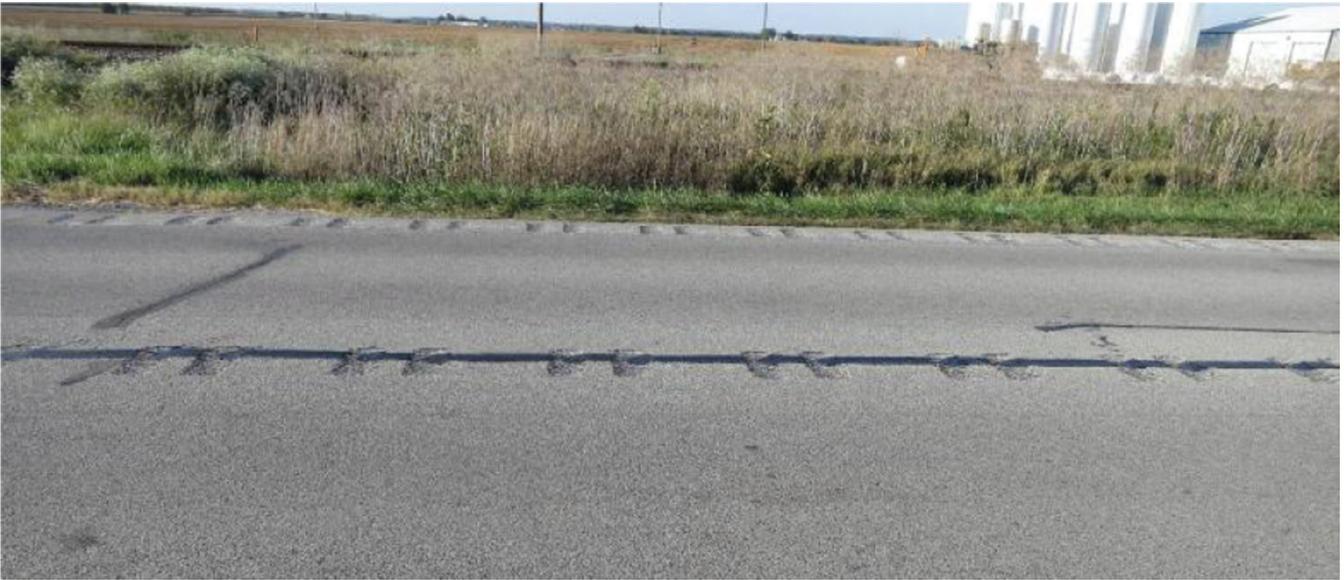
Figure C.27 Joint sealant applied to centerline joint.

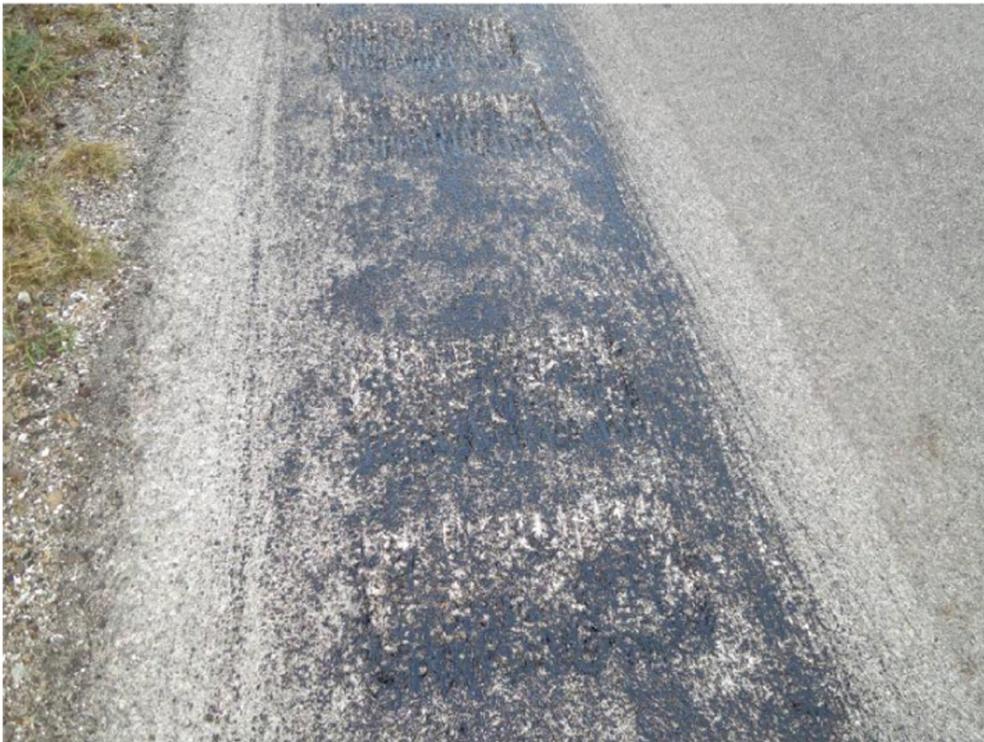
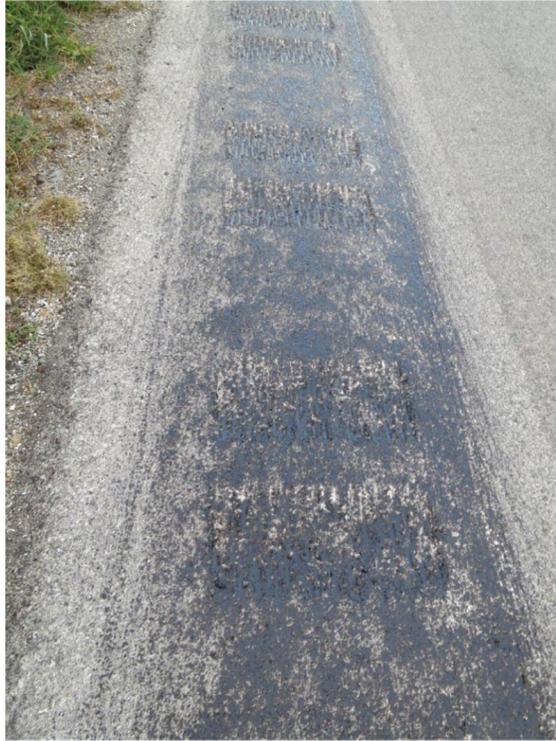
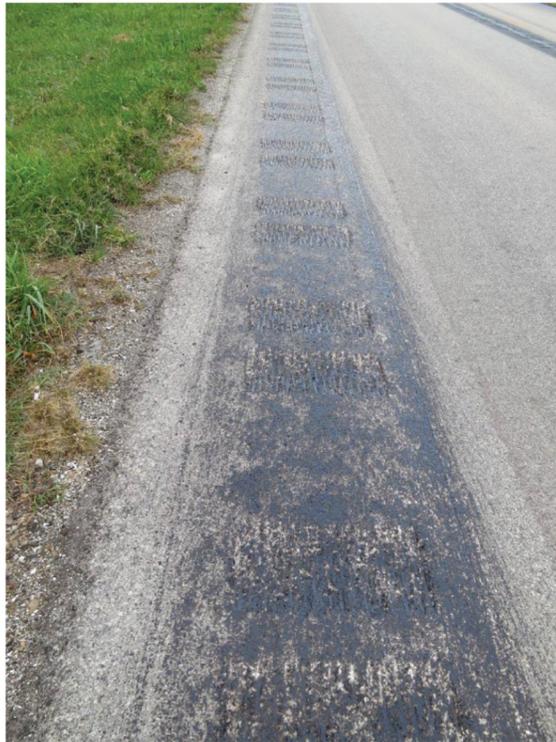
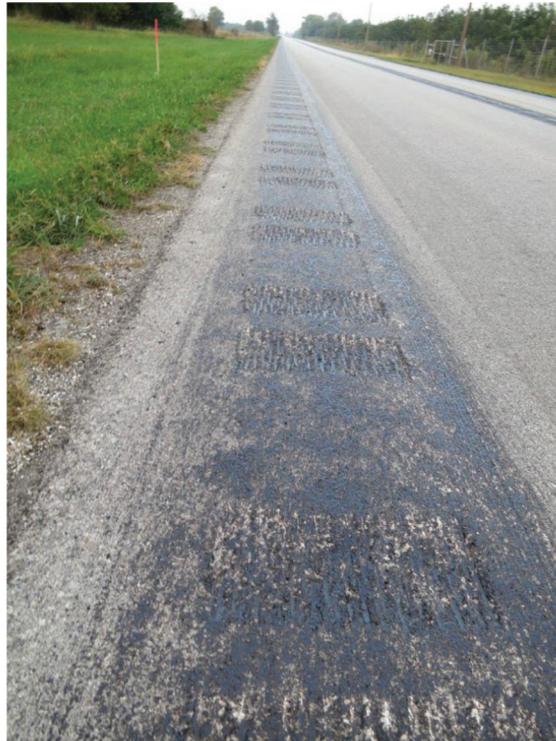
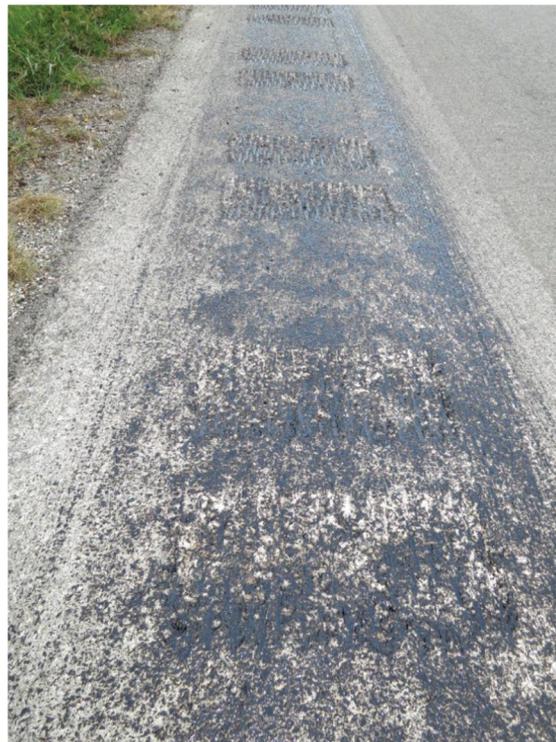
Figure C.28 Fog sealant applied to edgeline (thin application).

Figure C.29 Fog sealant applied to edgeline (thin application).

Figure C.30 Fog sealant applied to edgeline (thin application).

Figure C.31 Fog sealant applied to edgeline (thin application).

Figure C.32 Fog sealant applied to edgeline (thin application).

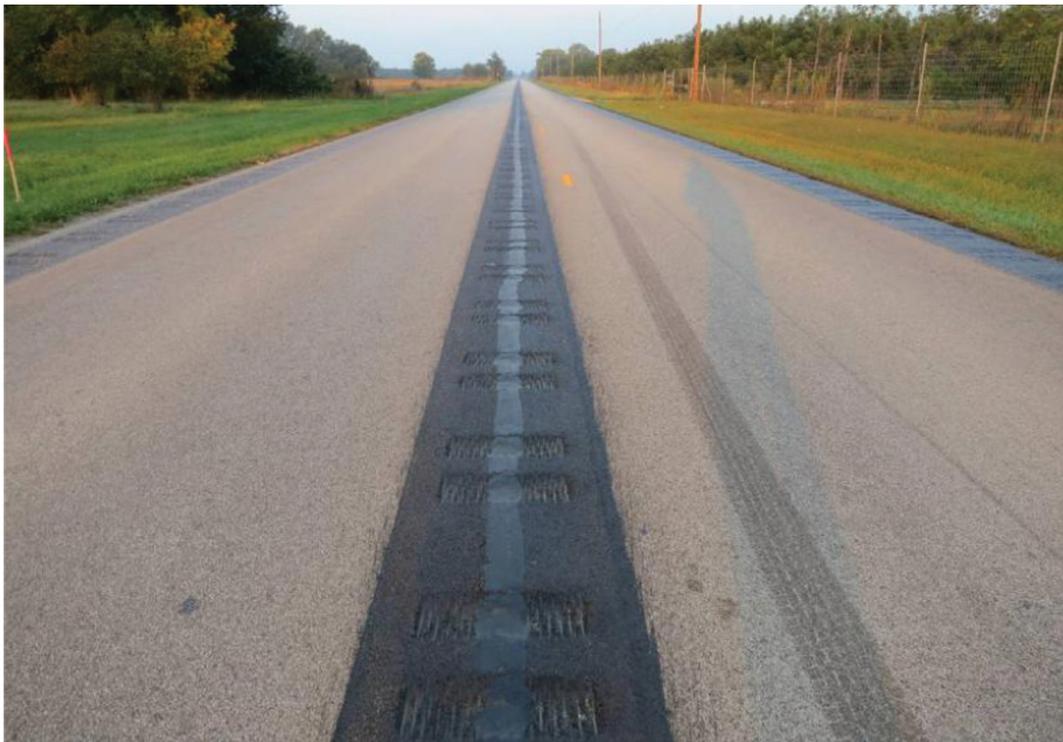
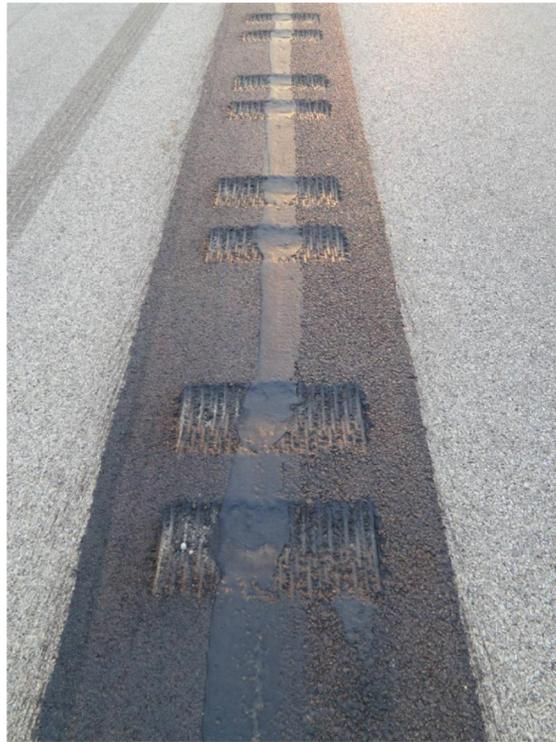
Figure C.34 Centerline fog seal.

Figure C.35 Centerline fog seal close up.

Figure C.36 Centerline fog seal close up.

identify recommended material and application procedure so that sufficient coverage (Figure C.34 to Figure C.36) is achieved in first pass, but without over application that increase curing time before lines can be painted.

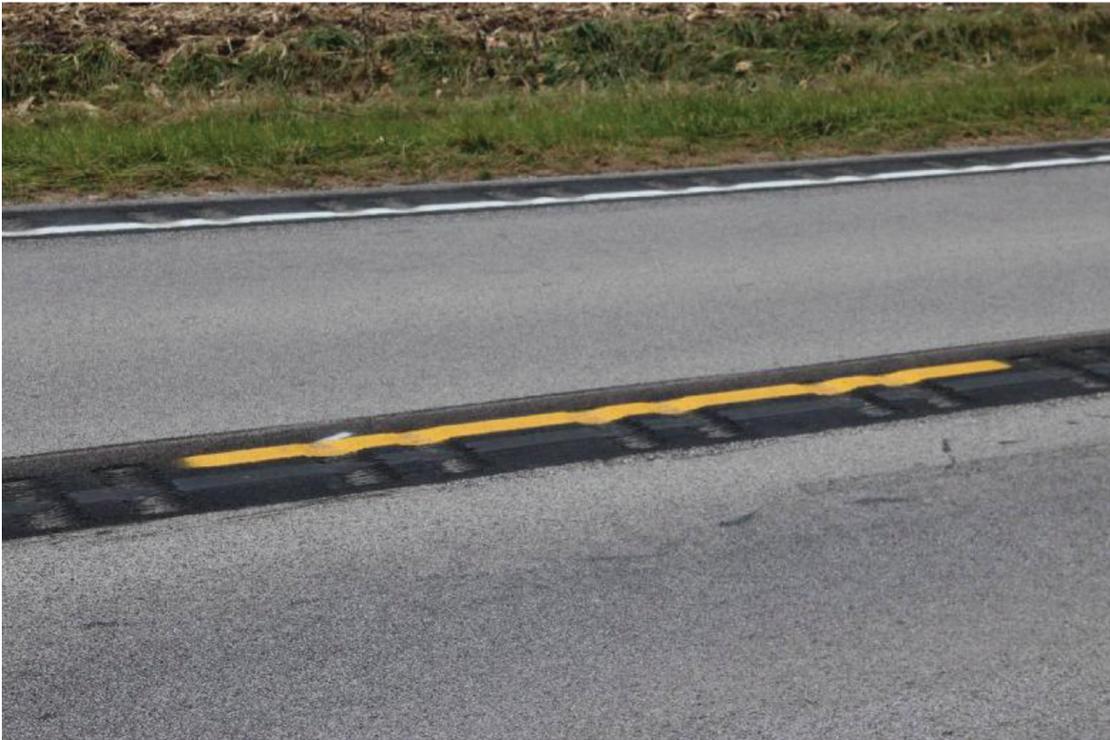
Figure C.40 Close up of centerline rumble stripe.
