Comparison and Testing of Various Noise Wall Materials

Prepared by:
Deborah S. McAvoy, Ph.D., P.E., PTOE
and
Ryan Theberge, EIT

Prepared for:
The Ohio Department of Transportation,
Office of Statewide Planning & Research

June 2014

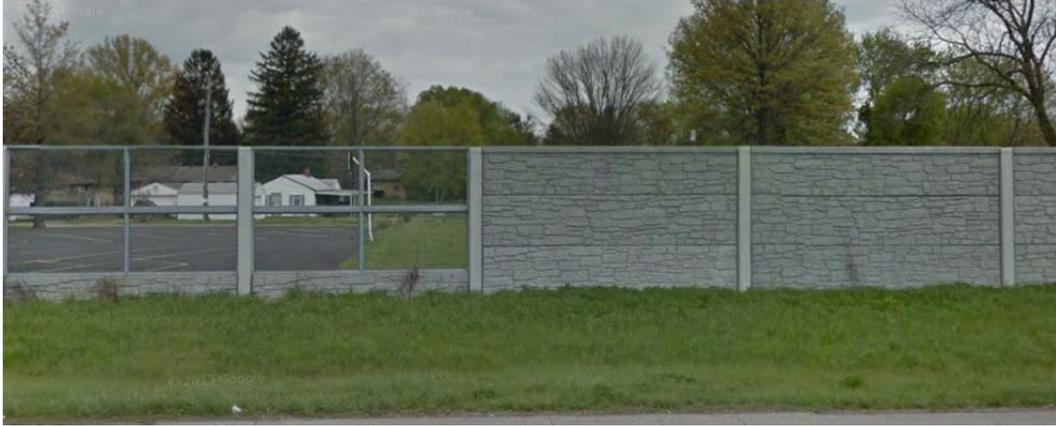
Figure 3.1. Site 1 highway view of part concrete wall and part clear wall

Site 1 was a part clear and part absorptive concrete single noise barrier located in a residential area along I-71 North near the Lighthouse Church. The portion of the barrier that was chosen for analysis was the clear section. Figure 3.1 shows the point where the noise barrier changes from a complete concrete barrier to a clear and concrete barrier. Approximately four feet from the ground up is concrete while the other eight feet is made of clear panels, as seen in Figure 3.2. As stated in the Field Recording section, there were five microphones placed behind the wall and two placed in front of the wall. Microphone 1 was located five feet above the wall. This configuration can be seen in Figure 3.3.

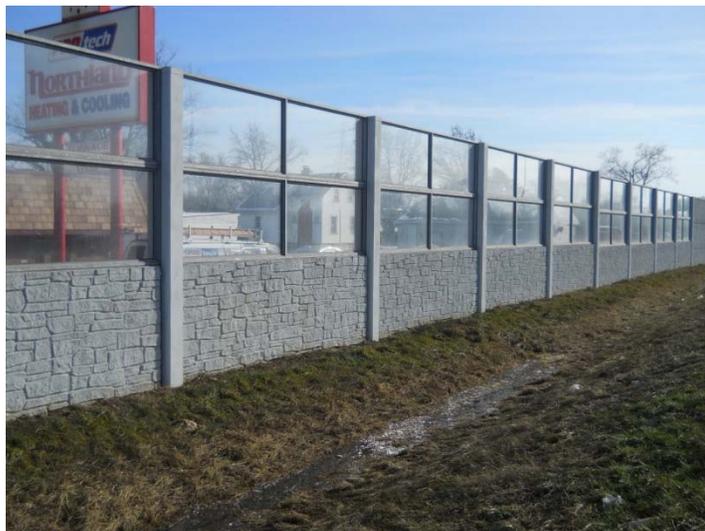
Site 2 was a part clear and part absorptive concrete single noise barrier located in a residential area along I-71 North near Moon Road. The portion of the barrier that was chosen for analysis was the clear section. Approximately six feet from the ground up was concrete while the other ten feet was the clear panels as seen in Figure 3.4. The microphone locations at Site 2 varied from the other sites. Due to the spatial restrictions caused by the garage behind Microphone 4, Microphones 5 and 6 were placed 25 feet to the south of Microphones 2 and 3, respectively. Microphone 1 was located five feet above the wall. The configurations of the five microphones placed behind the wall, two placed in front of the wall and one above the wall can be seen in Figure 3.5.

Figure 3.4. Site 2 highway view of clear wall testing location

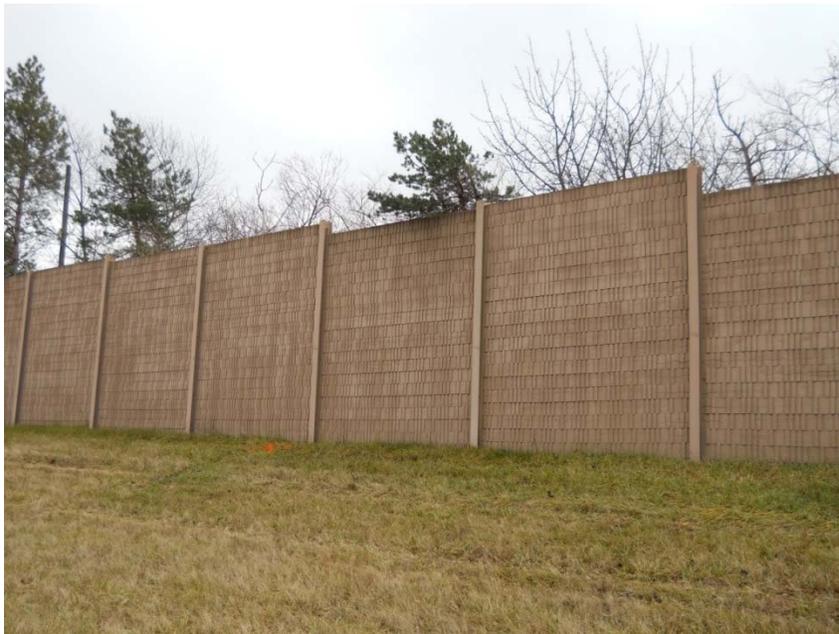
Figure 3.6. Site 3 highway view of reflective concrete wall testing location

Site 3 was a reflective concrete parallel noise barrier located in a residential area along I-675 near McEwen Road. The northbound wall was chosen for analysis. The wall was approximately 13 feet tall and is shown in Figure 3.6. The microphone locations at Site 3 followed the array distance from the wall of 25 feet with the exception of Microphone 6. Due to a large tree located in the desired position, Microphone 6 was placed 25 feet to the east of Microphone 5. Microphone 1 was located five feet above the wall. The configurations of the five microphones placed behind the wall, two placed in front of the wall and the one above the wall can be seen in Figure 3.7.

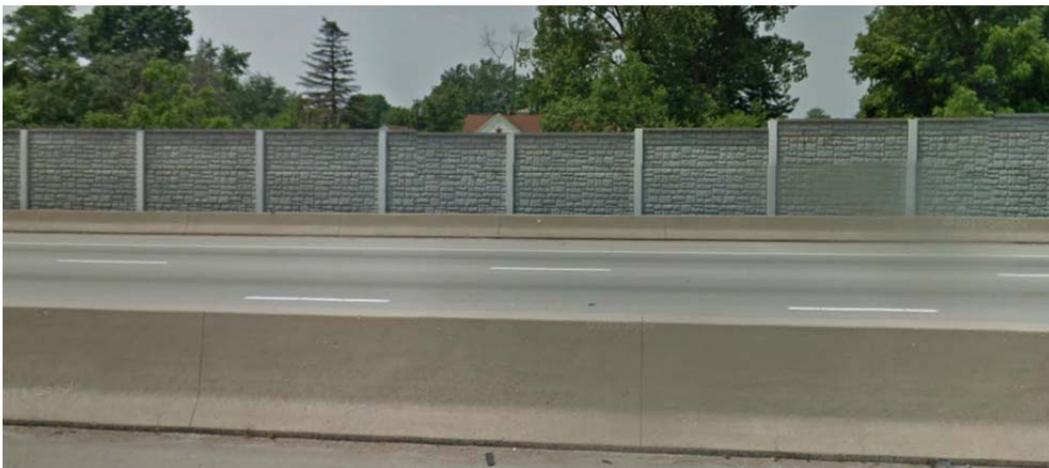
Figure 3.8. Site 4 highway view of absorptive concrete wall testing location

Site 4 was an absorptive concrete single noise barrier located in a residential area along I-75 South near Stop 8 Road. The wall was approximately 15 feet tall with a 2 ½ feet tall Jersey barrier located 1 ½ feet to the east of the wall. This configuration can be viewed in Figure 3.8. The microphone locations at Site 4 were all set back 15 feet from the wall because the wall located directly on the I-75 South shoulder. From the point where the reference microphone was placed, the array distance of 25 feet behind Microphone 1 was followed with the exception of Microphone 6. Since the desired location for Microphone 6 was in the middle of Arthur Avenue, Microphone 6 was placed 25 feet to the east of Microphone 1. Microphone 1 was located five feet above the wall. The configurations of the five microphones placed behind the wall, two placed in front of the wall, and one above the wall can be seen in Figure 3.9.

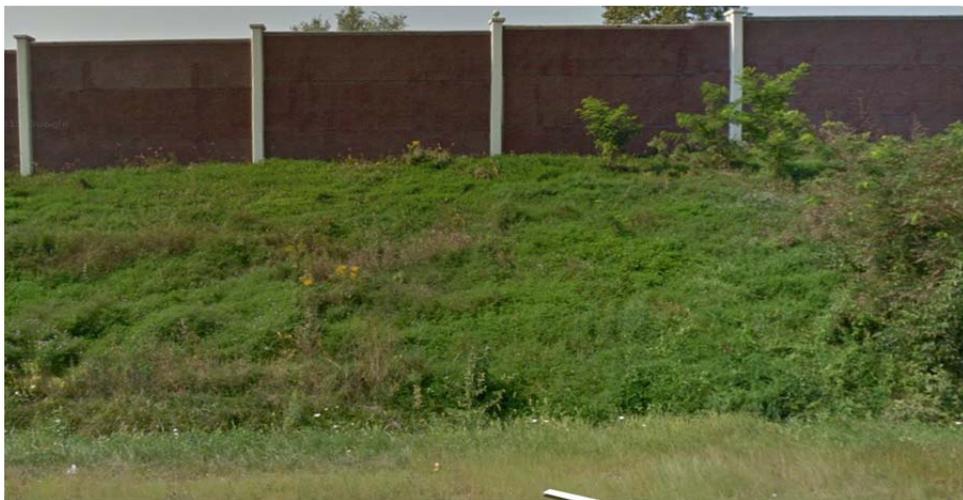
Figure 3.10. Site 5 highway view of absorptive concrete wall testing location

Site 5 was an absorptive concrete single noise barrier located in a residential area along I-77 South near Belden Village Street. The wall was approximately 17 feet tall and can be viewed in Figure 3.10. The locations at Site 5 for Microphones 2 through 6 were placed at the array distance of 25 feet behind the noise barrier while Microphones 7 and 8 were placed in front of the wall. Microphone 1 was located five feet above the wall. This configuration can be seen in Figure 3.11.

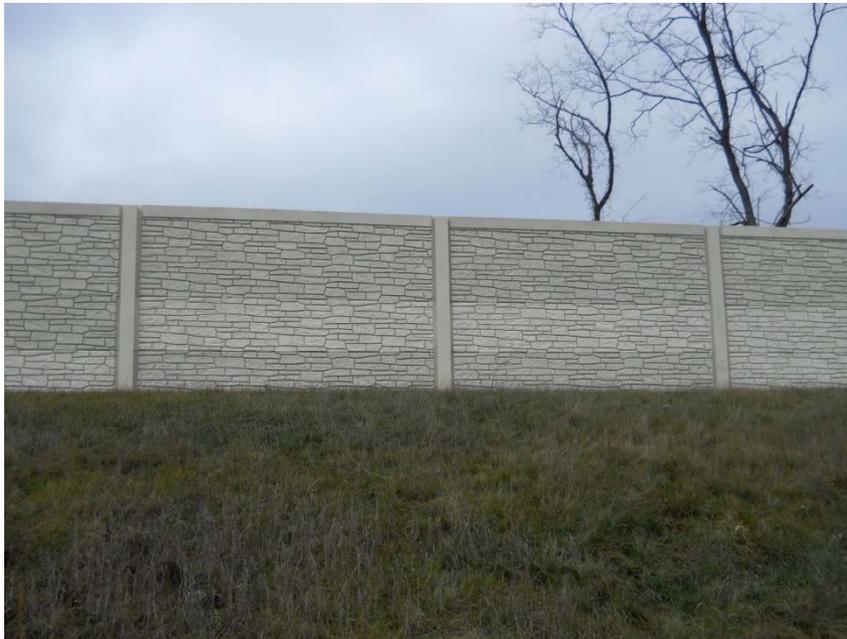
Figure 3.12. Site 6 highway view of absorptive concrete wall testing location

Site 6 was an absorptive concrete single noise barrier located in a residential area along I-75 South near Shaker Road. The wall was approximately 15 feet tall and can be viewed in Figure 3.12. The locations at Site 6 for Microphones 2 through 6 were placed at the array distance of 25 feet behind the noise barrier while Microphones 7 and 8 were placed in front of the wall. Microphone 1 was located five feet above the wall. This configuration can be seen in Figure 3.13.

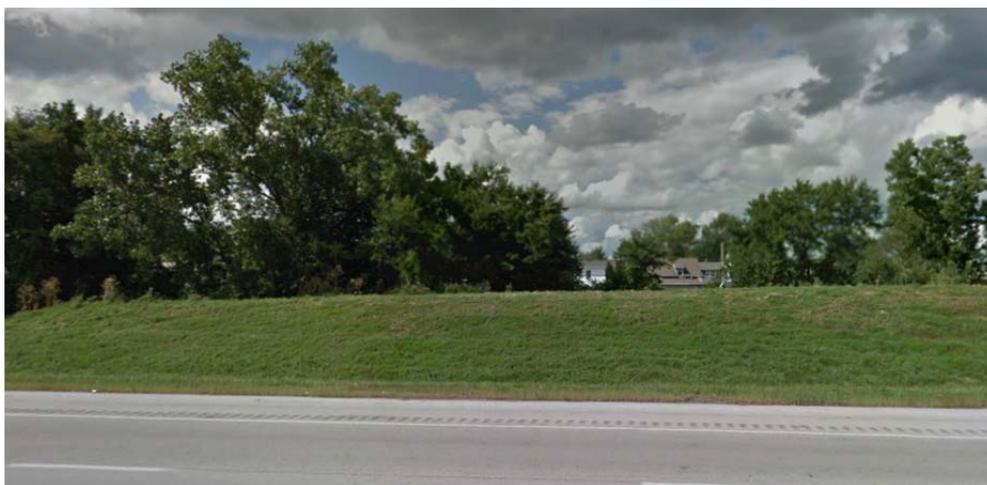
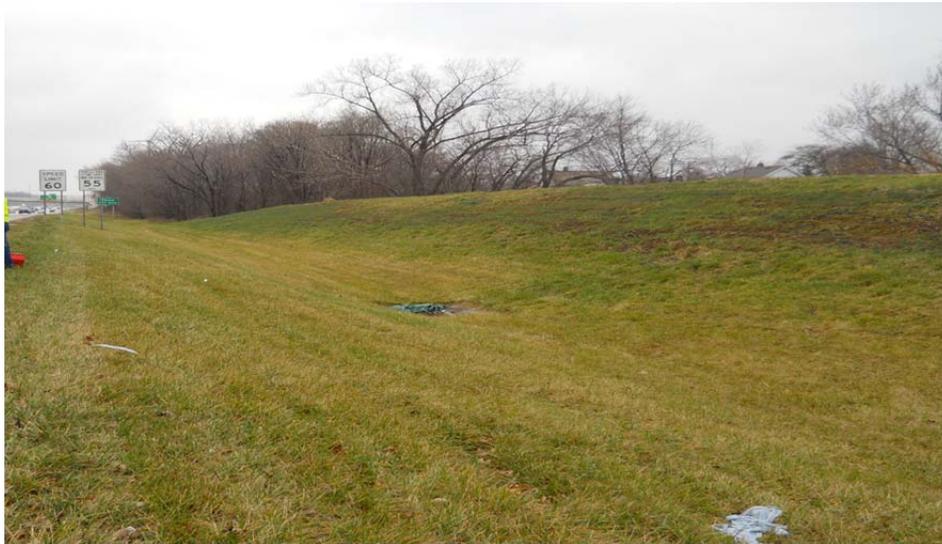
Site 7 was an earthen berm noise barrier located in a residential area along I-480 east near Pearl Road. The berm height from the ditch line to the top was approximately 15 feet, but the top of the berm was only around 8 feet above the roadway. This topography can be viewed in Figure 3.14 and Figure 3.15. The microphone locations at Site 7 were placed at the array distance of 25 feet. Microphone 1 was placed on the top of the berm, while Microphones 2 and 3 were placed on the back side of the mound and microphones 4, 5, and 6 were placed on flat ground behind the berm. Microphones 7 and 8 were placed in the ditch line in front of the berm. This configuration can be seen in Figure 3.16.

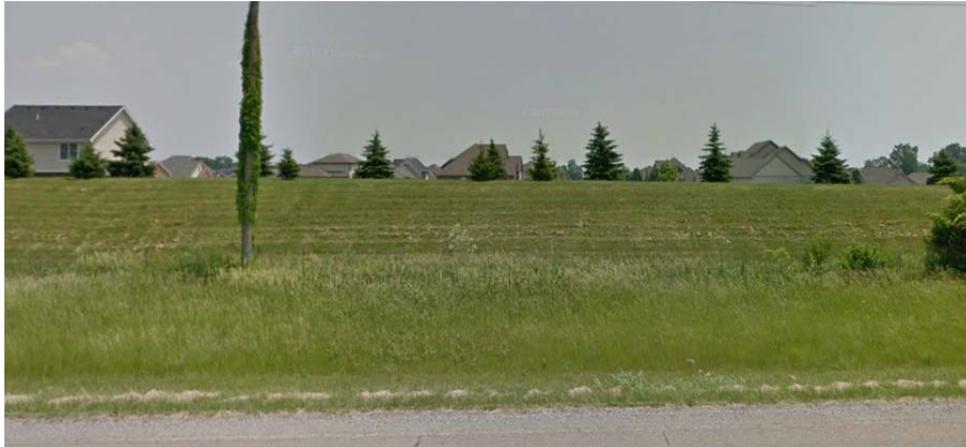
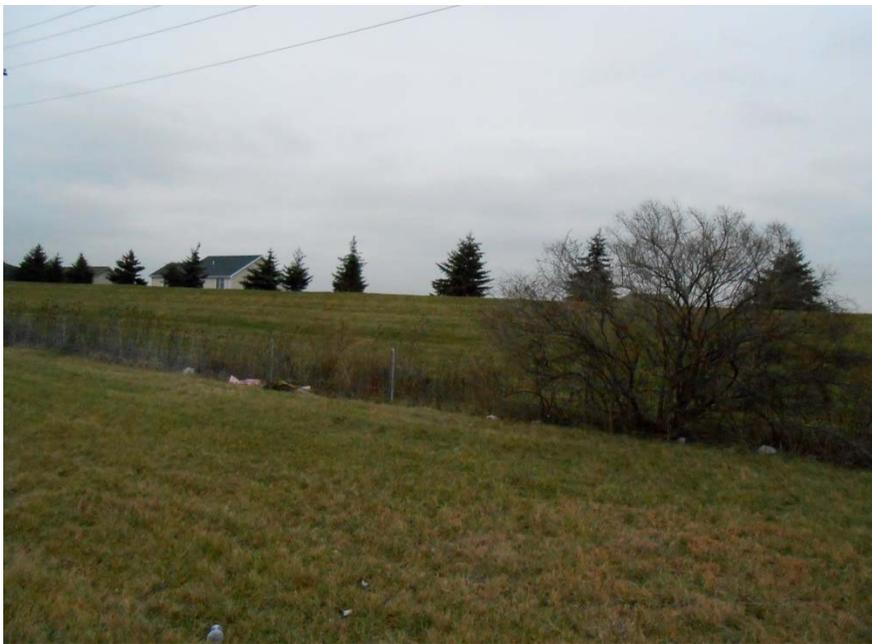
Site 8 was an earthen berm noise barrier located in a residential area along I-75 north near East Evanston Road. The berm height from the ditch line to the top was approximately 10 feet, but the top of the berm was only around 8 feet above the roadway. This topography can be viewed in Figure 3.17 and 3.18. The microphones at Site 8 were placed at the array distance of 25 feet. Microphone 1 was placed on the top of the berm, while Microphones 2 and 3 were placed on the back side of the mound and Microphones 4, 5, and 6 were placed on flat ground behind the berm. Microphones 7 and 8 were placed in the ditch line in front of the berm and fence. This configuration can be seen in Figure 3.19.

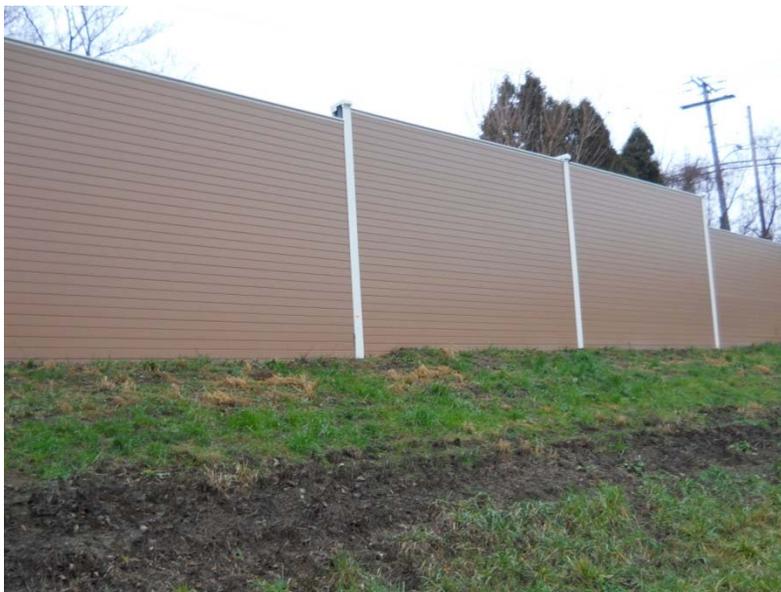
Figure 3.20. Site 9 highway view of hollow fiberglass wall testing location

Site 9 was a hollow fiberglass parallel noise barrier located in a residential area along I-71 near Sheldon Road. The southbound wall was chosen for analysis. The wall was approximately 18 feet tall and can be viewed in Figure 3.20. The locations at Site 9 for Microphones 2 through 6 were placed at the array distance of 25 feet behind the noise barrier while Microphones 7 and 8 were placed in front of the wall. Microphone 1 was located five feet above the wall. This configuration can be seen in Figure 3.21.

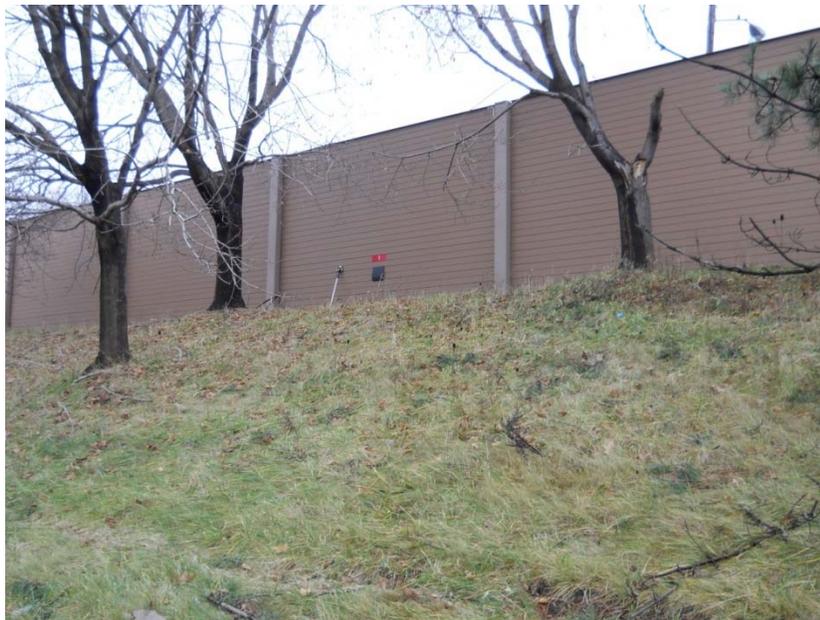
Figure 3.22. Site 10 highway view of hollow fiberglass wall testing location

Site 10 was a hollow fiberglass parallel noise barrier located in a residential area along I-90 near Wooster Road. The north bound wall was chosen for analysis. The wall was approximately 13 feet tall and can be viewed in Figure 3.22. Microphones 2 through 6 at Site 10 were placed at the array distance of 25 feet behind the noise barrier while Microphones 7 and 8 were placed in front of the wall. Microphone 1 was located five feet above the wall. This configuration can be seen in Figure 3.23.

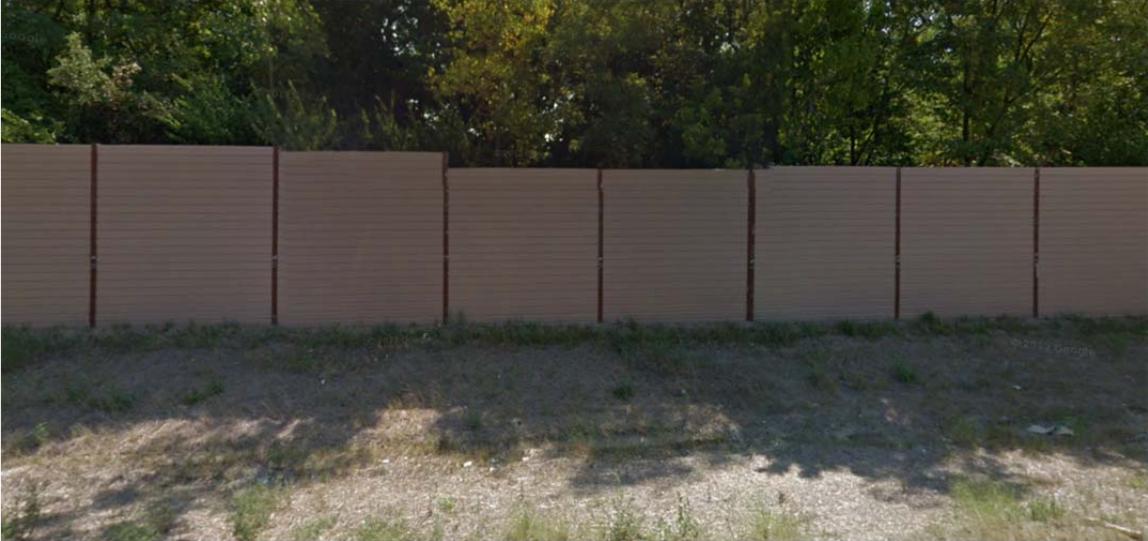
Figure 3.24. Site 11 highway view of rubber filled fiberglass wall testing location

Site 11 was a rubber filled fiberglass parallel noise barrier located in a residential area along I-675 near Indian Ripple Road. The northbound wall was chosen for analysis. The wall was approximately 13 feet tall and can be viewed in Figure 3.24. Microphones 2 through 6 at Site 11 were placed at the array distance of 25 feet behind the noise barrier while Microphones 7 and 8 were placed in front of the wall. Microphone 1 was located five feet above the wall. This configuration can be seen in Figure 3.25.

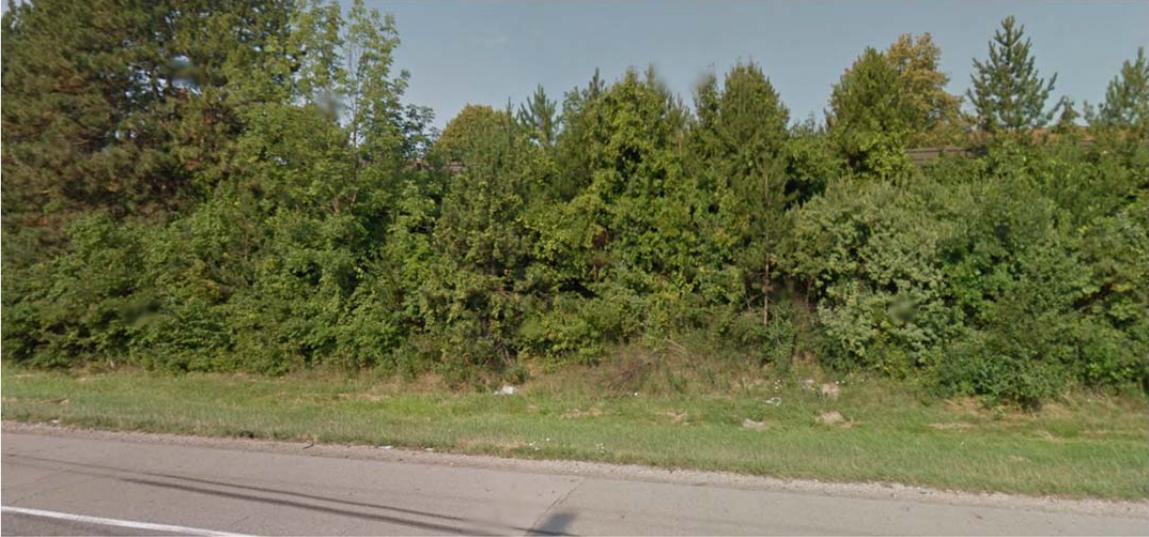
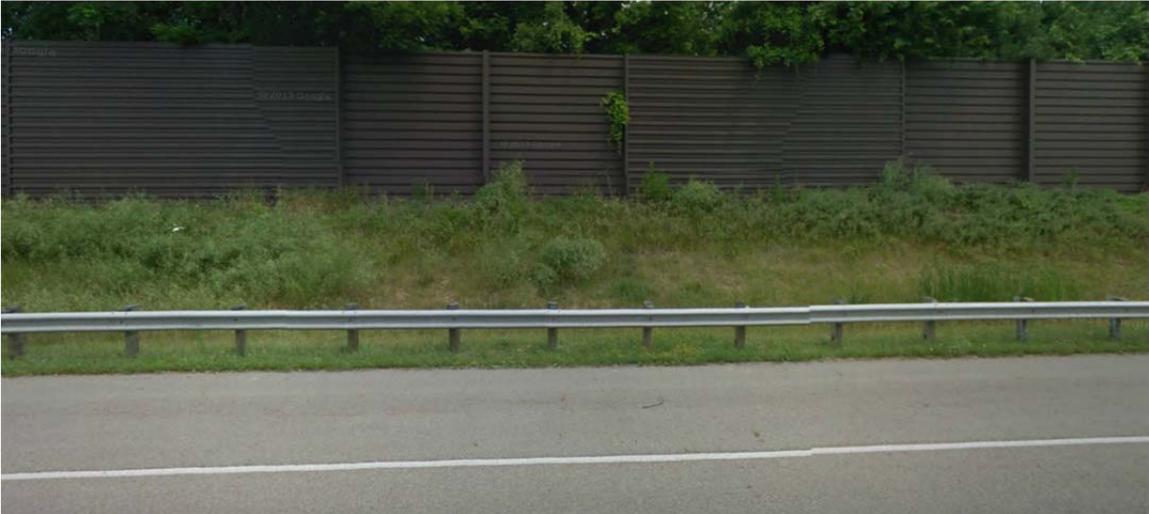
Site 12 was a steel parallel noise barrier and was located in a residential area along I-71 near Park Road. The south bound wall was chosen for analysis. Figure 29 shows the location chosen for analysis as viewed from the highway. Since the wall is not visible from the highway in Figure 3.26, Figure 3.27 was provided to show the north bound wall at the testing locations. Both of these walls are approximately 17 feet tall. Microphones 2 through 4 at Site 12 were placed at the array distance of 25 feet behind the noise barrier while microphones 5 and 6 were placed 25 feet north and south, respectively. Microphones 7 and 8 were placed in front of the wall. Microphone 1 was located five feet above the wall. This configuration can be seen in Figure 3.28.

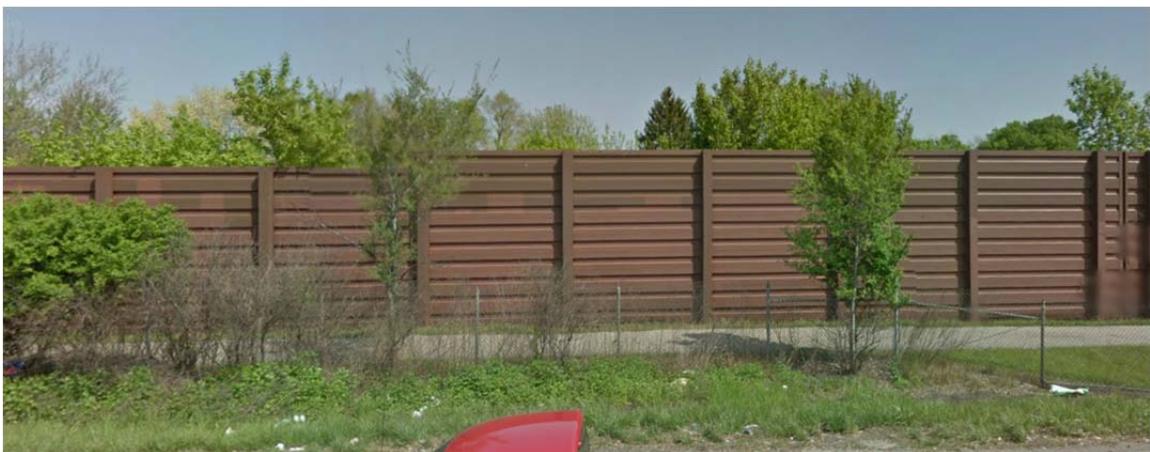
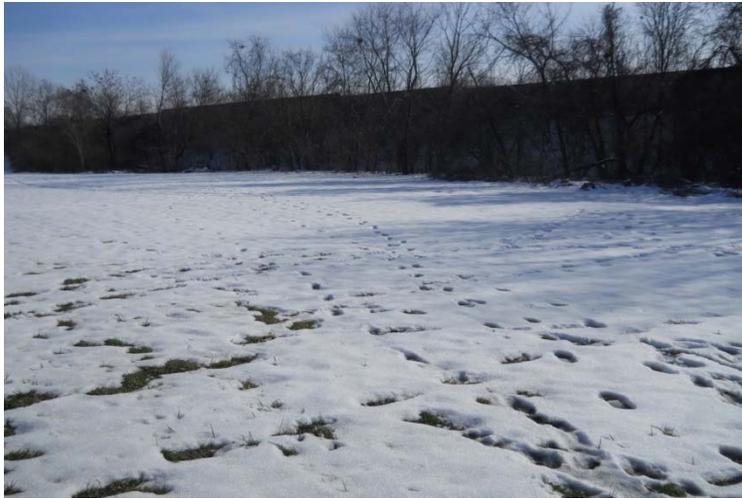
Site 13 was a steel single noise barrier located in a residential area along I-670 West near North Nelson Road. The wall was approximately 12 feet tall and can be viewed in Figure 3.29. Directly behind the barrier there was a steep decline in elevation into a flat open field this can be seen in Figure 3.30. Microphone 1 was placed on the top of the hill, while microphones 2 and 3 placed on the back side of the mound and Microphones 4, 5, and 6 were placed on flat ground behind the berm. Microphones 7 and 8 were placed in the ditch line in front of the wall along the walkway. This configuration can be seen in Figure 3.31.

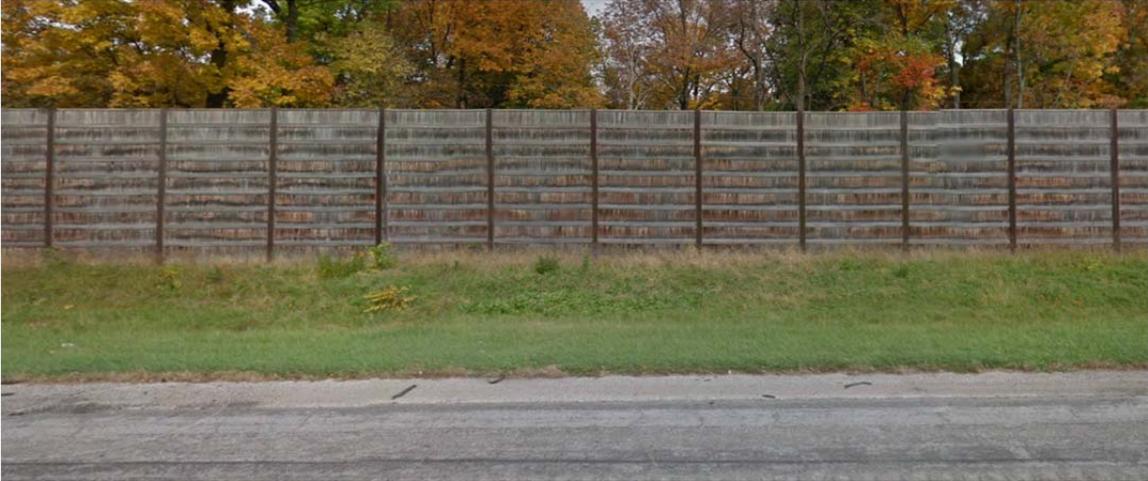
Figure 3.32. Site 14 highway view of wooden wall testing location

Site 14 was a wooden single noise barrier located in a residential area along I-70 West near Hilliard Rome Road. The wall was approximately 18 feet tall and can be viewed in Figure 3.32. Microphones 2 through 6 at Site 14 were placed at the array distance of 25 feet behind the noise

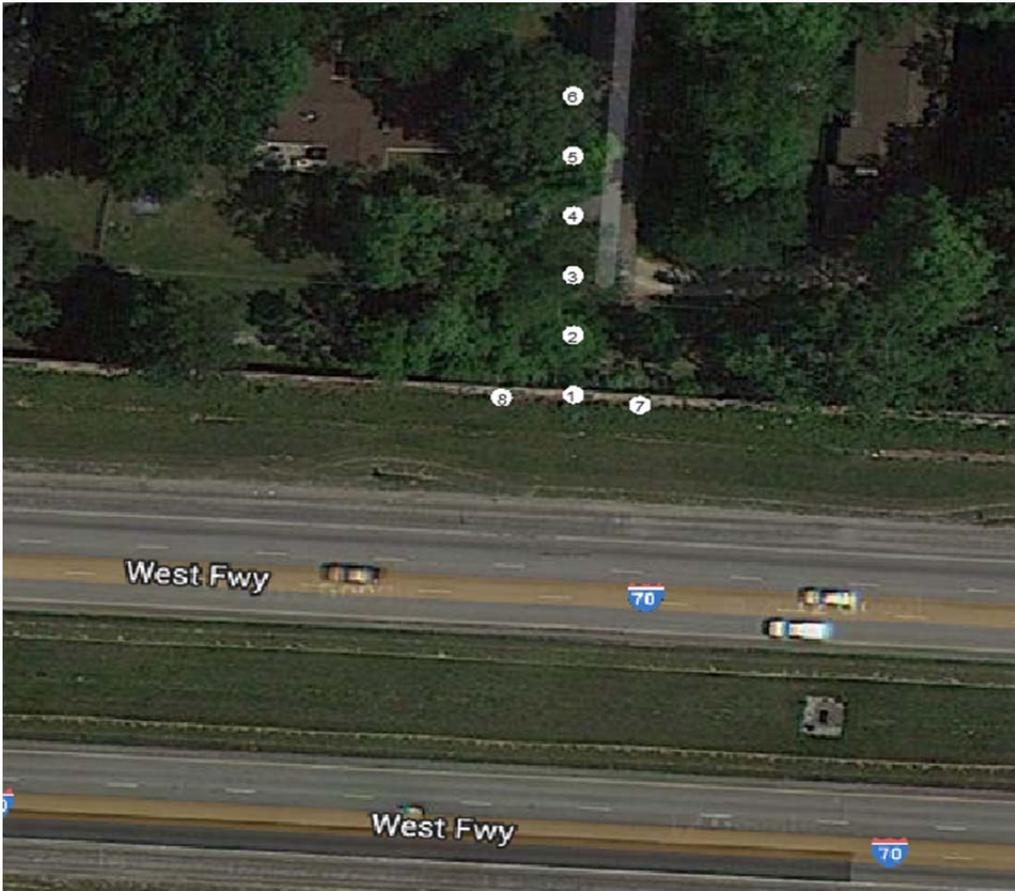
Figure 3.33. Site 14 microphone locations

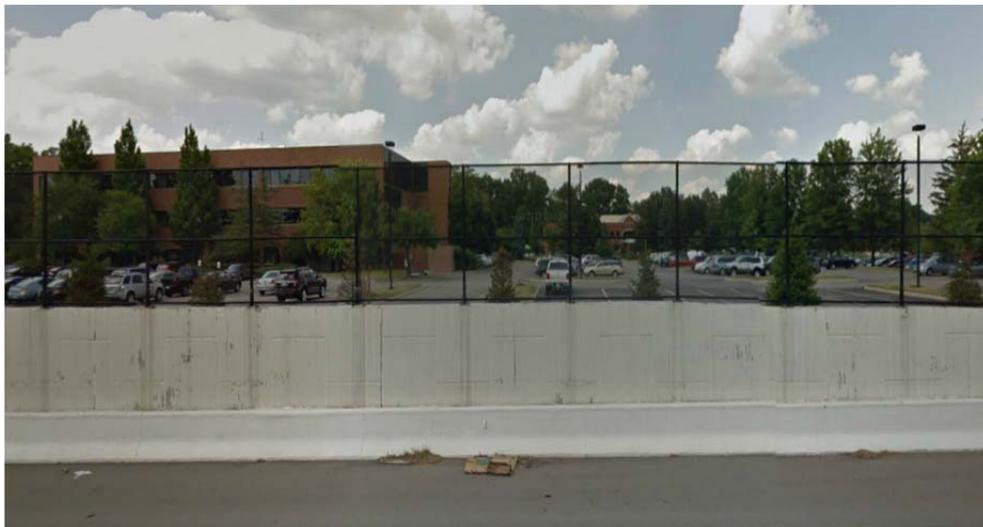
Figure 3.34. Site 15 highway view of acoustic fabric fence testing location

Site 15 was an acoustic fabric fence barrier and located in a commercial area along SR-161 Sunbury Road. The fence was a combination of a 7 foot permanent concrete wall and 10 foot tall chain-link fence. The roadside view of this structure can be viewed in Figure 3.34. Microphone 1 was located five feet above the wall, at approximately 13 feet. Microphone 2 was placed directly behind the fence at a height 3 feet. The setup for Microphones 1 and 2 was selected to measure the immediate insertion loss provided by the acoustic fabric. Microphone 3 was placed at 25 feet behind Microphones 1 and 2, while Microphone 4 was placed at 75 feet behind Microphone 1 due to the parking lot. Microphones 5 and 6 were placed at 25 feet east and west of the formation, respectively. Due to the proximity of the shoulder and traffic to the barrier wall, a microphone was not placed in front of the wall. Prior to proceeding with the placement of the acoustic fabric fence, it was determined there was no statistical difference between the noise level readings at the microphones in front of the walls (Microphones 7 and 8) and Microphone 1. Therefore, it was determined that only Microphone 1 was necessary for analysis. This configuration can be seen in Figure 3.35.

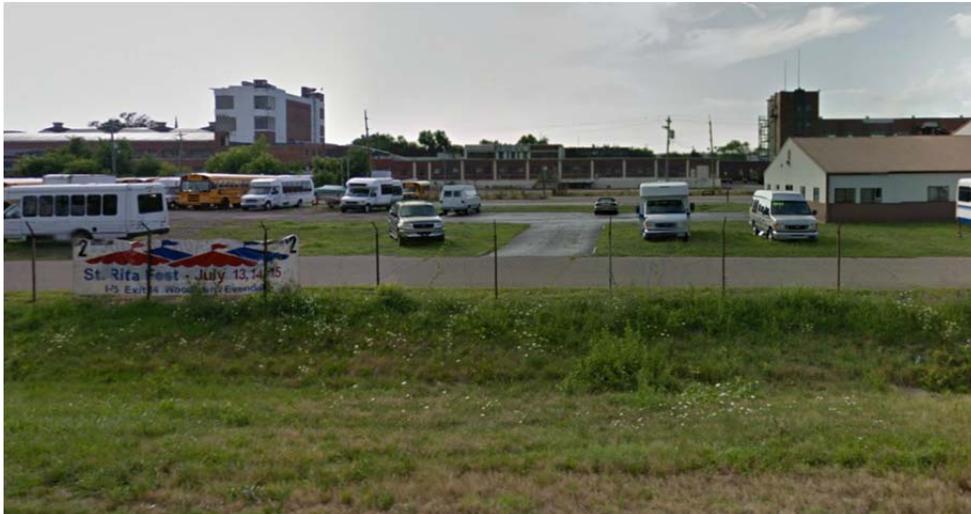
Figure 3.36. Site 16 highway view of acoustic fabric fence testing location

Site 16 was an acoustic fabric fence barrier located in an industrial area along I-75 South near Paddock Road. The fence was a 6 foot tall chain-link fence and can be viewed in Figure 3.36. Microphone 1 was mounted at a height of 11 feet directly above the fence. Microphone 2 was placed directly behind the fence at a height of 3 feet. The setup for Microphones 1 and 2 was selected in order to measure the immediate insertion loss provided by the acoustic fabric. Microphone 3 through 6 were placed at the array distance of 25 feet behind microphones 1 and 2. Prior to proceeding with the placement of the acoustic fabric fence, it was determined there was no statistical difference between the noise level readings at the microphones in front of the walls (Microphones 7 and 8) and Microphone 1. Therefore, it was determined that only Microphone 1 was necessary for analysis. This configuration can be seen in Figure 3.37.

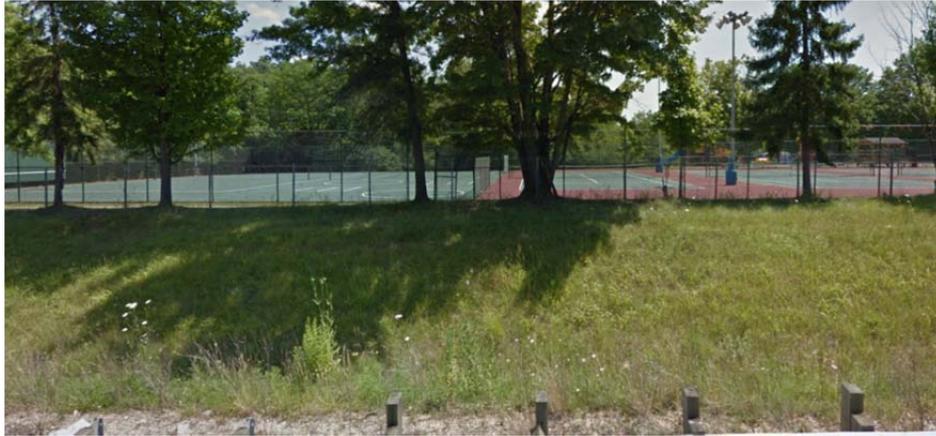
Figure 3.38. Site 17 highway view of acoustic fabric fence testing location

Site 17 was an acoustic fabric fence barrier located in a residential area along SR-126 near Kenwood Road. The fence was a 4 foot tall chain-link fence and can be viewed in Figure 3.38. Microphone 1 was located directly above the wall at a height of 9 feet. Microphone 2 was placed directly behind the fence at a height of 3 feet. The setup for Microphones 1 and 2 was selected in order to measure the immediate insertion loss provided by the acoustic fabric. Microphones 3 through 6 were placed at the array distance of 25 feet behind Microphones 1 and 2. Prior to proceeding with the placement of the acoustic fabric fence, it was determined there was no statistical difference between the noise level readings at the microphones in front of the walls (Microphones 7 and 8) and Microphone 1. Therefore, it was determined that only Microphone 1 was necessary for analysis. This configuration can be seen in Figure 3.39.

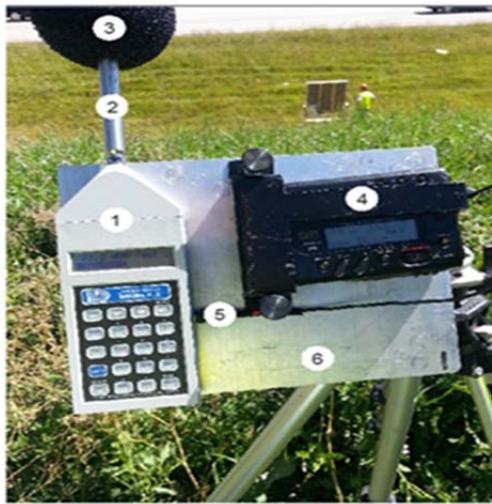
Figure 4.1. SLM and DAT setup

plate attached to a sturdy tripod. Each SLM was connected to the DAT using a 1/8-inch cable. Each SLM and DAT was numbered from 1 through 8 and paired with their corresponding number (i.e. SLM 1 paired with DAT 1). This set-up can be seen in Figure 4.1. Once the aluminum plate was placed on the tripod, the microphone head was placed at a height of five feet above the ground and at an angle of 70 degrees above horizontal [5]. The microphone was equipped with a foam wind noise reducing filter. From henceforth, the sets of SLMs and DATs will be referenced as microphones.

1. SLM
2. Preamplifier
3. Microphone
4. DAT
5. 1/8-in Cable
6. Aluminum Plate

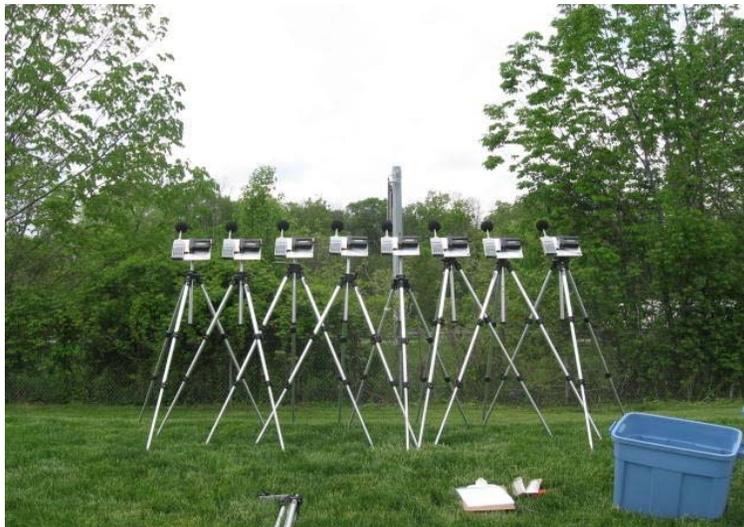
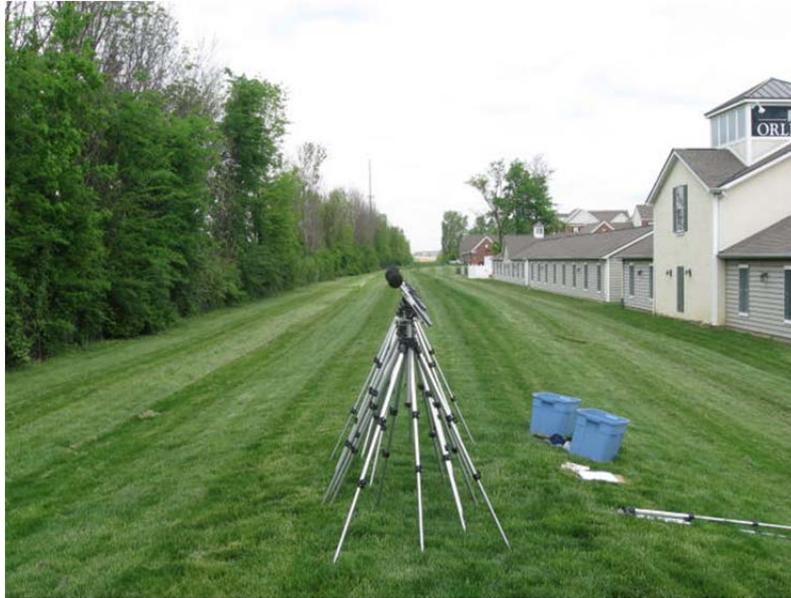
When using eight different microphones, small variations in measured sound levels between the devices were anticipated when recording the same noise source. The process of system normalization was done to negate this difference and is described herein. All eight microphones were positioned next to each other at a close distance (<1ft) and at a height of five feet above the ground parallel to the roadway. They were positioned like this so that each set was exposed to the same traffic noise at the same time. This set-up can be seen in Figure 4.3 and Figure 4.4. A fifteen minute recording session was completed and then was analyzed using the RTA to find the microphones 1/3-octave frequency bands. Microphone 1 was selected to be the master and was compared to Microphone 2 through Microphone 8. Each of the seven comparisons equated to a correction factor for the remaining sets. These correction factors are used to calculate levels recorded by Microphone 2 through Microphone 8 corresponding to the same values recorded by Microphone 1. Normalization factors for each of the eight recording sets were embedded in the analysis spreadsheet used to finalize the acoustic data.

Figure 4.3. Front view of system normalization

Figure 4.4. Side view of system normalization

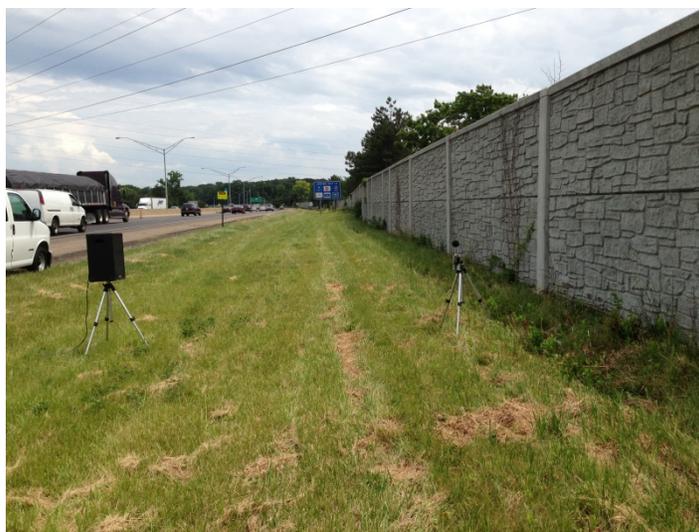
All test equipment was located in the roadside areas between the edge of pavement and the noise barrier. Two categories of test equipment were utilized: noise sending and noise receiving. The noise sending equipment consisted of a power supply, a digital audio tape (DAT) and player containing the test signals, an amplifier, and a loudspeaker to broadcast the test signals. The receiving equipment consisted of sound level meters, complete with microphones and preamplifiers, DAT recorders to store the received noise. The received noise (a mix of traffic noise and test signals) was obtained from the preamplifier for direct transfer to the DAT. The sound level meters were only used for monitoring and reference during the measurements. The microphones, for all tests, were located between the loudspeaker and the noise wall as shown in the photo, Figure 4.6. Two separate sections of the noise barrier were selected at each location to better sample barrier performance. Each test consisted of a calibration tone followed by 20 repetitions of the test signals. From the six barrier sites distributed in Franklin and Hamilton Counties, a total of 34 separate data sets were obtained after disqualified tests had been eliminated. Each data set involved 20 test signal measurement samples.

Figure 4.6. Absorptive and Reflective Material Testing

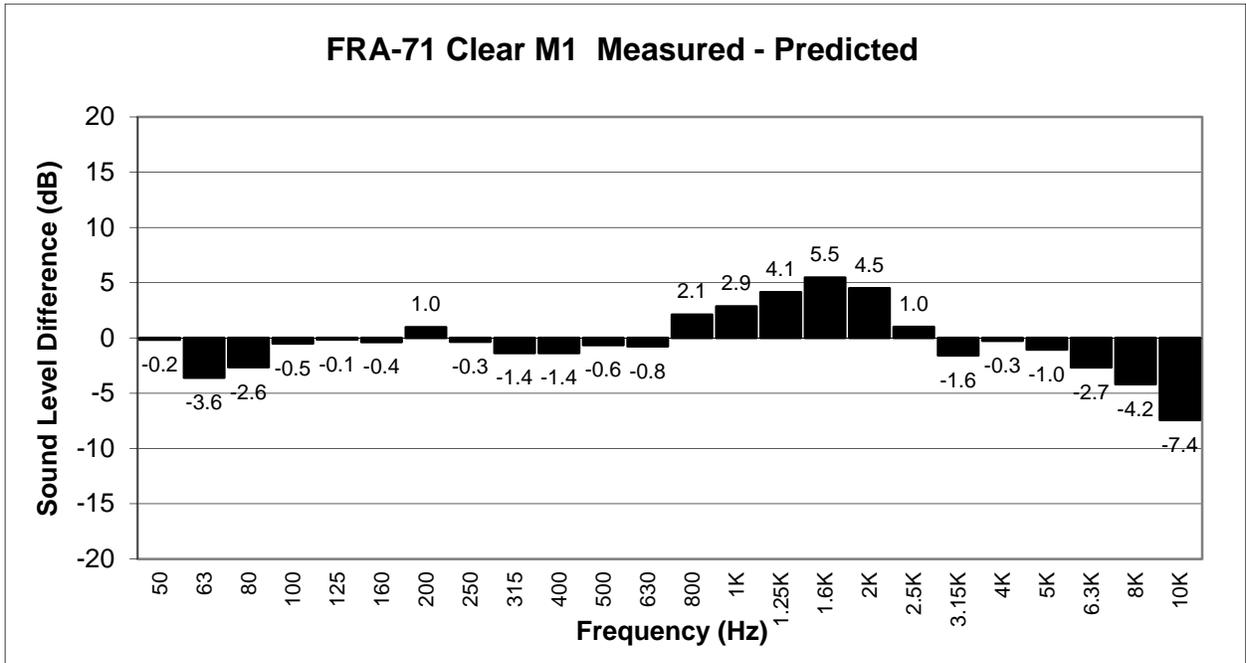
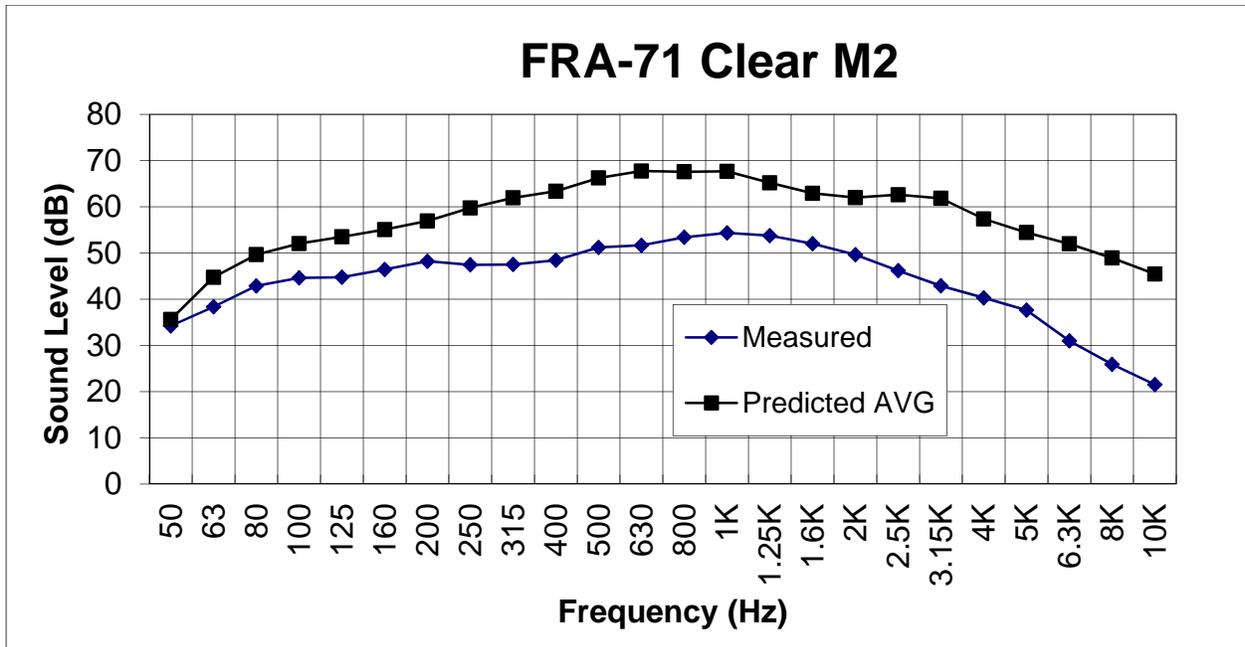
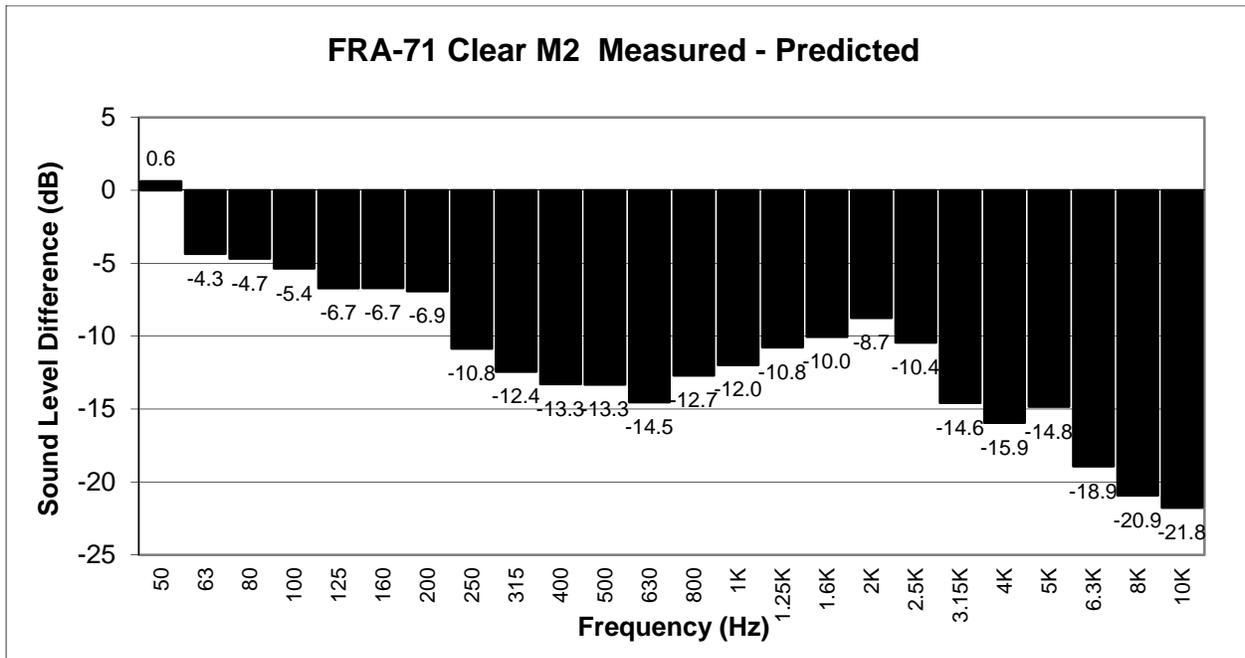
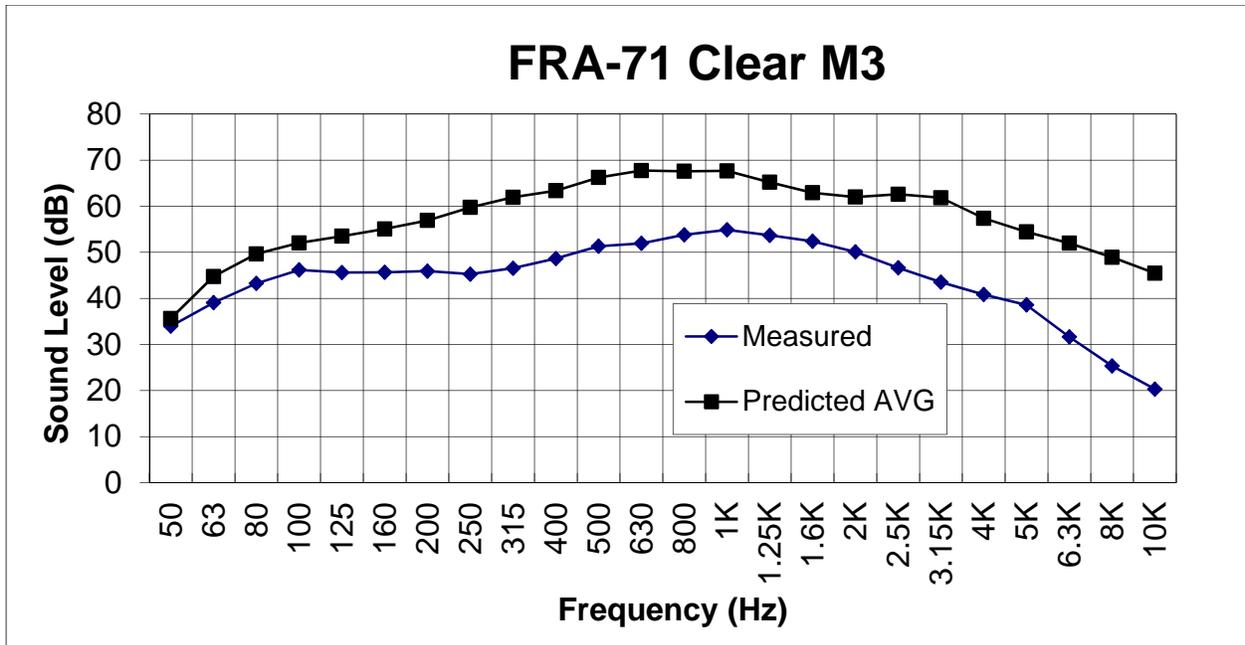
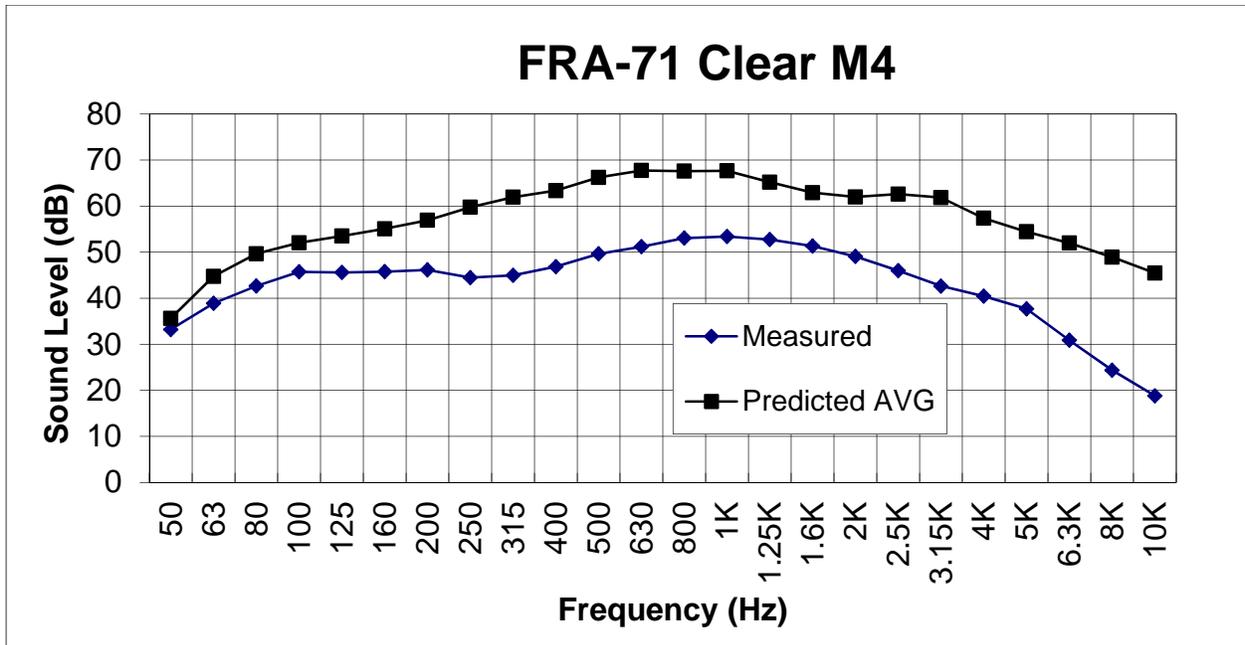
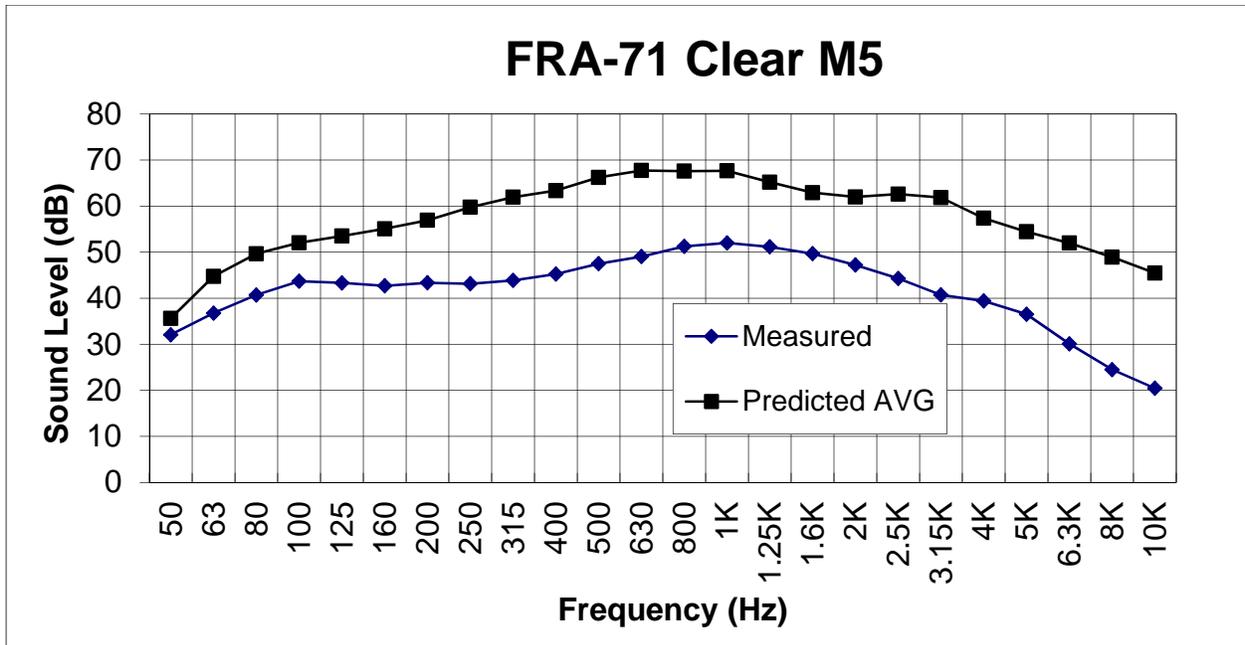
One-Third Octave Band Frequency Levels by Site and Microphone Location
