AN OVERVIEW OF JOINT DETERIORATION IN CONCRETE PAVEMENT

Mechanisms, Solution Properties, and Sealers

AN OVERVIEW OF JOINT DETERIORATION IN CONCRETE PAVEMENT: MECHANISMS, SOLUTION PROPERTIES, AND SEALERS

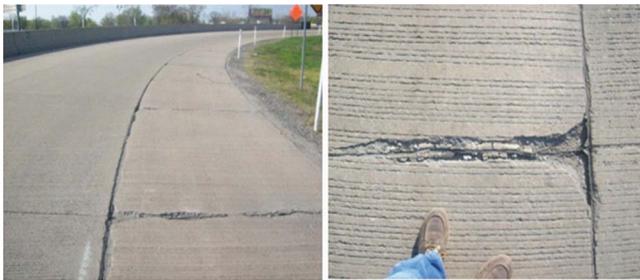
Figure 1.1 Field observation showing damage in pavement joints.

Figure 1.1 provides photographs showing the typical pavement joint damage that is being discussed in this report (12,13). This type of damage is frequently seen as one of two types of damage. The first type of damage consists of small cracks that progressively spall off; these cracks are parallel to the saw-cut face at fractions of an inch from the saw cut face. The second type of damage consists of the development of cracking parallel to the joint or spalling; the damage begins with a hollowed out region at the bottom of the saw cut, resulting in a crack to the surface of pavement that is typically four to six inches from the edge of the joint. Unfortunately, damage is not frequently observed at the surface of the pavement until a significant amount of damage has occurred inside the joint. During field inspections it has been observed that where the joints are damaged, the sealant is damaged and the joint contains a significant amount of standing water (or fluid), as shown in Figure 1.2. The pavements in Figure 1.2 were examined in 2005. The material in the pavement exhibited a complete destruction of the matrix while the aggregate remained intact. It should be noted that it had not rained for nearly two weeks; however, fluid was standing in the joint. It is important to note that while this damage is more likely to occur in pavements with poor air entrainment, damage occurs in both poorly air entrained and properly air entrained concrete.

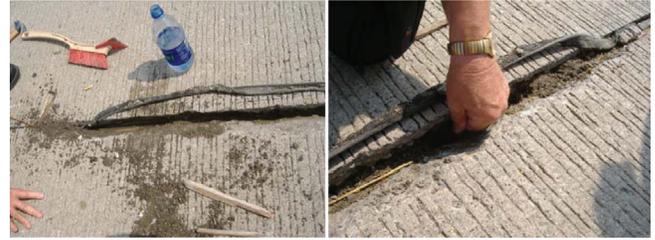
Figure 1.2 Field observation showing damage in pavement joints containing water.

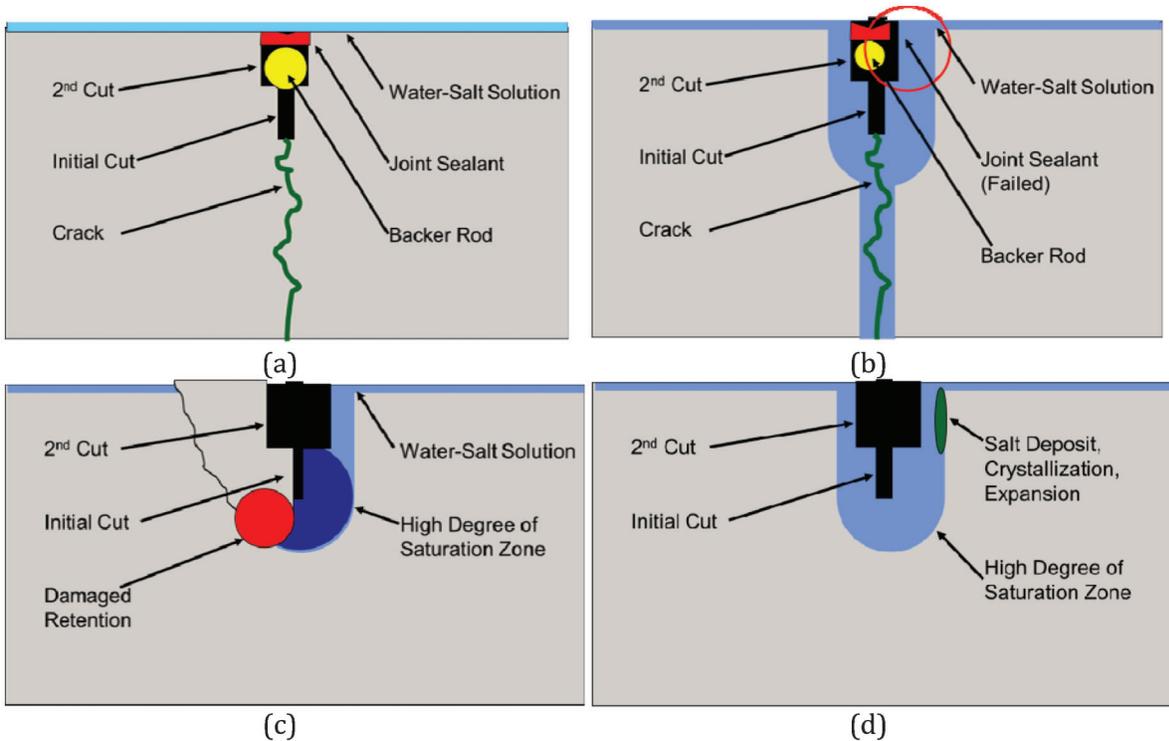
Figure 1.3 Potential degradation hypothesis: (a) an ideal joint; (b) a joint with damaged joint sealant but cracked; (c) a joint with damaged joint sealant that is uncracked; and (d) a joint illustrating potential salt crystallization locations.

Figure 1.3 illustrates a proposed series of mechanisms that appear to be partially responsible for this damage (1). In Figure 1.3 (a) D-1 construction joint is illustrated that is typical of that used by the Indiana DOT. The joint is created by saw-cutting the pavement shortly after placement with a single cut that is approximately 1/3 the depth of the pavement. The intention of this saw-cut is to provide stress relief, which can allow cracks to form at these locations. A

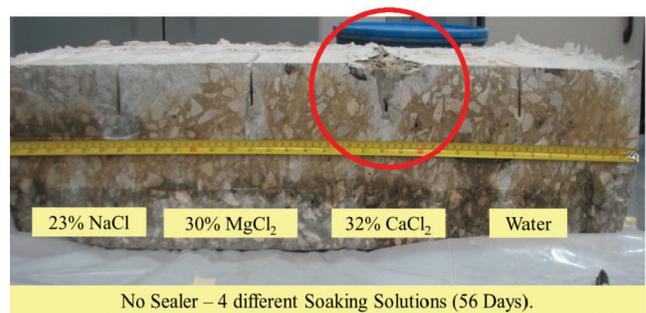
Figure 1.4 Damage development due to drying and wetting with deicing salts.

For example, Figure 1.4 illustrates the behavior of salts under only drying and wetting and it can be noticed that even in cases where freezing may not be occurring, damage can develop at the joint. At the current time this appears to be consistent with salt crystallization during drying and wetting or formation of an alternative phase (16); however, this mechanism has not been studied in great detail for pavement joints.

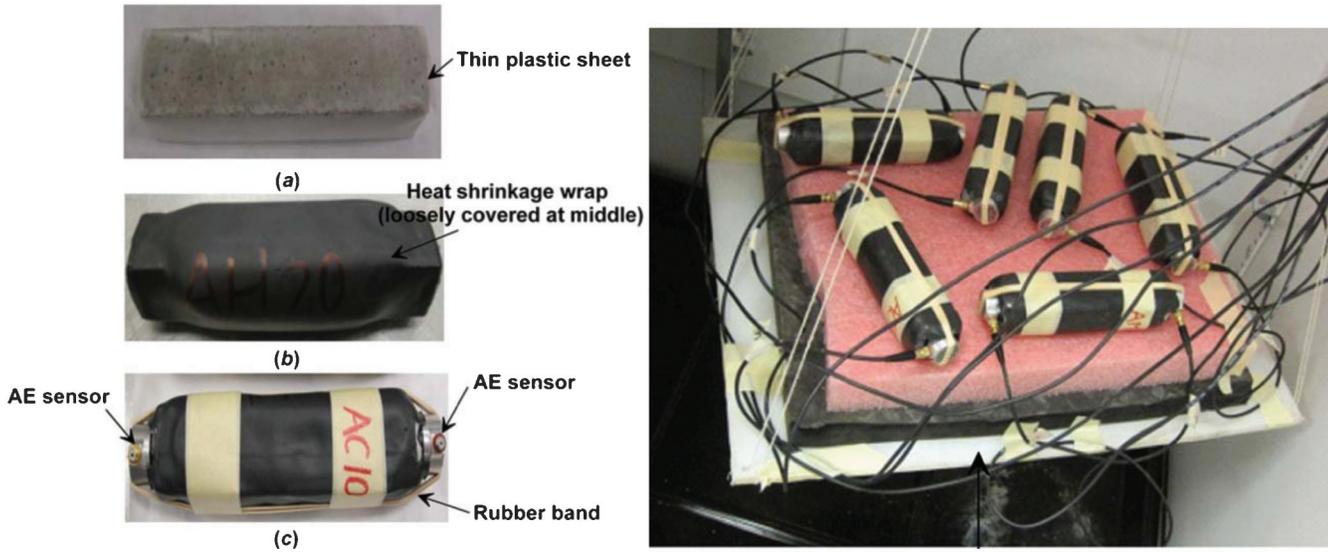
Figure 2.1 Left: preparation of specimens for AE testing during freeze-thaw cycle, and right: specimens placed on a suspended base to eliminate vibration and noise from surrounding environment (inside of freeze-thaw chamber) (33).

Figure 2.1 shows the procedure used for preparing the specimens for acoustic emission (AE) testing during freeze-thaw cycles. After saturating the specimens they were wrapped with a thin plastic sheet and then sealed with a loose fitting “heat shrink wrap” to further protect the specimens against moisture exchange with surroundings (prevent them from absorbing or releasing water during the freeze-thaw process keeping the degree of saturation constant). The AE sensors (transducers) were attached on the two ends with a thin layer of vacuum grease. All the specimens were placed on a suspended base in testing to minimize noise/vibration transmission from surrounding environment (Figure 2.1(d)). Each day, one cycle of freezing and thawing was applied. The temperature was controlled to vary from $10 \pm 1^\circ\text{C}$ to $-18 \pm 1^\circ\text{C}$. The rate of the temperature change was 14°C/h resulting in a 2-h transition period and two 10-h periods at $10 \pm 1^\circ\text{C}$ and $-18 \pm 1^\circ\text{C}$, respectively.

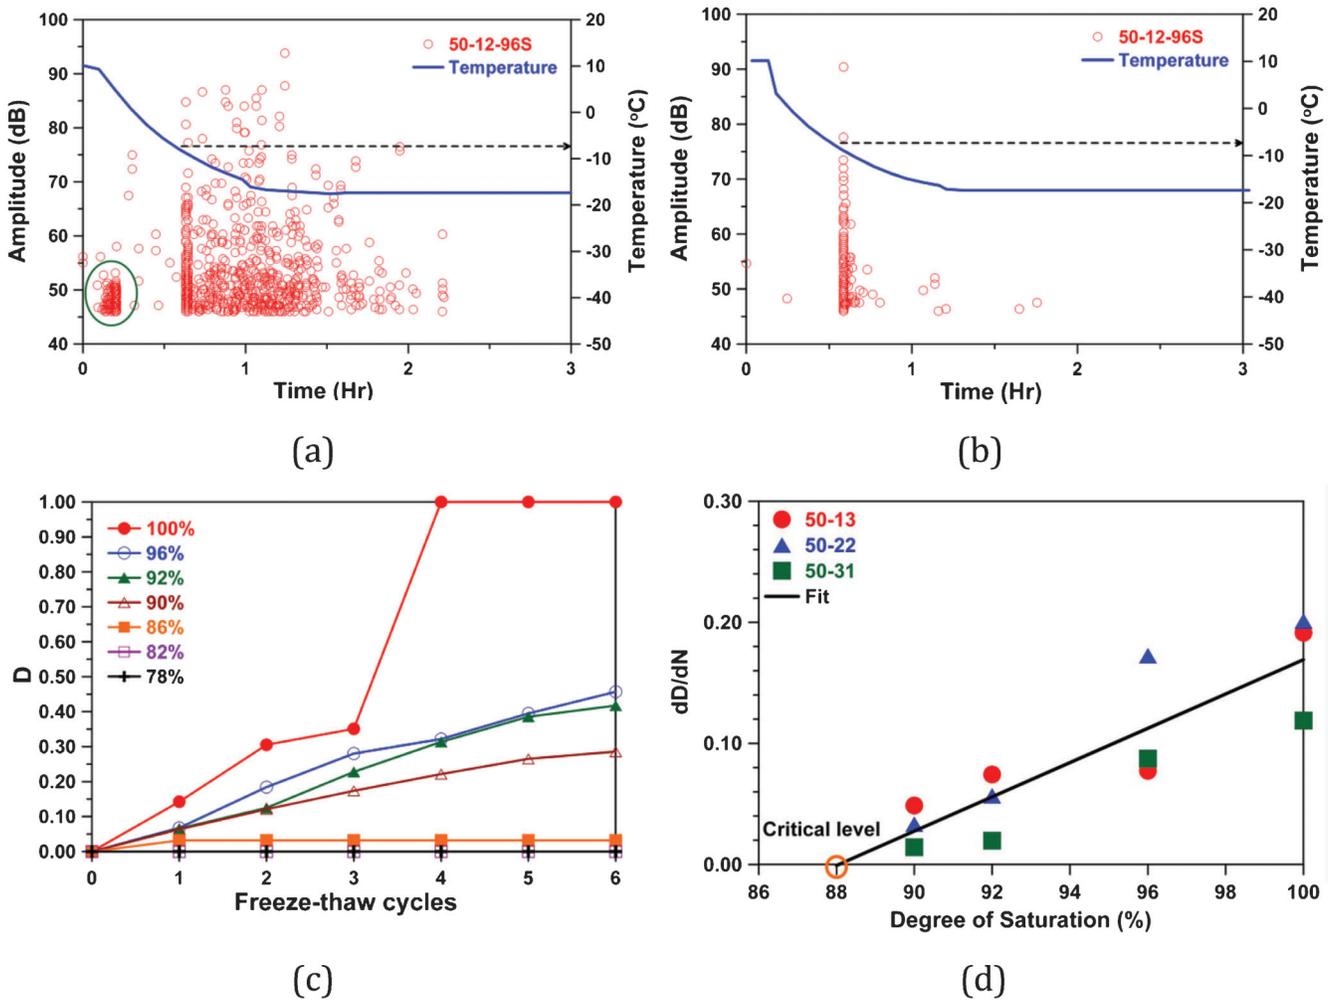
Figure 2.2 (a) Amplitude distribution for the first freeze-thaw cycle; (b) the amplitude distribution during the second freeze-thaw cycle; (c) decrease of the relative dynamic elastic modulus with freeze/thaw cycles of the specimen with 13% air content by volume of the paste; and (d) rate of decrease of relative dynamic elastic modulus with degree of saturation for different air content by volume of paste (33).

Figure 2.2 (a) and (b) shows the amplitude of the acoustic events as a function of time for a specimen with 96% degree of saturation and 13% air content (in the mortar) during first and second freezing cycle. This figure also shows the temperature at the center of the mortar specimen and the AE events that have occurred. A cluster of AE events is shown in Figure 2.2 (a) using the green ellipsoid during first cycle. This cluster of data is not seen during the second cycle in Figure 2.2 (b). These events can be attributed to micro-cracking of the specimen because of the thermal loading, which may be a result of temperature gradient or a result of thermal

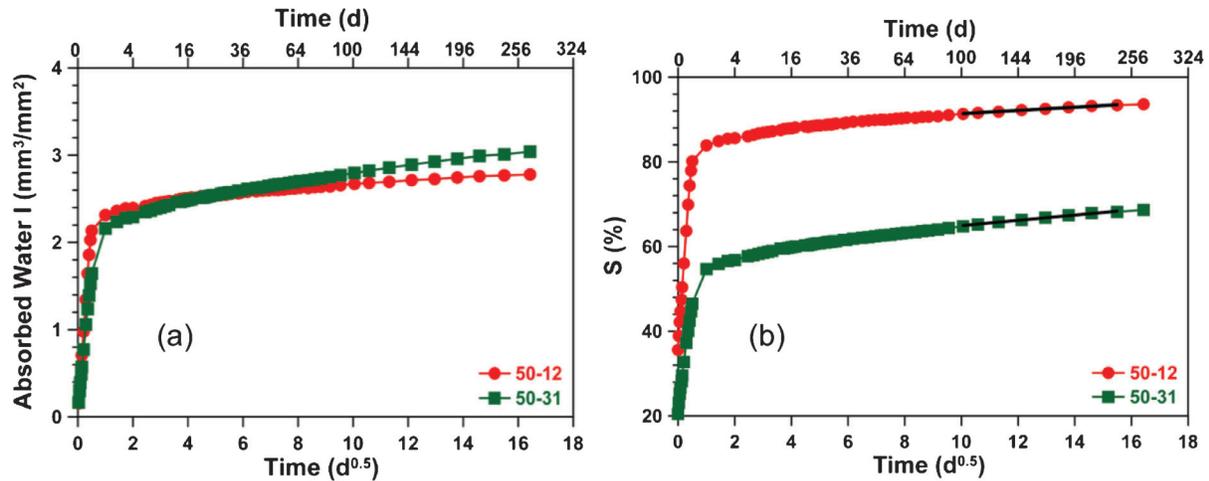
Figure 2.3 (a) Effect of air content by volume of paste and initial moisture on water absorbed for samples conditioned at 50% RH; (b) results of sorption test provided as increase in the degree of saturation for samples conditioned at 50% RH (33).

Figure 2.3 (a) illustrates the sorption results for the specimens with the low (13%) and high (31%) air contents. The specimens show a similar sorptivity (rate of water absorption or the slope of the curve) however, over time the specimens with higher volumes of air absorb more water. This occurs because the air voids provide space for water (43); however, the diffusion of air and the overpressure in the air bubbles slow the water absorption which corresponds to the long time to saturation (18,45). Figure 2.3 (b) shows data from Figure 2.3 (a); however, the vertical axis is plotted in terms of degree of saturation (S). The horizontal axis is shown as the square root of time while the upper horizontal axis corresponds to the actual time. The most striking feature of the graphs is the fact that at the same time the degree of saturation is substantially lower in the specimens with entrained air. At the end of the initial 6-h sorption period, samples with lower air content show higher degree of saturation. This suggests that for an equal time of exposure to water, the specimen with the higher air content has a lower degree of saturation. The secondary rate of increase in degree of saturation can be fitted with a linear function to estimate the amount of absorbed water over a long period of time. This implies that the non-air entrained concrete (red points in Figure 2.3 (b)) would be critically saturated after less than a week while the air entrained concrete would take 6 years to reach critical saturation under these conditions. This difference may

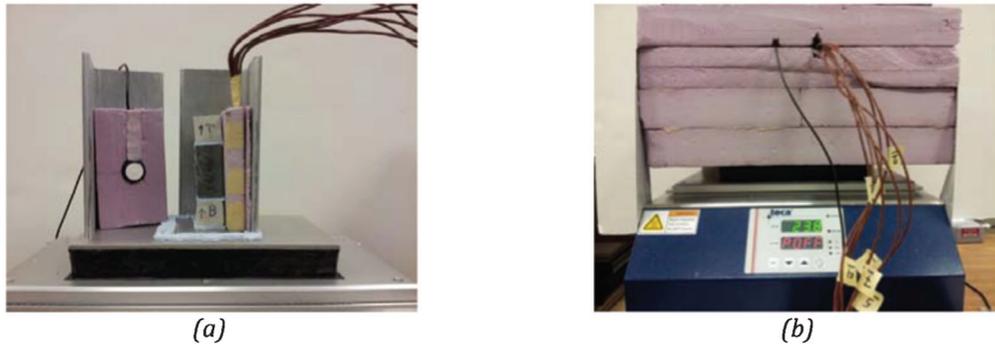
Figure 2.4 Experimental setup: (a) mortar sample and Pyroceram specimens on the two stage cold plate; (b) entire experimental setup with insulation and AE sensor (16).

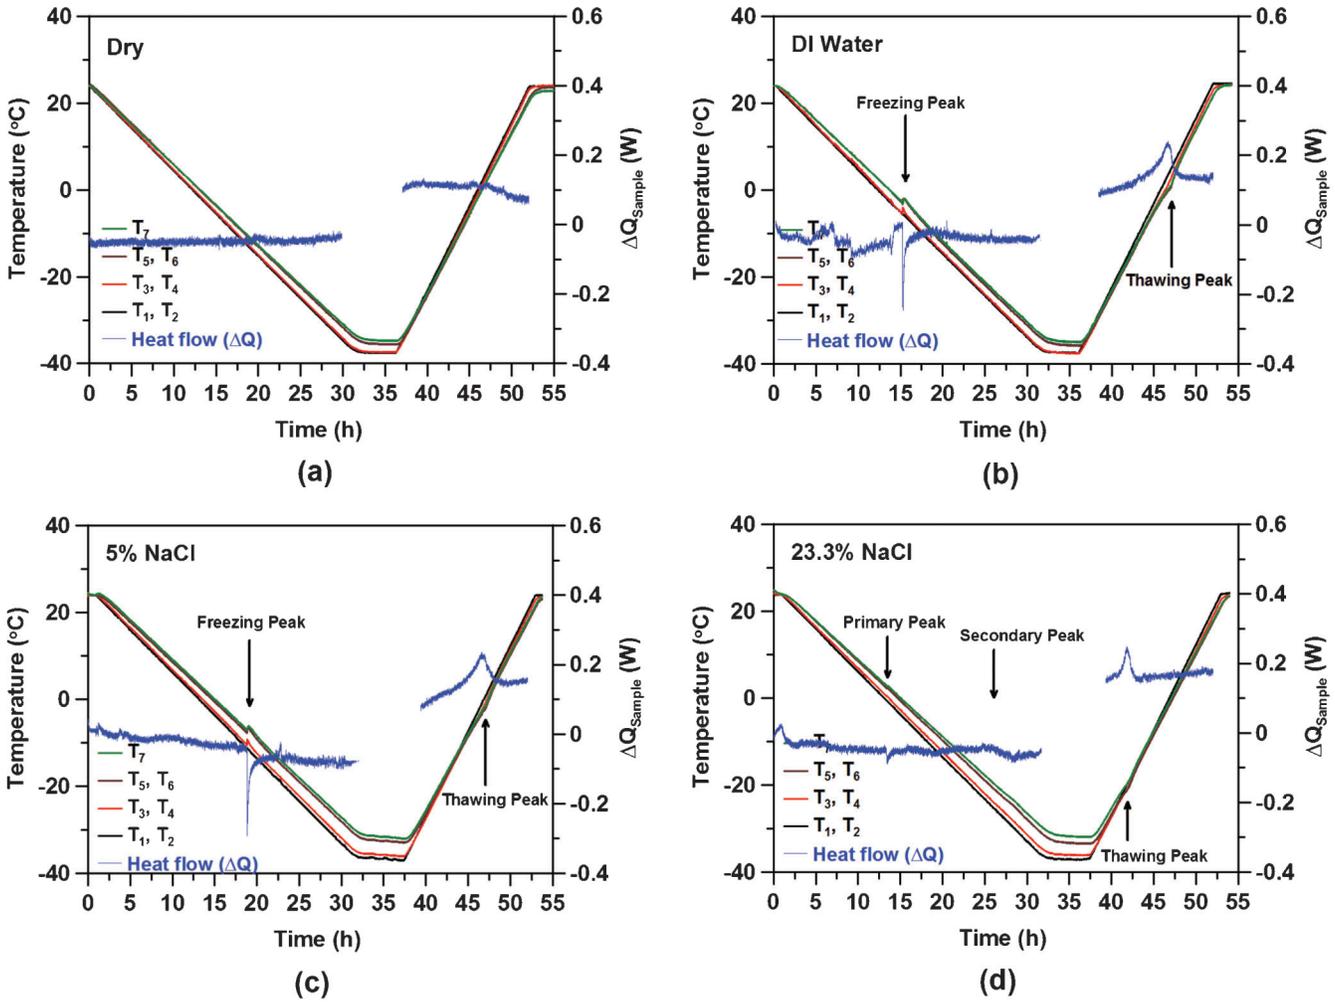
Figure 2.5 Temperatures of sample and Pyroceram meter bars at different locations together with corresponding consumed/ released heat flow (ΔQ_{Sample}) versus time (16).

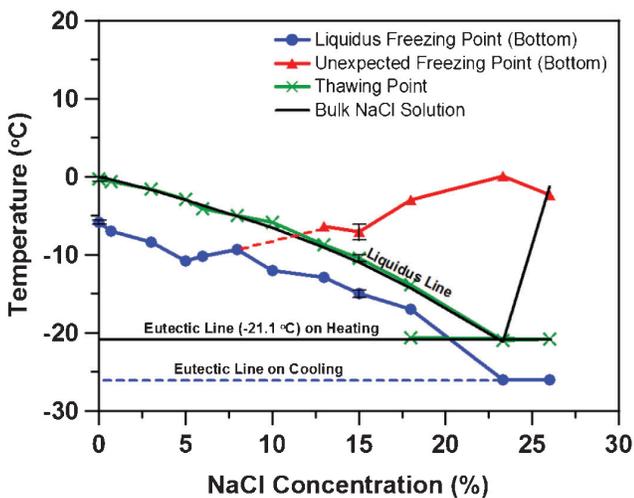
Figure 2.6 Freezing and thawing points of samples saturated with different NaCl solutions compared to the freezing points of bulk NaCl solution (16).

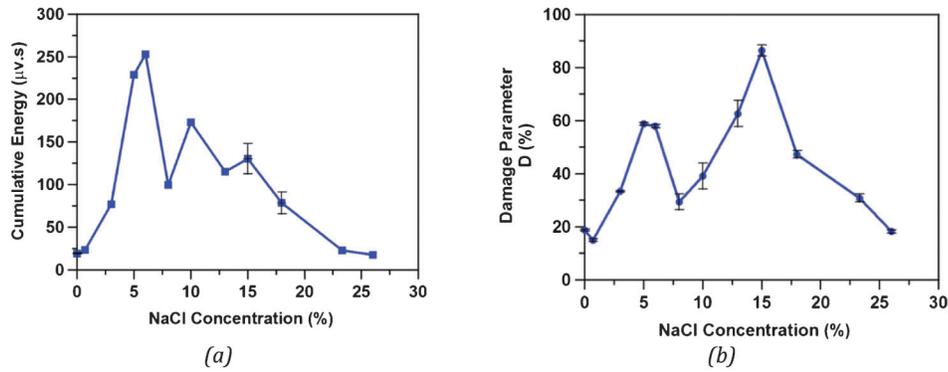
Figure 2.7 Total cumulative acoustic energy due to freeze/thaw damage (a) and decrease of the relative dynamic elastic modulus (damage parameter) due to freeze and thaw damage (b) for samples saturated with different NaCl solutions (16).

Figure 2.7 (a) shows the total cumulative acoustic energy recorded during one freeze-thaw cycle for samples saturated with different concentrations of NaCl solution. The damage index (D) for mortar samples is also shown in Figure 2.7 (b). It should be noted that the amount of damage varies with the concentration of NaCl solution. Two levels of high damage or AE activity (i.e., humps) can be seen. The damage that occurs at the lower concentrations of NaCl solution may be similar to what was observed during scaling tests, where more damage occurred due to a

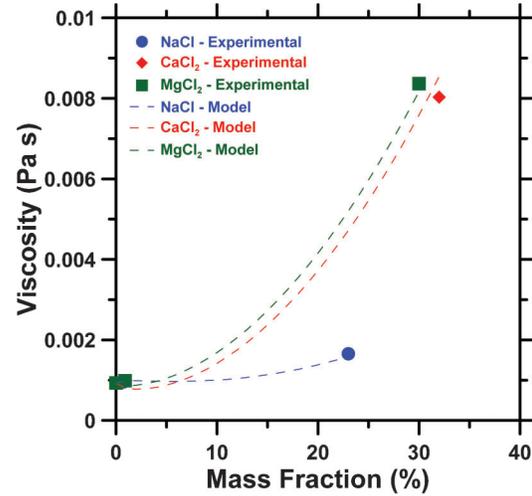
Figure 3.1 Viscosity as function of mass concentration for salt solutions at 23°C (32).

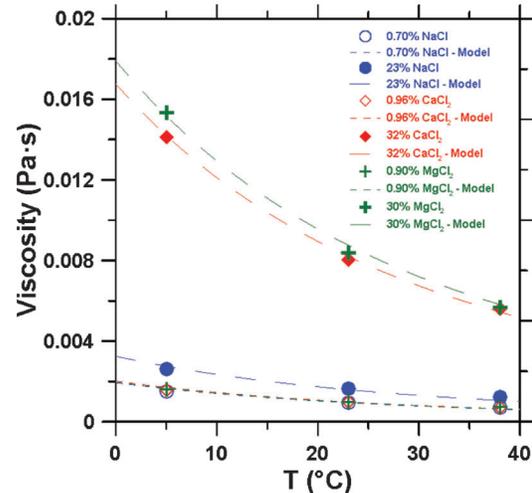
Figure 3.2 Effect of temperature on viscosities of salt solutions (32).

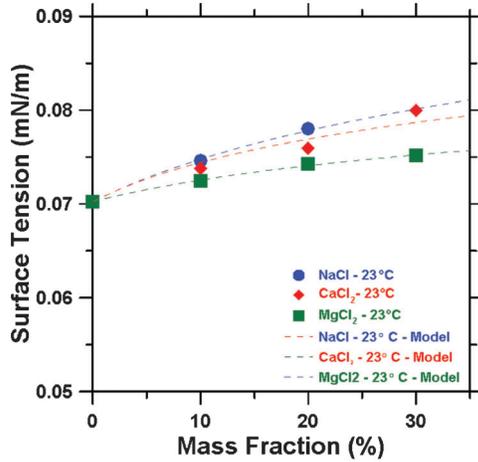
Figure 3.3 Surface tension measurements for different salt solutions at 23°C (32).

Surface tension measurements performed at $23 \pm 1^\circ\text{C}$ are shown in Figure 3.3. In Figure 3.3, the curves were obtained by fitting the Szyszkowski equation to experimental values of surface tension. In Figure 3.4,

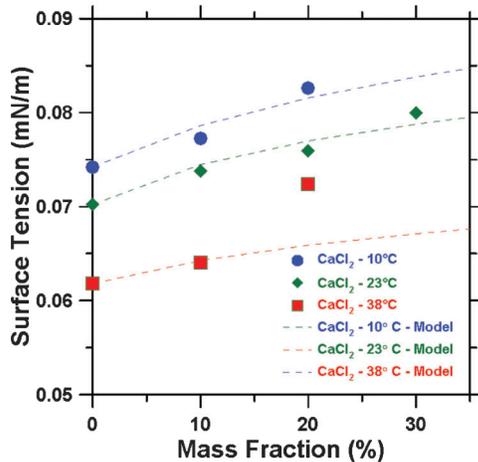
Figure 3.4 Influence of temperature on surface tension measurements for CaCl₂ solutions (72).

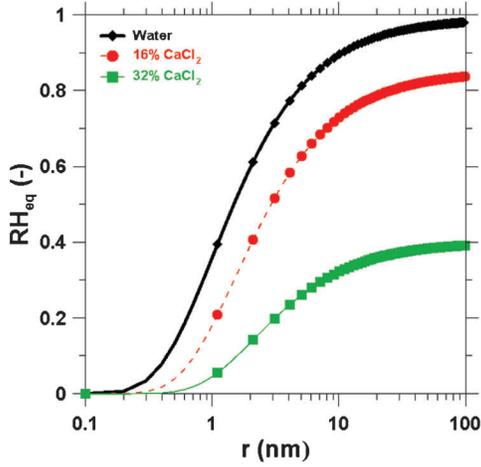
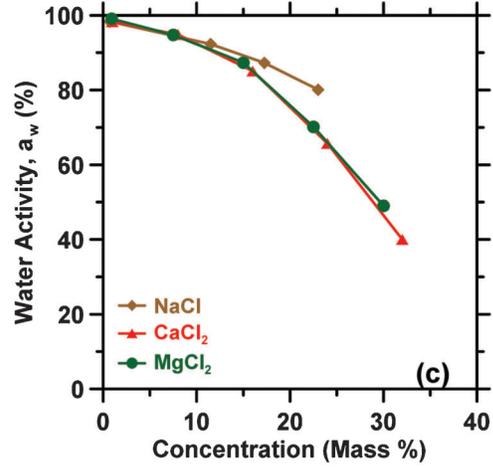
The equilibrium relative humidity (RH_{eq}) as a function of the pore radius is presented in Figure 3.5 (a) for the case of calcium chloride solutions. Specifically, the increase of surface tension and the decrease of water activity cause a decrease in the equilibrium relative humidity. The equilibrium relative humidity can be thought of as the boundary between evaporation ($RH < RH_{eq}$) and condensation ($RH > RH_{eq}$) (63). A decrease in RH_{eq} corresponds to a lower

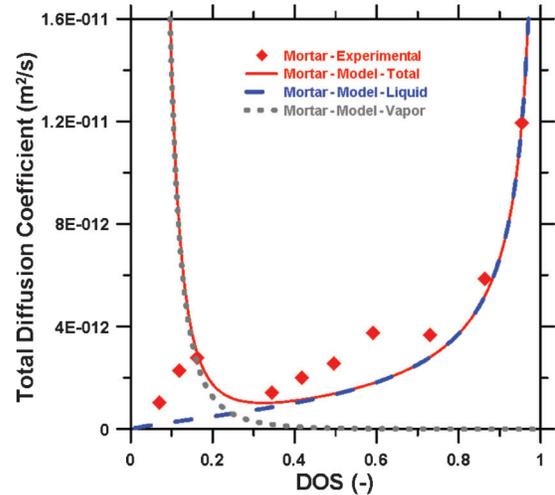
Figure 3.6 Vapor, liquid and total diffusion coefficient for mortar samples initially submerged in water.

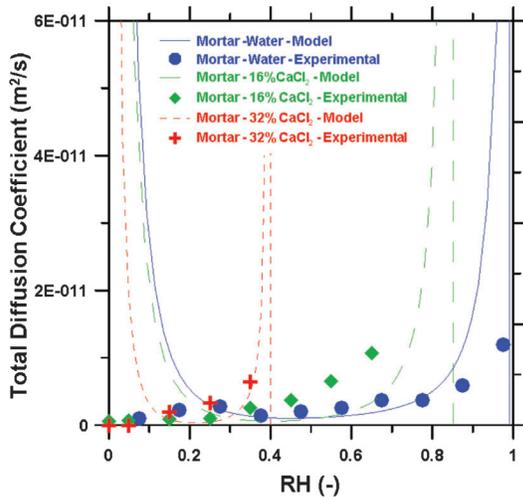
Figure 3.7 Total diffusion coefficient of mortar samples submerged in water and calcium chloride solutions.

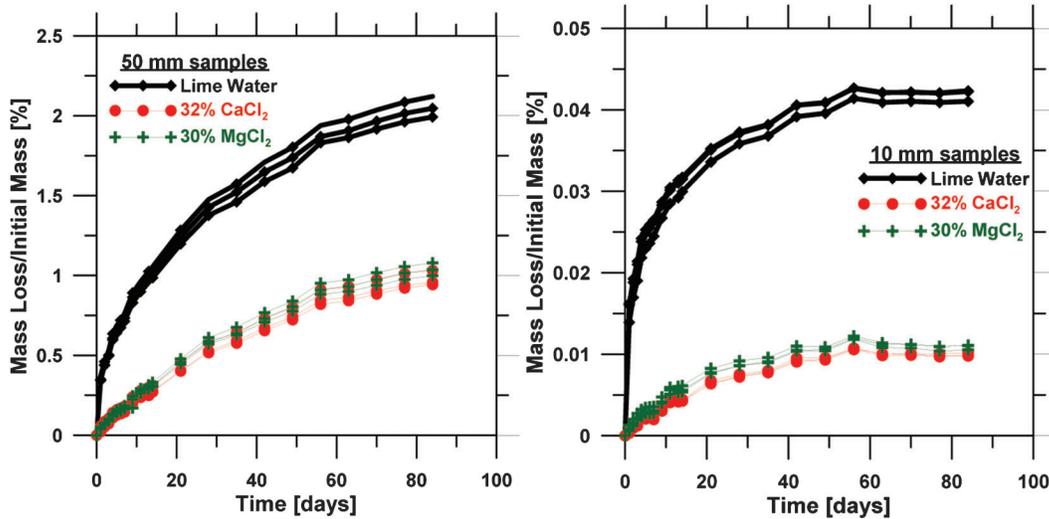
Figure 3.8 Mass loss from drying test for samples saturated with water, calcium chloride and magnesium chloride solutions.

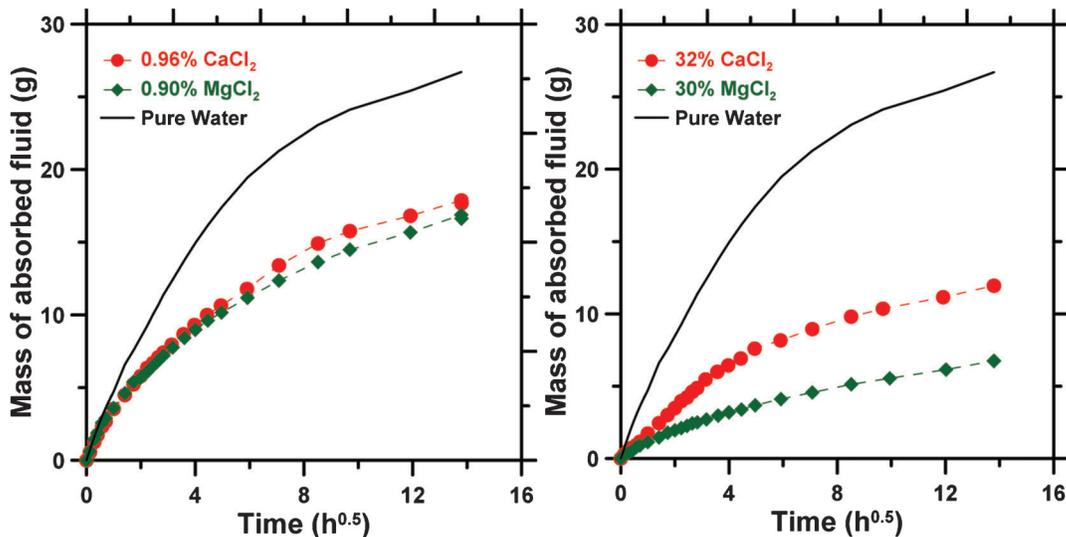
Figure 3.9 Sorptivity tests conducted on samples conditioned at 50% RH using different type of deicing salts (calcium chloride and magnesium chloride) in different concentration (31).

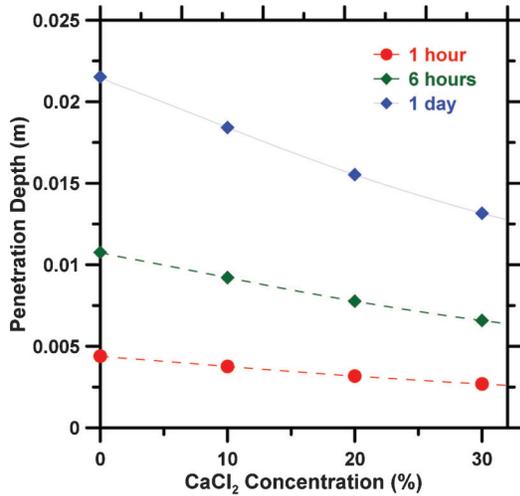
Figure 3.10 Penetration depth as function of calcium chloride solution concentration after 1 hour, 6 hours and 1 day of exposure to fluid absorption.

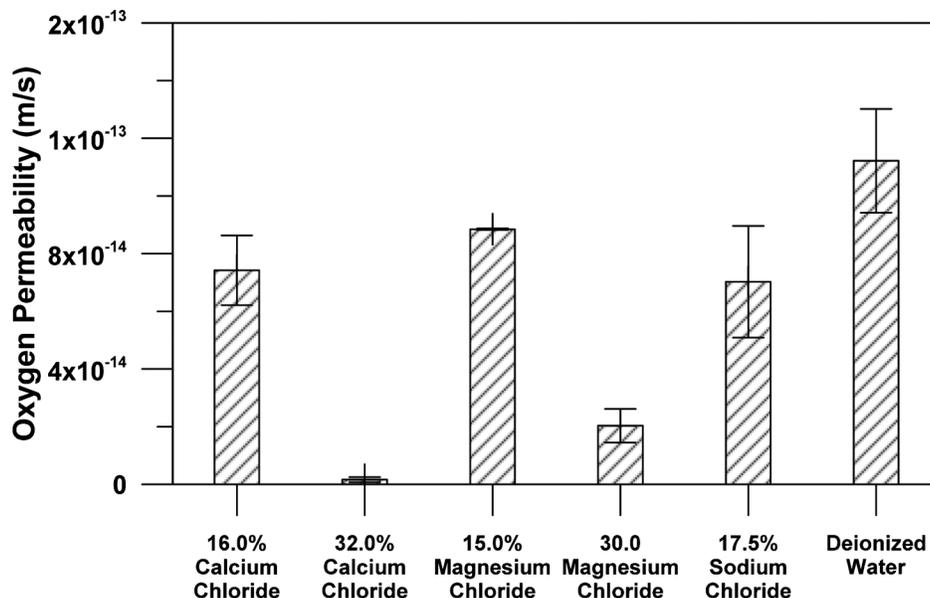
Figure 3.11 Oxygen permeability results for samples initially submerged in high and intermediate deicing salt solution concentration.

It is apparent from Figure 3.11 and Figure 3.12 that despite samples were all conditioned at the same relative humidity (65% RH), the samples that contained salt solutions showed a higher degree of saturation at equilibrium. When the degree of saturation increases a reduction is observed for both the oxygen permeability and diffusivity. A decrease in the case of oxygen diffusivity can be seen when the DOS is higher than 60% since the main vapor filled pores involved in gas transport are becoming filled with fluid and the vapor phase is becoming disconnected. This is in accordance to previous research results that related the degree of saturation with transport properties (93). The lower degree of saturation seen in the case of magnesium chloride might be related to the slightly lower

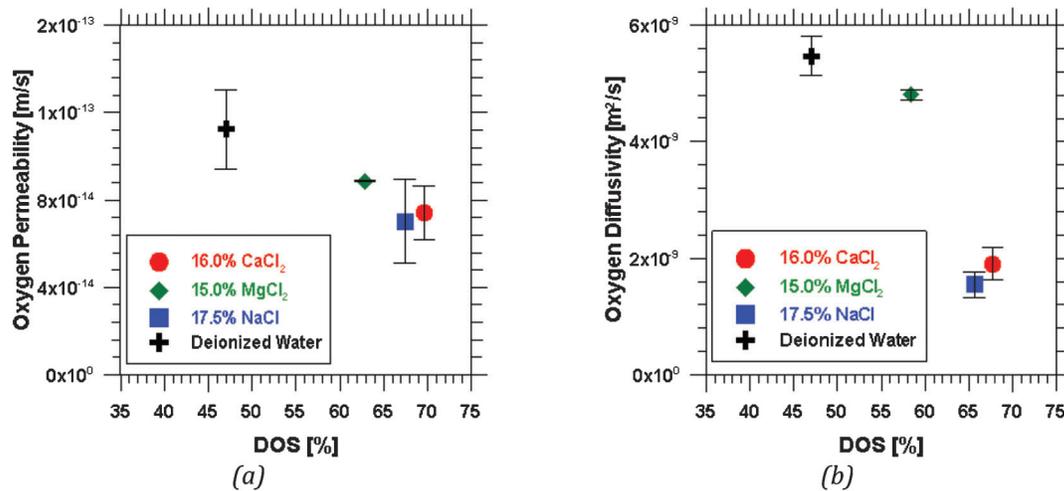
Figure 3.12 (a) Oxygen permeability results and (b) oxygen diffusivity results as function of the degree of saturation for samples initially submerged in intermediate concentration deicing salt solutions.

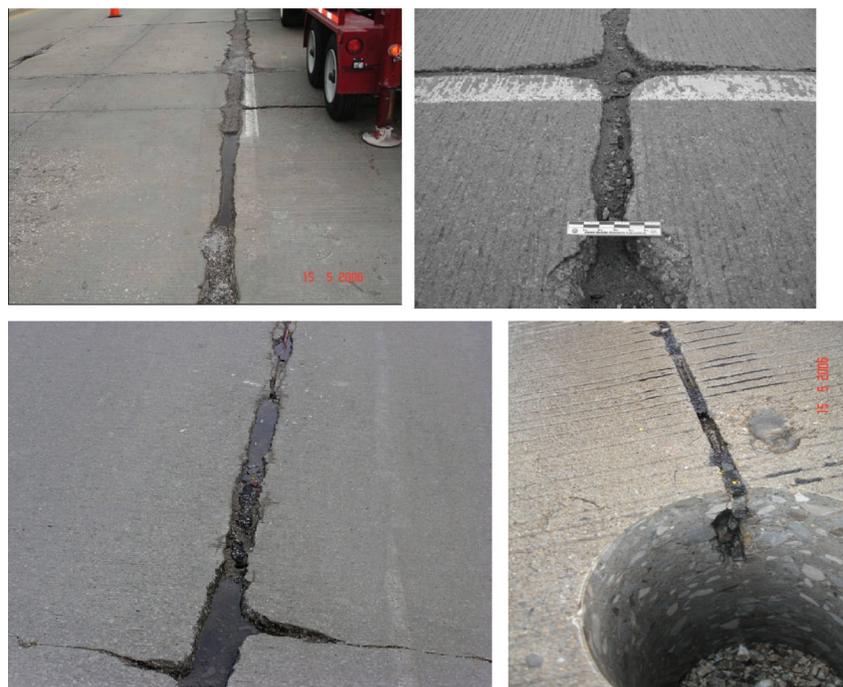
Figure 4.1 Examples of joint damage in the existing pavements.

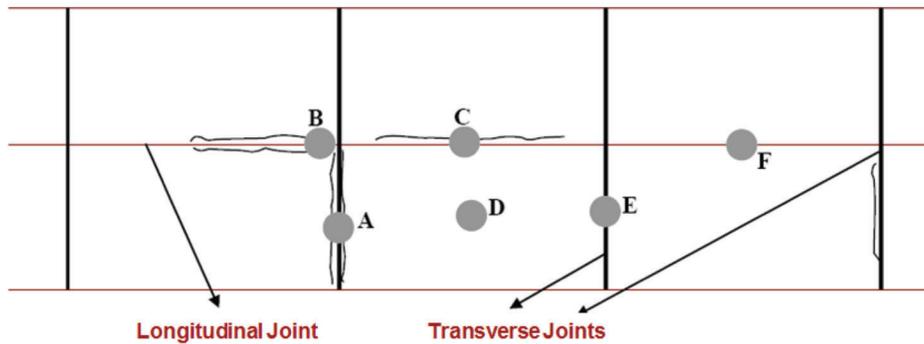
Figure 4.2 Location of cores within pavement structure.

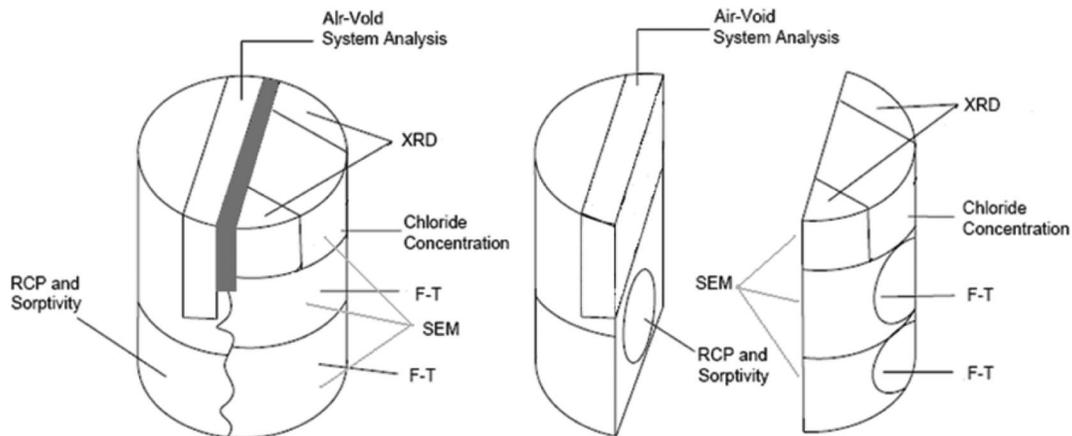
Figure 4.3 Schematic of test specimen locations within each core.

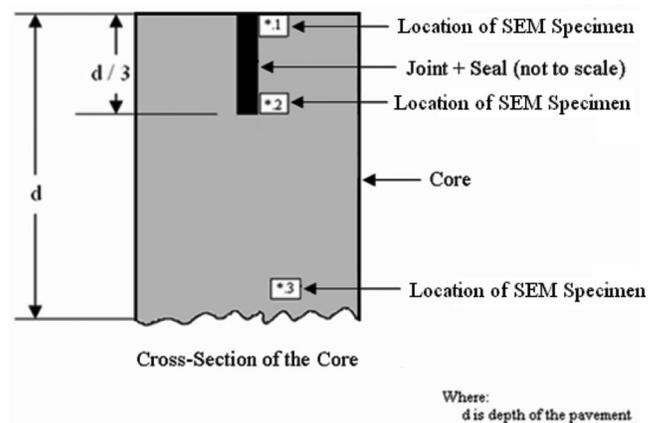
Figure 4.4 Location of the SEM specimens within the core.

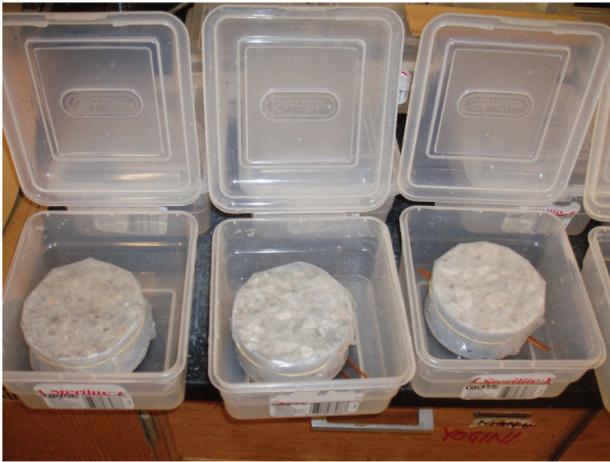
Figure 4.5 Setup for the sorptivity testing.

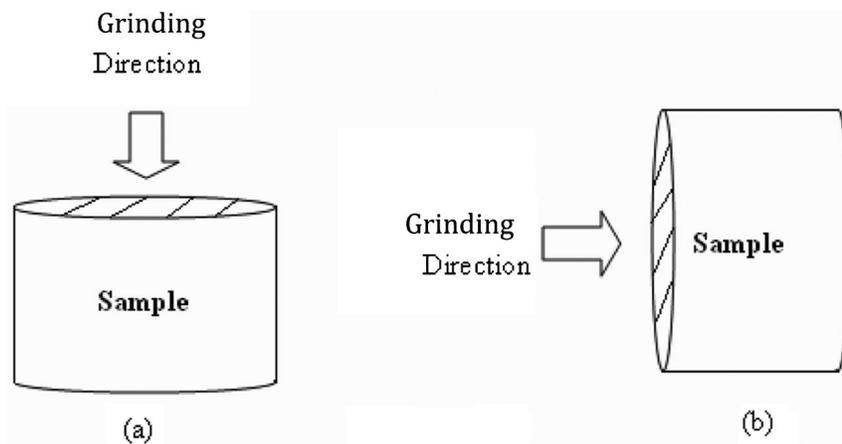
Figure 4.6 Grading directions for (a) mid-span cores and (b) joint cores.

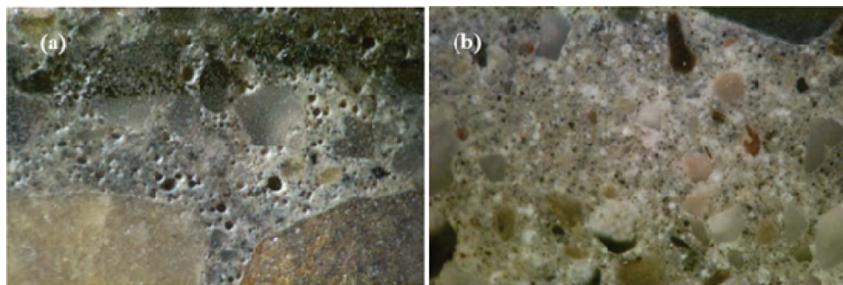
Figure 4.7 (a) Empty air voids in the top portion and (b) infilled air voids in the bottom (about 1 in. below the surface) portion of the specimen obtained from core #1A (ramp US-67) (10I).

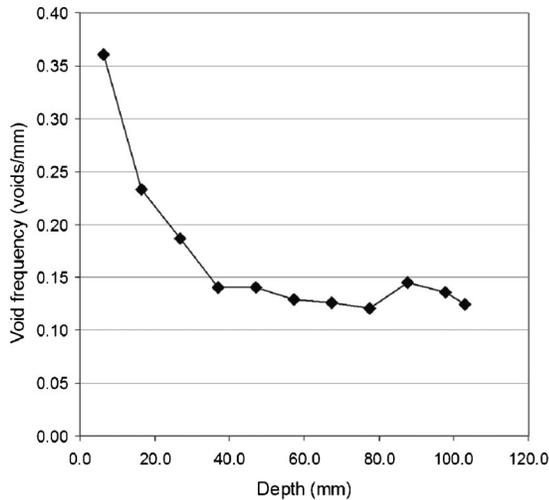
Figure 4.8 Void frequency vs. depth for US 67 core #1A (101).

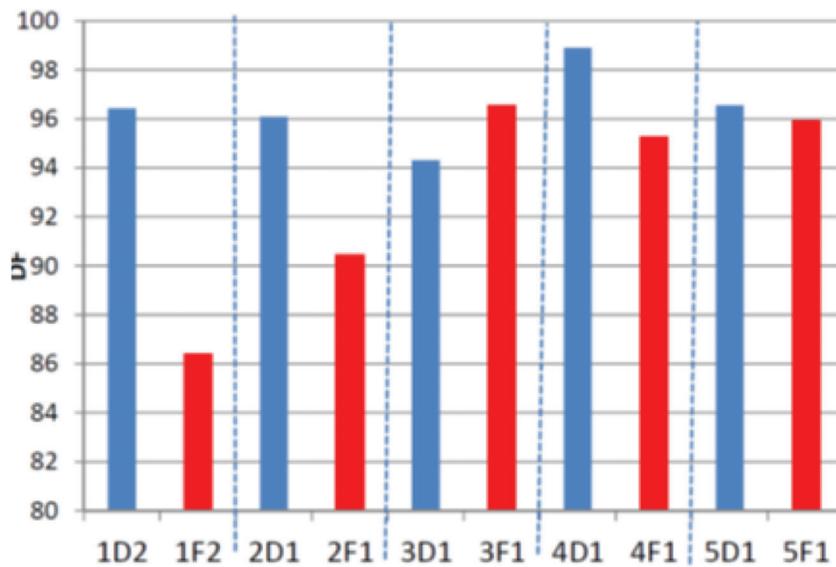
Figure 4.9 Average DF of F-T specimens taken at the sawn joint compared to corresponding mid-span of the same panel (11).

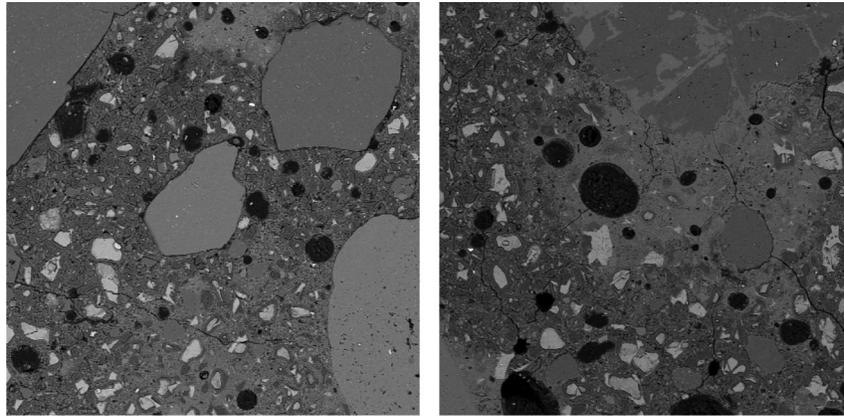
Figure 4.10 Microstructure of concrete near the top (SEM #1 in Figure 4.4) of the core mid-slab core (86AL 1D) with numerous empty air voids (101).

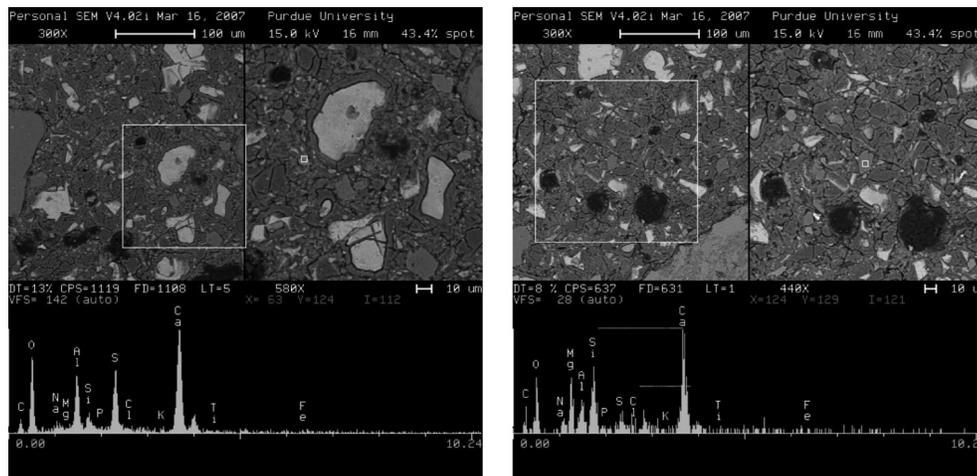
Figure 4.11 Higher magnification of the microstructure of concrete near the top (SEM #1 in Figure 4.4) of the core mid-slab core (86AL 1D) with local deposit of ettringite, monosulfate and either empty or partially filled air voids (101).

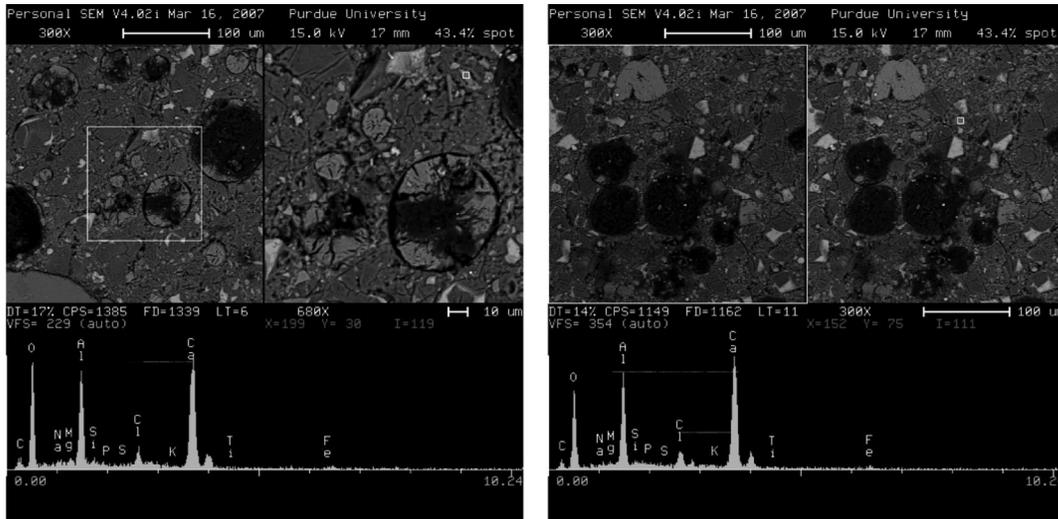
Figure 4.12 Microstructure of concrete near the bottom (SEM #3 in Figure 4.4) of the core mid-slab core (86AL 1D) with local deposit of ettringite, monosulfate, Friedel's salt and either empty or partially filled air voids (101).

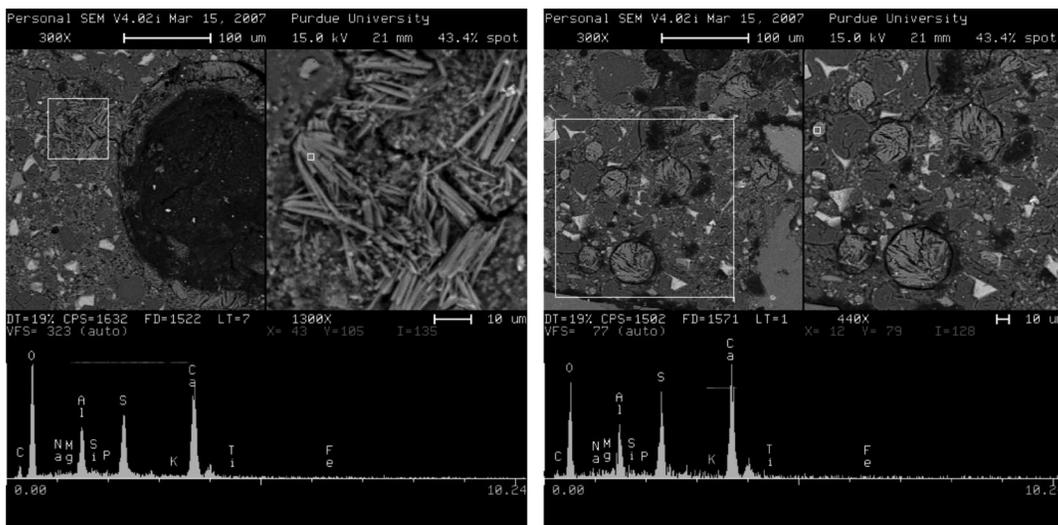
Figure 4.13 Microstructure of concrete near the top (SEM #1 in Figure 4.4) of the core located in the area of damaged longitudinal joint (core 86AL 11C) showing ettringite crystals infilling air void (left) and numerous pores in the matrix filled with ettringite (right) (101).

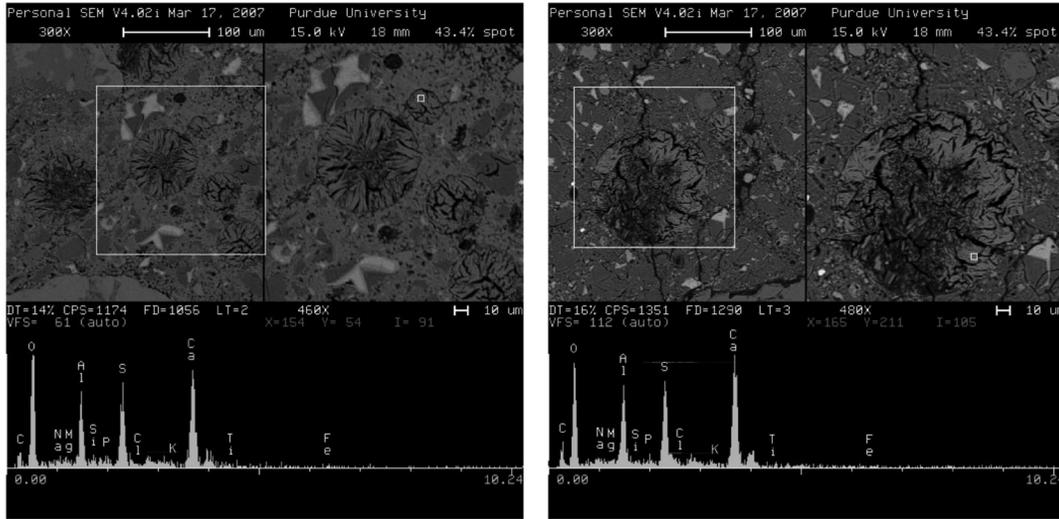
Figure 4.14 Microstructure of concrete near the bottom (SEM #2 in Figure 4.4) of the sealed and damaged longitudinal joint (core 86AL 11C) showing ettringite crystals infilling air numerous air voids (101).

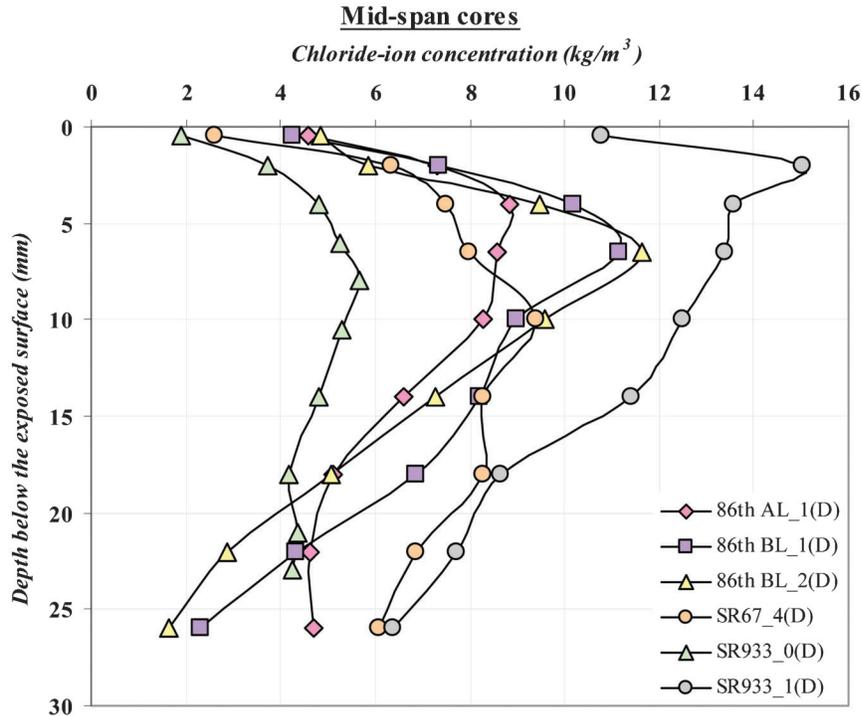
Figure 4.15 Chloride ion concentrations profile for mid-span cores (11).

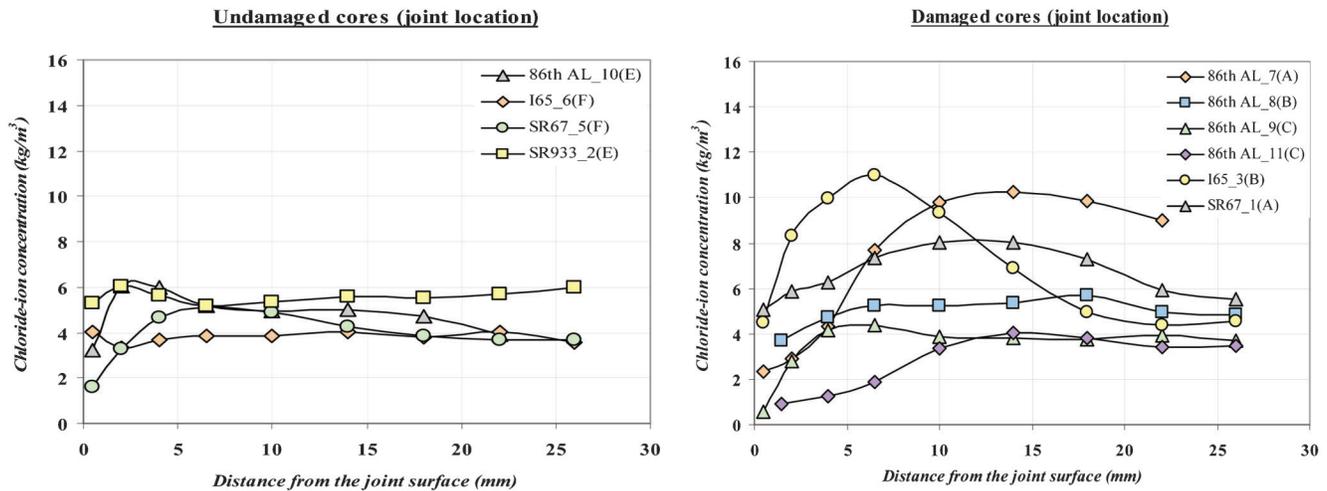
Figure 4.16 Chloride ion concentrations profiles (from joint faces inward) for undamaged joints (left) and damaged joints (right) (11).

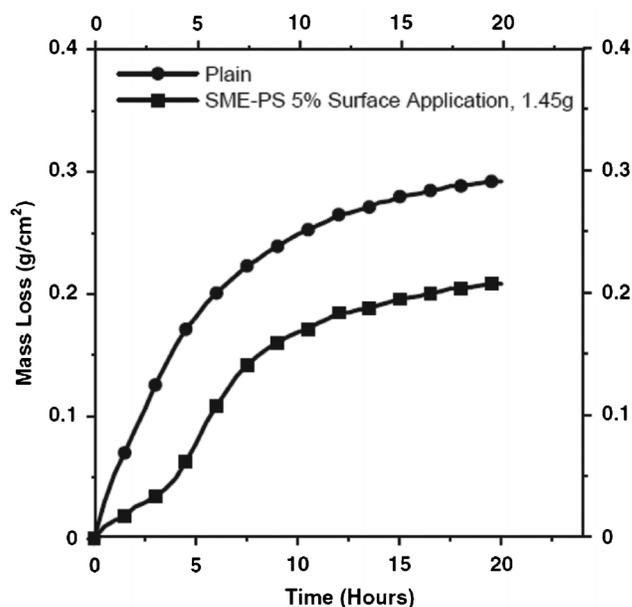
Figure 5.1 Evaporation of water over time in plain sample and sample topically treated with SME-PS.

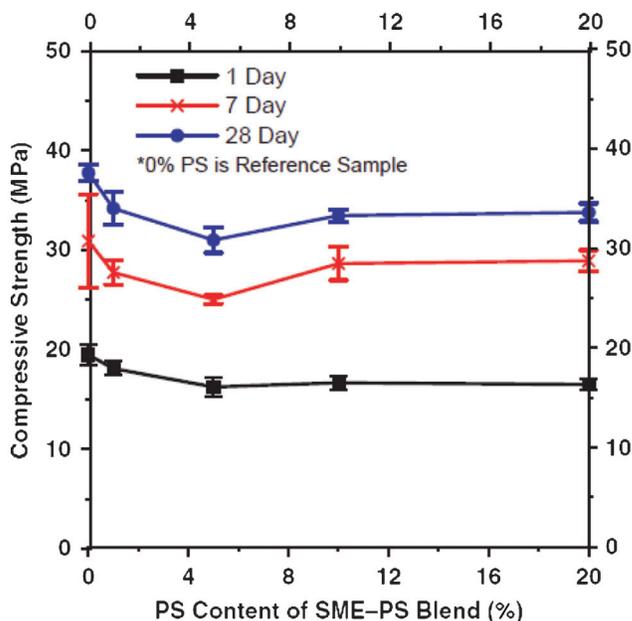
Figure 5.2 Compressive strength versus polystyrene content.

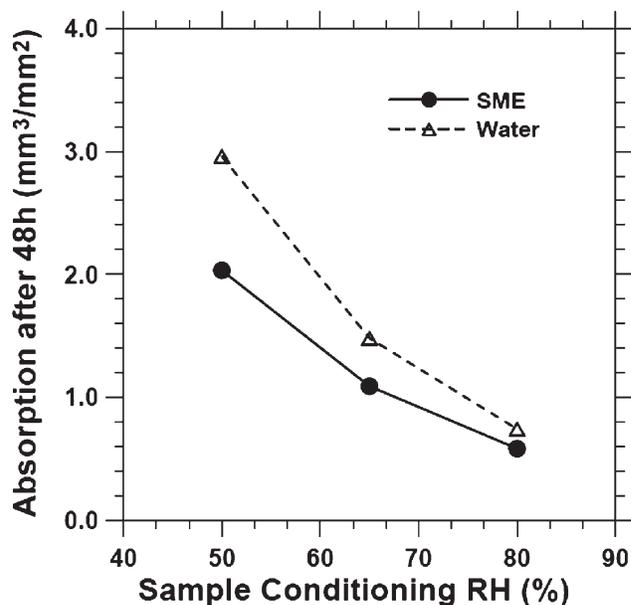
Figure 5.3 SME-PS and water absorption after 48 hours versus conditioning.
