AN OVERVIEW OF JOINT DETERIORATION IN CONCRETE PAVEMENT

Mechanisms, Solution Properties, and Sealers

AN OVERVIEW OF JOINT DETERIORATION IN CONCRETE PAVEMENT: MECHANISMS, SOLUTION PROPERTIES, AND SEALERS

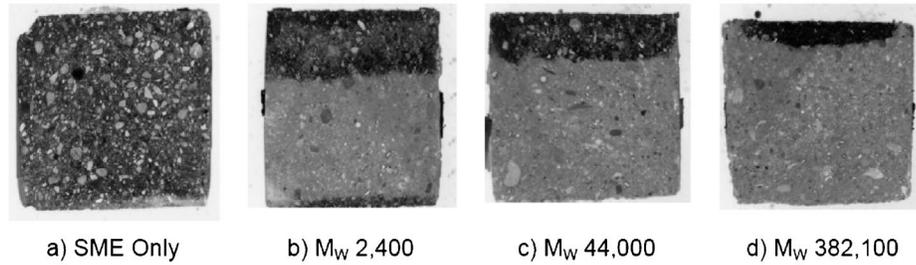
Figure 5.4 Penetration depth of SME-PS in black with varying PS chain lengths.

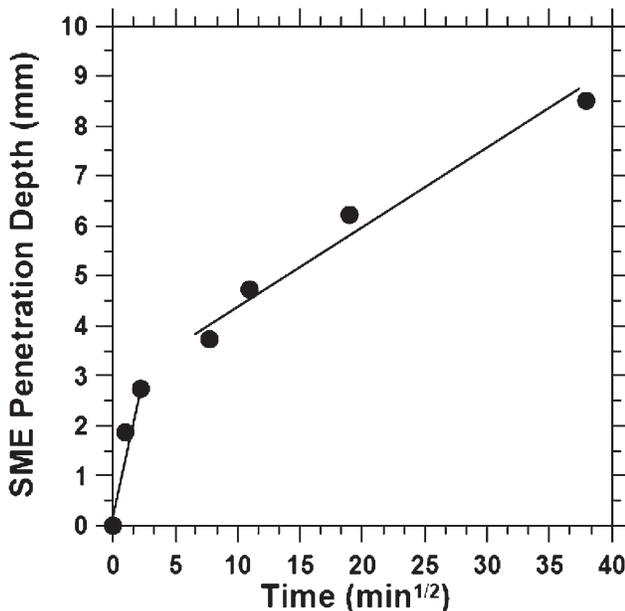
Figure 5.5 SME-PS penetration over time.

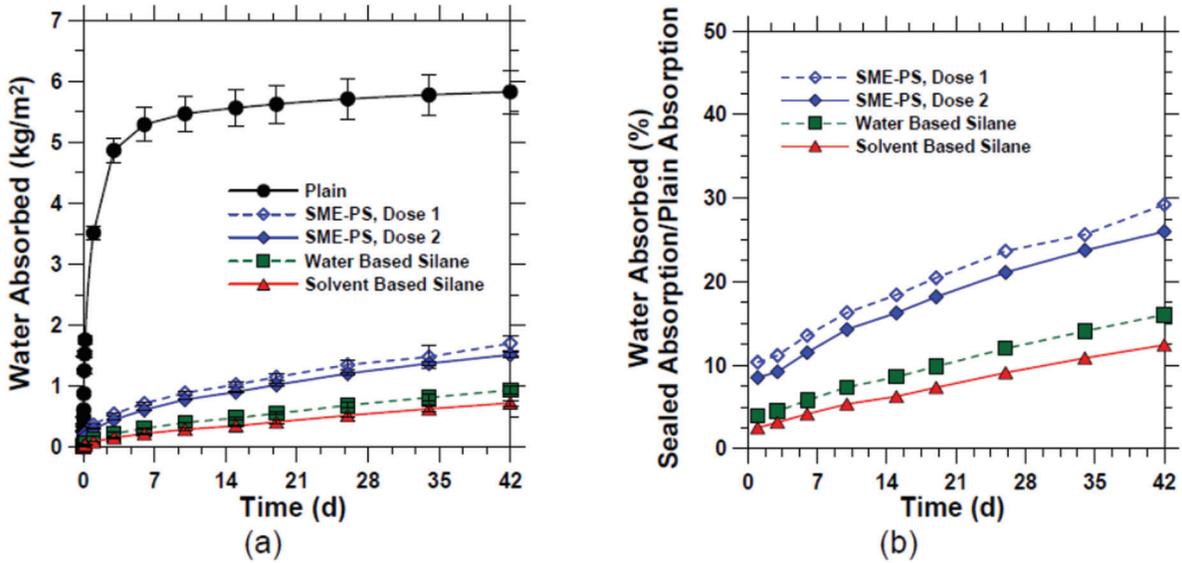
Figure 5.6 Water absorption where (a) is the amount absorbed and (b) is the percent reduction in absorption.

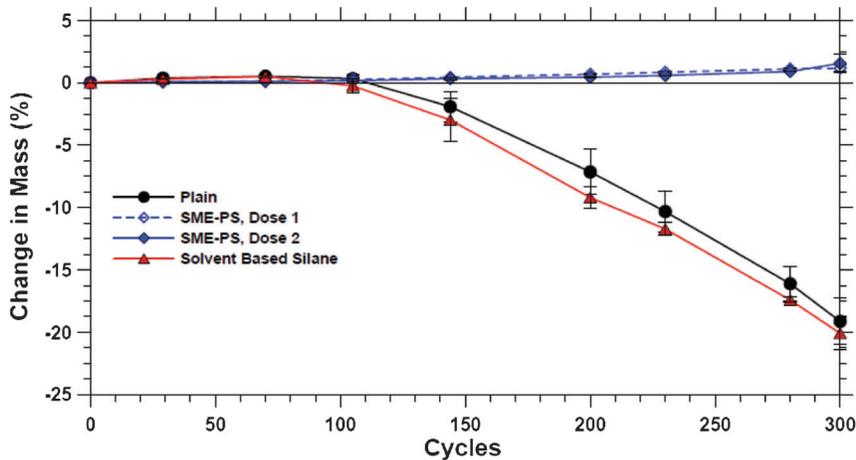
Figure 5.7 Mass change due to freezing and thawing.

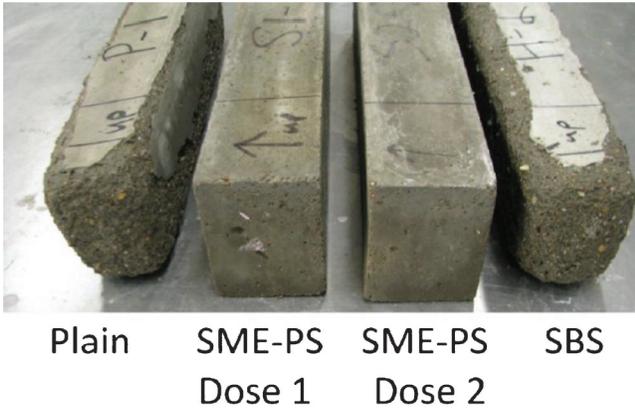
Figure 5.8 Samples after 280 cycles of freeze-thaw.

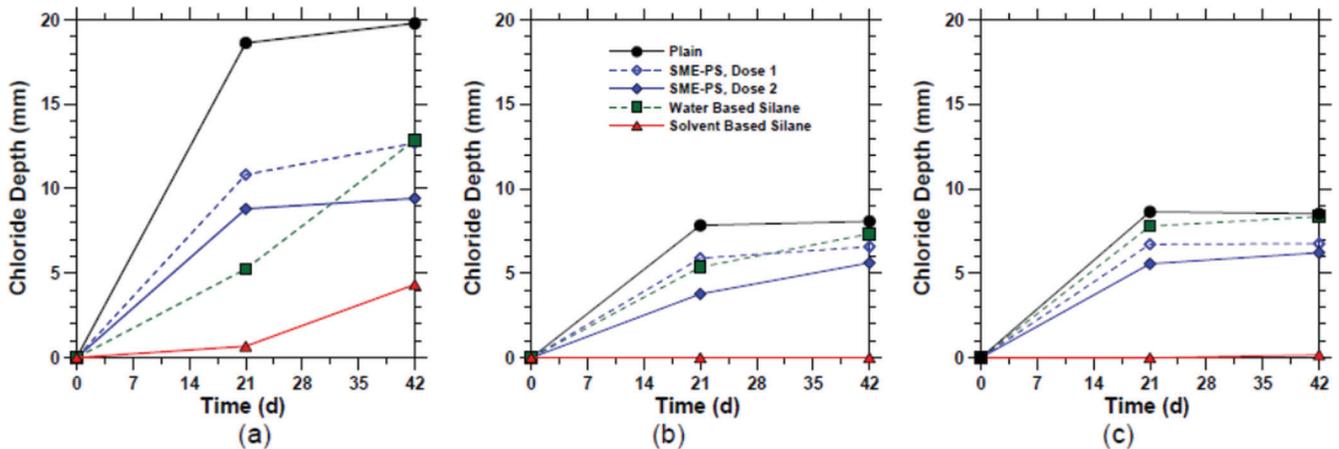
Figure 5.9 Chloride penetration depth for (a) sodium chloride, (b) magnesium chloride, and (c) calcium chloride.

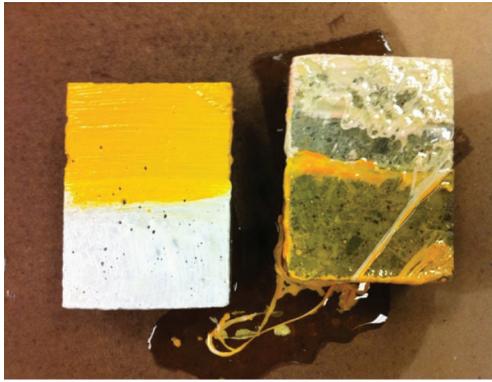
Figure 5.10 Tests of compatibility of SME-PS with INDOT road paint under normal exposure (left) and extreme exposure (right).

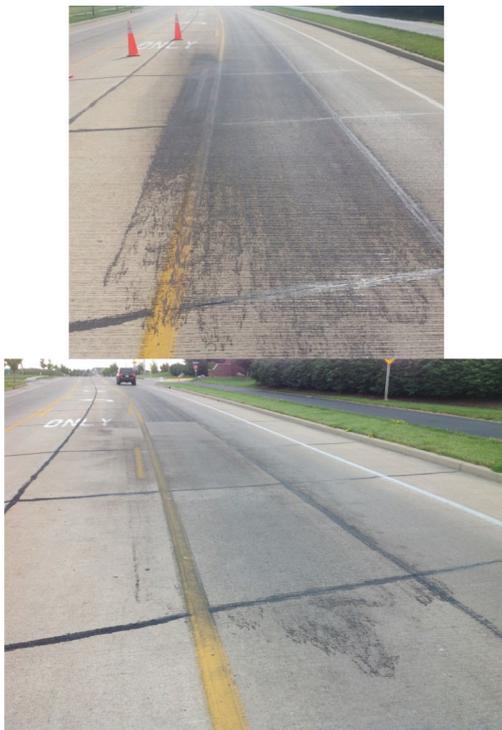
Figure 5.11 Asphalt spill on Kalberer Road before and after removal using SME-PS.

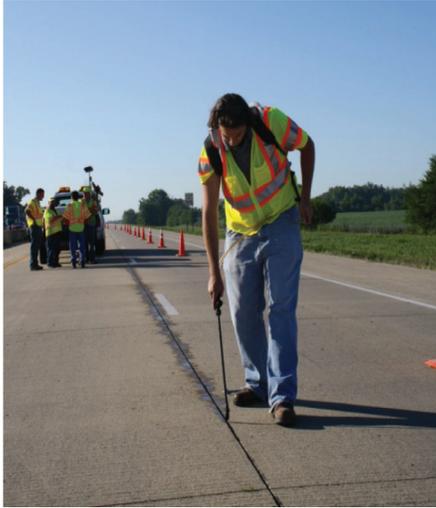
Figure 5.13 Demonstration of field application of SME-PS, on US-231 in Lafayette, IN.

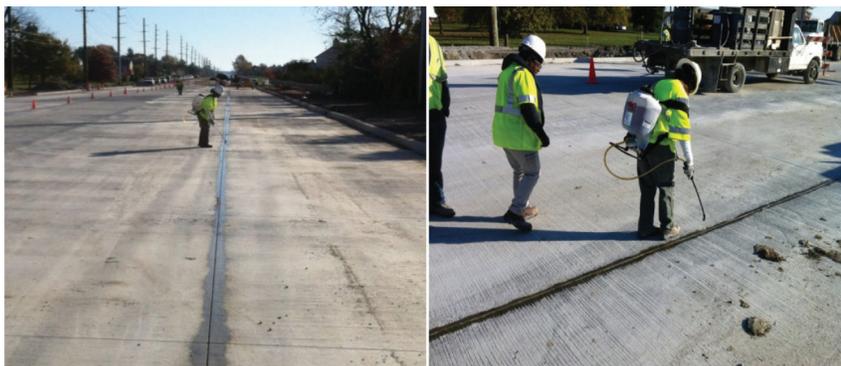
Figure 5.17 Application of SME-PS to 126th street in Fishers, IN, being performed by members of Berns Construction.

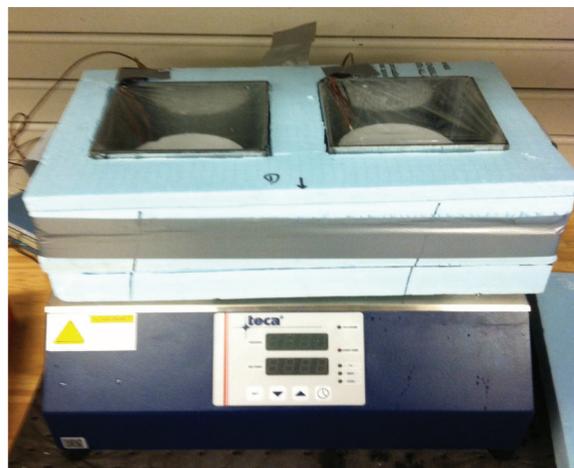
Figure 6.1 Schematic of experimental setup for freeze-thaw absorption with chloride solution.

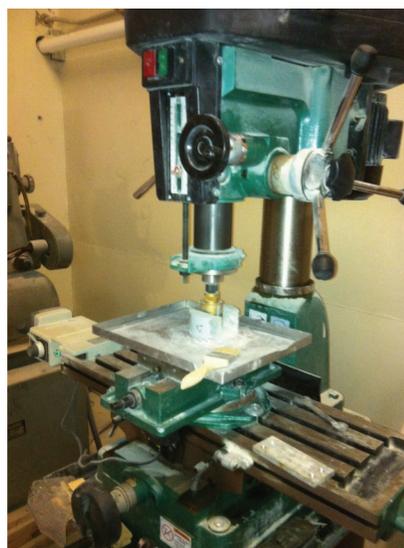
Figure 6.2 Surface grinding used obtain powder for titration. Samples were ground at depths of 2mm.

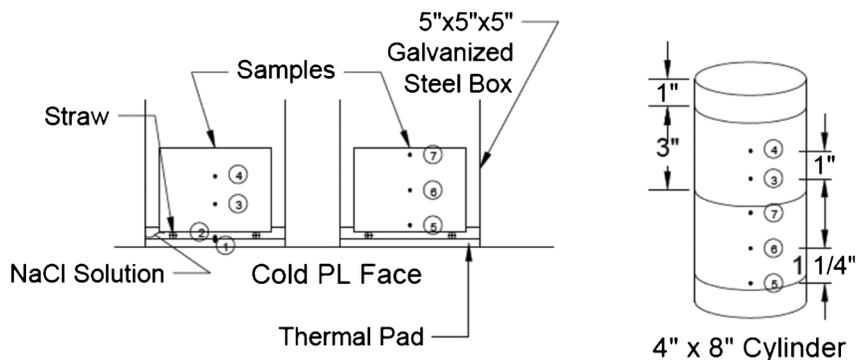
Figure 6.3 Section view of the test setup (left) and the locations of the thermocouple wiring in the cylinder (right).

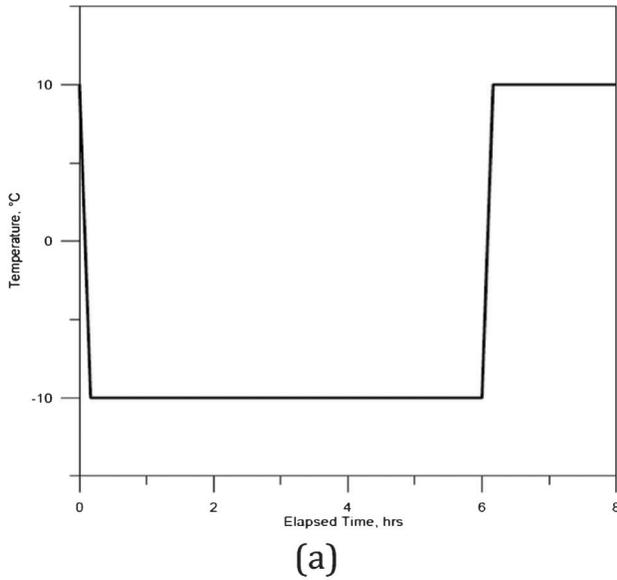
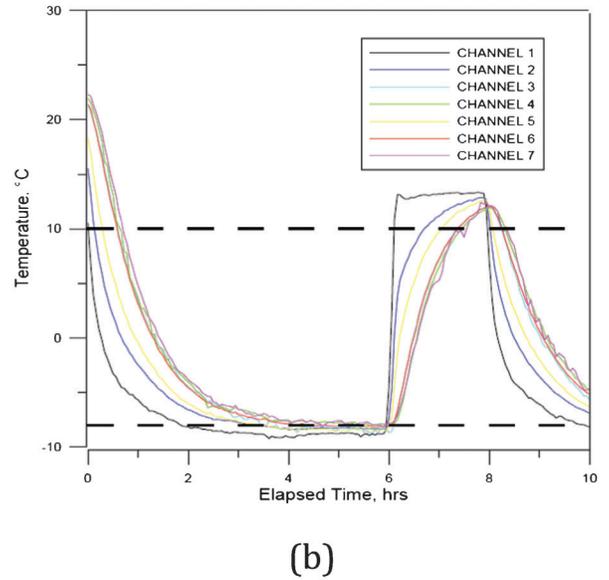
Figure 6.4 (a) Cycling of cold plate for temperature testing and (b) temperature output used to determine cycle lengths.

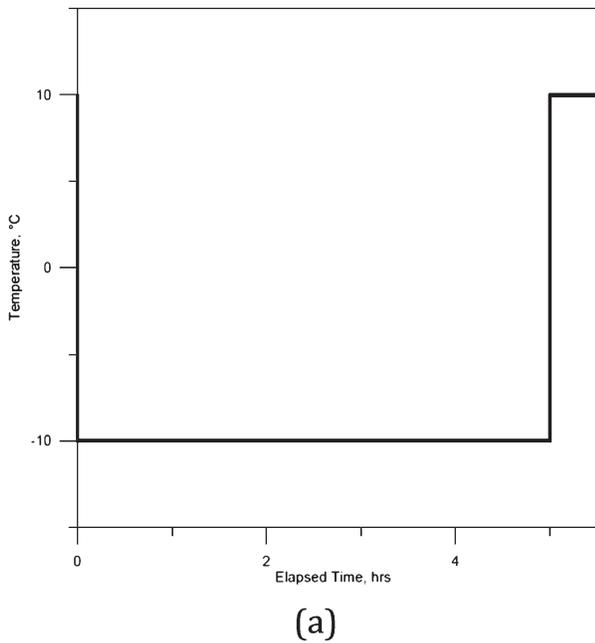
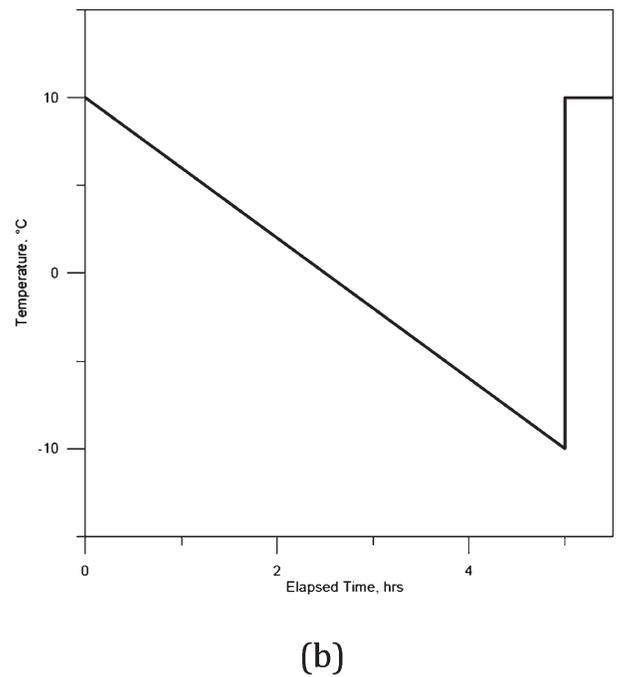
Figure 6.5 Cycling for determination of the freezing rate: (a) shows "quick" loading and (b) shows "slow" loading.

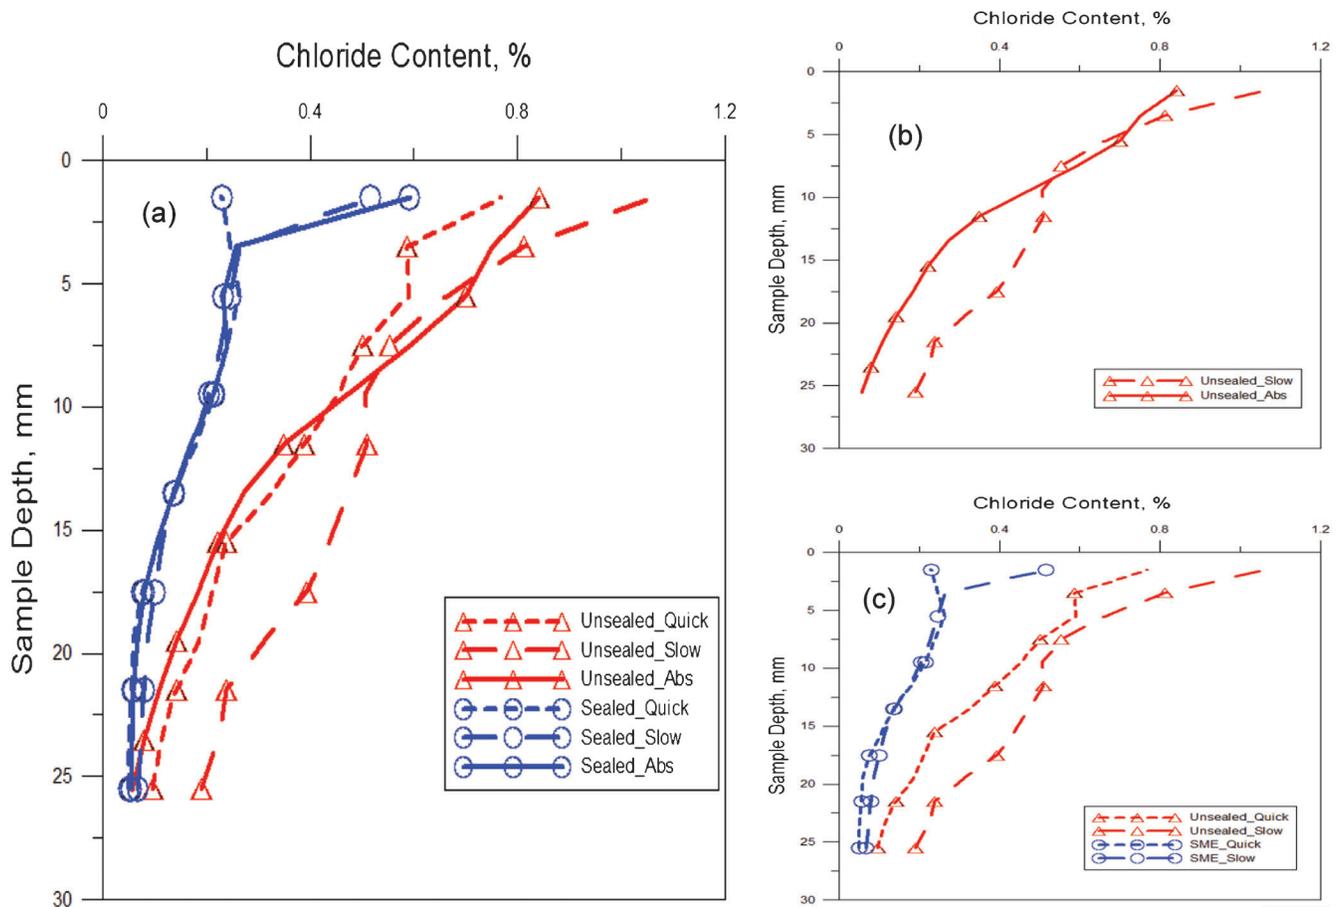
Figure 6.6 (a) Compares chloride concentration for sealed and unsealed samples at different loading rates; (b) demonstrates chloride pumping; and (c) is evidence that “slow” loading causes a higher concentration of chlorides further into the sample than quick loading.

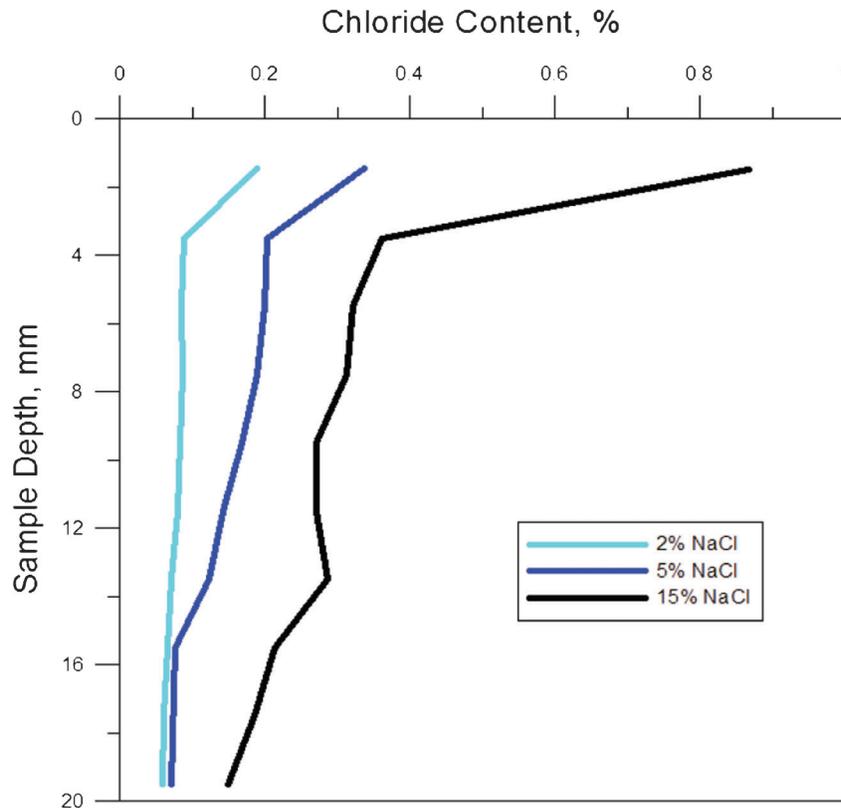
Figure 6.7 Chloride profile for solutions containing 2, 5, and 15% NaCl by mass.

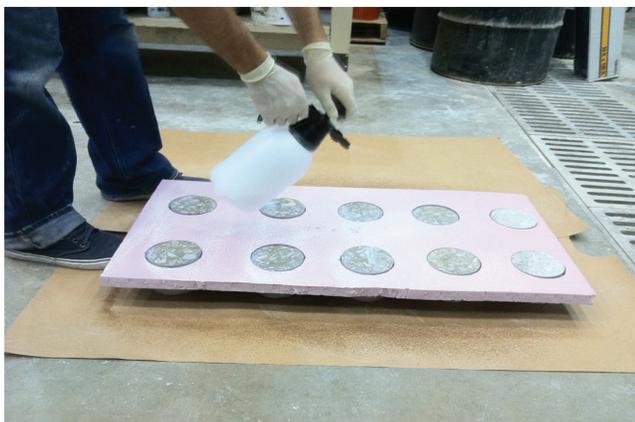
Figure 6.8 Uniform application of sealants to cylindrical concrete samples.

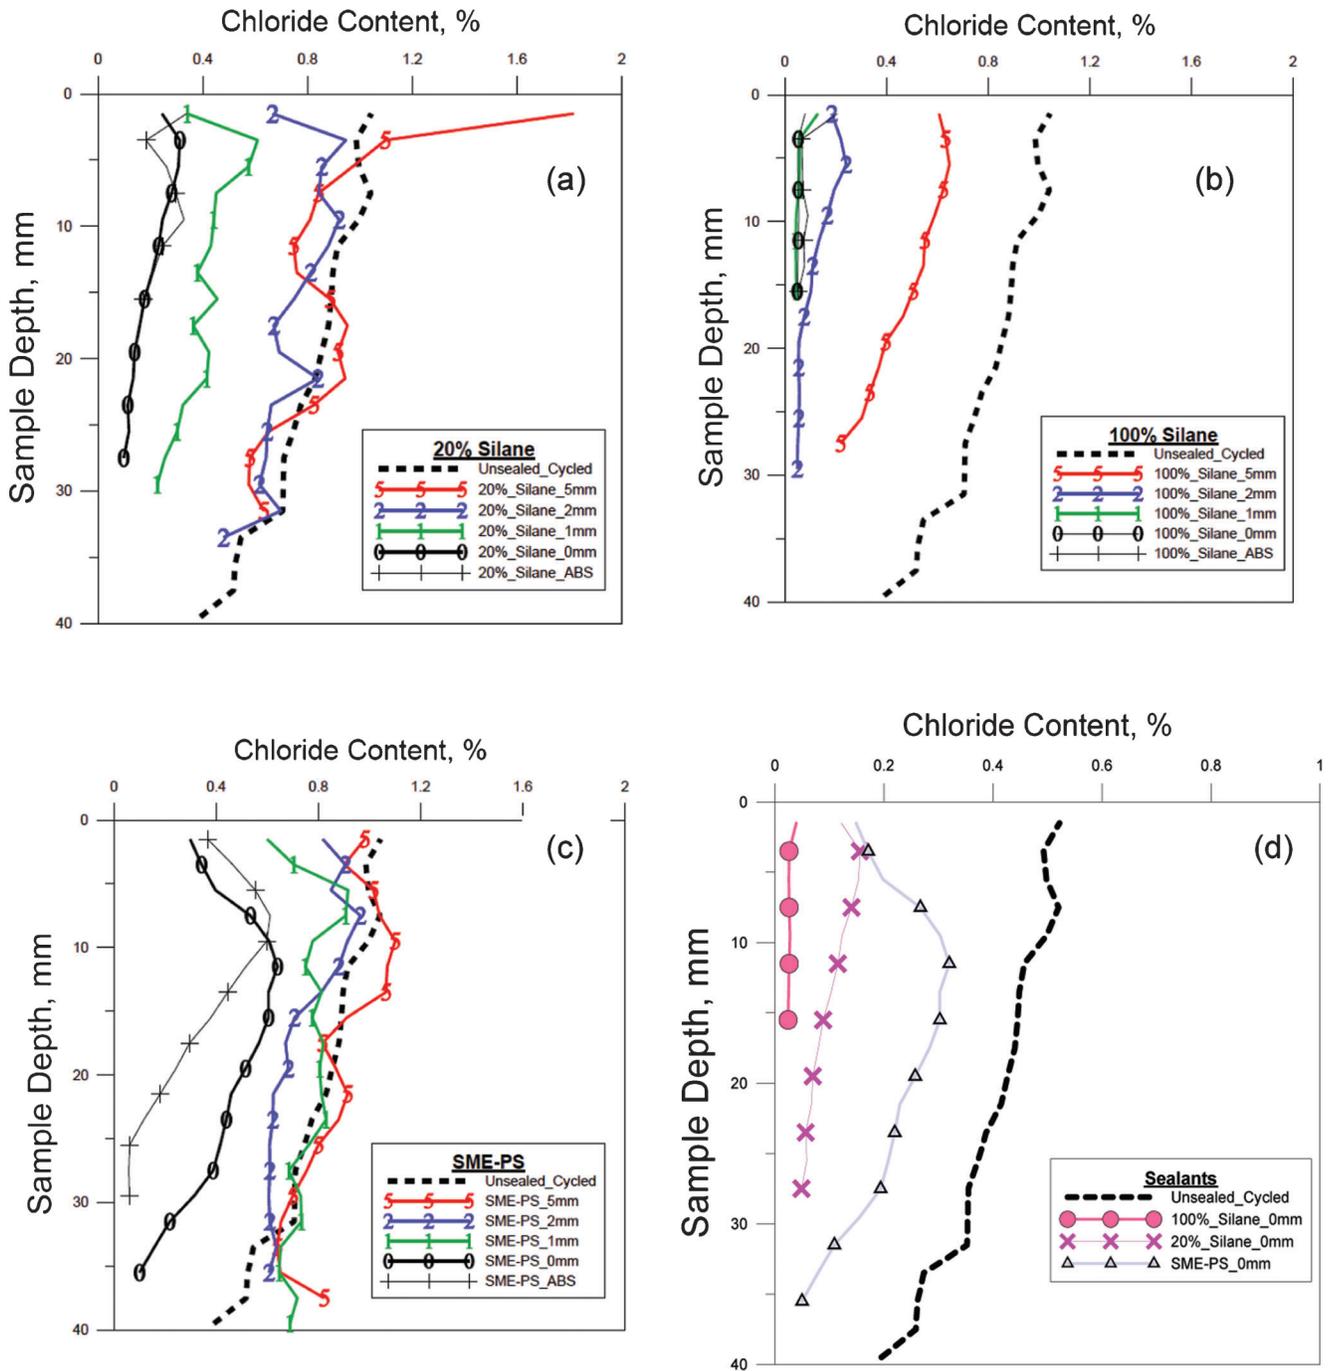
Figure 6.9 (a) Chloride profile for the 20% silane sealant used in this study; (b) chloride profile for the 100% silane sealant used in this study; (c) chloride profile for SME-PS (5% by mass) sealant used in this study; and (d) summary showing all three sealants without removal of the top surface.
