Transportation Research Division

Technical Brief 10 – 02

*Evaluation of the Kuper – Tuca SX36 Snow
Plow Cutting Edges*

June, 2010

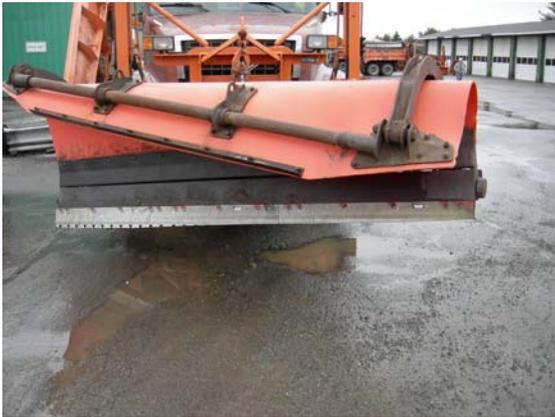
The set of blades used on the Route 15 route were worn to termination and removed from service on January 29th. The total distance plowed with this set was 1,239 miles (see Photos 1 and 2). Excessive wear at the left, or driver end of the plow may be indicating the crown of the road played a part in this early failure. It should also be noted that the plow that this set were attached to is a reversible, or quick switch plow. This plow type weighs approximately 3,000 pounds, or about 640 pounds more than a sweeper plow weighing 2,360 pounds.

Photo 1: Failed Blades/Reversible Plow

The Tuca SX36 blade is performing better on the standard sweeper plow than the reversible plows, which are approximately 650 pounds heavier than the sweeper.

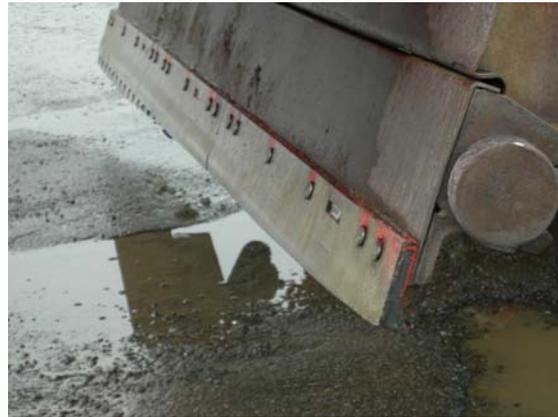
Photo 2: Failed Blades taken from the left end.

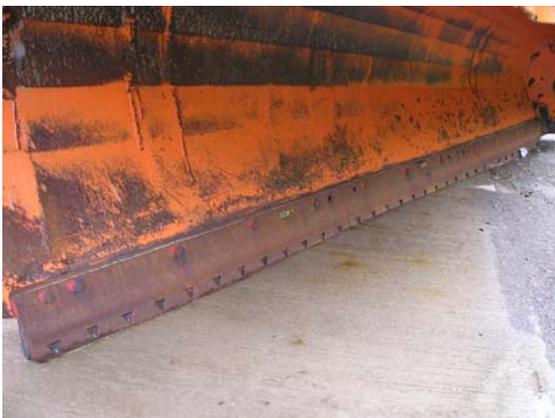
The second set of Kuper blades evaluated in Bangor were utilized on Interstate 95 and mounted on a sweeper plow. Once again, the early end to the winter season did not allow the blades to be worn to termination (see Photos 3 and 4). This set had 1,408 miles of service recorded when the winter weather ended on January 29th. The crew supervisor estimates that the blades have approximately one half of their life remaining.

Photo 3: Kuper Blades - Sweeper Plow

The supervisor and driver agreed that the Kuper blades are quieter than the standard blades. The driver did not feel they cleaned the road as well, while the supervisor believed they cleared the road about the same as the standard blade. The supervisor also theorized that the reason the Route 15 blades wore out before this set was because of the condition of the road. He feels the Kuper blade may be better suited for better constructed roadway sections, like the Interstate. He also feels that the Kuper blades are more susceptible to impact damage than the standard carbide blade.

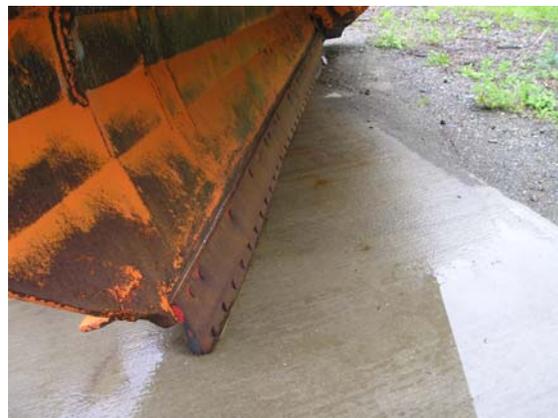
Photo 4: Kuper Blades – Sweeper Plow
