JOINT TRANSPORTATION RESEARCH PROGRAM

INDIANA DEPARTMENT OF TRANSPORTATION
AND PURDUE UNIVERSITY

Subsurface Condition Evaluation for Asphalt Pavement Preservation Treatments

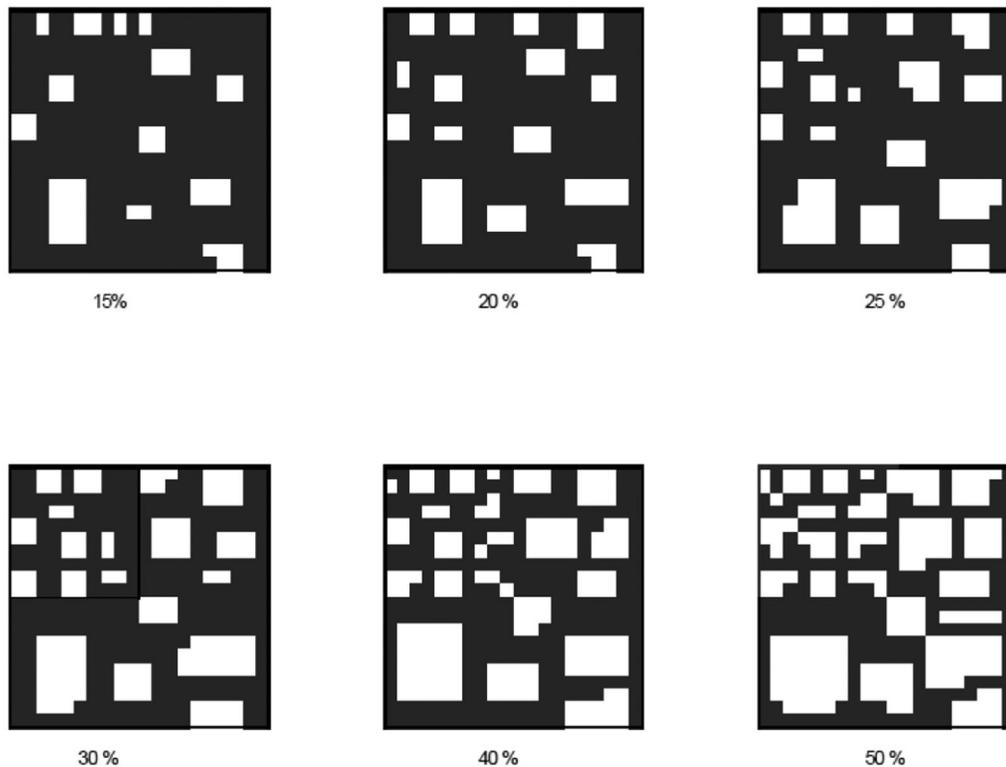
Figure 2.1 Core sample visual inspection guideline (Saskatchewan Highway and Transportation).

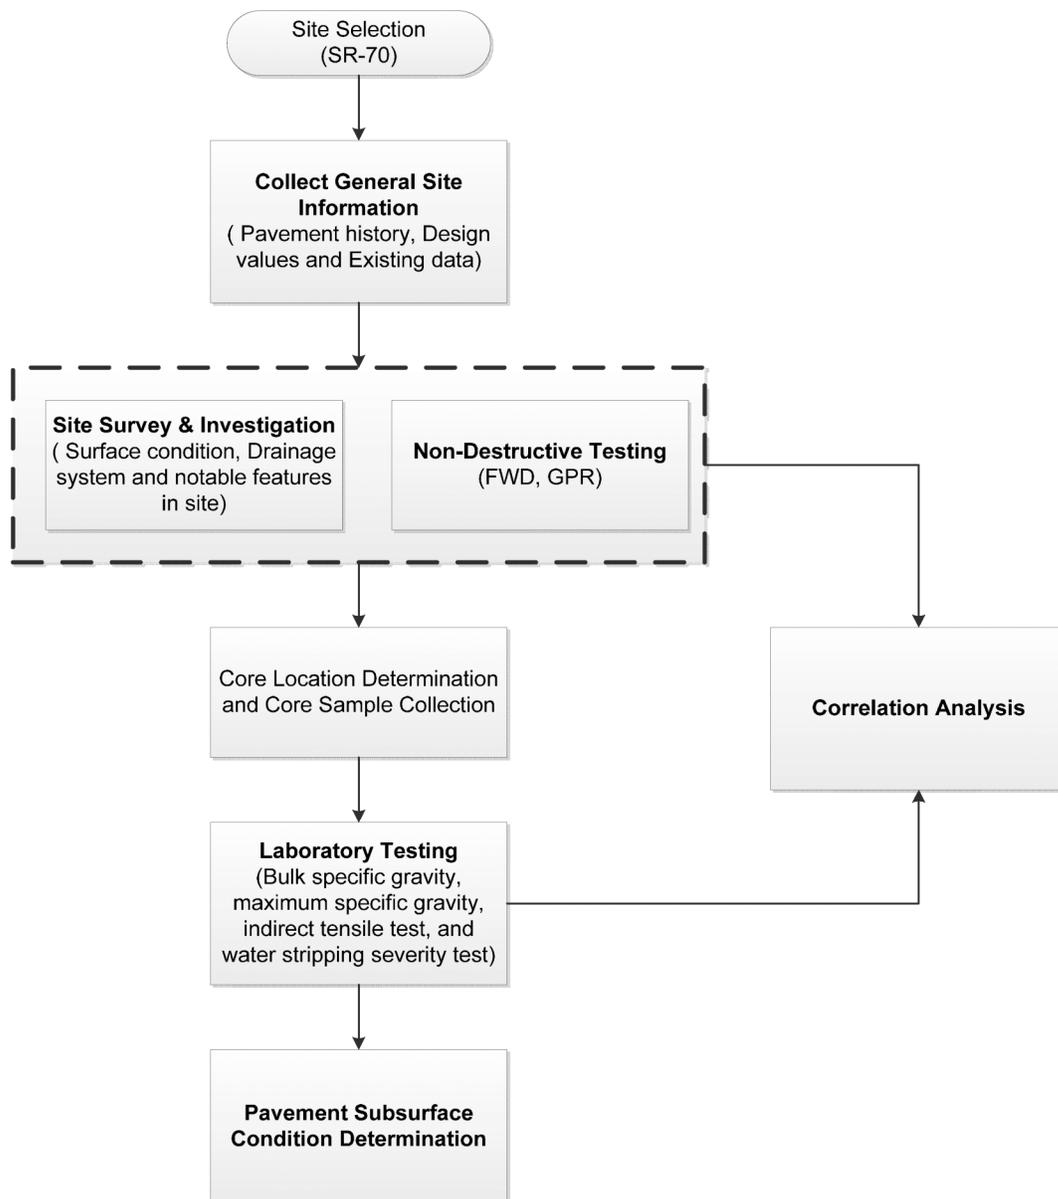
Figure 3.1 Diagram for experimental plan.

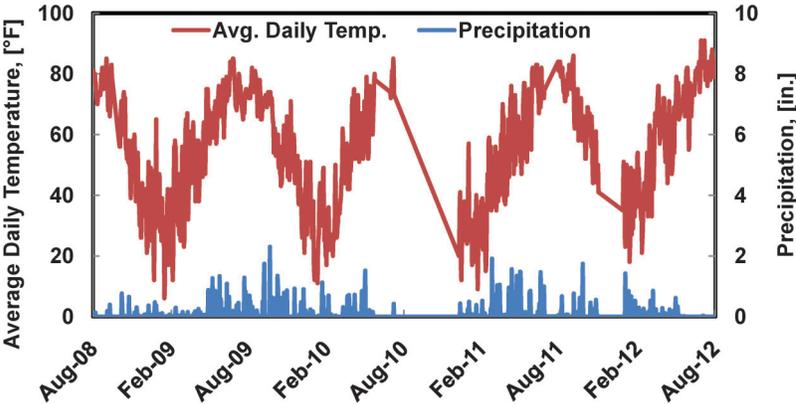
Figure 3.3 Climate condition of Tell City Sub-district (National Climatic Data Center).

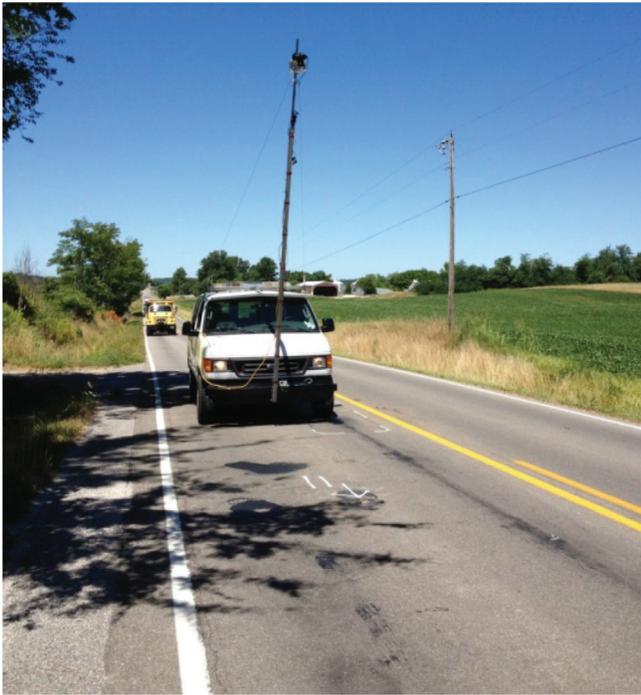
Figure 3.4 Surface distress survey vehicle.

A digital image acquisition system was developed using a digital camera mounted on a vehicle with a distance measuring instrument (DMI) unit connected to the digital camera, as shown in Figure 3.4. The digital camera, Nikon D300 providing 4,288 by 2,848 pixels color images, was mounted at 15 ft high from the ground. This setup covered an area of 12 ft by 9 ft. The digital camera periodically took digital images of the pavement surface ahead of the vehicle as the vehicle travels along the lane. A digital image acquisition system, which is integrated with a DMI unit, provides uniform coverage of pavement surface regardless of the vehicle traveling speed.

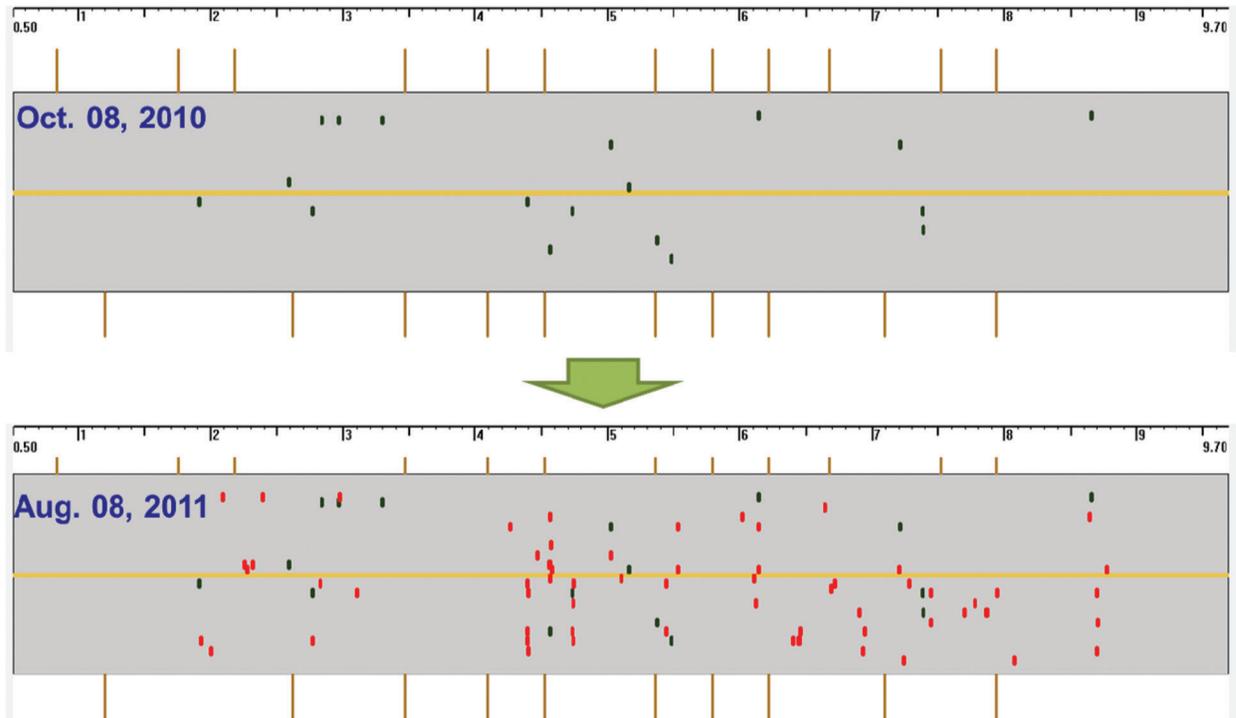
Figure 3.5 Visual analysis results from 2010 and 2011 on potholes and patches.

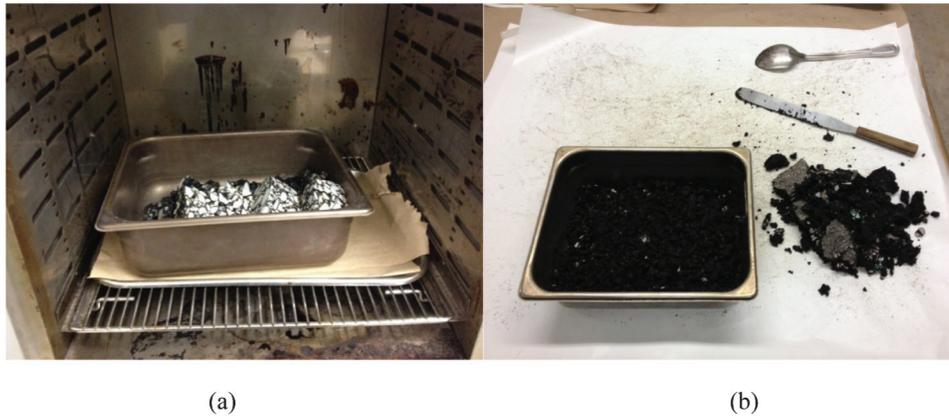
Figure 3.6 Sample preparation process for Gmm measurement: (a) Sample heating in the oven at 158 °F; (b) Separation of uncoated aggregates from coated aggregates.

aggregates with cut surfaces were removed, as shown in Figure 3.6. Then, the rest were separated without fracturing any aggregates until there were no aggregate particles larger than 0.25 in.

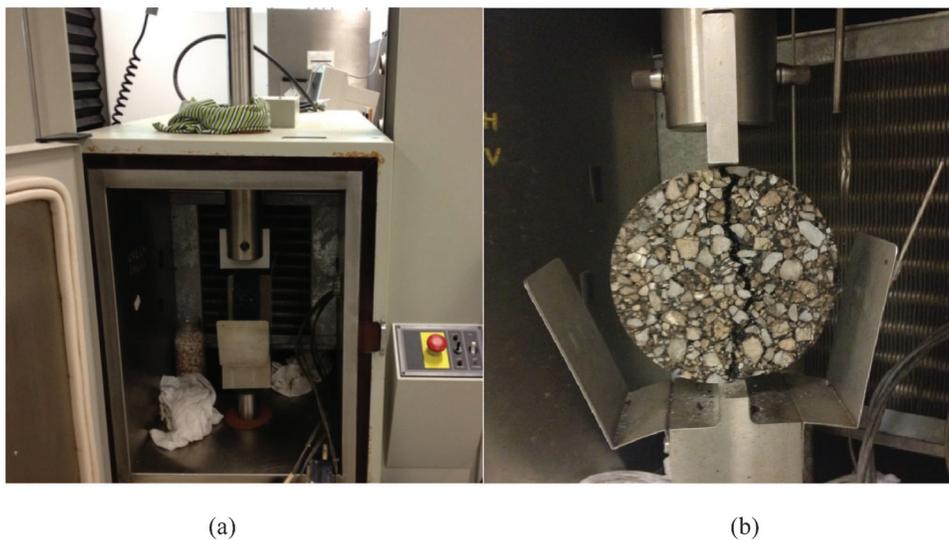
Figure 3.7 IDT setup: (a) IDT chamber; (b) specimen after IDT test.

Specimens completed with the bulk specific gravity measurement were tested by IDT and the specimen placed in the IDT equipment is shown in Figure 3.7. A load was applied to the specimen at a constant rate of 2 in. (50 mm) per min. The maximum load was recorded, and the load continued until the failure of the specimen. The tensile strength of the specimen was determined

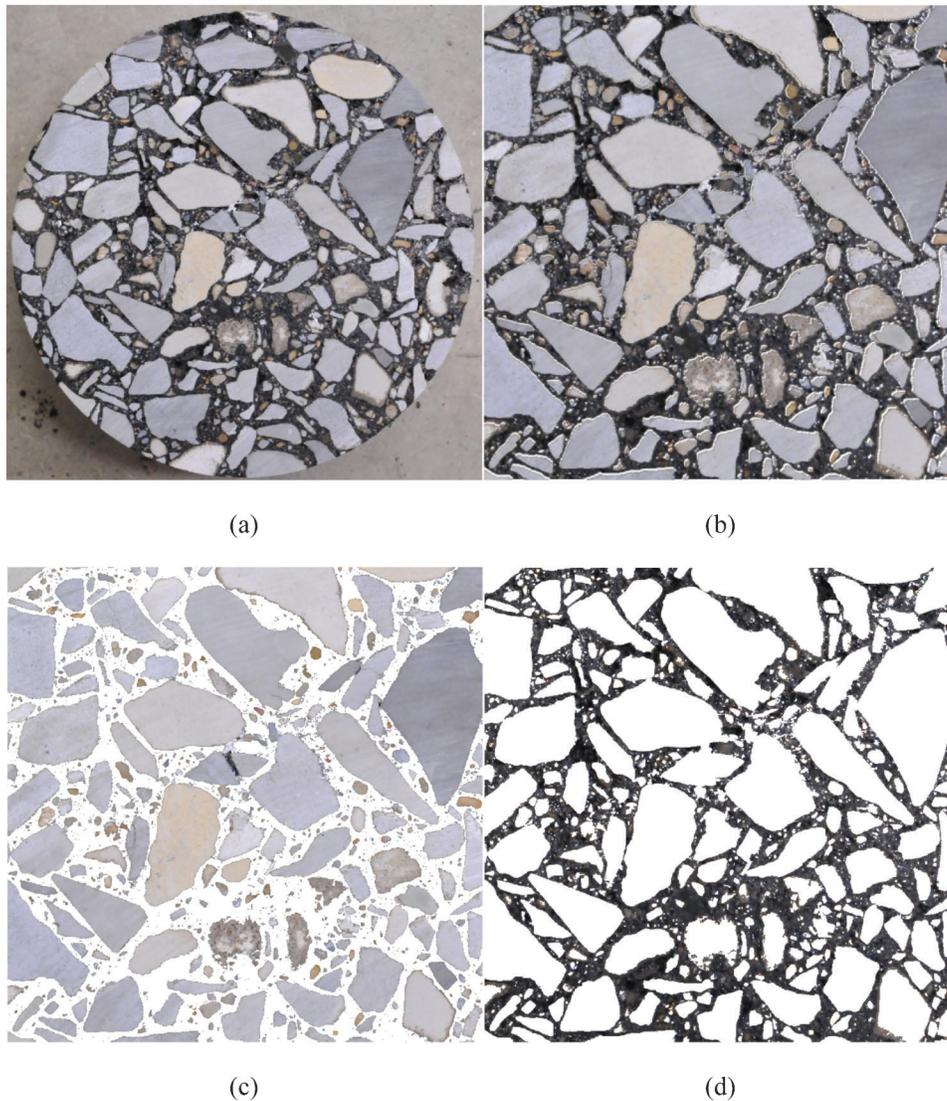
Figure 3.8 Images from DIA process for aggregate area calculation: (a) original image; (b) original image processed for DIA; (c) identified aggregates; (d) identified asphalt and air voids.

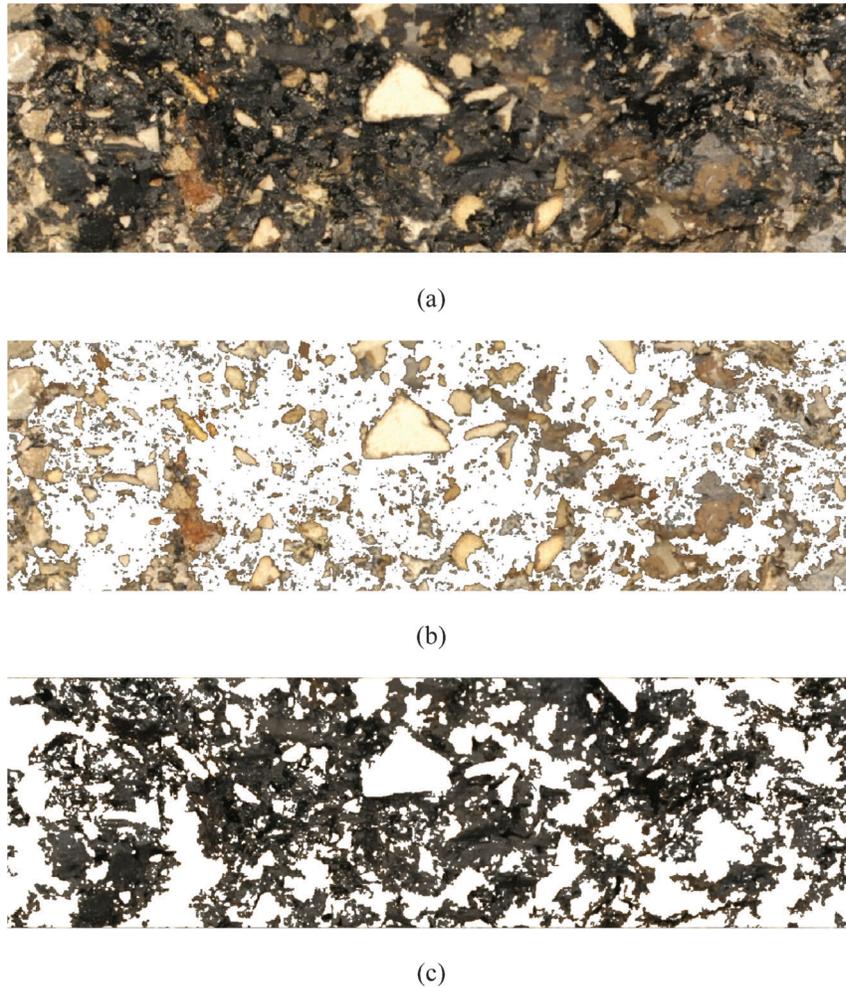
Figure 3.9 Images from DIA process for uncoated aggregate surface area calculation: (a) original image; (b) identified uncoated aggregate image; (c) identified asphalt image.

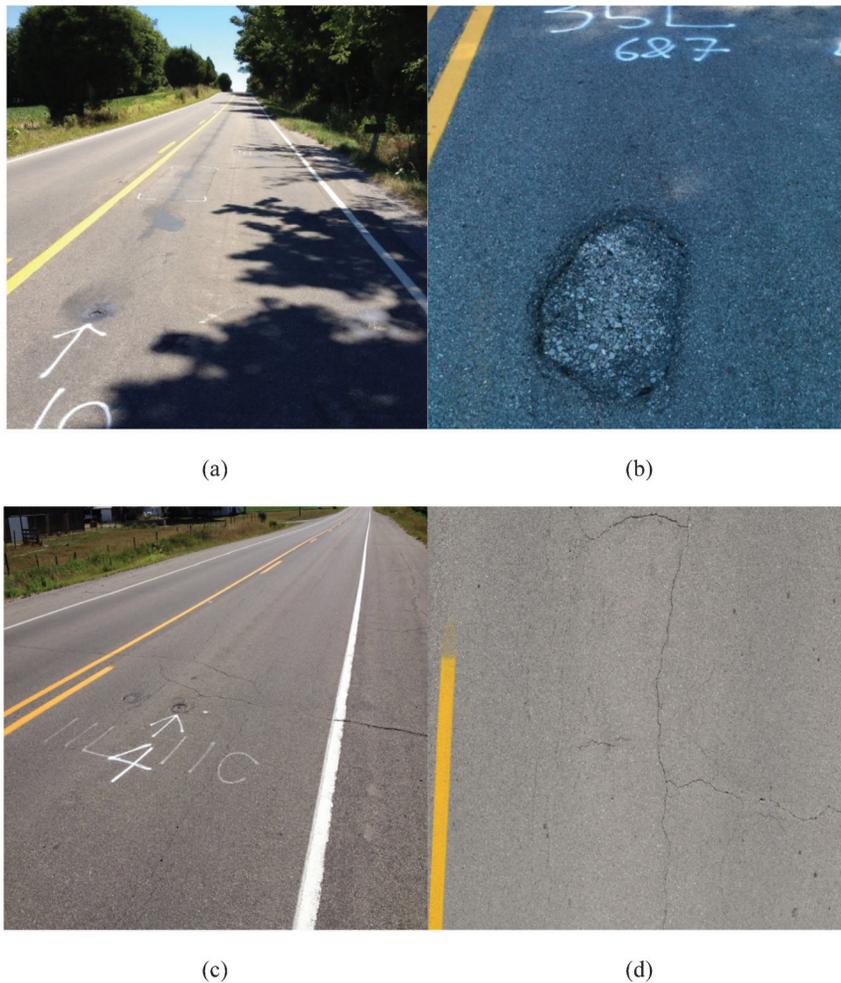
Figure 3.10 Surface distresses on the test section: (a) patch and core holes; (b) pothole; (c) fatigue cracks with core holes; (d) fatigue cracks.

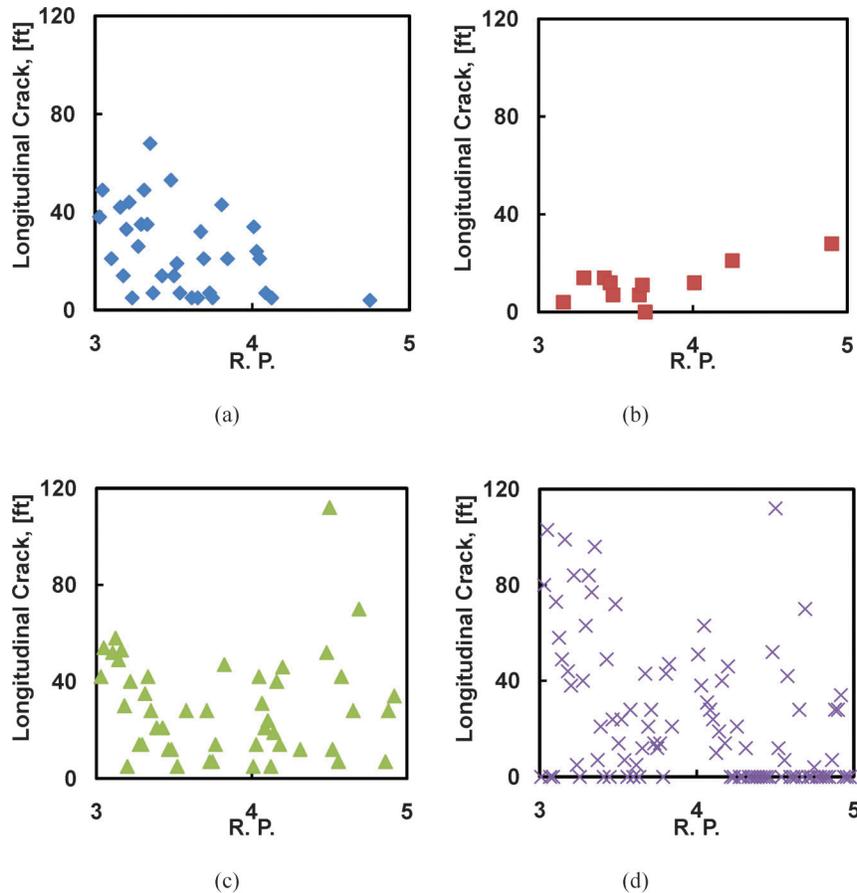
Figure 3.11 Extent of longitudinal crack by location: (a) left wheel path; (b) center of lane; (c) right wheel path; (d) total extent of longitudinal crack.

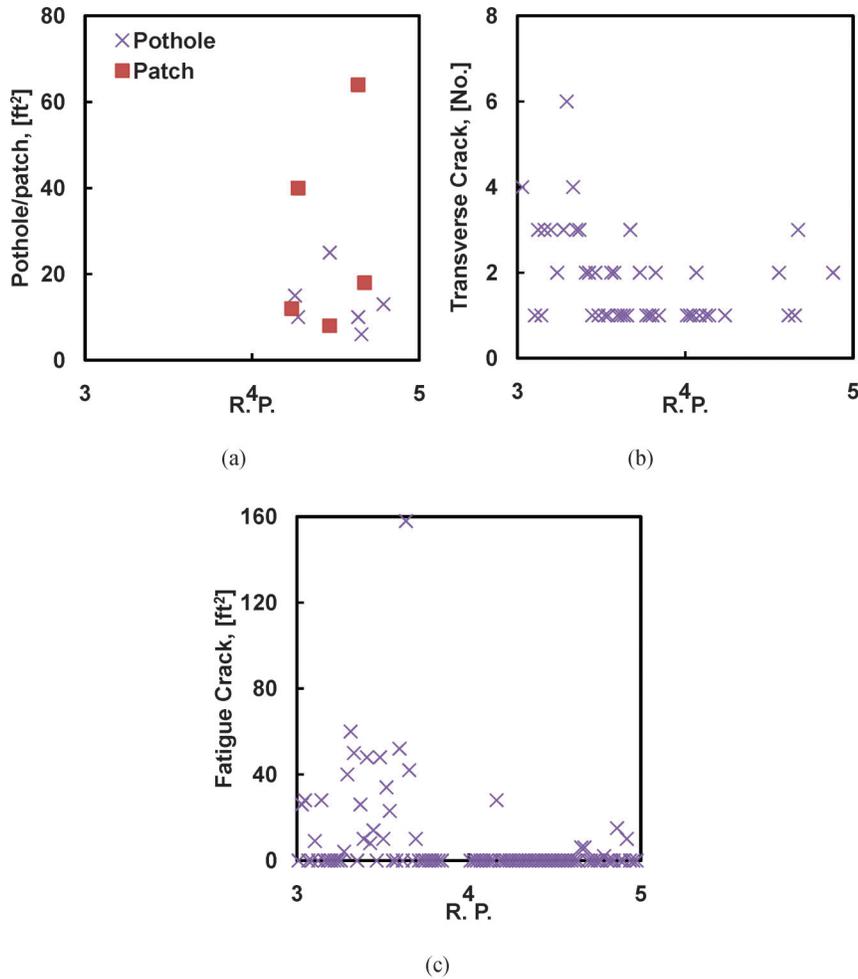
Figure 3.12 Extent of surface distress by location: (a) pothole/patch; (b) transverse crack; (c) fatigue crack.

Pothole/patch, transverse crack, and fatigue crack were also measured summarized in Figure 3.12. Generally, pothole distribution overlaps the patch

distribution in the test section. All potholes/patches were found between R.P. 4 and R.P. 5. The extent of transverse crack was the number of transverse crack in each 100 ft unit interval section. Transverse crack, which were shorter than a half of lane width (< 6 ft) was disregarded. Although transverse cracks were presented over the entire test section, slightly larger number of them occurred in the first 1-mile section (R.P. 3-R.P. 4). In addition, the distribution of the fatigue crack also showed similar trend as most of fatigue cracks occurred in the first 1-mile section. It should be noted that the distribution of pothole and patches was very different from that of transverse and fatigue cracks.

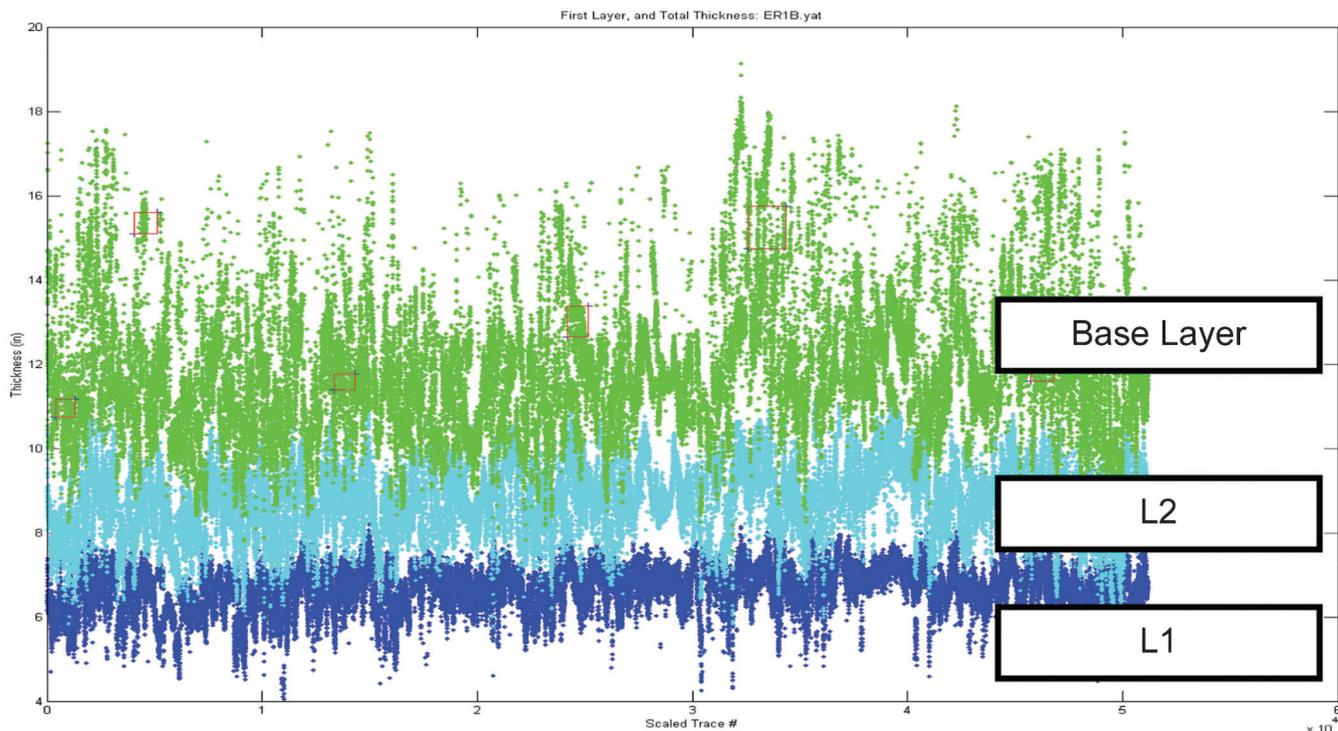
Figure 3.13 GPR layer interface detection result.

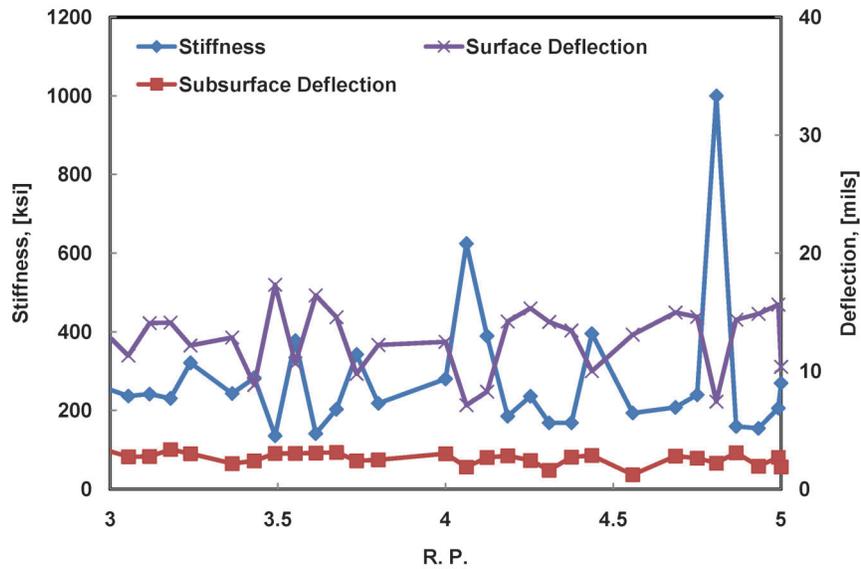
Figure 3.14 FWD test results from June, 2010.

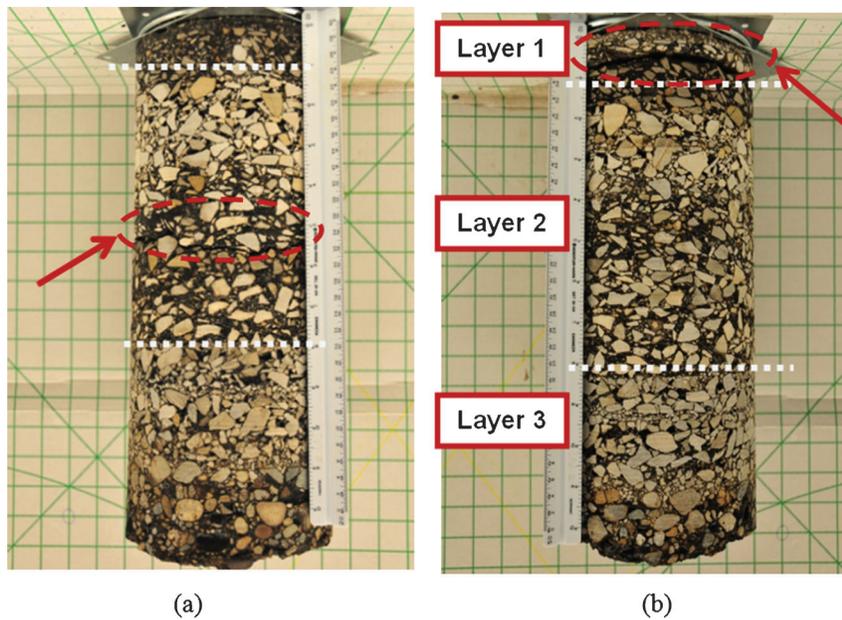
Figure 3.15 Core samples with damage: (a) mid-depth damage; (b) near surface damage.

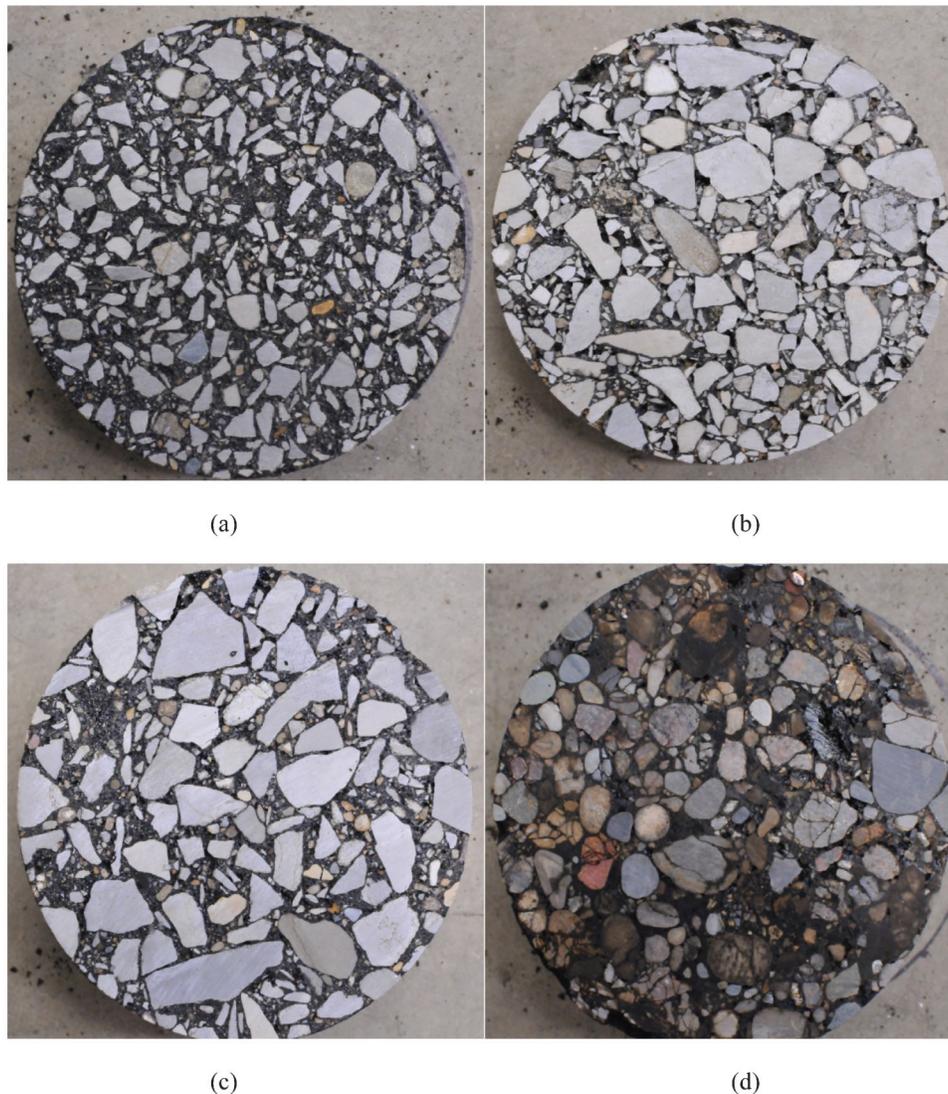
Figure 3.16 Cut-faces of layers: (a) Layer 1 (9.5 mm); (b) Layer 2 (19.0 mm); (c) Layer 3 (25.0 mm); (d) Unidentified layer.

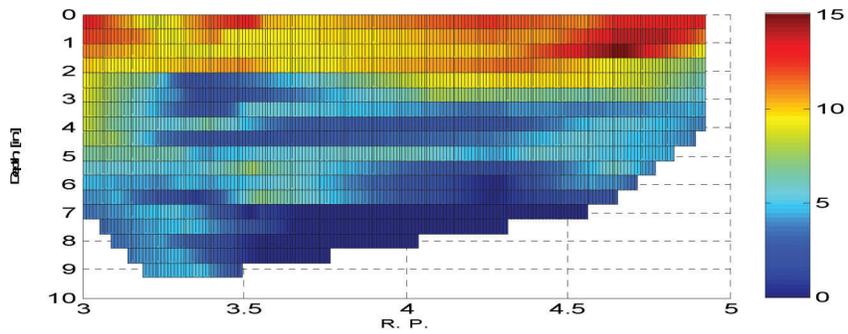
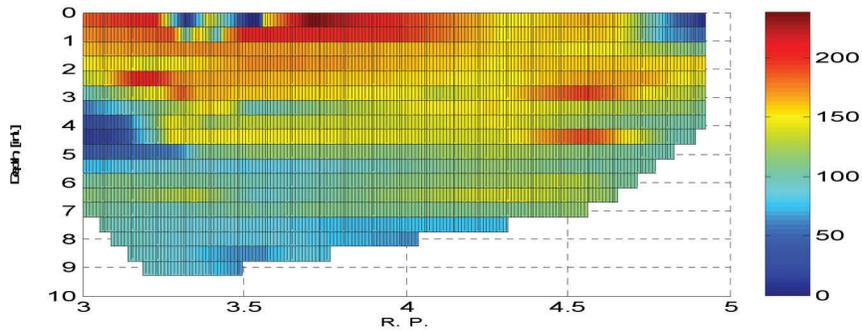
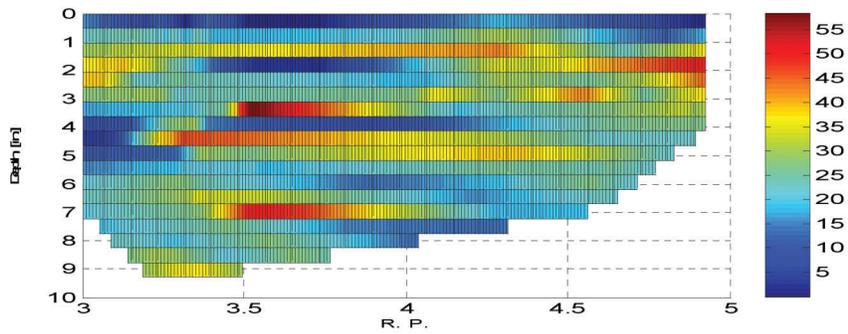
Figure 3.17 Core layers laboratory test results over test section: (a) air voids; (b) tensile strength; (c) water stripping severity.

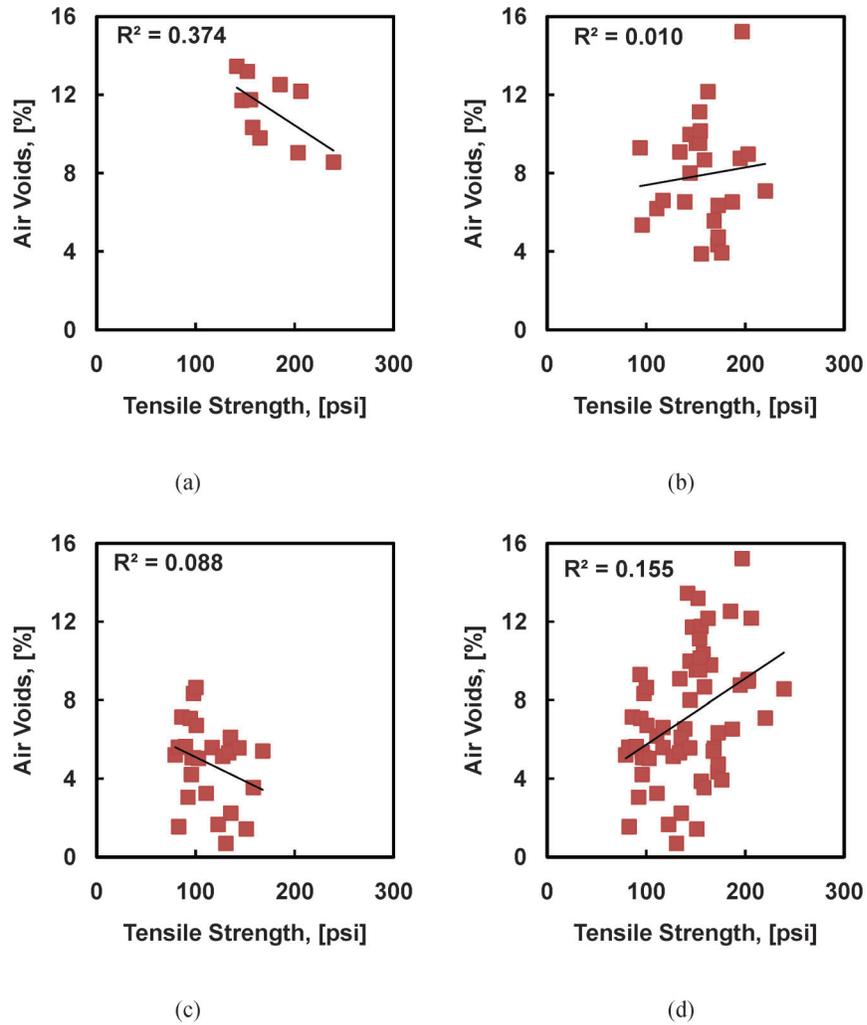
Figure 3.18 Air voids vs. tensile strength: (a) Layer 1; (b) Layer 2; (c) Layer 3, (d) overall layers.

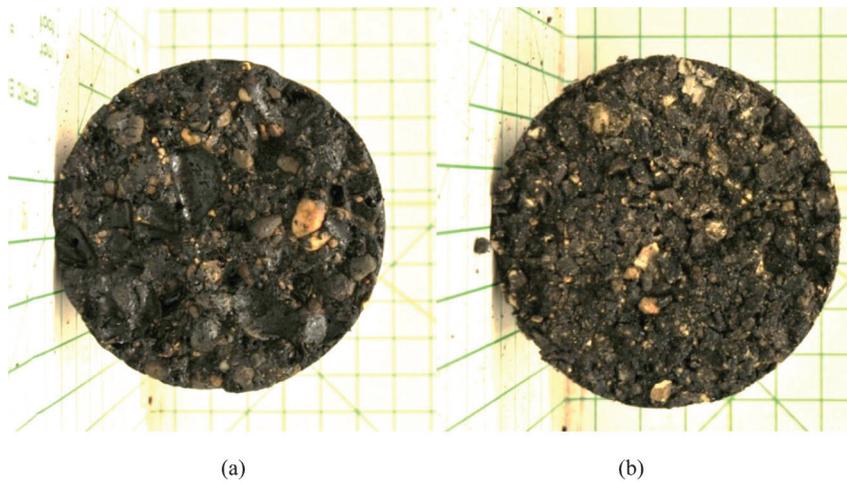
Figure 3.19 Damaged faces in core samples: (a) 18% severity; (b) 53% severity.

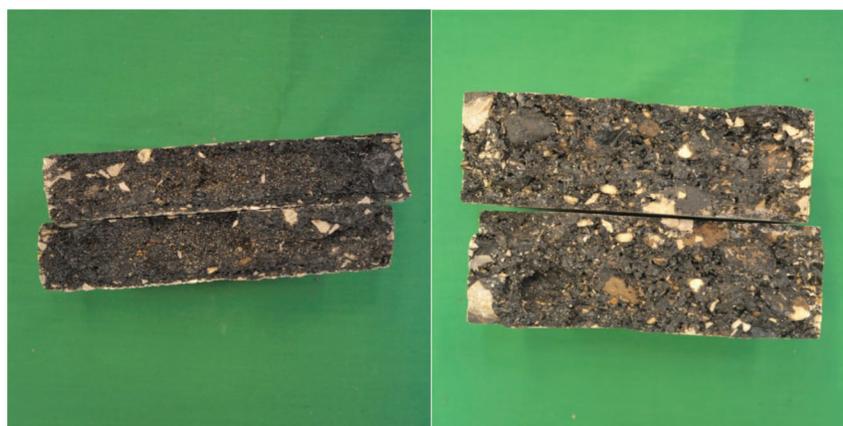
Figure 3.20 Example of water stripping severity: (a) 3.5% severity; (b) 64% severity.

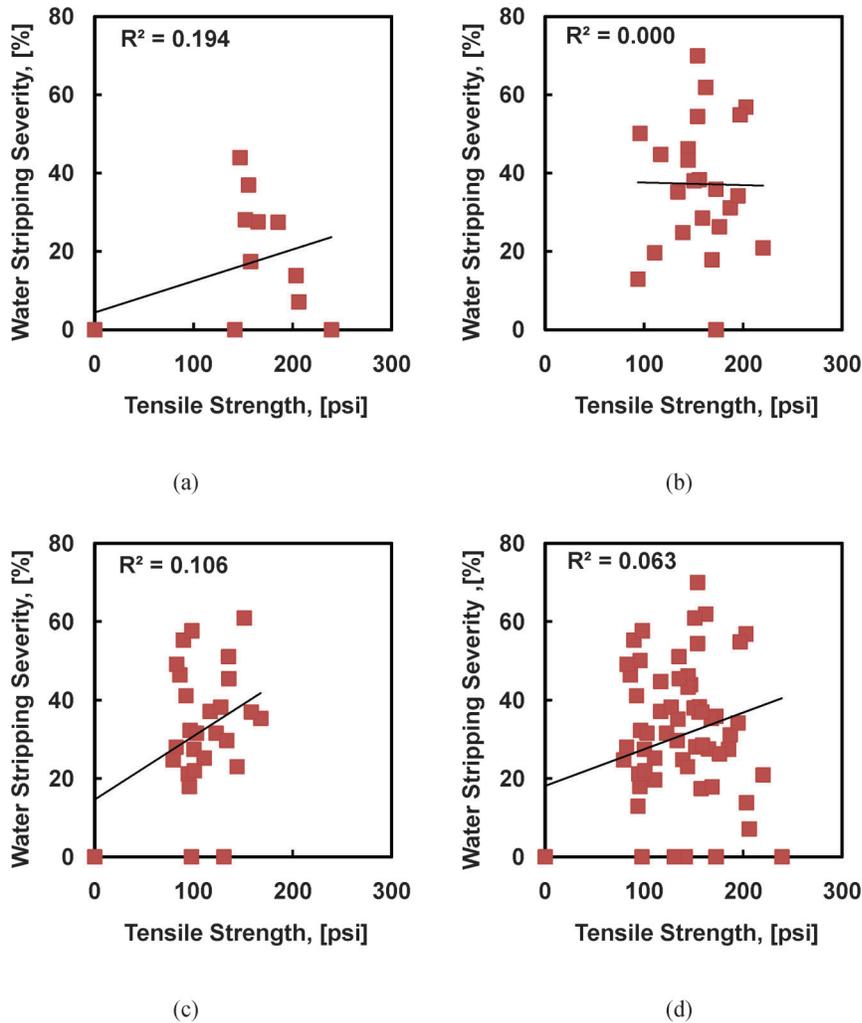
Figure 3.21 Correlation between water stripping severity and tensile strength by layer: (a) Layer 1; (b) Layer 2; (c) Layer 3; (d) Overall layers.

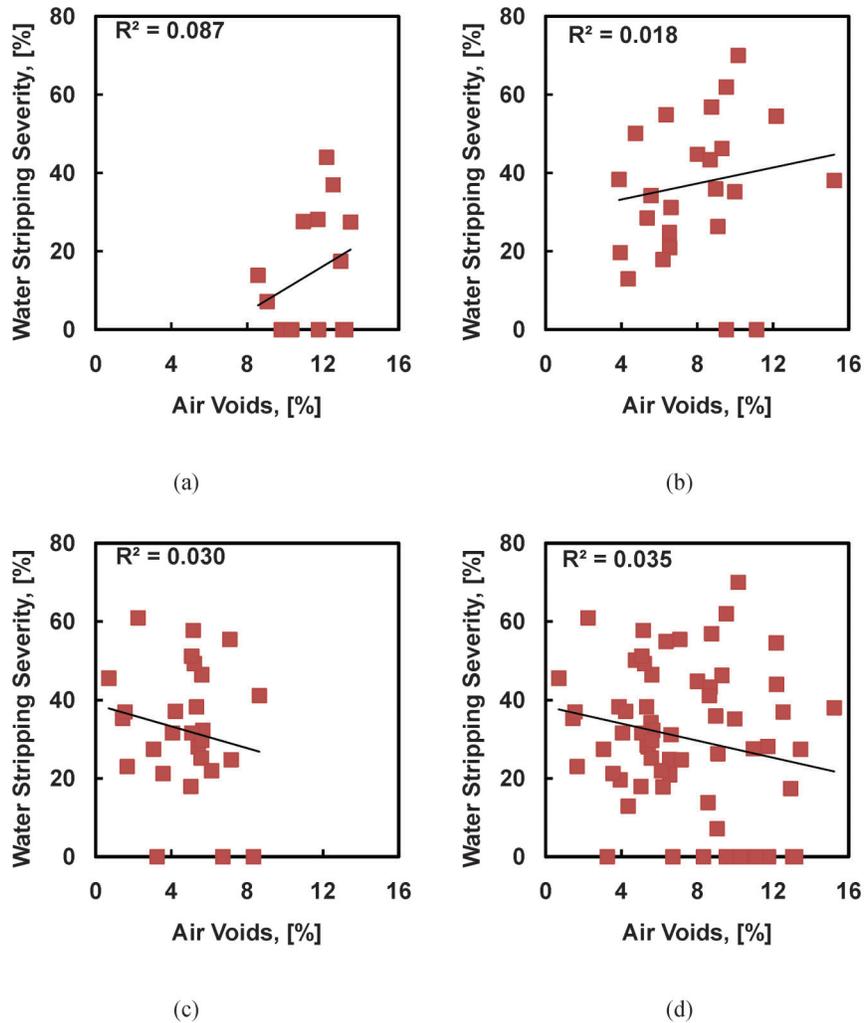
Figure 3.22 Correlation between water stripping severity and air voids by layer: (a) Layer 1; (b) Layer 2; (c) Layer 3; (d) Overall layers.

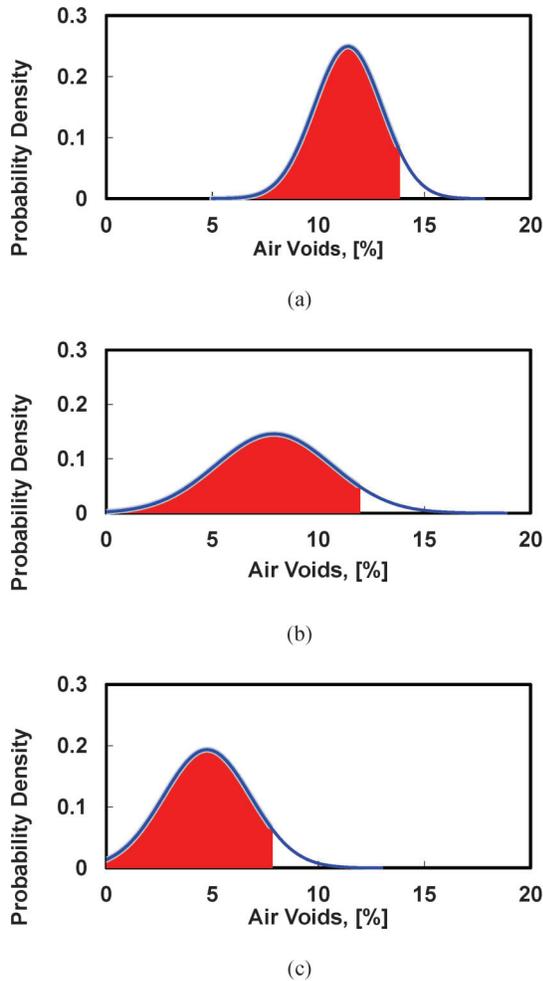
Figure 3.23 Air voids distributions and 90th percentiles by layer: (a) Layer 1; (b) Layer 2; (c) Layer 3.

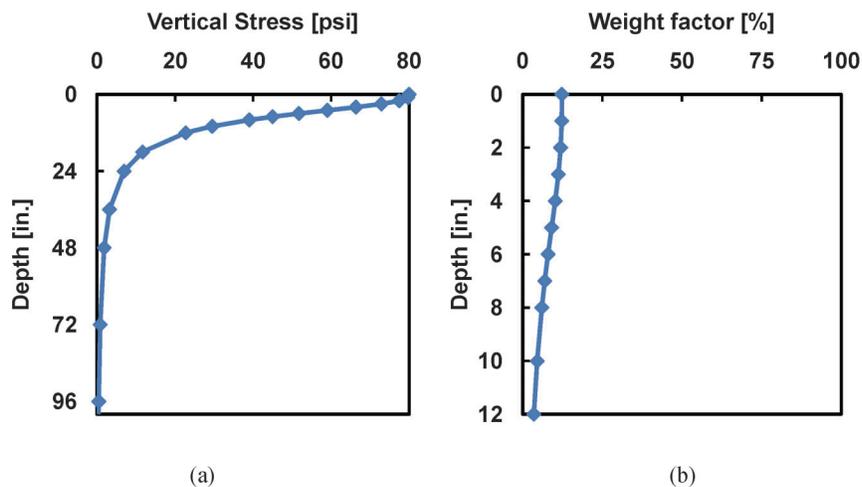
Figure 3.24 Kenpave analysis result on vertical stress over depth: (a) vertical stress change over depth; (b) percent vertical stress change over depth.

Weight factors in terms of depth were developed for calculating the representative laboratory values for locations. A multilayer elastic solution (i.e., Kenpave) was used to calculate vertical stress changes in terms of depth in pavement. The stress is used for determining the weight factor used for each layer. The pavement structure was simulated under a standard 18-kip single axle load with 88 psi tire pressure; layer thickness measured from the core specimens; and Poisson's ration of 0.35. Figure 3.24 (a) shows calculated vertical stress reduction over a range of depth from 0 in. (surface) to 100 in. Below the depth of 72 in., vertical stress was determined to be less than 1 and vertical stress below that depth were assumed to be negligible. In order to determine how much stress was applied over different depth, weight factor was calculated using Equation 3.3, as shown in Figure 3.24 (b)

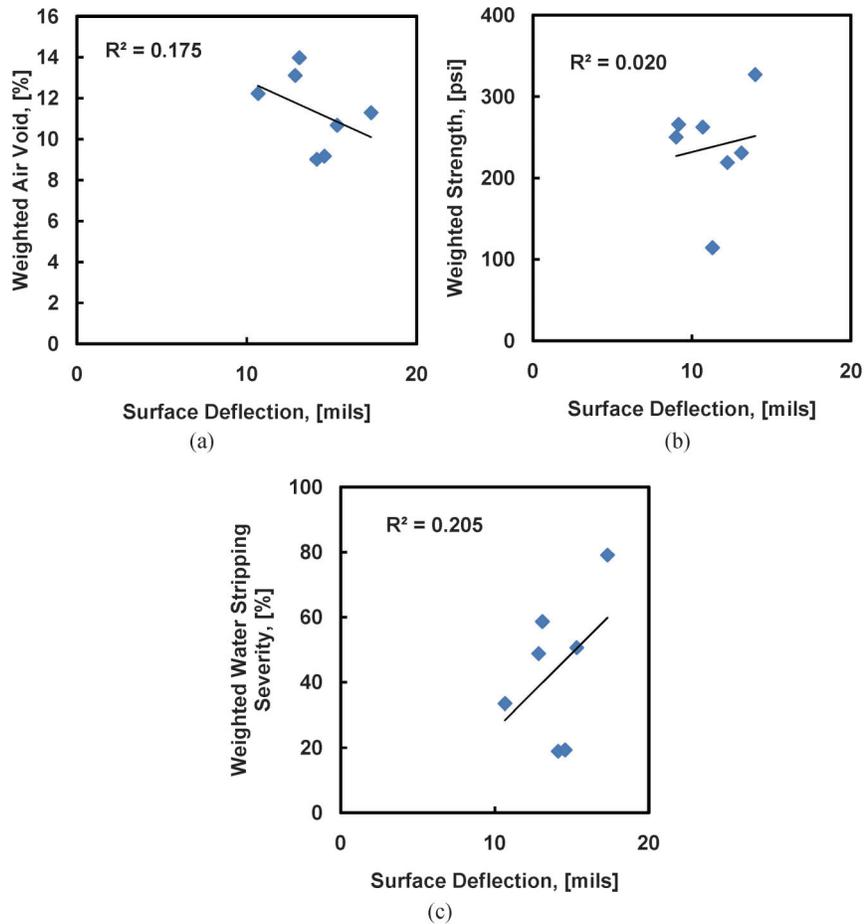
Figure 3.25 Plot of weighted laboratory test results and surface deflection: (a) weighted air voids, (b) weighted tensile strength; (c) weighted water stripping severity.

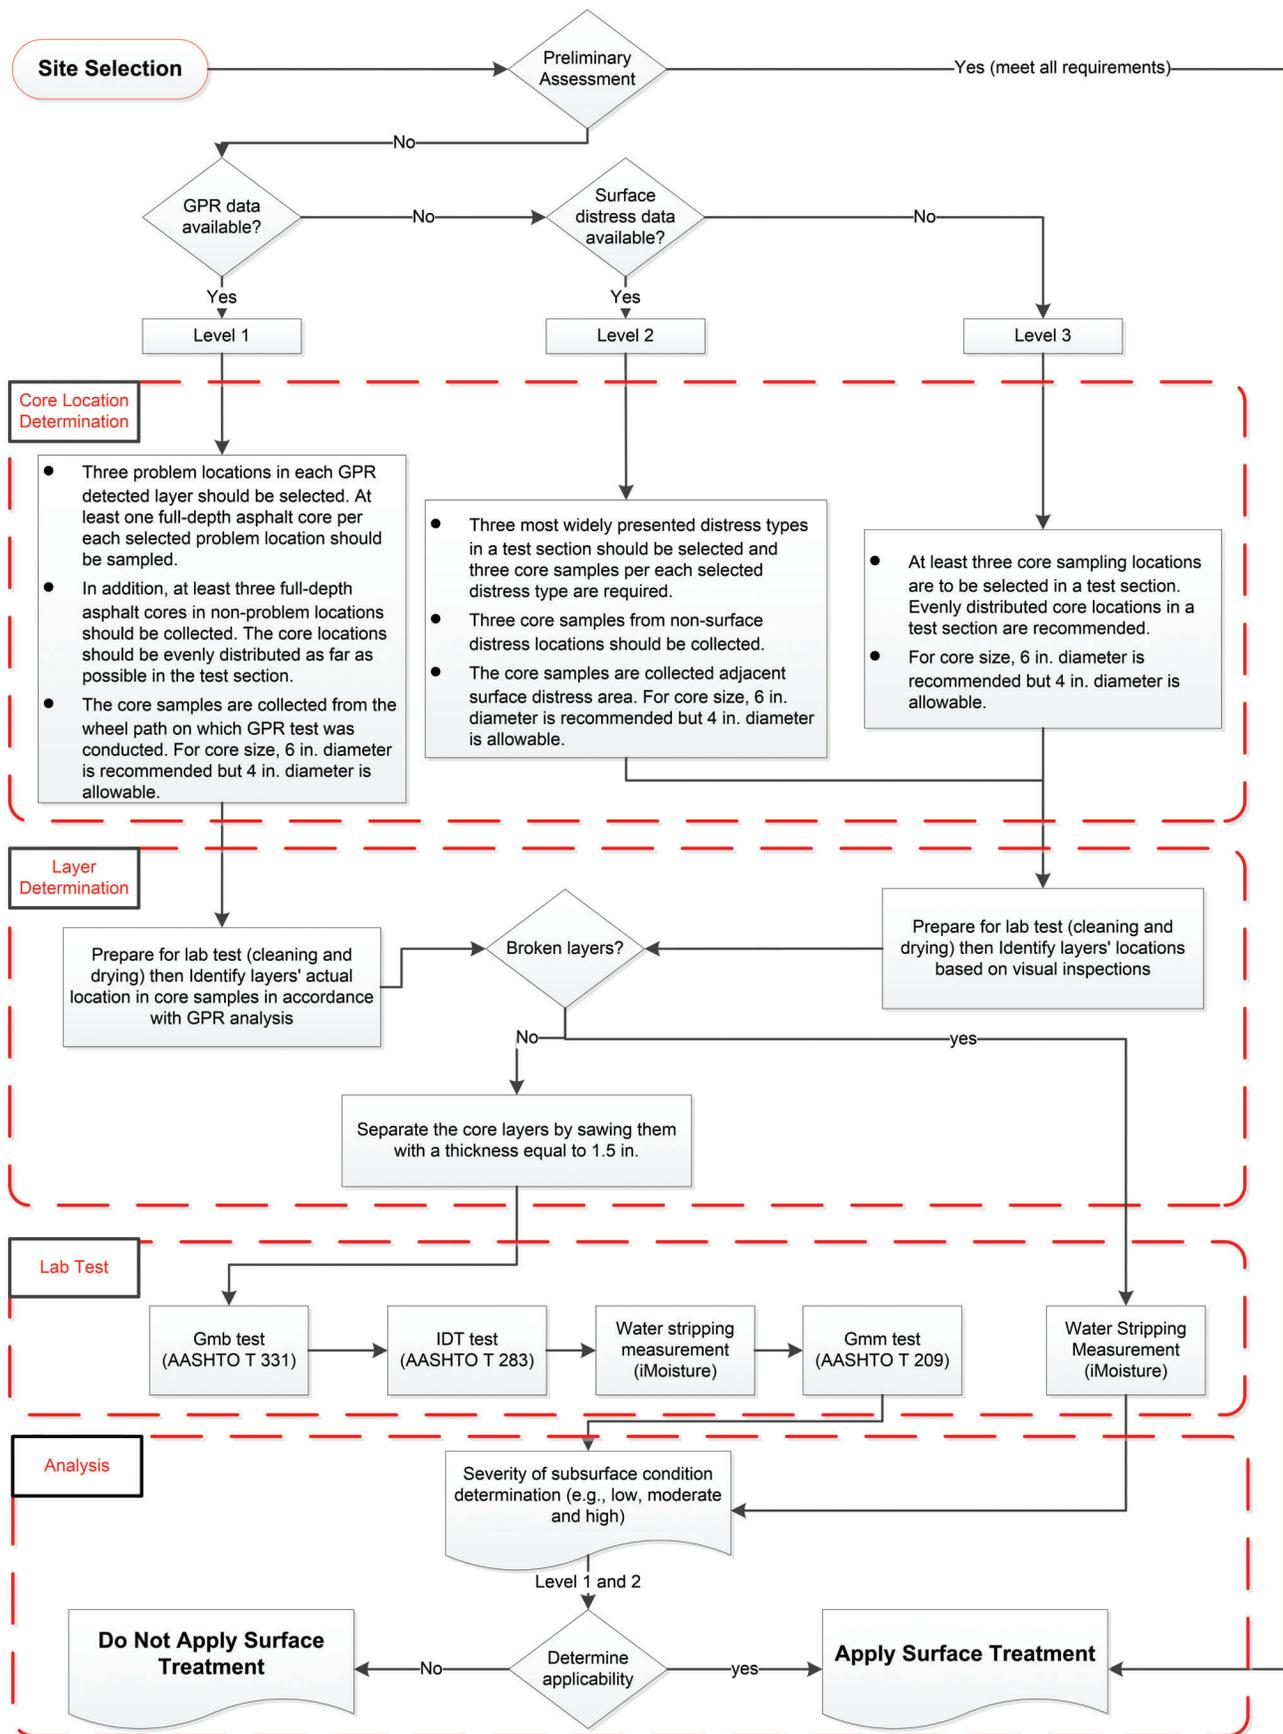
Figure 4.1 Schematic of evaluation process.

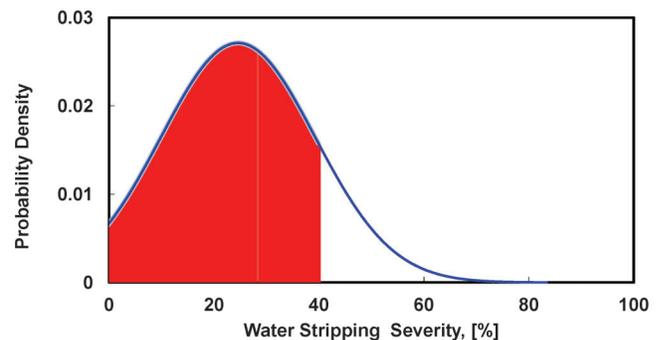
Figure 4.4 Water stripping severity distributions and 90th percentiles.
