JOINT TRANSPORTATION RESEARCH PROGRAM

INDIANA DEPARTMENT OF TRANSPORTATION
AND PURDUE UNIVERSITY

Subsurface Condition Evaluation for Asphalt Pavement Preservation Treatments

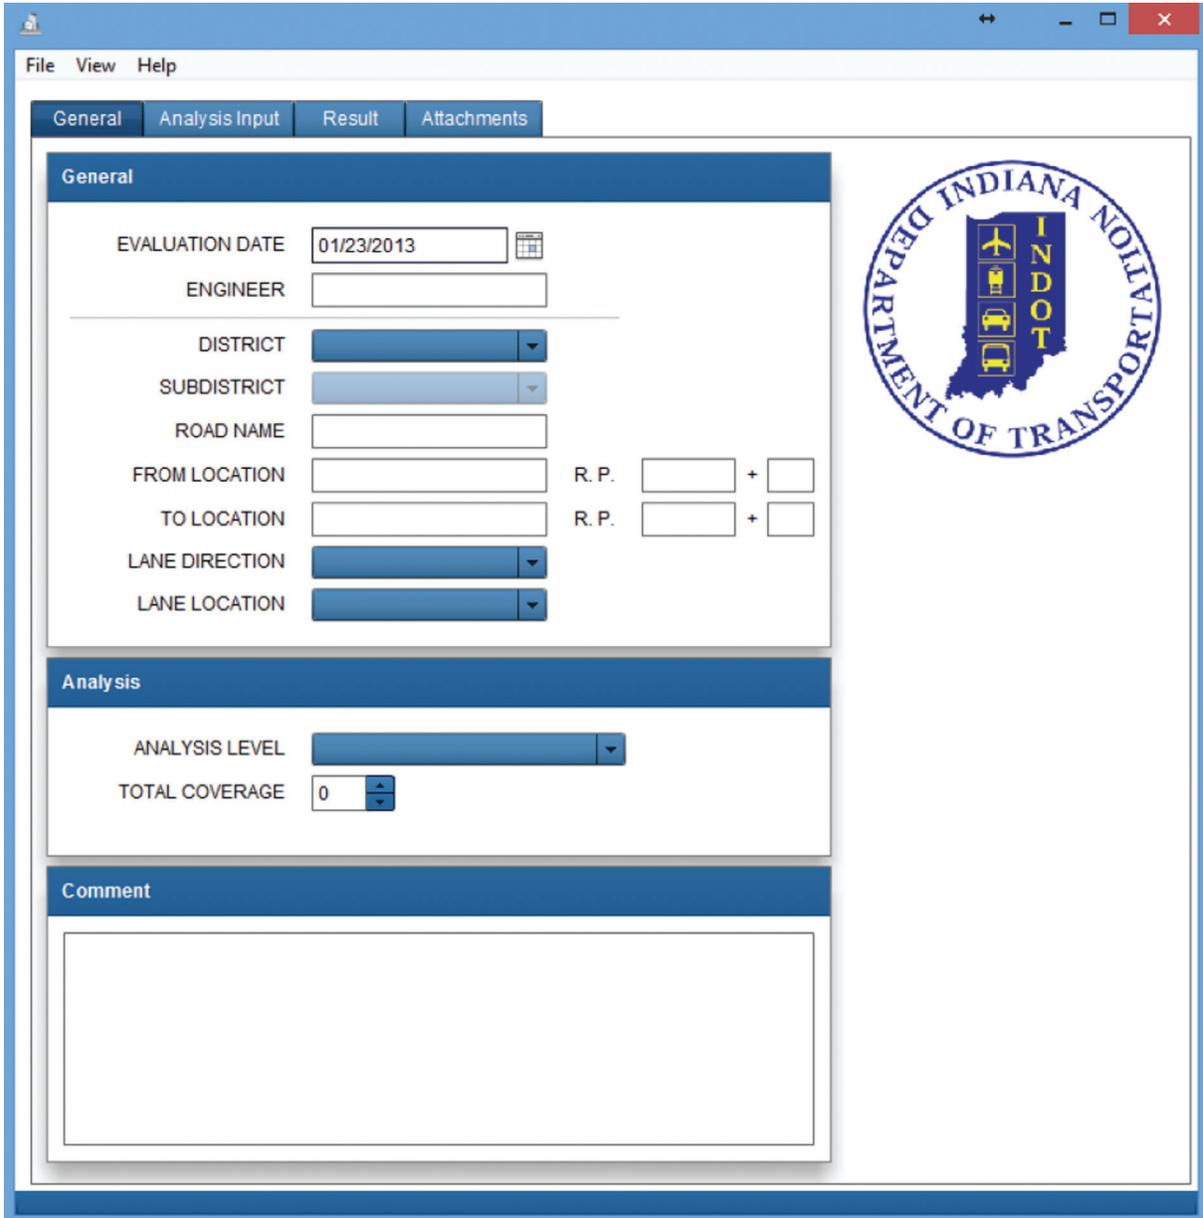
Figure 4.5 iSub: INDOT Subsurface Condition Evaluation Software.

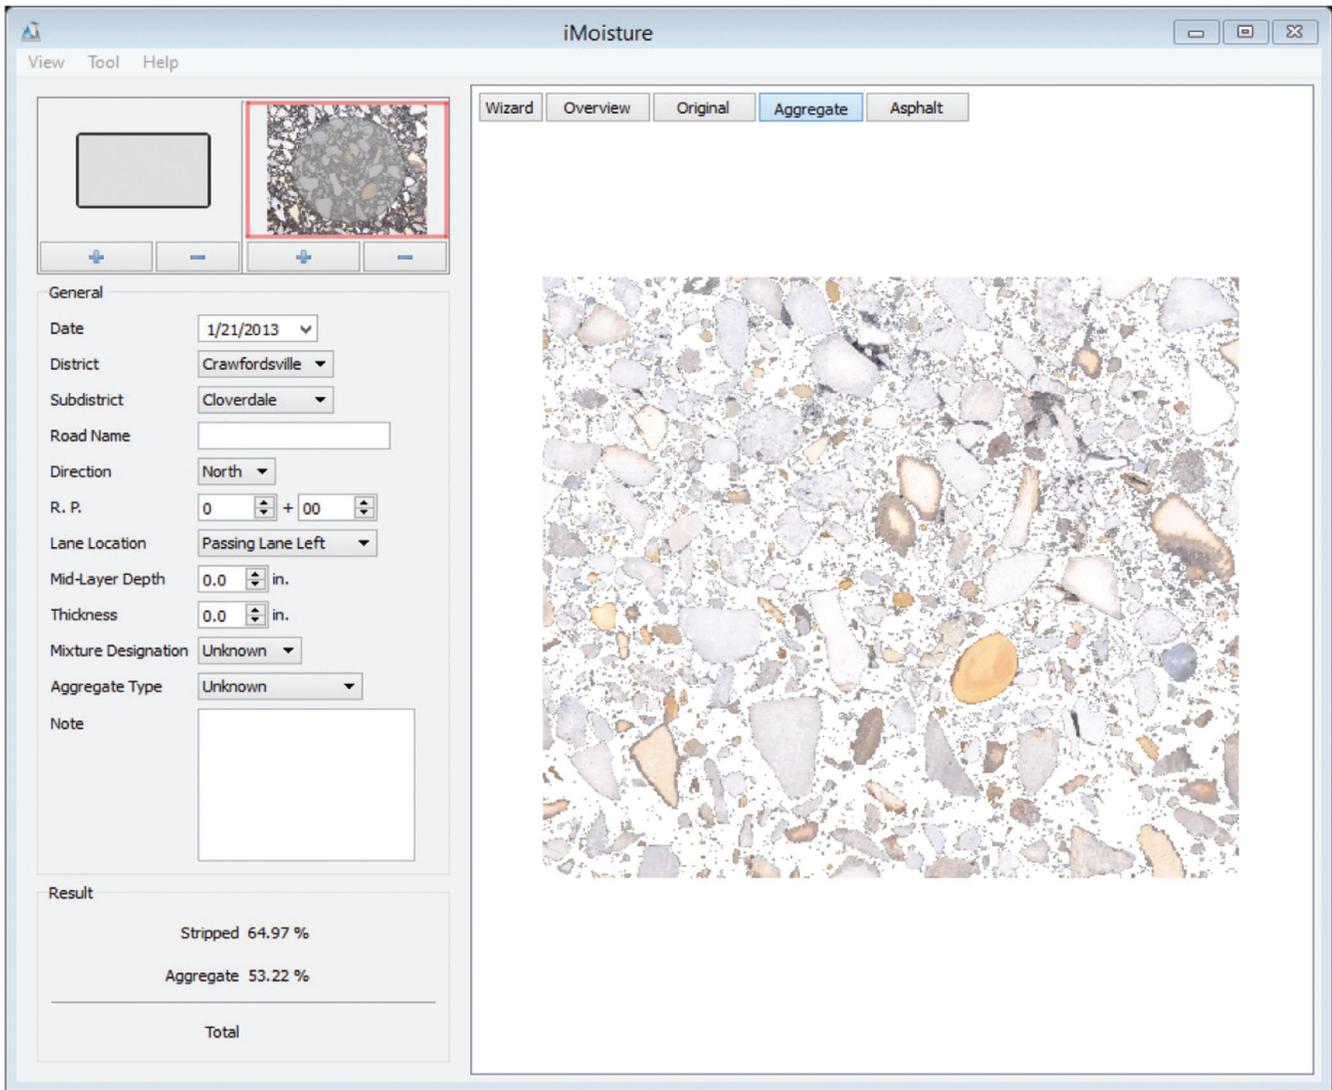
Figure 4.6 iMoisture: INDOT Water Stripping Severity Evaluation Software.

The evaluation software “INDOT Water Stripping Severity Evaluation (iMoisture)” (see Figure 4.6) was developed to aid the water stripping severity evaluation and incorporate INDOT subsurface condition evaluation process. Asphalt mixture is primarily composed of asphalt and aggregate. Aggregates should be completely coated by asphalt. Thus, the uncoated aggregate is an index of water stripping, iMoisture detects uncoated aggregates and quantifies the area in a sample by employing the digital image analysis technology. For additional details, please refer to the iMoisture user manual (Appendix G).

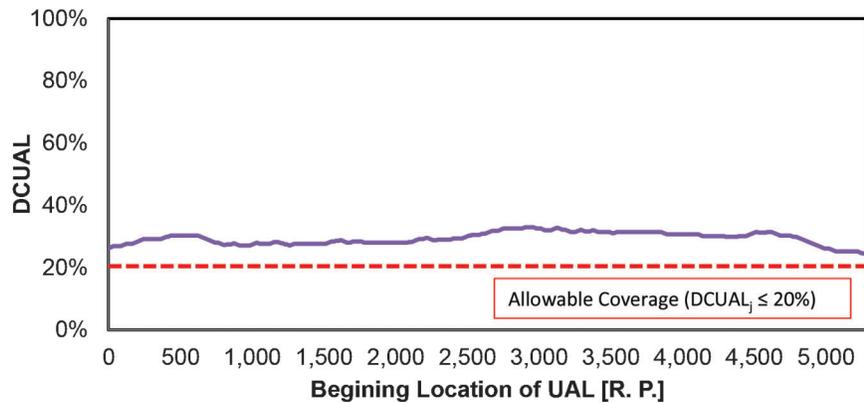
Figure 5.1 Distress distribution analysis of SR-70 based on GPR analysis.

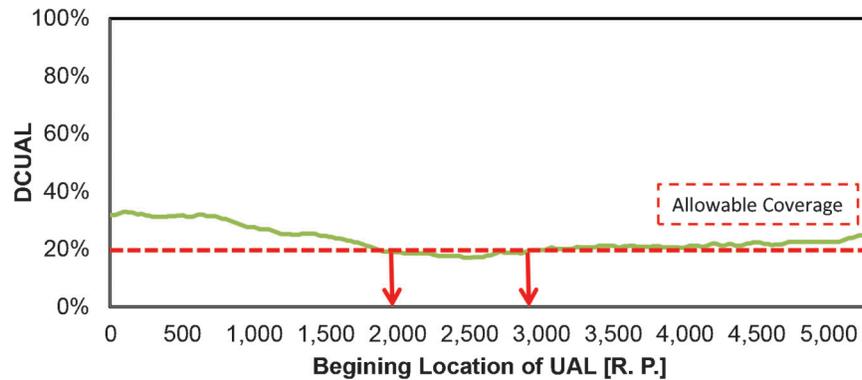
Figure 5.2 DCUAL distribution analysis of SR-70 based on surface distress.
